QUEENS PUBLIC LIBRARY - FY 2019

Asset Name : ARVERNE BRANCH LIBRARY
Address : 312 BEACH 54 STREET
Borough : QUEENS **Agency's Number** : N/A
Program / Asset # : QPL0A02.000 / 14216 **Yr Built/Renovated** : 1964 / 1997
Area Sq Ft : 5,000 **Project Type** : QUEENS PUBLIC LIBRARY
Date of Survey : 03-May-2016 **Landmark Status** : NONE
Areas Surveyed : Roof, Floors 1
Block : 15890 **Lot** : 18 **BIN** : 4301922

QUEENS PUBLIC LIBRARY - 039
ARVERNE BRANCH LIBRARY
Asset # : 14216

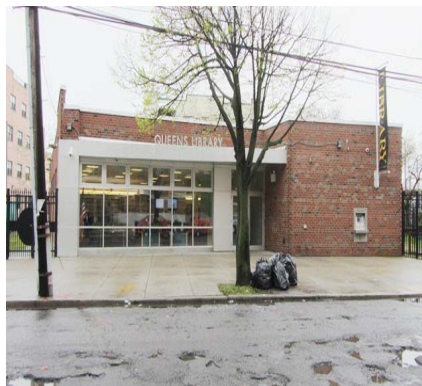
Architecture		Current Repair		Future Replacement		Maintenance		Priority
System Component Type	% of Total	Fail Date (Years)	Estimated Cost	Year FY	Estimated Cost	Cycle (Yrs)	Estimated Cost	
Exterior								
Exterior Walls								
Masonry: Brick	100%			LIFE	**	5	\$17,500	
Windows								
Aluminum	100%			2043	**	5	\$1,900	
Parapets								
Masonry: Brick	80%			LIFE	**	5	\$1,400	
Metal Panel	20%			2047	**	5	\$1,300	
Roof								
Single Ply Membrane	100%			2032	**	10	\$5,400	
Interior								
Floors								
Carpet	60%			2026	\$64,500	3	\$9,800	
Cast in Place Concrete	5%			LIFE	**	5	\$900	
Ceramic Tile	10%			2036	**	5	\$800	
Vinyl Tile	25%			2032	**	3	\$1,000	
Interior Walls								
Ceramic Tile	5%			2040	**	5	\$700	
Glass: Single Pane	10%			LIFE	**	5	\$1,000	
Gypsum Board	85%			LIFE	**	5	\$6,900	
Ceilings								
AcousTileConcealSpLn	100%			2044	**	5	\$10,200	
Site Enclosure								
Fence/Gates								
Iron Picket	100%			2062	**

Heating								
Energy Source Natural Gas	100%			2053	**	1		
<i>Recent Installation, Extent : Light, Area Affected : 100%</i>								
<i>Location : 1st Floor</i>								
Conversion Equipment Furnace	100%			2035	**	1	\$2,500	
<i>Recent Replace Evident, Extent : Light, Area Affected : 100%</i>								
<i>Location : Rooftop</i>								
<i>Other Observation, Extent : Light, Area Affected : 100%</i>								
<i>Location : Throughout</i>								
<i>Explanation : Entire Facility Was Recently Renovated</i>								
Distribution Ductwork/Diffusers	100%			LIFE	**	2-5	\$2,800	
<i>Recent Replace Evident, Extent : Light, Area Affected : 100%</i>								
<i>Location : Throughout</i>								
Air Conditioning								
Energy Source Electricity	100%			2049	**	1		
<i>Recent Replace Evident, Extent : Light, Area Affected : 100%</i>								
<i>Location : Throughout</i>

<i>Location : Rooftop</i>					
<hr/>								
Plumbing								
	H/C Water Piping							
	Brass/Copper	100%			2053	**	1	
			<i>Recent Replace Evident, Extent : Light, Area Affected : 100%</i>					
			<i>Location : Throughout</i>					
<hr/>								
	Water Heater							
	Gas Fired	100%			2026	\$3,000	2	\$100
			<i>Other Observation, Extent : Light, Area Affected : 100%</i>					
			<i>Location : Mechanical Room</i>					
			<i>Explanation : 1-40 Gallon Water Heater - Recent Install</i>					
<hr/>								
	Sanitary Piping							
	Cast Iron	100%			LIFE	**	1	
<hr/>								
	Storm Drain Piping							
	Cast Iron	100%			LIFE	**	1	
<hr/>								
	Fixtures							
	Generic	100%						
<hr/>								
Fire Suppression								
	Sprinkler							
	No Component	95%						
	Generic	5%			2053	**	1-2	\$100
			<i>Recent Installation, Extent : Light, Area Affected : 100%</i>					
			<i>Location : Over Book Return</i>

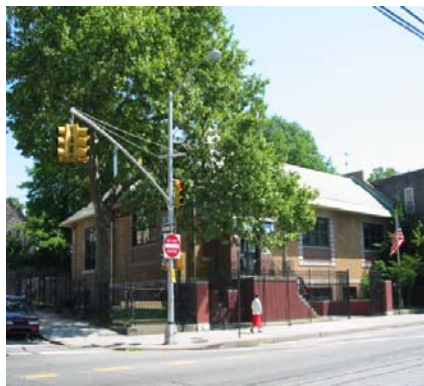
QUEENS PUBLIC LIBRARY - 039
ASTORIA BRANCH LIBRARY
Asset # : 13274

Architecture		Current Repair		Future Replacement		Maintenance		Priority
System Component Type	% of Total	Fail Date (Years)	Estimated Cost	Year FY	Estimated Cost	Cycle (Yrs)	Estimated Cost	Priority
Exterior								
Exterior Walls								
Masonry: Brick	75%	Now	\$82,300	LIFE	**	5	\$13,200	
<i>Jnt Mortar Miss/Erod, Extent : Moderate, Area Affected : 50%</i>								
<i>Location : East Facade</i>								
<i>Vertical Cracks, Extent : Moderate, Area Affected : 10%</i>								
<i>Location : West Facade</i>								
<i>Water Penetration, Extent : Severe, Area Affected : 25%</i>								
<i>Location : Foundation At East Facade</i>								
Masonry: Limestone	5%			LIFE	**	5	\$700	
Metal Panel	15%	Now	\$3,900	2034	**	5	\$4,900	
<i>Broken/Missing Elements, Extent : Moderate, Area Affected : 20%</i>								
<i>Location : At Eaves</i>								
<i>Deformed/Dented, Extent : Moderate, Area Affected : 25%</i>								
<i>Location : At Eaves</i>

Stucco Cement	5%	Now	\$2,600	2029	\$26,400	5	\$1,100	
<i>Cracking/Crumbling, Extent : Moderate, Area Affected : 25%</i>								
<i>Location : At Foundation On East Facade</i>								
Windows								
Aluminum	100%			2040	**	5	\$2,300	
Roof								
Slate	100%	Now	\$56,700	LIFE	**			1
<i>Gut/DS Non Func/Miss, Extent : Severe, Area Affected : 25%</i>								
<i>Location : East Side</i>								
<i>Water Penetration, Extent : Severe, Area Affected : 20%</i>								
<i>Location : Basement Storage Room</i>								
Interior								
Floors								
Carpet	65%			2023	\$91,400	3	\$13,800	
Ceramic Tile	5%			2033	**	5	\$500	
Panel/Paver: Cer/Brk	5%			2040	**	5	\$1,200	
Vinyl Tile	25%	Now	\$23,400	2034	**	3	\$1,000	
<i>Poor Subfloor Evident, Extent : Moderate, Area Affected : 25%</i>								
<i>Location : Basement</i>								
<i>Worn/Eroded, Extent : Moderate, Area Affected : 25%</i>								
<i>Location : Basement</i>

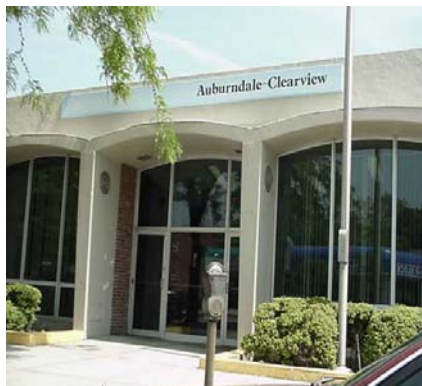
Architecture		Current Repair		Future Replacement		Maintenance		Priority
System Component Type	% of Total	Fail Date (Years)	Estimated Cost	Year FY	Estimated Cost	Cycle (Yrs)	Estimated Cost	
Exterior								
Exterior Walls								
Cast in Place Concrete	50%			LIFE	**	5	\$29,100	
<i>Repairs in Progress, Extent : Light, Area Affected : 25%</i>								
<i>Location : Throughout</i>								
<i>Other Observation, Extent : Moderate, Area Affected : 100%</i>								
<i>Location : Throughout</i>								
<i>Explanation : Sidewalk Shed In Place</i>								
Masonry: Brick	30%			LIFE	**	5	\$3,500	
Pre-Cast Concrete	2%			LIFE	**	5	\$800	
Window Wall	18%			2044	**	5	\$7,900	
Windows								
Aluminum	100%			2032	**	5	\$4,800	
Parapets								
Cast in Place Concrete	100%			LIFE	**	5	\$8,500	
<i>Repairs in Progress, Extent : Light, Area Affected : 25%</i>								
<i>Location : Throughout</i>								
<i>Other Observation, Extent : Moderate, Area Affected : 100%</i>

<i>Location : Throughout</i>								
<i>Explanation : Sidewalk Shed In Place</i>								
Roof								
Under Construction	100%							
Interior								
Floors								
Carpet	35%			2025	\$50,800	3	\$5,800	
<i>Recent Replace Evident, Extent : Light, Area Affected : 100%</i>								
<i>Location : Throughout</i>								
Cast in Place Concrete	10%			LIFE	**	5	\$2,400	
Ceramic Tile	5%			2033	**	5	\$500	
Vinyl Tile	50%			2032	**	3	\$2,700	
<i>Recent Replace Evident, Extent : Light, Area Affected : 100%</i>								
<i>Location : Throughout</i>								
Interior Walls								
Ceramic Tile	5%			2033	**	5	\$500	
Concrete Masonry Unit	90%			LIFE	**	5	\$3,300	
Glass: Single Pane	5%			LIFE	**	5	\$300	
Ceilings								
AcousTileConcealSpLn	90%			2029	\$82,700	5	\$12,300	
<i>Staining/Discoloring, Extent : Moderate, Area Affected : 25%</i>								
<i>Location : Throughout</i>								
<i>Worn/Eroded, Extent : Light, Area Affected : 25%</i>

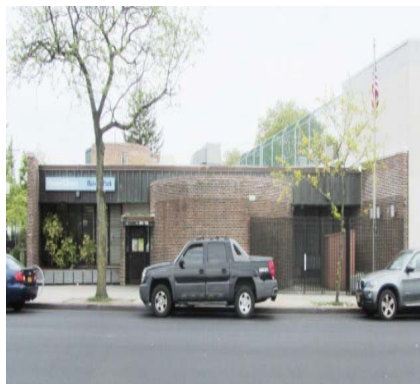
Architecture		Current Repair		Future Replacement		Maintenance		Priority
System Component Type	% of Total	Fail Date (Years)	Estimated Cost	Year FY	Estimated Cost	Cycle (Yrs)	Estimated Cost	Priority
Exterior								
Exterior Walls								
Copper/Terne	15%	2-4	\$189,600	2062	**			
<i>Deformed/Dented, Extent : Moderate, Area Affected : 100%</i>								
<i>Location : Copper Cladding</i>								
Masonry: Brick	85%	Now	\$45,300	LIFE	**	5	\$14,500	
<i>Diagonal Cracks, Extent : Moderate, Area Affected : 5%</i>								
<i>Location : Exit At Northeast Corner, Penthouse</i>								
<i>Horizontal Cracks, Extent : Moderate, Area Affected : 5%</i>								
<i>Location : Penthouse</i>								
<i>Spalling, Extent : Light, Area Affected : 10%</i>								
<i>Location : Penthouse</i>								
Windows								
Aluminum	98%	Now	\$70,400	2052	**	5	\$800	
<i>Air Infiltration, Extent : Severe, Area Affected : 100%</i>								
<i>Location : Throughout</i>

<i>Caulking Deteriorated, Extent : Severe, Area Affected : 100%</i>								
<i>Location : Throughout</i>								
Metal Louvers	2%	Now	\$1,000	2042	**			
<i>Bent/Warped Elements, Extent : Moderate, Area Affected : 20%</i>								
<i>Location : Penthouse</i>								
<i>Deformed/Dented, Extent : Moderate, Area Affected : 10%</i>								
<i>Location : Penthouse</i>								
<i>Deteriorated Finish, Extent : Moderate, Area Affected : 50%</i>								
<i>Location : Penthouse</i>								
Parapets								
Masonry: Brick	33%	Now	\$1,100	LIFE	**	5	\$100	
<i>Cracking/Crumbling, Extent : Moderate, Area Affected : 10%</i>								
<i>Location : Penthouse</i>								
<i>Jnt Mortar Miss/Erod, Extent : Moderate, Area Affected : 15%</i>								
<i>Location : Penthouse</i>								
Metal Panel	60%			2037	**	5	\$400	
Pre-Cast Concrete	7%			LIFE	**	5	\$100	
Roof								
Modified Bitumen	100%			2035	**	10	\$17,100	
Interior								
Floors

Carpet	5%			2026	\$6,700	3	\$1,000	
Cast in Place Concrete	5%			LIFE	**	5	\$1,100	
Ceramic Tile	5%			2030	**	5	\$500	
Vinyl Tile	85%	2-4	\$76,300	2037	**	3	\$3,200	
<i>Adhesion Failure, Extent : Moderate, Area Affected : 50%</i>								
<i>Location : Throughout</i>								
<i>Loose/Delam Surface, Extent : Moderate, Area Affected : 50%</i>								
<i>Location : Throughout</i>
