UNITED STATES ENVIRONMENTAL PROTECTION AGENCY

**Re: Final Remedial Investigation Report**

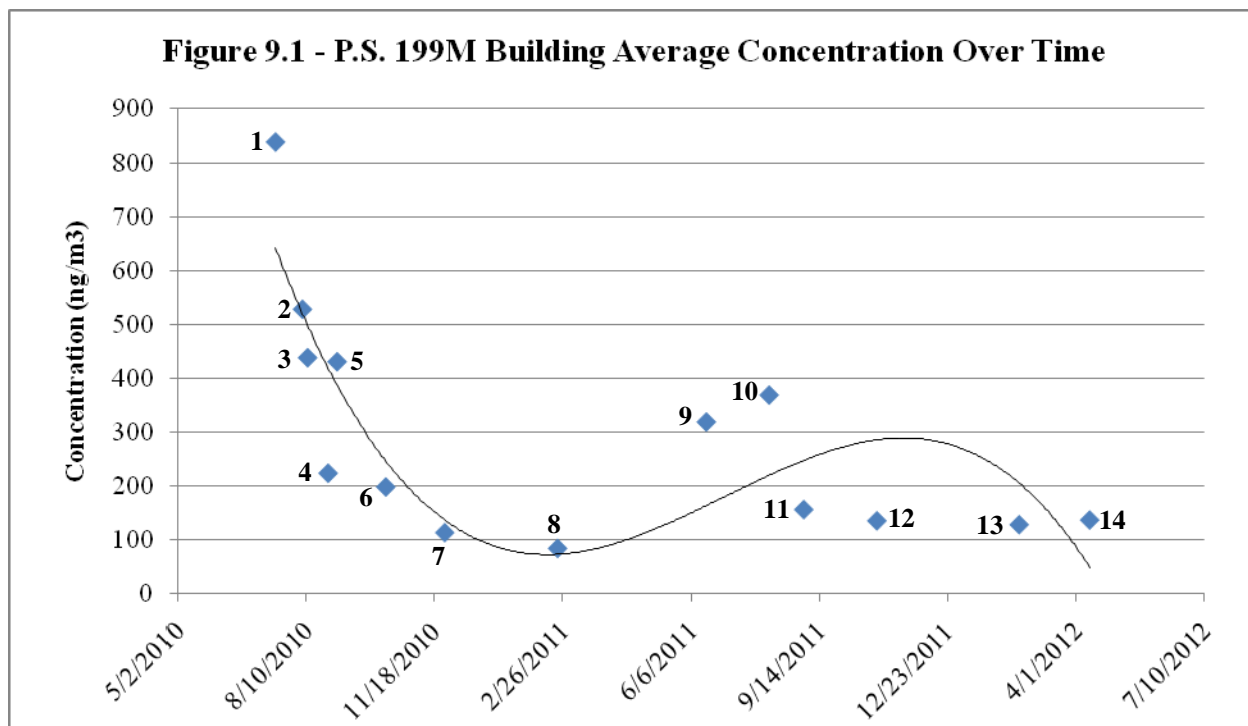
Between August 23, 2008, and April 12, 2012, twenty (20) rounds of wide-scale testing were performed in P.S. 199M. Four (4) of these rounds were performed prior to the initiation of the Pilot Study, and the other sixteen (16) rounds were performed as part of the Pilot Study. Eight (8) rounds of sampling were performed in August, three (3) rounds in October, two (2) rounds each in February and September, and one (1) round each in January, April, June, July and November. Building-wide monthly PCB averages ranged from a high of  $839.67\text{ ng}/\text{m}^3$ , measured in July, 2010, to a low of  $78.06\text{ ng}/\text{m}^3$ , in February 2011. Please refer to Figure 9.1 for a graphical representation of the building-wide airborne PCB average concentration trend since the beginning of the Pilot Study in June, 2010.

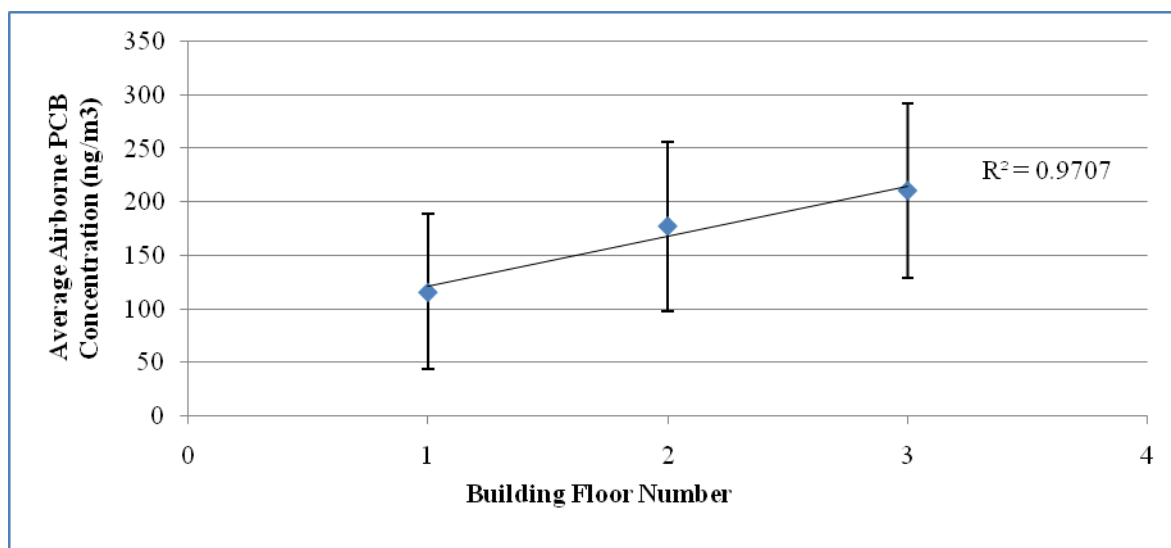
**Figure 9.2 - Average Airborne PCB Concentrations for Various Rooms by Floor at P.S. 199M**

The results suggest that there is a positive relationship between the building floor level and the average concentration of airborne PCBs measured within classrooms grouped by floor. The same trend has also been noted in P.S. 309K, as detailed in Supplemental Report #1 located in Appendix M of this report.

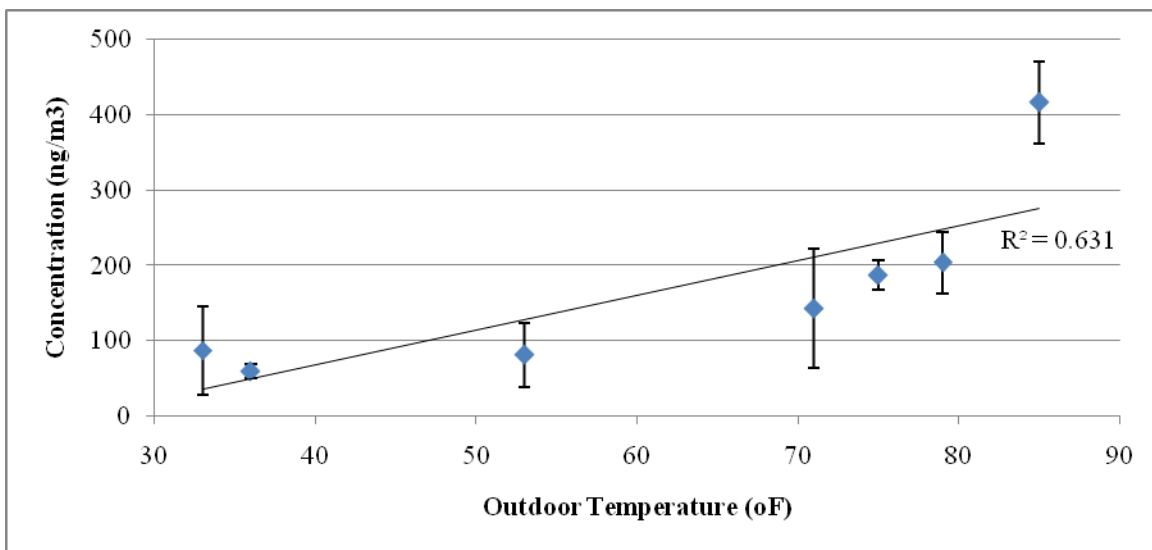
**Figure 9.3 – 1<sup>st</sup> Floor Classroom Average Total Airborne PCB Concentrations versus Maximum Outdoor Air Temperature**

These particular data sets were selected because multiple rooms were sampled on each date, allowing a direct comparison between the results. In addition, all of the sampling events took place after the exhaust fans on the roof had been replaced, which was completed in September, 2008. For the second floor, an insufficient number of rooms were sampled during the same time period to perform a similar statistical analysis. For each sampling event, the maximum outdoor air temperature measured during the sampling period, as reported by Weather Underground for Central Park, was used in the comparison. As depicted in the following figures, there appears to be a positive correlation between the two variables.

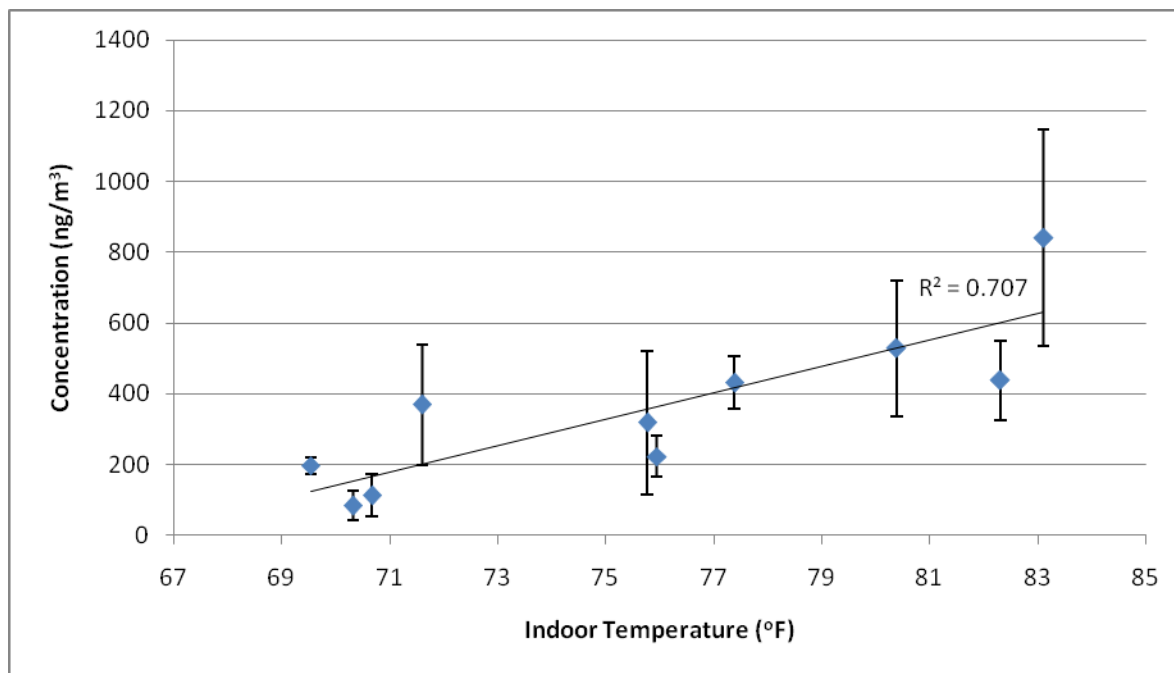
**Figure 9.5 – Building Average Total Airborne PCB Concentrations versus Average Indoor Air Temperature**

Due to limitations regarding the building-wide data depicted above (e.g. temperature was only measured in one location of the building), a statistical analysis of the temperature data was not completed. However, the above comparison of temperature and PCB data suggests a positive relationship may exist between indoor air temperatures and airborne PCB concentrations.

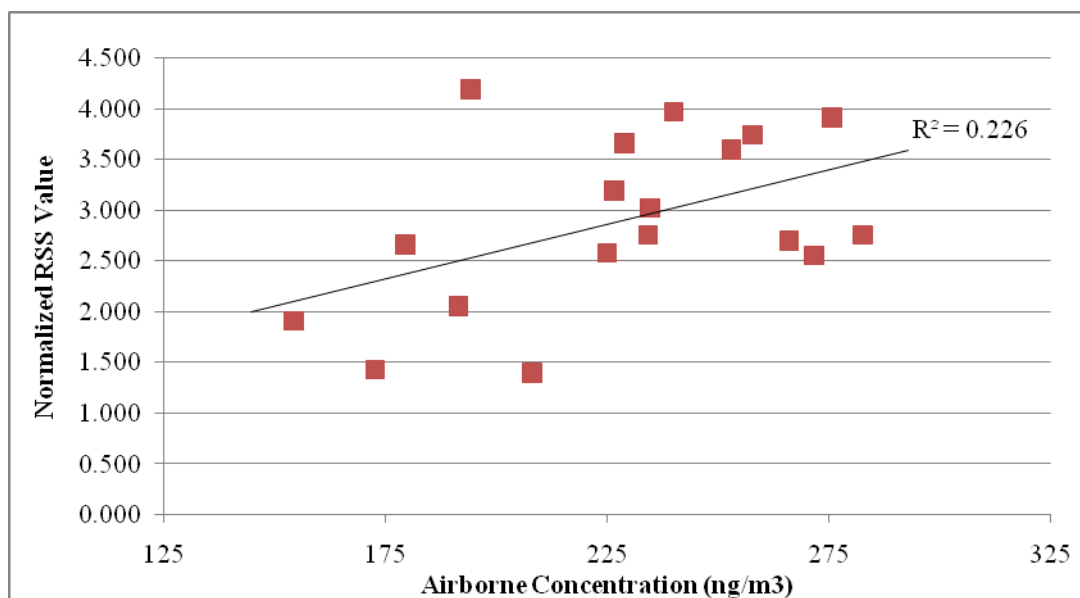
**Figure 9.6 - Total Normalized Relative Source Strength versus Total Airborne PCB Concentration for Various Rooms Measured on 8/27/2010**

The results suggest that there is no direct, positive correlation between the total quantity of other PCB containing materials in the various classrooms and the concentration of airborne PCBs measured within those rooms.

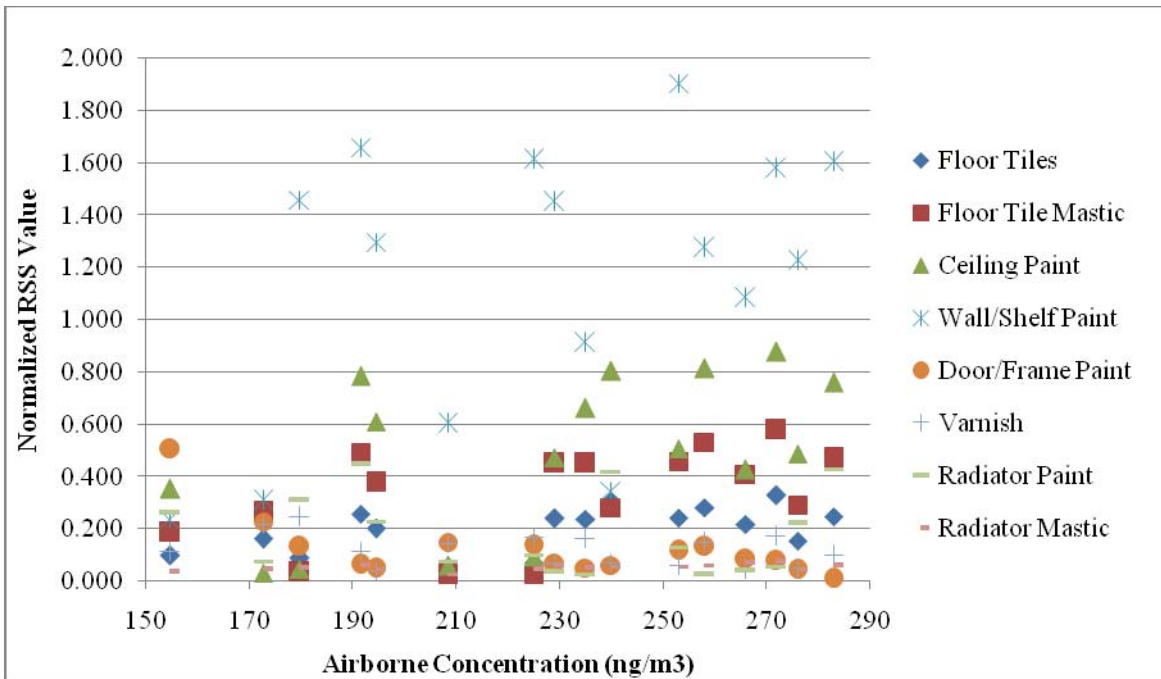
**Figure 9.9 - Total Normalized Relative Source Strength versus Total Airborne PCB Concentration for Various Materials and Rooms Measured on 8/27/2010**

The results suggest that there is no direct, positive correlation between the quantity of other, specific PCB containing materials in the various classrooms and the concentration of airborne PCBs measured within those rooms.

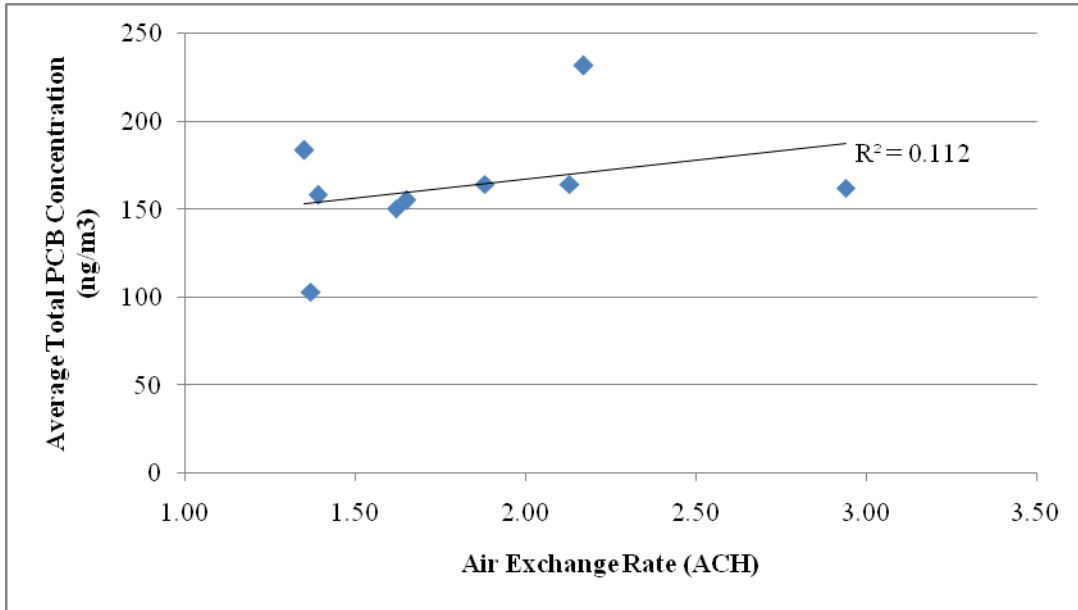
**Figure 9.12 – 1<sup>st</sup> Floor Classroom Average Total Airborne PCB Concentrations versus Measured Air Exchange Rates at P.S. 199M**

These particular data sets were selected because multiple rooms were sampled on each date, allowing a direct comparison between the results. In addition, all of the sampling events took place after the exhaust fans on the roof had been replaced, which was completed in September, 2008. As depicted in the following figures, no readily apparent correlation exists between the two (2) variables. Analysis of the airborne PCB concentration data versus the measured air exchange rates for both the first and third floor classrooms showed a slight positive correlation - as the air exchange rates increased, so too did the PCB concentrations. A slight negative correlation, however, was noted for the second floor classrooms.
