New York City  
Department of Buildings

**51st Street Crane  
Investigation**

51st Street Crane  
Investigation Report

March 2009

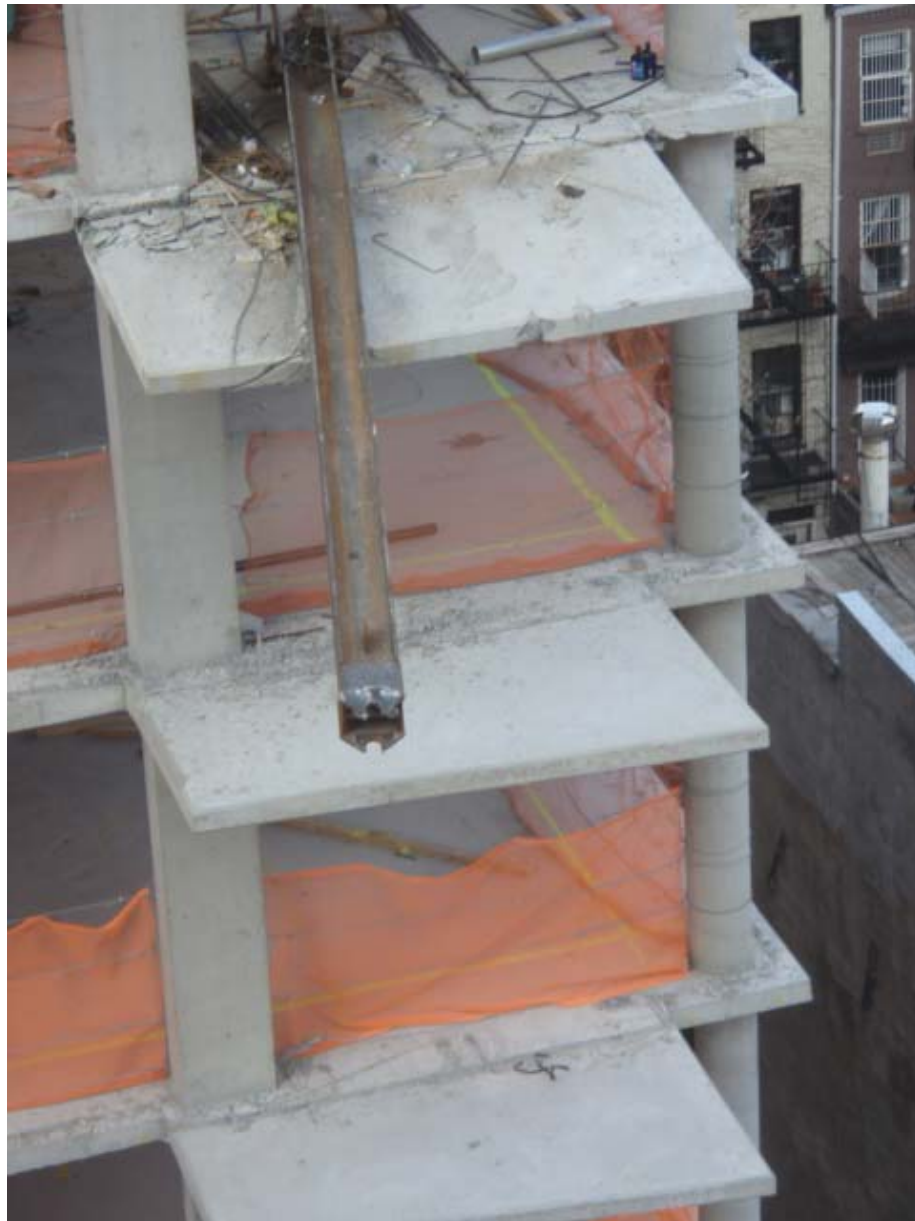
**Photograph 1.13 - Failed pin end of Beam B5 at the 9<sup>th</sup> floor level as seen immediately following the collapse. Photo provided by the NYCDOB.**

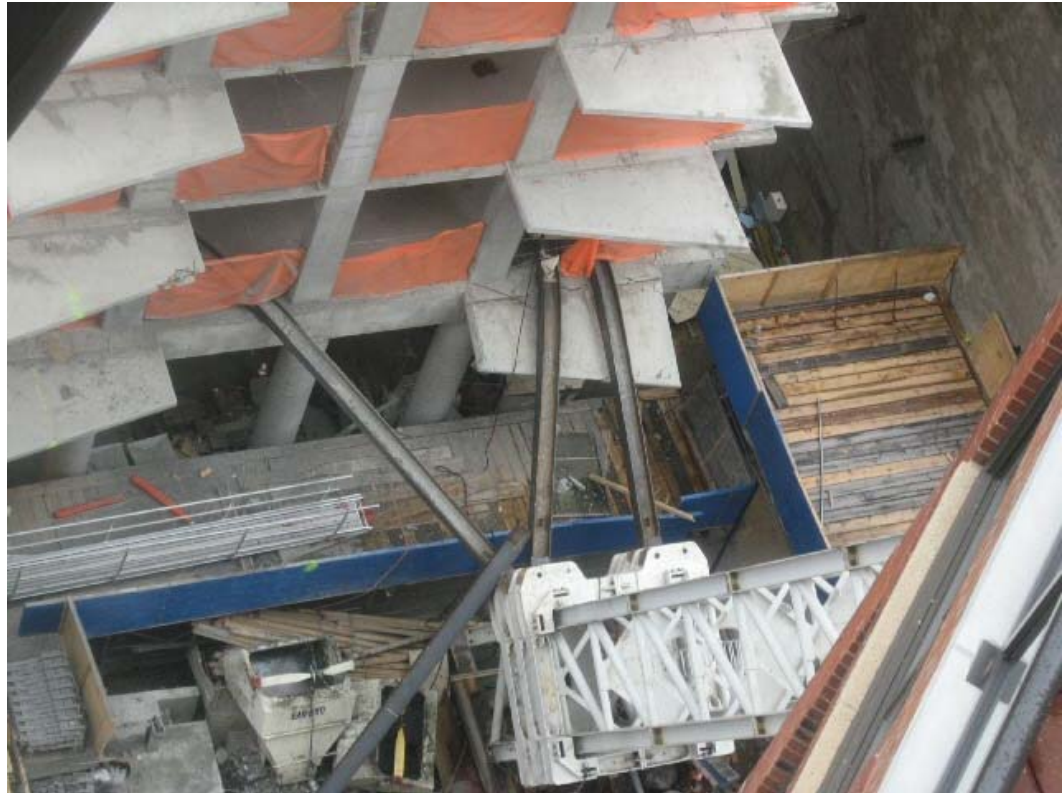
**Photograph 1.14 - 3rd floor collar assembly following the collapse. The 9th floor collar and 18th floor collar rest atop the 3rd floor collar. Source: New York County District Attorney IMG\_0355\_085.jpg.**

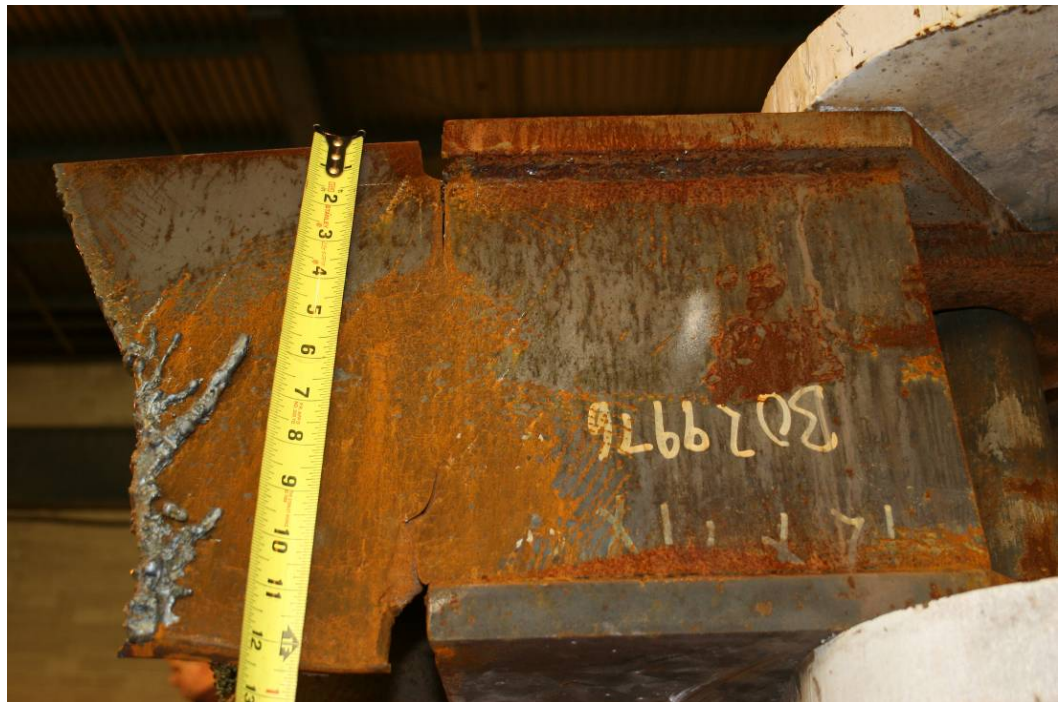
**Photograph 1.15 - Fracture of a tie-beam which did not fully fail on the 3rd floor collar. (The fracture of interest is to the right of the tape measure. The damage to the left of the tape measure is a flame-cut (post failure) to assist in the removal of the debris. Photo by Arup.**

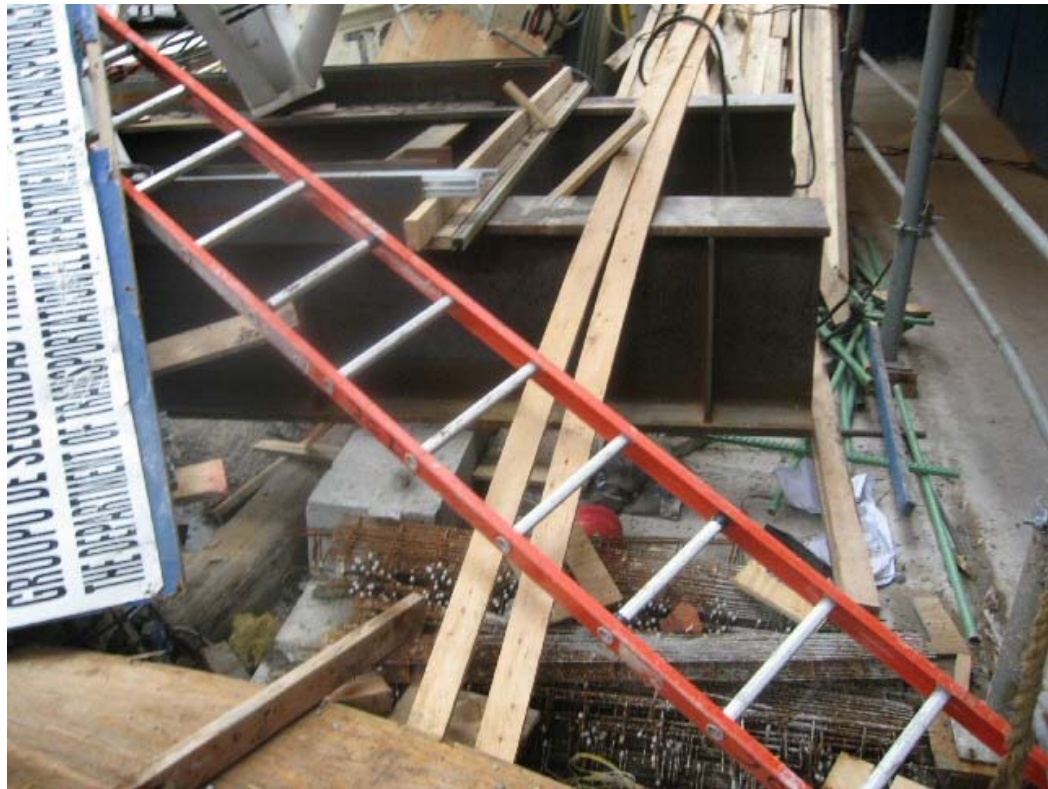
**Photograph 1.17 - View of building side (north) of tower base after collapse. The dunnage beam has been displaced towards the building and the plywood bearing pads are off of the foundation wall. Lifting of the back tower legs and slippage of the front tower legs is also visible. Photo by New York County District Attorney IMG\_379\_109.jpg.**

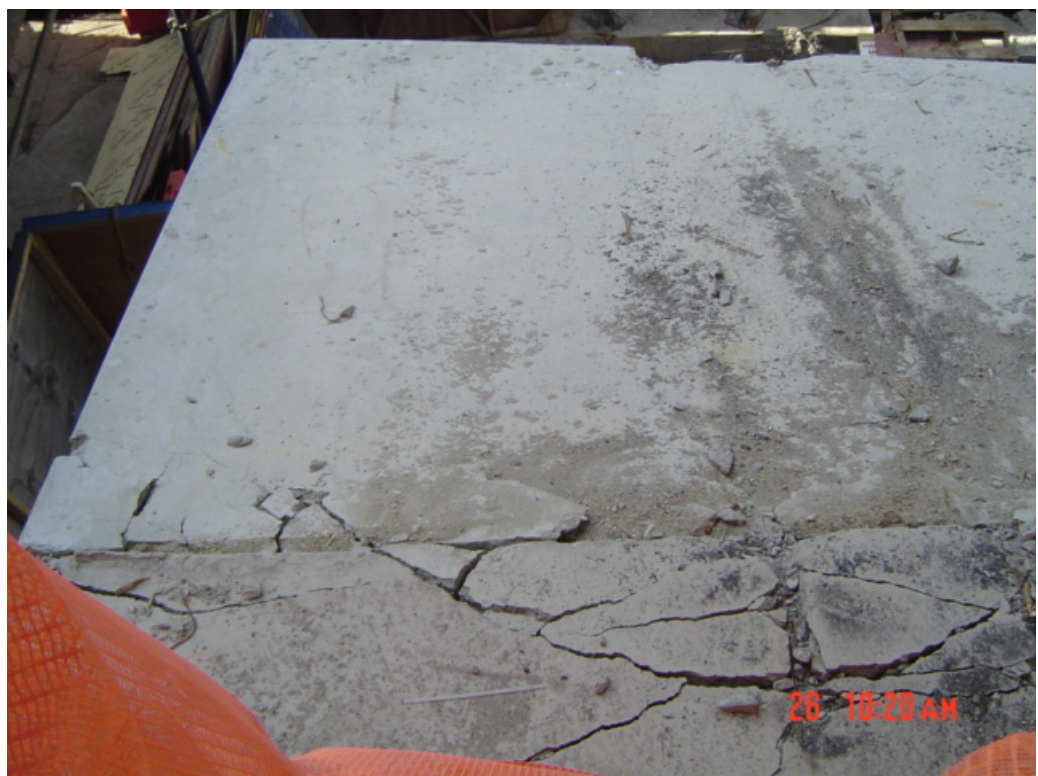
**Photograph 1.19 - Damage to 3rd floor balcony. Photo by Arup.**

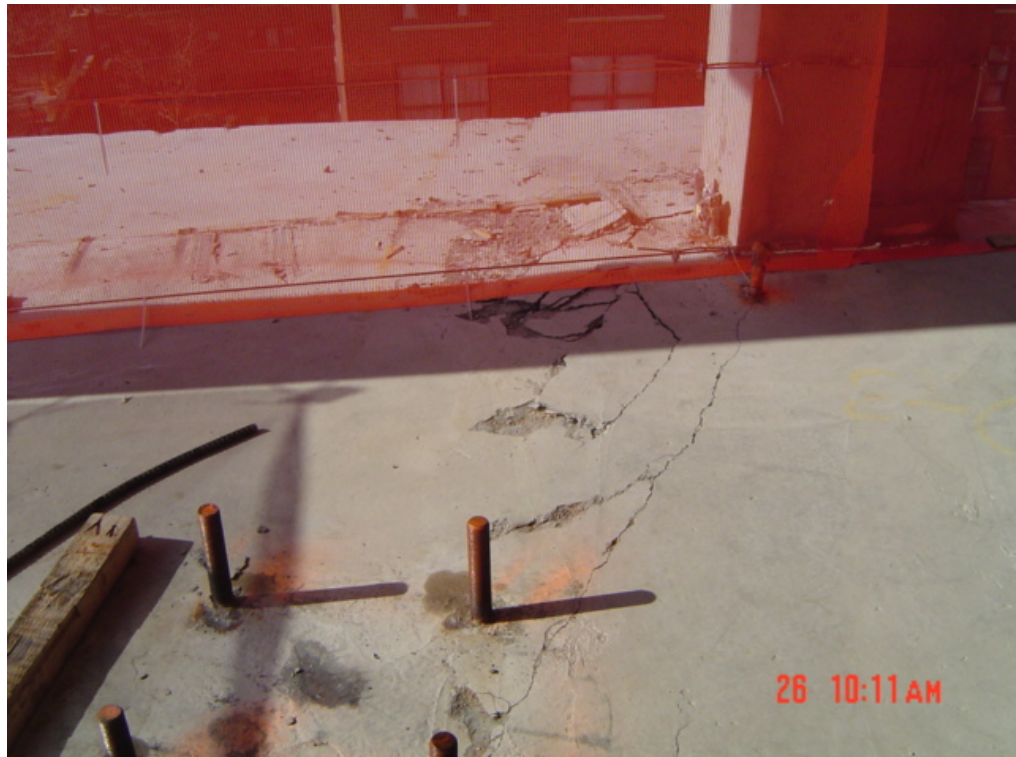
**Photograph 1.20 - Minor spalling of concrete in the vicinity of the bolted connections to the 9th floor slab. Photo by Arup.**

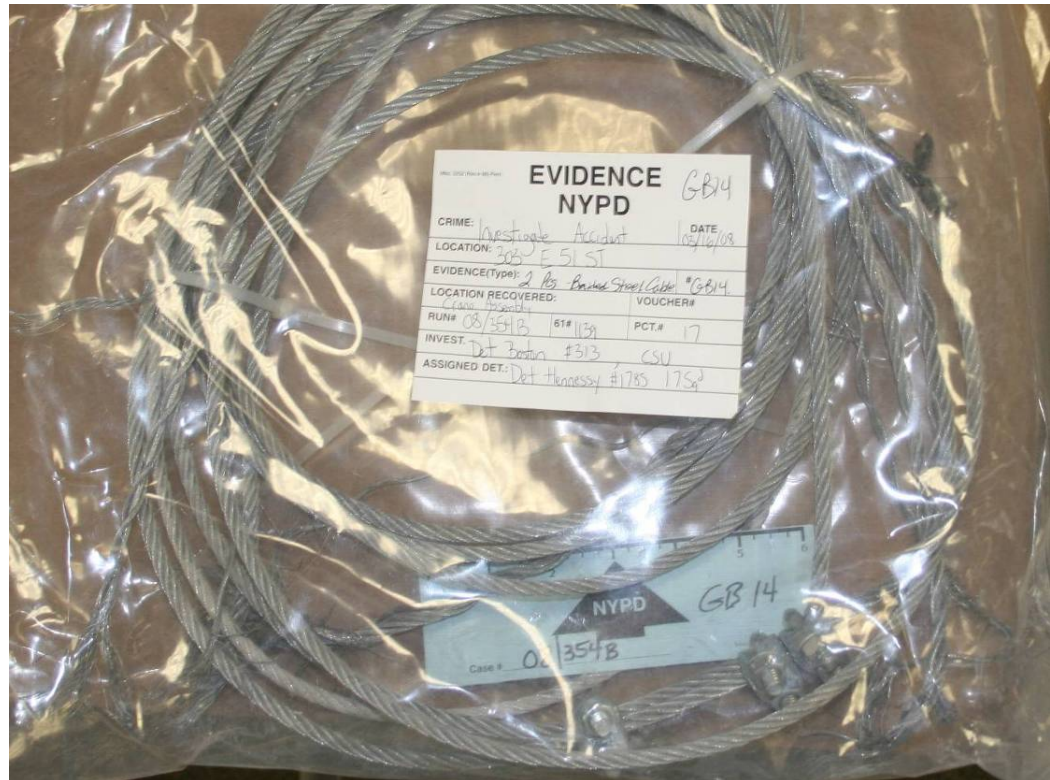
**Photograph 3.3 - OSHA evidence GB14 from NYPD. Note spacing of the U-bolt clips in the lower right of the photograph. Photo by Arup.**

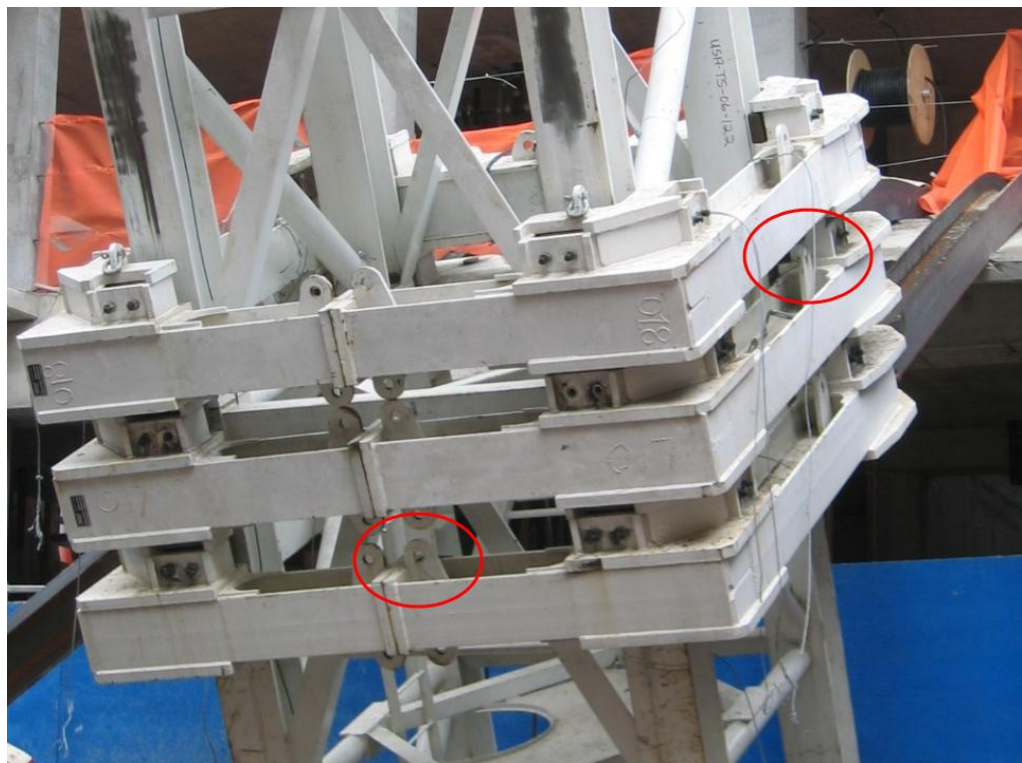
**Photograph 3.6 - View the south and east elevations of the collapsed tower collars. The location of visible wire rope attachments to the collars are circled. Note the lack of thimbles in the formed sling. Photo from the crane engineer, Peter Stroh, IMG\_0081.jpg.**

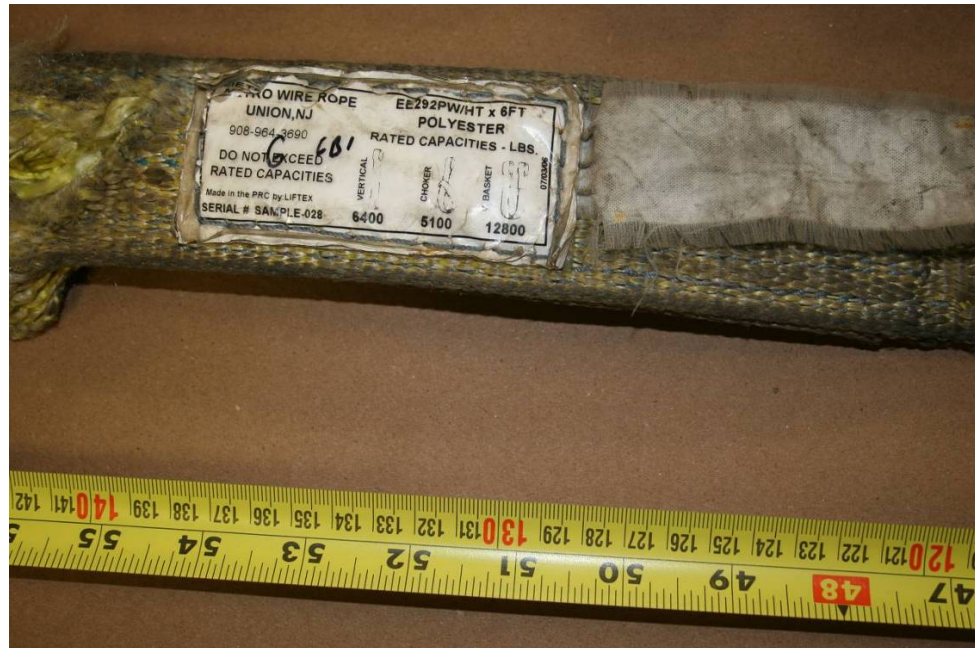
**Photograph 3.8 - OSHA evidence item 1. Polyester web sling removed from the collapse site. Note the faded label. This was taken from the southwest corner of the 9th floor collar. It was attached to the lifting point via a chain fall. Photo by Arup.**

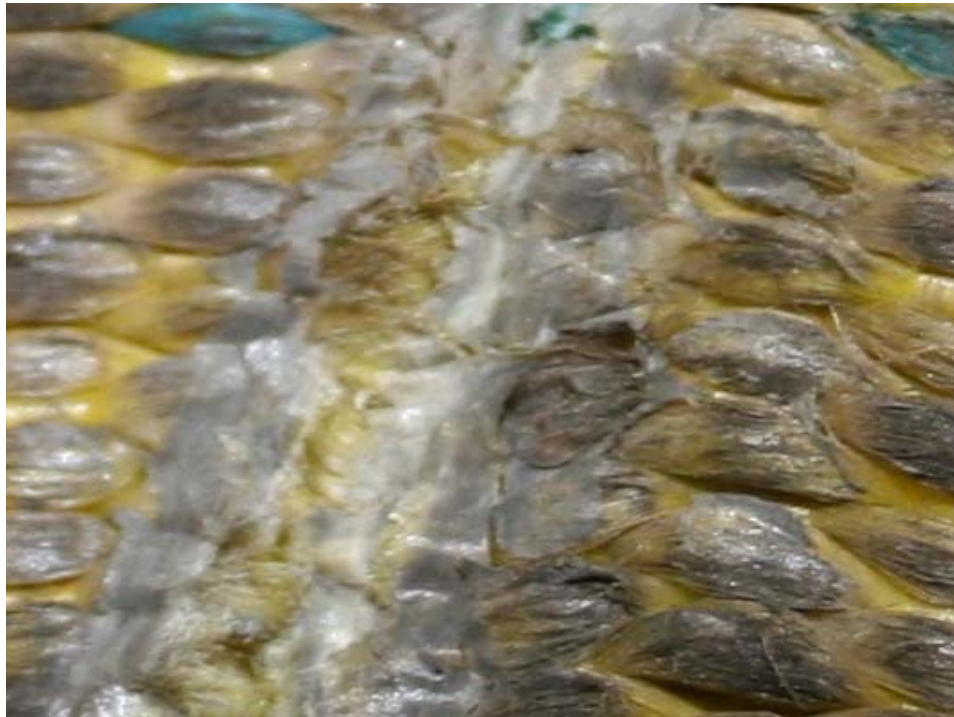
**Photograph 3.11 - OSHA evidence item 1. Polyester web sling removed from the collapse site. This was taken from the southwest corner of the 9th floor collar. Note both the melted and cut fibers within the melted region. Magnification is approximately 10x. Photo by Arup.**

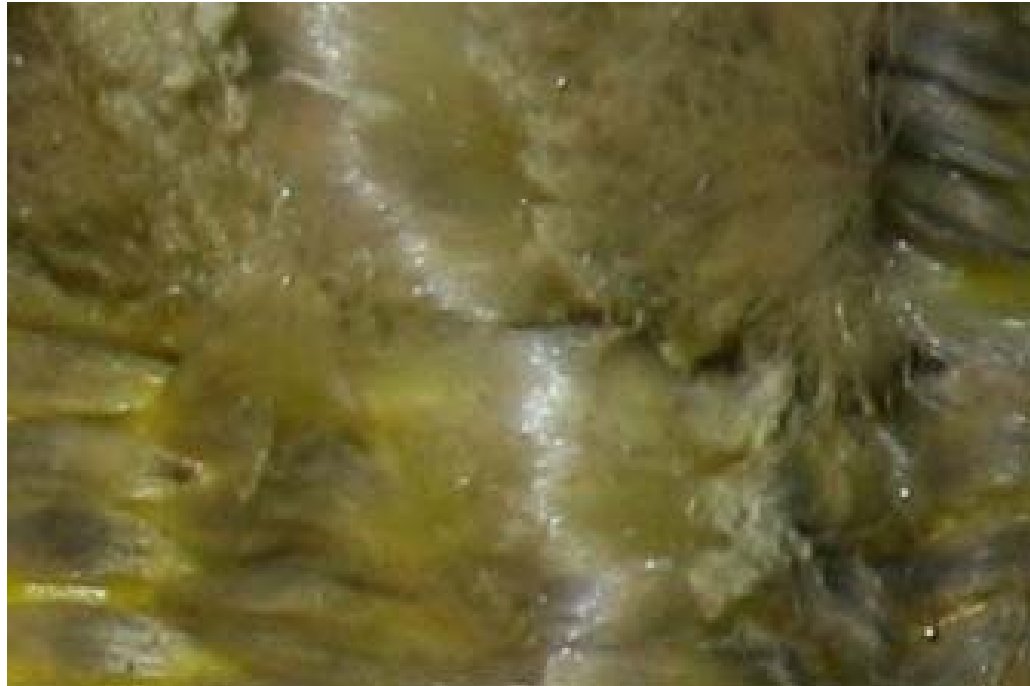
**Photograph 3.17 - Close-up of both cut and melted fibers for OSHA item no. 2. Magnification approximately 9x.. Photo by Arup.**

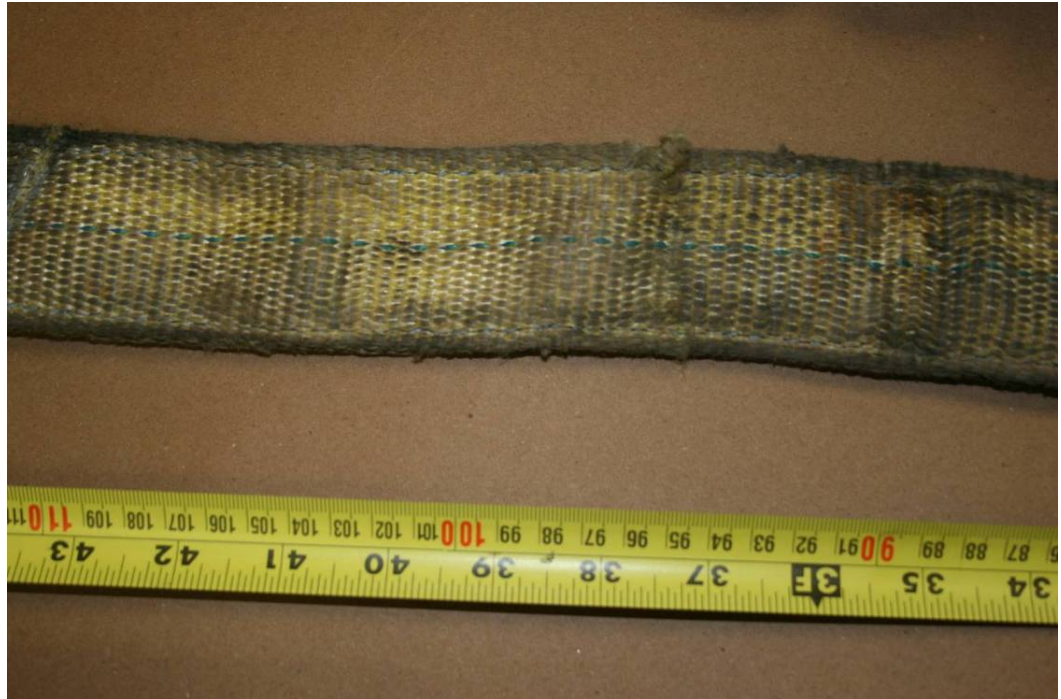
**Photograph 3.18 - Liftex polyester web sling (OSHA item no. 1). Damage can be seen along the edges, as well as wear within the width of the sling, at uneven intervals, unlike the other polyester web slings where damage occurs at approximately 12 inch intervals. Photo by Arup.**

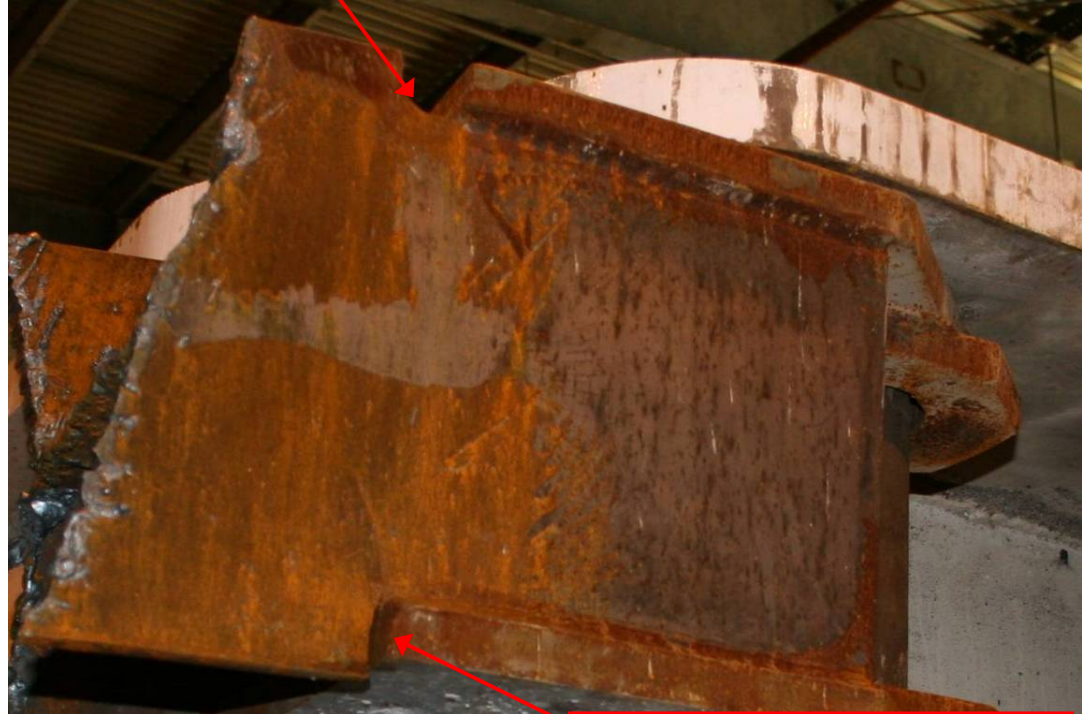
Insufficient radius, lack of clearance and  
excessive cut

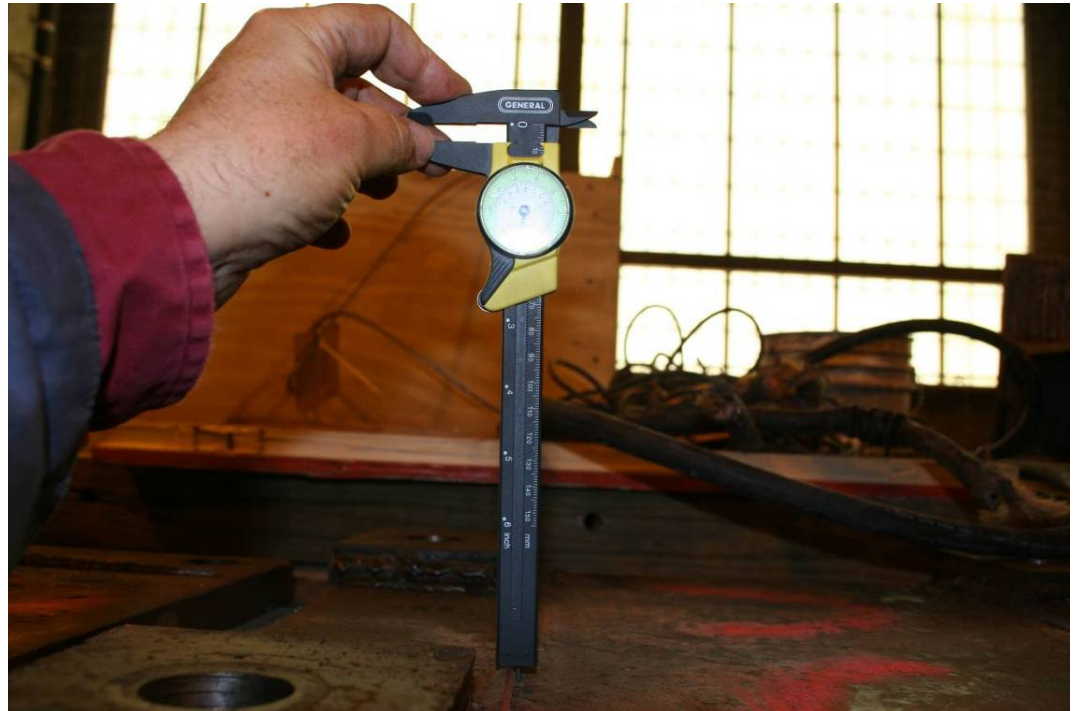
**Photograph 3.22 - Fillet weld measurement of base plate 9C. Measurement is shown to be 7 mm, just under 9/32 inch which is 11.8% under the specified 5/16 inch. Photo by Arup.**

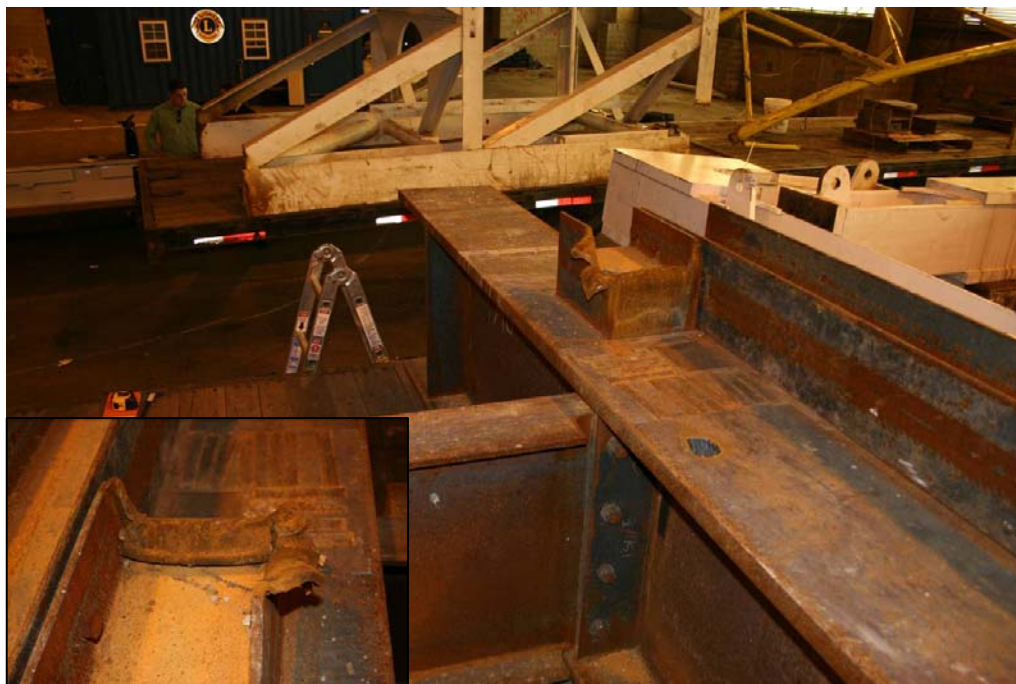
**Photograph 7.1 - Dunnage foundation.** The inward deformation visible in the closeup of the deformed pocket indicates that the steel plate at the end of the pocket was squashed due to a downward force from the tower legs. Had failure occurred due to a horizontal sliding load the plate would have been deformed in the opposing direction. Photo by Arup.

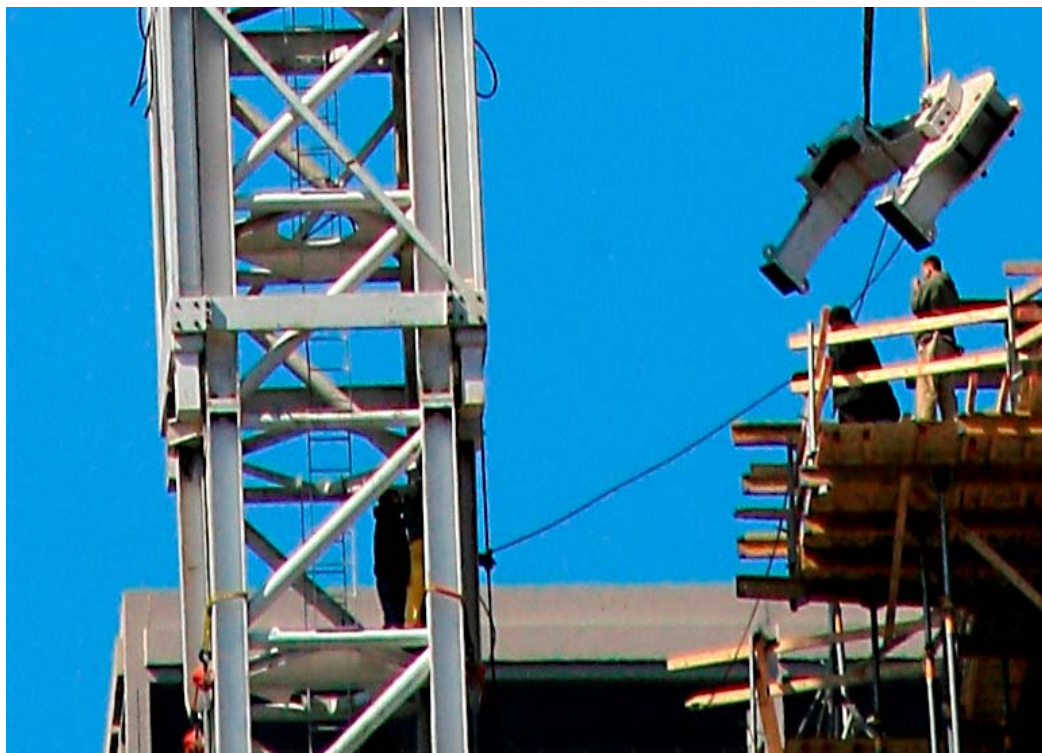
**Photograph 8.1 - View of tower crane with collar half being lifted into place via polyester web slings attached to improper lifting lugs resulting in a non-horizontal position of the collar half during lift (right of photo) and chain falls incorporating polyester web slings choke hitched around the tower legs. (Source: photograph by Gary Halby).**

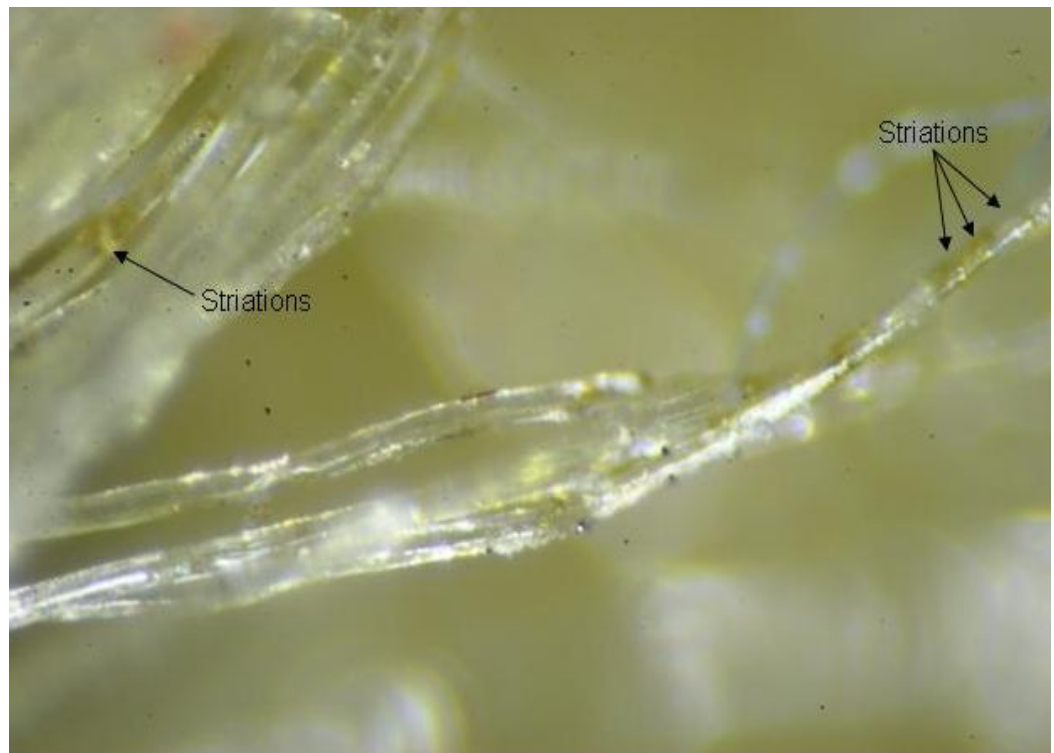
**Photograph 8.3 - Microphotograph of Metro/Liftex sling failure surface showing striations.**  
Photo by Arup.

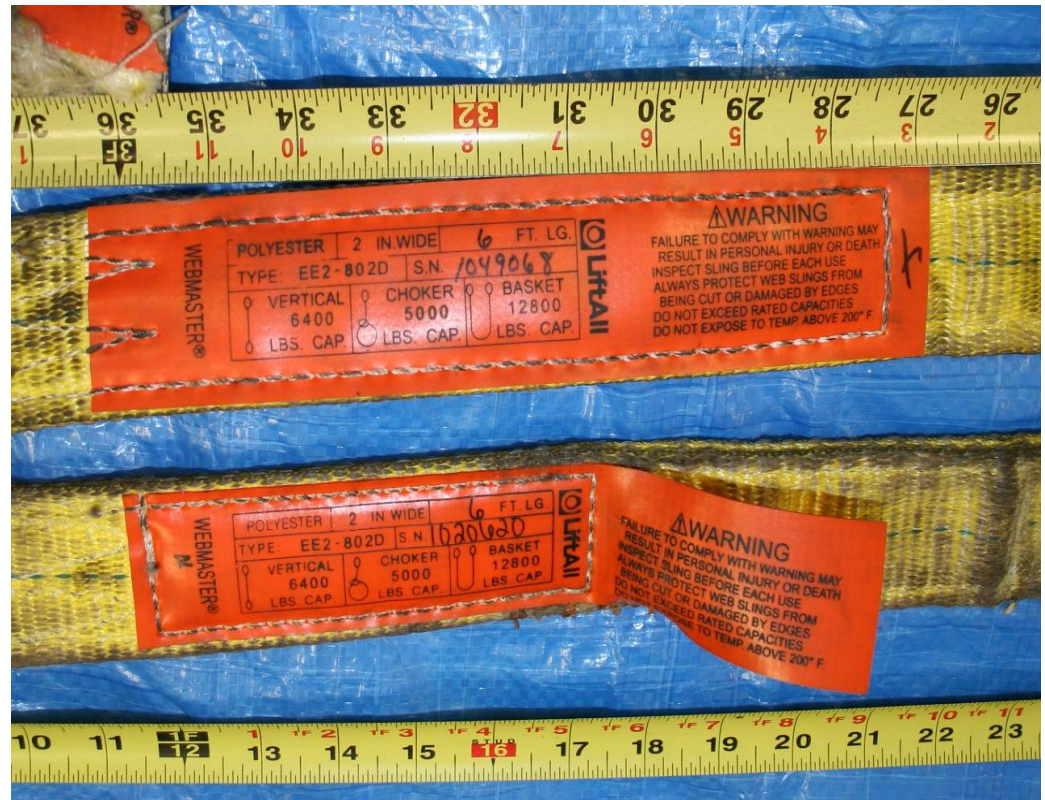
**Photograph 8.4 - Warning labels on slings recovered from the collapsed tower crane clearly require inspection before use and use of protection at all edges. Photo by Arup.**

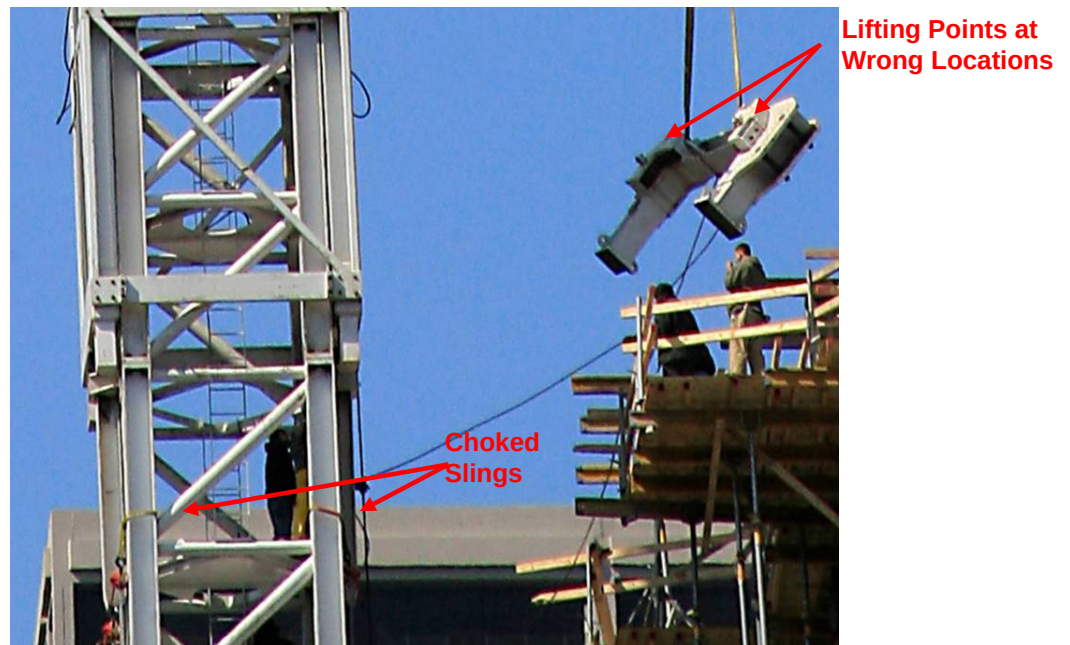
**Photograph 8.5 - Installation of the 2<sup>nd</sup> section of the collar at the 18<sup>th</sup> floor. The slings are choked around the tower crane legs without protection against the flange edges at the 1<sup>st</sup> section of the collar (red arrow). (Source: photograph by Gary Halby).**

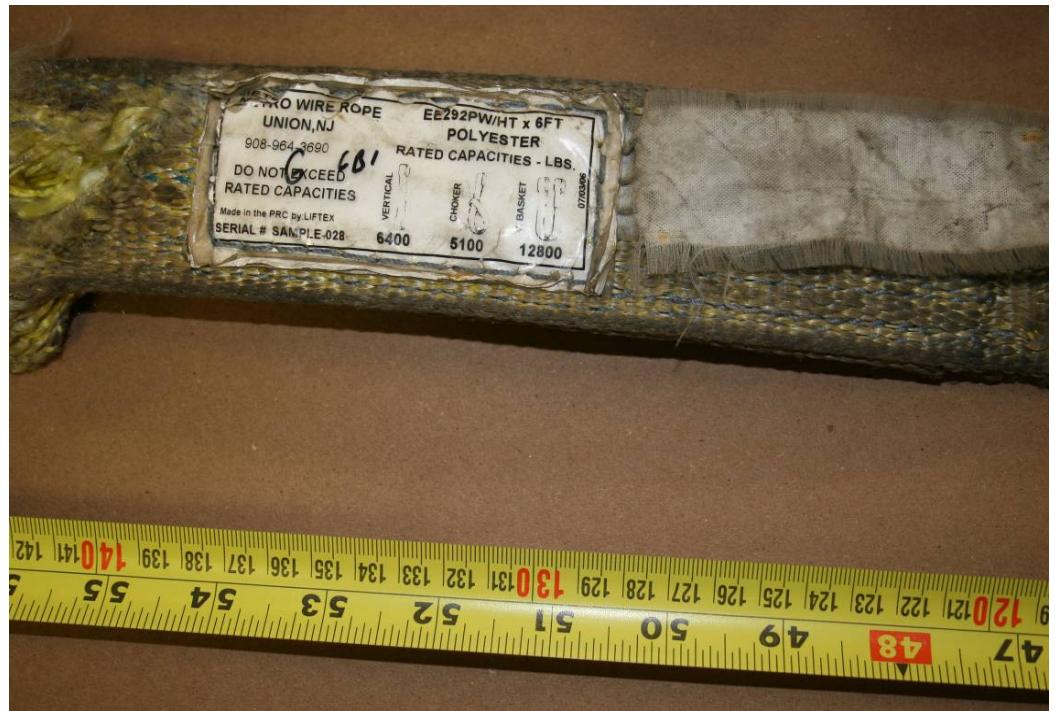
**Photograph 8.6 - Metro/Liftex sling recovered from tower crane. Not the faded label and faded appearance of the sling exterior. Photo by Arup.**

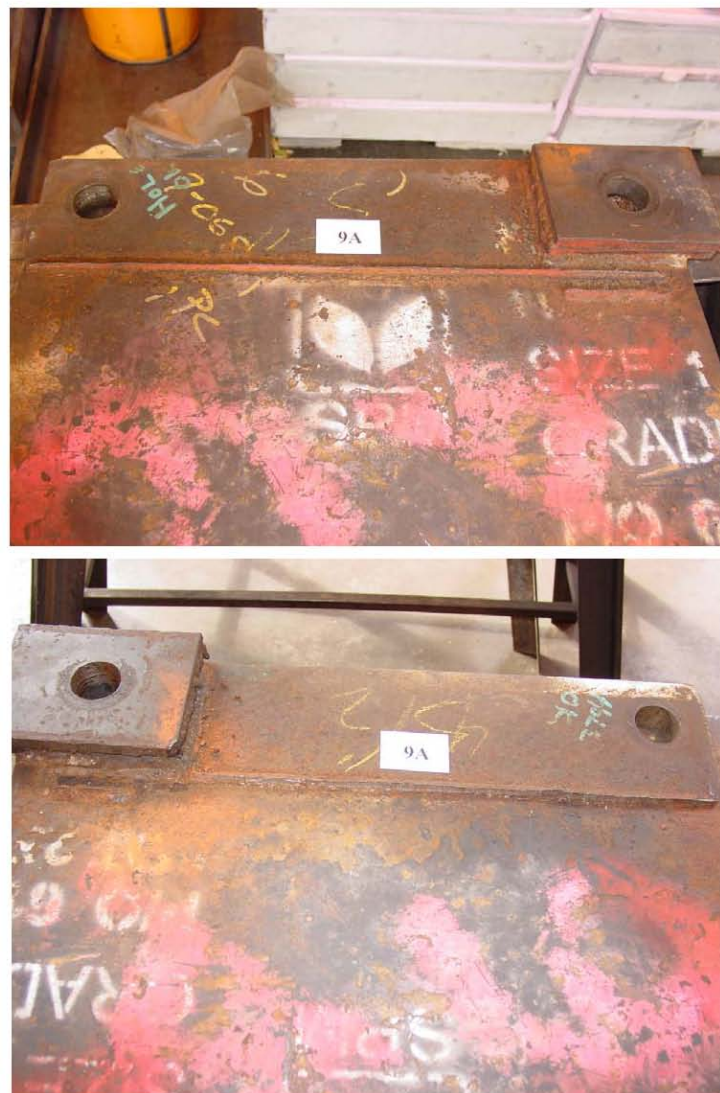
**Figure 11** General Views of the Weld Fracture on Base Plate 9A.

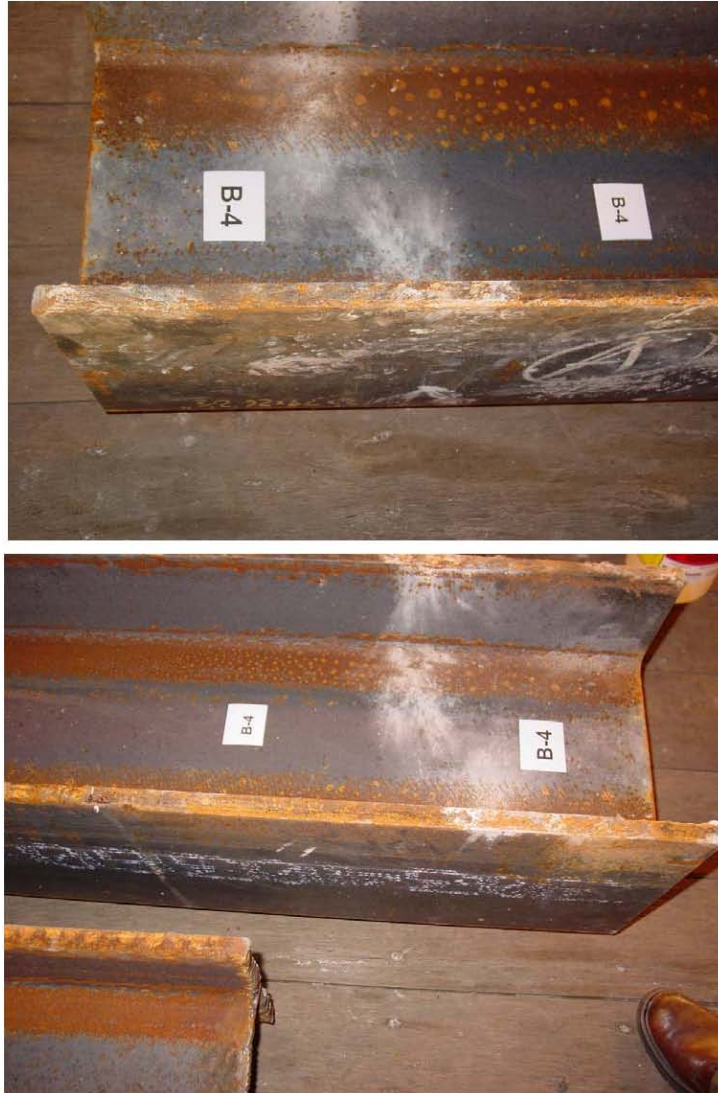
**Figure 12** General Views of Weld Fracture on Tie Beam B4.

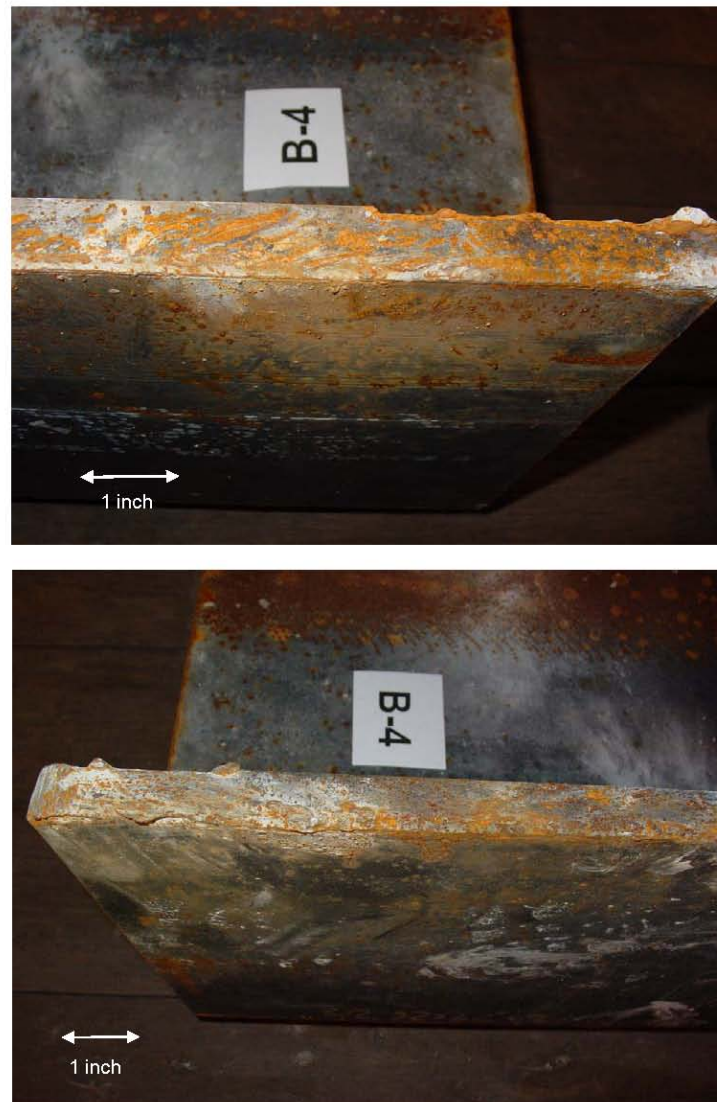
**Figure 14** Enlarged Views of Ductile Weld Fracture on Tie Beam B4. Note Small Size of Deposited Weld.

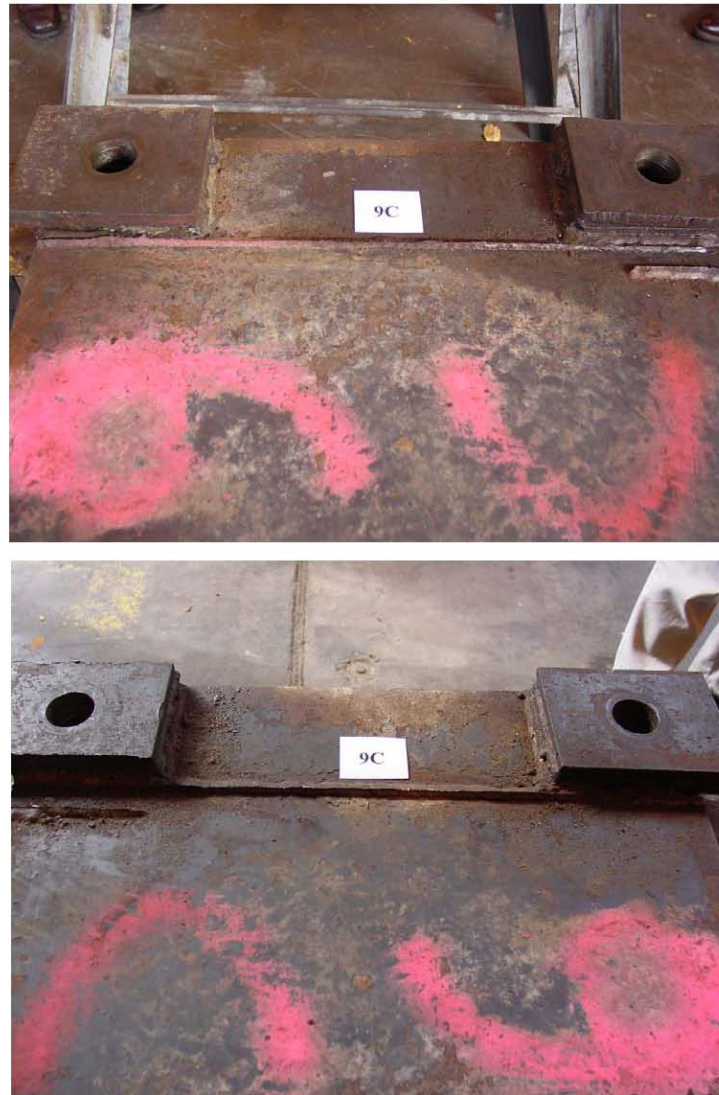
**Figure 16** General Views of the Weld Fracture on Base Plate 9C.

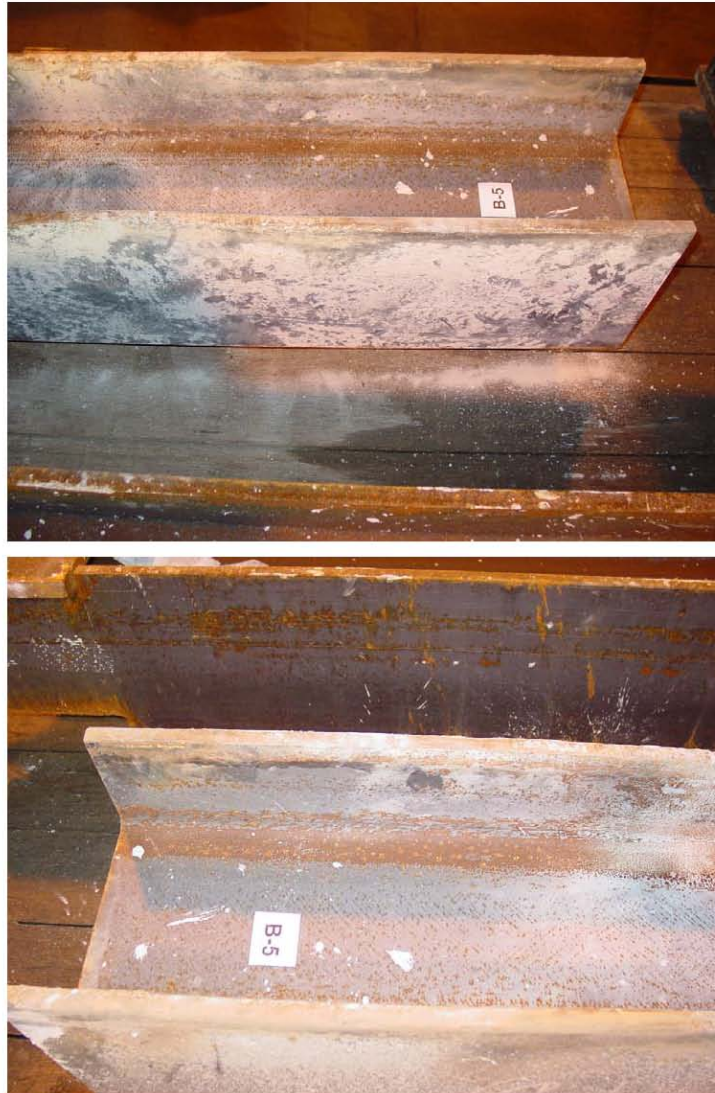
**Figure 17** General Views of Weld Fracture on Tie Beam B5.

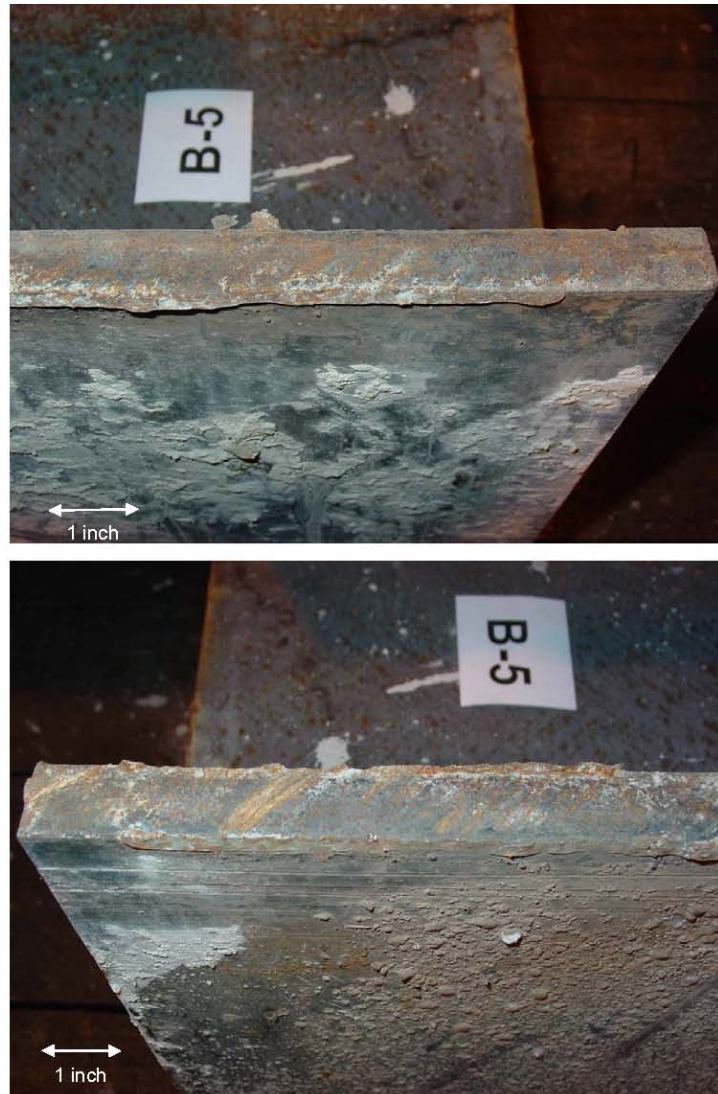
**Figure 19** Enlarged Views of Ductile Weld Fracture on Tie Beam B5. Note Small Size of Deposited Weld.

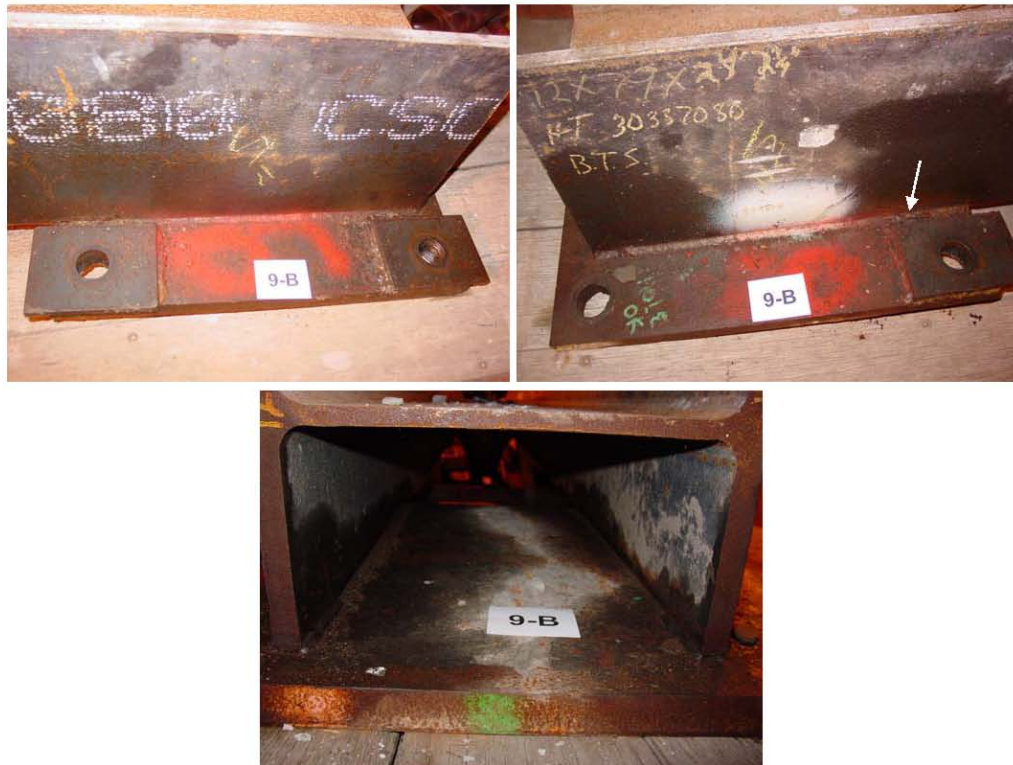
**Figure 20** General Views of the Base Plate/Tie Beam Welds From Base Plate 9B.(Arrow Shows Location of Weld Toe Crack)
