**808 COLUMBUS AVENUE
REPORT OF INVESTIGATION
FEBRUARY 15, 2008**

**DAN ESCHENASY, PE
DEPUTY ASSISTANT COMMISSIONER
FORENSIC ENGINEERING UNIT**

I. EXECUTIVE SUMMARY

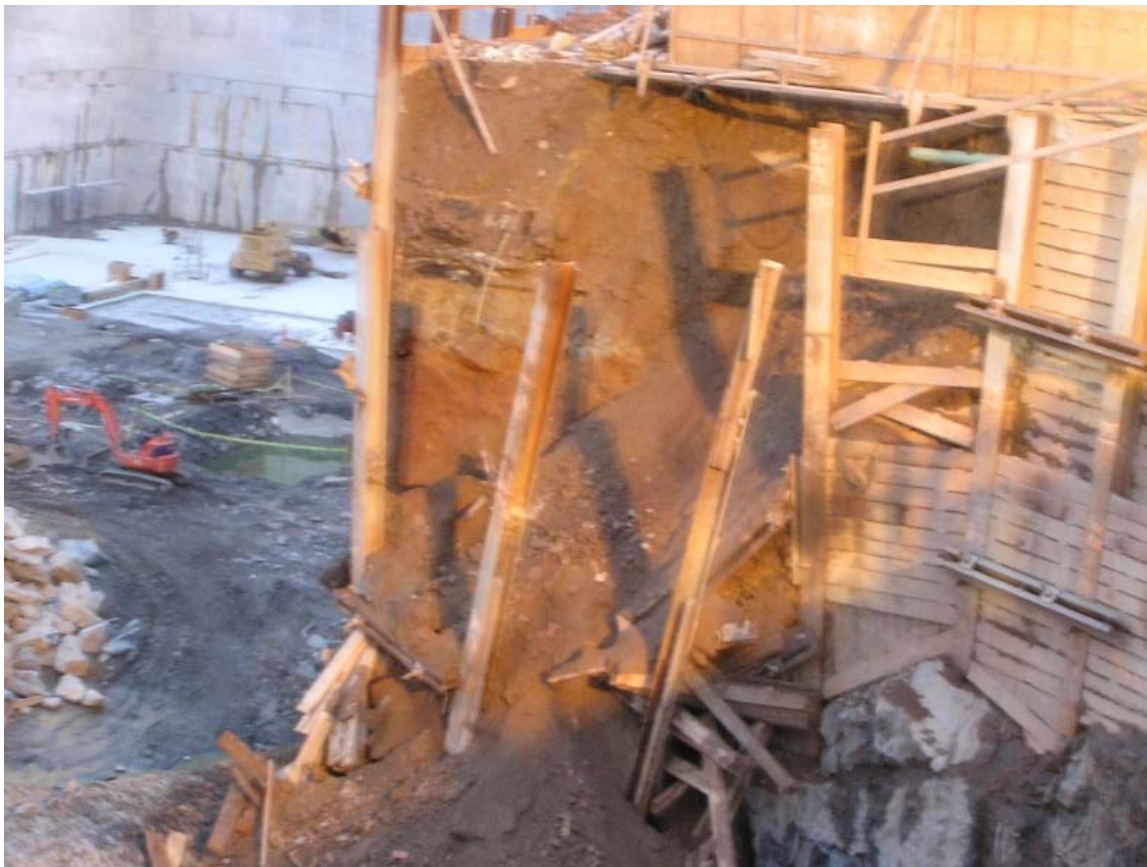
Photo 1 – The Collapsed Sheeting

The piles were stabilized in the adjacent soil through the use of anchors (also commonly referred to as “tiebacks”) embedded in the soil behind the sheeting (**Figure 6**). The anchor heads are still visible in **Photo 1** in the wales that are exposed. There is a poor image of an anchor exposed in the soil wall between pile #1 and #2 sloping down to the right at approximate elevation 65. All anchors heads were recovered, some of which appear to have been torn during the remedial work. One anchor head might have failed before the remedial work.

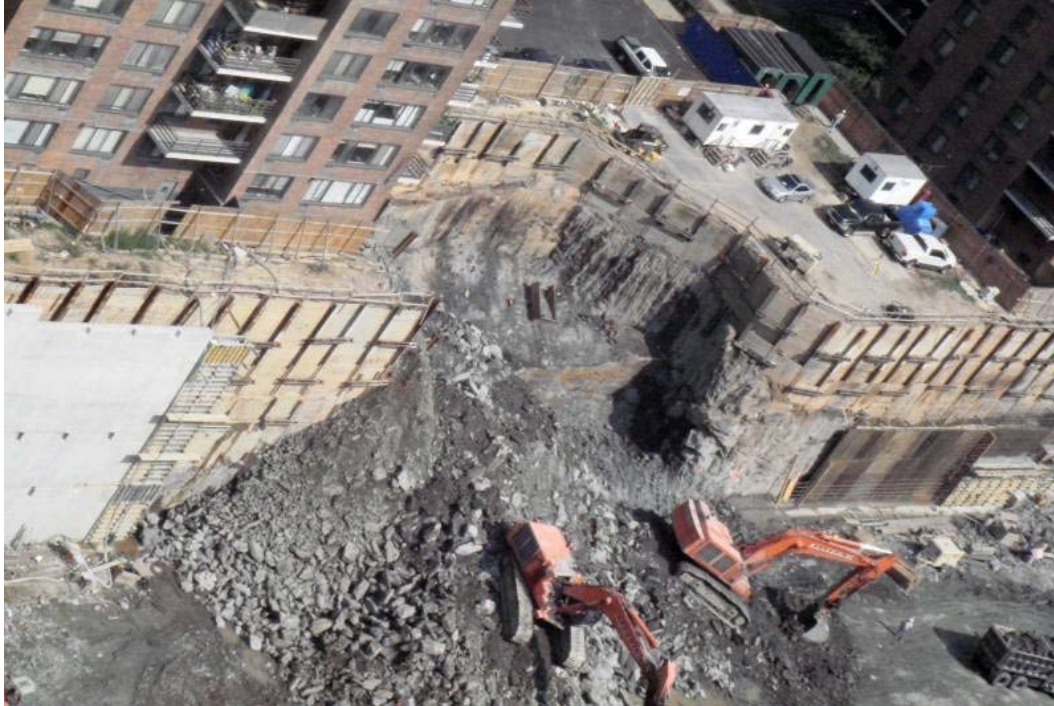
Photo 2 – Stabilization Berm

Shortly after the collapse at approximately 10:00 p.m., the contractor created an earthen berm where the collapse occurred and against the foundation of 784 Columbus. In addition to the creation of the berm, soil remediation was performed over the next few days consisting of grouting the area around the possibly affected building foundation of 784. The remediation was

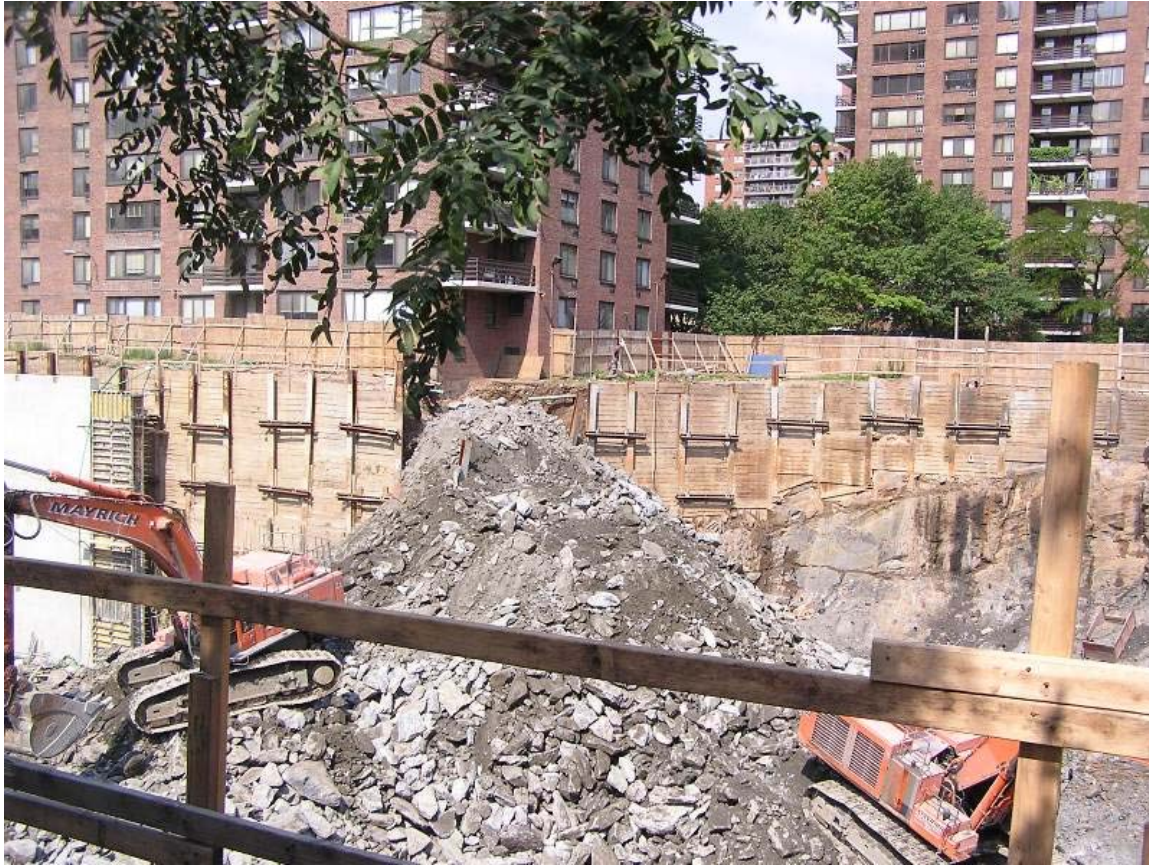
Photo 3 – Stabilization –Earthen Berm

designed by Robert Alperstein, P.E. of RA Consultants, the geotechnical engineer of record for the new building. The remediation consisted of grouting of the area around the corner foundation. During remediation the building was monitored with optical survey and dynamic monitoring.

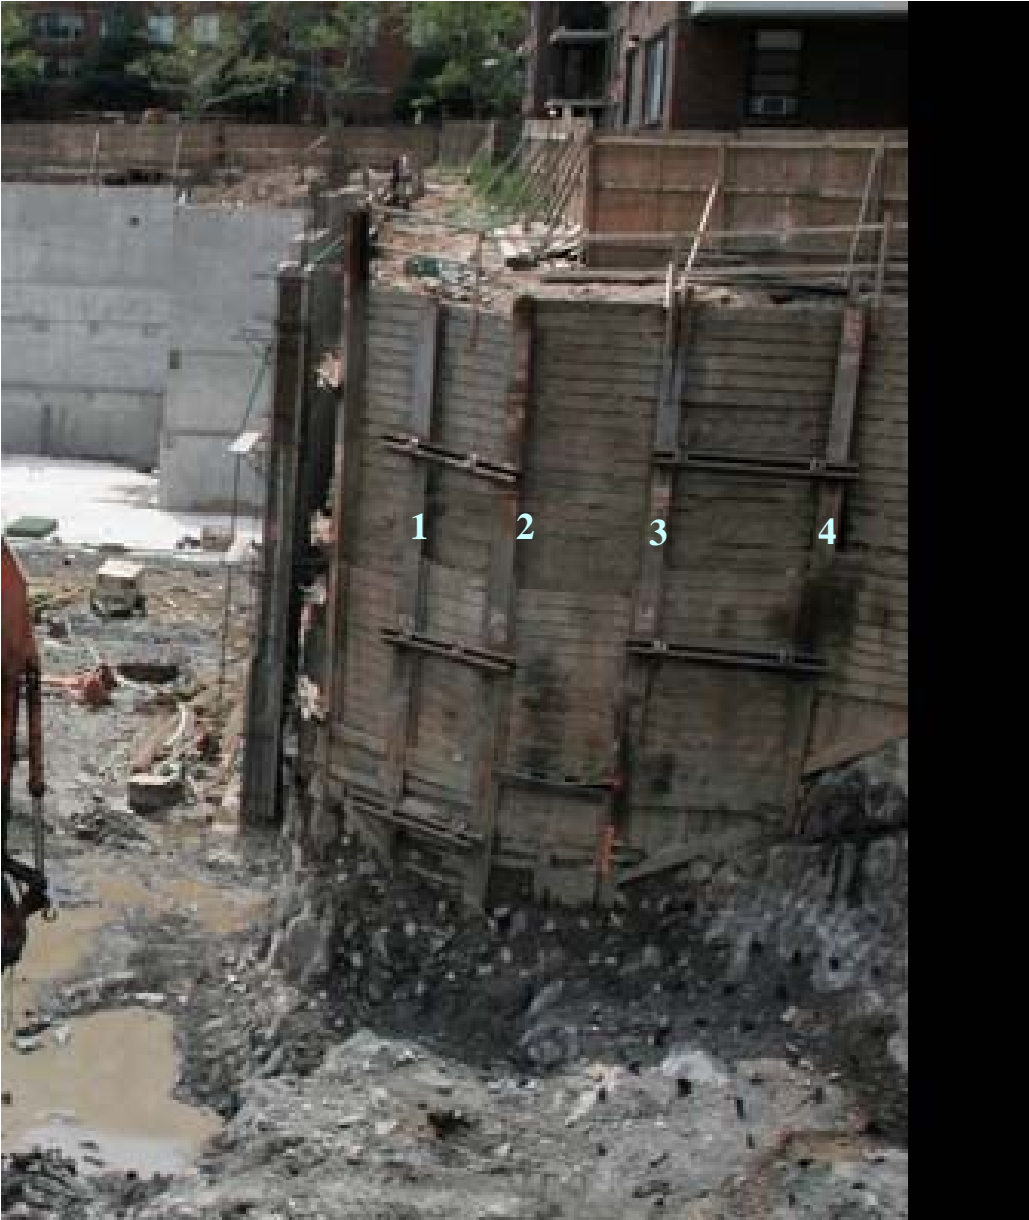
Photo 4 – The Sheet Piling Wall Pre-Collapse –Bernstein photo 7/20/2007

The Bernstein July 20 (photograph 4) is unclear but it appears that the toe of the wall is covered with rubble. The debris is more typical of blast rock rather than the larger blocks typically produced by a hydraulic breaker. It is unknown what method was used to excavate the rock in this area prior to July 20.

These and other photographs show that the excavation was down to the final grade level as far as Pile #2 and all of the toe of the wall was exposed, apart from the rubble covering.

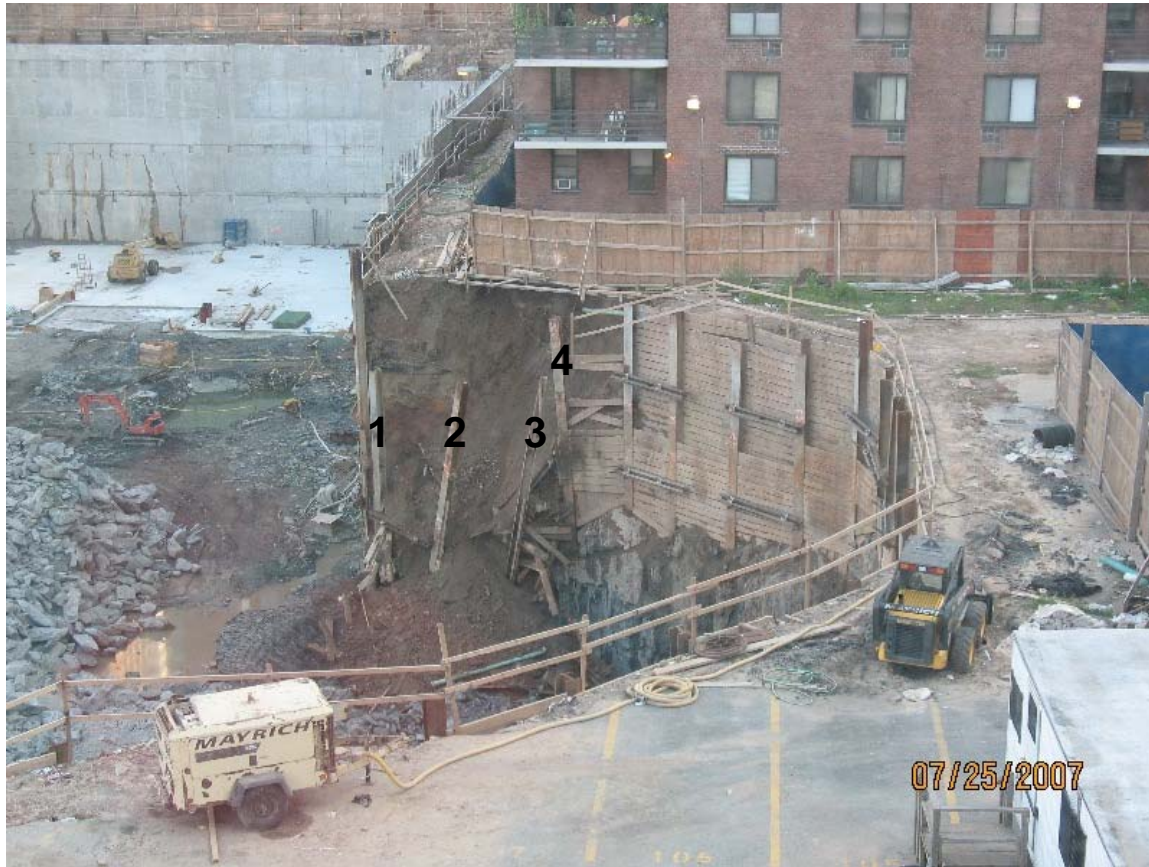
Debris layout is shown in photo 5 and figure 4. Only pictures produced immediately after the

Photo 5 – Collapsed Sheet piling

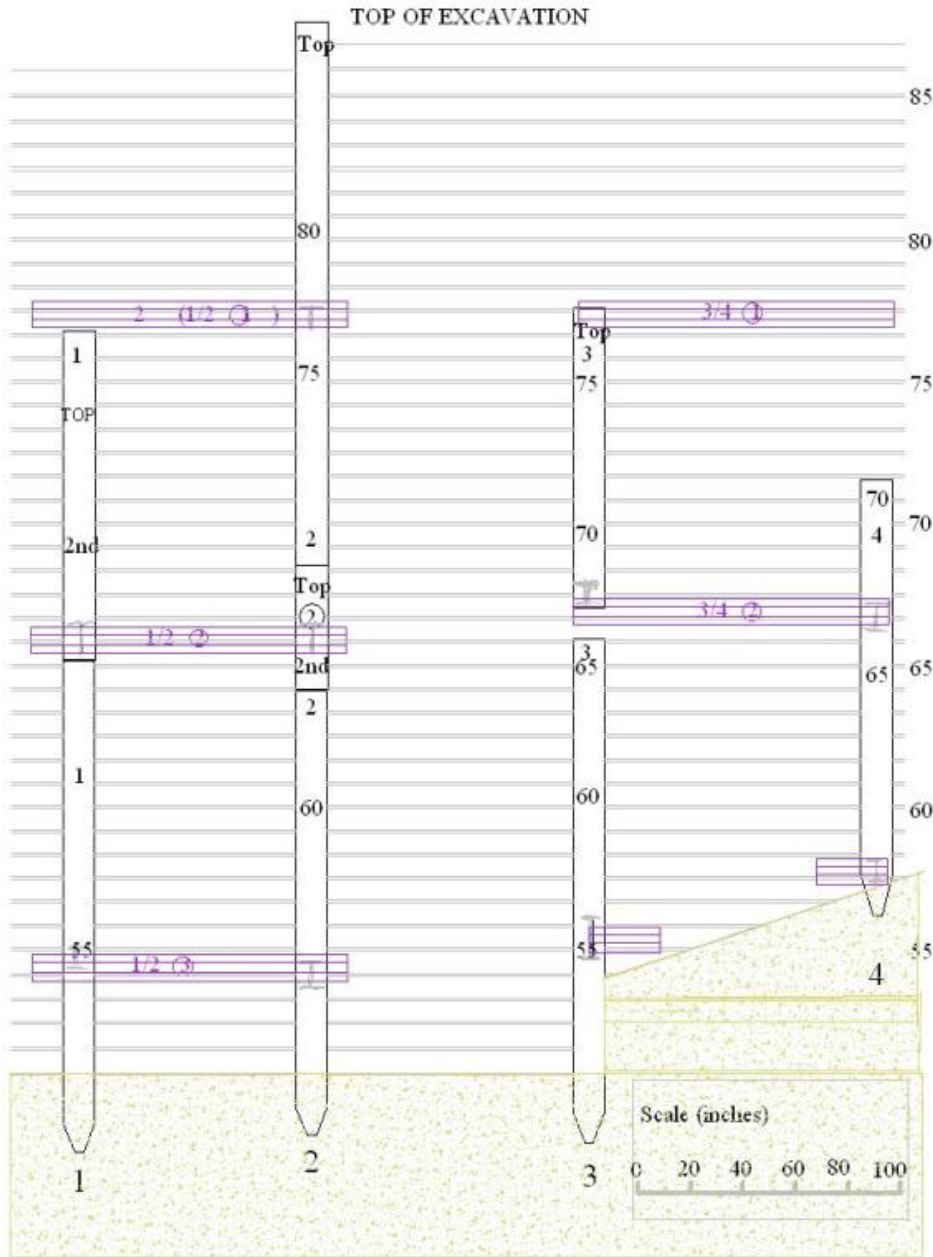
contained any essential data. The welds around the plates connecting the wales to the soldier piles failed. The welds measured 3/16 of one inch.

Figure 3 Recovered Pile Segments -Set-up

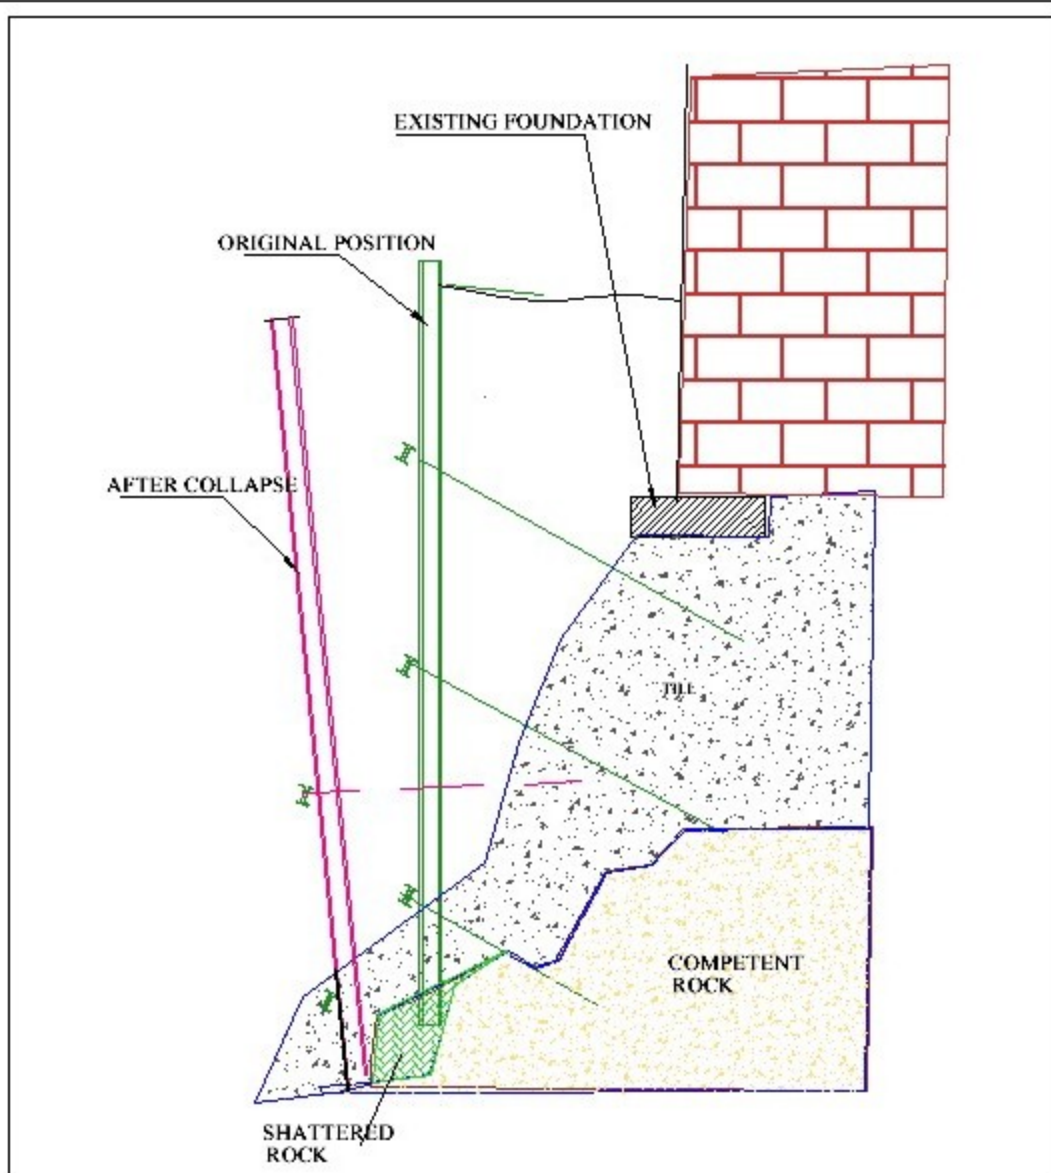
The wood planking that is installed between the piles is known as “lagging.” From examination of the photographs after the collapse, all of the wooden lagging between the piles was out of place except between Pile #4 and Pile #5 below elevation 73. The lagging between #1 and #2 appears to be in front of the piles. Most of the lagging is obscured by the debris pile between Pile #2 and #3 and the lagging between Pile #3 and #4 appears to be behind Pile #3. In many cases, the lagging lies close to the piles is partly fixed. The lagging was significantly damaged when the berm was built because heavy rocks were dropped on top of the debris.

Figure 4 Rendering Section Looking East –Sheeting before and after collapse.

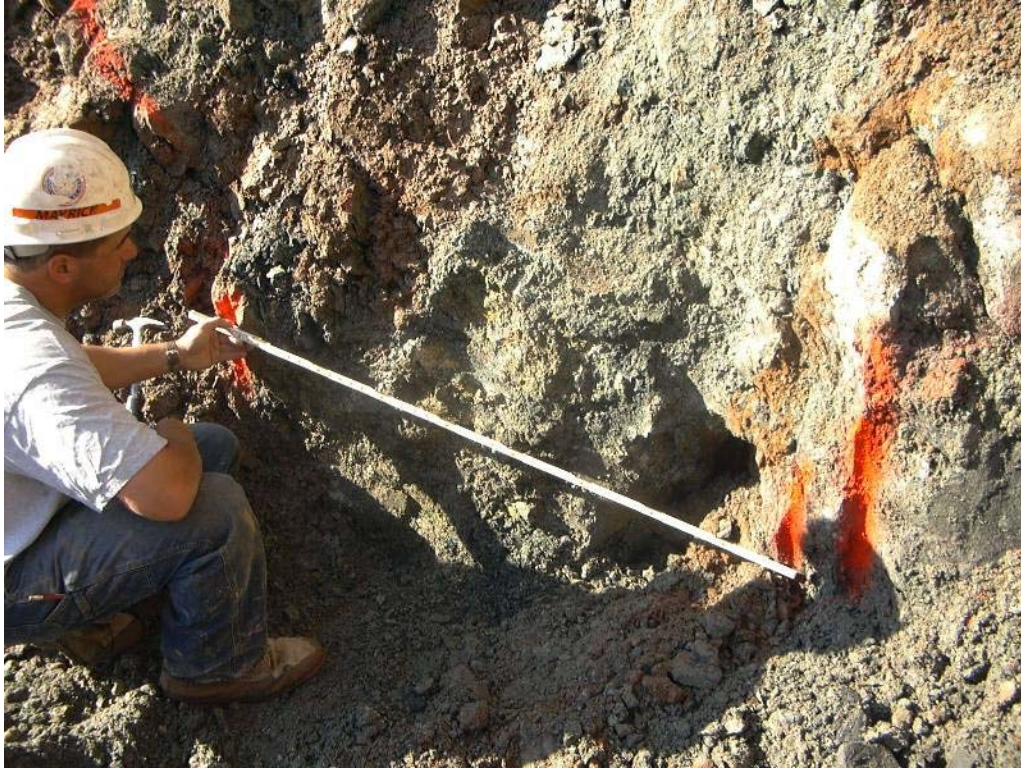
The investigation revealed that the area of the collapse coincided with a geological structure trending approximately north-south. The feature is most likely a complex fault due to intersection of more than one fault, possibly a conjugate system. The faulting has caused extensive fracturing and reworking of the material to produce angular sand to coarse gravel size fragments of rock to platy shards of brittle rock bordered by closely spaced blocky rock. The fault extends from between the corner pile and #1 pile and almost to #3 pile which is nearly 20 feet wide. The fault is made up of two distinct components: an altered region and a shattered region.

Photo 6 – Weathered Rock Below Sheeting

The altered region is approximately 6 feet thick between #2 and #3 piles dipping between 50° and 60° to the southwest trending 194°. It is greenish grey, loose, highly to completely fractured and chloritic comprising silt to gravel-sized lithorelics with released quartz, plagioclase feldspar and mica. The quartz and feldspar are not discolored but the surface of the feldspar crystals is powdery and matte. The mica is dominantly biotite and softened, possibly transitioning to chlorite. There is evidence of oxidation of minerals and other mineralization that indicates accelerated decomposition due to exposure to near surface conditions but there may be a history of hydrothermal alteration in this zone as well.

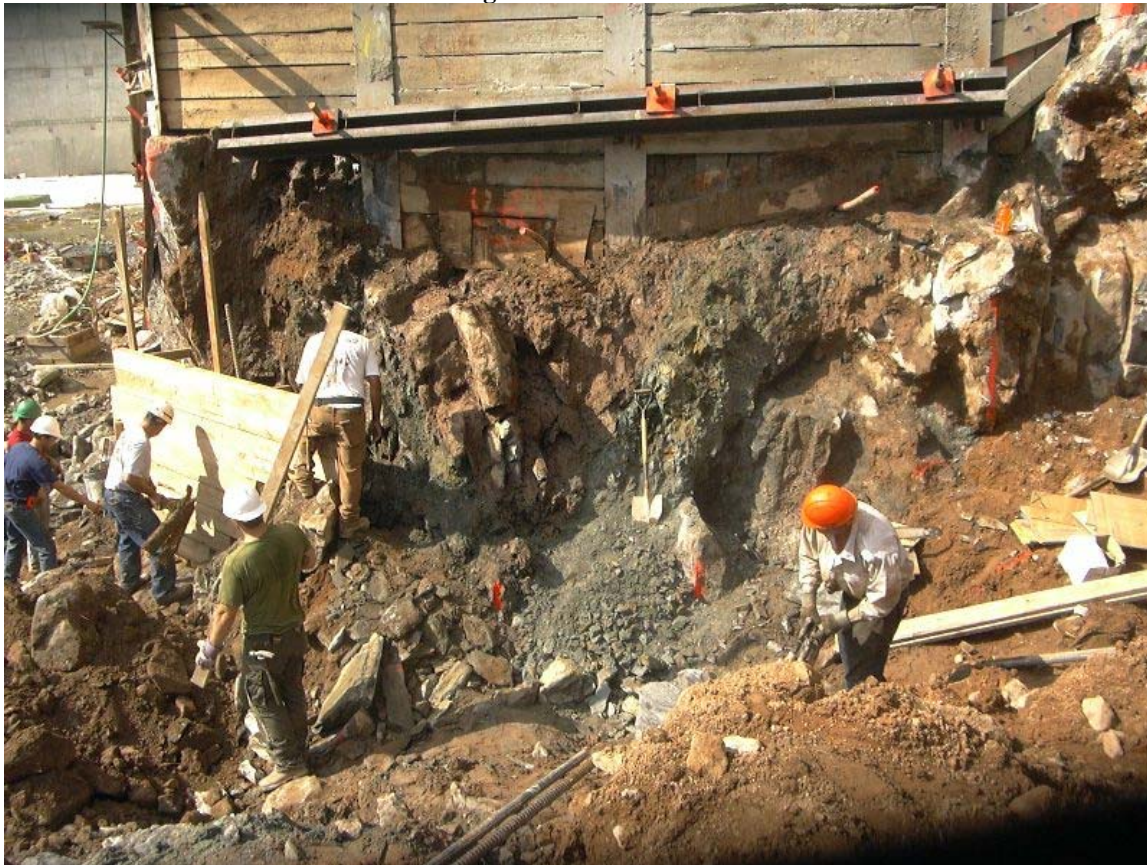
Photo 7 New Sheeting Installed Several Feet Away From Original. Note Weathered Condition of Rock

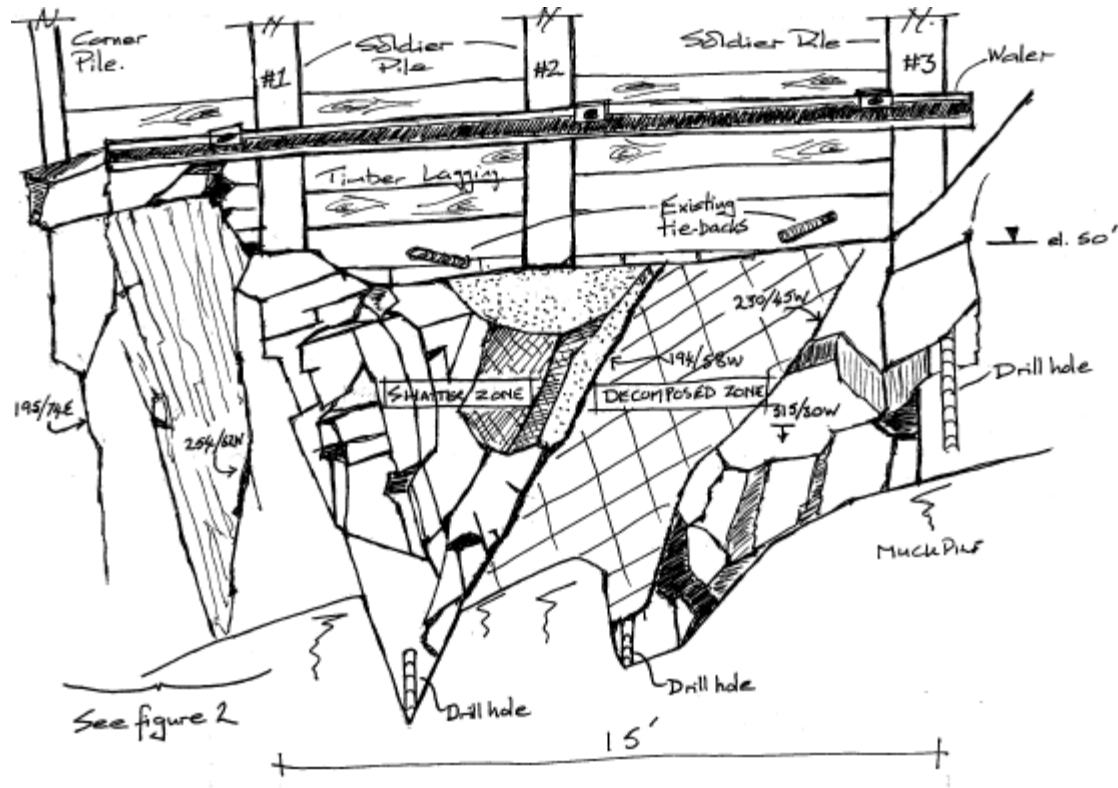
Figure 5 Sketch Rock Condition Under New Sheeting (several feet away from collapsed area)

The weathered zone extends from the corner pile to pile #1 forming the westerly border of the altered region and is described as dark grey to black mica and possibly amphibole rich schist with extremely close to closely spaced, carbonate, hematite and chlorite coated sub-vertical fractures with sub-vertical conformable seams of decomposed mica schist and vertical convoluted foliation.

These conditions indicate a complex faulted region with significant drag and destruction. It is more than likely that this is an intersection of at least two faults with advanced decomposition and weathering. The product is an extremely weak rock mass with the properties of a loose soil in places.

The design required each of the soldier piles to have its toe founded on competent rock. However the exposed rock in the area below piles #2 and #3 is a severely weathered rock which was not the design intent.

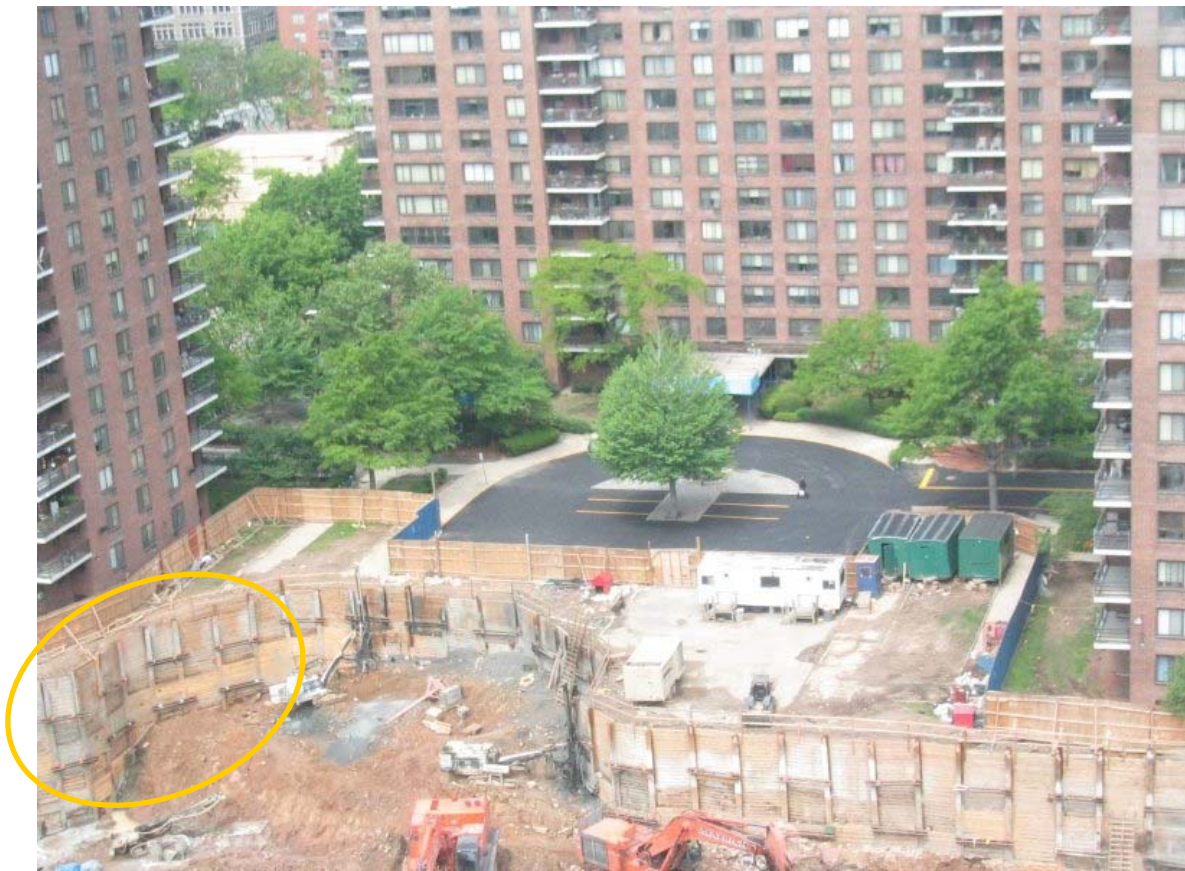
The segment of the sheet piling system wall that failed was the southeast corner of a bay approximately mid-way along the length of the west wall of the excavation. The start of the bay was the Corner Pile and there is a curved section to #5. The investigation could not establish with absolute precision the location of piles 1, 2, 3 and 4. The attached plan sketch [Figure 2] was created based on field observations and drawings from Mayrich. The piles might have been located +/- 1 foot from the position shown on the drawing. The sketch of the vertical configuration is based on the Bernstein July 20 (photo 4), on photos submitted by neighbors (Photo 8) and on examination of steel debris.

Photo 8 – Area of the Collapse of the Sheet piling Is Marked

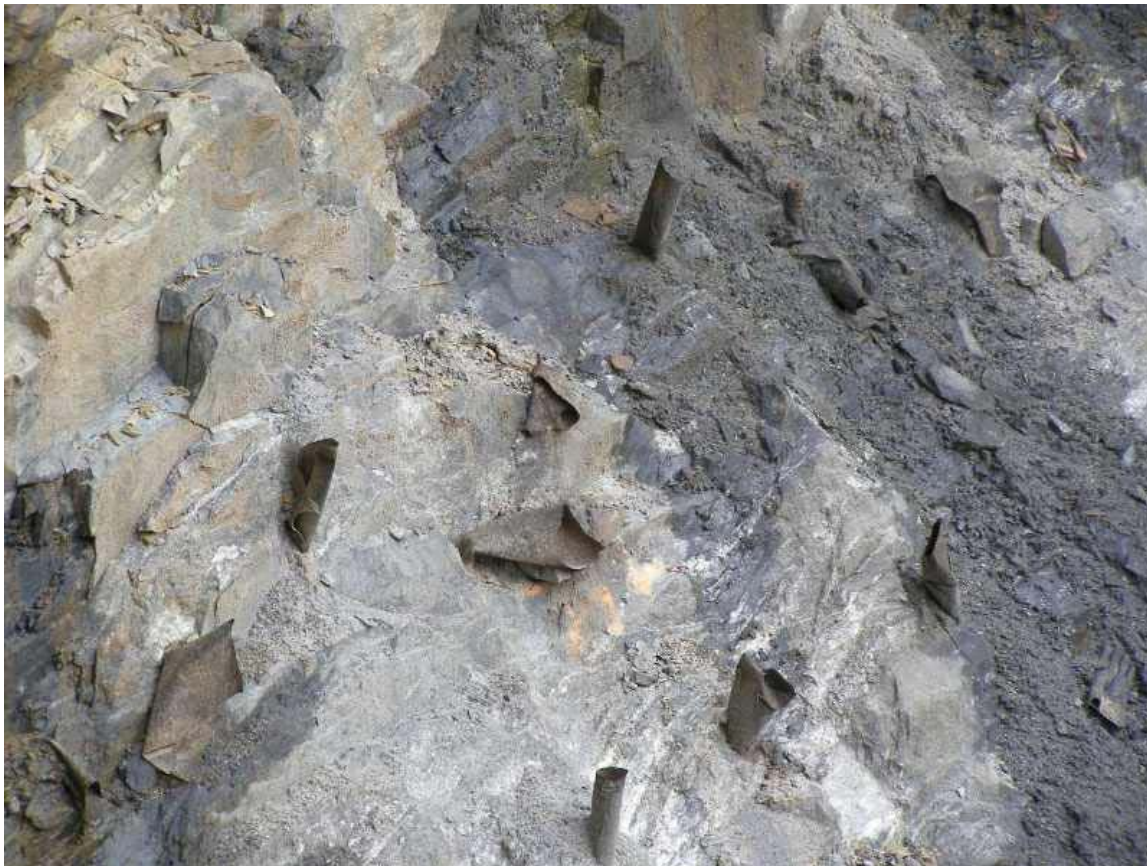
Photo 9 – Marks of Drillings

The bay was line drilled and all the blast holes were drilled and marked. The blaster noted during

drilling the blast holes that the ground was soft in the area of the failure. However, he did not consider it significant enough to alter the round or notify others.

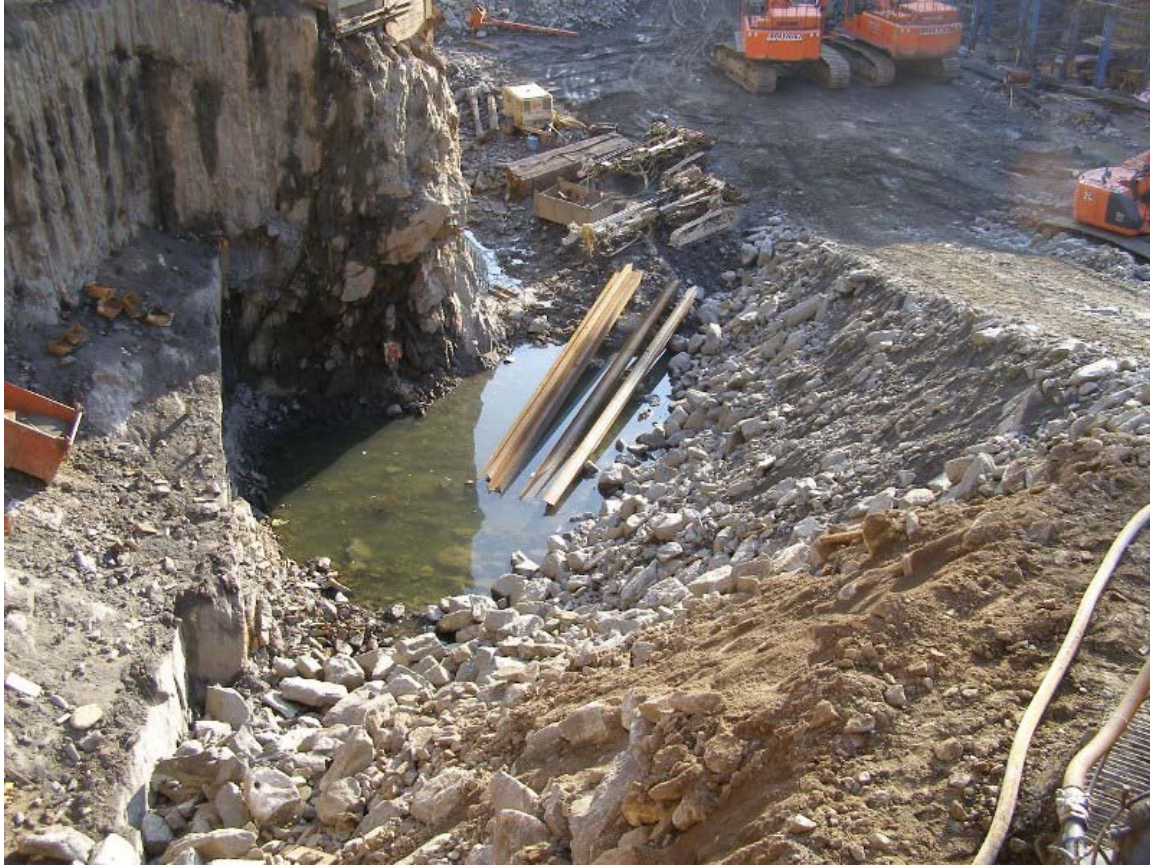
Photo 10 – Face of Rock after Blasting on 7/25/07

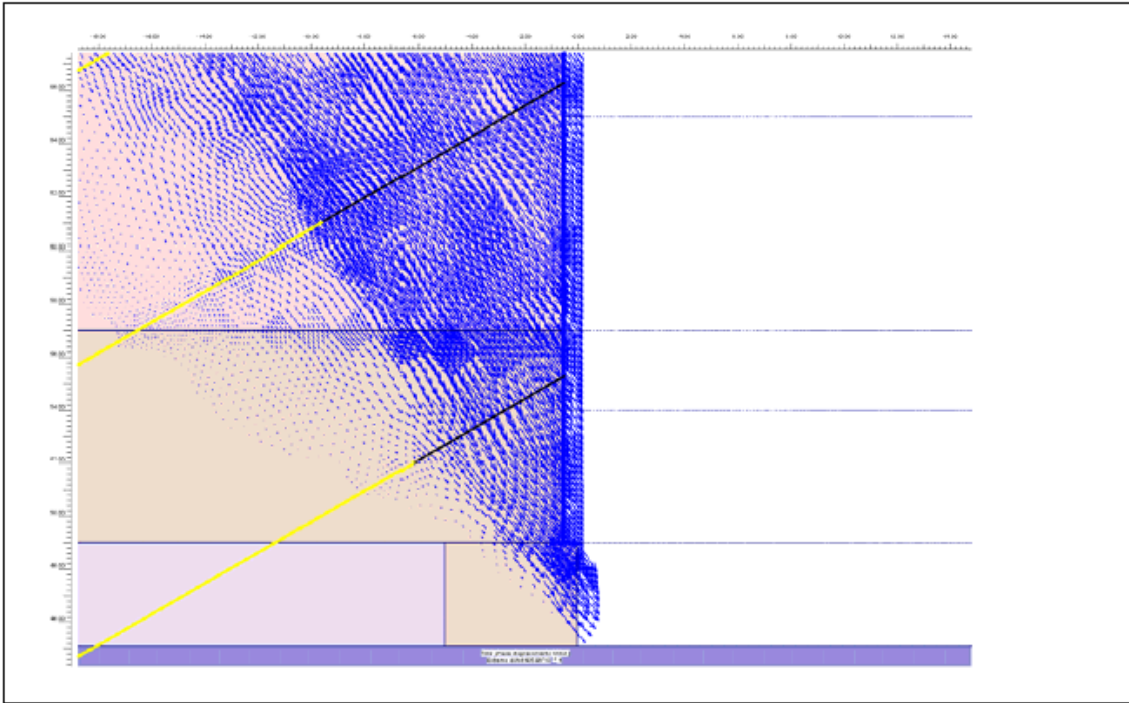
Figure 16 Plaxis Analysis – Vector Displacement Vector for four additional feet of excavation

Both of these analyses show that the toe of the wall becomes unstable with the presence of the weak rock mass below the toe, causing downward and outward movement of the wall. This movement would have caused the bottom anchors to fail in tension or pullout, subsequently causing progressive failure of the middle and top anchors.

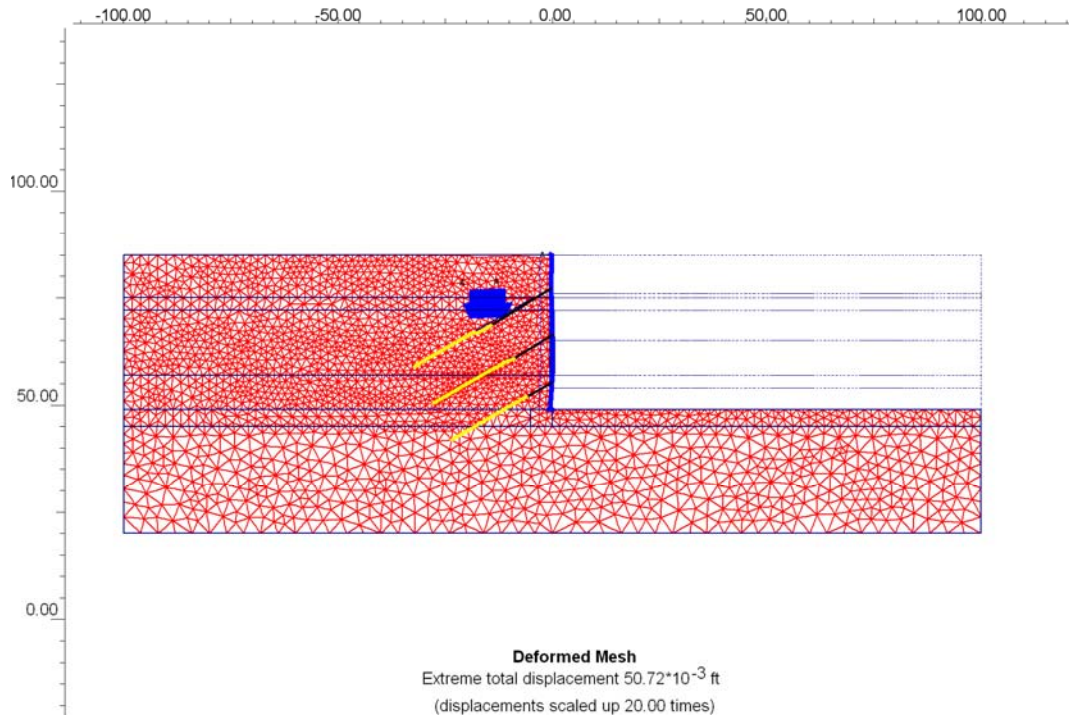
The second analysis simulates four more feet of excavation below the toe of the wall, replaces the material below the toe of the wall with soft elastic material and prescribes a 6-inches settlement to the wall. The deformed mesh of the analysis is shown below. The load in the bottom anchor is 302 kips.

Figure 17 Plaxis Analysis –Deformed Mesh for excavation to bottom of pile

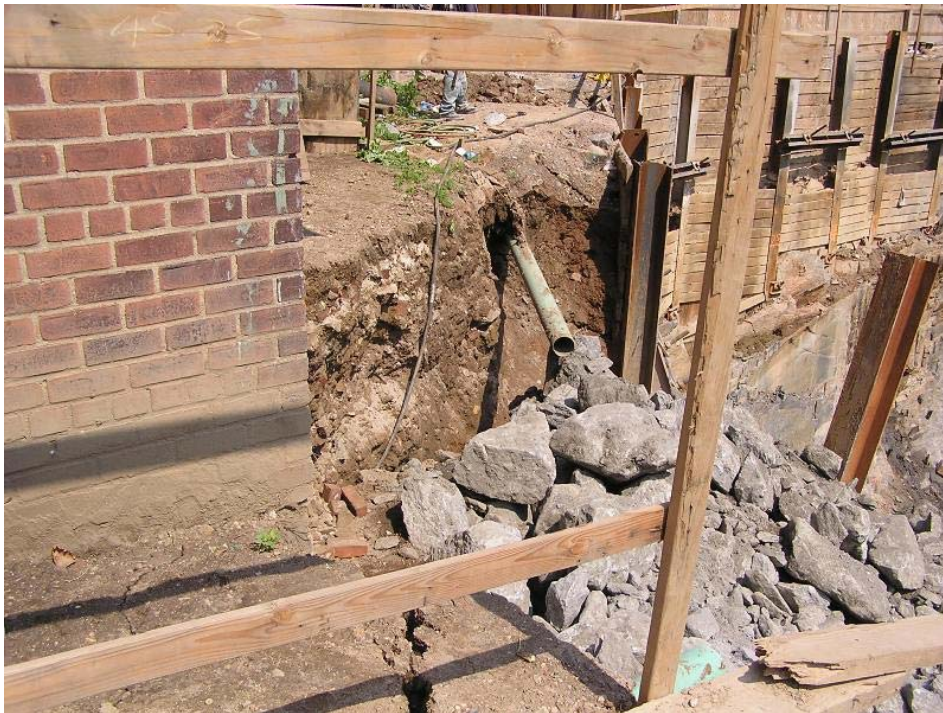
Water infiltration was present on the site, and a broken pipe was found in the incident area although it is not clear whether the breakage preceded the incident or not. In addition, two days before the incident there was a considerable rain with flash flood conditions throughout the region. Nevertheless, the setting of the sheet piling boards was such that water could not have accumulated behind them. More importantly, calculations considering an increase of the hydrostatic pressure of 25% show that a sheet piling system similar to the one in question would not have collapsed due to the presence of water.

Photo 11 – Broken drainage pipe at collapse area
