Audit Report on the Metropolitan Transportation Authority's Maintenance of Metro-North Railroad Stations within the City

FN06-063A

May 5, 2006

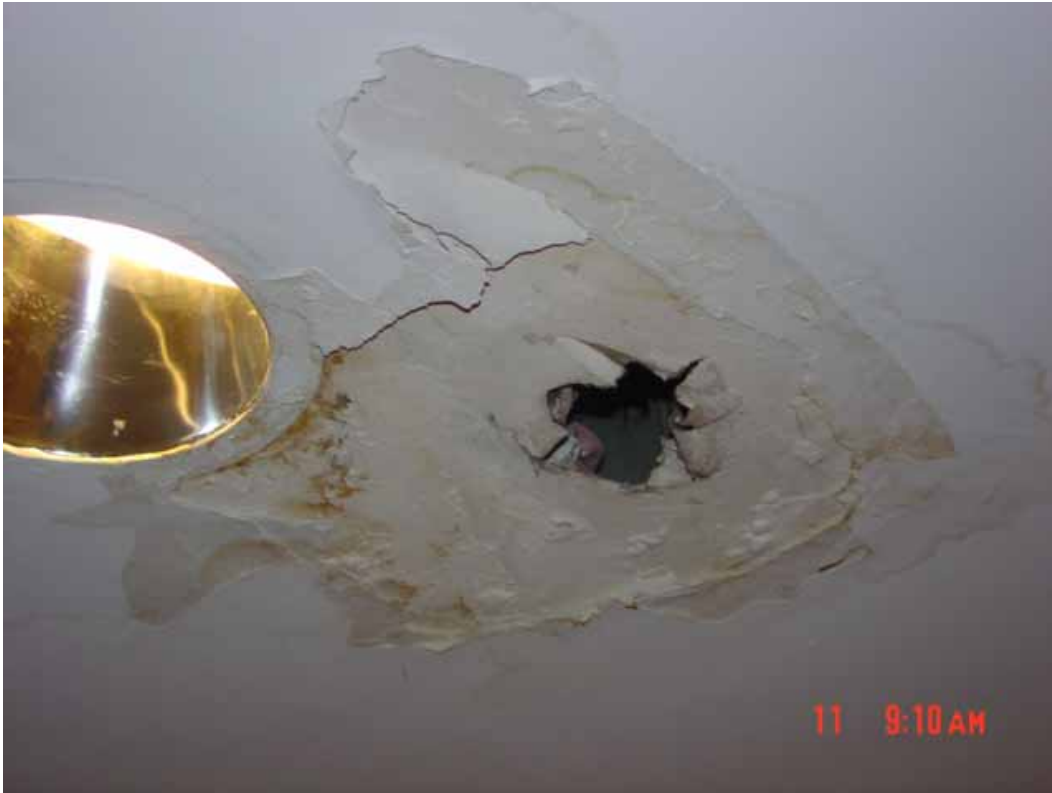
- The ceiling in the Stationmaster Office’s waiting room had a hole (see page 1 in the Appendix).
- A circuit breaker box on the Track 38 platform had no cover.

GRAND CENTRAL TERMINAL Hole in the ceiling of the Stationmaster Office's waiting room. Observed: October 11, 2005.

- The ceiling in the Stationmaster's Office in GCT is in the process of being repaired.
- Circuit Breaker box issues in GCT were taken care of on the day the inspection was performed.

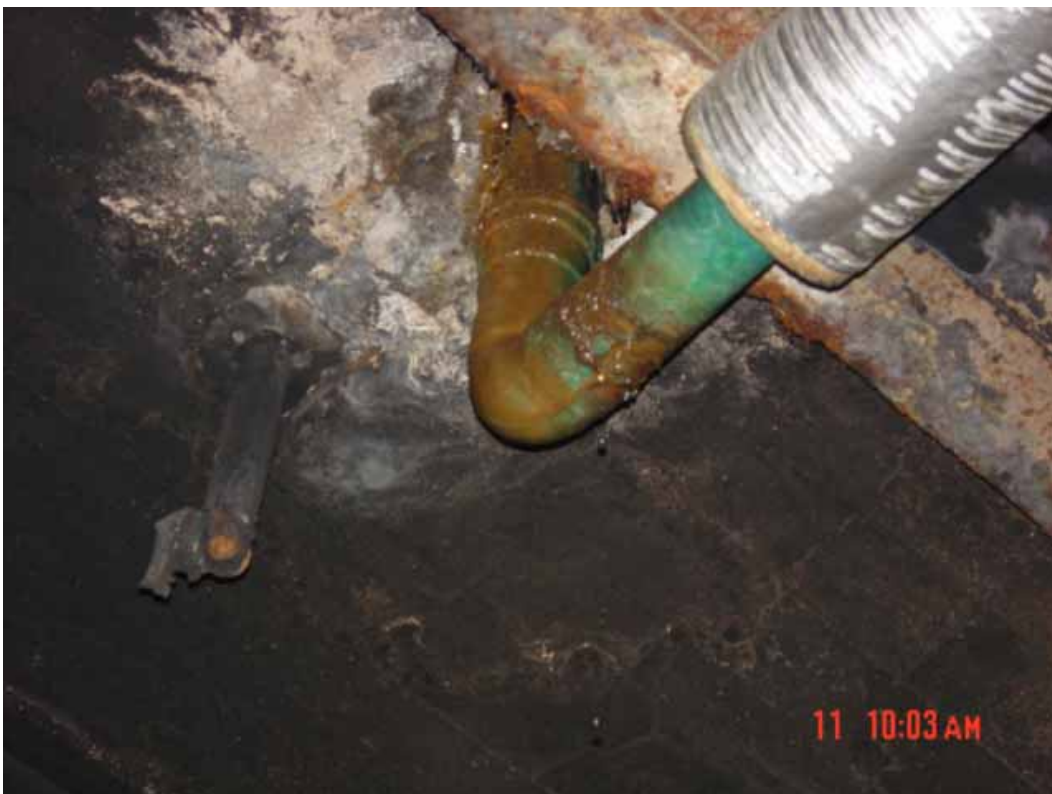
- The covers for three fuse boxes were unlocked and were opened.
- Water leaked from the ceiling pipes to platform Tracks 11, 14, 16, 17, 20, 29, 35 (see page 1 in the Appendix), 36, 37, 38, 39, 40, 41, 42, 107, 112, and 116.

GRAND CENTRAL TERMINAL Water leaking from the ceiling pipes to Track 35. Observed: October 11, 2005.

Water leaks within Grand Central Terminal remain an area of concern by both Metro-North and the City. There are continuing leaks throughout areas of Grand Central Terminal, which have been cited in audits conducted by the New York City Comptroller's Office. Metro-North has a capital project for Leak Remediation in GCT and the first phase has been completed by Metro-North, which included design. The major leaks around the station are the result of surface issues that need to be coordinated with New York City's Department of Transportation, as they require street repairs by the DOT. A tentative draft agreement in the form of a Memorandum of Understanding with the NYC DOT has been drafted jointly by Metro-North Counsel and NYC DOT Legal Department. The memorandum provides for shared funding of the project costs and specific elements of the scope of work. This includes replacement or rehabilitation of expansion joints on the viaduct, 42nd Street, Vanderbilt Ave., various sidewalks, and NYC DOT added work for traffic signals. We are presently working with the NYC DOT updating the agreement with the NYC DOT and working out the funding specifics. In the interim, Grand Central Building Maintenance will continue to make leak repairs as possible.

- Graffiti on columns in GCT has been removed.
- In GCT, water leaks as well as platform edges cannot be repaired via routine maintenance. As discussed in the conference these repairs are part of capital projects designed to address expansion joints and deteriorating platforms. This also is causing peeling paint. Leaks that are not due to leaking expansion joints have been repaired. The water leaks in GCT will be addressed with the Capital Project with the NYC DOT.

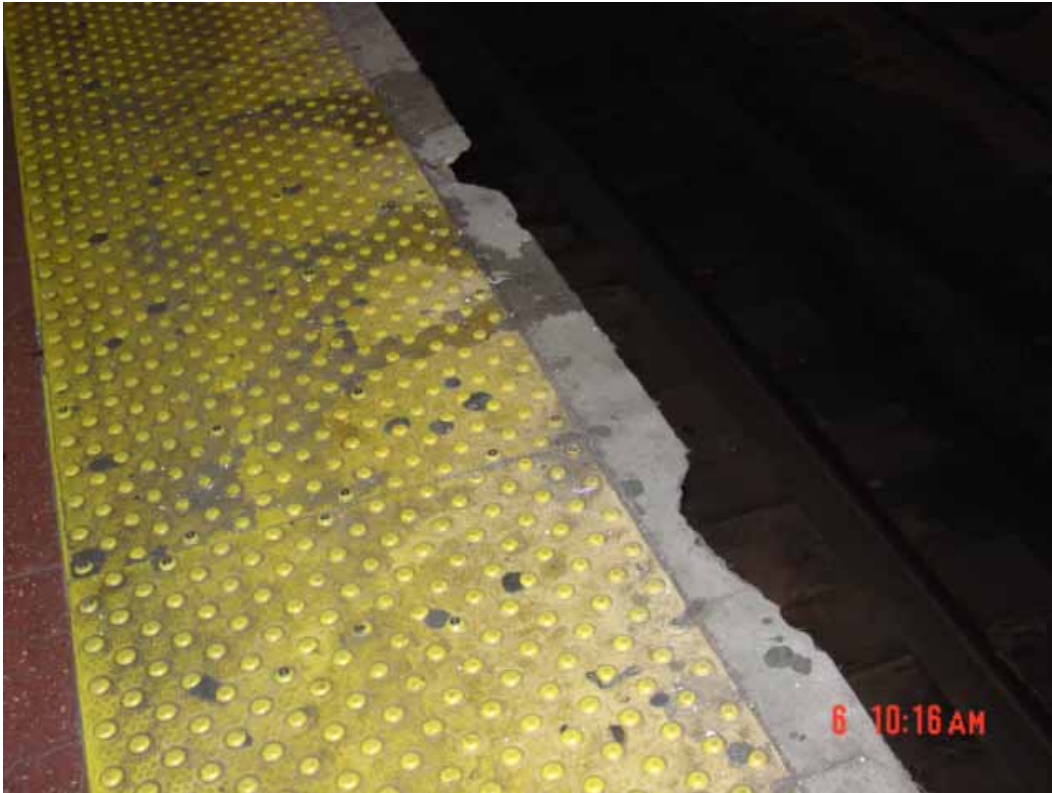
- There were raised and broken expansion joints on the platforms of Tracks 33, 34, 35, and 41, and broken platform edges on Tracks 11, 13, 16, 17, 19, 20, 21, 23, 24, 25, 26, 28, 29, 30, 32, 33, 34, 37, 38, 103, 107, 109, 110 (see pages 2 and 3 in the Appendix).

GRAND CENTRAL TERMINAL Broken platform edges at the south end of Track 16. Observed: October 6, 2005.

2. Partial Platform edge replacement (measured from the platform edge to the edge of the warning tactile strip) of the following:
 - Platform edge adjacent to track 33
 - Platform edge adjacent to track 32
 - Platform edge adjacent to track 30
 - Platform edge adjacent to track 29
 - Platform edge adjacent to track 26
 - Platform edge adjacent to track 23

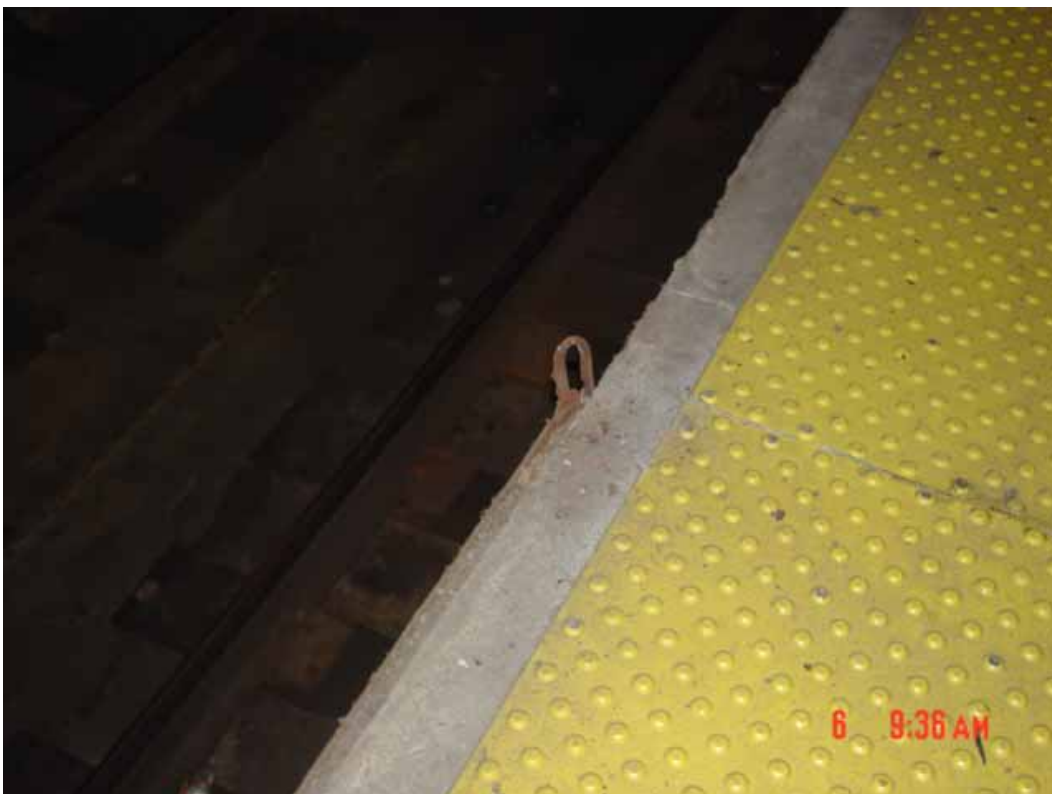
GRAND CENTRAL TERMINAL Piece of metal protruding from the Track 11 platform. Observed: October 6, 2005.

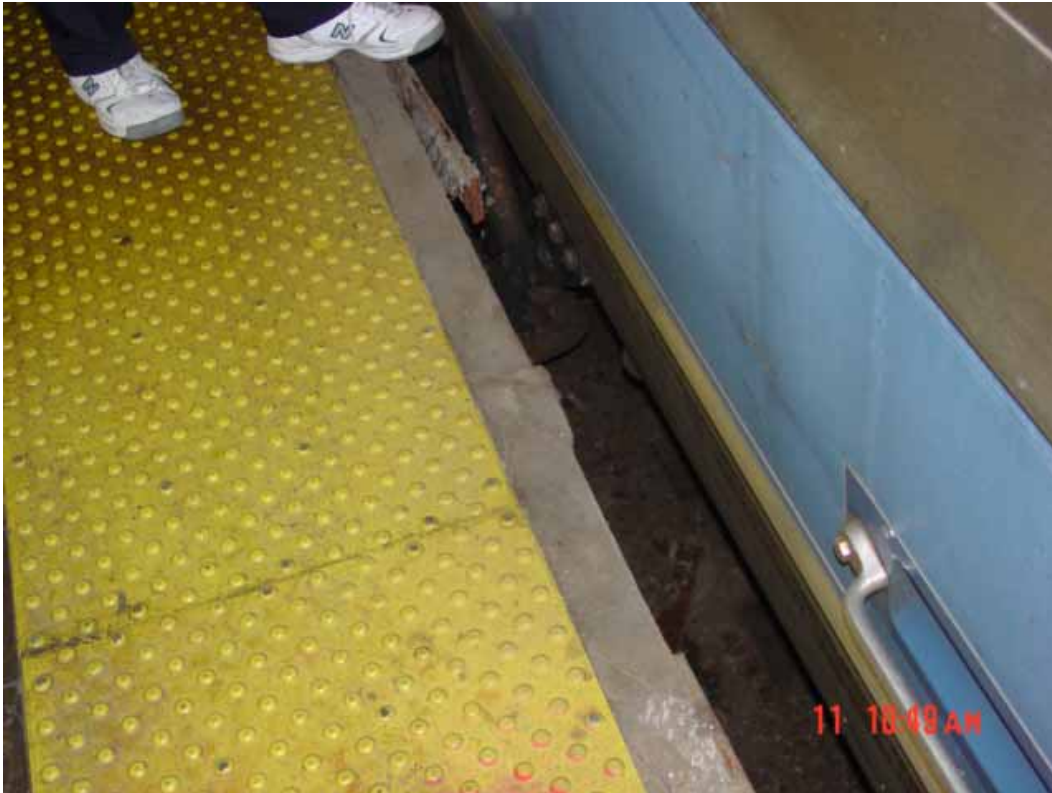
GRAND CENTRAL TERMINAL Loose and missing edgeboard on Track 38 platform. Observed: October 11, 2005.

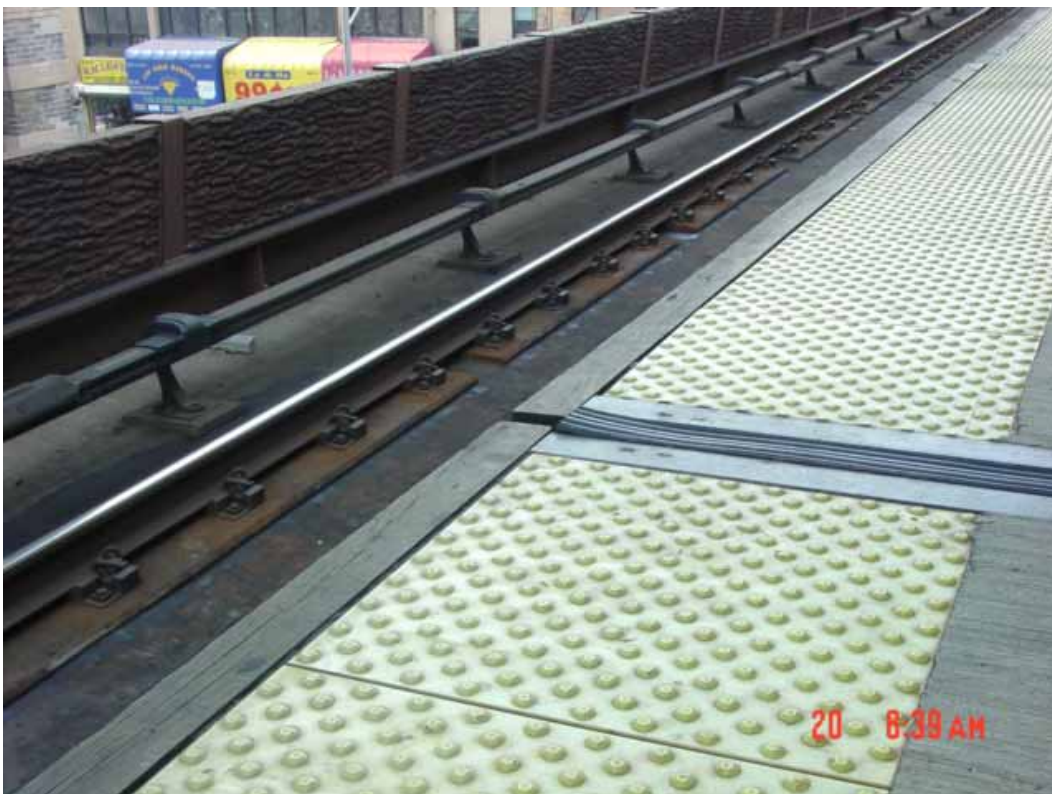
HARLEM-125th STREET Raised expansion joint on the Track 3 northbound platform. Observed: September 20, 2005.

- Metro-North's Track and Structures has made repairs at 125th Street Station, Fordham, Botanical Gardens, University Heights, and Spuyten Duyvil Station. Edgeboards were inspected and no repairs are required at this time. Missing edgeboards at Spuyten Duyvil Station were replaced.

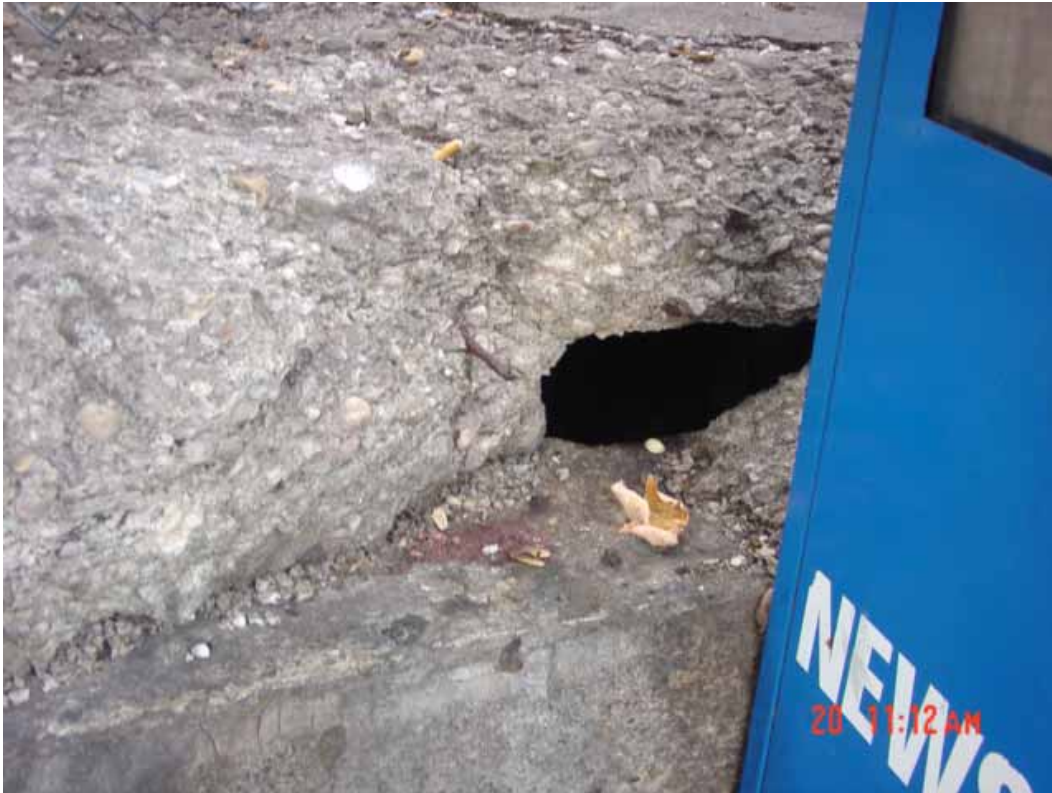
- There was broken and crumbling concrete by the staircase on northbound platform that exposed large holes and a metal rod (see page 4 in the Appendix).
- Litter (mostly bottles and cans) behind the fence on the northbound platform was not collected.
- Paint was peeling and wood was rotting from the ceiling of the ticket office building.
- Paint was peeling from the support beams of the canopy on the northbound platform.
- The metal chairs in the front of the northbound platform were loose and not properly secured.

FORDHAM Broken and crumbling concrete exposing a large hole by the Track 3 staircase. Observed: September 20, 2005.

- Attached is an update on the status of Capital Work at New York City Stations. It summarizes capital construction at all New York City stations. Fordham Station work is underway and the Fordham Station building will be completely rehabilitated as part of our Capital Program. The scope is currently under development. In GCT, expansion joint replacements and platform edge replacements will commence in 2007.

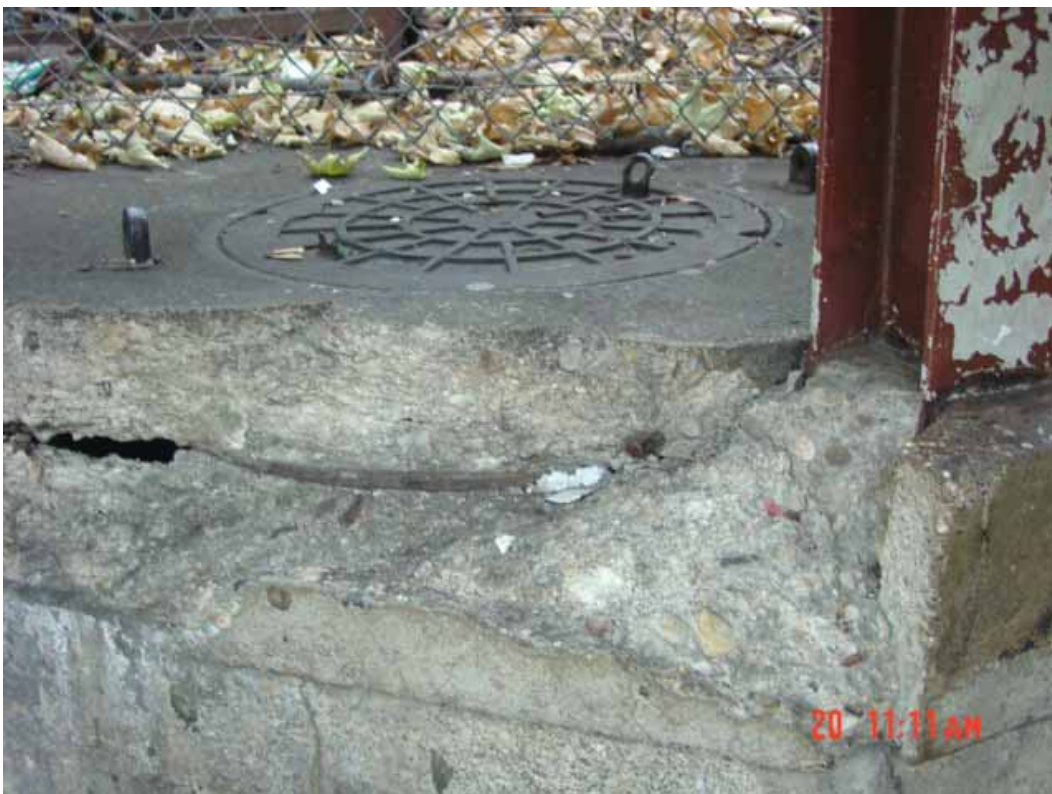
FORDHAM Broken and crumbling concrete exposing metal rods, and paint peeling from pole on the Track 3 of the northbound platform. Observed: September 20, 2005.

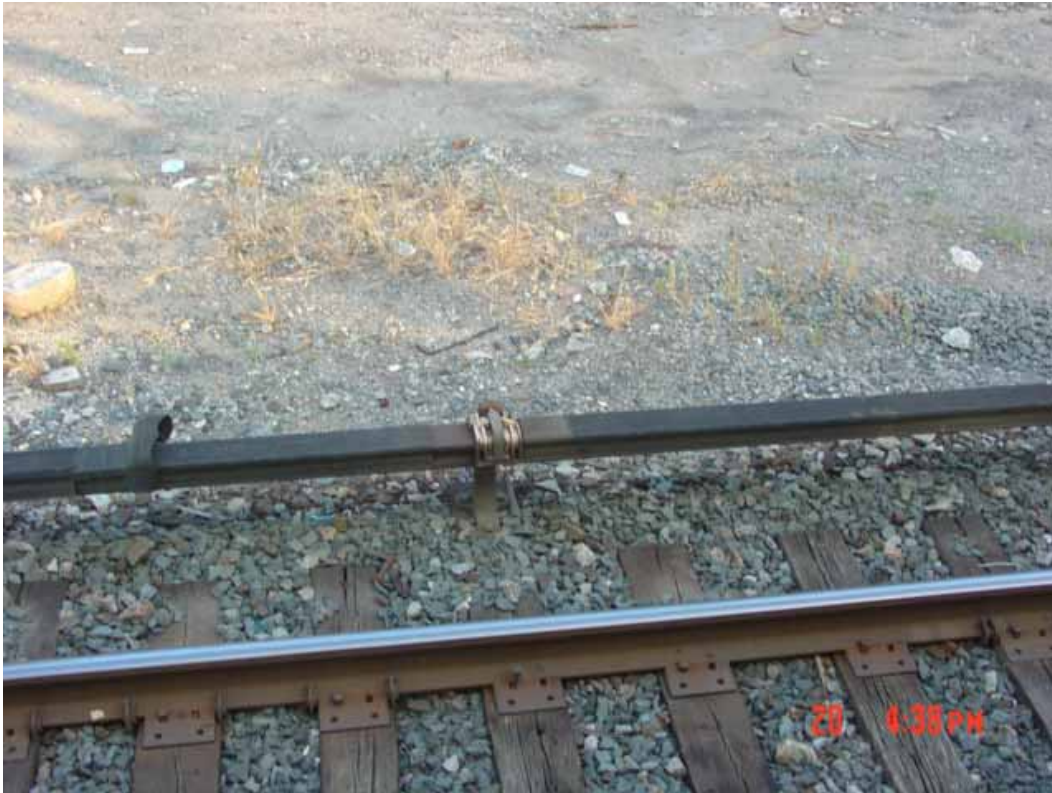
- A third rail protective cap was missing from the northbound track adjacent to the platform (see page 5 in the Appendix).

MORRIS HEIGHTS Broken third-rail cap on the northbound track at the rear of the platform. Observed: September 20, 2005.

- Metro-North's Power Department repaired all third rail covers in February 2006 and addressed areas identified in the report. The Power Department inspects the mainline quarterly and effects repairs as required.

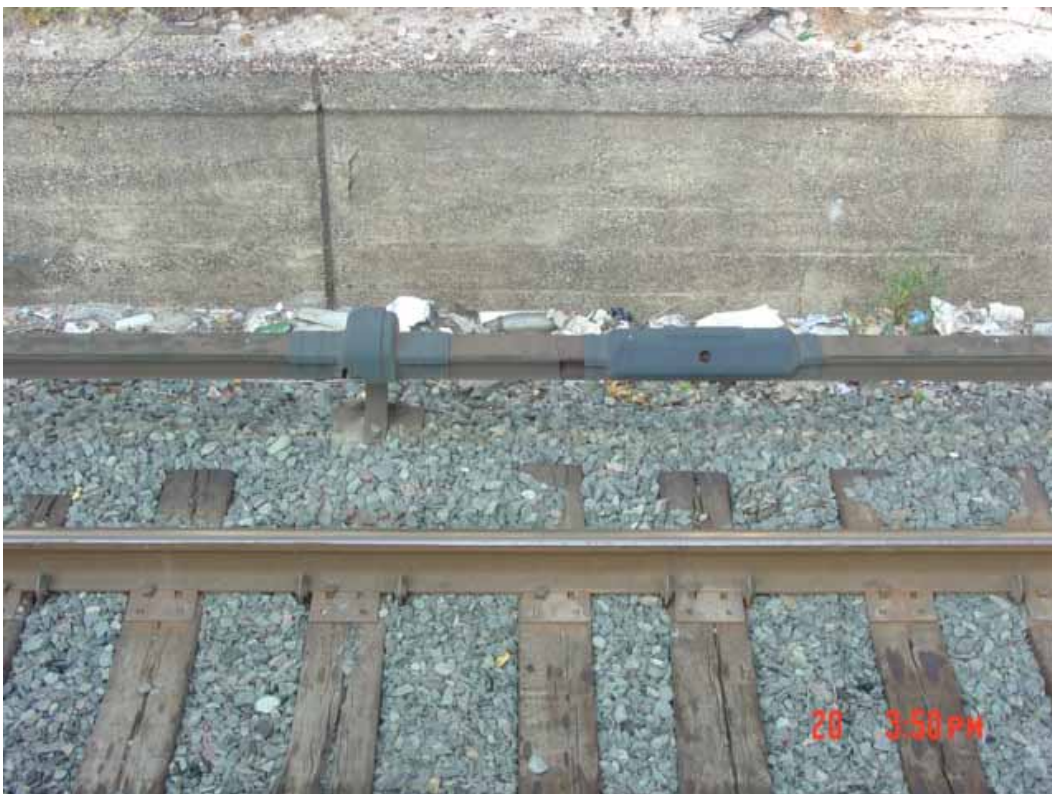
- A third rail protective cap and sleeve cover were missing from the northbound track adjacent to the platform (see page 5 in the Appendix).

MARBLE HILL Missing third-rail sleeve cover on northbound track at the front of the northbound platform. Observed: September 20, 2005.

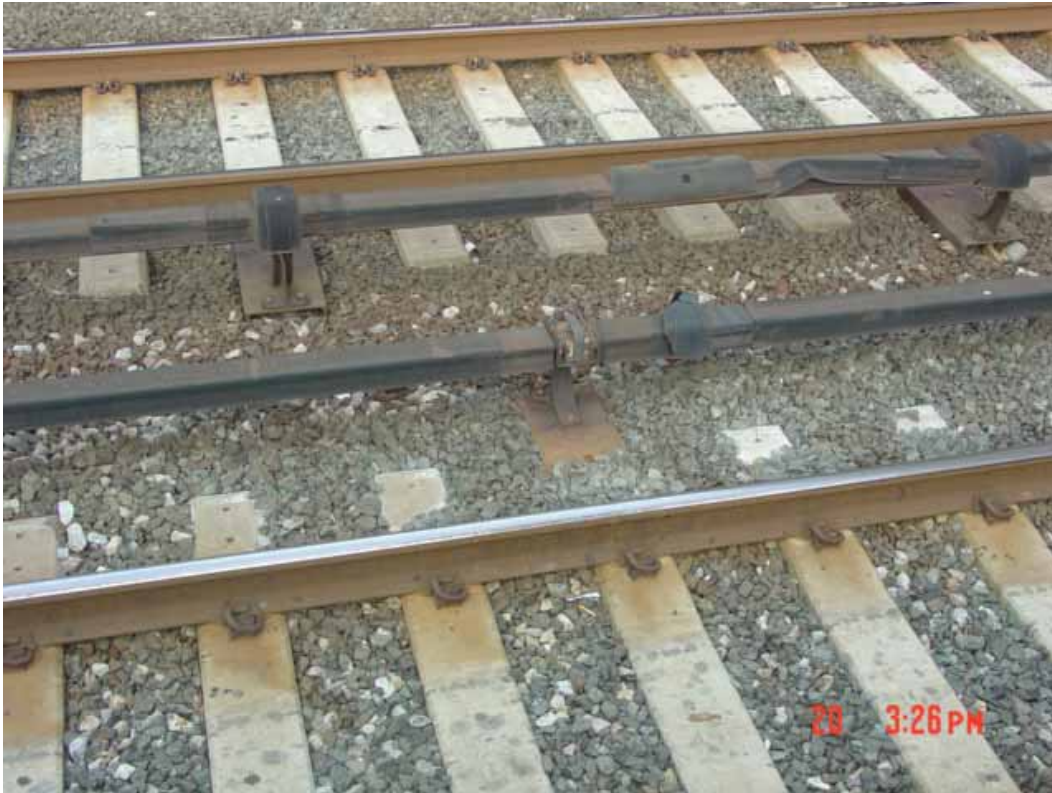
- The middle of the southbound platform was missing an edgeboard.
- The northbound platform had cracked and splintered edgeboards.
- Third rail protective caps were missing along the tracks at the middle of the northbound and southbound platforms. (see page 6 in the Appendix).

SPUYTEN DUYVIL Broken third-rail cap on the northbound track by the front of the northbound platform. Observed: September 20, 2005.

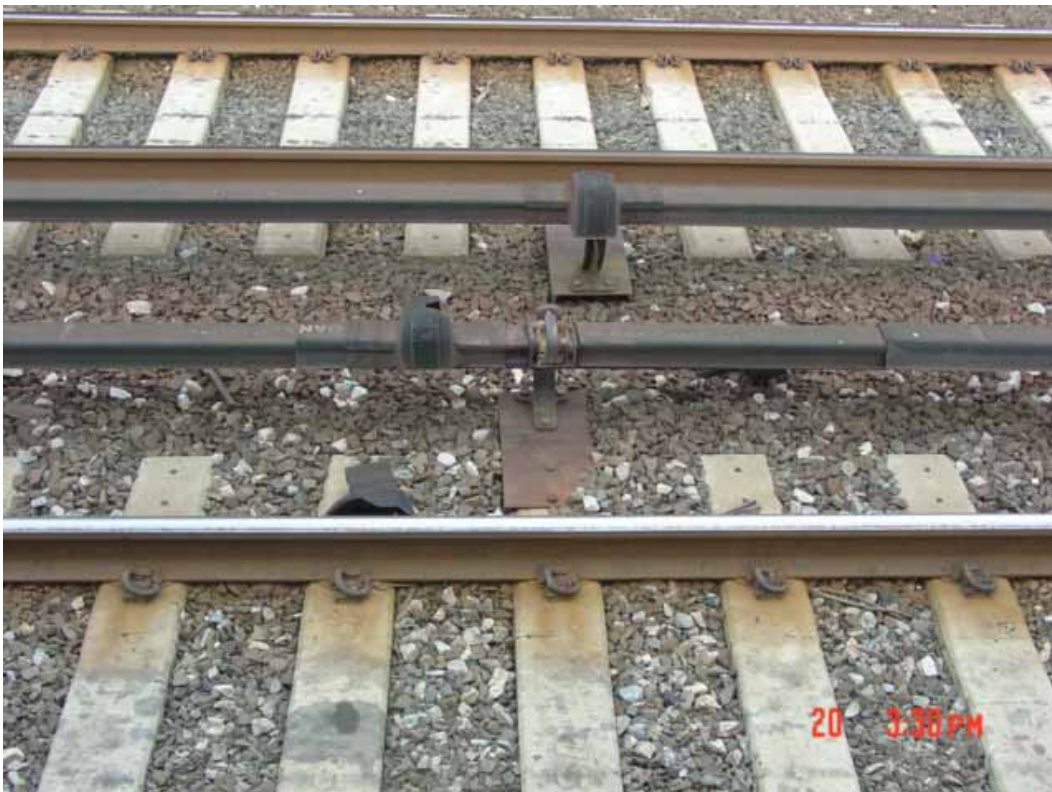
SPUYTEN DUYVIL Broken third-rail cap on the southbound express track by the front of the southbound platform. Observed: September 20, 2005.
