Audit Report on the Metropolitan Transportation Authority's Maintenance of Long Island Rail Road Stations within the City

FN06-062A

May 5, 2006

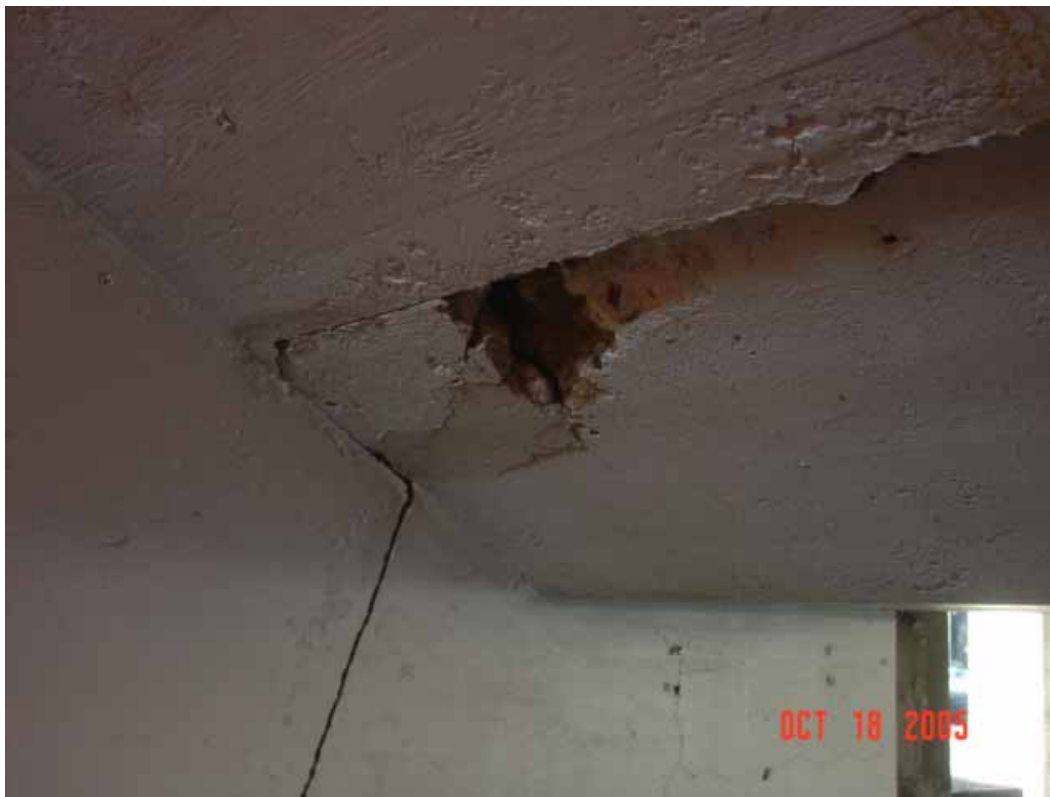
- The east end staircase had broken and crumbling concrete that created a hole under the staircase (see page 1 in the Appendix).
- Paint was peeling from the walls of the west end staircase.

AUBURNDALE Broken and crumbling concrete underneath the east end staircase. Observed: October 18, 2005.

Location	Condition	Remedy	Corrective Action
Anburndale	The east end staircase had broken and crumbling concrete that created a hole under the staircase. Paint was peeling from the walls of the west end staircase.	Repair the concrete on east end staircase and correct peeling paint from walls of west end staircase.	Trouble tickets have been generated and work will be scheduled when weather conditions permit and manpower is available.
Bayside	Concrete was broken and crumbling by the yellow tactile safety strip in the middle of the eastbound platform. Piece of the westbound platform edge was missing. Graffiti at the rear of the eastbound platform embankment. Paint was peeling from the westbound platform canopy.	Repair the concrete by tactile strip, replace westbound platform edge, remove graffiti and correct peeling paint on canopy.	Trouble tickets have been generated. Concrete work commenced on 3/27. Painting request to be scheduled when weather permits.

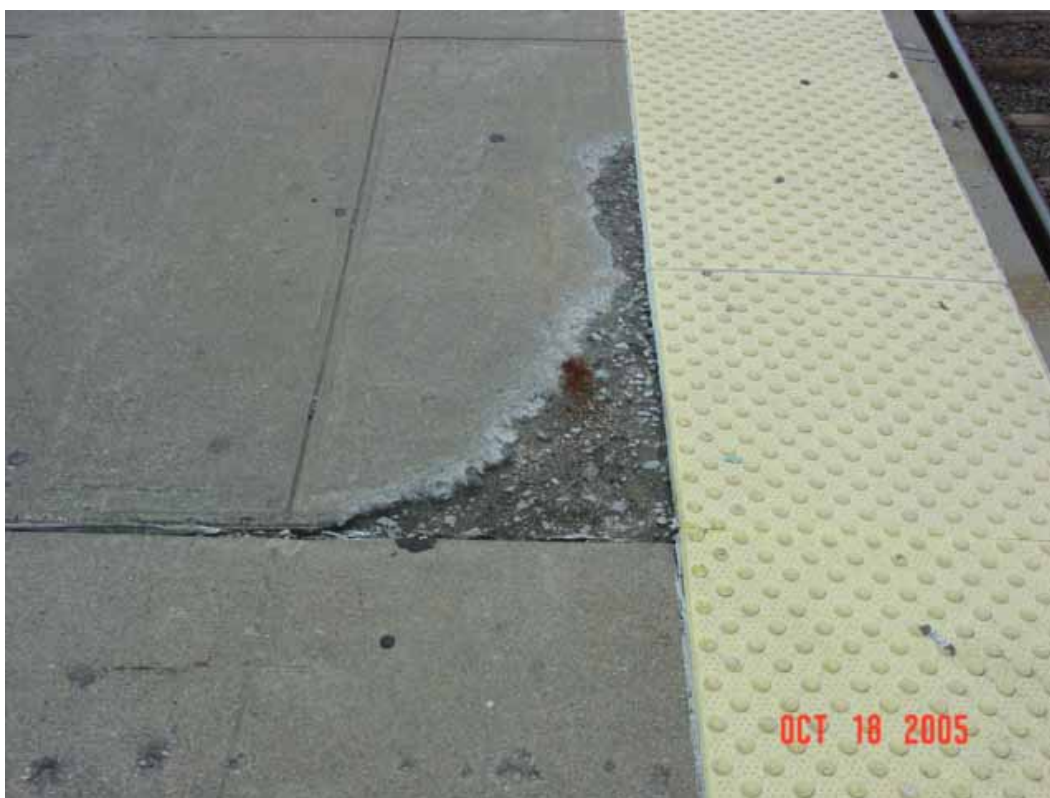
- Concrete was broken and crumbling by the yellow tactile safety strip in the middle of the eastbound platform (see page 1 in the Appendix).
- A piece of the westbound platform edge was missing (see page 2 in the Appendix).
- There was graffiti at the rear of the eastbound platform.
- Paint was peeling from the westbound platform canopy.

BAYSIDE Broken and crumbling concrete by the tactile strip on the eastbound platform. Observed: October 18, 2005.

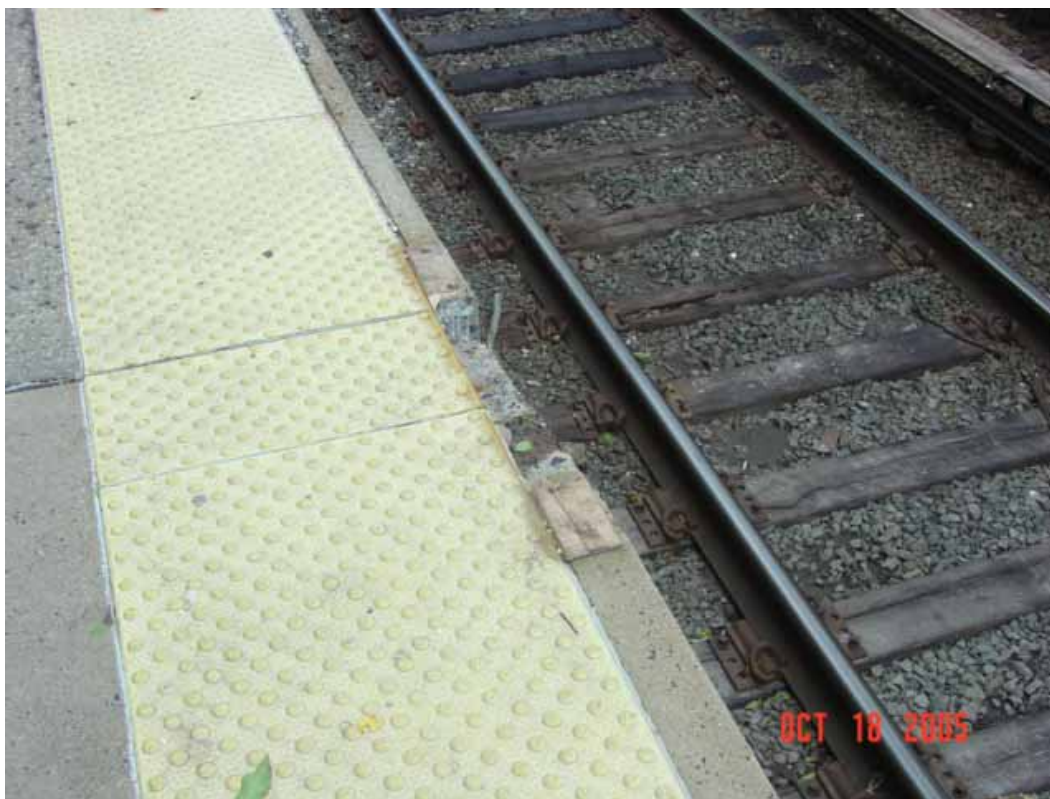
BAYSIDE Broken platform edge on the westbound platform. Observed:
October 18, 2005.

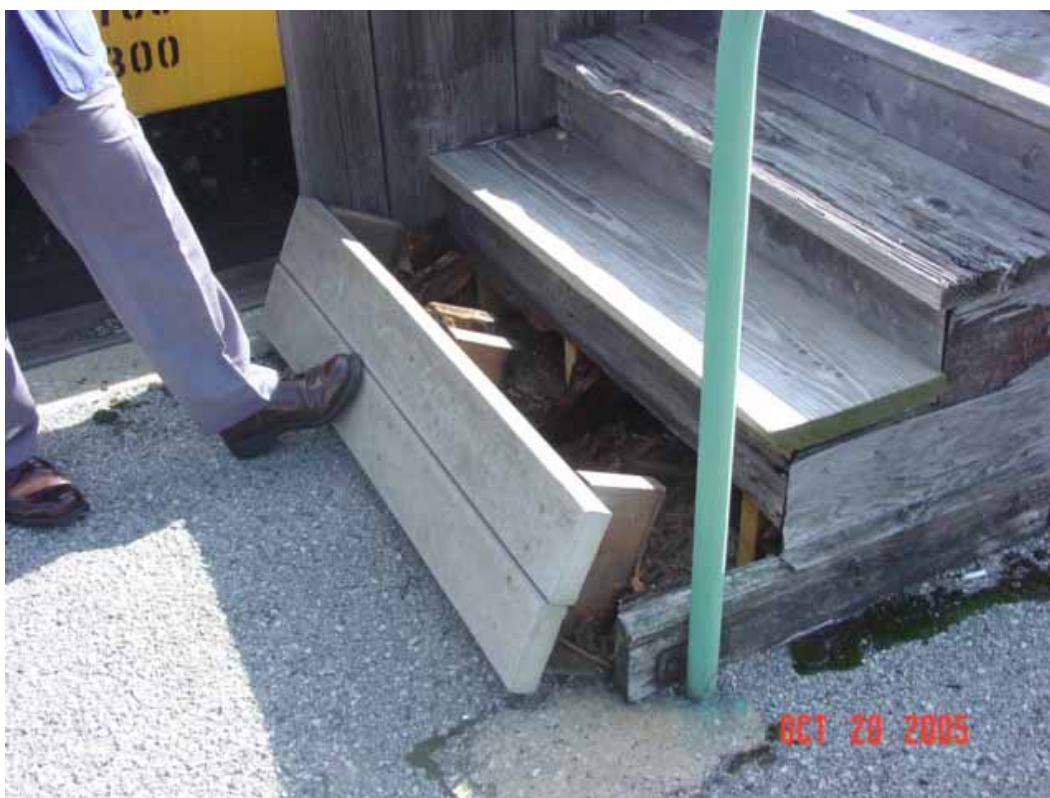
- The platform canopies on Track 1-2, Track 3-4, Track 5-6, and Track 7-8 had rotted wood, peeling paint, and rusted roofs, and sections of the Track 7-8 platform canopy were missing.
- Broken and discarded railroad ties were placed by the Track 2 staircase.
- The wooden staircases on Tracks 2, 3, 4, 6, and 7 had loose and broken planks and broken steps (see page 2 in the Appendix), some with rusted nails protruding from them.

BELMONT PARK Damaged step on staircase 14 of Track 7. Observed:
October 20, 2005.

Belmont Park	Platform canopies on Track 1-2, Track 3-4, Track 5-6, and Track 7-8 had rotted wood, peeling paint, and rusted roofs, and sections of the Track 7-8 platform canopy were missing. Broken and discarded railroad ties were placed by the Track 2 staircase. Wooden staircases on Tracks 2, 3, 4, 6 and 7 had loose and broken planks and broken steps, some with rusted nails protruding from them.	As indicated in our prior responses, this station is the responsibility & is maintained by the New York Racing Association.	Passenger Services & Engineering Departments inspect Belmont Park before every racing season and large racing events. Repairs have been made by LIRR forces as required to provide customer safety, but ultimately it is the responsibility of the NYRA.
Broadway	This station is currently undergoing capital renovations.	None at this time.	Station platform renovations are ongoing at this time.

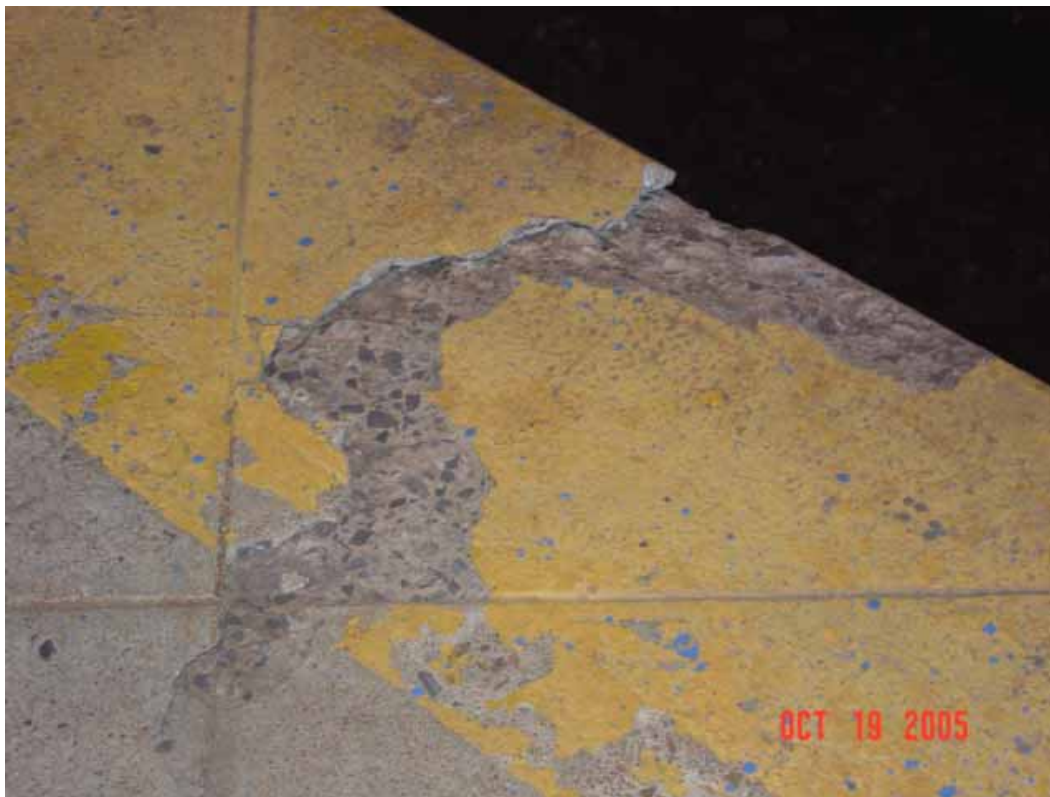
EAST NEW YORK Broken concrete at the edge on the westbound platform.
Observed: October 19, 2005.

Douglaston	Westbound platform ticket office building had a loose gutter hanging from its roof.	Repair gutter.	Trouble Ticket was generated and job was completed.
East NY	A large piece of concrete on the westbound platform was broken and crumbling, as was the concrete at the platform edge of the rear eastbound platform. Steps and treads on the Van Sinderen Avenue staircases were broken and chipped. Top of the Van Sinderen Avenue staircase had graffiti.	This station continues to be subjected to a high degree vandalism with these conditions occurring continuously and are being addressed upon notification.	Trouble Tickets are repeatedly generated and worked on with passenger services and engineering responding to all station maintenance concerns, vandalism and support. As quickly as the problems are corrected they will sometimes reoccur only days later.
Far Rockaway	Handicapped access ramp had broken and crumbling concrete. Track 1 platform had deteriorating edges.	Repair the concrete access ramp and the platform edges on track 1.	Trouble Ticket was generated for the access ramp and job was completed. Trouble ticket generated for the platform edges, work to be scheduled when manpower is available.

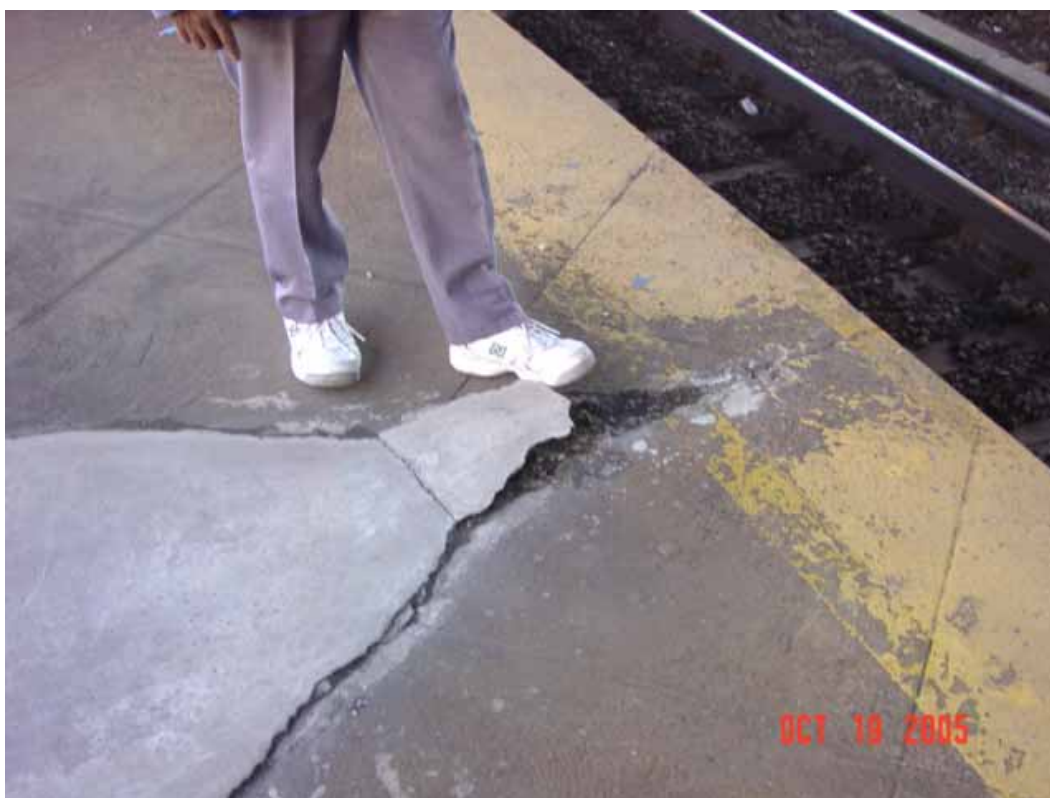
- A large piece of concrete on the westbound platform was broken and crumbling (see page 3 in the Appendix), as was the concrete at the platform edge of the rear eastbound platform (see page 5 in the Appendix).
- The steps and treads on the Van Sinderen Avenue staircases were broken and chipped (see page 4 in the Appendix).
- The top of the Van Sinderen Avenue staircase had graffiti.

EAST NEW YORK Broken and crumbling concrete on the westbound platform.
Observed: October 19, 2005.

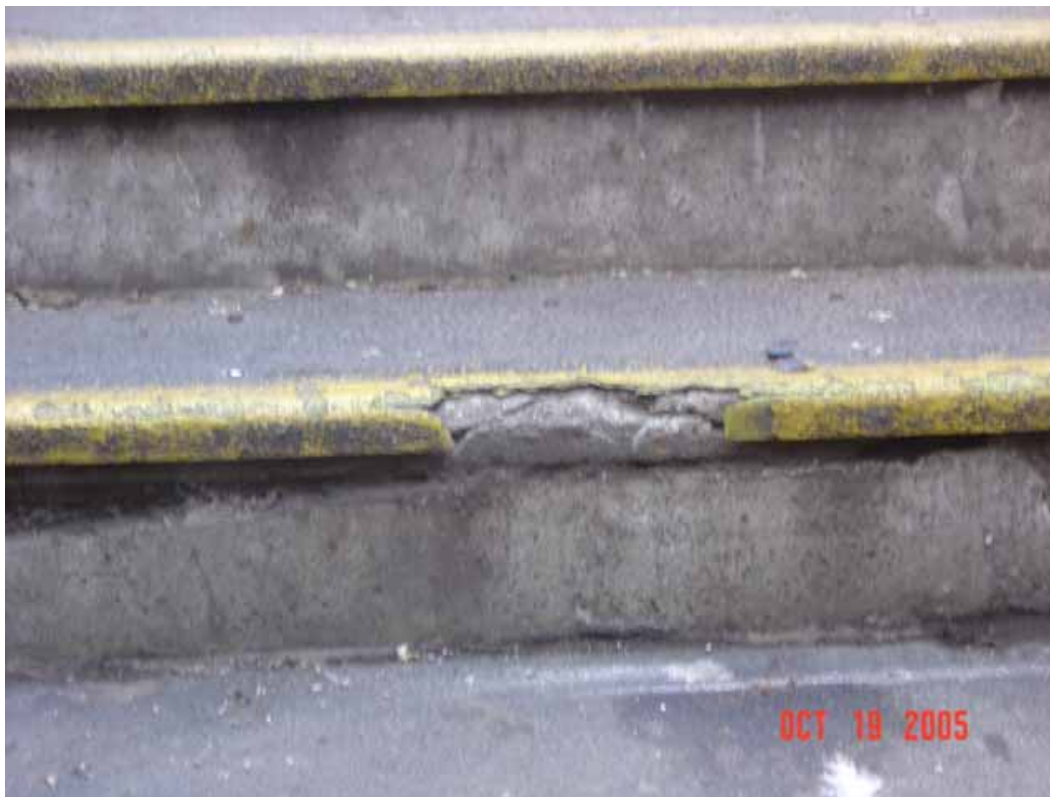
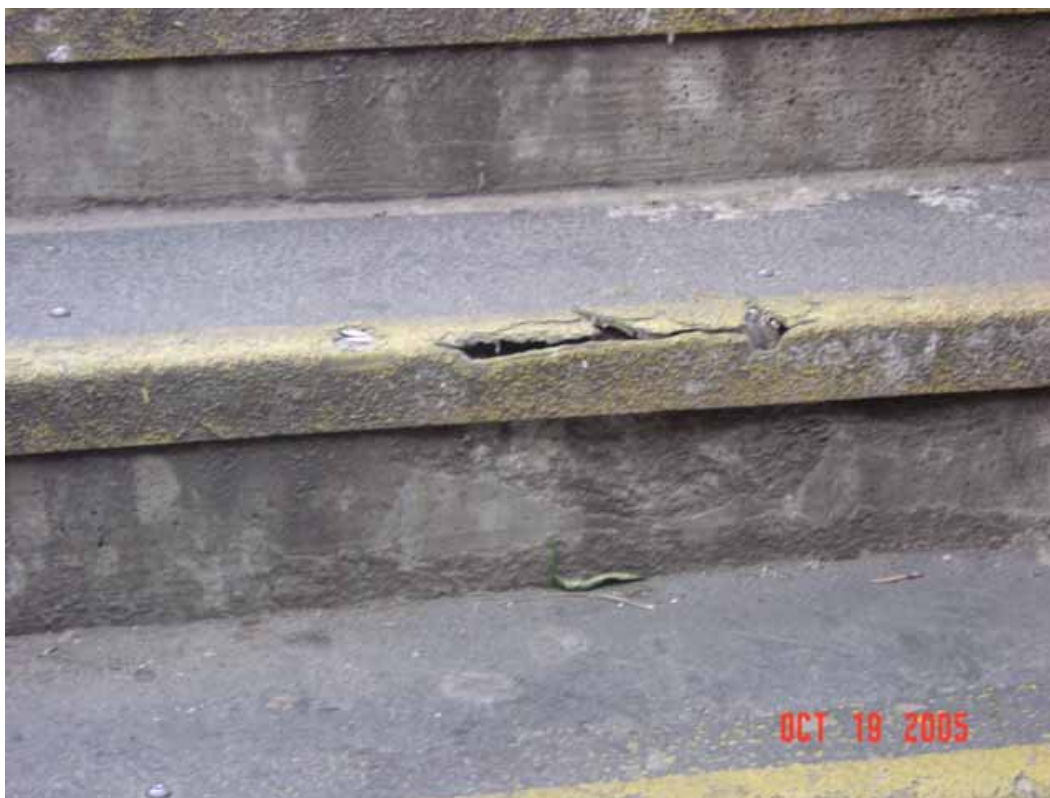
EAST NEW YORK Broken stair tread on the Van Sinderen Avenue staircase.
Observed: October 19, 2005.

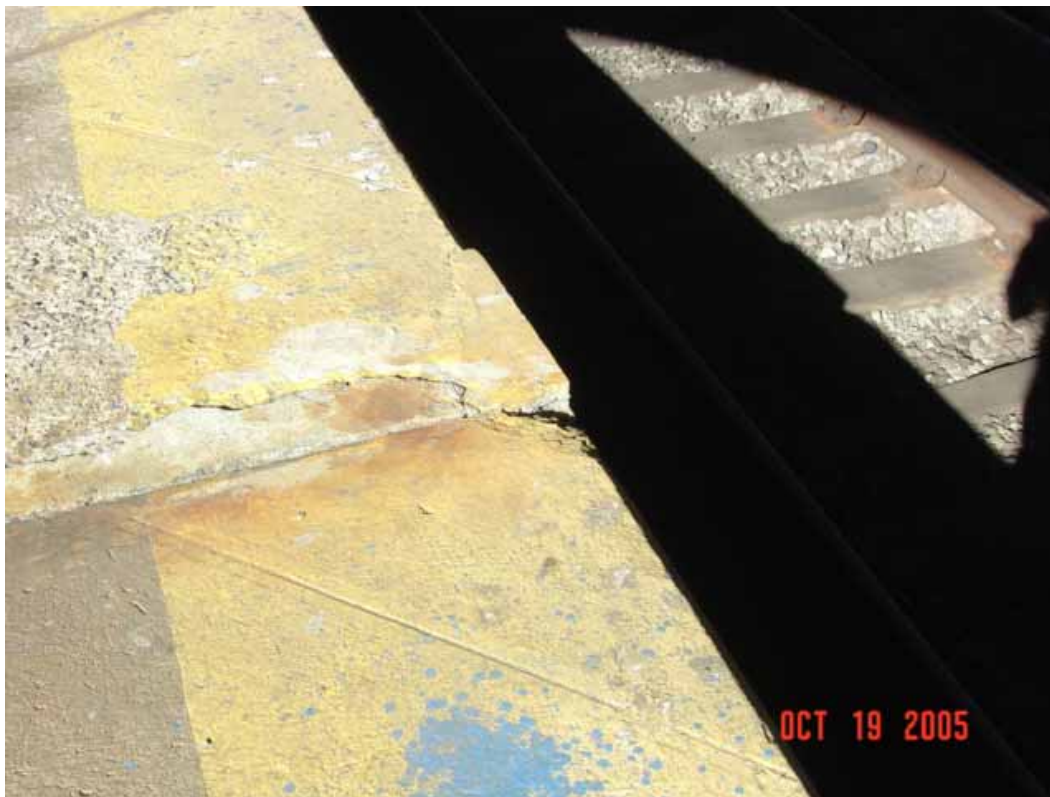
EAST NEW YORK Broken concrete at the edge of the eastbound platform.
Observed: October 19, 2005.

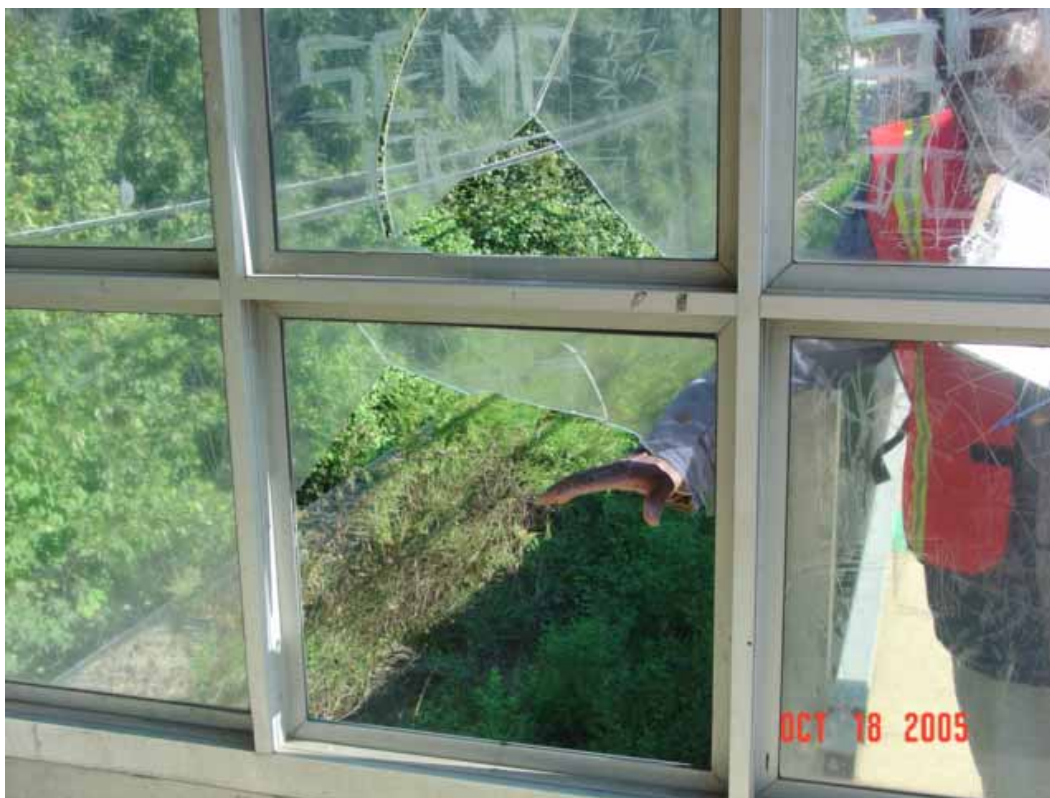
- There were two broken plexiglass window panes with jagged edges at the west end shelter, which is in the front of the westbound platform (see page 5 in the Appendix).
- There was a large hole in the fence in the front of the eastbound platform.
- Graffiti was on the pillars under the rear of the eastbound and under the front of the westbound platforms.
- Litter went uncollected at the side of the eastbound staircase.

FLUSHING MAIN STREET Two broken Plexiglas window panes in the west end shelter on the westbound platform. Observed: October 18, 2005.

Location	Condition	Remedy	Corrective Action
Flatbush Ave.	This station is currently undergoing capital renovations.	None at this time.	Station building renovations are ongoing at this time.
Flushing	There were two broken Plexiglas window panes with jagged edges at the west end shelter located at the front of the westbound platform. There was a large hole in the fence in the front of the eastbound platform. Graffiti found on the pillars under the rear of the eastbound platform and under the front of the westbound platform. Litter went uncollected at the side of the eastbound staircase.	Repair broken windows in the shelter shed and large hole in fence. Remove graffiti and all litter & debris at the sides of the east bound staircase, which is a continuous problem and is being addressed upon notification.	Broken windows in the shelter shed were repaired. All litter and debris was removed on 12/27/05. The large hole in the fence has been repaired.

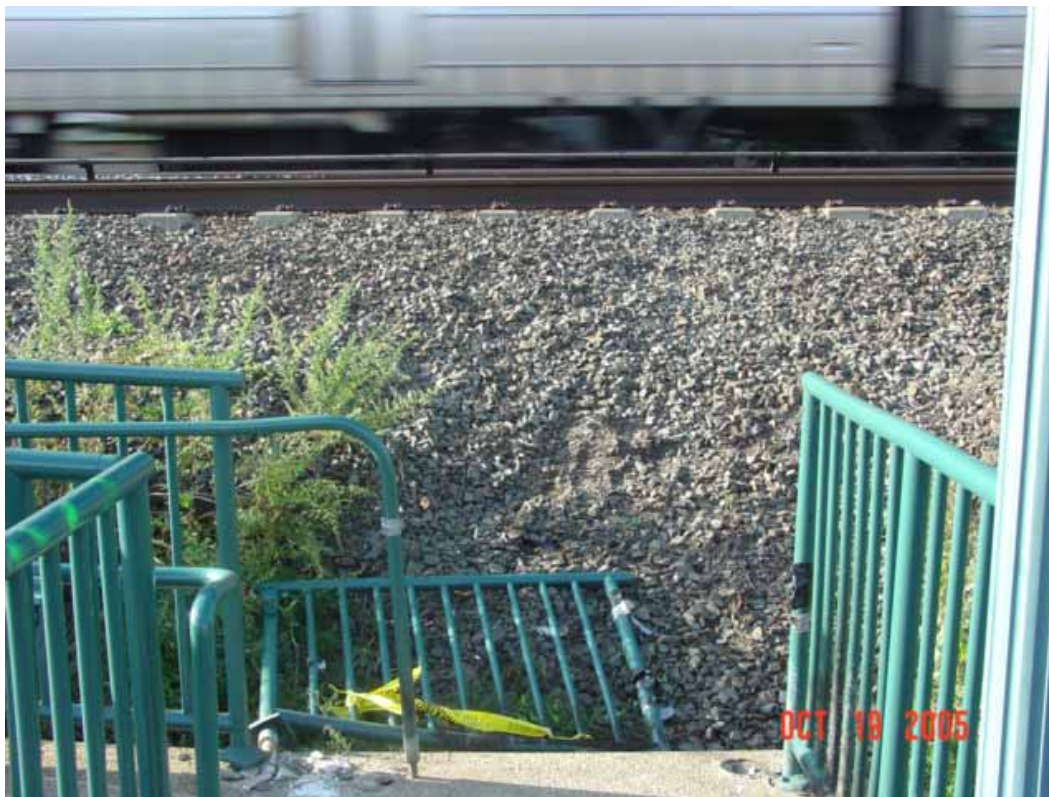
- A section of the handicapped railing leading to the westbound platform collapsed, and the remainder of the railing was loose (see page 6 in the Appendix).
- Windows in the waiting areas at the front of the westbound platform and at the rear of the eastbound platform were broken and cracked (see page 6 in the Appendix).
- Graffiti was found beneath the westbound platform.

FOREST HILLS Broken railing on the handicapped ramp at the front of the westbound platform. Observed: October 19, 2005.

Forest Hills	A section of the handicapped railing leading to the westbound platform collapsed and the remainder of the railing was loose. Windows in the waiting areas at the front of the westbound platform and at the rear of the eastbound platform were broken and cracked. Graffiti found beneath the westbound platform.	Repair handicapped railing, broken & cracked windows in waiting areas and remove graffiti under the westbound platform.	Handicapped railing was repaired and broken & cracked windows repaired. Trouble ticket has been generated for graffiti removal and is waiting to be scheduled.
Hollis	The stone side railings on the eastbound and westbound platforms had broken concrete that exposed rusted metal. Litter by the westbound platform was uncollected.	Repair broken concrete and exposed metal on stone railings on both east and west bound sides. Remove litter and debris by westbound platform.	Litter and debris occur continuously and have been addressed constantly upon notification. Trouble Ticket for repair of concrete and exposed metal has been generated and is waiting to be scheduled for completion.

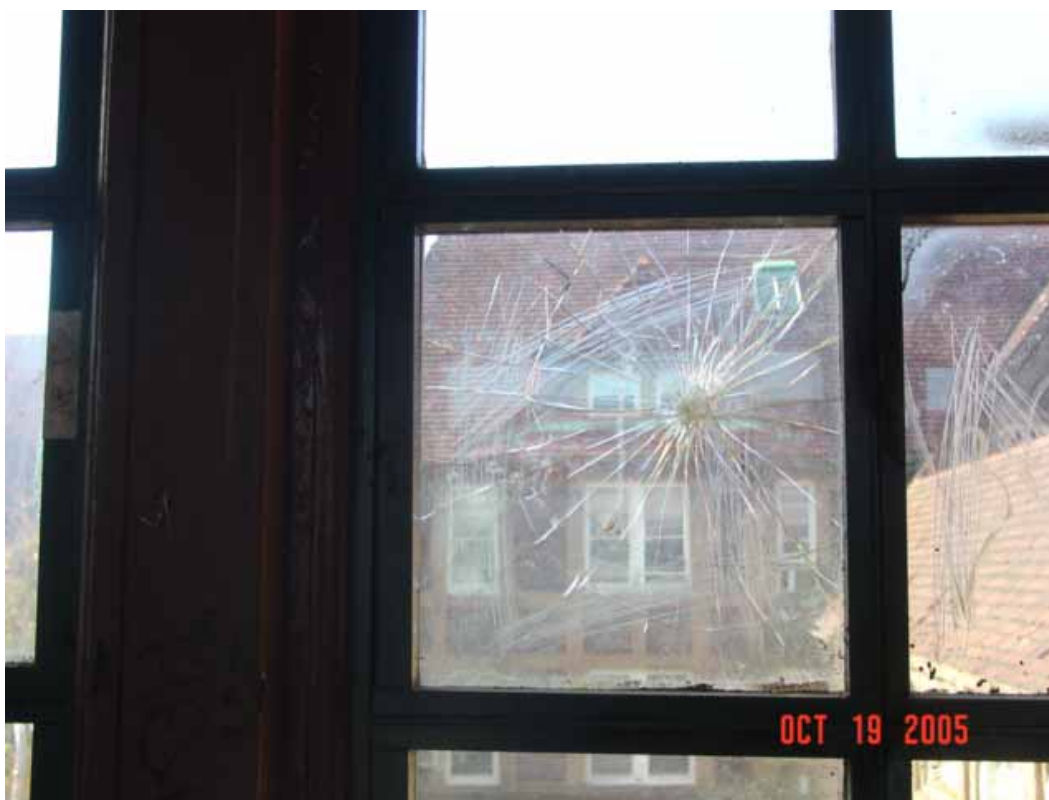
FOREST HILLS Cracked and broken window pane in the eastbound waiting area. Observed: October 19, 2005.

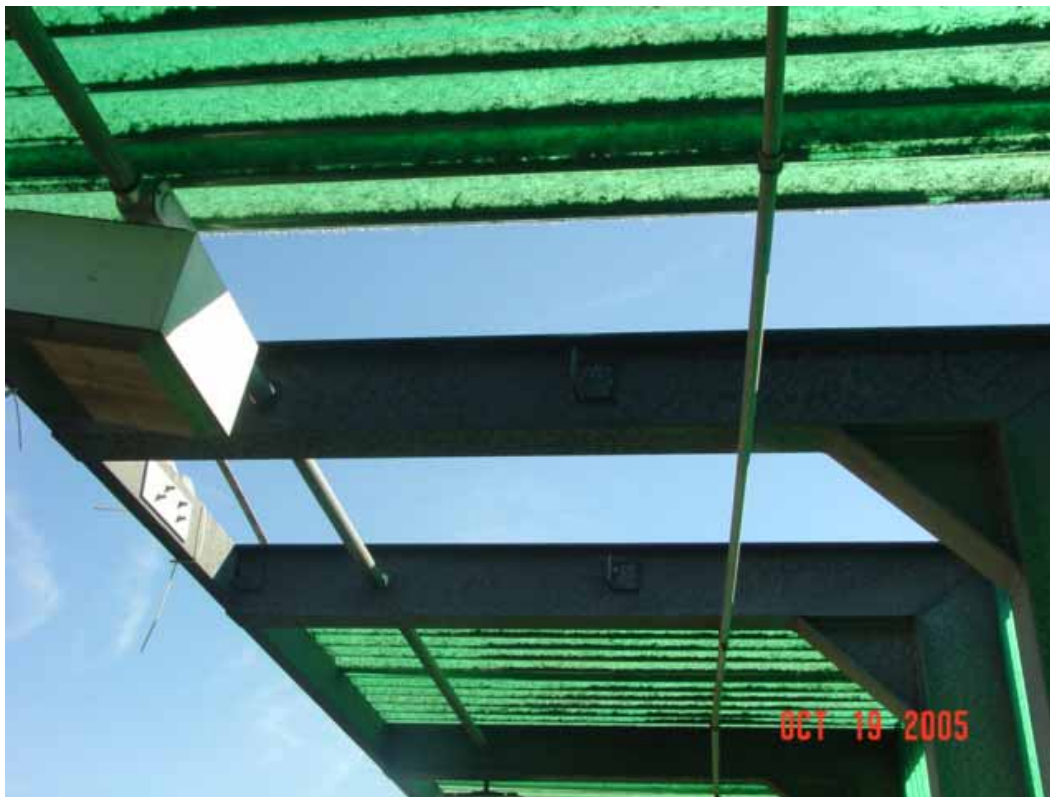
NOSTRAND AVENUE Missing fiberglass covers over the eastbound platform canopy. Observed: October 19, 2005.

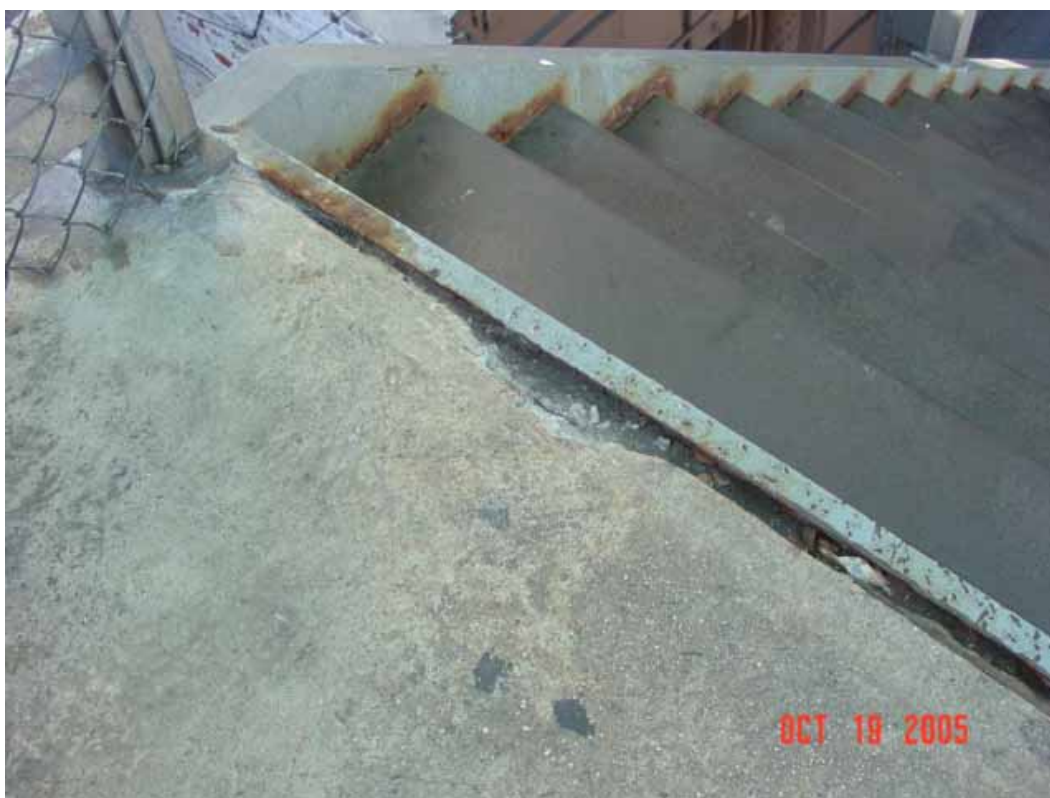
NOSTRAND AVENUE Broken concrete at the top of the west end staircase. Observed: October 19, 2005.

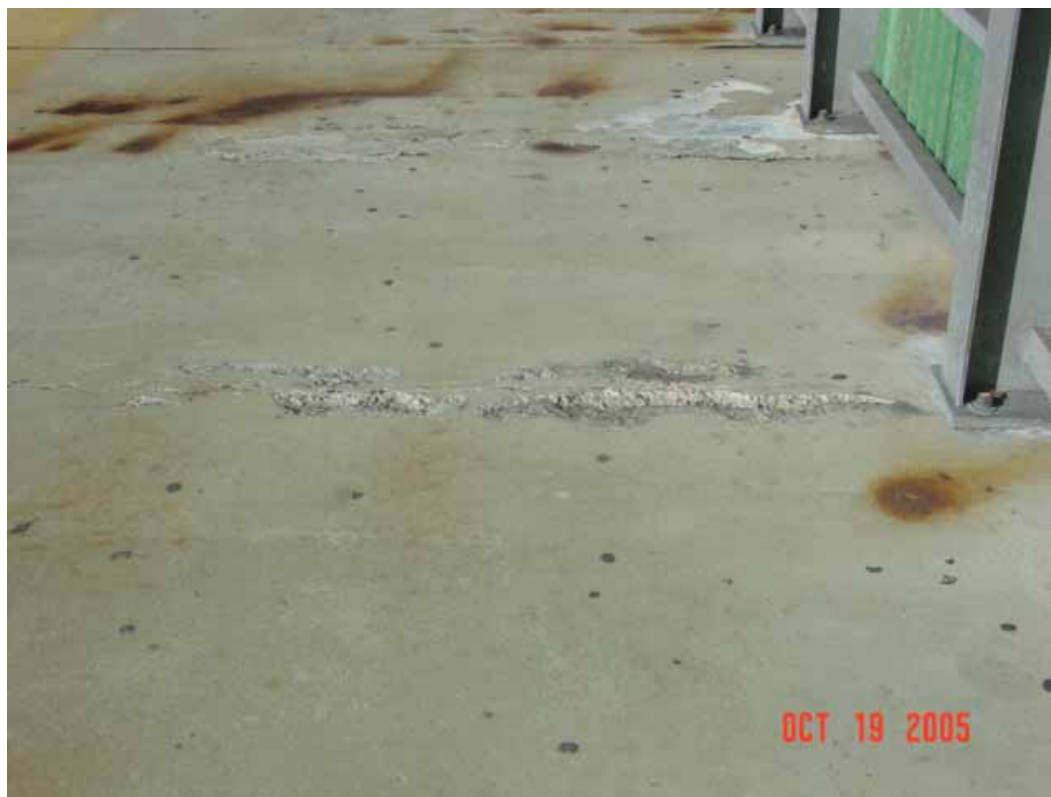
NOSTRAND AVENUE Broken and crumbling concrete at the front of the westbound platform. Observed: October 19, 2005.

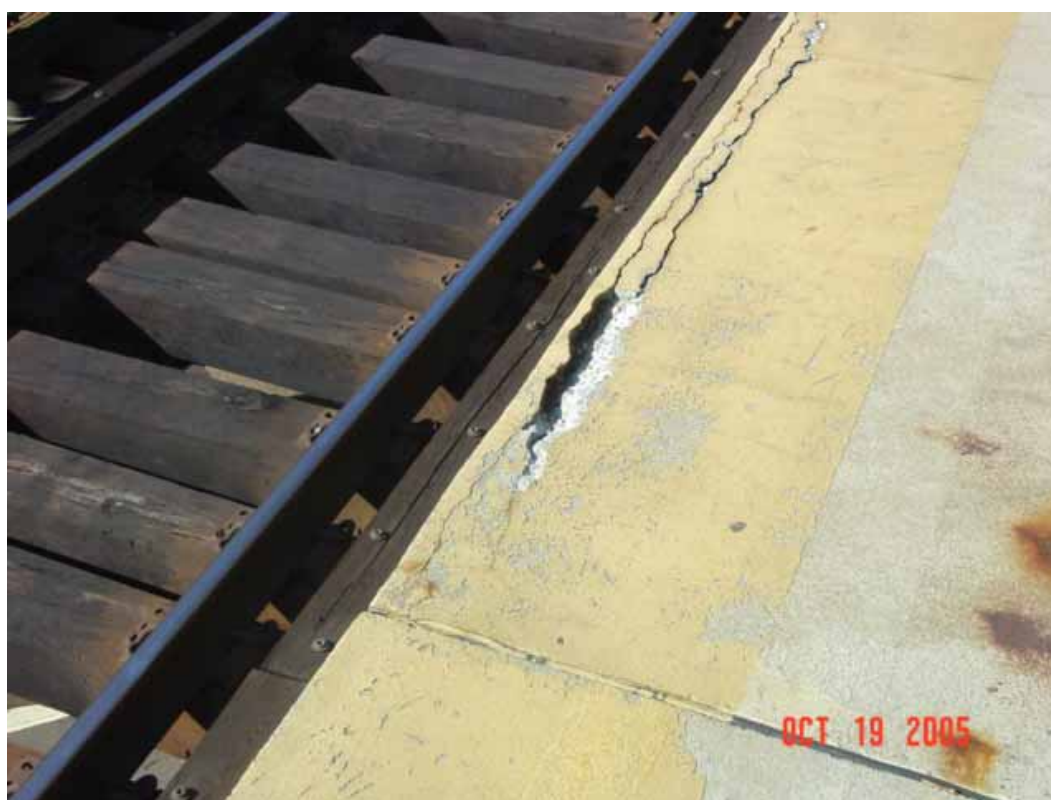
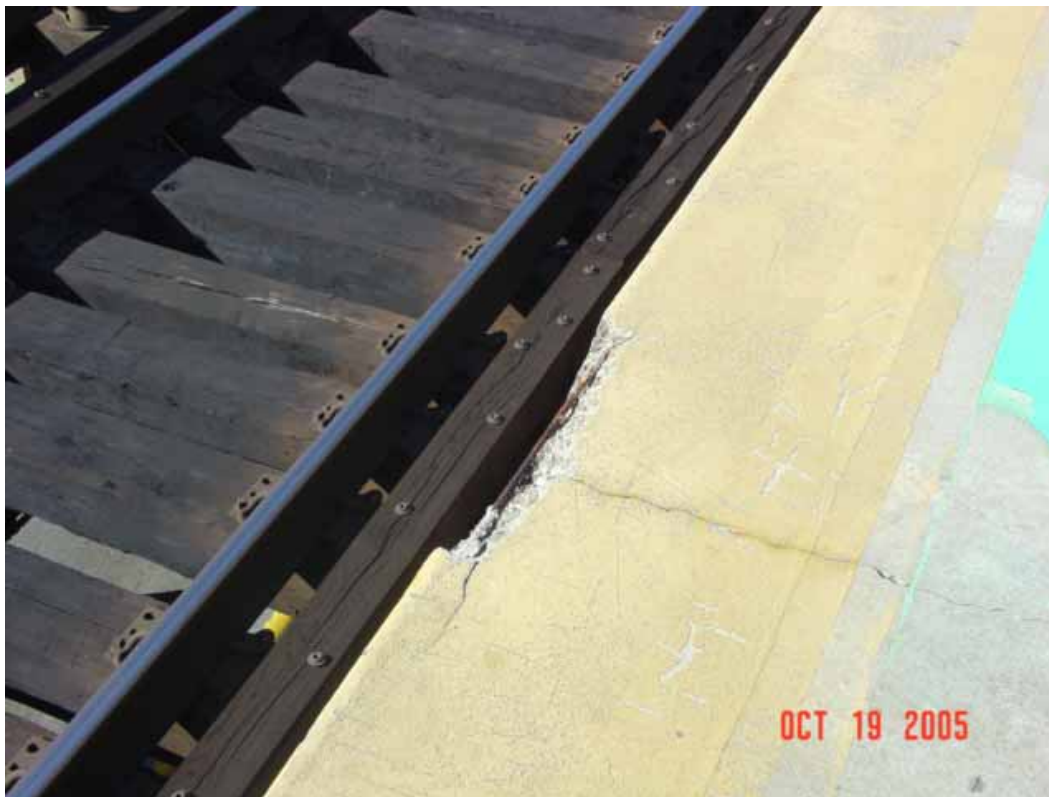
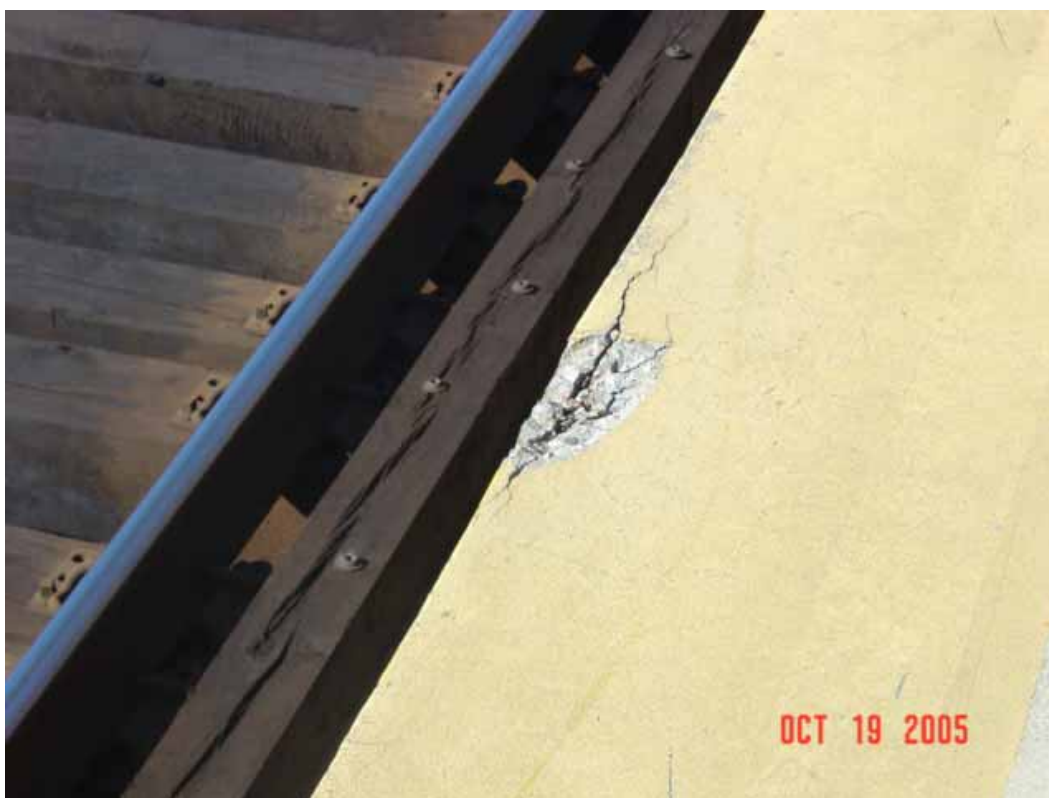
- Sections of the eastbound platform canopy were missing (see page 7 in the Appendix).
- All staircases were rusted, and there was broken concrete that created a gap at the top of the west end staircase (see page 7 in the Appendix).
- The westbound platform had broken and crumbling concrete and broken edges (see pages 8 and 9 in the Appendix).

NOSTRAND AVENUE Broken and crumbling concrete at the edge of the westbound platform. Observed: October 19, 2005.

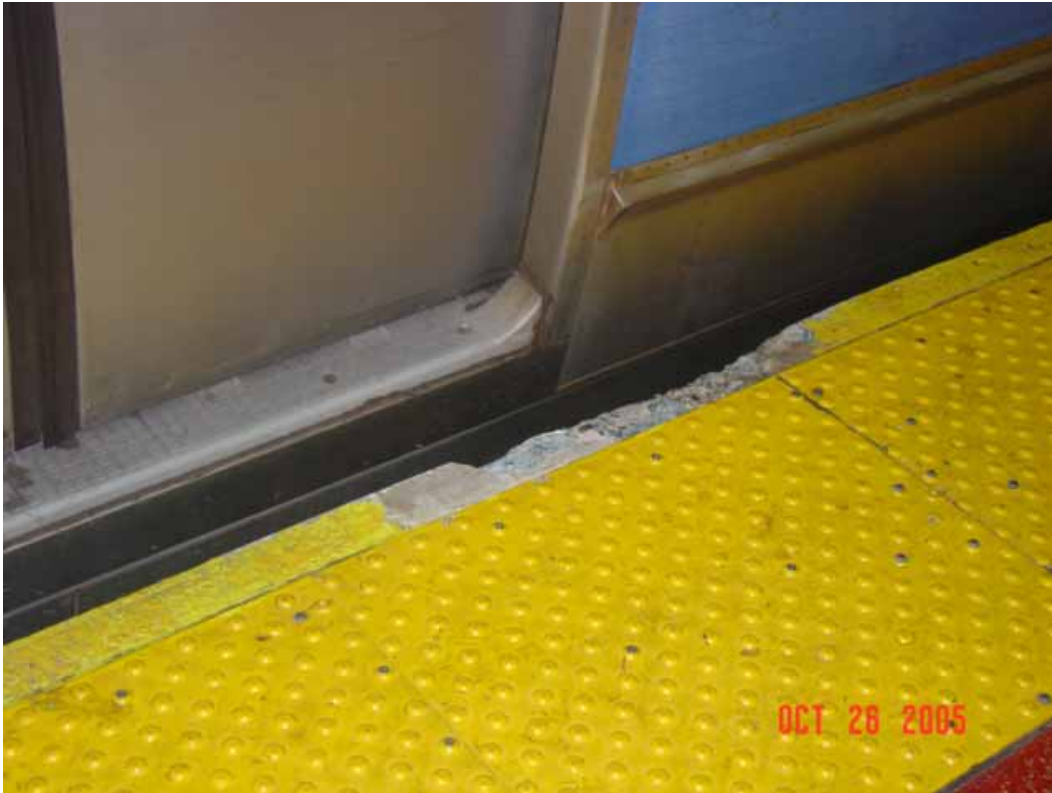
- There were broken platform edges at location B on Track 14, at the west end of Track 15 and at the west end of Track 19 (see page 10 in the Appendix).
- Electrical wiring was exposed at the edge of Track 17 platform (see page 10 in the Appendix).
- Grease leaked from the ceiling to the west end of the Tracks 19 and 20 platforms (see page 11 in the Appendix).
- There was broken platform concrete and wall tiles at the west end of Track 13 and at the east end of Track 15.

PENN STATION Broken concrete at the edge of the Track 19 platform.
Observed: October 26, 2005.

Penn Station	There was broken platform edges at location B on Track 14, at the west end of Track 15 and the west end of Track 19. Electrical wiring was exposed at the edge of Track 17 platform. Grease leaked from the ceiling to the west end of the Tracks 19 and 20 platforms. There was broken platform concrete and wall tiles at the west end of Track 13 and the east end of Track 15. Water leaked from the ceiling to the platforms at the west end of Track 17, the east end of Track 18 and the west end of Track 19.	Penn Maintenance - AMTRAK	Penn Station maintenance is Amtrak's responsibility.

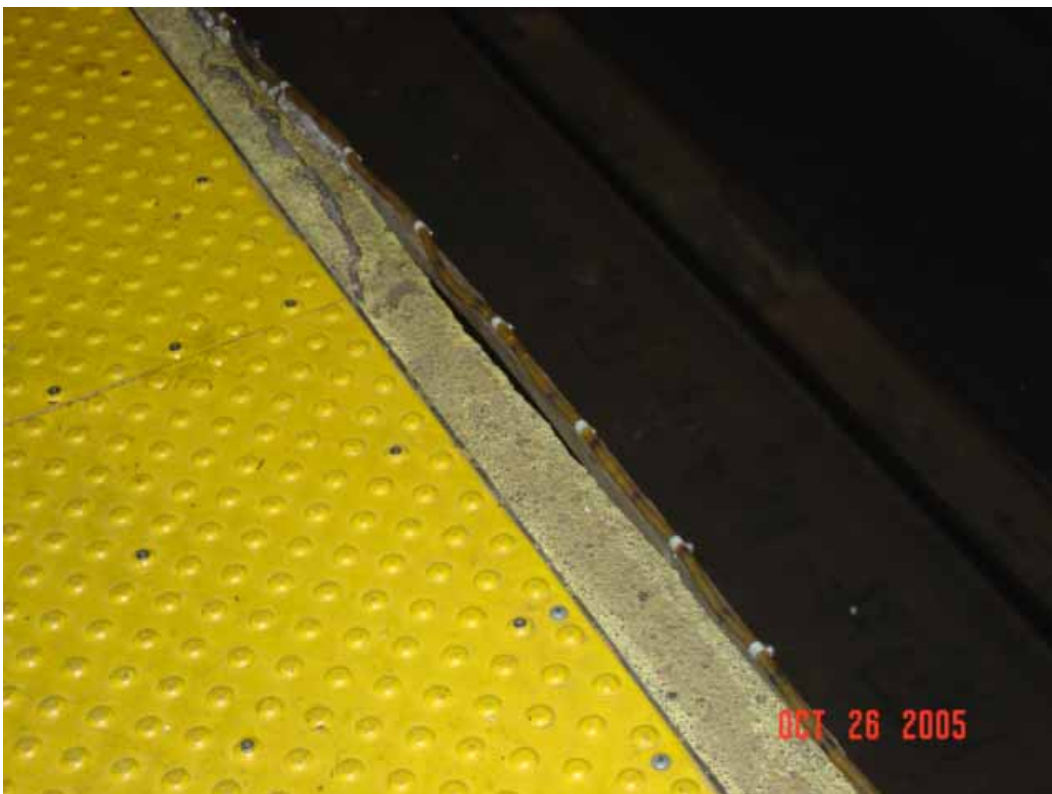
PENN STATION Exposed wiring at the edge of the Track 17 platform.
Observed: October 26, 2005.

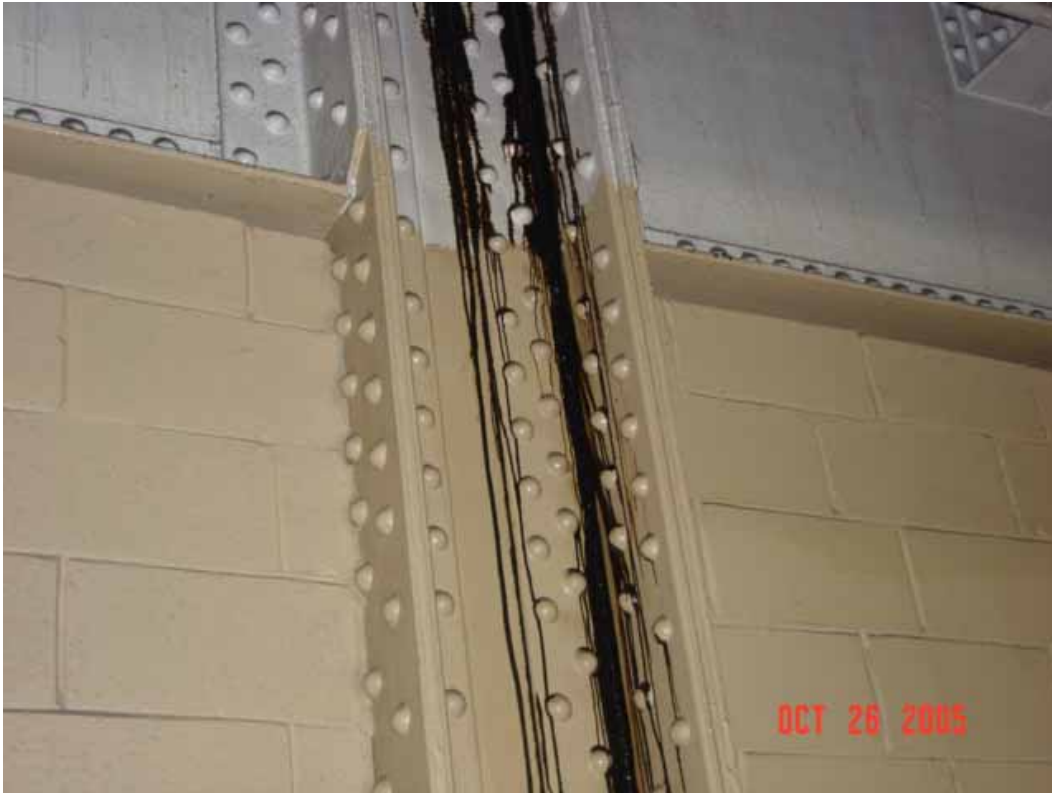
PENN STATION Grease leaking from ceiling of support beam at the west end of Track 19. Observed: October 26, 2005.

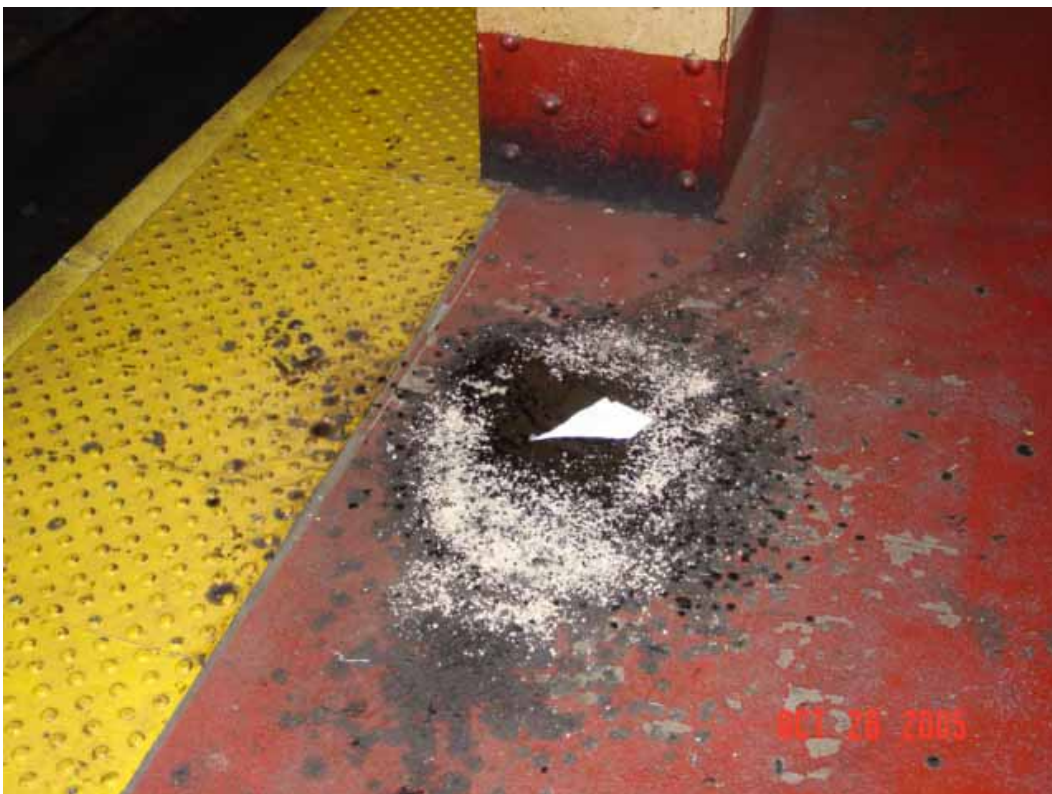
PENN STATION Grease on the platform of Track 20. Observed: October 26, 2005.

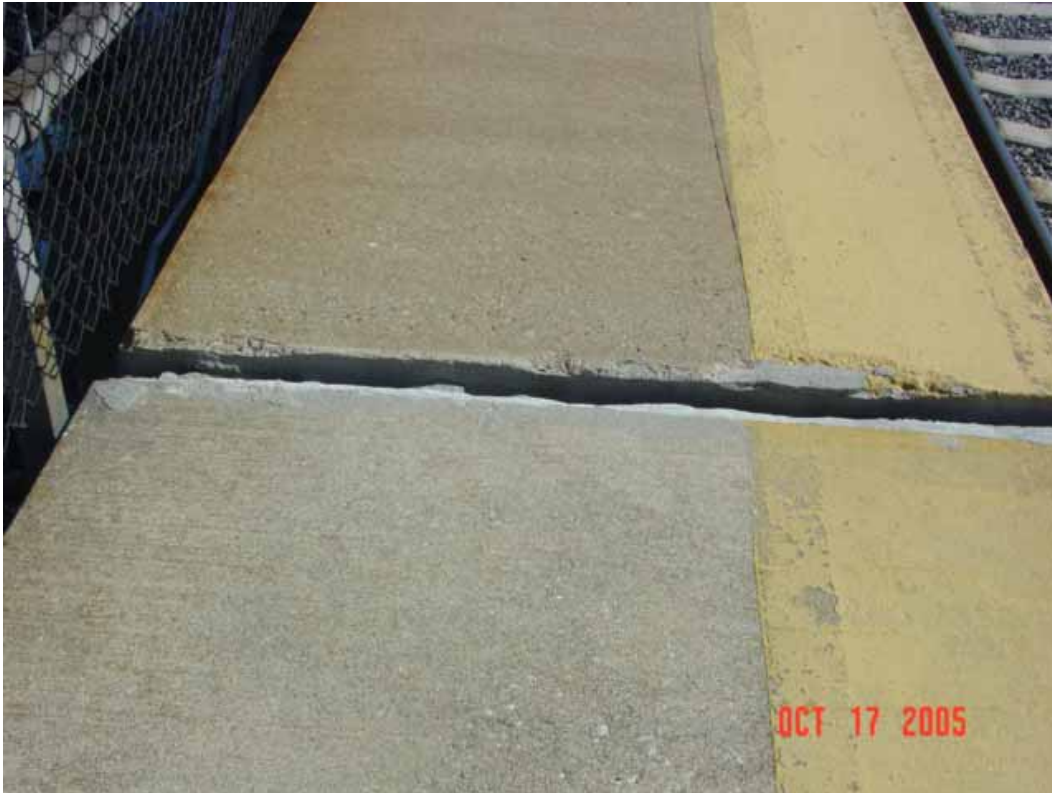
- The westbound platform had a large gap that caused a section of the pavement to be raised (see page 12 in the Appendix).
- There was a large hole and exposed wood in the ceiling of the westbound staircase (see page 13 in the Appendix).
- Paint was peeling from the walls of the westbound staircase by the ticket vending machine (see pages 12 and 13 in the Appendix).

QUEENS VILLAGE Large gap and separated pavement on the westbound platform. Observed: October 17, 2005.
