Audit Report on the Metropolitan Transportation Authority's Maintenance of Long Island Rail Road Stations within the City

FN06-062A

May 5, 2006

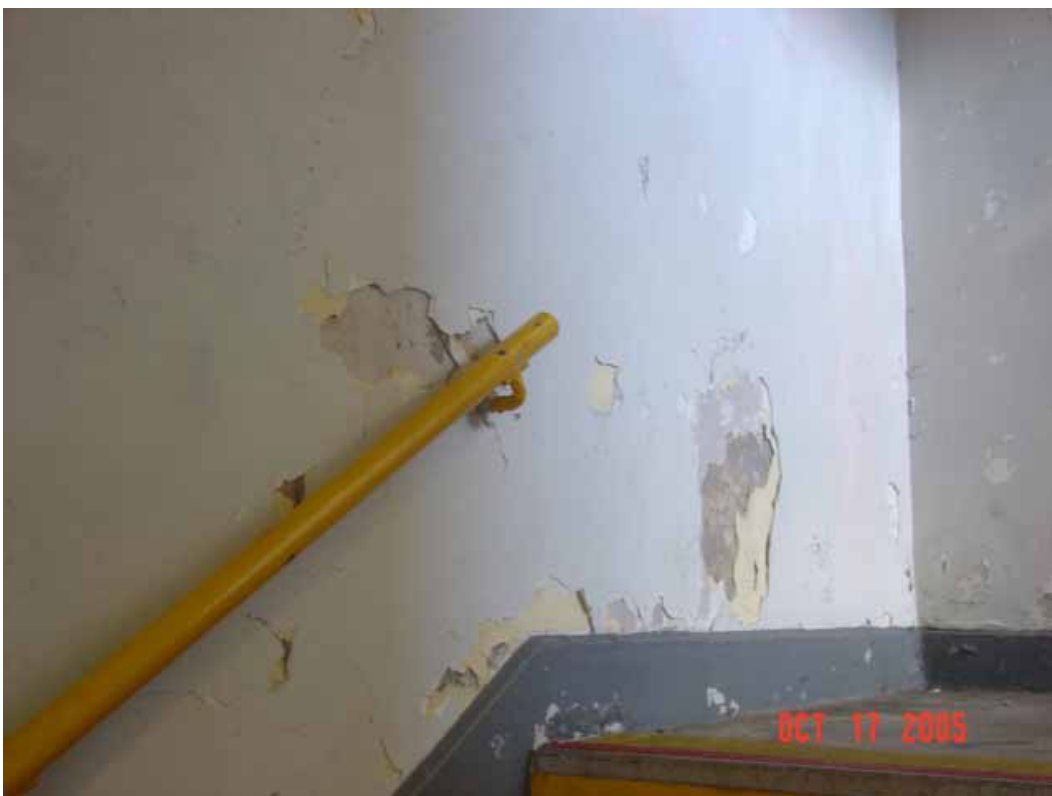
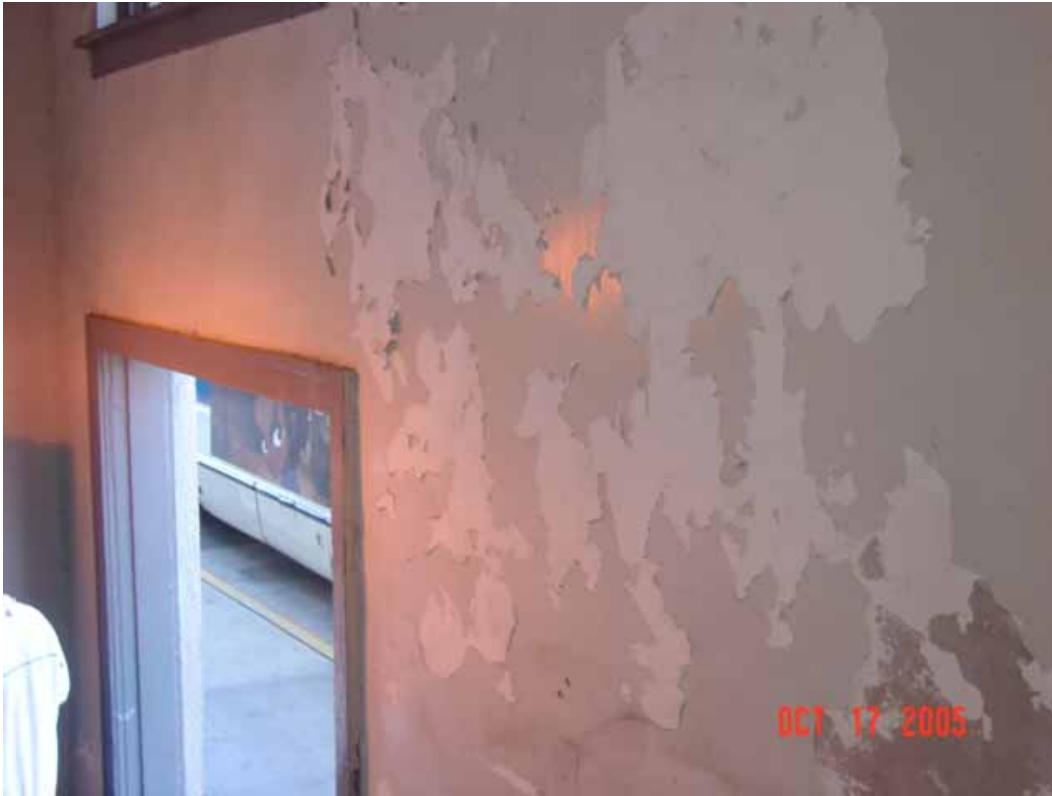
QUEENS VILLAGE Peeling paint on the entrance walls near the station's ticket vending machine. Observed: October 17, 2005.

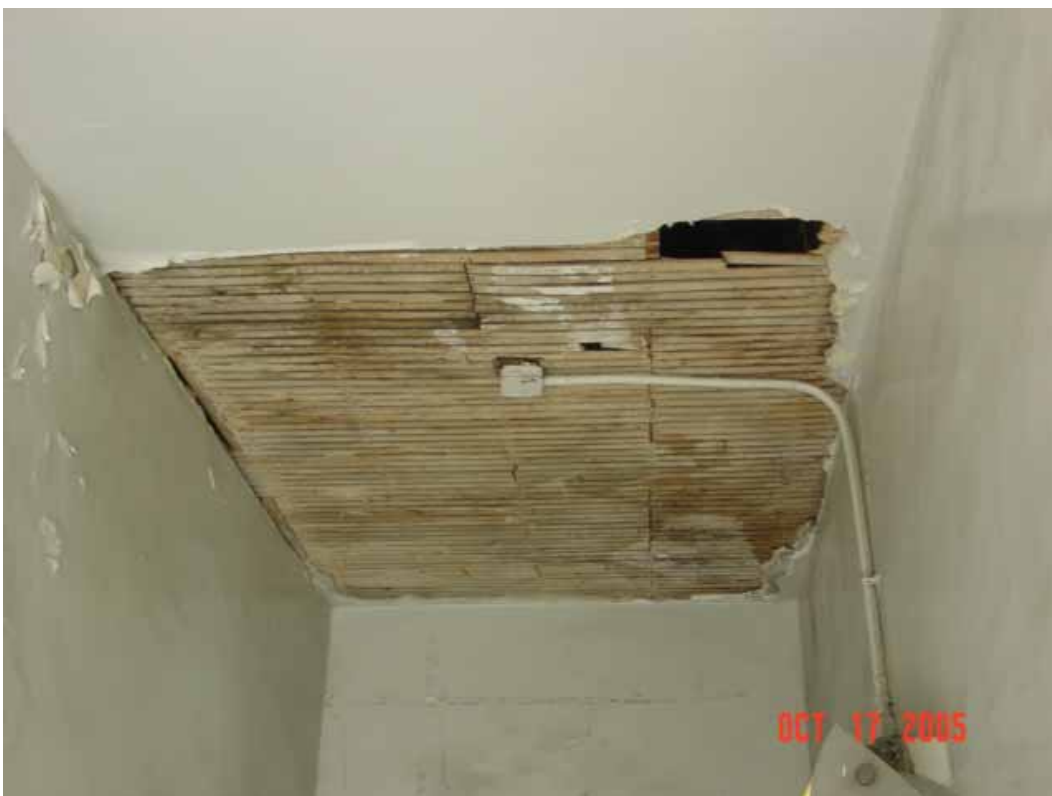
QUEENS VILLAGE Broken ceiling exposing a large hole in the ceiling of the westbound platform staircase. Observed: October 17, 2005.
