PROJECT REPORT

Bank Stabilization East Branch Rondout Creek Demonstration Project Ulster County Highway Garage

Report produced by John G. Perrella, Construction Supervisor

Fall/Winter 2011

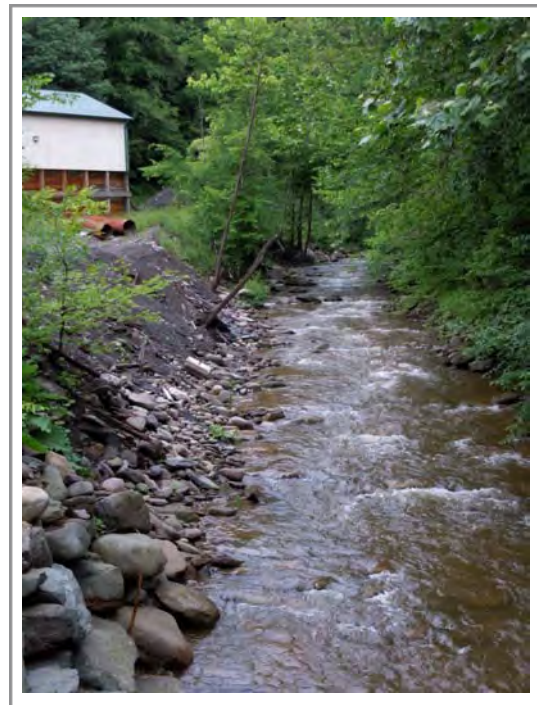
Pre-Construction Conditions June 23, 2011

The project area covers approximately 700 linear feet of the stream corridor and includes the road abrasive storage yard for the Ulster County Highway Garage located on the right bank. At the time of the site inspection, there were several coarse gravel piles in two grading material storage locations that were not contained by silt fencing or other stormwater best management practices. The gravel piles closest to Sheely Road appeared to be eroding during rain events with gravel conveyed by runoff onto the right bank and into the channel, leading to bank failure at this location.

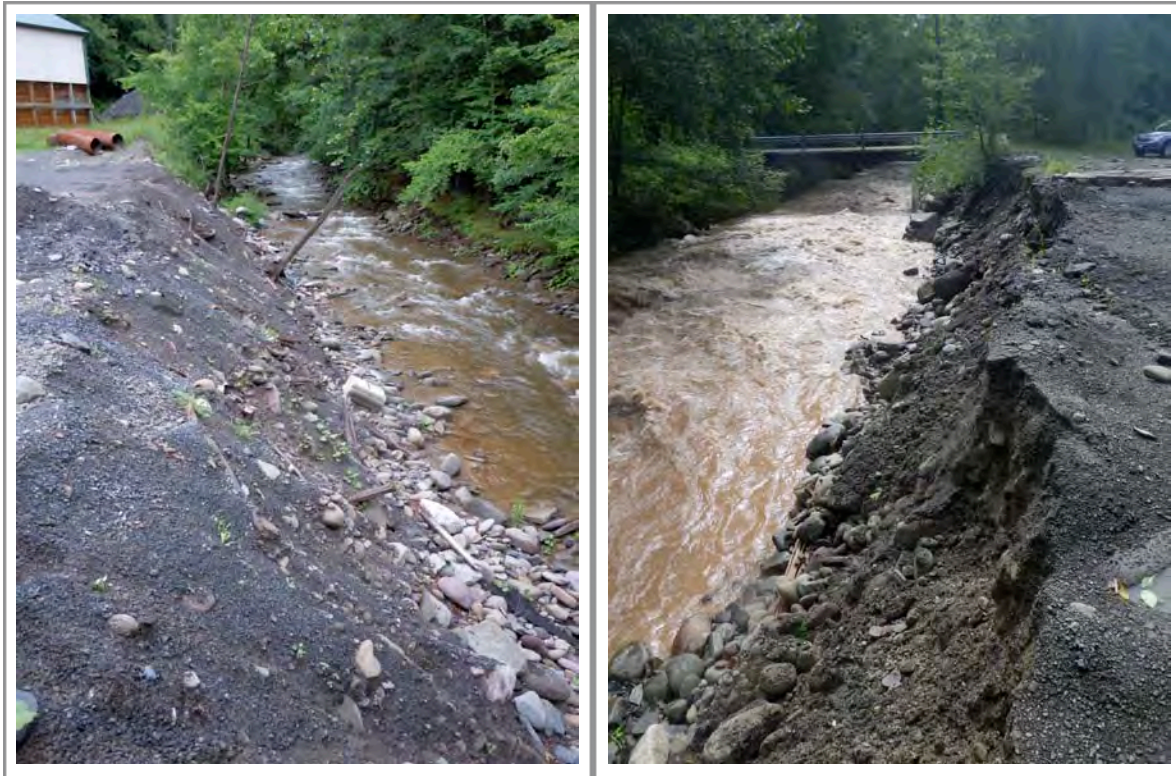
On July 28, 2011 Tropical Storm Irene swept through the Catskills and inflicted major damage to much of the area. This storm affected the demonstration site by scouring a substantial amount of material from the stream bank of the demonstration site. The photo above left shows existing conditions just upstream of the demonstration site before storm event. On the right hand photo above it can clearly be seen that a large amount of material was removed from the bank resulting in a change order to the contract (Appendix I).

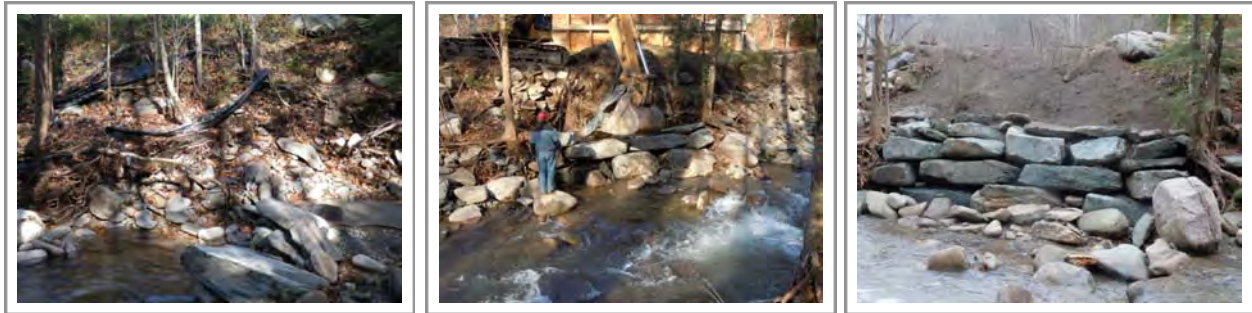
The advent of Tropical Storm Irene in late August 2011 produced three areas of scouring just upstream of the cribwall in the demonstration project. These three areas were designated A, B and C and were treated with a combination of large stone, root wads and plantings. A series of photos depicting the the three areas before treatment, during the construction process and the final result of the corrective measures which were taken follow.

Section A utilizes large stones to stabilize the bank at the base. Willow clumps or local origin are planted among the stones.

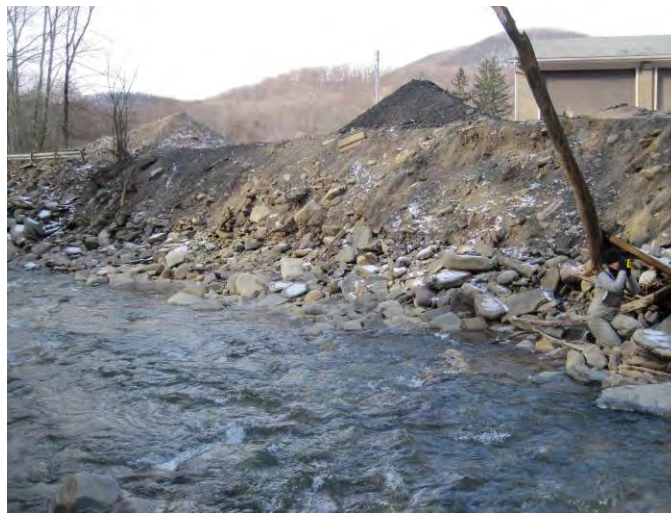
The study reach is characterized as being confined by high ground, straight alignment, and having a rocky rapids bed. The mean bed slope is 2.6%. The right bank downstream of the private drive bridge has a 2:1 slope with a sparse woody buffer extending from the bankfull height to the top of the bank. Near station 14+00, the woody buffer is replaced with fine gravel and sand deposited by surficial runoff from the eastern edge of the DPW garage staging area. From the Sheely Road Bridge to station 13+25, the right bank has a combination of stone retaining wall and placed riprap on the lower slope and gravel cover on the upper slope at the DPW garage. About 175 linear feet of the right bank has had a slope failure between station 11+50 and station 13+25 (Photo 1).

Photo 1: Bank Failure site on right bank upstream of Sheely Road Bridge.

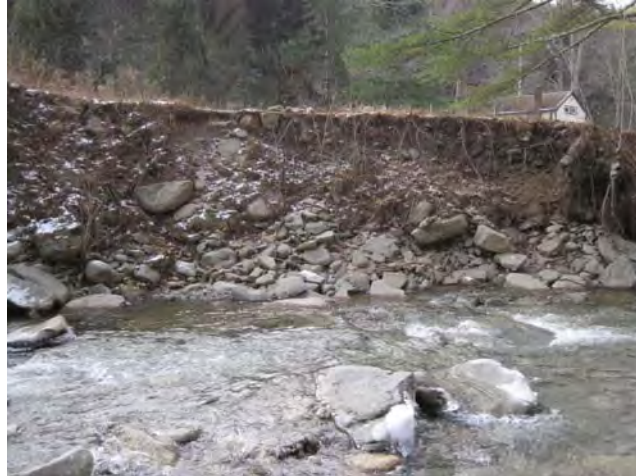
The left bank is also steep with a 2:1 slope with dense hardwood forest cover. Downstream of the unnamed private drive bridge, there are approximately 50 feet of scour exposing unsorted glacial till (Photo 2) followed by approximately 25 linear feet of undercut bank exposing roots of the 30-inch diameter at breast height (DBH) white pines overhead and glacial till. The bank is undercut by up to three feet in some locations.

Photo 2: Bank scour on left bank downstream of unnamed private drive bridge.

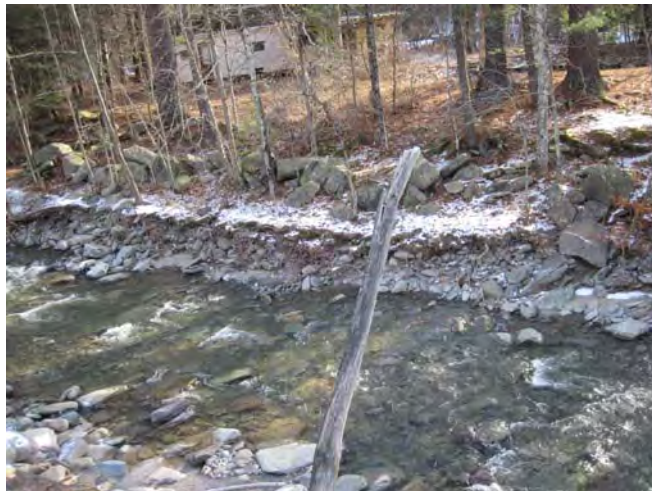
Beginning at station 15+75 through station 11+00, there is a dense forested buffer at least 20 feet thick. Near station 14+75, a terrace has formed at bankfull height that continues to station 12+25 (Photo 3).

Photo 3: Bankfull bench on left bank.

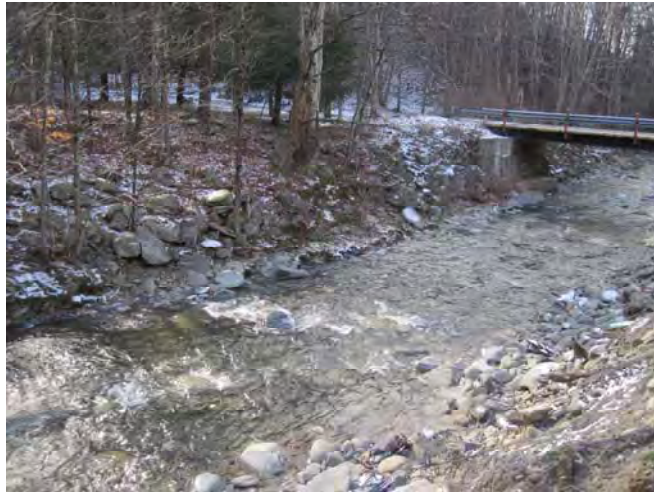
The channel perimeter below the bankfull height is composed of three distinct materials: a dense cover of static boulders that armor the bed and lower banks, a semistatic armor of cobbles and small boulders, and mobile gravel and rounded small cobbles (Photo 4). The latter material is in limited quantity, found in pockets and small bars. The bank and bed roughness is high (estimated Manning's $N=0.06$).

Photo 4: Rapids bed form and channel roughness of study reach.

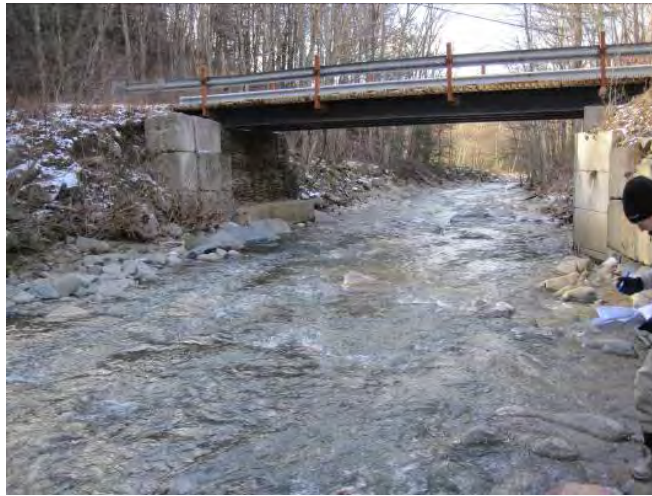
The Sheely Road Bridge over East Branch Rondout Creek is approximately 28 feet long by 12 feet wide. The bridge consists of a concrete deck slab on concrete abutments. The abutments are composed of stacked concrete blocks that extend upstream and downstream of the bridge approximately two feet on the right bank (Photo 5). The footings are not visible, and the abutment base elevation is unknown. There is no visible bedrock. The downstream right and left abutments appear to be subject to scour and erosion.

Photo 5: Looking downstream at Sheely Road Bridge.

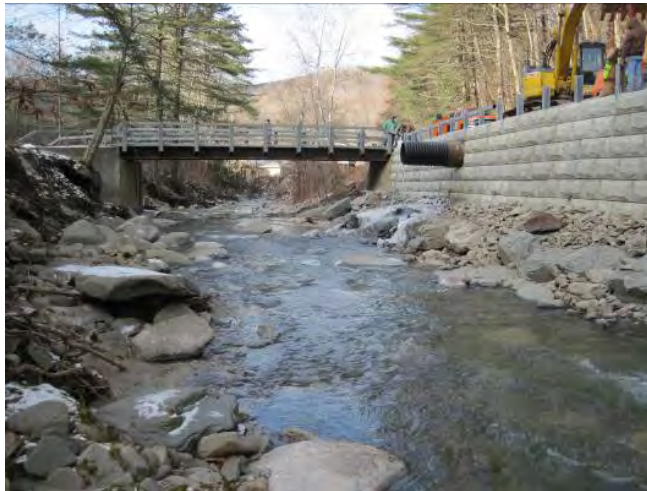
The unnamed private drive bridge over East Branch Rondout Creek is approximately 46 feet long and 18 feet wide. The bridge consists of a concrete deck slab on concrete abutments. The parapets are approximately 25 feet long, 42 inches high, and two feet wide. The upstream right bank consists of a modular concrete unit wall approximately 10 feet in height that extends approximately 100 feet upstream of the bridge crossing (Photo 6). The stone wall is nearly flush with the right bank abutment. Downstream of the crossing, the concrete abutment transitions to a stacked stone wall that extends downstream approximately 20 feet. The left concrete abutment extends approximately six feet into the channel and is limited to the width of the bridge crossing. There are no wingwalls upstream or downstream of the left abutment. The left bank bridge abutment shows signs of scour damage on the downstream side, and the upstream side is not armored. The channel bed in front of the structure is accumulating coarse bed material and is aggrading. Some material is being pushed into the structure.

Photo 6: Looking downstream at unnamed private drive bridge.
