HISTORIC STRUCTURES REPORT FOR
HIGH BRIDGE

BRONX AND MANHATTAN, NEW YORK

VOLUME III
APPENDICES I-0

REHABILITATION OF THE HIGH BRIDGE OVER THE HARLEM RIVER BOROUGH OF MANHATTAN AND BRONX, NEW YORK

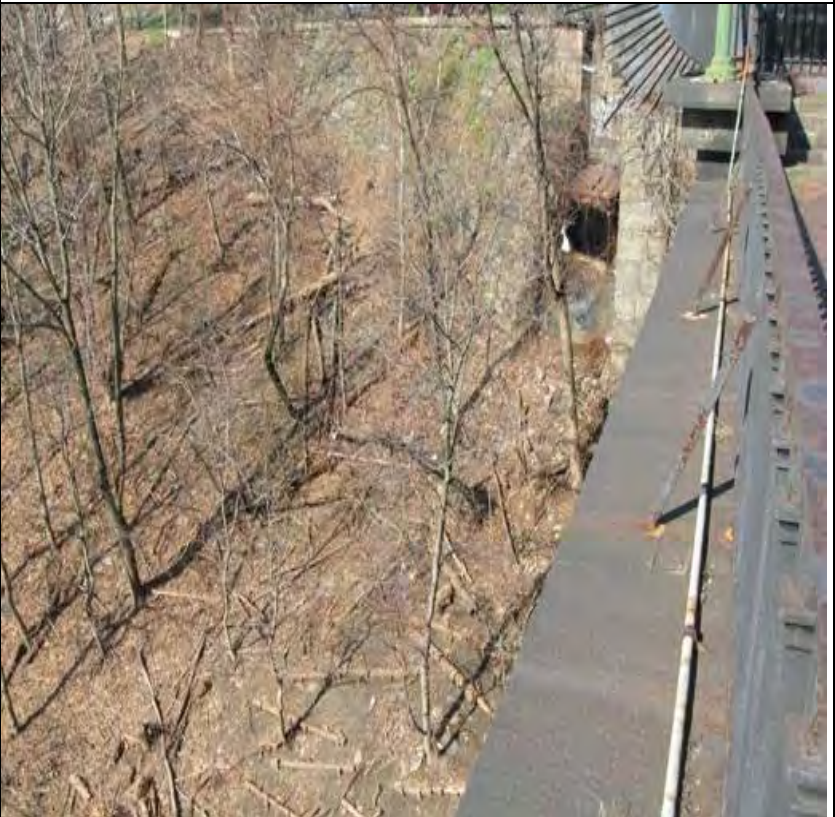
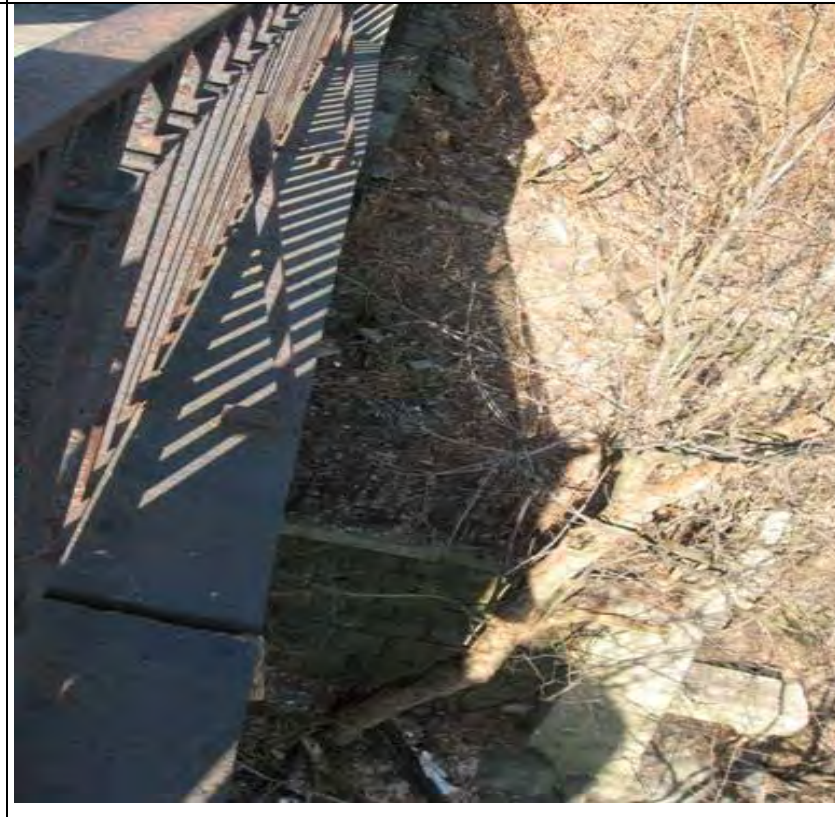
<p>Photo No. 3</p>		<p>Photo No. 4</p>
<p>Description: Picture looking west at the southwest wingwall of the western abutment. Picture shows general terrain, metal shanty and area of observed litter.</p>		<p>Description: Picture looking west at the northwest wingwall of the western abutment. Picture shows retaining walls/foundation of previous pumping station, and general terrain.</p>

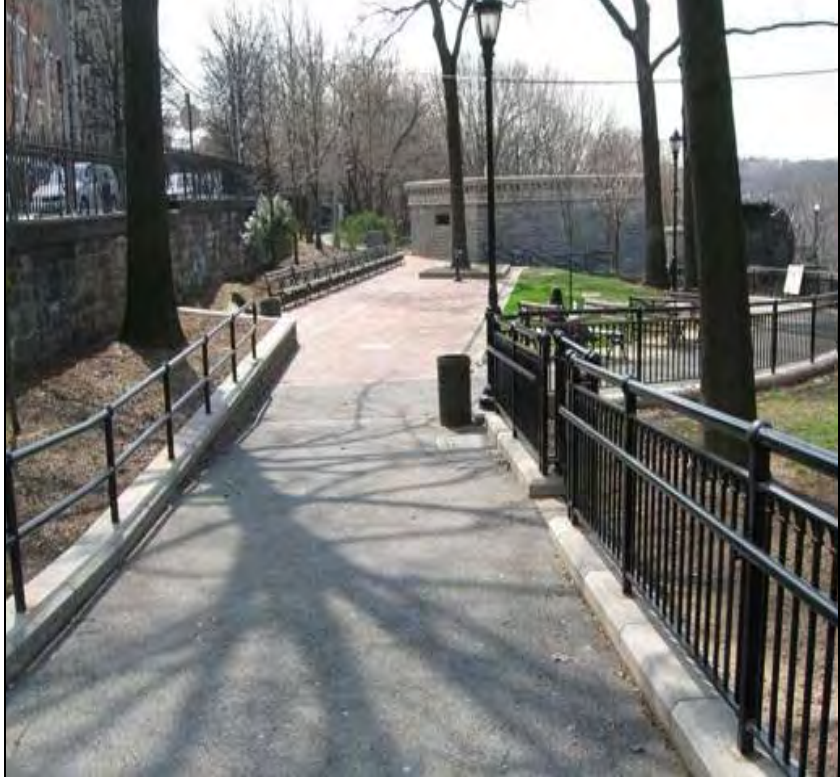
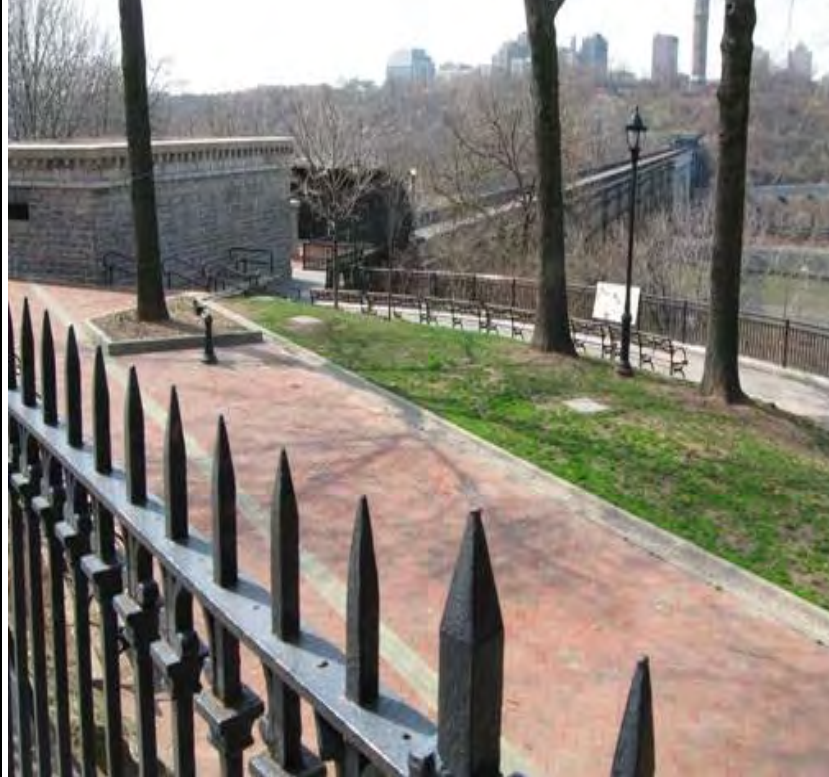
<p>Photo No. 5</p>		<p>Photo No. 6</p>
<p>Description: Picture looking south at the eastern Gatehouse and parkgrounds of the eastern project area. A smaller structure identified as an office is located out of view behind the gatehouse structure. Picture shows general conditions of the area; residential apartment buildings are left across University Avenue.</p>		<p>Description: Picture looking southwest at eastern abutment and beyond.</p>

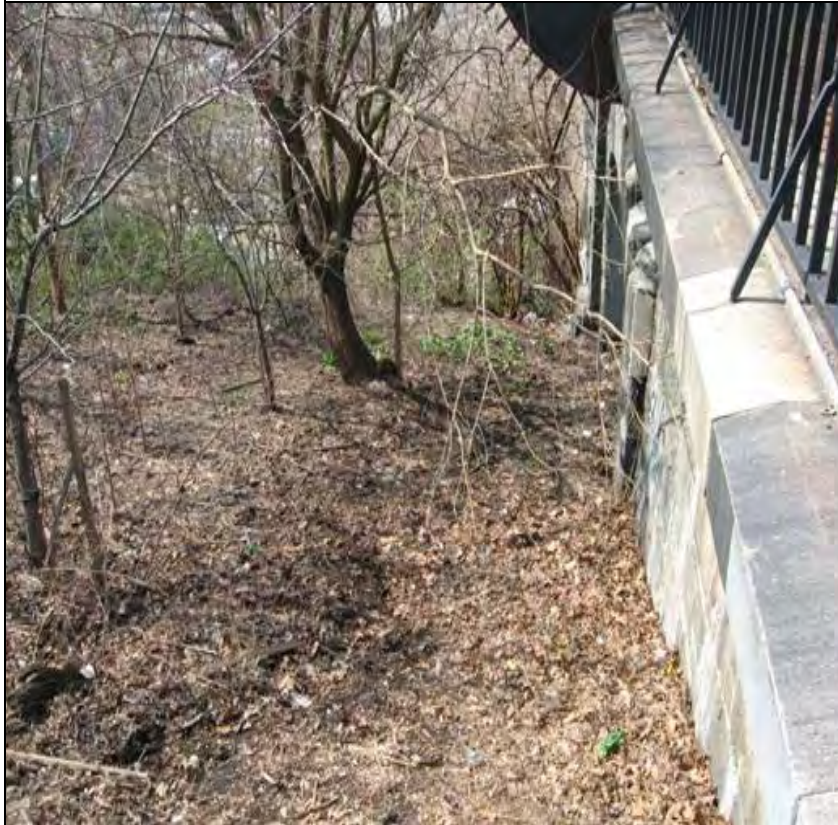
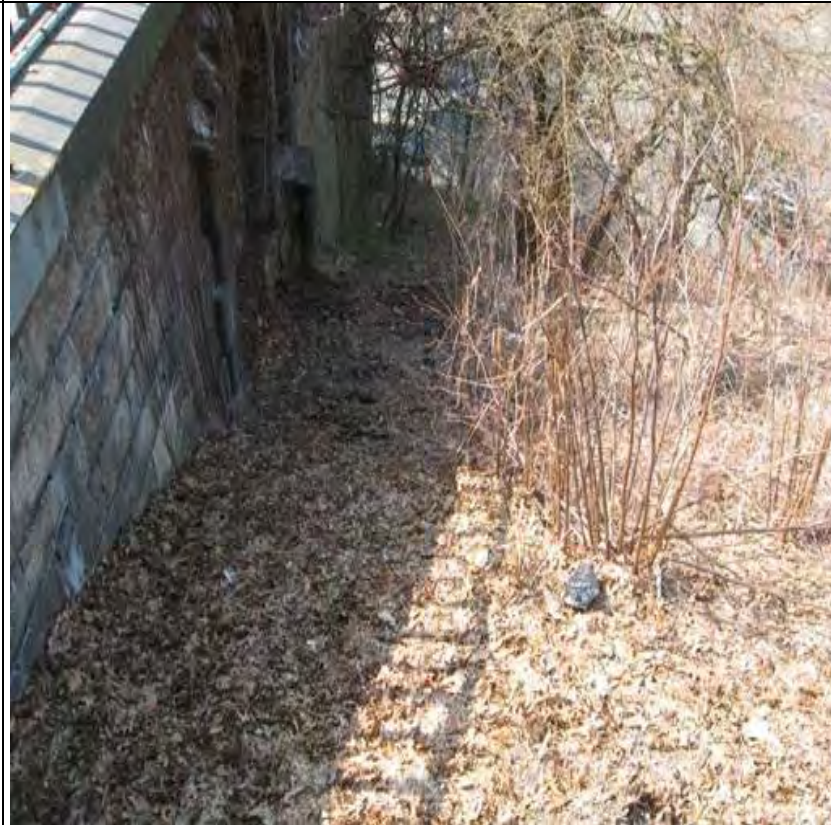
<p>Photo No. 7</p>		<p>Photo No. 8</p>
<p>Description: Picture looking west at the southeastern wingwall of the eastern abutment. Picture shows general terrain.</p>		<p>Description: Picture looking west at northeastern wingwall of the eastern abutment. Picture shows general terrain.</p>

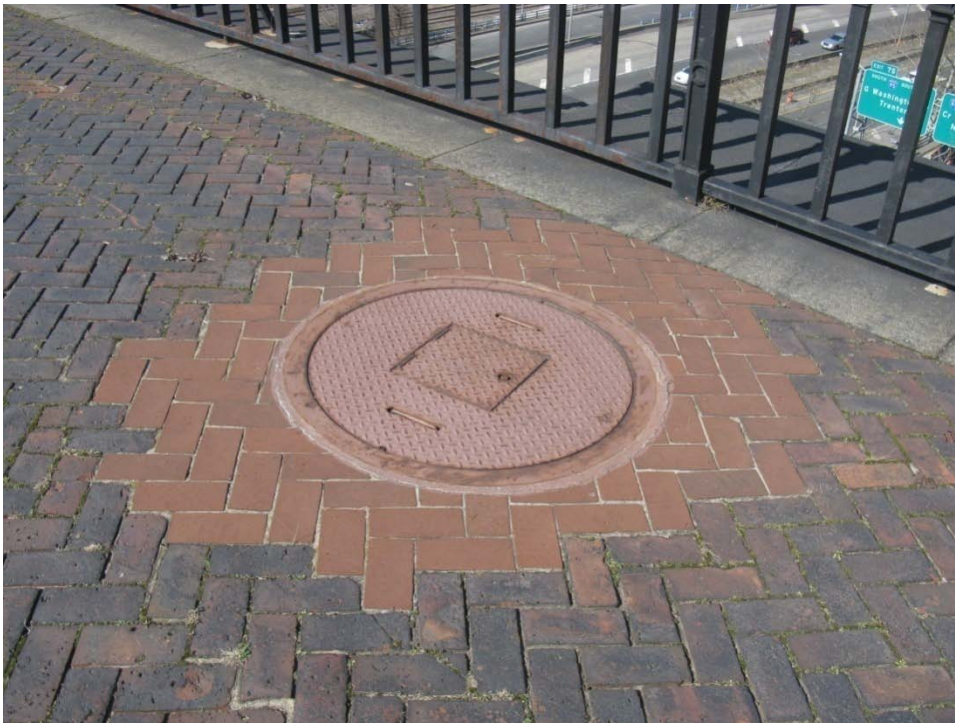
FIGURE 323. *Detail view of a non-historic manhole cover has been installed at a location that previously had a vault lights. Note the surrounding non-matching brick at the area of repair.*

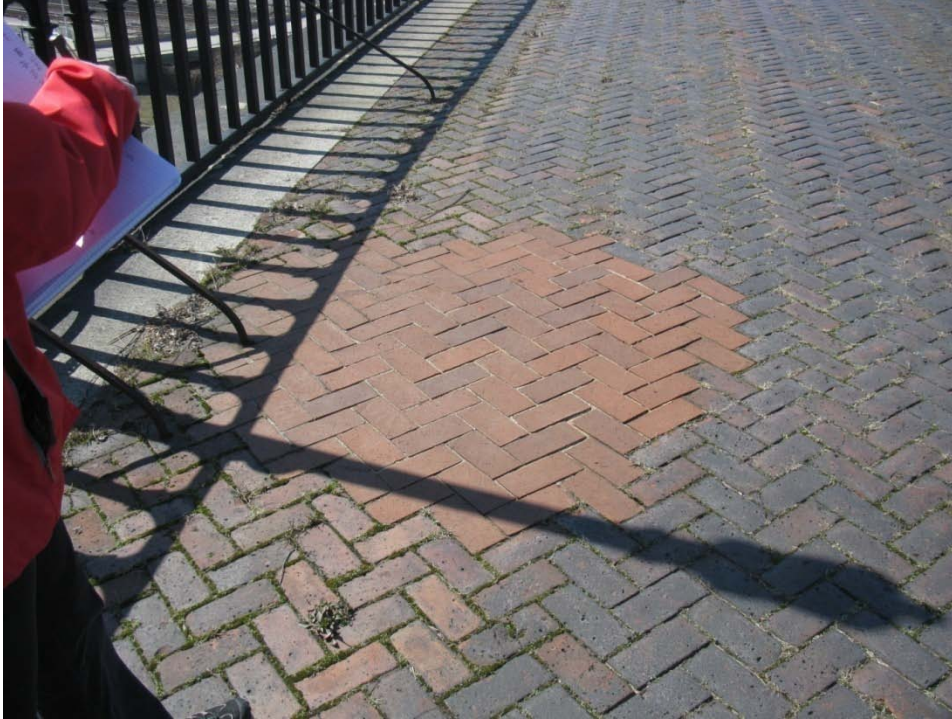
FIGURE34. *Detail view of an existing bridge deck opening covered with a with a non-historic patch*

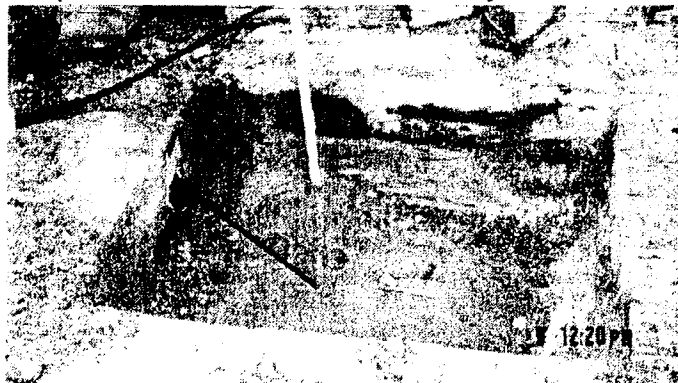
"The vertical portion of the Z-plate that bridges the height difference between the roof plate and the coping plate was found to have a hole rusted completely through it when it was exposed as part of the investigation of the roof plate condition (See Photo 17). The steel members supporting the roof at that location were found to be deteriorated due to water damage (This subject is covered in more depth in the Water Main Gallery Evaluation in Section 5.5). Based on the large number of locations where similar deteriorations in supporting members were found, it is likely that the Z-plates are deteriorated in many other locations."

Photo 17: Hole through the Z-plate at the edge of the south coping plate.

The design team has recently proposed ~~a similar approach~~ ^{an approach} to remediation: ^{using} a reinforced concrete extension of the existing underlayment slab. The extension of the concrete slab has definite advantages with respect to replacing the z-section in-kind – including elimination of a connection joint between steel sections where water intrusion may occur, as well as accommodation of a continuous curb section to provide a base for the bridge rail in the event the deck ~~cross slope~~ ^{cross slope} is reduced.
