# NYC WASTEWATER RESILIENCY PLAN

## CLIMATE RISK ASSESSMENT AND ADAPTATION STUDY

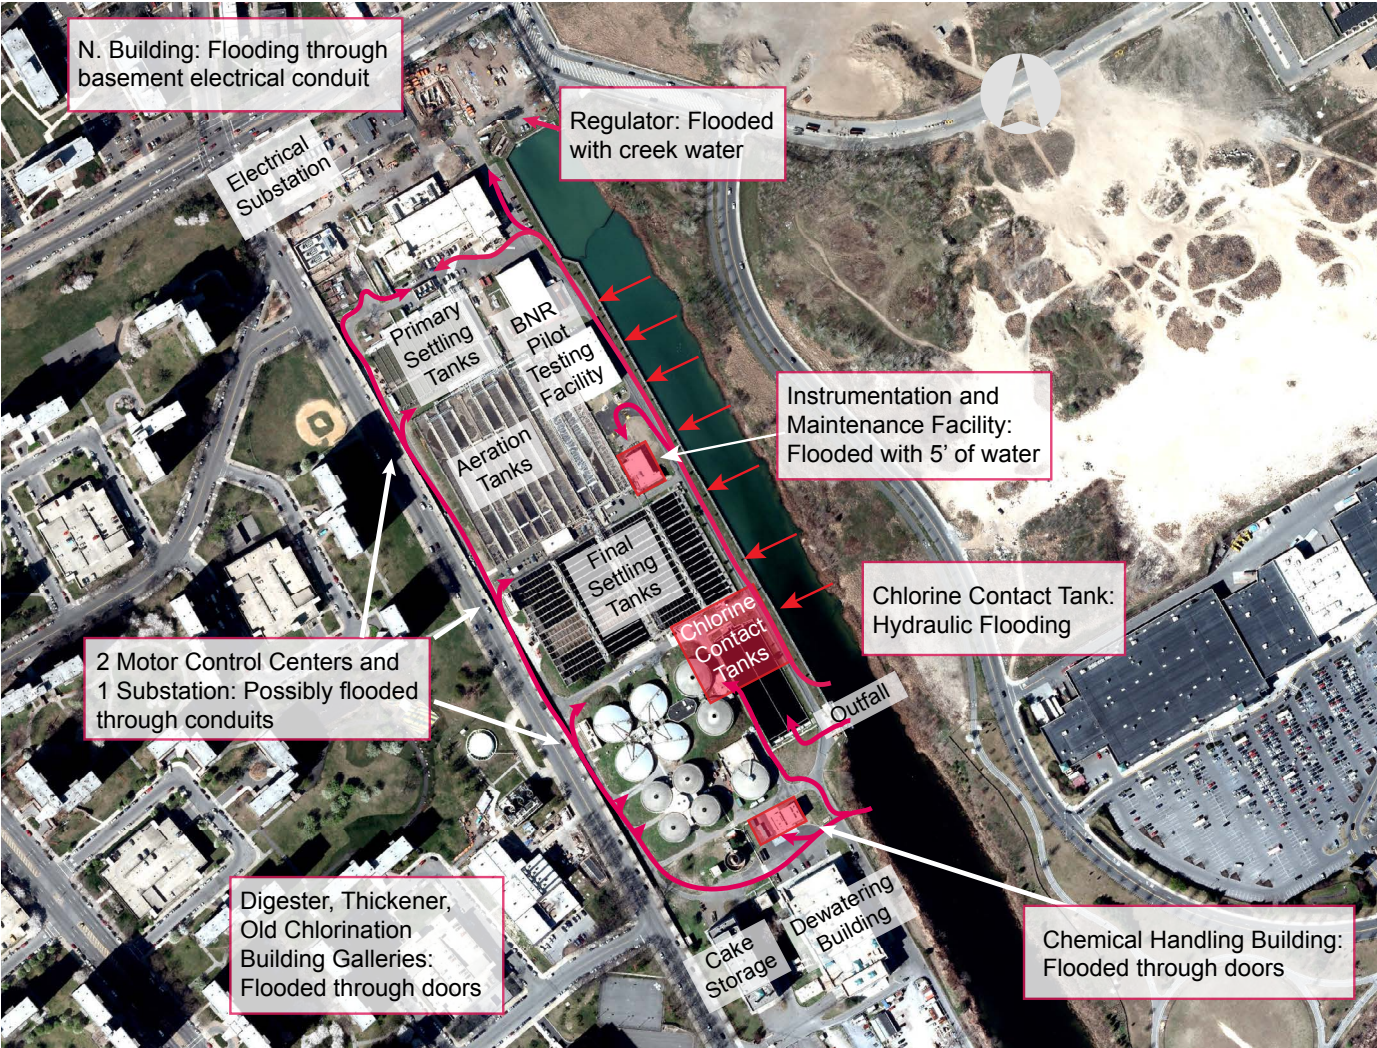
Plant staff worked actively before, during, and after the storm to protect the plant and bring it back to normal operation. Electrical power was proactively shut off throughout the plant during the storm surge, except in the North Building, to prevent short circuiting as the water level continued to rise. After the storm, all flooded areas were dewatered and flooded motors and electrical equipment were cleaned, dried, and repaired or replaced depending on their condition.

Flood pathways and areas flooded during Hurricane Sandy are highlighted in red.

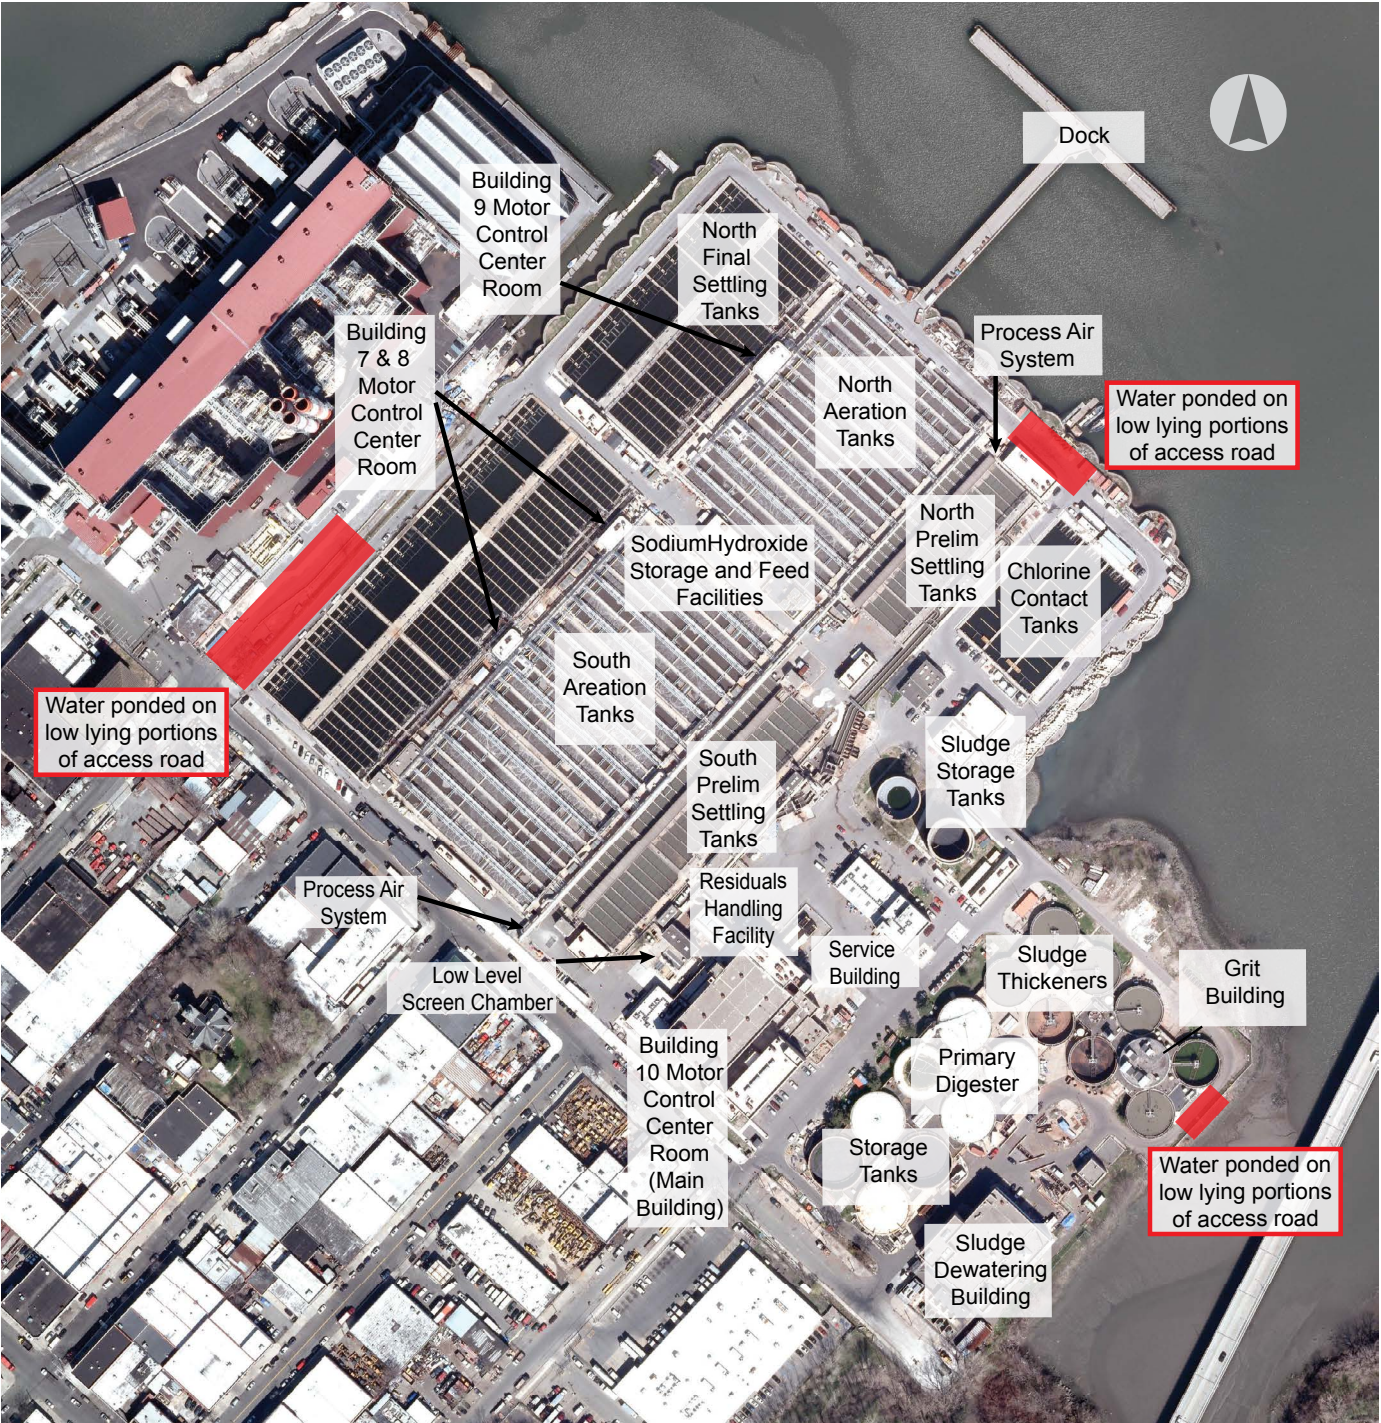
storm surge caused minor damage to several temporary contractor office trailers, several storage sheds, and the barge dock. Plant staff took precautions ahead of the storm, which included sandbagging buildings and other routine emergency preparation procedures outlined in the plant’s Wet Weather Operations Plan. The plant maintained electrical power and continued normal wet weather operation throughout the storm.

Flood pathways and areas flooded during Hurricane Sandy are highlighted in red.

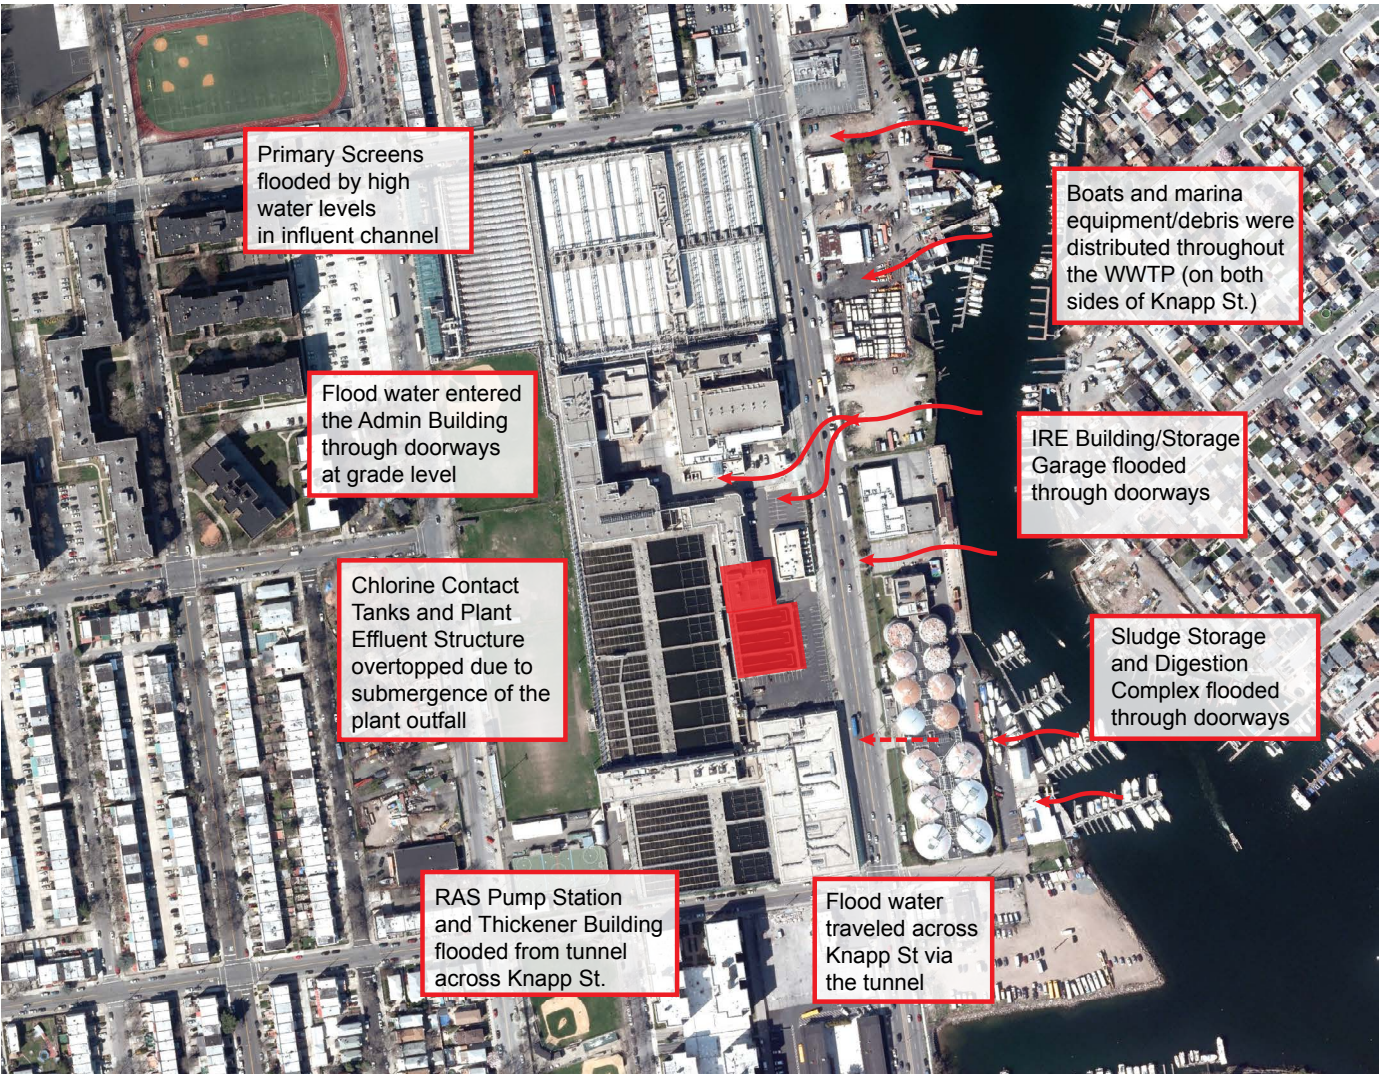
The plant staff took precautions ahead of the storm, which included sandbagging low-lying buildings, relocating some of the portable equipment, filling chemical tanks, ensuring emergency power equipment was operational, closing certain inflow pipes to reduce inflow of combined sewage to the plant, and other procedures outlined in their Wet Weather Operations Plan. Despite the damage, the plant maintained normal wet weather operation through the storm event.

Flood pathways and areas flooded during Hurricane Sandy are highlighted in red.

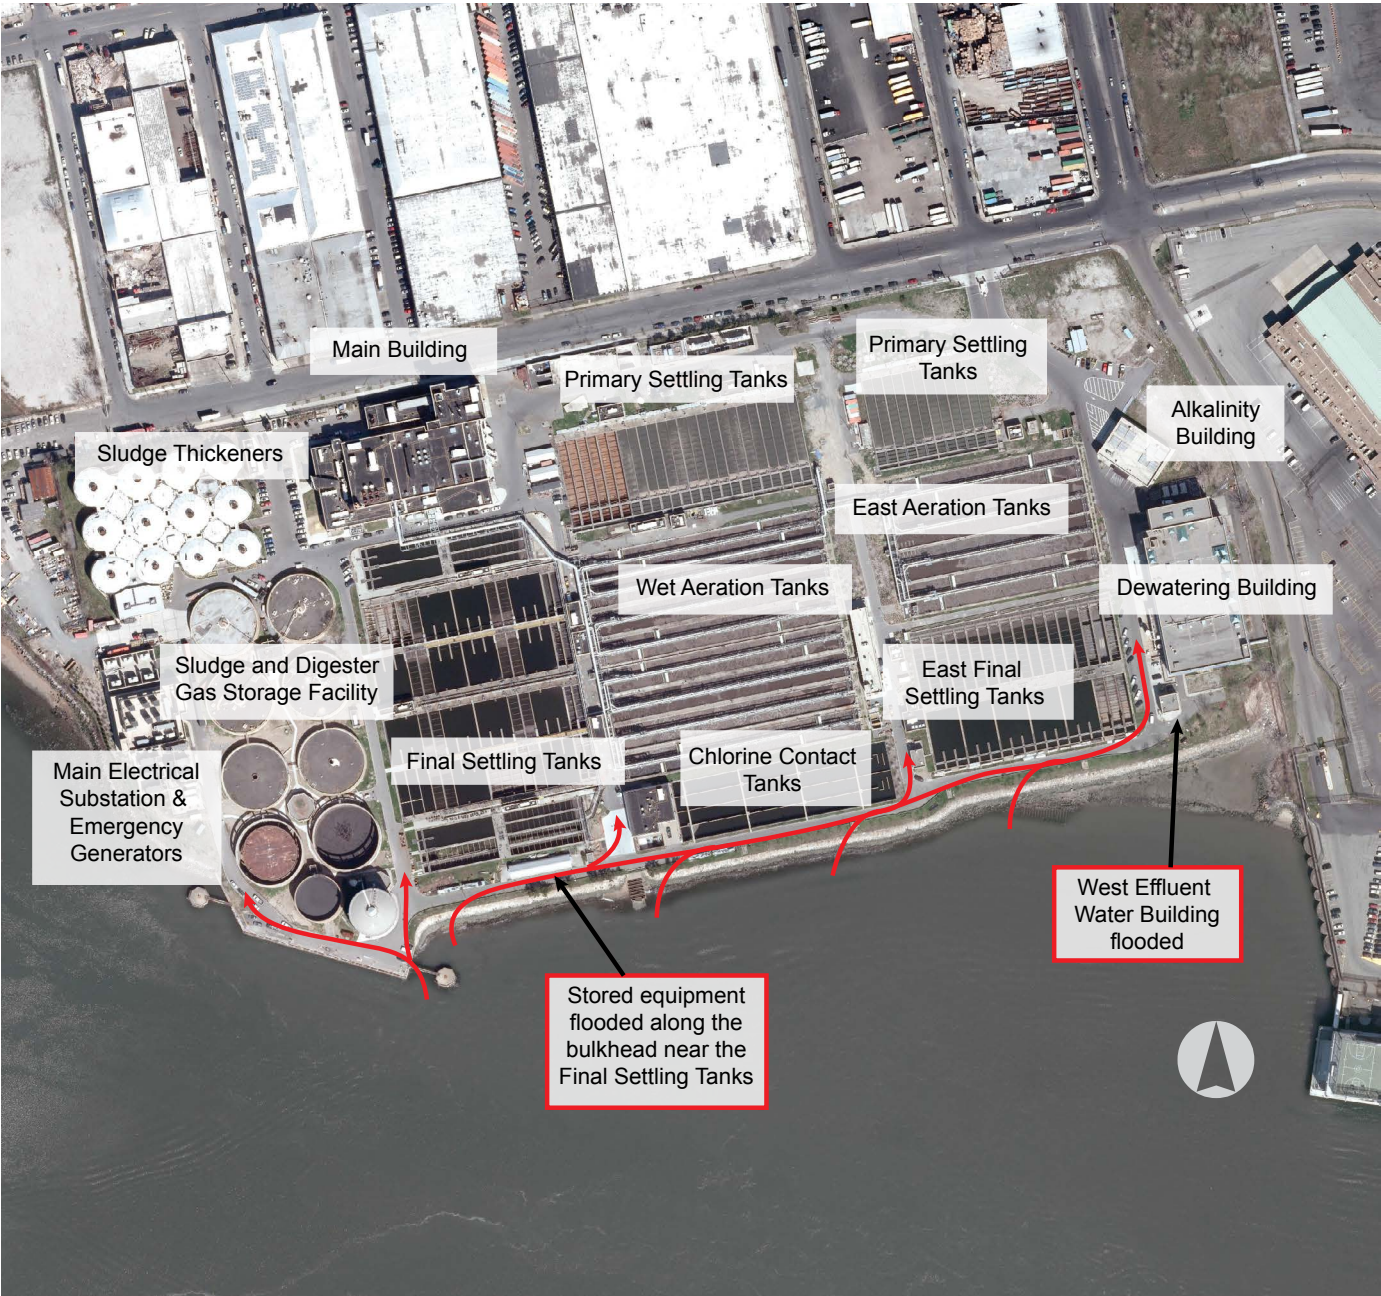
Water Building flooded and many electrical components, including motors, were damaged. Equipment in the storage buildings behind the South Final Settling Tanks was also damaged. The plant maintained normal wet weather treatment operation during and after the storm.

Flood pathways and areas flooded during Hurricane Sandy are highlighted in red.

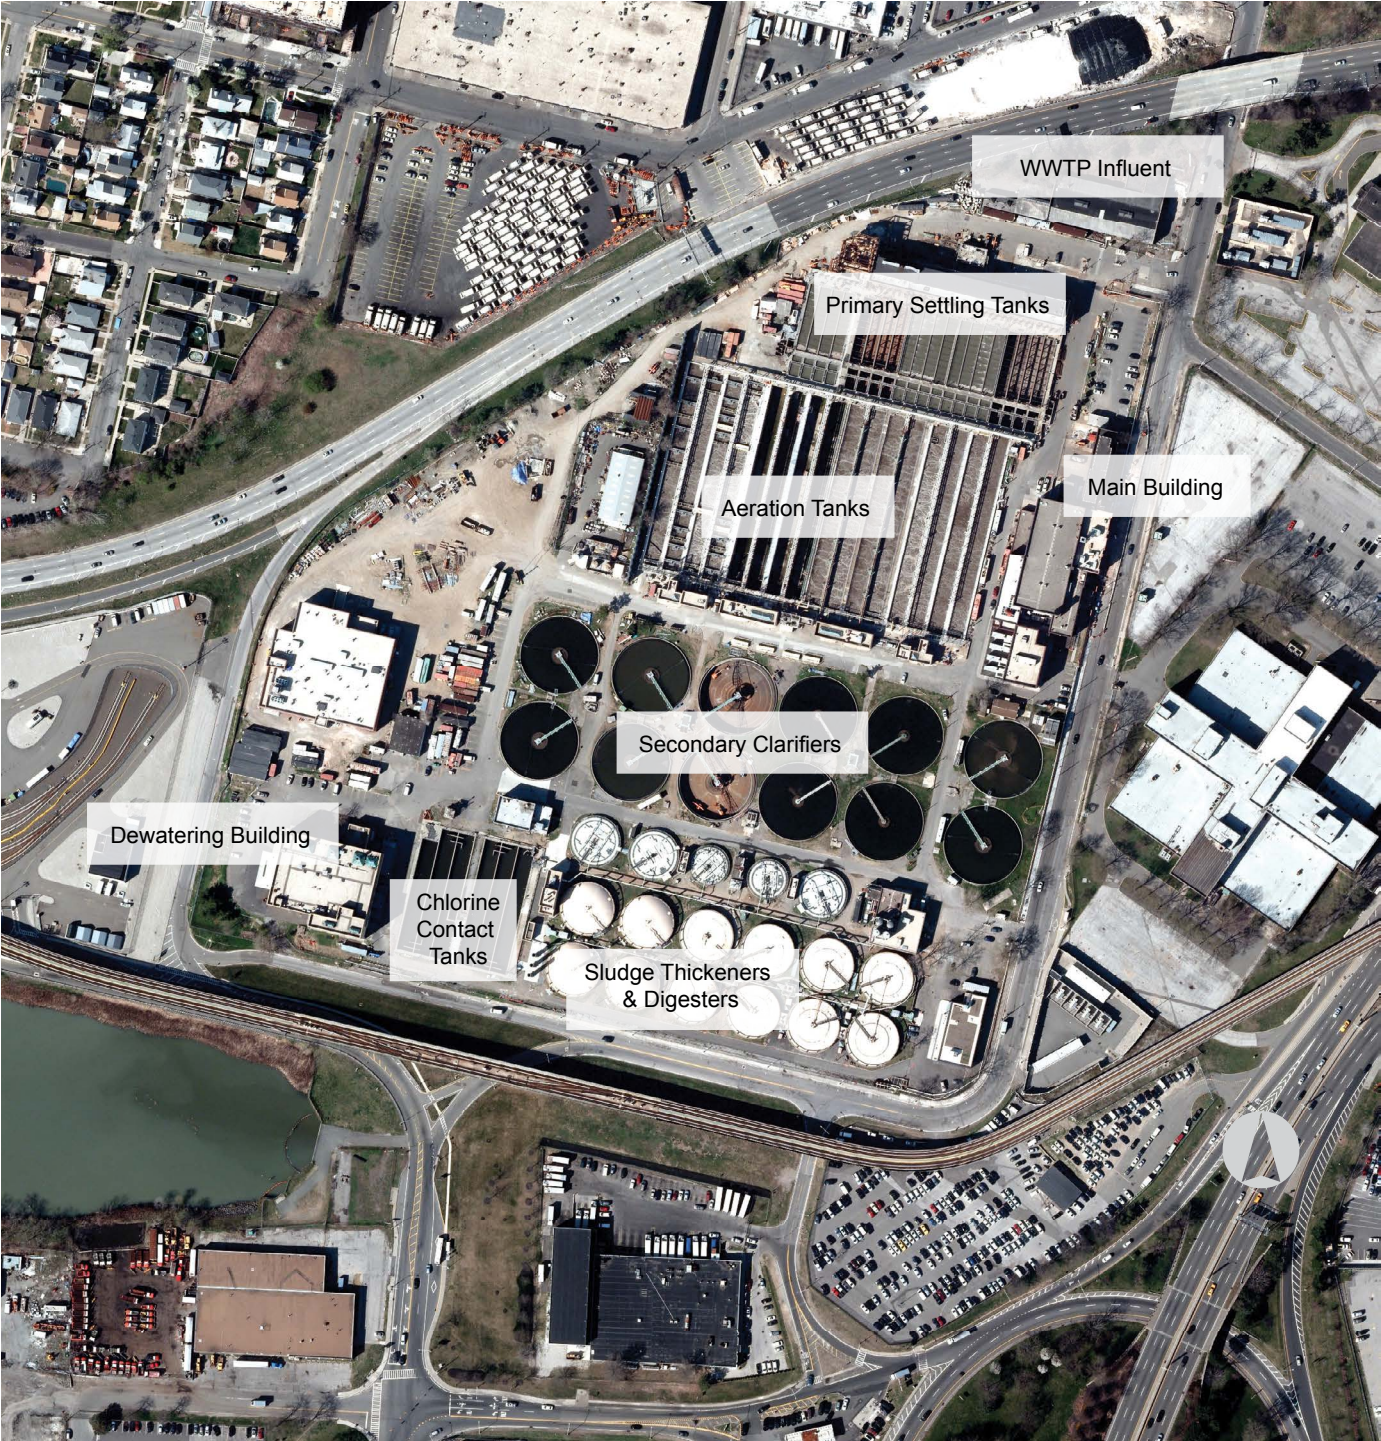
The Jamaica Wastewater Treatment Plant did not sustain any damage due to flooding during Hurricane Sandy.

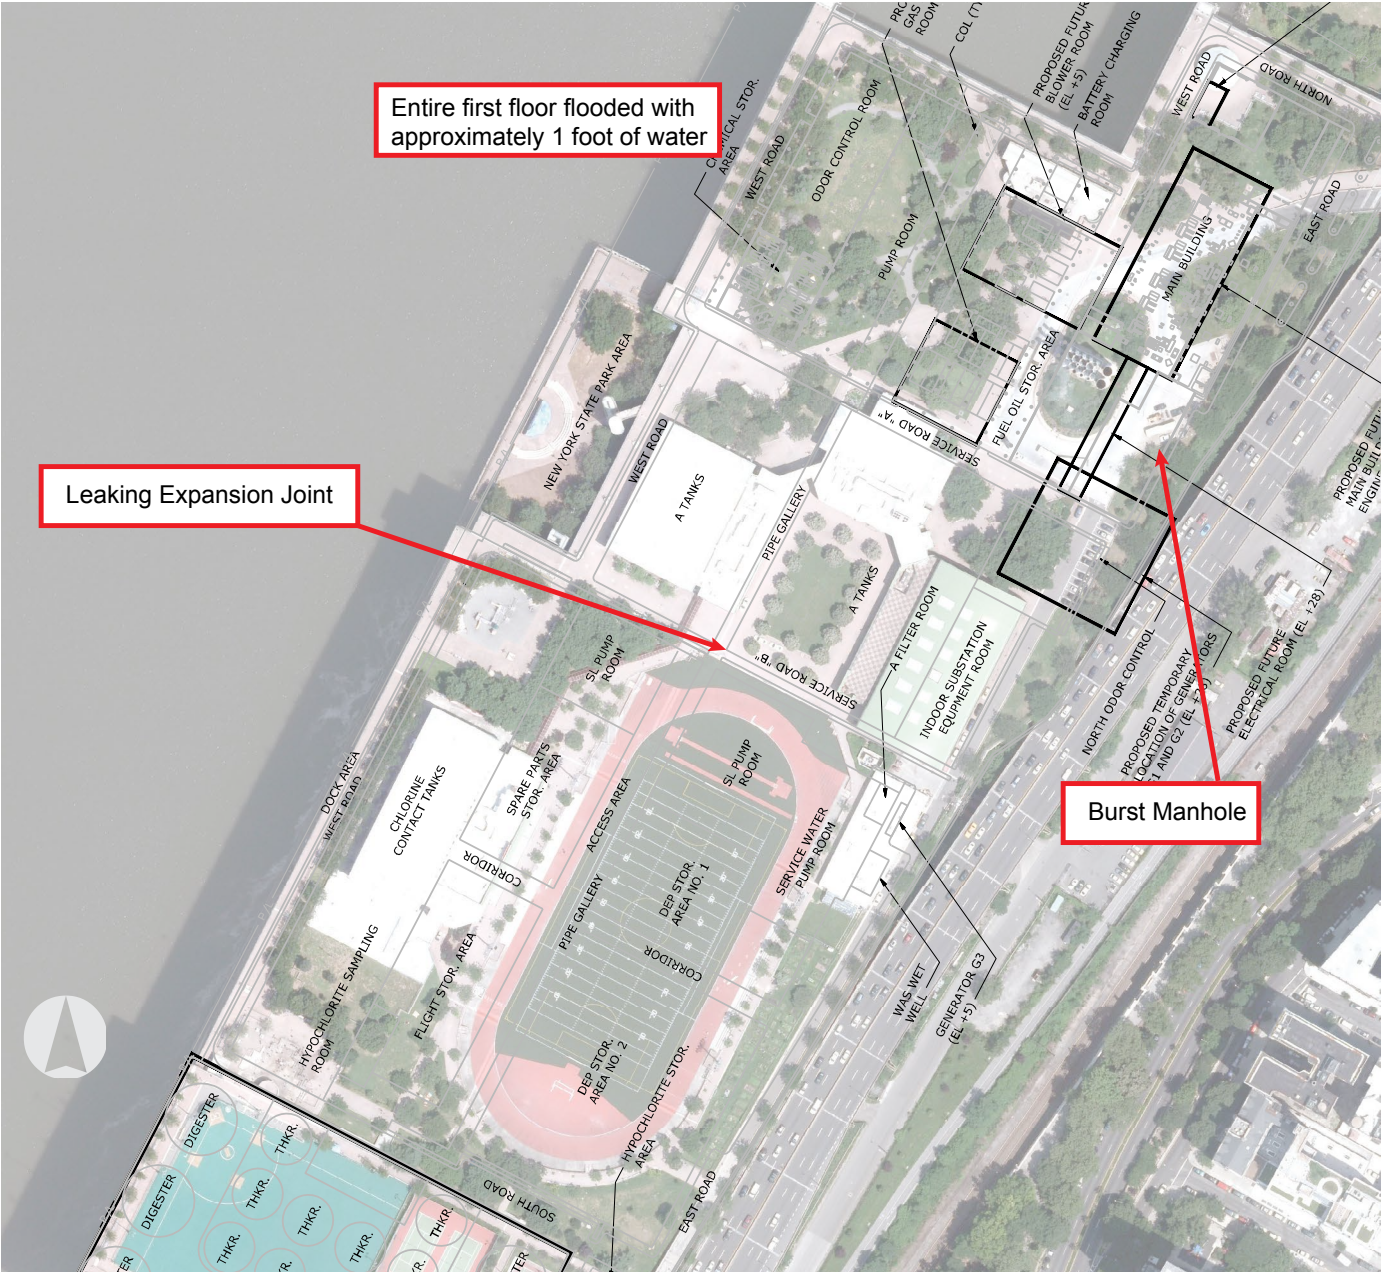
The plant did not lose power; however, certain critical components were proactively shut down for up to 7 hours to prevent short circuiting in case the water level continued to rise. Water flooded the low-lying areas of the building first, including the Raw Influent Pump Dry Well through the first floor stairwells. It was at this point that plant staff turned off the electricity in critical plant areas. Once it was safe to restore power to the facility, a single pump was used to empty the dry well, and maintenance was performed on the remaining pumps when the dry well was emptied. After the storm, floodwater on the first floor flowed out of the plant through the ruptured manhole and through the various drains and sump pumps.

Flood pathways and areas flooded during Hurricane Sandy are highlighted in red.

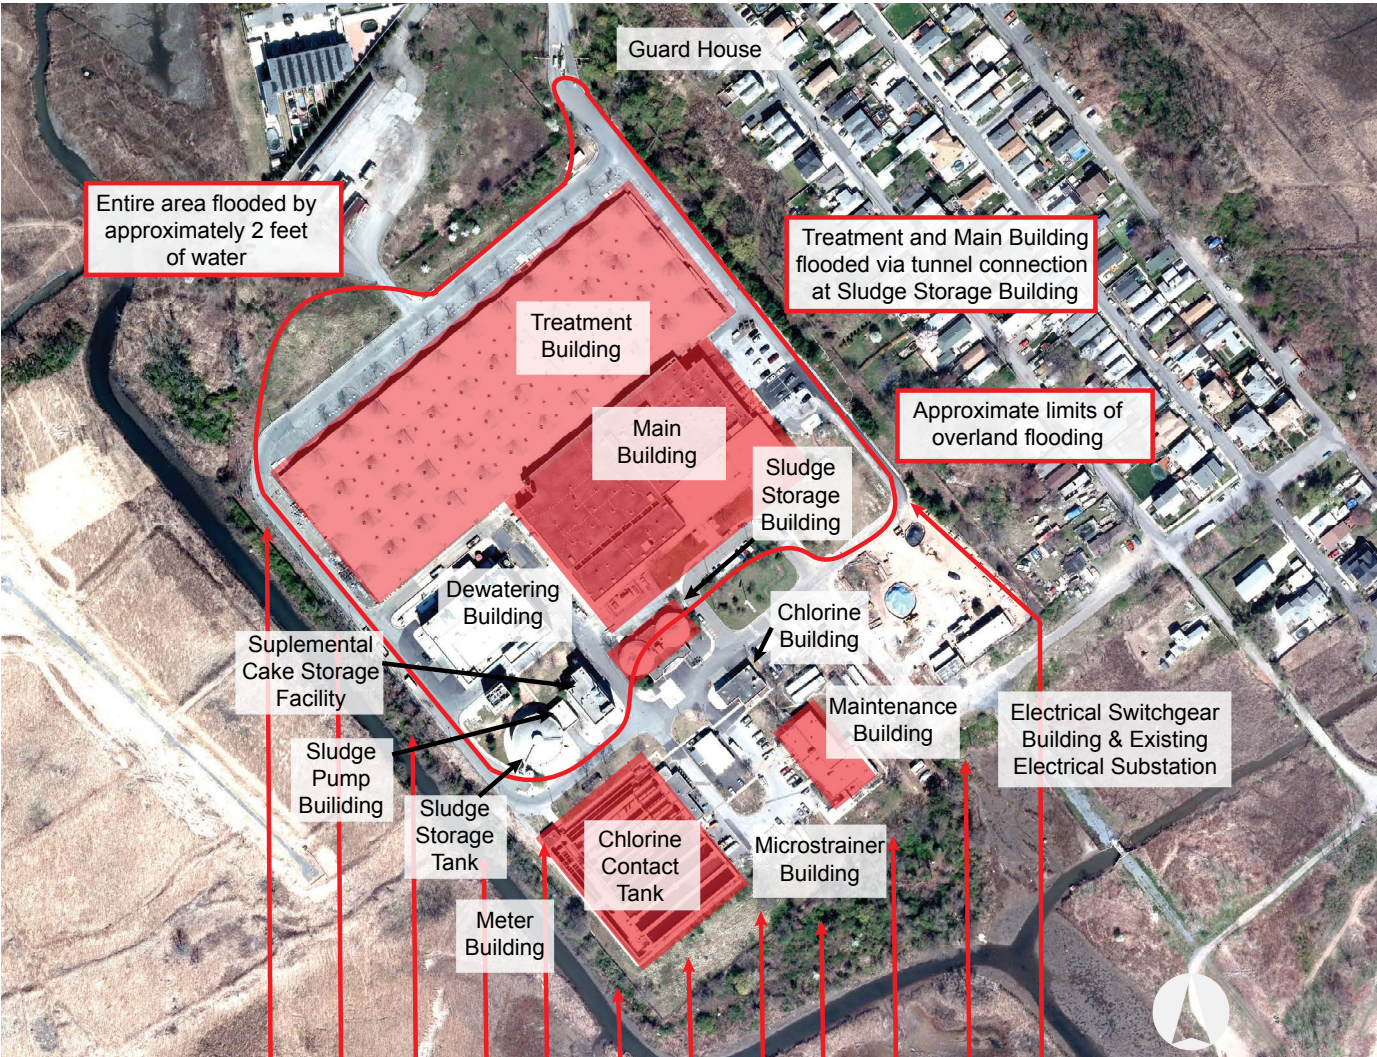
Plant staff worked actively before, during, and after the storm to protect the plant and bring it back to normal operation. Power from one of the plant’s two electrical service feeders was lost during the storm, forcing operators to partially operate on emergency generators and suspend power to the aeration blowers for a period of time. Sandbags were placed ahead of the storm to protect the low-lying temporary substation and temporary electrical generator. When power was restored, the plant resumed normal wet weather treatment with no apparent damage to critical equipment.

Flood pathways and areas flooded during Hurricane Sandy are highlighted in red.

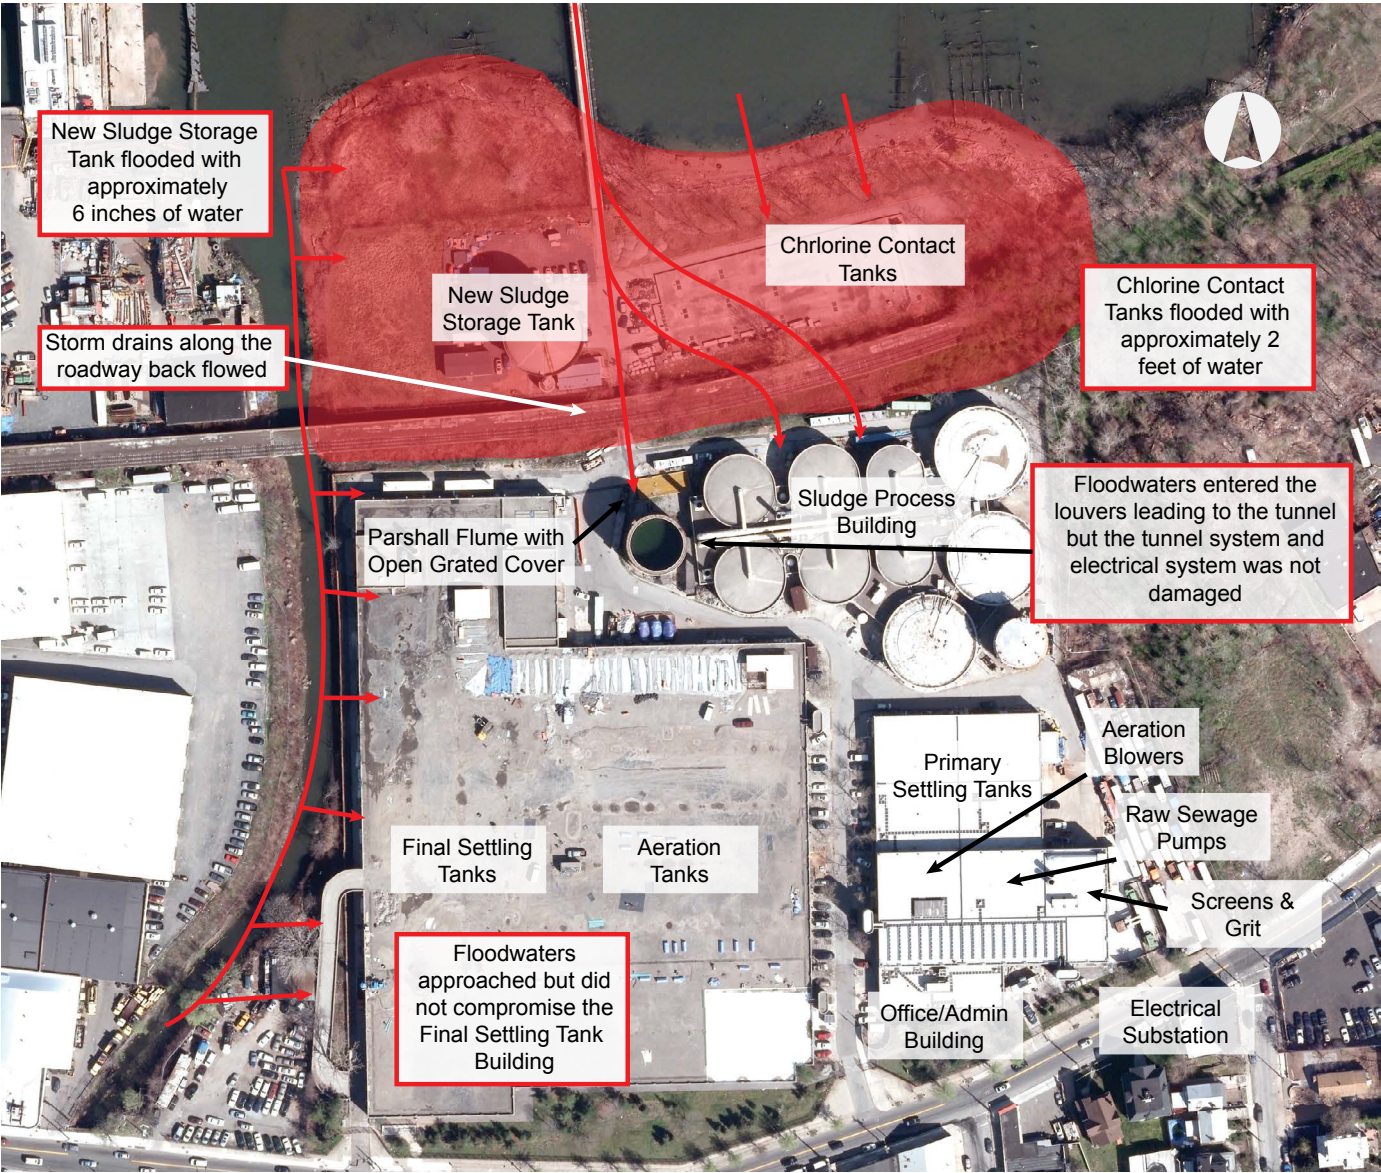
The plant staff worked actively before, during, and after the storm to protect the plant and quickly resume normal operation. Just prior to the hurricane, plant staff placed sandbags at multiple locations on the site. Sandbag placement at the New Sludge Storage Facility provided adequate protection and only allowed a minimal amount of water to enter the building, protecting pumps and most electrical equipment. Large intake louvers to the heaters located on the west side of the Sludge Process Building were also protected with sandbags, which prevented water from entering the tunnel system. Power was out for three days, and the on-site generator was used to power the primary treatment facilities during that time.

Flood pathways and areas flooded during Hurricane Sandy are highlighted in red.

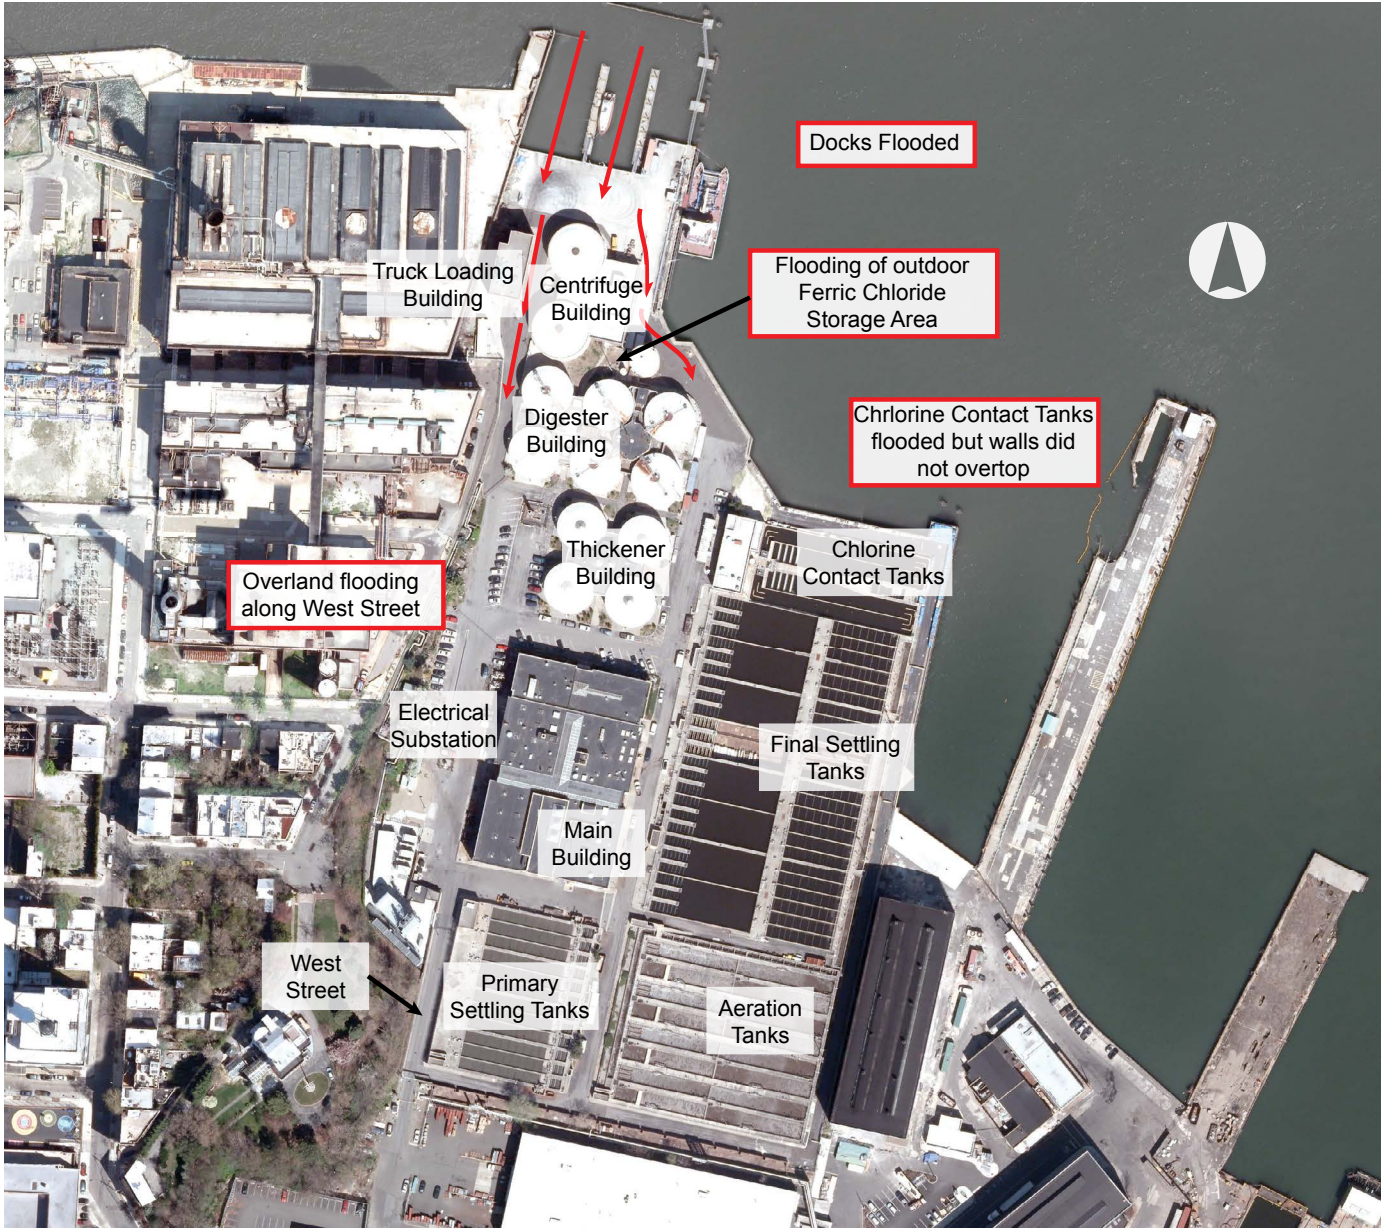
Floodwater that entered through the plant outfall caused build up in the Chlorine Contact Tanks, but did not overtop the tank walls. The plant staff worked actively before, during, and after the storm to protect the plant by sandbagging doors in locations at the north end of the plant, including the Sludge Storage Tanks, Dewatered Sludge Truck Loading Building, Centrifuge Building and Digester Building. Critical equipment needed to perform basic (primary) treatment at the plant was not damaged.

Flood pathways and areas flooded during Hurricane Sandy are highlighted in red.

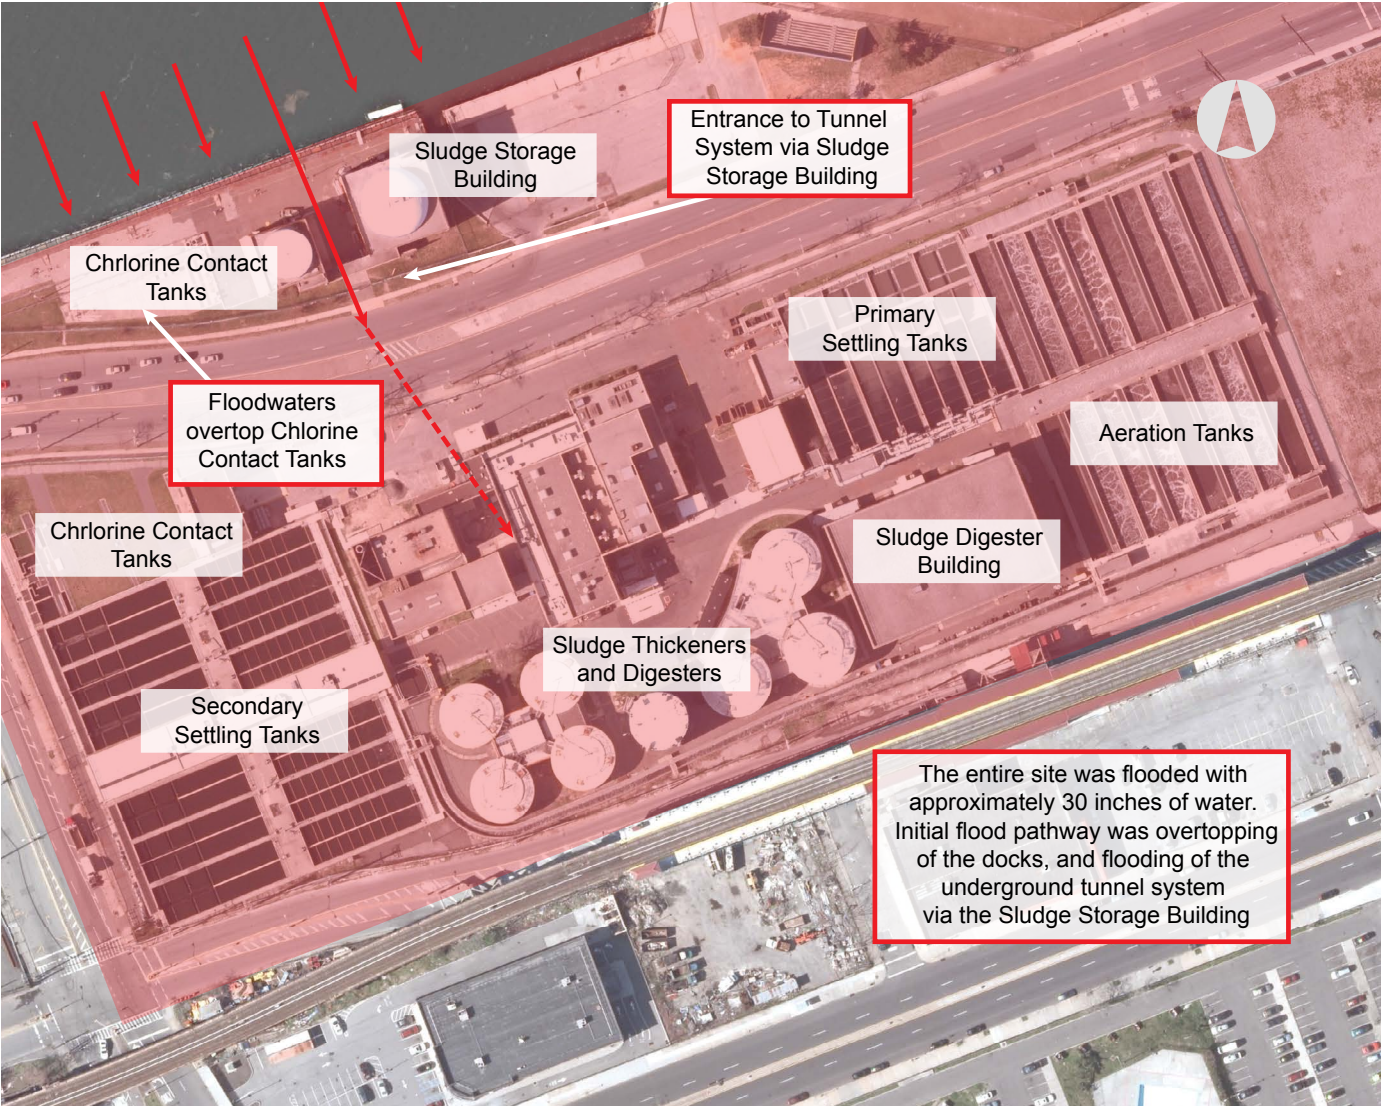
Flood pathways and areas flooded during Hurricane Sandy are highlighted in red.

DEP is also investigating the feasibility and logistics of converting Rockaway into a pumping station, amongst other alternatives, which would reduce the need to fund substantial capital projects to heavily protect and reinforce many of the buildings on site.

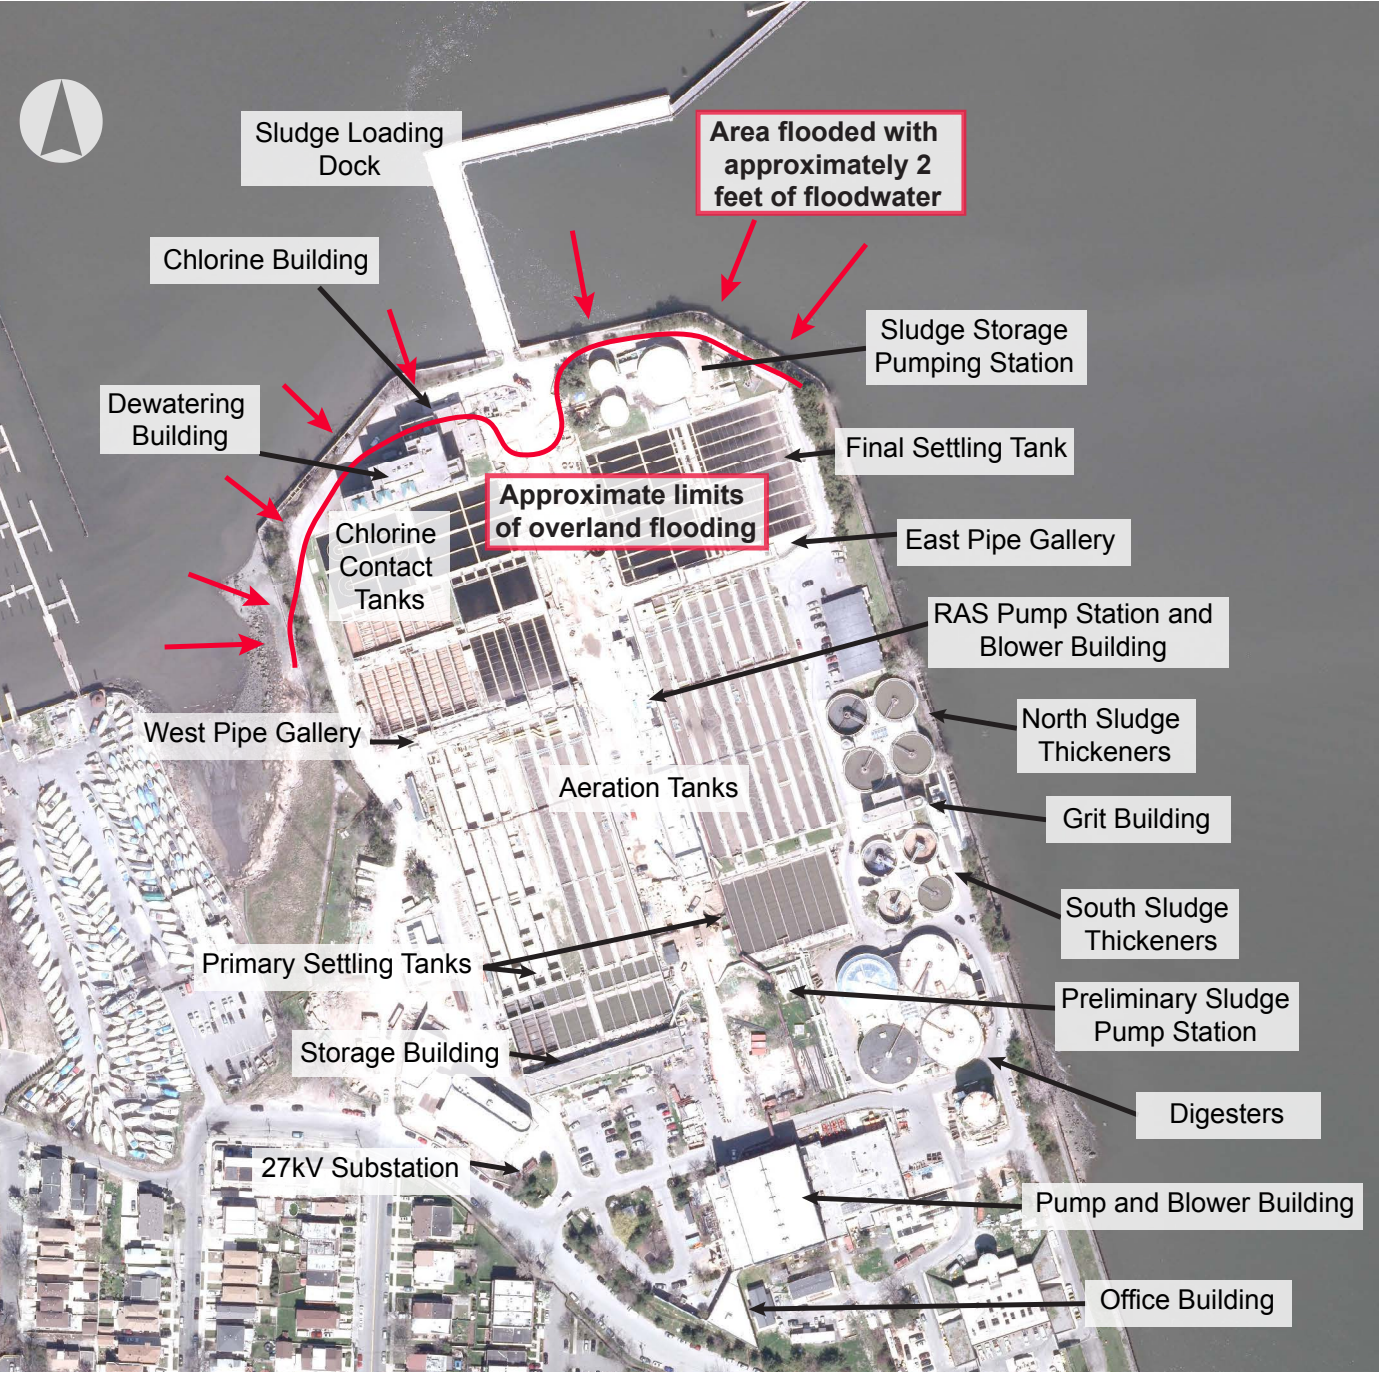
ways. However, flooding was reduced by plant staff who took precautions ahead of the storm by placing temporary slide gates and sandbags coupled with concrete traffic barriers across flood pathways. In addition, the sump pumps within the Chlorine Building maintained operation during the flood and no equipment in the building was significantly affected. While the plant did not endure significant flood damage, the wooden boardwalk surrounding the plant was severely damaged in the areas where the storm surge overtopped the perimeter bulkhead.

Flood pathways and areas flooded during Hurricane Sandy are highlighted in red.
