**Re: Integrated Sentinel Monitoring Report Calendar Year 2023**

# INTEGRATED SENTINEL MONITORING REPORT CALENDAR YEAR 2023

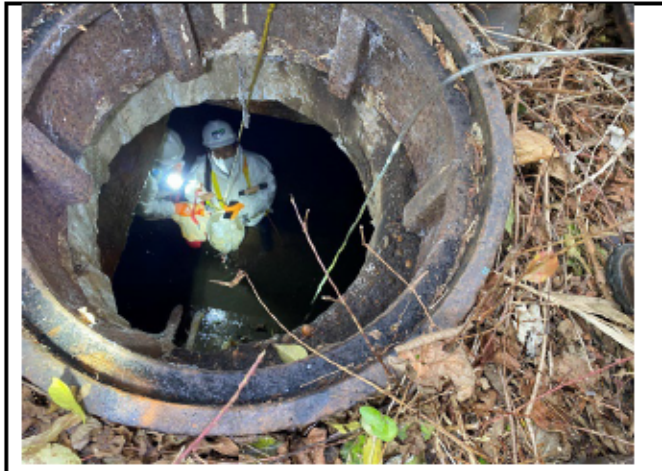
BWSO has made repairs to the grit chamber upstream of the outfall. CMS conducted a sewer walk in the area. Flow was observed from Long Island Lake Success area into the storm sewer to TI-684. As part of the investigation, CMS conducted sewer walks in the storm sewer to the outfall. CMS also conducted sewer sampling and is continuing to collect samples in the area as of 2024. TI-008 and Oakland Lake are compliant.

<p>CMS conducting a sewer walk in the sewer to Alley Creek</p>	<p>CMS conducting sewer walk in Alley Creek area</p>

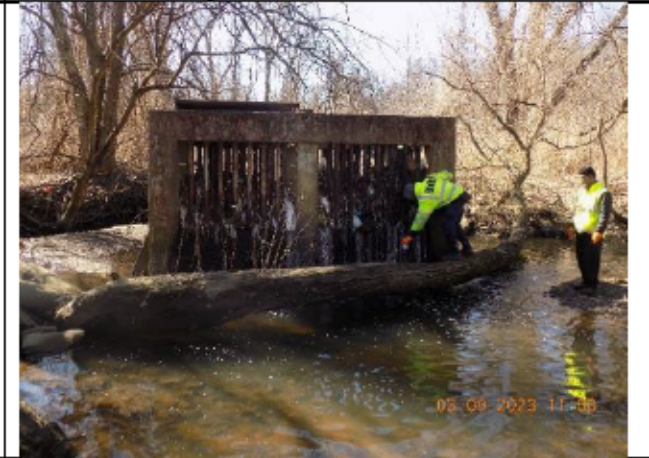
<p>CMS collecting samples in the sewer area</p>	<p>CMS collecting samples at TI-684 outfall.</p>

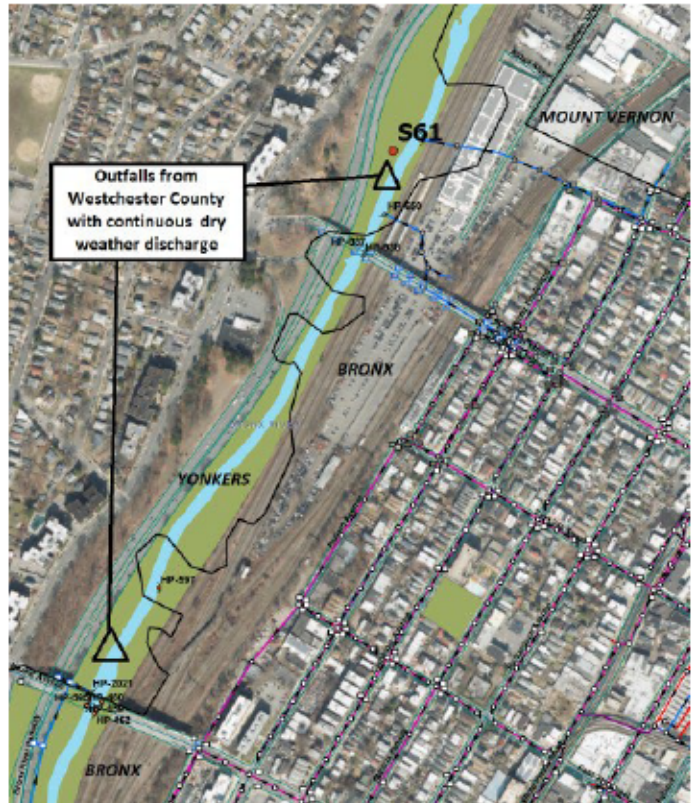
An outfall belonging to Yonkers at Nereid Avenue, discharging during dry weather.

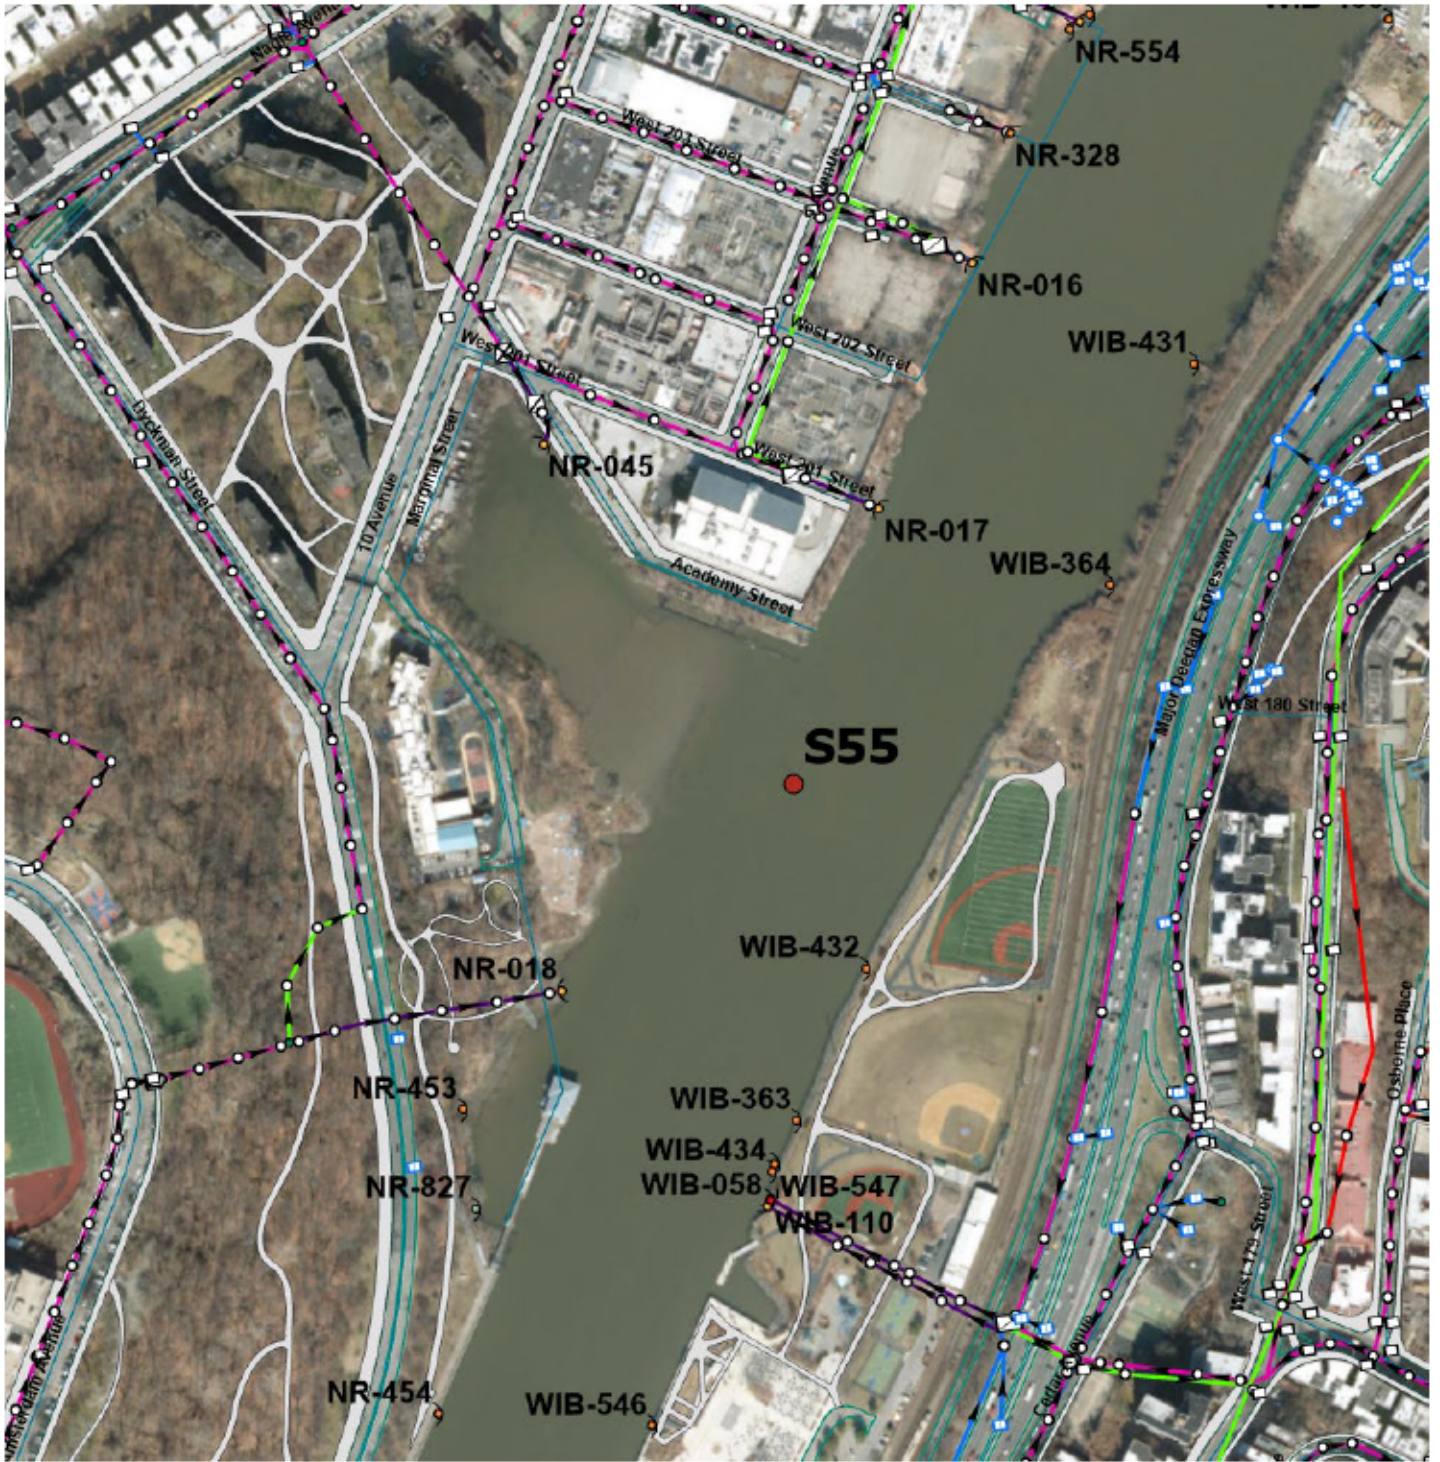
S55 and the CSO sewers in the area leading to the sentinel station.

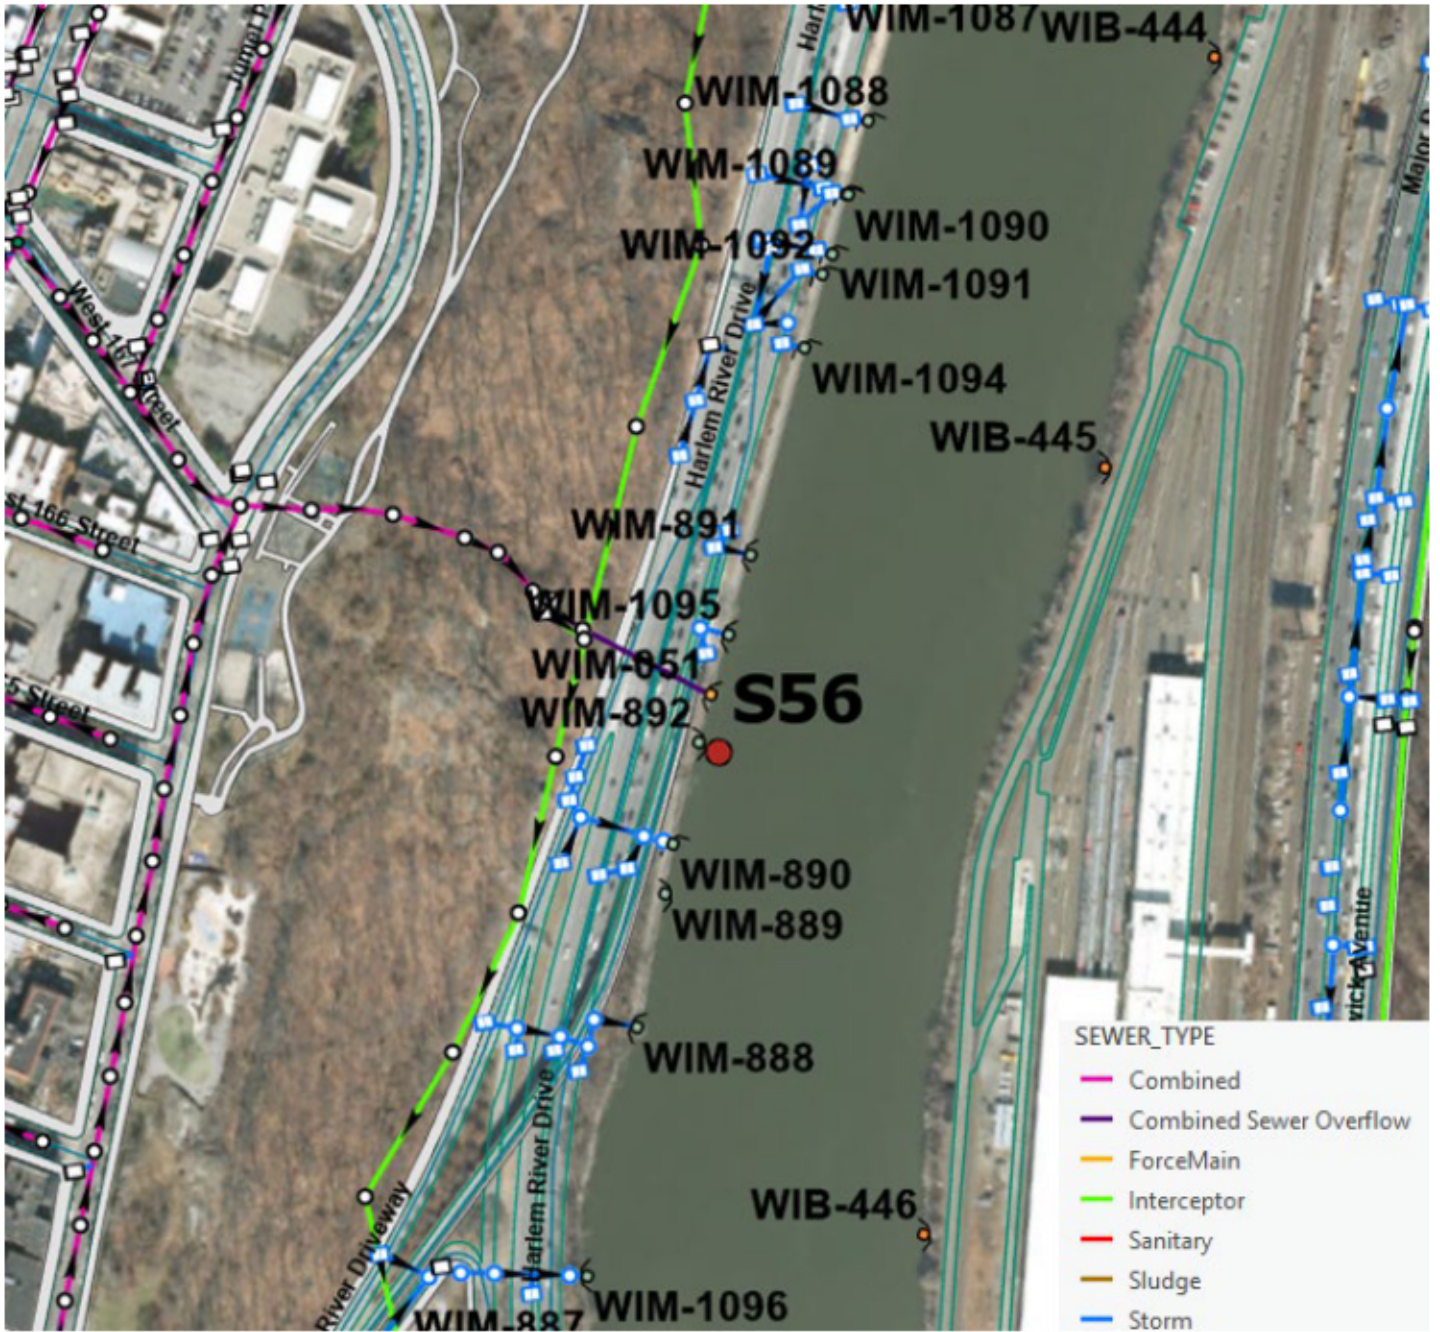
S56 and the CSO and MS4 outfalls in the area

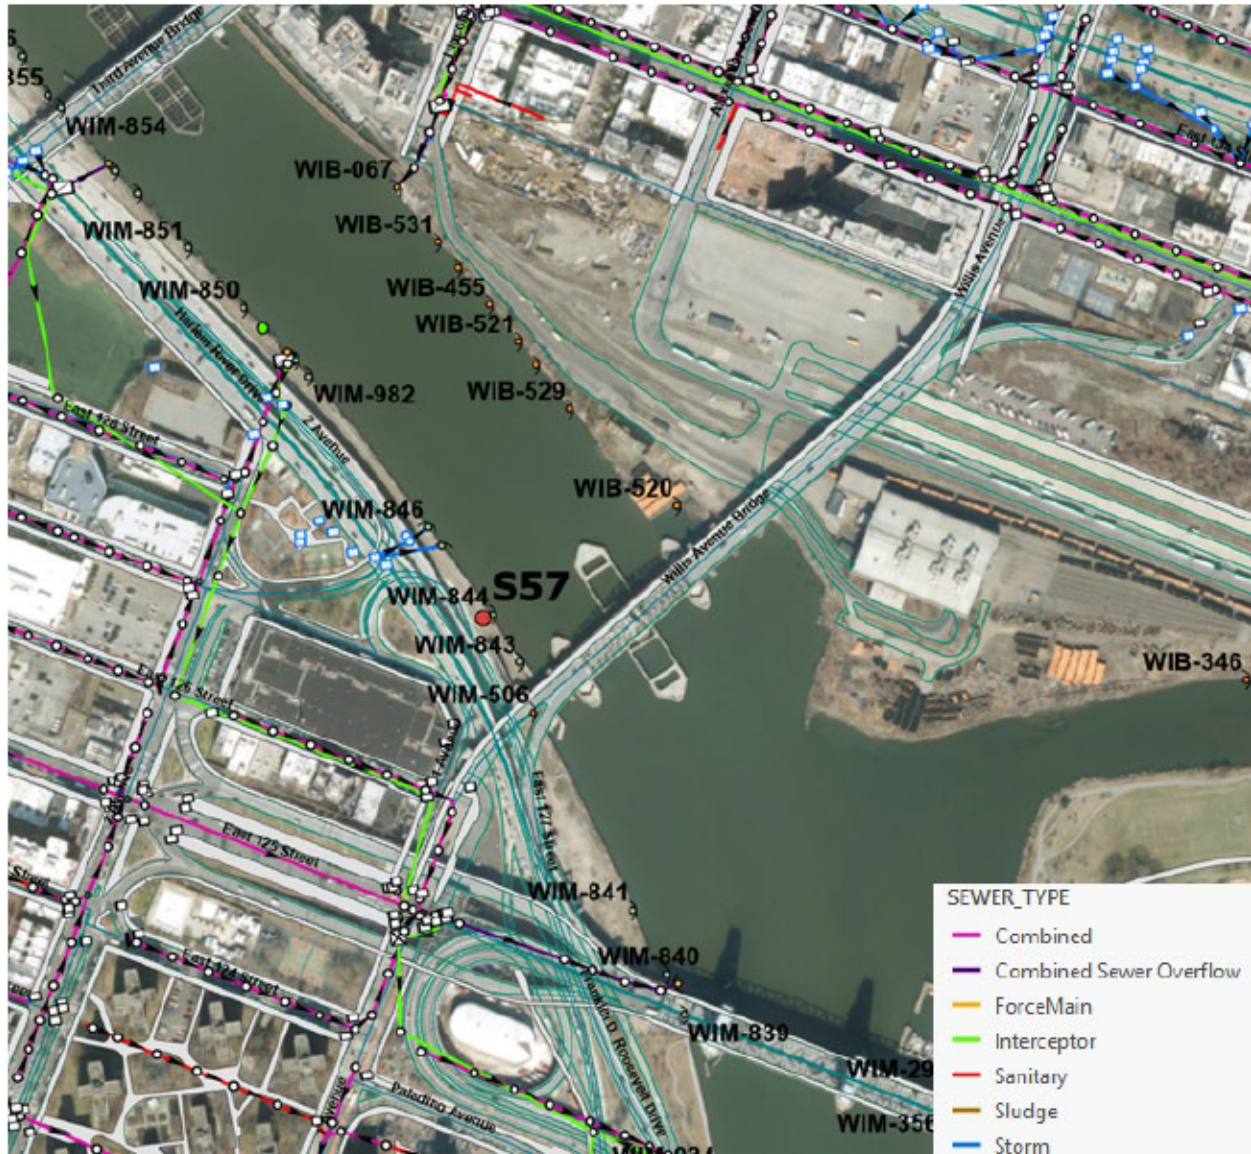
S57 and the outfalls in the area.

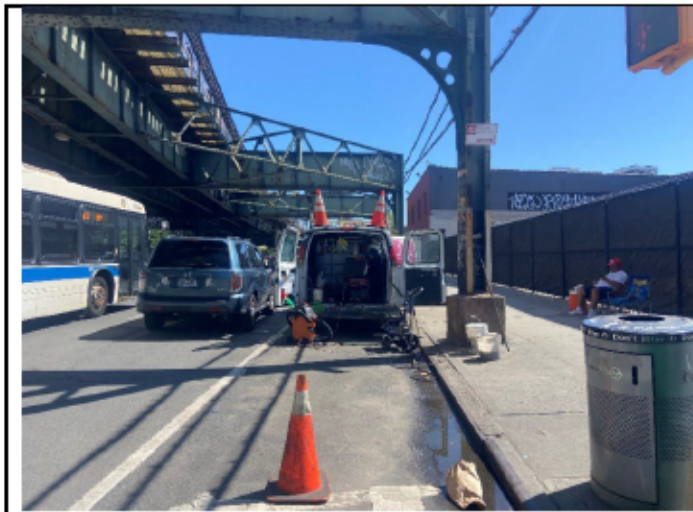
10<sup>th</sup> Ave between W 207<sup>th</sup> St to W 215<sup>th</sup> St (Car wash on the Street)

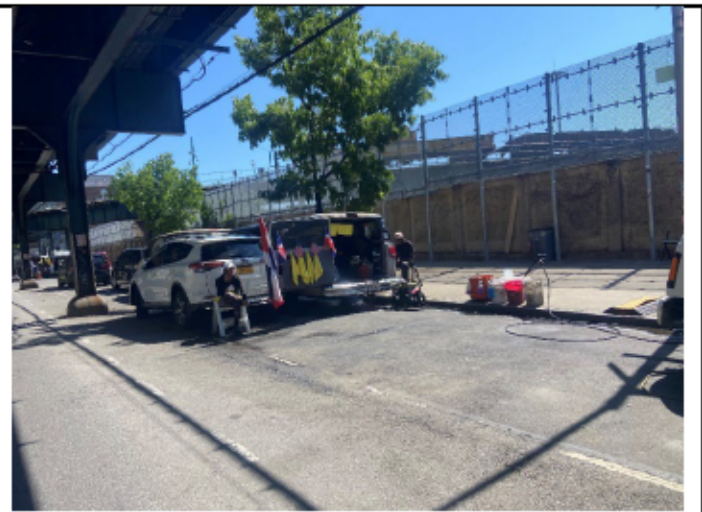
10<sup>th</sup> Ave between W 207<sup>th</sup> St to W 215<sup>th</sup> St (Car wash on the Street)

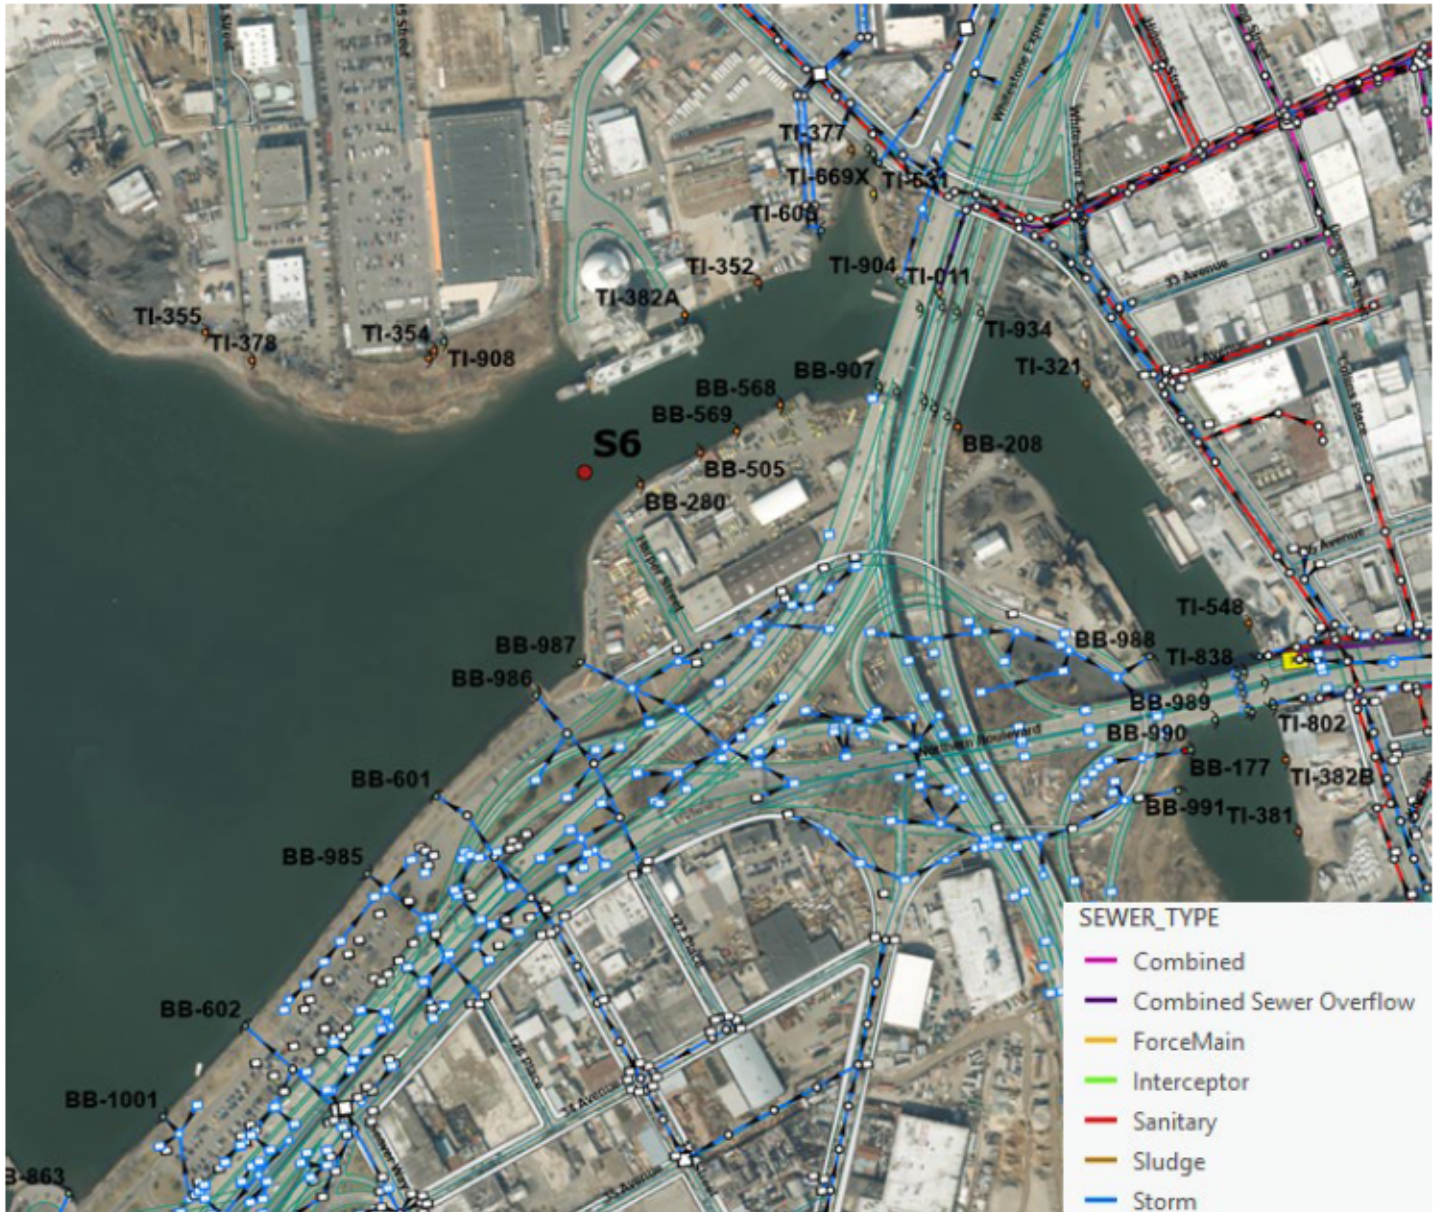
S6 and the outfalls in the sentinel station area.

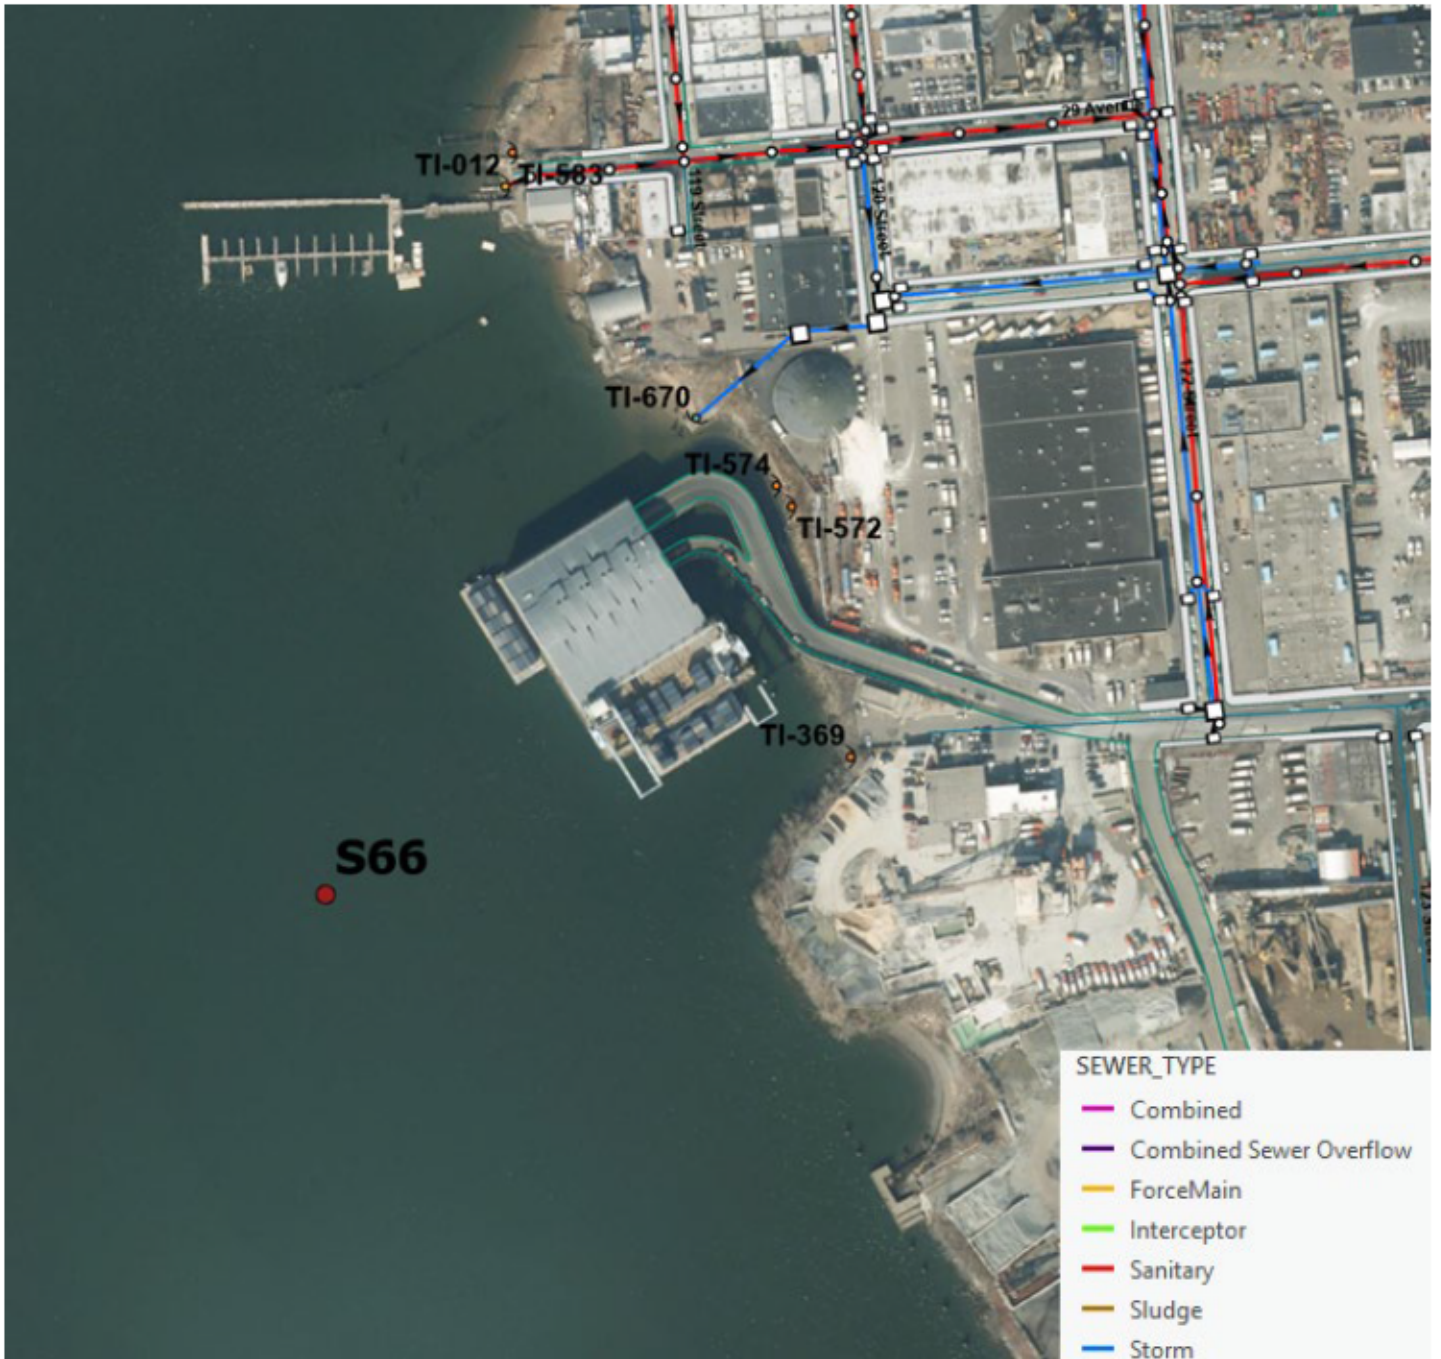
S66 and the lack of sewers in the sentinel station area

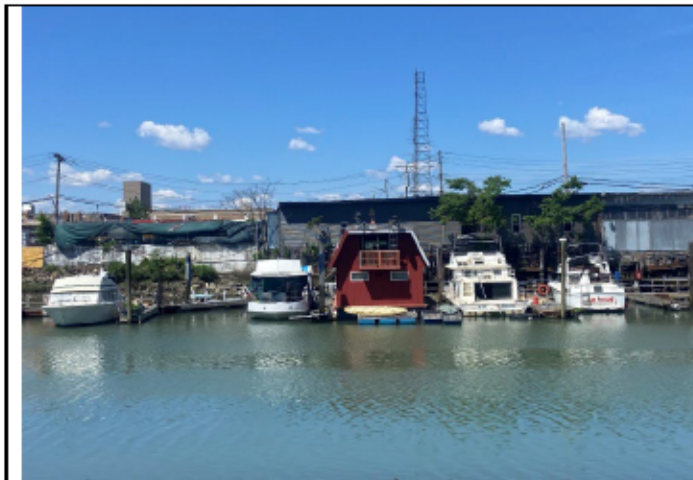
Westchester Creek (House Boats)

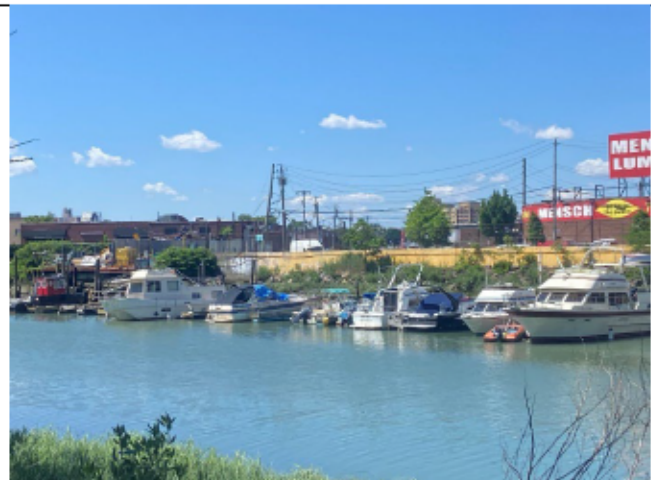
Westchester Creek (House Boats)

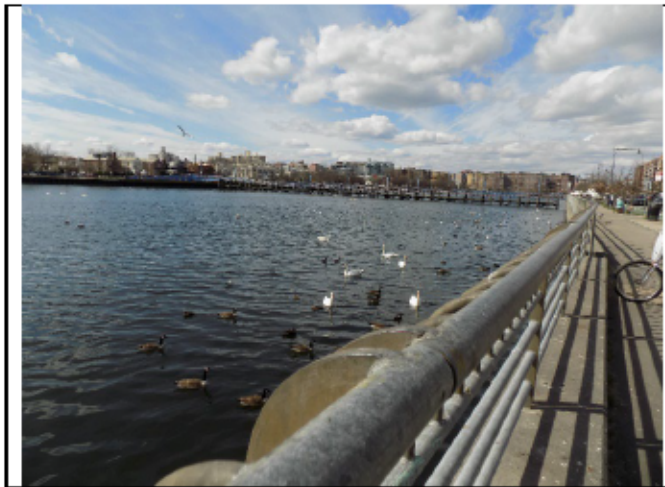
S82 and Sheepshead Bay. Abundant birds are present in the waterbody.

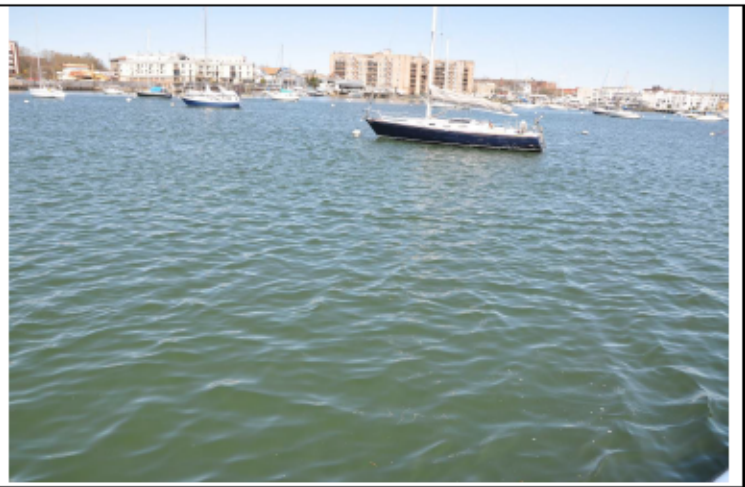
Boats located in Sheepshead Bay

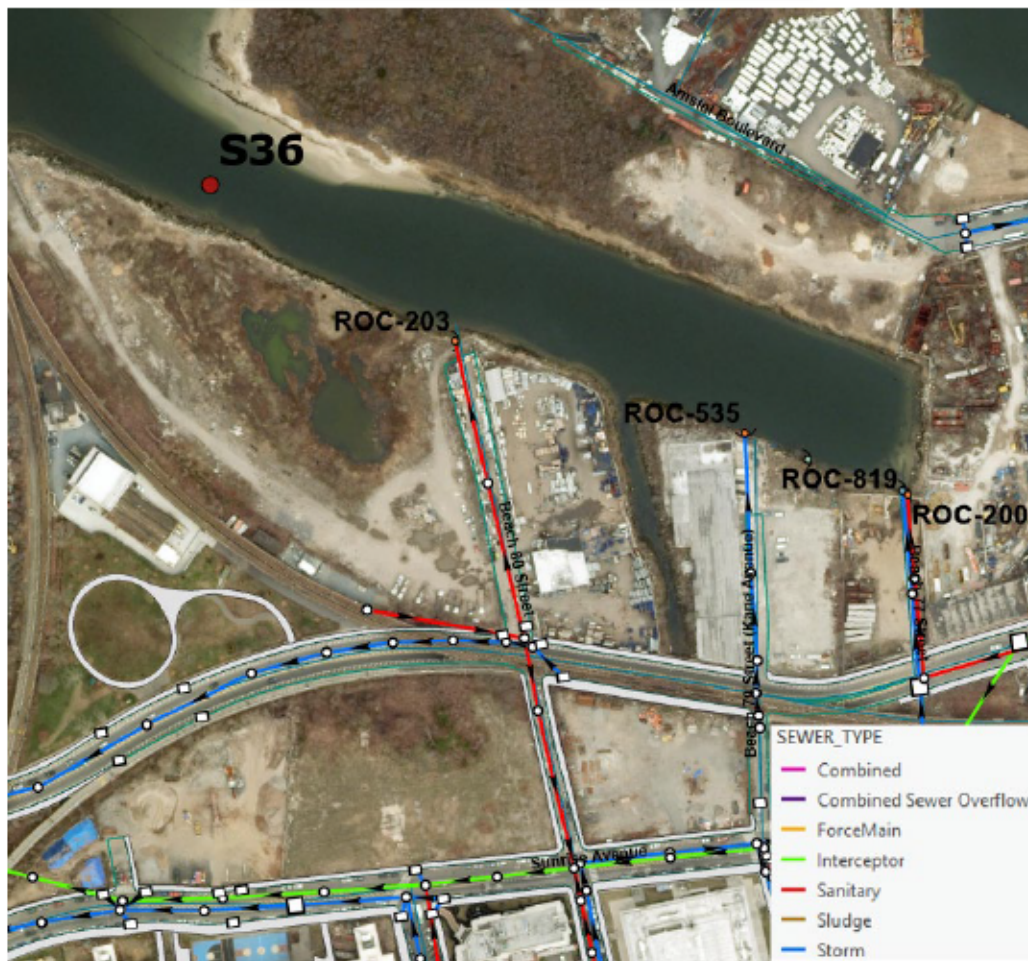
S36 and the sewers in the sentinel station area. The sewer map requires changing.

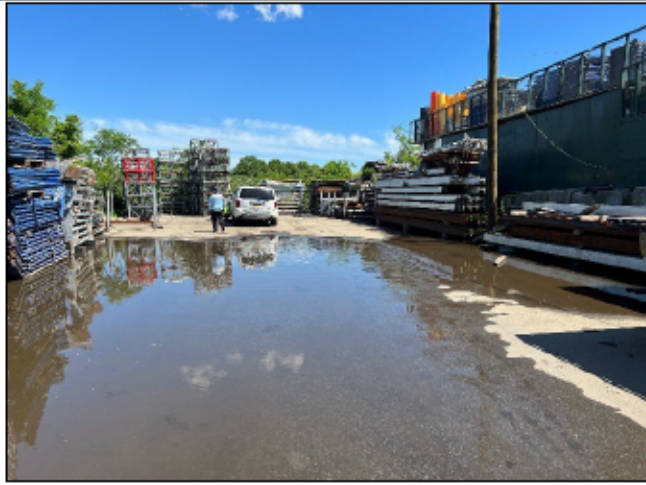
Industrial activity occurring in the Barbadoes Basin drainage area.

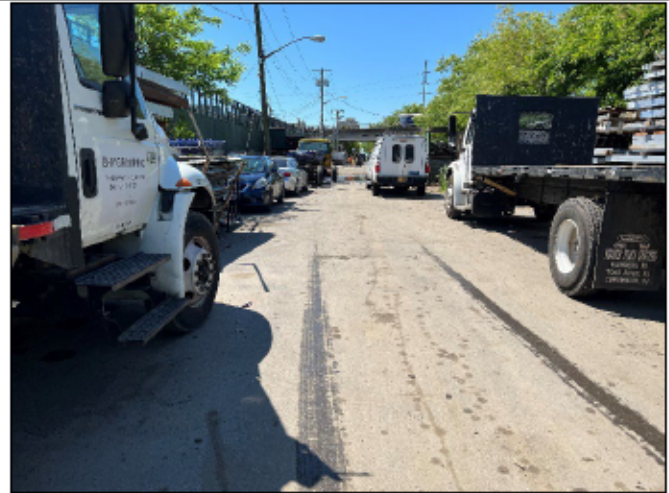
Industrial activity occurring in the Barbadoes Basin drainage area.
