New York City
Department of Buildings

**51st Street Crane
Investigation**

March 2009

Ove Arup & Partners Consulting Engineers PC
155 Avenue of the Americas, New York NY 10013
Tel +1 212 229 2669 Fax +1 212 229 1056
www.arup.com

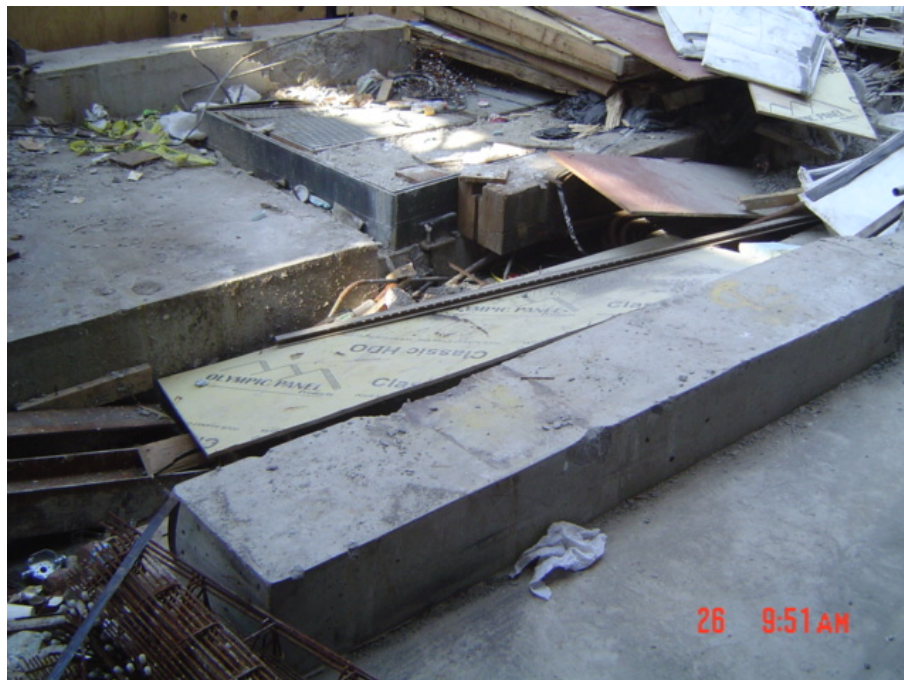
Photograph 1.2 - Tower foundations (source: photograph entitled "Manhattan Crane Collapse (03-26-08) 005" from March 26, 2008 visit to the collapse site by Arup). The foundation wall for the building is in the foreground. The foundation support wall, which was constructed specifically for the dunnage beams, is in the background. The Con-Ed vault can be seen between the foundations (in the center of the photo). Note the absence of anchorage for the dunnage steel, as per the design. Also note the absence of significant damage to the foundations (limited spalling evident only).

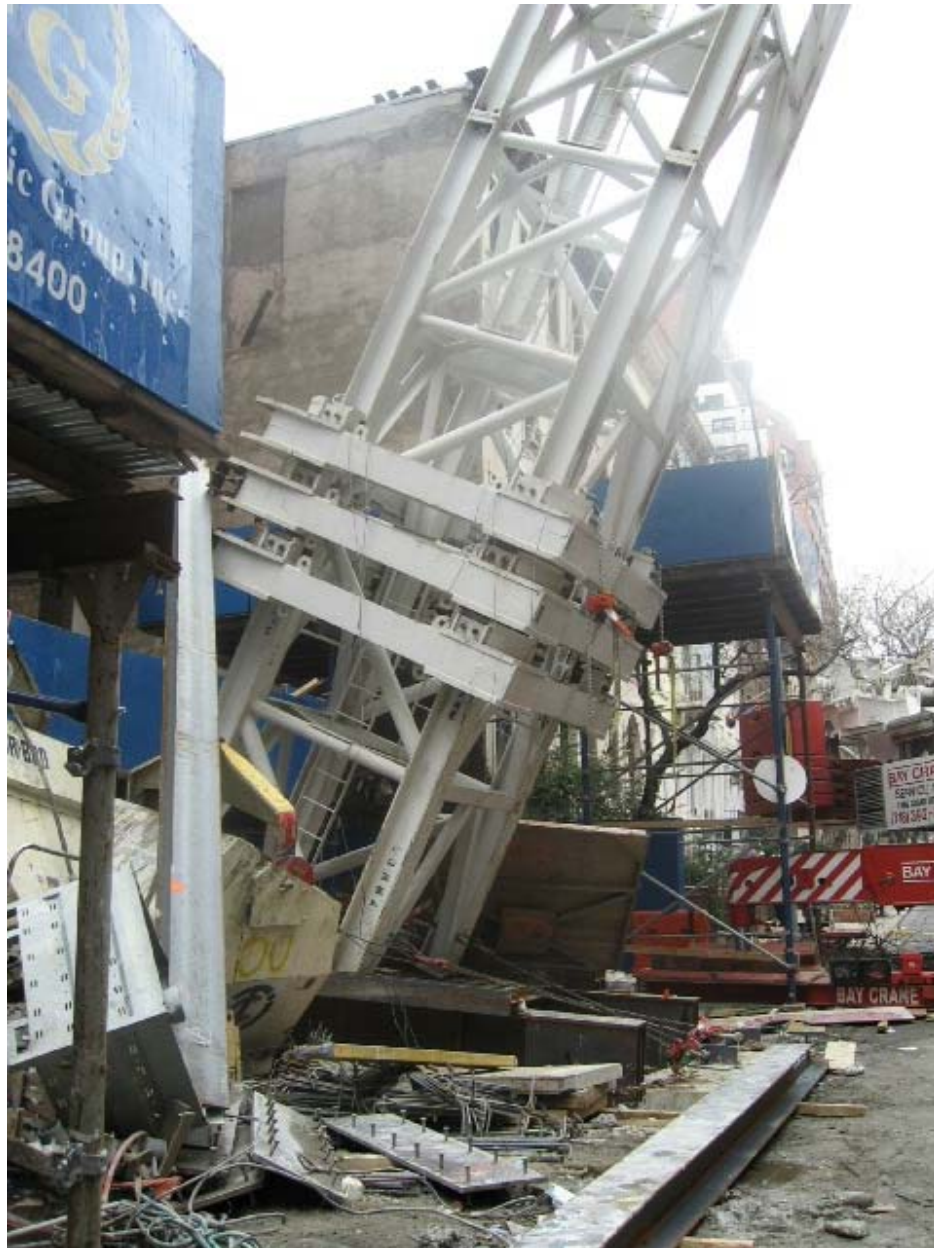
Photograph 1.3 - Photograph showing conditions at tower base following the collapse (source: New York County District Attorney's Office, Photograph ID No. IMG-0326-056).

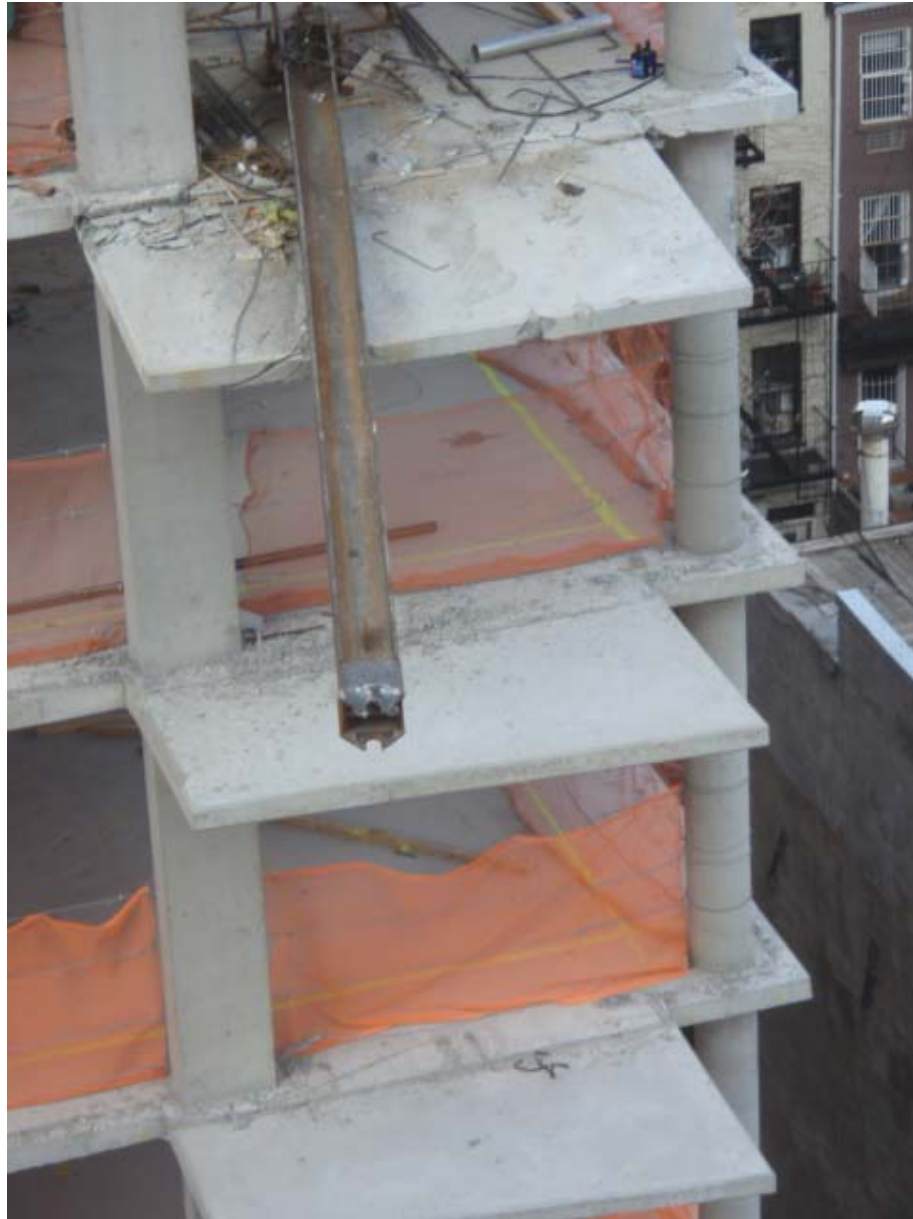
Photograph 1.13 - Failed pin end of Beam B5 at the 9th floor level as seen immediately following the collapse. Photo provided by the NYCDOB.

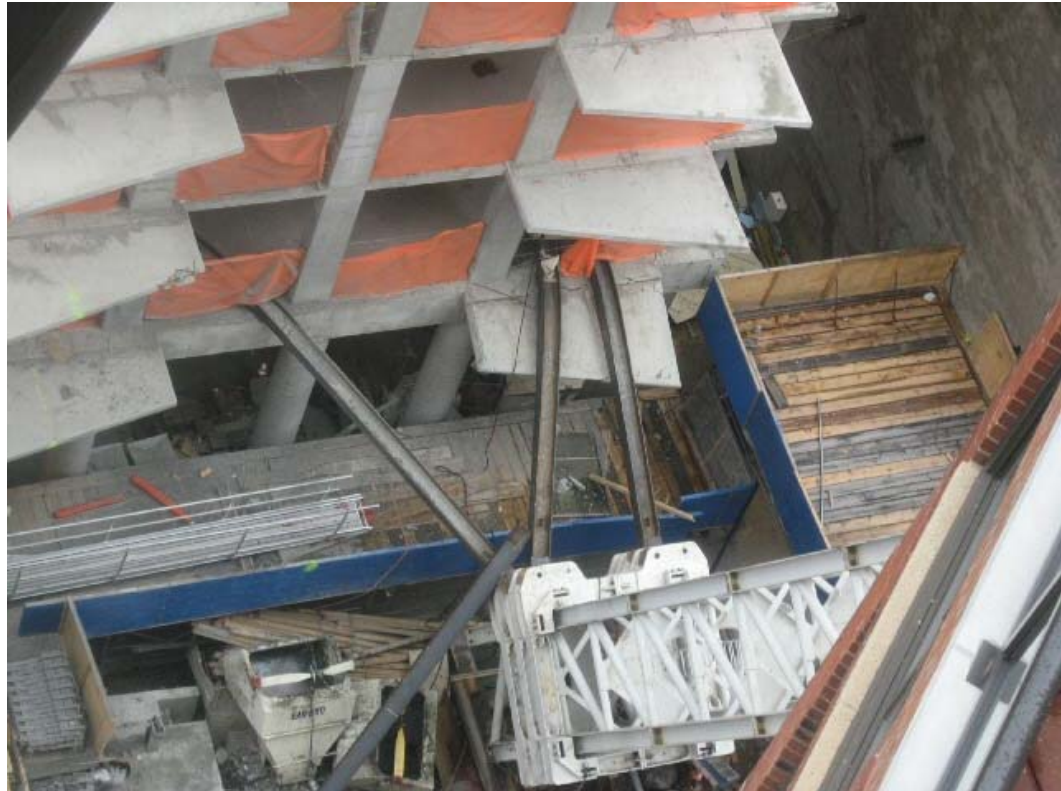
Photograph 1.14 - 3rd floor collar assembly following the collapse. The 9th floor collar and 18th floor collar rest atop the 3rd floor collar. Source: New York County District Attorney IMG_0355_085.jpg.

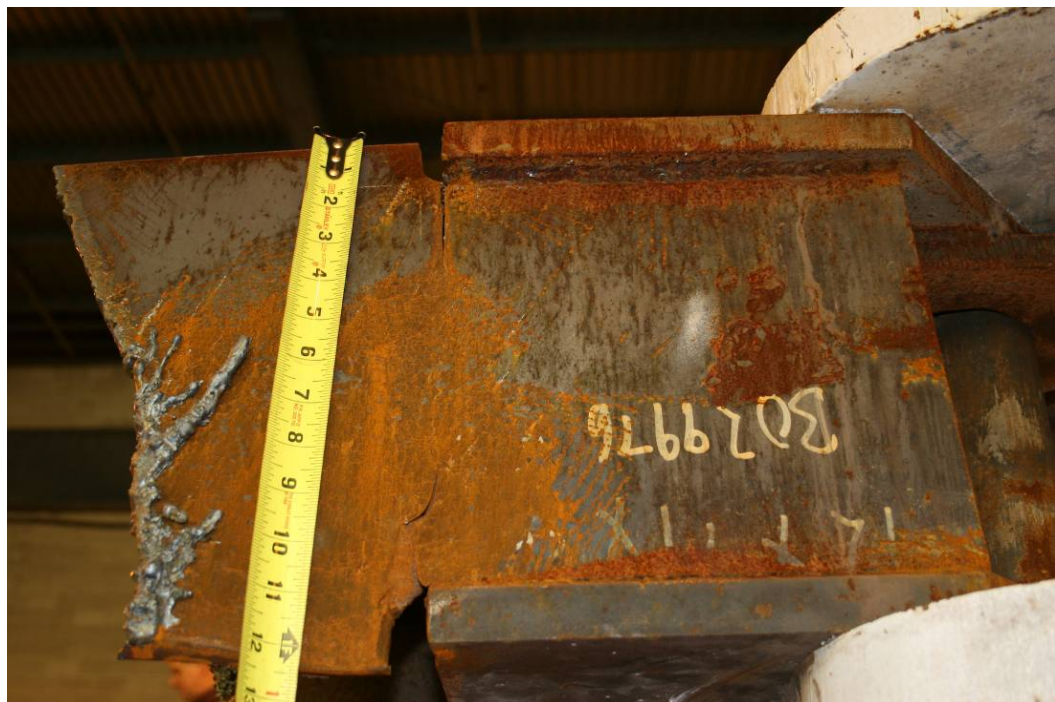
Photograph 1.15 - Fracture of a tie-beam which did not fully fail on the 3rd floor collar. (The fracture of interest is to the right of the tape measure. The damage to the left of the tape measure is a flame-cut (post failure) to assist in the removal of the debris. Photo by Arup.

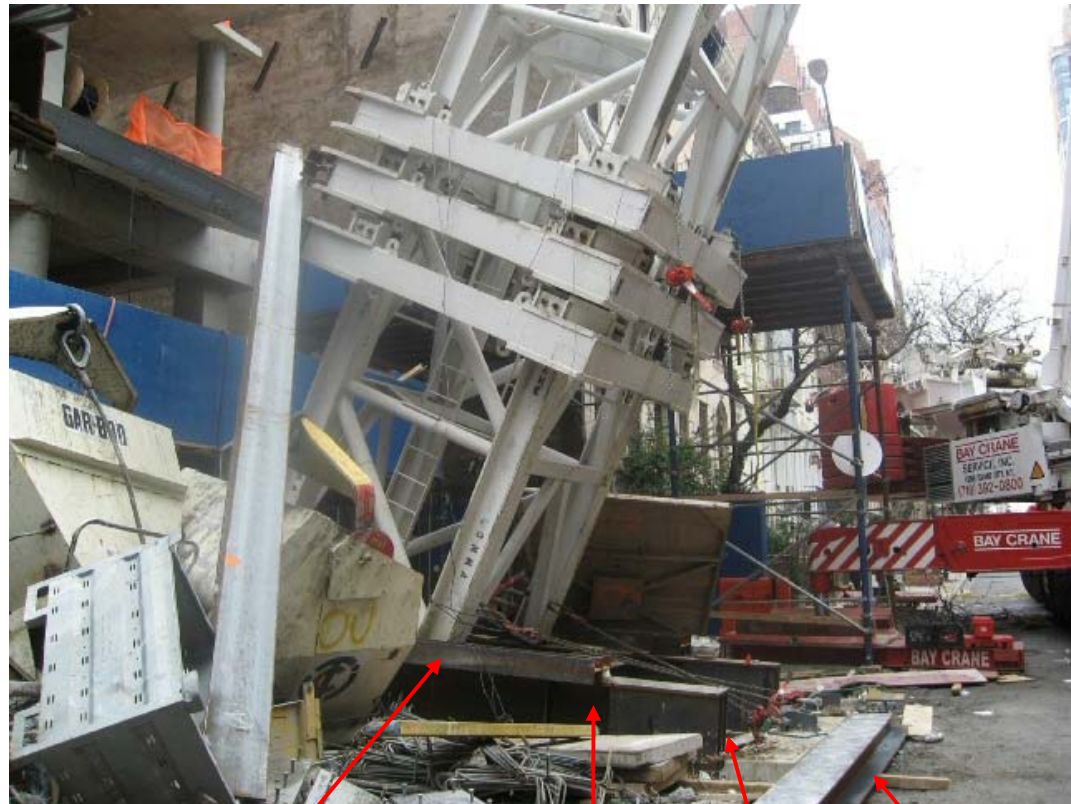
Photograph 1.16 - View of street side (south) of tower base after failure. The dunnage beam is no longer on the supporting concrete foundation wall. Photo by New York County District Attorney IMG_0327_057.jpg.

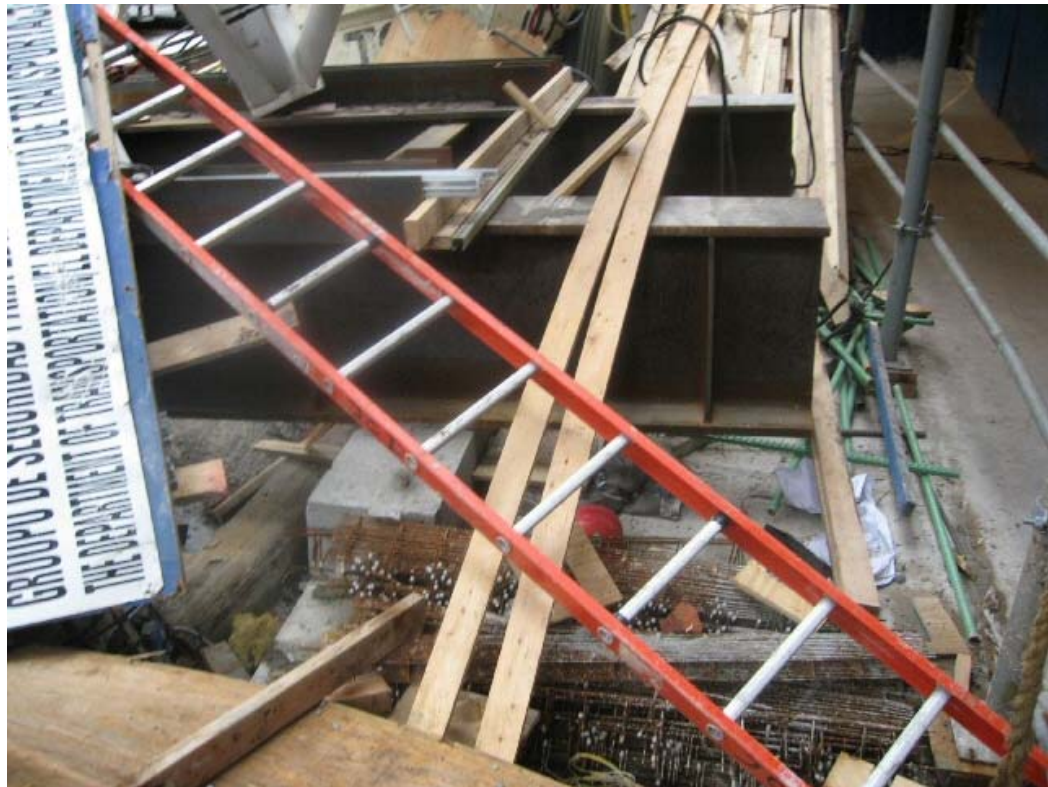
Photograph 1.17 - View of building side (north) of tower base after collapse. The dunnage beam has been displaced towards the building and the plywood bearing pads are off of the foundation wall. Lifting of the back tower legs and slippage of the front tower legs is also visible. Photo by New York County District Attorney IMG_379_109.jpg.

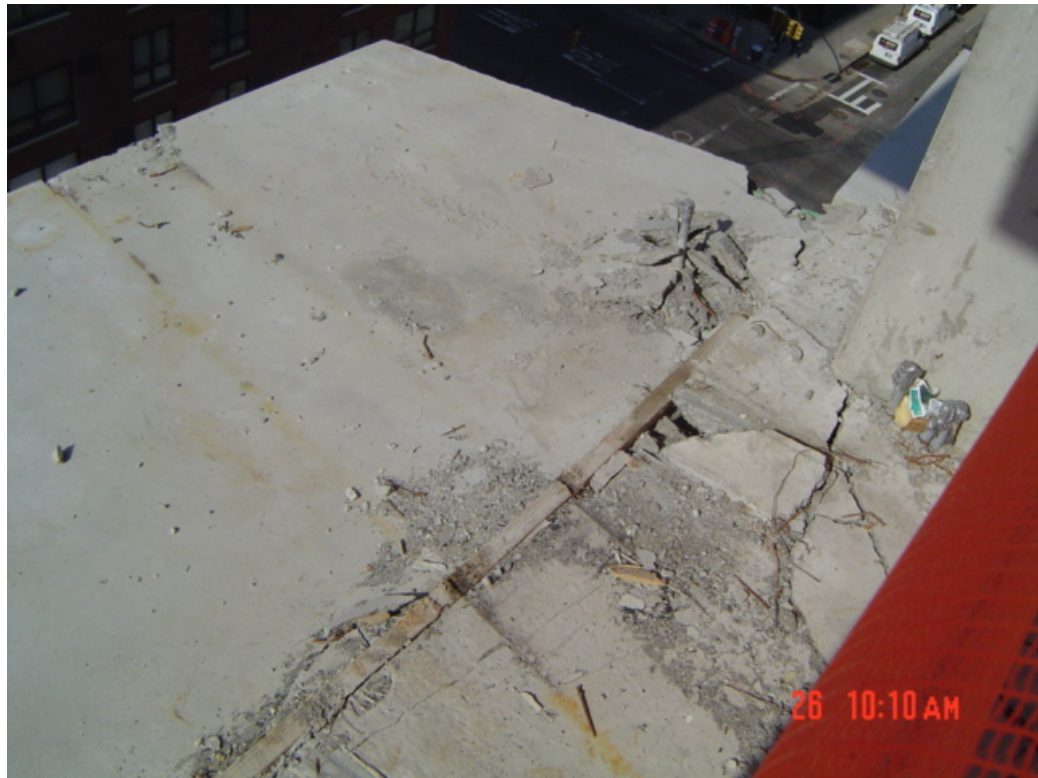
Photograph 1.18 - Damage to 9th floor balcony. The imprint in the slab is from Beam 9B. Photo by Arup.

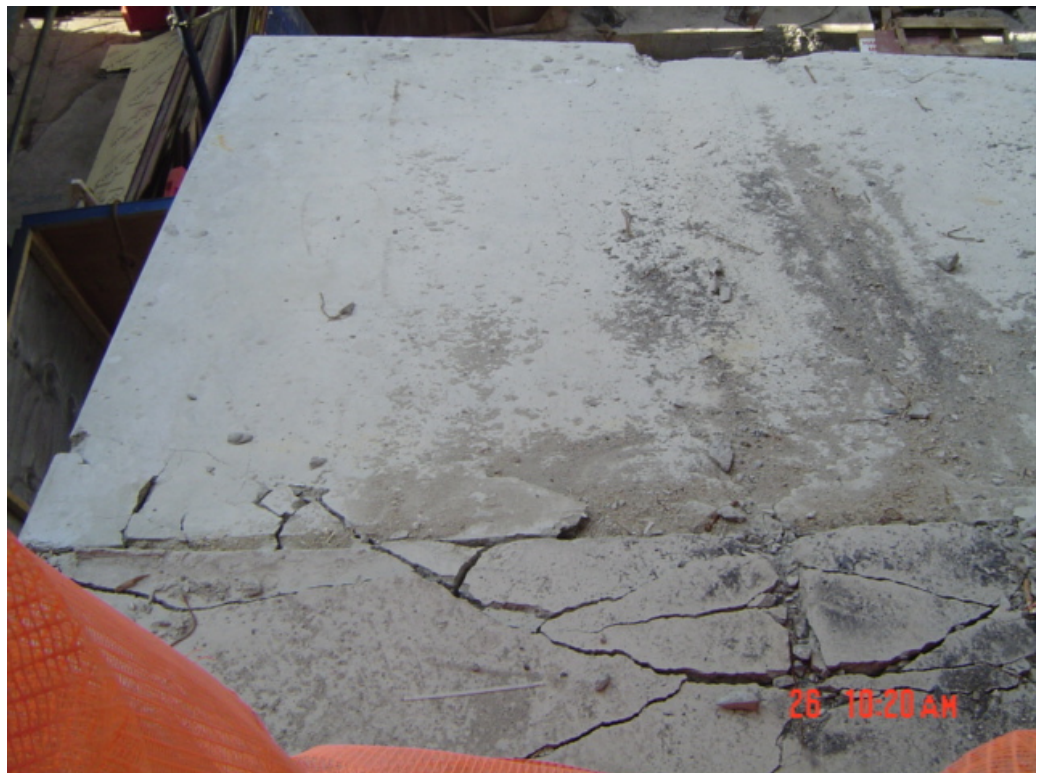
Photograph 1.19 - Damage to 3rd floor balcony. Photo by Arup.

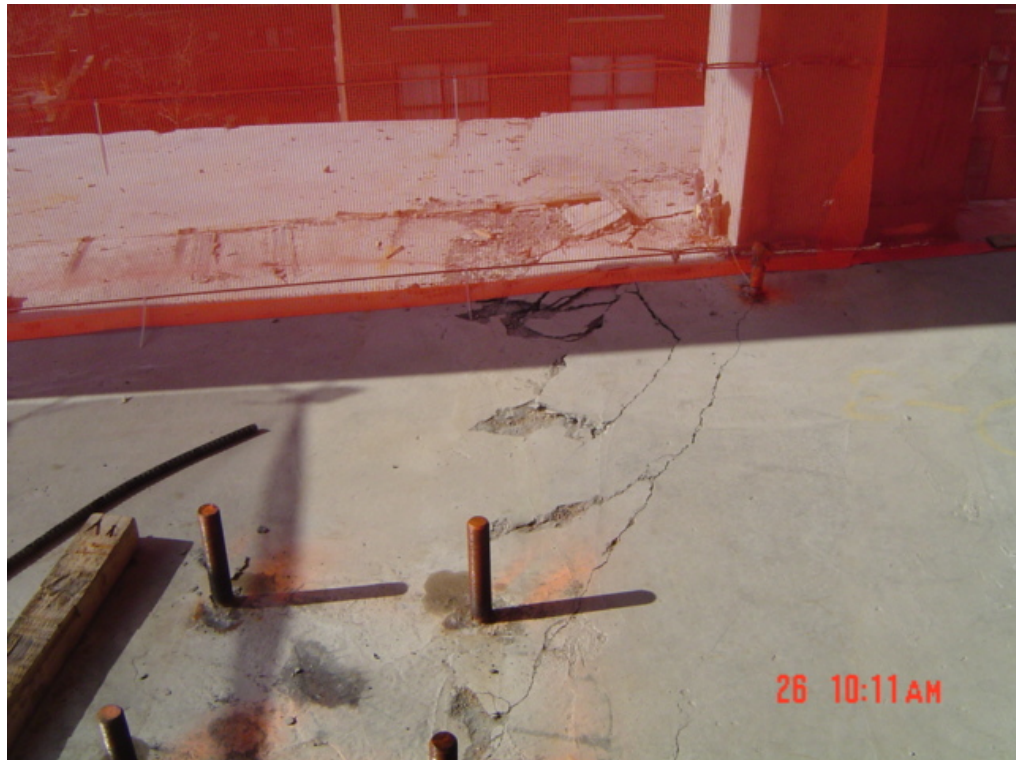
Photograph 1.20 - Minor spalling of concrete in the vicinity of the bolted connections to the 9th floor slab. Photo by Arup.

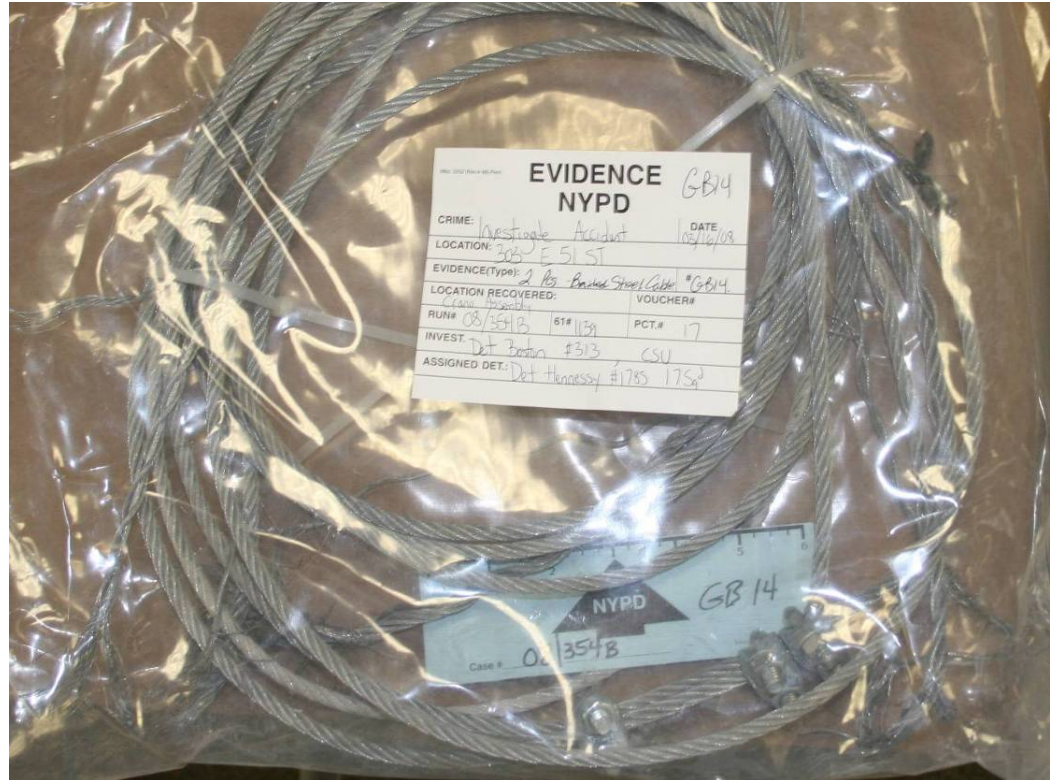
Photograph 3.3 - OSHA evidence GB14 from NYPD. Note spacing of the U-bolt clips in the lower right of the photograph. Photo by Arup.

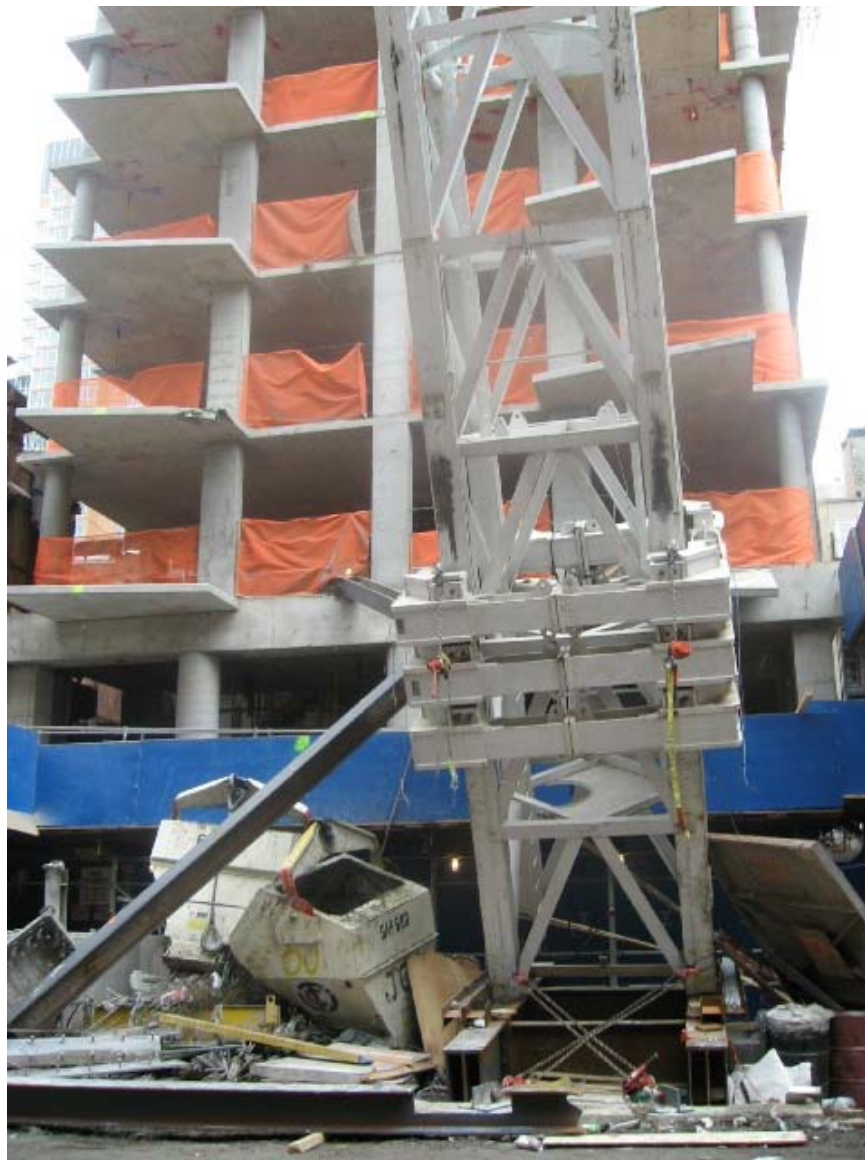
Photograph 3.4 - Base of tower crane after collapse. Note the lack of knee bracing at the base, the dunnage beam on which the tower stands and the slippage of the dunnage beam off of the submerged concrete wall foundation. Photo from New York County District Attorney IMG_332_062.jpg.

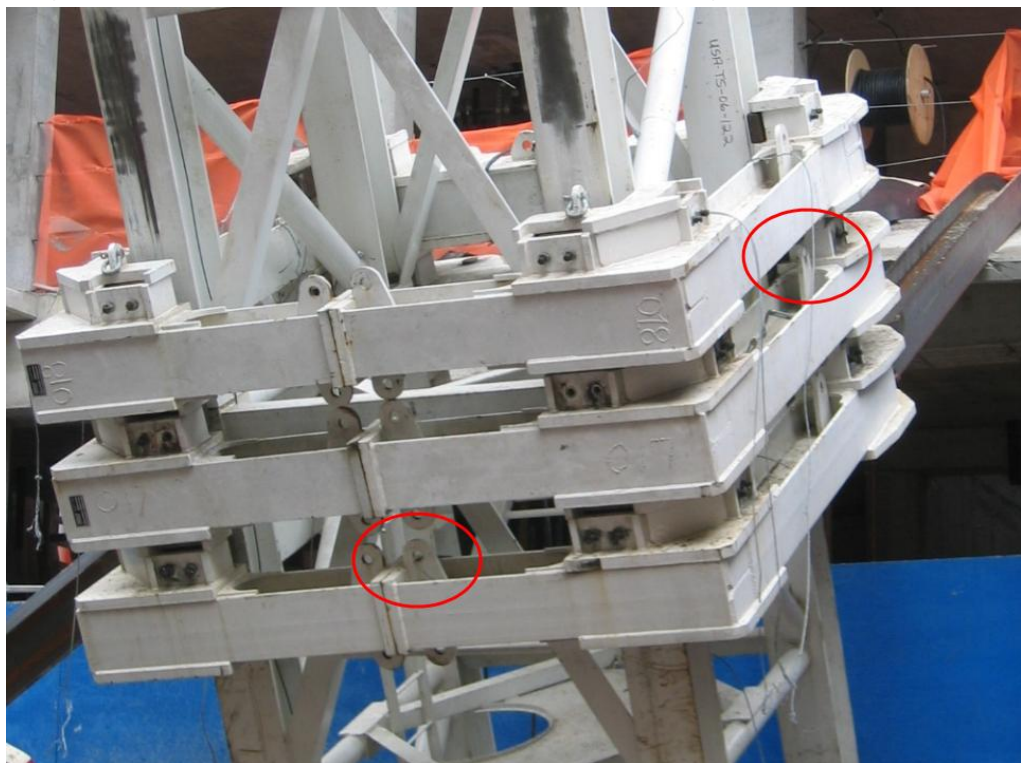
Photograph 3.6 - View the south and east elevations of the collapsed tower collars. The location of visible wire rope attachments to the collars are circled. Note the lack of thimbles in the formed sling. Photo from the crane engineer, Peter Stroh, IMG_0081.jpg.

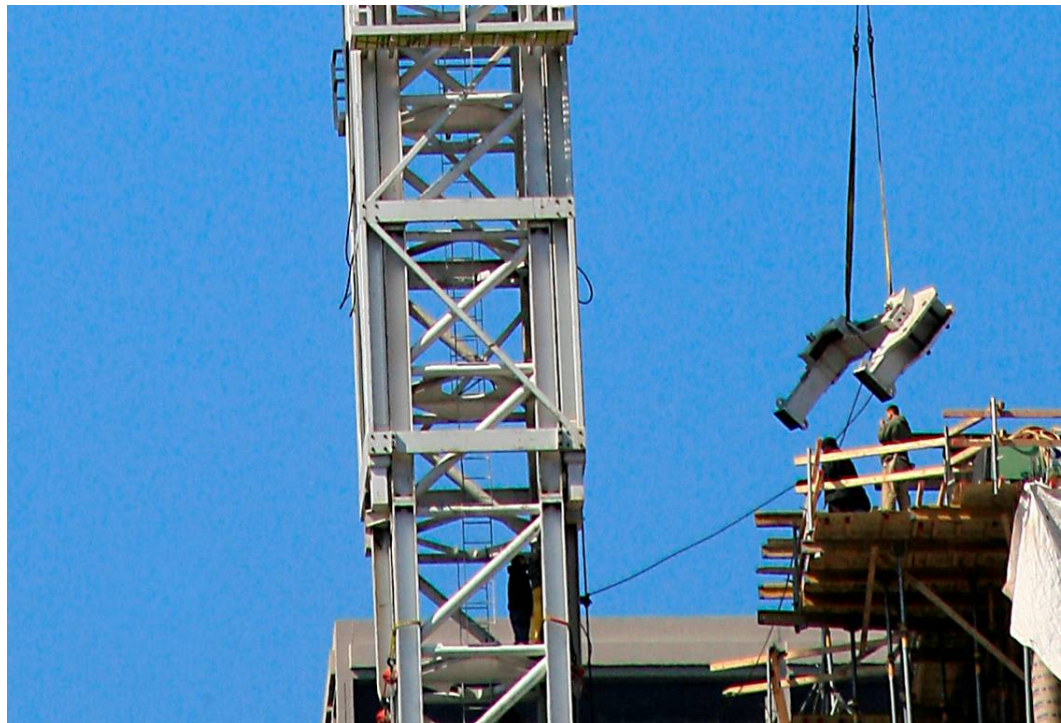
Photograph 3.7 - View of tower crane with collar half being lifted into place via polyester web slings (right of photo) and chain falls incorporating polyester web slings choke hitched around the tower legs (lower portion of tower). (Source: photograph by Gary Halby).

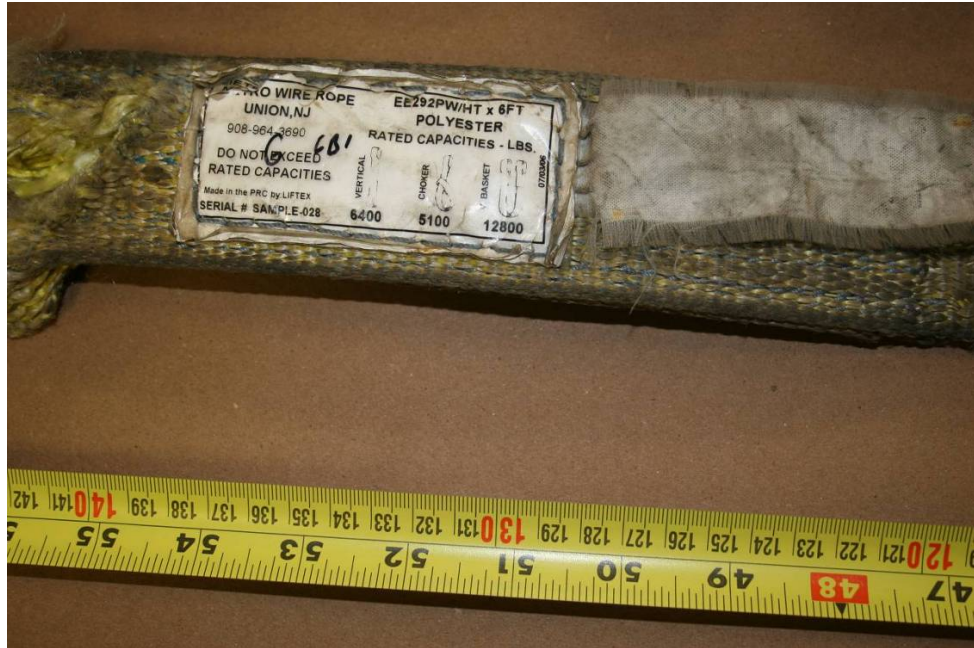
Photograph 3.8 - OSHA evidence item 1. Polyester web sling removed from the collapse site. Note the faded label. This was taken from the southwest corner of the 9th floor collar. It was attached to the lifting point via a chain fall. Photo by Arup.

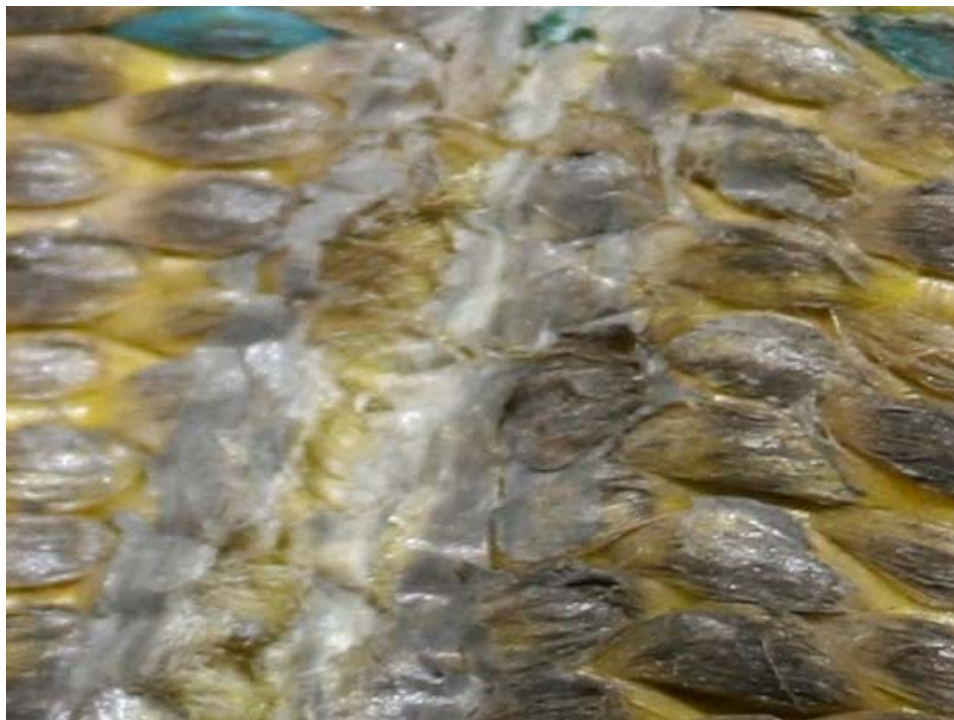
Photograph 3.11 - OSHA evidence item 1. Polyester web sling removed from the collapse site. This was taken from the southwest corner of the 9th floor collar. Note both the melted and cut fibers within the melted region. Magnification is approximately 10x. Photo by Arup.

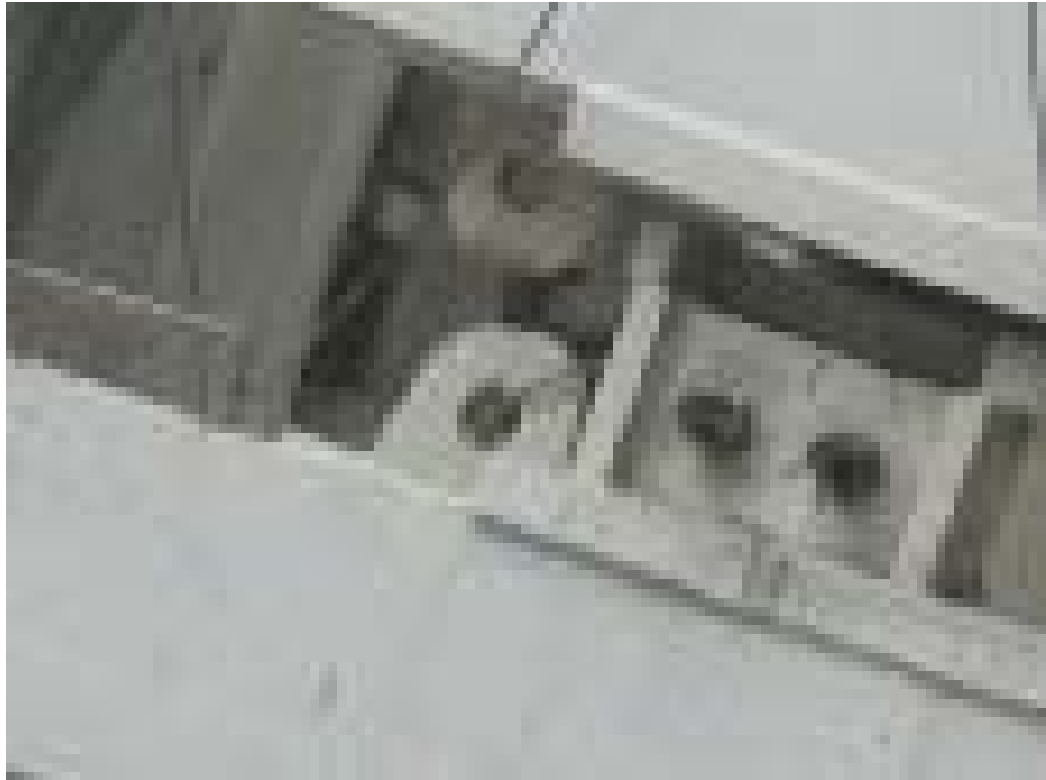
Photograph 3.16 - Close-up of 3rd floor level collar, west elevation, south corner, after collapse, showing the lack of evident protection or thimbles in the formation of the wire rope sling. Photo from New York County District Attorney 328_58.jpg.

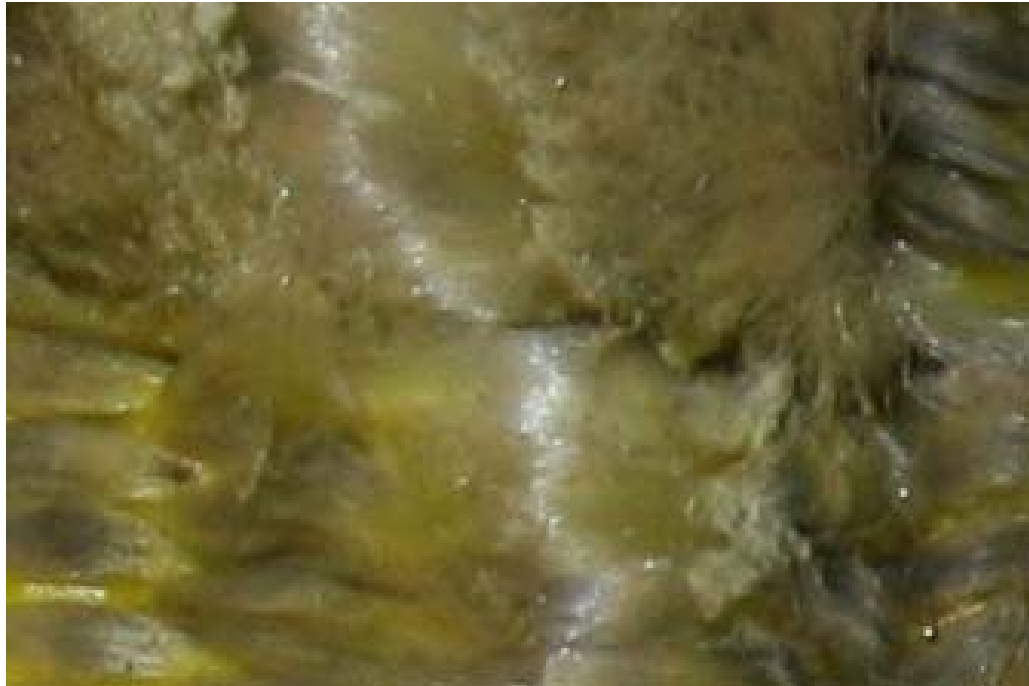
Photograph 3.17 - Close-up of both cut and melted fibers for OSHA item no. 2. Magnification approximately 9x.. Photo by Arup.

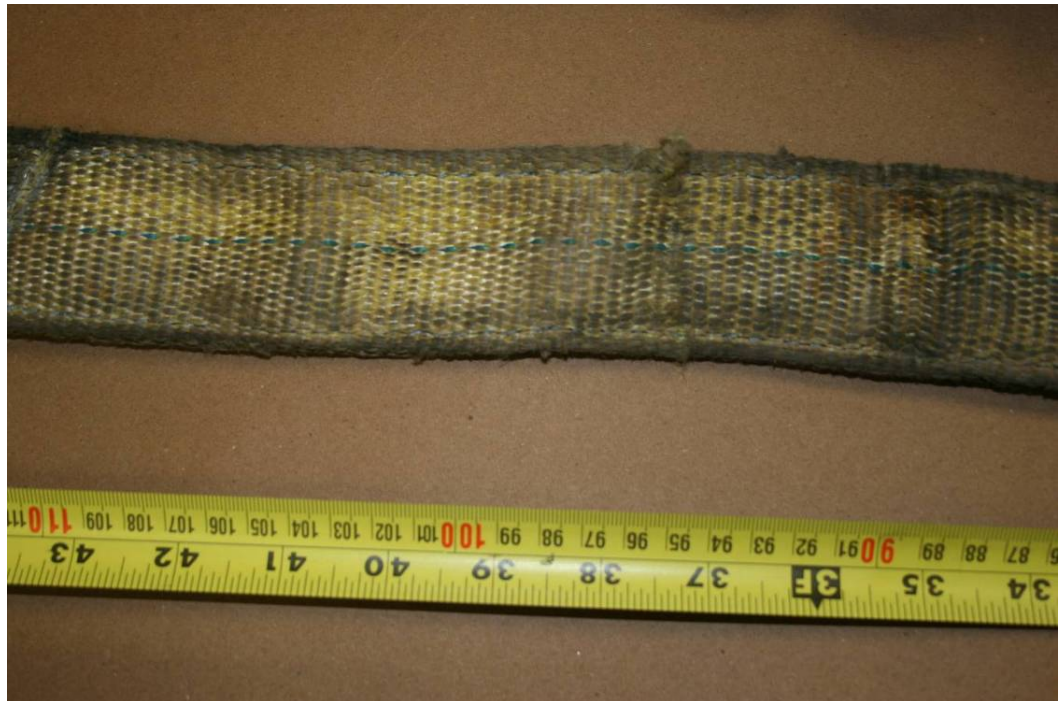
Photograph 3.18 - Liftex polyester web sling (OSHA item no. 1). Damage can be seen along the edges, as well as wear within the width of the sling, at uneven intervals, unlike the other polyester web slings where damage occurs at approximately 12 inch intervals. Photo by Arup.

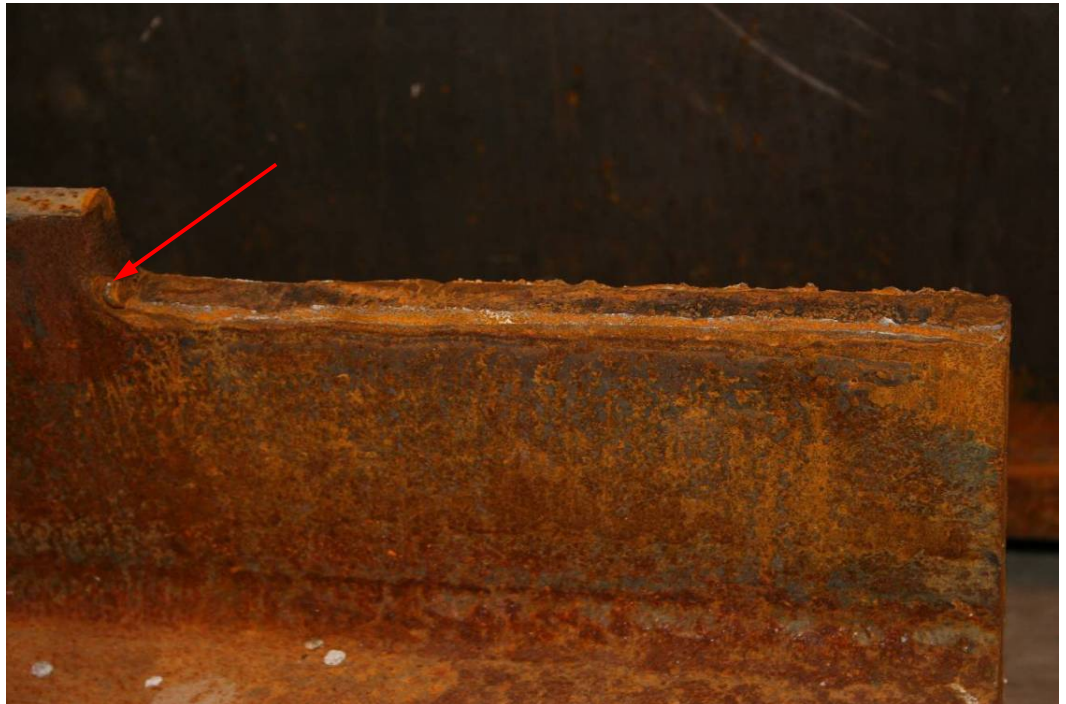
Photograph 3.20 - Tie-Beam 9A (9th floor level collar, formerly located at the east side of the collar). Collar end. Note the lack of clearance between the end of the failed fillet weld and the radiused cut in the beam flange (at arrow location). Photo by Arup.

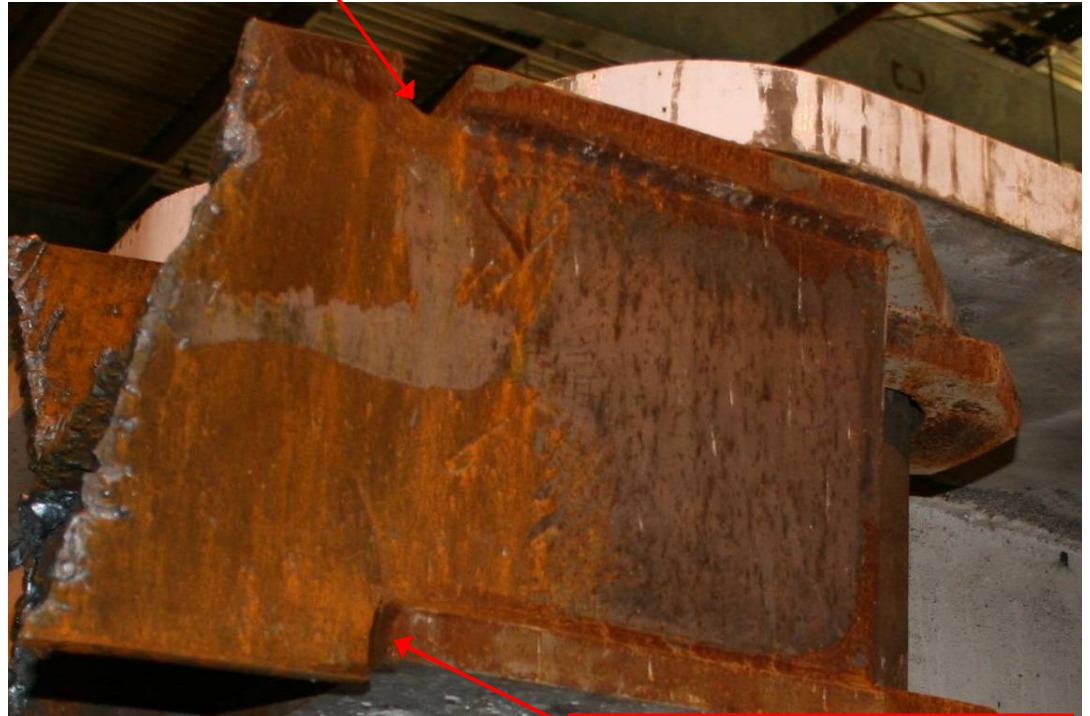
Insufficient radius, lack of clearance and
excessive cut

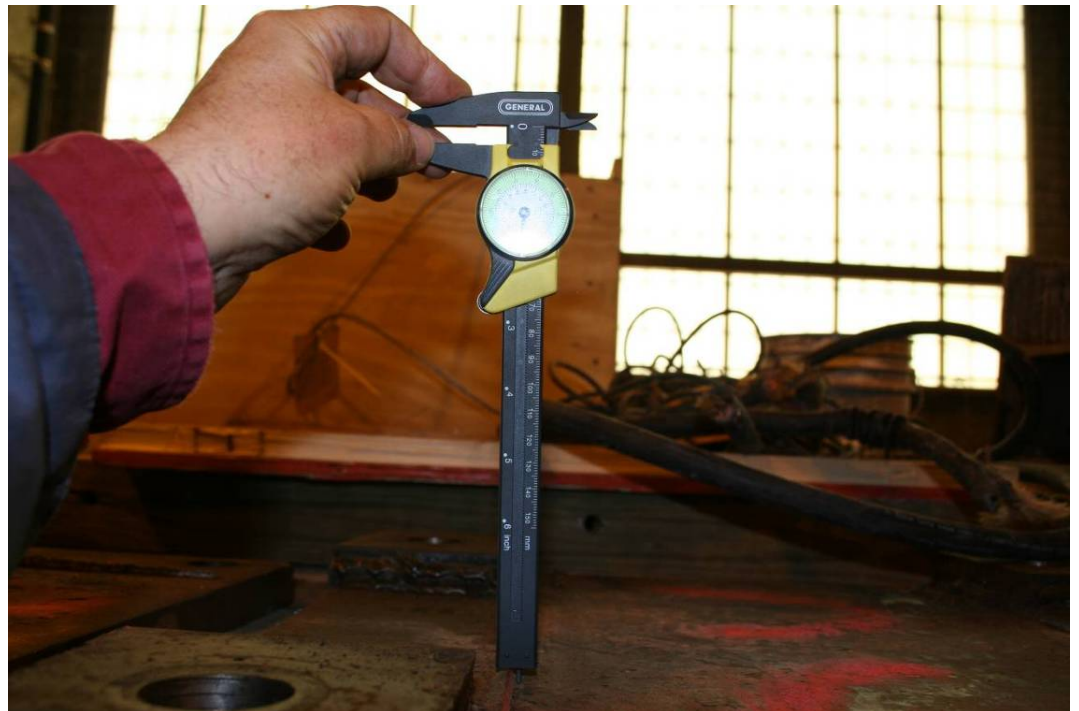
Photograph 3.22 - Fillet weld measurement of base plate 9C. Measurement is shown to be 7 mm, just under 9/32 inch which is 11.8% under the specified 5/16 inch. Photo by Arup.

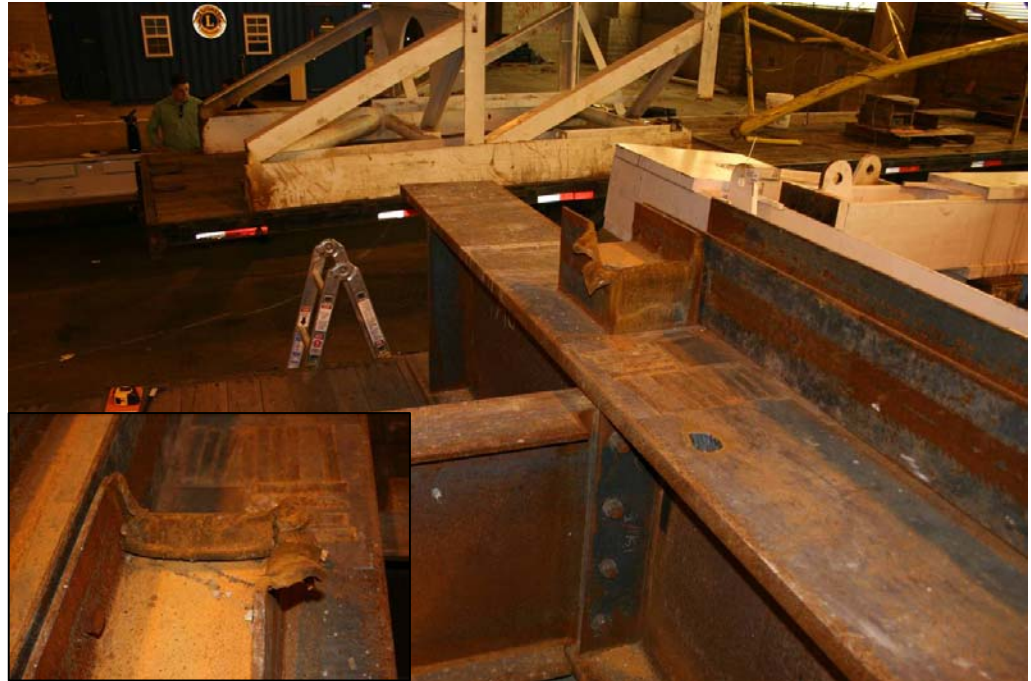
Photograph 7.1 - Dunnage foundation. The inward deformation visible in the closeup of the deformed pocket indicates that the steel plate at the end of the pocket was squashed due to a downward force from the tower legs. Had failure occurred due to a horizontal sliding load the plate would have been deformed in the opposing direction. Photo by Arup.

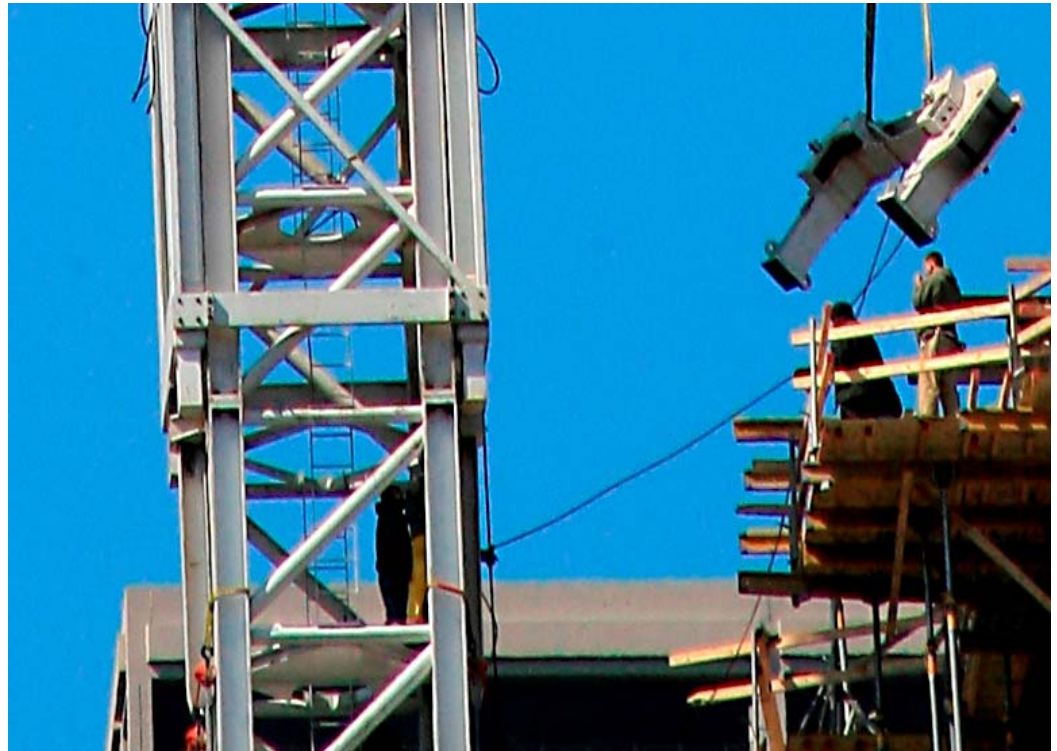
Photograph 8.1 - View of tower crane with collar half being lifted into place via polyester web slings attached to improper lifting lugs resulting in a non-horizontal position of the collar half during lift (right of photo) and chain falls incorporating polyester web slings choke hitched around the tower legs. (Source: photograph by Gary Halby).

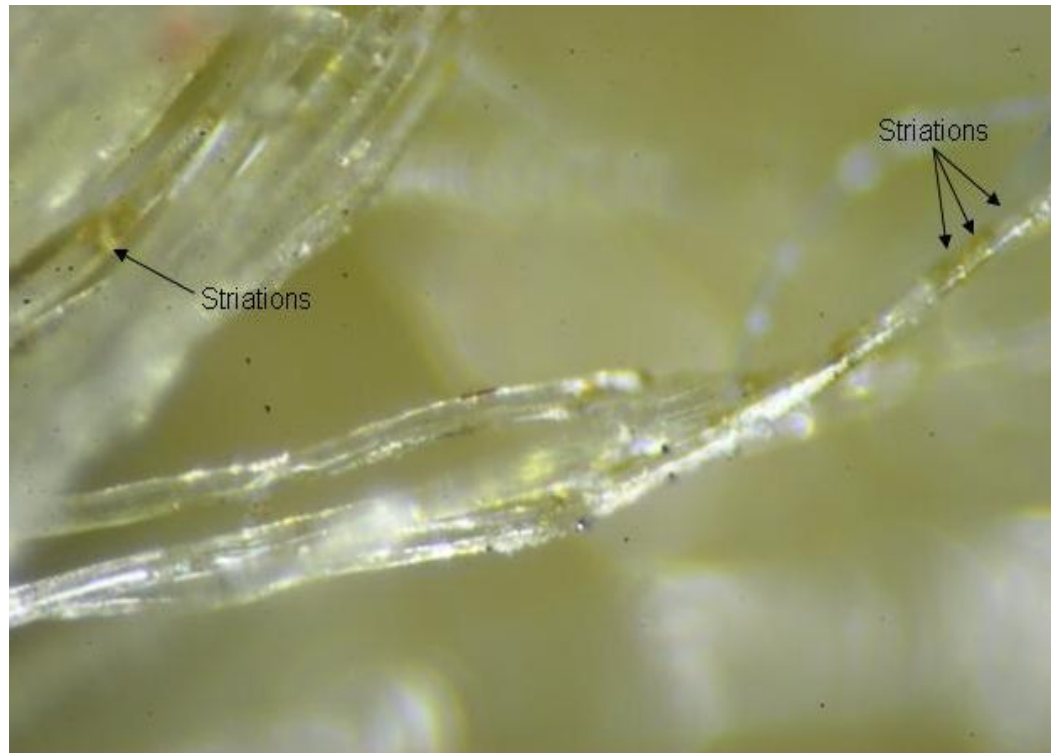
Photograph 8.3 - Microphotograph of Metro/Liftex sling failure surface showing striations. Photo by Arup.

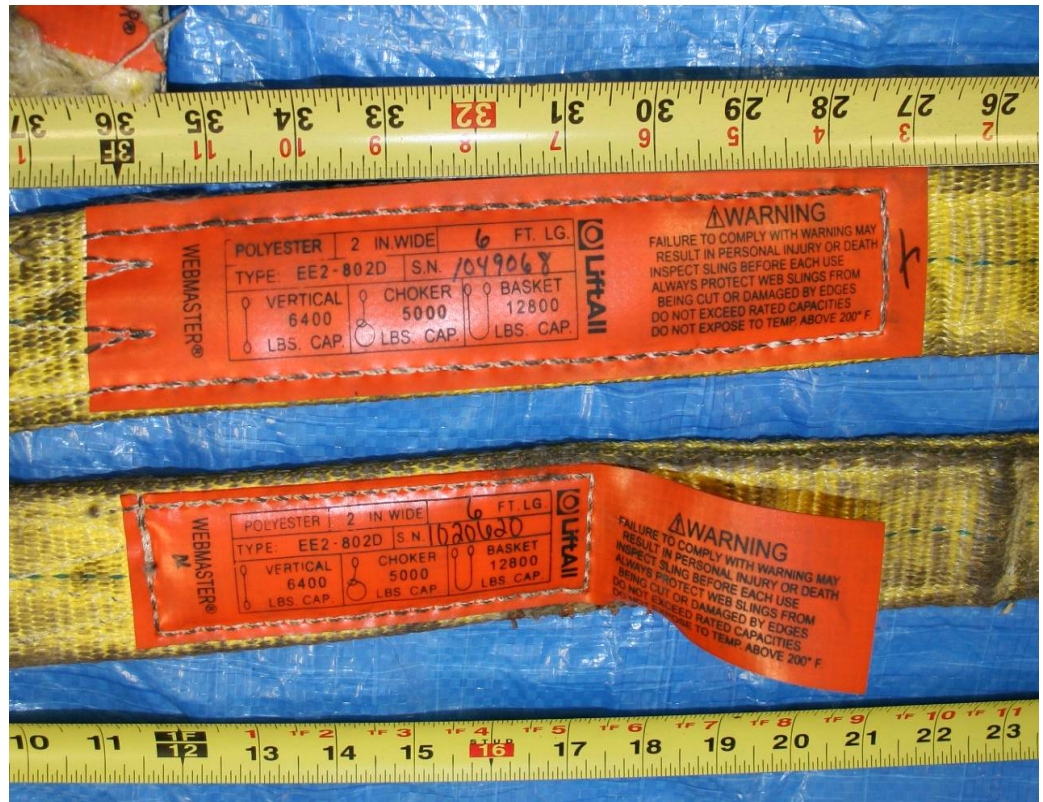
Photograph 8.4 - Warning labels on slings recovered from the collapsed tower crane clearly require inspection before use and use of protection at all edges. Photo by Arup.
