New York City
Department of Buildings

**51st Street Crane
Investigation**

March 2009

Ove Arup & Partners Consulting Engineers PC
155 Avenue of the Americas, New York NY 10013
Tel +1 212 229 2669 Fax +1 212 229 1056
www.arup.com

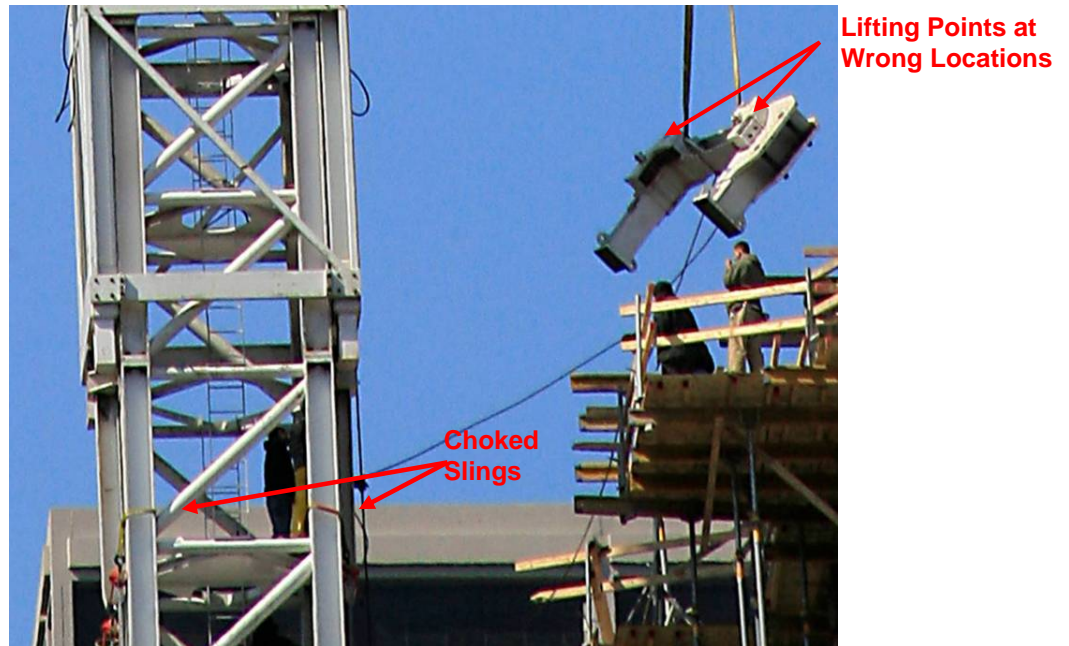
Photograph 8.5 - Installation of the 2nd section of the collar at the 18th floor. The slings are choked around the tower crane legs without protection against the flange edges at the 1st section of the collar (red arrow). (Source: photograph by Gary Halby).

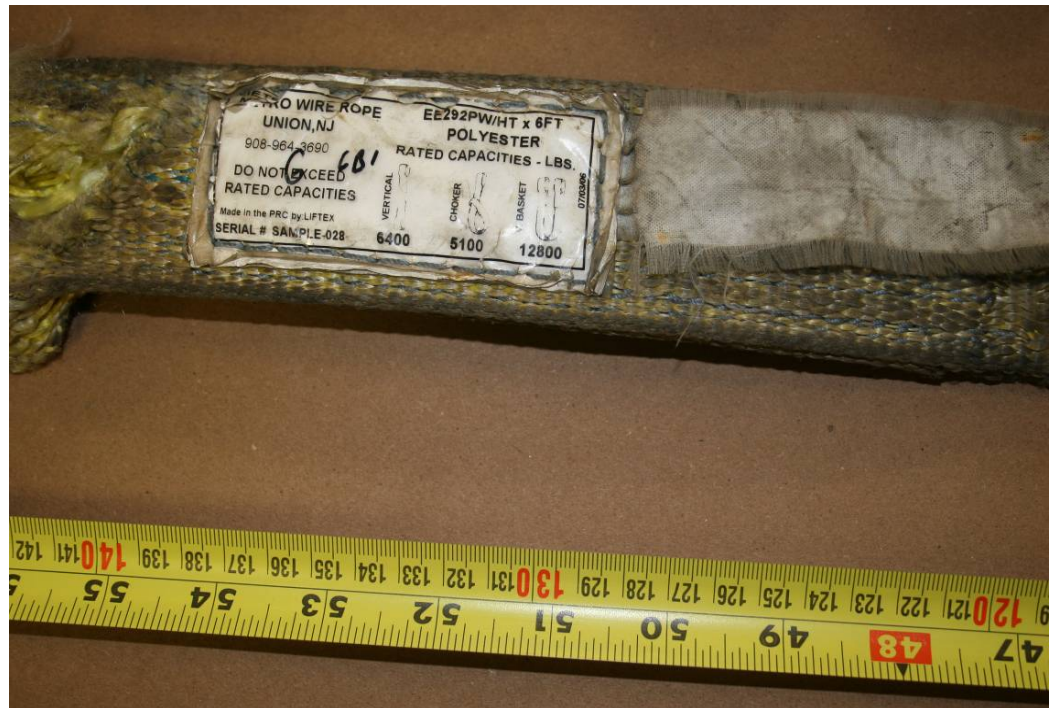
Photograph 8.6 - Metro/Liftex sling recovered from tower crane. Not the faded label and faded appearance of the sling exterior. Photo by Arup.

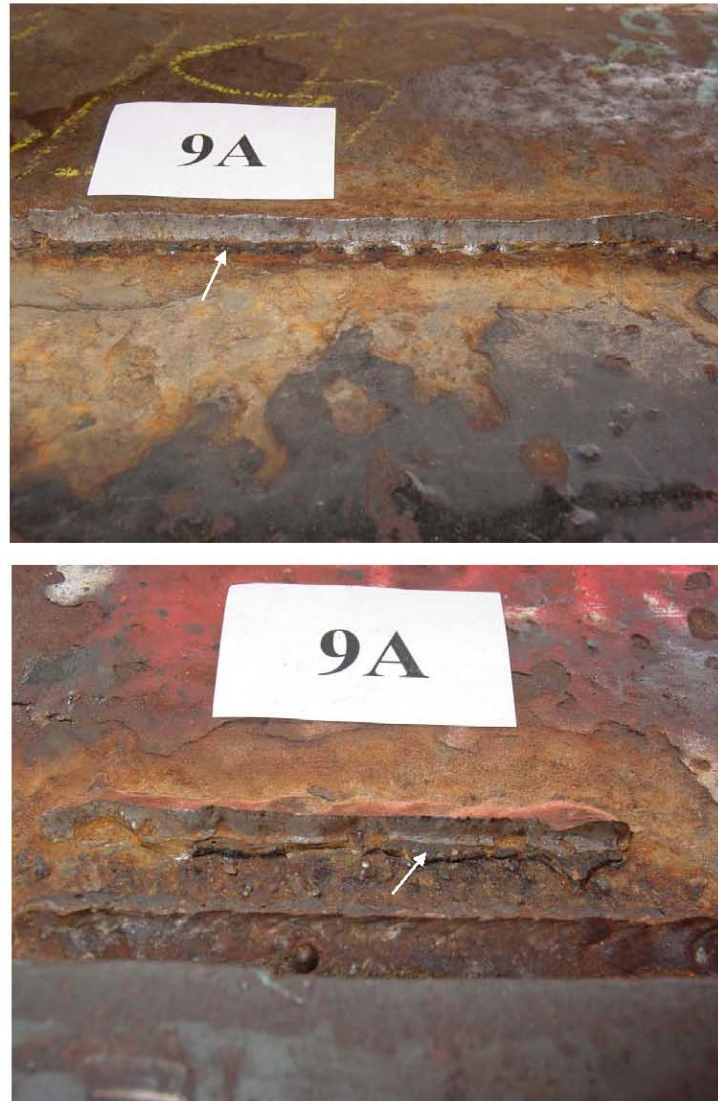
Figure 13 Enlarged Views of Cleaned Weld Fracture on Base Plate 9A Showing Ductile Weld Metal Fracture. Note Weld Metal Flow Into Weld Root Opening (see arrows).

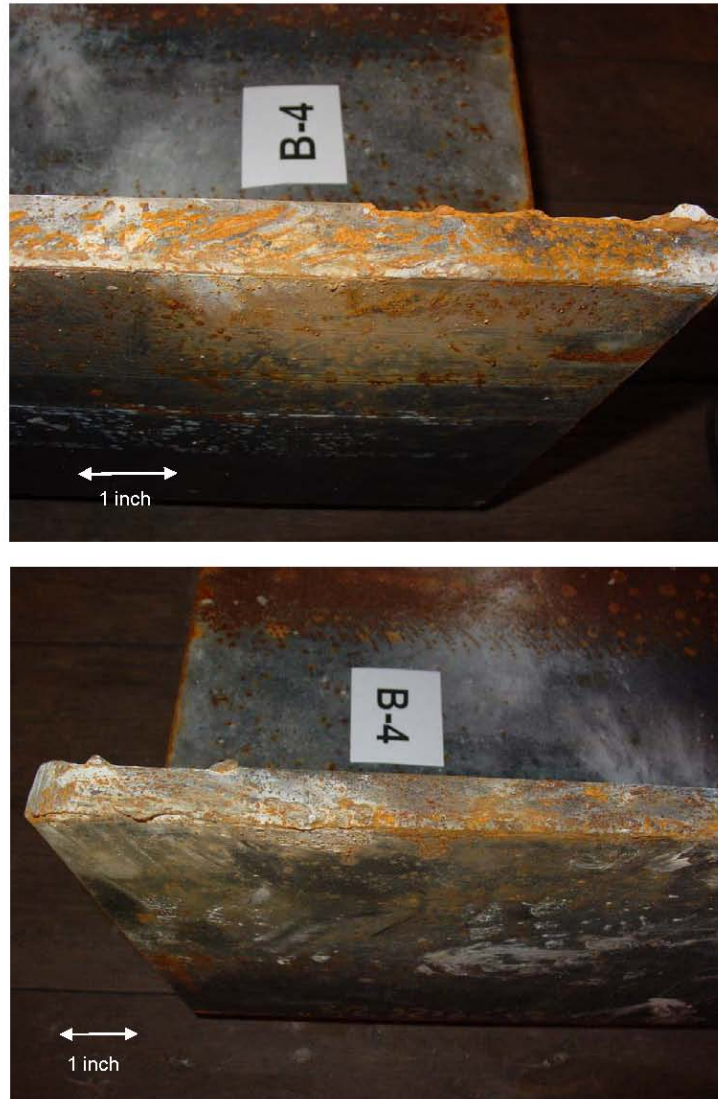
Figure 14 Enlarged Views of Ductile Weld Fracture on Tie Beam B4. Note Small Size of Deposited Weld.

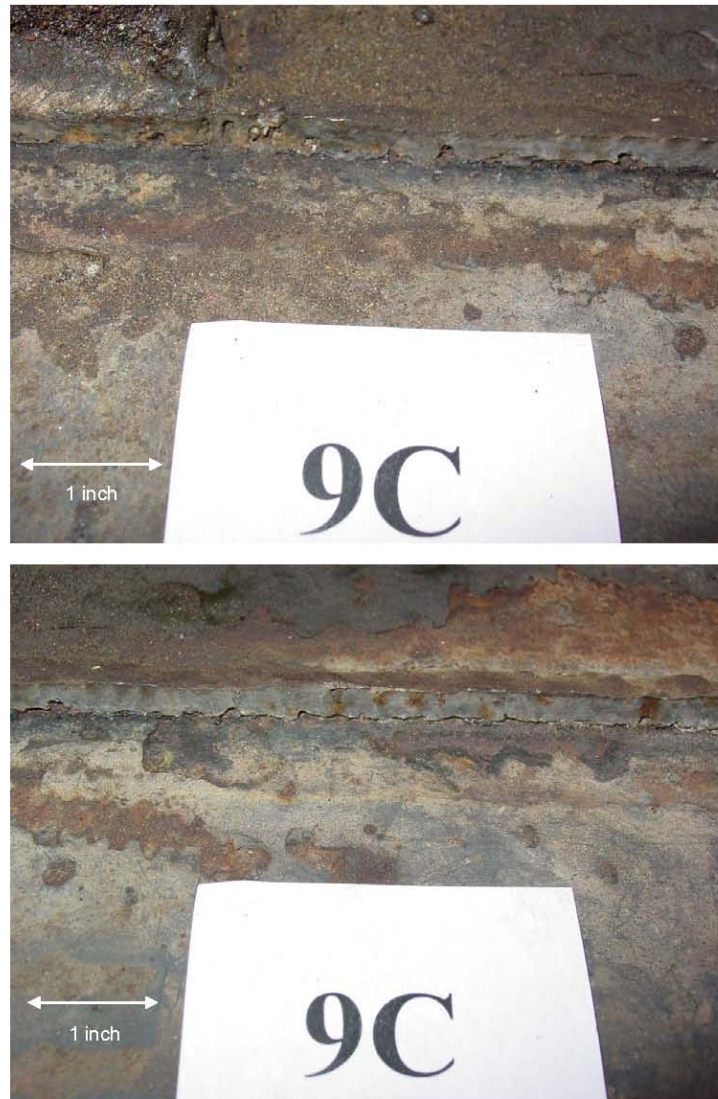
Figure 18 Enlarged Views of Cleaned Weld Fracture on Base Plate 9C Showing Ductile Weld Metal Fracture. Note Weld Root Opening.

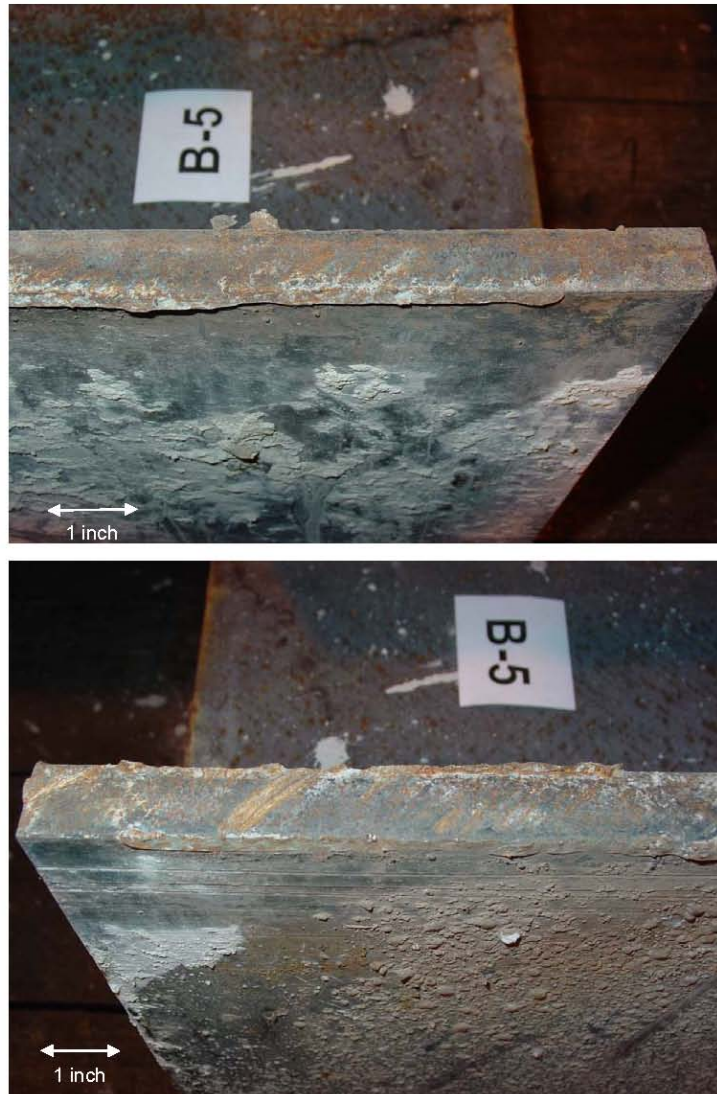
Figure 19 Enlarged Views of Ductile Weld Fracture on Tie Beam B5. Note Small Size of Deposited Weld.

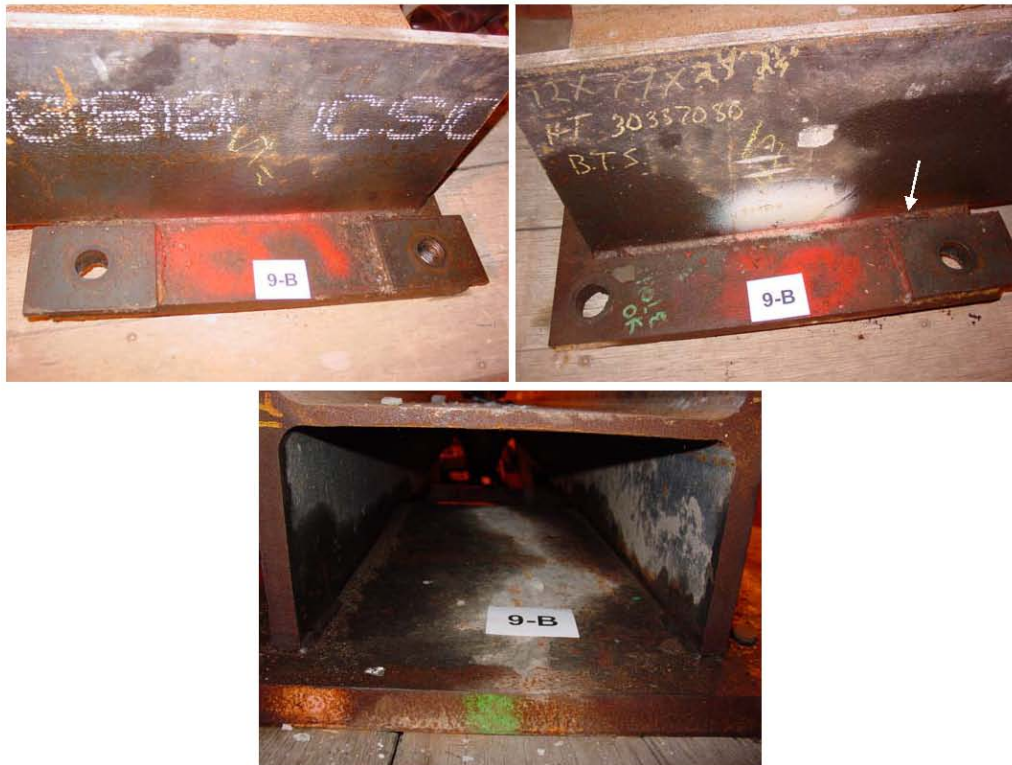
Figure 20 General Views of the Base Plate/Tie Beam Welds From Base Plate 9B.(Arrow Shows Location of Weld Toe Crack)
