Report for
Buildings Commissioner Robert D. LiMandri

CTL, PC Project No. 500108

High Risk Construction Oversight Study

June 5, 2009

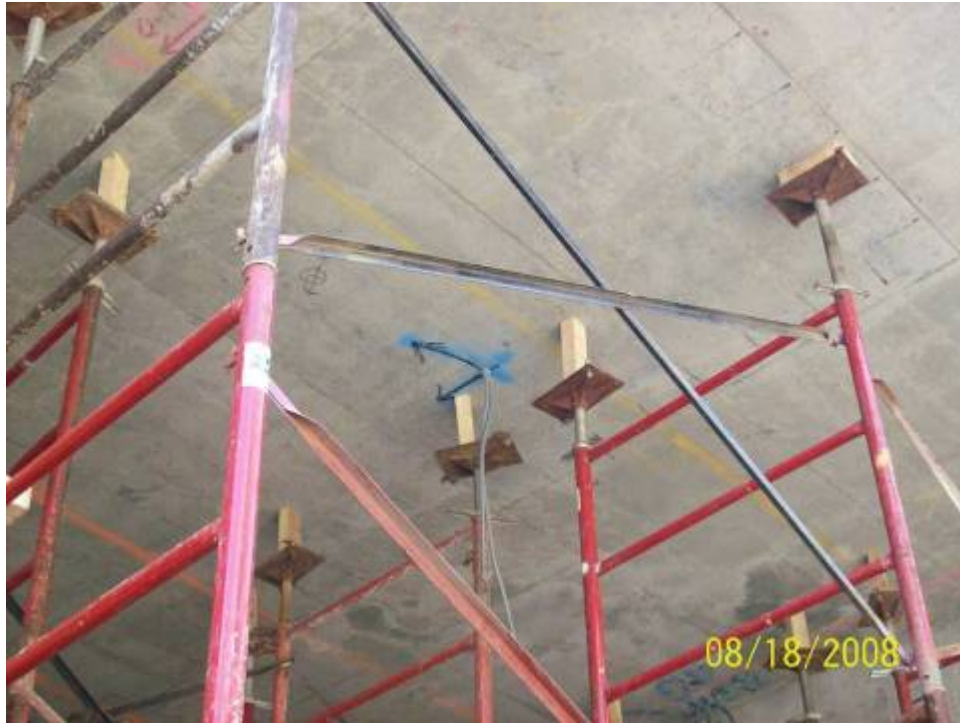
Figure B.6.2: Formwork Construction Not in Conformance with Design, Unstable Timber Posts used as Filler between Steel Shoring Tower and Concrete Soffit

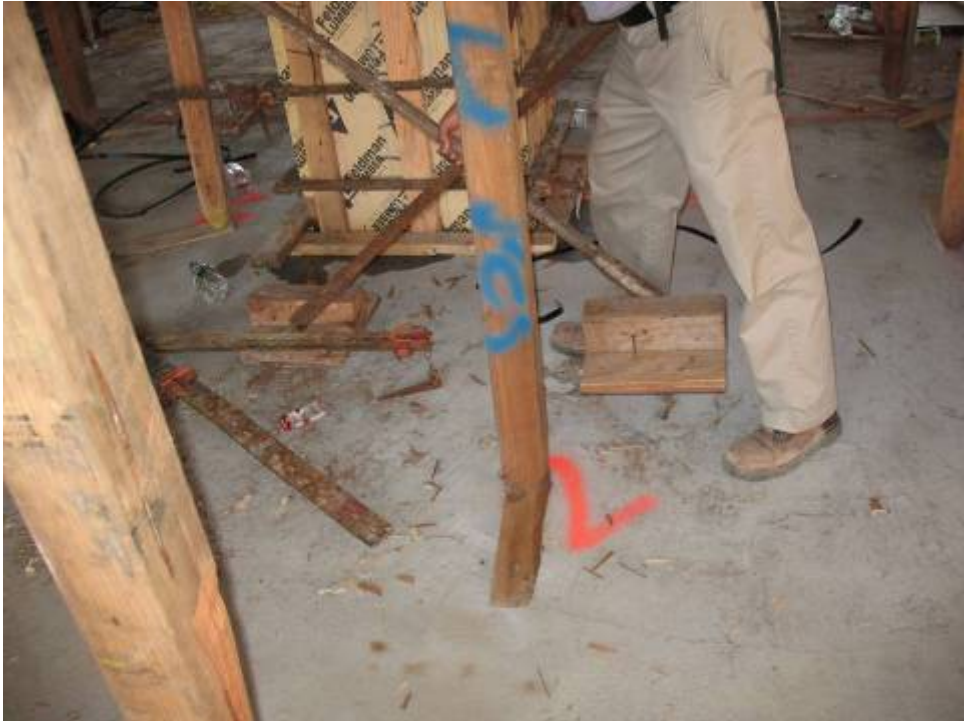
Figure B.6.4: Formwork Construction not in Conformance with Design, Damaged Timber Post

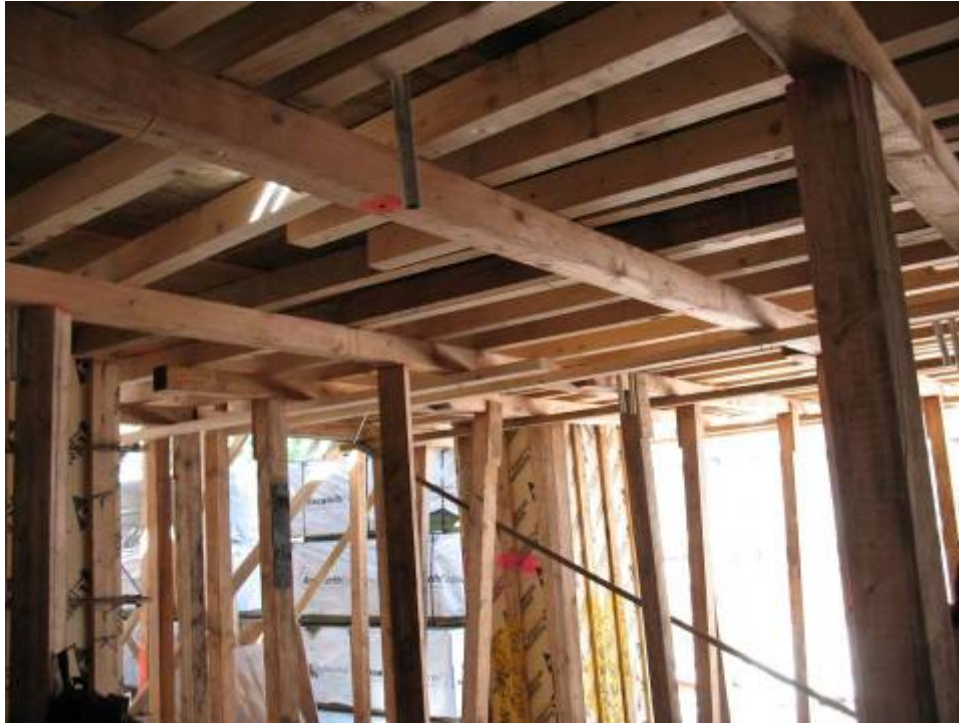
Figure B.6.5: Insufficient Post Spacing, Missing Posts at Stringer Element (Top Center)

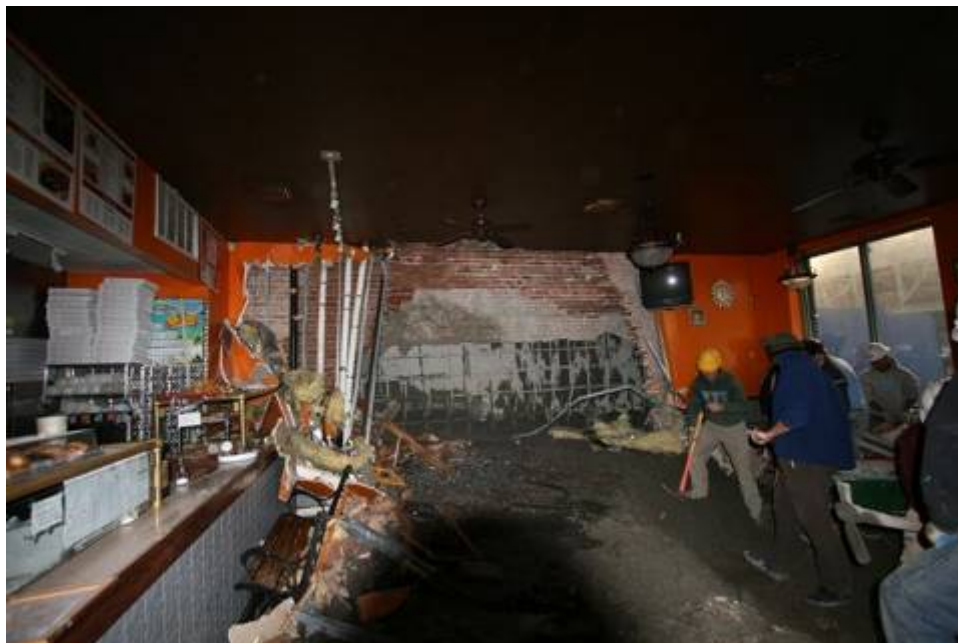
Figure B.6.6: Wall Failure Attributed to Concrete Pressures Imparted by Adjacent Construction

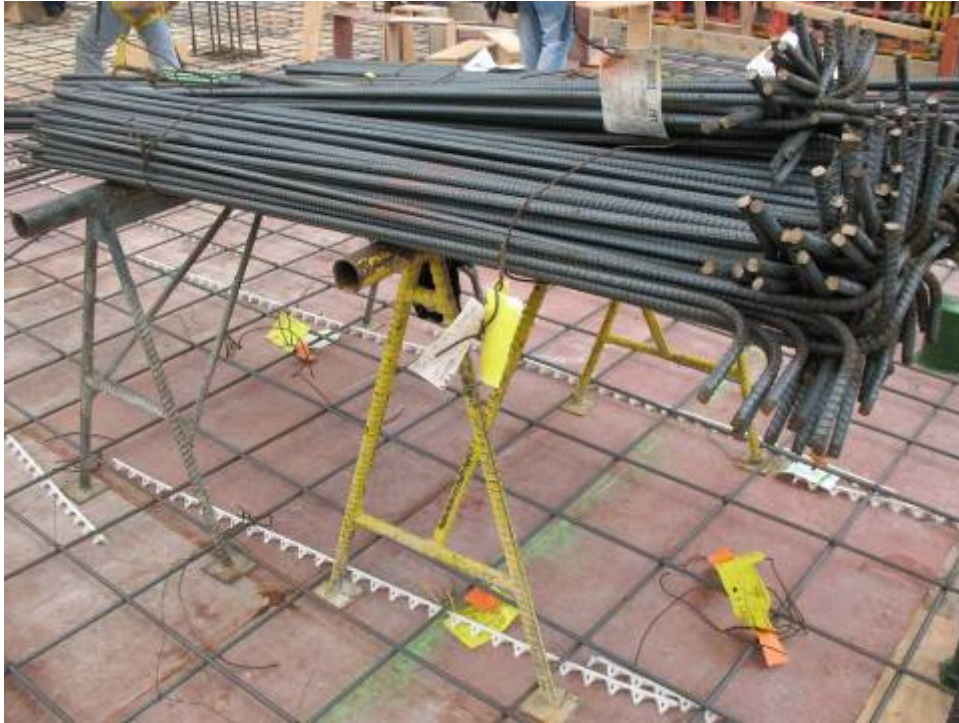
Figure B.6.7: Construction Loads can be Significant⁷. Verification of Proper Formwork Assembly is Critical

⁷ Configuration Shown Likely to Exceed 150 Pounds per Square Foot

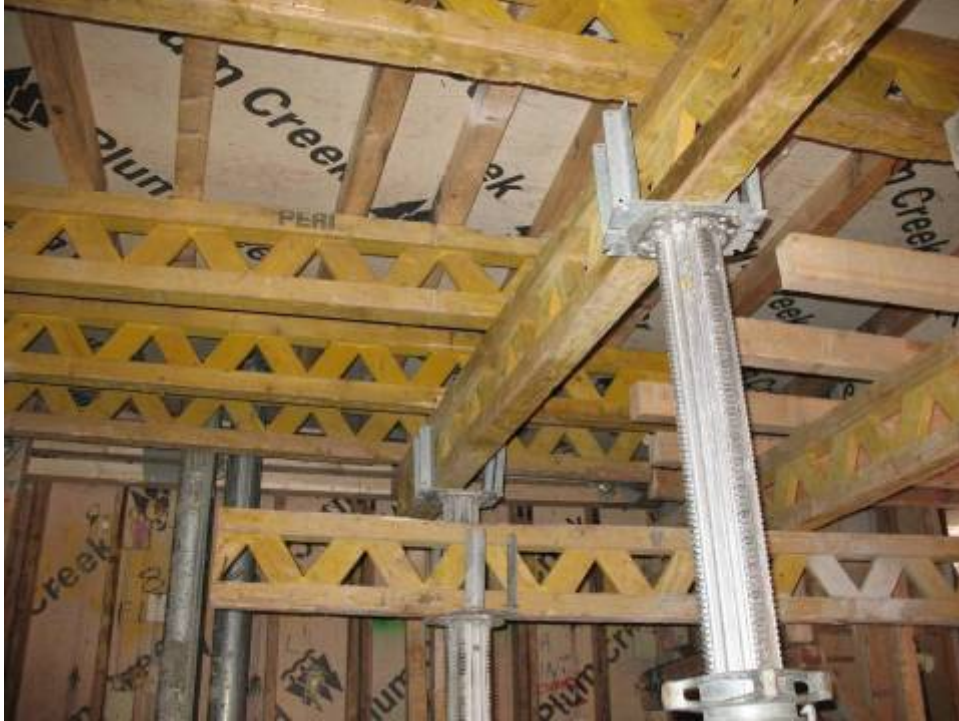
Figure B.6.8: Unstable⁸ Stacked Truss-Type Stringer Assembly, Not in Conformance with Design

⁸ Prone to failure through twisting (Lateral Torsional Buckling) of wood truss elements

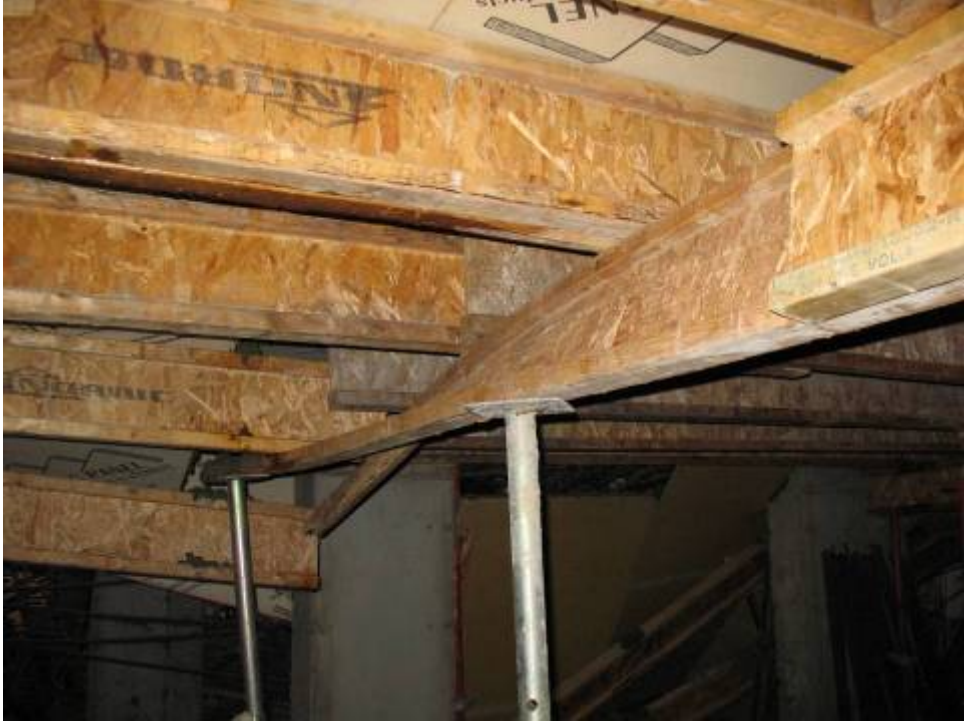
Figure B.6.9: Stacked Engineered Lumber Formwork Failure in Queens Attributed to a Lack of Lateral Bracing.

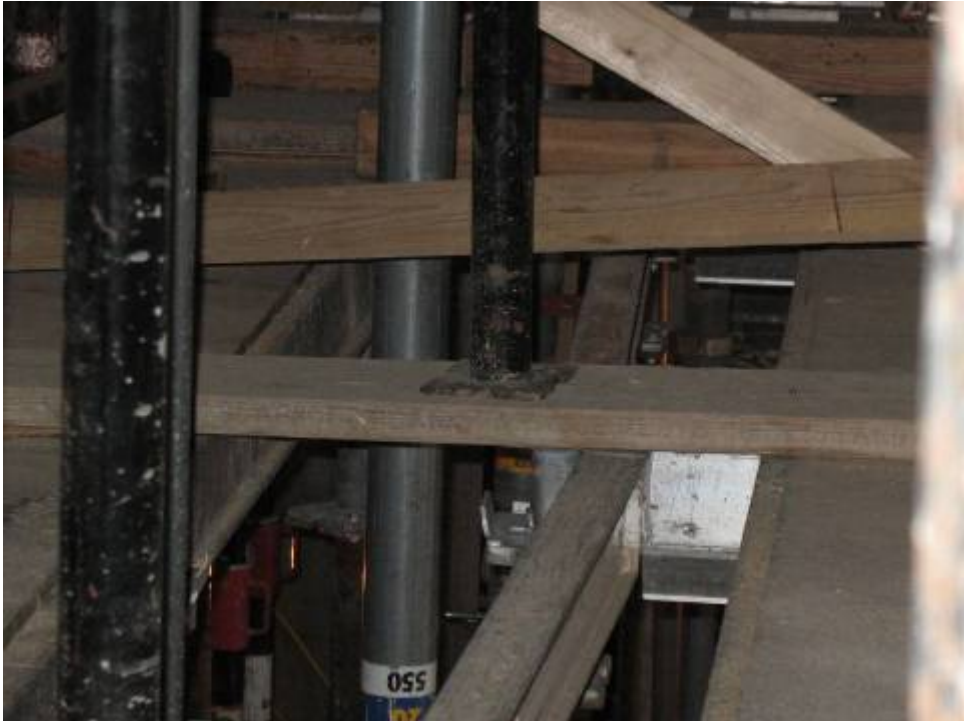
Figure B.6.10: Lack of Adequate Support under Post Base (Center), Not in Conformance with Design.

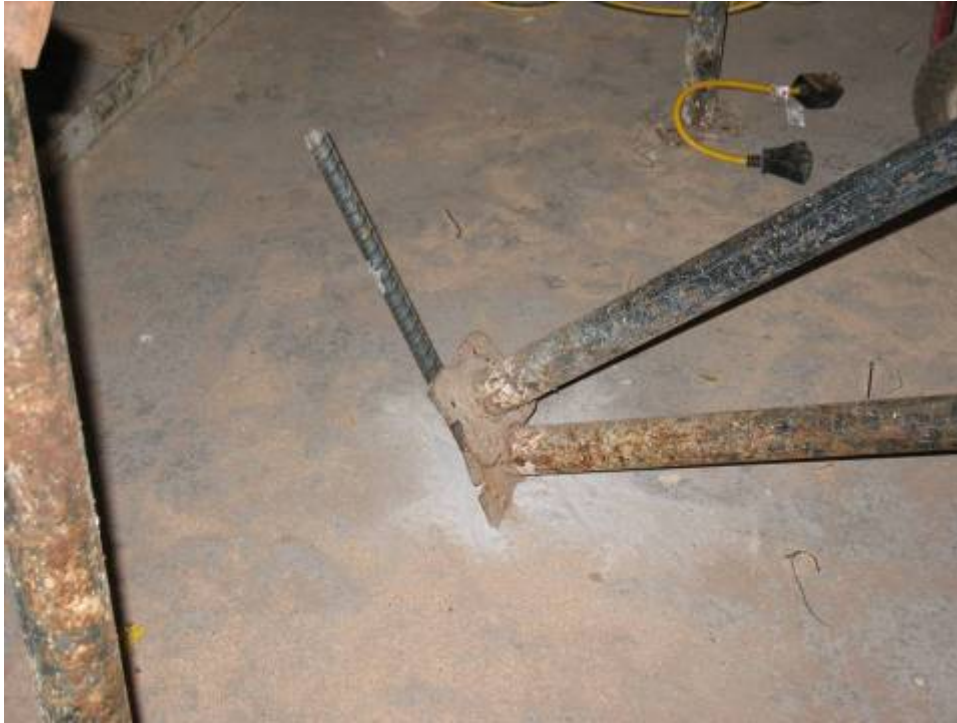
Figure B.6.11: Improper Lateral Bracing Installation, Not in Conformance with Design. Lateral Braces are not Secured to Slab, Unable to Resist Load Reversals

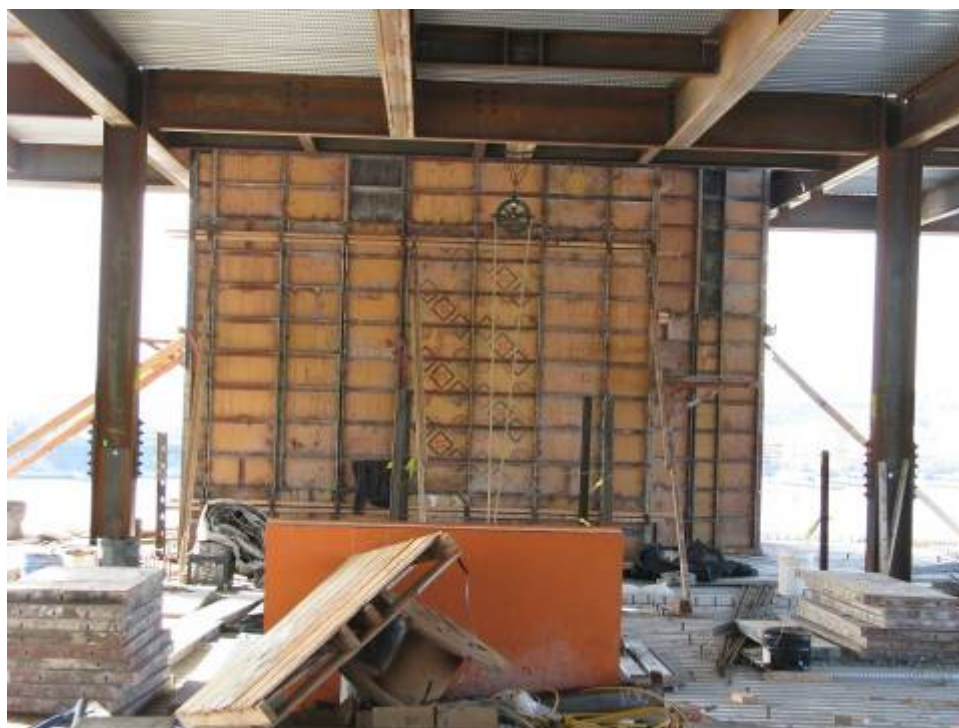
Figure B.6.12: Vertical Formwork Configuration, Missing Walers Specified by Formwork Designer

Subsequent protective action by the Department of Buildings included a mandatory re-inspection by the formwork designer prior to resuming work, and required production of signed and sealed written procedures for future placements.

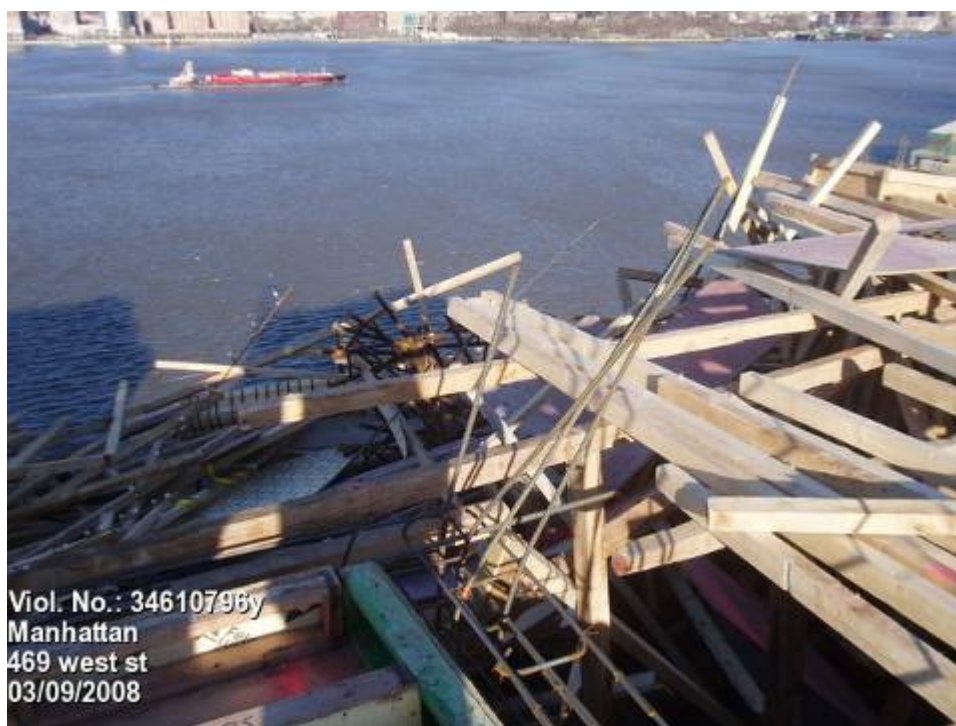
Figure B.6.16: Formwork Failure at Hudson River Exposure

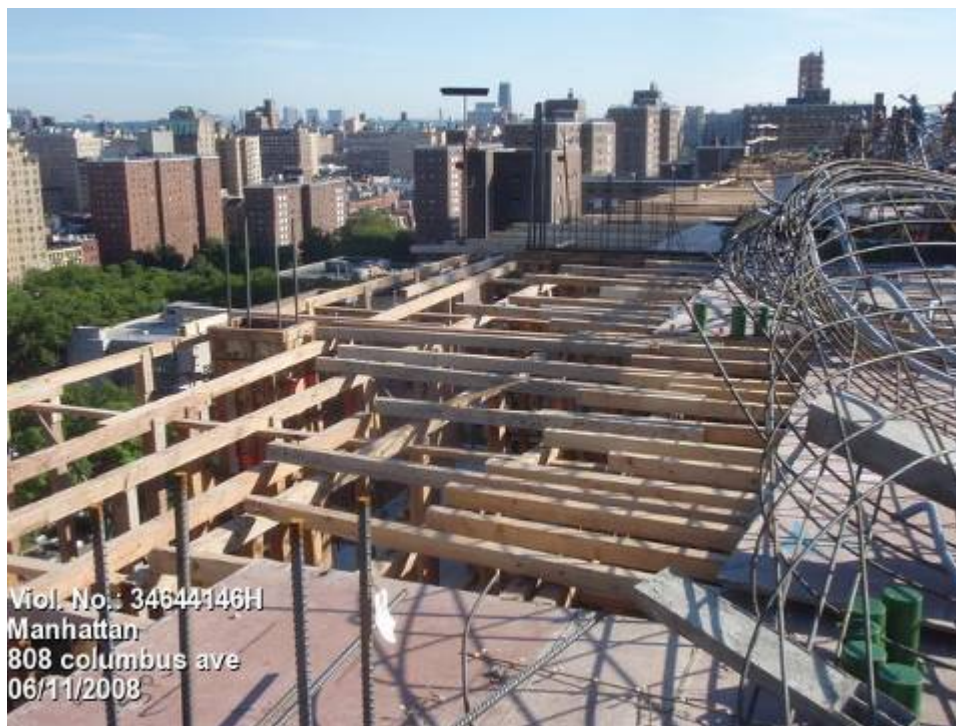
Figure B.6.17: Formwork Failure in Reported 30-40 mph Winds

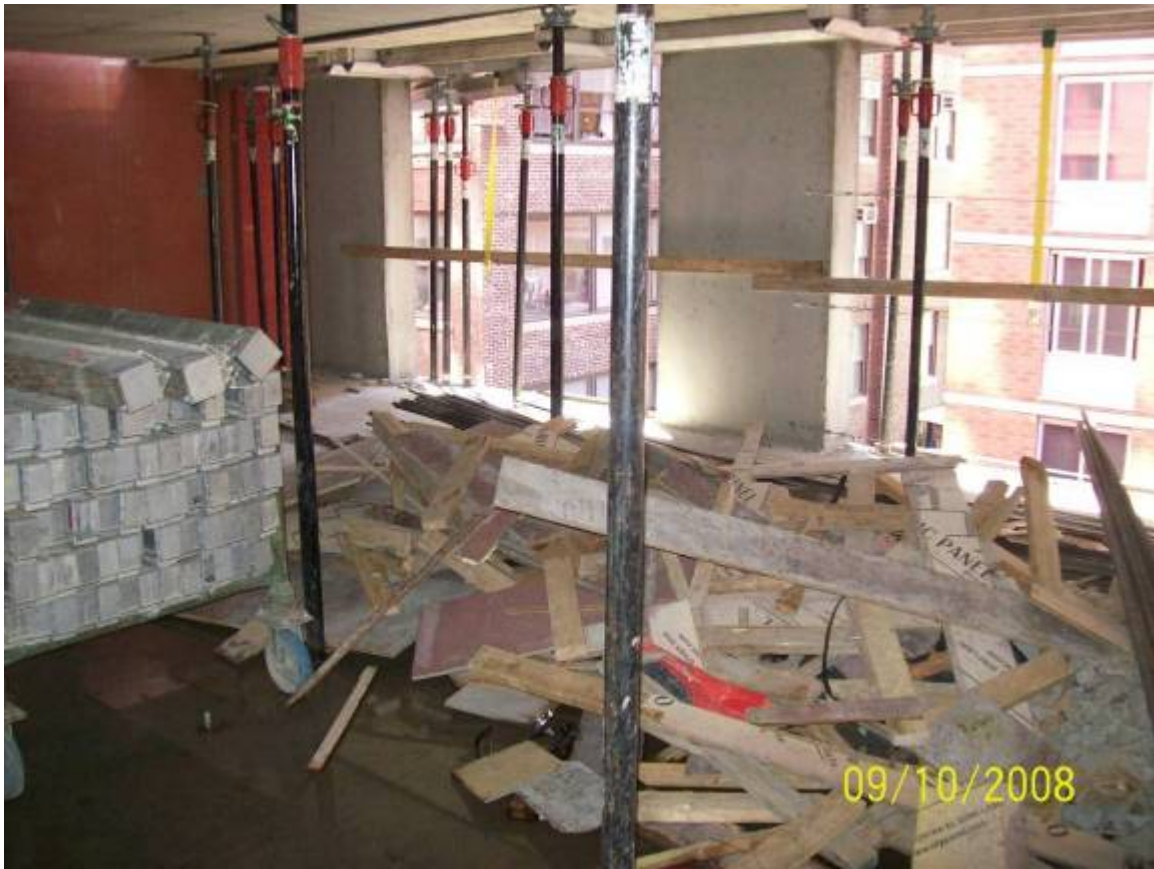
Figure B.7.1: Debris Accumulation Presenting a Public and Worker safety Hazard. Note Unprotected and Unsecured Building Edge (Background).

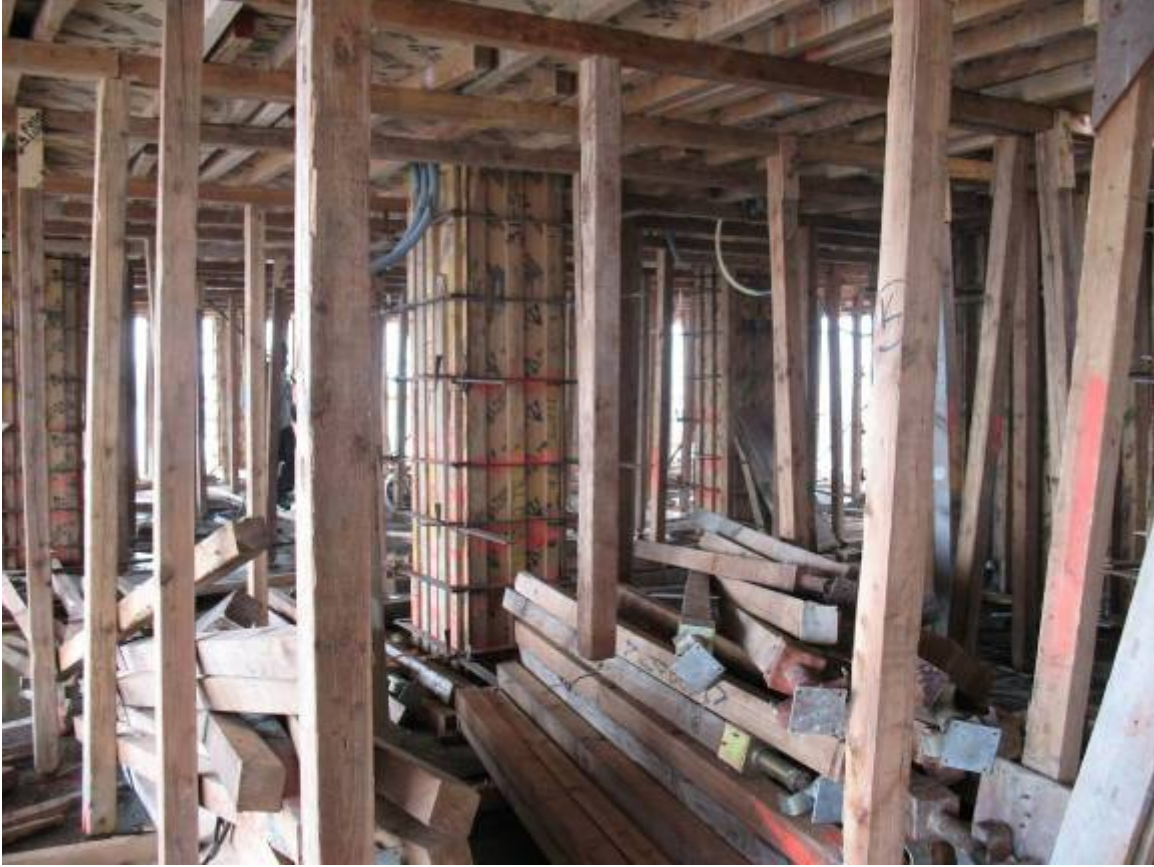
Figure B.7.2: Unacceptable Debris Accumulation and Material Storage during Formwork Operations. Lack of Storage Space Concentrates Material within Work Areas, Impeding Egress Pathways. Note Shoring Post (Center) Stopped Short of Floor over Stacked Material.

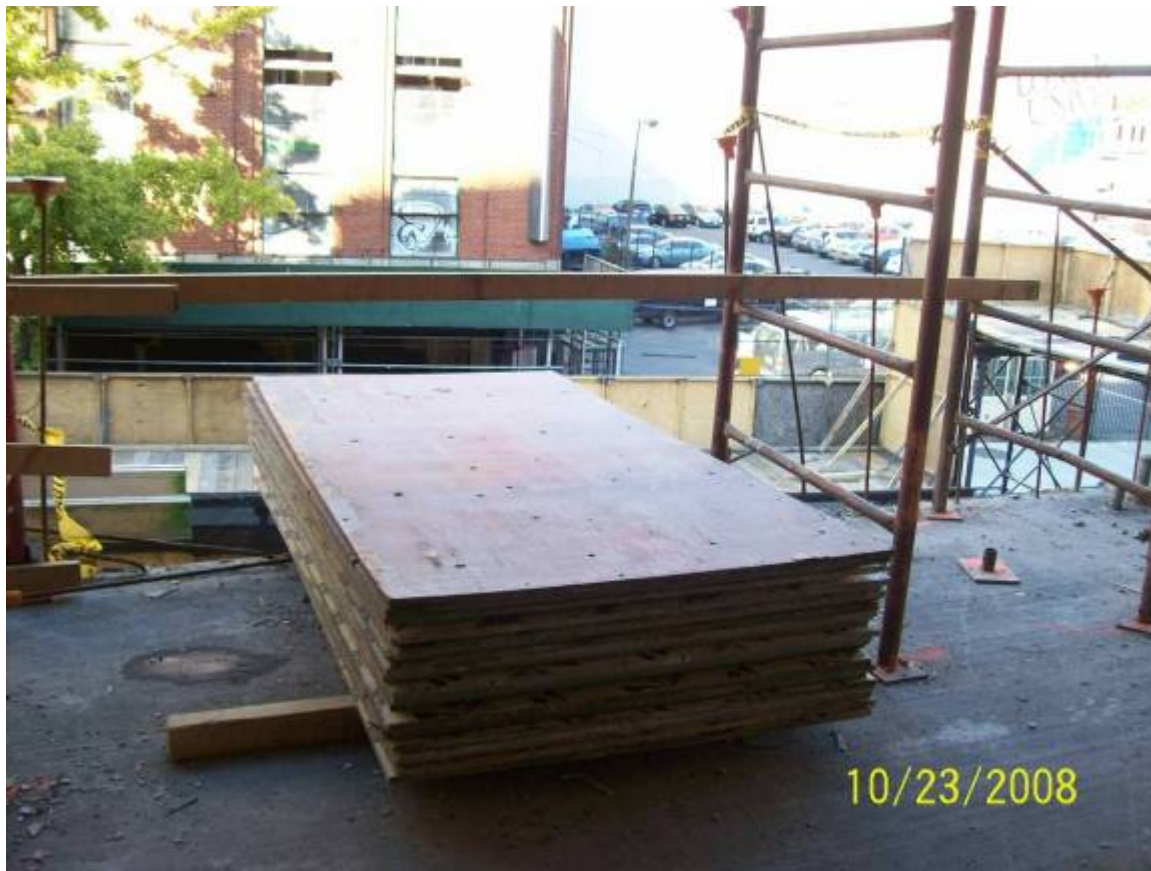
Figure B.7.3: Stacked and Unsecured Material Presents a Wind Borne Debris Hazard When Placed Near Building Edges

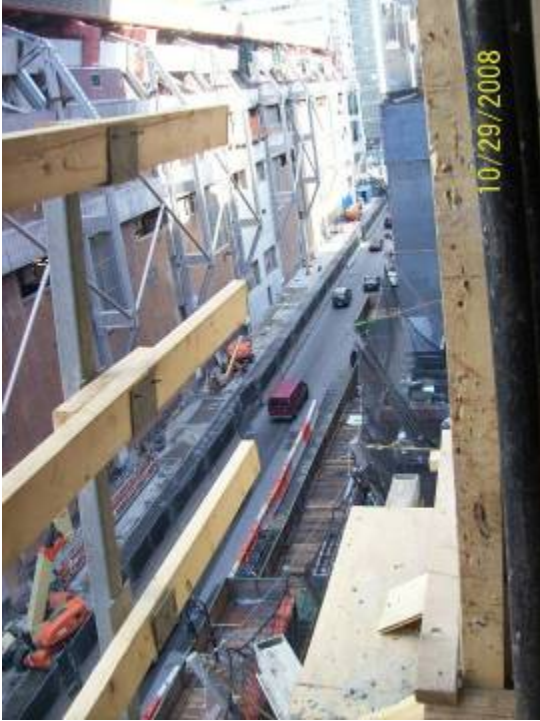
Figure B.7.4: Localized Gap Condition at Guardrail. Lack of Specificity Regarding Allowable Gap Distance (if any) Forces Inspector to Make a Potentially Inconsistent Judgment Call

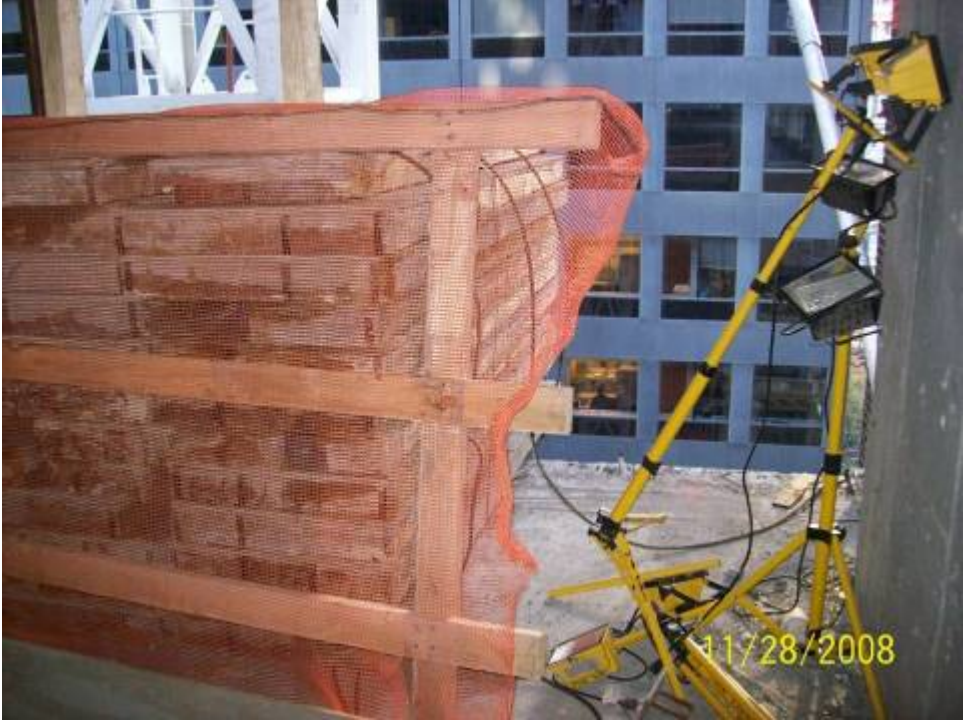
Figure B.7.5: Localized Discontinuous Guardrail Condition at Material Storage Location. Lack of Specificity Regarding Allowable Gap Distances Forces Inspector to Make a Potentially Inconsistent Judgment Call

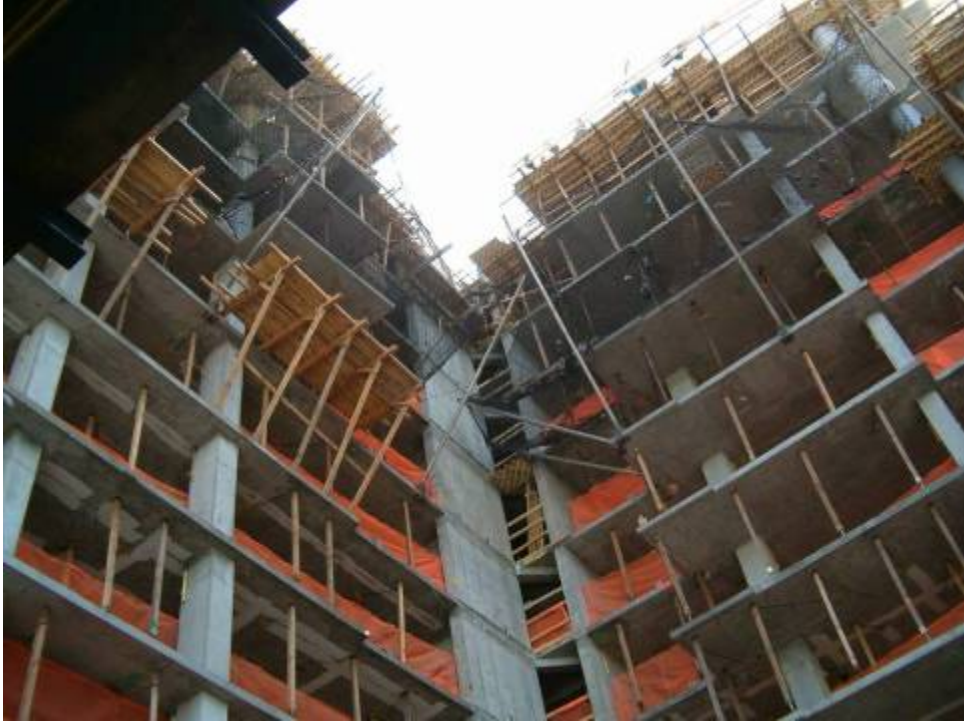
Figure B.7.6: Building Exposure with Incomplete Edge Protection. Code Provisions Do Not Address Violation Thresholds Relating to Percentage of Exposure without Protection

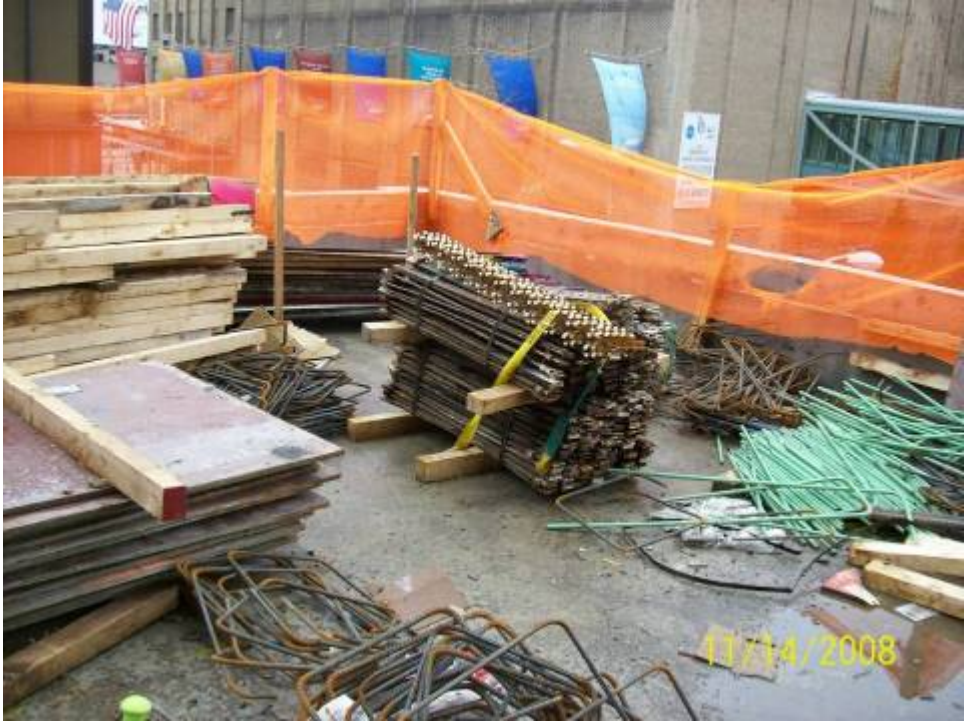
Figure B.7.7: Localized Variation in Guardrail Height. Code Provisions Do Not Address Allowable Height Tolerances (if any). Lack of Specificity Forces Inspector to Make a Potentially Inconsistent Judgment Call

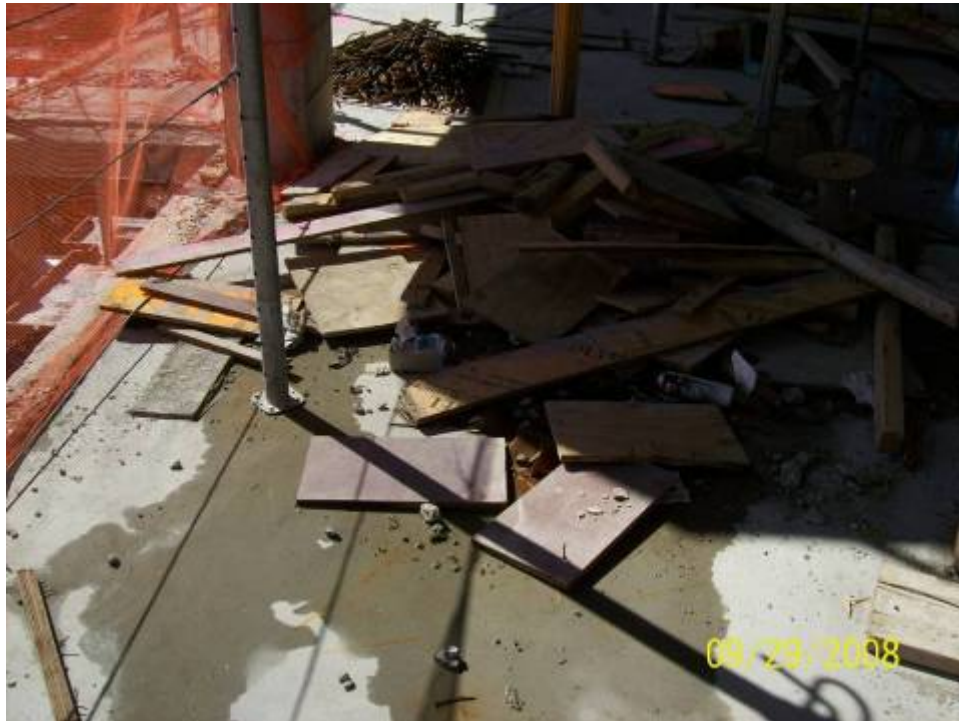
Figure B.7.9: Unacceptable Level of Debris Accumulation. Enforcement Level: Violation

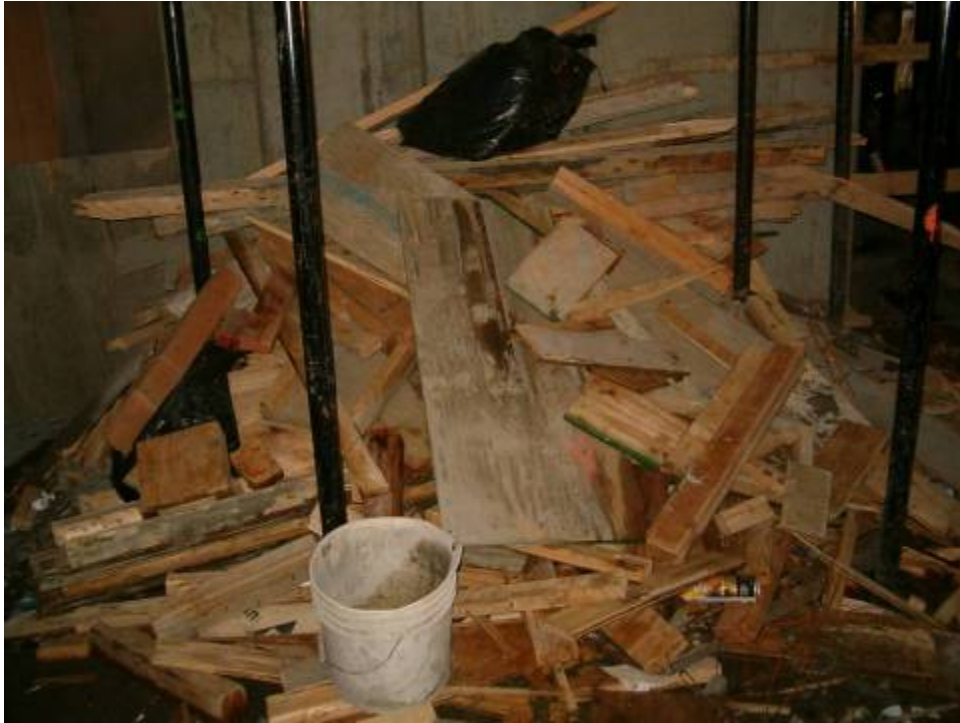
Figure B.7.10: Unacceptable Level of Debris Accumulation Presenting a Major Impediment to Egress. *Enforcement Level: Stop Work Order*

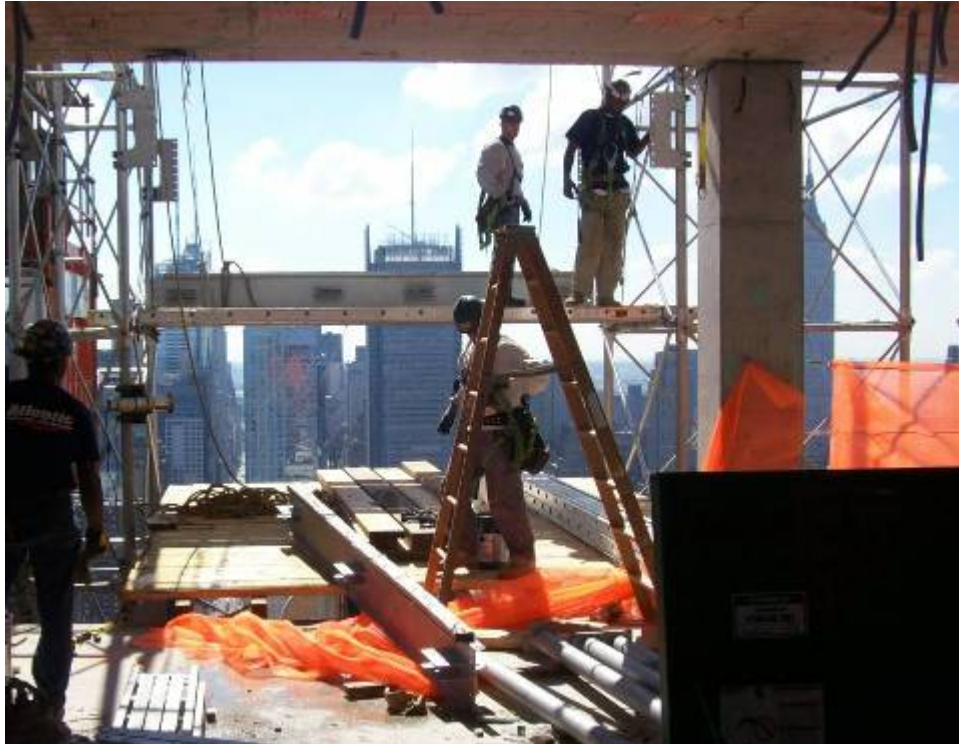
Figure B.7.12: Failure to Tie-off within 10 feet of Unprotected Edge

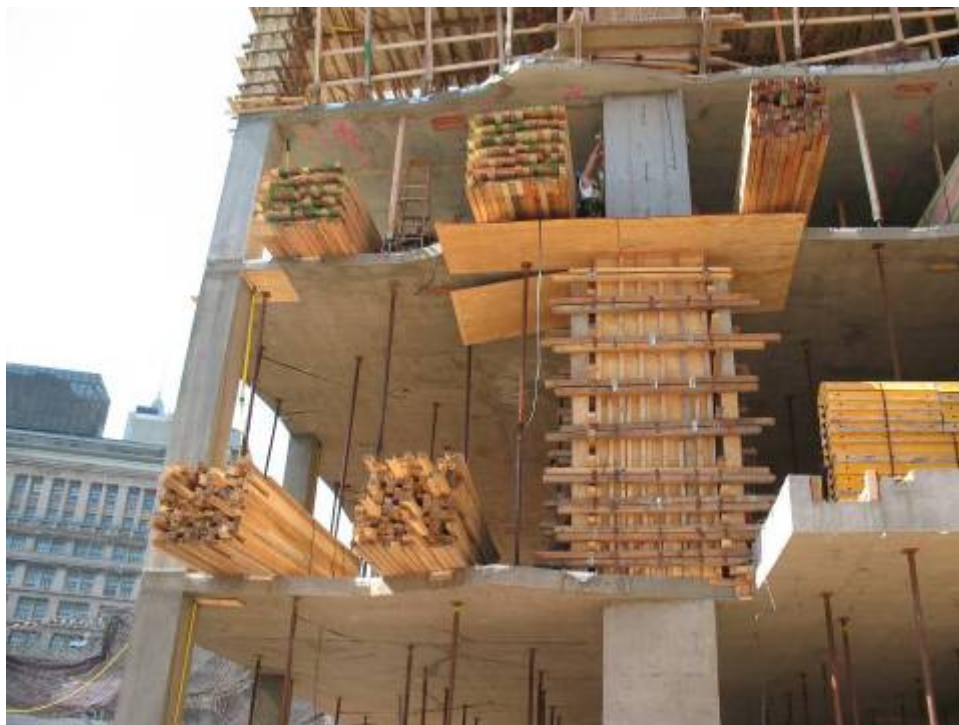
Figure B.7.18: Typical Unacceptable Lack of Edge Protection at Building Edge Coincident with Material Storage. Guardrails Removed over a Large Portion of This Building's Exposure to Accommodate Material Piles

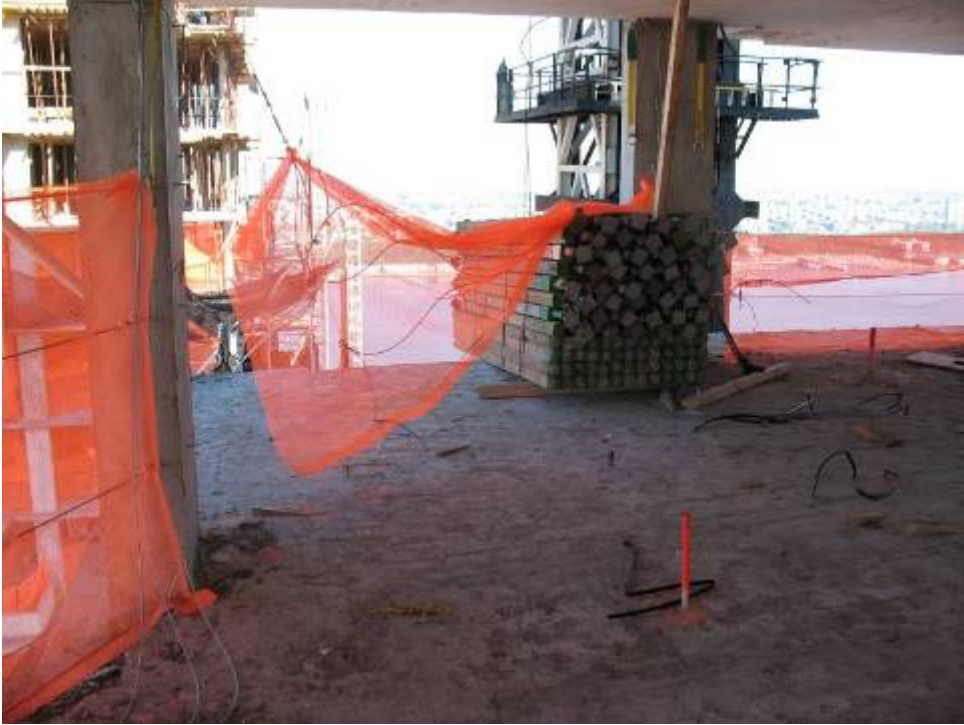
Figure B.7.19: Current Code-Compliant Material Storage Practice (Piled Material is Banded and Braced) and Accompanying Fall Hazard at Unprotected Edge (Left)

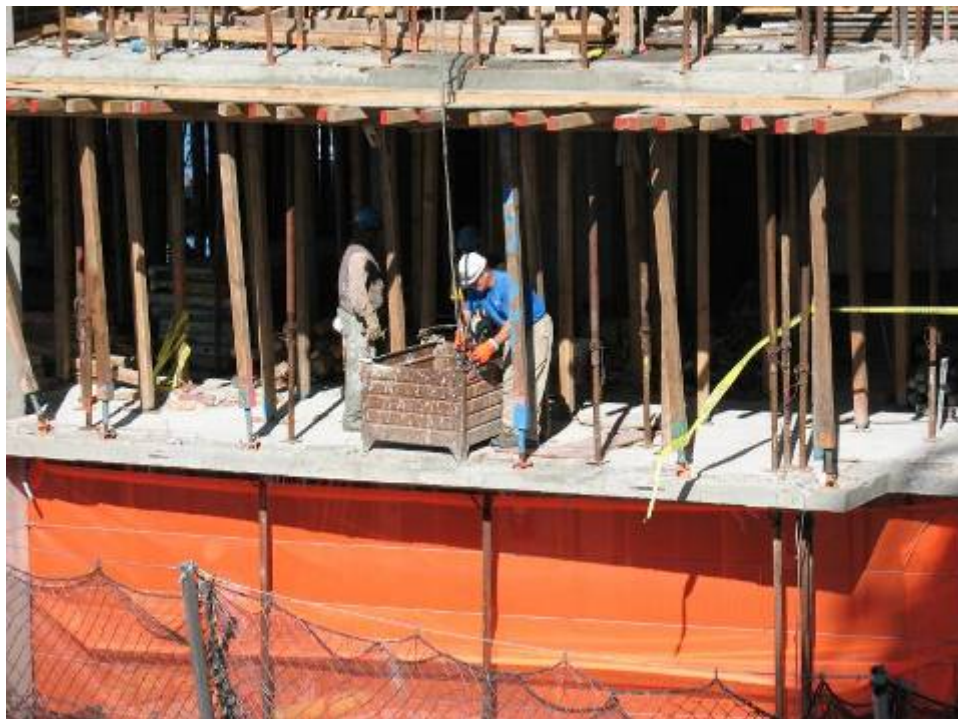
Figure B.7.20: Hoisting of Debris Container (Mini) Requires Rigging Operations at Unprotected Edge. Hoisting Will Also Require Crane “Side-Pulling”. Note Lack of Proper Worker Tie-Off

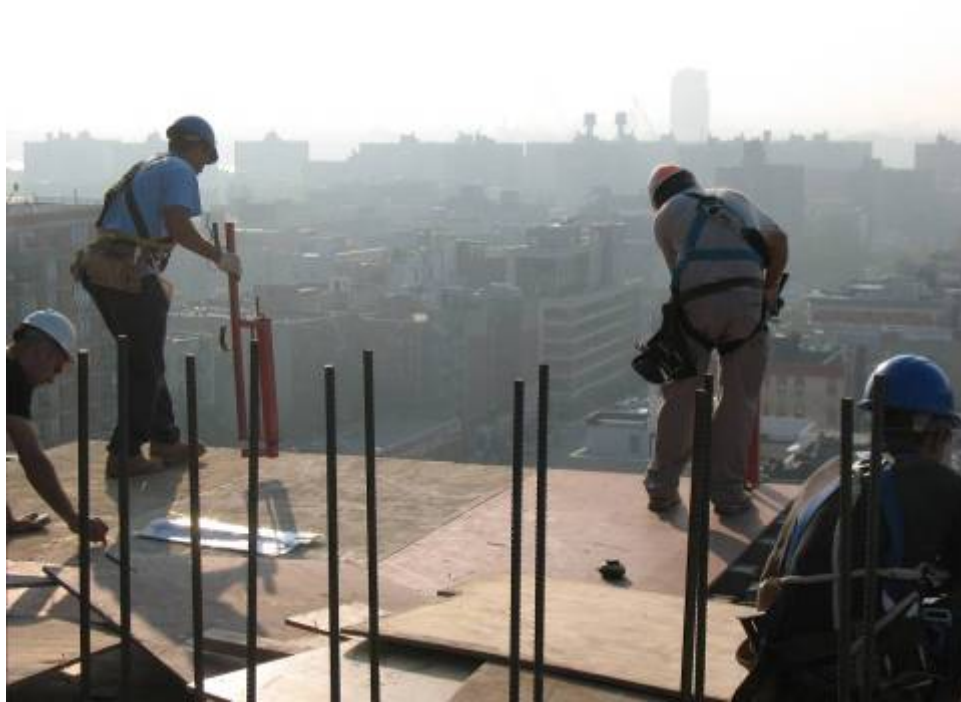
Figure B.8.1: Failure to Tie-off During Decking Operations. Retractable Lanyards Could Have Been Utilized, Anchoring to Formwork Subassembly

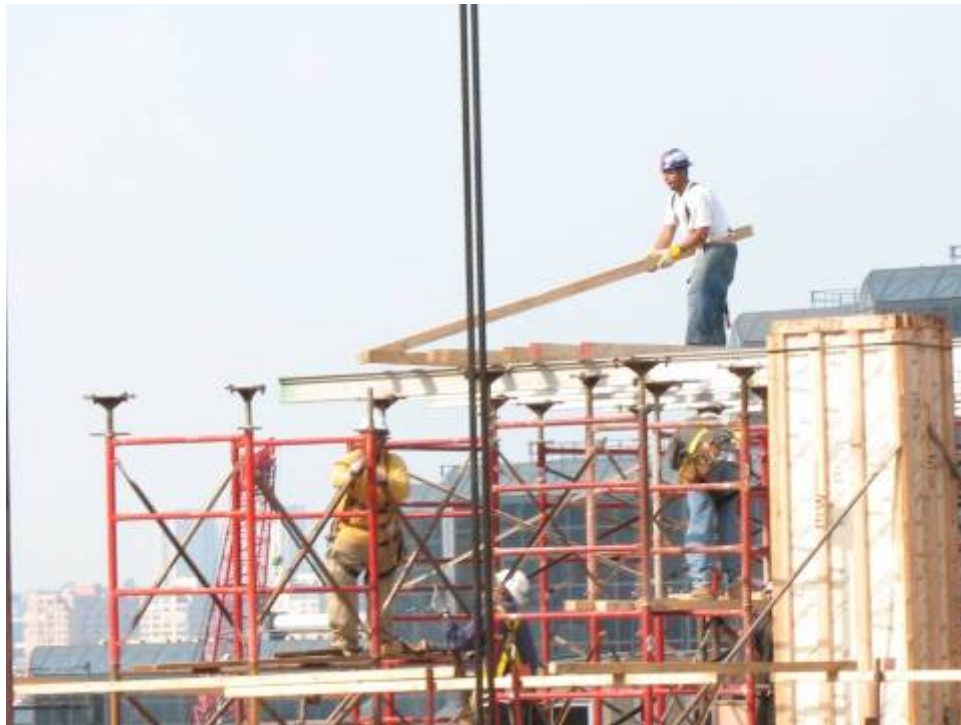
Figure B.8.6: Commonly Observed Failure to Tie-off During Formwork Erection Operations

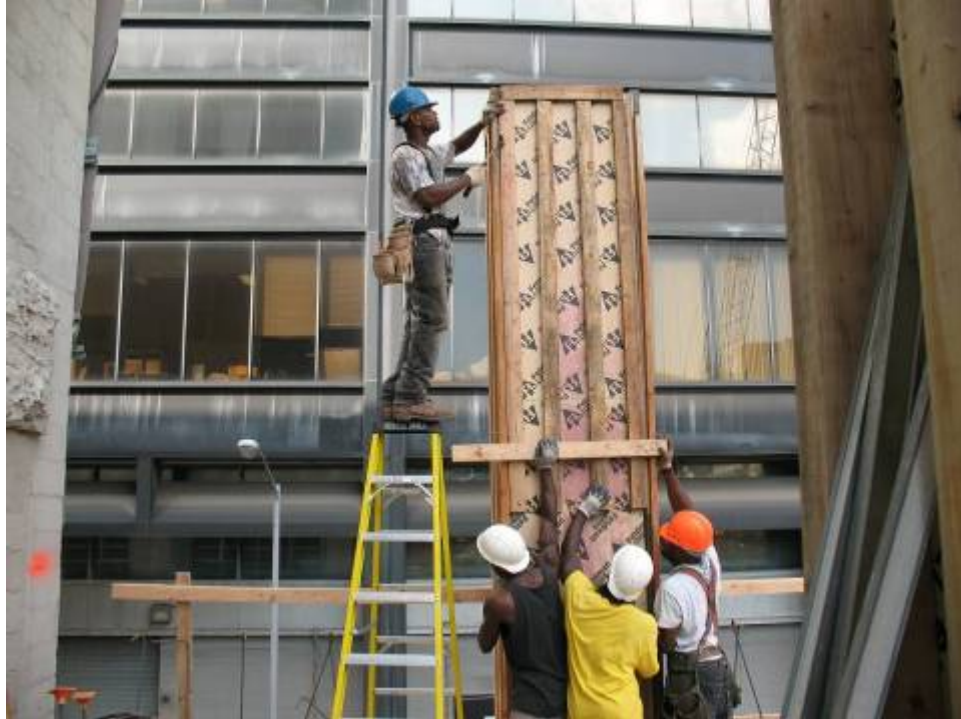
Figure B.8.7: Initial Failure to Tie-off at Site No. 86, 3-Sept. 2008 (OSHA Violation)

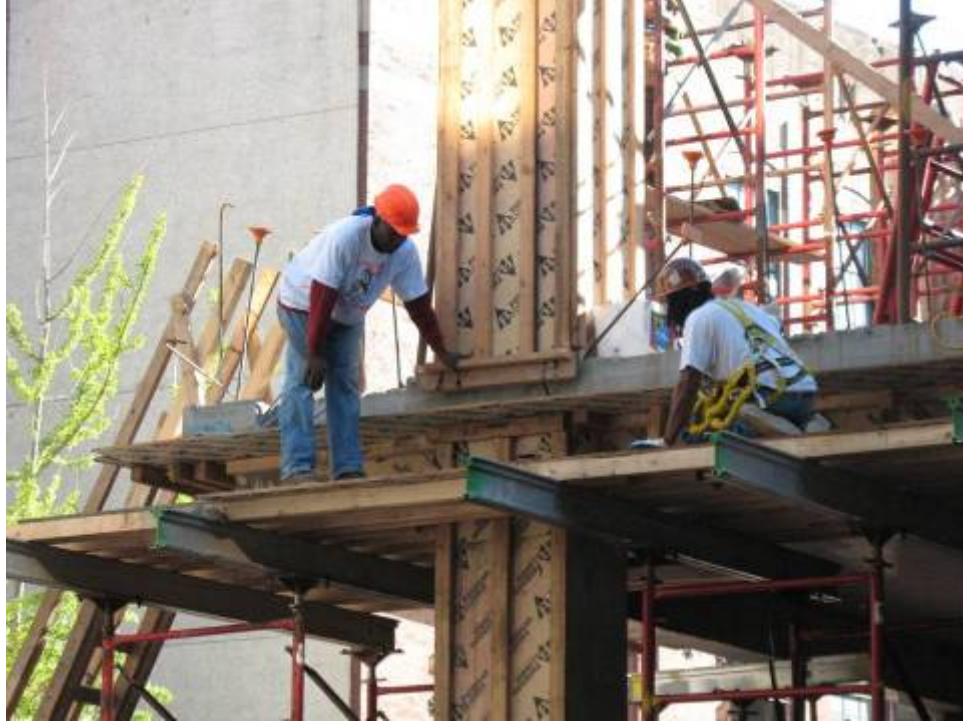
Figure B.8.8: Repeat Failure to Tie-off at Site No. 86, 10-Sept. 2008 (OSHA Violation)

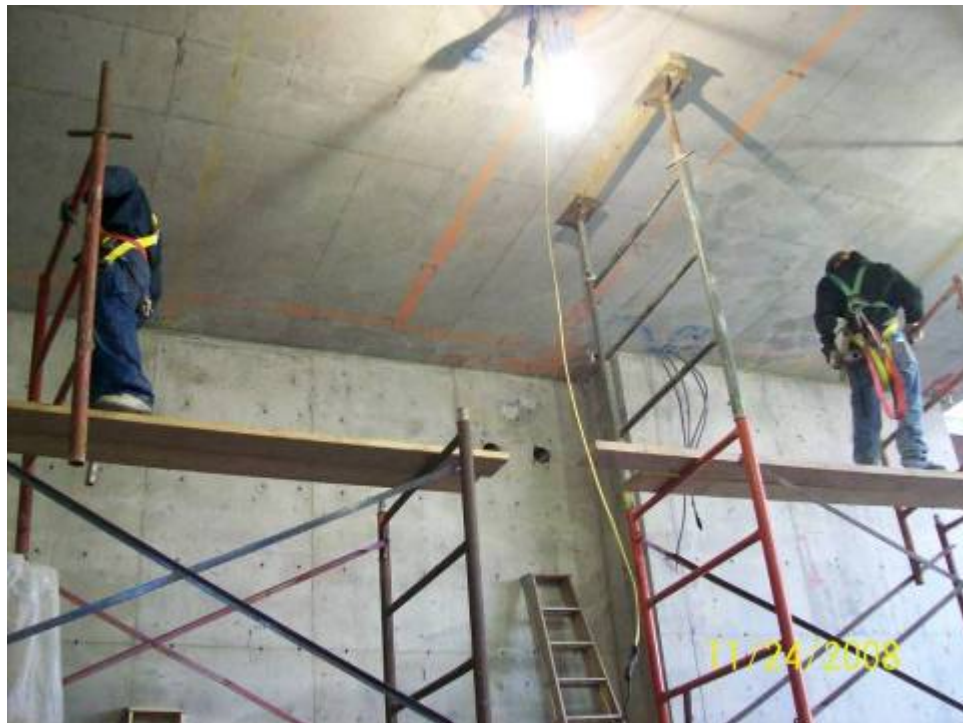
Figure B.8.9: Repeat Failure to Tie-off at Site No. 86, 24-Nov. 2008 (OSHA Violation)

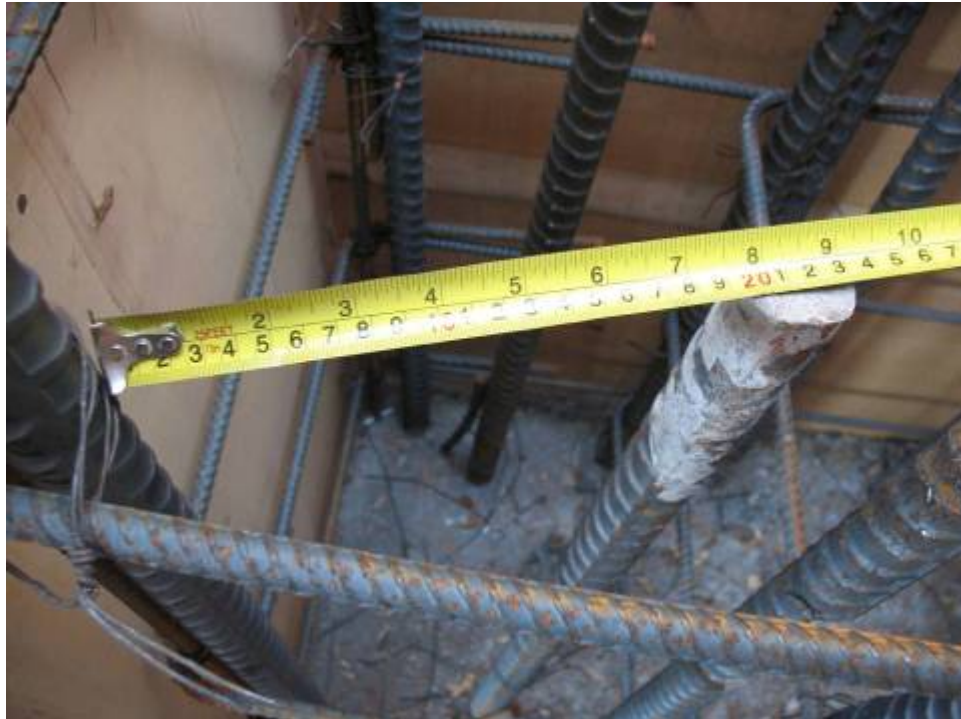
Figure B.9.1: Typical Critical Quality Defect: Column Splices Noncompliant with ACI. Conditions Subsequently Remedied to the Satisfaction of the Engineer of Record
