Report for
Buildings Commissioner Robert D. LiMandri

CTL, PC Project No. 500108

High Risk Construction Oversight Study

June 5, 2009

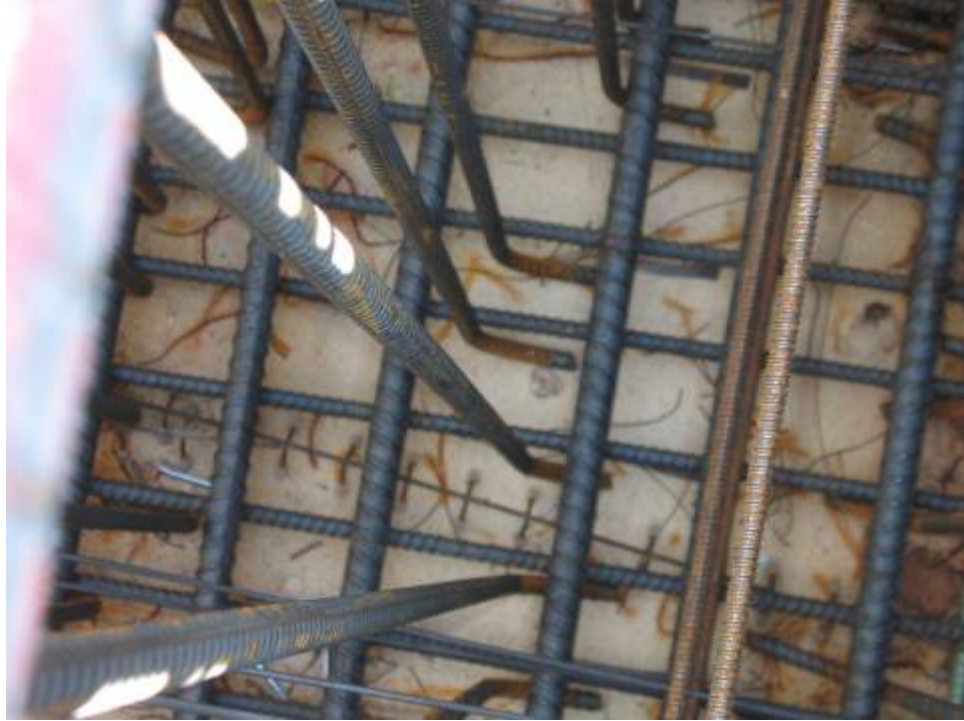
Figure B.9.3: Typical Critical Quality Defect: Improper Shear Stirrup Engagement. Conditions Subsequently Remedied to the Satisfaction of the Engineer of Record

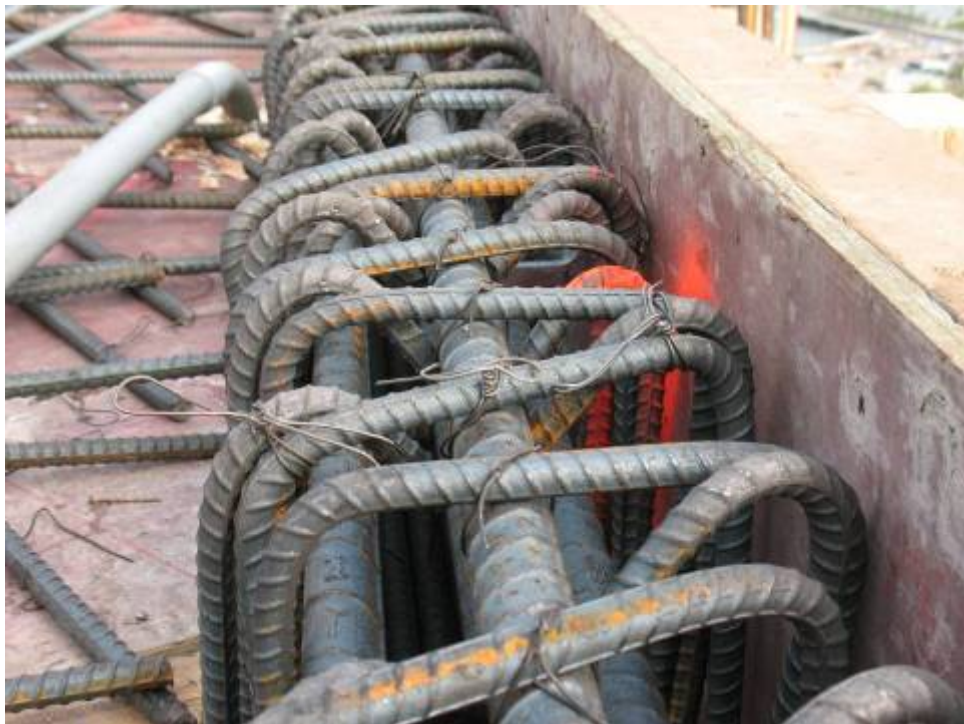
Figure B.9.4: Typical Critical Quality Defect: Bar Congestion and Improper Shear Stirrup Engagement. Conditions Subsequently Remedied to the Satisfaction of the Engineer of Record

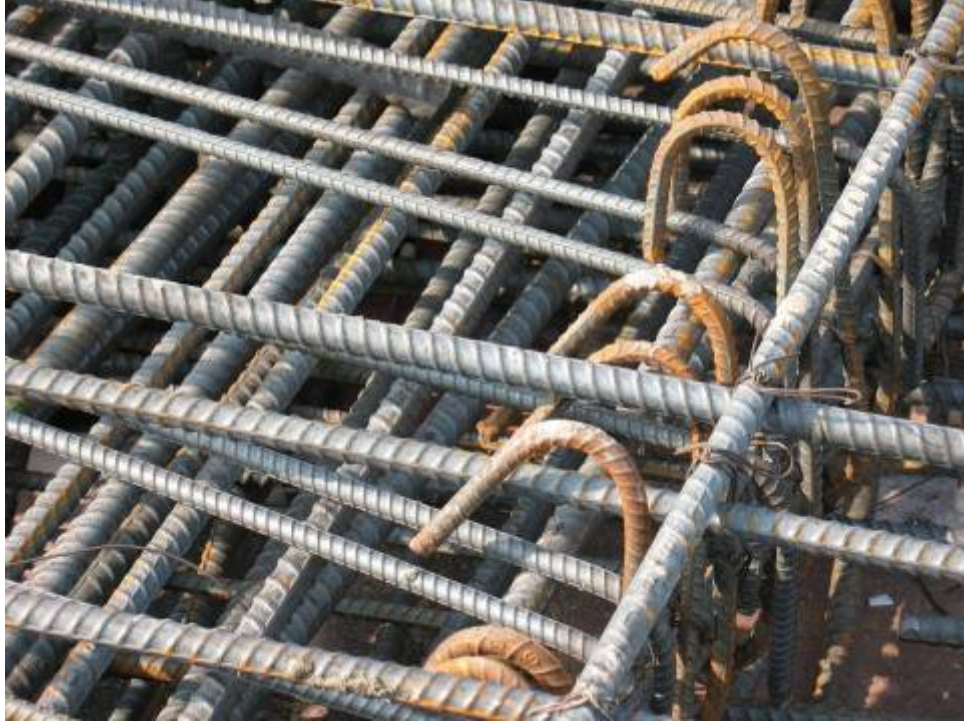
Figure B.9.6: Improperly Fabricated Shear Stirrups, Resulting in Improper Stirrup Engagement. Conditions Subsequently Remedied to the Satisfaction of the Engineer of Record

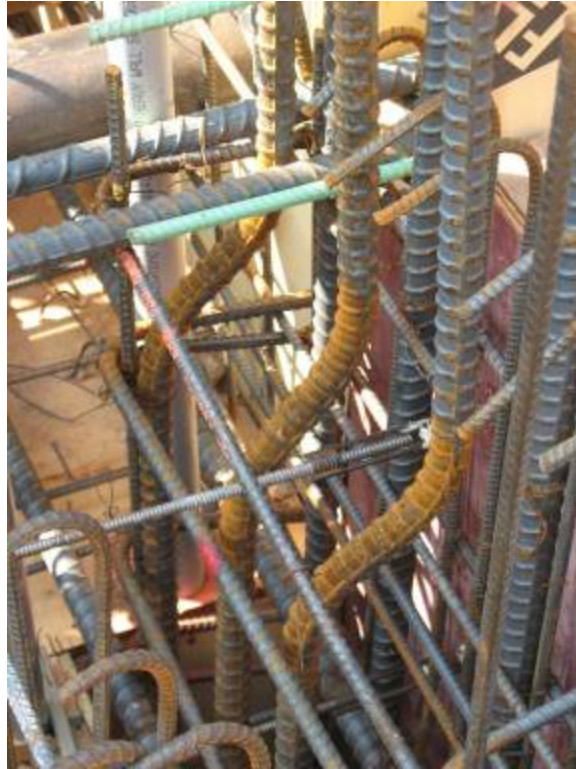
Figure B.9.7: Bar Fabrication Noncompliant with ACI²⁸. Conditions Brought to the Attention of the Engineer of Record

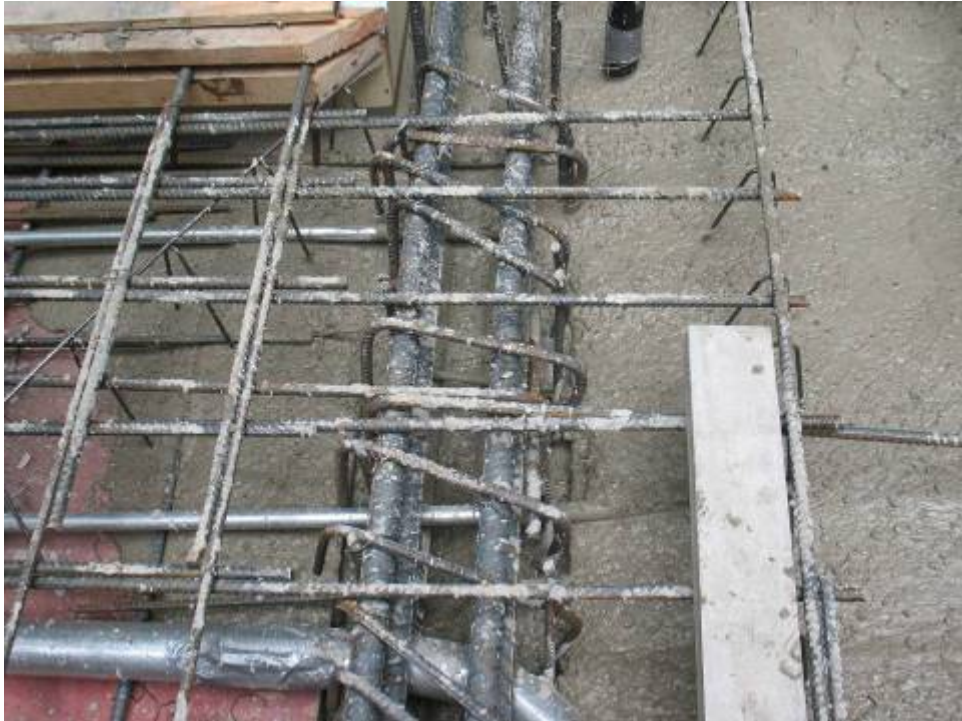
Figure B.9.8: Lack of Proper Shear Stirrup Engagement. Condition Soon to be Hidden by Concrete Encasement. Conditions Brought to the Attention of the Engineer of Record

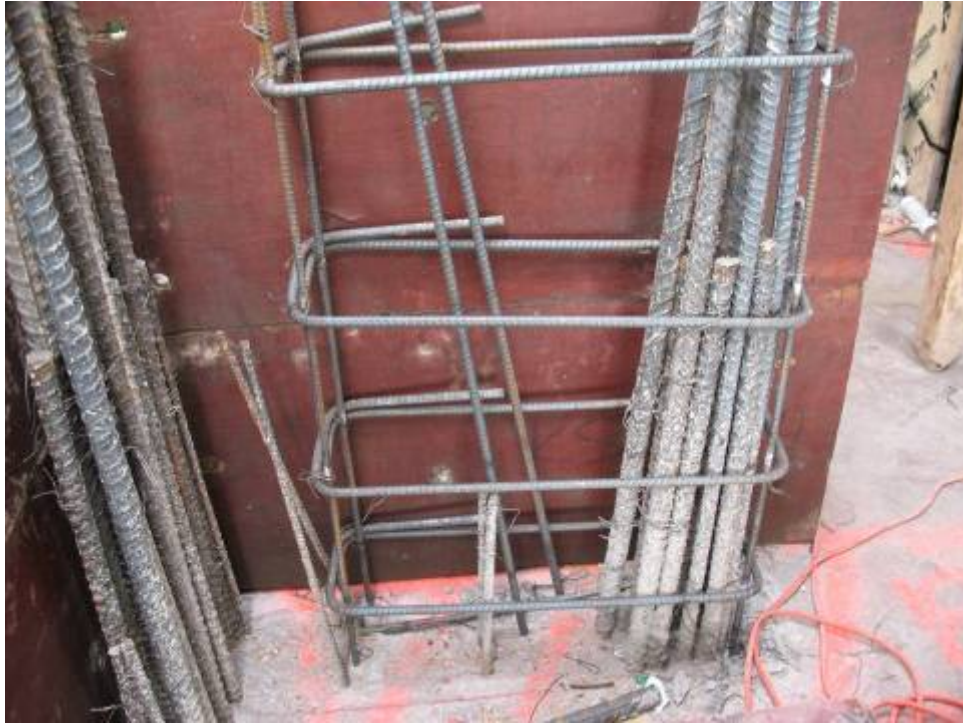
Figure B.9.9: Column Bar Congestion. Conditions Brought to the Attention of the Engineer of Record

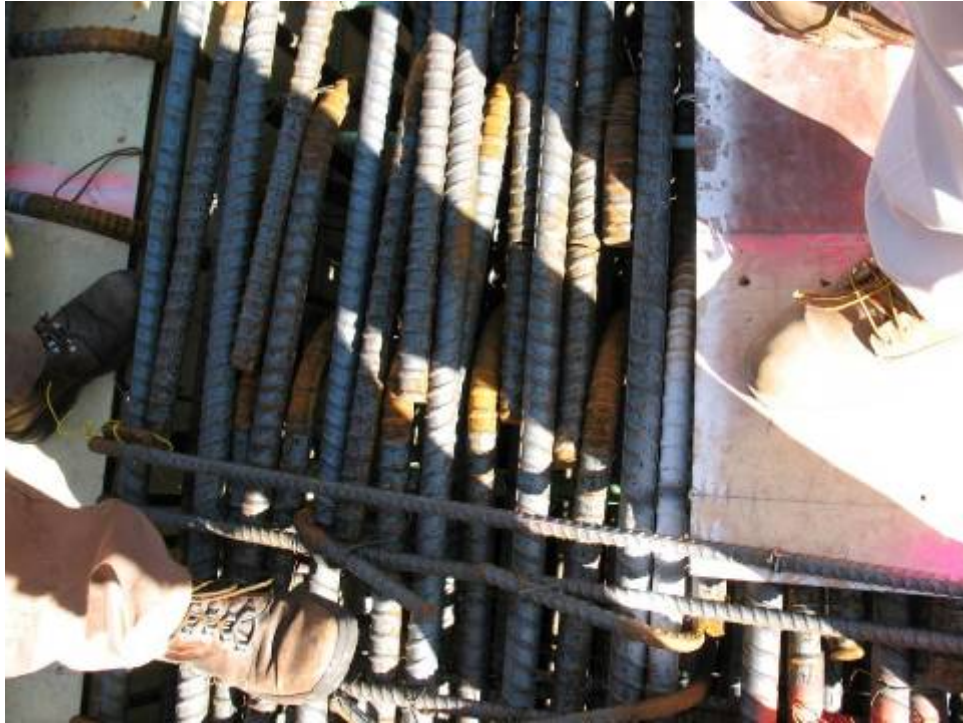
Figure B.9.10: Severe Bar Congestion²⁹. Conditions Brought to the Attention of the Engineer of Record

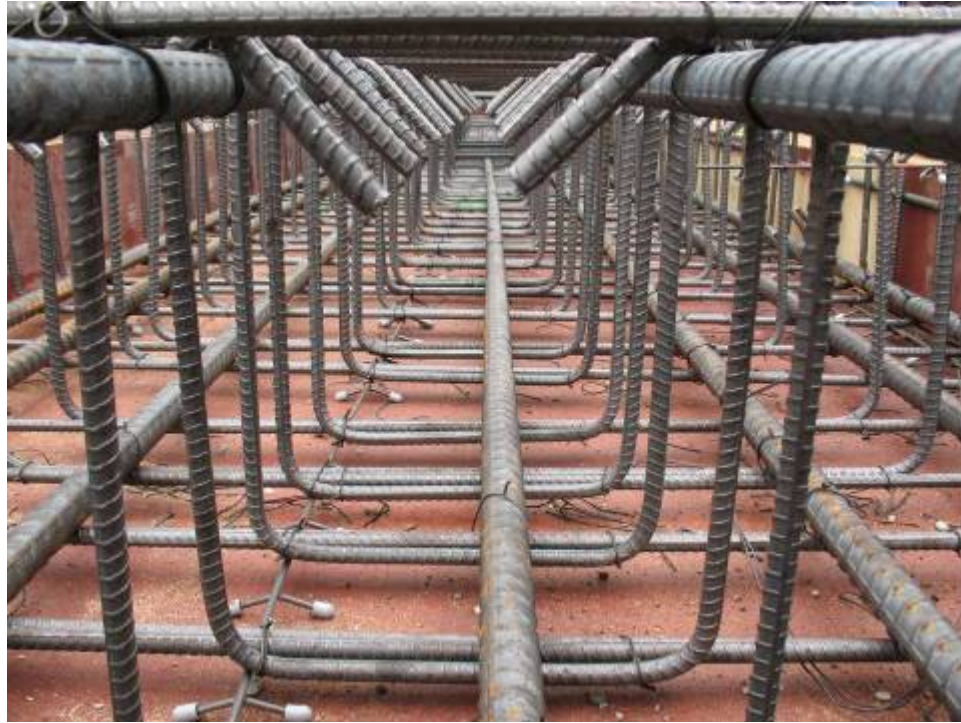
Figure B.9.11: Second Floor Transfer Girder with Improperly Developed Shear Reinforcing. Site No. 47

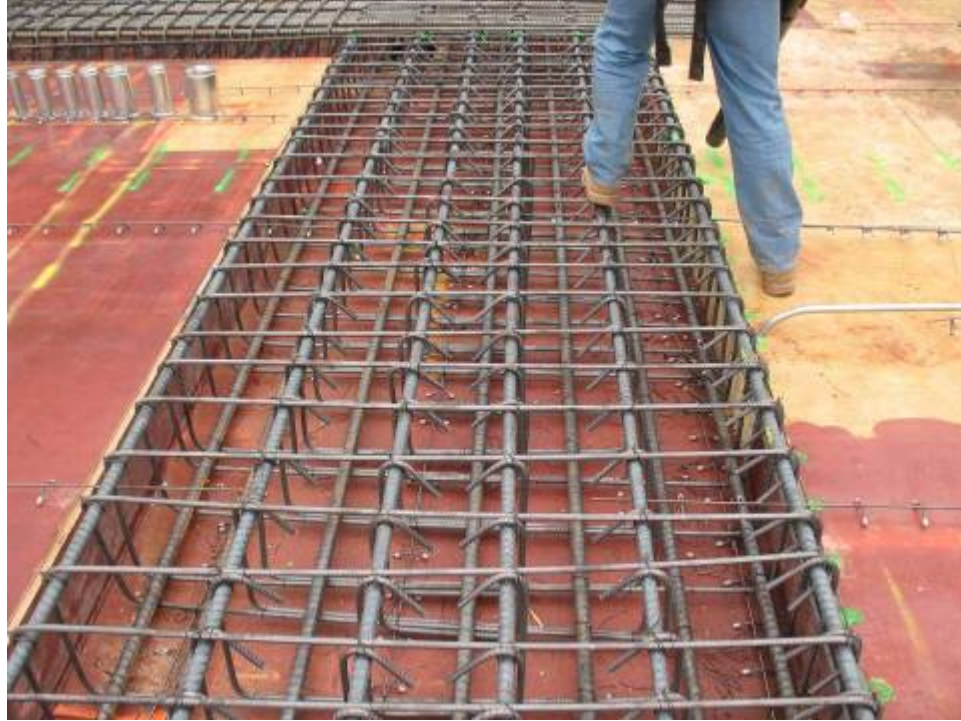
Figure B.9.12: First Floor Transfer Girder with Insufficient Numbers of Installed Shear Reinforcing Sets. Site No. 47

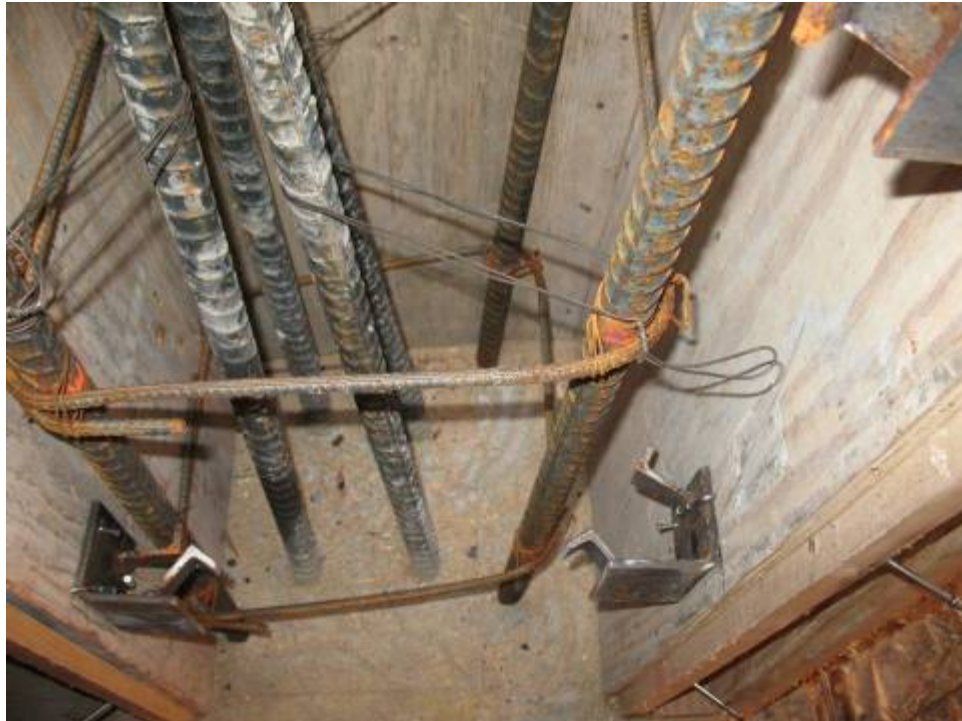
Figure B.10.1: Splice Condition Requiring Additional Information from the Engineer of Record.

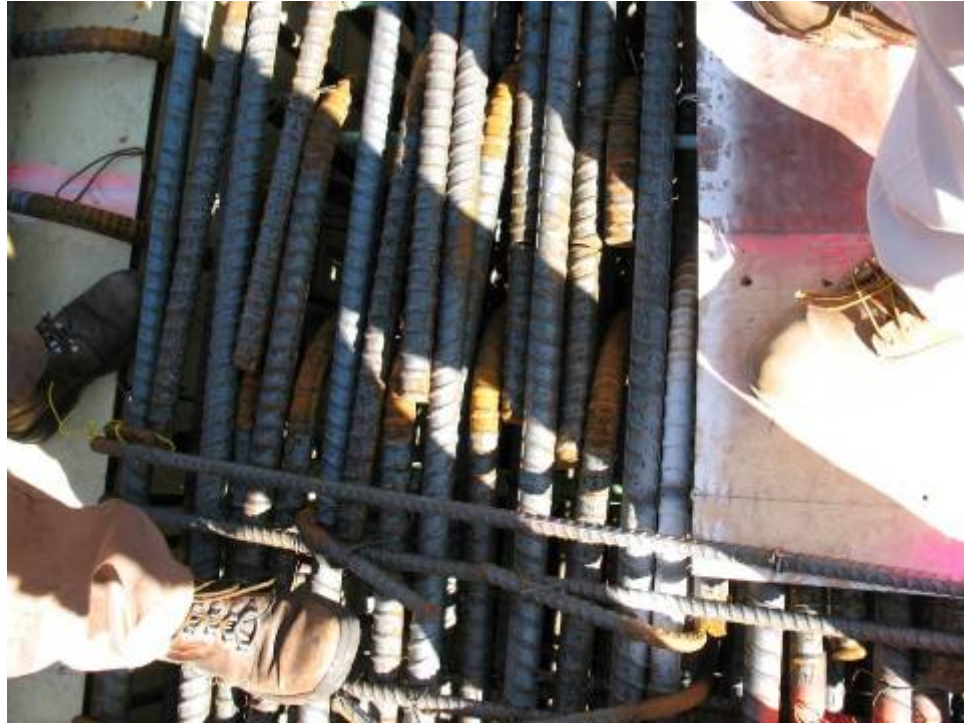
Figure B.10.2: Constructability Issues at Beam-Column Connection

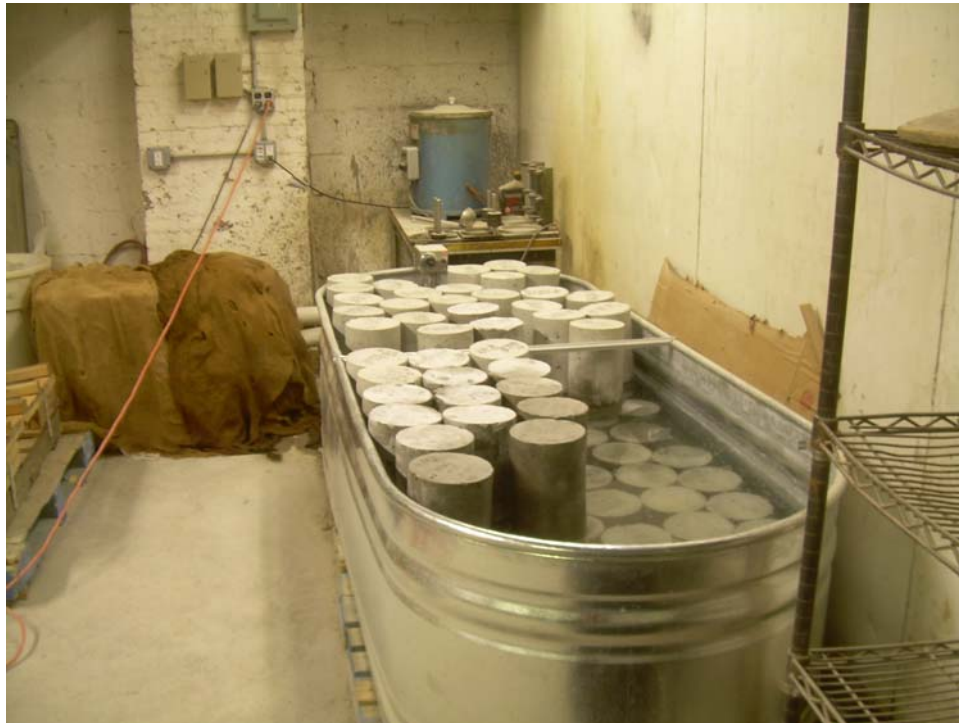
Figure 1: Improper Cylinder Curing Procedures, Some Cylinders Partially Immersed

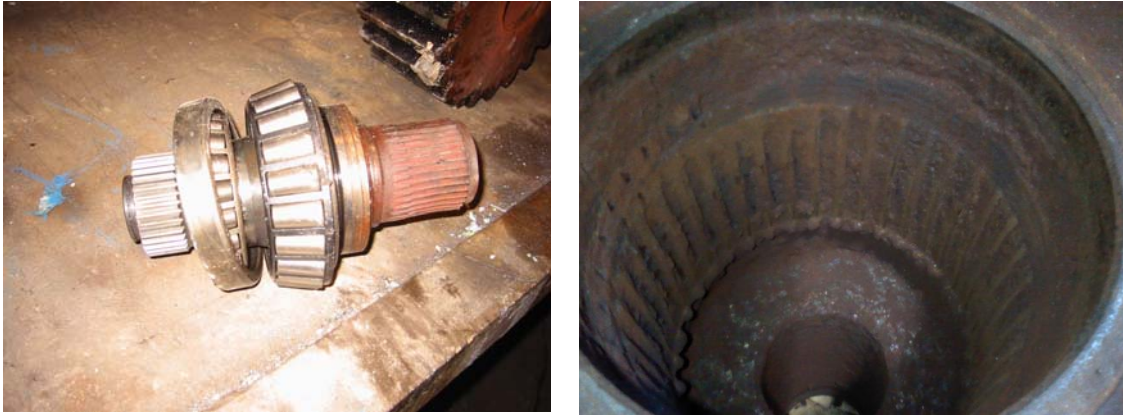
Figure C.6.4: Worn Pinion and Pinion Spine

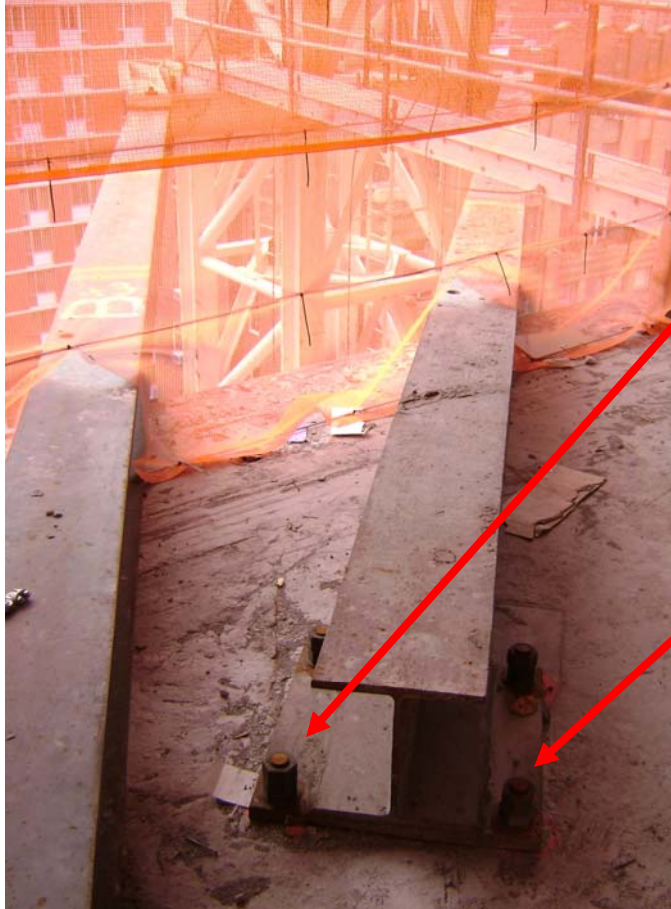
Example of loose bolt on a friction connection

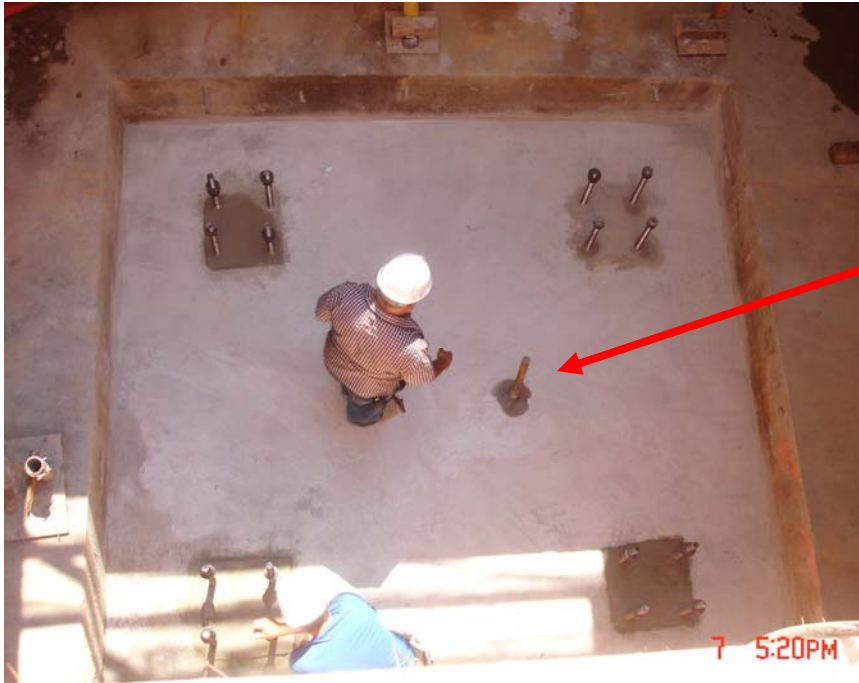
The foundation is poured and the rebar placement cannot be checked.

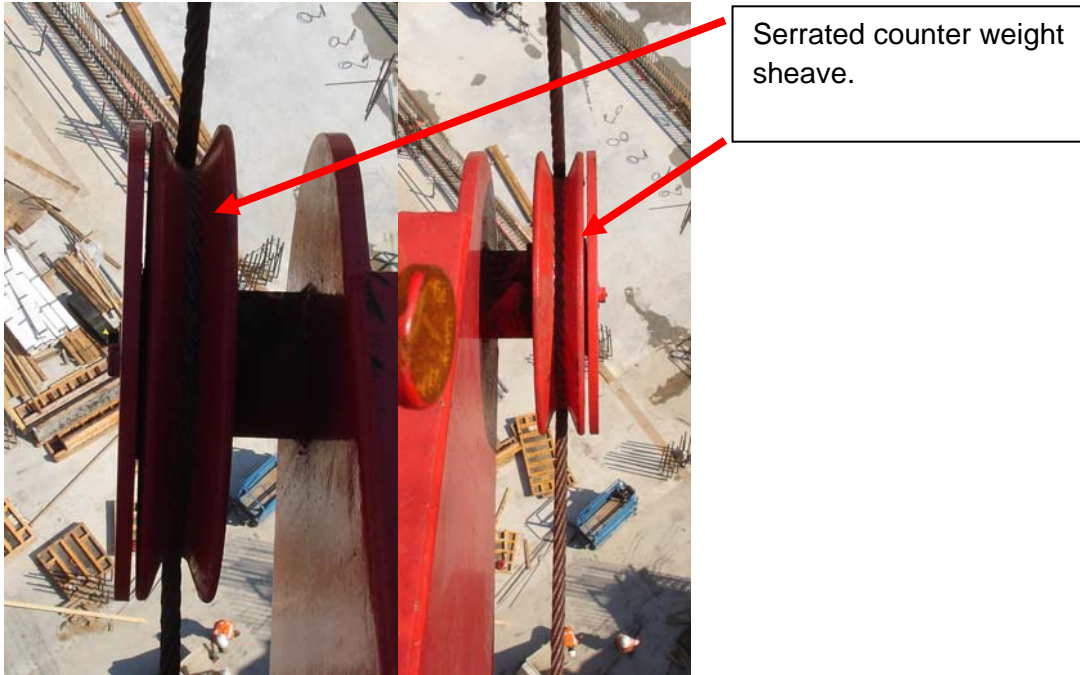
Figure C.7.15: Serrated Counter Weight Sheaves (Site C-22, 9/4/08)

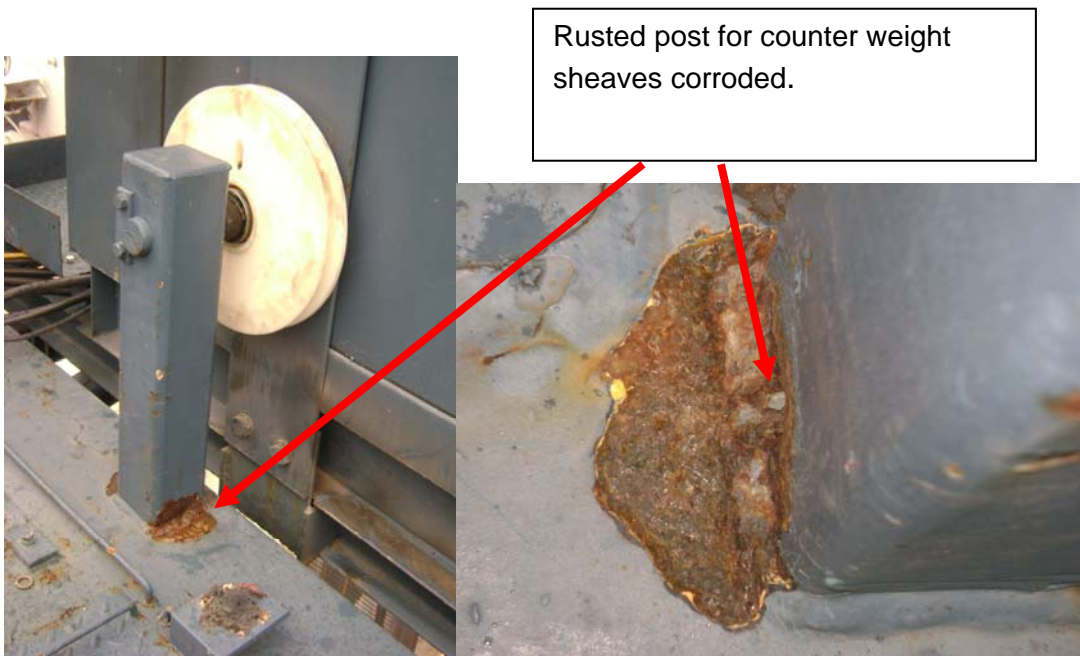
Figure C.7.16: Rusted Counter Weight Sheave Posts (Site C-61, 11/5/08)
