The City of New York
Department of Investigation

**DOI REPORT ON THE FATALITY OF A NYCHA CARETAKER FOUND IN A GARBAGE HOIST
CALLS FOR NYCHA TO PERMANENTLY DECOMMISSION THESE UNITS**

Safety Issues Relating to Garbage Hoists Utilized at Certain NYCHA Facilities

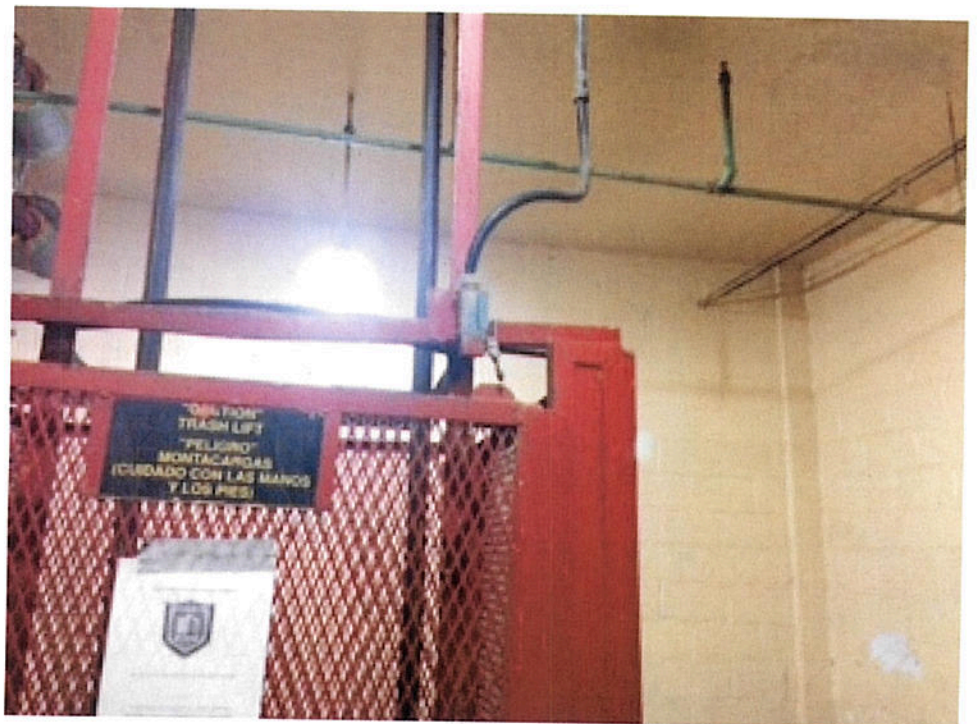
PHOTO #1

On April 6, 2015, DOI investigators visited and inspected the basement compactor room, the garbage hoist system, and the ground level transfer room. During this inspection, DOI made the following observations: at the basement level, the hoistway terminates in a red metal mesh cage with a door designed to be secured with a bolt, but the locking mechanism is broken. The cage is marked with two identical signs warning in English "CAUTION - TRASH LIFT," and in Spanish

“PELIGRO - MONTACARGAS (CUIDADO CON LAS MANOS Y LOS PIES).”⁴ See Appendix A, Photos #1 and #2. The cage is equipped with a safety cage interlock switch that is designed to break the electrical circuit and prevent the hoist car from moving when the cage door is open. However, the cage door is damaged and bent so that it does not make contact with the safety cage switch. See Appendix A, Photos #3 and #4. The hoist car travels up from the basement level, through a hole in the basement ceiling/ground level floor. See Appendix A, Photo #5. DOI observed that there is no operating switch for the hoist at the basement level.

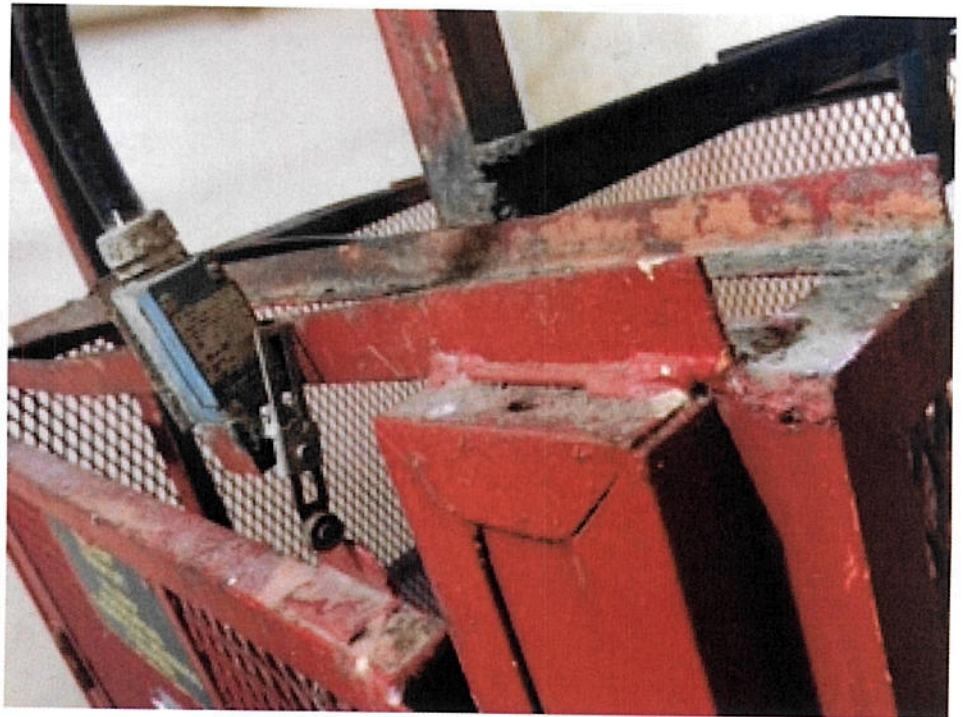
PHOTO #3

The hoist car measures approximately 2’ square by 4’ tall. The car has two doors that bolt closed and are designed to swing only in an outward direction, but the hinges are broken so that the doors can also swing inward. See Appendix A, Photo #6. The hoist, model #37874 or 3Z874, is powered by a 1-ton Dayton motor, #9K602F. See Appendix A, Photo #7. Investigators observed that the hook connecting the car to the hoist chain is enclosed in duct tape. See Appendix A, Photo #8.
