NYC WASTEWATER RESILIENCY PLAN

CLIMATE RISK ASSESSMENT AND ADAPTATION STUDY

October 2013

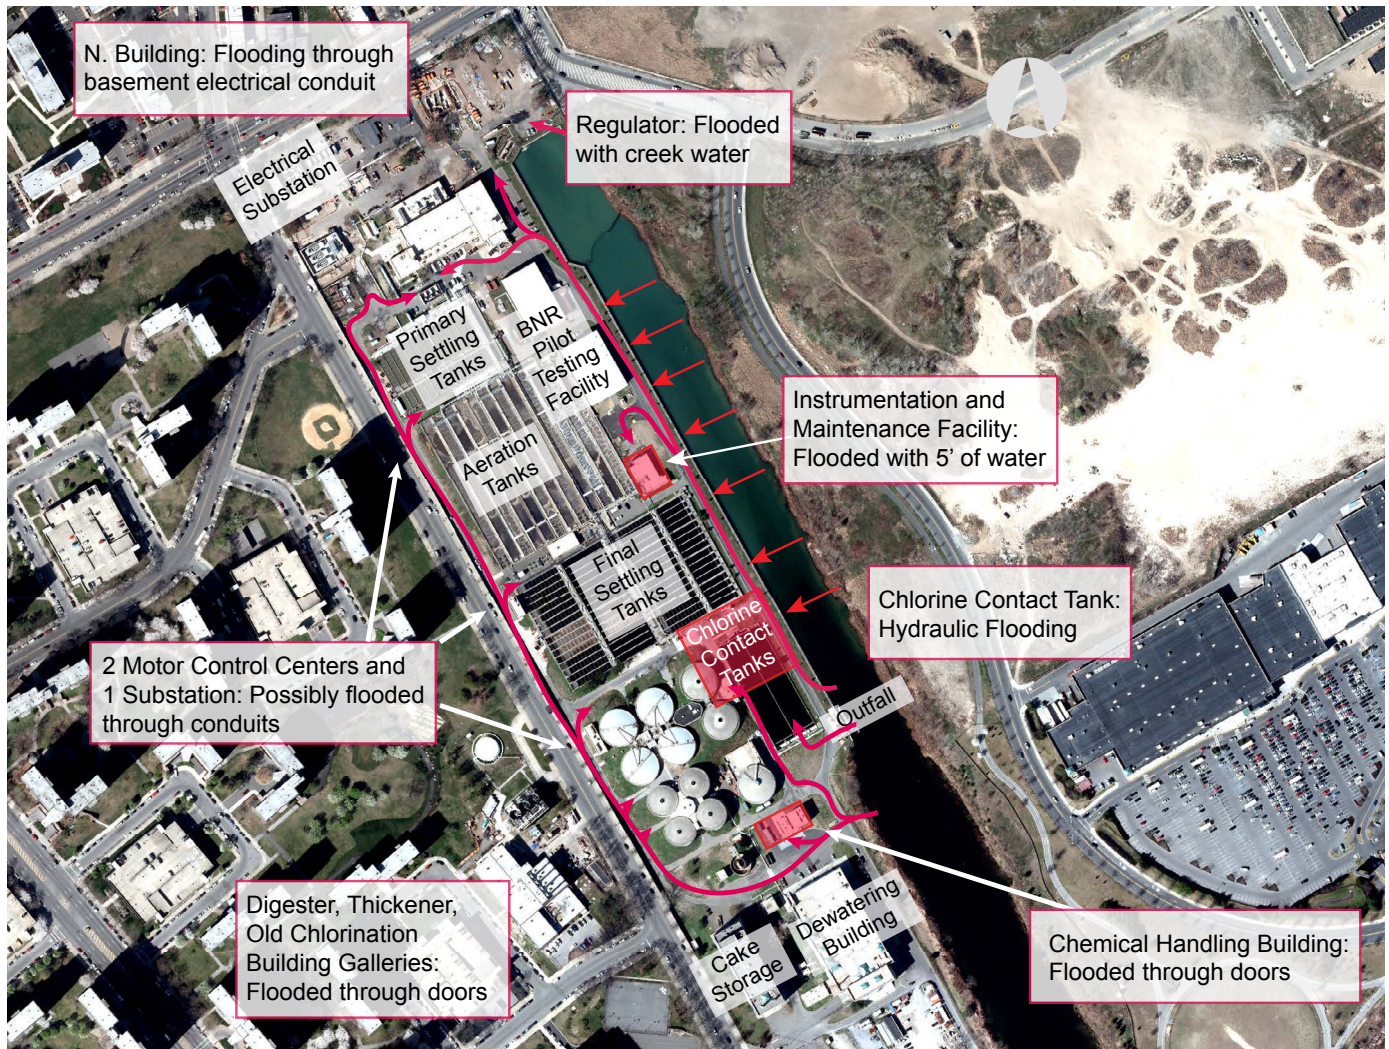
26th Ward Wastewater Treatment Plant

Plant staff worked actively before, during, and after the storm to protect the plant and bring it back to normal operation. Electrical power was proactively shut off throughout the plant during the storm surge, except in the North Building, to prevent short circuiting as the water level continued to rise. After the storm, all flooded areas were dewatered and flooded motors and electrical equipment were cleaned, dried, and repaired or replaced depending on their condition.

Flood pathways and areas flooded during Hurricane Sandy are highlighted in red.

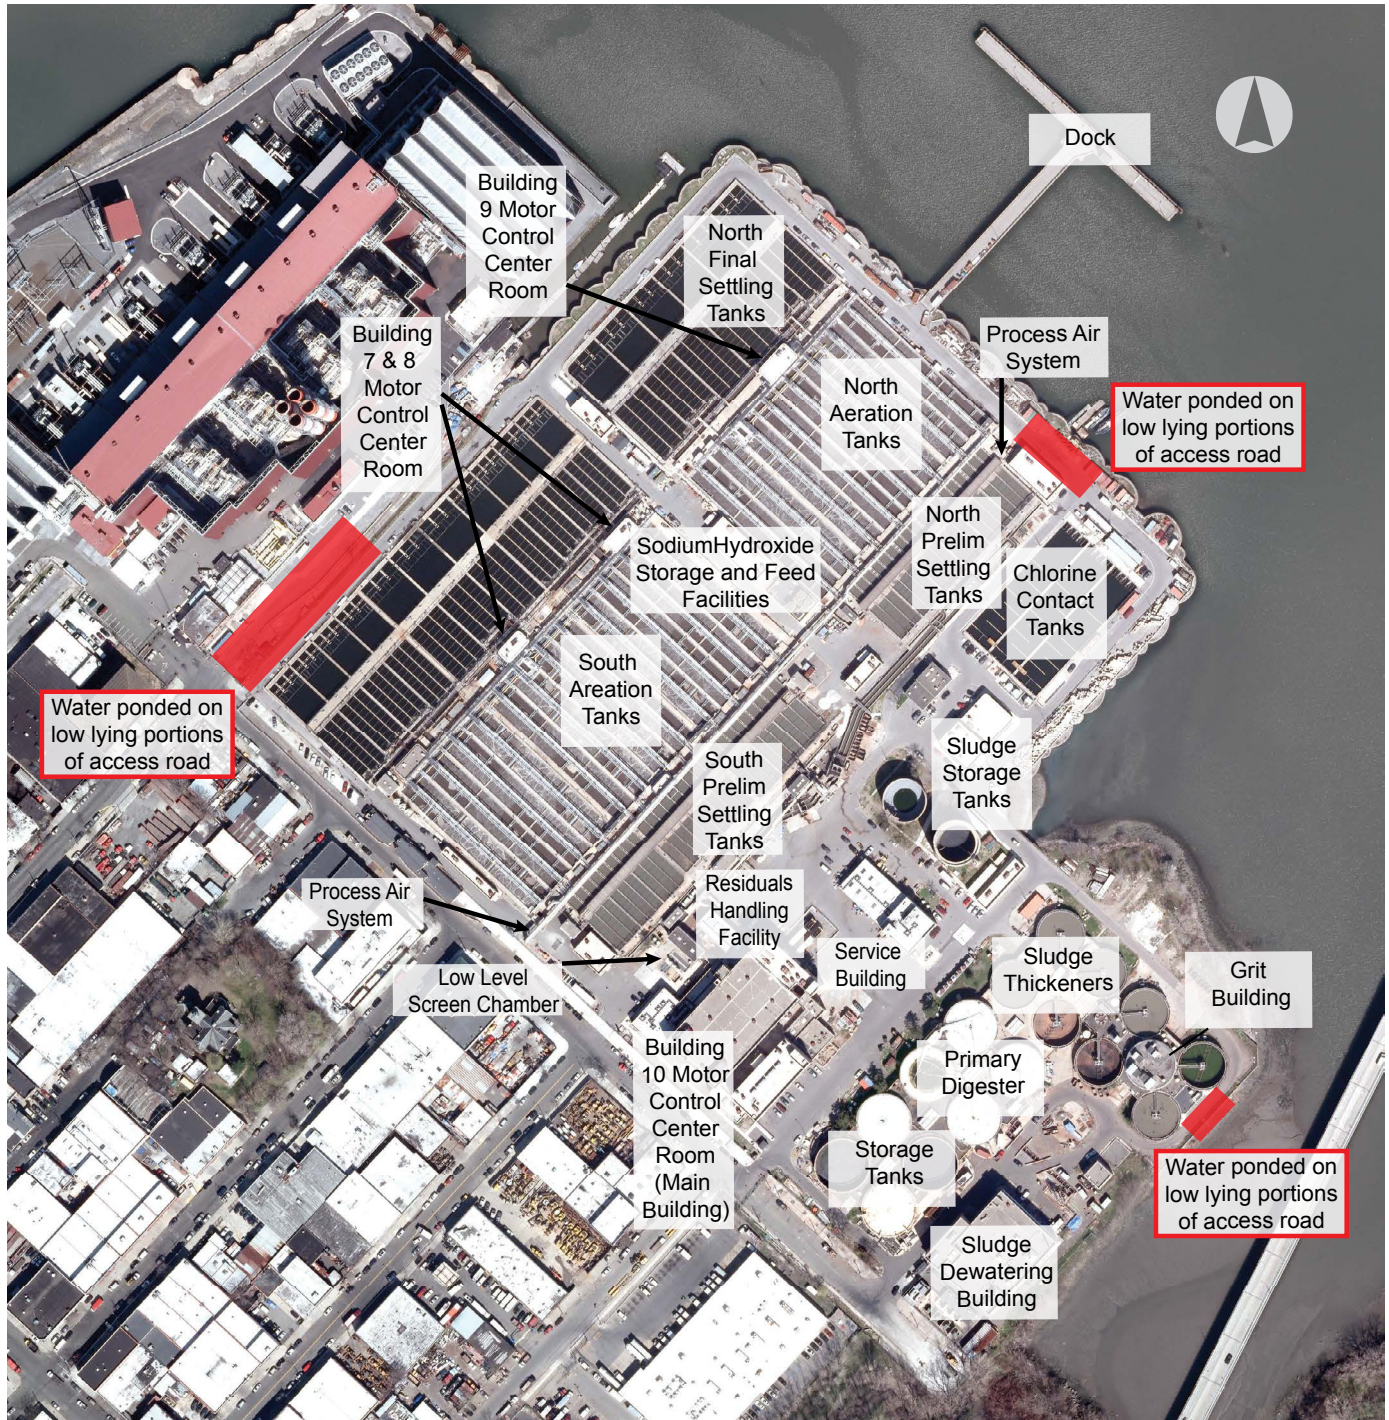
Bowery Bay Wastewater Treatment Plant

storm surge caused minor damage to several temporary contractor office trailers, several storage sheds, and the barge dock. Plant staff took precautions ahead of the storm, which included sandbagging buildings and other routine emergency preparation procedures outlined in the plant's Wet Weather Operations Plan. The plant maintained electrical power and continued normal wet weather operation throughout the storm.

Flood pathways and areas flooded during Hurricane Sandy are highlighted in red.

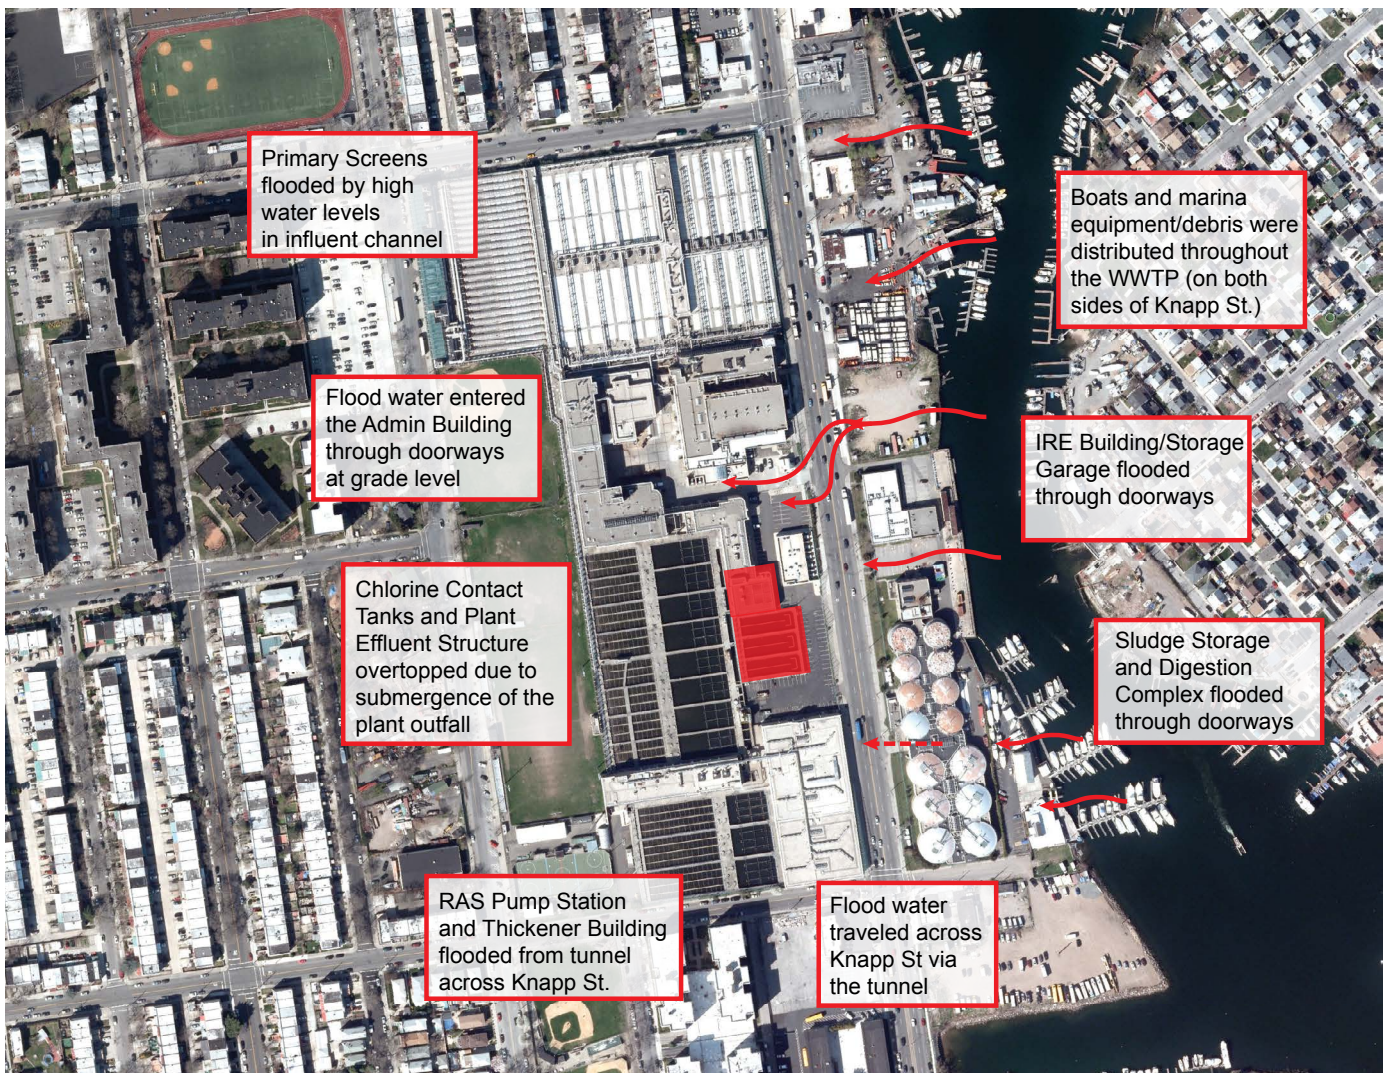
The plant staff took precautions ahead of the storm, which included sandbagging low-lying buildings, relocating some of the portable equipment, filling chemical tanks, ensuring emergency power equipment was operational, closing certain inflow pipes to reduce inflow of combined sewage to the plant, and other procedures outlined in their Wet Weather Operations Plan. Despite the damage, the plant maintained normal wet weather operation through the storm event.

Flood pathways and areas flooded during Hurricane Sandy are highlighted in red.

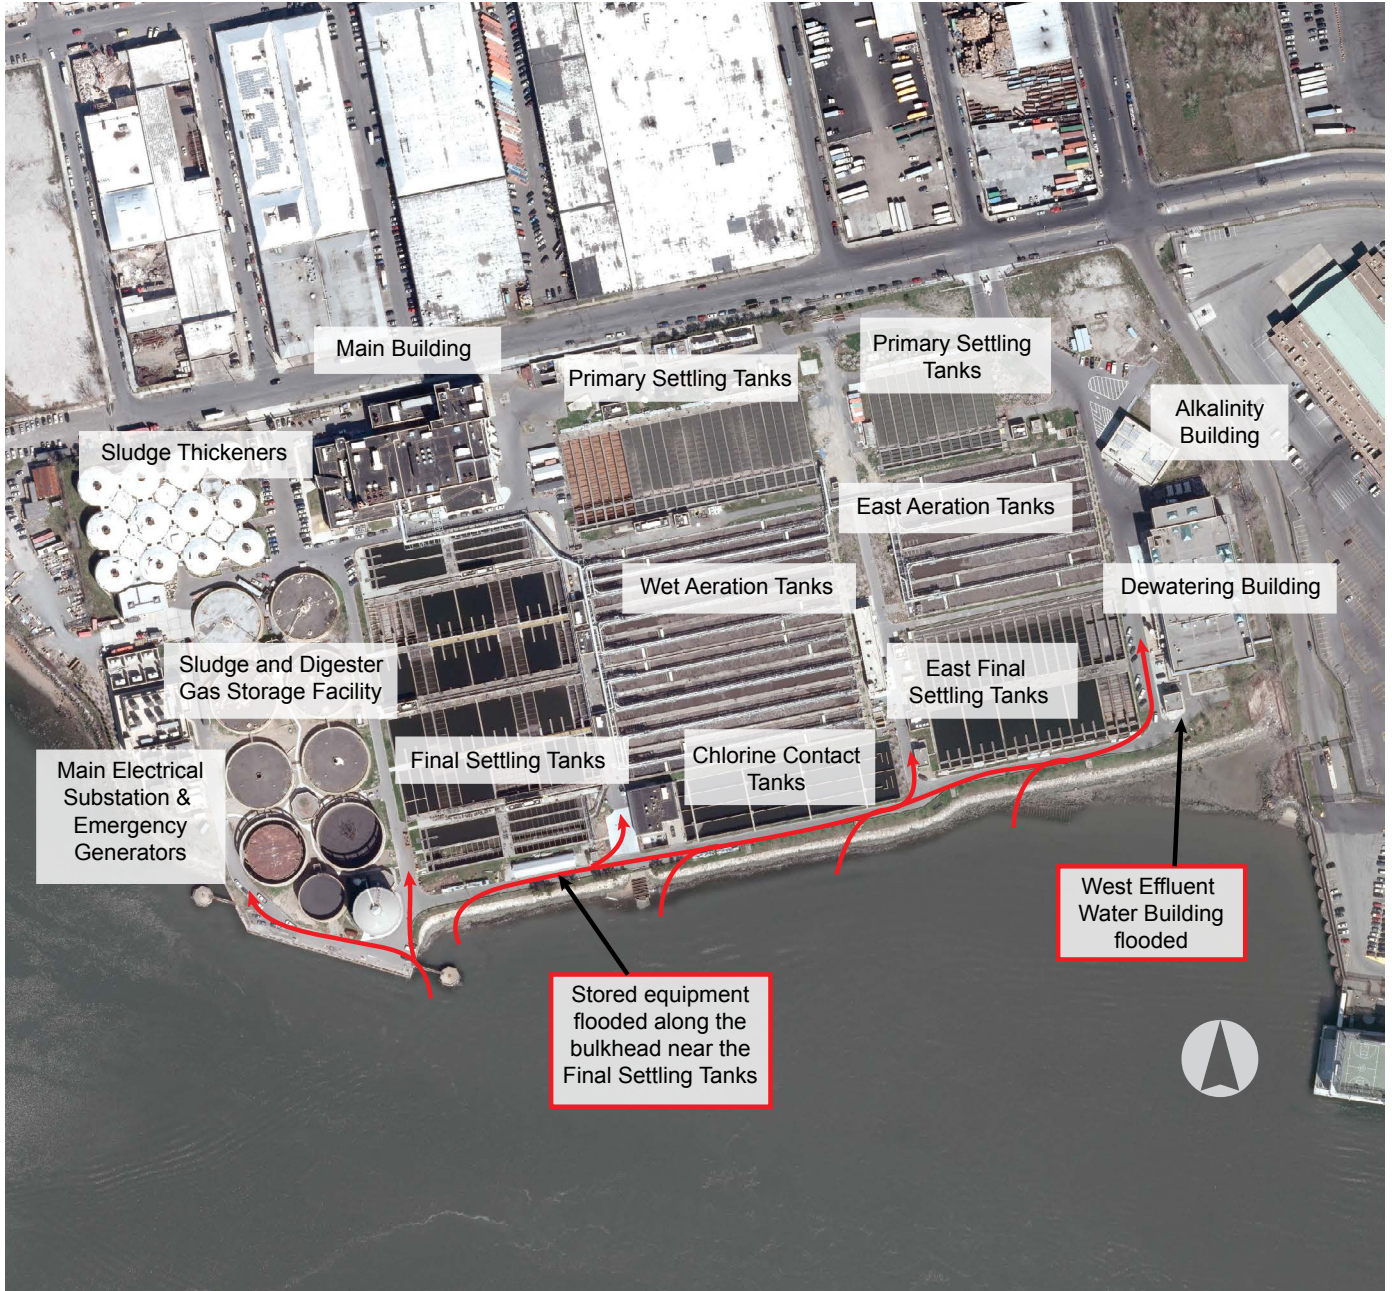
Hunts Point Wastewater Treatment Plant

Water Building flooded and many electrical components, including motors, were damaged. Equipment in the storage buildings behind the South Final Settling Tanks was also damaged. The plant maintained normal wet weather treatment operation during and after the storm.

Flood pathways and areas flooded during Hurricane Sandy are highlighted in red.

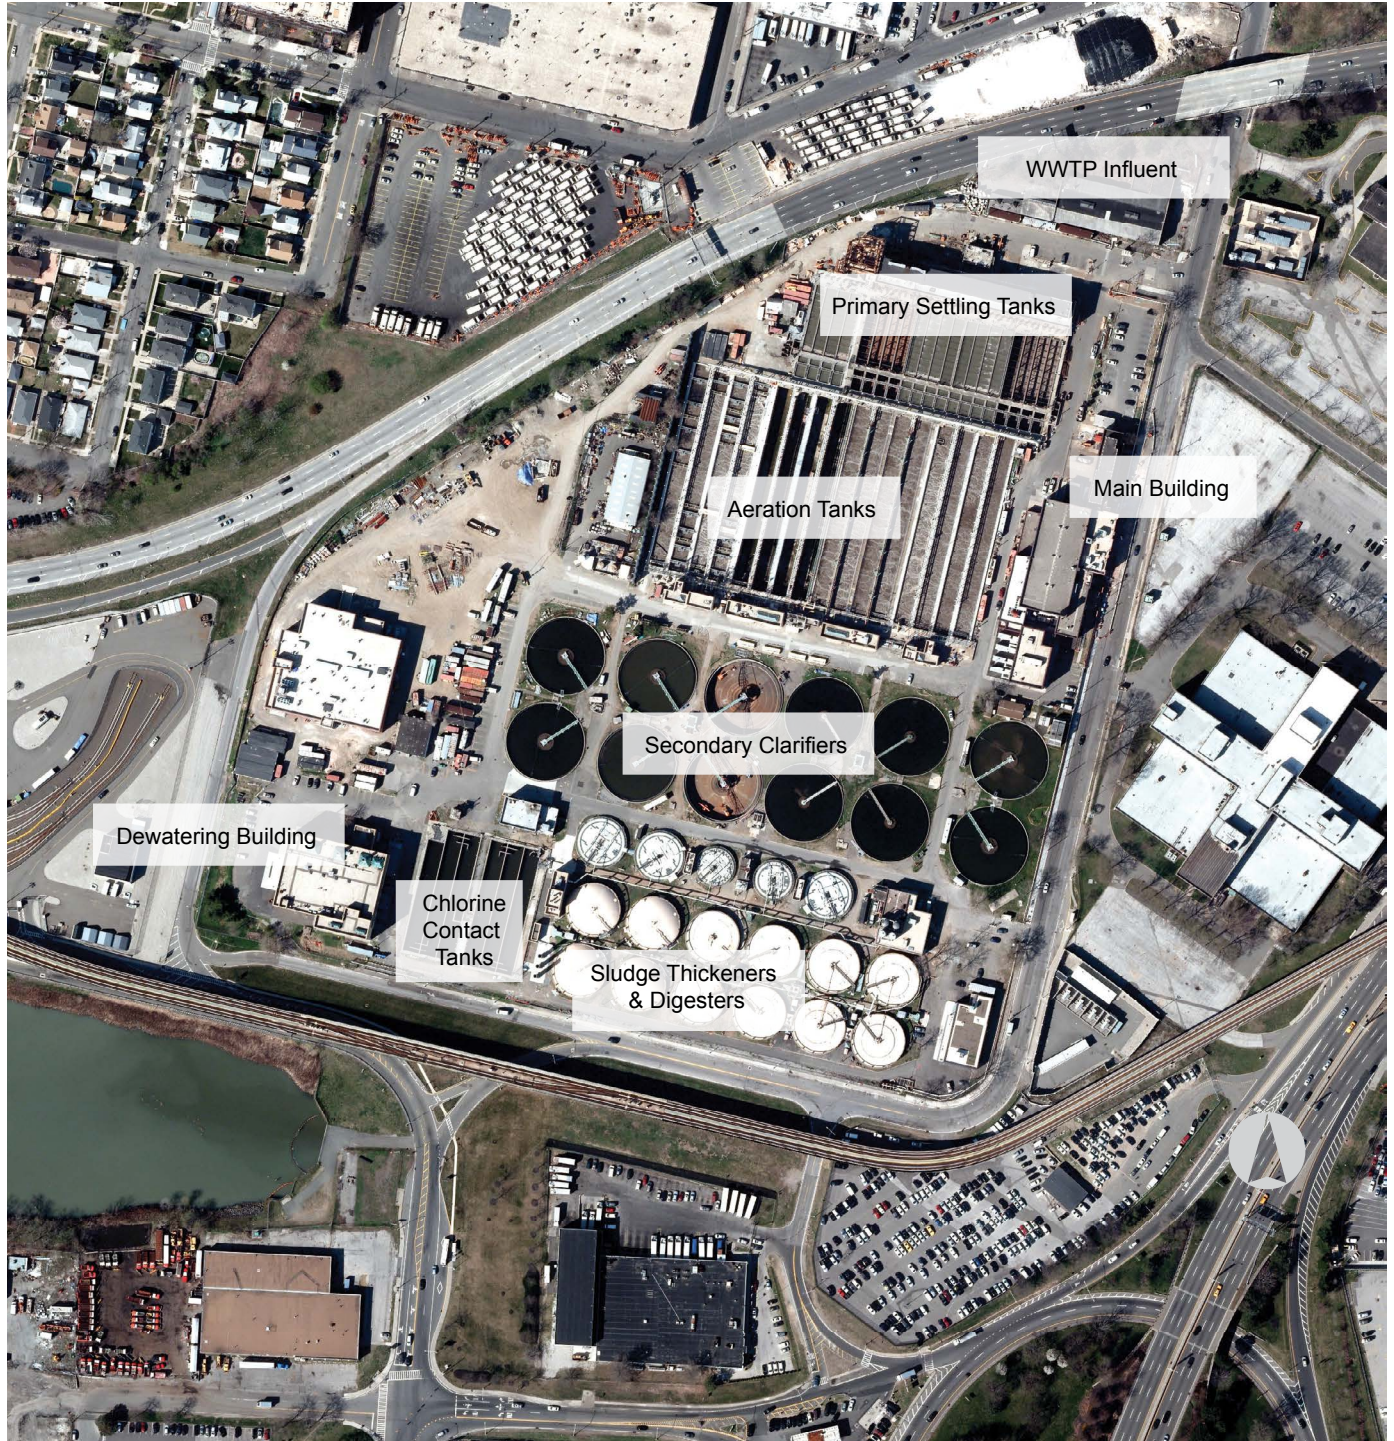
power was continuous during and after the storm event. All primary treatment equipment operated throughout the storm and the plant maintained normal wet weather treatment operations. The only minor damage sustained was from wind, which tore off the siding of a temporary office building on site.

The Jamaica Wastewater Treatment Plant did not sustain any damage due to flooding during Hurricane Sandy.

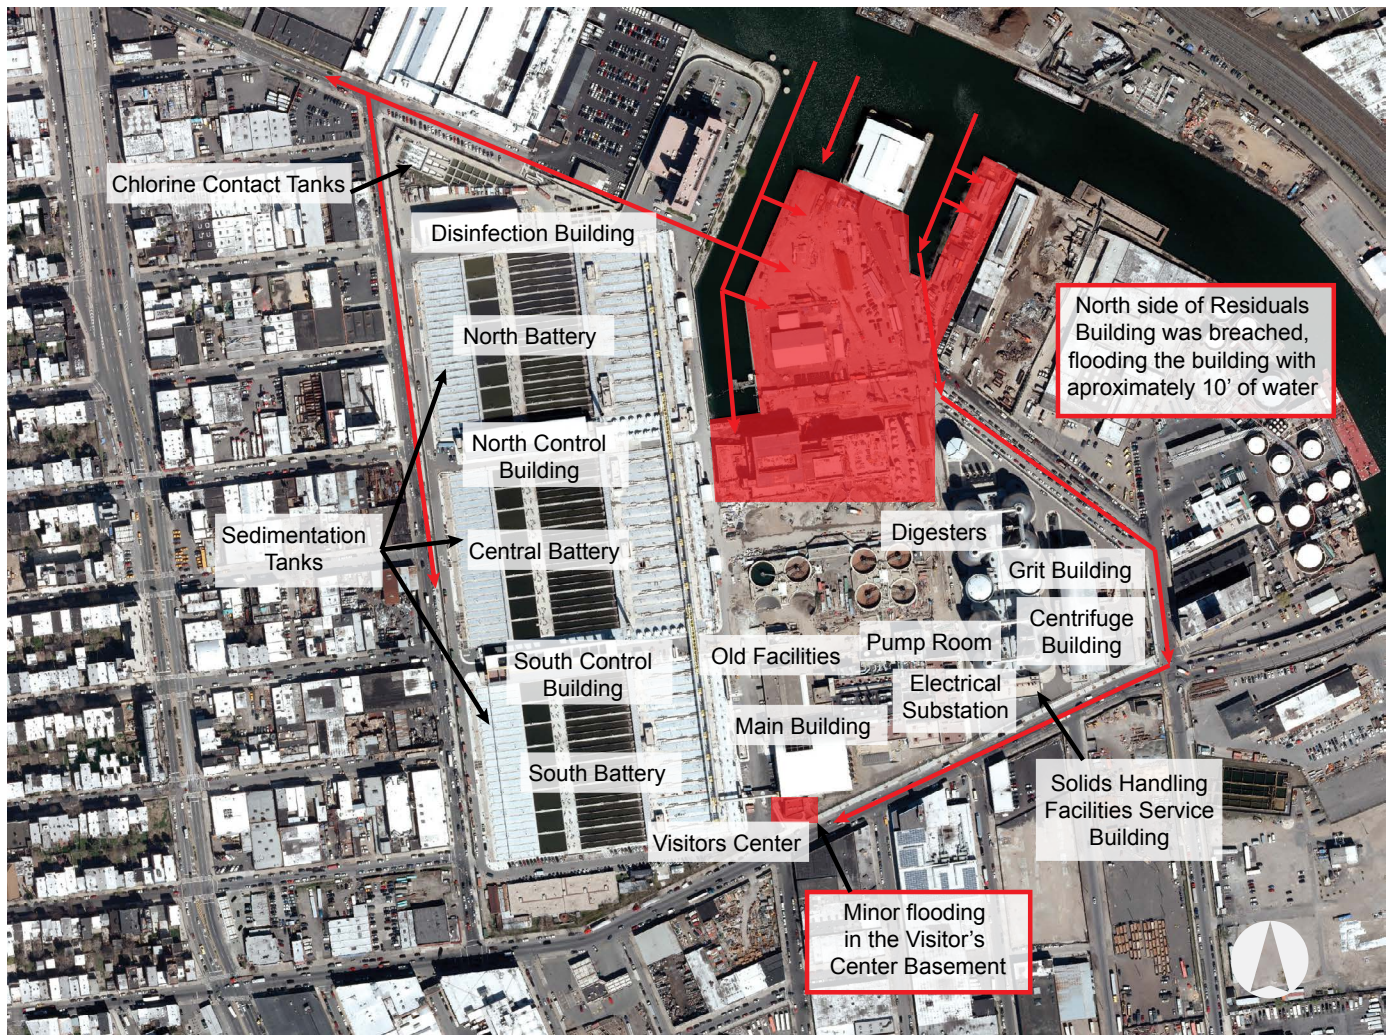
Newtown Creek Wastewater Treatment Plant

The only significant damage to Newtown Creek's treatment process occurred offsite during the storm. The Manhattan Pump Station, where sewage from some sections of Manhattan is screened and then pumped to Newtown Creek, experienced significant flooding and damage. During Hurricane Sandy, several feet of floodwater surrounded and entered the pumping station and sewage backed up into the dry wells, damaging pump motors.

Flood pathways and areas flooded during Hurricane Sandy are highlighted in red.

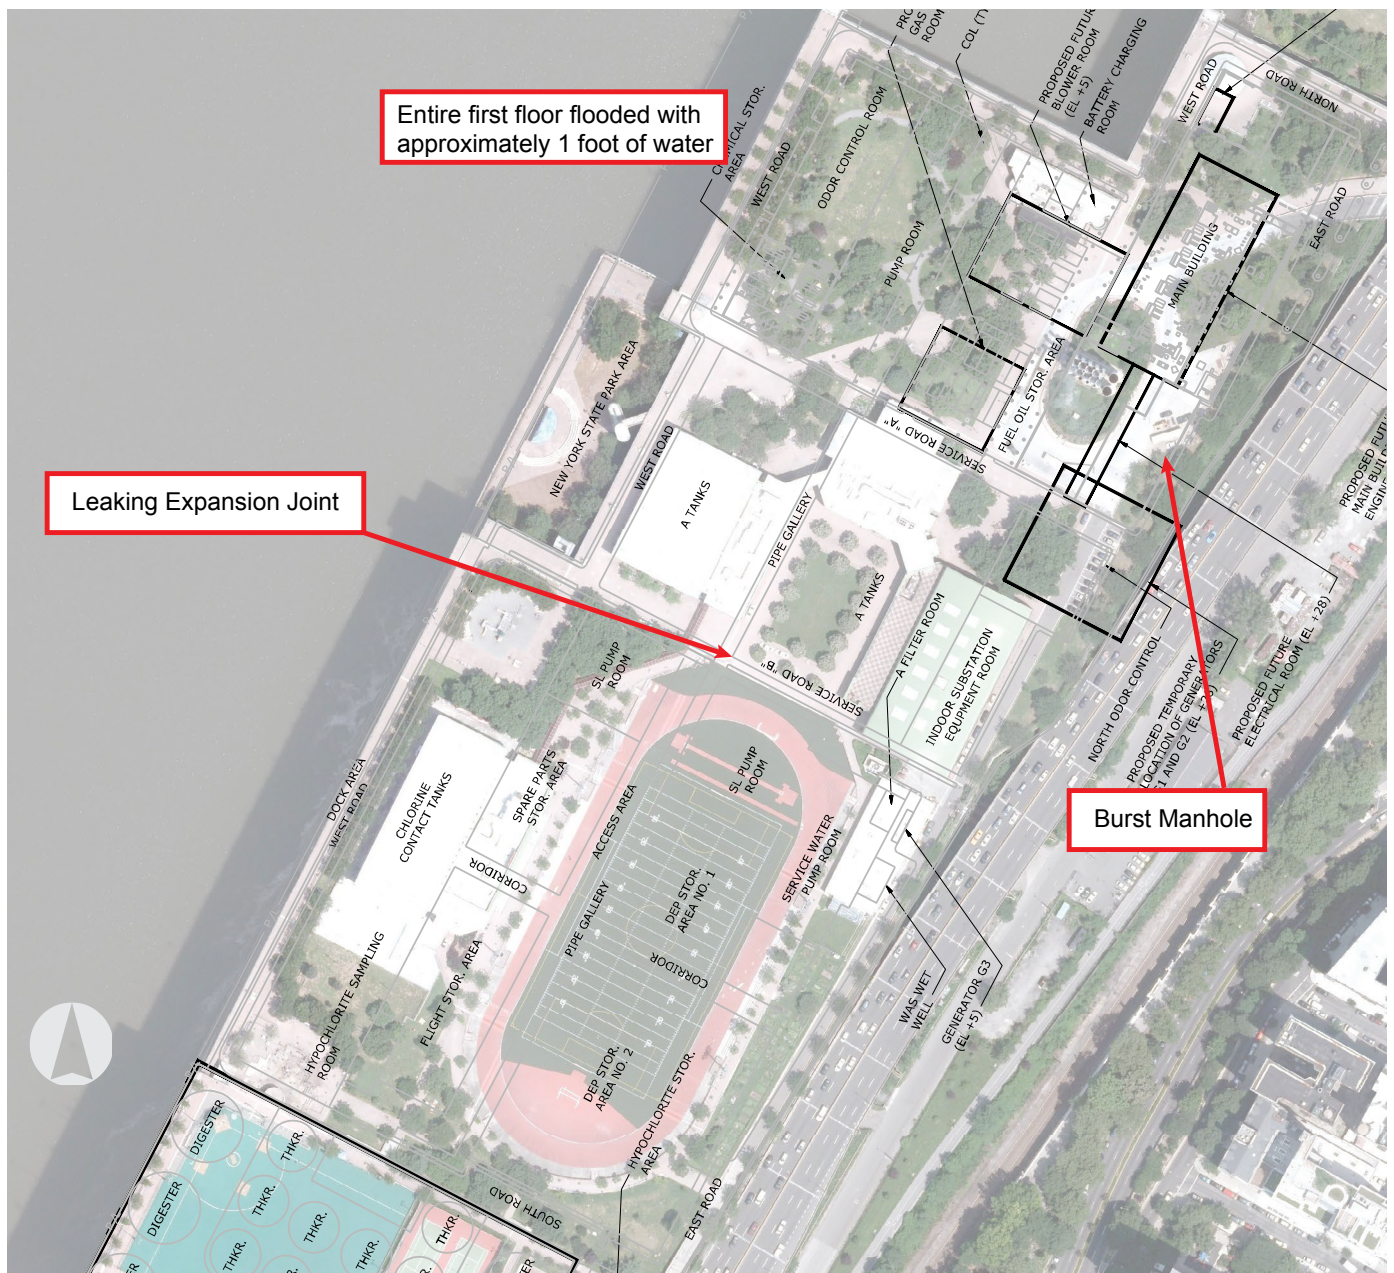
North River Wastewater Treatment Plant

The plant did not lose power; however, certain critical components were proactively shut down for up to 7 hours to prevent short circuiting in case the water level continued to rise. Water flooded the low-lying areas of the building first, including the Raw Inflow Pump Dry Well through the first floor stairwells. It was at this point that plant staff turned off the electricity in critical plant areas. Once it was safe to restore power to the facility, a single pump was used to empty the dry well, and maintenance was performed on the remaining pumps when the dry well was emptied. After the storm, floodwater on the first floor flowed out of the plant through the ruptured manhole and through the various drains and sump pumps.

Flood pathways and areas flooded during Hurricane Sandy are highlighted in red.

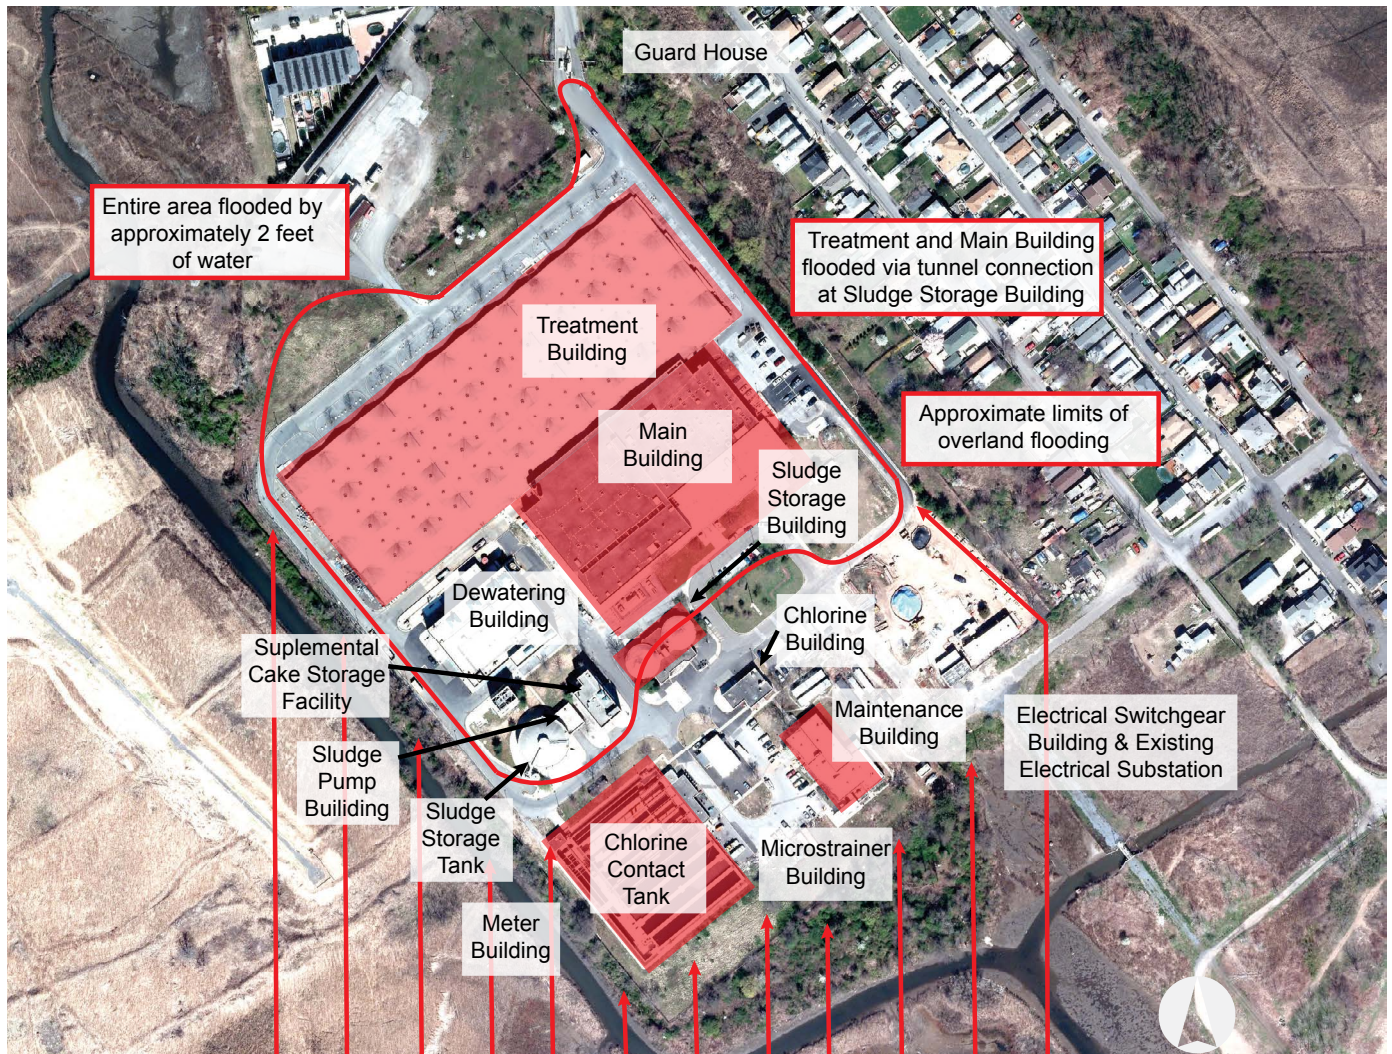
Oakwood Beach Wastewater Treatment Plant

Plant staff worked actively before, during, and after the storm to protect the plant and bring it back to normal operation. Power from one of the plant's two electrical service feeders was lost during the storm, forcing operators to partially operate on emergency generators and suspend power to the aeration blowers for a period of time. Sandbags were placed ahead of the storm to protect the low-lying temporary substation and temporary electrical generator. When power was restored, the plant resumed normal wet weather treatment with no apparent damage to critical equipment.

Flood pathways and areas flooded during Hurricane Sandy are highlighted in red.

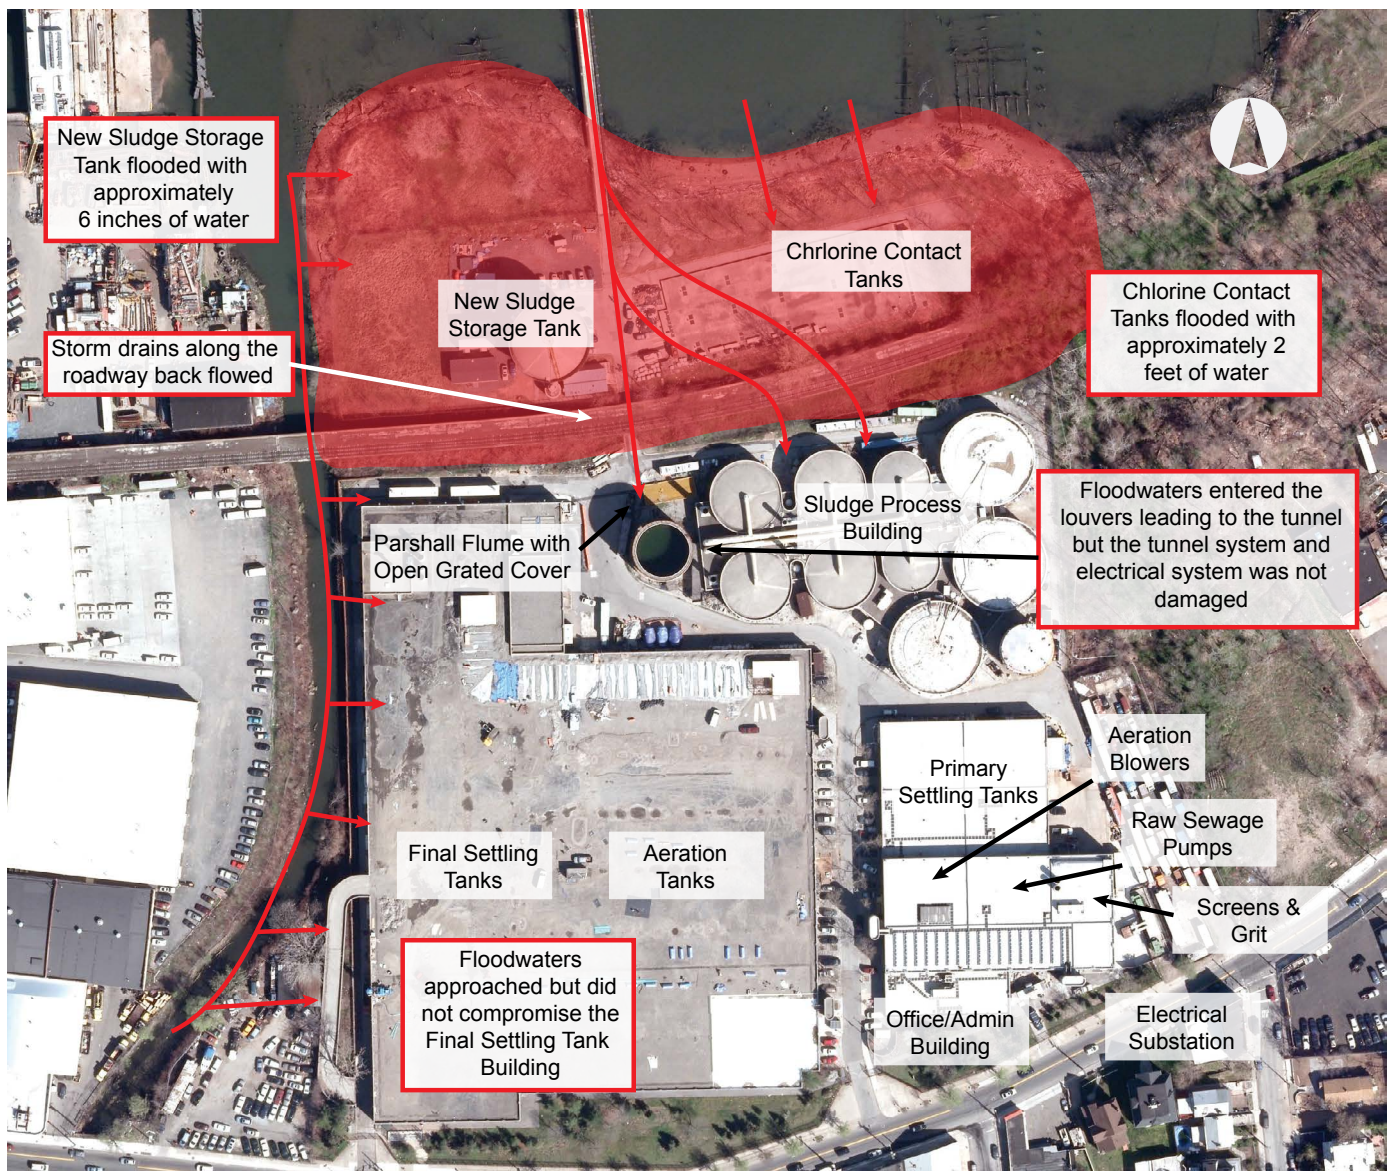
Port Richmond Wastewater Treatment Plant

The plant staff worked actively before, during, and after the storm to protect the plant and quickly resume normal operation. Just prior to the hurricane, plant staff placed sandbags at multiple locations on the site. Sandbag placement at the New Sludge Storage Facility provided adequate protection and only allowed a minimal amount of water to enter the building, protecting pumps and most electrical equipment. Large intake louvers to the heaters located on the west side of the Sludge Process Building were also protected with sandbags, which prevented water from entering the tunnel system. Power was out for three days, and the on-site generator was used to power the primary treatment facilities during that time.

Flood pathways and areas flooded during Hurricane Sandy are highlighted in red.

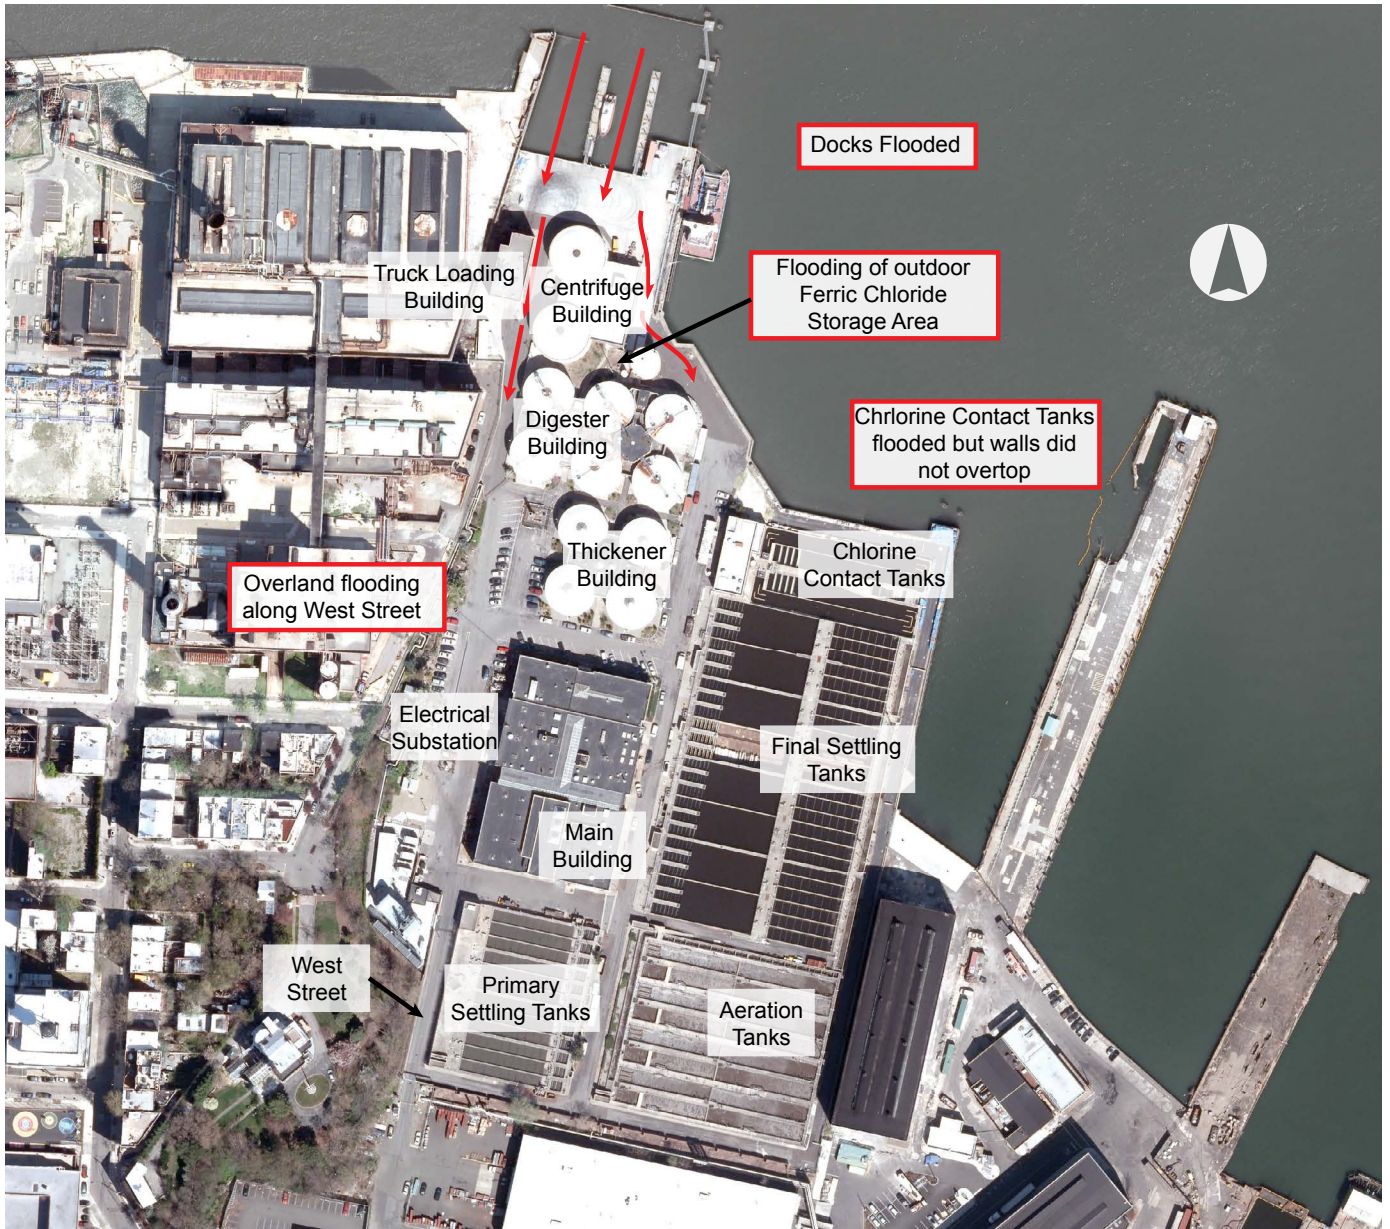
Red Hook Wastewater Treatment Plant

Flood pathways and areas flooded during Hurricane Sandy are highlighted in red.

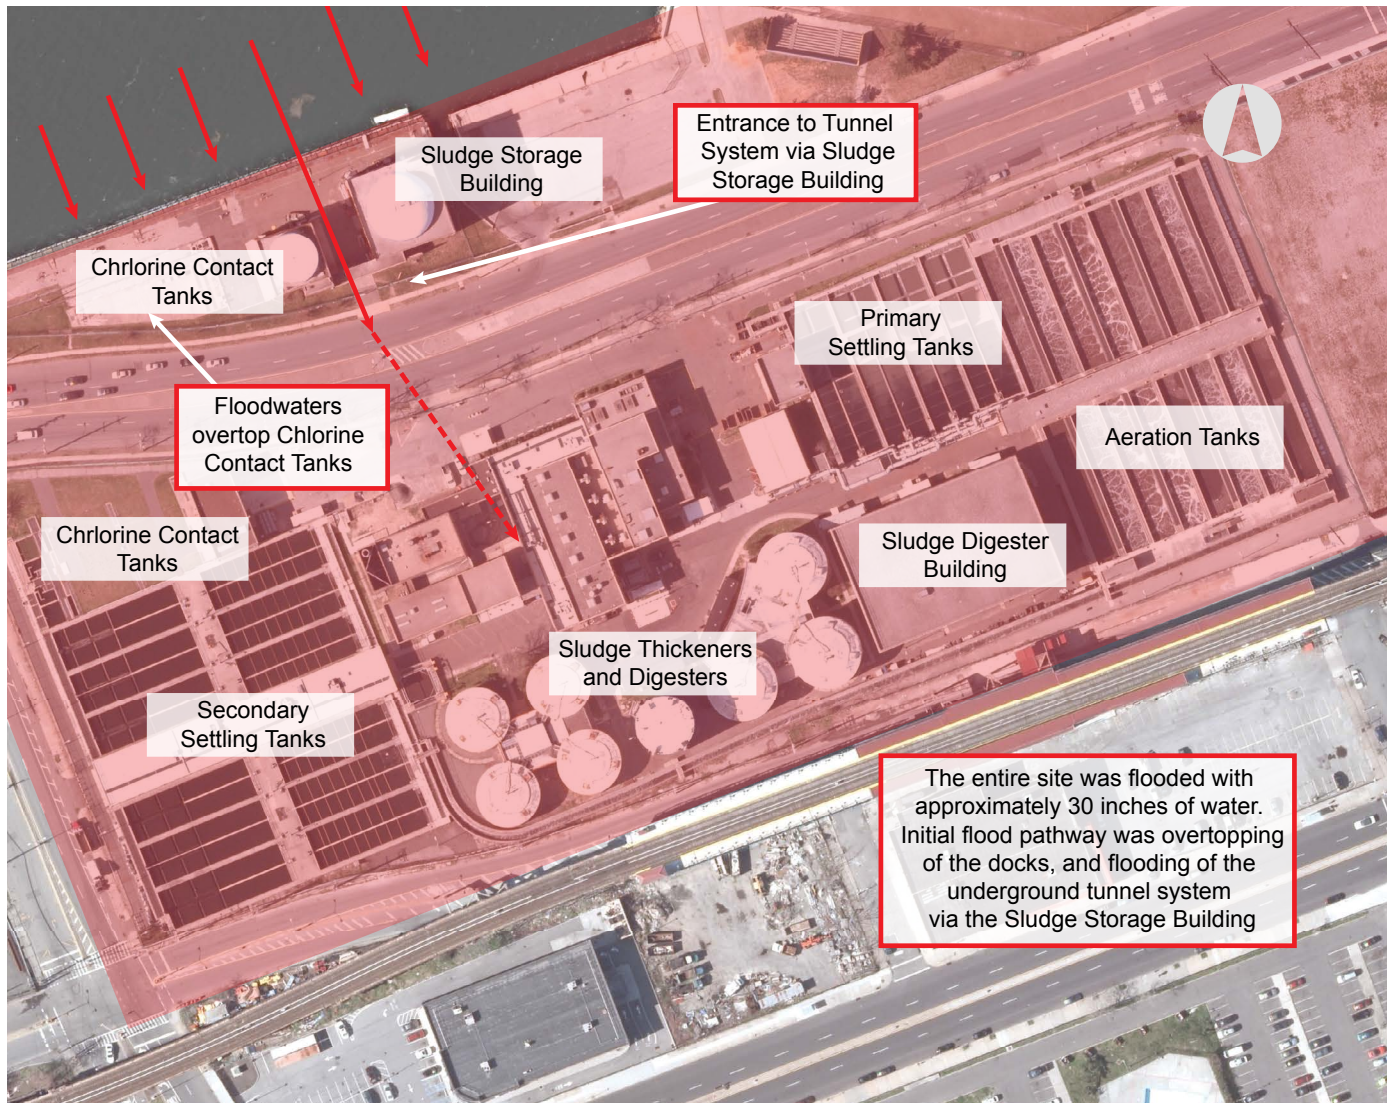
Flood pathways and areas flooded during Hurricane Sandy are highlighted in red.

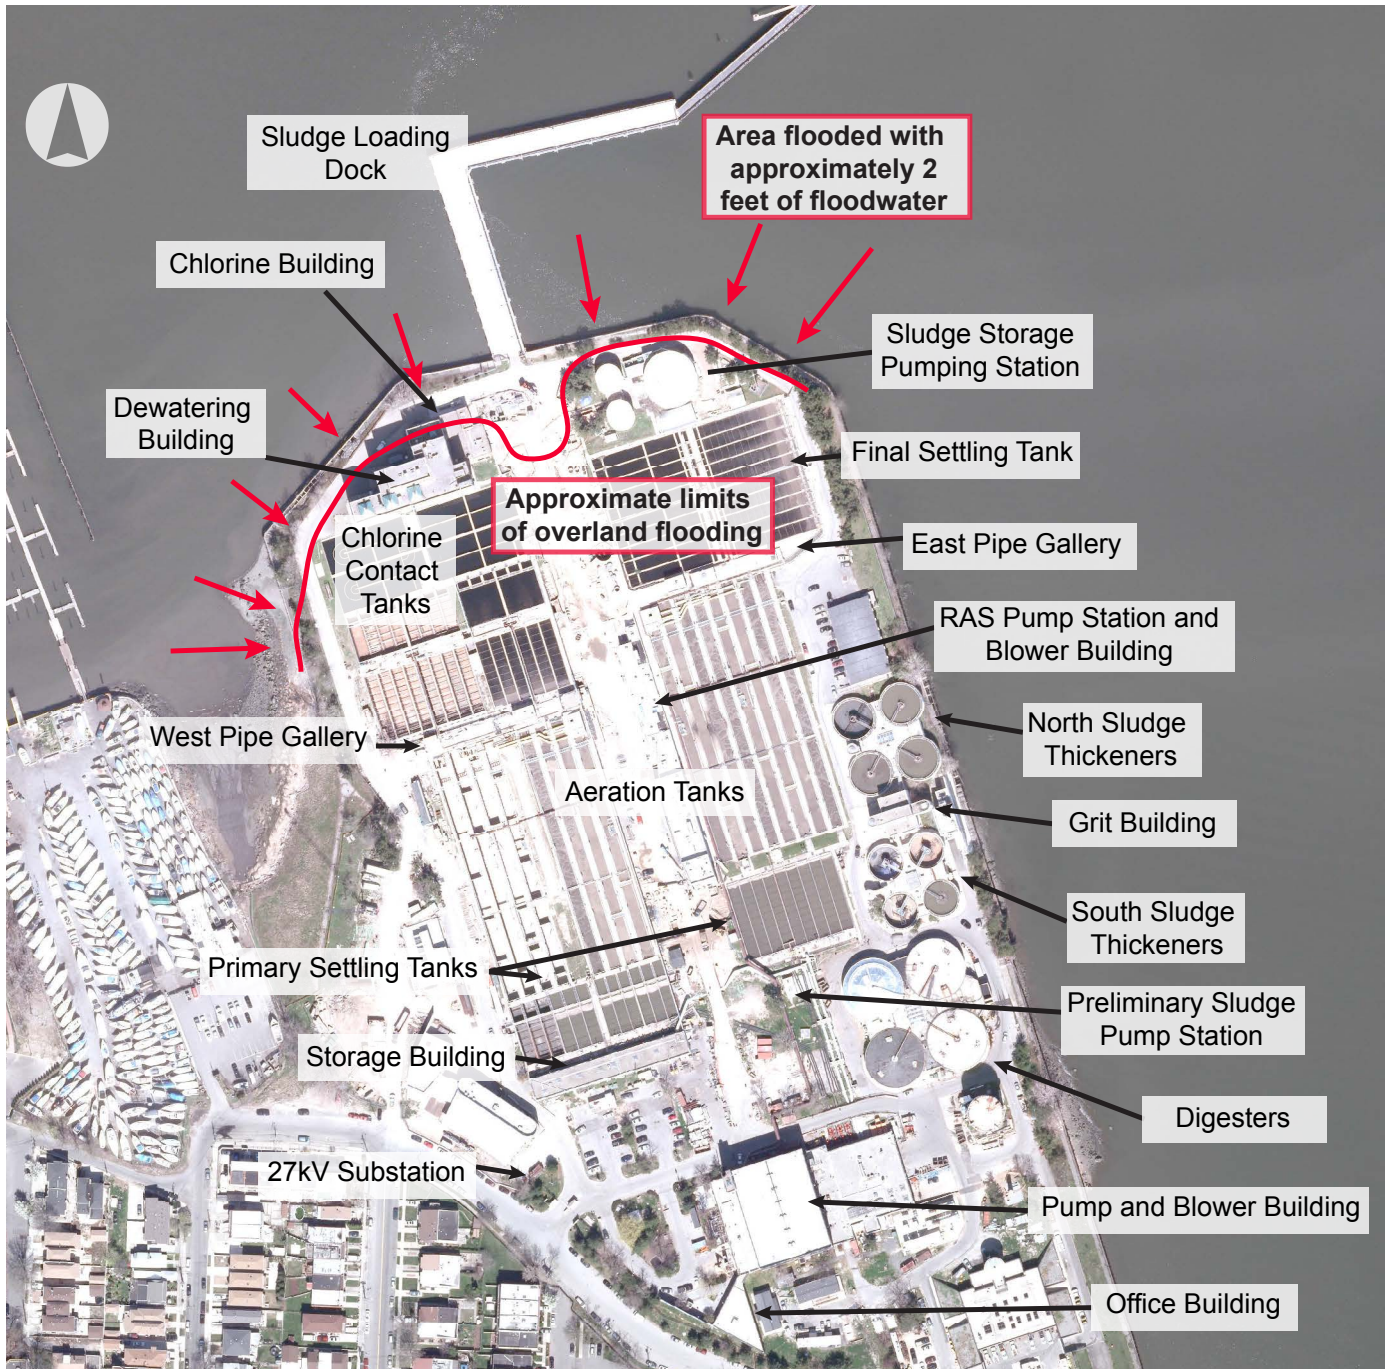
Tallman Island Wastewater Treatment Plant

Flood pathways and areas flooded during Hurricane Sandy are highlighted in red.

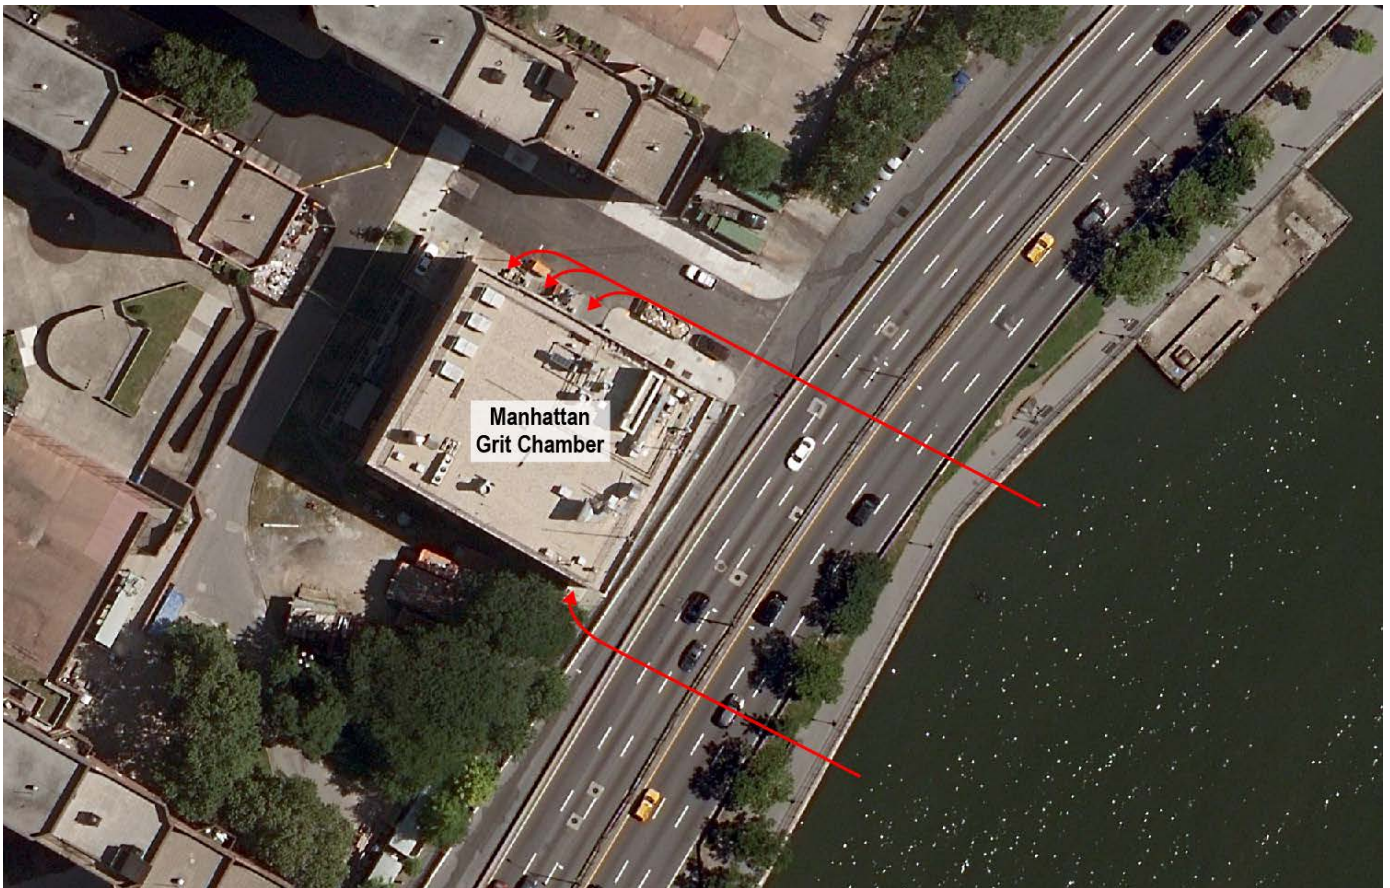
Wards Island Wastewater Treatment Plant

Flood pathways and areas flooded during Hurricane Sandy are highlighted in red.
