NYC WASTEWATER RESILIENCY PLAN

CLIMATE RISK ASSESSMENT AND ADAPTATION STUDY

October 2013

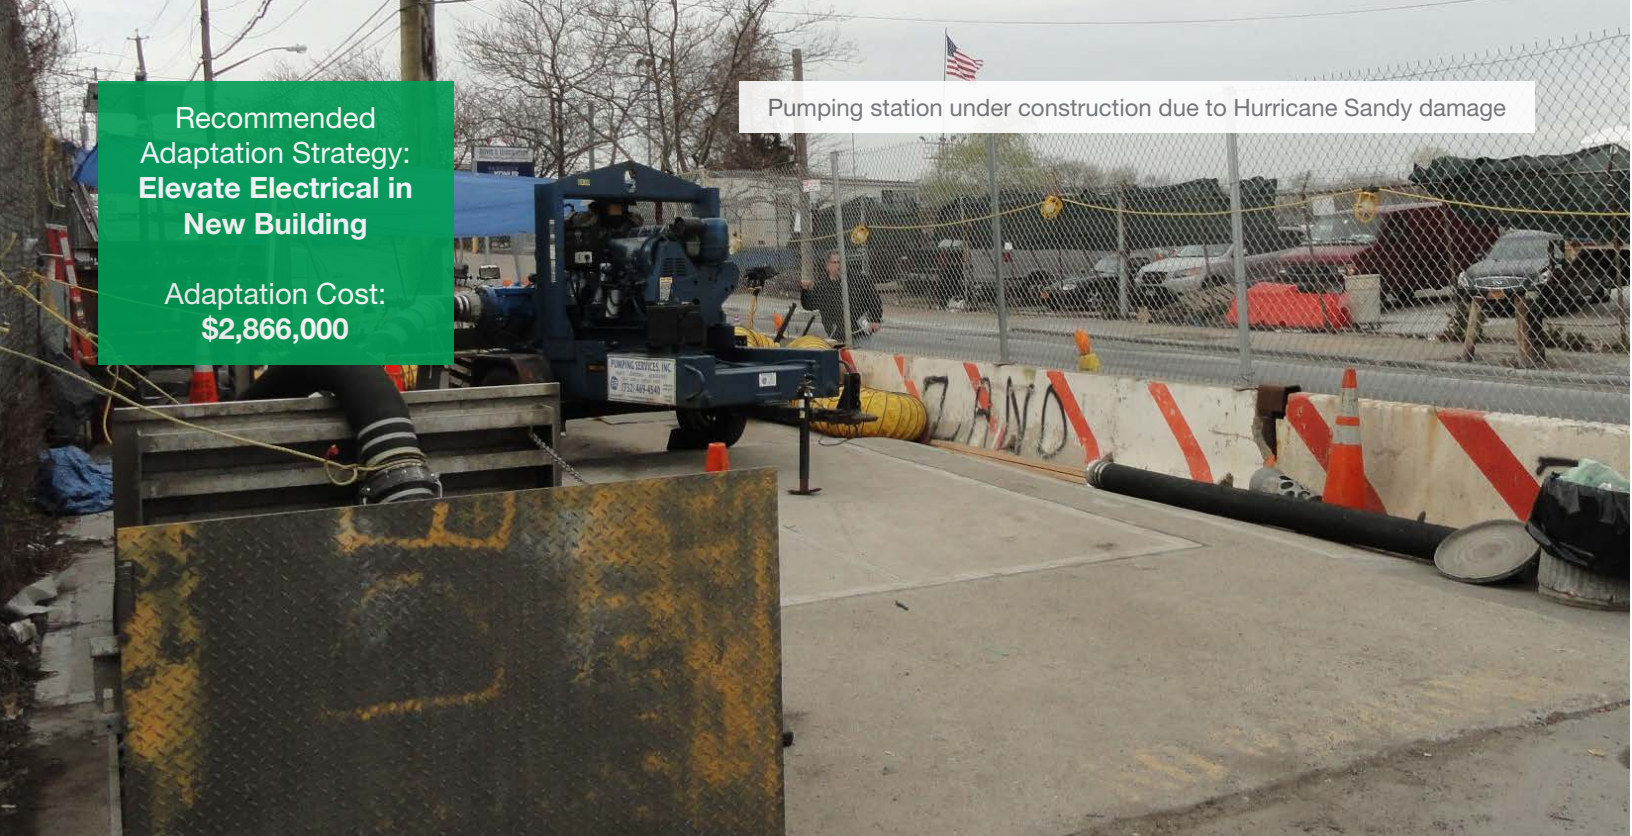
Pumping station under construction due to Hurricane Sandy damage

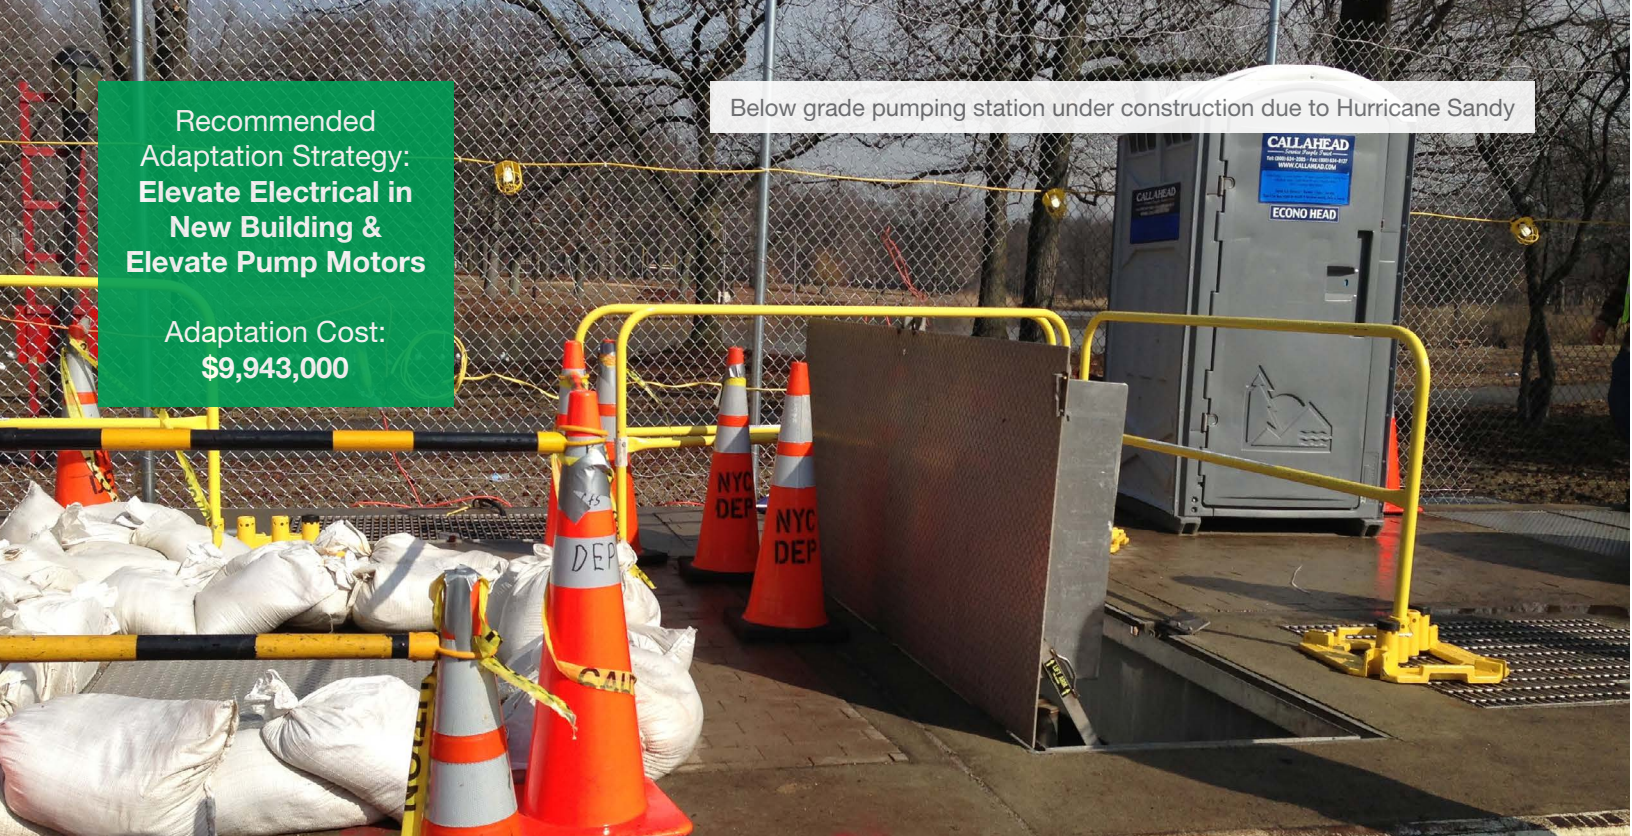
Below grade pumping station under construction due to Hurricane Sandy
