INVESTIGATION REPORT:

JANUARY 14, 2008 SHORING COLLAPSE AT 9 DOMINICK ST. (AKA 246 SPRING ST.) MANHATTAN

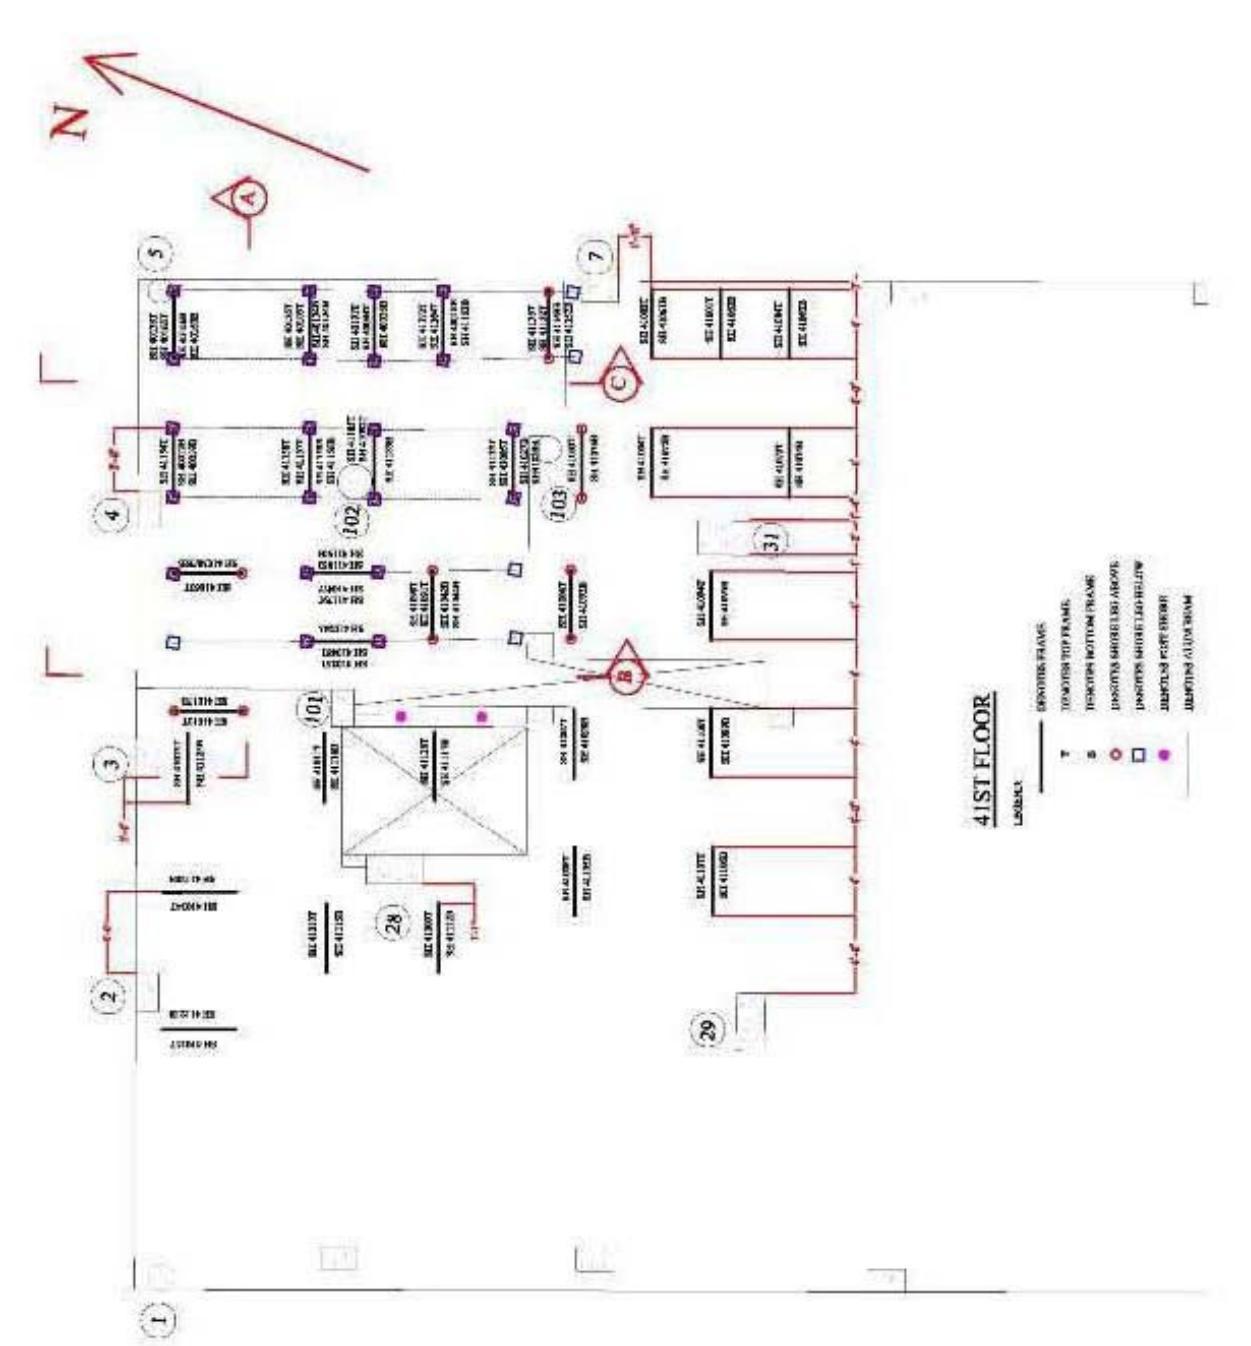
Figure 3 Plan Shoring at 41st Fl. Reconstruction

As mentioned above, the aluminum stringers in the area had different lengths (10, 12 and 16 ft). While the stringer centerline plan position (alignment) was established with good reliability, the identification of each stringer length location is less definitive (see Figure 3 Plan Shoring 41st Fl. and Figure 4 Plan Shoring 42^{nd}).

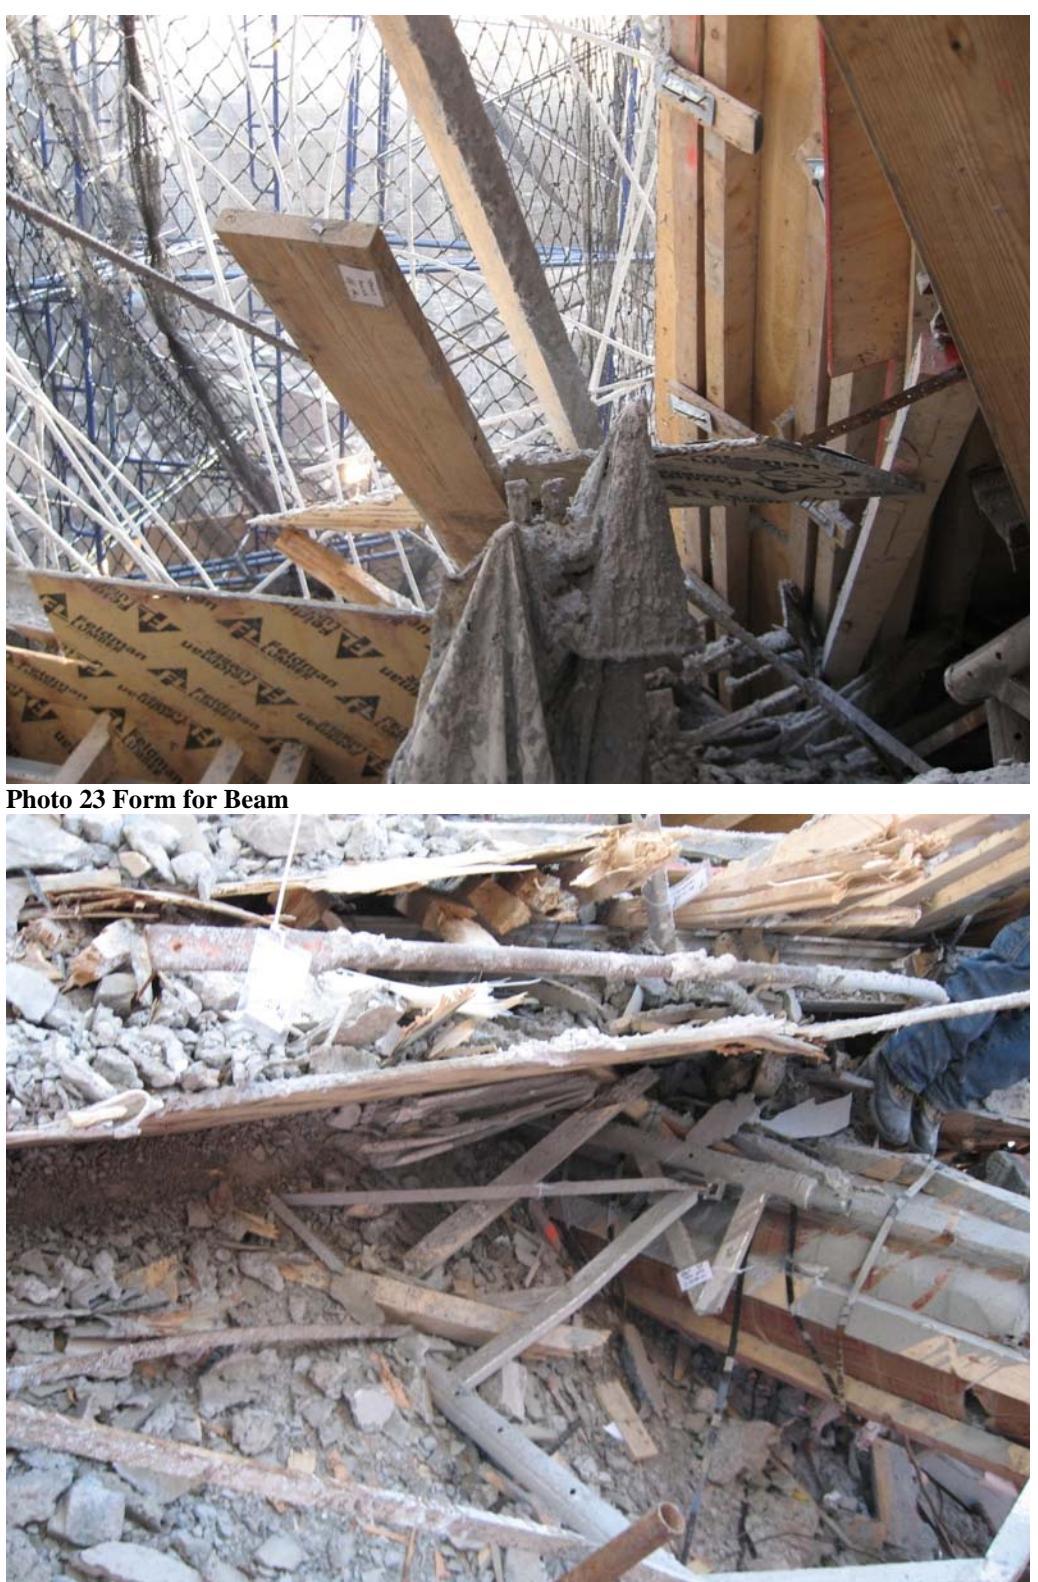
Photo 24 Tie (Assumed)

At the site's east side the formwork relied on a cantilever system that was loosely set. Only one tie-back was positively identified in the debris when each frame at both levels should have been tied back. Our calculations show that the system as installed failed analysis required by the code (27-1035).

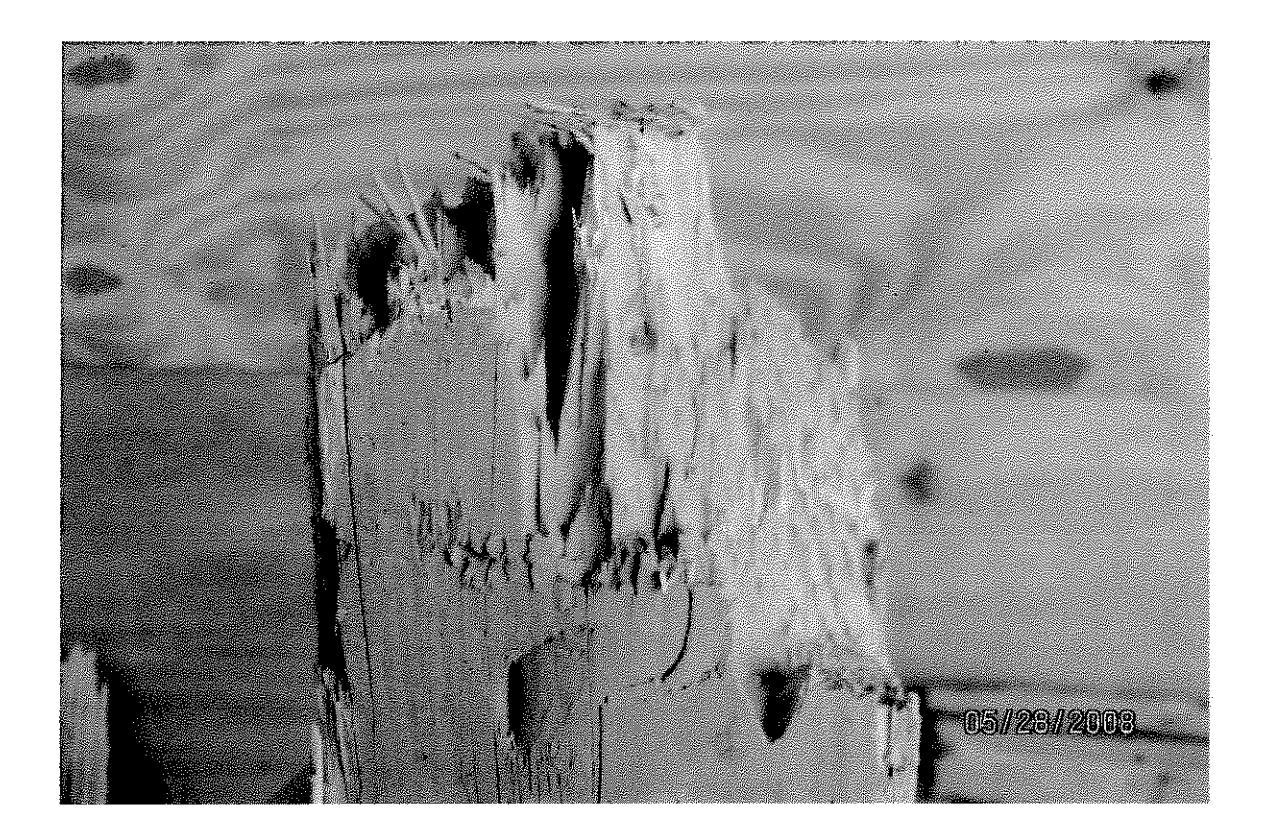
Photo 1 - Brash failure with partial tension finger in 3x4 stored on 40^{th} floor.

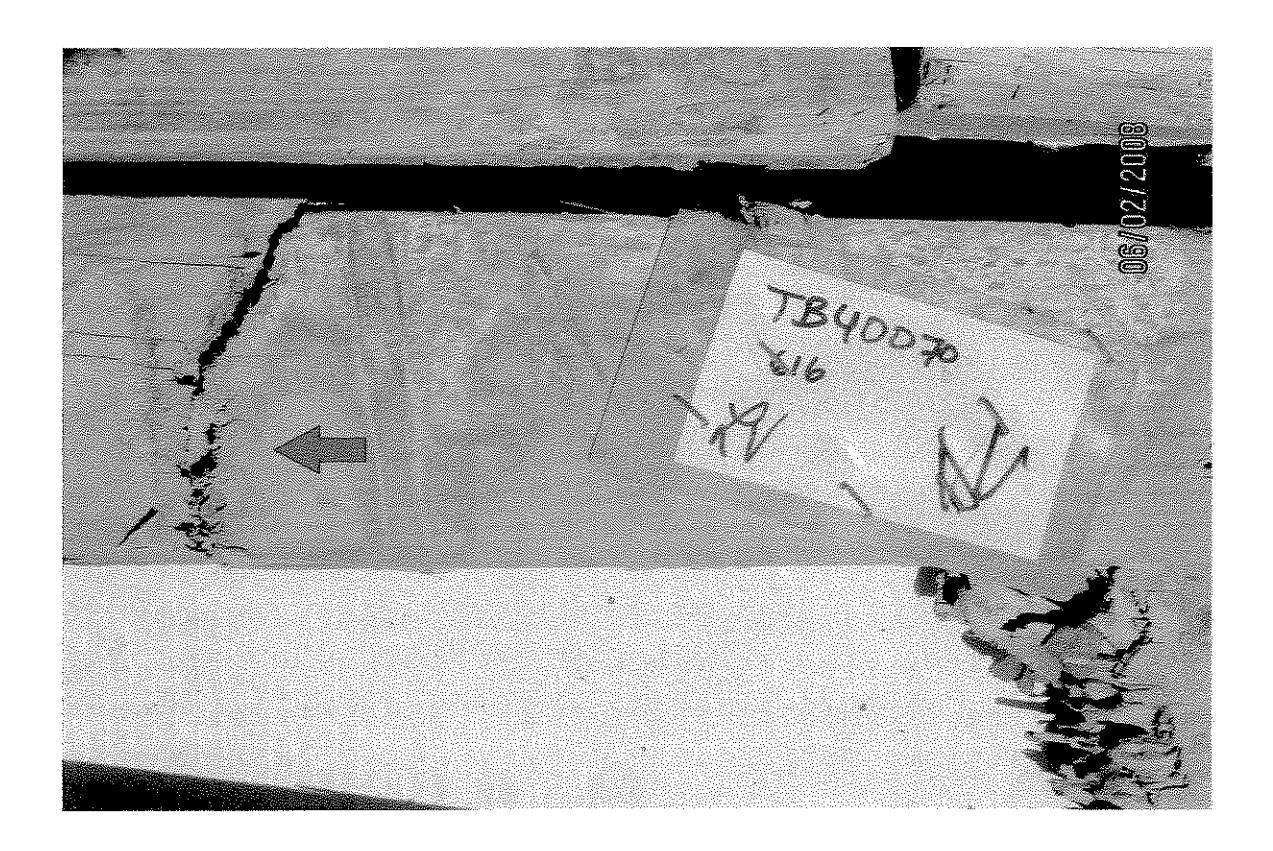
Photo 2 - Brash failure along bottom edge of sample with DOB #TB40070.

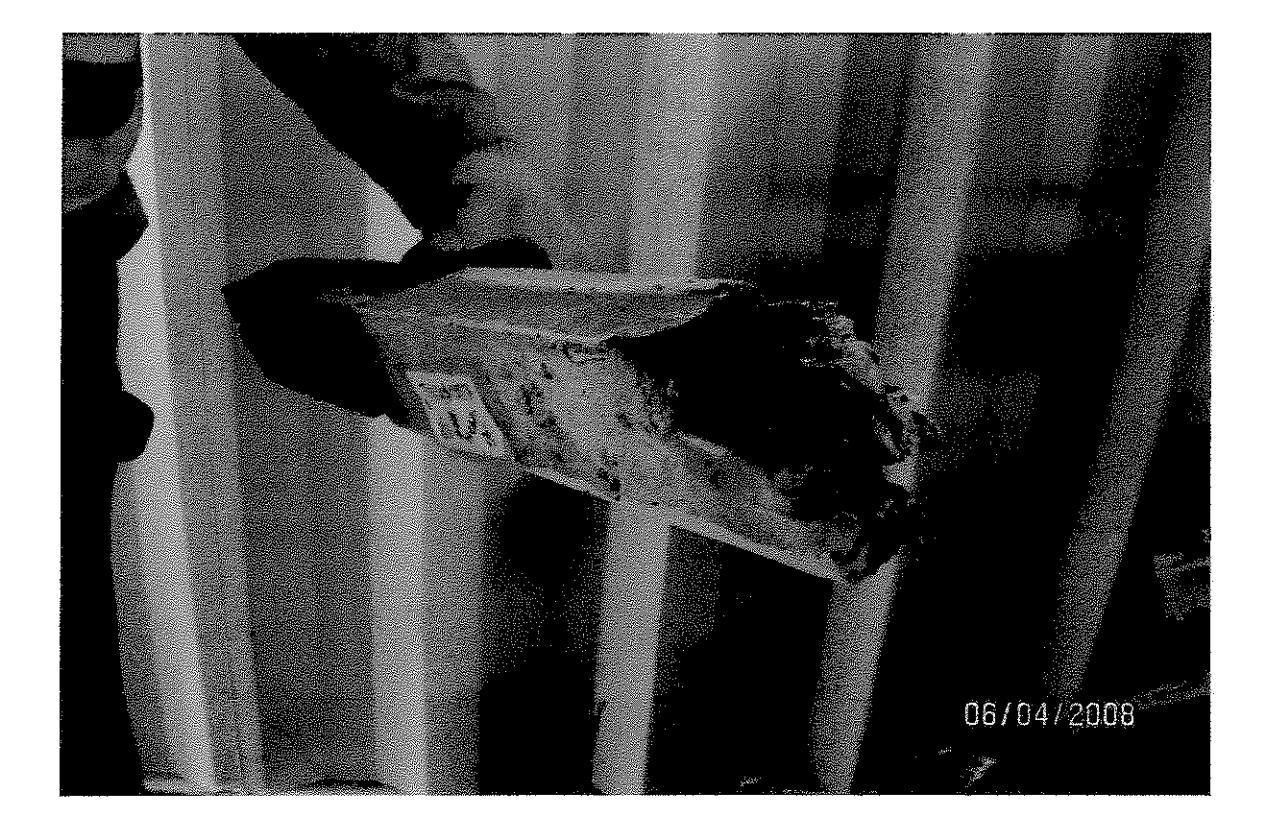
Photo 3 - Brash failure in sample with DOB #TB40087.

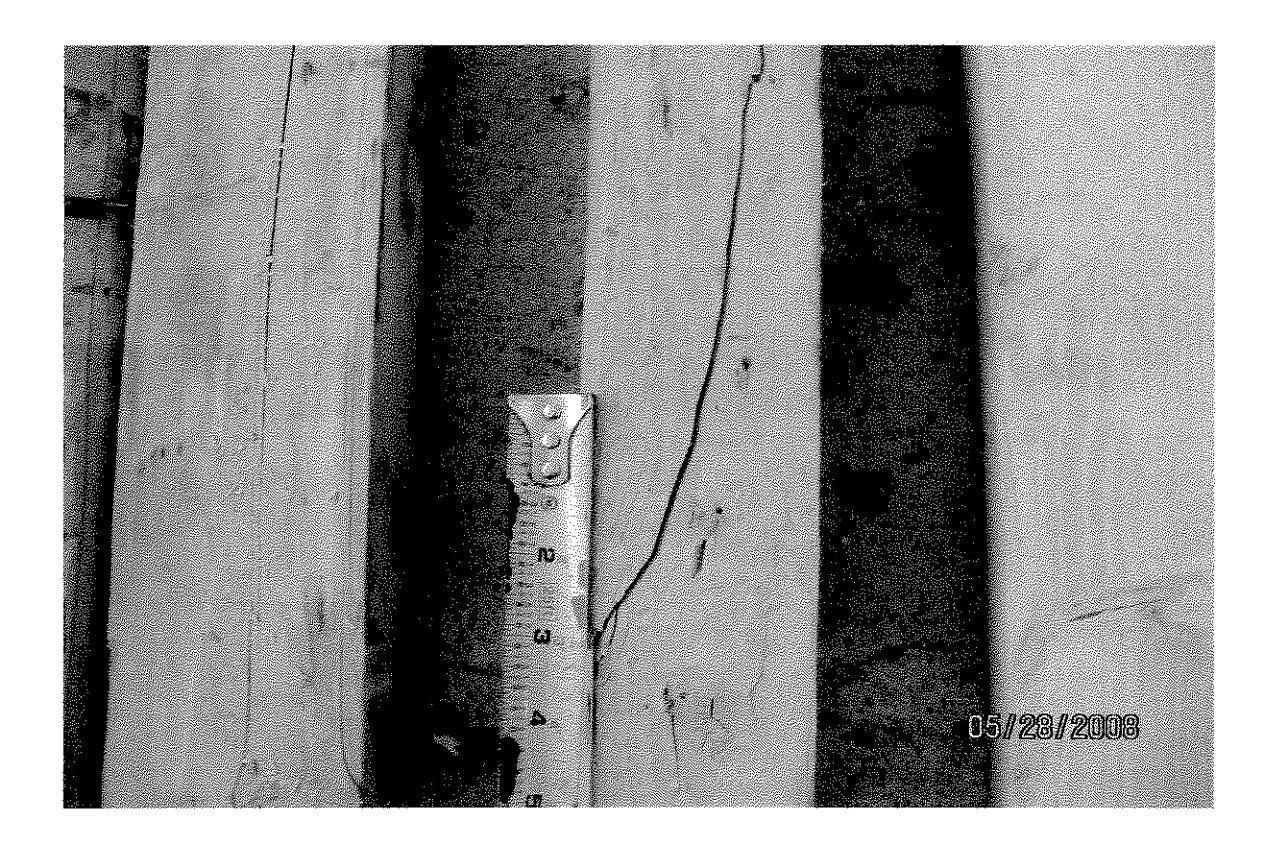
Photo 4 - Slope-of-grain of 1:3 in 3x4 stored on 40^{th} floor.

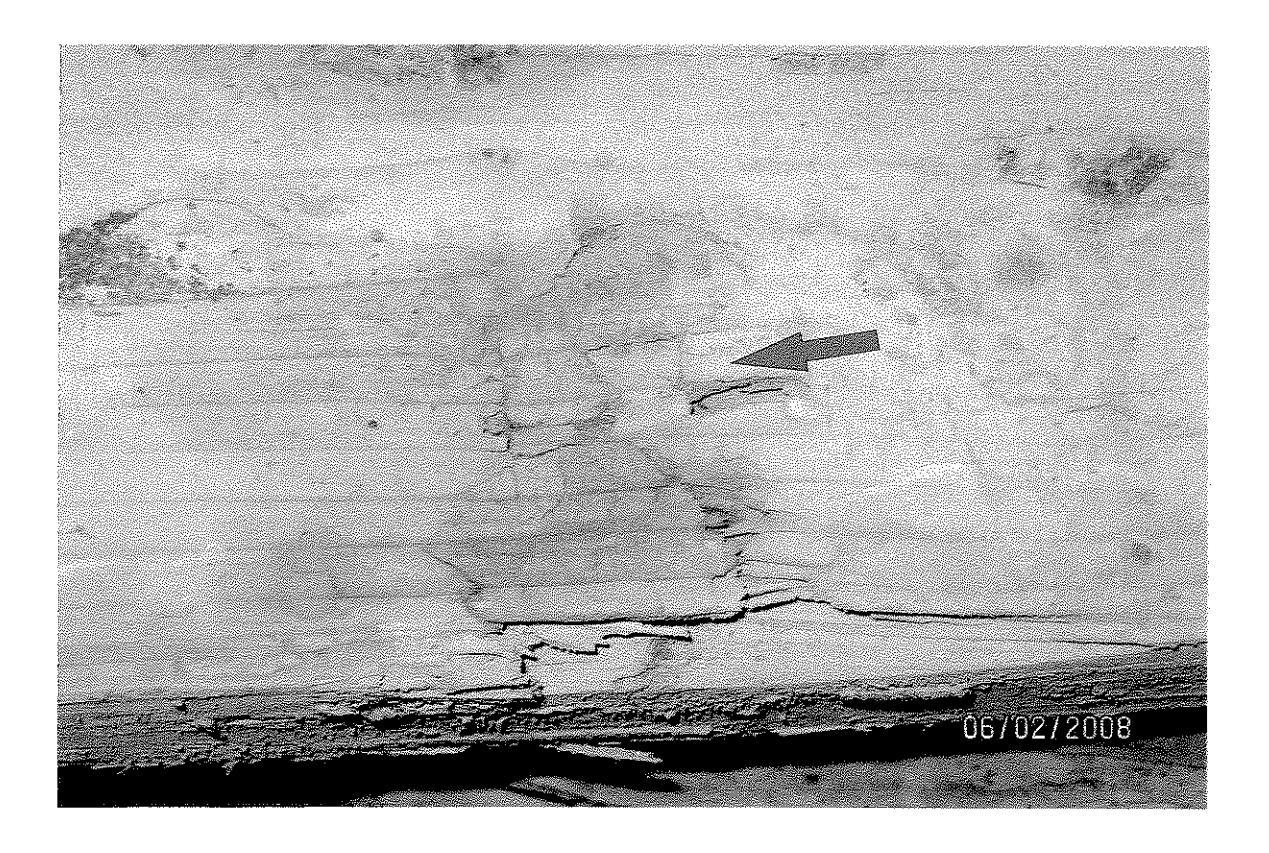
Photo 8 - Visible wood decay growth on 3x4 lumber specimen marked DOB #TB40291.

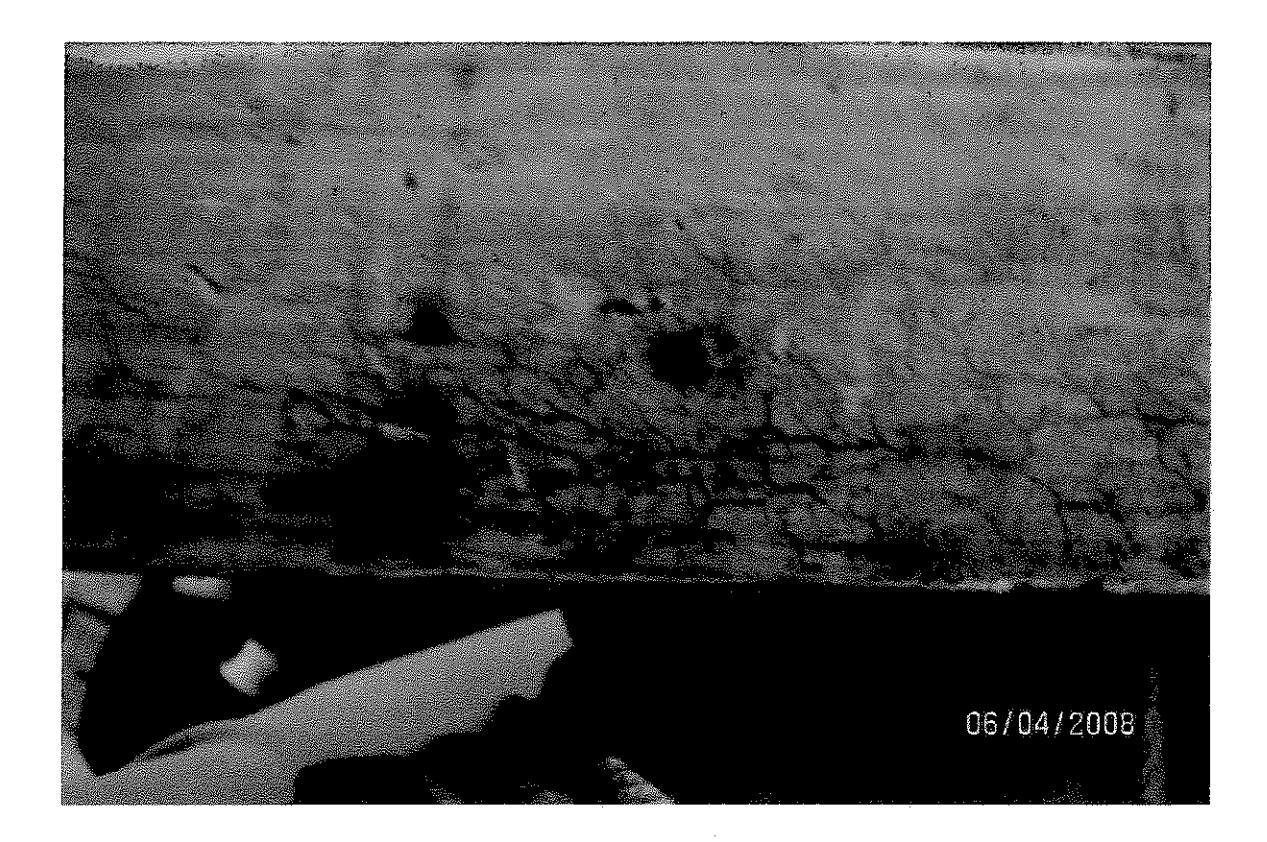
Photo 9 - Visible wood decay growth on 3x4 lumber specimen marked DOB #TB40101.

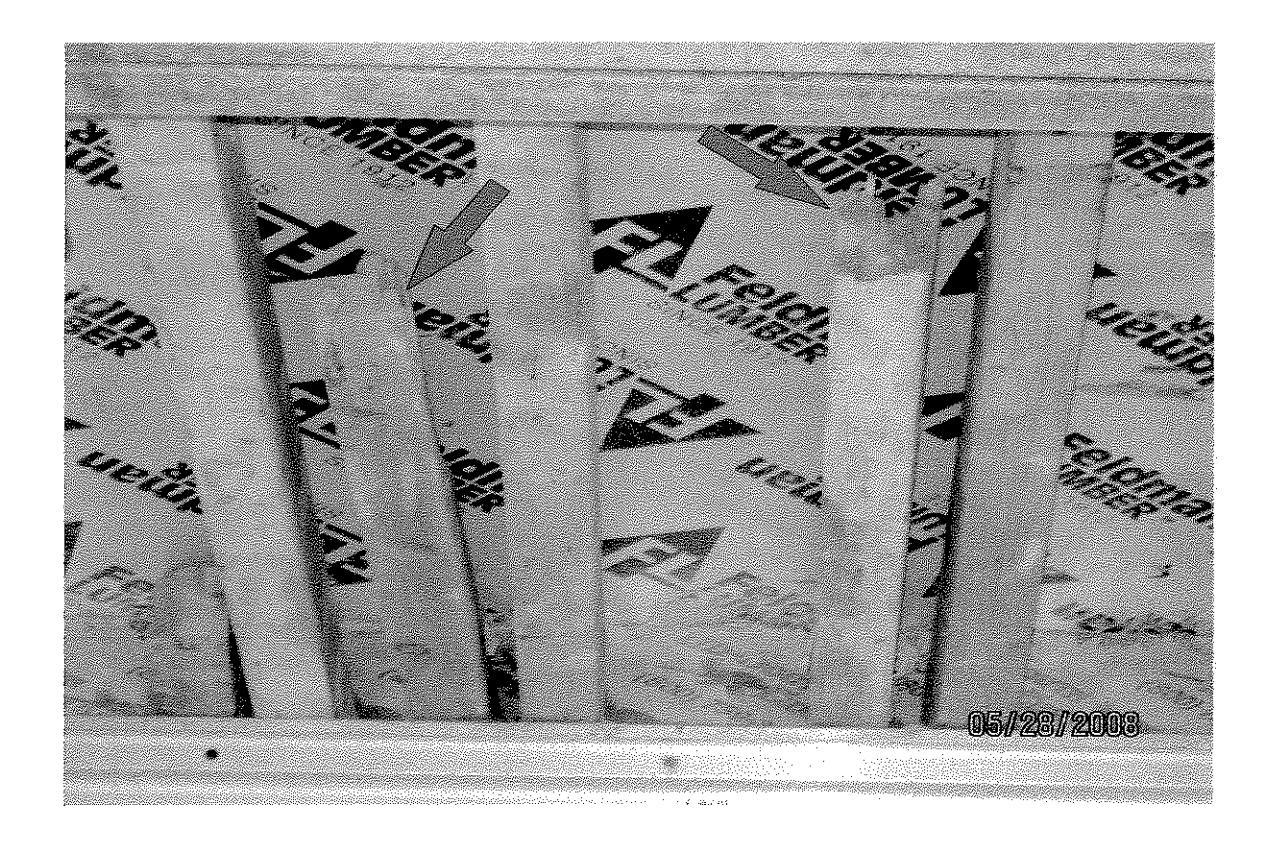
Photo 12 - Two 3x4 lumber ribs exhibiting brash failures at the ends.

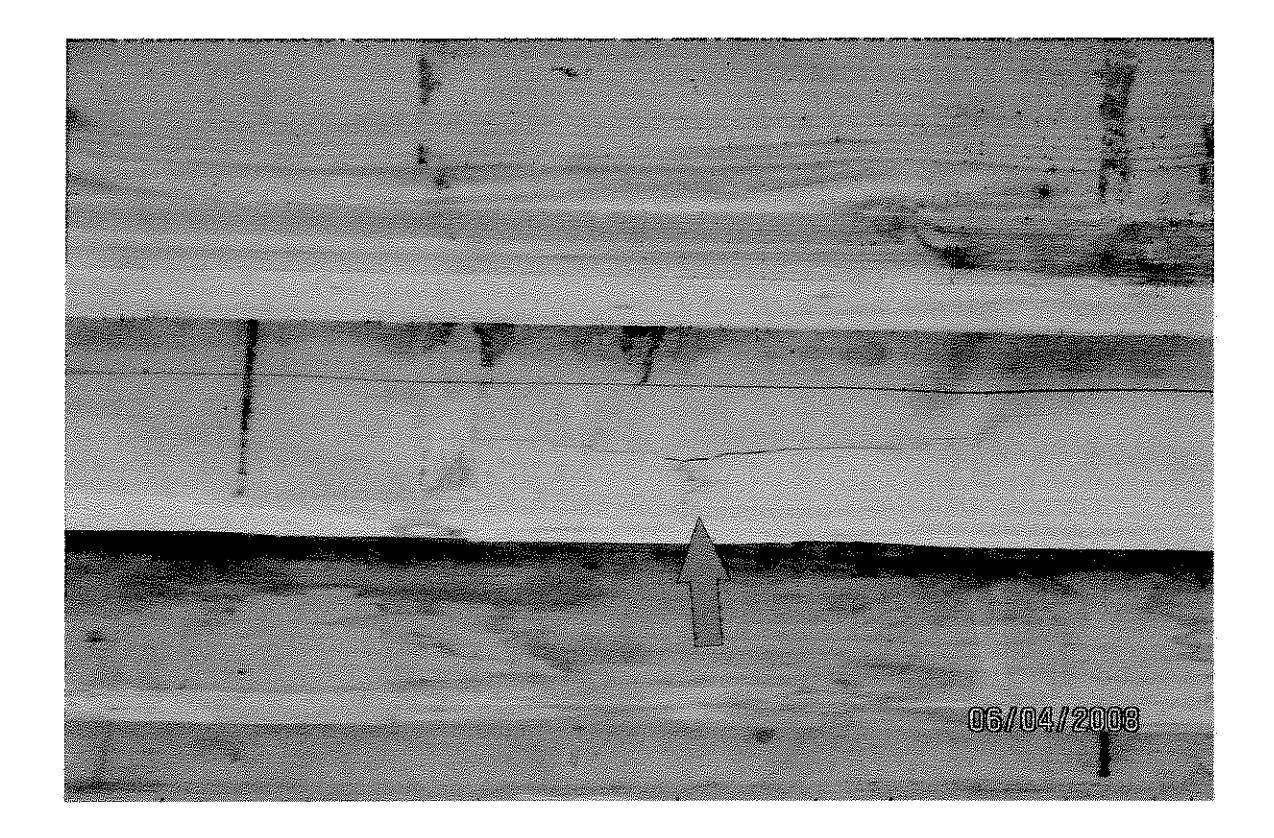
Photo 13 - A 3x4 lumber rib exhibiting a brash failure being used in formwork during our inspection.

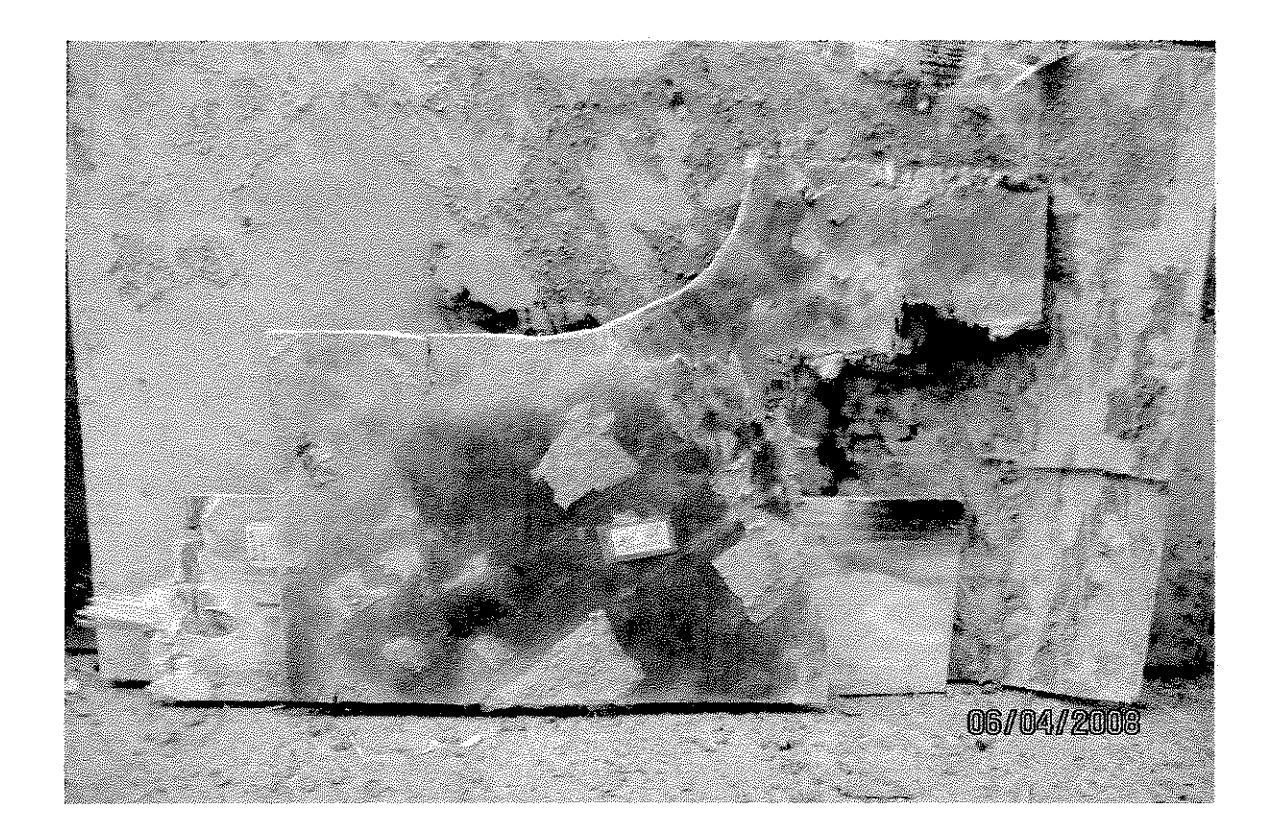
Photo 17 - Failure pattern consistent with a base plate punch through failure in panel DOB #PW41019.

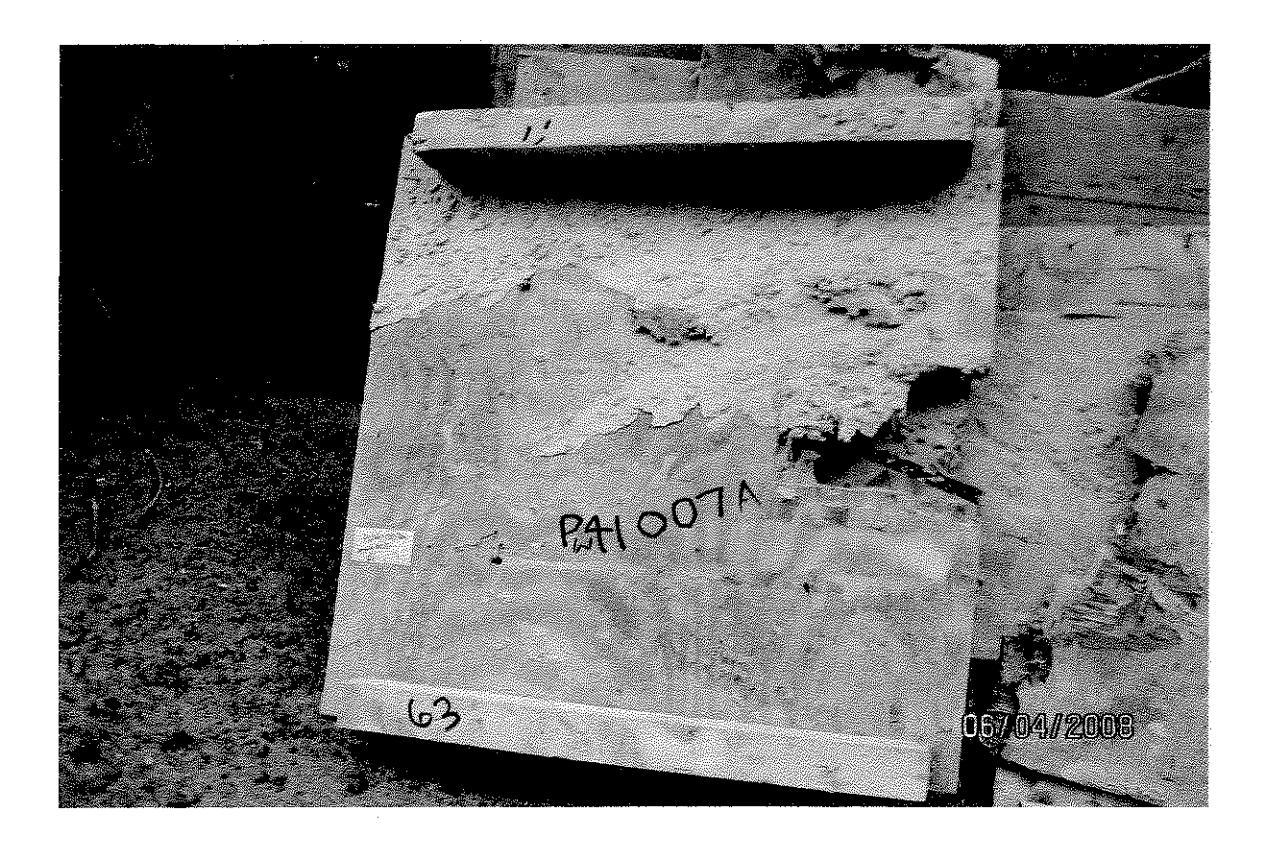
Photo 18 - Failure pattern consistent with a base plate punch through failure in panel DOB #PW41007A.

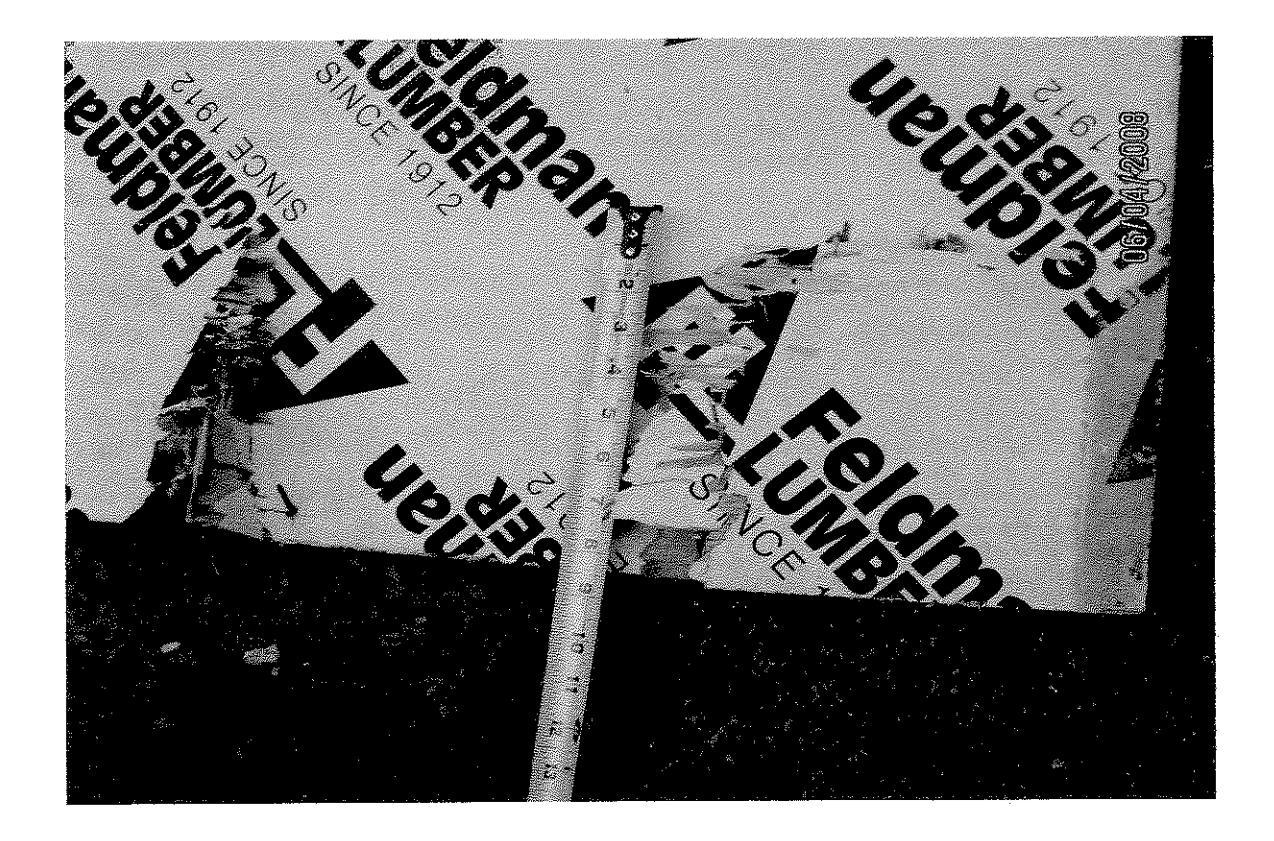
Photo 19 - Failure pattern consistent with a base plate punch through failure in panel DOB #PW41003.

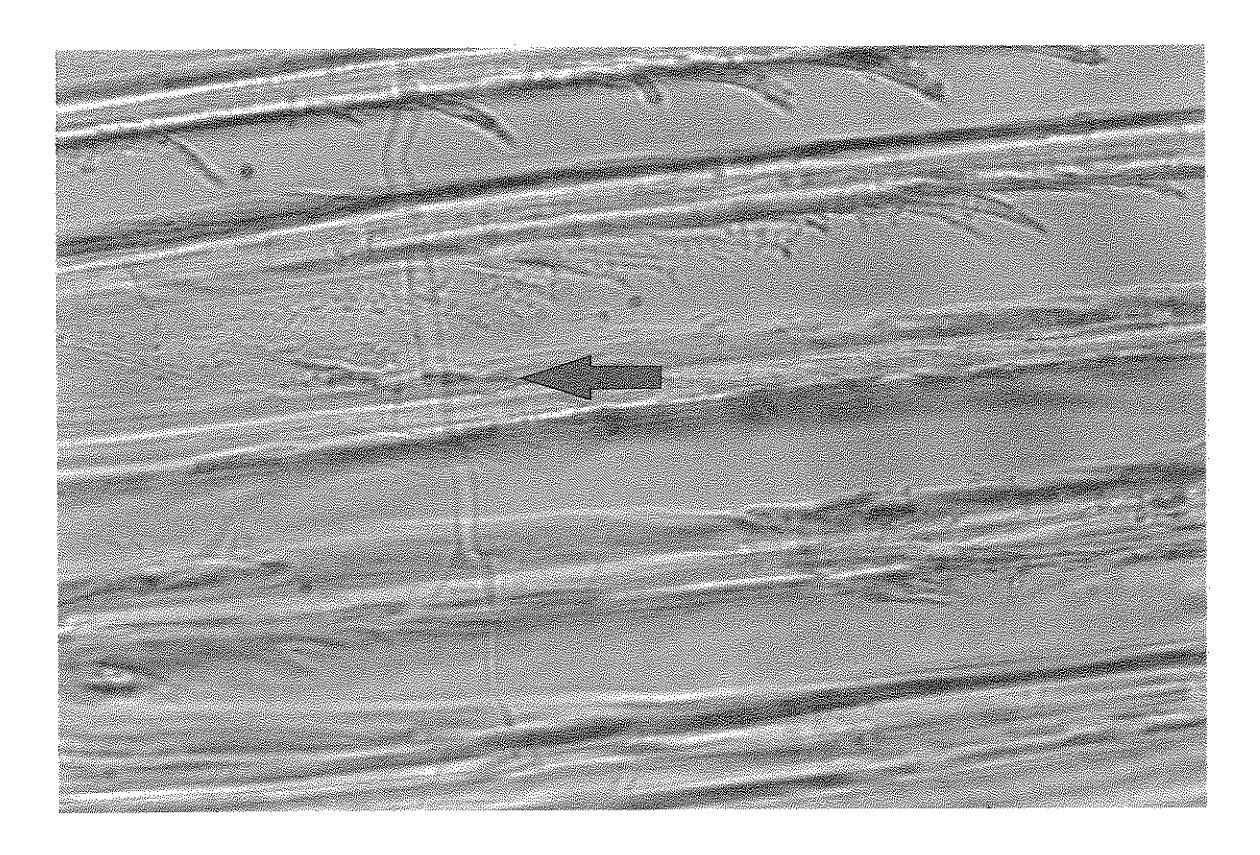
Photo 20 - Occasional wood decay hyphae observed near the surface of TP3-A.

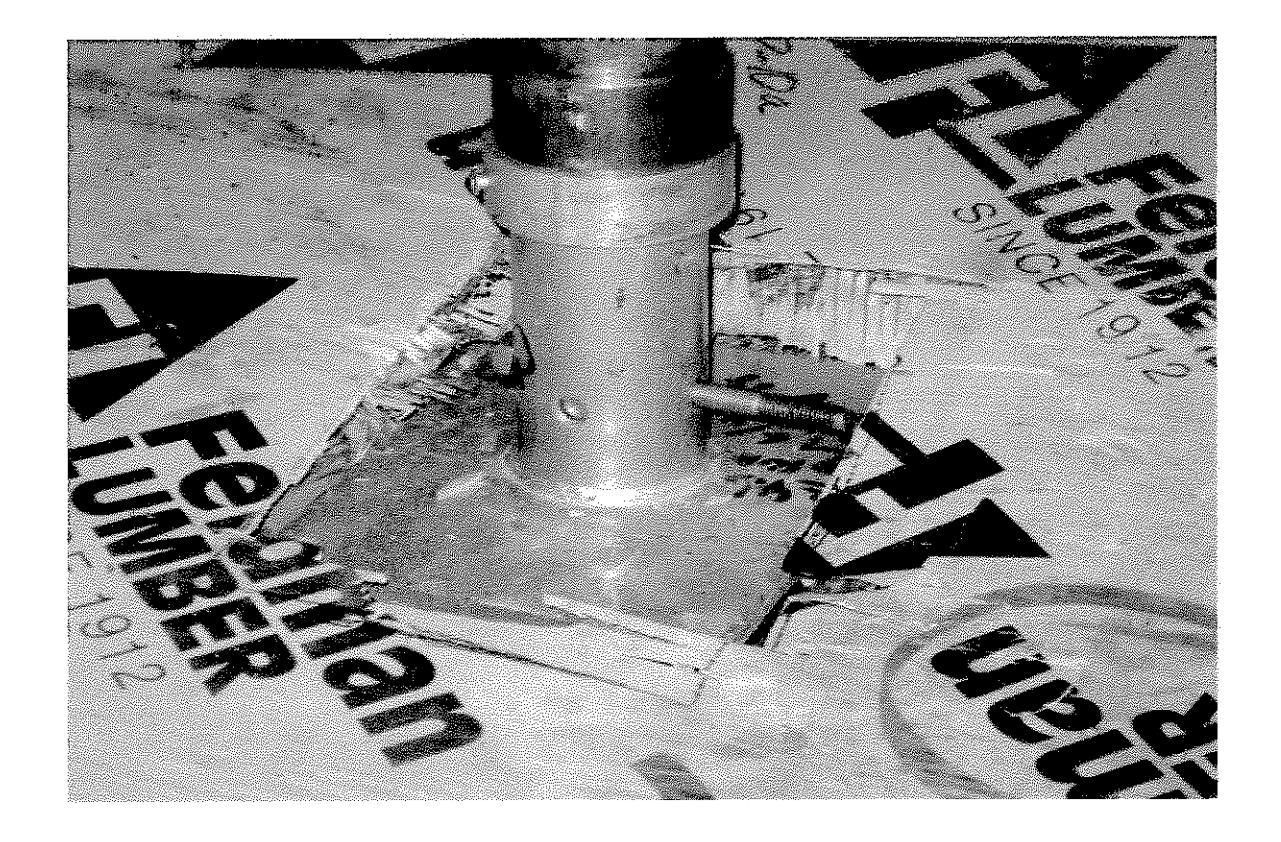
Photo 25 - Punch through failure of test specimen TP10-A.

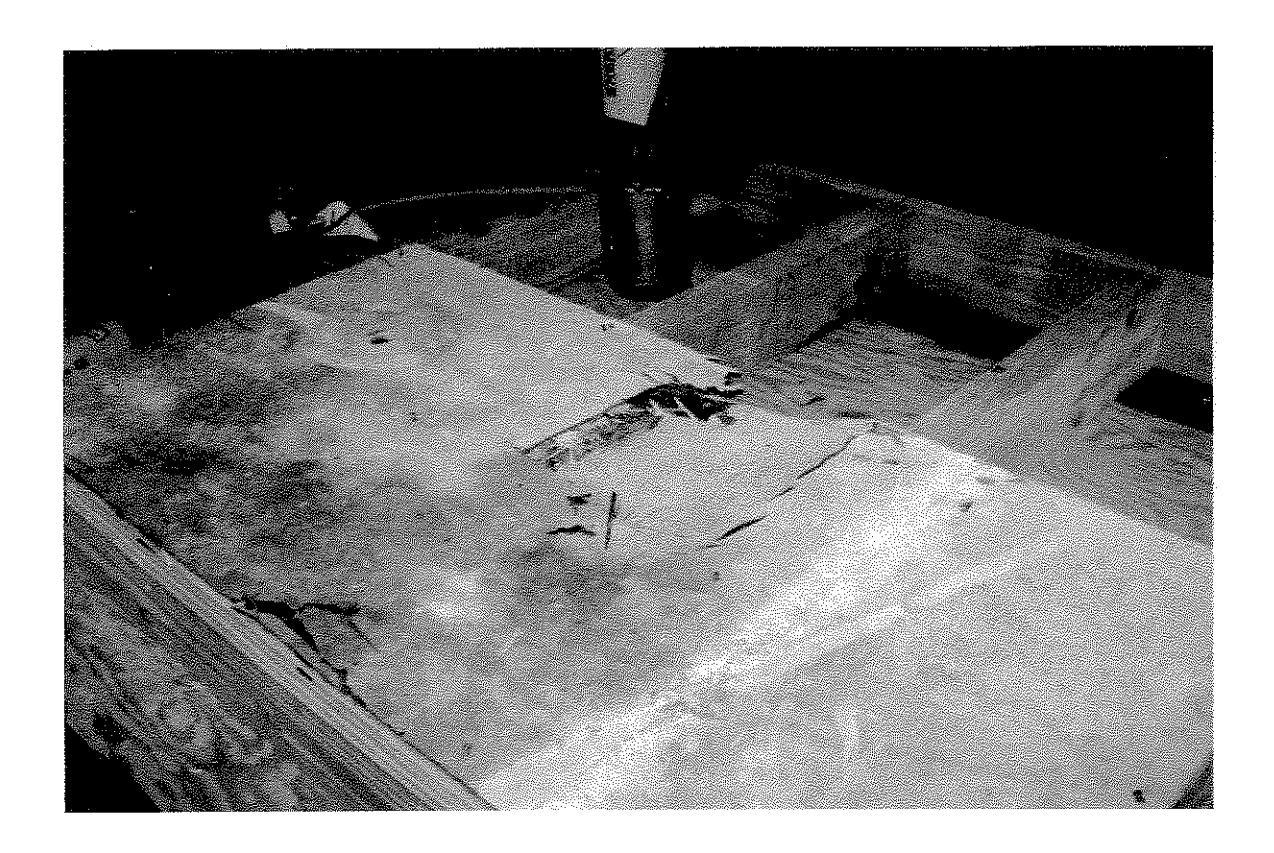
Photo 26 - Punch through failure of test specimen TP9-A.

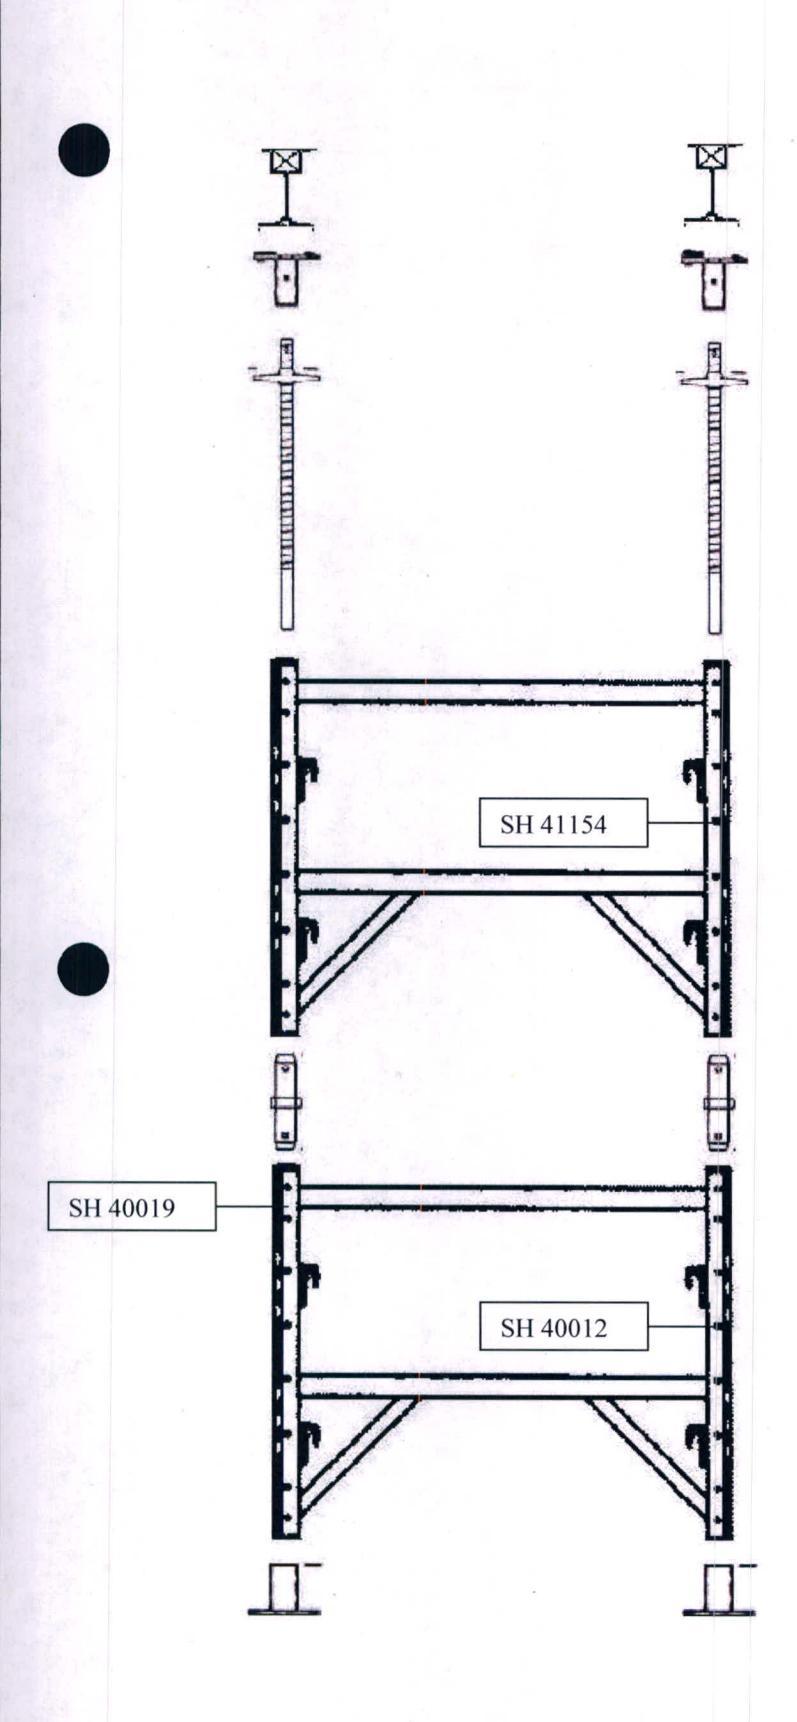
SH 40012 (on 41st floor) Broken Bottom frame with SH 40019 (3'-6") Zone 40B

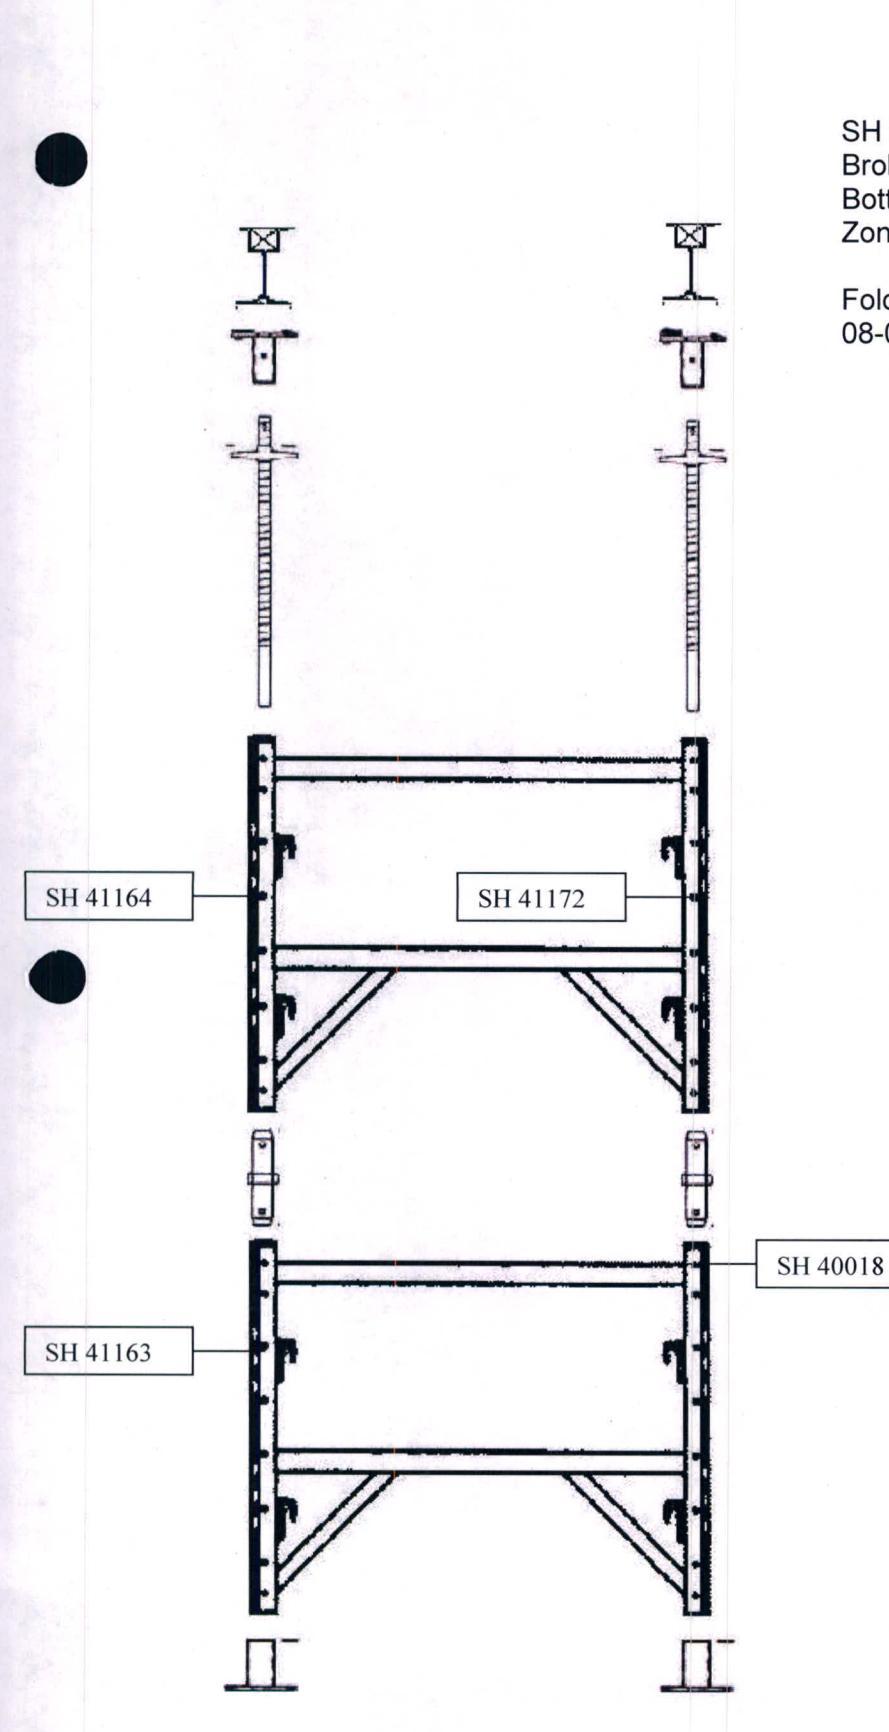
SH 40018 Broken Bottom Frame on 41st floor Zone 40G

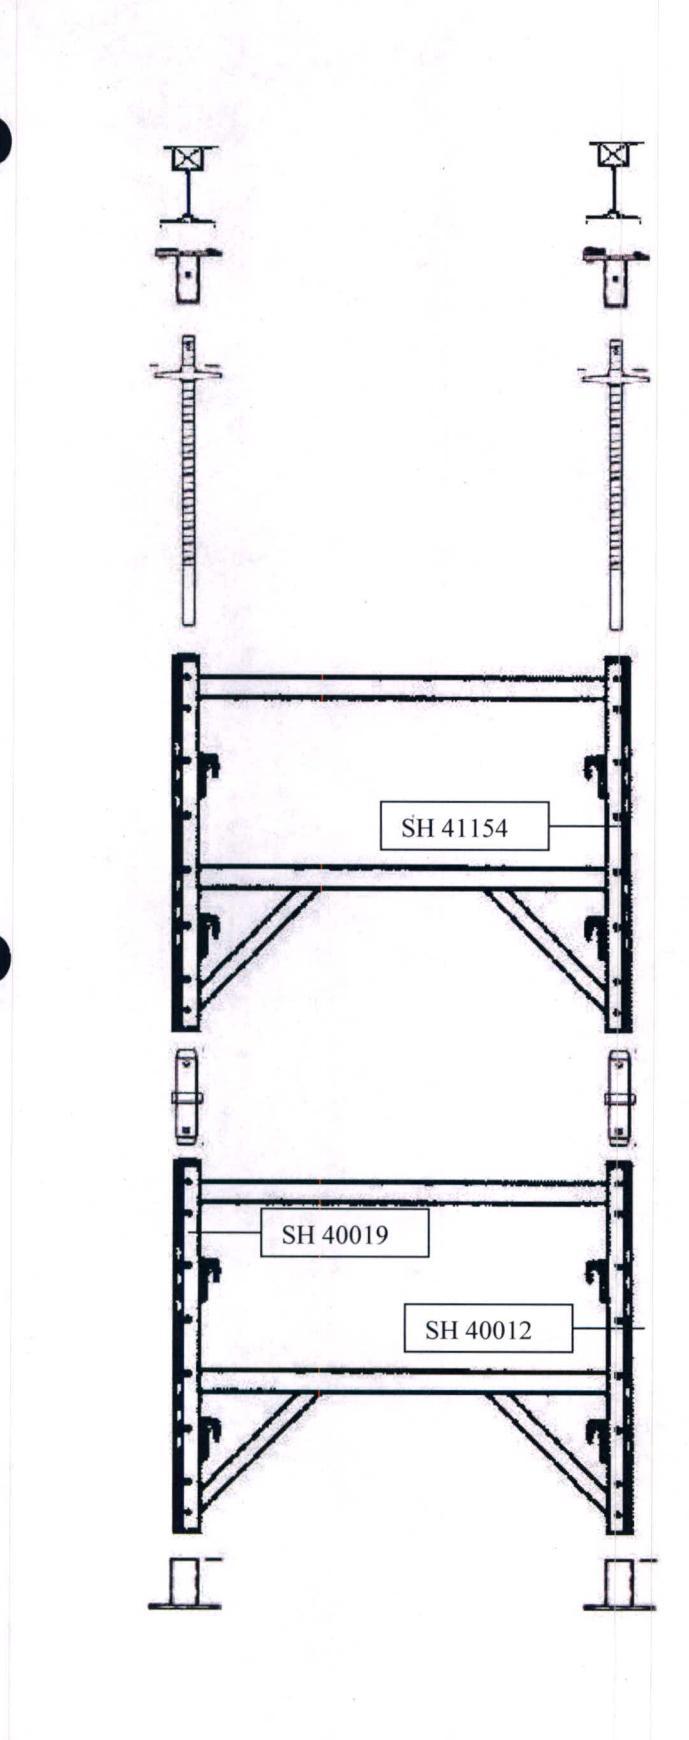
SH 40019 41St Floor Bottom Frame Broken with SH 40012
