INVESTIGATION REPORT:

JANUARY 14, 2008 SHORING COLLAPSE AT 9 DOMINICK ST. (AKA 246 SPRING ST.) MANHATTAN

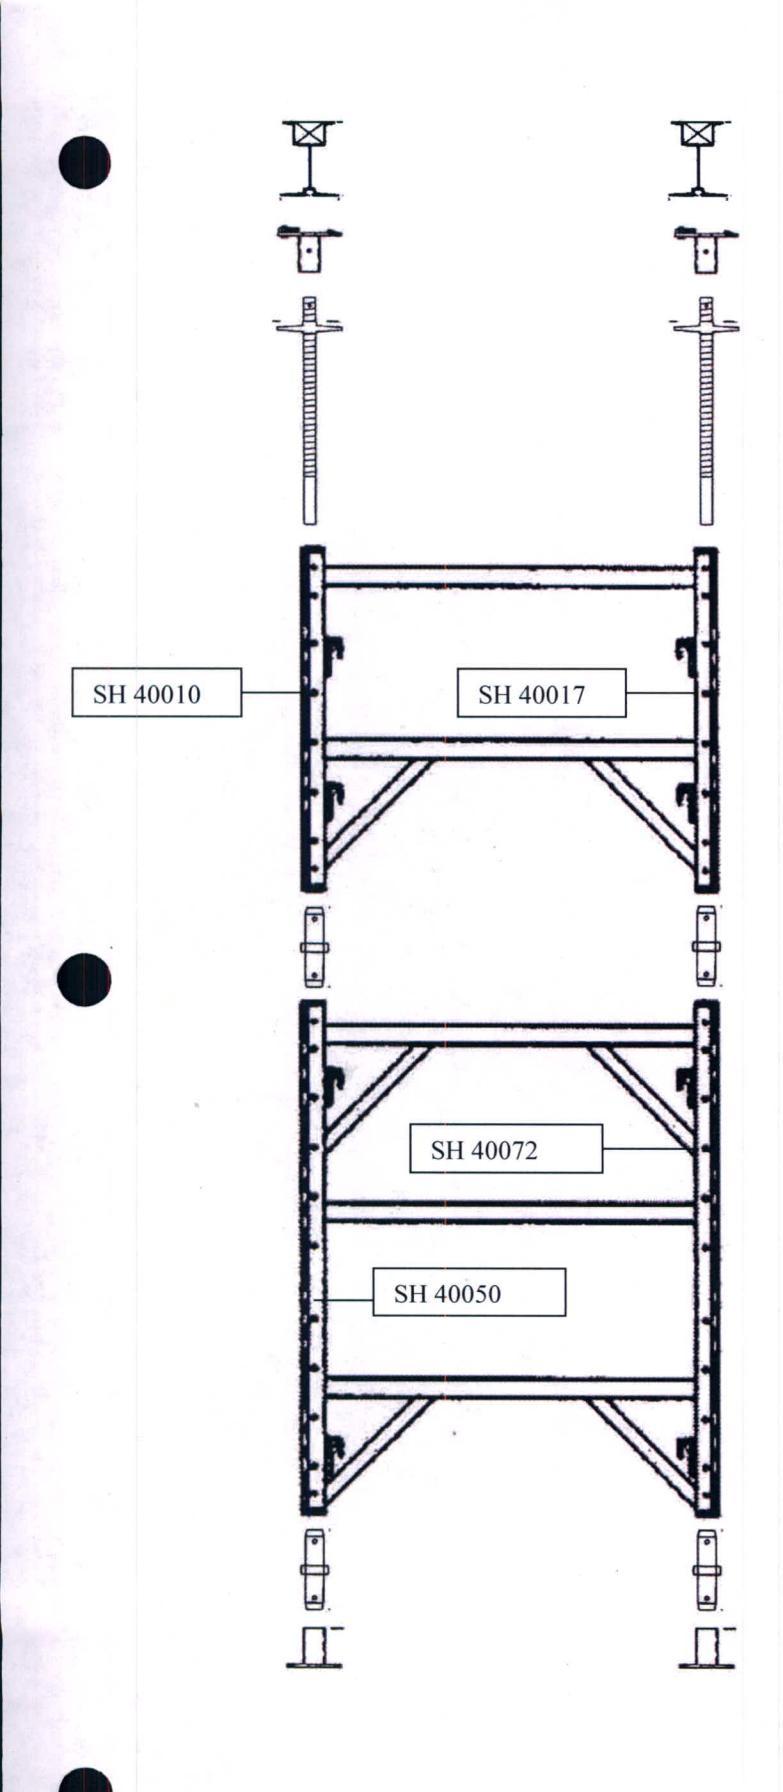
SH 40050 Bottom shore broken connect SH 40072 to make full frame Shore Connect to SH 40010 with brace to make tower Zone 40B

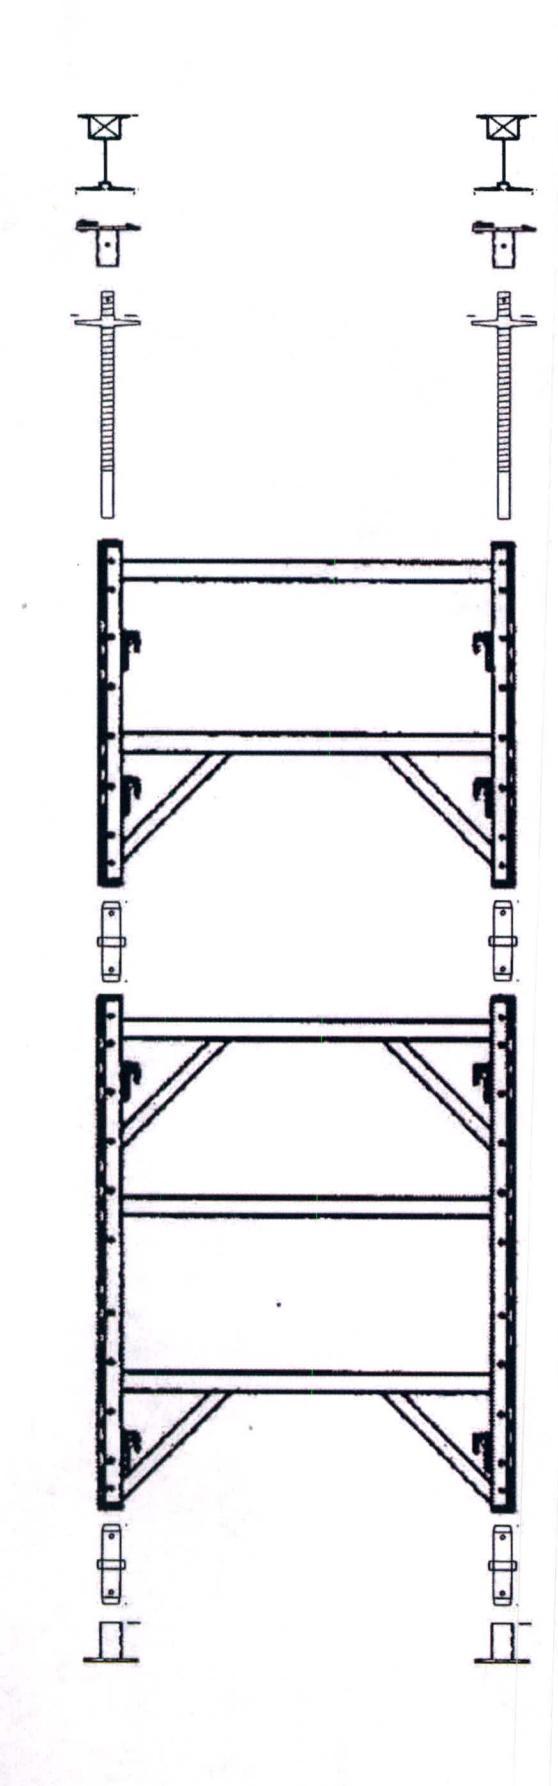
SH 40112 Broken piece of frame Moved from original position Zone 40J

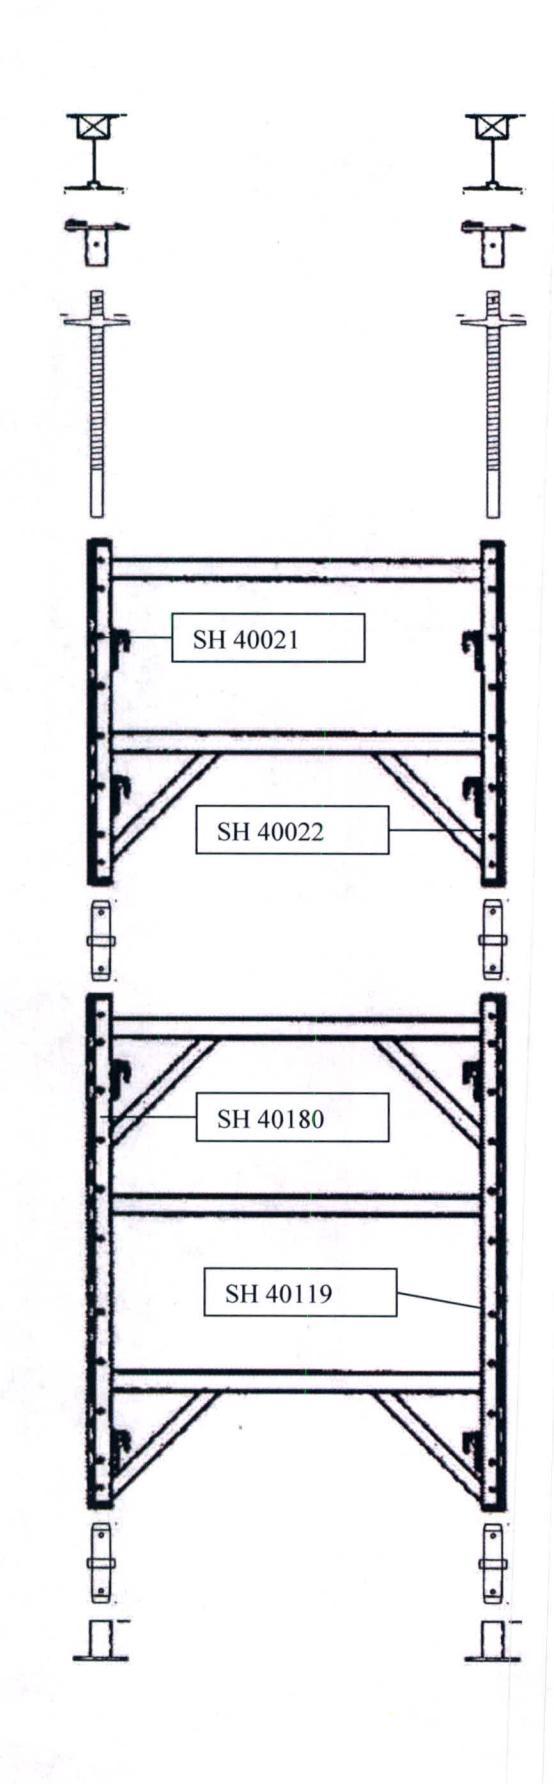
SH 40119 Bottom Shore Broken with SH 40180 Zone 40F

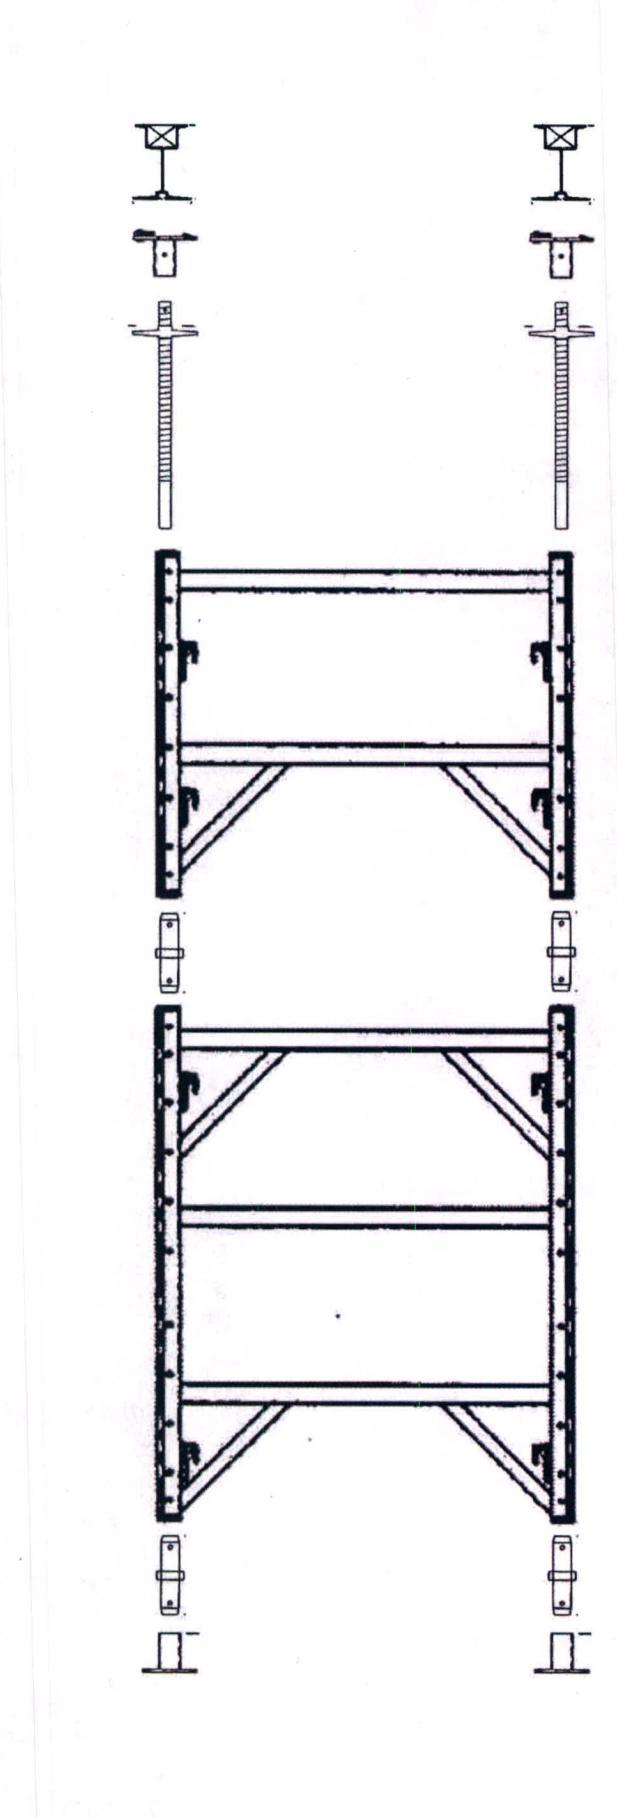
SH 40125 Broken piece near SH 40124 Zone 40G

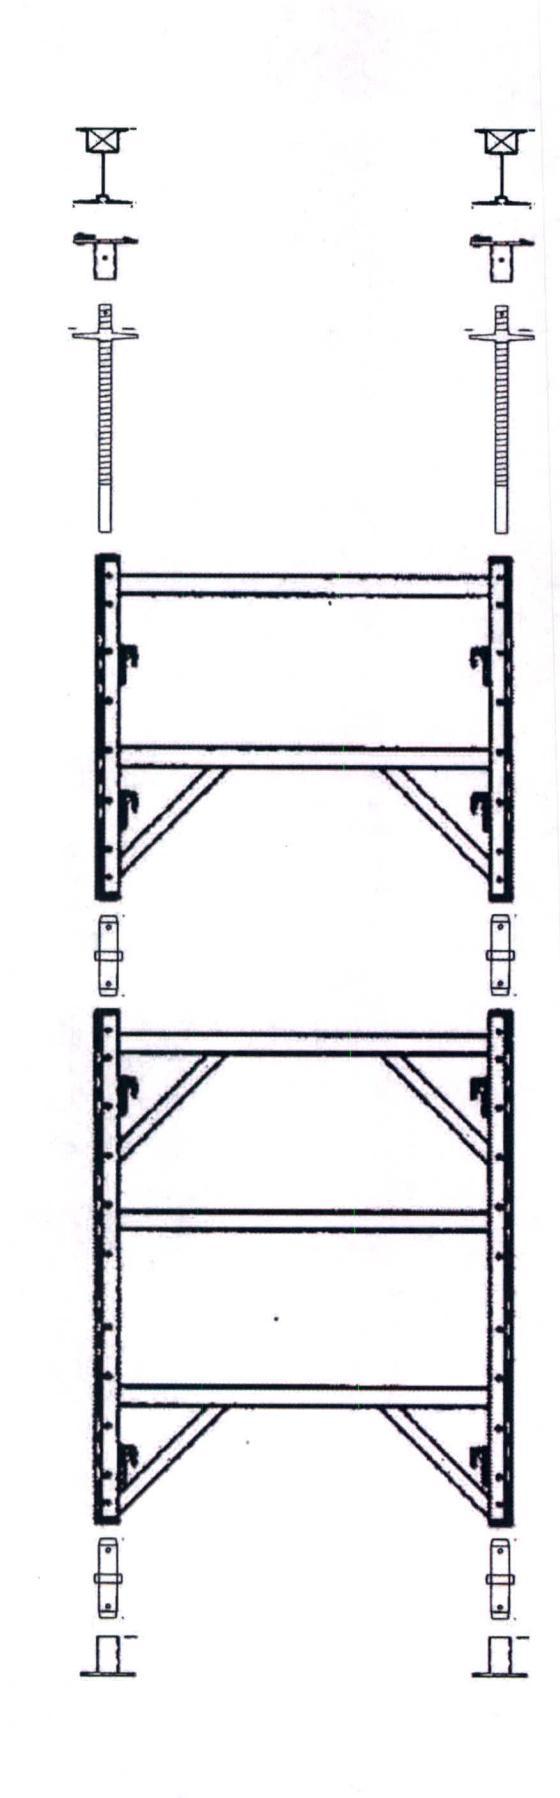
SH 40127 Broken piece Zone 40F

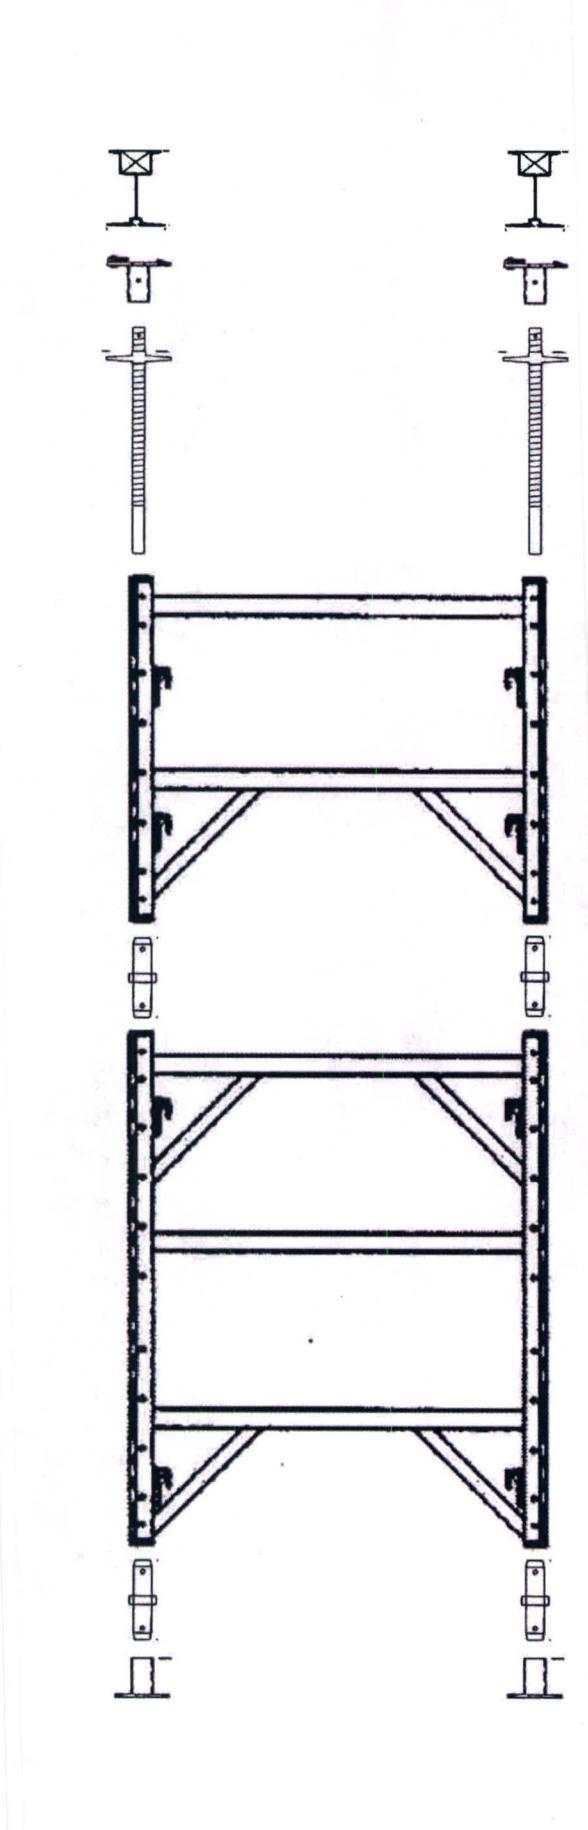
SH 40128 Broken Piece Zone 40G

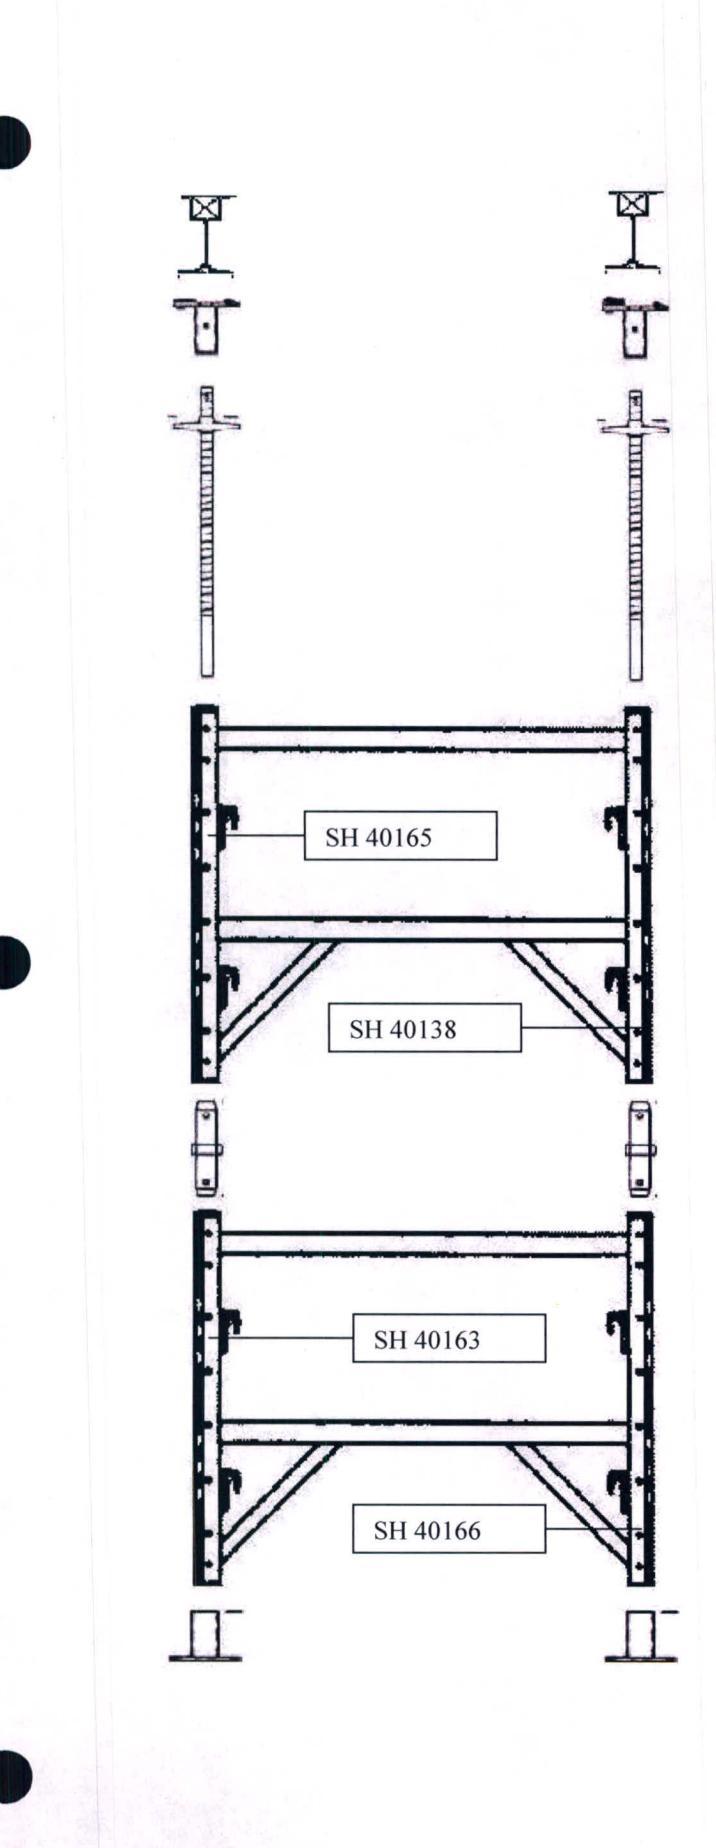
SH 40138 on 41st floor Broken top frame of SH 40166 Zone 40F

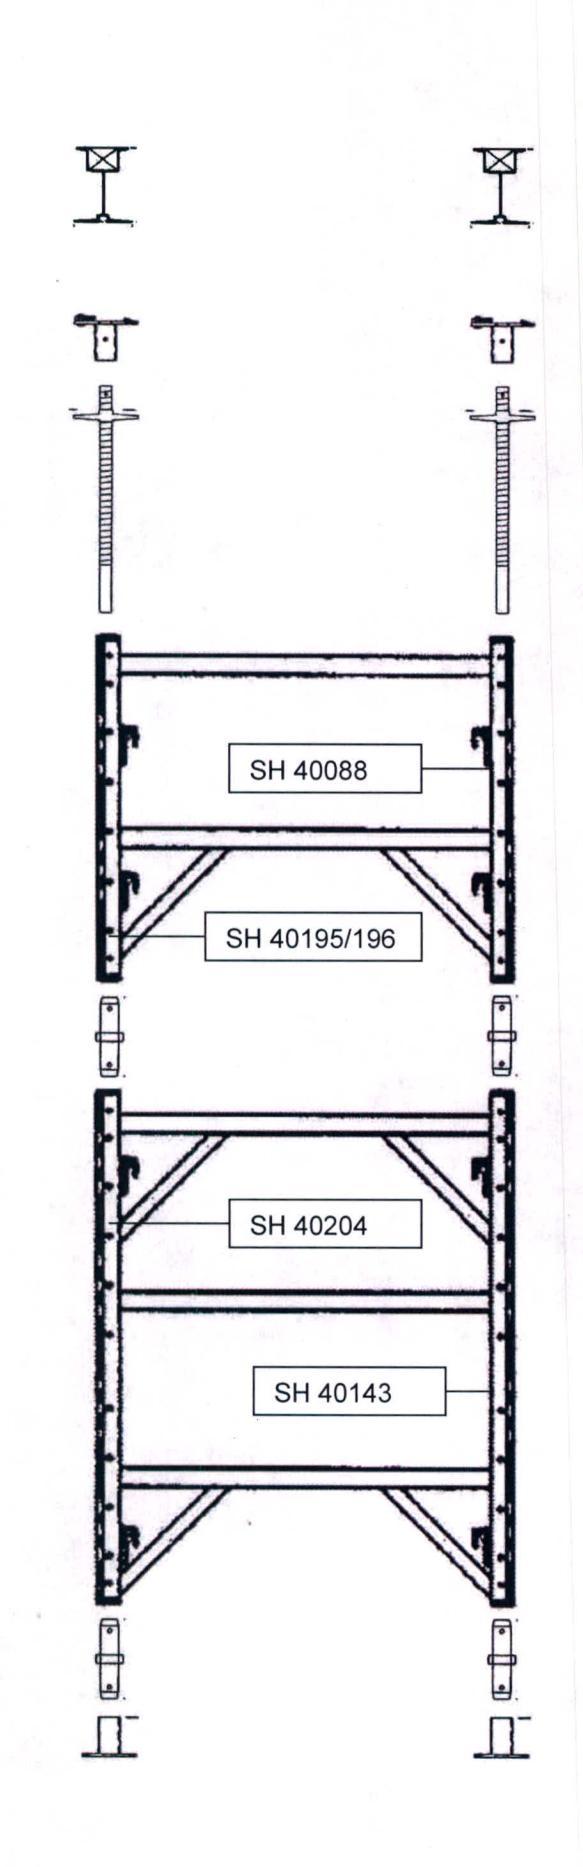
SH 40143 Screw jack and Broken Bottom Frame Zone 40G-C

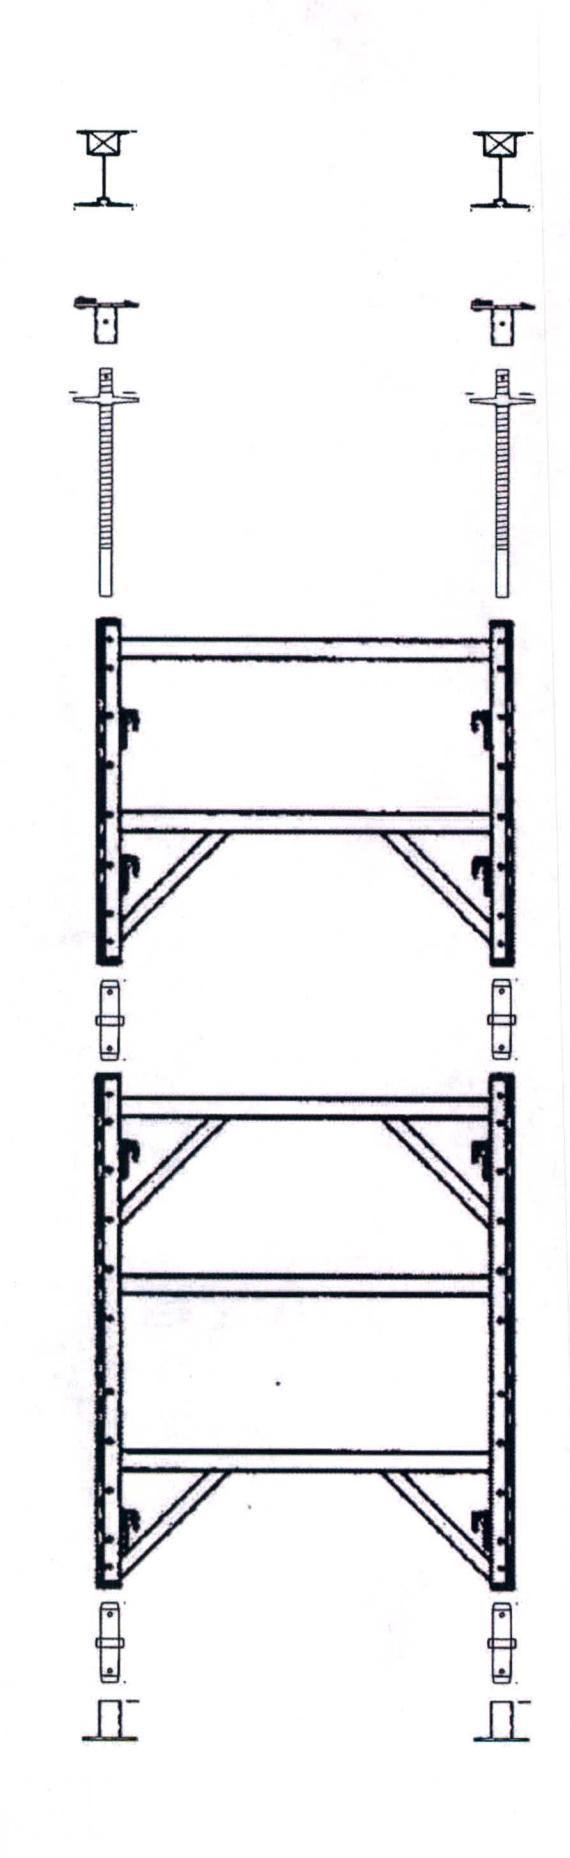
SH 40145 Broken piece of frame Zone 40F

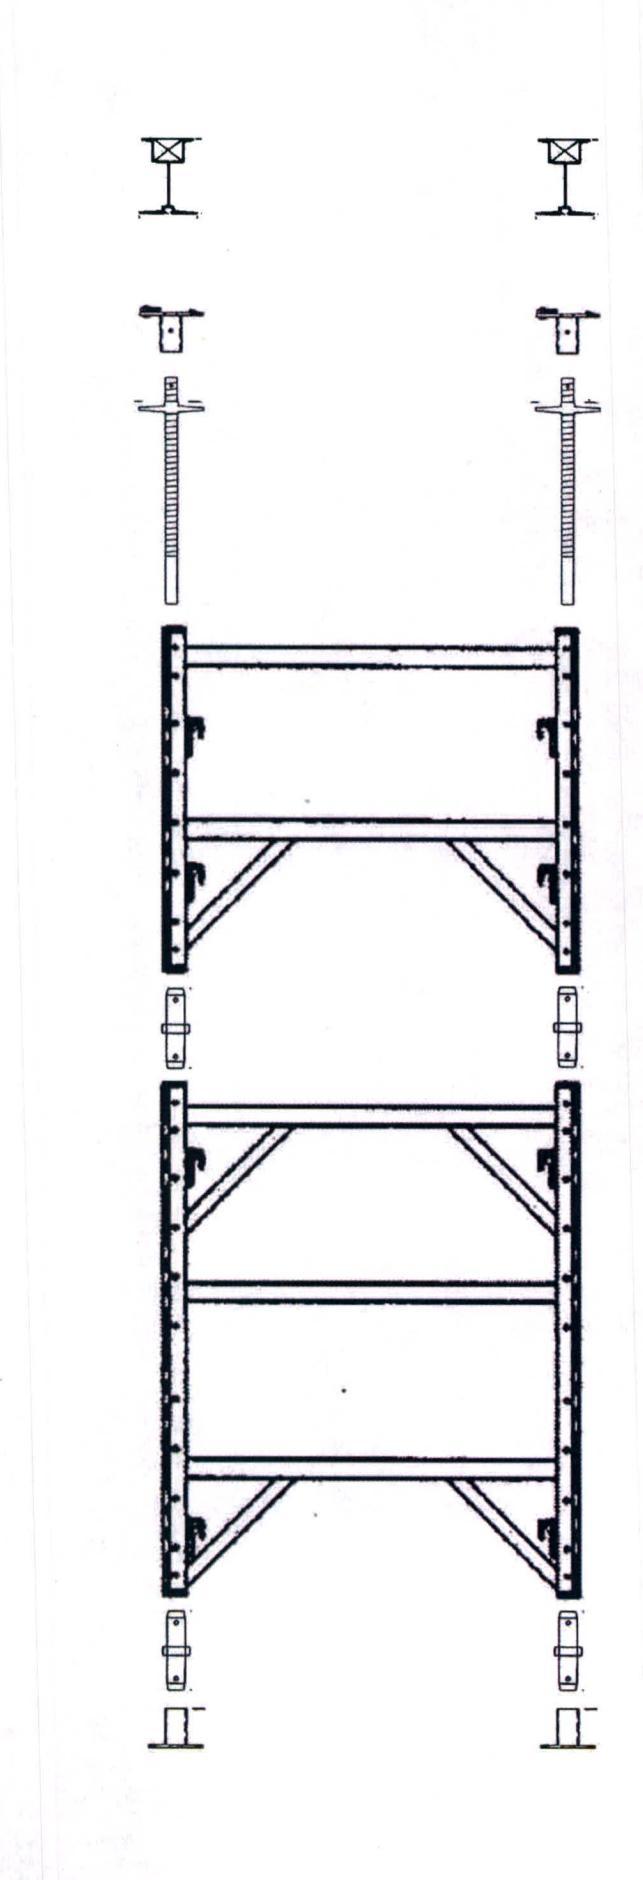
SH 40146 Broken piece of frame Zone 40F

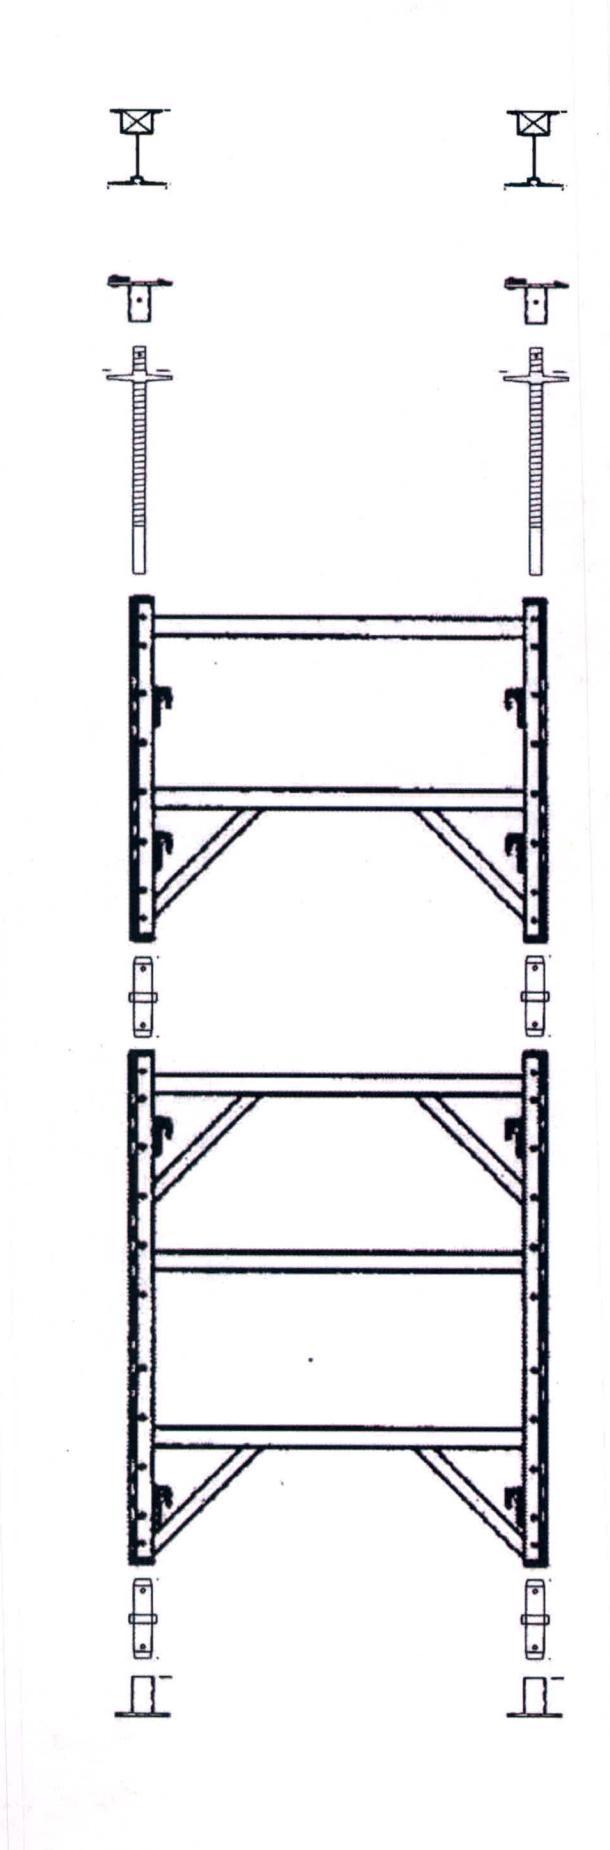
SH 40149 Broken piece of frame Zone 40G

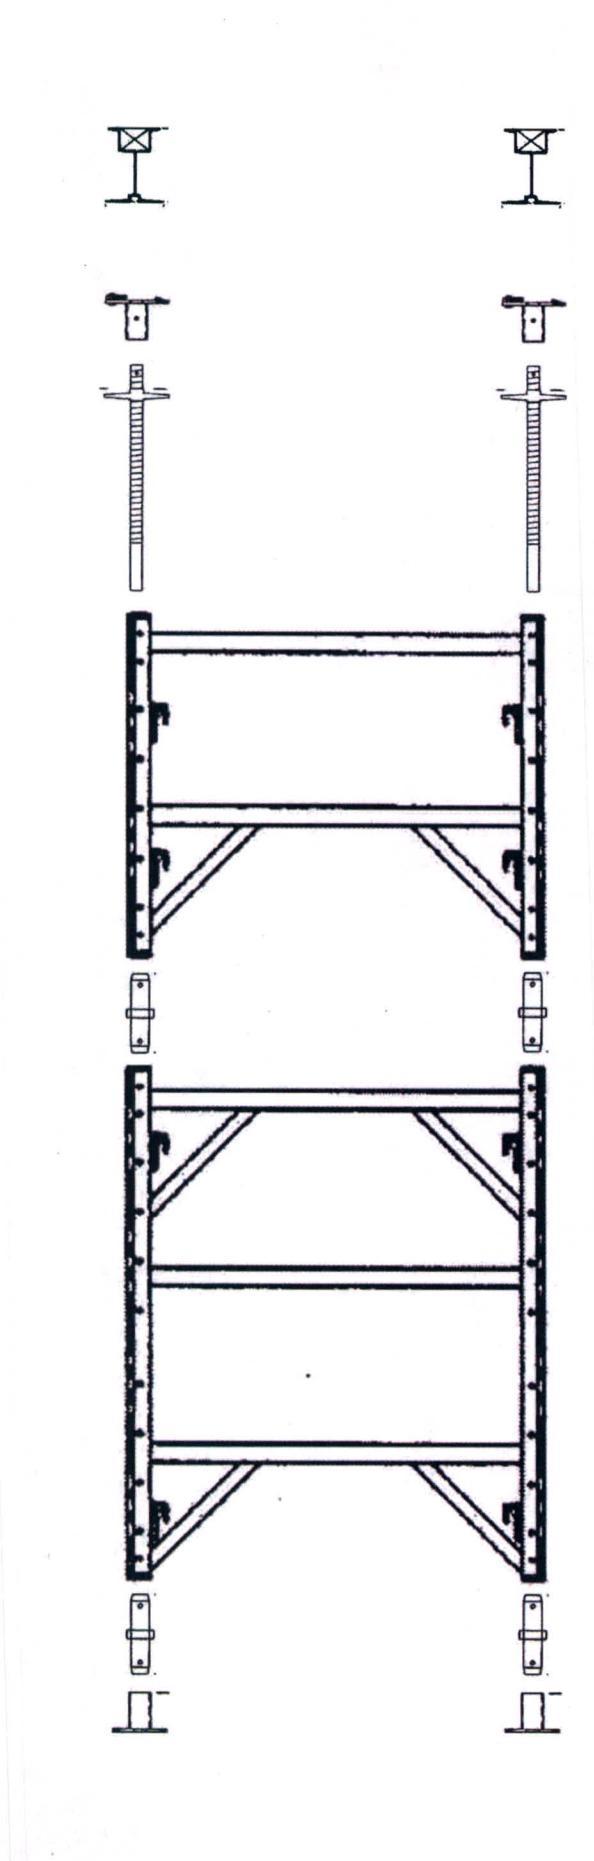
SH 40157 Broken piece of Frame Zone 40G

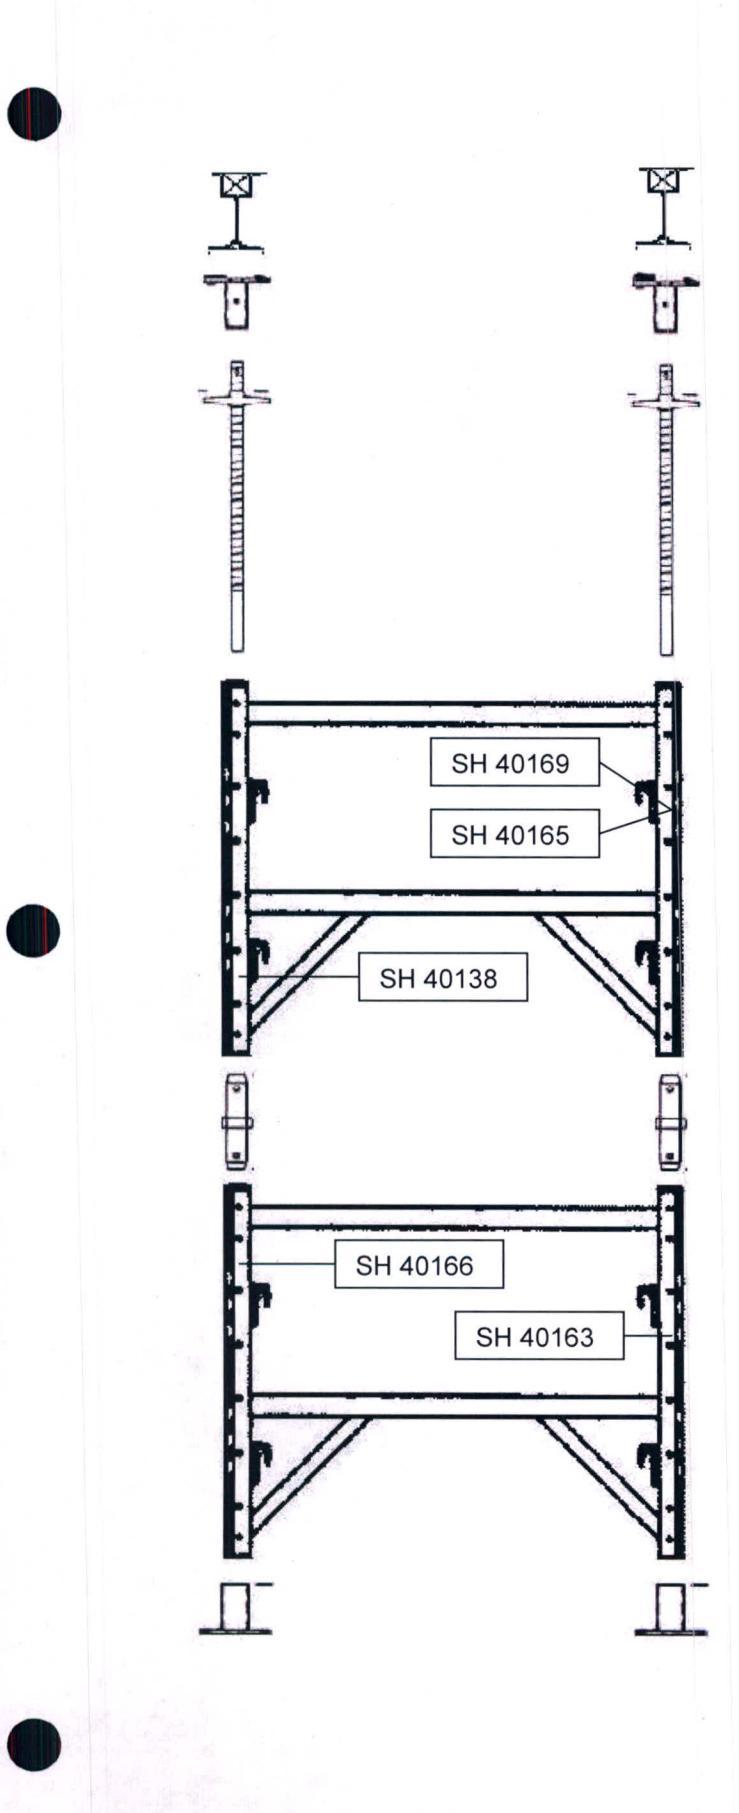
SH 40169 Broken frame part of SH 40165 Zone 40G

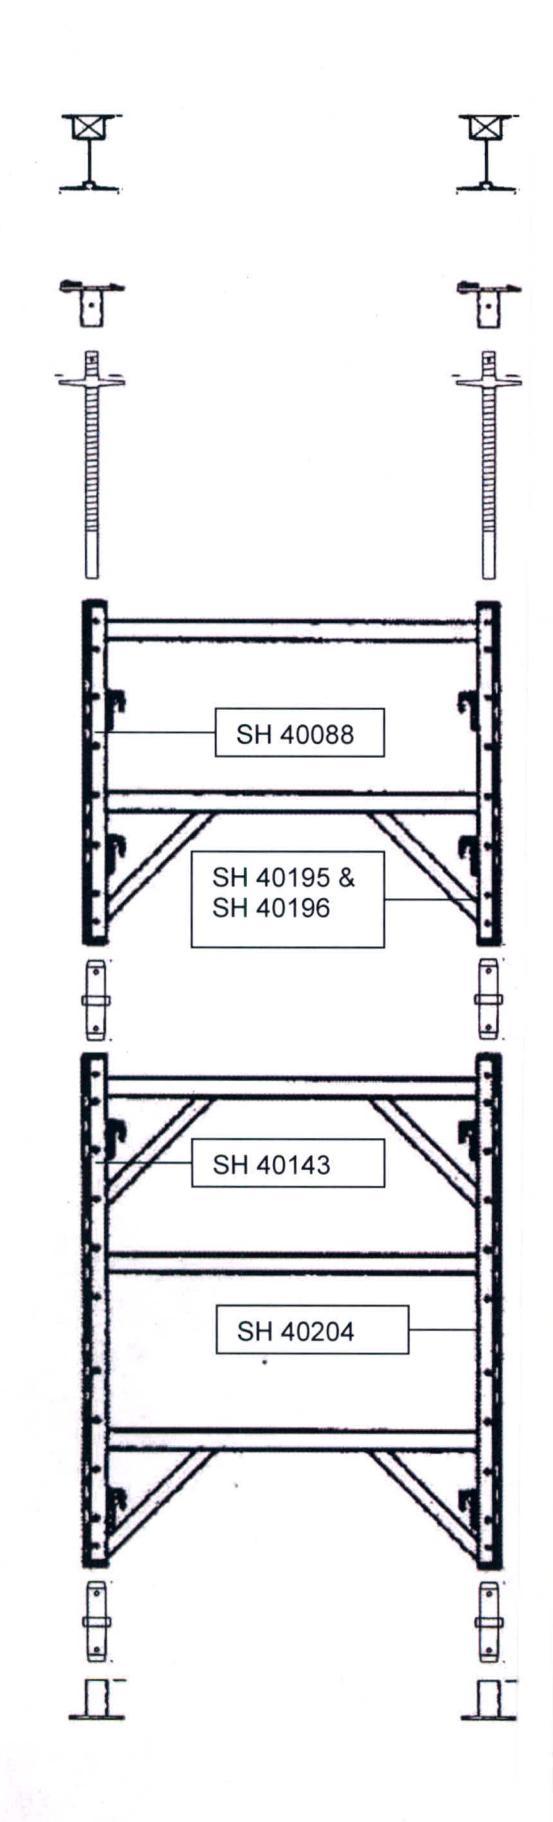
Top frame fractured off from SH 40196 SH 40185 and SH 40195 were connected Zone 40C

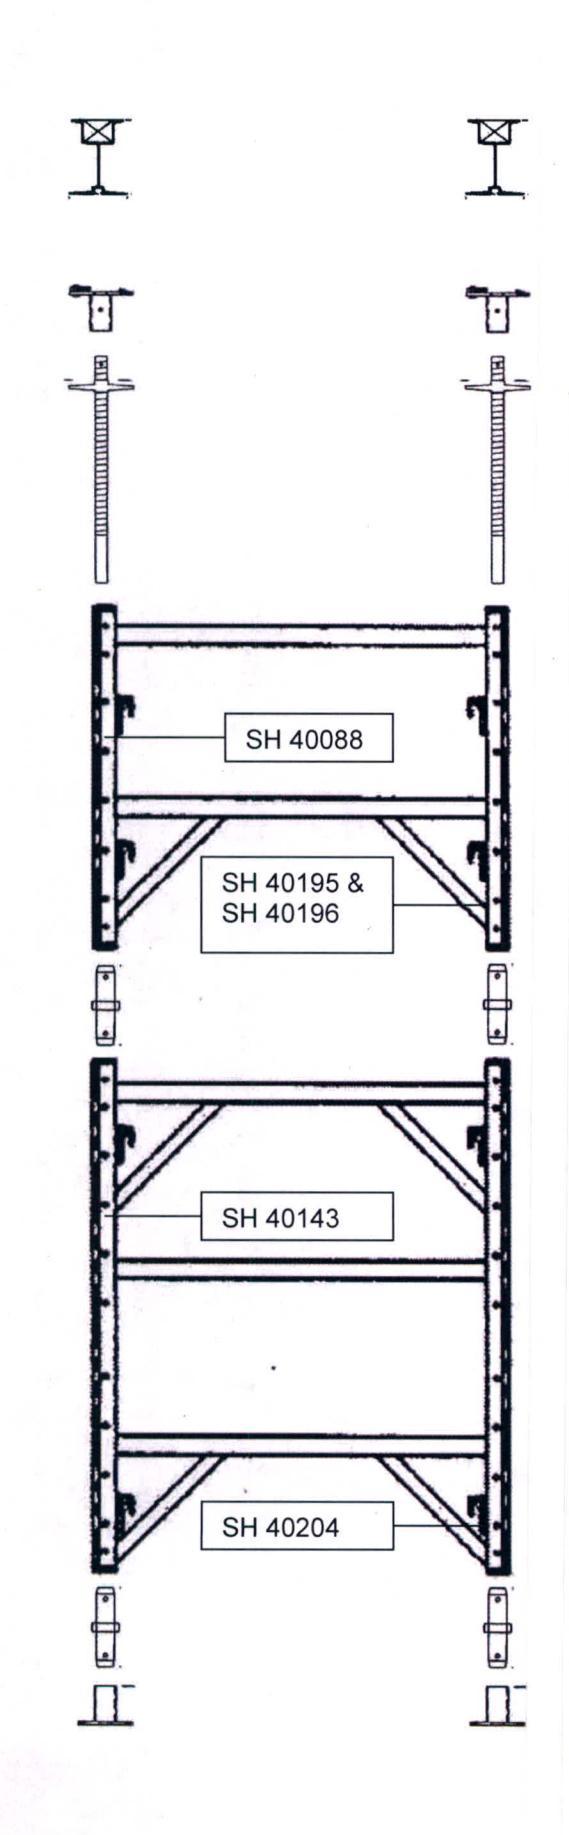
SH 40196

Remaining fractured part of SH 40195 frame buried in concrete Zone 40C

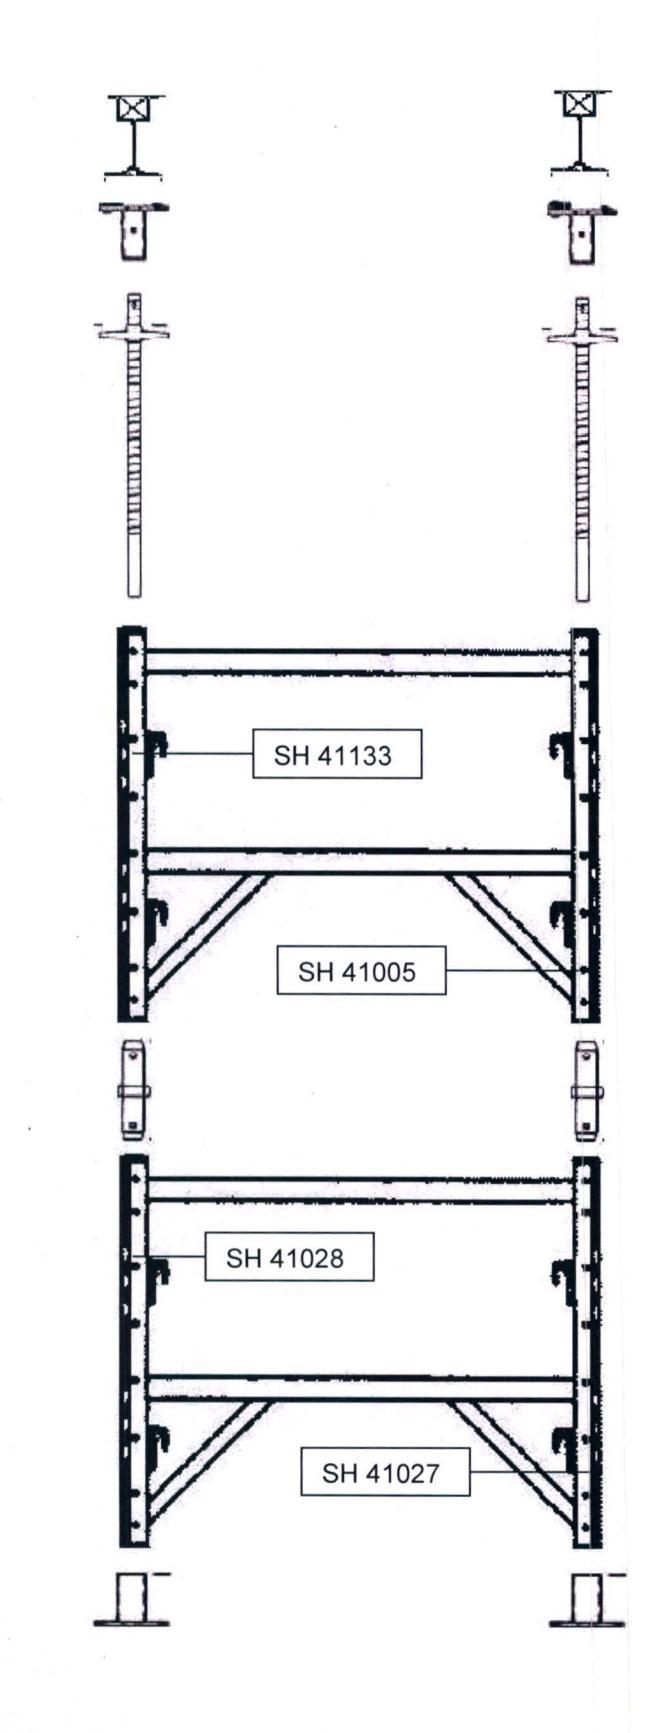
SH 41005 Broken Top Frame Bottom Frame SH 41027 and SH 41028 Supports AB 41004 Zone 41G

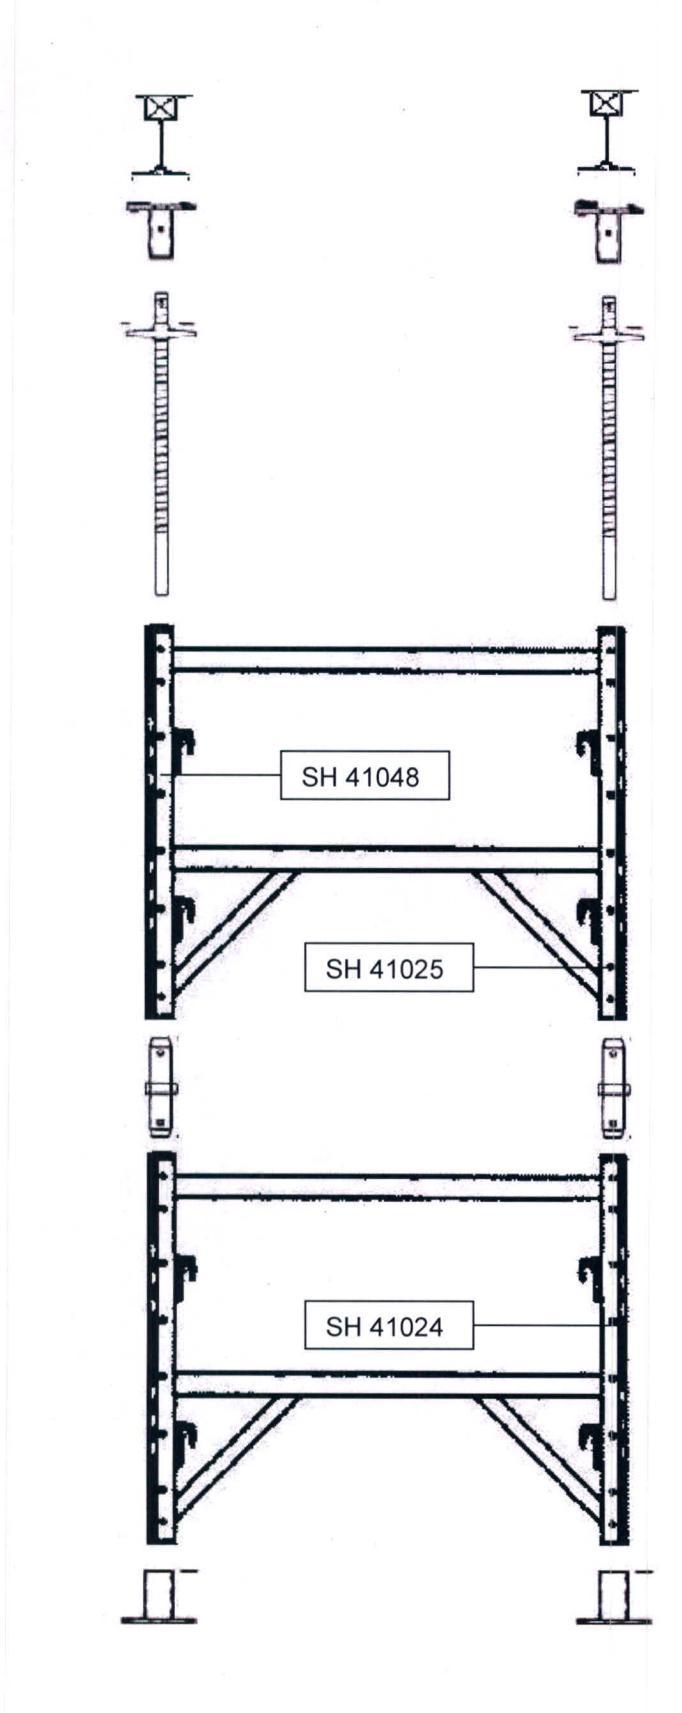
SH 41025 Broken Top Shore of SH 41024 Connect to top plate SH 41026 Zone 41F

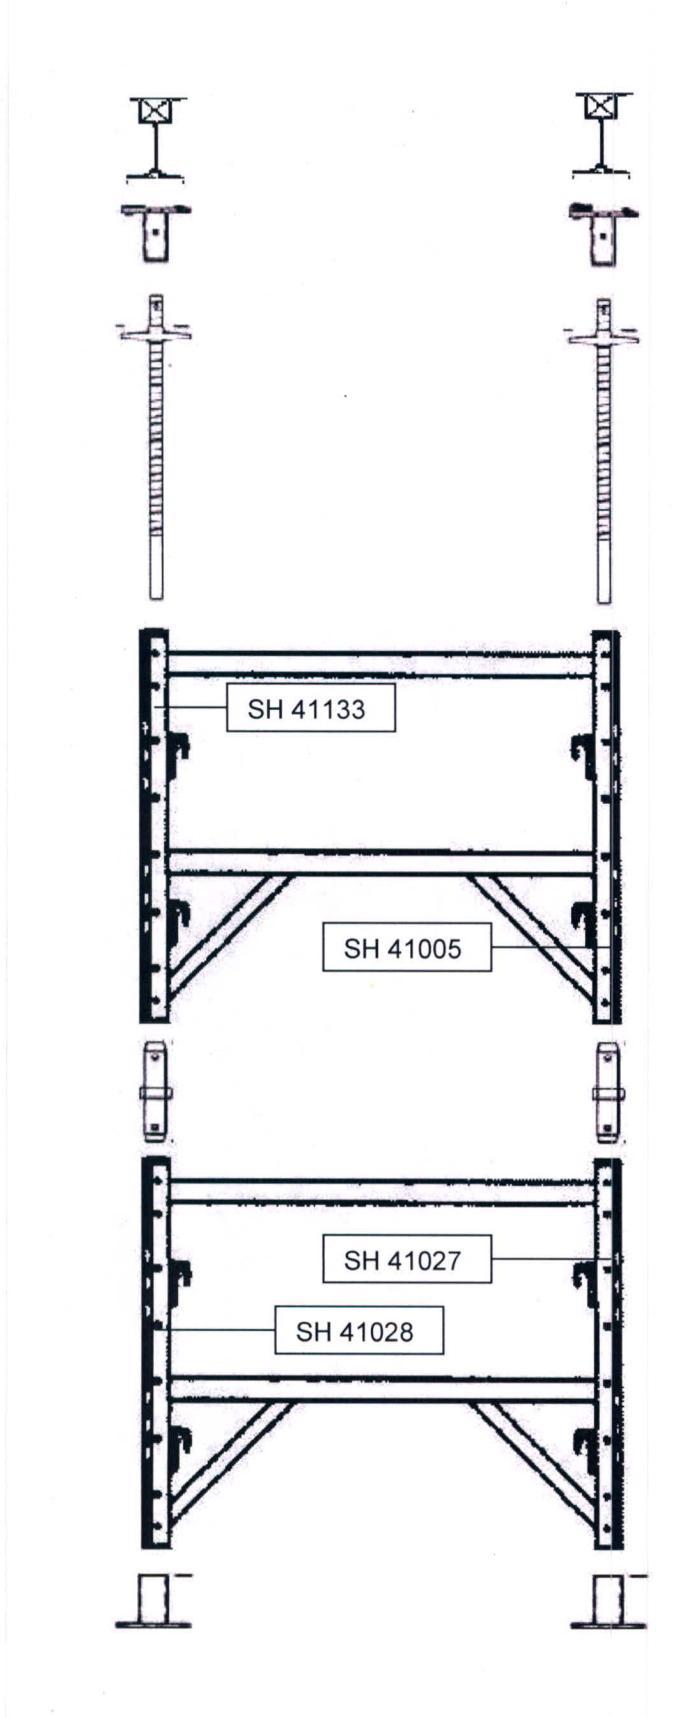
SH 41027 Broken Bottom Frame of SH 41005 Zone 41G

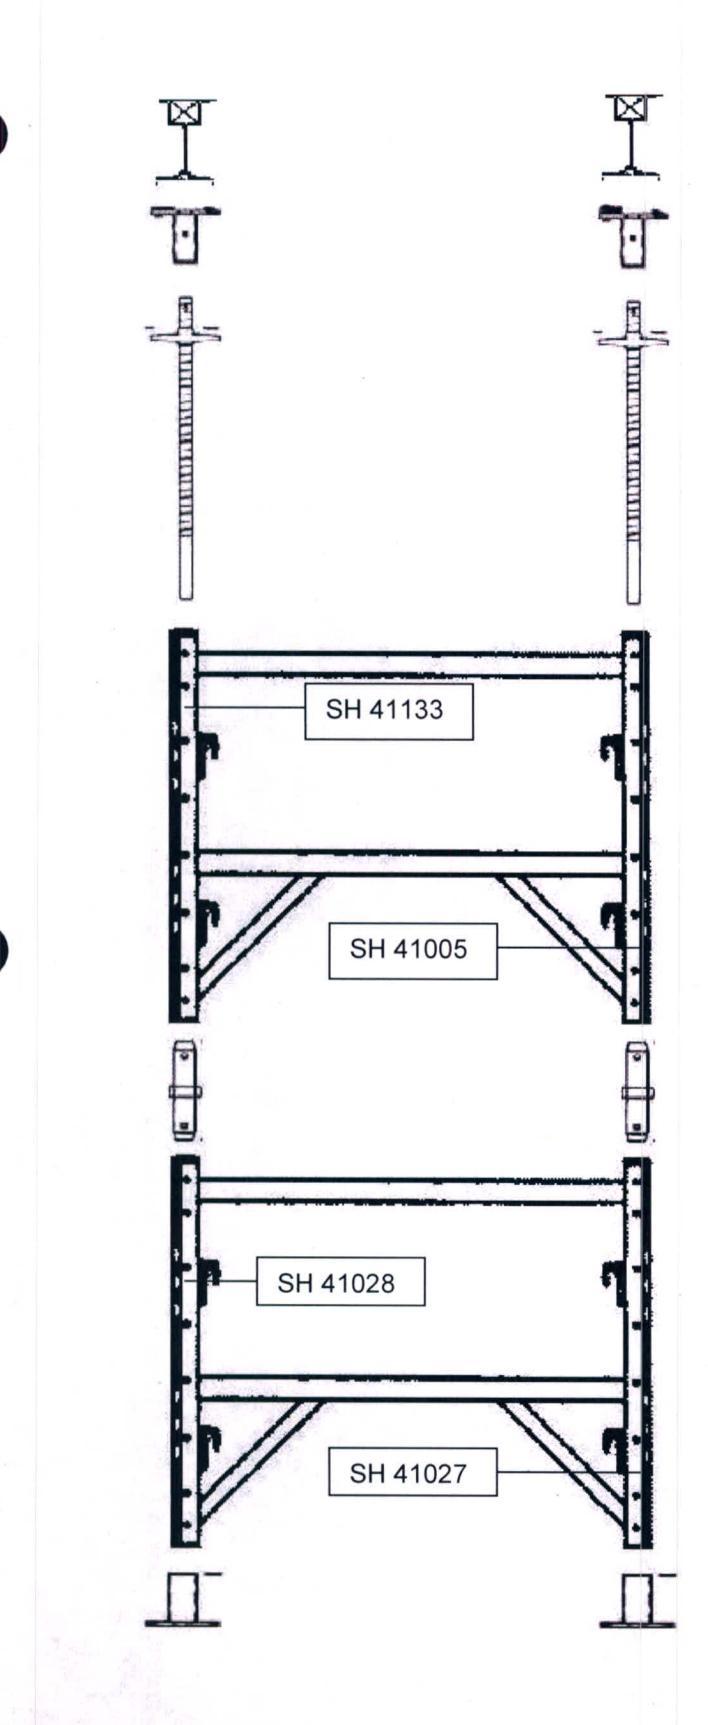
SH 41028

Broken Bottom Frame 3'6" Bottom Shore of SH 41005 Connected to brace SH 41030 Zone 41G

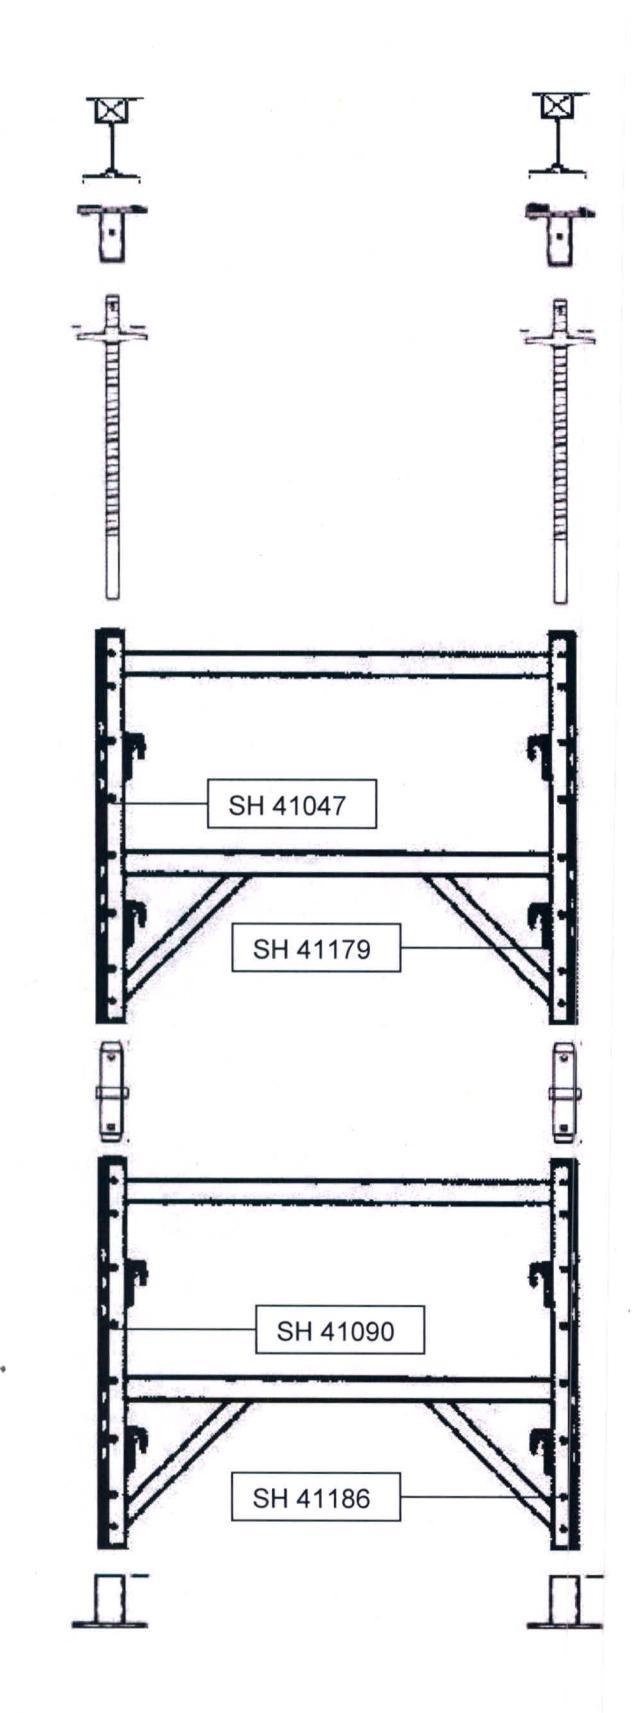
SH 41047 Broken With SH 41179 Top Shore of SH 41186 & SH 41190 Attached to brace SH 41046 Zone 41F
