INVESTIGATION REPORT:

JANUARY 14, 2008 SHORING COLLAPSE AT 9 DOMINICK ST. (AKA 246 SPRING ST.) MANHATTAN

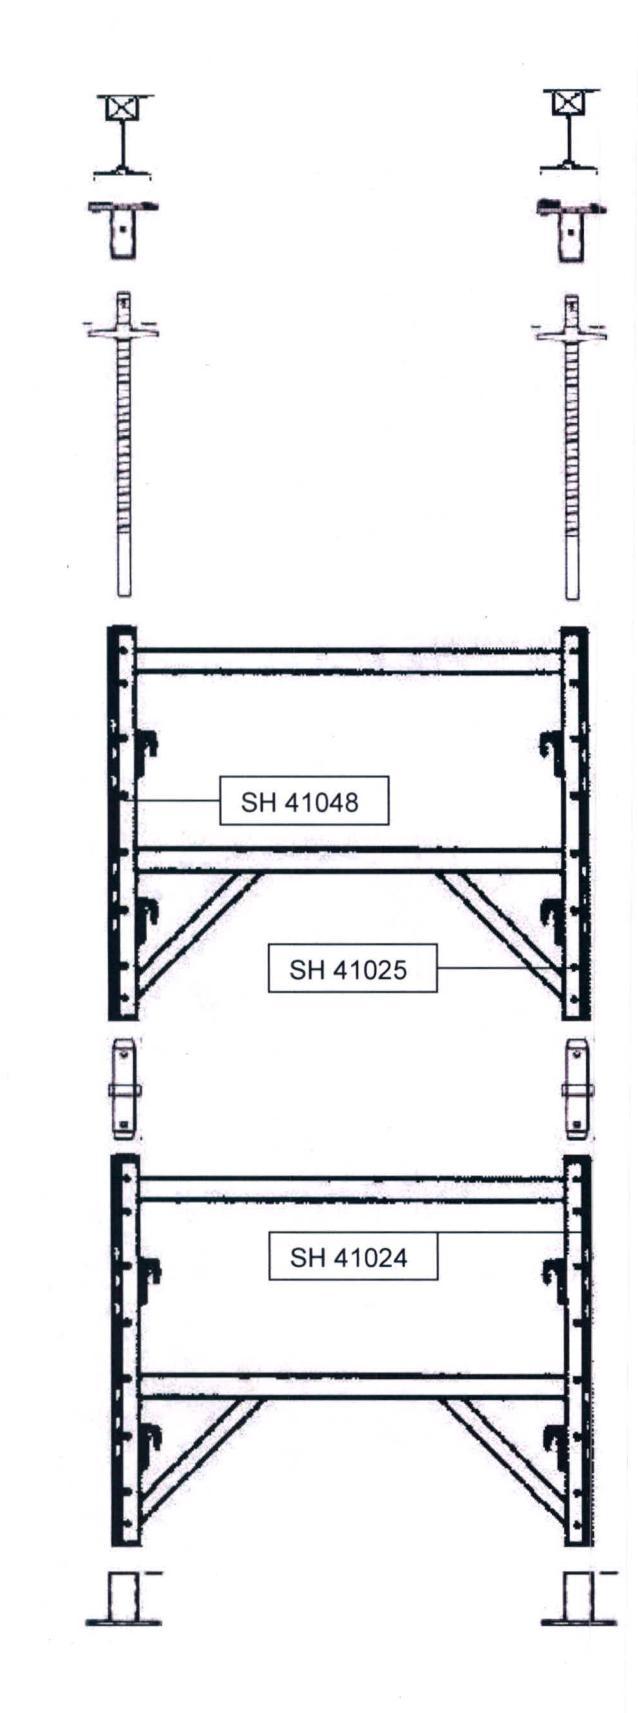
SH 41048 Broken Top Shore Attached to SH 41046 on top SH 41024 Piece of Frame SH 41049 Zone 41F

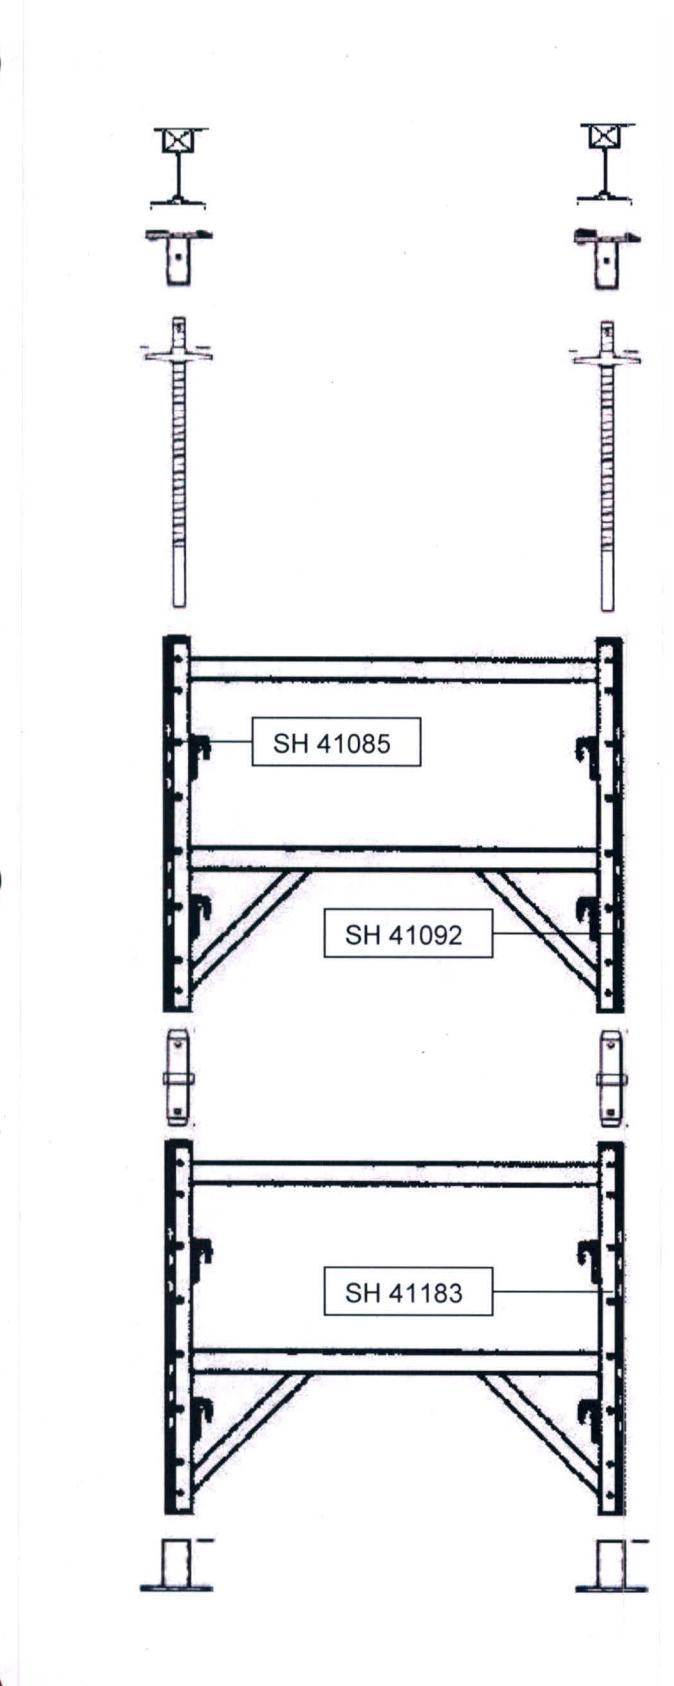
SH 41092 Broken with SH 41185 Top Frame of SH 41183 Connects to SH 41029 and SH 41005 Zone 41F-G
