**NEW YORK CITY
DEPARTMENT OF DESIGN + CONSTRUCTION**

November 2012

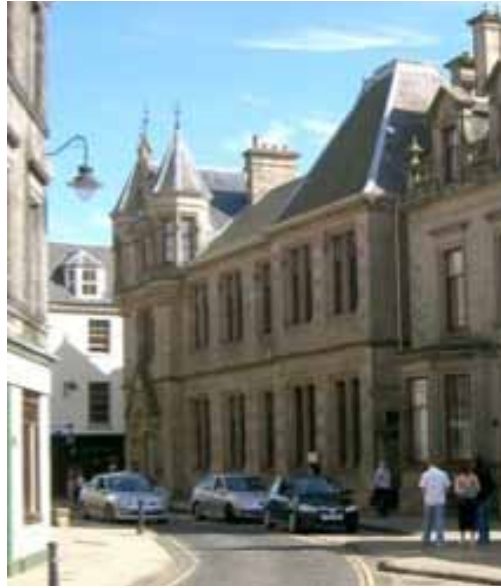
Figure 1. Andrew Carnegie's first donated library, Dunfermline, Scotland.

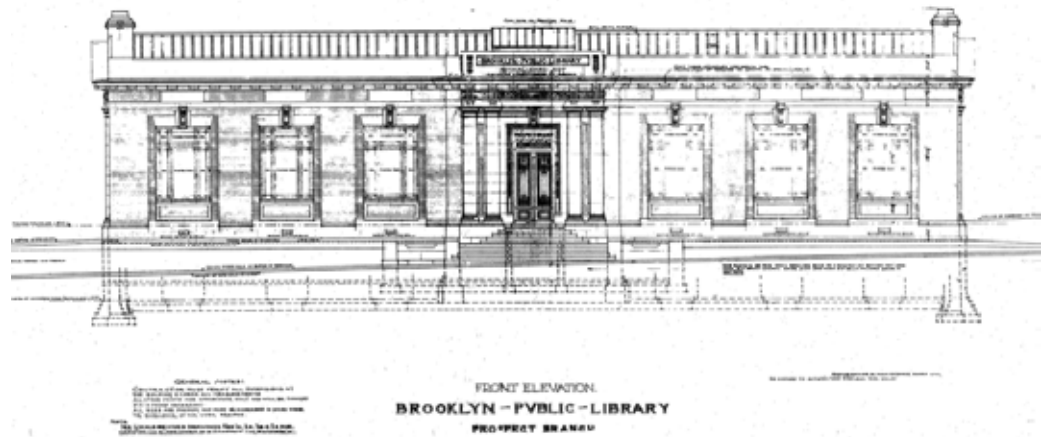
Figure 5. Original architect's drawing of the front elevation. Note: Full-size files of the architectural drawings, as well as additional drawings and photographs not part of the paper copies, can be found on the compact disc located on the inside rear cover of this report and in the web version at www.nyc.gov/ddc

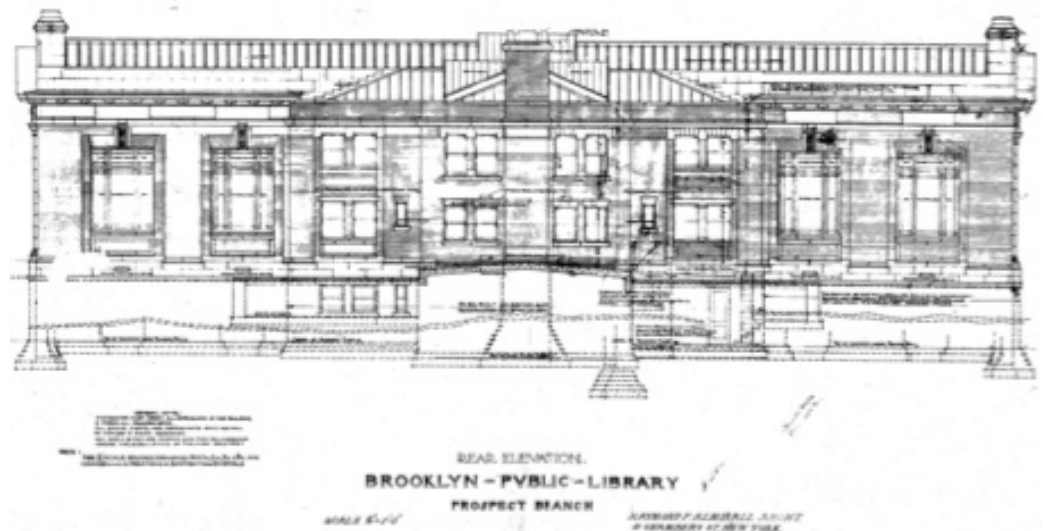
Figure 6. Original architect's drawing of the rear elevation.

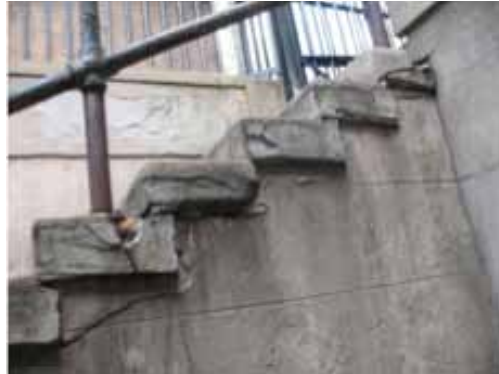
Figure 8. Example of an original parged wall, scored and pointed to resemble stone blocks. Also visible are the deteriorated bluestone steps and original pipe handrail.

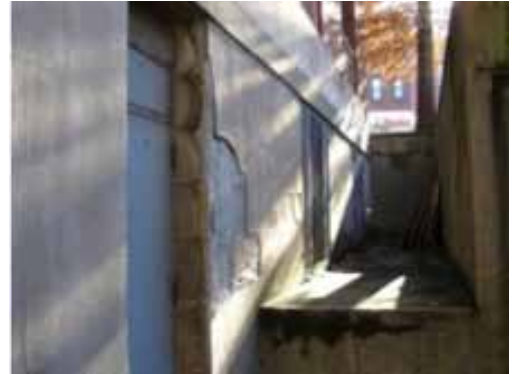
Figure 9. Basement wall of bluestone, now with deteriorated stucco covering.

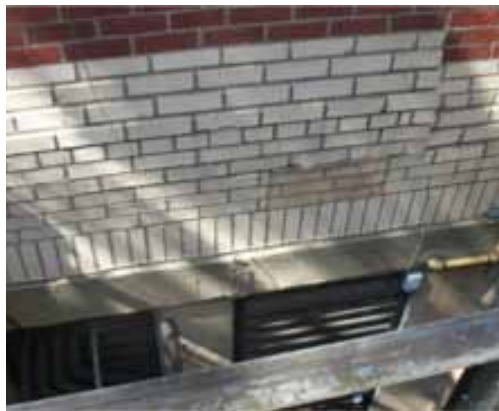
Figure 10. Originally substituted for limestone at the rear of the building to save money, the white brick is in deteriorated condition.

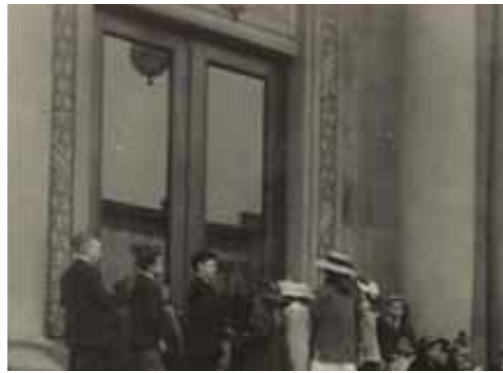
Figure 12. Original wood and glass entrance doors, without ironwork or transom.

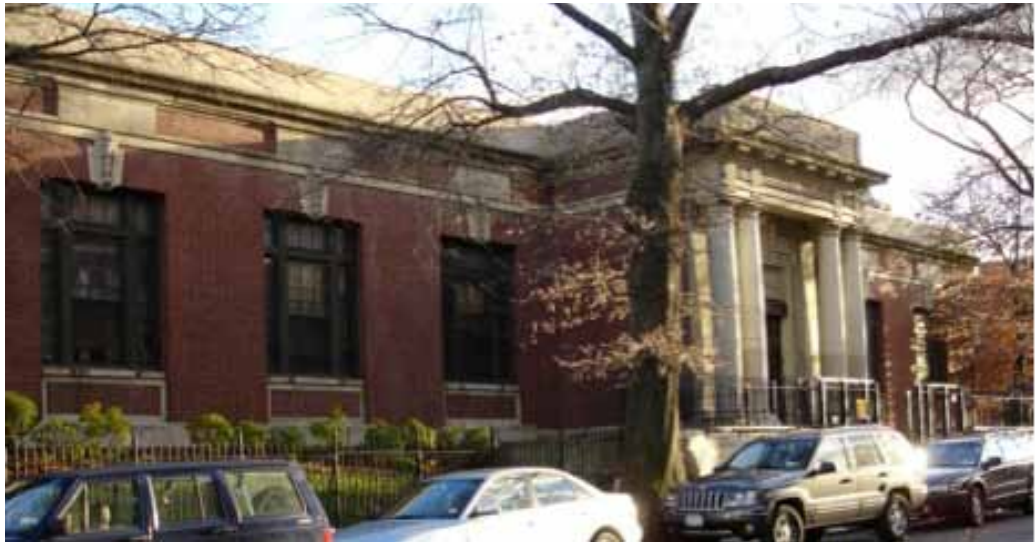
Figure 14. Main facade, looking from the northwest, ca. 2010. Other than the replacement windows and the picket fence, the building appears unchanged from its original condition.

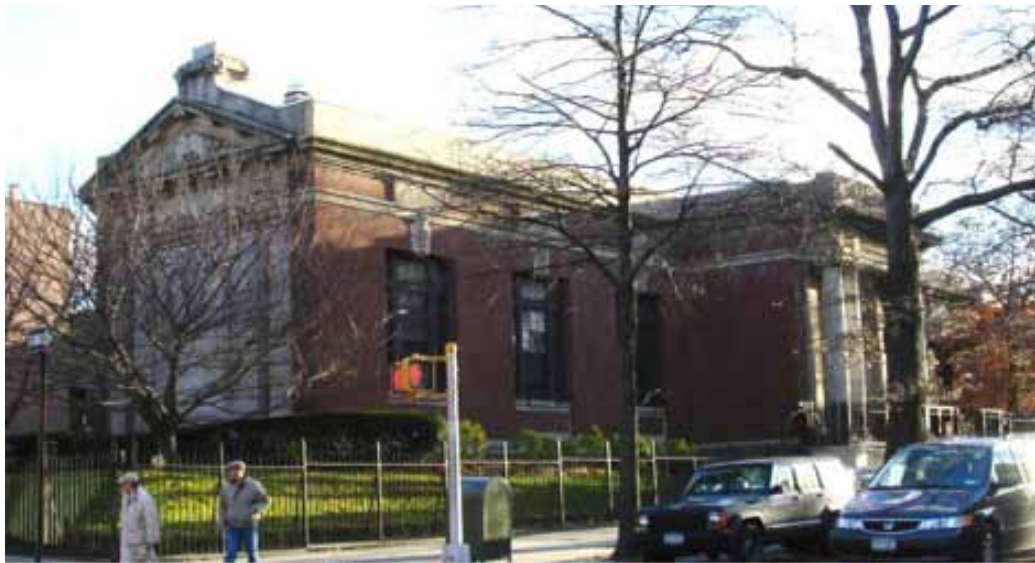
Figure 15. Main and north end facades, ca. 2010, showing the generous, planted site and picket fence. The deeper cornice and consoles that are seen at the end wall and over the main entrance were to have continued around the entire building, but their use was limited to save money.

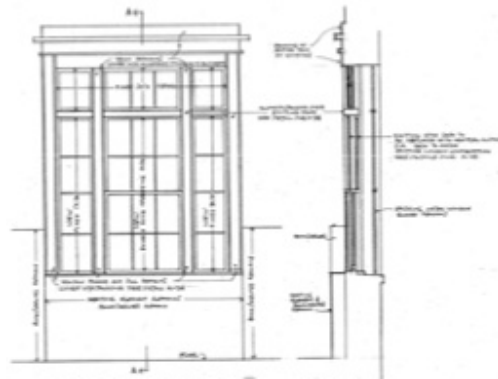
Figure 21. 1985 elevation and section of new monumental aluminum windows, replacing non-original wood windows of similar configuration.

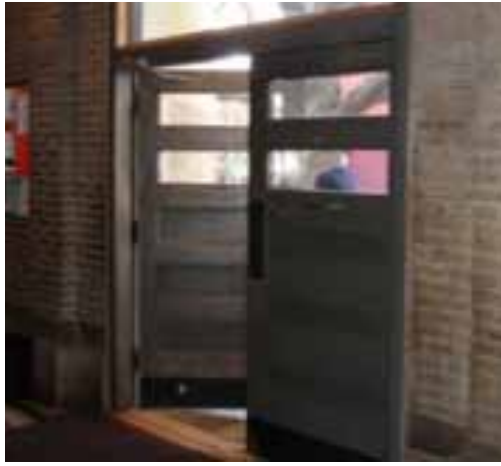
Figure 22. Main entry doors from the 1979 renovation.

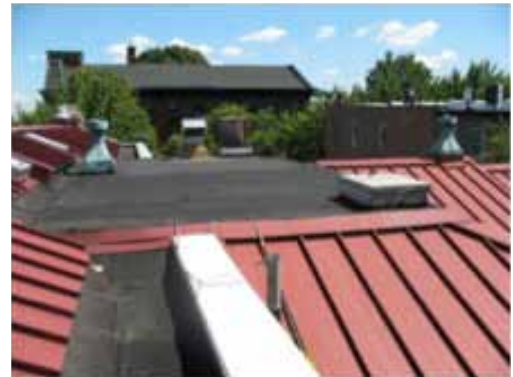
Figure 24. Typical roof conditions. The sky light over the book stacks was partly in the flat area of roll roofing and extended into the pitched roof, creating what must have been a complex sky light.

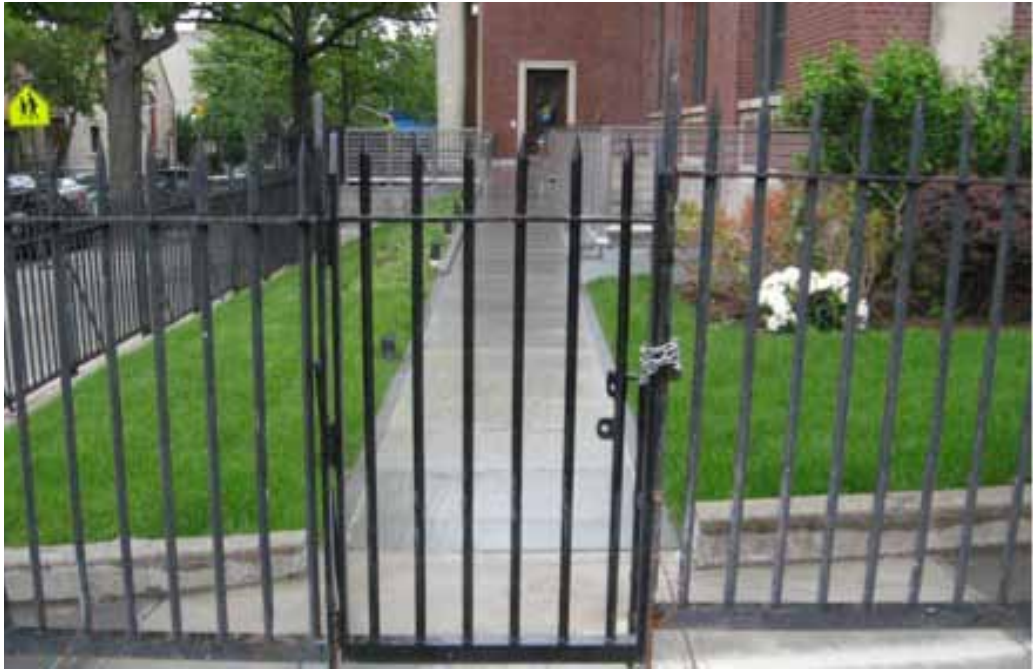
Figure 26. The phase 1 accessible entrance, including a new gate, bluestone walk and curbs, lights, bridge over the areaway, and new limestone-trimmed door into the Vestibule.

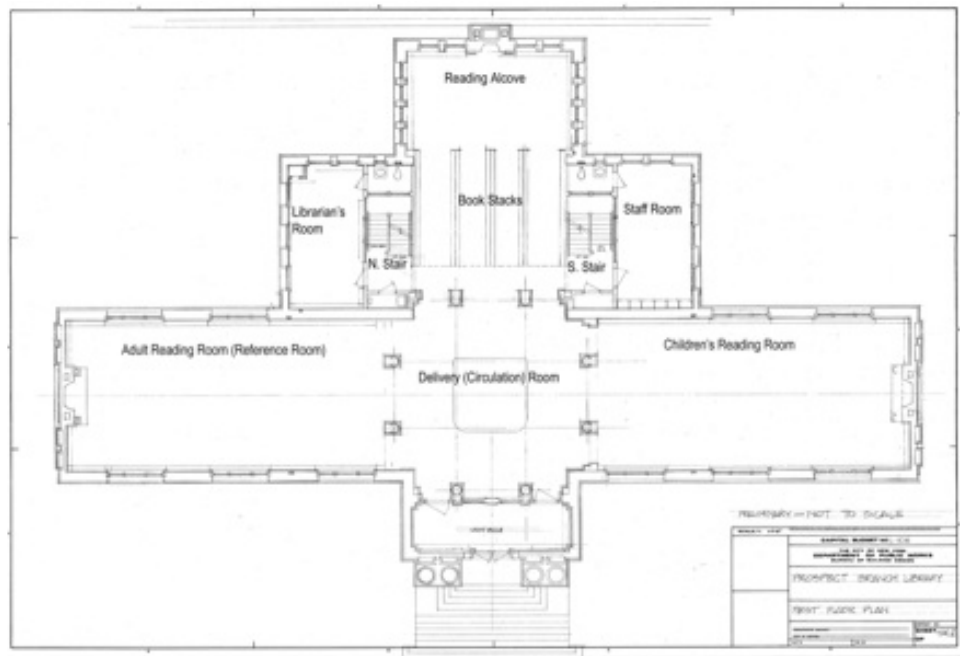
Figure 27. Original First Floor Plan.

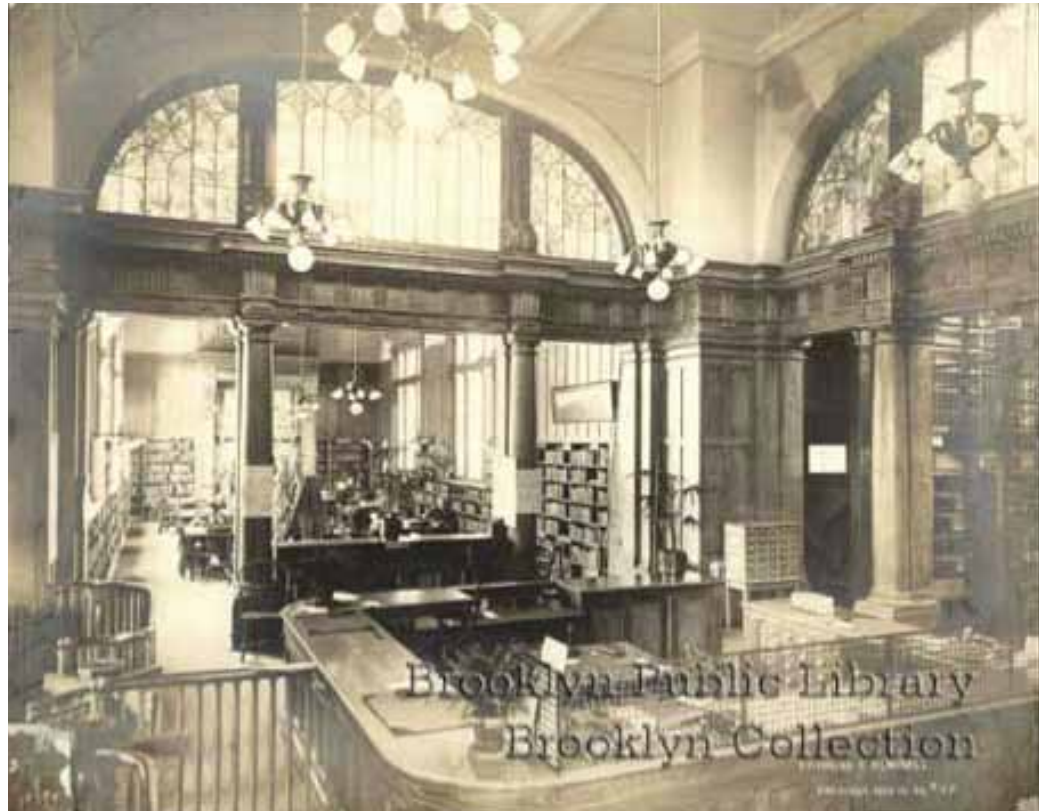
Figure 34. The main and mezzanine floors of the library were originally flooded with natural light from the monumental reading room windows and from three opalescent leaded-glass lay lights with sky lights above. Photo is ca. 1906. Many early photographs of the interior, including figs. 34-38, were taken by Frank Pearsall, Photographer, 1227 Bedford Avenue.

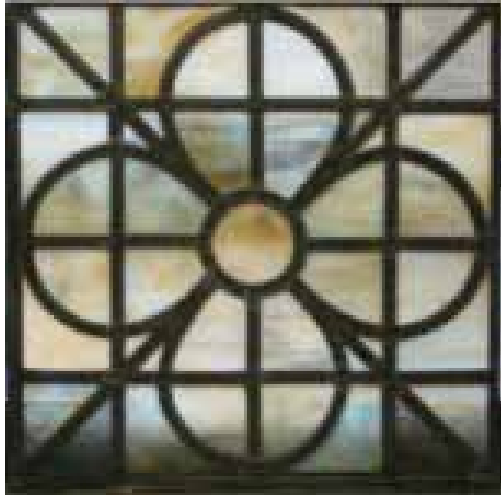
The main and mezzanine floors of the library were originally flooded with natural light from the monumental reading room windows and from three opalescent leaded-glass lay lights with sky lights above. (See “Exterior” section for a discussion of the windows.) The opalescent glass may have been manufactured by Kokomo Opalescent Glass of Kokomo, Indiana.¹³ Still in business today, Kokomo was founded in 1888 and in its early years, according to its web site, supplied glass to Louis C. Tiffany, J&R Lamb, and LaFarge.¹⁴ Light passed between rooms by means of enormous arched, translucent, leaded-glass transoms separating the delivery space from the reading rooms, mezzanine, and entrance vestibule. It is not known who fabricated the glass into leaded, ornamental panels.

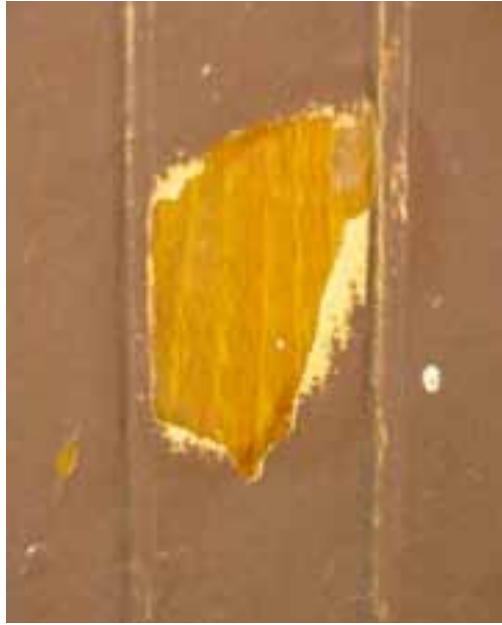
Figure 40. Likely original finish of the bead board wainscot at the south stairway, beneath later coats of paint.

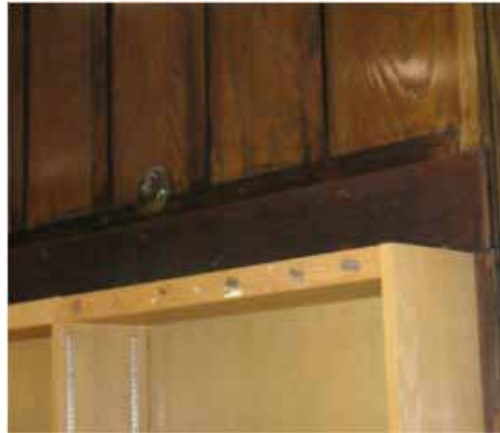
Figure 41. Typical condition of reading room paneling at the start of construction. Note also the blanked off wall sconce location and the infill board between the 1979 shelves and bottom of the panels.

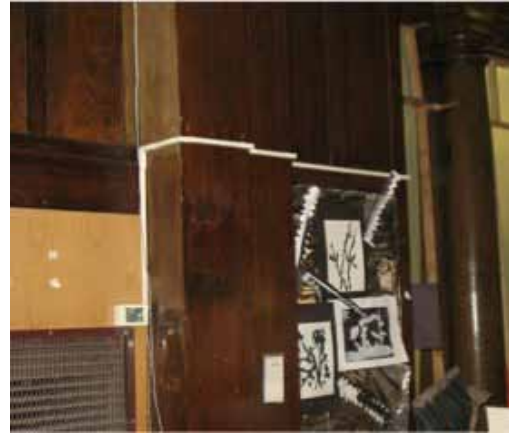
Figure 42. Mismatched wood at the air duct and badly-designed accretions mar the original design.

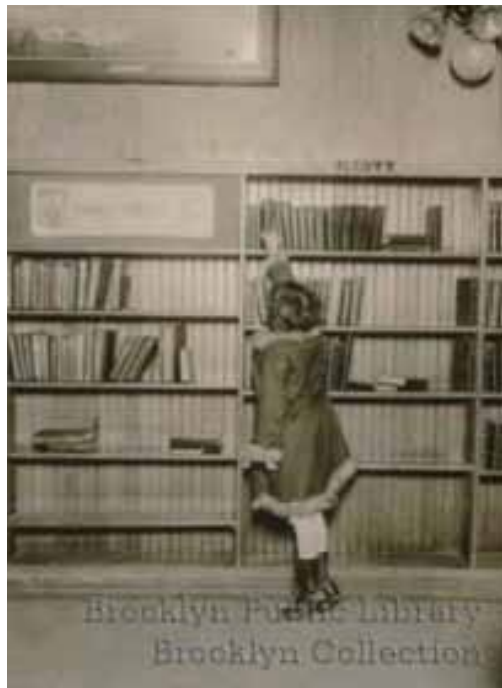
Figure 45. Original wood shelving in the Children's Room, showing the beadboard backing.

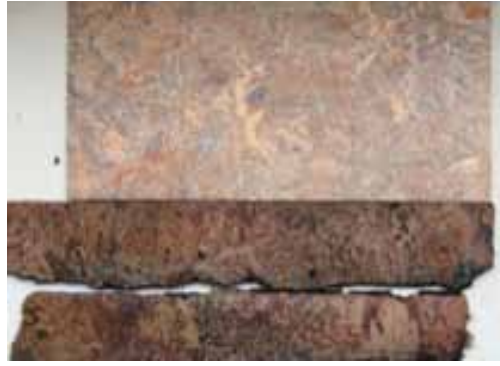
Figure 48. The two strips at the bottom are remnants of the original flooring in the public rooms; on top, the modern linoleum ("Donkey Island" by Forbo) is the closest available match.

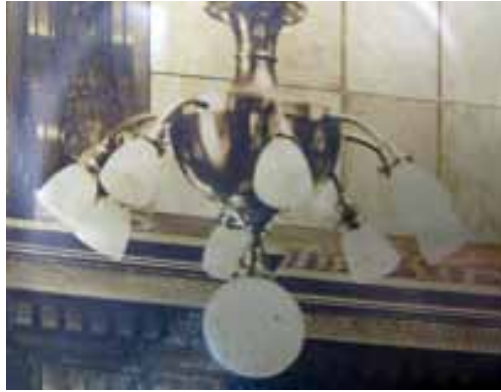
Figure 49 Original 9-light chandelier in the delivery room. Fixtures in the reading rooms were similar, but with 7 lights.

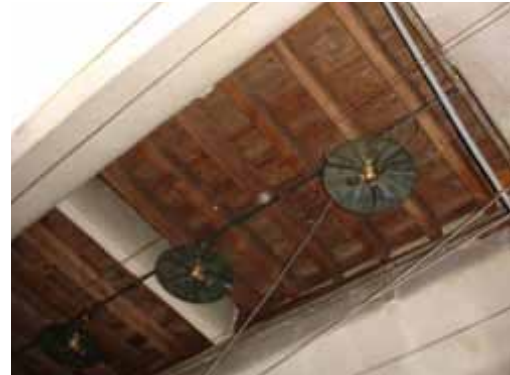
Figure 52. View above the vestibule lay light, showing original reflector light fixtures and ropes for extending and retracting the fabric shades. Unpainted wood elements infill the original skylight locations.

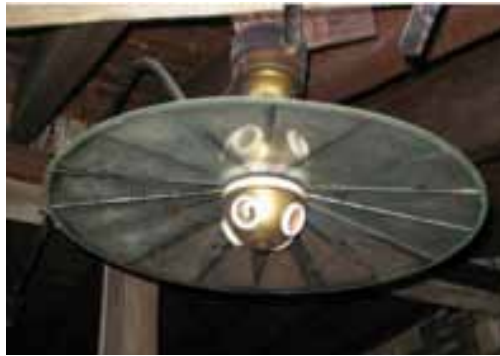
Figure 53. One of 6 original 4-bulb mirror reflector fixtures above the book stack lay light.

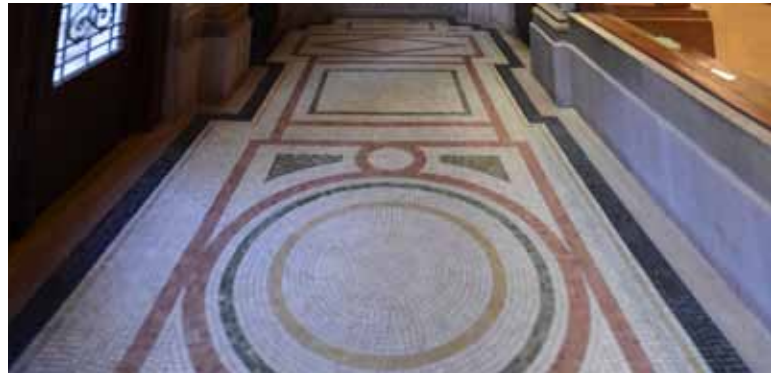
Figure 56. The original mosaic tile vestibule floor is in very good condition.

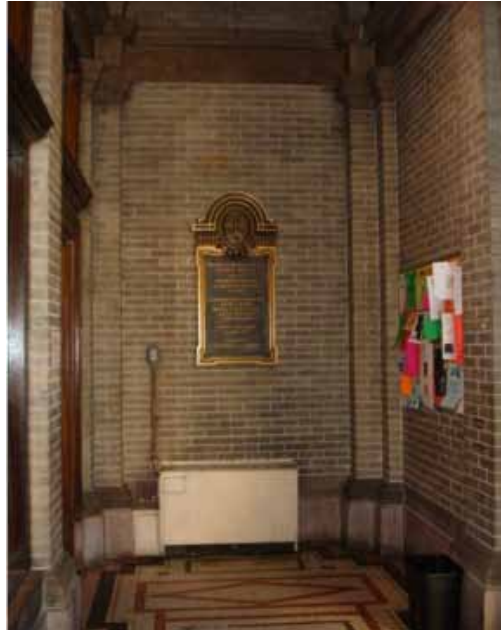
Figure 57. The main vestibule looking south towards the location of the new accessible door. The original plaque will be relocated to the opposite wall.

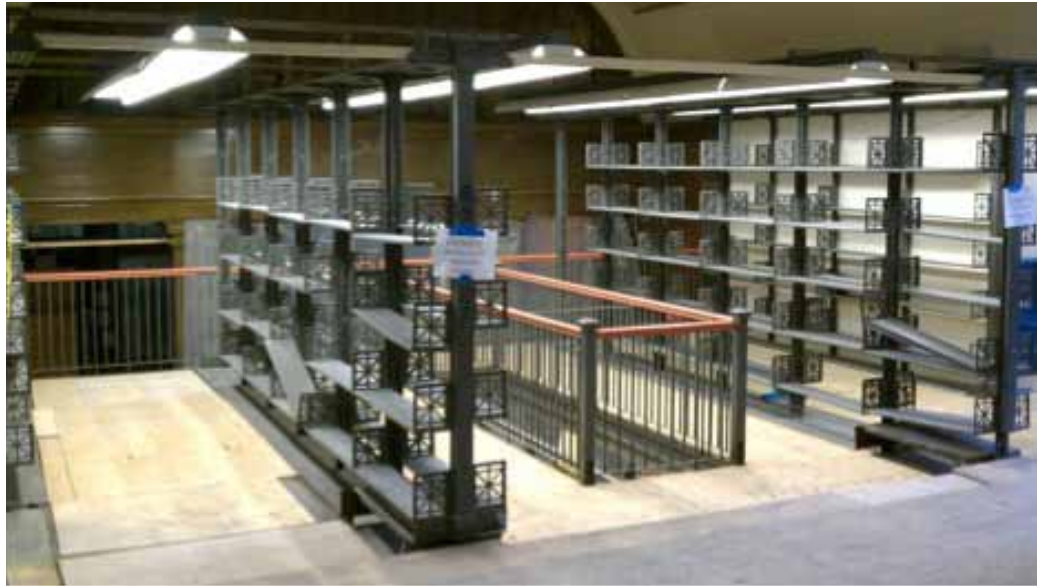
Figure 59. Pre-phase 3 construction showing second level of original Library Bureau stack system, including railings, vertical standards (originally bronze plated), shelves and bookend brackets (originally painted black). Glass floor remains under vinyl tile and plywood. Lights probably date from the 1950s.

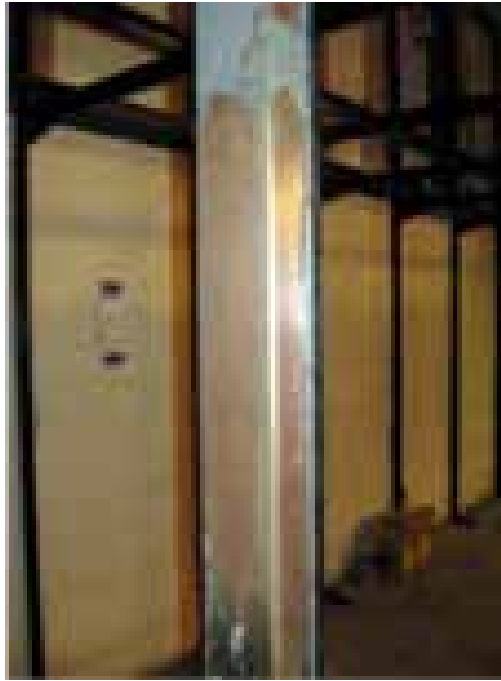
Figure 60. Test stripping of an end pilaster revealed the original bronze plating.

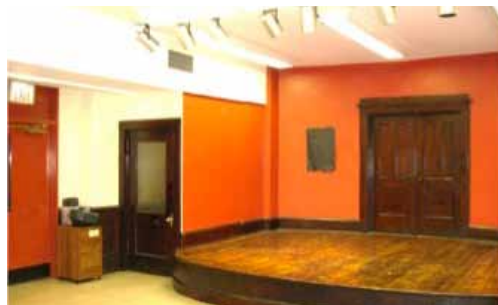
Figure 68. Original stage, apron, and double doors to the reception room. The single wood and glass door is probably typical of the original doors in the building. At the far left is the modern door leading to the lower vestibule.

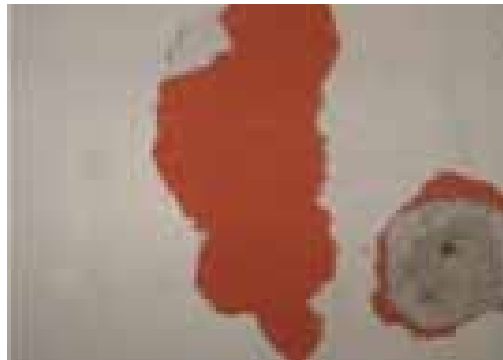
Figure 69. As in the mezzanine reference alcove (fig. 65) and lower vestibule (fig. 71) this terra-cotta paint in the reception room appears to be the first layer on a sanded plaster base.

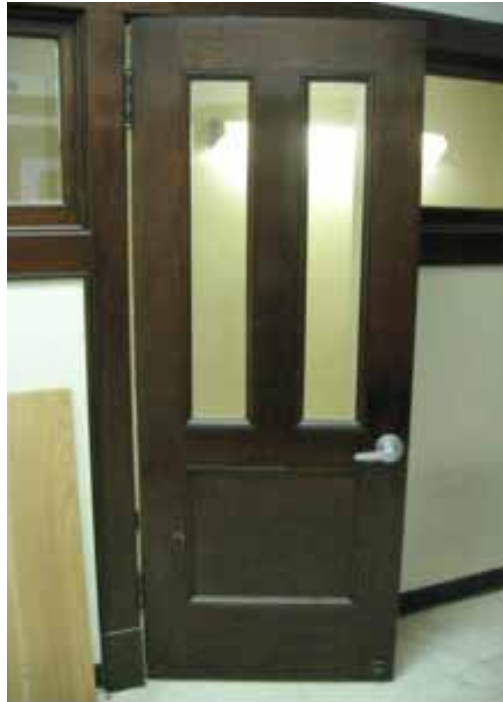
Figure 70. Another original oak door, flanked by transom windows. This view looks out from the reception room to the corridor.

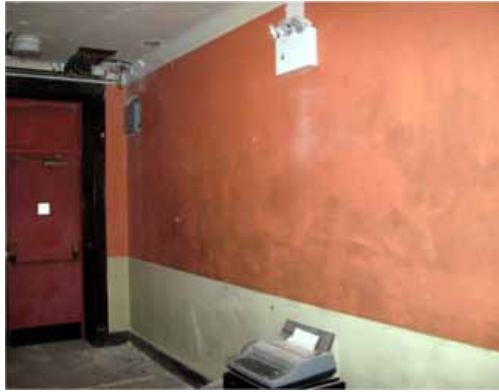
Figure 71. Lower vestibule with possible original paint finishes. At the left is one of the double leaves of the modern doors (casing is original) leading to the outside areaway. The room has since been painted white by Brooklyn Public Library.

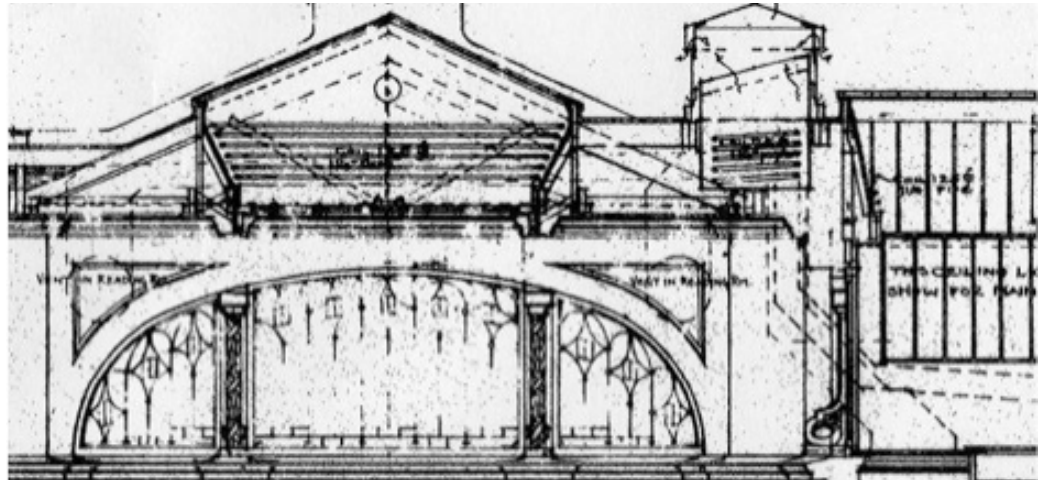
Figure 72. Detail of the original architect's drawing showing part of the elaborate ventilation system. Note the "Vents in Reading Room" (no longer extant) leading to a "Star Ventilator" on the roof with heating coils to ensure good upward air flow.

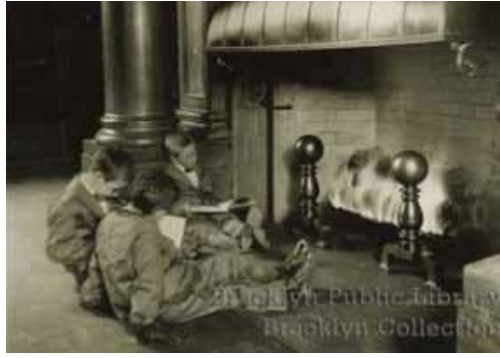
The extensive, well-maintained plantings on the site enhance the building and its immediate environment. The historic perimeter fence is in relatively good condition but needs painting, including especially the original section of decorative fence at the east property line. It is recommended that the added portions of the fence, including its extensions on top of the front bluestone walls and across the stoop, be removed to present a less forbidding aspect to the neighborhood. New street trees should be requested at the intersection of 9th Street and 6th Avenue, where two or three large trees have recently been removed. This planting would enhance the green oasis character of the library's site.
