APPENDIX “B”
Wood Formwork Testing and Report
Wood Advisory Services

Submitted to:
Mr. Dan Eschenasy, PE
Chief Engineer
NYC Department of Buildings
280 Broadway • 7th Floor
New York, NY 10007

Evaluate the lumber and plywood associated with the 42nd floor concrete formwork collapse at 246 Spring Street, New York, NY. Inspect and determine the visual grades of the lumber, document grade stamps observed, perform microbiological analyses to verify the presence or absence of wood decay, and perform mechanical testing to determine residual property values. Provide current allowable working stresses for the lumber and the estimated ultimate strength of the lumber at the time of the collapse.

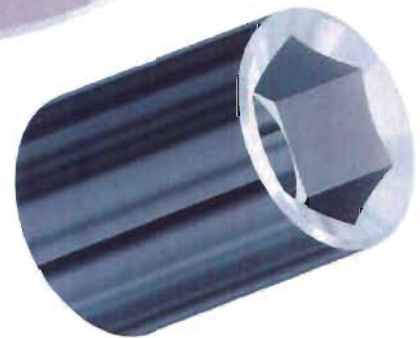
(1001) ST-1 SNAPTIE - STANDARD

The ST-1 Standard Snaptie has round heads, anti-turn deformations and 1" breakback. A 1/2" breakback is available on special order. The Snaptie is available equipped with either plastic spreader cones or loose metal washers. For additional rust and corrosion resistance, the Standard Snaptie is available in stainless steel as an ST-8.

NOTE: The plastic cones, furnished from high impact polystyrene, are available in the sizes 1x1, 1x1-1/2 and 1x2. Cones are preferred over a loose washer tie since it covers the break back portion of the tie. Such guarantee of break back is not available with the loose washer tie. When removed the plastic cone also provides a better cavity for grouting purposes. Attempting to break-back any tie, before the concrete has been allowed to properly set, may result in the entire tie turning freely in the wall, making the normal breakback procedure no longer possible. Washer style snapties should be removed before 24 hours of concrete pour.

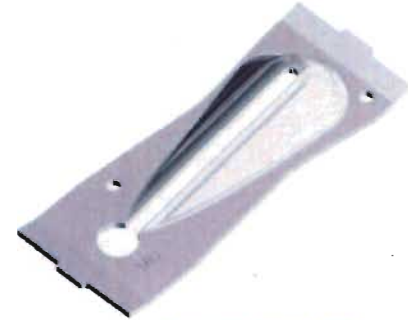
The ST-21 Snaptie Wrench is used to quickly and easily break-back snapties. After the forming has been stripped the Snaptie Wrench captures the snaptie end. The tie is bent down to a position nearly parallel to the face of the concrete and a subsequent clockwise rotation of the wrench breaks the tie at the breakback point.

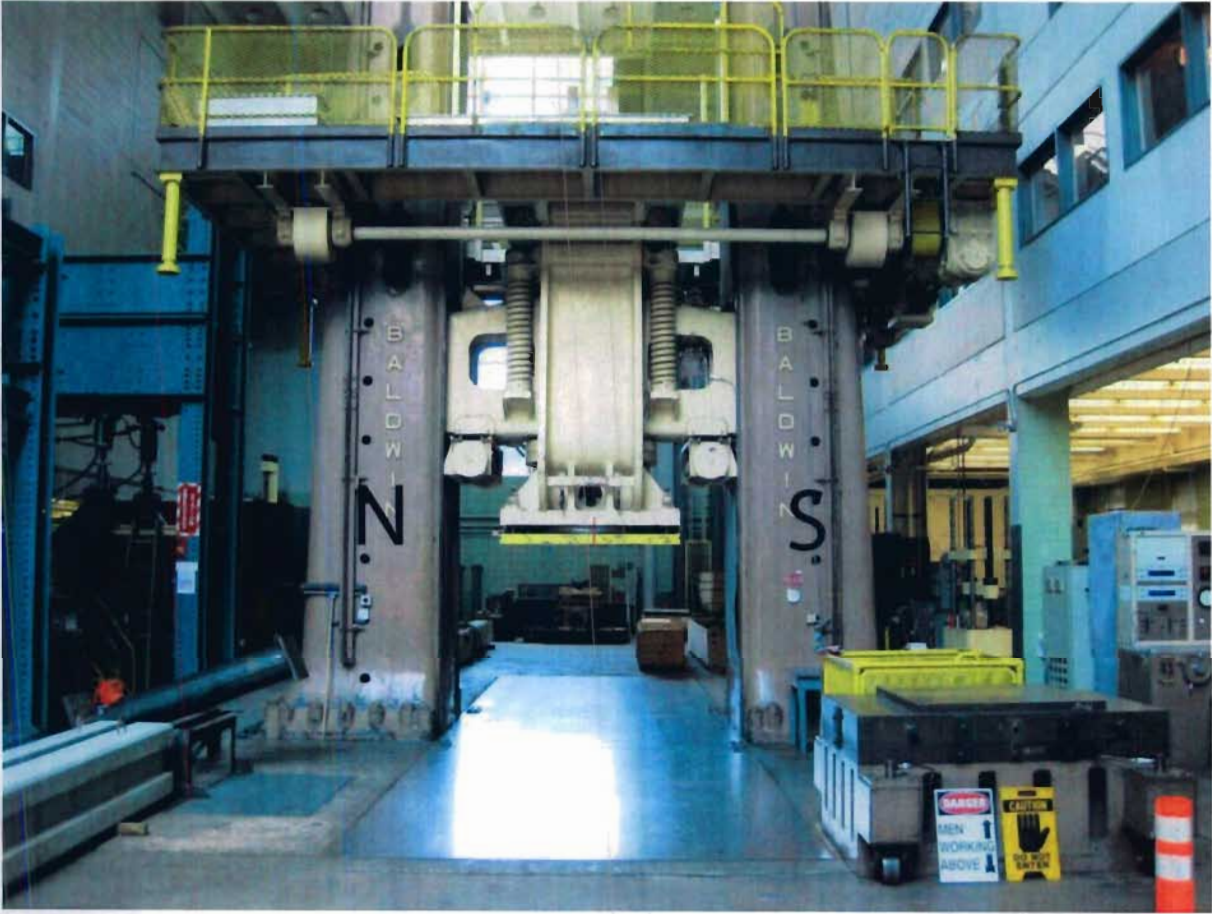
Figure 13: 5,000K Machine with Columns Labeled N for North and S for South West is in front of the machine, and East is in the back

The locations of the sensors used for the testing are given using the cardinal directions. Figure 13 Shows the North and South directions relative to the 5,000K testing machine. Figure 14 shows the five string pots and their designations.
