2016 NYC DOT Bridges & Tunnels Annual Condition Report

NEW YORK CITY DEPARTMENT OF TRANSPORTATION DIVISION OF BRIDGES 2016 BRIDGES AND TUNNELS ANNUAL CONDITION REPORT

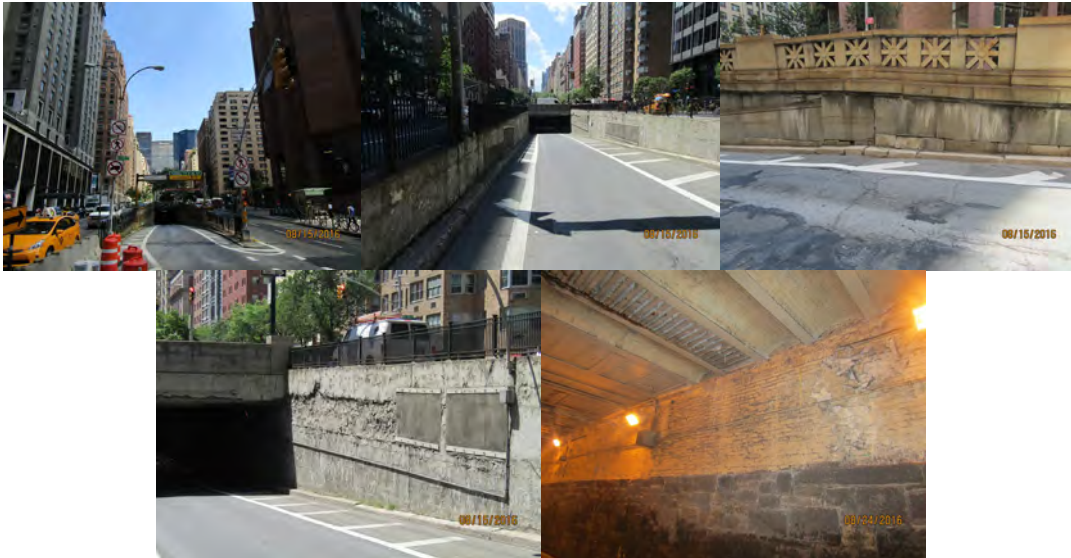
Park Avenue Tunnel – Left and Right Elevations in 2016. Begin Left Wingwall - Stones are Partially Dislodged, Cracked and With Missing Mortar. End Right Wingwall - Wall is Spalled and Exhibits Hollow Concrete Areas That are Shielded With Wire Mesh. End Abutment (Near South Portal) – Bricks Exhibit Deteriorated Mortar. (Credit: NYSDOT)

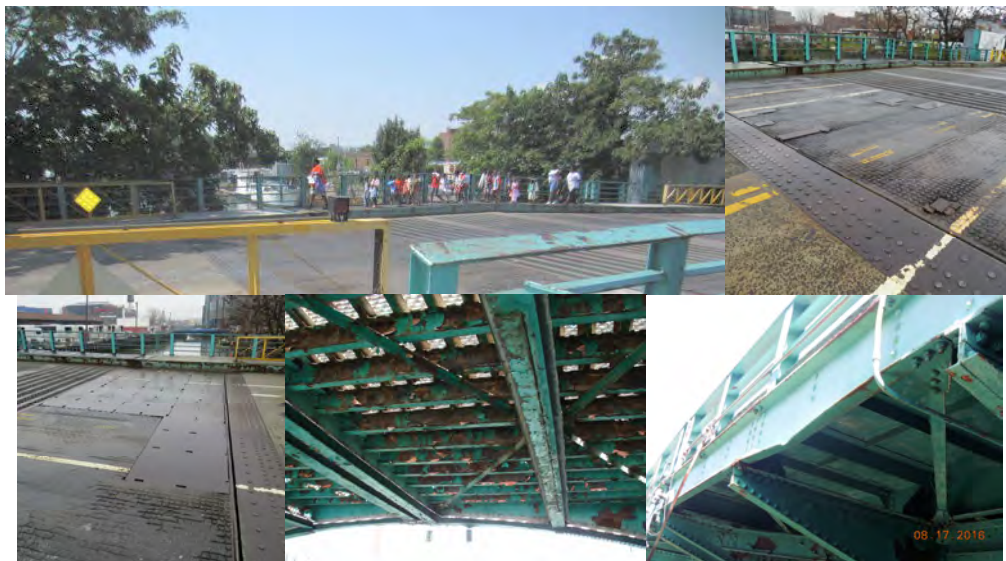
Union Street Bridge - Schoolchildren Crossing in 2012. (Credit: NYSDOT) Steel Plates Covering the Steel Grid Deck. 2016: Severe Corrosion and Peeling Off Paint Under Deck of Span #3. Span 3 - The Left Fascia Stringer Exhibits Impact Damage. (Impact Credit: NYSDOT)

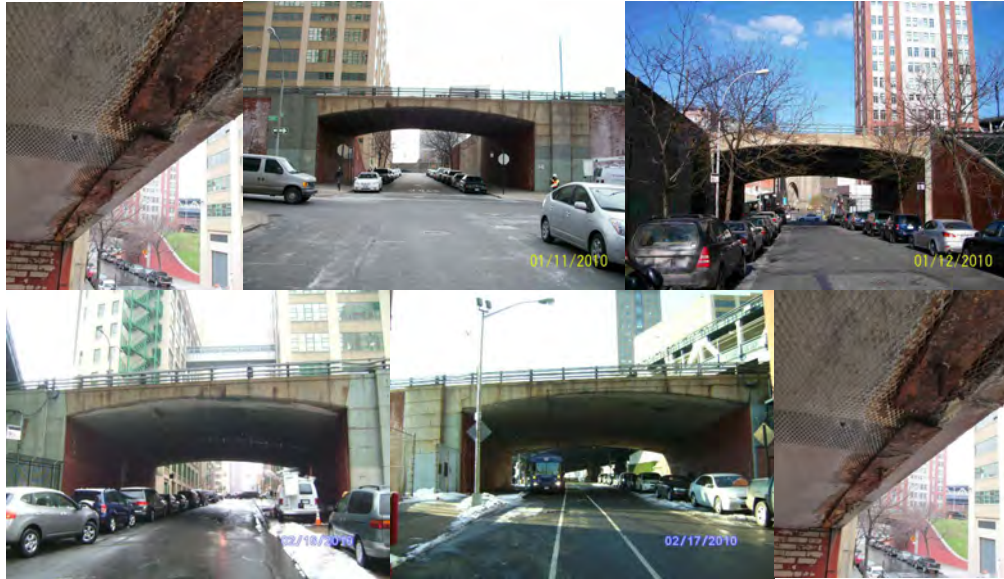
In general, the arch bridges have an adequate load-carrying capacity, however, there are areas of map cracking and visible leakage through the joints. Mesh has been installed at the underside of the deck to prevent debris from falling on vehicles or pedestrians below.

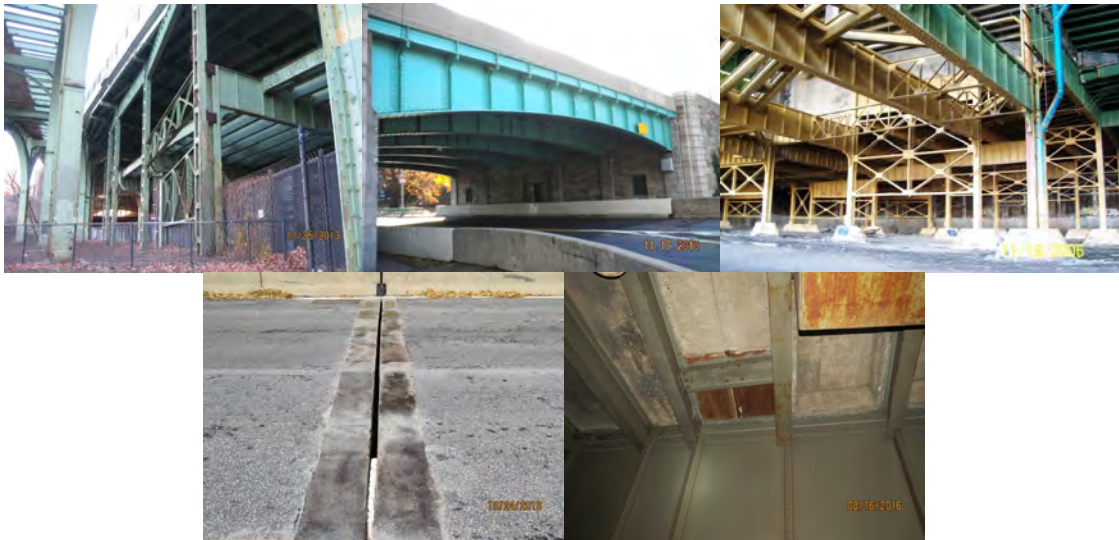
West 72nd Street Viaduct Left Elevation Spans #1 -5, and Span #107. Piers #3 – 10. 2016: Pier 102, Deck Joint at Southbound Roadway – Missing Joint Sealer Material. Span 143, Underside of Deck – Deep Spall.
(Credit: NYSDOT)

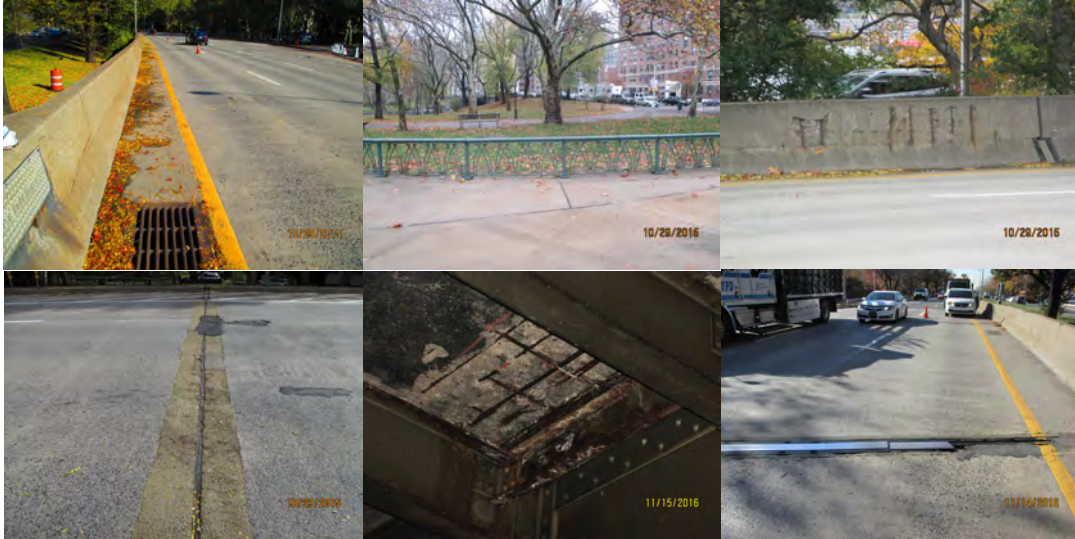
West 94th Street Viaduct – 2015: Span 34 Left Lane. Span 12 Right Railing and Left Side Concrete Parapet. Span 31 Top of Deck. 2016: Span 4 – Spall With Exposed Rebar. Pier # 3, Deck Joint, Northbound Henry Hudson Parkway, Left Lane – Joint Missing Metal Plate. (Credit: NYSDOT)

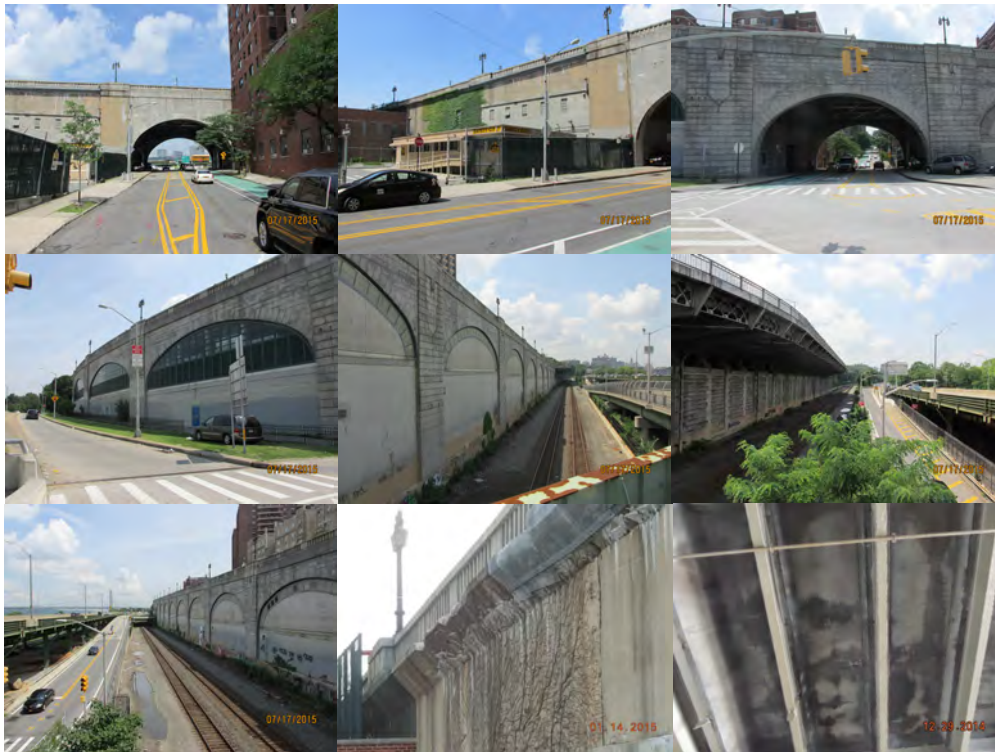
2015: Left Elevation Span 14, Spans 15 – 20. Right Elevation Span 14, Spans 13 – 1, 15 – 77, 41 – 77, and 43 – 13 (Section over NYCDOT Maintenance Garage Area). (Credit: NYSDOT) Spans 19-21, East Fascia Overhang, Looking Southwest - Large Edge Spalls with Numerous Cracks and Heavy Efflorescence Throughout Overhang. Span 52 Looking South - General View of Underside of Deck Showing Extensive Dampness and Cracks with Efflorescence.

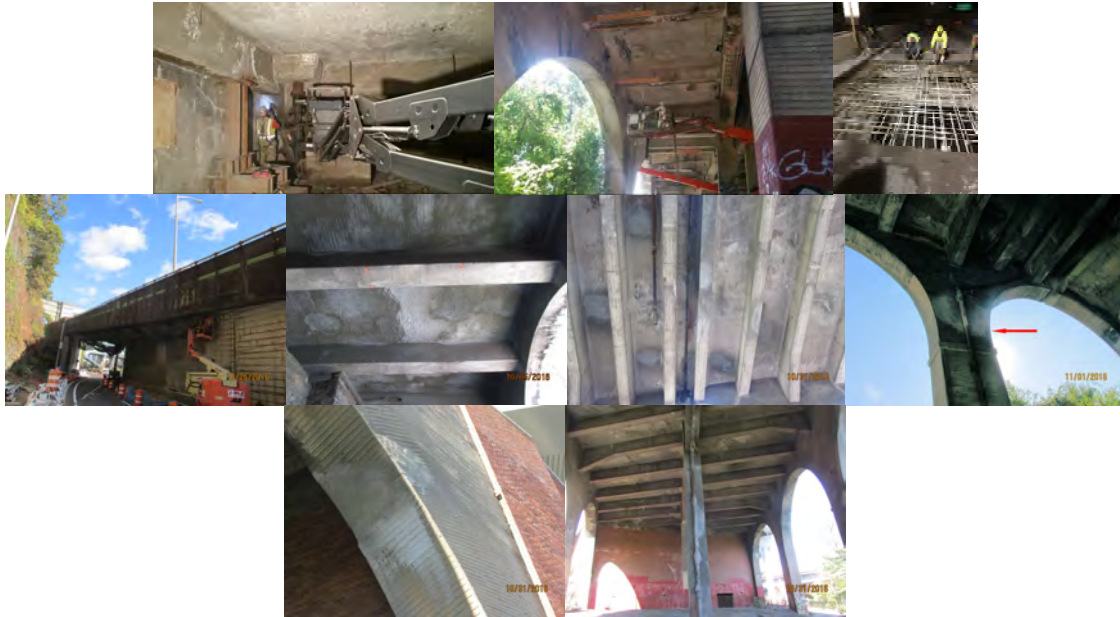
2016: Demolition of Spalled Concrete. Application of Shotcrete. Through Hole Deck Repairs. October 2016: Spans 11-18 Nylon Shielding. Span 27 Deck Repairs. Span 47 Floor Beam Repairs. Pier 43 Right Column Repairs. Span 51, Underside of Right Arch - Concrete Repairs. Pier 49, at Center Column - Concrete Repairs. (Shielding and Repair Credit: NYSDOT)

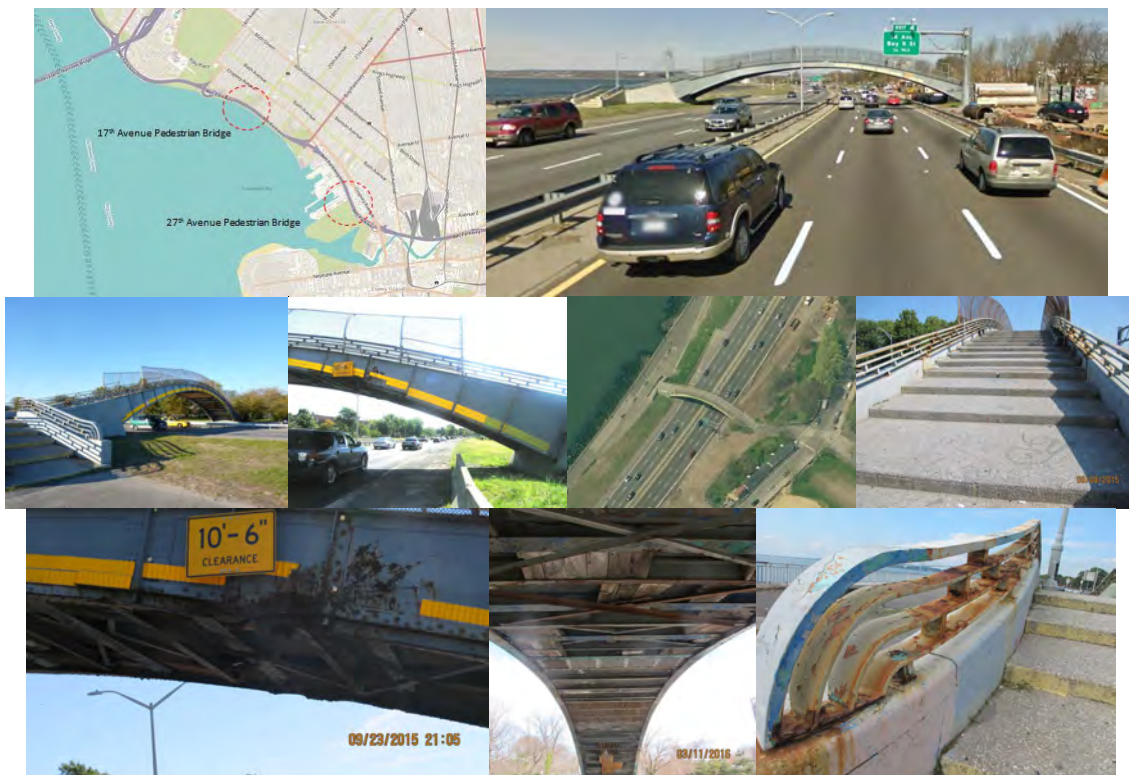
Location Map. 17th Avenue Bridge – Existing Conditions. Deteriorated Left Girder. Top of Span 1, Looking North – Wearing Surface has Extensive Scaling with Exposed Aggregates. Span 1 Left Girder over Belt Pkwy Eastbound Left Lane was Struck in September 2015. March 2016: New Bracing Under Span 1. October 2016: Beginning Approach, Left Side – Extensive Corrosion on the Guide Railing.

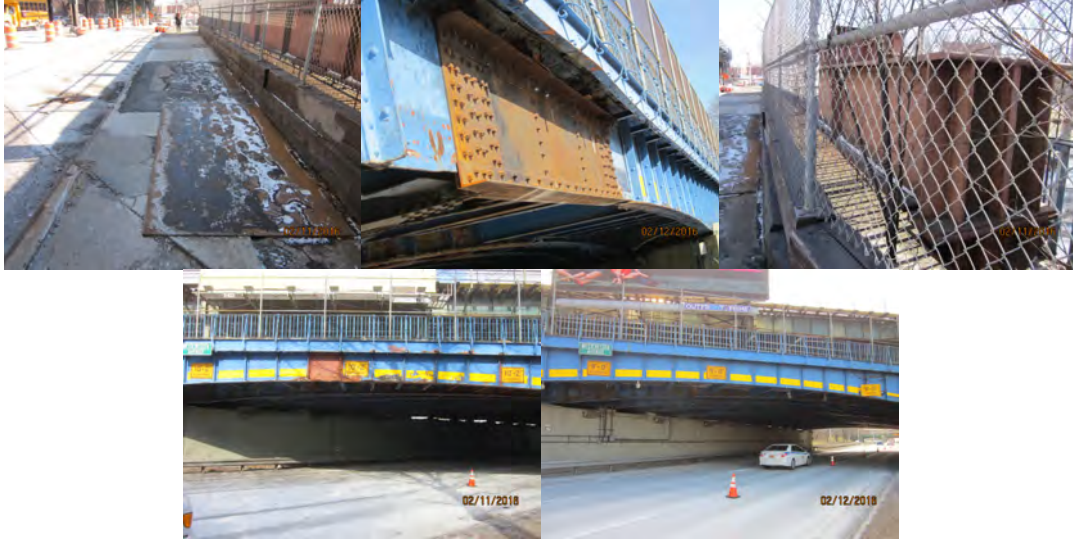
2016: Span 1 Right Sidewalk Near Beginning Abutment – Steel Plates. Girder Reinforced With New Steel Plate and Angles. Strongback Girder at Right Side of Span 1. Right and Left Fascia. (Credit: NYSDOT)

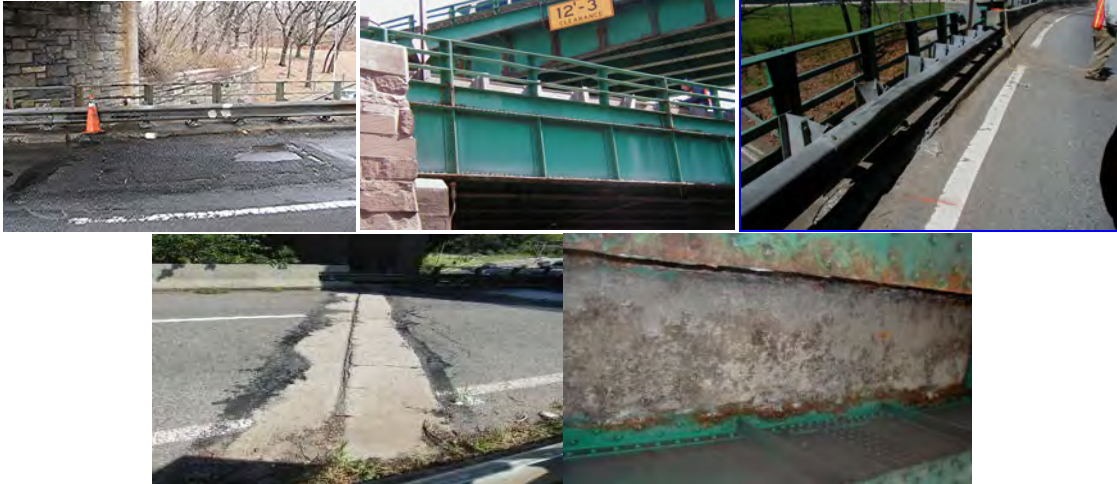
South and North Fascia - Along the Fascias are Built-Up Riveted Steel Girders. The Steel Railing Posts are Welded at the Base to the Top Flange of the Fascia Steel Girders. Deterioration of Joint at Abutment. Underside of Deck with Scaling and Efflorescence.

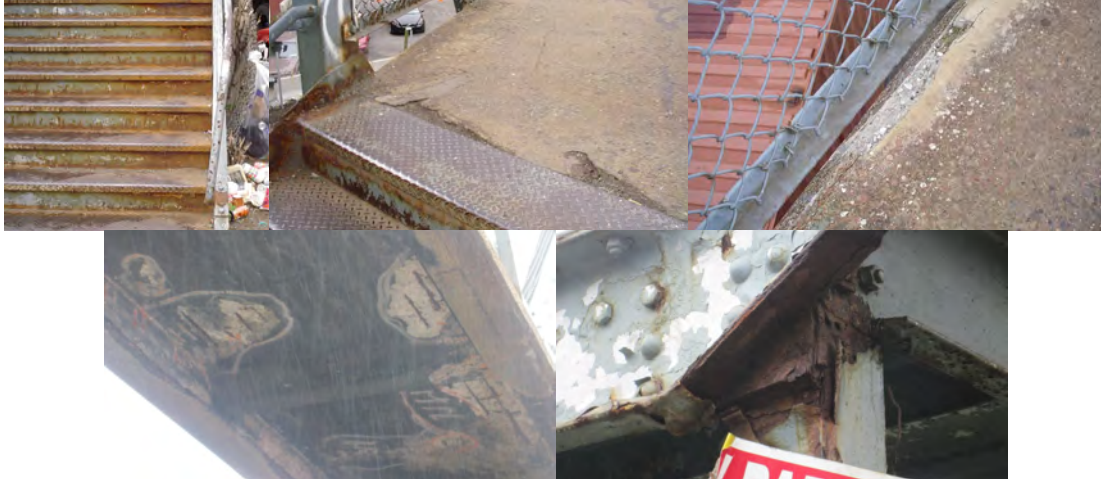
Existing Conditions: Rusted Steps and Damaged Railing. Deteriorated Deck. Spalled Concrete Deck on Main Span. Spalled Concrete – Underside of Deck. Deteriorated Steel.

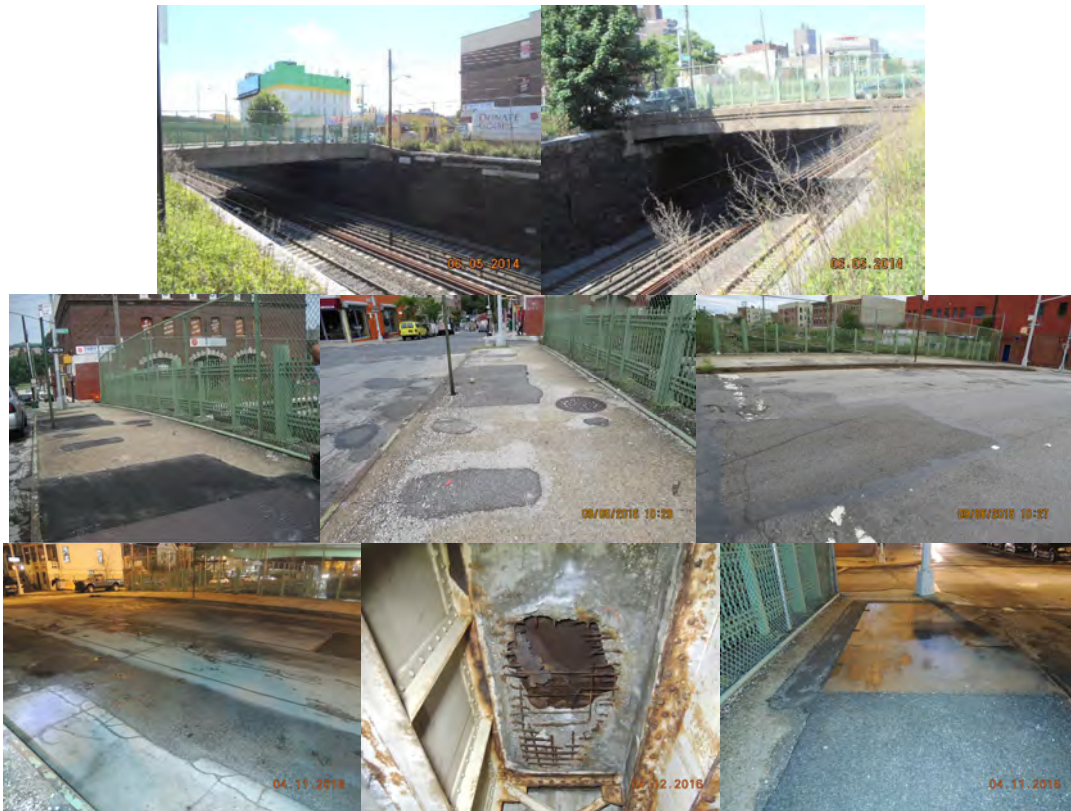
2014: East 175th Street Bridge Left and Right Elevations. (Credit: NYSDOT) Sidewalk and Road Conditions in 2016. April 2016: Span 1, Wearing Surface at Mid-Span – Uneven Asphalt Patches on Approximately 40% of the Surface Area. Underdeck of Span 1- Through Hole and a Deep Spall With Exposed Rebar Near the End Abutment. There is a Steel Cover Plate Above. (April Credit: NYSDOT)

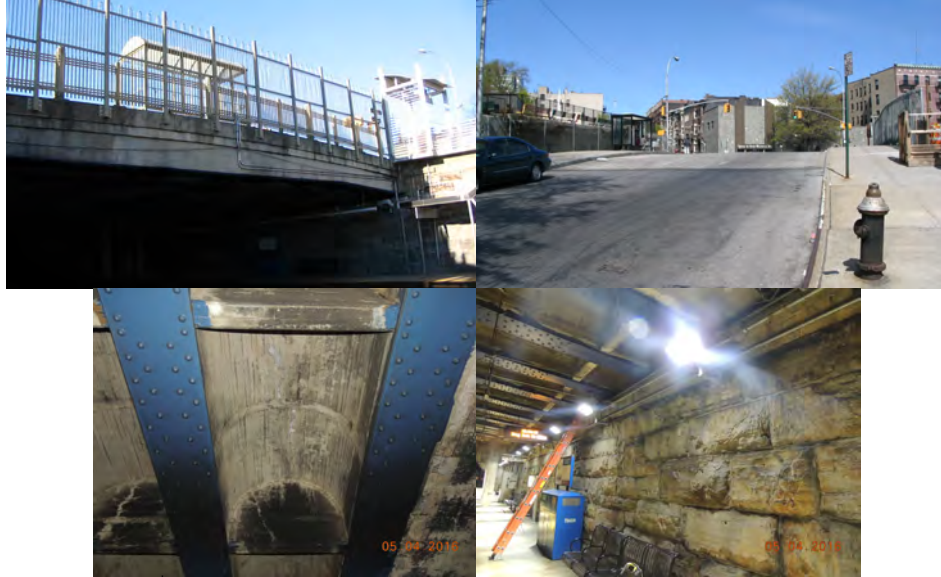
East 162nd Street Bridge over MNRR. May 2016: Span 1, Underside of Deck Exhibits Longitudinal Cracks With Efflorescence. End Abutment Stem. (Credit: NYSDOT)

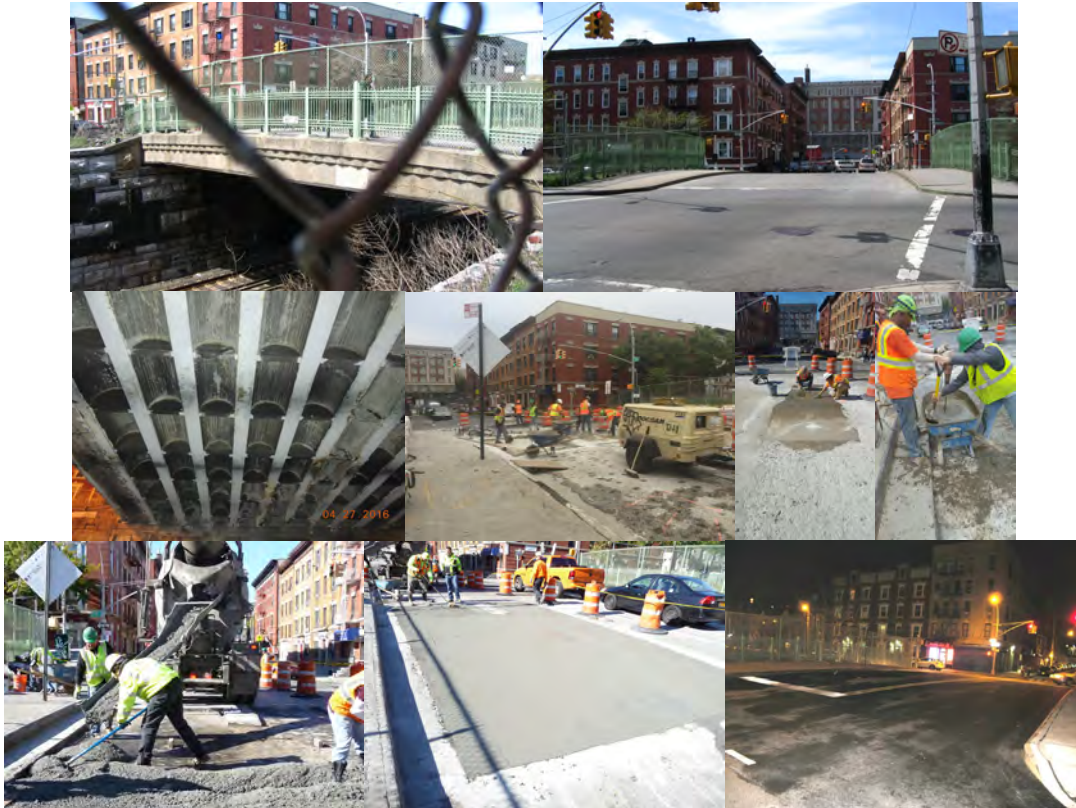
East 187th Street Bridge over MNRR. April 2016: Span 1, Underside of Deck Exhibited Minor Mapcracking and Efflorescence. (Credit: NYSDOT) Work in July and October 2016. Top of Span 1 – Wearing Surface Paved With New Asphalt.

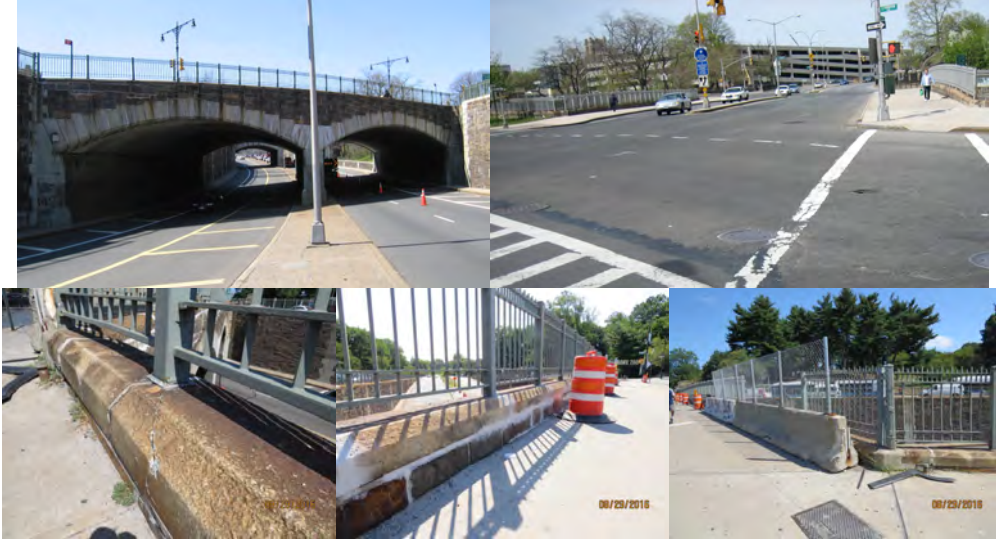
Southern Boulevard Bridge over East Fordham Road. August 2016: Cracked Cap Stone at Right Wingwall. Repaired Joints on Right Parapet. Jersey Barriers and Fence Above the Deck on Span 1.

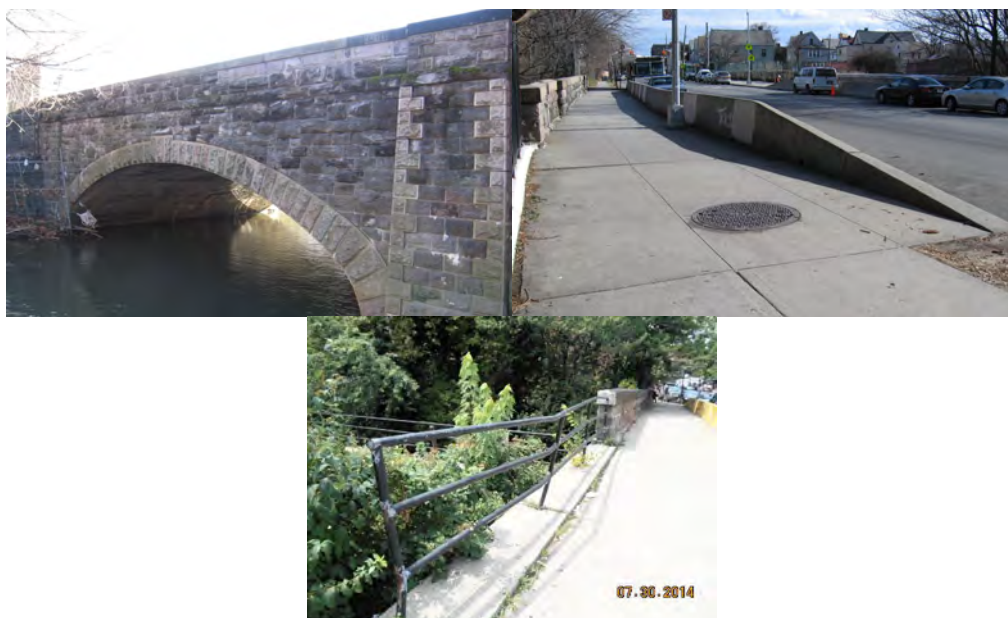
East 180th Street Bridge over Bronx River. July 2014: Bent Railing at Side Approach.
(Railing Credit: NYSDOT)

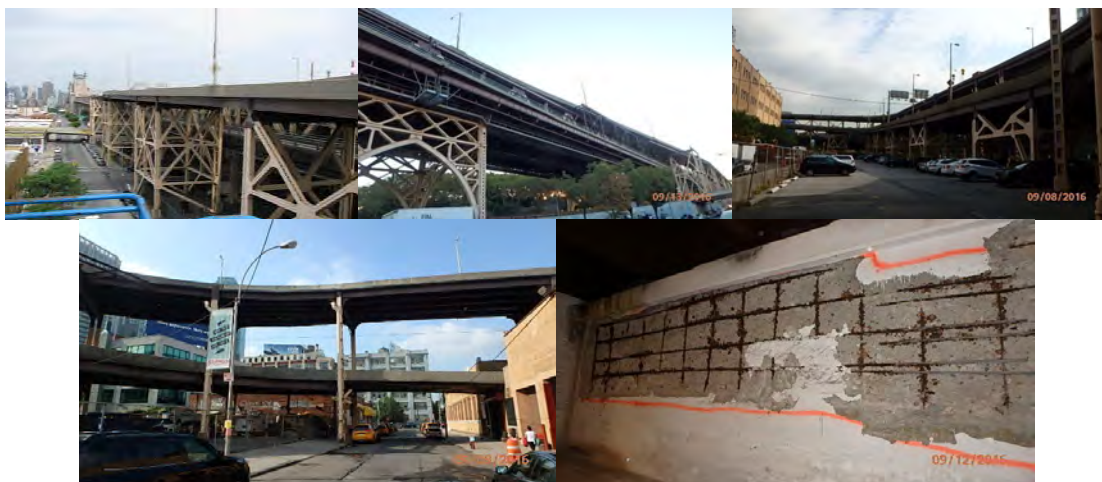
Ramp to 21st Street From NY Over 22nd Street. September 2016: Elevation Right Spans 1 to 12, 22 to 36, and 37 to 39. End Abutment Stem Wall – Spalled Concrete With Exposed Rebar. (Credit: NYSDOT)

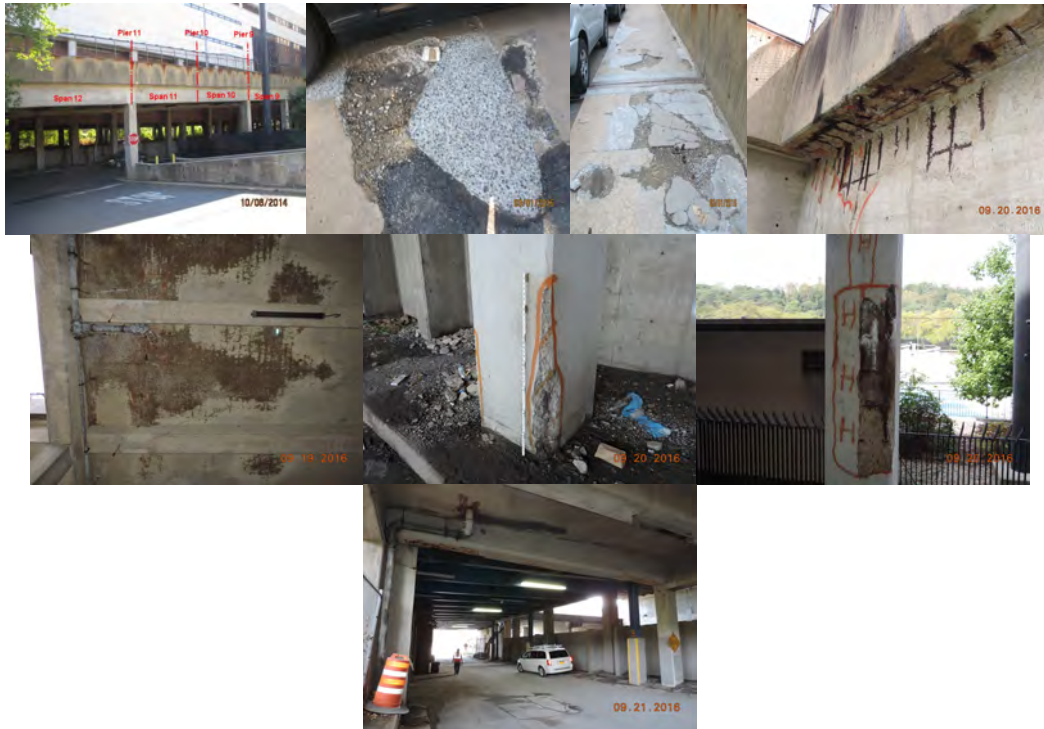
Matthewson Road Bridge over MacCracken Avenue. (Credit: NYSDOT) March 2016: Spalled and Exposed Rebar on Wearing Surface of Span 2. Left Sidewalk on Span 8. September 2016: Span 2, Underside of the Left Parapet and Left Face of Girder Exhibit Spalls with Exposed Rebar. Pier 7, Right and Left Columns Exhibit Exposed Rebar and Hollow Sounding Concrete. End Pier. (September Credit: NYSDOT)

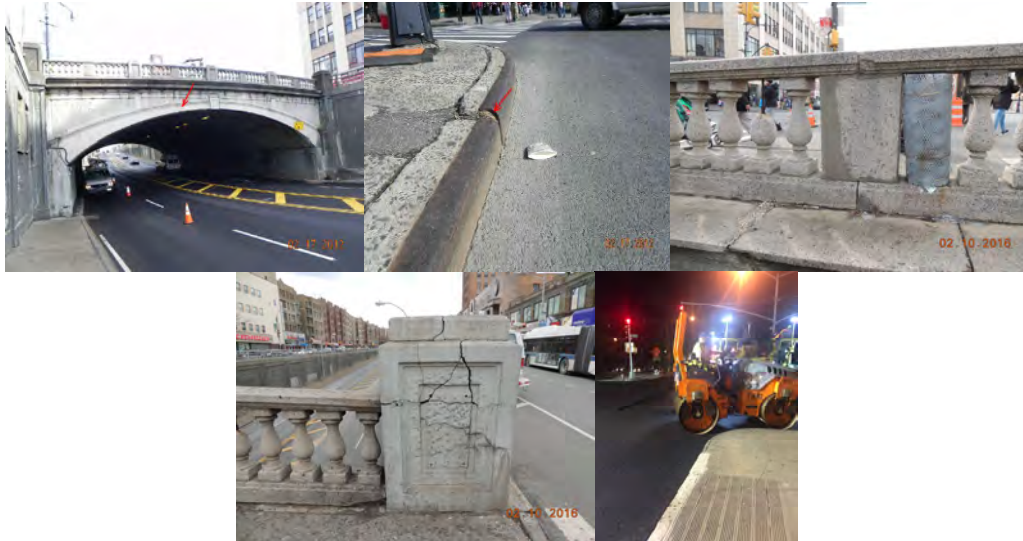
East Fordham Road Bridge over Grand Concourse. February 2016. Span 1, Left Railing Near End Abutment. Railing Balustrade Completely Spalled and Covered With Wire Mesh Netting. Span 1, Left Railing - End Pylon Exhibits Scattered Cracks Throughout. (Credit: NYSDOT) August 2016.
