The City of New York  
Department of Environmental Protection

# NYC's Hydrologic Database Water Budget for Croton Reservoir System

Final Report

March 1, 2002

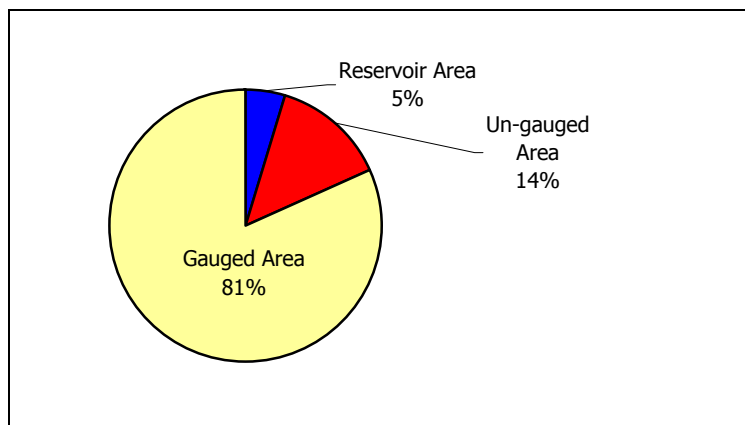
**Figure 1. Gauged Area of the Croton Watershed.**

Initial project planning identified a lack of streamflow data from un-gauged areas of the New Croton/ Muscoot Reservoir watershed. The majority of project time was spent in the development of two new stream gauging stations to fill these gaps. As a result, the watershed area of un-gauged tributaries to the New Croton/ Muscoot Watershed decreased by 14% and currently 81% of the watershed area for the entire Croton Water Supply watershed is now gauged.

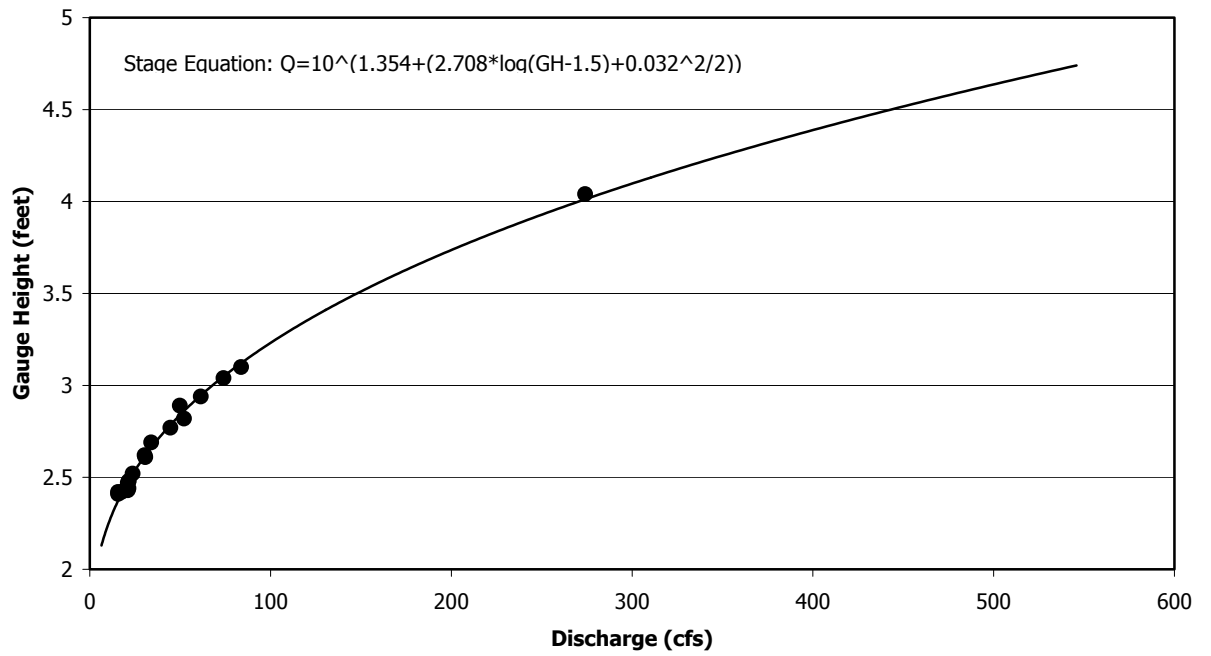
Figure 4. Stage Discharge Rating- Muscoot River at Wood Street near Katonah, NY

With the stations recording water level (stage) in the stream, the next step was to establish a relationship between stream-flow (discharge) and stage. Training was provided by the DEP Watershed Hydrology group on measuring stream discharge. Discharge measurements could then be collected to define the stage-discharge relationship. To develop the relationship, a regression analysis is used on the stage-discharge data. A total of 33 discharge measurements were completed during the project and adequately define the stream flows between 6.47 and 546 cfs at the Muscoot River site and between 0.453 and 125 cfs at the Plum Brook site. Tables 2 and 3 show a summary of the discharge measurements completed while figure 4 depicts the rating curves at each location. Programming for the data recorder required an additional level of sophistication with the addition of stream-flow.

<b>DATE</b>	<b>WIDTH (feet)</b>	<b>AREA (ft2)</b>	<b>MEAN VEL. (ft/sec)</b>	<b>GAUGE HEIGHT (feet)</b>	<b>MEAS. DISCHARGE (cfs)</b>	<b>RATING DISCHARGE (cfs)</b>	<b>% DIFF</b>
18-Jul-00	16.7	15.4	1.37	2.47	21.1	20.8	1.37
24-Jul-00	25.8	51.8	0.408	2.43	21.1	18.6	13.6
23-Aug-00	34.8	52.3	0.413	2.48	21.6	21.4	0.93
29-Aug-00	35.6	43.5	0.403	2.42	17.5	18.0	-2.97
14-Sep-00	25.9	50.4	0.424	2.44	21.4	19.1	11.9
20-Sep-00	35.5	59.2	0.753	2.77	44.6	43.2	3.29
28-Sep-00	35.1	51.0	0.464	2.52	23.7	23.8	-0.63
31-Oct-00	29.8	31.8	0.493	2.42	15.7	18.0	-12.9
06-Nov-00	30.1	30.8	0.512	2.41	15.7	17.5	-10.3
27-Nov-00	35.4	55.6	0.552	2.61	30.7	30.0	2.38
14-Dec-00	35.2	61.0	0.816	2.89	49.8	55.1	-9.68
24-Jan-01	34.6	53.6	0.567	2.62	30.4	30.7	-1.05
20-Feb-01	36.5	55.8	0.608	2.69	34.0	36.2	-6.09
13-Mar-01	40.1	76.8	1.09	3.10	83.7	80.7	3.71
20-Mar-01	38.1	78.6	0.942	3.04	74.0	72.8	1.69
20-Mar-01	38.1	75.7	0.811	2.94	61.4	60.7	1.19
04-Jun-01	38.8	68.7	0.758	2.82	52.1	47.9	8.68

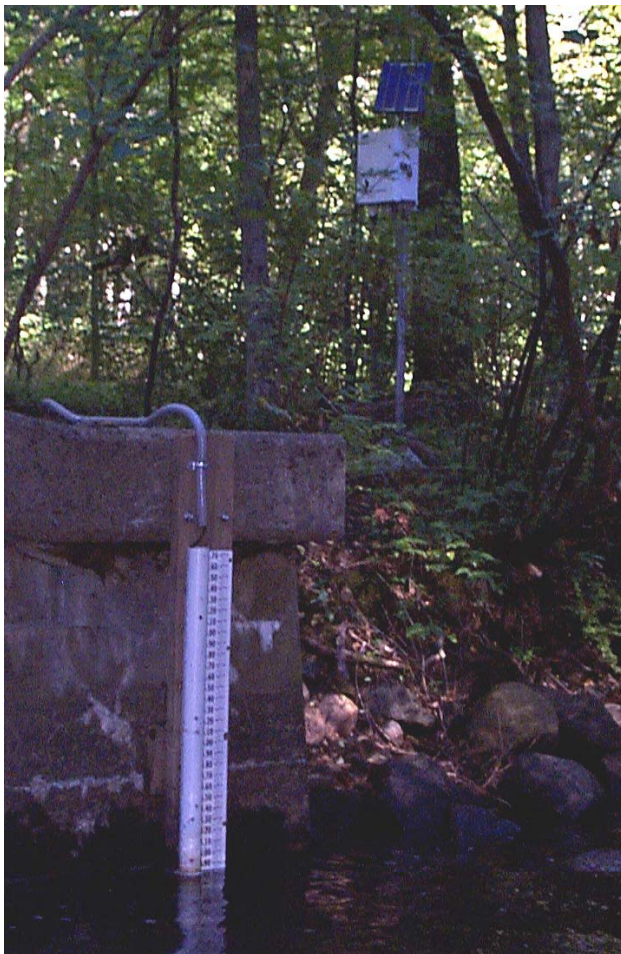
**Figure 7. DEP Gauging Station at Plum Brook**

DEP operates multiple gauging stations and an SOP is in place for their installation. The first step involves the installation of a visual staff gauge. Next a Keller model 173 pressure transducer was installed to measure water level in the stream. The transducer was installed in a PVC stilling well and attached to the staff gauge framework. The transducer is connected to a Campbell Scientific CR10X data recorder, which converts the electronic signal to a water level. Power is supplied via a 12 volt battery and is maintained by a 10W solar panel. An environmental enclosure mounted on a steel pole houses the battery and data logger. To provide a secure platform the pole is set in a concrete footing below the frostline. A custom program was developed for the CR10X to measure and record the water level at the stations. The program records and stores values at 10 minute intervals. Installation went smoothly and the stations started stage data collection on August 10, 2000.

The sites have been operating for over one year. Some problems with vandalism and theft of a solar panel at the Plum brook site prompted staff to reconfigure a more secure installation. Several equipment malfunctions led to the loss of some data. Missing data were estimated using data from another USGS gauge as a reference (see next section for the method of estimating un-gauged flows). Data collection occurs on a twice-monthly basis and a routine maintenance schedule was implemented to help ensure station accuracy. Data collected is processed and imported into a flow database established for the project. Monthly hydrographs and status reports are prepared for data review and quality control. These are submitted to the group supervisor for approval. DEP Hydrology has incorporated these sites into its routine program and will continue their operation in the future. To facilitate data storage and validation site records will soon be stored in the USGS ADAPS database. Figures 7-9 show various images of the gauging stations and the discharge measurements process.

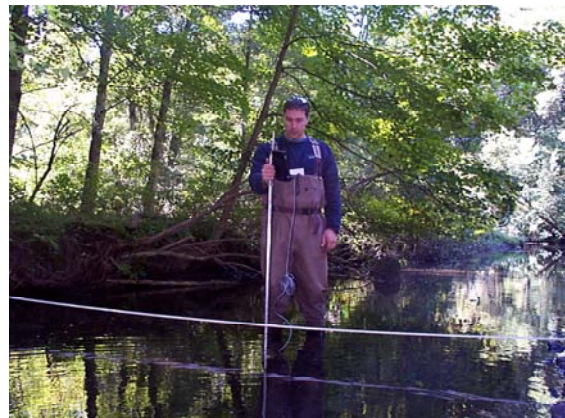
**Figure 8. Discharge Measurement at Plum Brook**

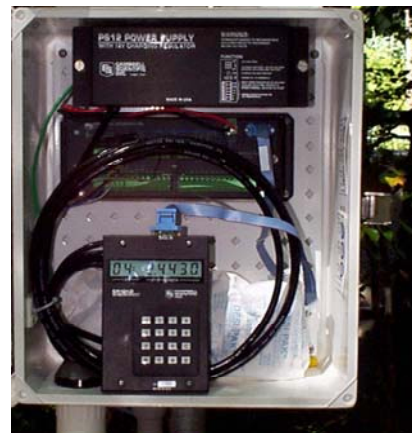
**Figure 9. Campbell Datalogger at Muscoot River site**
