Improving Traffic Safety

The Department has actively accelerated its efforts to improve pedestrian and traffic safety by instituting a proactive and systematic approach to the identification of locations throughout the city that have repeatedly been the site of traffic or pedestrian-related accidents.

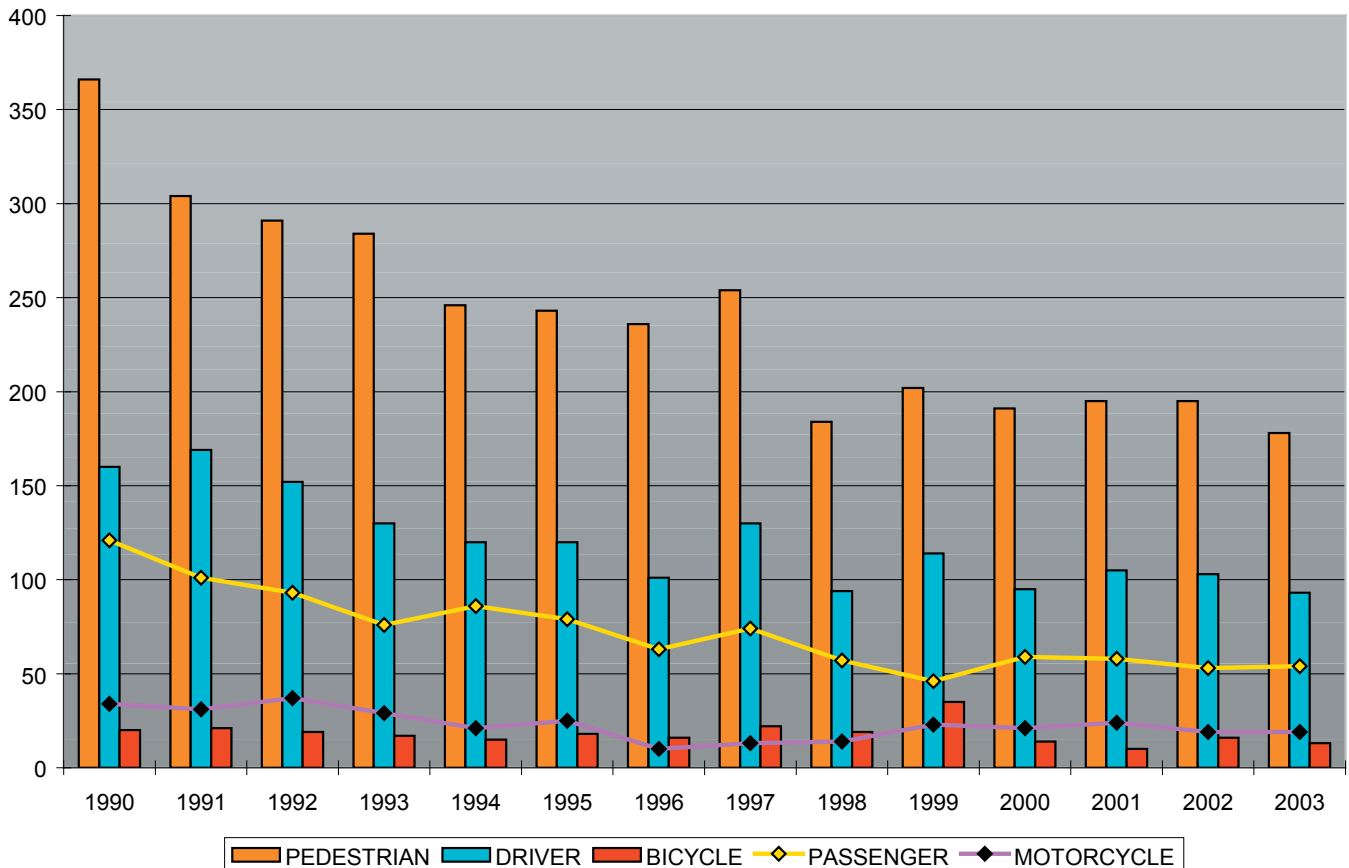
**CHART 1
TOTAL FATALITIES BY MODE 1990-2003**

This downward trend in overall fatalities is further expanded in Table 2 and Chart 1 where fatalities by mode are detailed for the past 14 years. Over this period, all modes have followed a steady decline in the number of fatalities.

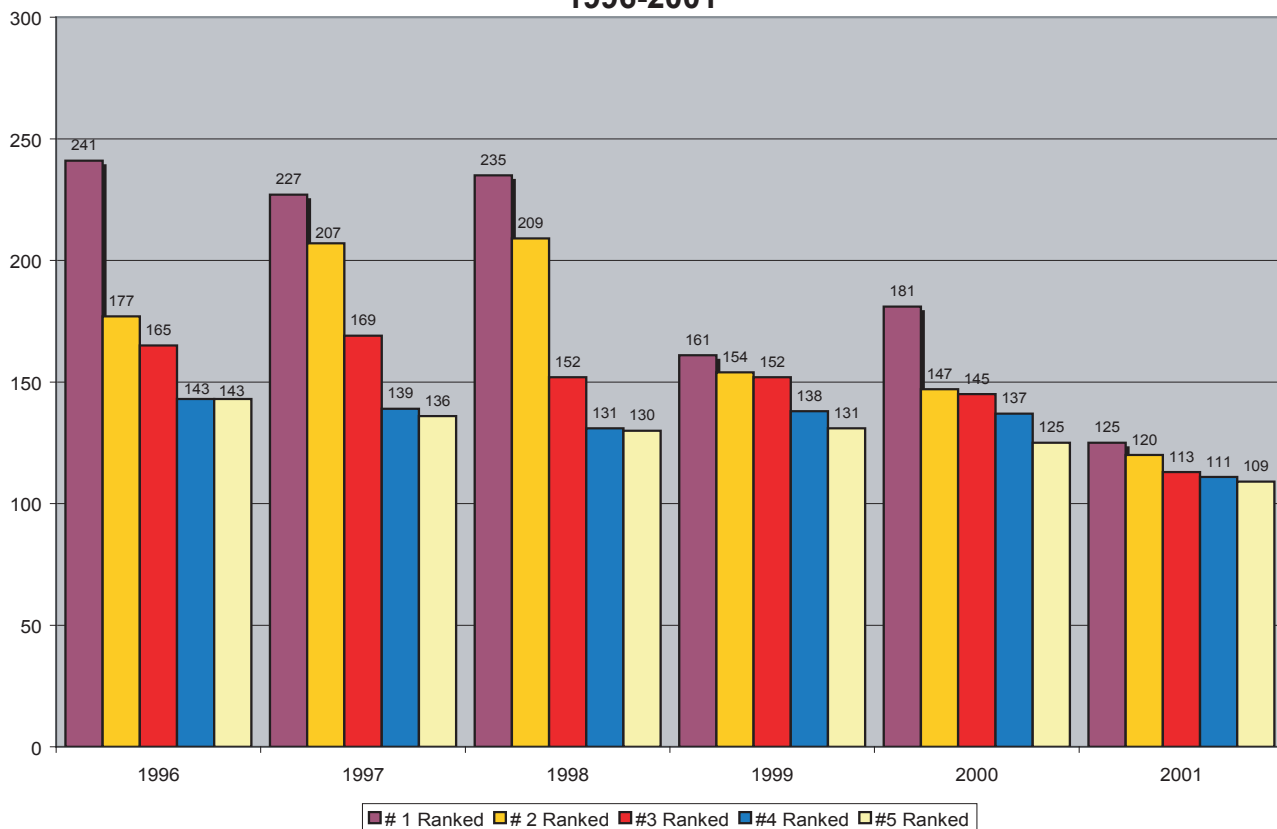
**CHART 2
COMPARATIVE ACCIDENT HISTORY OF TOP 5 CITYWIDE ACCIDENT LOCATIONS
1996-2001**

This downward trend is magnified when looking at the annual accident experience at each of the top five ranked locations since 1996. As indicated in Chart 2 below, accidents at each of the top five locations each year have been progressively declining. An even more striking trend is the dramatic decline at the highest ranked location each year. The top ranked location,

which has varied between Queens Boulevard/Van Dam Street/Thomson Avenue (1996,1997), Flatbush Avenue/Eastern Parkway/Grand Army Plaza Circle (1998,1999,2000) and Flatbush Avenue Extension/Tillary Street (2001) has exhibited a decline of nearly one-half since 1996 (to 125 at Flatbush Avenue Extension/ Tillary Street in 2001 from 241 at Queens Bouelvard/Van Dam Street/Thomson Avenue in 1996).

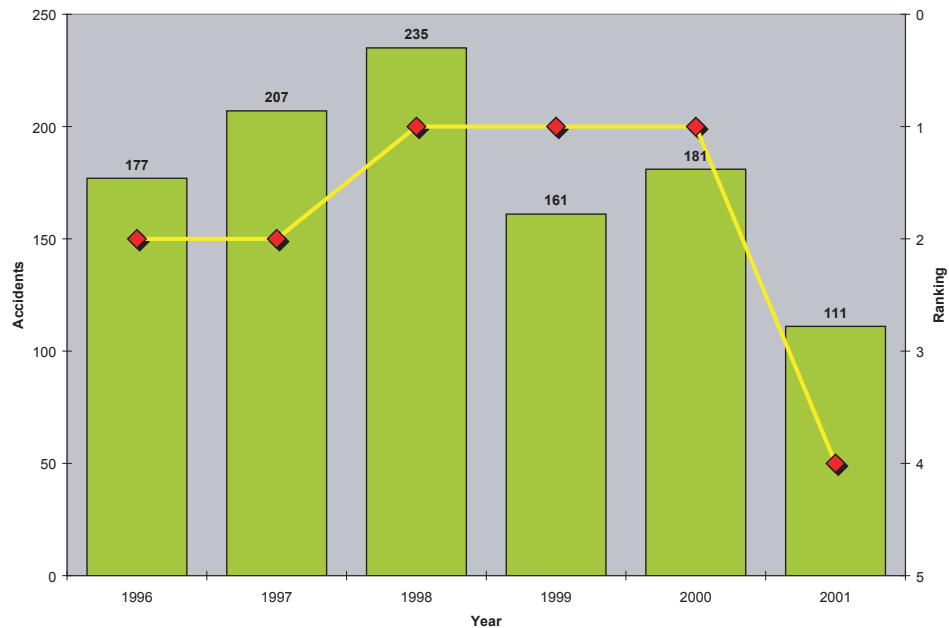
Grand Army Plaza
Accident Experience and Citywide Ranking 1996-2001

ambitious program to improve vehicular safety. Implemented measures included new signage throughout the intersection and its approaches, signal modifications, improved street lighting, and new roadway markings. Historically, this location has held either one of the top two spots in accident occurrences (See Table 4 for accident history). Beginning with measures implemented in 1999, there has been a remarkable improvement in conditions at this intersection with accidents decreasing

sharply by 31.4 % (to 161 from 235) in 1999. Although accidents increased slightly to 181 in 2000, this was still below 1998 levels. In 2001, when many of the improvements were completed, total accidents decreased significantly by 52% (to 111 from 235 in 1998). Comparatively, with 111 accidents and a ranking of fourth, this location would not have ranked any worse than eighth in any of the preceding five years. Therefore, we believe this location is indicative of the overall trend in declining accidents in New York City as well as the impacts of the Department’s safety improvements.

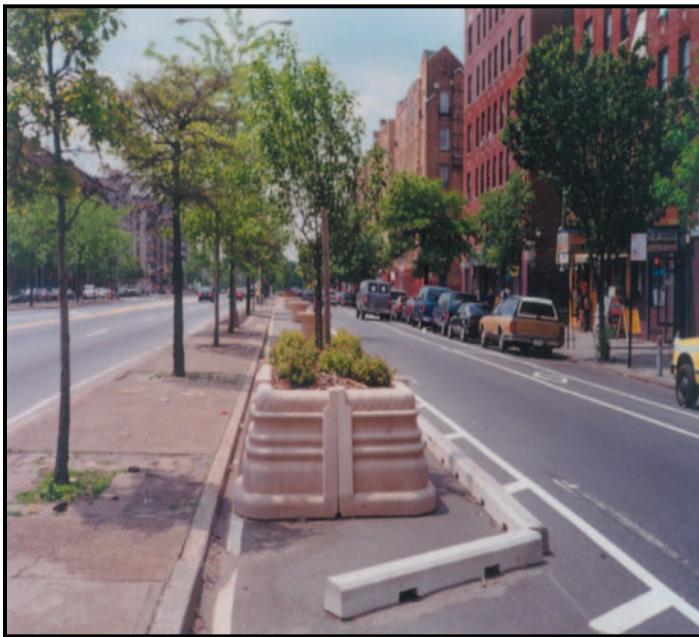
Example of innovative treatments used as part of the Pedestrian Safety Demonstration Project

Some of the initial treatments that were implemented during this phase included the installation of nearly 3,800 linear feet of pedestrian fencing in high pedestrian volume locations to discourage midblock crossing, the modification of traffic signal timing (to a 120 from a 90 second cycle length) to provide increased time for pedestrians to cross the Concourse, the installation of pedestrian signals at 25 intersections, the installation of red

light cameras and the simplification of advance and exit directional signage for motorists traversing between service roadways and main roadways.

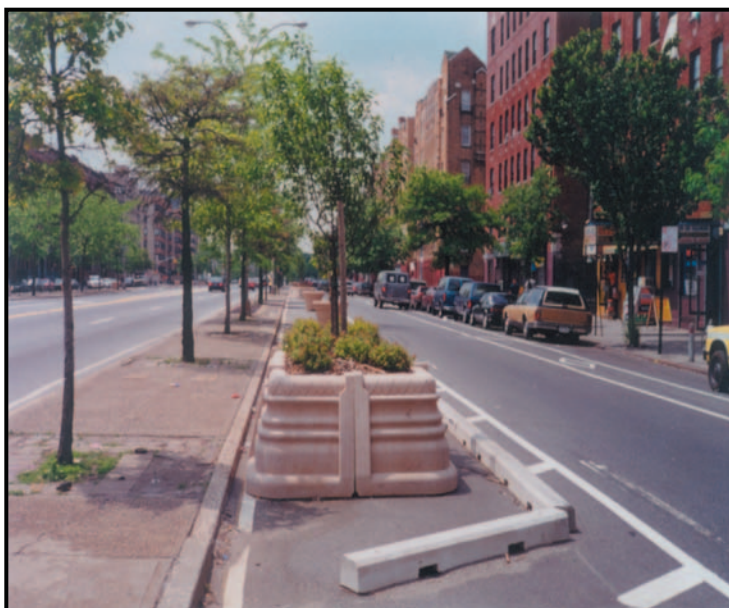
Typical roadway planter used on Grand Concourse

- Placement of 24 concrete planters in six sections connected by bolts and plates, with three inches of stone placed in the bottom of each planter.
- Placement of 42 large plastic planters with three inches of stone placed in the bottom of each planter.
- Placement and bolting down of concrete (495 pieces) and plastic (367 pieces) parking stops.
- Fork lifts and flat bed trucks were used to install the planters and parking stops. Landscaping, including soil was provided by the Parks Department's "GreenStreets" Program. DOT provided gravel/millings for drainage.

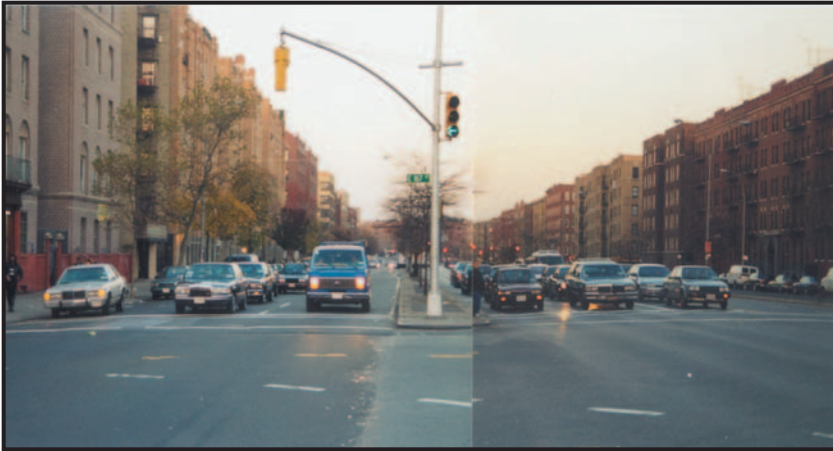
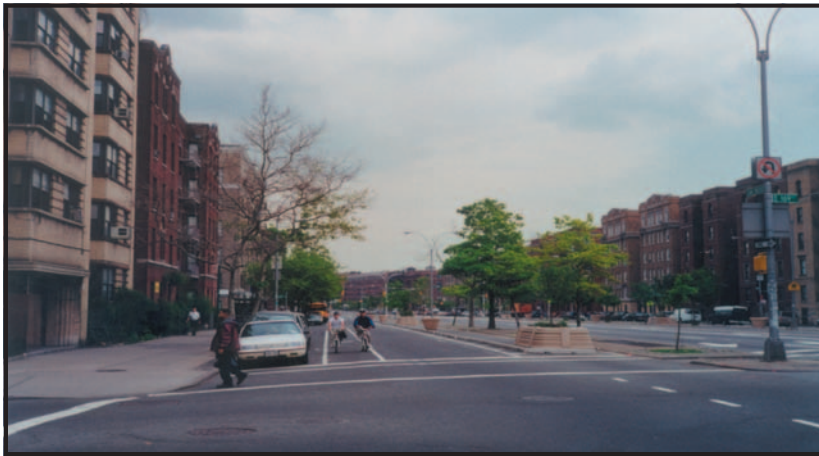
Above: Grand Concourse Main Line and Service Road prior to implementation of safety project

Below: Grand Concourse / East 169th Street Service Road after implementation of safety project

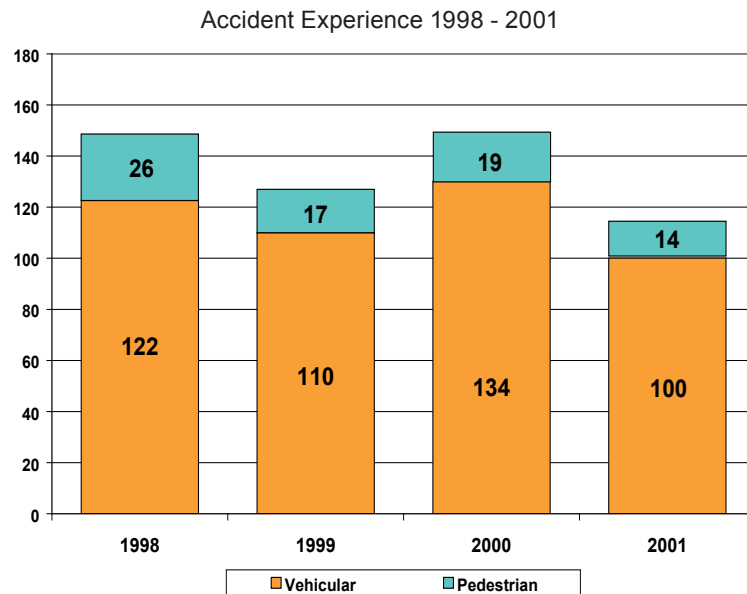
Overall, the accident experience along this section of the Grand Concourse has shown a significant improvement in pedestrian and vehicular safety since 1998. In 1998, there were a total of 148 accidents, of which 26

involved pedestrians. In 1999, the year in which the pedestrian safety demonstration project was implemented (November), total accidents declined to 127, of which 17 involved pedestrians. For comparison purposes we are using the full year (1998) for “before” data because the project was not implemented until late 1999. In 2000, although total accidents increased to 153, pedestrian accidents decreased by 27% (to 19 from 26 in 1998). In 2001, total accidents fell 23% (to 114 from 148 in 1998) and pedestrian accidents to fell significantly by 46% (to 14 from 26 in 1998). In 1998, there was one fatality and in June 1999, there were two fatalities, both of which were the result of a single accident. Since 1999, there have been no fatalities along this portion of the Grand Concourse.

Overall, the Department believes the impacts of the treatments implemented at this location have been successful, especially in reducing the number of pedestrian accidents along this stretch of the Grand Concourse. The Department continues to support these treatments and is actively engaged in trying to make these safety improvements permanent.

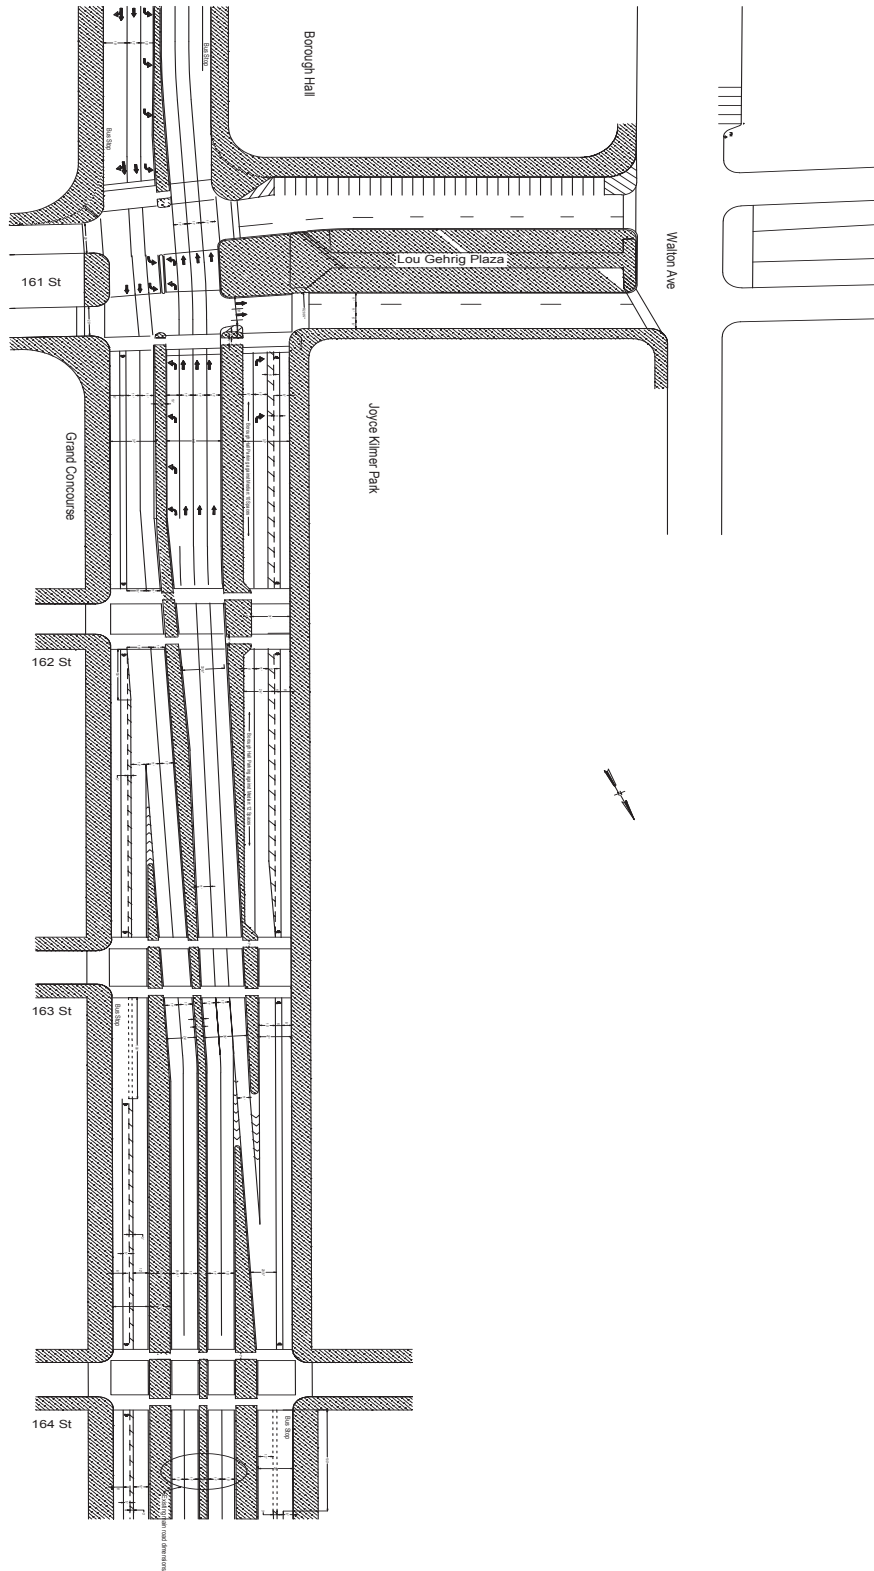
NOTE
 1. SEE DRAWING TRB-1 FOR BUFFER AND BUS STOP INSTALLATION DETAILS
 2. GRAND CONCOURSE RECONSTRUCTION CONTRACT ENDS AT E 163 STREET

The proposed realignment is shown on the following page.

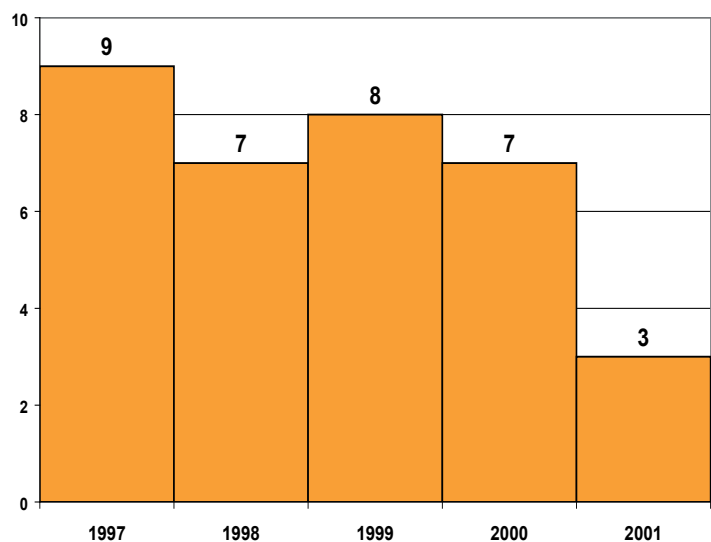
Pedestrian Accident Experience 1997 - 2001

nine). In 1999 there were eight pedestrian accidents, which is 11% less than 1997. In 2000, pedestrian accidents decreased to seven, which is 22% less than 1997. ***In 2001, pedestrian accidents decreased significantly to three which is 67% less than 1997. The Department believes these treatments have improved safety at this location.***

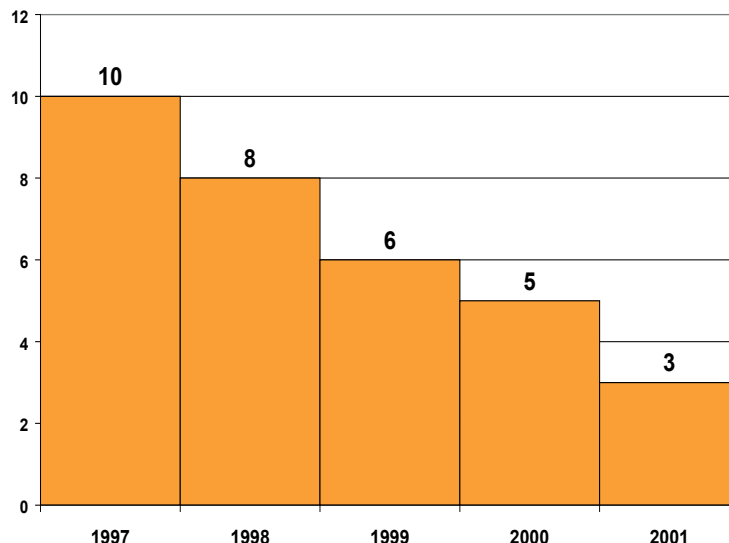
Pedestrian Accident History 1997 - 2001

treatments were installed, pedestrian accidents decreased to five, which is 50% less than 1997. In 2001, pedestrian accidents declined to three, which is 70% less than 1997.

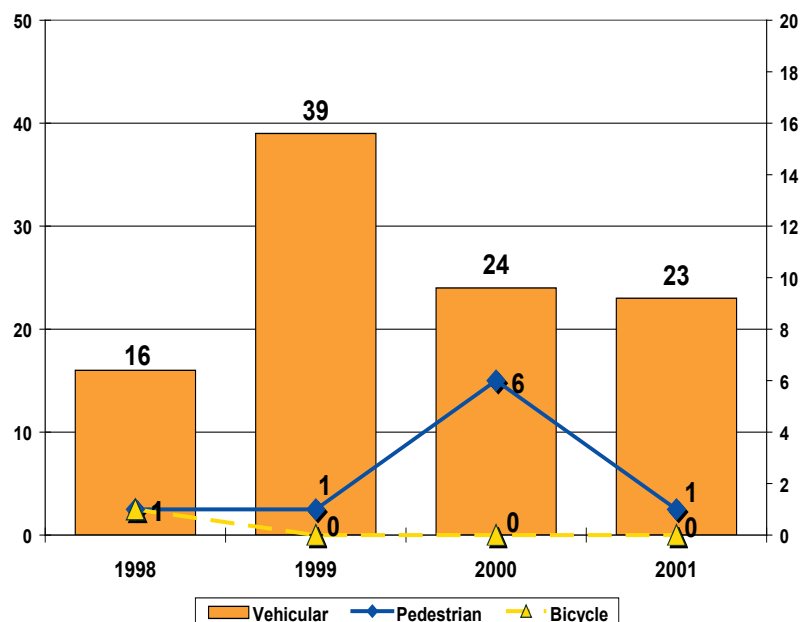
Accident Experience 1998 - 2001

improvements implemented at this location should continue the downward trend in accidents at this location since 1999.

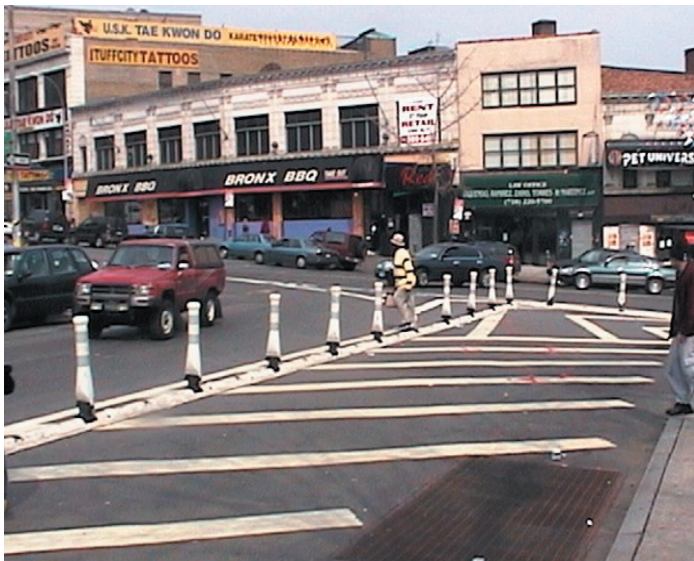
Flexible delineators and markings provide for increased pedestrian and vehicular safety

- Converted the East Kingsbridge Road slip roadway to one-way westbound from East Kingsbridge Road to East Fordham Road mainline to reduce conflicts and improve safety
- Widened the triangular park to the west and north with pavement markings and flexible delineators to narrow the street, discourage double parking, increase pedestrian sidewalk space, and decrease crossing distance.

- Installed a modified neckdown on the northwest corner of the East Kingsbridge Road slip/East Fordham Road intersection to increase pedestrian sidewalk space and decrease crossing distance.
- Widened the East Fordham Road north sidewalk (and install delineators) approaching Bainbridge Avenue/East Kingsbridge Road and widen the east sidewalk of East Kingsbridge Road west of Bainbridge Avenue to reduce pedestrian crossing distance and provide more sidewalk space.
- Installed Stop bars, lane assignment arrows, and double yellow and lane lines as appropriate.
- Modified signal faces as appropriate.

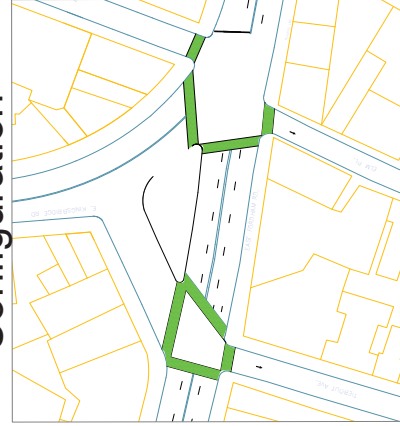
**East Fordham Road @ East Kingsbridge Road
Safety Improvements**

- * INSTALL REFLECTIVE EDGE MARKINGS ON SIDES OF ZEBRA PAVERS TO IMPROVE VISIBILITY OF CROSSWALKS AT NIGHT TO APPROACHING MOTORISTS.
- * INSTALL STOP BARS ON ALL APPROACHES.
- * EXISTING ZEBRA PAVERS SHOWN TO REMAIN.

**Reconfigured
Intersection**

**Original
Configuration**

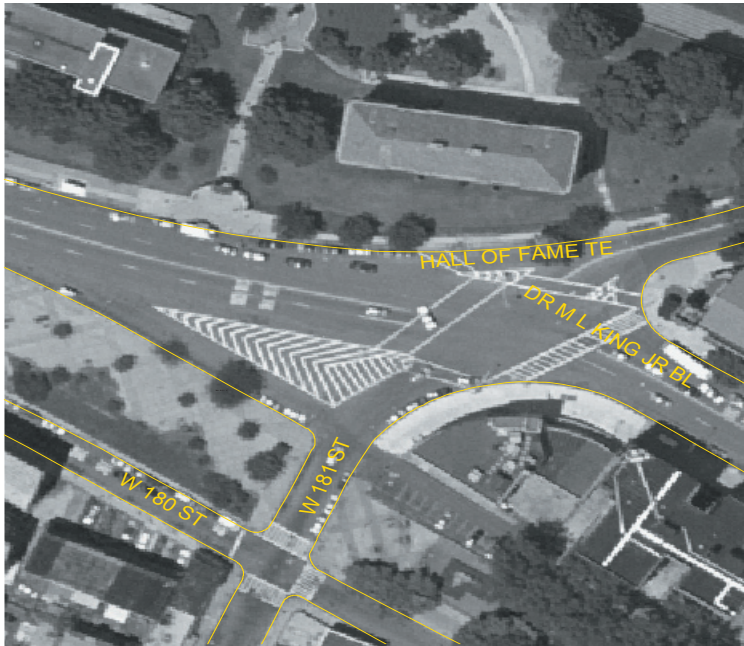
Original Configuration of Roadway

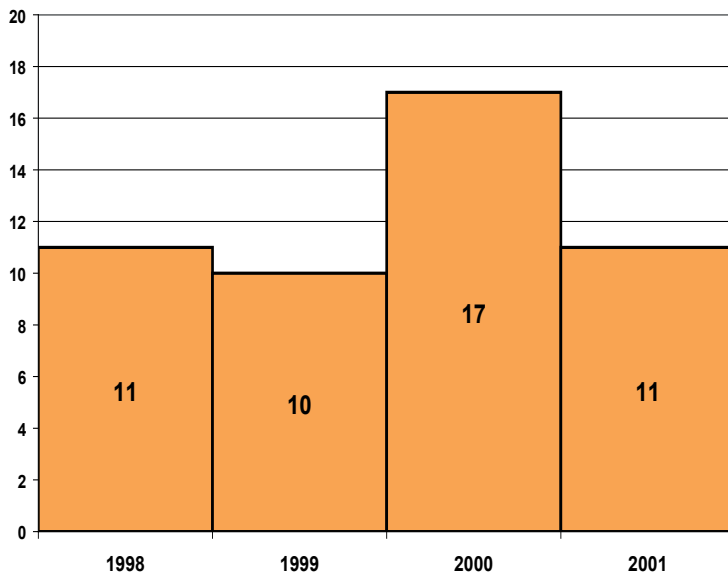
Accident Experience 1998 - 2001

One of the primary concerns at this location is frequent jaywalking across University Avenue, (approximately 230 feet south of the signal) which is the result of a natural pedestrian path from a park on the east side of University Avenue to the entrance of Bronx Community College on the west. ***While not a high accident location, this intersection was of concern to the Department due to the surrounding land uses and increase in accidents in 2000, leading the Department to take a proactive***

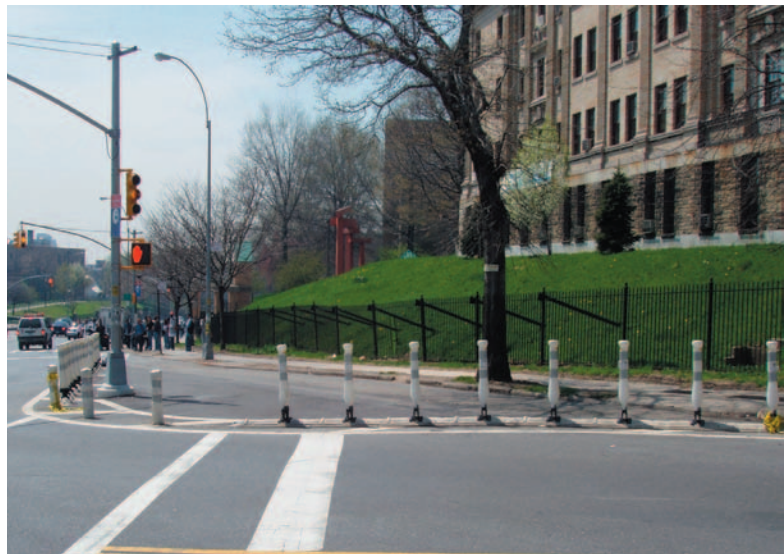
Reconfigured intersection and the use of bollards provides refuge and space for pedestrians.

- Installed a new pedestrian crossing signal with a high visibility crosswalk (approximately 230 feet south of West 181st Street) at the park walkway.
- Installed a pedestrian separator on the west side of University Avenue (in front of the entrance/exit of Bronx Community College) to direct pedestrians to the signalized crossings.

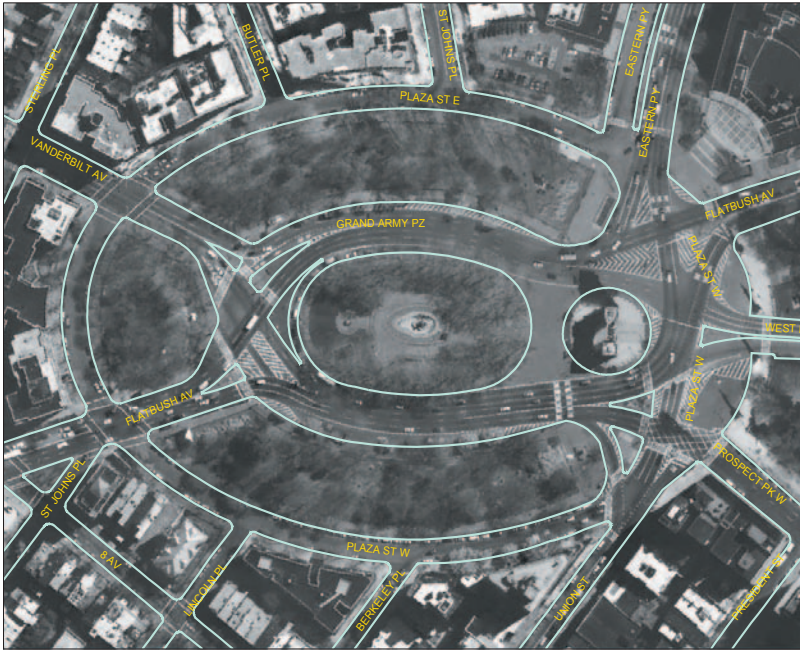
Aerial view of reconfigured intersection

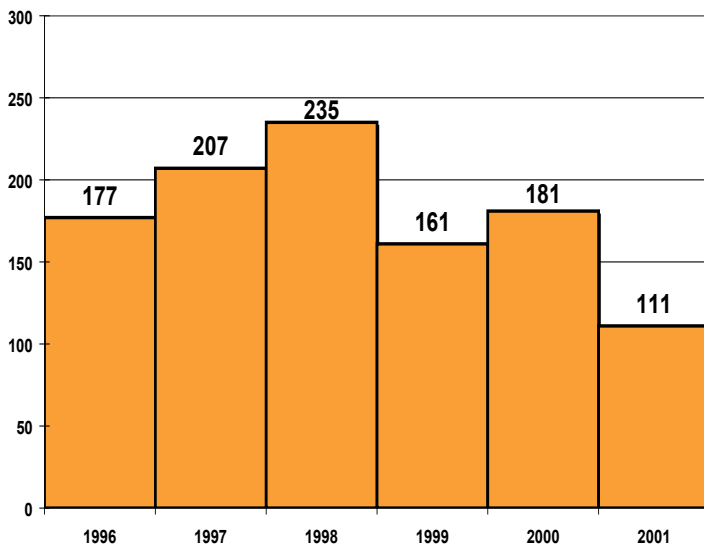
Accident Experience 1996-2001

In the Spring of 1999, the Department conducted an in-depth analysis of the traffic conditions at Grand Army Plaza and the supporting roadways. At the time of the study, this location had consistently ranked as one of the highest overall accident locations in the city. In terms of the accident experience at this location, accidents were on an upward trend between 1996 and 1998, the year prior to the implementation of safety improvements. In 1996, there were 177 total accidents, which ranked second citywide. In 1997, accidents increased considerably to 207, which again ranked

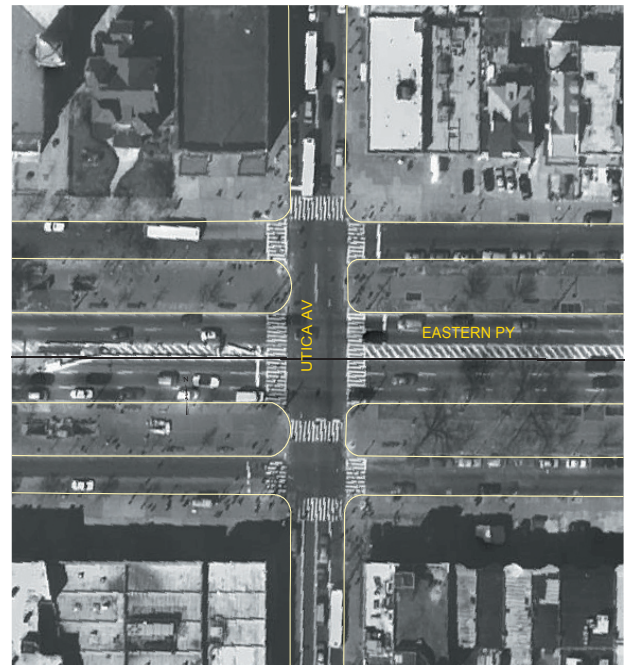
Aerial view of reconfigured intersection

The intersection of Eastern Parkway and Utica Avenue is a center of intense pedestrian and motor vehicle activity serving the needs of thousands of commuters and others daily. The intersection also serves as an important intermodal transfer point for public transportation as three bus lines, two subway lines and numerous for-hire vehicles provide public transportation at the intersection. Of the three bus lines, the B14 and B17 begin their routes at the southwest corner, and the B46 passes through the intersection in the middle of its route. The B14 runs between Crown Heights and East New York via Pitkin and Sutter Avenues. The B17 runs between Crown Heights and Canarsie via Remsen Avenue. The B46 runs between Williamsburg and Kings Plaza via Utica Avenue.

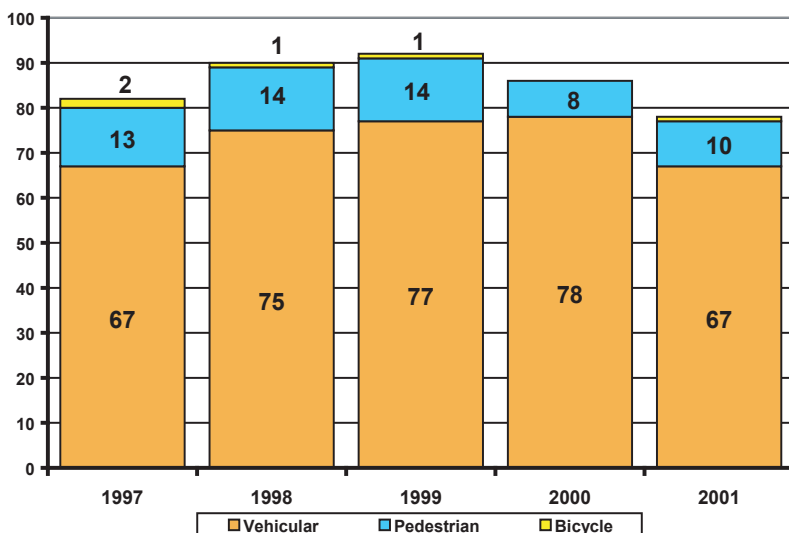
Accident Experience 1997- 2001

Although the ranking in 2001 jumped to fifth from tenth in 2000, this number is still less than the pedestrian accident experience between 1997 and 1999. In addition, there have been no fatalities at this intersection since 1998.

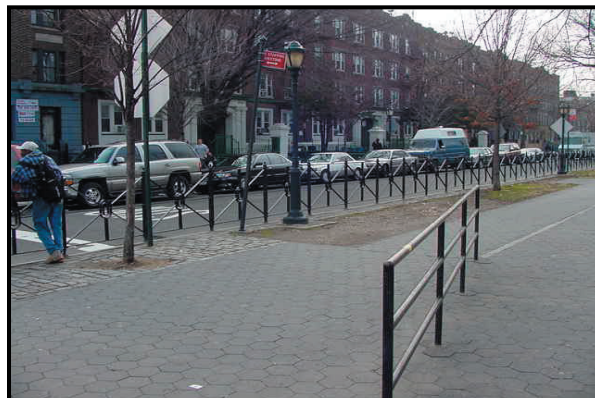
Pedestrian barriers along service road island prevent individuals from crossing service road midblock

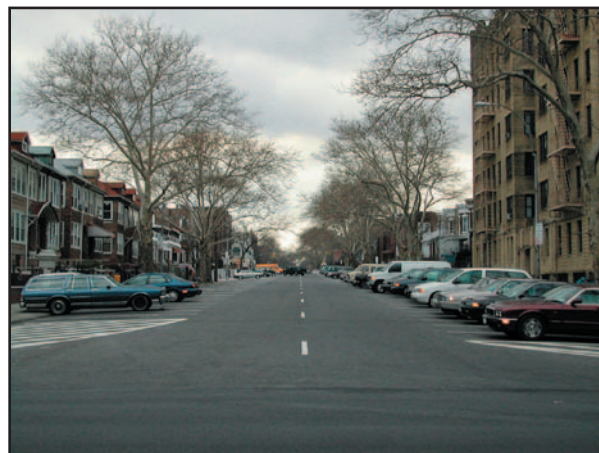
Angle parking on President Street

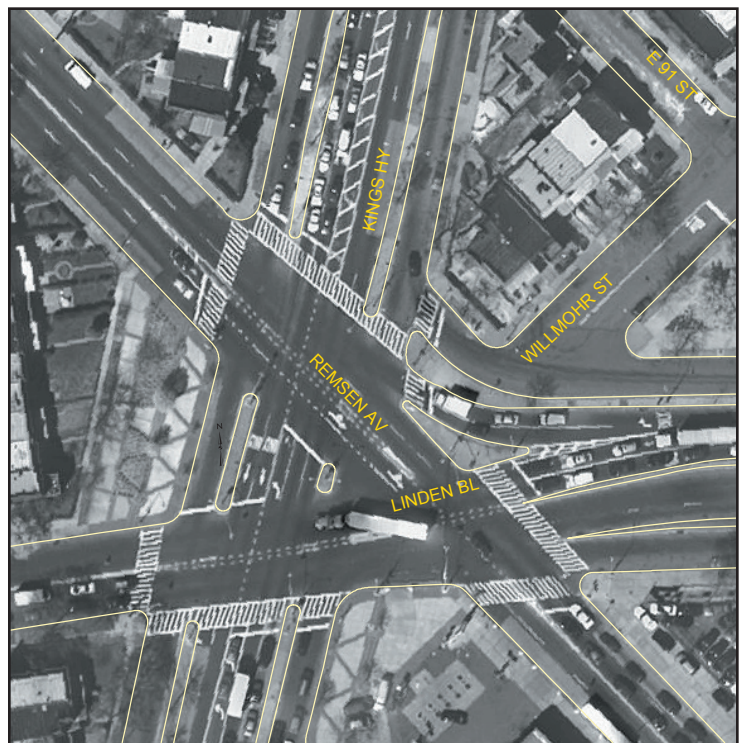
Aerial view of intersection

Due to the complexity of this multi-legged intersection, there is a high accident rate. Left turn, rear end, and overtaking are the primary causes of these accidents. In 1998 and 1999, there were a total of 131 accidents (each year) at this location. However, total accidents increased 12% to 147 in 2000. ***In 2001, the Department began to implement numerous improvements at this location. As***

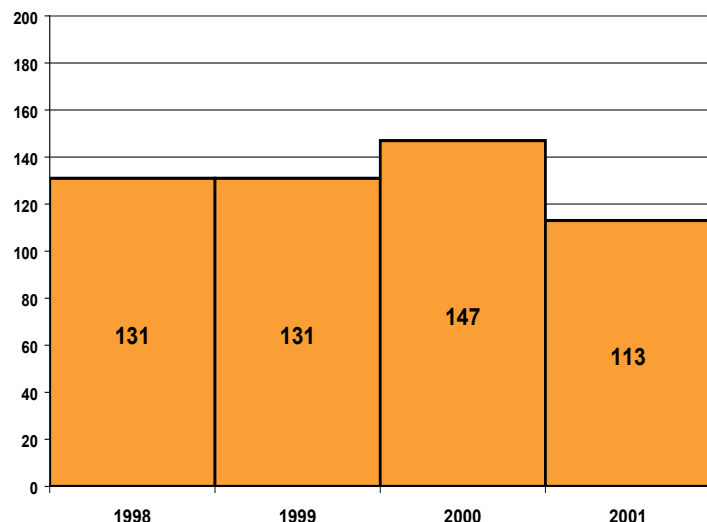
Accident Experience 1998 - 2001

such, total accidents decreased by 23% (to 113 from 147 in 2000). The Department believes this decrease can be attributed to the improvements implemented at this location. In addition, the work implemented in 2002 should continue to improve both pedestrian and vehicular safety at this intersection.

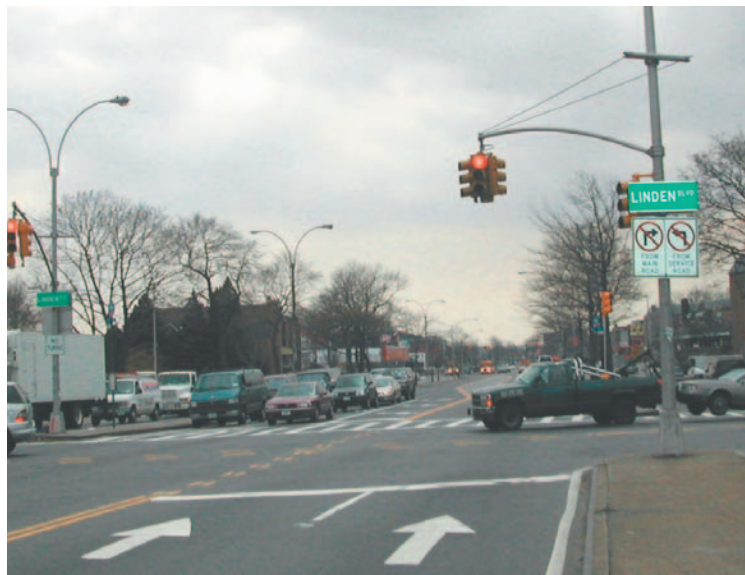
New markings, turning lanes and signage were installed to improve safety

- A left turn signal phase was installed for southbound Remsen Avenue to eastbound Linden Boulevard. A new signal pole was installed on the southwest corner (of Linden Boulevard and Remsen Avenue) to improve the visibility of the signals for southbound Remsen Avenue motorists. To accommodate the additional turning phase, a specialized solid state signal controller was installed. The signal cycle will remain at 120 seconds in peak periods but will be increased from 90 to 120 seconds during all off-peak periods. In coordination with this left-turn signal phase, through and left pavement arrows will be installed on southbound Remsen Avenue prior to eastbound Linden Boulevard. Most pavement marking modifications were installed in November 2001 and some further enhancements were completed in January 2002. The signal work was completed in March 2002.

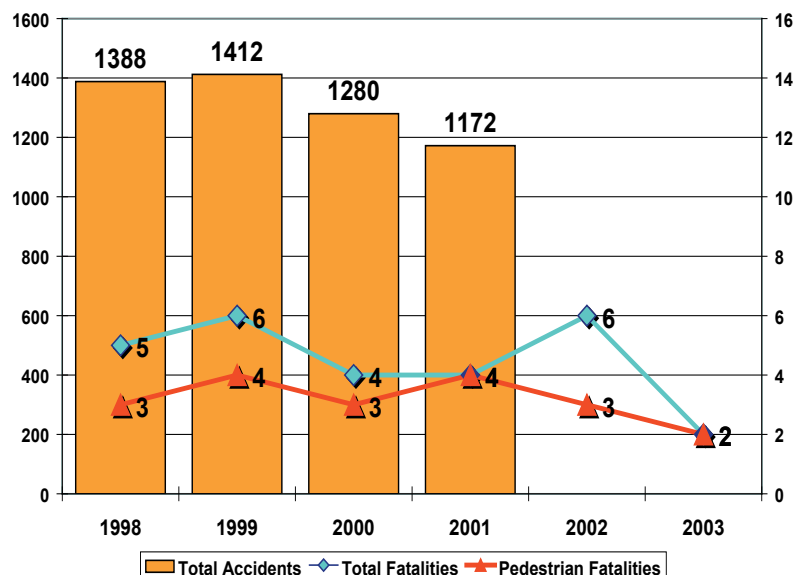
Accident Experience 1998 - 2003

Between 1998 and 2001, overall fatalities and pedestrian fatalities remained fairly consistent. In 2002, although there were six fatalities, of which three were pedestrians, none of these occurred in the second half of the year. This trend corresponds to the improvements made along the Ocean Parkway corridor during the year. In 2003, total fatalities were significantly lower with only two, both of which involved a pedestrian.

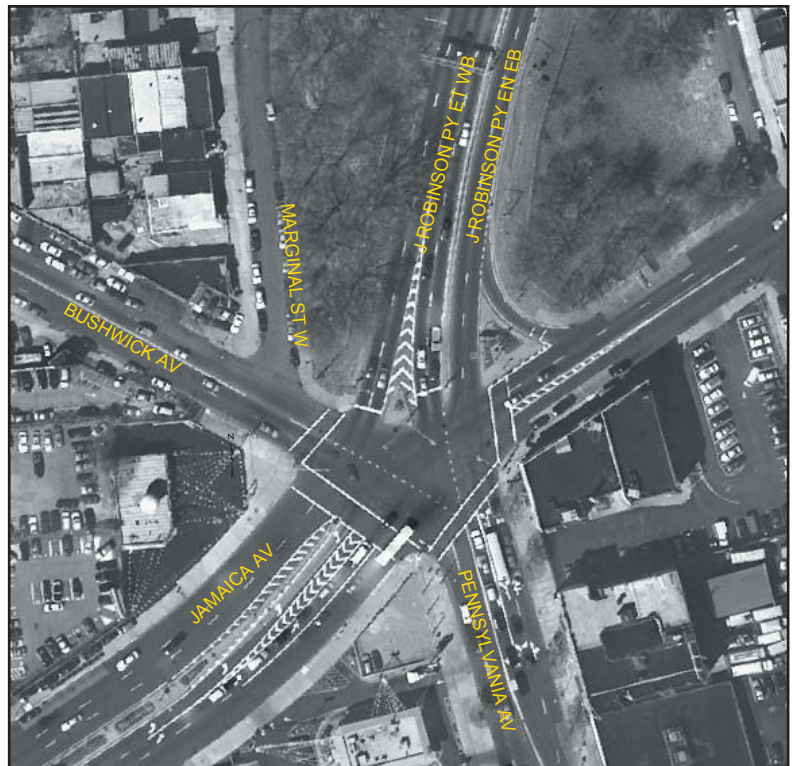
Aerial view of intersection

Pennsylvania Avenue has three lane designations: an exclusive left turn lane, a thru/left turn lane, and a thru/right turn lane. Prohibited movements include: the left turn from eastbound Bushwick Avenue onto the Jackie Robinson Parkway; Jackie Robinson Parkway southbound motorists in the left two lanes can only proceed straight to Pennsylvania Avenue (no right or left turns are permitted).
