**NEW YORK CITY**  
**DEPARTMENT OF ENVIRONMENTAL PROTECTION**  
**BUREAU OF WATER SUPPLY**

**Kensico Water Quality Control Program**  
**Semi-Annual Report**

**January 2013**

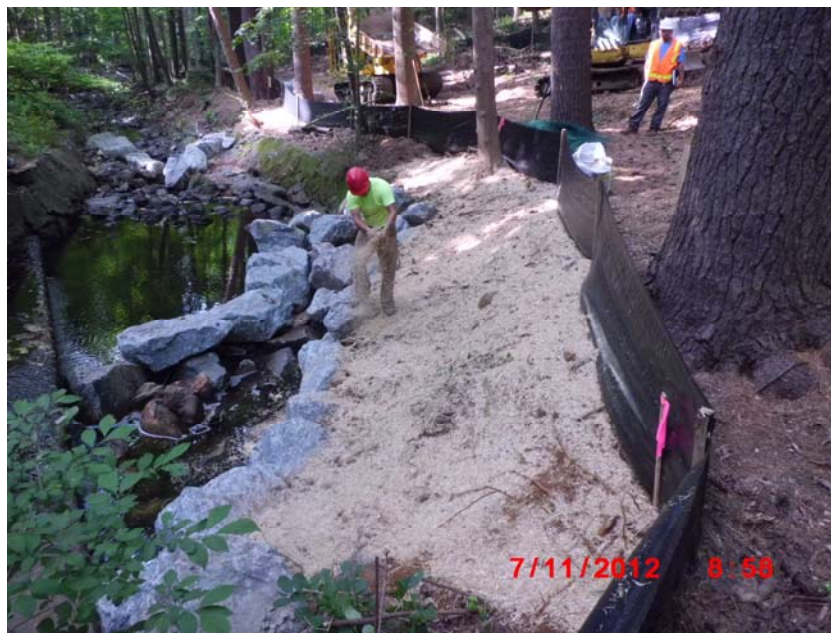
Seeding and mulching at Whippoorwill

Construction work at the Whippoorwill site was completed in 2012. Activities included construction of a temporary access road, installation of stream bed rock structures, temporary dewatering, bypass, and sediment control measures, and site restoration. It is anticipated that planting and seeding will be completed in the first half of 2013. Photographs of work at the Whippoorwill site are below.

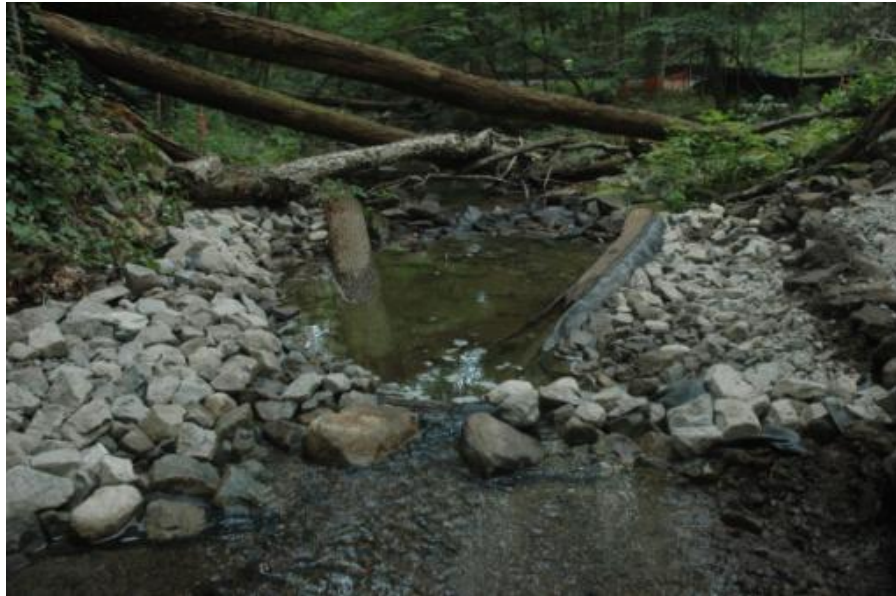
Log vane structure at Whippoorwill

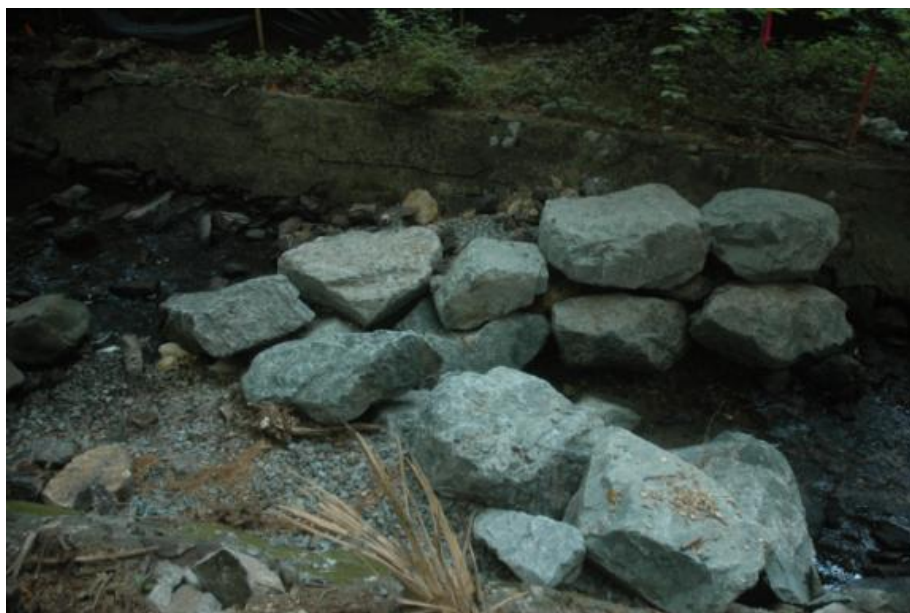
Rock cross vane at Whippoorwill
