East River Bridges

A \$3.6 billion reconstruction program is underway to rehabilitate all four East River crossings. In 2008, these bridges carried some 477,211 vehicles per day. In 2002, working in coordination with the NYPD and other law enforcement agencies, the Division implemented enhanced security measures on these bridges. This work is ongoing.

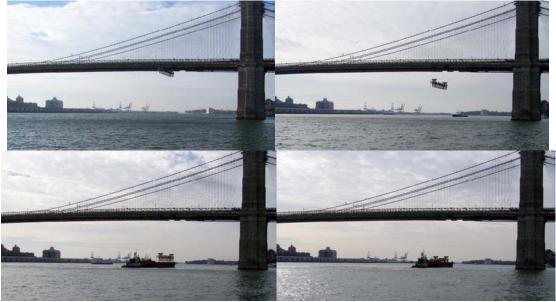
Removing the Brooklyn Bridge Main Span Travelers in 2007.

The \$25 million recently completed construction contract replaced the four existing travelers with a new state-of-the-art technology system including motors, reducers, braking systems, electrical controls, programmable logic controller system, and trouble shooting devices, as well as AC motors that provide enhanced operational performance and gear boxes that increase life cycle and reliability of the new travelers. A Notice to Proceed was issued to the contractor with a start date of November 22, 2006. During 2007, the existing track beams, supports and electrical equipment (including conductor bars, transformers, conduits, wires and breaker boxes) were removed. All four travelers were removed in November 2007. The fabrication work for the new travelers to be installed was underway at the end of 2007.

conductor bars, painting, and finally, the removal of the temporary platform and demobilization. The traveler replacement contract was substantially completed on July 8, 2009, and all work was completed by August 31, 2009.

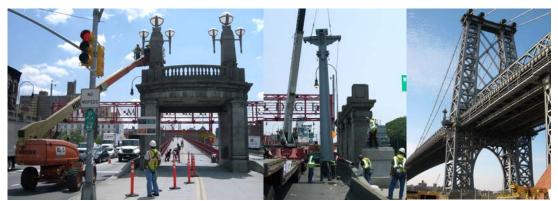
2008: Installation of Luminares at the Manhattan Plaza Bridge Entrance. Erection of the Manhattan Entry Electrolier. Brooklyn Tower in October 2008. (Tower Credit: Russell Holcomb)

Work completed in 2008 includes the installation of the Brooklyn anchorage hoist, the bridge indentification system, the barrier transfer machine, the removal of the main bridge flexible shield system, the top chord transverse truss bearings, the erection of the new Manhattan entry electroliers and rehabilitated main tower electroliers, and the seismic retrofit of the intermediate tower bases.

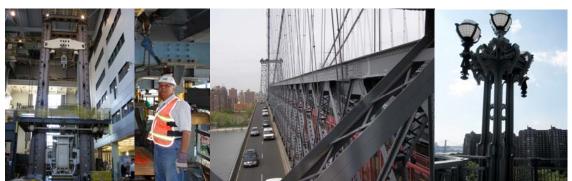
Contract #8 in 2009: Testing the Intermediate Tower Bearings at Lehigh University in January 2009. Assistant Engineer-in-Charge Anil Rudra on the Bridge in July 2009. Resurfaced South Outer Roadway. (Roadway Credit: Bojidar Yanev). Looking South at the Manhattan Main Tower Electrolier in December 2009.

Contract #8 began on March 3, 2003, and is scheduled to finish by the end of 2010. This \$277 million project will see the rehabilitation of the tower bearings, the truss system, the steel structure of all eight towers, and the north comfort station houses, the replacement and/or adjustment of the cable suspenders, the installation of maintenance travelers (inspection platforms) under the main span, as well as painting of the stiffening trusses. Architectural work will include the restoration of decorative lights on the main towers and in the Manhattan Plaza. Work inside the anchorage houses on both the Manhattan and Brooklyn sides will include the construction of new stairs, a hoisting system, ventilation and lighting, and oiling platforms. The project will also include the installation of several Intelligent Transportation System components, including variable message signs and closed circuit television cameras.

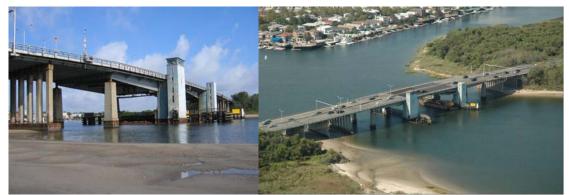
Belt Parkway Bridge Over Mill Basin. Aerial View.

The existing Mill Basin Bridge is 864-feet long and 14 spans, including double movable leaf bascule spans and a steel superstructure, supported on reinforced concrete pier on timber piles, and abutments supported on pre-cast concrete piles. The existing structure and immediate approaches will be demolished and replaced.

The replacement will be a 1,757-foot, 11 span fixed bridge, north of the existing structure. The bridge will have a 36-foot wide roadway with a 12-foot wide right shoulder and a 4-foot wide left shoulder in each direction. The eastbound side will carry a dedicated pedestrian/bike path along

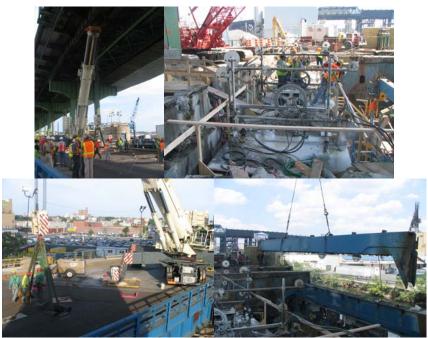
Removing the East Span in July 2007.

In Stage I, the Manhattan-bound span was closed from June 29, 2007 to August 31, 2007, and it was replaced. The Manhattan-bound bascule span was removed in halves on July 2 and July 6, 2007. Due to the contractor's chosen means and methods, the new east leaf of the Hamilton Avenue Bridge was not "floated-in" as originally proposed, but was trucked-in, and assembled at the site. The Manhattan-bound span reopened three days earlier than scheduled on the morning of August 31, 2007. The contractor will earn an incentive for early completion of this milestone.

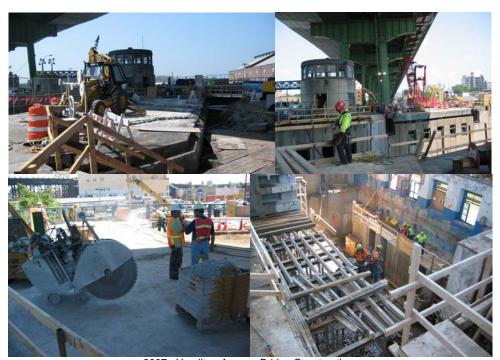
2007: Hamilton Avenue Bridge Construction.

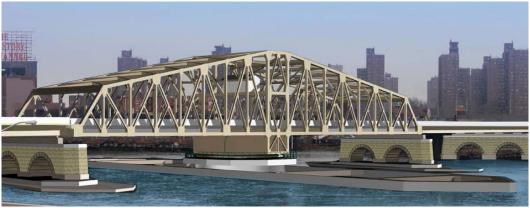
Rendering of the New Willis Avenue Bridge.

Because of substandard curves that are present on the structure's approaches, the Willis Avenue Bridge has been one of the City's most accident-prone crossings. Between 1992 and 1994, there were 809 vehicular accidents on the bridge, for an average of 269 per year. The ramp from the FDR Drive is now out of service and traffic enters the bridge from a temporary loop ramp installed as part of the project. Under the Department's proposed reconstruction program, these substandard curves will be eliminated.

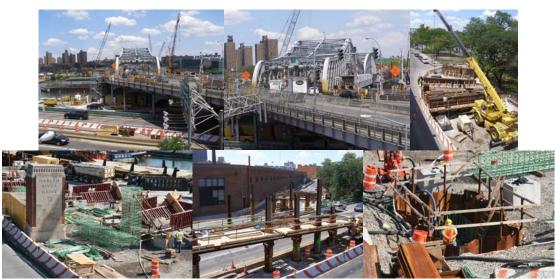
Current Willis Avenue Bridge and Construction Site in July 2008.

On January 3, 2008, the East 125th Street exit ramp off the northbound FDR Drive was closed. This closure was necessary so that work on the construction of a temporary ramp, as well as construction of the new north-bound FDR Drive ramp to the Willis Avenue Bridge, could begin. The East 125th Street exit ramp, which typically carries only a low volume of traffic, will not reopen until the temporary ramp is removed in June 2011.

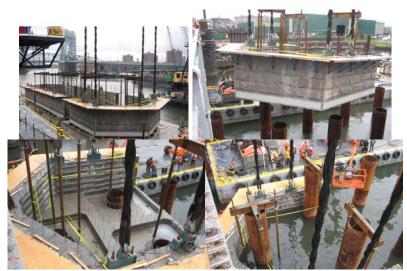
The First River Pier in November 2008.

In 2008, the project focused on foundation construction work, along with construction of a temporary ramp from the north-bound FDR Drive onto the bridge. At the end of 2008 the loop ramp was nearing completion. It went into service on January 24, 2009. This will allow the removal of the existing ramp and the construction of the new ramp to proceed. One half of the foundations for the new FDR Ramp were installed. Additionally one of the four piers in the river was in place, and work on a second had begun. The foundations in the Harlem River Rail Yard were more than 50 percent complete, and work had begun on the footings for the new Bruckner Boulevard Ramp.

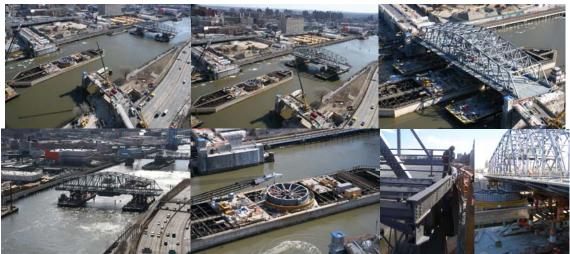
Floating In the New 145th Street Span in February 2007. (Close-up Credit: Bojidar Yanev)

A Notice to Proceed for the \$69.4 million reconstruction of this bridge was issued to the contractor with a start date of July 15, 2004. Fabrication of steel components for the approach and new swing span occurred in Pennsylvania. The new swing span was assembled in Albany, New York in late 2005, and was floated-in on February 9, 2007.

The project included the complete replacement of the swing span and six approach spans, seismic retrofitting, partial reconstruction of substructures and the reconstruction of the approach roadways, sidewalks, and bridge railing. The design for the bridge utilized elements prefabricated off-site so as to allow a very quick replacement of the existing bridge in 3 stages totaling 18 months. Traffic was only impacted for the 15-month period of March 16, 2006 to June 18, 2007.

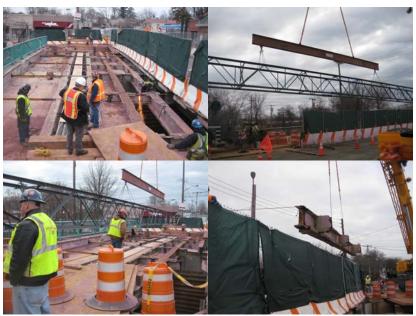
Annadale Road Bridge: Stage I Construction in February 2009. Saw Cutting the Diaphragms, Removing the Stringers, And Placing a Temporary Truss to Support Utility Conduits.

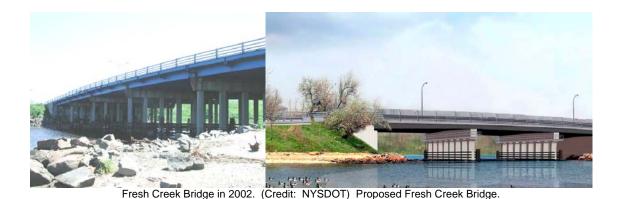
The replacement bridge will be a 309-foot, 3 span structure; the new structure will have only two support piers, resulting in a wider channel. The proposed construction will result in improved landscaping on the bridge approaches. The bridge deck and approaches will be widened to 120 feet from the existing 86 feet to accommodate three 12-foot lanes in each direction, 12-foot wide shoulders, and a 12-foot wide bike path, separated from the traffic lanes by a barrier system. The pedestrian and bicycle pathway will be maintained at all times.

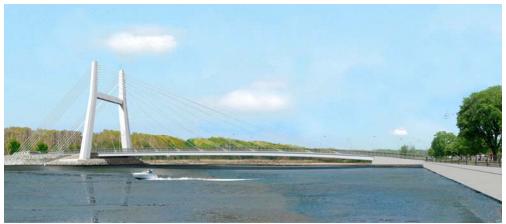
Side View Rendering of New City Island Road Bridge.

The existing bridge will be replaced along the same alignment with a new single span, single tower cable-stayed bridge which will be a unique structure type in the NYC area. The new bridge will be approximately 17 feet wider than the existing one to accommodate three standard 12-foot wide traffic lanes, a 6-foot wide bicycle lane and a 6-foot wide pedestrian walkway on each side. The tower and concrete counterweight for backstay anchorage of the new bridge will be located in Pelham Bay Park. The new bridge will be designed to current standards and with its wider roadway width, will allow future repair and rehabilitation to be carried out while maintaining one 12-foot lane in each direction. In order to maintain traffic during the demolition of the existing bridge and construction of the new bridge, a temporary bridge will be constructed on the south side of the existing bridge.

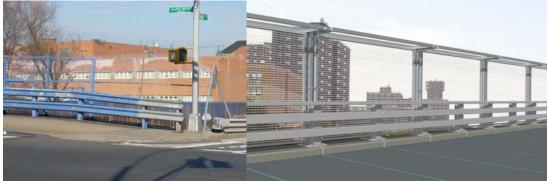
Existing North Side Guardrail and Fence. Proposed Guardrail and Fence.

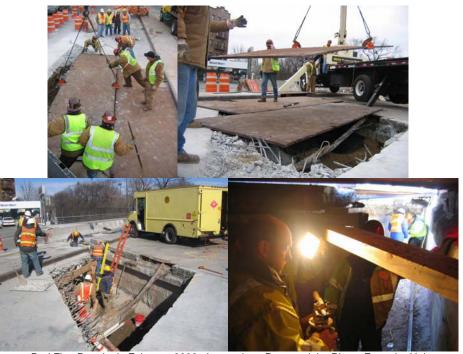
Red Flag Repairs in February 2006: Ironworkers Removed the Plates From the Holes and Replaced Them at the End of Each Day. They Also Placed Reinforcing Bars for the New Concrete Slab. Supervisor Bridge Repairer and Riveter Gean Pilipiak Monitoring Red Flag Repairs in 2006. (Credit: Peter Basich)

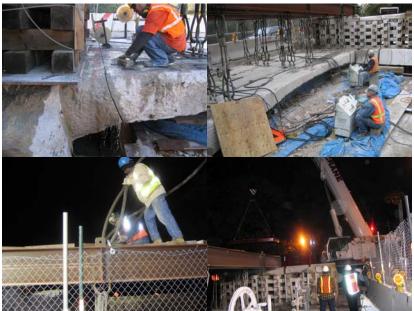
2006: Wire Sawing the Deck and Removing the Existing West 252nd Street Bridge Sections Over the Parkway.

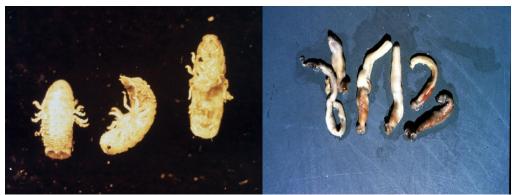
Marine Borer - Limnoria Species

Marine Borer - Teredo Species

Marine borers pose an immediate and serious danger to the thousands of piles and other structures of timber built in the marine environment. In New York Harbor, as the water quality improved due to many years of clean up efforts, marine borer (limnoria, teredo, etc.) activity has increased significantly in recent years. The recent inspections of timber structures by various local agencies (such as The Port Authority of NY & NJ, NYS Department of Transportation, NYC Department of Sanitation, and NYC Economic Development Corporation) indicate increasing damage to their structures resulting from marine borer activity. These agencies are implementing measures to protect the structures against marine borers.

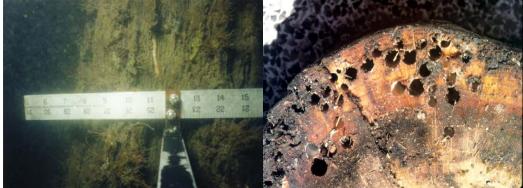
Medium Limnoria Infestation

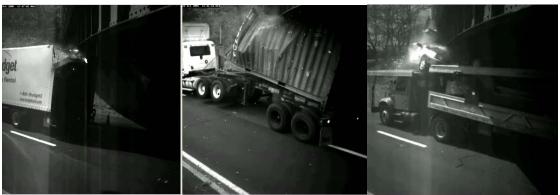
Video Stills From the Westchester Avenue Bridge BDSS.

The Westchester Avenue Bridge's vertical clearance over the Hutchinson River Parkway is substandard. Due to the number of truck and bus vehicles that mistakenly enter the Hutchinson River Parkway, where commercial vehicles are not allowed, the fascia steel girders of the bridge have been severely impacted and damaged numerous times. The planned lowering of the parkway will make it possible to eliminate the existing sub-standard vertical clearance of the bridge over the parkway without adversely impacting the NYCT elevated structure and its transit train operations. The total length for the lowering of the parkway will be 1000 feet (north and south), with a maximum lowering of the parkway of 2.5 feet under the Westchester Avenue Bridge.

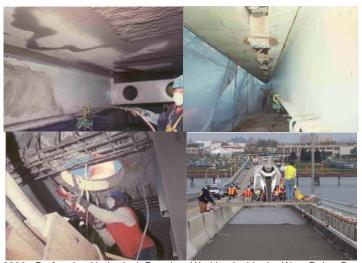
2006: Performing Underdeck Repairs. Working Inside the West Rebar Box Frame. Beam Repair. Concrete Placement.

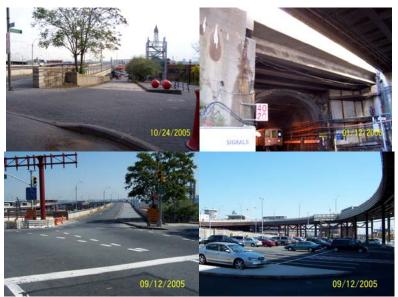
Ramp A - Borough Place over SIRT Tracks. Ramp B - Bus Entrance Ramp over SIRT Tracks & South Municipal Parking Field.

Currently a series of eight ramps carry bus and passenger car traffic in and out of the facility. The eight vehicular ramp structures consist of 73 spans that provide access to the Staten Island Ferry Terminal for pedestrians, private vehicles, taxis, and New York City Transit buses. The ramps span over the Staten Island Railway, terminal buildings, and terminal parking. Two of the structures serve as a bus station as well as providing a roof over the rail station below. Limited parking is provided on several of the ramps. The North Ramp provides access to the North Municipal Parking Field and the Richmond County Bank Stadium and stadium parking lot, which provides supplemental parking to the Ferry Terminal. The five span pedestrian bridge provides access between the main Ferry Terminal building and the 69th Street Terminal building as well as access to the Bus Entrance Ramp (Ramp B) above and the Commuter Pick-Up and Drop-Off Area below.

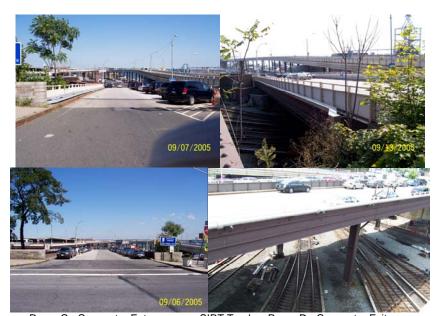
Ramp C - Commuter Entrance over SIRT Tracks. Ramp D - Commuter Exit over SIRT Tracks & Employee Parking Lot.

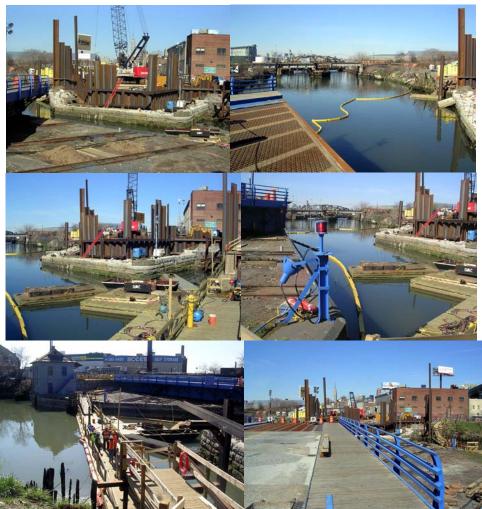
Reconstruction of West Abutment of the Borden Avenue Bridge in April 2009. (Credit: Bernard Ente)

In the spring of 2008, the Department observed that an existing crack in the west abutment's wingwall had opened up further. Following a series of subsequent inspections, it was determined that there is continuing movement of the west abutment wall. In an effort to mitigate this condition, two pressure relief joints were installed in the roadway, and the speed limit for eastbound traffic was posted at 15 miles per hour. Unfortunately, these measures did not stop or slow the abutment wall's movement.

The movement of the wall is undermining the stability of the bridge. Due to the potentially serious danger to life, public safety and property posed by the current condition, it is critical that the repair work be performed as expeditiously as possible.

The repairs will include the following: removal of the fill material under the roadway and sidewalks from behind the west abutment and between the wingwalls; relocation of the existing utilities; digging of a test pit to inspect the supporting piles; inspection of the condition and the taking of measurements; and the implementation of the appropriate repair solution based on the inspection findings.

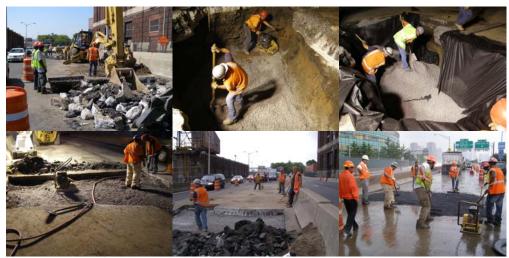
Filling the Excavation on the FDR Drive.

The Department's preliminary assessment of the collapse was that a tidal surge from the East River apparently entered the supporting fill in the area of the undermined portion of the roadway.

The conditions at the base of the timber piles were immediately addressed by placement of normal weight concrete around the exposed timber. The next phase included the "forming and filling" of the area beneath the platform. A light weight cementitious fill was utilized for the majority of the structure, and a 10-inch thick reinforced structural layer was utilized at the timber deck elevation. Due to lead time issues on material, the contractor used stay-in- place forms. Finally, for sealing purposes and additional lateral support, a steel sheet pile bulkhead backed with normal weight concrete was constructed in front of the platform. The full roadway was restored to traffic, and construction was substantially completed on October 16, 2009.

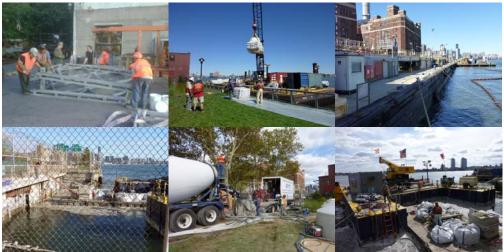
Emergency Repairs on the FDR Drive in August and September 2009.

The right lane was closed on August 13, and the remainder of the northbound FDR Drive between Houston and 20th Streets was fully closed to traffic at 9:00 PM on August 18. The emergency contractor placed a timber mat across the entire width of the northbound FDR Drive near 15th Street. The mat was approximately 60 feet long, with 75 foot approach ramps to and from the mat. The Roadway Repair and Maintenance Division placed asphalt on the mat and ramps, and the Traffic Operations Division striped the roadway and placed appropriate signage. The northbound Drive was reopened to two lanes of traffic at 2:00 AM on August 20.

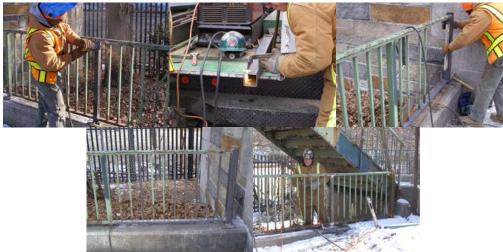
Fixing the Railing at the West 148th Street Pedestrian Bridge over Amtrak 30th Street Branch in January 2009.

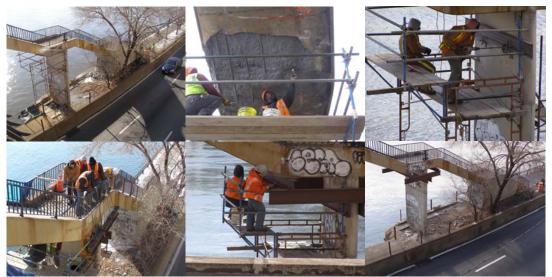
Installing Steel Shoring at the 81st Street Pedestrian Bridge over FDR Drive in January and February 2009.

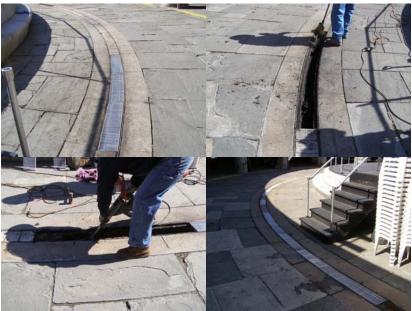
Installing Steel Grating for the Circular Gutter at the West 79th Street Rotunda in March 2009.

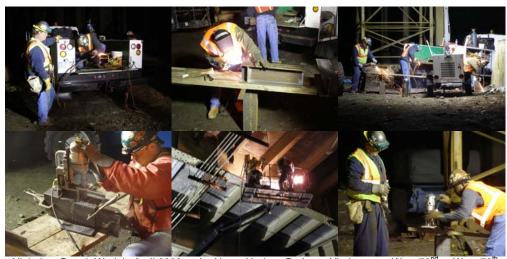
Nighttime Repair Work in April 2009 at the Henry Hudson Parkway Viaduct over West 72nd to West 79th Street.

In response to a series of red flags for the deteriorated stringers supporting the Henry Hudson Parkway between 72nd Street and 96th Street, the When & Where contractor was mobilized to perform emergency steel repairs. Rapid coordination was achieved with Amtrak to enable these emergency repairs to proceed unimpeded. The work is still on-going, during night shifts.

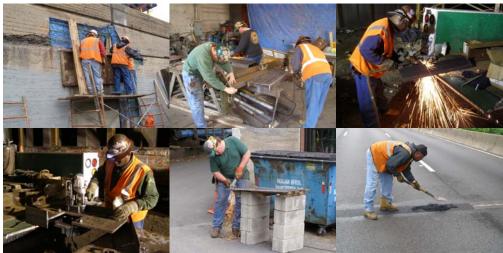
Repairs at the Henry Hudson Parkway Viaduct in May and June 2009.

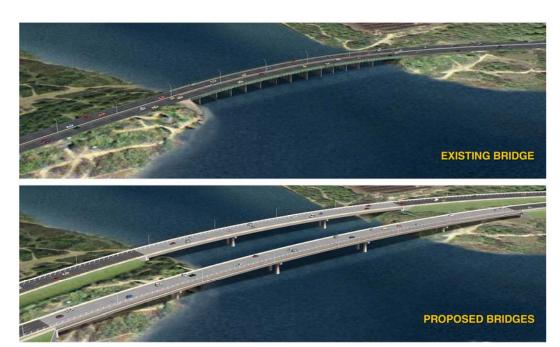
Rendering of Existing and Proposed Belt Parkway Bridges Over Paerdegat Basin. (Credit: Alexander Berens)

Projects underway in 2009 included the Belt Parkway Bridge over Paerdegat Basin in Brooklyn. The existing bridge with its nest of thirteen piers will be replaced in its entirety by two split bridges, one each for eastbound and westbound traffic. The bridge for eastbound traffic will have four piers whereas the bridge for westbound traffic will have two piers. This is the first bridge to be designed by NYCDOT with trapezoidal steel box girders utilizing high performance steel and seismic isolation sliding bearings. In addition, the aesthetics of the bridge will be enhanced by its nightly illumination utilizing light emitting diodes on both fascias and piers. This project will also include wetland mitigation and landscaping in the immediate vicinity of the proposed bridges. The construction commenced on October 26, 2009 along with two other adjacent bridges in the Belt Parkway Corridor as a combined contract.

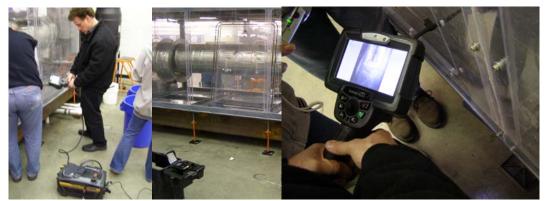
Director of Bridge Management Kevin McAnulty Utilizing a Borescope to Investigate the Suspension Cable Model at Columbia University. The Cable is 20 Inches Thick and 20 Feet Long, Made of 10,000 Steel Wires, Each Five Millimeters in Diameter. Sensors in the Cable Measure Corrosion Rates, Temperature, Humidity, Acidity and Chlorine Content, and Microphones Detect Cracking in the Steel Strands. (Credit: Bojidar Yanev)
