**New York City Department of Environmental Protection
Bureau of Water Supply**

**Stream Management Program
Request for Approval for Three Water Quality Stream Projects:
East Branch of the Neversink River at Ladleton
(Neversink Basin)
West Branch of the Delaware River at Riverhaven Farm
(Cannonsville Basin)
and
West Branch of the Delaware River at Birdsong Farm
(Cannonsville Basin)**

November 2020

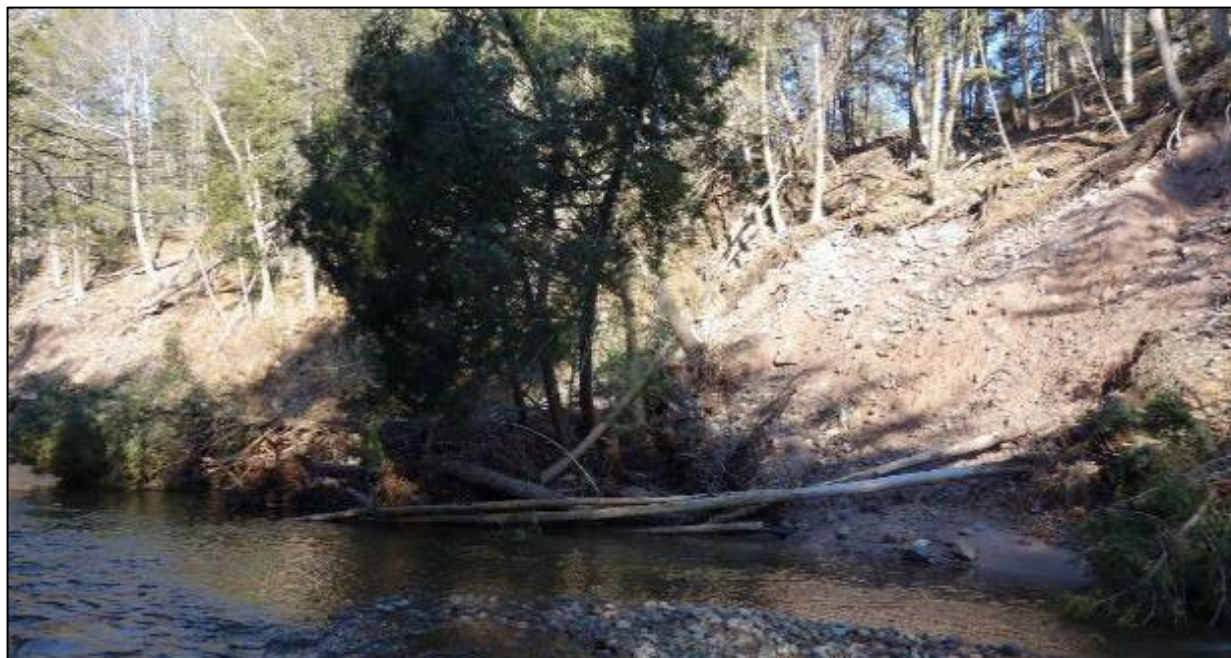
Figure 2. Primary hillslope failure at the East Branch of the Neversink River at Ladleton.

The Upper Neversink River Stream Management Plan, completed in 2013, recommended additional monitoring at Ladleton to confirm the rate of erosion and support development of treatment options. A Bank Erosion Monitoring Study conducted in 2014 ranked 46 bank erosion sites on the Neversink River's mainstem and tributaries in terms of total area contributing fine sediment; the Ladleton site ranked near the top of that list. The clay-rich glacial till in the hillslope and in the eroding bank opposite and downstream has been observed on numerous occasions, especially during freeze/thaw cycles, to create significant turbidity during elevated flow events. Hydraulic erosion at the toe of the hillslope has undermined its stability, maintaining an over-steepened condition that prevents the establishment of a stable angle of repose and natural revegetation, resulting in the ongoing introduction of both fine and coarse sediment and large wood. The channel alignment has evolved over the past decade to acquire a tight radius of curvature at the base of the hillslope, increasing velocity vectors and impinging shear stress. Site analysis of monitoring data in the years since the Bank Erosion Monitoring Study concluded that the hillslope is unlikely to restabilize within reasonable management time frames without significant intervention.

The following four images further support the nomination of the Ladleton project as a FAD-approved WQSP. Figure 1 depicts the project location within the Neversink basin. Figure 2 depicts the primary hillslope failure at the project site. Figure 3 depicts the secondary lower bank at the project site. Figure 4 provides an aerial view of the project site, with bank failure locations highlighted in red shading.

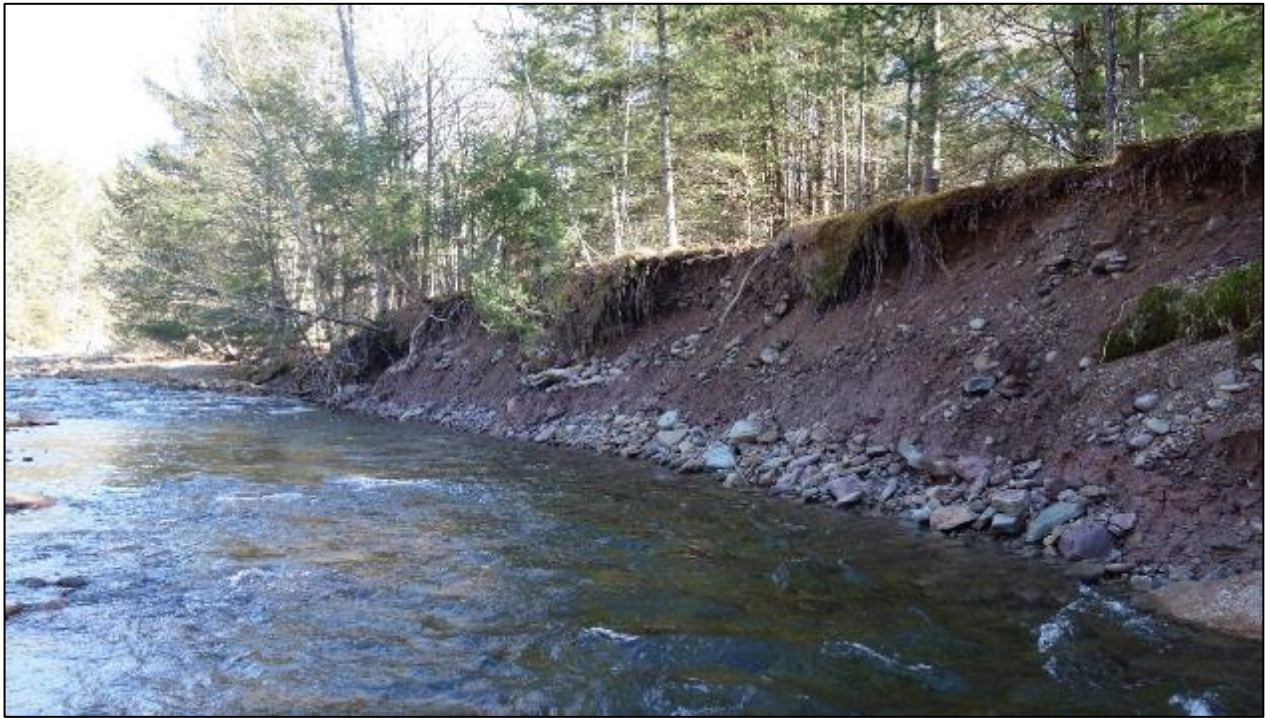
Figure 3. Secondary lower bank at the Ladleton project site.

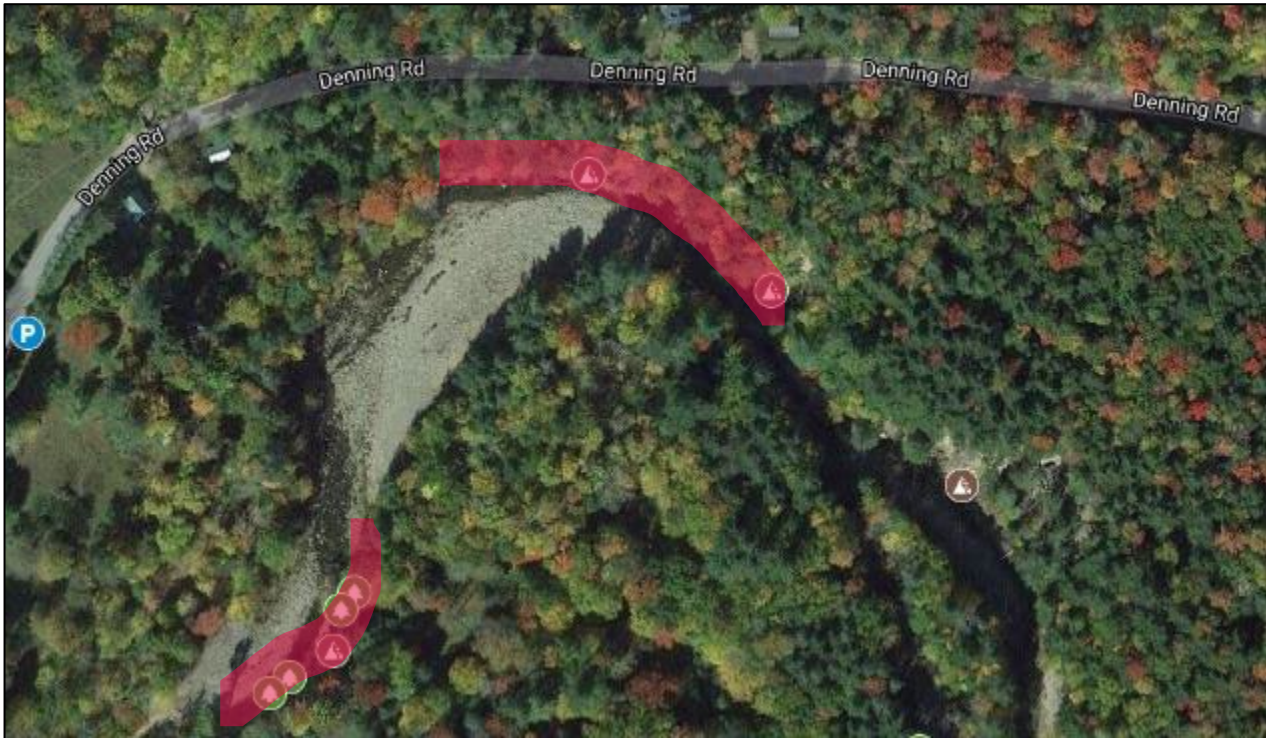
Figure 4. Aerial view of the Ladleton project site, with bank failure locations highlighted.

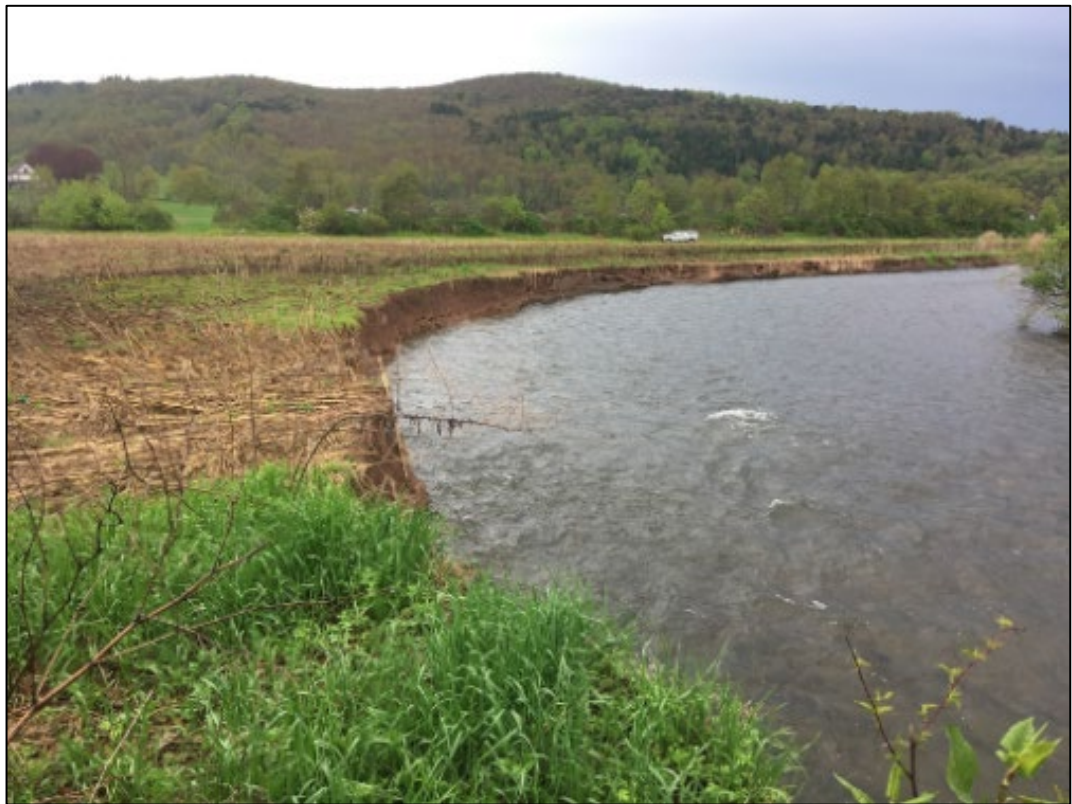
Figure 5. Accelerated erosion at the Riverhaven Farm project site (upstream view).

Instability at this site is attributable to (1) tributary confluence dynamics (flooding and sediment delivery), (2) channel alignment with hydraulic shear stress against a bank composed of unconsolidated fine sediment with no woody riparian vegetation, and (3) in-channel deposition leading to increased shear against the eroding bank.

The following two images further support the nomination of the Riverhaven Farm project as a FAD-approved WQSP. Figure 5 illustrates the accelerated erosion at the project site. Figure 6 provides orthoimagery of the project site with superimposed extents of streambank erosion as of 2019. The location of this project site is depicted in a map (Figure 9) at the end of this report.

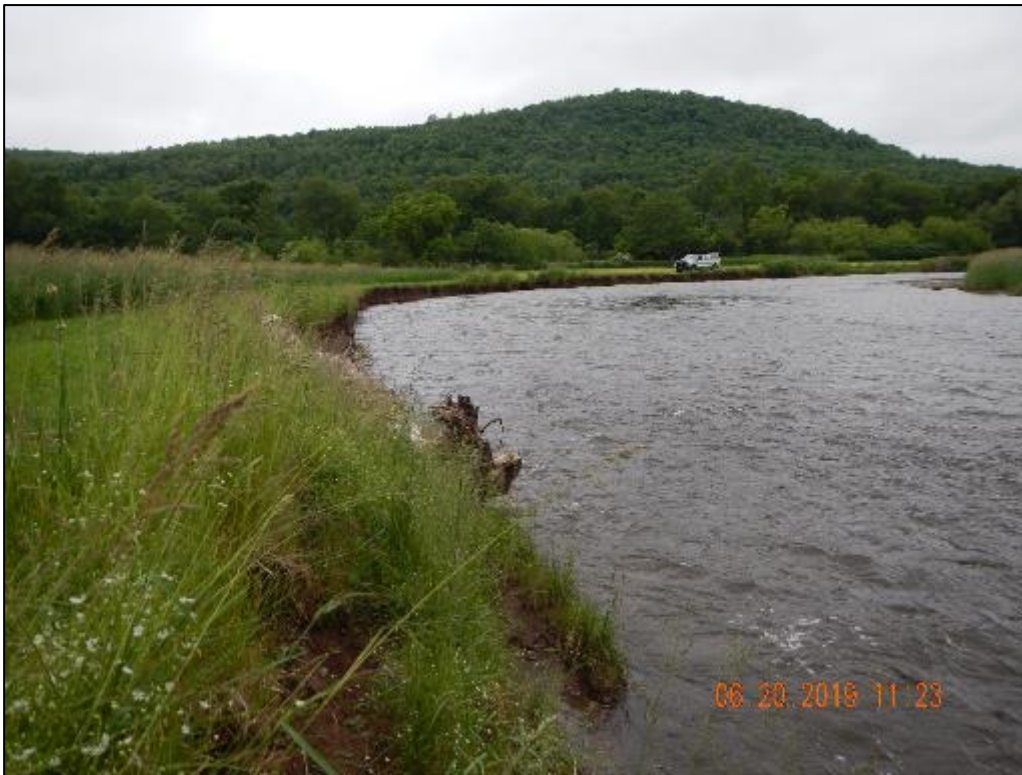
Figure 7. Accelerated erosion at Birdsong Farm on the West Branch Delaware River (upstream view).

At Birdsong Farm, remotely sensed imagery indicates that an island upstream of the current instability began forming in the early 2000s. This island directed flow towards a sparsely vegetated streambank, resulting in accelerated erosion that has over-widened the stream channel causing increased deposition and further exacerbating channel erosion. This lateral migration of the WBDR continues to erode and push downstream.

The following three images further support the nomination of the Birdsong Farm project as a FAD-approved WQSP. Figure 7 illustrates the accelerated erosion at the project site. Figure 8 provides orthoimagery of the project site with superimposed extents of streambank erosion as of 2019. Figure 9 shows the location of this project site, along with the proposed Riverhaven Farm site, within the Cannonsville basin.

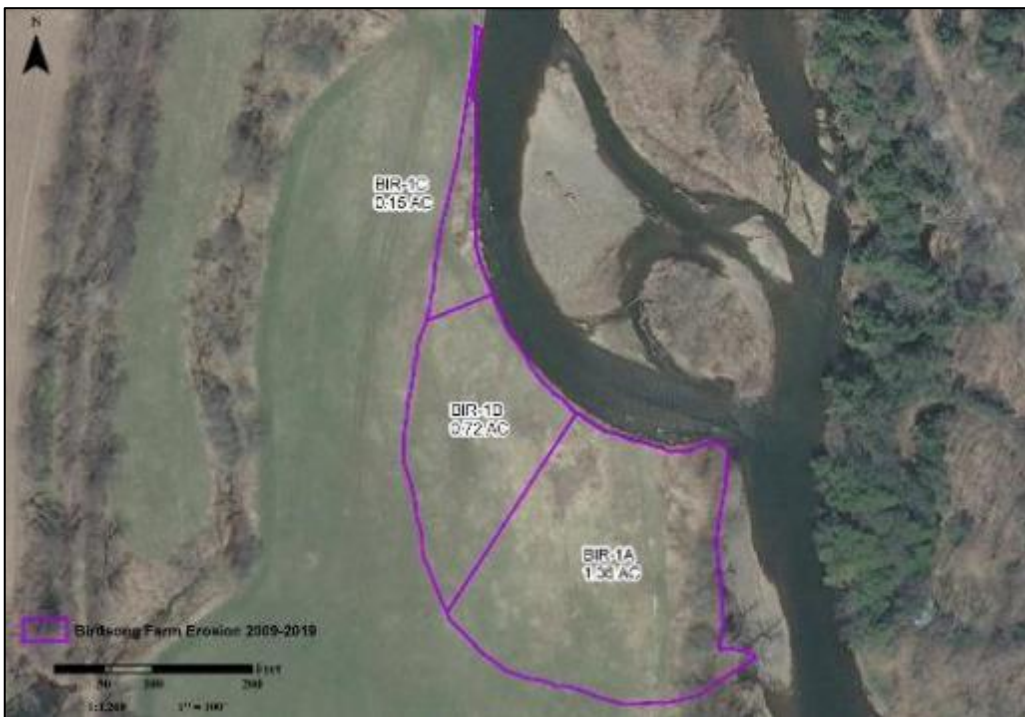
Figure 8. Orthoimagery of Birdsong Farm on the West Branch Delaware River with superimposed extents of streambank erosion as of 2019.

The SFI prioritization for the WBDR Stream Corridor Management Plan identified management unit 20 as the most unstable unit on the WBDR. DCSWCD has identified the Birdsong Farm reach, located within this management unit, as a second WQSP for its disproportionate contribution of fine sediment and nutrients. Analysis by DCSWCD of remotely sensed imagery between 2009 and 2016 determined that the measured erosion at Birdsong Farm made up 77% of the erosion within management unit 20. Using the method described in the Riverhaven Farm analysis, DCSWCD estimates 16,005 cubic yards (889 dump truck loads) of soil were eroded into the WBDR and the eroded soil may have yielded approximately 11,896 pounds of TP and 70,458 pounds of TN between 2009 and 2019.
