WEST BRANCH NEVERSINK RIVER

Aquatic Habitat Demonstration Restoration at Frost Valley Road

AQUATIC HABITAT DEMONSTRATION RESTORATION AT FROST VALLEY ROAD

AQUATIC HABITAT RESTORATION DEMONSTRATION PROJECT WEST BRANCH NEVERSINK RIVER AT FROST VALLEY ROAD COUNTY BRIDGE 187 AT COUNTY ROAD 157, CLARYVILLE SULLIVAN COUNTY, NEW YORK

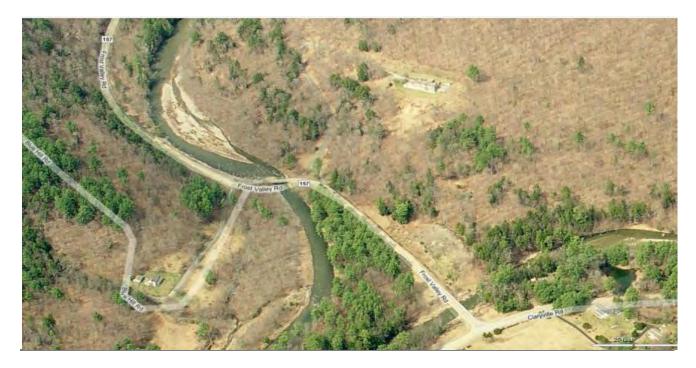
Stream channel runs adjacent to road disconnecting riparian corridor.

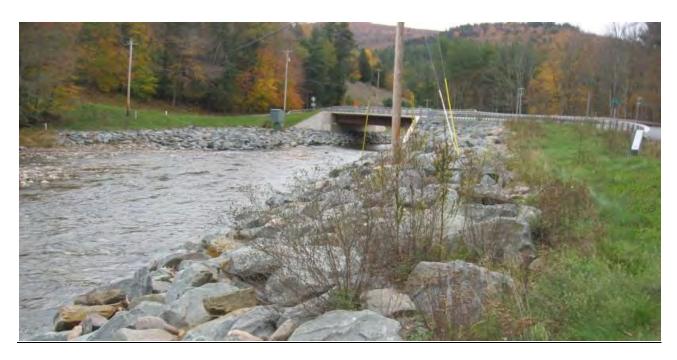
Area identified to demonstrate new road buffer planting practice with Stinger and live willow stakes.

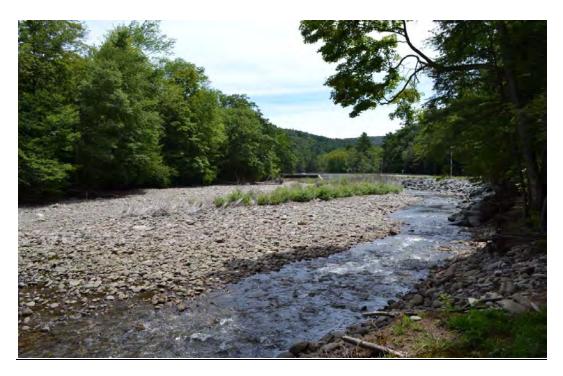
Looking downstream at pre-existing channel alignment.

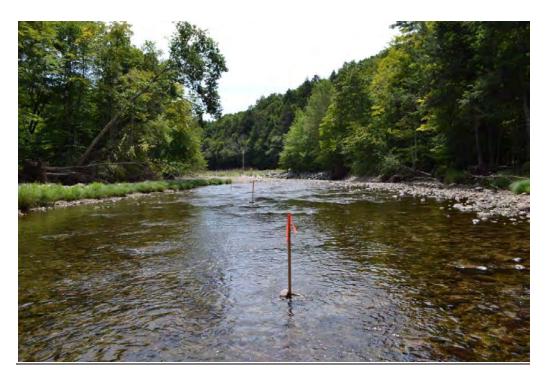
Staking out new center of channel.

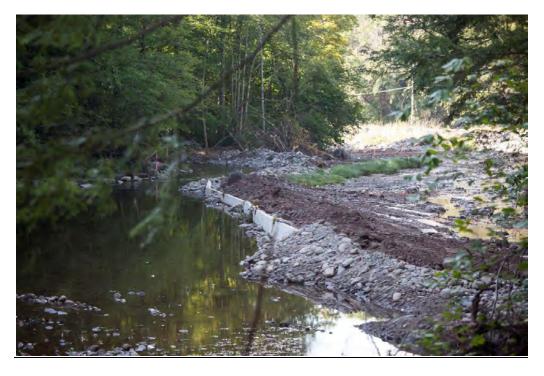
Coffer dam installation to create bypass channel; diverts stream around project site.

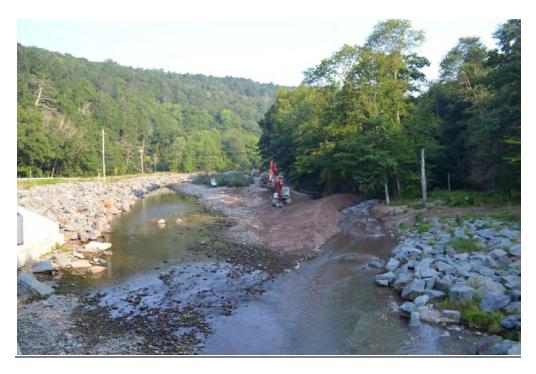
Construction of bypass channel/water diversion.

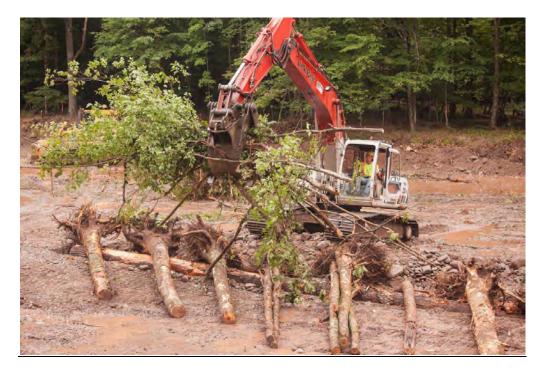
Constructing the base of the new stream bank with root wad revetment.

- Construction of root wad revetment underneath the floodplain bench to protect the base of the
 new channel stream bank using downed large woody debris located on site. Facing root wads
 upstream slows near-bank velocities and provides cover, shade and thermal refuge increasing
 trout habitat value. This practice is proving to be a cost-effective bank stabilization practice for
 post-flood emergency periods throughout the Catskills;

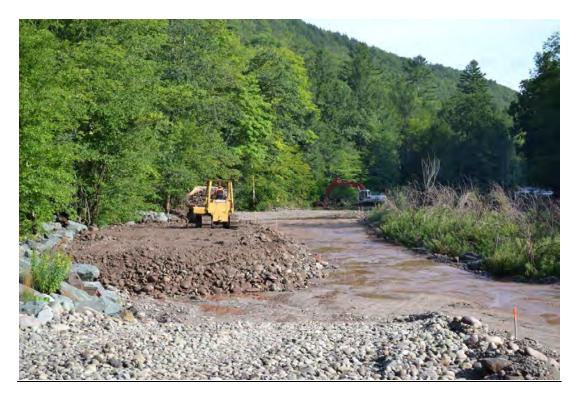
Building the new floodplain bench.

- Construction of a bankfull-stage rock-and-soil bench along the base of the rip-rapped embankment, tied into stable vegetated buffer at the upstream end of the meander bend; transplanted"willow clumps" from the vegetated center bar to this bench;

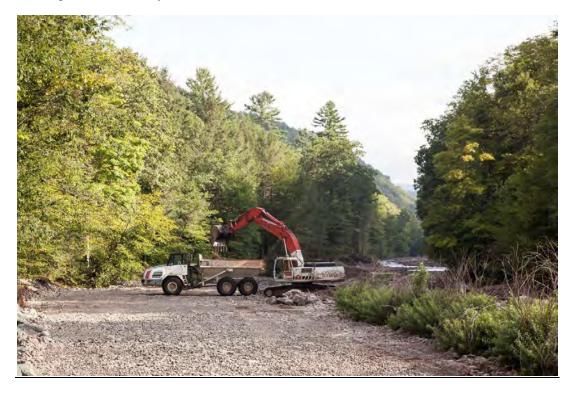
New floodplain elevation.

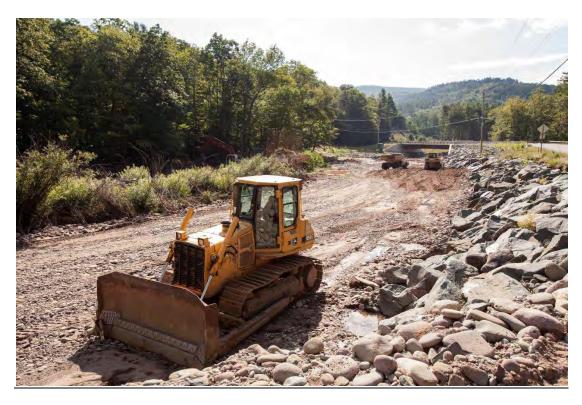
View of new right stream bank riparian buffer to be planted in fall.

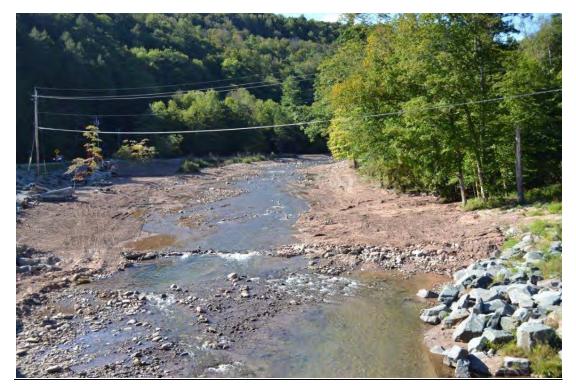
With the bypass channel released, site restoration begins.

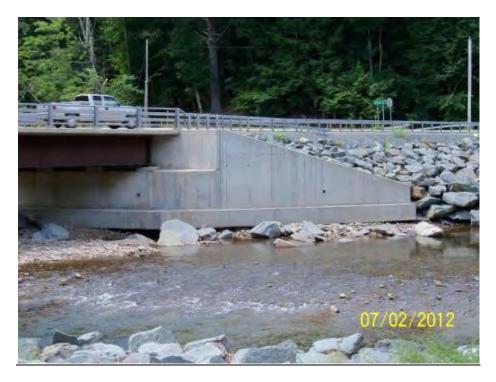
During the stream feature inventory, it was noted that the bridge abutment would likely sustain damage by scour during high flows. This was confirmed during Tropical Storm Irene in August 2011, when high flows damaged the north side rip rap and nearby downstream abutment. Before construction could begin, the site had to be resurveyed and redesigned in order to resubmit the permit application to NYS DEC for construction in 2012.

Damage from Tropical Storm Irene goes unseen from the road.

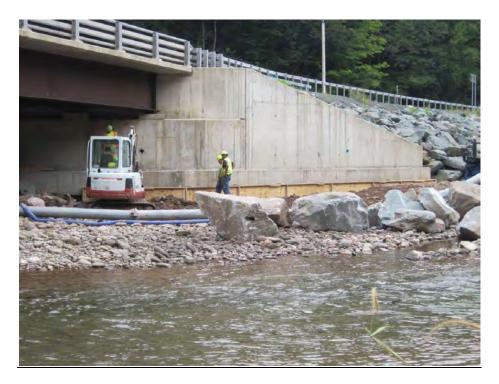
Repairs are made during project construction through a partnership with Sullivan County.

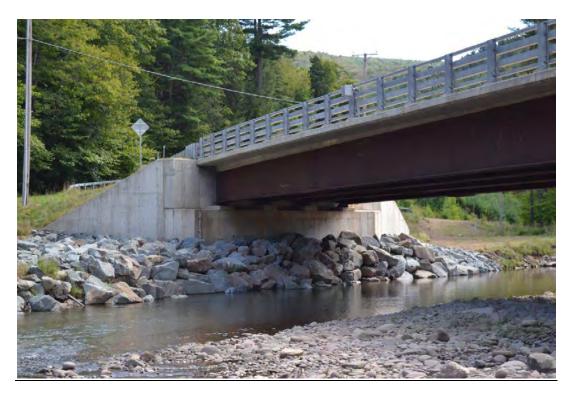
Claryville Fire District requests permission to install new access for water tanker, downstream right.

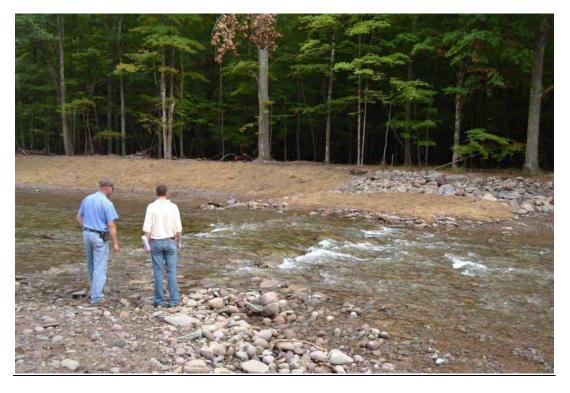
Contractor and engineer inspect installation of rock run, a project design element.

- Design incorporates trout habitat improvement structures built into both banks: boulder clusters, lunker structures, rock runs and concave rock vanes, to provide overhanging cover, and flow diversion structures to maintain or improve scour pool habitat;

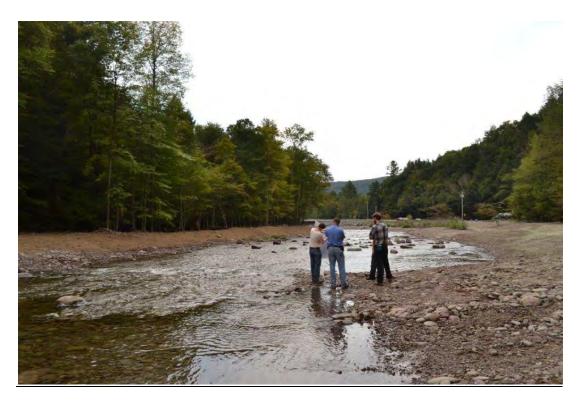
Forested left bank is restored with native seed mix and mulch; hydroseeding of right bank follows.

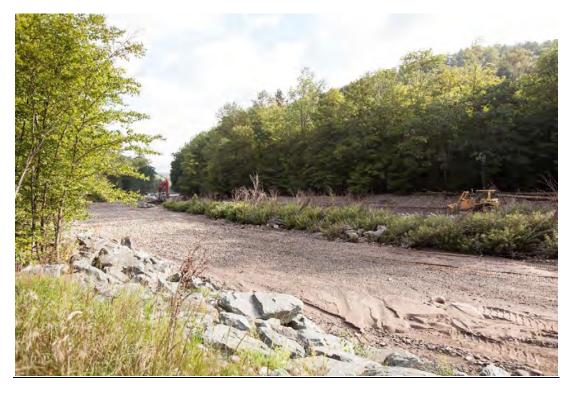
New riparian area ready for planting with trees, shrubs and live stake Stinger demonstration.

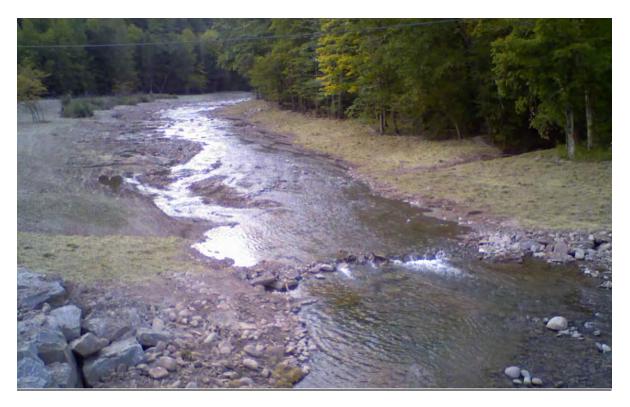
Site restoration as of August 31, 2012.

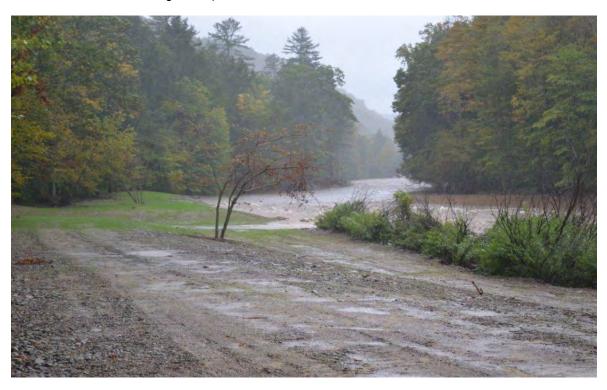
As water is rising on September 18. 2012, which will eventually prove to be a \sim 50-yr flood.

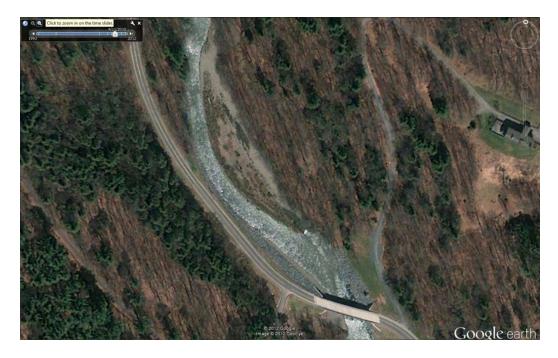
Prior to construction of demonstration project, stream channel threatening embankment, no riparian buffer.

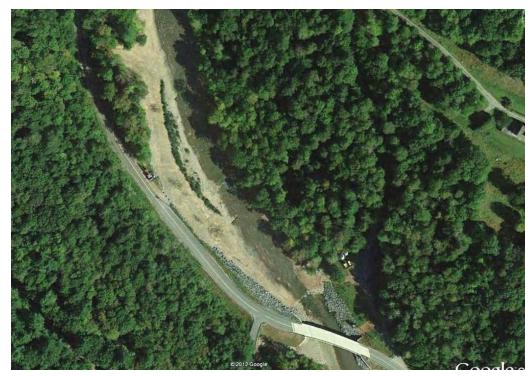
Immediately following substantial completion, buffer bench established, but not yet vegetated.

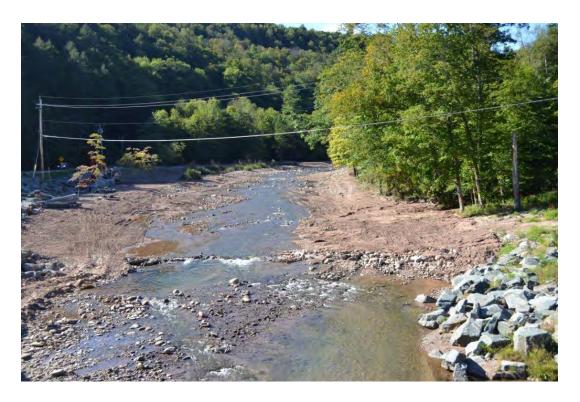
Looking upstream into project at substantial completion, but before revegetation of the floodplain bench, left.

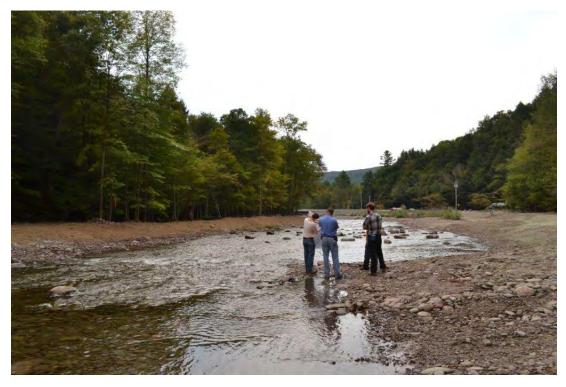
Final channel inspection with engineers at substantial completion, looking downstream through project.

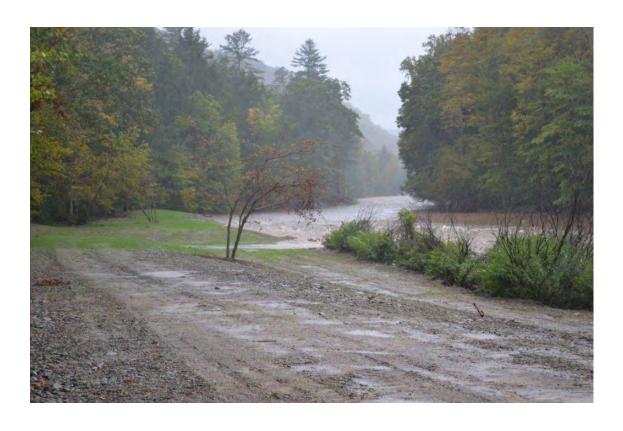
Water rising at project on September 18, 2012

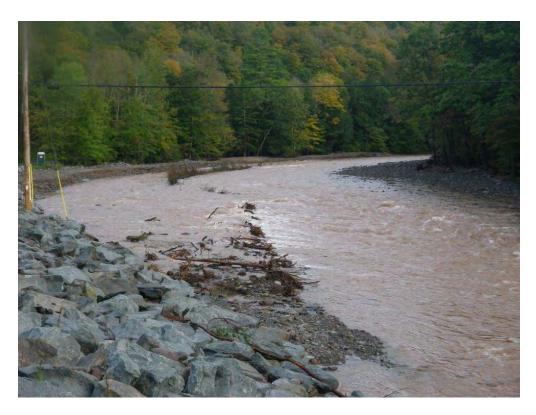
Inundation of floodplain bench

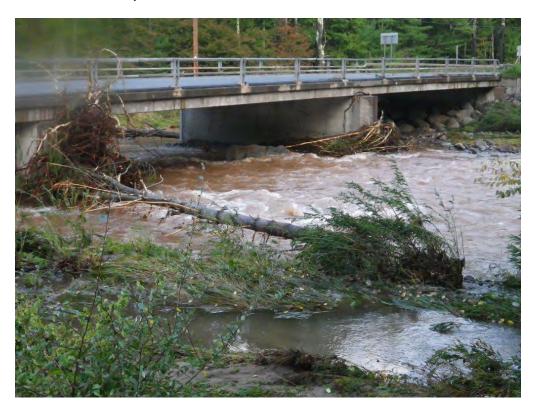
High water and large woody debris at bridge

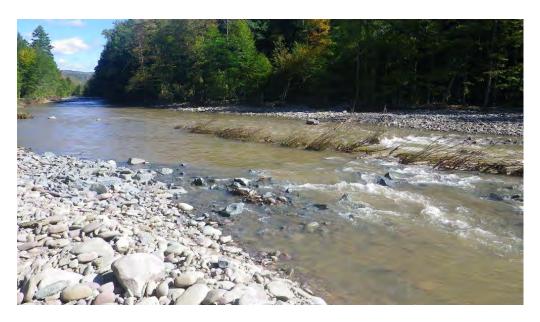
A localized 50-year flood event occurred on September 18 on the Neversink River (a 2% chance annual event). The newly constructed, but still unvegetated bankfull stage bench was significantly scoured. A

Following ~50yr flood, loss of significant bench material

post-flood survey and hydraulic model are being processed by the engineering firm Milone and Macbroom so that repair options can be considered for the floodplain bench, currently planned for late 2012 or in 2013. In either case, a short-term re-vegetation project will take place to prepare the site for this winter:

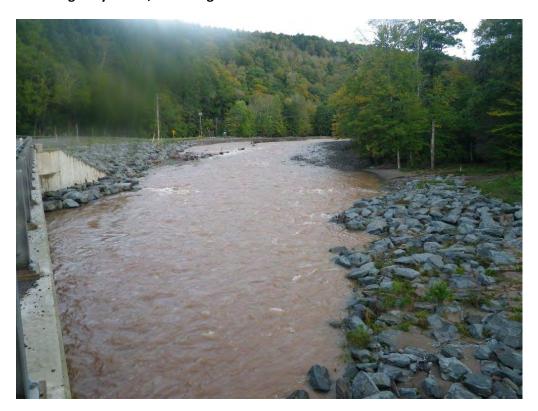
Looking upstream from bridge

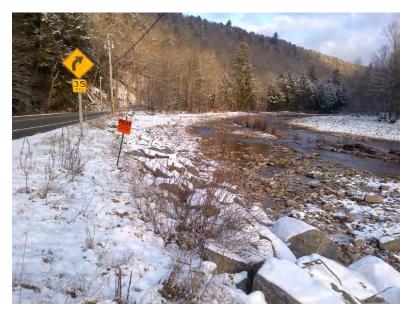
November 2012, remaining bench and revetment, prior to being interplanted

- The embankment will be treated with willow stakes, set into the rock, and the fringe of the road berm will be replanted with shrubs and/or trees.
- A piece of bioengineering equipment called "the Stinger" will be constructed to demonstrate itseffectiveness in creating voids for interplanting installed rip-rap with new vegetation (scheduled during willow dormancy November 2012). This equipment will subsequently be made available watershed-wide for use in similar riparian buffer improvement projects
- And then in Spring 2013, the floodplain bench will be interplanted with potted native tree and shrub stock.

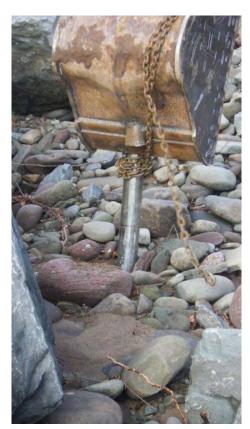
"The Stinger" being used to interplant willow posts into preexisting rip-rap

- Use of a "Stinger" tool for interplanting rip-rap with live willow stakes. Upon proof of concept, Sullivan County Soil & Water would extend its use throughout the region.

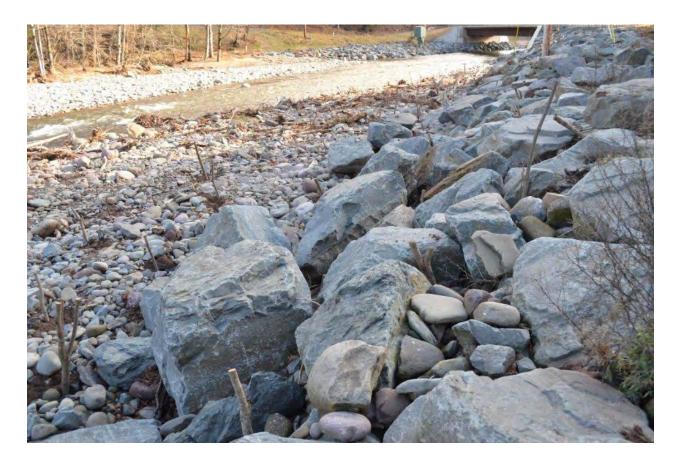
Revetment and bench after Stinger installation
