***QUEENS***

# Queens Boulevard

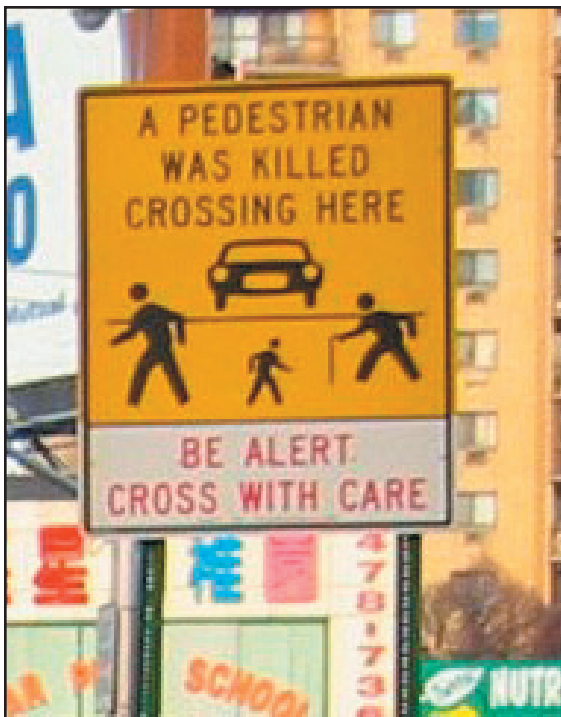
Example of Pedestrian Crossing sign on  
Queens Boulevard

where pedestrian fatalities have occurred. At eight intersections where there had been three or more fatalities since 1993, signs were installed with the legend “A Pedestrian Was Killed Crossing Here/Be Alert/Cross With Care”. At 27 intersections, signs were installed with the legend “Be Alert/Cross With Care”. In addition, at the 36 intersections, signs were installed with the legend “Begin Walking on a Fresh Walk/If Don’t Walk is Flashing Continue to Next Safety Island/Wait for a Fresh Walk/Cross With Care”.

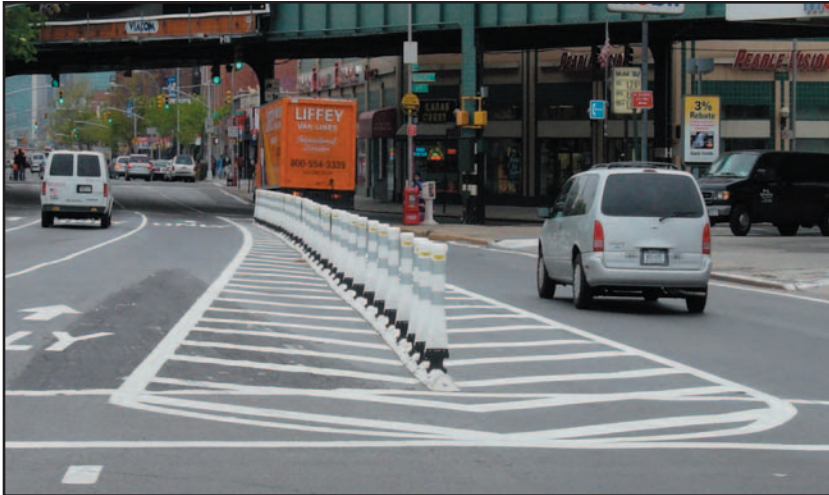
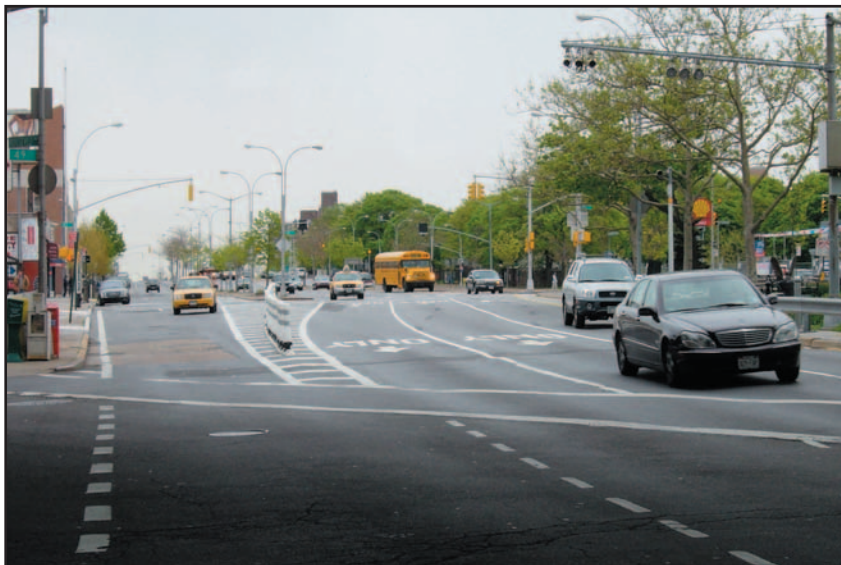
Roadway markings on Queens Boulevard between  
51<sup>st</sup> Street and Roosevelt Avenue

- In spring 2003, additional markings (shown to the left and on the following page) were installed to ease the transition for westbound vehicles on Queens Boulevard between 51<sup>st</sup> Street and Roosevelt Avenue where the service road merges with the main roadway.
- In spring 2003, the Department replaced and/or repaired 259 linear feet of pedestrian separators along Queens Boulevard.

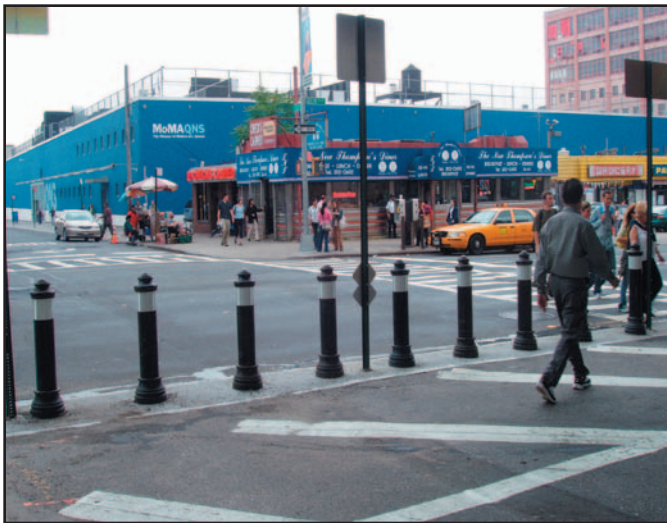
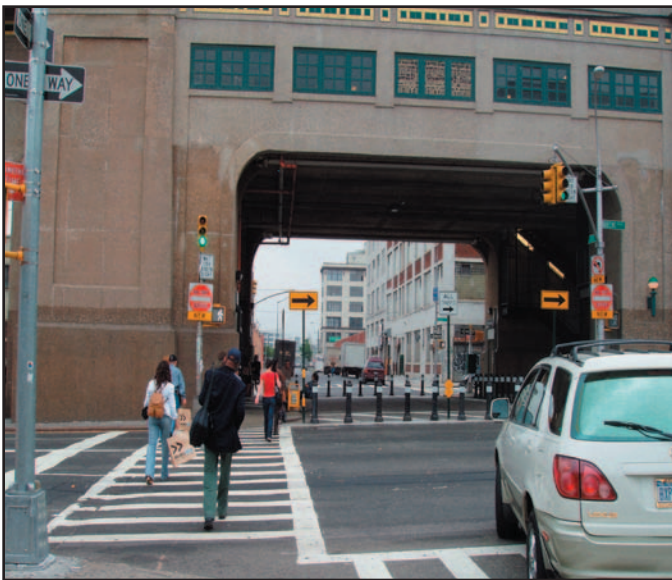
Above: Treatments used to implement Full closure of cross street  
Below: Example of treatment used to close access to parking areas

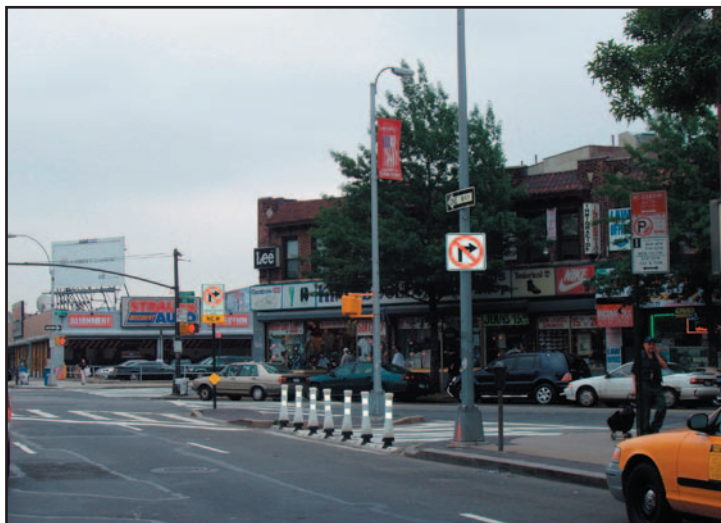
Treatment eliminating free right turn onto Greenpoint Avenue

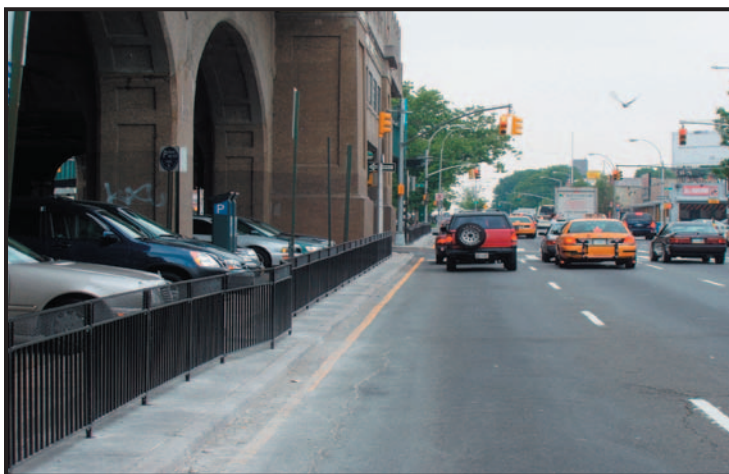
Pedestrian Fencing installed along parking facilities @ 47th Avenue and Queens Boulevard

In addition to the scheduled work on the study, the Department has installed an additional 24,000 linear feet of pedestrian fencing along the medians of the entire study area (excluding the section between Roosevelt Avenue and Van Dam Street). The installation of the fencing was completed in September 2003.

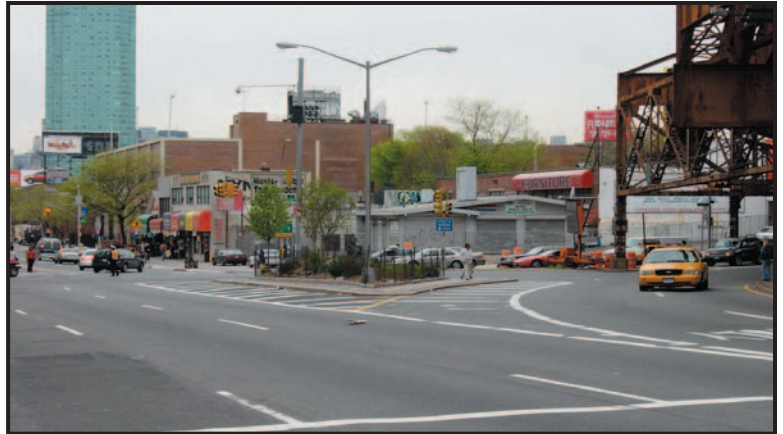
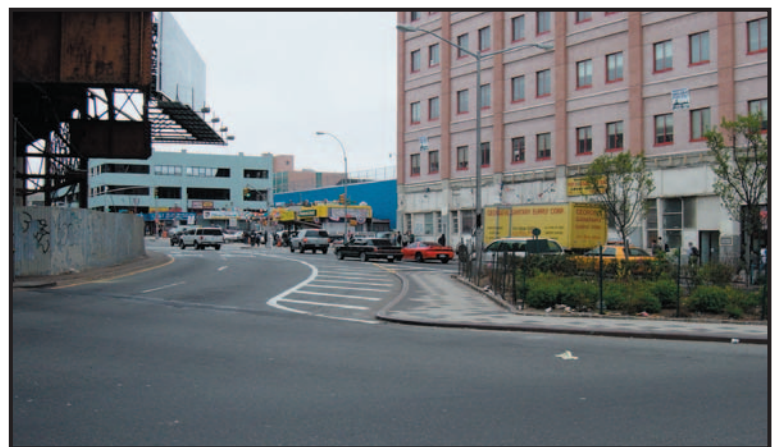
Channelization and markings @ Van Dam Street

In November 2002, an additional channelization (shown to the right and on the following page) was installed to narrow the roadway on eastbound Queens Boulevard to two lanes just north of the traffic island where Thomson Avenue and Queens Boulevard converge. The new channelization removed the conflict between vehicles entering Queens Boulevard from those continuing eastbound on Queens Boulevard.

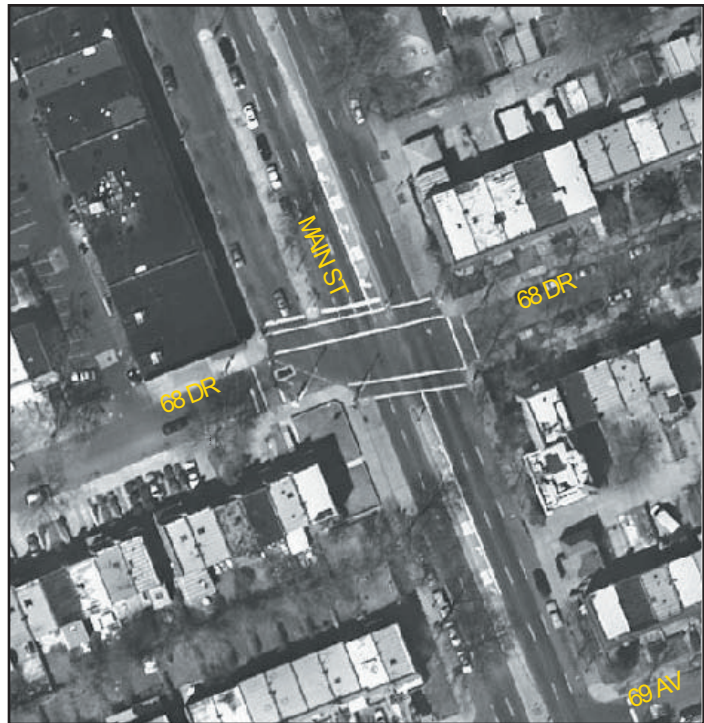
Aerial view of intersection

There are left turn bays for both northbound and southbound traffic. There is also a southbound service road that is separated from the main roadway by a concrete median than ends at 68<sup>th</sup> Drive. The convergence of these roadways causes poor alignment and motorists frequently make unsafe merges onto mainline roadway. In addition, motorists frequently fail to obey the traffic signals. For pedestrians, the unique geometry of the intersection causes the crosswalks to not be aligned with the pedestrian signals.

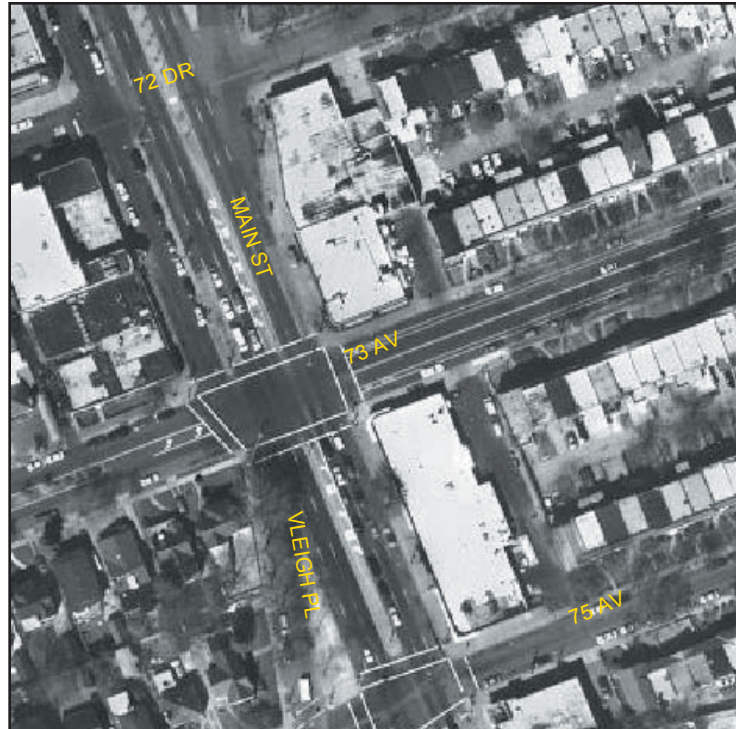
Aerial view of intersection

Main Street is a major north-south corridor that runs through central Queens. Along various portions of the corridor, a service road runs alongside the southbound portion of the roadway. At the Intersection of Main Street and 73<sup>rd</sup> Avenue, this service road comes to an end. This causes poor roadway alignment and dangerous movements as the service road and mainline traffic merge in an unsafe manner.

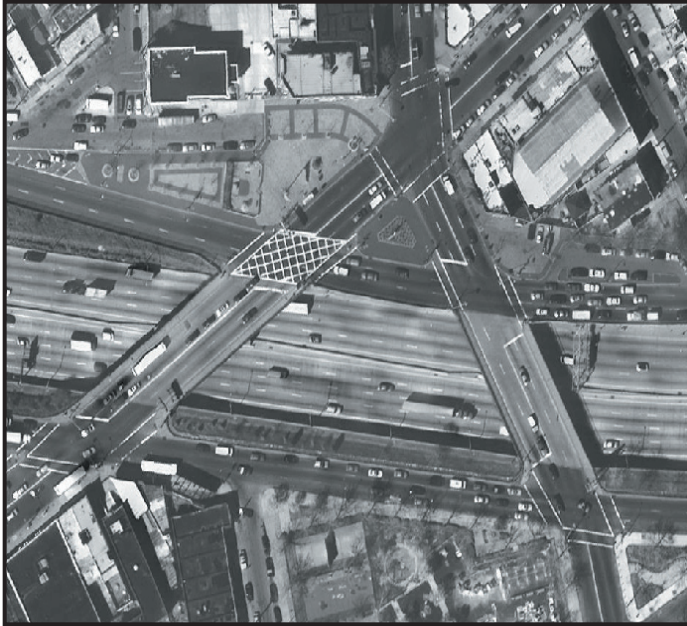
Aerial view of intersection

The interchange of 69<sup>th</sup> Street, Grand Avenue and the Long Island Expressway Service roads form a complex set of 5 closely spaced intersections. This configuration is due to the unusual roadway created by 69<sup>th</sup> Street and Grand Avenue crossing each other, the trenched Long Island Expressway, and the eastbound and westbound Long Island Expressway Service Roads. Speeding, heavy truck traffic exiting the LIE and motorists hurrying through this complex intersection contribute to the unsafe conditions. Additionally motorists and pedestrians alike must be cognizant of the varying directions traffic is moving through the intersection.

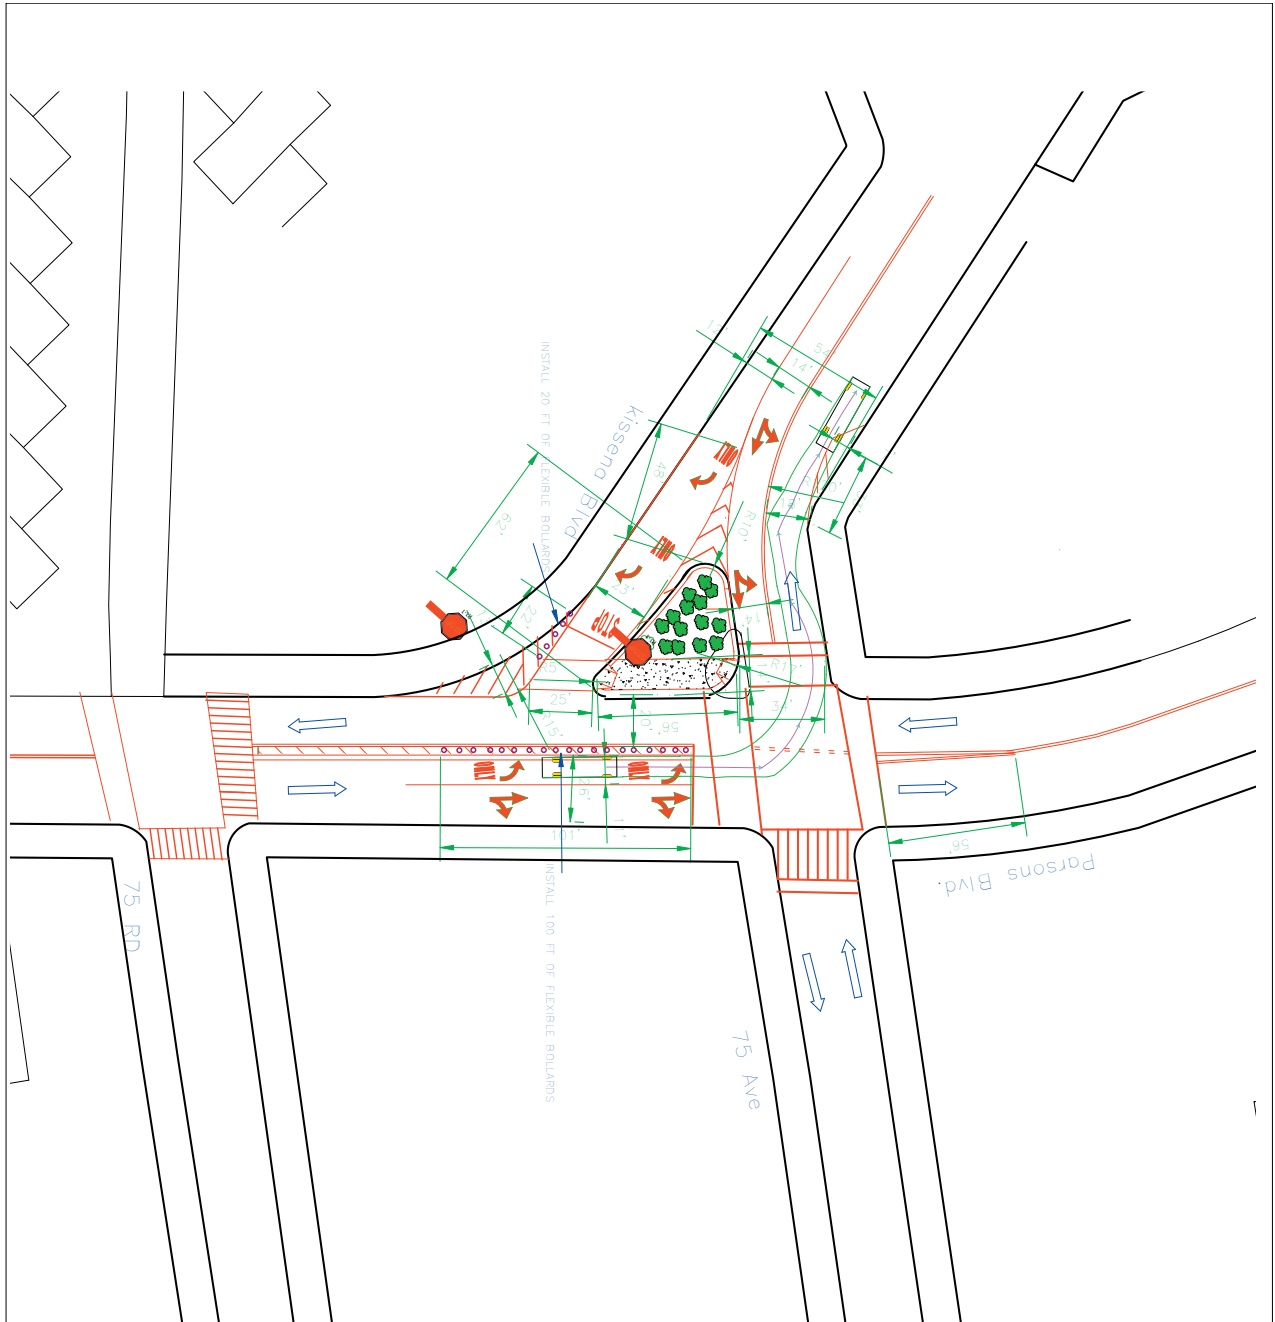
- ***Installation of a traffic signal at the intersection of Parsons Boulevard and 75<sup>th</sup> Avenue.***
- ***Installation of Stop controls, a Stop word message and a crosswalk for southbound Kissena Boulevard where it will intersect with southbound Parsons Boulevard.***
- ***Installation of a raised center median on Parsons Boulevard between 75<sup>th</sup> Avenue and 75<sup>th</sup> Road, which eliminated the unsafe movements into the strip mall. Vehicles exiting the strip mall will be forced to turn right onto northbound Parsons Boulevard.***
- ***Installation of lane use arrows and “ONLY” messages for Kissena Boulevard.***
- ***Removal of parking meters and the installation of parking restrictions on the east side of Parsons Boulevard between 75<sup>th</sup> Avenue and 75<sup>th</sup> Road.***

***The improvements are shown on the following page.***

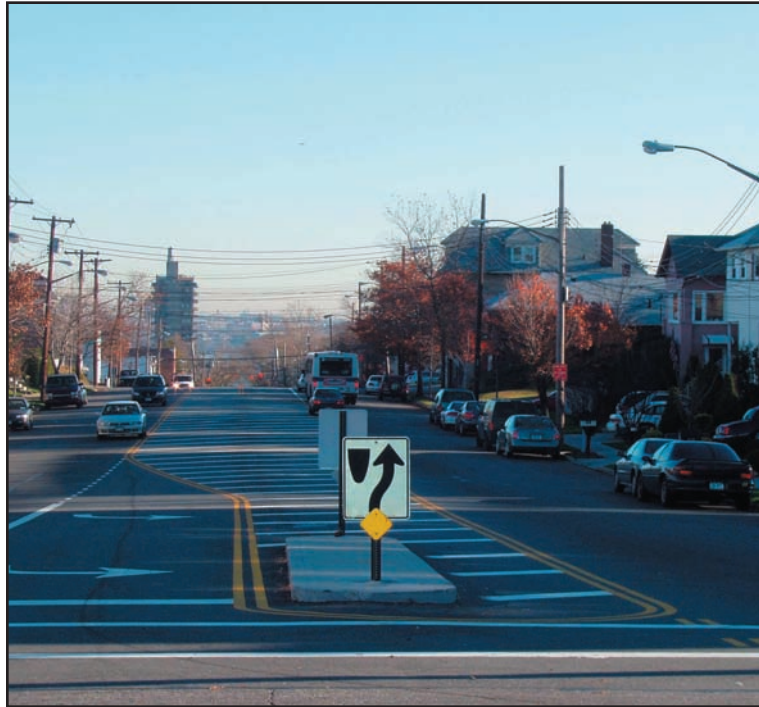
Roadway markings and raised intersection at Hylan Boulevard and Reynolds Avenue

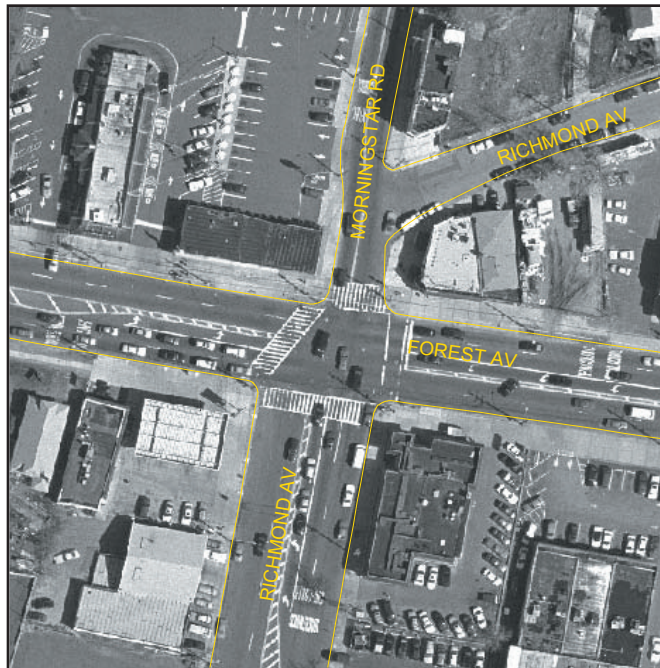
Original Configuration of Intersection

Based upon an increasing number of accidents and concerns about the illegal movements of vehicles at this intersection, the Department took a proactive approach at addressing these concerns. The accident history at this location indicates a steady increase in accidents between 1998 and 2000. In 1998, there were a total of 35 accidents, of
