### Safe Streets for Seniors YORKVILLE

Yorkville Safe Streets for Seniors Final Report Page 6

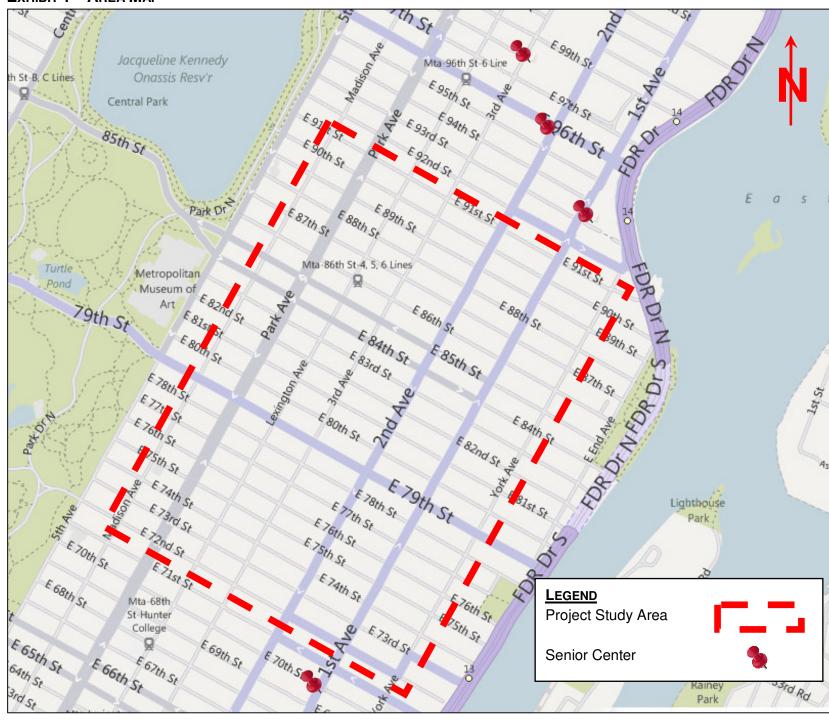
### EXHIBIT 1 – AREA MAP

Land-use in the Yorkville Study Area is a mix of commercial and residential buildings.

There are three nursing homes in the area (not shown on Exhibit 1 – Area Map):

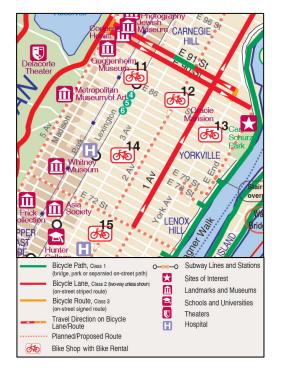
### EXHIBIT 2 - BIKE MAP

The 2010 NYC Bike Map shows "existing" and "planned/proposed" bicycle facilities throughout the city. In the vicinity of Yorkville Study Area, East 90<sup>th</sup> Street, East 91<sup>st</sup> Street and First Avenue are existing bike routes. In addition, East 72<sup>nd</sup> Street, East 79<sup>th</sup> Street and East 78<sup>th</sup> Street between East End and York Avenue, Second Avenue and Fifth Avenue are planned / proposed striped on street bike routes (Exhibit 2).

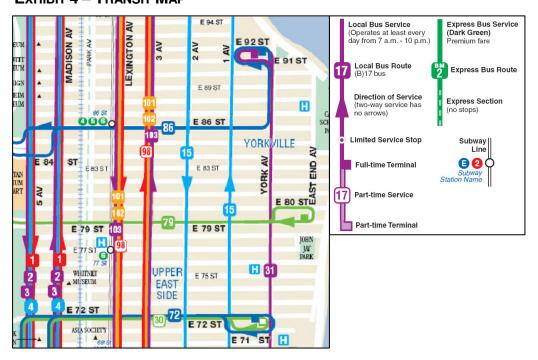
### **EXHIBIT 4 – TRANSIT MAP**

The M15 bus line is part of the Select Bus Service, a MTA Regional Bus Operations for Bus Rapid Transit Service (see Appendix F). The Lexington Avenue Line runs through the study area. A subway station for the 6 is on East 77<sup>th</sup> Street and for the 4, 5 and 6 is on East 86<sup>th</sup> Street (Exhibit 4).

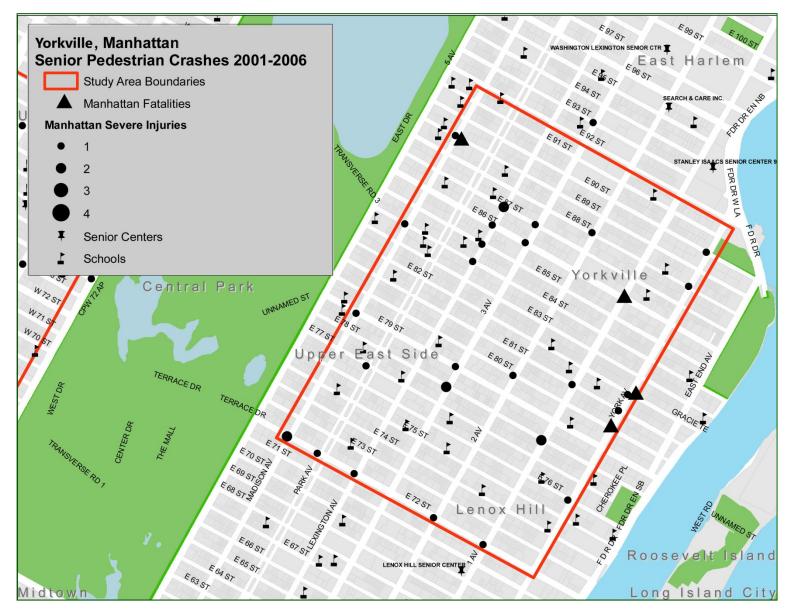
EXHIBIT 6 - PEDESTRIAN CRASH STATISTICS (2001-2006)

Crash data was obtained from the New York City Department of Transportation (NYCDOT) in the Yorkville study area from 2001 through 2006. This data provides some detail relating the circumstances and cause of each crash. Table 1 and Exhibit 6 show a summary of crashes.

There were several accidents in the study area including 34 senior pedestrian accidents, four of which resulted with fatalities from 2001 to 2006. Most of these accidents occurred during the day at signalized intersections where pedestrians were crossing with the signal. The combination of heavy traffic and pedestrian volumes, operational factors and geometric factors make these corridors difficult for a senior pedestrian to safely cross.

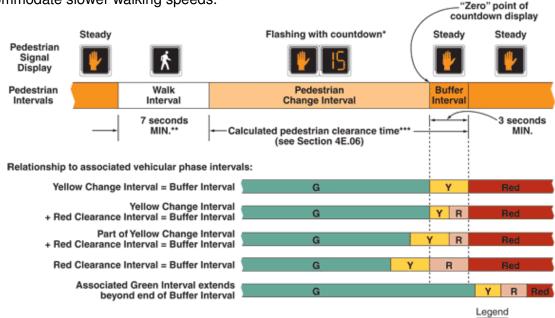
Figure No. 1: Pedestrian Intervals from MUTCD 2009

- \* The countdown display is optional for Pedestrian Change Intervals of 7 seconds or less.
- \*\* The Walk Interval may be reduced under some conditions (see Section 4E.06).
- \*\*\* The Buffer Interval, which shall always be provided and displayed, may be used to help satisfy the calculated pedestrian clearance time, or may begin after the calculated pedestrian clearance time has ended.

- Y = Yellow Change Interval (of at least 3 seconds)
- R = Red Clearance Interval
- Red = Red because conflicting traffic has been released

According to MUTCD 2009 (Manual on Uniform Traffic Control Devices) Section 4E.06, a minimum of seven (7) seconds is allocated for a walk interval, in addition to a pedestrian clearance time based on a walking speed of 3.5 feet per second. All signalized intersections in the study area were modified to provide a clearance interval of 3 feet per second to accommodate slower walking speeds.

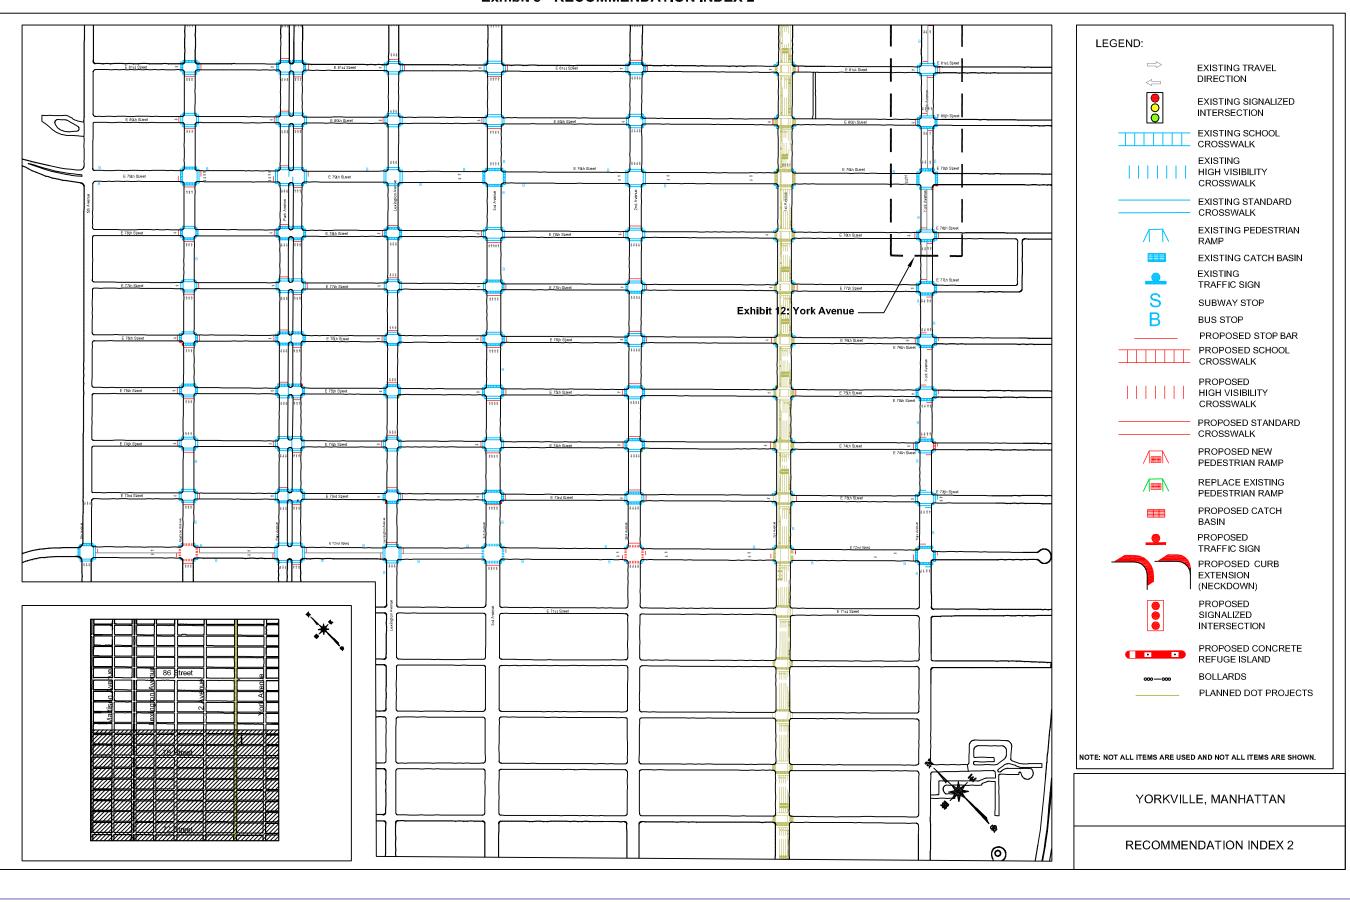
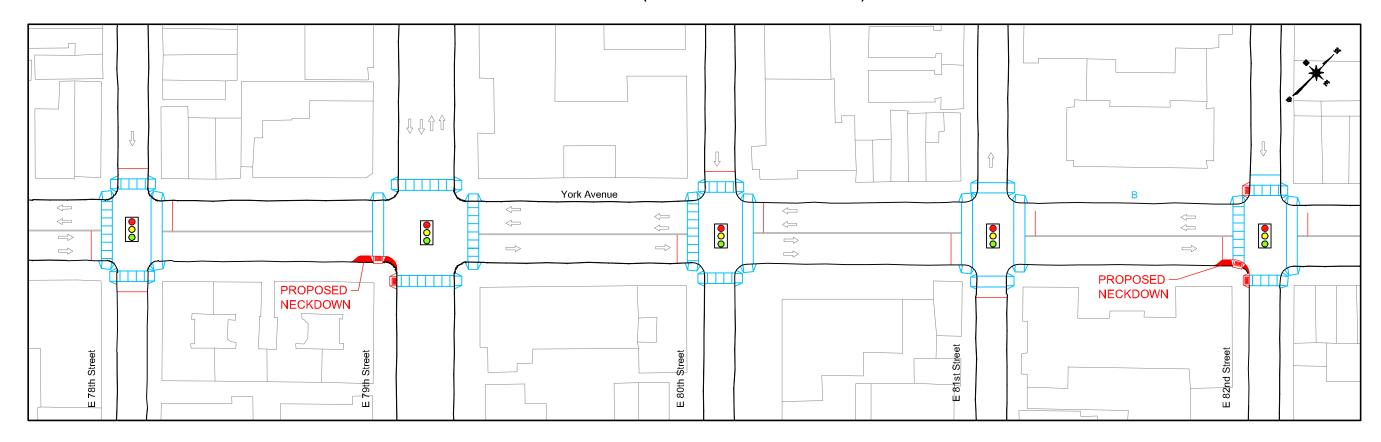
- Time all signals for seniors and where feasible, the crossing time will be extended
- Install new advanced stop bars
- Install a neckdown
  - -southeast corner of York Avenue & E 79th Street
  - -southeast corner of York Avenue & E 79th Street

- Turning vehicles not yielding to pedestrians
- Signal timing (insufficient crossing time)
- Missing or inadequate pedestrian ramps

Neckdowns are recommended for the following intersections to shorten the crossing distance and slow turning traffic:

- Southeast corner of York Avenue & 79<sup>th</sup> Street
- Southeast corner of York Avenue & 82<sup>nd</sup> Street

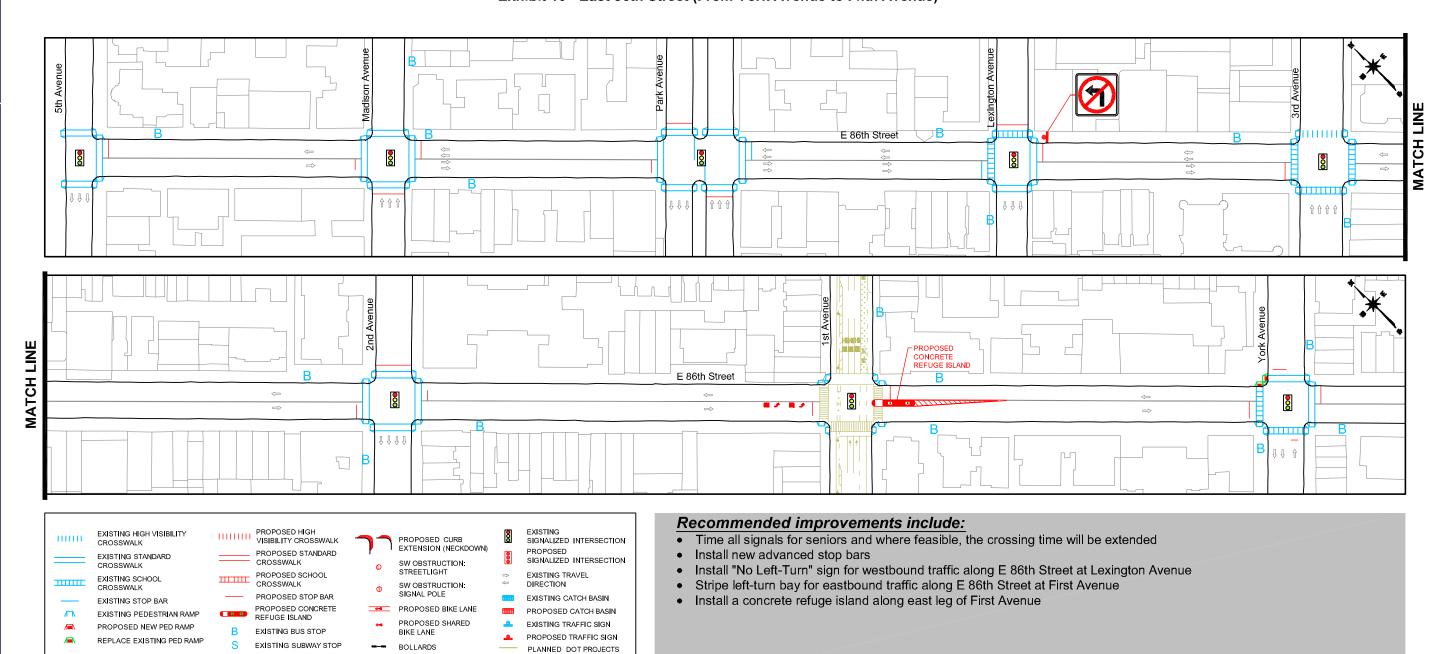
- Turning vehicles not yielding to pedestrians
- Signal timing (insufficient crossing time)
- Missing or inadequate pedestrian ramps

Α new concrete refuge island recommended for the east leg of 86th Street and First Avenue. Vehicle turning was reviewed and the proposed concrete refuge island allows for vehicles to safely complete all legal turns (Appendix E). The new median turning traffic, discourage

On the west leg of 86<sup>th</sup> Street and First Avenue, a left-turn bay is recommended to help improve the flow of traffic along 86th Street. The left-turn bay will reduce the "shock wave" effect caused by a speed differential. Shock waves occur when left-turning vehicles are forced to decelerate in the through lanes, causing through traffic to decelerate. The flow of traffic at the intersection will be improved by the 100-feet left-turn bay.

At the intersection of 86<sup>th</sup> Street and Lexington Avenue, a left-turn ban is recommended. The left-turn ban will reduce the conflict between pedestrians and left-turning vehicles and allow more crossing time for the pedestrians.

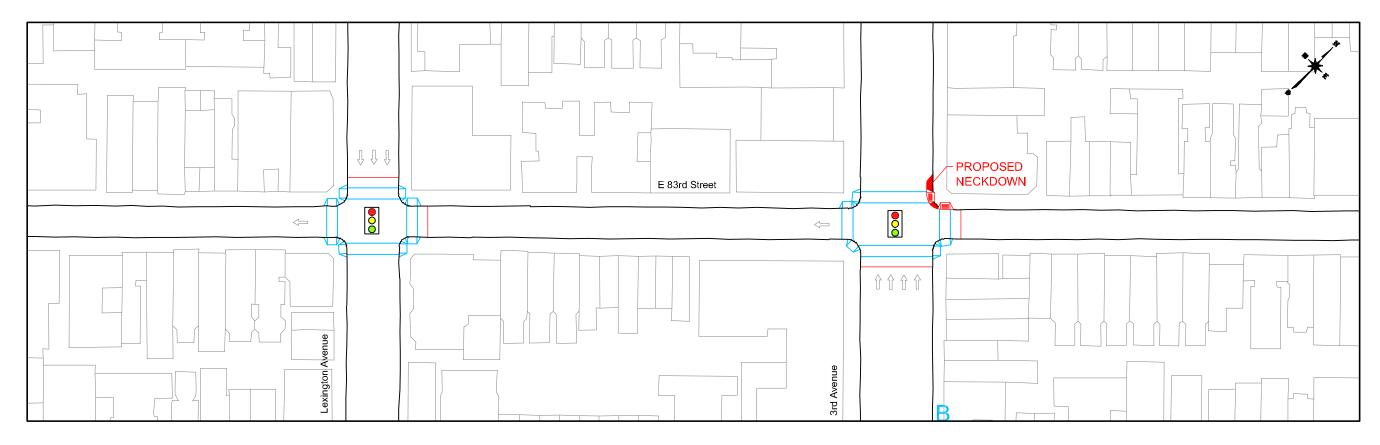
- Time all signals for seniors and where feasible, the crossing time will be extended
- Install new advanced stop bars
- Install a neckdown at the northeast corner of Third Avenue & E 83rd Street

- Turning vehicles not yielding to pedestrians
- Signal timing (insufficient crossing time)
- Missing or inadequate pedestrian ramps

At the northeast corner of 83<sup>rd</sup> Street, a single neckdown along Third Avenue is recommended to shorten the crossing
