NEW YORK CITY DEPARTMENT OF TRANSPORTATION

SAFE STREETS NYC

TRAFFIC SAFETY IMPROVEMENTS
IN NEW YORK CITY

APRIL 2006

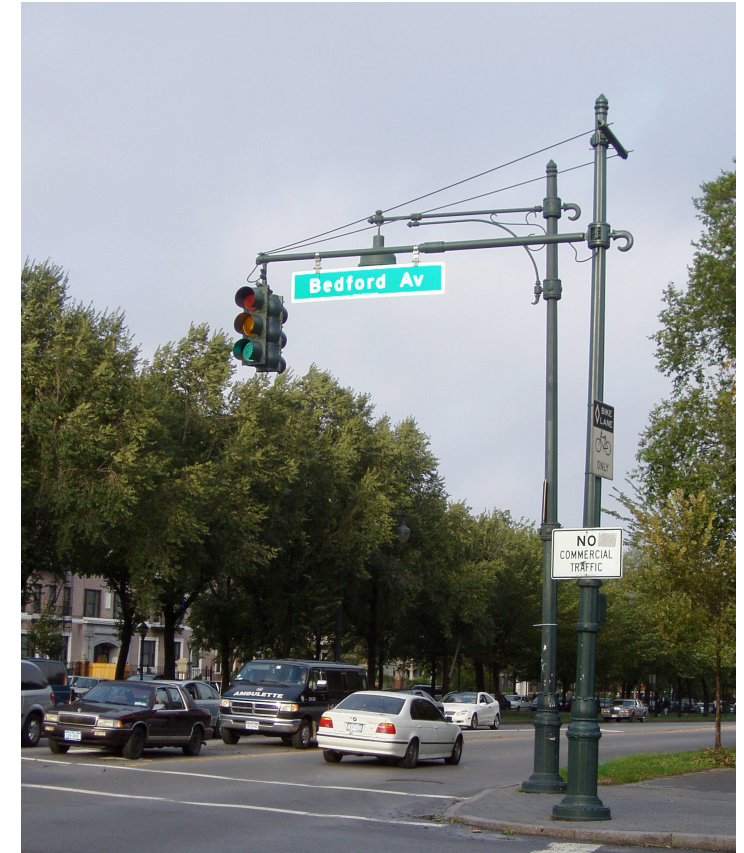
These signs serve to assist motorists to easily identify cross streets on wide urban arterials. For most motorists, reading street names on corner posts is difficult or impossible. These signs help the motorist identify the street and reduce speed accordingly to facilitate turning movements.

This program has been conducted in two phases. Beginning in 2003, dozens of corridors citywide began to receive these improvements at select intersections. By December 2004, approximately 1,000 signs had been installed as part of Phase I of the Oversized Street Name Sign Program. Phase II expanded the program to install an additional 1,500 signs on new arterials and along intermediate locations on arterials where such signs were previously installed. The following list identifies many of the corridors where oversized signs have been placed. As of January 2006, nearly 2,200 total signs have been installed during Phases I and II of the program. This includes 204 signs in the Bronx, 308

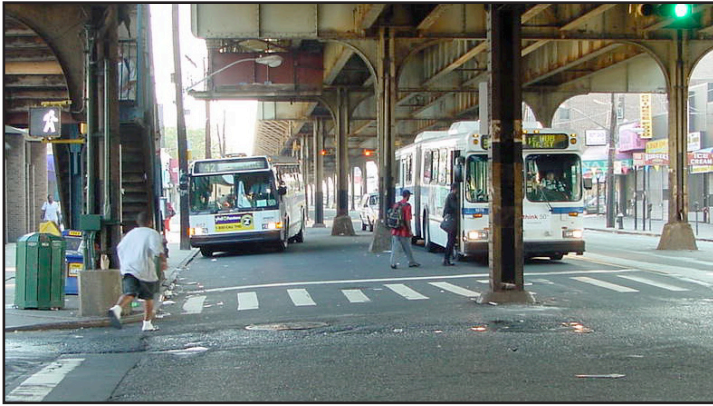
Buses using both the curb and travel lane to pick-up-discharge passengers at East 233rd Street

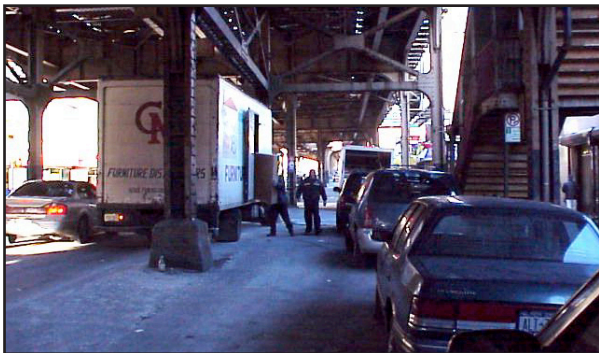
Above: Truck deliveries frequently block all travel lanes leading to unsafe conditions at Burnside Avenue and Jerome Avenue.

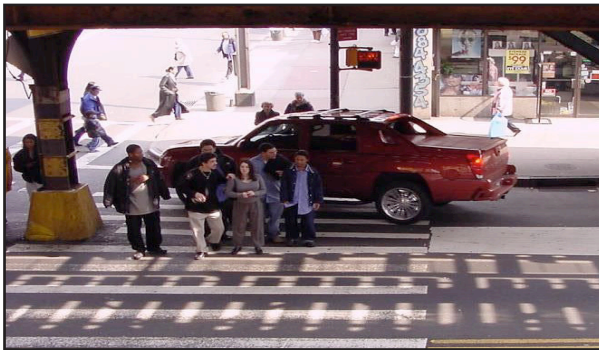
Below: shadows from elevated structure and pedestrians waiting for the bus in the roadbed at Broadway and West 231st Street

Because of the placement of support columns in the roadway, there is insufficient roadway width for two lanes of traffic in each direction, but too much roadbed for one lane in each direction. Typically, the roadway underneath the elevated structures is comprised of two 12' moving lanes situated within the pillars and two 15' parking/ other lanes on the outside or curbside of the pillars. The excess roadbed has a variety of uses; turn lanes, loading and unloading, weaving, travel lane and bus stop loading and unloading. This alignment is especially problematic for through vehicle movements around these bus stops. Finally, buses are unable to access the curb at these stops due to the placement of the columns, causing them to stop within the travel lane and delay traffic behind them.

An additional problem created by the elevated structure relates to visibility. During all hours of the day, visibility is compromised due to the elevated structure. This includes blocked sunlight, shadows and glare, as well as the columns themselves blocking the visibility of pedestrians and vehicles. During the evening, poor lighting and shadows impede vision for both vehicles and pedestrians.

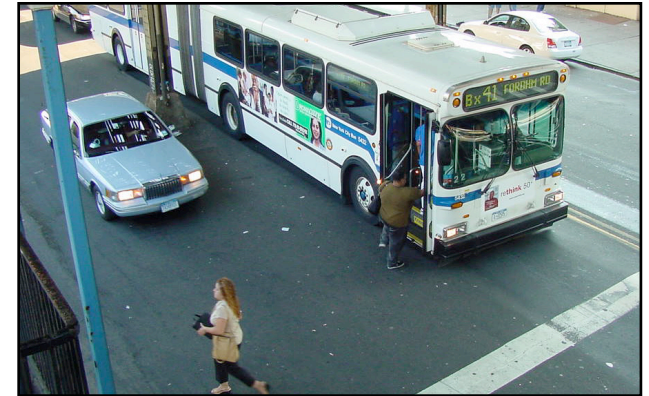
Vehicles tend to weave around buses when picking-up discharging passengers leading to conflicts

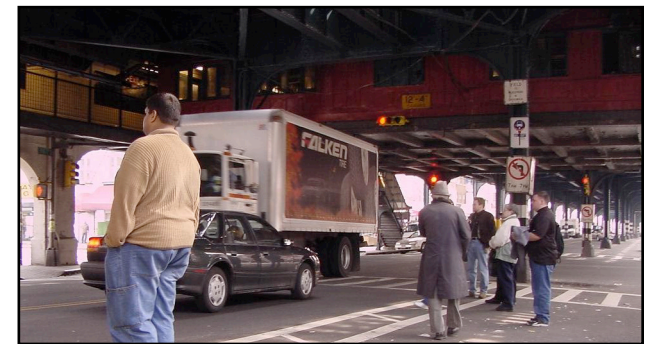
Pedestrians waiting for bus in roadbed at Bay Parkway and 86th Street

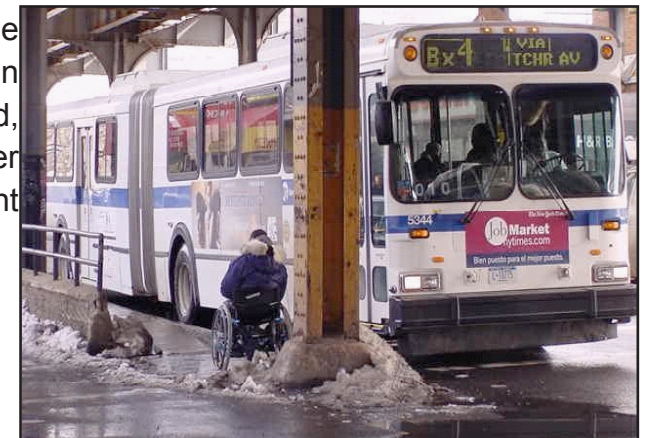
Unusual alignment and poor weather present difficulties for users, especially handicapped, wheelchair users which must board at back of bus. This image is at Morrison Avenue and Westchester Avenue.

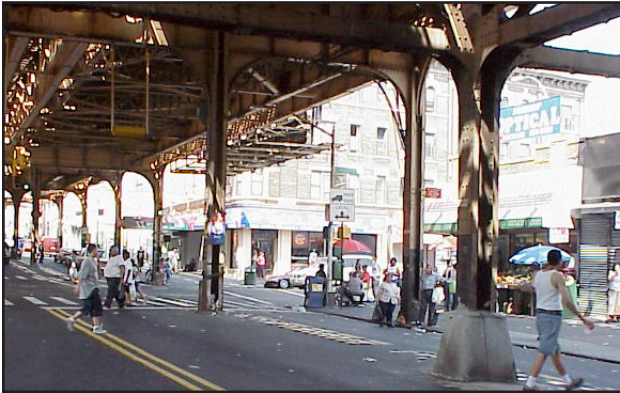
Pedestrians is a frequent problem at the intermodal stations, due in part to commercial activity and changes between modes

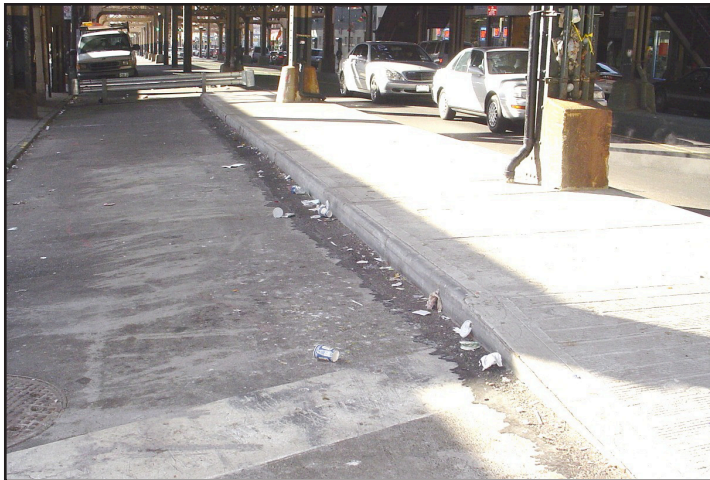
The raised median and guardrails provide a safe, dedicated environment for pedestrians waiting for the bus. One issue relating to the design is the tendency for garbage to accumulate in the area that is closed off.

As a short term improvement, the Department constructed two concrete refuge islands in December 2003. These raised islands, 75 feet in length on the northwest corner and 85 feet on the southwest corner are aligned with the column footing and are 8 feet in width. In addition to providing the raised median, the Department also installed guardrails with reflectors that limited vehicles from accessing the lane between the sidewalk and the new refuge island. These treatments reduced the pedestrians exposure to vehicles while waiting for the bus and provided additional refuge for pedestrians waiting to cross the street.

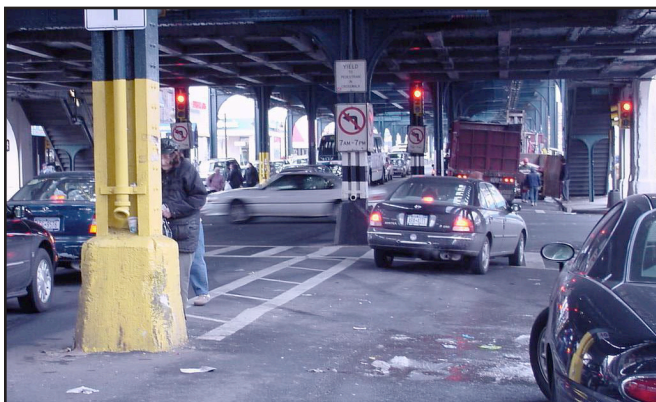
Vehicles frequently utilize the curb lane for right turns and are in conflict with pedestrians waiting for the bus as depicted above.

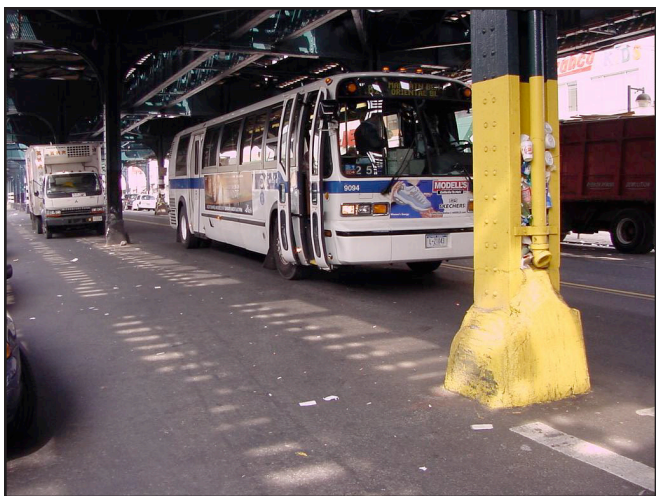
When more than one bus arrives, they frequently load/unload behind the bus stop as they are at a full stop. This causes congestion and vehicles try to weave around the stopped vehicle.

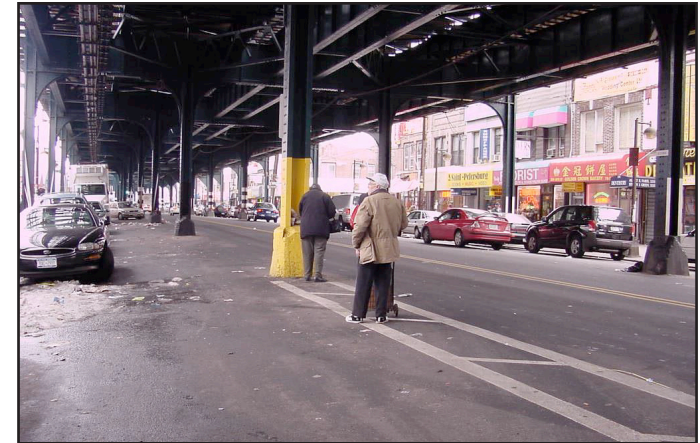
Pedestrians waiting for the bus at Bay Parkway and 86th Street

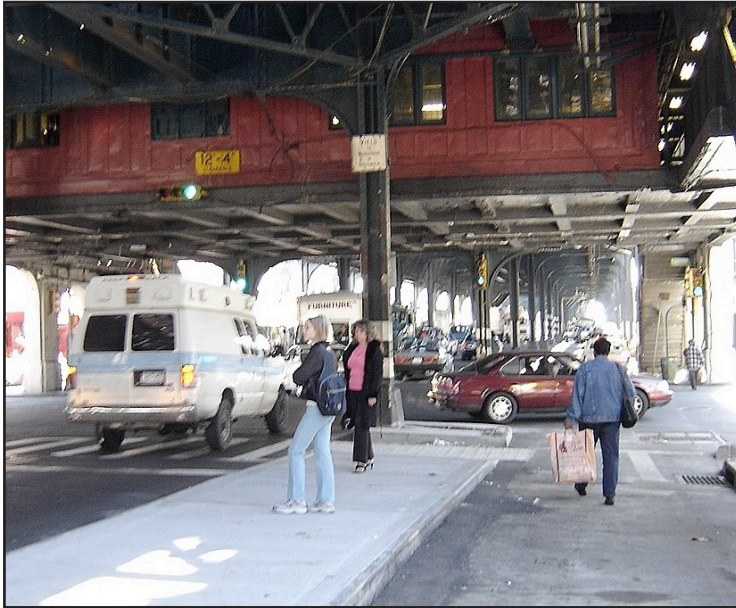
Actual raised median as installed at this location provides refuge and safety for pedestrians waiting for the bus and crossing the street

In September 2004, as a short-term improvement, the Department constructed two concrete refuge islands to provide a refuge for pedestrians. These raised islands are 80 feet in length and 8 feet wide and aligned with the column footing. Vehicles are prohibited from entering the space between the island and sidewalk through the use of metal gates that are only opened when the Department of Sanitation needs to sweep the roadway. The gates are supplemented with roadway striping. Two parking meters were removed from each corner to allow for the installation of the island.

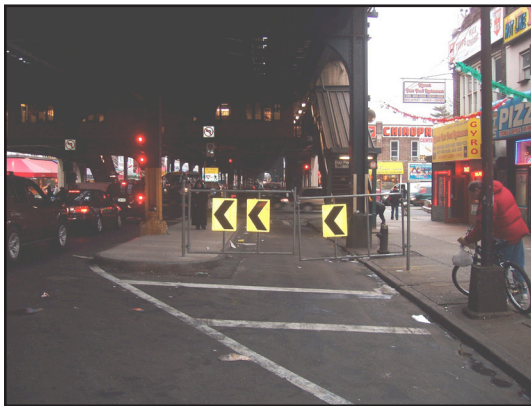
Metal gates, reflective signage and striping direct vehicles toward travel lane. Gate can be opened for sanitation purposes

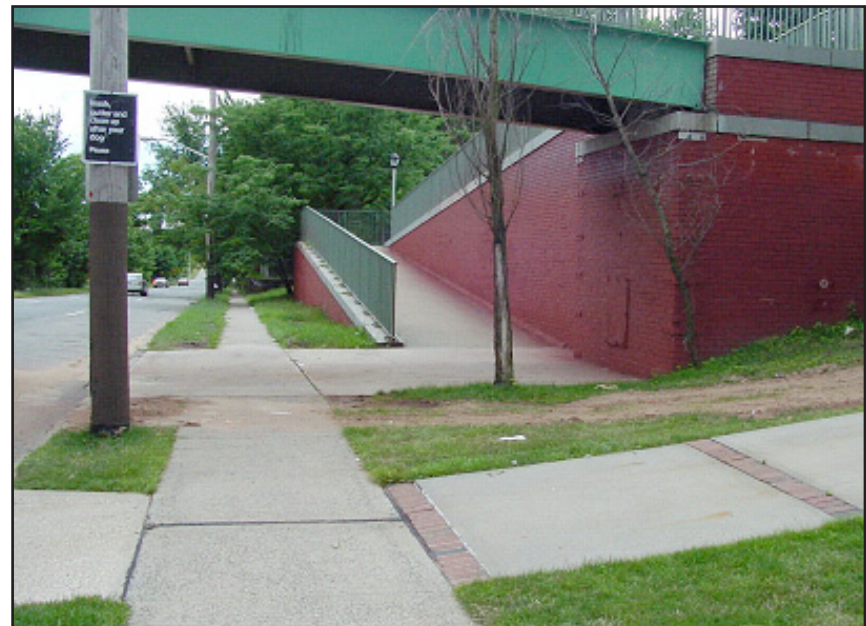
Type 1 Pedestrian Bridge at Jefferson Boulevard over the Korean War Veterans Parkway in Staten Island

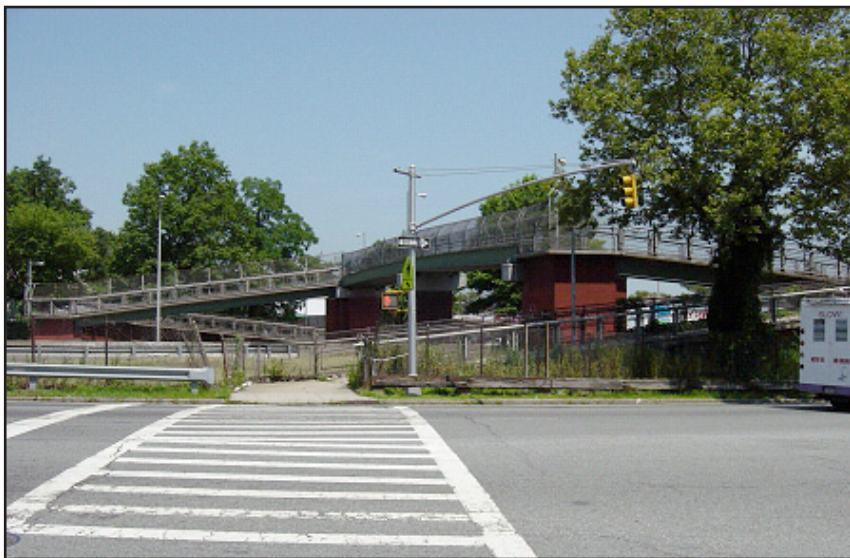
Type 2 Pedestrian Bridge at Fresh Meadows Lane and the Long Island Expressway Service Road in Queens

Type 2 bridges, of which there are 13 citywide, carry a higher risk factor. At the landings of each of these bridges, the passageway exits directly into a controlled intersection and/or street. Under this

configuration, bridge users immediately enter upon the roadway after exiting the bridge. Although the intersection control provides safe passage for a bridge user who comes to a complete stop on the landing before entering the roadway, this can be problematic for wheeled users accelerating down the incline and failing to stop before entering the intersection, as both the driver and cyclist have limited sight distances and opportunities to react to each other.

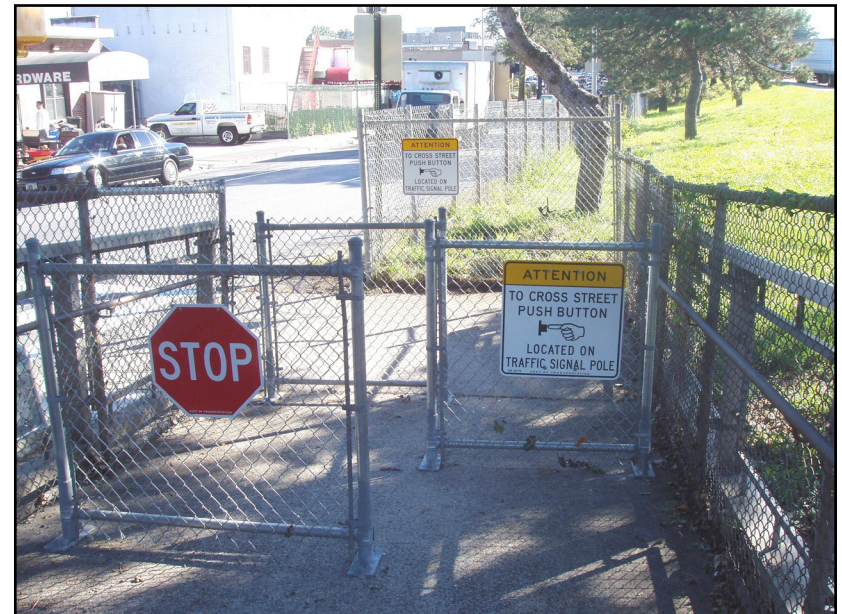
Slalom fencing design requires bridge users to come to a stop at the end of the bridge. In addition, STOP signage and instructions to use pedestrian activated signals are posted along the fencing.

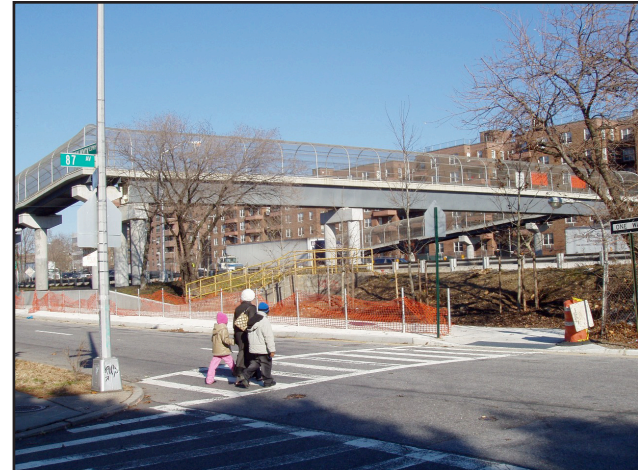
Pedestrians crossing the service road cross at an unsignalized intersection. The newly constructed bridge is depicted in the background, as well as location of pedestrian fencing.

In March 2006, the New York State Department of Transportation completed construction of a new pedestrian bridge over the Van Wyck Expressway at 87th Street. Given the design of the landing and the existence of fencing along the curb, pedestrians are directed to the corresponding crosswalk at the corner. Therefore there is no need for the “slalom” fences at this location. However, the “experimental” push-button signal and associated signage were installed on both approaches. All work was completed in late March 2006. The images to the right depict the bridge and roadway while under construction.

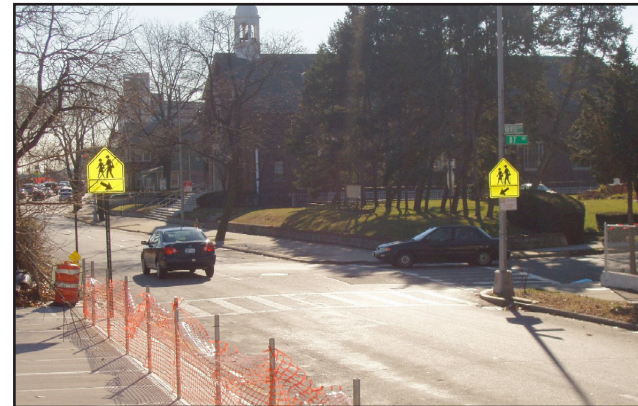
NYCDOT installed a push-button activated signal at this intersection. Orange mesh fencing indicates location where fencing will be installed to direct pedestrians to cross at the controlled intersection
