412 East 85th Street House, 412 East 85th Street, MANHATTAN

Built: c. 1860: Architect undetermined

Landmark Site: Borough of Manhattan Tax Map Block 1564, Lot 7503

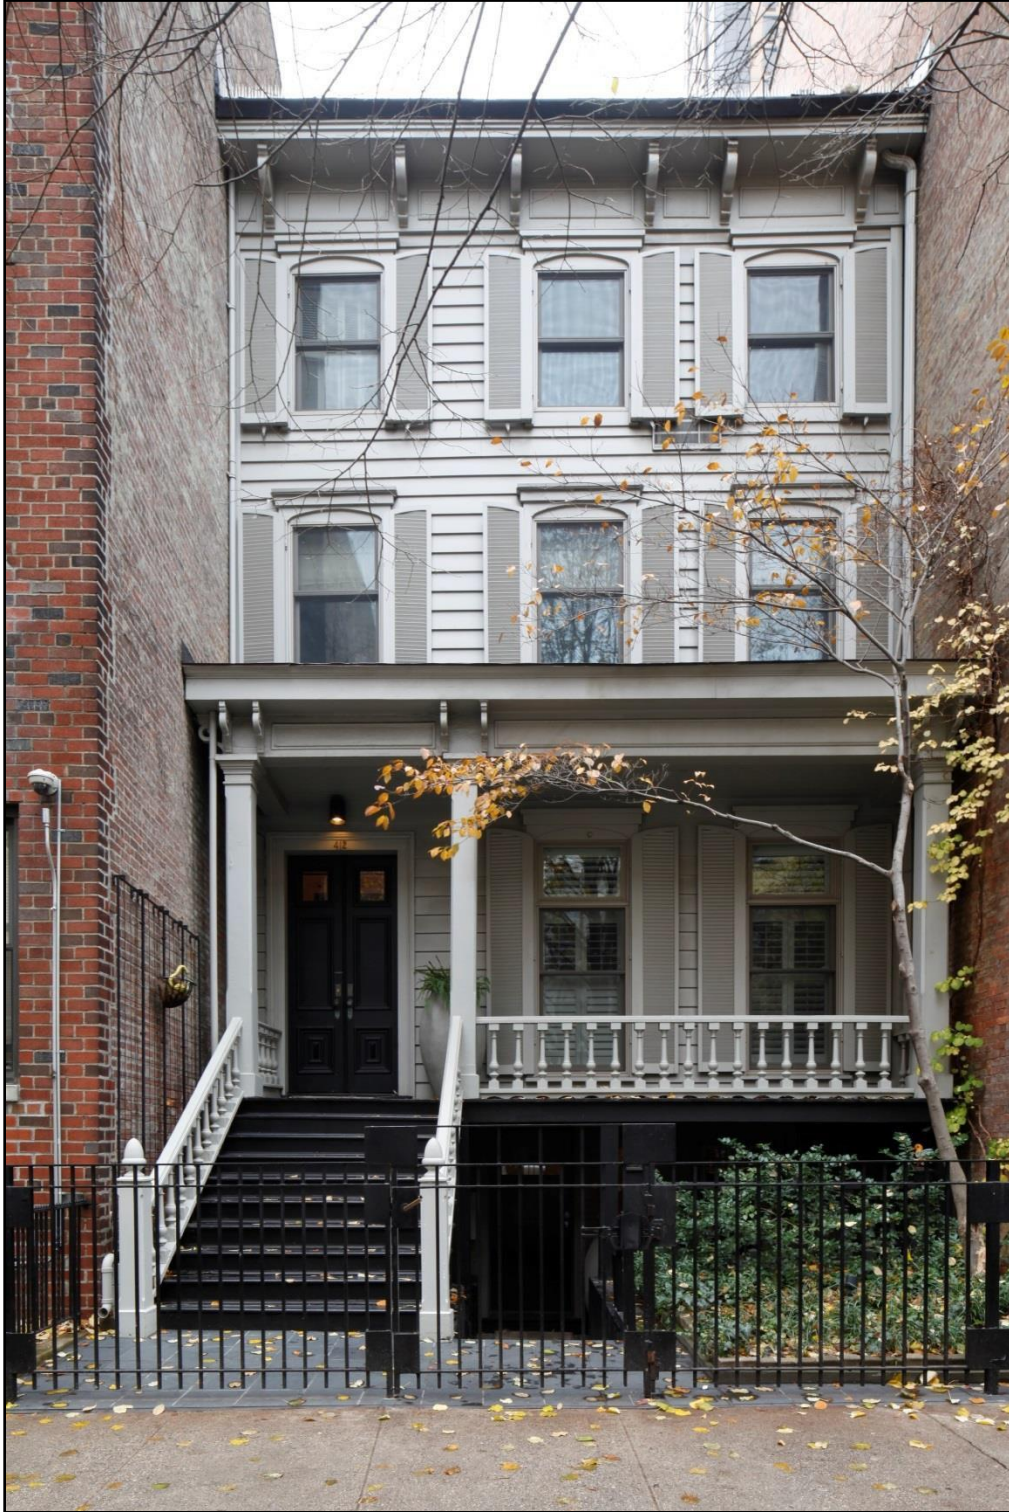
412 East 85th Street House
412 East 85th Street, Manhattan
Photo: Sarah Moses, 2016

The primary (north) façade is three bays wide, clad in wood clapboards above the raised brick basement, with a wood porch at the first floor level, and wood trim. It has gone through a series of alterations over time, while retaining its overall historic character, including the locations and sizes of its entrance and windows.

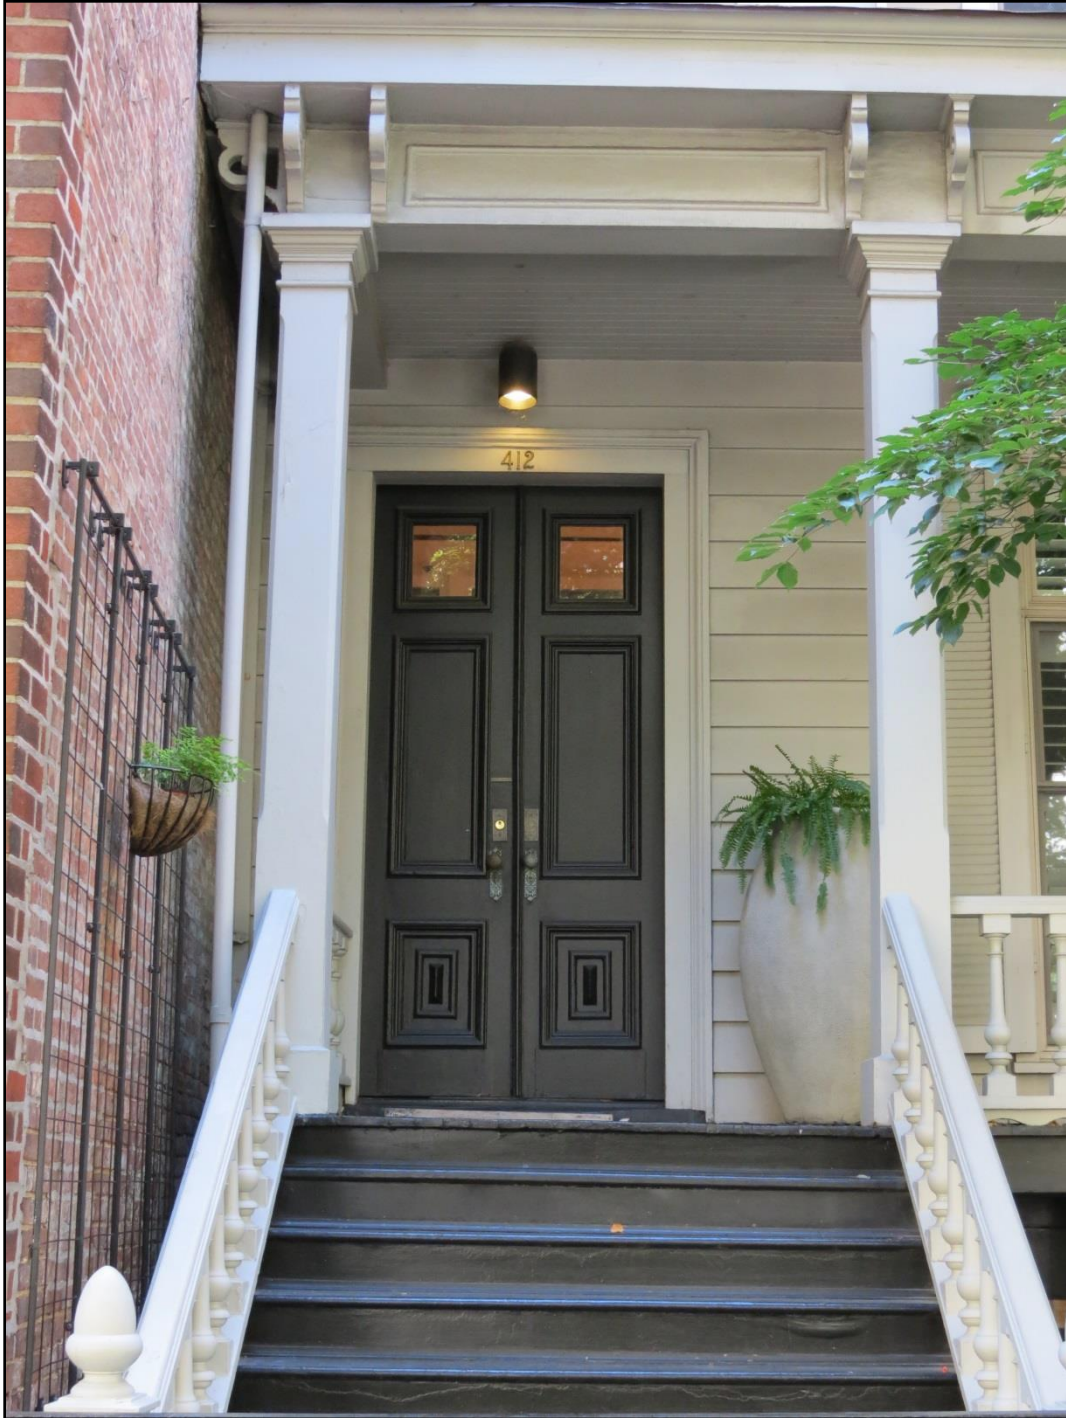
412 East 85th Street House
Entry Door
Photo: Jessica Baldwin, 2016

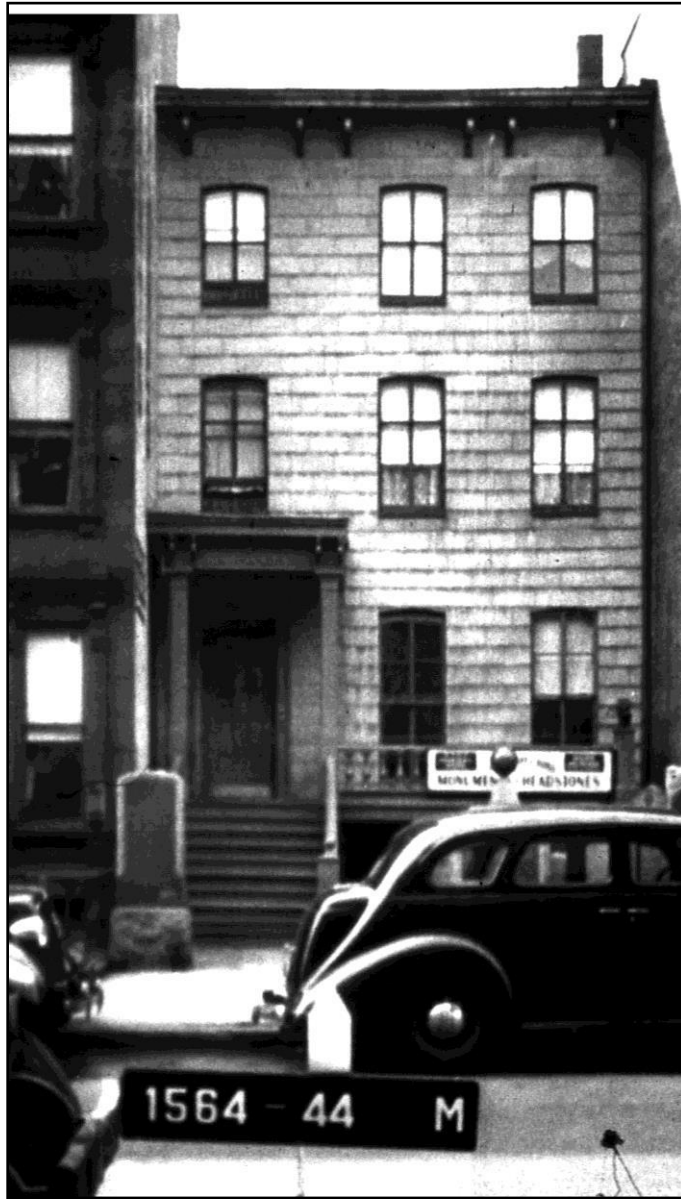
412 East 85th Street House
Showing shingles and porch alterations
Photo: New York City, Department of Taxes (c. 1939-41), Municipal Archives

The monument shop operated at that location until the 1950s. Around this time, 412 East 85th Street was purchased by a Dr. Douglas Torre.¹⁴ Dr. Torre, a dermatologist, removed shingles that had long replaced the clapboard siding of the home and re-clad it to match older photographs of the clapboard

siding. He recreated some of the lost details of the vernacular Italianate style house, including rebuilding the historic three bay wide porch, which over the years had been altered to just one bay around the entry.¹⁵
