New York City  
Department of Environmental Protection

# 2009 Kensico Water Quality Control Annual Report

*Part I - 2007 FAD Section 4.1.0 Kensico Water Quality Control Program*

*Part II - 2007 FAD Section 4.1.0 Kensico Water Quality Annual Report*

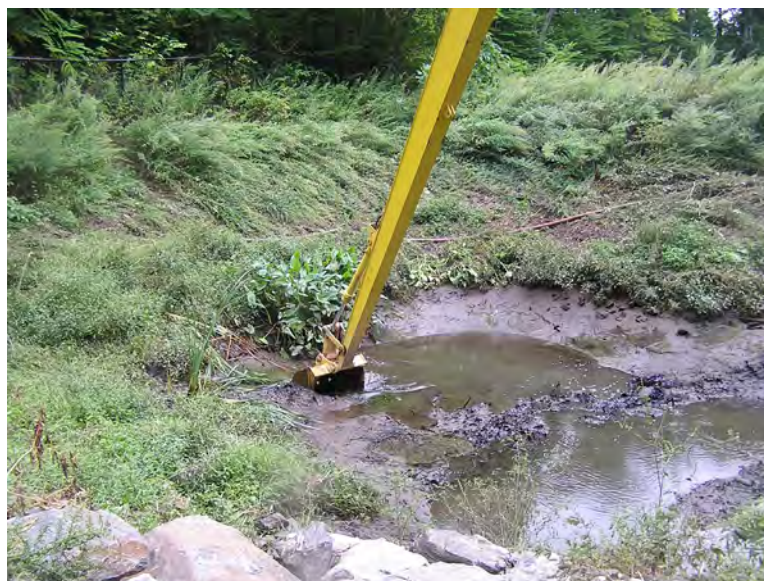
Figure 1.2 Accumulated sediment being removed at BMP 37.

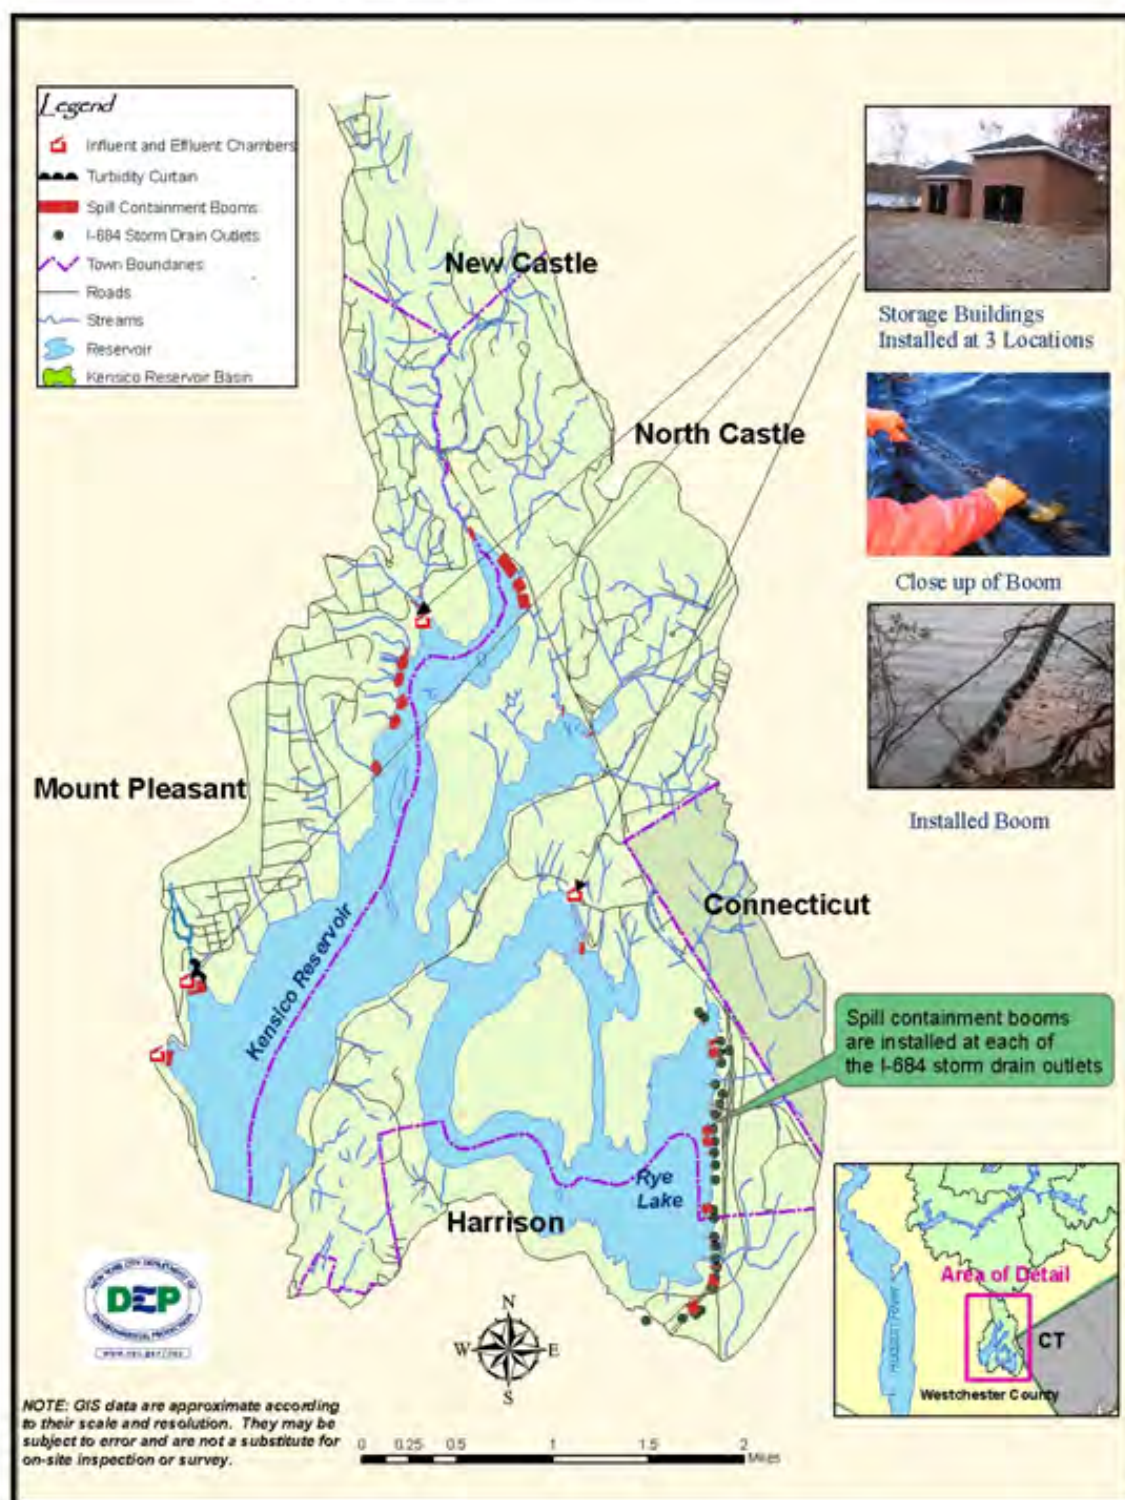
Figure 1.3 Spill containment facilities in Kensico Reservoir.

DEP installed, and now maintains, spill containment facilities around Kensico Reservoir (see Figure 1.3). The facilities improve spill response, cleanup, and recovery, thereby minimizing water quality impacts in the event of a spill. In 2009, DEP continued to maintain the 39 spill containment facilities installed at the outlets of 26 storm drains along Interstate 684 and Route 120 (see Figure 1.4).

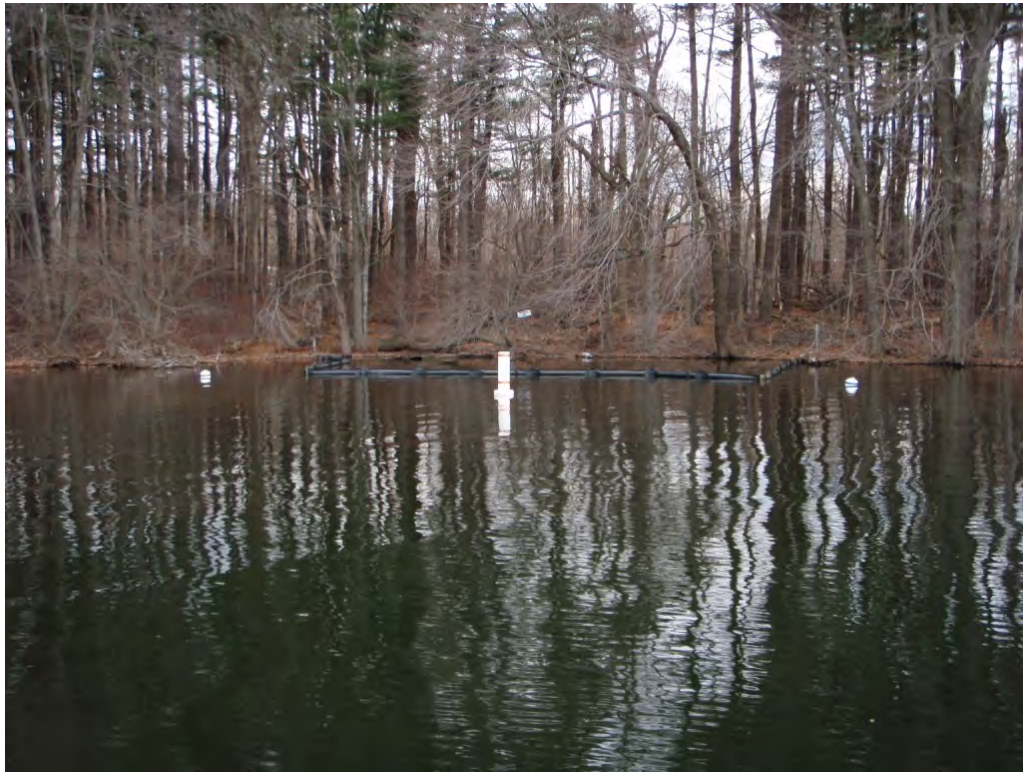
Figure 1.4 Kensico spill boom - Site 11.

Although no spills have been reported on Interstate 684 or the roads surrounding Kensico since the booms were installed, the booms have functioned as designed. Temporary booms were located at the end of the boat ramp that can encircle the ramp in the event of a spill. No spills or discharges occurred, nor was boom deployment required.

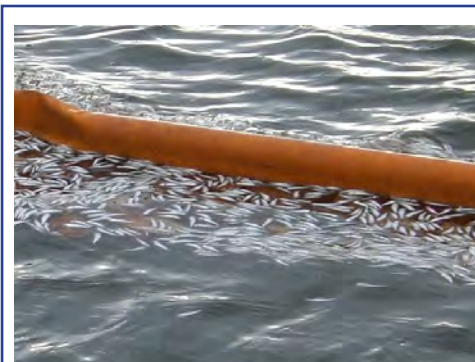
Figure 2.2 Dead alewives collected by boom at Kensico Reservoir.

- Record daily surveillance of water influent facilities for alewives (*Alosa pseudoharengus*), a baitfish. Dead and dying alewives transported through the NYC aqueducts from upstream reservoirs to Kensico attract waterbird foraging. To eliminate this feeding attraction, containment booms are used to collect the fish. Baitfish deterrent measures are being investigated to prevent the transport of alewives from Ashokan Reservoir to Kensico.

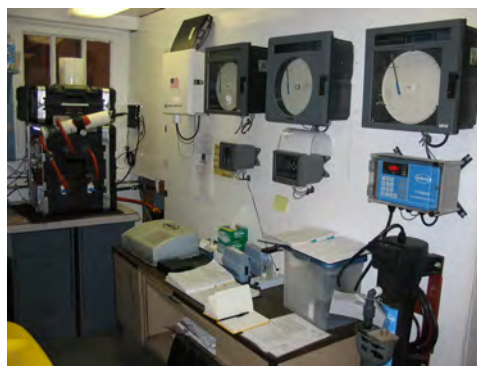
Figure 3.2 Continuous monitoring instrumentation at Kensico Reservoir (Catskill Lower Effluent Chamber).

DEP routinely conducts water quality compliance monitoring at the four aqueduct keypoints at Kensico Reservoir. The CATALUM and DEL17 influent keypoints represent water entering Kensico Reservoir from the NYC upstate reservoirs via the Catskill and Delaware Aqueducts, respectively. The CATLEFF and DEL18 effluent keypoints represent Kensico Reservoir water entering the Catskill and Delaware Aqueducts, respectively, at points just prior to disinfection (Figure 3.2); this water ultimately travels down to distribution. The CATALUM and DEL17 influent keypoints are monitored via grab samples for fecal coliforms (5D/week), turbidity (5D/week), and nutrients (monthly, except TP is collected weekly at CATALUM as one of the monitoring requirements of the Catskill Influent Chamber (CATIC) SPDES Permit) as part of DEP operations. The information is used as an indicator of water quality entering Kensico Reservoir, which is in turn used to optimize operational strategies to provide the best possible water exiting the reservoir. The CATLEFF and DEL18 effluent keypoints are monitored via grab samples for fecal coliforms (daily), turbidity (every four hours, in accordance with SWTR regulations), and nutrients (monthly). All four keypoint sites are also equipped with continuous monitoring of temperature, pH, conductivity, and turbidity. The exceptional importance of these keypoints (for optimal operations (influent) and as source water compliance monitoring sites (effluents)) warrants this high intensity monitoring.

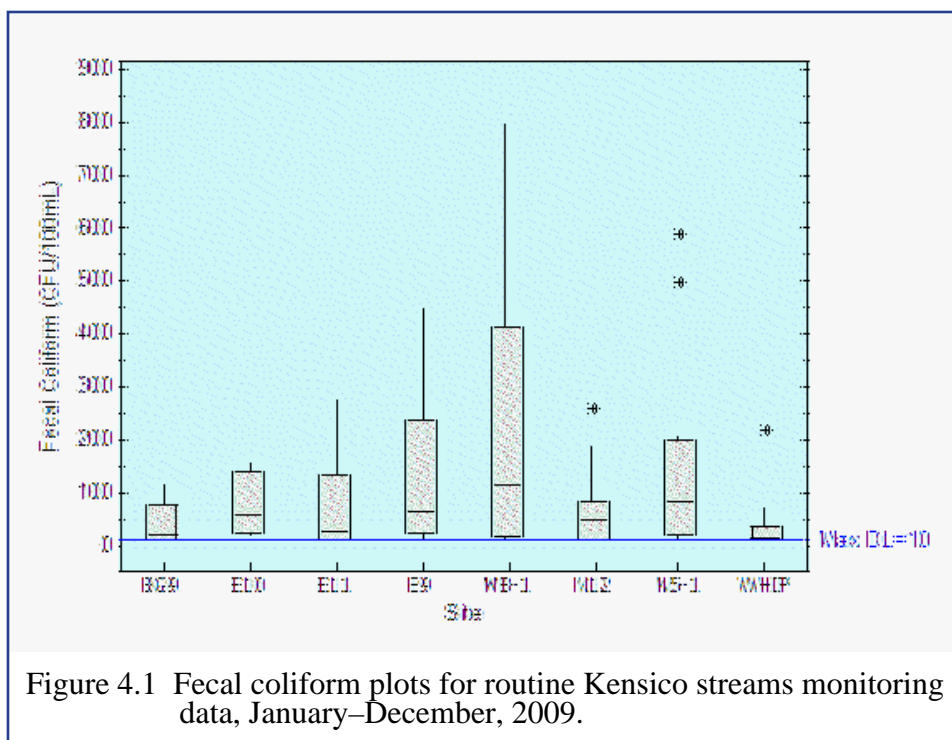
Figure 4.1 Fecal coliform plots for routine Kensico streams monitoring data, January–December, 2009.

The routine fecal coliform data for the period January 2009 through December 2009 are plotted in Figure 4.1. Box plots are used to display data which contain censored data (i.e., non-detects, where the data are either less than a detection limit, or, in some cases, greater than a maximum detection limit). Coliform data often contain censored data, and while box plots can be used to display these data, a modification is needed. A horizontal line is drawn at the maximum detection limit (Max DL), and the portions of the box plot below this limit are unspecified. By doing this, all of the detected values are correctly distributed; however, the data below the maximum detection limit are not displayed.

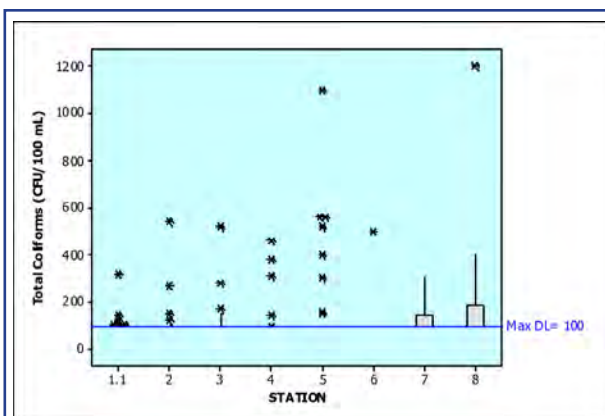
Figure 4.2a Total coliform plots for routine Kensico Reservoir monitoring data, April–November, 2009.

During this reporting period all sites had estimated median total coliform values less than 100 CFU 100mL<sup>-1</sup>. There were three sites where the box plots extended above the Max DL. These were Sites 3, 7, and 8, and the median values were estimated as 17, 36, and 33 CFU 100mL<sup>-1</sup>, respectively. At all the sites there were several occasions where the total coliform exceeded the guidance value. These higher levels were typically observed in late summer and autumn. Seasonality of total coliform levels is a routine observation in many of the NYC reservoirs.

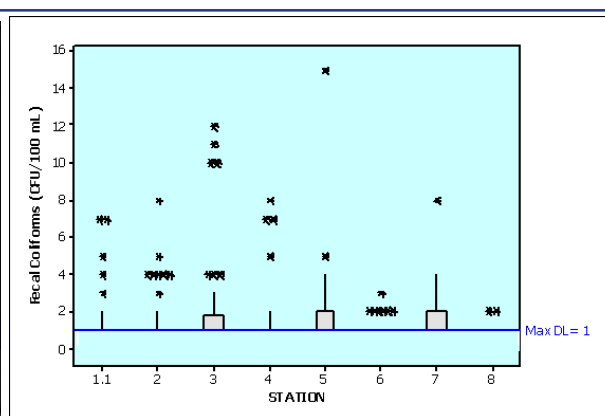
Figure 4.2b Fecal coliform plots for routine Kensico Reservoir monitoring data, April–November, 2009.

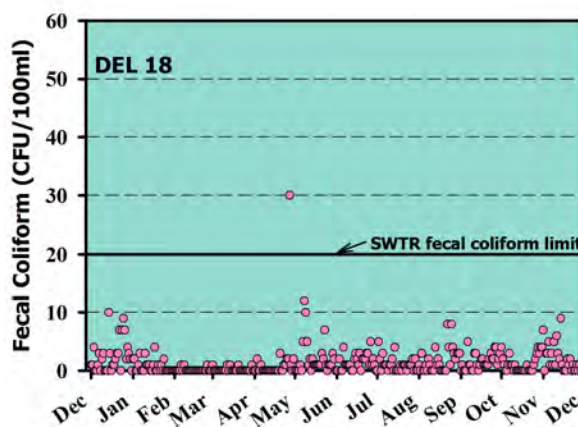
Figure 4.4b Daily monitoring fecal coliform grab sample results, as per the SWTR, at the Delaware Aqueduct Kensico effluent keypoint (DEL18).

For the fecal coliform concentrations measured at the Kensico effluents from December 1, 2008 to November 30, 2009, medians of 1 CFU 100mL<sup>-1</sup> at CATLEFF and 1 CFU 100mL<sup>-1</sup> at DEL18 were calculated. Similarly, the Kaplan-Meier mean values (calculated in a similar way) were 1.05 CFU 100mL<sup>-1</sup> at CATLEFF and 1.81 CFU 100mL<sup>-1</sup> at DEL18. During the same period, values above the regulatory benchmark of 20 CFU 100mL<sup>-1</sup> were only observed once (at DEL18) (Figure 4.4a,b). For reference, the 2008 fecal coliform data indicated two exceedances at CATLEFF and 4 exceedances at DEL18. Hence, 2009 had fewer fecal coliform exceedances than 2008. According to the regulations, 18 values above 20 CFU 100mL<sup>-1</sup> are permitted within any 6-month period at each keypoint. DEP's source water at Kensico is therefore well within the SWTR limits for fecal coliforms.

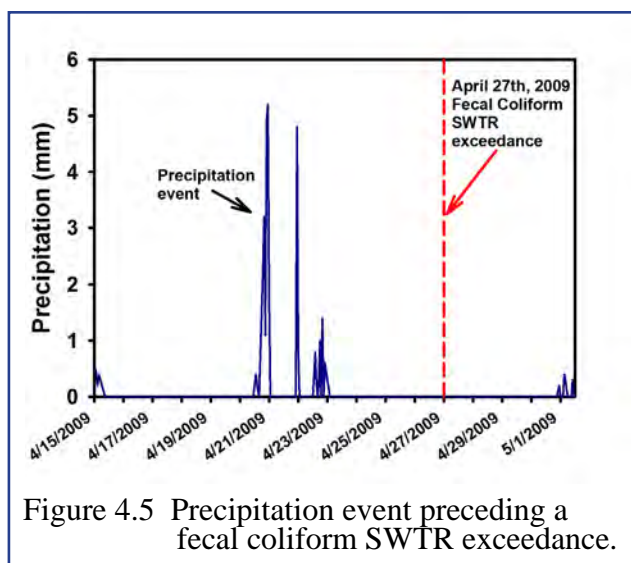
Figure 4.5 Precipitation event preceding a fecal coliform SWTR exceedance.

The single exceedance in 2009—30 CFU 100mL<sup>-1</sup>—occurred on April 27, following three successive days of rain on April 21, 22, and 23, totaling about 1.39 inches (Figure 4.5). This supports the conclusions of previous DEP studies, which have indicated that, since the inception of DEP’s Waterfowl Management Program (See Section 2.1), elevated fecal coliform levels have generally coincided with precipitation events occurring within a few days before the elevated fecal coliform conditions were observed.

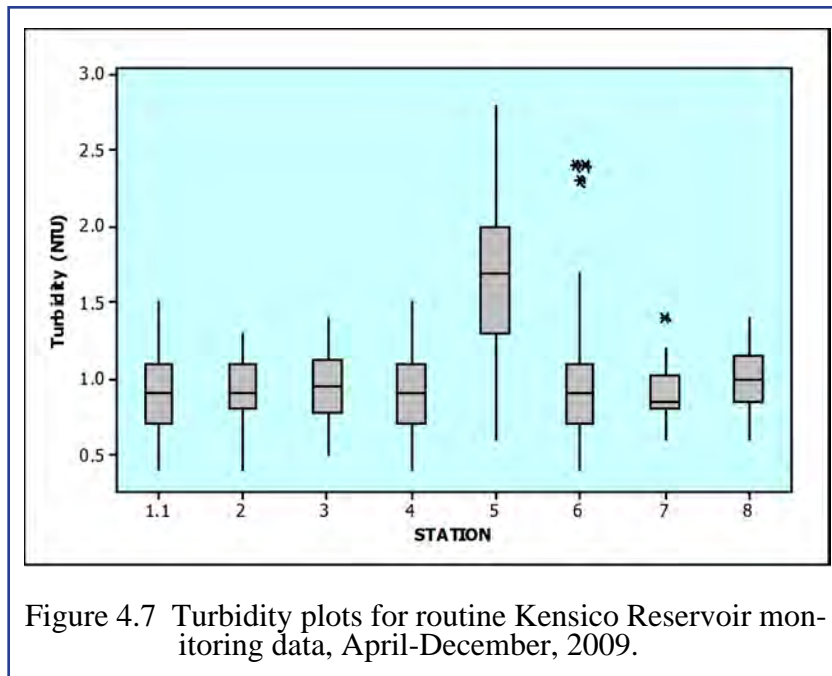
Figure 4.7 Turbidity plots for routine Kensico Reservoir monitoring data, April-December, 2009.

The routine monitoring of Kensico Reservoir during the April 2009 through November 2009 period yielded 418 turbidity samples. A box plot constructed using these data is presented in Figure 4.7. As in the past, Site 5 showed the highest median turbidity (1.7 NTU) and entries for this site exceeded 2.0 NTU nine times. At the other sites the turbidity was below 2.0 NTU with the exception of the following observations for Site 6: 2.4 NTU, 2.4 NTU, and 2.3 NTU on November 2, November 9, and October 27, respectively.

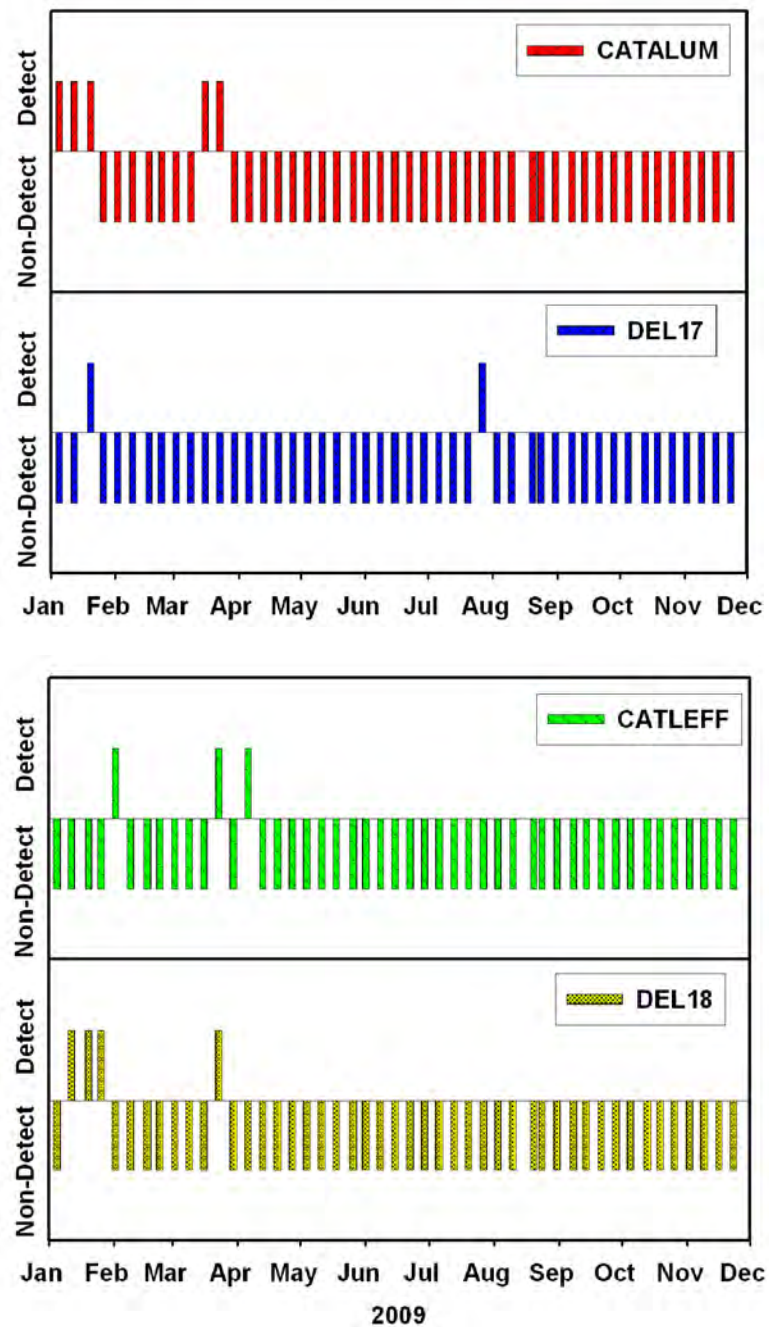
Figure 4.11 Positive detection frequency of human enteric viruses at the four Kensico keypoints, January 1 – November 23, 2009. HEV results for samples taken after November 24, 2009 are pending.

Average HEV detection rates at Kensico were quite low for all sites (Figure 4.10). Percent detection at the influent sites was equal to that at the effluents of Kensico Reservoir in 2009 (7.4%). As observed in past years, nearly all the detections of viruses occurred in the winter/spring period (Figure 4.11). The only exception in 2009 was a detect in late July at Del17.

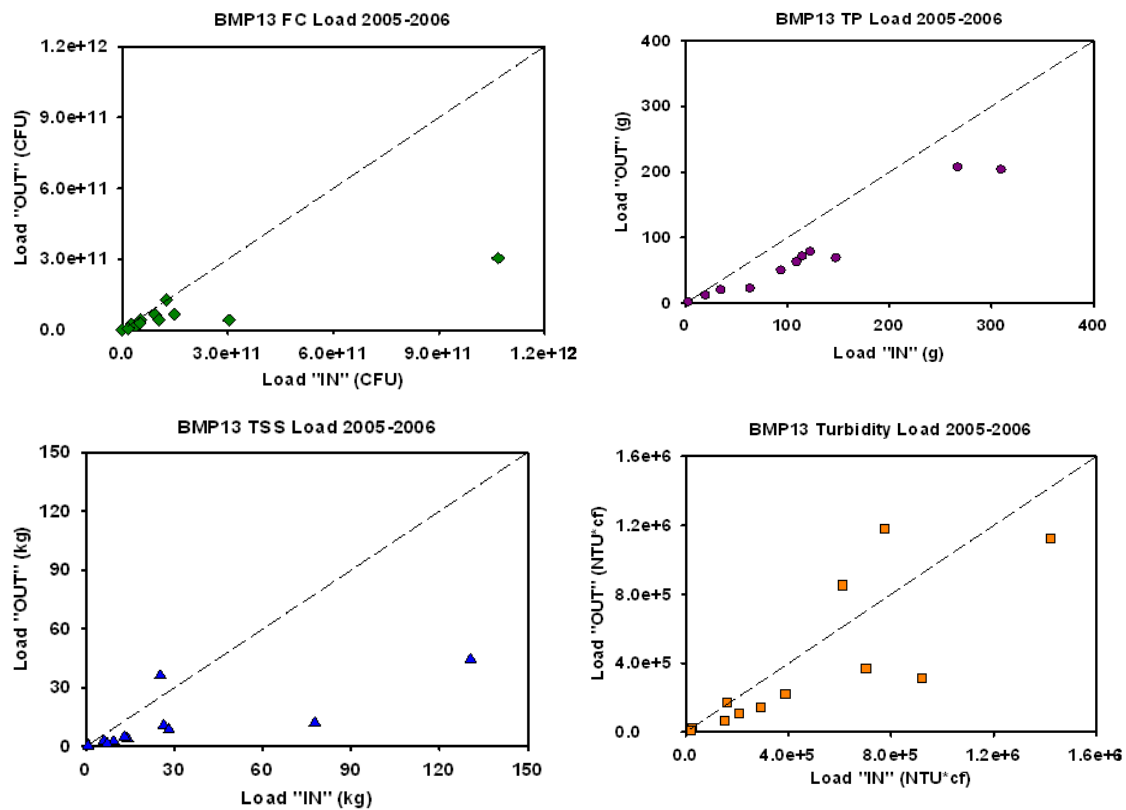
Figure 4.15 BMP13 efficiency assessment (comparison of influent versus effluent) for fecal coliform (FC) load, total phosphorus (TP) load, total suspended solids (TSS) load, and turbidity load.

The loading results indicate that all the BMPs produced some degree of load reduction for FC, TSS, turbidity, and TP, for storms within their design (Figures 4.14 through 4.18). However, load reduction was not a linear relationship, and in a few cases the BMPs even caused an increase. Load reduction was minimal at lower loads, but showed a tendency to improve as load increased. The lower load reductions at lower concentrations, usually associated with lower precipitation and hence a lower potential for transport across the reservoir, are likely related to the fact that the loads were close to the “irreducible pollutant concentration” (Schueler 1996), which is a threshold concentration which cannot be further reduced for a specific pollutant by a given BMP. On the other hand, the progressively increasing load reduction at the higher loads is more likely associated with larger storms, with their higher potential for transport. This demonstrates that the BMPs constructed on Kensico Reservoir are providing a benefit to water quality.
