Alma Realty Phase II Work Plan
8-01 26th Avenue, Astoria, NY
OER Project # Draft

Phase II Work Plan

8-01 26th Avenue

GCE Project Number 13-256-00

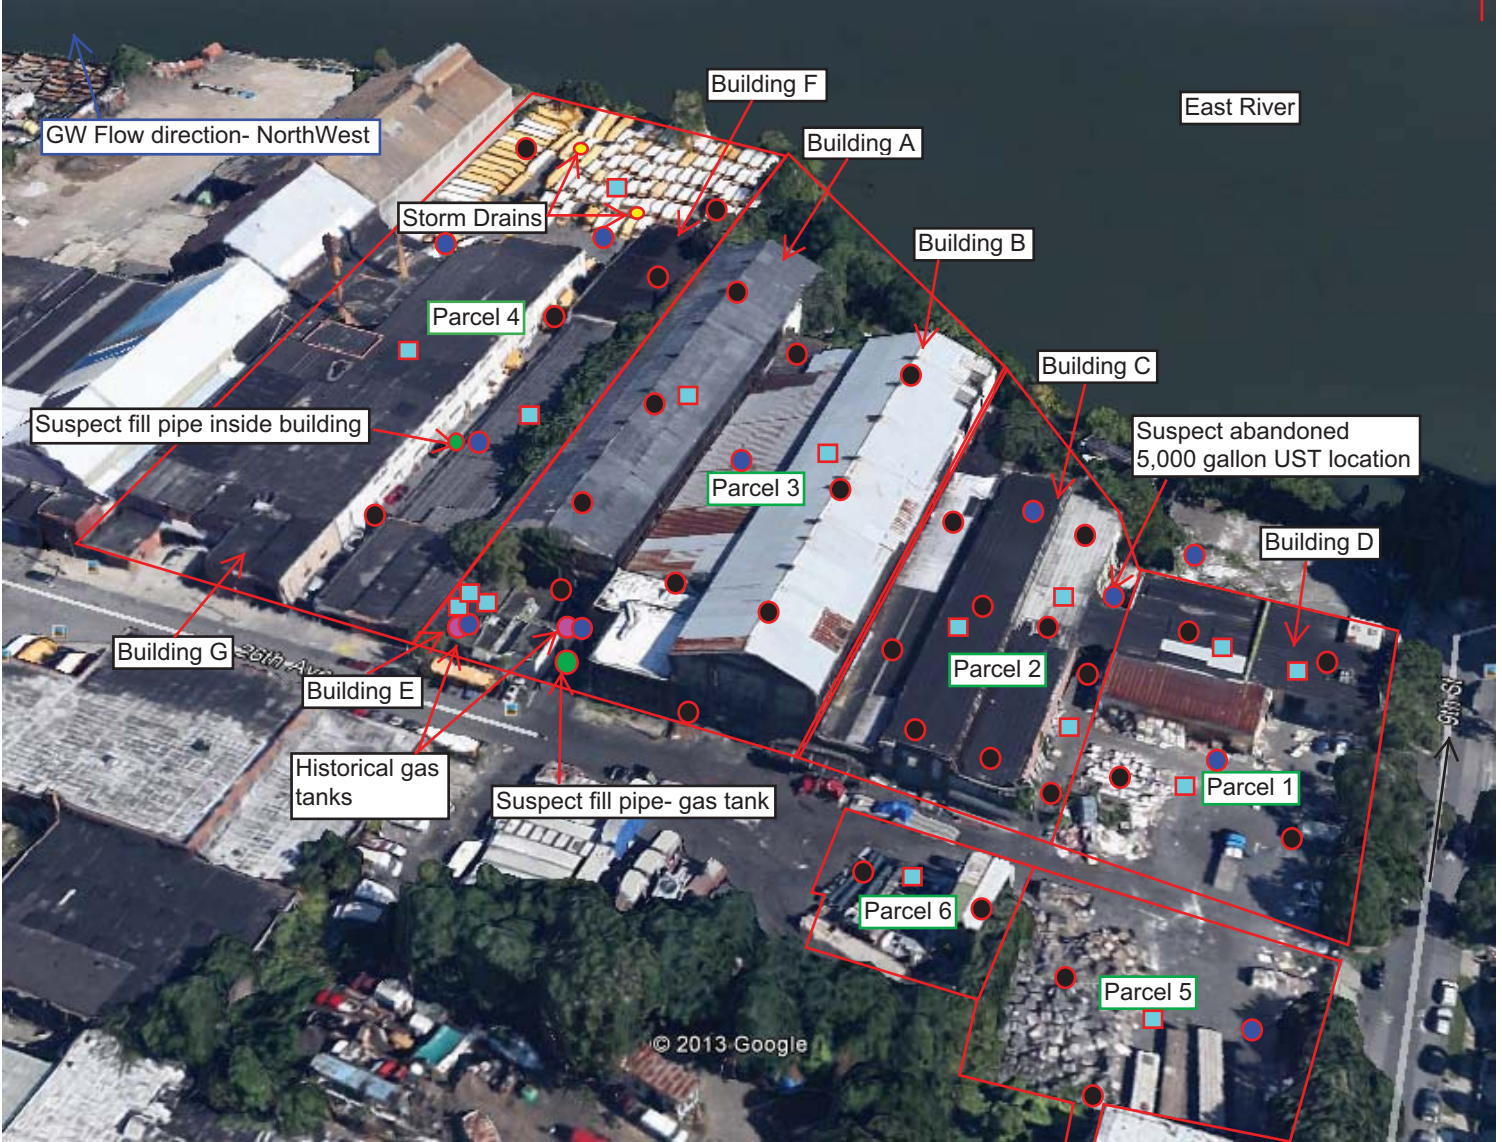
FIGURE 2
PROPERTY
MAP

- Proposed Soil Boring Locations
- Proposed Groundwater Boring Locations
- Proposed Soil Vapor/Subslab and Indoor Air sampling Locations

A total of sixteen (16) of soil vapor/sub slab/ indoor air (screening) samples will be collected from the proposed soil vapor locations on the Sampling Location Map (Figure 2). All samples will be collected in accordance with the Final Guidance for Evaluating Soil Vapor Intrusion in the State of New York (NYSDOH October 2006). Conditions in the field may require adjustment to the sampling locations.

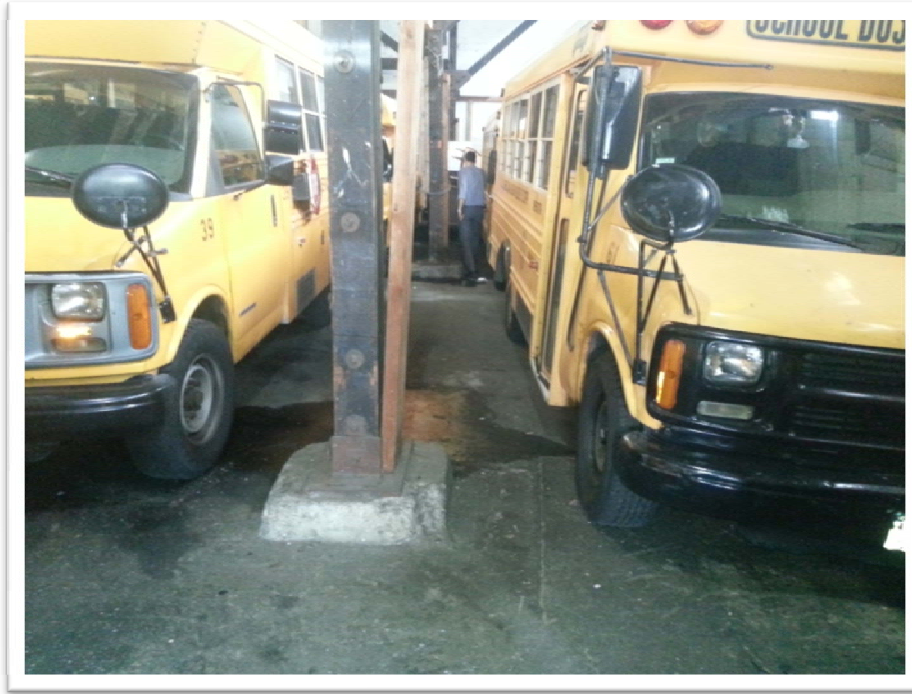
5. Rainbow Transit Service Area- Building F

REC4- GCE's visual inspection revealed the presence of one (1) Above Ground Storage Tank of approximately 250-gallon, seen inside the tenant space of "Rainbow Transit" located on the northern portion of Building F in Parcel 4. GCE's visual inspection also revealed the presence of a machine/service shop for service of buses inside the building. Historical usage of service areas associated with the "Rainbow Transit" along with the AST may have environmentally impacted the Parcel 4 in general. This is considered to be a *recognized environmental condition*.

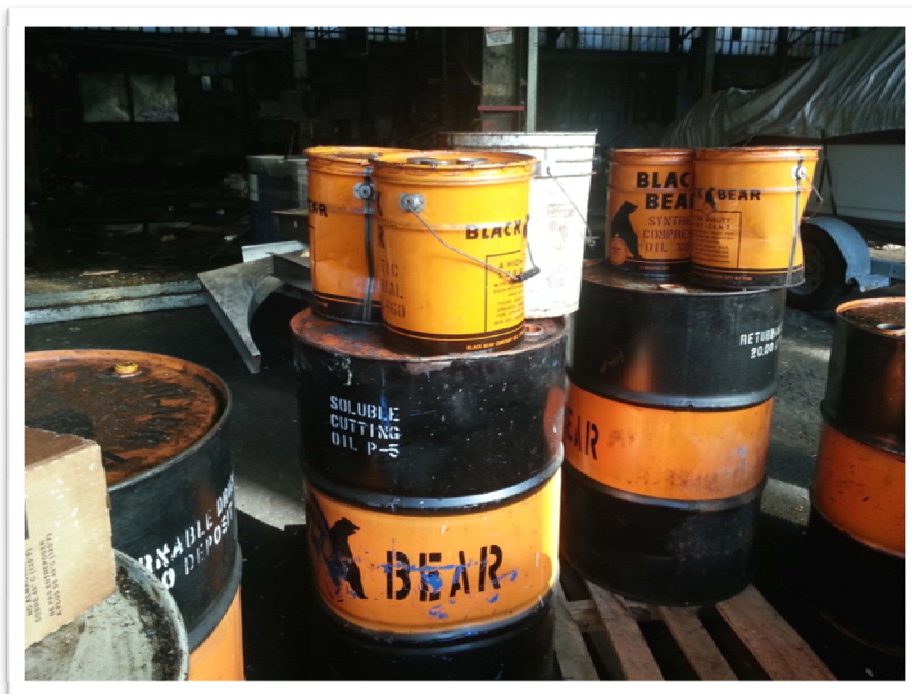
5. Empty 55 gallon cutting oil drums- Building B

REC16-GCE's visual inspection revealed the presence of oil stains on the floors in Building C associated with the historic use of machinery equipment. Poor housing was evident throughout the buildings B, C and D. GCE's visual inspection revealed the presence of leaked silica bags, paint buckets, empty 55-gallon drums, manufacturing supplies etc throughout and surrounding

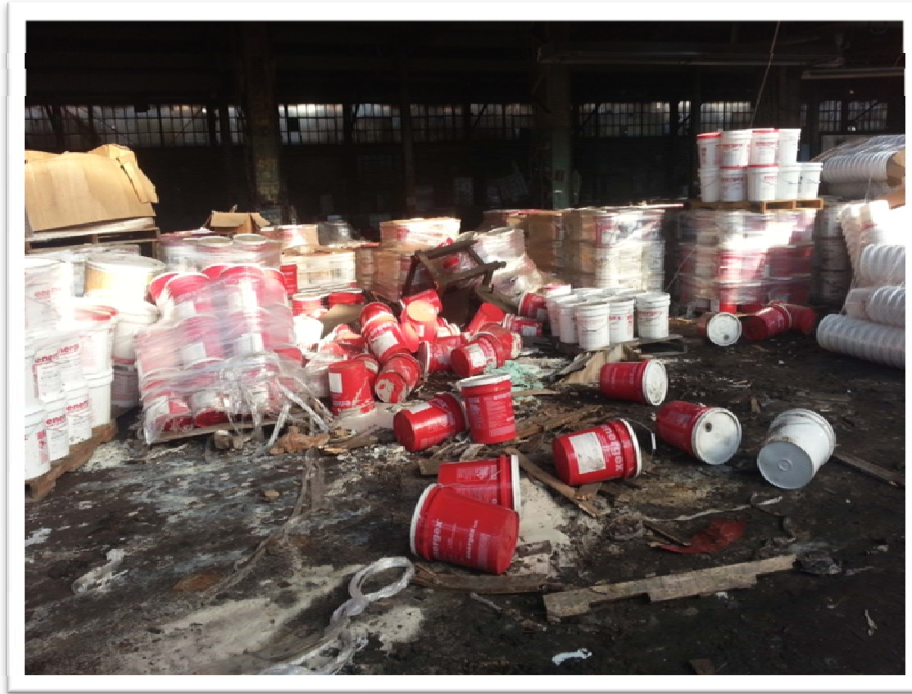
6. Poor housekeeping- Building B & C

these buildings. The poor housekeeping practices, with evidence of historic leaks associated with the machinery, and the observed current condition of the Site, is considered to be a *recognized environmental condition*.

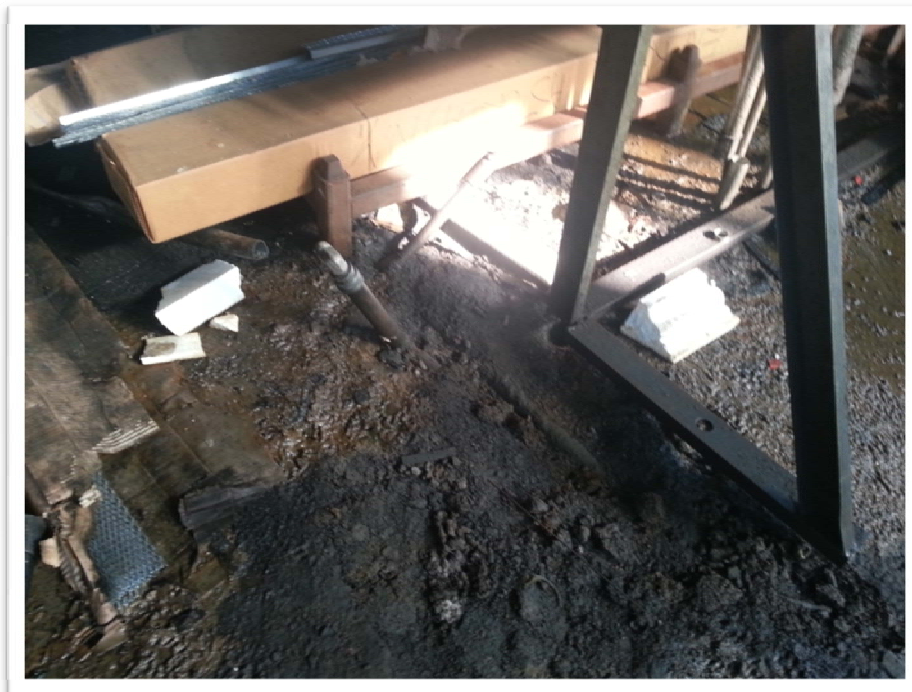
4. Oil fill lines & Staining- Building C

REC12- GCE's visual inspection revealed the presence of oil lines in Building C of Parcel 3. Historic USTs may have been present associated with the manufacturing process may have impacted Parcel 3 in general. This is considered to be a *recognized environmental condition*.

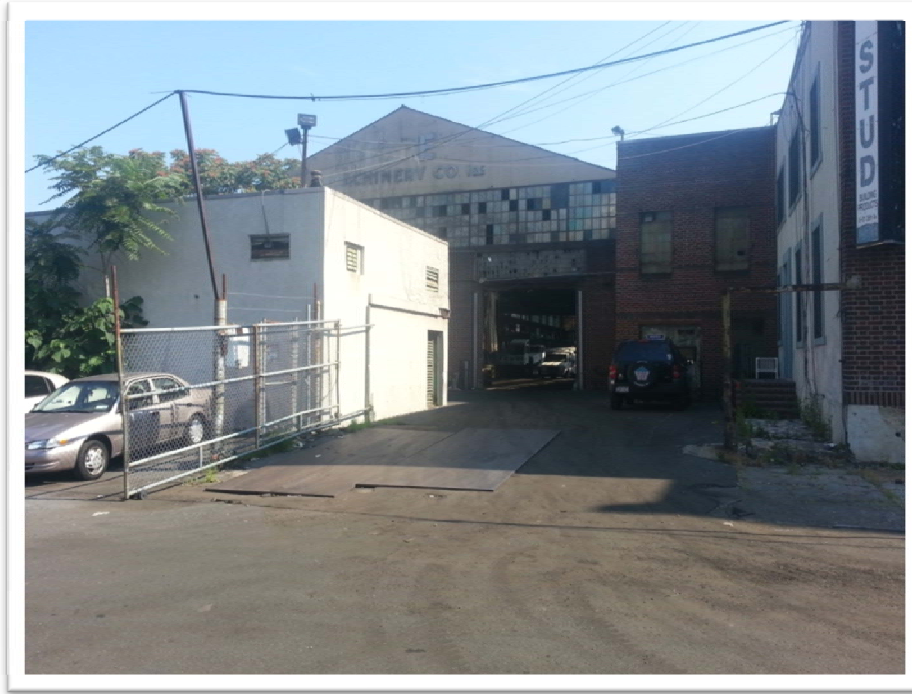
6. Building E- Historical Auto Repair

REC9- The 1985-2006 Sanborn shows Building E as occupied with “Auto Repair” facility. According to the New York City Building, Buildings A, B, C, D and E in Parcel 4 were constructed between c 1931 to 1943. The main contaminants generated from the metal manufacturing facilities include cutting oils, degreasing and cleaning solvents, acids, alkalis and heavy metals from metal cutting/forming process, solvents, emulsifying agents, acids and alkalis from surface preparation, acids, metals, solvents and paints from surface finishing process. Handling of chemicals from auto/service facilities may generate environmental pollution through activities associated with usual service work such as: the replacement of auto parts, oil changes, tune-ups and even through regular change of fluids (e.g., PCB’s, oil, transmission fluid). These repair/service activities introduce or have the potential to introduce contaminants (handled chemicals) in the environment through accidental spills or leaks, as well as through volatilization of the auto repair solvents during regular handling activities. Historical property usages as “Superior Steel Studs”, “Machine Shop”, “Auto Repair” and “Coal Yard/Door Factory” may have environmentally impacted the Parcel 4 in general and are thus considered to be a *recognized environmental condition*. #

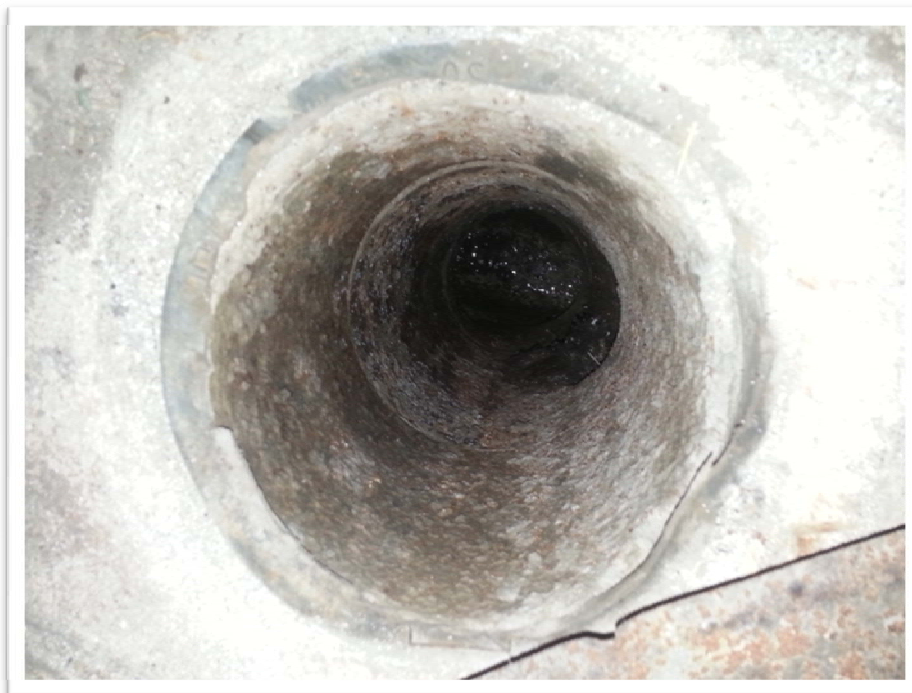
6. Suspect Floor Drains

REC15-GCE's visual inspection revealed the presence of suspect floor drains in Building F & G. Historical usage of Parcel 4 as "Lumber/Wood Working", "Rainbow Transit" and "Machine Shops" may have environmentally impacted the property via these floor drains. This is considered to be a *recognized environmental condition*.
