Ridgewood South Historic District Designation Report

October 26, 2010

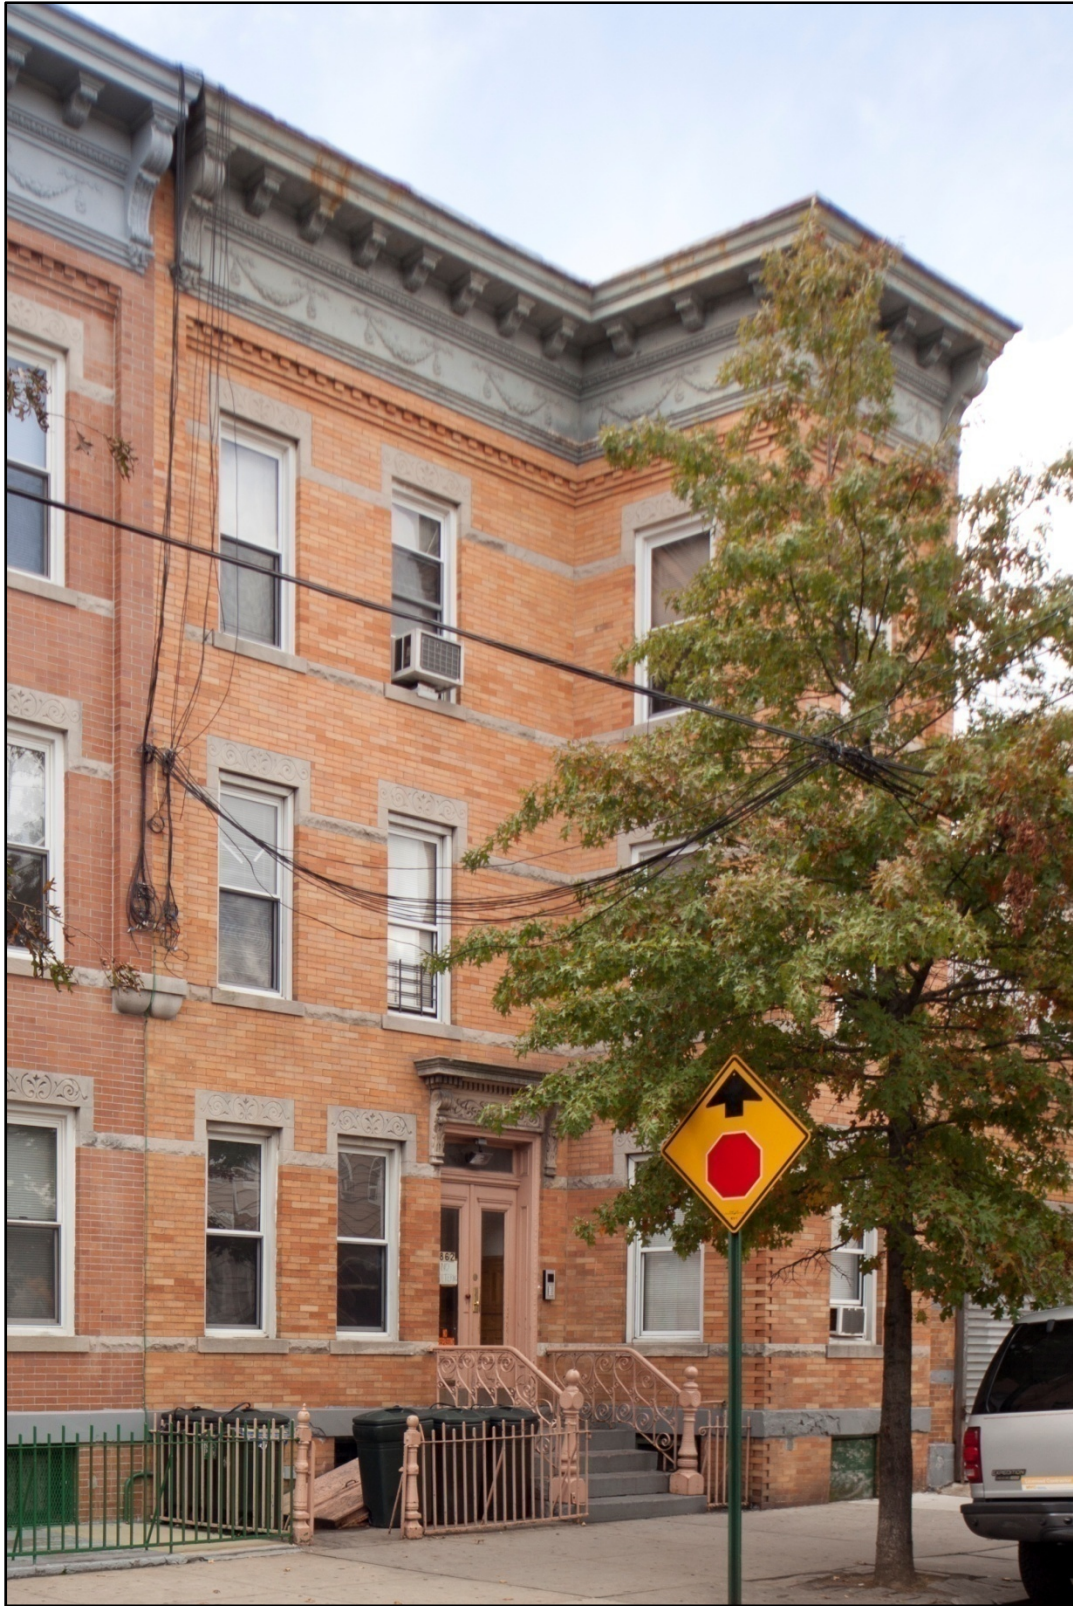
Figure 3: 57-17 to 57-27 Catalpa Avenue.
Photo: Christopher D. Brazeel, 2010.

In addition to being innovative in plan, the tenements are striking in appearance. (Figure 3) Built after 1905 when fire codes in Ridgewood began requiring masonry construction for attached rows, the buildings have load-bearing masonry walls constructed of light colored Kreisler brick. Using mainly pale-yellow- and amber-colored brick, the buildings have fine detailing, including corbelled, projecting, recessed, contrasting and geometric patterned brickwork, brick pilasters, and contrasting brick or carved-stone string coursing. With mainly flat

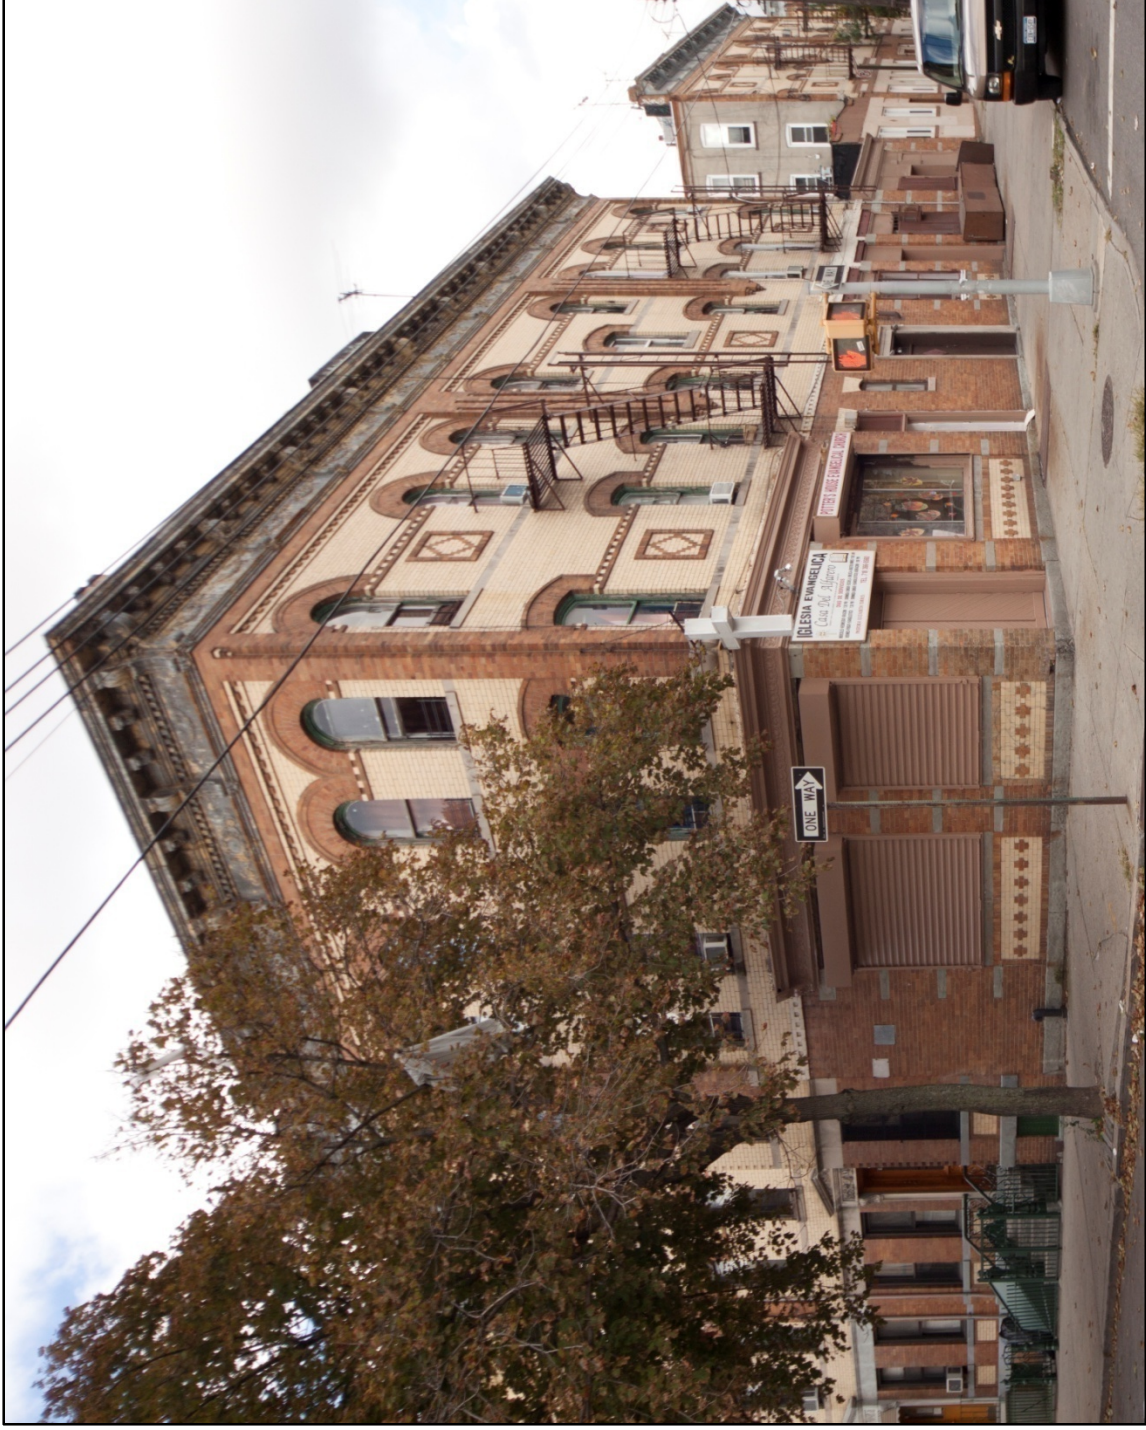
Figure 4: 862 Woodward Avenue.
Photo: Christopher D. Brazee, 2010.

facades, the mid-block buildings are recessed from the street wall of the corner buildings, (Figure 4) adding further interest to the row.

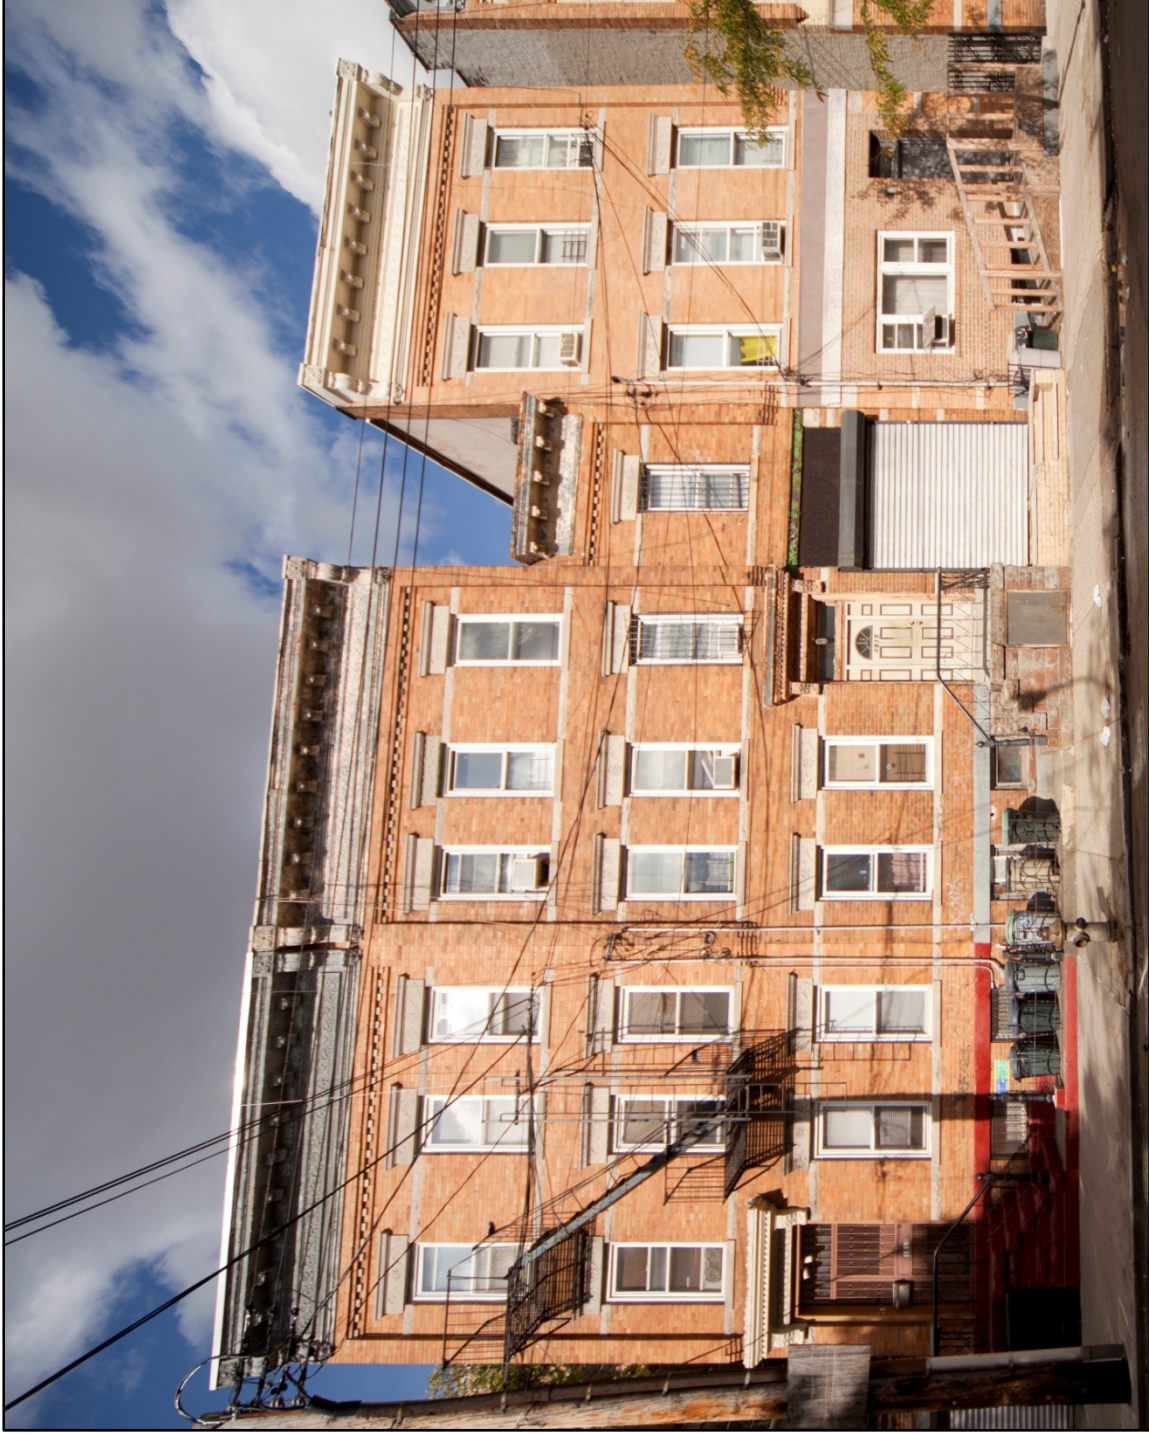
Figure 8: 862 Woodward Avenue, detail of pressed-metal cornice with swags and garlands.
Photo: Tara Harrison, 2010.

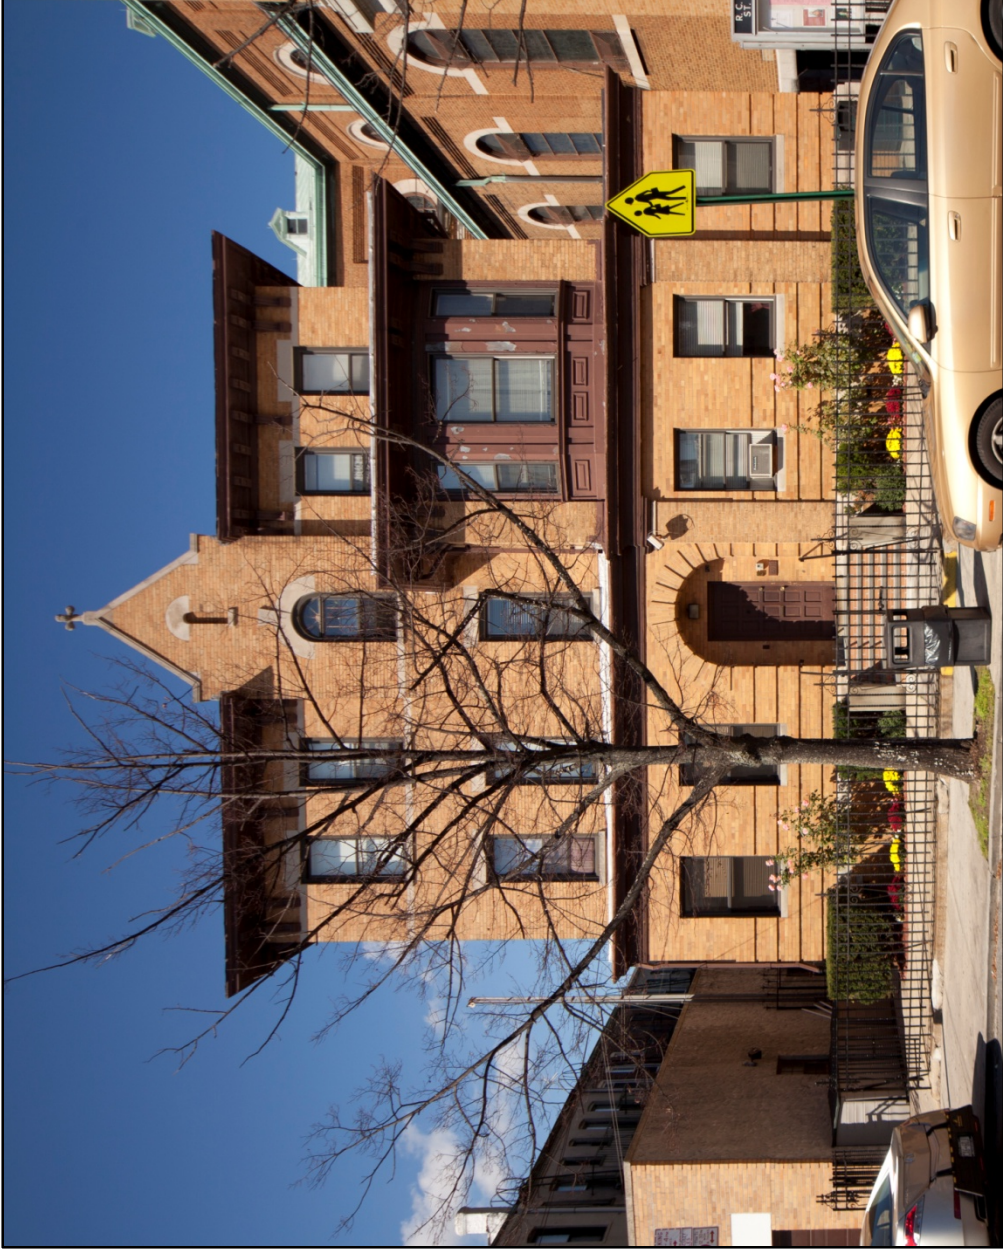
Figure 16: St. Matthias Church Complex, c. 1983.
Source: Diamond Jubilee booklet (St. Matthias Church: 1983).

Before selling the bulk of the family farm to G.X. Mathews, the Meyerrose heirs sold a large lot fronting on Catalpa Avenue to the Roman Catholic Archdiocese of Brooklyn for the construction of a new church. Between 1909 and 1926, a combined church-school, rectory, convent, and larger church were constructed for the newly formed parish of St. Matthias, all designed in a Classically-inspired style by local architect Francis J. Berlenbach, Jr.⁵⁸ (Figure 16)
