## OFFICE OF THE COMPTROLLER

Audit Report on the New York City  
Housing Authority's Oversight of  
Contracts Involving Building Envelope  
Rehabilitation

SE16-065A

June 30, 2017

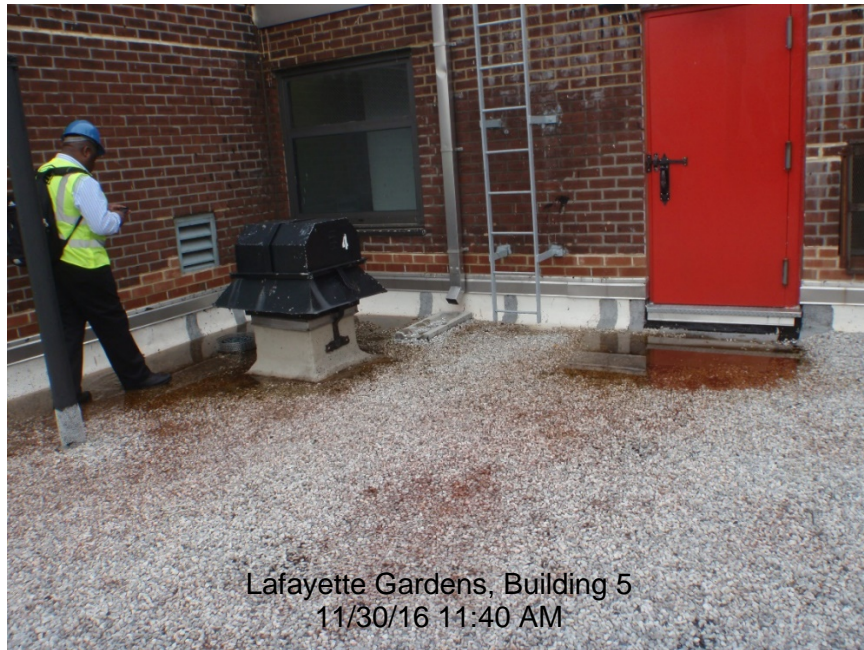
During our field inspection of Lafayette Gardens, Building 5 at 411 Lafayette Avenue in Brooklyn, we noted that portions of the roof (specifically areas around the bulkhead door, ventilator curb and roof drain) had significant ponding of water of up to approximately four to five inches shortly after a period of rain. In those areas, the gravel was also stained, which indicated reoccurring and prolonged standing water.

**Photograph 1**  
**Auditor-observed Ponding Condition Post Rainstorm**  
**at Lafayette Gardens Building 5**

1. Correct the identified deficiency on Lafayette Gardens' Building 5 roof.

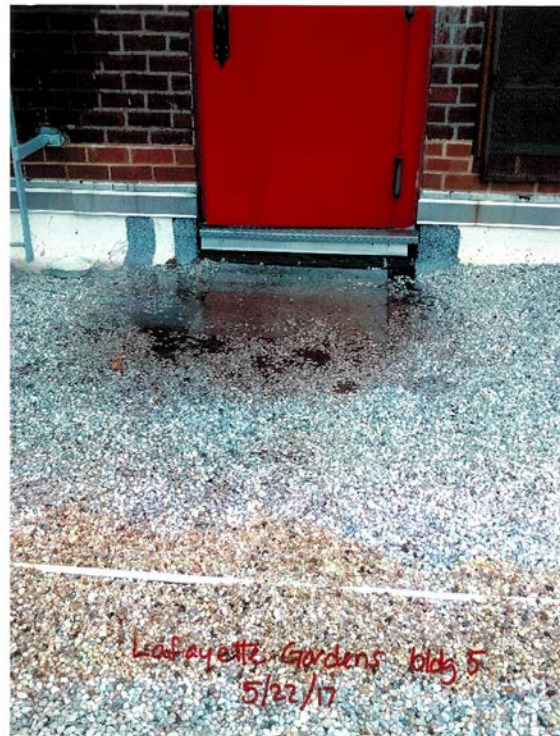
During the exit conference, NYCHA informed us that after receiving our preliminary draft audit report the agency conducted its own inspections of the cited ponding condition at Lafayette Gardens Building 5 and found no ponding 48 hours after a rainstorm ended.<sup>8</sup> To support that claim, NYCHA later provided us with photographs—one set NYCHA called "post-storm," purportedly taken shortly after a rainstorm, which shows ponding water, and another set taken approximately 48 hours after the storm, showing no ponding. However, when we compared the photograph taken during our initial inspection on December 2, 2016, shortly after a period of rain (Photograph 1), with NYCHA's photograph taken during its initial inspection on May 22, 2017, shortly after a rainstorm (Photograph 2), significant differences became apparent. Specifically, our photograph depicts ponding over a larger area and at a greater depth than that shown in NYCHA's photograph. From that comparison it appears possible that a larger volume rain had fallen before our initial inspection than had fallen before NYCHA's initial inspection. That or other factors may account for the differing results of the follow-up inspections conducted, respectively, by us and by NYCHA approximately 48 hours after the rains ended—where we observed ponding and NYCHA did not. (See Photographs 3 and 4.) Moreover, the absence of ponding 48 hours after one rainstorm does not negate the fact that ponding was observed 48 hours after a different rainstorm; to the contrary, the differing results reinforce the advisability of periodic inspections, particularly after "severe weather conditions" as recommended by the roof's manufacturer. Those are the conditions that the roof will endure during its useful life. Therefore, we find no reason to revise this finding or the associated recommendations.

**Photograph 2**  
**NYCHA-observed Ponding Condition Post Rainstorm**  
**at Lafayette Gardens Building 5**

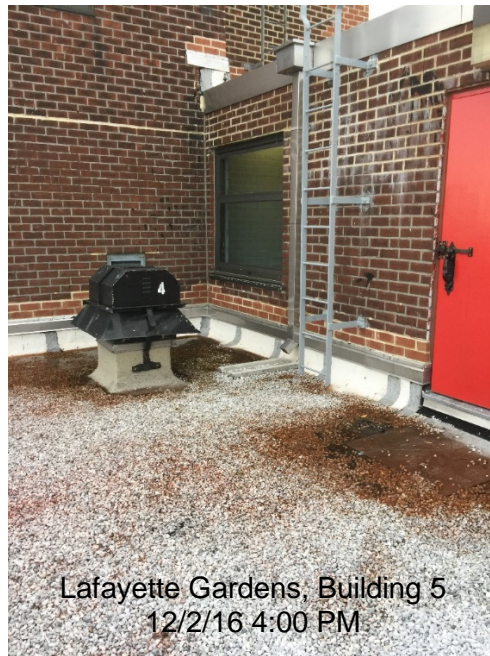
According to the National Roofing Contractors Association (NRCA), an acceptable duration for ponding water to remain on a roof after a rain for a built-up 4-ply roof system is 48 hours. A follow-up site visit conducted approximately 48 hours after the rain stopped found that standing water was still present, contrary to the industry standard requiring complete drainage within that timeframe.<sup>4</sup>

The Lafayette Gardens' contract specification Section 07 52 00 Part 1 - 1.13 C.1.b. states that "[i]f any work leaks, fails to stay in place or results in ponding," the work will be judged as defective work.<sup>5</sup> Accordingly, the areas we observed with ponding present after 48 hours reflect defective work under this contract.

**Photograph 3**  
**Auditor-observed Ponding Condition Approximately 48 Hours Post Rainstorm  
at Lafayette Gardens Building 5**

**Auditor Comment:** During our audit fieldwork, we used the same NRCA criteria that NYCHA references in its response. However, as stated in our finding (and as evidenced by Photograph 3), we found standing water still present on the roof of Building 5 at Lafayette Gardens more than 48 hours after the rain ended. Although, as NYCHA observes, ponding may or may not occur based on the conditions of the specific rainstorm, nevertheless, the acceptable duration for ponding water to remain on a roof is 48 hours. Therefore, the presence of ponding water during our observation more than 48 hours after the rain ended established the deficiency. The absence of ponding water during NYCHA's inspection after a different rainstorm does not negate our inspection finding; instead, it reinforces the need to conduct periodic inspections, including after severe weather as recommended by the manufacturer. Accordingly, we reiterate that there is a deficiency on the Lafayette Gardens' Building 5 roof that requires correction.

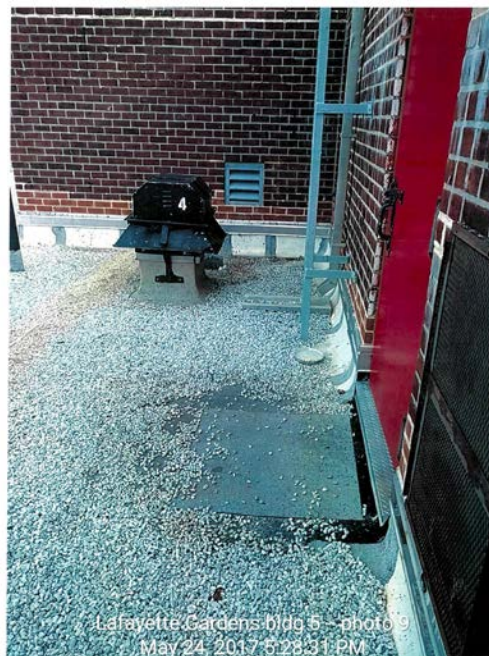
**Photograph 4**  
**NYCHA-observed Ponding Condition Approximately 48 Hours Post Rainstorm  
at Lafayette Gardens Building 5**

**NYCHA Response:** NYCHA disagreed with the recommendation. "According to the National Roofing Contractors Association (NRCA), an acceptable duration for ponding water to remain on a roof after a rain for a built-up 4-ply roof system is 48 hours. NYCHA conducted its own inspections of the ponding at this and other locations cited (on May 22, 2017 and on June 21, 2017) and found no ponding 48 hours after the rain storm ended."

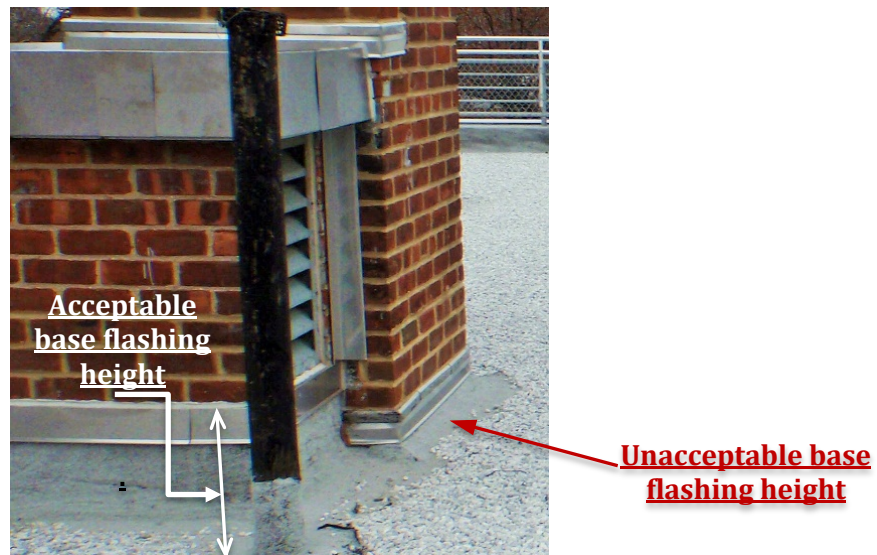
Our audit found that some of the base flashing around the bulkheads at Pomonok Houses North in Queens, did not comply with the industry standard of extending a minimum of eight inches above the bottom of the cant strip. The NRCA refers to an eight-inch flashing height as a minimum in all details, as do most manufacturers. This lack of compliance was discovered during our field inspection of Pomonok Houses North in Queens, Buildings 2, 6, and 8, when we, accompanied by NYCHA representatives, observed that the height of the counter-flashing above the roof appeared to be less than typical, thereby not permitting the upturn of the base flashing to meet the eight-inch minimum. A follow-up visit was made to inspect the other buildings at this

Allowing for the 3/4-inch average thickness of a 4-ply built up roof, the flashing height should be more than seven inches when measured vertically from the finished roof level. At Buildings 4, 5, 6, 8, and 9, we found 965 linear feet of base flashing whose height above roof level ranged from 4-1/2 to seven inches, consequently indicating non-compliance with the eight-inch minimum standard (see Table II below).

There are several reasons for establishing an eight-inch minimum vertical flashing height. One reason is to protect the flashed joint at the wall from moisture infiltration caused by driven rain or snow buildup. The eight-inch height also provides sufficient work space when applying a base flashing and fastening the flashing's top edge to a vertical surface. The height also allows a minimum four-inch overlap for counter-flashing over the top edge of a base flashing termination, which is intended to shed water off of and away from the wall. When NYCHA does not meet industry standards, it fails to ensure that the roofing system will, at a minimum, achieve its expected useful life and maintain its water-tightness. (See Photograph 5.)

**Photograph 5**  
**Building 6 Base Flashing Installation**

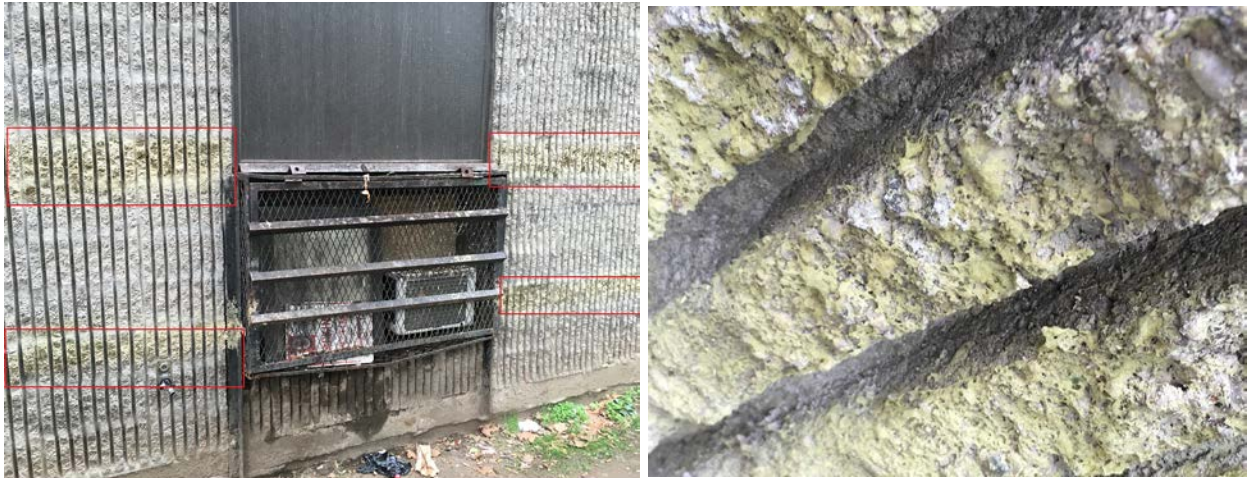
Not only does this stain/growth adversely impact the appearance of the building, it could possibly cause deterioration of the facade block and pose a health risk to residents. Without knowing the exact nature of the growth, it is not possible to develop an accurate estimate for the cleaning/remediation cost.

### Photographs 6 and 7 Yellow Stain/Growth on Façade

10. NYCHA should investigate and determine the nature and cause of the stain/growth, and properly remediate the condition. If it is found that the condition was caused by something related to the construction work, NYCHA should require the contractor to correct at no additional cost.

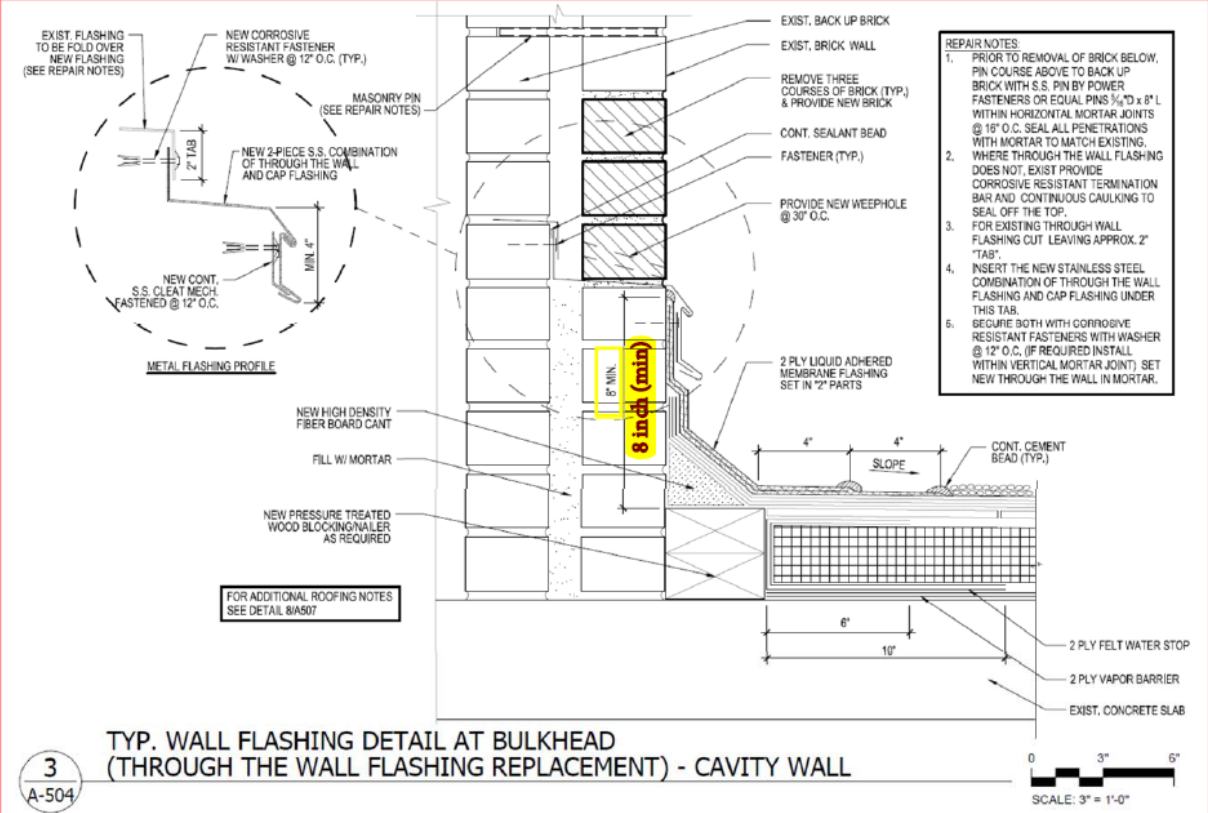
**Wall Flashing Detail at Bulkhead**

It should be noted that the detail included in NYCHA’s contract drawings, Detail 3/A-504, Typ. Wall Flashing at Bulkhead (Through Wall Flashing Replacement) – Cavity Wall, shows an eight-inch minimum upturn of the flashing (see Appendix II). Also, contract specifications Section 07 52 16 Part 1 C.5.a.C.1 requires the eight-inch minimum and Part 3 F.1. requires inspecting for conformance with the eight-inch minimum height and bringing non-conforming areas to the attention of the Owner’s Representative.

The “wall flashing detail” section of the contract drawings called for the installation of base flashing to a minimum height of eight inches—as recommended by GAF. However, the same “wall flashing detail” called for the installation of new counter-flashing—which must overlap with and cap the base flashing—at its pre-existing location. That requirement, if followed, would prevent the new base flashing from meeting the prescribed minimum eight-inch height, because the pre-existing location of the counter-flashing was less than eight inches above the base of the cant strip. In short, by maintaining a fixed pre-existing location for the counter-flashing, contract drawings would not permit the installation of base flashing to a height of eight inches. Therefore, the contract drawings were both internally inconsistent and—insofar as resulting in the new base
