UPPER EAST SIDE HISTORIC DISTRICT EXTENSION Designation Report

March 23, 2010

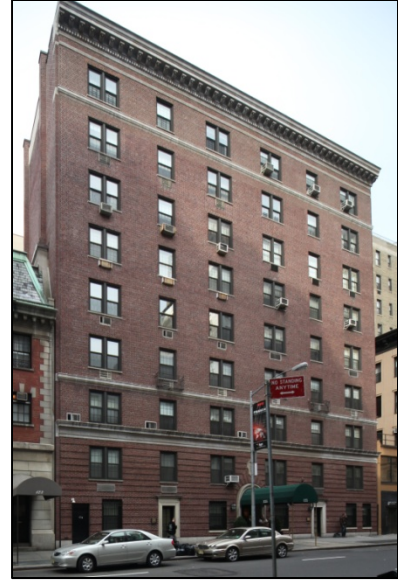
History: The apartment building at 125 East 63rd Street, sometimes noted in early advertisements as 125 to 135 East 63rd Street, was designed by architects Sugarman & Hess and A.G. Berger in 1922 for the 125 East 63rd Street Corporation. Louis Cowan (c. 1888-1961), president of the building company, built several large apartment and office buildings in New York City and elsewhere during his career, collaborating with both Sugarman and Berger on at least two other projects. The building, which replaced six four-story and basement row houses built in the 1880s, was projected to cost \$350,000. Shortly after its completion, 125 East 63rd Street was the recipient of the 1924 architectural merit award for buildings of more than six stories by the New York Chapter of the American Institute of Architects.

Description: Nine-story Colonial Revival style apartment building with one visible primary elevation and two visible secondary elevations. East 63rd Street Facade: Tripartite vertical composition consisting of a two-story base, six-story shaft and one-story capital; red brick, rusticated at base, laid in an English bond at shaft and capital; granite base trim; six symmetrical bays; rectangular window openings with slightly projecting limestone sills typical, except where

noted; wider typical window openings at first, third and fourth bays at first story; two slightly wider typical window openings at sixth bay at first story; decorative iron window guards at first-story fenestration; iron shutter hook affixed beneath window openings at sixth bay at first story; round-arched opening between third and fourth bays at first story contains primary residential entry; primary residential entry consists of rectangular door opening raised on a low granite step containing double doors with decorative iron screens and surmounted by an arched marble transom with decorative iron scroll and fretwork; door opening features molded limestone surround on granite plinths with paneled soffit and reveals; entranceway surmounted flush voussoirs which come to a point and masonry cartouche; rectangular door opening with metal door to left of first bay at first story; rectangular door openings featuring molded limestone surrounds on granite plinths and containing wood-and-glass doors with molded frames raised on low granite steps with marble thresholds and surmounted by molded limestone entablatures at second and fifth bays at first story; wider typical window openings containing paired windows at central and outer bays above first story; terra-cotta entablature with molded cornice above base, serves as sill course for third-story fenestration; brick soldier-course lintels at third story fenestration; molded terra-cotta bands above third story, shaft and capital; decorative iron balconettes at second and fifth window openings at fourth story; terra-cotta cornice featuring foliate brackets and dentil course at roofline; recessed strips flank elevation at base, shaft and capital. West Facade: Secondary elevation, partially visible; divided into two sections by light well (only section closest to East 63rd Street visible); horizontal masonry and terra-cotta details return from East 63rd Street elevation as blocks; two brick chimneys capped with masonry coping project above roofline; flush brick soldier-course border frames visible section; soldier-course band extends across near roofline; masonry coping at roofline. East Facade: Mirror image of west elevation, except where noted; no chimneys; partially visible light well; beige brick light well wraps slightly to visible portion of east elevation. Light Well at East Facade: Partially visible; beige brick laid in a common bond, where visible; one bay of wider typical window openings containing paired windows visible at south-facing wall. Site: Metal in-ground cellar hatch in front of sixth bay at East 63rd Street elevation. Alterations: All windows replaced; portion of west elevation painted white between chimneys at roofline; several through-wall holes punched for air-conditioning units at East 63rd Street elevation; awning at primary residential entry; numbering “125” affixed to elevation at left and right of primary residential entry; light fixtures affixed to elevation flanking primary residential entry; light fixture to left of door opening at fifth bay at East 63rd Street elevation; security camera affixed at first story towards left edge of East 63rd Street elevation; signage affixed to East 63rd Street elevation by door openings at third and fifth bays at first story; intercom at door opening at fifth bay at first story of East 63rd Street elevation; pipe affixed towards right edge of East 63rd Street elevation at first story.

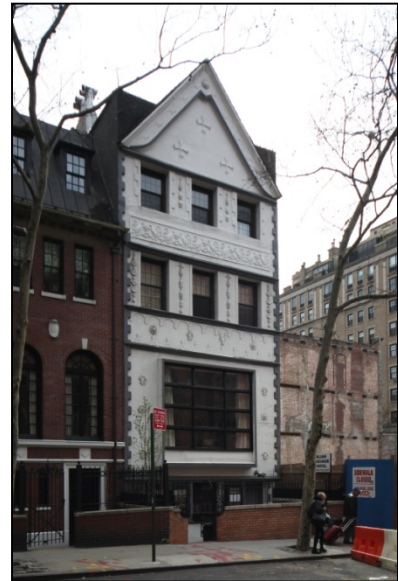
Date of Construction: altered 1922 (ALT 1444-22)
Architects: George Schmitt (1922)
Original Owners: Lewis Stuyvesant Chanler (1922)
Type: Row house; now commercial
Style: Medieval Revival
Stories: Three and basement
Material: Stucco

History: The building at 132 East 65th Street was originally constructed in 1870-71 as one of seven Italianate style brownstone-front row houses designed by architect Frederick S. Barus for speculative developers J. & G. Ruddell (NB 738-70). In 1922, the house received a new Medieval Revival style facade of ornamental stucco and false gable, designed by architect George Schmitt of the firm Schmitt Brothers. As part of this alteration, the home's original stoop was removed, basement-level entry introduced, and areaway steps and wrought iron fencing added. At the time of the alteration, the home was owned by Lewis Stuyvesant Chanler (1869-1942), great-grandson of John Jacob Astor and former Lieutenant Governor of New York during the administration of Charles E. Hughes (1906-08). The stucco work on the new facade is reminiscent of 866 Lexington Avenue which was modernized by architect Frederick Sterner in 1922. The similarity is probably not coincidental, as the Schmitt Brothers decorating firm had worked on previous projects for Sterner. Chanler was also the brother of one of Sterner's earlier clients.

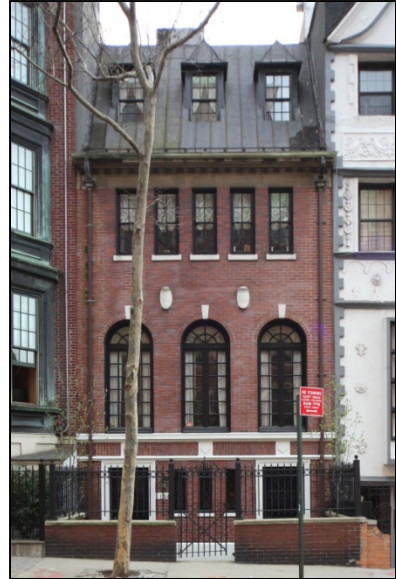
History: This three-story and basement brick-face row house was originally constructed in 1870-71 as one of seven Italianate style brownstone-front houses designed by architect Frederick S. Barus for speculative developers J. & G. Ruddell (NB 738-70). In 1919, the house received a new Colonial Revival style facade and dormered roof designed by architect Harry P. Knowles. As part of this alteration, which was estimated to cost \$14,000, the home's original stoop was removed and basement-level entry introduced. The owner at the time was Helen McMahon. Today the building contains two residential units.

Description: Three-story and basement Colonial Revival style row house; basement exposed within below-grade areaway; red brick laid in a running bond at all elevations; masonry water table at basement; three bays at basement and first story; rectangular door openings featuring molded masonry door surrounds and molded masonry lintels at outer bays at basement; three narrow rectangular window openings with projecting incised masonry sills and flush brick soldier-course lintels and containing possibly historic stained-glass windows with geometric details at central bay at basement; molded masonry band at basement continuous with door lintels; brick frieze with three inset square masonry panels with diamond details above molded band; molded masonry cornice above frieze serves as sill course for first-story fenestration; full-height round-arched window opening articulated by single-course flush brick relieving arch with masonry keystone at each bay at first story; multi-paned casement window, fanlight and molded frame recessed within each round-arched opening at first story; two masonry cartouches between first and second stories; five bays at second story; rectangular window opening with projecting, incised masonry sill and containing possibly historic four-over-four double-hung sashes at each bay at second story; overhanging masonry cornice supported on small brackets with flush architrave serving as lintel course for second-story fenestration; three flared hipped dormers at slightly flared mansard roof; single rectangular window opening at each dormer containing possibly historic six-over-six double-hung sashes; drain pipes at left and right sides of elevation intersect masonry bands; mechanical unit visible above roofline. Site: Red brick wall with masonry coping surmounted by decorative metal fencing and gate encloses below-grade

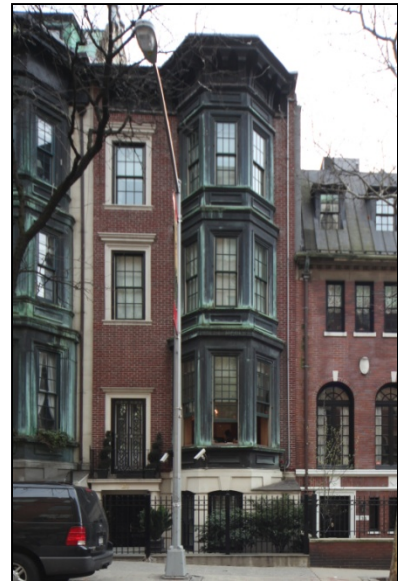
History: This three-story and basement brick-face row house was originally constructed in 1870-71 as one of seven Italianate style brownstone-front houses designed by architect Frederick S. Barus for speculative developers J. & G. Ruddell. In 1922, the house underwent numerous alterations under the ownership of James A. Miller. Architect James Gamble Rogers was responsible for the alterations, which resulted in the removal of the original stoop and introduction of primary entry at the basement level. The existing brick face, which necessitated the removal of small masonry brackets from the second- and third-story window openings of the left bay, probably also dates to this alteration. Around 1953, the building was converted into a multiple dwelling consisting of two duplex residential units (interior is not part of designation). Today the building is once again a single-family row house.

Description: Three-story and basement Colonial Revival style row house; basement exposed within below-grade areaway; rusticated limestone basement; red brick laid in a running bond at

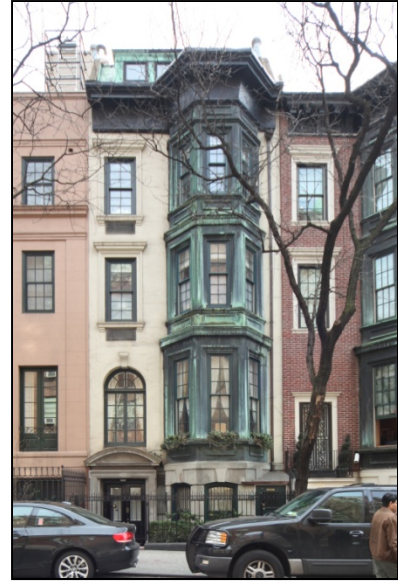
History: This three-story and basement row house was originally constructed in 1870-71 as one of seven Italianate style brownstone-front houses designed by architect Frederick S. Barus for speculative developers J. & G. Ruddell. Removal of the structure's original stoop, the introduction of primary entry with pedimented masonry portico at the basement level, and alteration of the original doorway into an arched window opening, appear to have taken place as early as 1906 (ALT 76-06) by owner H.E. Holt and architect Samuel Edson Gage. A later alteration in 1924 by architect Gurdon S. Parker brought about changes to the interior of the structure (interior is not part of designation) and the addition of the existing penthouse (ALT 1510-24). The owner at the time was Harold Otis. Today the building contains two residential units.

Description: Four-story and basement Colonial Revival style row house; basement exposed within below-grade areaway; rusticated limestone basement; brownstone at first through third stories; two bays at basement and first through third stories with continuous three-sided bay window at right bay (limestone at basement, metal at first through third stories); primary entry at left bay at basement (*see Alterations*); primary entry features wide rectangular door opening with molded masonry door surround and segmental-arched pediment; right side of three-sided bay window at basement has been "straightened" and presently contains rectangular door opening (*see Alterations*); segmental-arched window openings with stylized limestone keystones at left and central sides of bay window at basement; ornamental iron window guards at basement fenestration; slightly projecting limestone band with molded lip above basement; first story slightly taller than other stories; full-height round-arched window opening at first bay at first story contains recessed multi-paned rectangular casement window and fanlight and features masonry keystone and paneled soffit (*see Alterations*); single rectangular window openings featuring molded masonry window surrounds surmounted by molded cornices and molded bracketed sills at second and third stories at first bay; rectangular window openings with slightly projecting window surrounds at each side of bay window at first through third stories, paneled fascia beneath sills, and continuous cornices at first through third stories at bay window; additional paneled fascia above third story at bay window; possibly historic nine-over-nine double hung sashes at first story at bay window; possibly historic six-over-six double hung sashes at second and third stories at bay window; drain pipe to right of bay window; overhanging cornice above third story (*see Alterations*); mansard roof at fourth story features wide flat-roofed dormer containing four rectangular window openings (*see Alterations*). Site: Low concrete curb

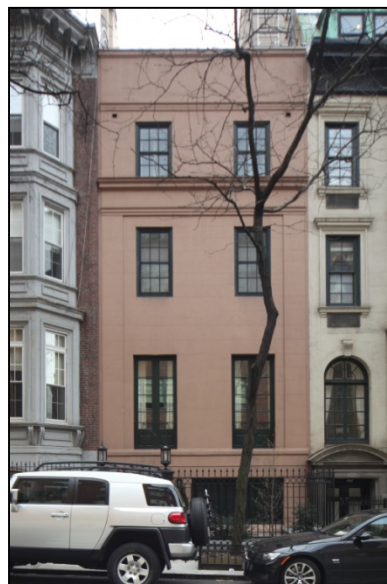
History: This three-story and basement row house was originally constructed in 1870-71 as one of seven Italianate style brownstone-front houses designed by architect Frederick S. Barus for speculative developers J. & G. Ruddell. During the 1910s, the building functioned as a clubhouse for the nearby Church of St. Vincent Ferrer (1918, 869 Lexington Avenue, a designated New York City Landmark). In 1925, the house underwent major alterations under the ownership of Mary B. Tolfree. Architects Treanor & Fatio were responsible for the alterations which resulted in the present simplified Colonial Revival appearance and which included the removal of the original stoop, double-height bay window and original cornice, the introduction of primary and service entries at the basement level, resurfacing with imitation brownstone, and addition of areaway steps and wrought iron fencing. Plans filed with the New York City Department of Buildings indicate that

a mansard roof with copper-covered dormers may have been added as part of this alteration, but was not present at the time of the c. 1939 tax photograph. Today the building continues to function as a single-family home.

Description: Three-story and basement simplified Colonial Revival style row house; basement exposed within below-grade areaway; masonry at all stories, rusticated at basement (*see Alterations*); masonry water table with molded lip at basement; two bays at all stories; primary entry at left bay at basement (*see Alterations*); primary entry features short, rectangular door opening containing recessed door; wide rectangular window opening containing triple windows at right bay at basement (*see Alterations*); first story slightly taller than other stories; rectangular door opening at each bay at second story containing paneled wood-and-glass or metal-and-glass double doors with metal knobs and low decorative metal rails (*see Alterations*); molded masonry sill course at first-story; second and third stories flanked by continuous, slightly projecting masonry pilasters supporting and entablature consisting of a molded masonry band, wide frieze, and molded masonry cornice (which doubles as sill course for third-story fenestration); rectangular window opening at each bay of second and third stories (slightly shorter window openings at third story); molded masonry band above third-story fenestration; molded masonry band at parapet. Site: Low masonry wall surmounted by tall decorative metal fencing and security gate encloses below-grade areaway; light fixtures on large metal posts flanking security gate; areaway accessed by concrete stairway; granite countertop with cabinets below at right side of areaway; areaway, but not present areaway elements, date to before ca. 1939 tax photograph. Alterations: Original stoop, bay window and cornice removed, new window at second story, new door openings at basement, and entire facade resurfaced with imitation brownstone in 1925 (ALT 1076-25) (original appearance of row house similar to present appearance of 138 East 65th Street) (*see Description*); two basement window openings after initial alteration, altered into one wide basement window opening after ca. 1939 tax photograph (*see Description*); all windows replaced; all doors replaced; facade stuccoed and painted; light fixture to right of primary entry; metal railing at right side of elevation above parapet.

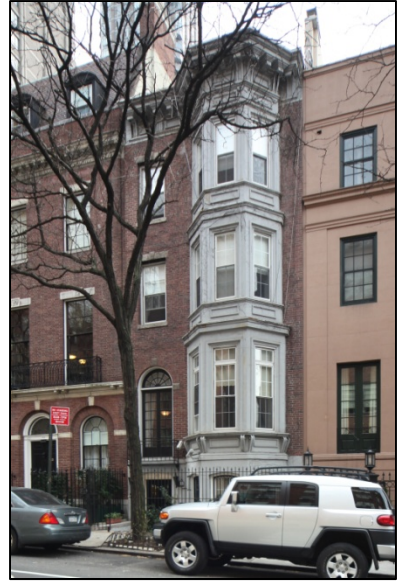
History: This three-story and basement brick-face row house was originally constructed in 1870-71 as one of seven Italianate style brownstone-front houses designed by architect Frederick S. Barus for speculative developers J. & G. Ruddell. The first occupant of the row house was Charles C. Pope, a businessman who specialized in baking powder and chemicals, but who did not own the home. Charles N. Dreshfield, who was in the lace business, acquired the house in 1885 and was the first owner-occupant. In 1889, Frederick Seibel, a butcher with a shop on Second Avenue and East 84th Street, moved here from the Lower East Side. After Seibel's death, his heirs sold the house to Judge Learned Hand who occupied the building from 1906 until his death in 1961, along with his wife Frances, several children, and one or two servants. Judge Hand was appointed to the Federal Court in 1909 by President William H. Taft and served for 52 years, writing more than 2,000 opinions during his career.

In 1961, the house was acquired and altered by a new owner, Henry K. Young. At the time it was the only intact house of the original row of seven. Alterations from this time include the removal of the original stoop, introduction of primary entry at the basement level, and the addition of brick facing. The house was also subdivided into two residential units, one consisting of the basement through second stories, and a second unit on the third story which could be accessed via elevator from the basement (interior is not part of designation). The house was purchased in 1973 for \$350,000 by lawyer Lester J. Tanner. It remained in Tanner's possession until 1979 when it was purchased by former President Richard M. Nixon and his wife Patricia Nixon for \$750,000. The Nixons moved into the house in 1980, but quickly resold the property in 1981 for a reported \$2.6 million to the Permanent Mission of the Syrian Arab Republic to the United Nations, which still owns the property. Records indicate that the house continues to contain two residential units.

Description: Three-story and basement Colonial Revival style row house; basement exposed within below-grade areaway; limestone basement with areas of rustication at three-sided bay (*see Alterations*); red brick laid in a running bond at first through third stories (*see Alterations*); two bays at basement and first through third stories with continuous three-sided bay window at right bay (limestone at basement, metal at first through third stories); primary entry at left bay at basement (*see Alterations*); primary entry features segmental-arched door opening containing

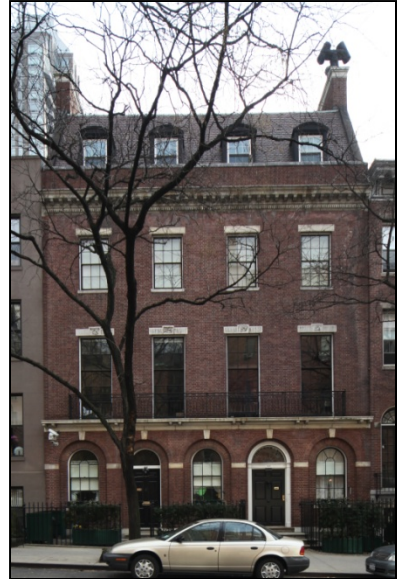
History: This four-story single-family home was designed by architects Treanor & Fatio in 1924 for the Adlin Corporation. The building, owned by Adrian Iselin (1846-1935), the company's head, replaced one of seven three-story and basement Italianate style row houses designed in 1870-71 by architect Frederick S. Barus for speculative developers J. & G. Ruddell (NB 738-70) and one of an adjacent row of neo-Grec style houses designed in 1880 by architect S. Murphy for owner Mary Murphy (NB 465-80). In 1948, 144-146 East 65th Street was referred to in the *New York Times* as "one of the finest town houses on the East Side." The building, which until then had remained under the ownership of the Iselin family, was sold that same year.

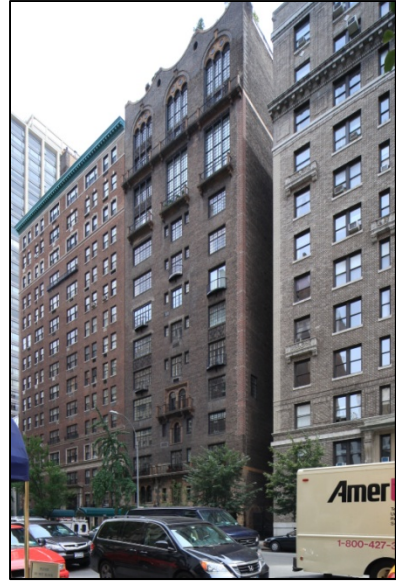
History: The apartment building at 158-162 East 72nd Street, frequently listed under its residential address 160 East 72nd Street, was designed by Taylor & Levi in 1927 and was completed in 1928 at a projected cost of \$400,000. It was erected for the Arezzo Realty Company, Inc. in conjunction with the Rhoades-Kennedy Security Corporation and replaced three single-family dwellings that had been erected in the late 1870s or early 1880s as part of a larger row at 150 to 160 East 72nd Street during the first major period of development on the Upper East Side.

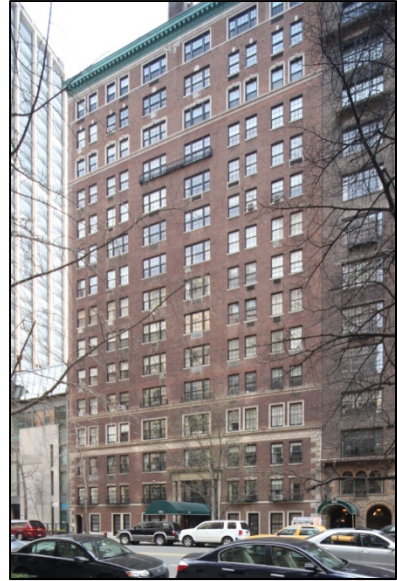
History: The apartment building at 164-172 East 72nd Street, frequently listed under its residential address 164 East 72nd Street, was designed by the firm of Rouse & Goldstone and was completed in 1925 at a projected cost of \$700,000. It was erected for a holding company related to the prominent real estate firm of Brown, Wheelock: Harris, Vought & Co, Inc. and replaced five houses, likely part of at least two distinct rows that had been erected in the late 1870s or early 1880s during the first major period of development on the Upper East Side.

Description: 15-story Colonial Revival style apartment building with one visible primary facade and one partially-visible side elevation. East 72nd Street Facade: Tripartite composition consisting of a three-story base, nine-story shaft, and three-story capital, all clad in red brick laid in common bond; elevation is divided vertically into six bays in an “AABBAA” pattern; three-story base has slightly projecting limestone watertable and rusticated limestone quoins at the building’s corners; main residential entrance is in right-middle bay and has a two-story limestone enframing consisting of an entablature—which has an architrave decorated with ovals, a plain frieze with paired triglyphs and topped with an egg-and-dart molding, and a molded cornice with shallow mutule—supported by pairs of narrow engaged fluted columns with foliate capitals; entrance opening is fitted with a pair of multi-paned glazed wood doors with flanking sidelights; left bay at ground floor contains a small service entrance with molded limestone enframing at left and a rectangular window opening with molded limestone enframing at right; second-from-left bay at ground floor contains a small multi-paned glazed entrance door at left and a rectangular window

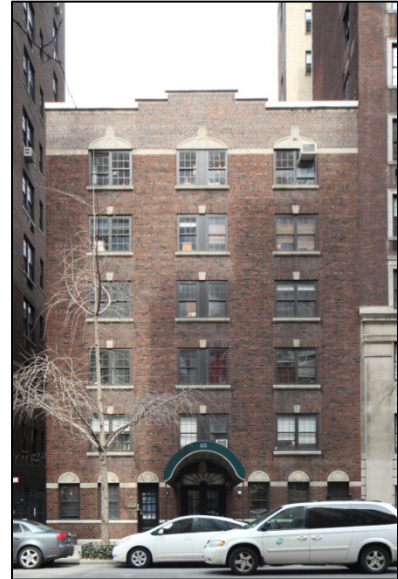
Date of Construction: 1934 (NB 48-34)
Architect: Schwartz & Gross
Original Owner: 115 East 72nd Street, Inc.
Type: Apartment Building
Style: Colonial Revival
Stories: Six
Material: Brick with cast-stone

History: The apartment building at 113-115 East 72nd Street, frequently listed under its residential address 115 East 72nd Street, was designed by the firm of Schwartz & Gross in 1934 and was completed in 1934 at a projected cost of \$100,000. It replaced a pair of row houses—originally part of larger row at 111 to 123 East 72nd Street—that had been erected in 1879 during the first major period of development on the Upper East Side. The building’s original owner of record, 115 East 72nd Street, Inc., was headed by Jourmire Silverman—a little-known real estate agent who had begun developing apartment buildings throughout Midtown and Upper Manhattan at least as early as the mid 1920s.

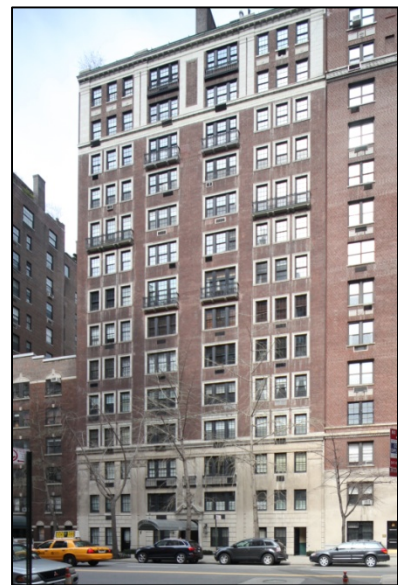
History: The apartment building at 117-123 East 72nd Street, frequently listed under its residential address 117 East 72nd Street, was designed by the architecture firm of Kenneth Murchison and was completed in 1928 at a projected cost of \$850,000. It was commissioned by a holding company apparently associated with the Rhoades-Kennedy Security Corporation and replaced a set of four row houses—originally part of larger row at 111 to 123 East 72nd Street—that had been erected in 1879 during the first major period of development on the Upper East Side.

railings located in sidewalk in front of building; standpipe located between the left-hand “A” and “B” sections. Alterations: Cloth sidewalk awning installed above primary entrance; several holes for through-wall air-conditioning units punched through facade; all windows replaced.

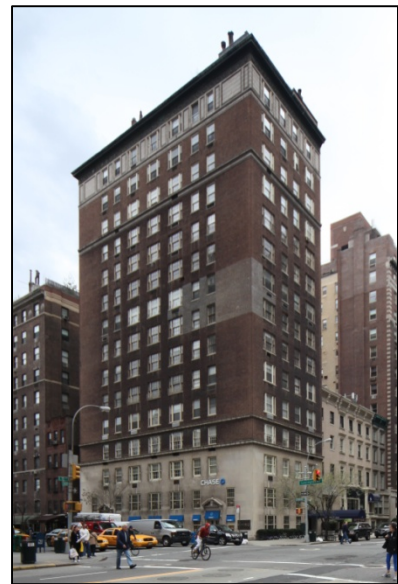
History: The apartment building at 141 East 72nd Street was designed by the noted architecture firm of Rouse & Goldstone and was completed in 1923 at a projected cost of \$480,000. It was commissioned by a holding company associated with a prominent cooperative apartment construction firm, and replaced a synagogue that had been erected in 1886-87 for Congregation Beth Israel (NB 377-86).

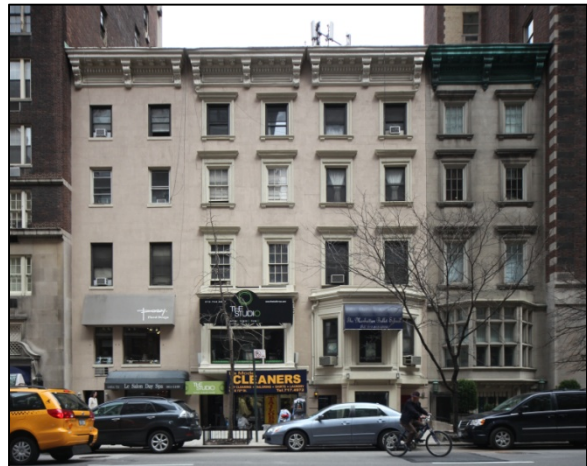
History: This row of four neo-Grec style brownstone dwellings was built in 1881-82 for developer Henry J. Chapin during the building boom that followed the city's recovery from the Panic of 1873. It is likely that each of the dwellings was initially occupied by an individual family, often with a number of live-in servants—a fact borne out in census records from 20 years later in 1900. It also appears that the early ownership patterns varied from property to property; some were rented out from the beginning as a source of income, while others were owner-occupied for several decades by the same family.

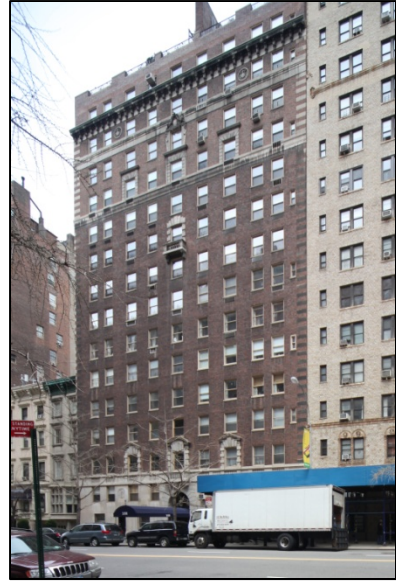
Description: 15-story Renaissance Revival style apartment building with one visible primary facade, one partially-visible side elevation, and one partially-visible rear facade. East 72nd Street Facade: Tripartite composition consisting of a two-story base clad in limestone, a nine-story red brick shaft, and a four-story red brick capital with limestone ornament; brick is laid in Flemish bond; elevation is divided vertically into nine bays and is generally symmetrical about the central fifth bay; the first and second, and the eighth and ninth bays are grouped more closely together, while the remaining bays are regularly spaced across the facade; the limestone cladding of the building's base is laid in smooth ashlar above a low granite watertable; the primary residential entrance is centered under the fifth bay and features a double-height rusticated enframing with radiating voussoirs, quoins, and a keystone with scroll and figurehead ornament; entrance is fitted with multi-pane double doors flanked by multi-pane side lights, with a multi-pane blind transom light and transom bar ornamented with swags and wreaths; an ornamental bronze light fixture hangs from the entrance soffit; in addition to the primary entrance there are seven ground floor openings, four plain rectangular window openings arranged under the first bay, between the third and fourth bays, between the sixth and seventh bays, and between the eighth and ninth bays, as well as three small, unornamented entrance openings arranged between the second and third bays, between the seventh and eighth bays, and to the right of the ninth bay; the left

entrance is fitted with a paneled wood door, the center-right entrance with a replacement metal-and-glass door, and the right entrance with a metal security gate; the window openings on the ground floor are fitted with security grilles; bas-relief panels featuring cornucopia are arranged in the spandrels above the second and third ground floor window openings; the second story contains simple rectangular window openings arranged similarly to the upper floors; bas-relief rondels are located between the window openings in third and fourth, and the eighth and ninth bays on the second story; a pair of projecting limestone beltcourses separates the building's two-story base from its nine-story shaft, with a series of engaged balusters located under each bay of windows; except where noted, the window openings of the upper floors consist of plain rectangular openings punched through the brick facade with simple projecting limestone sills; the window openings in the third and seventh bays on the third story have substantial limestone enframements with triangular pediments, projecting triple keystones, and quoins; the window opening in the central fifth bay on the third story features a similar limestone enframement, with segmental-arched pediment and scrolled and foliate capitals, and is set above a projecting balconette with limestone balustrade; the window opening in the central fifth bay on the tenth story features a limestone enframement with keystone and radiating voussoirs, quoins, and a projecting balconette with balustrade supported by scrolled brackets; the window openings in the third, fifth, and seventh bays on the 12th story feature limestone enframements with projecting molded lintels and flat radiating voussoirs and quoins; the window opening in the central fifth bay on the 13th story features an elaborate limestone enframement with a projecting cartouche supported on molded scrolled brackets; the upper stories feature limestone quoins at the building's corners; smaller bathroom window openings are located to the right of the ninth bay on every other floor starting at the fourth story; a molded limestone beltcourse separates the building's nine-story shaft from its four-story capital, while another beltcourse runs between the 13th and 14th stories; bas-relief limestone roundels are located between the window openings in the second and third, and the seventh and eighth bays on the 14th story; a projecting, bracketed limestone cornice runs above the 14th story; a brick parapet with metal railing caps the building; chimney projects above cornice at center. West Facade: Side facade partially visible from street level; red brick facade with recessed light court clad in buff brick; a single bay of rectangular window openings is located towards the front of the building just in front of a projecting brick chimney; other window openings of various sizes are visible facing onto the light court; the limestone quoins on the primary facade have a slight return on the side facade. North Facade: Rear facade partially visible above adjacent buildings on East 73rd Street; facade clad in buff brick; seven bays of regular rectangular window openings interspersed with three bays of smaller bathroom window openings; metal railing runs along the building's roofline; chimney projects above the roofline at left; a penthouse structure with a round-arched window openings is visible above the roofline. Site Features: Cellar light wells with metal grates located in sidewalk in front of left-most window, to the left of the primary entrance, and at the right side of the building; a bronze standpipe is located in the sidewalk at the right side of the building. Alterations: Several holes for through-wall air-conditioning units punched through the facade; parapet repointed or rebuilt; projecting cloth sidewalk awning installed above primary entrance.

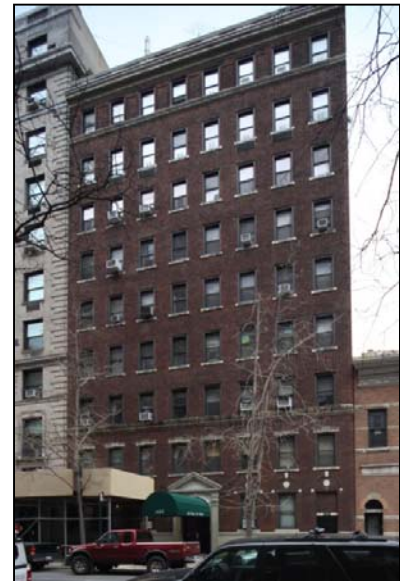
History: The apartment building at 153-157 East 73rd Street, frequently listed as 155 East 73rd Street, was designed by architect George F. Pelham in 1923 for the estate of Henry Goodman and Wolf & Kohn (attorneys). The building, which was projected to cost \$250,000, replaced several older three-story row houses constructed on the site before the turn of the century. Upon completion, the building contained four apartments per story in addition to one penthouse and one basement-level apartment, for a total of 38 residential units. Advertisements appearing in the *New York Times* in the 1940s were specifically targeted to attract would-be “suburban dwellers.” These advertisements lauded the “complete comfort and convenience” of urban living in contrast to “commuting in darkness,” the “drafty trains” and the wartime “rationing” allegedly more acutely felt in the suburbs. In 1988, the building became a cooperative apartment house. Today there are 20 residential units in the building, indicating that some of the original modestly-sized apartments may have been combined into larger units in the intervening years (interior is not part of designation).

Description: Nine-story penthouse and partially-exposed basement Colonial Revival style apartment building with one visible primary elevation and one partially-visible secondary elevation. East 73rd Street Facade: Tripartite vertical composition consisting of two-story brick and limestone base, six-story brick shaft and one-story brick capital; limestone at partially-exposed basement; red tapestry brick laid in a Flemish bond at first through ninth stories; two rectangular window openings at partially-partially-exposed basement; granite base trim serves as sill course for basement fenestration; seven symmetrical bays at first story; single rectangular window openings typical at each bay at first through ninth stories, except where noted; round-arched door opening at central bay at first story serves as primary residential entry and features a molded limestone surround with keystone and is flanked by paneled limestone pilasters with stylized capitals supporting a denticulated triangular pediment; primary residential entry contains recessed double doors raised on one granite step and surmounted by leaded fanlight; flush brick window surrounds at first-story window openings featuring terra-cotta corner details and surmounted by round-arched brick pediments with terra-cotta keystones and tympanums in a stack bond with terra-cotta roundels; flush rectangular masonry sills at first-story fenestration; rectangular service doorway with flush masonry lintel and featuring similar surrounding details as first-story fenestration at seventh bay at first story; eight symmetrical bays at second through ninth stories; single rectangular window openings typical at each bay at second through ninth stories; projecting incised terra-cotta sills, slightly projecting brick window surrounds, and terra-cotta lintels with floral and garland details at second-story fenestration; projecting incised terra-cotta sills and slightly projecting brick window surrounds at third through ninth-story fenestration, except where noted; molded, denticulated terra-cotta cornice serves as sill course for third-story and ninth-story fenestration; brick panels between window openings and flanking ninth story; overhanging molded terra-cotta cornice with dentil and egg-and-dart cornice courses at roofline. East Facade: Secondary elevation, partially visible; divided into two sections; beige brick laid in an English bond at both sections, where visible; flush red brick band above fourth story, where visible; single rectangular window openings with slightly projecting incised masonry lintels typical at each story, where visible; red brick wraps slightly from East 73rd Street elevation; vertical red-brick band at right edge of left section; one central bay at left section; several irregularly-spaced bays at right section, at least one at offset height and one wider-than-typical bay containing paired windows; irregular roofline at right section; masonry coping; penthouse partially visible above roofline. Alterations: Several through-wall holes punched for air-conditioning units at east elevation; all windows replaced; painted limestone base and door surround and fenestration details at first story; awning at primary entry; numbering “155” to left of primary entry; light fixtures flanking primary entry; intercom at reveal of primary entry; door at primary entry; screen door at service doorway; right window at basement closed off; metal screen at left window opening at basement.

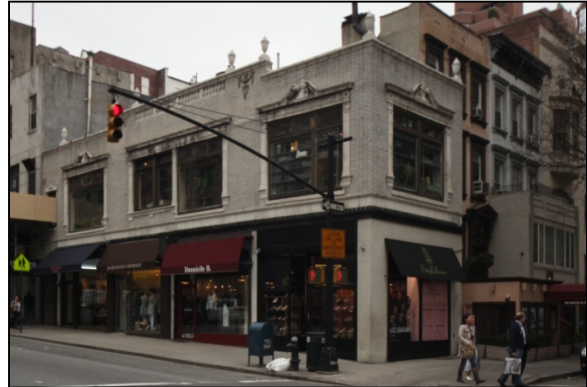
Date of Construction: 1923 (NB 76-23)
Architect: Charles B. Meyers
Original Owner: Berstrum Realty Corporation
Type: Commercial
Style: Colonial Revival
Stories: Two
Material: Brick and terra cotta

History: The commercial building at 142 East 74th Street was designed by architect Charles B. Meyers in 1923 for the Berstrum Realty Corporation. The two-story “taxpayer” was projected to cost \$15,000 and replaced one of a group of 28 Italianate style row houses designed in 1871-75 by architect John G. Prague for speculative builder Warren Beeman (NB 1040-71). Upon completion, 142 East 74th Street contained three stores on the first floor and several offices on the second. At various times, the second-story spaces have also served as club or meeting rooms. The building is most frequently listed as simply 142 East 74th Street, and is sometimes erroneously noted as 1034 Lexington Avenue.

Description: Two-story Colonial Revival style commercial building with two visible primary elevations. Lexington Avenue Facade: White iron-flecked brick laid in a Flemish bond; one slightly recessed bay at far left of elevation at first and second stories; round-arched door opening at recessed bay at first story containing door with arched transom raised on a low step; four storefronts to right of recessed bay at first story (*see Alterations*); possibly historic metal checkerboard panel above fourth storefront at first story (*see Alterations*); molded metal cornice with foliate crest above storefronts (continuous with East 74th Street elevation) (*see Alterations*); terra-cotta entablature featuring small molded terra-cotta cornice above first story (continuous with East 74th Street elevation; only molded cornice continuous at recessed left bay); rectangular window opening at recessed bay at second story featuring geometric terra-cotta lintel with urn detail and slightly projecting incised terra-cotta sill; flush masonry band above window opening at recessed bay at second story; three bays to right of recessed bay at second story; rectangular display windows at outer bays at second story flanked by engaged terra-cotta pilasters supporting an entablature with broken scroll pediment and sculptural urn detail and architrave with floral roundels, and featuring rectangular terra-cotta sills (*see Alterations*); paired rectangular display windows at central bay at second story flanked by engaged terra-cotta pilasters supporting architraves with urn and floral roundel details and a continuous molded terra-cotta cornice; shorter display window at left featuring molded terra-cotta sill on stylized brackets; taller display window at right featuring rectangular terra-cotta sill (*see Alterations*); brick parapet above central bay at second story featuring terra-cotta balustrade and garland and cartouche details; molded terra-cotta cornice at roofline and at parapet; small terra-cotta scroll brackets at parapet; six urn sculptures above cornice (rightmost urn shared with East 74th Street elevation). East 74th

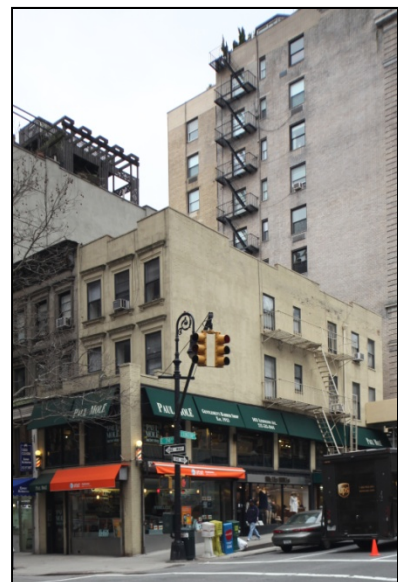
History: The four-story building at 144 East 74th Street was originally constructed in 1871-75 as one of a group of 28 Italianate style homes designed by architect John G. Prague for

speculative builder Warren Beeman. The homes were constructed on the south side of East 74th Street between Madison and Third Avenues and on Lexington Avenue just south of East 74th Street. 120 through 140 East 74th Street, located east of Lexington Avenue, retain many of their original Italianate style details and are part of the Upper East Side Historic District. The address 1031 Lexington Avenue, presently associated with this building, historically referred to a house that stood on Borough of Manhattan Tax Map Block 1408, Lot 53 ¼, later demolished for construction of 1019-1029 Lexington Avenue.

Like the other houses of the group, 144 East 74th Street originally featured a brownstone front, stoop and exposed basement. In 1925-26, the house underwent numerous “modernizing” alterations under the ownership of the Benenson Realty Corporation. Architect S. Cohen was responsible for the alterations, which included a two-story commercial addition along Lexington Avenue, installation of copper and plate glass storefront and office windows at the first and second stories, and installation of a new galvanized iron cornice (since removed). Following the alterations, the upper stories continued to be used for residential purposes. Today, 144 East 74th Street contains four residential units. In 1987-88, the building was renovated under the direction of architect Julius G. Perry, at which time concerns over settling brick and masonry were addressed.

Description); all windows replaced; bracketed cornice removed from Lexington Avenue and East 74th Street elevations at roofline (removed after 1987); all elevations stuccoed and/or painted; awnings at first-story storefronts and second-story display windows at Lexington Avenue and East 74th Street elevations; barbershop pole to left of first storefront at Lexington Avenue elevation at second story; intercom at door reveal at East 74th Street elevation; conduit and electrical boxes at east elevation.

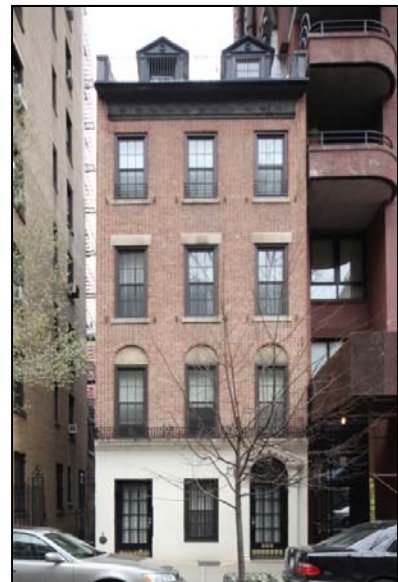
History: This three-story and basement brick-face row house was originally constructed in 1878-79 as one of eight brownstone-front houses designed by architect John B. Snook for speculative developer W.H. Browning (NB 617-78). A fourth story was added in 1906 by owner Alice C. Frazier and architect S.E. Gage. In 1923 the house received a new, more modern Colonial Revival style facade designed by architect Henry S. Lion. Wooden shutters, also added as part of this alteration, were removed at some point after the c. 1939 tax photograph.

Description: Four-story and exposed basement Colonial Revival style single-family house with one visible primary elevation, one visible secondary elevation, and one partially-visible secondary elevation. East 74th Street Facade: Tripartite vertical composition consisting of one-story limestone base, three-story brick shaft, and one-story capital; red brick laid in a stack bond; three bays at base and shaft; rough-cut limestone base trim; rectangular door opening containing recessed door with decorative metal screen door raised on one low granite step at first bay at basement; rectangular window opening at central bay at basement; possibly historic metal window guard at basement window opening; round-arched door opening containing primary entry at third bay at basement flanked by Corinthian pilasters supporting a triangular modillioned pediment and raised on a low granite platform; primary entry contains rectangular door surmounted by leaded fanlight and decorative metal screen doors; circular copper vent and spigot to left of first bay at basement; molded, galvanized iron cornice above base serves as sill course for second-story fenestration and is slightly intersected by pediment of third bay of basement; decorative iron balconette railing above cornice spans width of elevation; single rectangular window openings typical at each bay at shaft; soldier-course base trim at first-story between window openings; flush round-arched brick window surrounds at first-story fenestration featuring slightly recessed limestone pediments with roundel details; incised limestone sills at second- and third-story fenestration; slightly projecting rectangular limestone lintels at second-story fenestration; flush brick soldier-course lintels at third-story fenestration; ornamental S-shaped tie rods flank lintels at second and third stories; overhanging metal cornice featuring dentil course and architrave with triglyphs and floral roundels caps shaft; ornamental iron railing surmounts cornice; two peaked-roof dormers at capital; single rectangular window openings at each dormer; pilasters flank dormer fenestration and support triangular pediments with floral details at tympanums; sloped roof of fourth story not visible from street; brick parapet walls with limestone coping from east and west elevations extend above roofline. West Facade: Secondary elevation; red brick laid in a modified common bond, except where noted; brick from East 74th Street elevation returns slightly, laid in a common bond at basement story; flush brick soldier course from first story of East 74th Street elevation wraps slightly; projecting masonry base trim, continuous to where sidewall of alley stoop from 1033-1041 Lexington Avenue (aka 145-149 East 74th Street) abuts elevation; rectangular window openings with slightly projecting flush sills typical, except where noted; two irregularly-spaced window openings at basement; single taller typical window opening at first story; two off-center window openings at second story (left window shorter than typical); peaked, irregular parapet with masonry coping. East Facade: Secondary elevation, partially visible (where neighboring building recessed from lot line); red brick in a stack bond (same as East 74th Street elevation); no fenestration; horizontal masonry and brick details from East 74th Street return slightly. Site: In-ground metal cellar hatch centered

in front of elevation. Alteration: Present appearance of building dates to a 1906 alteration (ALT 1874-06) (which added a fourth story) and a 1923 alteration (ALT 842-23), which removed the original front of the building and extended it to the lot line; wood shutters added at time of alteration removed after ca. 1939 tax photograph; limestone base painted at East 74th Street elevation; all windows replaced; door at first and third bays at basement at East 74th Street elevation; light fixture at fanlight at third bay at basement at East 74th Street elevation; numbering “151” at left pilaster at third bay at basement at East 74th Street elevation; window guards at third-story fenestration at East 74th Street elevation; window guards at basement at west elevation; conduit at west elevation; repointing at east elevation.

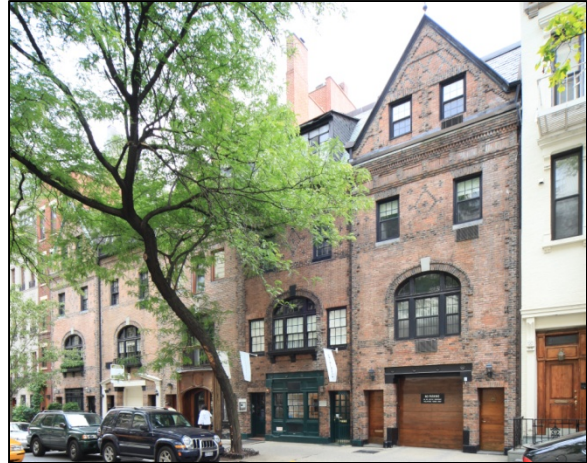
Borough of Manhattan Tax Map Block
1409 Lots 51, 50, 149 (Historic Lot 49
½), 49, 48

Date of Construction: altered 1902 (ALT 107-02)
Architects: Hill & Stout (1902)
Original Owner: Edmund C. Stout (1902)
Type: Row houses; later automobile stables; now
mixed use
Style: Arts and Crafts
Stories: Four
Material: Brick

The five row houses at 168 to 176 East 75th Street were originally constructed in 1880-81 as three-story brownstone-front houses designed by architect B. Muldron for speculative builder Brian McKinney (NB 404-80). The present appearance of the buildings dates to a 1902 alteration by owner Edmund C. Stout who converted the row houses into five four-story “automobile stables” with fronts of Harvard brick. Soon after completion, they were noted in the *New York Times* as the first automobile garages erected for private use in the city. In a 1906 issue of the *Architectural Record*, the buildings were praised for being “straightforward and unpretentious,” and for showing “a minimum expenditure of everything except brains.” Speculatively constructed, the buildings were intended for purchase by wealthy New Yorkers living in nearby mansions who sought private accommodations for their automobiles. Among the earliest owners were horse owner C.G.K. Billings, who owned no. 172, financier and philanthropist George F. Baker, who owned no. 168, and banker Mortimer Schiff, who owned no. 174.

168 East 75th Street Four-story Arts and Crafts style converted garage and residential structure with one visible elevation; rustic red brick laid in a running bond typical, except where noted;

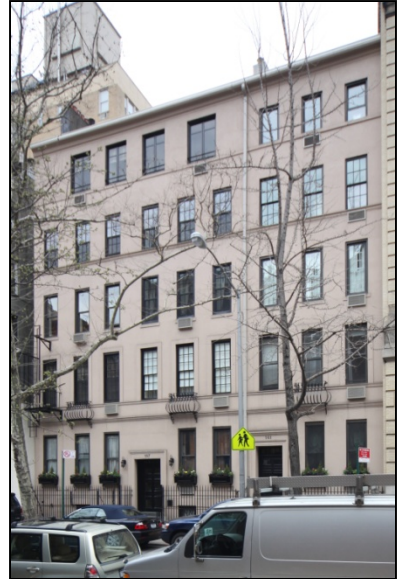
History: The two five-story buildings at 157-159 and 161 East 75th Street were originally constructed in 1881-82 as three of a group of four four-story brownstone-front tenements designed by architect John C. Burne for builder Mrs. S.T. McCoolle. In 1920, a group of builders called the Seventy-Fifth Street Syndicate began buying buildings on both sides of East 75th Street between Lexington and Third Avenues with the intent of “converting the block into a fine residential area.” The syndicate’s first project was to combine the houses at 157 and 159 Lexington Avenue into one cooperative apartment house and to modernize the properties by removing original brownstone detailing and iron cornices, applying tinted stucco to the facade, and adding a fifth story. 161 Lexington Avenue underwent similar changes in 1926 under the direction of architect Harry M. Clawson and owner Harriet Rogers, at which time it became either a single- or two-family home. Upon completion, 157-159 Lexington Avenue contained a total of 10 apartments ranging from seven to 10 rooms. Today there are a total of 12 residential units at no. 157-159, and five residential units at no. 161.

basement; molded lip caps basement and serves as sill course for first-story fenestration; three bays at each section at first through fourth stories; single rectangular window openings typical at each bay at first through fourth stories, except where noted; rectangular door opening with molded masonry surround raised on four-step masonry stoop at left bay at central section at first story; rectangular door opening with molded masonry surround and molded masonry lintel raised on four-step concrete stoop with rounded first riser at left bay at right section at first story; possibly historic window planters supported on metal scroll brackets at first-story fenestration (present in ca. 1939 tax photograph); molded masonry band above first story; simple, projecting masonry window surrounds at second-story fenestration; molded masonry sill course at second story; decorative, bracketed metal balconettes at central window openings at each section at second story; possibly historic nine-over-nine double-hung sashes at window openings of left and central bays at second story; slightly projecting rectangular masonry sills at third-story fenestration; molded masonry sill course at fourth story; two slightly wider rectangular window openings at left and central sections at fifth story (*see Alterations*); three typical window openings at right section at fifth story; masonry sill course at fifth-story fenestration; molded cornice at roofline; drain pipe between second and third bays, intersects banding; brick chimney partially visible above roofline towards left side of elevation. Site: Iron fencing between stoops encloses narrow areaway along length of elevation; iron fencing continuous with handrails at stoops; areaway accessed via below-grade stairways at left and right of elevation. Alterations: Present appearance of building dates to before ca. 1939 tax photograph, including removal of original stoop and alteration of door opening into window at left bay of left section at first story; molded masonry lintel removed from above door opening at left bay at central section after ca. 1939 tax photograph; fenestration pattern at central bay at fifth story altered before ca. 1939 tax photograph, and again at a later date; elevation stuccoed and painted in an peach color; visible portion of brick chimney stuccoed; through-wall holes punched for air-conditioning units throughout elevation; windows replaced, except where noted above; window at left bay at basement closed-off; all doors replaced; window guards at basement fenestration; light fixtures flanking first-story door openings; fire escape at left bay of left section at third and fourth stories dates to after ca. 1939 tax photograph; address plates at first-story door openings; intercoms at first-story door opening reveals; intercom at basement.

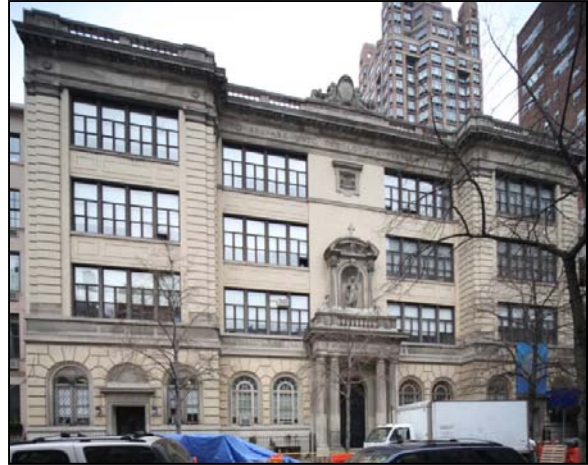
Borough of Manhattan Tax Map Block
1410 Lot 26 (Historic Lots 26, 27, 28, 28 ½,
29 and 30)

Date of Construction: 1925-26 (NB 65-25)
Architect: Robert J. Reiley
Original Owner: Church of St. Jean Baptiste
Type: Religious school
Style: Renaissance Revival
Stories: Four and basement
Material: Limestone

History: The religious school building at 163-173 East 75th Street was designed in 1925-26 by architect Robert J. Reiley for the Church of St. Jean the Baptiste. The school, which was projected to cost \$300,000, replaced five four-story brownstone-front tenements designed in 1881-82 by architect John C. Burn (NB 46-81) and one of an adjacent row of five four-story tenements designed by the same for builder Mrs. S.T. McCool (NB 45-81). In 1920, a group of builders called the Seventy-Fifth Street Syndicate began buying buildings on both sides of East 75th Street between Lexington and Third Avenues with the intent of “converting the block into a fine residential area.” The syndicate announced plans to develop the six lots as a community development reminiscent of Pomander Walk (1921, King & Campbell, 3 through 22 Pomander Walk, et al, a designated New York City Landmark) that would combine the conveniences of apartment life with the privacy of separate dwellings. Although plans were drawn by architects Suarez & Hatton and published in the *New York Times* in 1922, the development was not constructed. In 1923, the Church of St. Jean Baptiste, located on an adjacent site to the rear, purchased the six lots. The cornerstone for the school was laid in the fall of 1925 and its doors opened in 1926.

Description: Four-story and partially-exposed basement Renaissance Revival style school structure with one visible primary elevation and two partially-visible secondary elevations. East 75th Street Facade: Limestone at partially-exposed basement and at base of first story; beige brick laid in an English cross bond above limestone; composed of three symmetrical sections; central section recessed from outer sections. Left Section: Partially exposed basement projects slightly from rest of elevation; two wide rectangular window openings with flush limestone sills at partially-exposed basement containing paired windows and wood frame separated by wood mullion; inset limestone panel at left inscribed with date of construction (“A.D. 1925”) and a cross; rusticated brick at first story; three bays at first story; round-arched window openings featuring brick voussoirs at outer bays at first story; first-story window openings contain paired windows surmounted by fanlights set within a molded limestone window surround with roundel detail at spandrel and limestone Corinthian column between windows; possibly historic four-over-four double-hung sashes at first-story window openings; rectangular door opening at central bay at first story, raised on one limestone step, features molded limestone surround with paneled reveal and soffit and is surmounted by paneled frieze inscribed with the word “BOYS” and a molded denticulated cornice; slightly recessed round-arched limestone pediment with roundel detail above cornice, surrounded by brick voussoirs; door opening contains possibly historic metal-and-glass paneled double doors
