UPPER EAST SIDE HISTORIC DISTRICT EXTENSION Designation Report

March 23, 2010

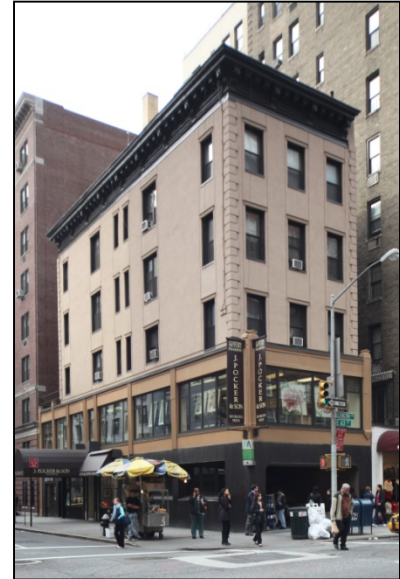
824 Lexington Avenue (aka 127-137 East 63rd Street)
Borough of Manhattan Tax Map Block 1398 Lot 14

Date of Construction: 1872 (NB 130-72)
Architect: Frederick S. Barus
Original Owner: James Cunningham
Type: Tenement; now mixed use
Style: Altered neo-Grec
Stories: Five
Material: Stucco

History: The building at 824 Lexington Avenue was designed by architect Frederick S. Barus in 1872 for builder and contractor James Cunningham. In 1921, a one-story pavilion containing a commercial laundry was added directly north of the structure (NB 56-21). Plans to add a story to the structure and to alter the lower floors of the building into stores and offices were filed with the Department of Buildings in 1916 and again in early 1929, but not completed. In late 1929, Anna Bryan (nee Galbraith), owner of the building since 1902, leased the property to the 824 Lexington Avenue Corporation, which agreed to make many of the previously proposed alterations, including adding commercial spaces to the first and second stories and extending the building to the rear lot line. The first-story of the building was condemned by the City of New York and redesigned in the mid-1980s to provide access to the new below-grade Lexington Avenue/63rd Street station of the “F” subway line, which opened in 1989. In 2006, all of the building’s original masonry surfaces were removed. Soon thereafter, the building underwent a “facade restoration/renovation” by the firm Superstructures Engineers & Architects. All facades of the building were stuccoed and painted as part of this project, which also included the replacement (in whole or in part) of the metal cornice and failing second-story masonry elements, and replacement of doors and windows.

East 63rd Street Facade: First and second stories project slightly from elevation (*see Alterations*) and extend to the west further than third through fifth stories (abutting 125 East 63rd Street); ribbed black metal facing at first story, except where noted; three asymmetrical bays at first story; first bay at first story contains elevator access to below-grade subway station; second bay at first story consists of two large storefront windows and a centered rectangular door opening flanked by fluted pilasters and surmounted by a rectangular masonry panel; door opening contains deeply recessed primary commercial entry raised on one concrete step; rectangular door opening between first and second bays at first story contains primary residential entry with door raised on a low concrete step; third bay at first story consists of two wide rectangular window openings with canted sills containing deeply recessed triple windows; masonry second story features seven asymmetrical bays each containing a rectangular display window with projecting rectangular sill; second-story display windows flanked by fluted pilasters; pilasters flanking narrow fourth bay are continuous with pilasters flanking central-bay door opening at first story; left pilaster at first bay features decorative capital and extends to ground (stylized base at ground); pilaster between first and second bays features decorative capital and corbel; pilaster between third and fourth bays features decorative corbel; pilasters flanking sixth bay abut first-story metal facing; right pilaster at seventh bay features decorative corbel and capital (shared with Lexington Avenue elevation); metal railing at second-story roofline at west of elevation; five symmetrical bays at third through fifth stories; single rectangular window openings with molded masonry lintels and slightly projecting rectangular sills typical at third through fifth-story bays, except where noted; two narrower typical window openings at central bay at third through fifth stories; wider typical window openings containing paired windows at second and fourth bays at third through fifth stories; vertical score marks flank bays at third through fifth stories; masonry quoins flank elevation; same cornice as Lexington Avenue elevation at roofline (continuous with East 63rd Street elevation); portion of brick bulkhead or chimney visible above roofline towards right of elevation.

Lexington Avenue); cornice painted; one-story pavilion at Lexington Avenue painted white; subway signage at East 63rd Street elevation; alarm bell at East 63rd street elevation; awnings at storefront and primary commercial entry at East 63rd Street elevation; awning at one-story pavilion at Lexington Avenue; subway and commercial signage at corner of Lexington Avenue and East 63rd Street elevation; intercom at primary residential entry; light fixture and air-conditioning unit above primary residential entry; oversized pipe vent towards left edge of west elevation; drain pipe towards left edge of west elevation; conduit between first and second bays at west elevation.

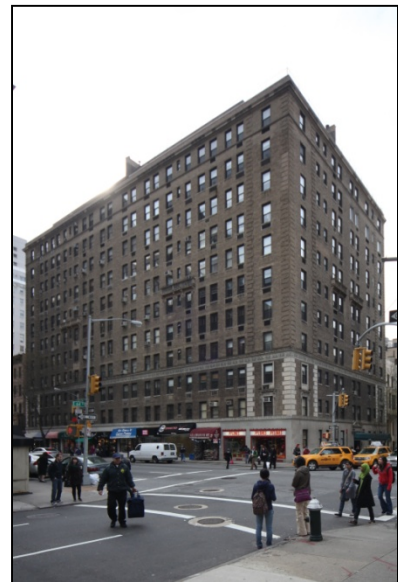
History: The apartment building at 826-842 Lexington Avenue, frequently listed under its residential address 136 East 64th Street, was designed by architect George F. Pelham in 1928 for the Whitecourt Construction Company, headed by Joseph Polstein (c. 1865-1938). The sizable building site was leased from the Beekman Estate, which controlled the lands of the former Beekman farm since 1906. The Beekman farm, comprising the land between Third and Park Avenues, East 62nd and 65th Streets, was subdivided in 1868 into lots of 25 by 100 feet on the basis of 20-year ground leases that stipulated against the construction of multi-family housing. Citing dramatic physical changes in the neighborhood, a suit was brought, and won, which granted an exception for the construction of this building. Upon its completion, the 11-story apartment house, which had a projected cost of \$1.5 million, was notable for being one of the largest residential buildings in the neighborhood.

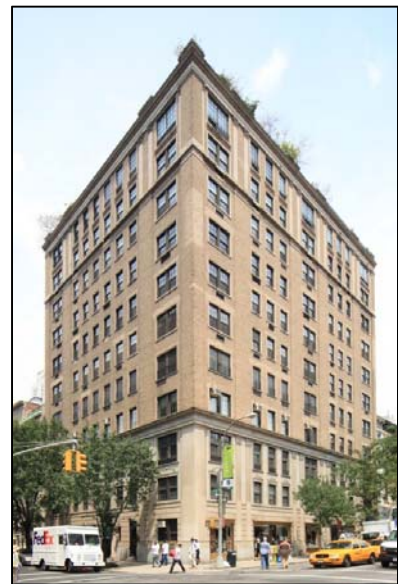
History: The apartment building at 844-854 Lexington Avenue, frequently listed under its residential address 133 East 64th Street, was designed by the architecture firm of Kenneth M. Murchison in 1926 and was completed in 1927 at a projected cost of \$600,000. It was erected by the prominent construction firm Starrett Brothers and replaced a row of six residences along Lexington Avenue and another on East 64th Street that had been built in the late 1870s or early 1880s during the first major period of development on the Upper East Side. These earlier houses had been commissioned by the Beekman family, whose farm—comprising the land between Third and Park Avenue from East 62nd and East 65th Street—was subdivided in 1868 into lots of 25 by 100 feet on the basis of 20-year ground leases that stipulated against the construction of multi-family housing. These restrictions prevented redevelopment of the site, so in 1926 the owners sued for their removal on the grounds that “great, impressive, unexpected, radical and prominent changes have been made in the character of the neighborhood...and in the character and use of the buildings,” making the construction of an apartment house desirable.

bay on East 64th Street facade; metal fence enclosing serviceway installed along East 64th Street to west of building. Alterations: Projecting signage installed in upper left corner of third and fifth storefronts on Lexington Avenue; air-conditioning units installed in transoms above entrances in the second and third storefronts; projecting awning installed above primary residential entrance on East 64th Street; light fixture installed in soffit of smaller right side entrance on East 64th Street; small, flush signage installed on building facade beside both smaller entrances on East 64th Street; building number installed to left of primary residential entrance on East 64th Street; all windows replaced, some brickwork rebuilt, particularly above window openings and at the building's corner; several holes for through-wall air-conditioning units and for apartment exhausts punched through both the Lexington Avenue and East 64th Street facades; some terracotta ornamentation replaced with matching precast concrete.

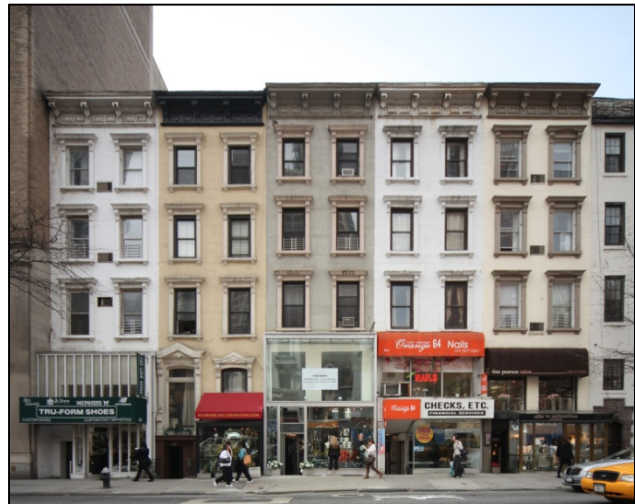
Borough of Manhattan Tax Map
Block 1399 Lots 57, 157 (Historic Lot
57 ½), 58, 59, 159 (Historic Lot 59 ½)

Date of Construction: 1878-79 (NB 697-78)
Architect: A.B. Ogden
Original Owner: William P. and Ambrose M.
Parsons
Type: Row houses; now mixed use
Style: Neo-Grec with alterations
Stories: Four and basement
Material: Brownstone

History: This row of five neo-Grec style brownstone dwellings was built in 1878-79 for developers William P. and Ambrose M. Parsons during the building boom that followed the city's recovery from the Panic of 1873. Census records from 1880 indicate that each of the houses in the row was initially occupied by an individual family, often with a number of live-in servants and the occasional boarder. The early residents of these buildings were employed in a number of different professions—Henry J. Hayne of no. 856, for example, worked as a broker of naval stores, while Joseph A. Dwyer of no. 858 and John J. Reid of 862 were both medical doctors. The ownership patterns of the dwellings varied; some were rented out from the beginning as income-producing properties while others were owner-occupied for several decades by the same family.

Many of the houses in the row were altered during the 1920s and early 1930s as Lexington Avenue became increasingly commercialized following the opening of the subway in 1917. These alterations often involved the removal of the building's tall stoop and the conversion of the basement and parlor floors for commercial use—which sometimes involved the erection of a

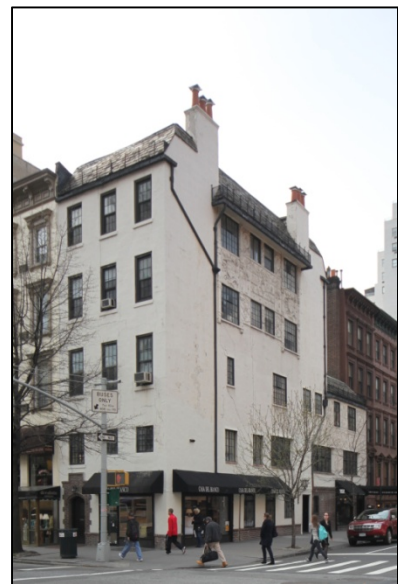
History: This building was originally erected as a four-story and basement neo-Grec style brownstone dwelling in 1878-79 for developers William P. and Ambrose M. Parsons during the building boom the followed the city’s recovery from the Panic of 1873. It was a companion to the row of five houses immediately to the south at 856 to 864 Lexington Avenue, although it was built under a separate new building permit and was three bays wide rather than two. Shortly after its completion the Parsons sold the property to Henry Zeimer, an Austrian immigrant who worked as an importer of artificial flowers. Census records from 1880 indicate the Zeimer family occupied the house as their own dwelling. They maintained possession of the property into the early 1900s.

In 1921 the building was purchased by Frederick J. Sterner, an architect who had pioneered the artistic reconstruction of older row houses. Sterner soon filed plans to completely rehabilitate the building by removing all of the historic detailing and covering the facade with light-colored textured stucco. The general configuration of windows on the Lexington Avenue facade was retained, although Sterner fitted them with multi-pane double-hung windows painted green. The primary entrance, decorated with an enframing of corbelled red brick, was moved to the left bay of what had been the basement level. The window openings on the East 65th Street facade were fitted with steel casement windows on the upper floors and leaded casements on the lower two stories. A secondary entrance to an office space was also added to the side elevation and a three-story extension clad at the ground story with red brick was erected at the rear of the building.

The most striking feature of Sterner's renovation is the wildly ornamented pargetry that covers much of the East 65th Street elevation. The windows of the fourth and fifth floor are completely framed with fanciful Tudor-style details such as vines, coats-of-arms, allegorical animals, roses, and caryatids. The upper floors of the rear extension are also covered with florid pargetry decoration, while a plaque reading "Parge House 1921" is located above the secondary office entrance.

The house remains highly intact from Sterner's rehabilitation. Several commercial storefronts were punched through the ground floor sometime prior to the c. 1940 Division of Taxation's tax photograph, and the windows on the Lexington Avenue facade have been replaced. Otherwise the artistically redesigned stucco facade and pargetry detailing appear largely as they did in 1921.

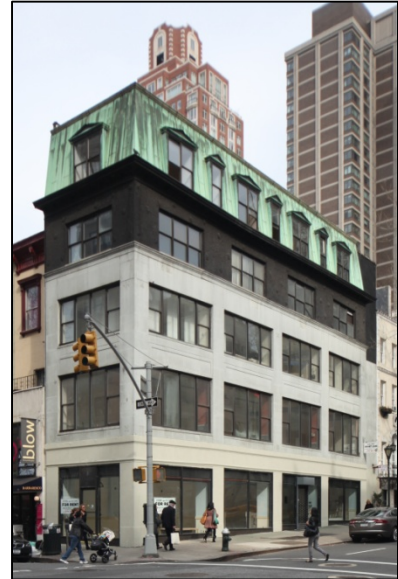
History: 841 Lexington Avenue was designed by the noted architecture firm of Thomas W. Lamb in 1929. It replaced a three-story neo-Grec style townhouse that had been erected in 1880-81 as a part of a row of 12 residences at 841 to 863 Lexington Avenue, most of which are still extant. The building was apparently constructed as a speculative business venture; the *New York Times* reported in 1930 that three of the floors had been leased to Miss Josephine Howell, purveyor of “old wall papers, chintzes and antiques,” with one of the floors to be used as her living quarters. The Department of Building’s Certificate of Occupancy from the same years indicates the ground floor was to contain a store, the second stores and offices, the third office space, and the upper two stories were to have an apartment each.

Description: Five-story simplified Colonial Revival style limestone stores and apartment building with two visible primary facades and two partially-visible side elevations. Lexington Avenue Facade: One bay wide; limestone cladding on lower three floors; ground floor bay features large rectangular storefront opening; simple corbelled cornice above ground floor; second and third floors feature large rectangular window openings with slightly projecting sills, with a recessed spandrel panel set above the second floor; a molded belt course separates the third and fourth floors; fourth floor features a textured stucco surface and a smaller rectangular window opening with plain limestone sill set immediately above the third floor belt course; pressed metal cornice with modillion course above fourth floor; fifth floor features a copper-clad mansard roof and a projecting dormer with pediment; a molded copper cornice tops the mansard roof. East 64th Street Facade: Same as Lexington Avenue facade except where noted; four bays wide with a fifth bay at right recessed back to the line of the adjacent building; each of the four primary bays contains opening similar to those on the Lexington Avenue facade; the recessed fifth bay contains a ground-floor entrance with molded lintel, pilasters, and paneled double doors with transom above; upper floors of fifth bay feature plain rectangular window openings with flush sills, with the first through third floor clad with limestone and the fourth and fifth floors are covered in textured stucco; the return back to the recessed fifth bay contains a plain ground-floor service door; dormers of similar design to Lexington Avenue facade top each of the four primary bays and are interspersed with narrower dormers. North Facade: Side elevation partially visible from street; plain brick wall, parged at fifth floor. East Facade: Small portion of side elevation partially visible from street; plain brick wall with projecting chimney. Site Features: Large metal diamond-plate cellar hatch located

in sidewalk in front of fourth bay, and smaller metal diamond-plate cellar hatch in sidewalk in front of third bay, on East 64th Street facade. Alterations: Storefront infill in ground floor openings replaced; cloth awning installed above entrance in Lexington Avenue facade storefront opening; hardware for awnings installed above ground floor storefront openings in East 64th Street facade; cloth awning installed above, and security camera and intercom unit installed to right of, entrance in recessed fifth bay of East 64th Street facade; several holes for previous signage drilled through limestone on upper floors; small projecting sign with metal anchor installed to right of right-most primary bay on East 64th Street facade; all windows replaced; security grilles installed on second floor window of recessed bay and on one of the fifth floor dormer windows on the East 64th Street facade; ground floor painted.

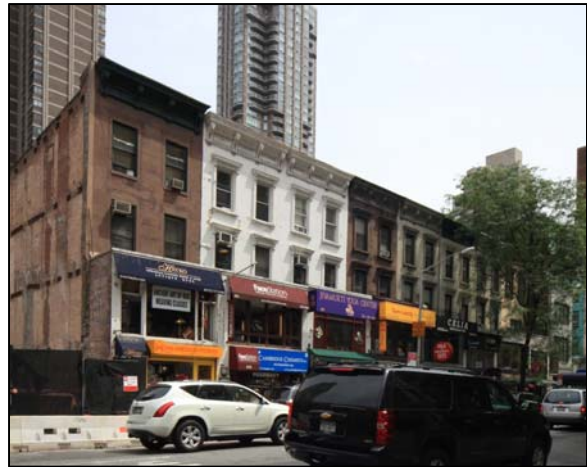
History: This row of neo-Grec style brownstone dwellings was built in 1880-81 for developer John Hodge during the building boom that followed the city's recovery from the Panic of 1873. The row originally consisted of 12 houses, of which eight remain. It is likely that each of the dwellings was initially occupied by an individual family, often with a number of live-in servants and the occasional boarder—a fact borne out in census records from 20 years later in 1900. It also appears that the early ownership patterns varied from property to property; some were rented out from the beginning as a source of income, while others were owner-occupied for several decades by the same family.

Many of the houses in the row were altered during the 1920s and early 1930s as Lexington Avenue became increasingly commercialized following the opening of the subway in 1917. These alterations often involved the removal of the building's tall stoop and the conversion of the basement and parlor floors for commercial use—which sometimes involved the erection of a two-story front extension to the property's lot line. Frequently the upper floors of the dwellings were also partitioned into a number of apartments or non-housekeeping boarding rooms. Most of

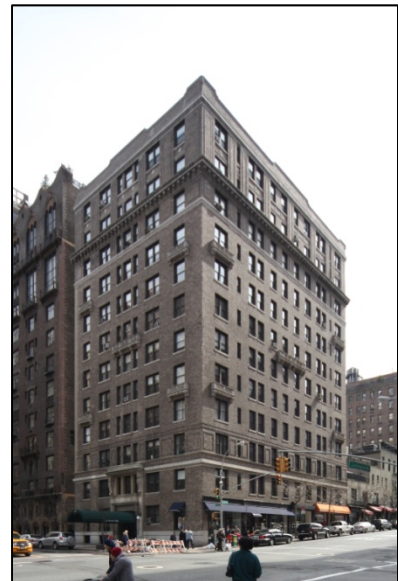
Date of Construction: 1913-14 (NB 323-13)
Architect: Schwartz & Gross
Original Owner: EAL Realty
Type: Apartment Building
Style: Renaissance Revival
Stories: 12
Material: Brick with limestone and terra cotta

History: The apartment building at 993-999 Lexington Avenue, frequently listed under its residential address 150 East 72nd Street, was designed by the noted architecture firm of Schwartz & Gross and was completed in 1914 at a projected cost of \$250,000. It was developed by the firm of prolific real estate promoter Edgar A. Levy and replaced six row houses—four fronting East 72nd Street, two fronting Lexington Avenue—that

had been erected in the late 1870s or early 1880s during the first major period of development on the Upper East Side.

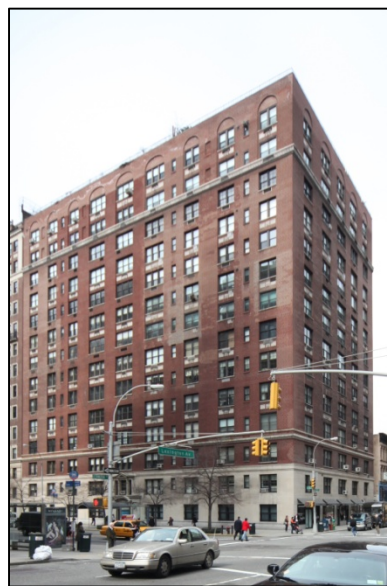
History: The apartment building at 1004-1010 Lexington Avenue, frequently listed under its residential address 125 East 72nd Street, was designed by the architecture firm of Schwartz & Gross and was completed in 1916 at a projected cost of \$700,000. It was erected by the prominent construction company of Julius Tishman & Sons, Inc. and replaced a pair of early residential hotels—the Hotel St. Lorenz (1891-93, NB 1132-91) and Hotel Premier (also known as The Lexington; 1890, NB 1243-90)—that had previously occupied the site.

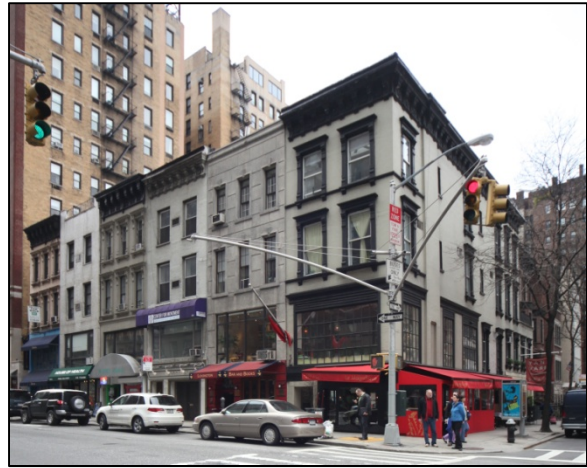
History: This row of six neo-Grec style brownstone and brick dwellings was built in 1880-81 for developer James Judge during the building boom that followed the city’s recovery from the Panic of 1873. It is likely that each of the houses was initially occupied by an individual family, often with a number of live-in servants and the occasional boarder—a fact borne out in census records from 20 years later in 1900. It also appears that the early ownership patterns varied from property to property; some were rented out from the beginning as a source of income, while others were owner-occupied for several decades by the same family.

Many of the houses in the row were altered during the 1920s and early 1930s as Lexington Avenue became increasingly commercialized following the opening of the subway in 1917. These alterations often involved the removal of the building’s tall stoop and the conversion of the basement and parlor floors for commercial use—which sometimes involved the erection of a two-story front extension to the property’s lot line. Frequently the upper floors of the dwellings were also partitioned into a number of apartments or non-housekeeping boarding rooms. Most of these early commercial alterations have undergone further changes and little historic fabric remains at the basement and parlor floors. The upper stories of several of the dwellings remain largely unchanged from the original 1880-81 construction, while others have either had much of the original detail stripped or an entirely new facade installed.

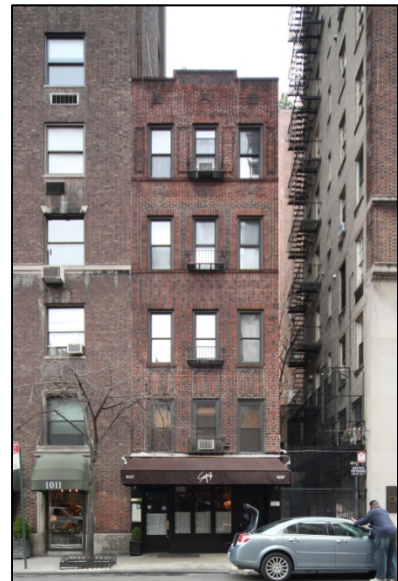
Date of Construction: 1925 (ALT 561-25)
Architect: Henry Z. Harrison (1925)
Original Owner: George J. Gunshar (1925)
Type: Row house; now apartment building
Style: Arts and Crafts
Stories: Five
Material: Brick

History: This building was originally erected in 1879-80 for developer Richard Hennessey during the building boom that followed the city's recovery from the Panic of 1873 (NB 848-79). It was part of a row of six houses at once stood at 1007 to 1017 Lexington Avenue and was initially occupied as a single-family dwelling. The building was largely reconstructed in 1925 when owner George J. Gunshar commissioned a new facade of

patterned brick designed in the Arts and Crafts style by architect Henry Z. Harrison; a street-level storefront and a rear extension were also added at this time and the upper floors converted into non-housekeeping apartments (ALT 561-25). The upper floors remain largely unchanged from this 1920s alteration, while the storefront infill in the ground floor has subsequently been replaced.

Description: Three-bay, five-story Arts and Crafts style brick apartment building with one visible primary facade and one partially-visible side elevation. Lexington Avenue Facade: Ground floor commercial storefront; upper floors feature decoratively-patterned brickwork punctured with rectangular window openings; second floor features window enframing of dark patterned brick; third floor features projecting brick window sills set above spandrels of patterned brick, with a string course of soldier brick serving as a continuous lintel above the window openings; fourth floor features window enframements of red colored brick with decorative square corner panels and a string course of projecting header brick over a course of soldier brick serving as window sills; the fifth floor features a string course of projecting header brick serving as window sills, spandrels with decorative diaper patterning, window lintels of soldier brick, and decorative brick patterning on the piers between window openings; each of the center windows on the upper floors is fitted with a wrought-iron balconette; stepped brick parapet with decorative brick patterning. South Facade: Plain brick facade with three bays of window openings located towards the rear of the building. Site Features: Metal diamond-plate cellar hatch located in sidewalk in front of building. Alterations: Ground floor features a wood paneled storefront with residential entrance to upper floors at right, a set of three display windows at center, and an entrance to the commercial space at right; menu holder installed on pier to left of commercial entrance; light fixtures installed on both piers to either side of ground floor opening; light fixtures with exposed metal conduit installed above the cloth awning on either side of the building; a band of molded wood panels runs above the ground floor opening the width of the building; retractable cloth awning installed above ground floor; all windows replaced.

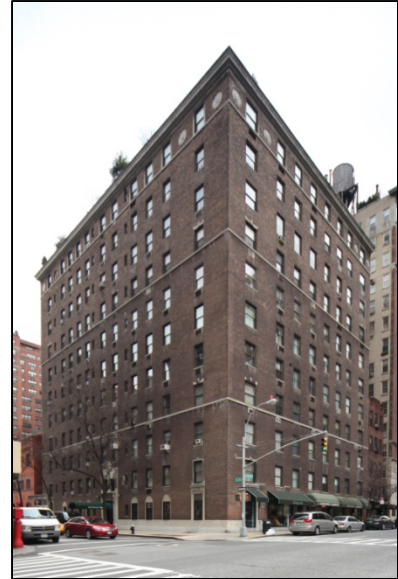
History: The apartment building at 1009-1017 Lexington Avenue, frequently listed under its residential address 150 East 73rd Street, was designed by the noted architecture firm of Cross & Cross and was completed in 1923 at a projected cost of \$750,000. It replaced five row houses fronting Lexington Avenue that had been erected in 1879 during the first major period of development on the Upper East Side, as well as a double-lot stable building facing East 73rd Street.

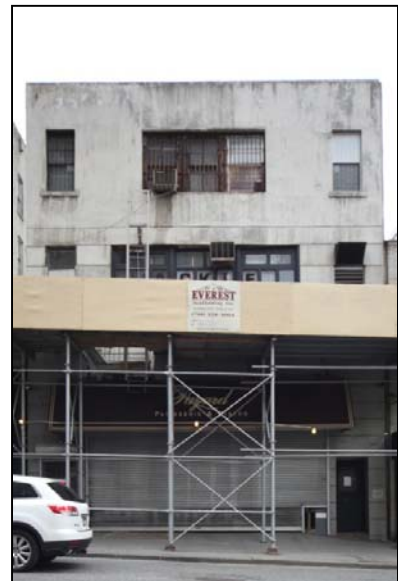
History: The row houses which stood at 1032 and 1034 Lexington Avenue were originally constructed in 1871-75 as part of a group of 28 Italianate style homes designed by architect John G. Prague for speculative builder Warren Beeman (NB 1040-71). The homes were constructed on the south side of East 74th Street between Madison and Third Avenues and on Lexington Avenue just south of East 74th Street. 120 through 140 East 74th Street, located east of Lexington Avenue, retain many of their original Italianate style details and are part of the Upper East Side Historic District. 1032 and 1034 Lexington Avenue underwent numerous alterations beginning as early as 1909, at which time they were converted into garage structures by owner Philip Lewisohn and architect Harry A. Jacobs. In 1927-28, the two separate buildings were combined into one commercial and residential structure under the ownership of E. Guggenheimer. Architect Joseph J. Furman was responsible for the alteration, which included installation of a new facade and new steel display windows. A mansard roof,

present in the c. 1939 tax photograph but since removed, may have also been part of this alteration, which cost a projected \$30,000. The building continues to contain one upper-story residential unit today, in addition to the commercial spaces of the lower stories.

Description: Three-story no style commercial and residential building with one visible primary elevation and two partially-visible secondary elevations. Lexington Avenue Facade: three bays all stories; rusticated masonry at first and second stories; rectangular door openings at outer bays at first story; door at third bay at first story raised on one granite step; wide, recessed storefront at center bay at first story (*see Alterations*); rectangular door opening at right bay at first story; rectangular door openings at outer bays at second story (*see Alterations*); small metal balconette at second bay at second story; wide rectangular window opening containing possibly historic multi-paned triple windows and projecting masonry sill central bay at second story; fire escape at first bay at second story; rectangular window openings with projecting rectangular sills at outer bays at third story; wide rectangular window opening containing triple windows at central bay at third story; possibly historic multi-paned upper sash at first bay at third story. North Facade: secondary elevation, partially visible; solid wall with no visible fenestration; mechanical units visible above roofline towards portion of elevation farthest from Lexington Avenue. South Facade: secondary elevation, partially visible; solid brick wall with no visible fenestration; divided into three sections at third story by recessed light well; irregular roofline. Site: Metal diamond-plate cellar hatch in-ground in front Lexington Avenue elevation. Alterations: Present appearance of building dates mostly to a 1927-28 alteration (ALT 2134-27) (originally two single-family brownstone row houses); molded cornice, mansarded parapet, decorative window surrounds at second-story fenestration, and other architectural elements dating to initial alteration and present in ca. 1939 tax photograph have been removed; fire escape at first bay at second store dates to after ca. 1939 tax photograph (other fire escape appears in ca. 1939 tax photo at central bay of second and third stories, but have been removed); Lexington Avenue elevation painted; north elevation painted and/or stuccoed; south elevation painted; storefront replaced; all windows replaced, except where noted (*see Description*); all doors replaced; door opening at right bay at second story filled-in with louvered vent and surmounted by hooded vent; sign to right of third bay at first story; light fixtures at right and left sides of Lexington Avenue elevation; awning at storefront; gooseneck lighting above awning; window guards at third-story fenestration at central bay.

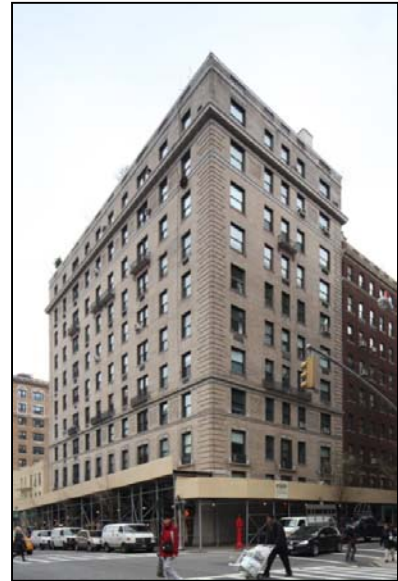
History: The apartment building at 1019-1029 Lexington Avenue, frequently listed under its residential address 145 East 73rd Street, was designed by architect J.E.R. Carpenter in 1924 for the 145 East 73rd Street Corporation. Robert Ferguson, president of the building company and of the related Ferguson Brothers and Robert Ferguson & Sons, was responsible for the construction of numerous five- to seven-story tenement houses throughout Manhattan in the early part of the century, and later, of larger apartment houses. The building, which was projected to cost \$500,000, replaced several older row houses and tenements constructed on the site before the turn of the century, including two of a group of 28 Italianate style row houses erected in 1871-75 by architect John G. Prague for speculative builder Warren Beeman (NB 1040-71). The building was built as a cooperative.

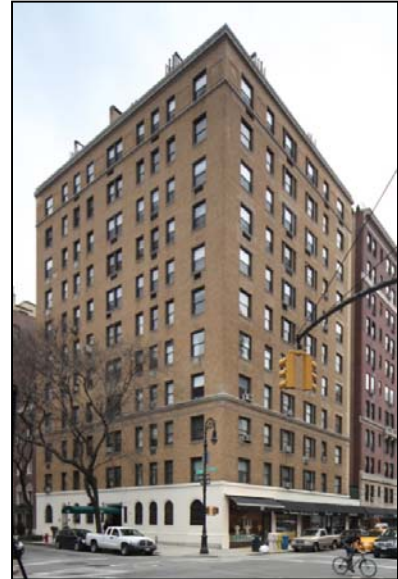
History: The apartment building at 1036-1038 Lexington Avenue, frequently listed under its residential address 135 East 74th Street, was designed by architect George F. Pehlman in 1924 for the Whitecourt Construction Company, headed by Joseph Polstein (c. 1865-1938). The building was projected to cost \$250,000 and replaced five three-story row houses constructed in the late 1870s at 135 to 143 East 74th Street. Early advertisements appearing in the *New York Times* touted the building for the “unusual comfort” of its “fine apartment[s] of ample size, just a step removed from the busy thoroughfare.” Upon completion, the building contained 31 modestly-sized apartments of three or six rooms in addition to stores on the ground floor and a residential penthouse unit. Today there are still 31 residential units in the building.

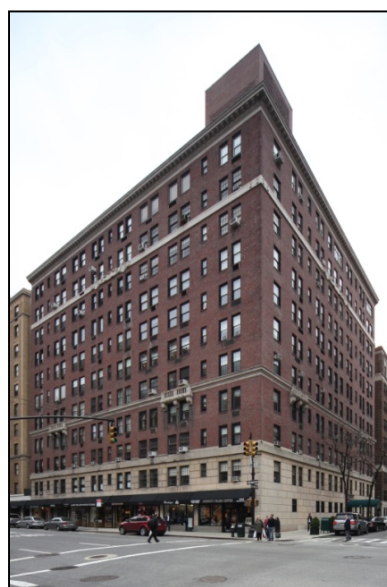
History: The apartment building at 1040-1054 Lexington Avenue, frequently listed under its residential address 130 East 75th Street, was designed by architects Schwartz & Gross in 1928 for the Jatison Construction Company. The building was projected to cost \$900,000 and replaced eight three-story row houses that fronted on Lexington Avenue, including 1040 through 1042 Lexington Avenue (NB 725-77) and 1044 through 1054 Lexington Avenue (NB 328-80). The Beaux Arts Institute at 126 East 75th Street was also among the buildings purchased for assemblage of the 132 x 120 foot site. Formerly known as the Schiff stable, 126 East 75th Street was remodeled in 1915 by the Society of Beaux Arts Architects for use as studio and exhibition space. Numerous strips of land, ranging from three to six inches, were also purchased to make the larger parcels contiguous.

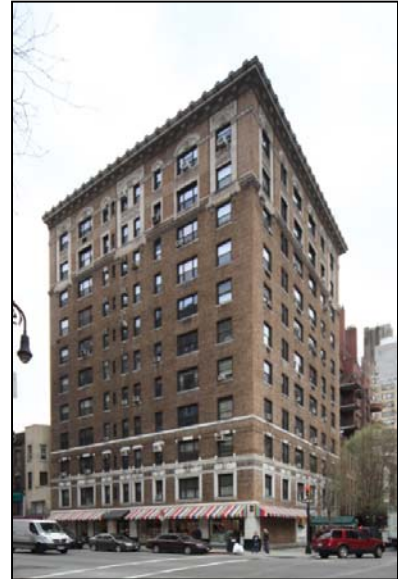
Date of Construction: 1922 (NB 471-22)
Architects: Gronenberg & Leuchtag
Original Owner: Bricken Realty Improvement Corporation
Type: Apartment building
Style: Renaissance Revival
Stories: 11 and penthouse
Material: Brick and masonry

History: The apartment building at 1033-1041 Lexington Avenue, frequently listed under its residential address 145 East 74th Street, was designed by architects Gronenberg & Leuchtag in 1922 for the Bricken Realty Improvement Corporation, headed by Abraham Bricken (c. 1884-1947). The Abraham Bricken Construction Company compiled the plot of 85 feet by 82.6 feet by purchasing five of a group of eight three-story brownstone-front row houses designed in 1878-79 by architect John B. Snook for speculative developer W.H. Browning (NB 617-78). Bricken, a Russian immigrant, is best known as one of the most prolific builders of Manhattan's garment district. Either alone or in association with the Bricken Construction Company (aka Bricken Construction and Improvement Corporation), Bricken is also responsible for the construction of large apartment and office buildings in other parts of the borough, including the 45-story Transportation Building at 225 Broadway, a 14-story residential and office building in the Carnegie Hill Historic District, a 13-story apartment building in the Upper East Side Historic District, and a 17-story apartment building in the Upper West Side/Central Park West Historic District. Bricken also constructed the skyscraper at 26 Court Street in Brooklyn.

Description: 11-story and penthouse Renaissance Revival style apartment building with two visible primary elevations and two partially-visible secondary elevations. Lexington Avenue Facade: Tripartite vertical composition consisting of three-story brick and masonry base, six-story brick shaft, and two-story brick capital with terra-cotta details; textured brown brick laid in a common bond; masonry first story projects forward slightly from rest of elevation; seven symmetrical bays at all stories; recessed storefront at each bay at first story, except where noted; central bay at first story contains primary commercial entry; pilasters between and flanking first-story storefronts raised on paneled granite plinths (rightmost pilaster and plinth shared with East 74th Street elevation); molded masonry coping at projecting first story; single rectangular

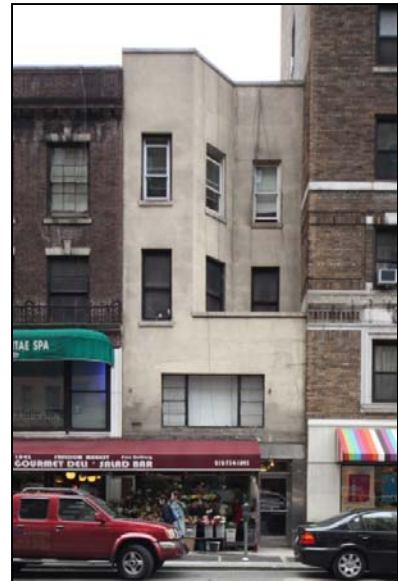
History: This four-story residential and commercial structure was constructed in 1878-79 as one of eight three-story neo-Grec style brownstone-front row houses designed by architect John B. Snook for speculative developer W.H. Browning. The building underwent numerous alterations beginning as early as 1911, at which time it was converted into a mixed-use building containing stores, offices, and bachelor apartments, by owner Henry Meyers and architects Gronenberg & Leushtag. In 1924, architect Louis B. Santangelo was responsible for replacing an existing second-story glass front with a brick wall more consistent with the structure’s present appearance. Later alterations further changed both the interior configuration and exterior appearance of the building (interior is not part of designation). Today the structure contains six residential units in addition to a first-story store.

Description: Four-story altered neo-Grec style row house with first-story commercial alteration; two bays at first story; storefront at left bay at first story (*see Alterations*); rectangular door opening at right bay at first story serves as primary residential entry and contains door surmounted by fixed transom (*see Alterations*); slightly projecting masonry band above first story; one bay at second story featuring a wide rectangular window opening (*see Alterations*); masonry coping at second story at right bay; three bays at third and fourth stories; second bay at third and fourth stories canted 45 degrees to rest of elevation; third bay at third and fourth stories

recessed from rest of elevation; single rectangular window openings with projecting masonry sills typical at each bay at third and fourth stories (*see Alterations*); masonry coping at parapet. Alterations: Present appearance of first- and second-stories is not original to the structure; the general appearance of the first and second stories dates to before the ca. 1939 tax photograph (possibly as early as 1911), but have been altered since that time, including the alteration of three rectangular second-story window openings into the present wide rectangular window opening; other architectural details, including splayed masonry lintels and bracketed cornice at fourth-story roofline, removed after ca. 1939 tax photograph; all windows replaced; entire elevation stuccoed and painted; awning at ground story (continuous with 1045-1047 Lexington Avenue).

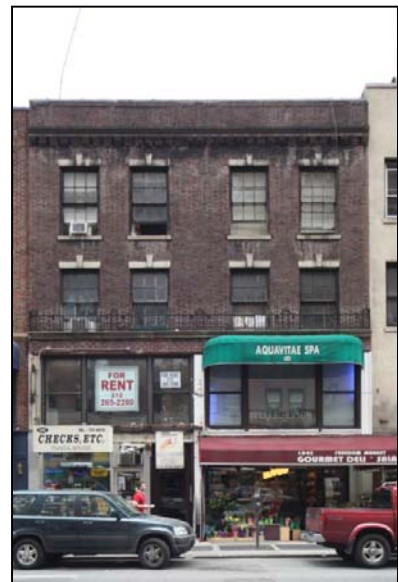
History: The commercial and residential building at 1045-47

Lexington Avenue is the result of the joining of two of six neo-Grec style brownstone-front row houses designed by architect William Picken for developer William H. McCarthy in 1877-78. In 1925, the two separate buildings at 1045 and 1047 Lexington Avenue were combined into one commercial and residential structure under the ownership of Martin Hulberth. Architect Michael Bernstein was responsible for the alteration, which included raising interior beams, installing storefronts and display windows on the first and second stories, and enlarging the building at the rear. The present Colonial Revival style facade and small penthouse unit (not visible from street) probably date to this alteration. Today the building contains a total of nine residential units in addition to first- and second-story commercial spaces.

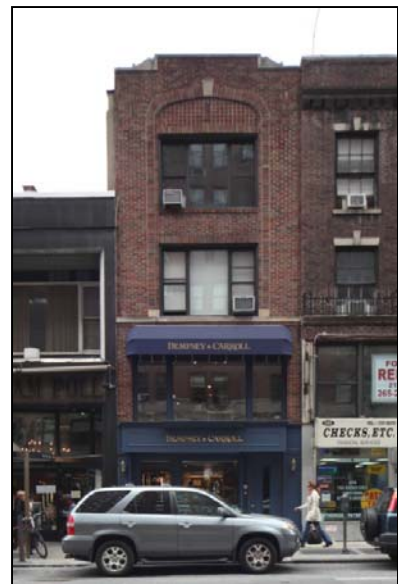
History: This four-story commercial and residential structure was originally constructed in 1877-78 as one of six neo-Grec style brownstone-front row houses designed by architect William Picken for developer William H. McCarthy (NB 692-77). In 1929, the house underwent major alterations under the ownership of the 1049 Lexington Avenue Corporation. Architect Samuel Pelton was responsible for the alterations, which resulted in the present Colonial Revival style facade. As part of this alteration, which cost a projected \$15,000, the building's original stoop, double-height bay window, and original cornice were removed, first- and second-story commercial space introduced, a fourth-story added, and the rear of the structure expanded. Although the new facade is similar in appearance to that of 1053 Lexington Avenue, the two were apparently installed under the direction of different architects. Today 1049 Lexington Avenue contains a store on each of its first and second stories, and a single residential unit spanning its third and fourth stories.

Description: Four-story Colonial Revival style residential building with historic first- and second-story commercial alterations; one visible primary elevation and one partially-visible secondary elevation. Lexington Avenue Facade: Dark red and gray brick laid in a running bond; one bay at each story; storefront with door at first story; rectangular door opening to right of storefront contains primary residential entry and consists of rectangular door surmounted by a fixed transom; rectangular display window at second story; three limestone diamond details inset above second-story fenestration; double-height, flush soldier-course brick window surround, continuous from third and fourth stories, feature flush, square masonry plinth details and culminates in a segmental, slightly pointed rowlock arch with limestone keystone; limestone sill course above a brick header-course band at third story; brick soldier-course lintels at second, third and fourth-story fenestration; slightly projecting brick header-course sill at fourth-story fenestration; brick tympanum laid in a stack bond at fourth-story fenestration; stepped parapet with limestone coping; stylized limestone scroll details flank raised step at parapet; third and fourth stories (including parapet) slightly recessed and framed by flush header-course border. East Facade: Secondary elevation, partially visible; irregular roofline with masonry coping. Alterations: Present appearance of building dates to a ca. 1929 alteration (ALT 1089-29); existing storefront at first story, including paneled pilasters flanking storefront and frieze with store name, date to ca. 2006; all windows replaced; all doors replaced; east elevation appears stuccoed and painted; awning at second story; intercom at door reveal at primary residential entry.

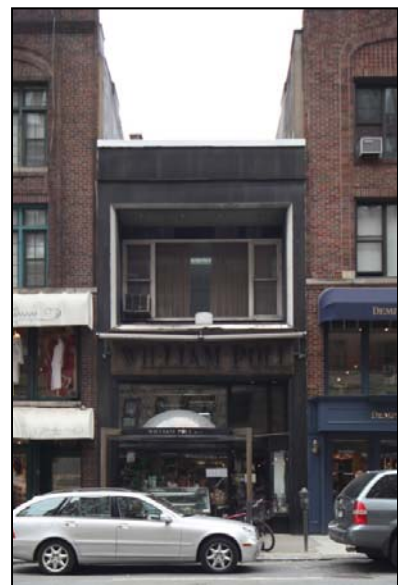
History: The commercial building at 1051 Lexington Avenue was originally designed by architects Schwartz & Gross in 1928 for the Teeson Construction Corporation, Alexander Tishman, president (*see 1040-1054 Lexington Avenue*). The two-story

“taxpayer” replaced one of six neo-Grec style brownstone-front row houses designed by architect William Picken for developer William H. McCarthy in 1877-78 (NB 692-77). In 1945, the building underwent major alterations under the ownership of Ralph T. Schneider. Architect Louis B. Santangelo was responsible for the alterations, which resulted in a new metal facade of Zourite (a heavy gauge aluminum) with Aluminite trim, and which has since been altered. Among the tenants that have taken commercial or office leases at 1051 Lexington Avenue are a private ambulance company, an automobile showroom, a market, and real estate office. William Poll, a gourmet food shop and catering company established in the 1920s, has occupied the first-story commercial space since c. 1959. The business was originated by Poll’s brother as a corner market a few blocks north on Lexington Avenue.

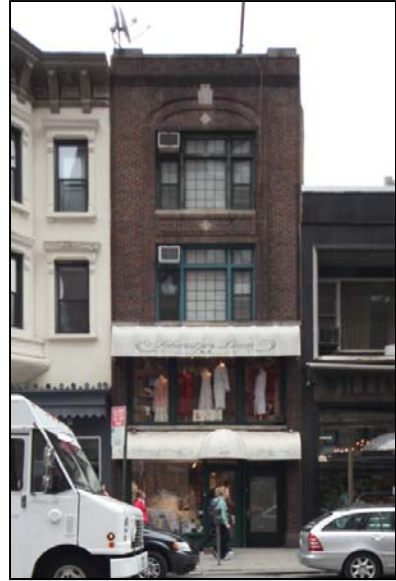
Date of Construction: altered 1928 (ALT 917-28)
Architects: Michael Bernstein (1928)
Original Owner: Ma-Ha Realty Corporation (1928)
Type: Row house; now mixed use
Style: Colonial Revival
Stories: Four
Material: Brick

History: This four-story commercial and residential structure was originally constructed in 1877-78 as one of six neo-Grec style brownstone-front row houses designed by architect William Picken for developer William H. McCarthy (NB 692-77). In 1928, the house underwent major alterations under the ownership of the Ma-Ha Realty Corporation. Architect Michael Bernstein was responsible for the alterations, which resulted in the present Colonial Revival facade. As part of this alteration, which cost a projected \$10,000, the building's original stoop, double-height bay window, and original cornice were removed, first- and second-story commercial space introduced, a fourth-story added, and the rear of the structure expanded. Although the new facade is similar in appearance to that of 1049 Lexington Avenue, the two were apparently installed under the direction of different architects. Today 1053 Lexington Avenue contains a store on each of its first and second stories and a residential unit on each of its third and fourth stories.

Description: Four-story Colonial Revival style residential building with historic first- and second-story commercial alterations; one visible primary elevation and one partially-visible secondary elevation. Lexington Avenue Facade: Dark red and gray brick laid in a common bond; one bay at each story; storefront with door at first story; rectangular door opening to right of storefront contains primary residential entry and consists of recessed door with fixed transom and molded metal frame; limestone trim at either side of storefront; rectangular display window with rectangular limestone lintel at second story; first and second stories slightly recessed and framed by header-course border; wide rectangular window openings containing triple windows with fixed transoms at third and fourth stories; double-height, slightly projecting brick window surround, continuous from third to fourth stories, culminates in a slightly projecting segmental rowlock arch with limestone keystone; limestone lintel course at third-story; brick soldier-course lintel at third-story fenestration; slightly recessed flush limestone sill at fourth-story fenestration; framed brick panel with limestone diamond-detail at center beneath fourth-story fenestration; brick header-course lintel at fourth-story fenestration; brick tympanum with limestone diamond-detail at fourth-story fenestration; brick corbelling above fourth story; brick parapet with masonry coping, taller at outer edges of elevation. West Facade: Secondary elevation, partially visible; irregular roofline; chimney with masonry coping towards rear of elevation (farthest from Lexington Avenue). Alterations: Present appearance of building may date to a 1928 alteration (ALT 917-28); all windows replaced; all doors replaced; masonry trim at Lexington Avenue elevation painted; west elevation appears stuccoed and painted; satellite dish at roofline at

Lexington Avenue elevation; flag pole extends over sidewalk at roofline at Lexington Avenue elevation; mailboxes and intercoms within reveal at primary residential entry.
