## ***DIVISION OVERVIEW***

## ACCOMPLISHMENTS & PLANNED PROJECTS

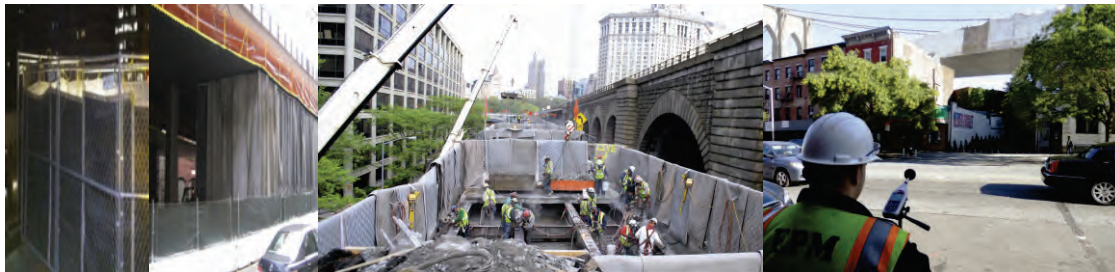
Noise Reduction Along the Sound Pathway – Acoustical Barriers on the Bridge During Night Construction Activities. Acoustical Curtains Along Frankfort Street. Two Crews Work Along Frankfort Street in April 2012. Cranes (On Left) Lift Material In And Out of Walled Enclosures of Sound Blankets. Inspector Taking Noise Measurements.

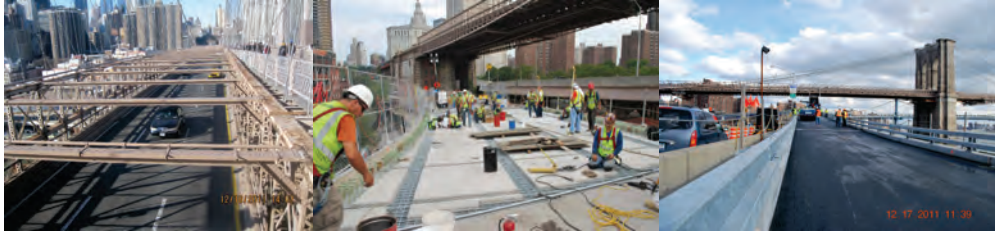
December 2011: Painted Top Struts of the Brooklyn-Bound Manhattan Side Span. Summer 2011: Manhattan Approach - Ramp C Deck Replacement. December 2011: Ramp C.

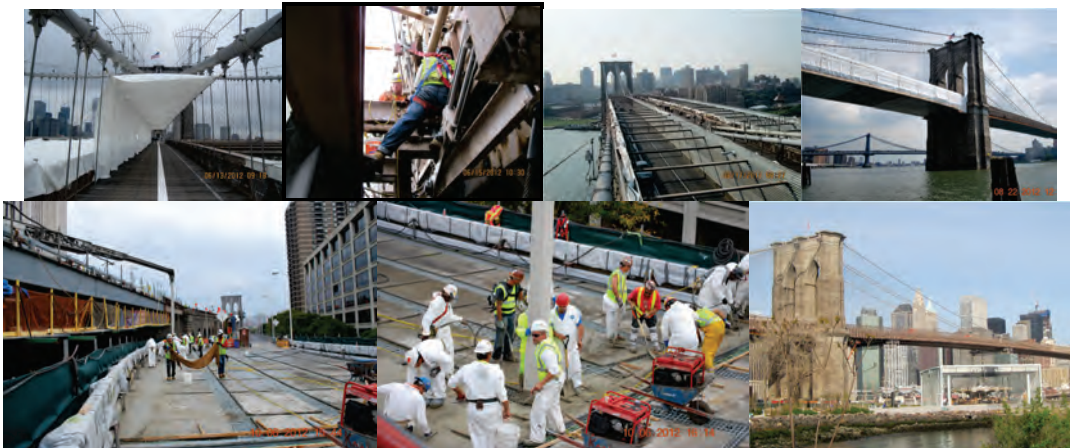
June 2012: Brooklyn Side Span Netting Protection for Main Cable and Suspender Rope Painting. June 2012: Structural Steel Repairs. 2012: Manhattan Main Span Vertical Wall. August 2012: Manhattan Side Span Containment at Manhattan Tower. First Full Roadway Closure: Ramp A Concrete Placement. Second Full Roadway Closure: Brooklyn Approach. December 2012: Brooklyn Main Span in Finish Coat.

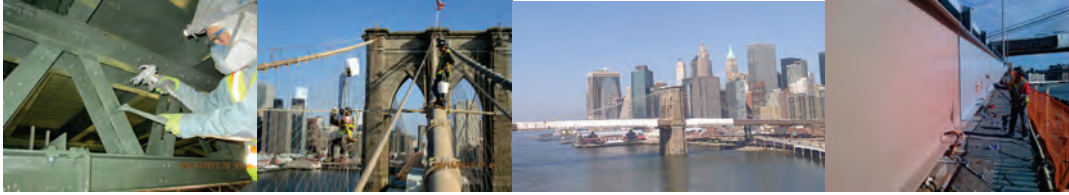
May 2013: Painter Applying Primer Stripe Coat on the Manhattan Main Span. June 2013: Painter on Sway Bracing on the Brooklyn Side Span. (View Credit: Earlene Powell) November 2013: Painting Fascia Steel on Ramp C.

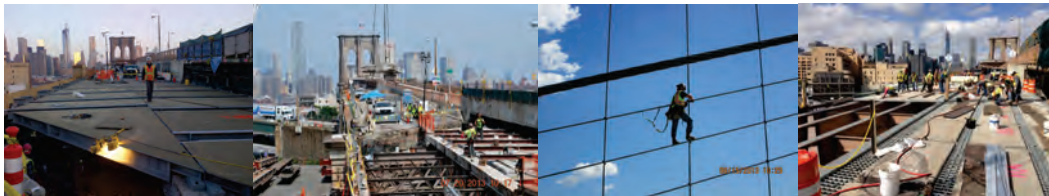
April 2013: Installation of Temporary Deck Units at the York Street Structure Over Brooklyn-Queens Expressway. July 2013: Removal of the Existing Concrete Slab on the Eastbound Main Street Structure. August 2013: Ironworker Replacing Cable Clamp Assemblies on the Suspended Span. October 2013: Grid Deck Panel Installation at the Eastbound Park Row Structure.

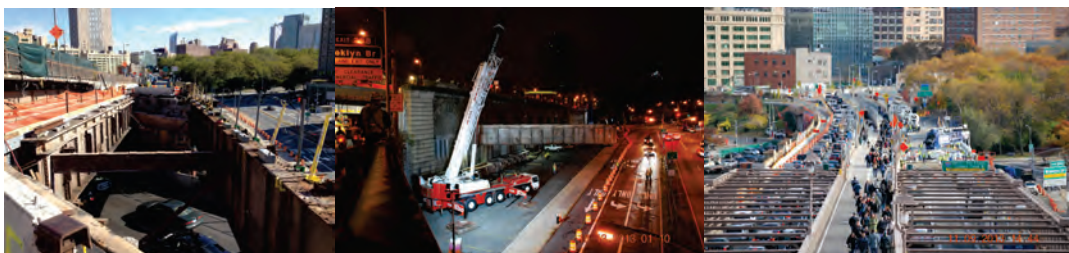
October 2013: Eastbound Brooklyn-Queens Expressway Traffic Flowing Under the Exposed Steel of the Eastbound York Street Structure. Removing the Fascia Steel From the Eastbound York Street Structure. November 2013: Concrete Placement at the Eastbound York Street Structure.

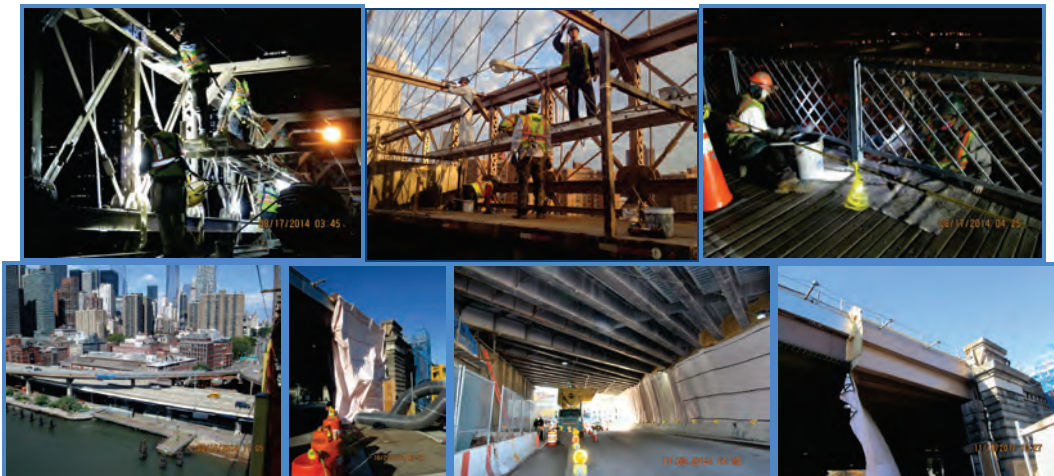
August 2014: Main Bridge Touch-Up Painting, and Painting Manhattan Main Span Promenade Railing.  
August 2014: Painted Manhattan Ramps. October and November 2014: Blasting and Painting – Brooklyn Approach Structures.

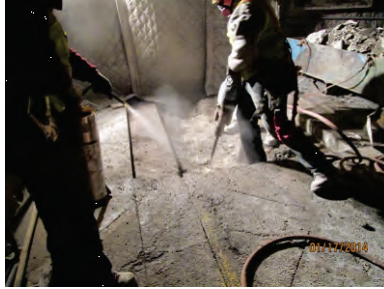
Respirable Dust & Airborne Silica Monitoring.

In response to residents' concerns about airborne silica, a type of dust that is emitted during concrete demolition operations, the project team conducted a series of tests to monitor the levels of this substance in the air in January 2014. In addition to three types of silica, the tests also monitored for general respirable dust. Monitors were placed in four locations near concrete demolition operations occurring at the Main Street and York Street structures on the Brooklyn approach. Two monitors were placed within 50 feet of the construction activities themselves, one was placed at ground level north of the activity, and another placed directly in front of a residential building just south of the work. Analysis was undertaken by the project's environmental experts using procedures established by the Occupational Safety and Health Administration (OSHA) and the National Institute for Occupational Safety & Health (NIOSH). All results were well below the permissible exposure levels as established by the NYS Department of Labor Public Employee Safety and Health and threshold limit values established by the American Conference of Governmental Industrial Hygienists.

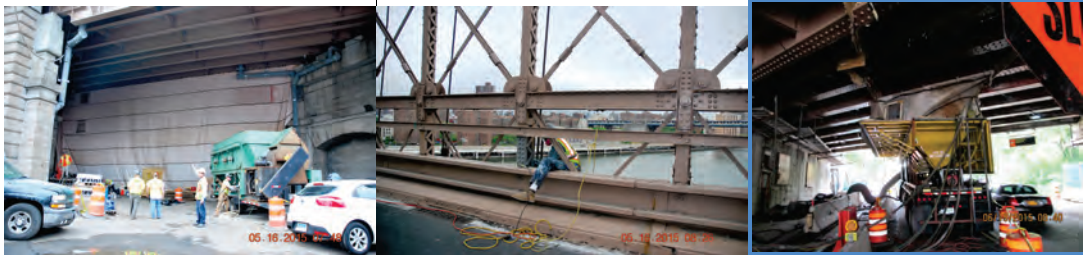
May 2015: Class 1A Abrasive Blast Containment System for the Main Street Structure Promenade Steel. Power-Tool Cleaning on Steel Repairs at the Suspended Spans. June 2015: Brooklyn Approach Structures.

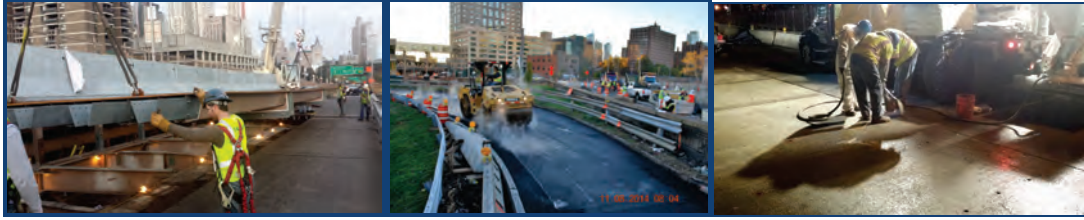
September 2014: Franklin Square Structure – New Orthotropic Deck. November 2014: Manhattan-Bound Brooklyn Approach Paving. December 2014: Super Slab Installation in Manhattan-Bound Lanes.

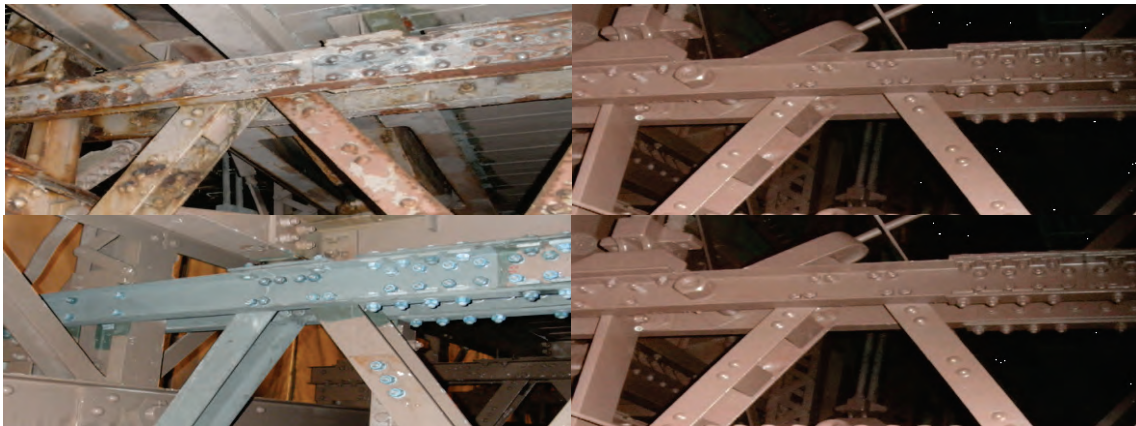
Steel Repair Process: Although Deteriorated Steel is Often Apparent Right Away, Many More Instances are Encountered Only After Removing the Paint. In Some Cases the Location of Deterioration is Painted Along With the Healthy Steel and its Location is Documented for Later Repair. Iron Workers Then Return to Those Locations and Replace the Deteriorated Sections With New Steel. The New Steel is Then Painted Over Again for the Final Protective Coating.

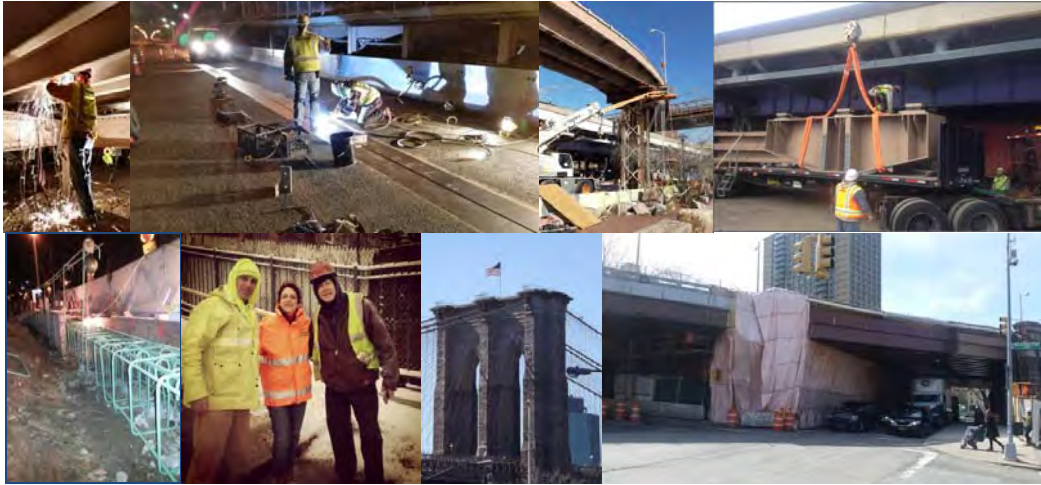
January 2015: Welding on the Bridge above Pearl Street (Franklin Square Structure). Replacing the First Column Supporting the Exit Ramp From the Northbound FDR Drive. Ramp C Steel Column Erection. Cast-in-Place Concrete Barrier Installation. Commissioner Polly Trottenberg Visited the Summit Street Pedestrian Overpass to Thank Division Staff for Clearing the Snow and De-icing the Walkway. March 2015: New Flag. April 2015: Containment System at Prospect Street.

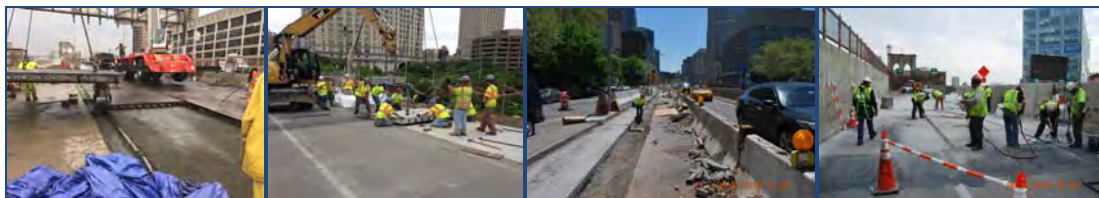
May 2015: Manhattan-Bound Approach SuperSlabs. New Curb Mall and Barrier on Adams Street Access Road. Brooklyn Approach Concrete Headers.

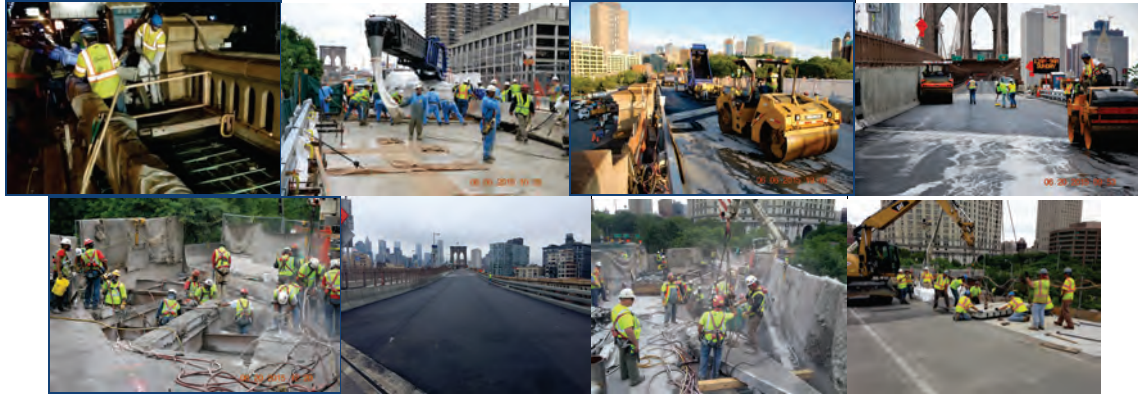
May 2015: Brooklyn Arch Blocks Steel-Faced Curb. June 2015: Division Quality Assurance Personnel Observe Closure Pour Concrete Placement at Westbound Park Row Structure. Asphalt Paving of Brooklyn Approach. Division Quality Assurance Personnel Observe Testing on the Newly-Applied Asphalt Overlay at the Westbound Brooklyn Approach. Manhattan-Bound Approach North Cantilever. Paving of the Manhattan-Bound Brooklyn Approach, Demolition at Ramp D in Manhattan, and Super Slab Installation During the Full Weekend Closure in June.

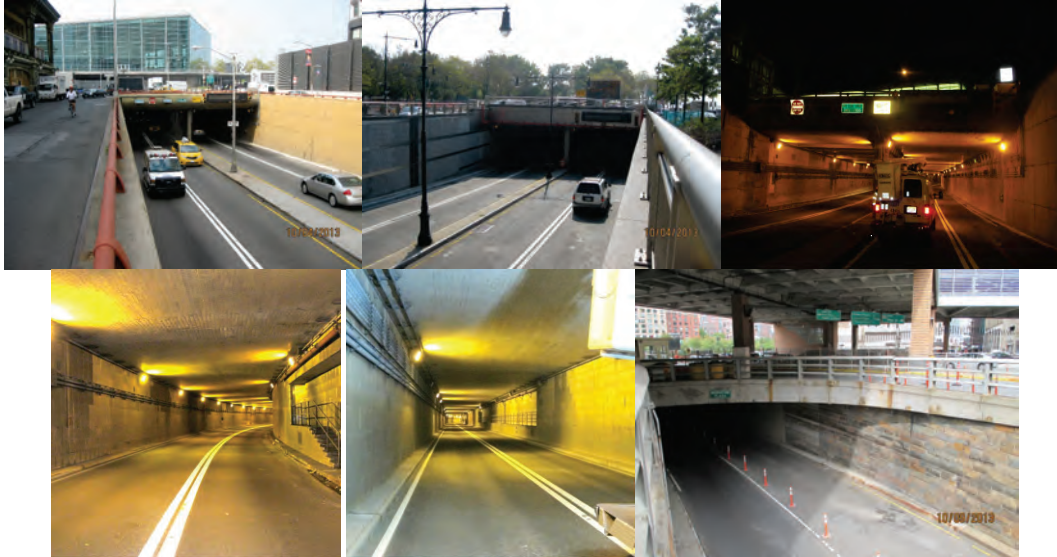
October 2013 – Battery Park Underpass – Elevation Right Span 1 and Left Span 1. (Credit: NYSDOT) September 2013 - Span 2 Looking Westbound (FDR Drive to West Street). June 2014 – The Underside of the Tunnel is Completely Covered With Tiles. October 2013 - West Street Underpass - Elevation Right Span. (Credit: NYSDOT)

On October 29, 2012, the New York Metropolitan area was impacted by Hurricane Sandy, causing flooding, loss of power and damage to many components of New York City's infrastructure. On October 30, 2012, a site inspection by the Department revealed major damage to both underpasses. Specifically, certain electrical, mechanical and structural issues with regard to the tunnels had to be addressed.

Salt water penetrated the electrical and mechanical equipment in both underpasses, including but not limited to, motors, lighting and pumps. It is therefore, necessary to solicit the services of a specialty contractor to perform all necessary repairs.

A Letter of Intent for the emergency repairs of these underpasses was issued to the contractor with a start date of February 17, 2015. The scope of work includes replacement of all of the exhaust fans, motors, sump pumps, traffic signals/VMS, heating and ventilation units, fire and CO monitoring control systems, and the street lighting and emergency response systems. The project will be constructed in four phases and was already in the second phase in Fall 2015. The scope of work also includes providing temporary fan control systems to operate based on CO levels, install permanent CO monitoring system and sump pumps and tunnel lighting at the West Street Underpass. Construction is expected to be complete in January 2018.

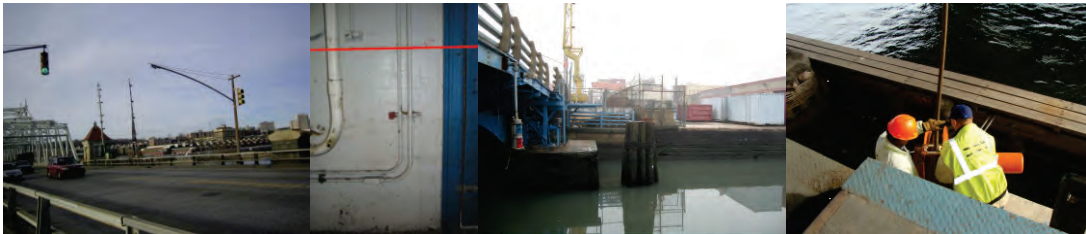
Inspection in Late 2012: East End of the West 207<sup>th</sup> Street Bridge - Missing Traffic Signal was Knocked Down by the Hurricane Winds. Borden Avenue Bridge Operator's House Basement Level - Depicted Flood Line was Approximately 5 Feet Above the Floor. Third Street Bridge - Northwest Channel Light Missing. Ninth Street Bridge - Manually Pulling the Cable Reel Because the Motor Failed.

The West 207<sup>th</sup> Street (University Heights) Bridge over the Harlem River is located between Manhattan and the Bronx and is a rim-bearing swing bridge that carries four lanes of vehicular traffic and two sidewalks. The bridge opens approximately 23 times per year. The bridge was subject to an extreme surge tide and the center pivot pier and fender were subject to flooding. The traffic signal assembly was subject to high winds and was damaged.

The contractor performed the following work on the Carroll Street Bridge in 2015: installed a new temporary operating system; removed the existing operating machinery from the control house; repaired the deteriorated sections of the existing rail tracks; removed the existing conduits and wiring in control house and pier; and repaired the leaking control house roof.

The contractor performed the following work on the Ninth Street Bridge in 2015: removed the span locks, including the motors, limit switches, brakes, and gear reducers driving the limit switches; and replaced the navigational lights on the fenders along with conduit, junction boxes and wiring.

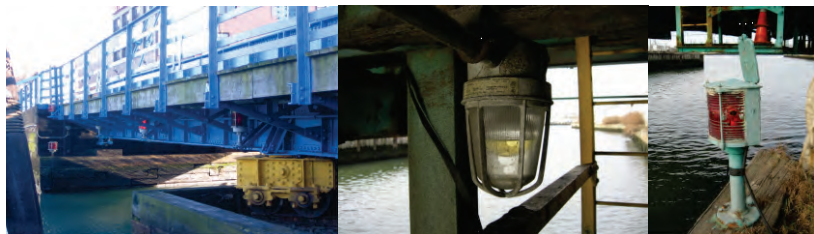
Inspection in Late 2012: Carroll Street Bridge - Navigational Fixtures on North Side of Span - Only the Center Span Fixture was Operational. Grand Street Bridge - Standing Water in the Access Light Fixture at the East Wedge Walkway. Typical Impact Damage to Pier Light.

The contractor performed the following work on the Grand Street Bridge in 2015: cleaned the center pivot and flushed the grease; repaired the southwest sidewalk hatch; and repaired the access platform under the bridge.

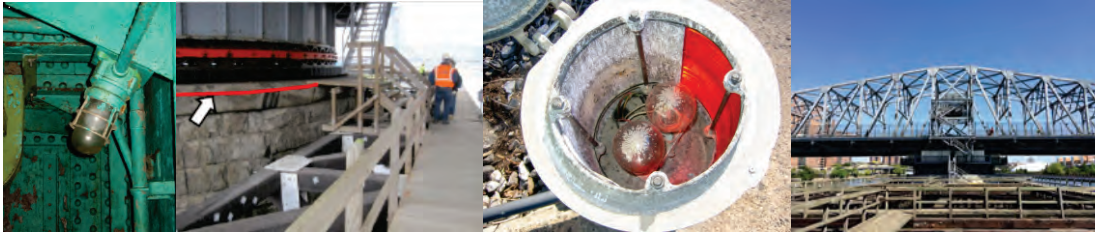
Inspection in Late 2012: Grand Street Bridge – Standing Water in the Access Light Fixture at the East Wedge Walkway. Union Street Bridge – Standing Water in East Span Maintenance Light. Madison Avenue Bridge - General View of Fender and Center Pier—the Red Line Depicts the Approximate Water Level. Macombs Dam Bridge – Pier Lighting Fixture with Cover Removed – Silt Deposit on Lamp Tops, and Corrosion on the Fixture Frame. 145<sup>th</sup> Street Bridge in August 2015. (Credit: Lity Barreto)

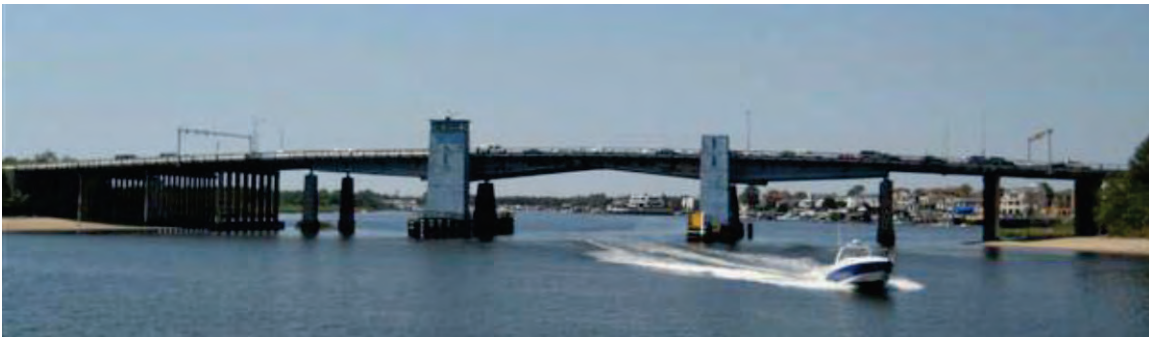
Mill Basin Bridge. (Credit: NYSDOT)

In 2015, on a New York State-mandated scale from 1 to 7, this bridge had a condition rating of 3.209, or "fair." While the bridge is not in any immediate danger of structural failure, its reconstruction is required in order to maintain mobility and public safety on this vital artery.

The existing Mill Basin Bridge is 864-feet long and 14 spans, including double movable leaf bascule spans and a steel superstructure, supported on reinforced concrete pier on timber piles, and abutments supported on pre-cast concrete piles. The existing structure and immediate approaches will be demolished and replaced.

The replacement will be a 2,645-foot long, 17 span, 60-foot high fixed bridge. It will consist of a steel composite superstructure and reinforced concrete substructure on piled footings, and will be constructed on a new alignment set on the north side of the existing bridge and partially overlapping with the existing bridge. The new bridge and approach will have three 12-foot wide traffic lanes, a 12-foot wide right shoulder on the bridge, a 10-foot wide right shoulder on the

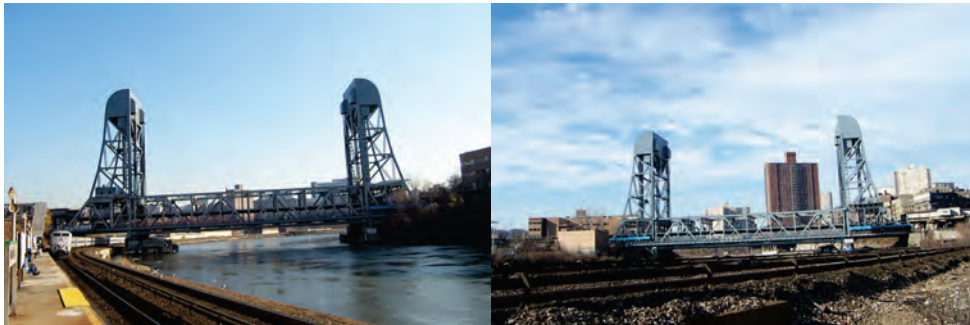
Broadway Bridge – West and East Elevations. (Credit: Bhaskar Gusani)

The vertical lift bridge is the third movable steel structure at this location. The original steam powered single-deck swing span built in 1895 carried only highway and pedestrian traffic. The second structure was built in 1905 to accommodate the extension of IRT subway into the Bronx from Manhattan. The second bridge was again a double deck swing span to carry the subway line on the upper deck and highway traffic on the lower deck. The current structure, a double deck vertical lift bridge to carry the subway and vehicular traffic, was built in 1960.

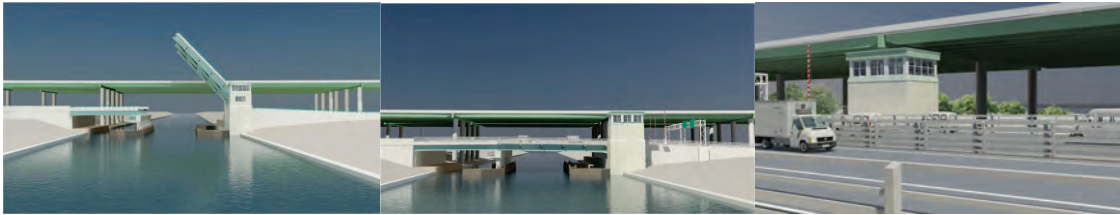
Proposed Twin Single Leaf Bascule (Looking North). Proposed Control House.

The project is in its final design phase for the replacement of the existing bridge with a new wider bridge. The project's scope of work includes: a complete replacement of the bascule, flanking, and approach substructures and superstructures, providing six 12-foot travel lanes with shoulders on both sides of the bridge; a new 12-foot bicycle/pedestrian path and a 8-foot sidewalk, separated from traffic with a barrier; replacement of the existing mechanical and electrical systems for the bascule span; reconstruction of the bridge operator and control houses, and replacement of the existing fender system, drainage system, street lighting, traffic signal facilities, and gates. Construction is anticipated to start in spring 2017.

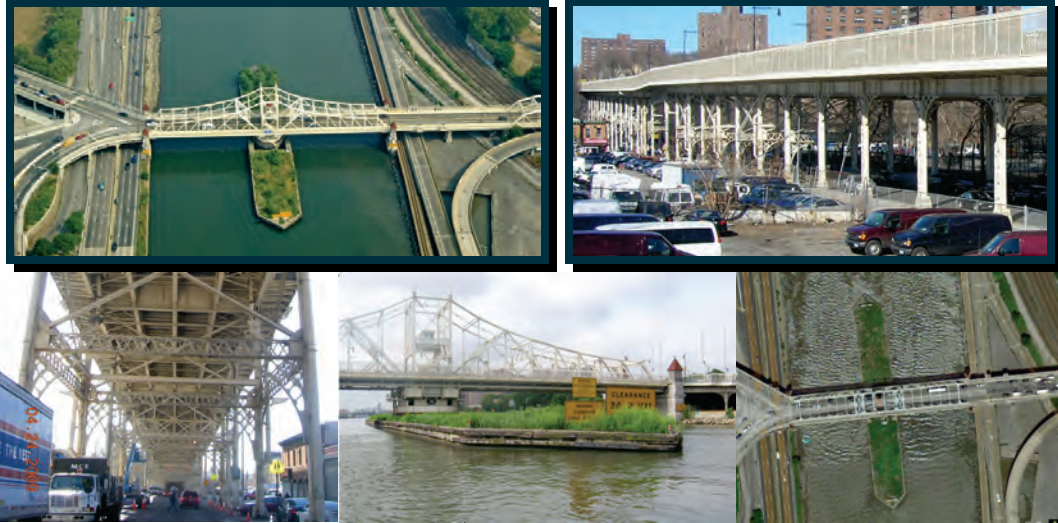
Aerial View. West 155<sup>th</sup> Street Viaduct. The Timber Fender.

A new project will rehabilitate the West 155<sup>th</sup> Street Viaduct and the fender system. The viaduct serves as the western approach to the bridge in Manhattan and provides connections to West 155<sup>th</sup> Street, Macombs Place, and Adam Clayton Powell Jr. Boulevard. The scope of work includes replacement of columns, floorbeams, girder ends, bearings, expansion deck joints above floorbeams, cross frames and lateral bracings, and the ornamental brackets. The existing swing span fender is misaligned with the swing span in open position, and the timber cribbing is under attack by marine borers which could lead to the failure of the timber cribbing and the collapse of the stone fill. The project's scope of work includes installing formwork around the perimeter of the existing fender, filling the voids in the fender sand-cement grout, bonding the existing timber and rock into one solid mass, and constructing a fender extension on the northeast corner. In addition, in connection with the fender repair, the work activities will include removal of debris located on the river bottom in the channels adjacent to the swing spans. A Notice to Proceed for this rehabilitation project was issued to the contractor with a start date of July 27, 2015. The currently expected construction duration is 30 months.

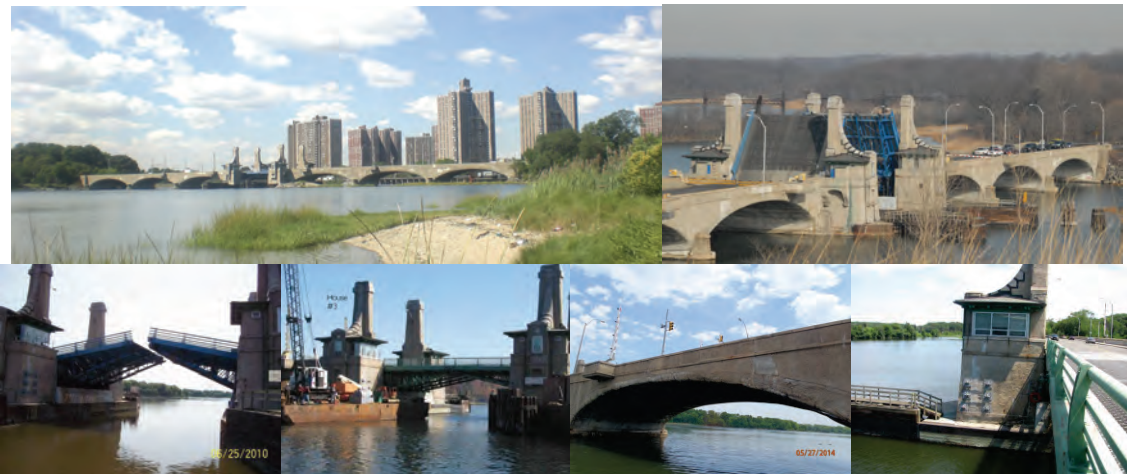
Open Bridge in 2007. (Open Credit: Peter Basich) Bridge Closing in 2010. (Credit: NYSDOT) General View of Bridge Operator House #3 in 2011. 2014 - Span 2 Left Fascia (Credit: NYSDOT) Bridge Operator House Exterior Wall in 2015.

effectively increase the vertical clearance above the navigation channel of the main span. In its closed position, the main span will have a vertical clearance above mean high water of approximately 35 feet. This clearance will accommodate 83% of marine vessels passing beneath. For taller vessels, the bridge will be drawn to its open position providing the required vertical clearance. With a longer main span than the existing structure, the mid-level bridge will offer a widened navigation channel as well as improved lateral clearance to the structure. These improvements are expected to lessen the likelihood of vessel damage to the fender system and the substructure when compared to the existing structure configuration. The increased vertical clearance above the navigation channel would also reduce wear on the bridge's mechanical and electrical components by decreasing the frequency of bascule openings and closings. The scope of work will include a complete replacement of the bascule, flanking and approach spans (superstructures and substructures) with a new widened structure that provides two lanes and standard shoulders in each direction, and a dedicated bike path and pedestrian path. There will be a new control house, new utilities, new machinery and electrical system, new fender system and dolphins, and new street lighting. In 2015, a detailed scope of work for procuring the design services was prepared and a request for proposals will be solicited in 2016. The design is anticipated to begin in early 2017 and the construction is anticipated to begin in 2020. The new bridge is anticipated to be in service in 2025.

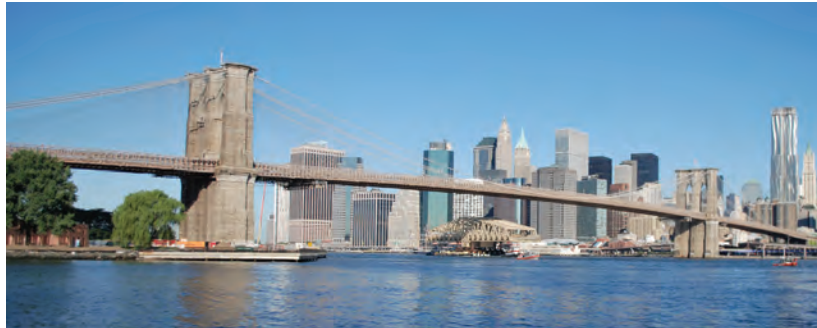
Voyage up the East River on July 26, 2010. New Willis Avenue Bridge Span Passing Under the Brooklyn Bridge. (Credit: Douglas Reese)

The swing span was floated down the river and towed to the bridge site on July 26, 2010. The new swing span was floated on to the new pier on August 9, 2010.

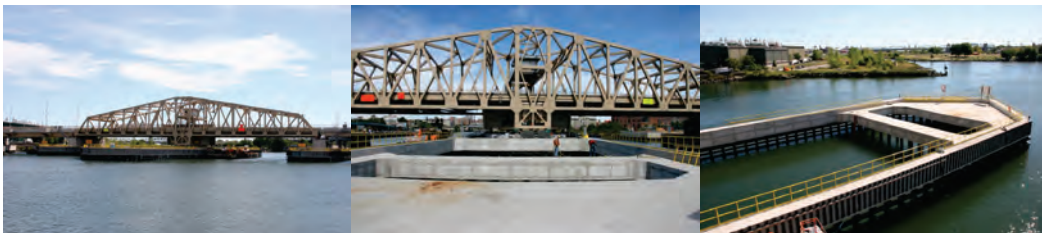
September 2012: Bridge Fender North Elevation Looking South. Bridge South Elevation Looking North.  
Pier 6 South Fender Looking South.

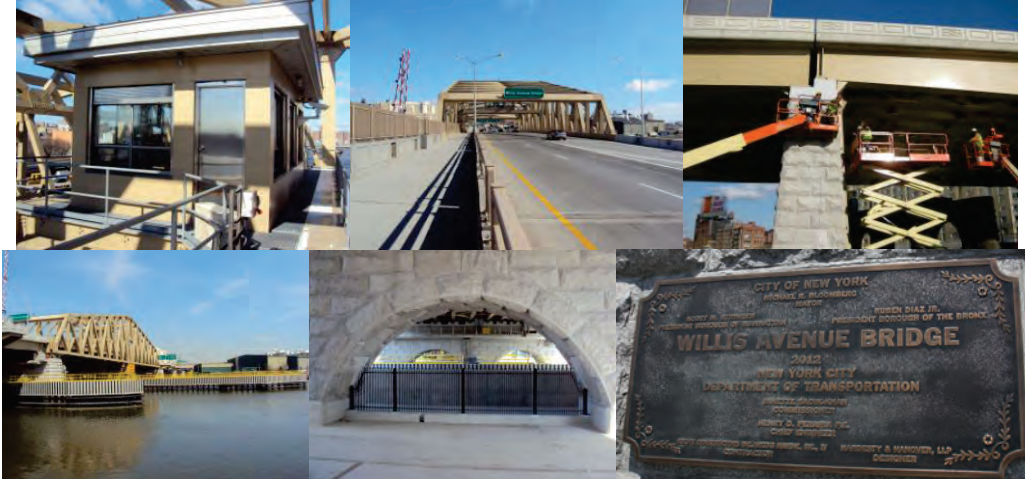
February 2013: Bridge Operator House. General View Taken From the West Side – Looking East. Pier 11- Continued installation of granite stone retrofit anchors. March 2013: Fenders of the River Piers. Pier 4 Picket Fence. Willis Avenue Bridge Plaque.

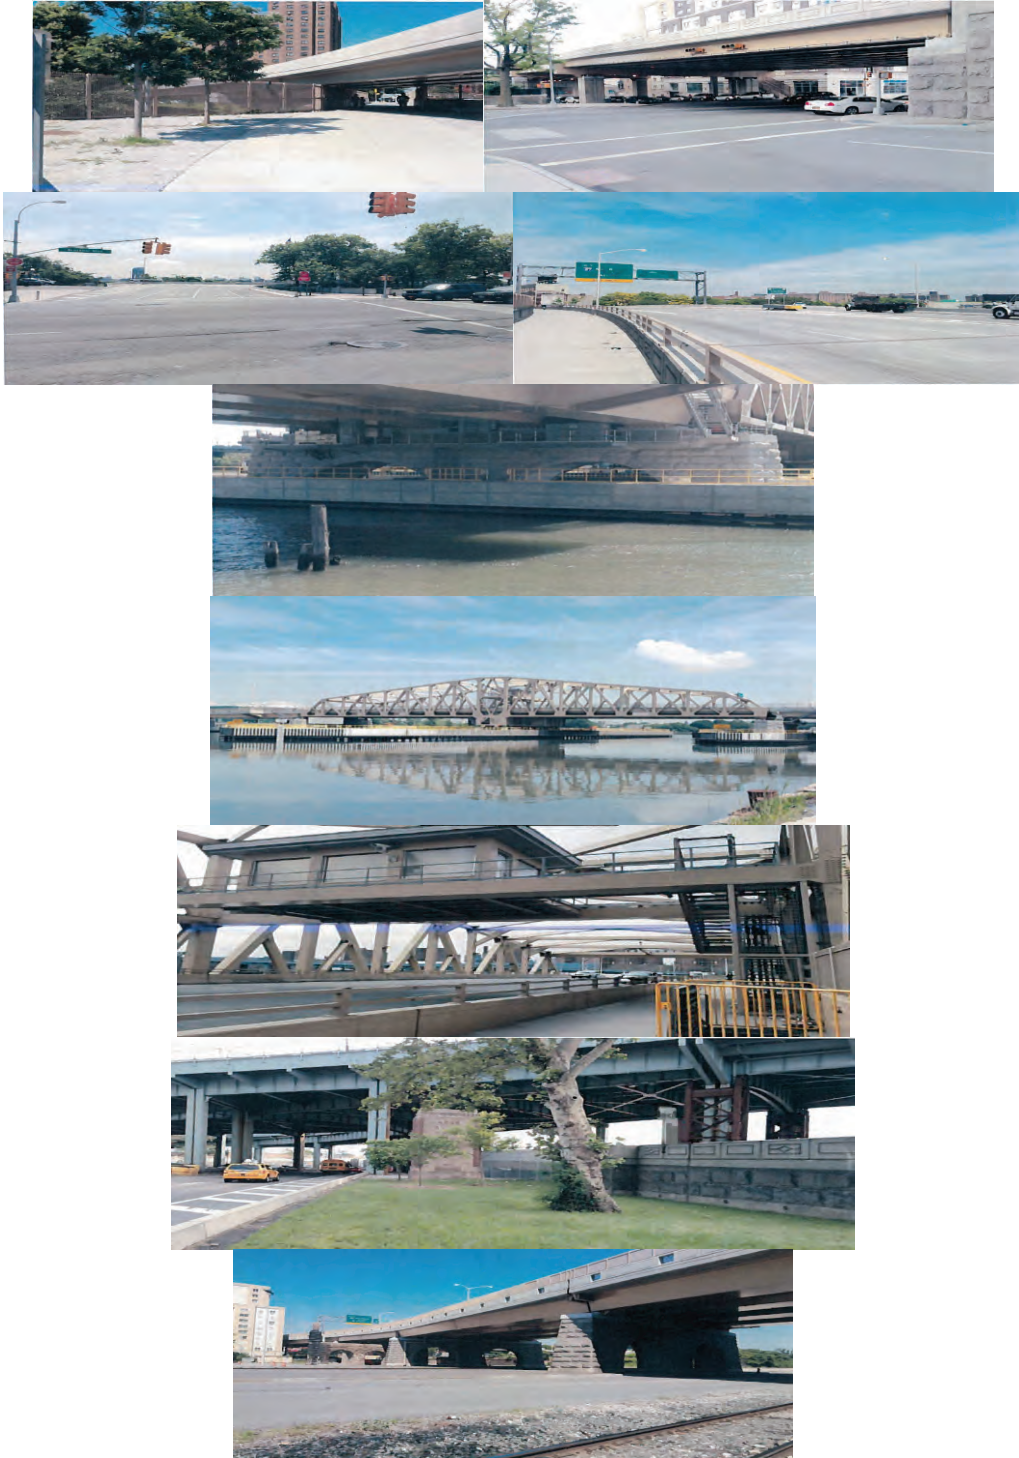
May 2015: Beginning Abutment of C Ramp and the West End of the Pedestrian Bridge. Bruckner Boulevard and Willis Avenue at Grade. Bruckner Boulevard and B Ramp at Pulaski Park. Bronx Spans 9 – 13. Pier 7 Rest Pier – Supports the East End of the Swing Span. Swing Span. Control Operating House. A Ramp. Piers 8 – 11.

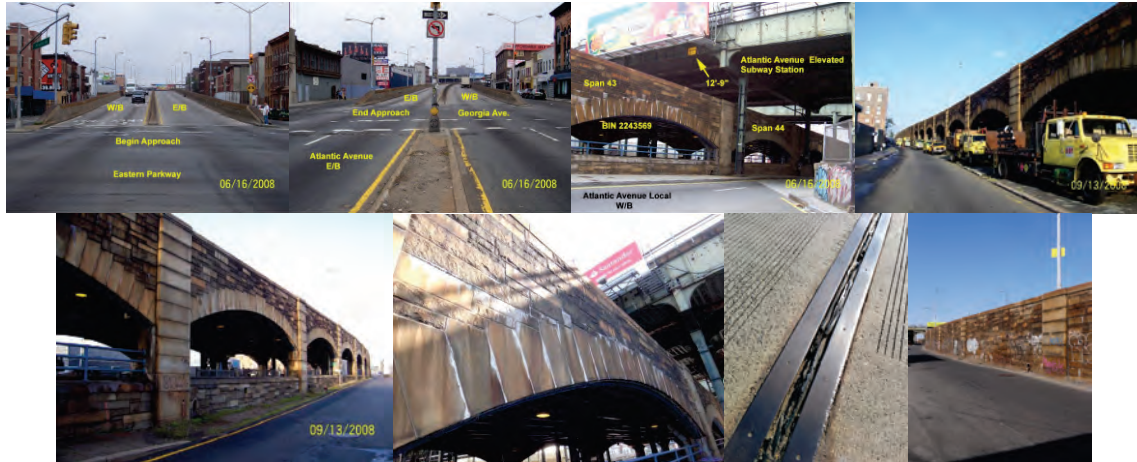
Beginning and End Approaches. Elevation Right – Spans 43 – 44. Elevation Left Spans 38 -43 and Elevation Right Spans 20 – 34. (Credit: NYSDOT) Span 43 South Arch Shows Typical Efflorescence at Mortar Joints of Ring Stones. Deteriorated and Leaking Seal at Expansion Joint. Stone Curtain Wall.

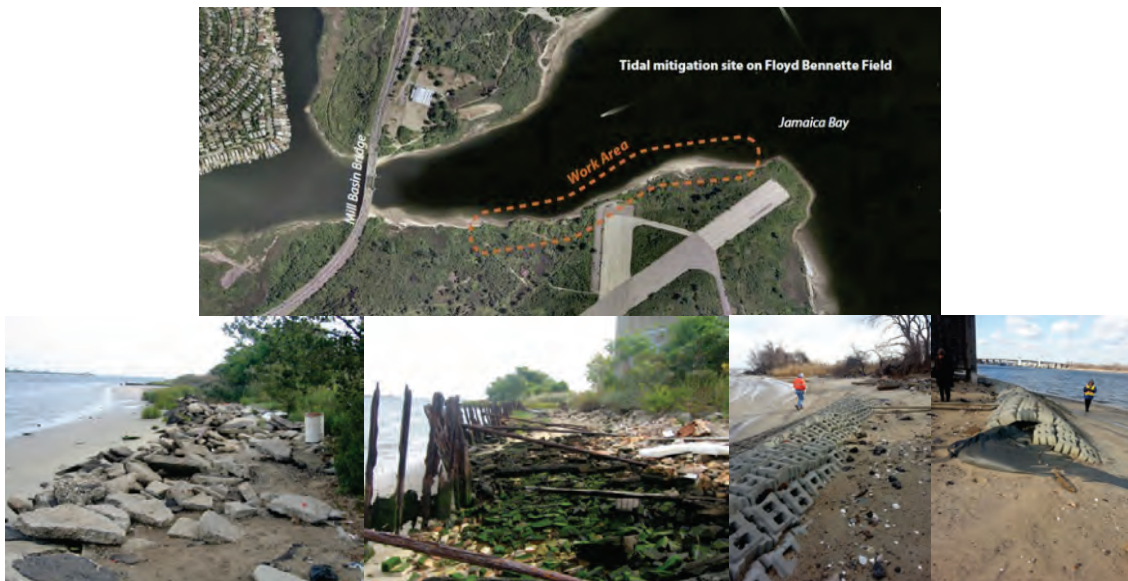
Tidal Wetland Mitigation Site. Before Mitigation – Large and Heavy Surface Debris and Deteriorated Bulkhead. Inspecting the Hurricane Sandy Damage at the Site in January 2013.

On October 29, 2012, Hurricane Sandy impacted the east coast and caused major damage. A survey after the storm discovered severe plant and revetment damage at the contract site. The established site grades were overwhelmed by the storm surge, ground protection and slope stabilization measures were displaced, and the plantings were uprooted and washed away. The National Park Service put the worksite off limits while Hurricane Sandy cleanup operations were in progress. A site inspection was held in the winter of 2013, and again in the summer of 2014. In June 2015, approximately 22,000 intertidal wetland plants (*Spartina Alterniflora*) were re-established. In addition goose fence and overhead protection were installed. The location of the planting was then adjusted to better fit the tidal contours. The plants were watered in June and July, and the site was monitored in September. The area will continue to be monitored through 2017.

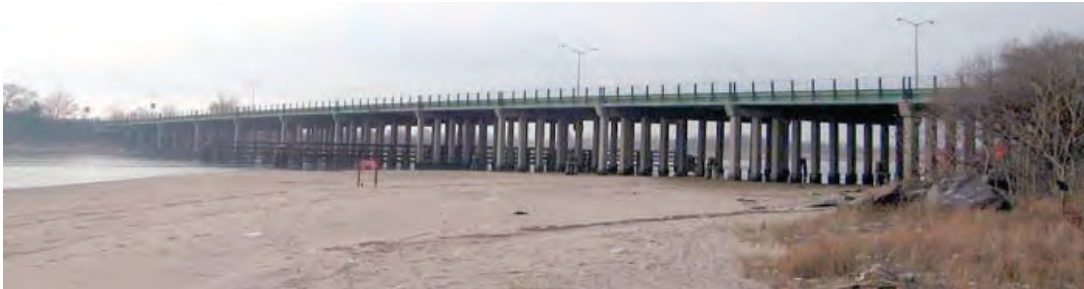
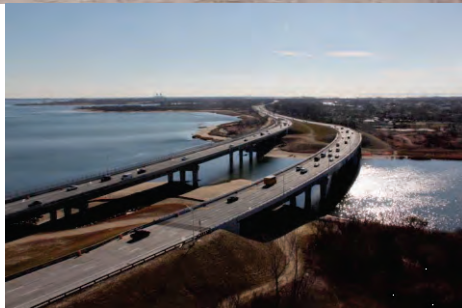
Old Paerdegat Basin Bridge. New Bridges in November 2013.

The old Paerdegat Basin Bridge was a 692-foot long, 13 span, multi-girder, simple supported steel superstructure, supported on reinforced concrete pier cap beams and abutments supported on reinforced concrete piles. The bridge had two 34-foot wide roadways carrying three lanes of traffic in each direction, with a 3-foot safety walk on the north side, a 4-foot wide center median/barrier, and an 8-foot wide south pedestrian/bicycle sidewalk. The existing structure and immediate approaches were demolished and replaced by two new bridges and new approach roadways on split alignments. The existing structure was permanently closed to traffic on December 20, 2012, upon opening of the new westbound structure. Demolition of the existing structure was completed in May 2013.

The two replacement bridges consist of trapezoidal steel box girder structures: the 825-foot, 3 span westbound bridge, north of the existing structure, and the 1,227-foot, 5-span eastbound bridge, south of the existing structure, remaining at 28 feet over the navigable channel. Both bridges have a 36-foot wide roadway with a 12-foot wide right shoulder. The eastbound bridge has a 4-foot wide left shoulder, while the westbound bridge has a 10-foot wide left shoulder. The southern structure carries eastbound traffic while the northern structure accommodates westbound traffic. Both the horizontal and vertical alignments changed, resulting in improved sight distances on the bridge and its approach roadways. The bridge carrying eastbound traffic also has a dedicated pedestrian/ bicycle path along the south side. The pedestrian/bicycle path is separated from traffic lanes by a concrete barrier on the bridge, and by a 15-foot wide grass mall on the approach roadways.

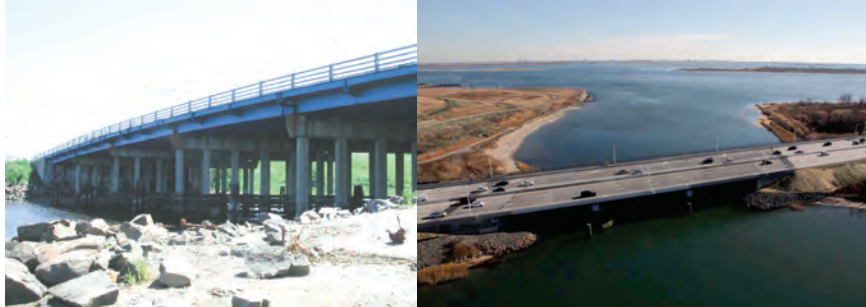
Old Fresh Creek Bridge. New Bridge in November 2013. (2002 Credit: NYSDOT)

The Fresh Creek Bridge was a 264.5 foot, 5-span, multi-girder, simple supported steel superstructure, supported on pre-cast concrete columns founded on four reinforced concrete piers on concrete piles with concrete gravity abutment walls on timber piles. One navigation channel passed under the bridge. The bridge had two 34'-2" wide roadways, a 5-foot wide center median/barrier, and a 10-foot wide south sidewalk. The parkway, east and west of the bridge,

The replacement bridge is a 316-foot, 3-span structure; the new structure has only two support piers, resulting in a wider channel. The bridge deck and approaches were widened to 126 feet from the former 86 feet to accommodate three 12-foot lanes in each direction, 12-foot wide right shoulders, and a 12-foot wide bicycle/pedestrian path, separated from the traffic lanes by a barrier system. The profiles of the approach roadways and bridge structure accommodate stopping sight distances for a design speed of 60 miles per hour. The remainder of the construction resulted in improved landscaping on the bridge approaches. The existing pedestrian and bicycle pathway were maintained and open at all times during construction.

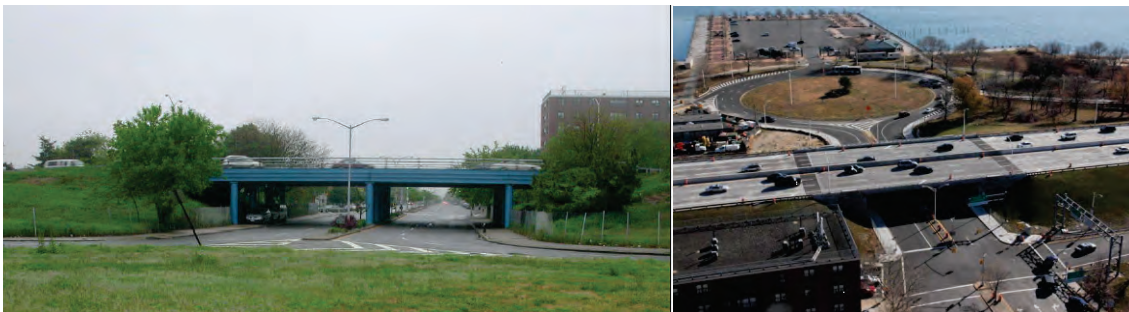
Old Rockaway Parkway Bridge. New Bridge in November 2013. (2002 Credit: NYSDOT)

The Rockaway Parkway Bridge was a 150-foot, 4-span, multi-stringer, simple supported steel superstructure, supported on steel cap beams on concrete filled steel pipe columns, and reinforced concrete abutment walls supported by concrete pile foundations. The bridge had two 34'-2" wide roadways, a 5-foot wide center median/barrier, and a 10-foot wide south sidewalk. The existing structure and immediate approaches were demolished in fall 2012, and the replacement structure was fully opened in August 2013.

The replacement bridge is a single span structure to improve visibility along Rockaway Parkway. The new structure was built in the same alignment as the existing bridge. The bridge deck was widened to 109 ½ feet from the former 84 feet to accommodate three 12-foot lanes with a 12-foot wide right shoulder and 4-foot left shoulder in each direction, including 5 ½ feet for median and parapet width. The right shoulder on each approach is 10 feet wide (while the width of the right shoulders on the bridge structure are 12 feet), with the other dimensions the same width as those on the bridge. In addition to reconstruction of the bridge, four access ramps were also reconstructed as was Rockaway Parkway in the vicinity of the Belt Parkway.

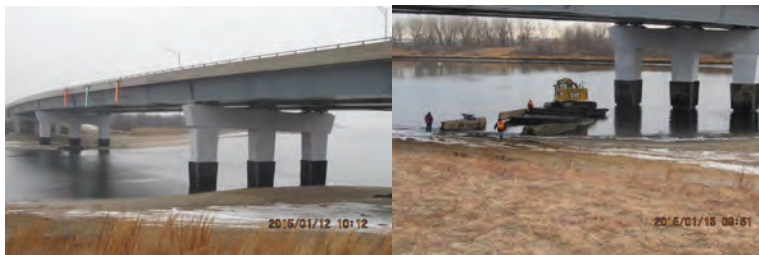
January 2015: Paerdegat Basin Bridges. Eastbound Belt Parkway Bridge over Paerdegat Basin. Newly installed Pier Bumpers at Low tide Facing East. Navigation Lights Over Center of Channel. Barge-Mounted Back Hoe used to Complete Installation of Pier Bumpers.

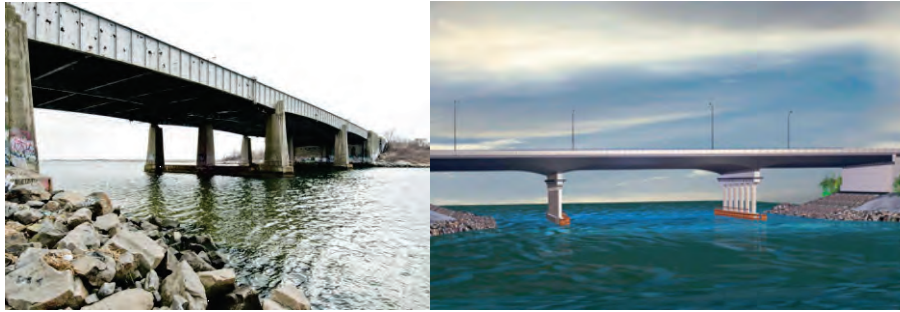
Gerritsen Inlet Bridge in 2013. Proposed Gerritsen Inlet Bridge.

The existing Gerritsen Inlet Bridge is a 520-foot long, 9-span, steel girder and reinforced concrete beam superstructure, supported on reinforced concrete piers, and abutments supported on timber piles. The existing structure and immediate approaches will be demolished and replaced.

The replacement bridge will consist of a 496-foot, 3-span bridge, aligned 10'-6" north of the centerline of the existing structure, and remaining 35 feet over the navigable channel. The bridge will have a 36-foot wide roadway with a 12-foot wide right shoulder and a 4-foot wide left shoulder in each direction. The eastbound side will carry a dedicated pedestrian/bicycle path along the south fascia. A Notice to Proceed was issued to the contractor with a start date of February 25, 2013.

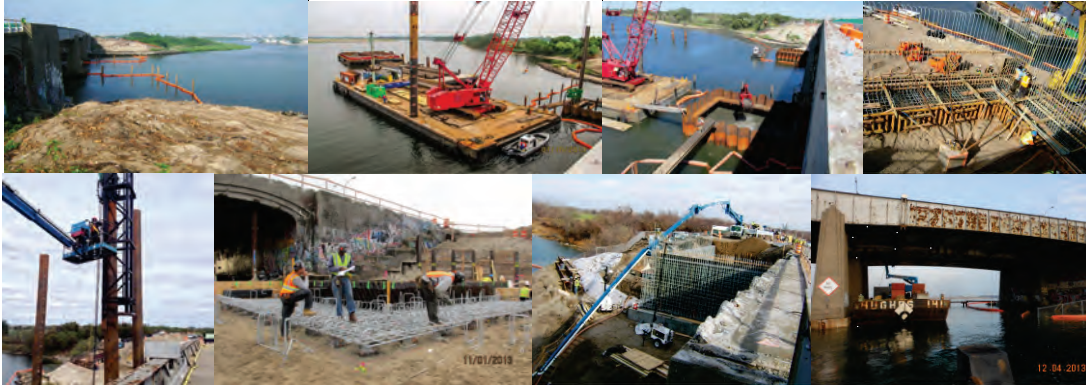
June 2013: North Side of Gerritsen Bridge - Turbidity Curtains Placed on Both Sides of Navigable Channel. July 2013: Work Barges Driving Steel Sheeting for Pier #1 Cofferdam. September 2013. October 2013: Rebars and Form Work for Footing and Walls at the Northwest Abutment. Stage 1 Piles. November 2013: Inspecting Rebar. December 2013: Tremie Concrete Pour at Pier #2. Inspecting Spans 7 & 8 of the Existing Bridge From a Barge. (Inspection Credit: NYSDOT)

In 2014, the contractor completed all of the Stage 1 (north side) substructure work, including the placement of the concrete piers and abutments. The Stage 1 concrete approach roadways on the north side of the project were also completed in 2014, as were the temporary asphalt transition areas on the approaches.

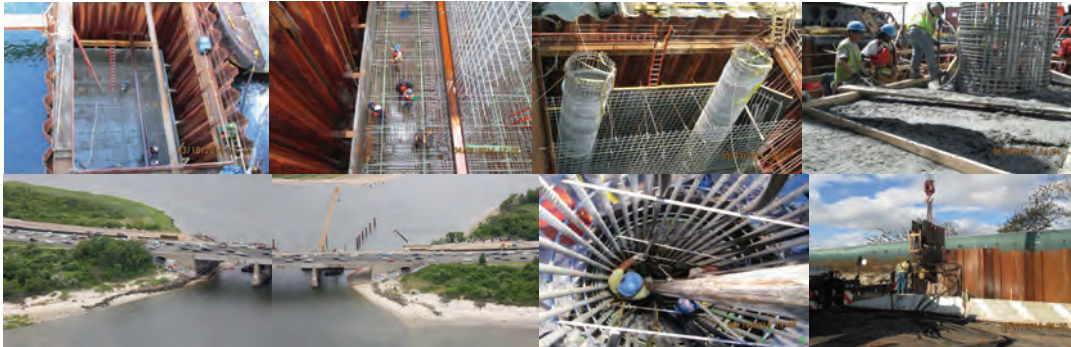
March 2014: Setting Footing Rebars Prior to Placing Pier Rebars and Concrete at Pier No. 2. April 2014: Setting Rebars for Footing and Pier Inside Cofferdam at Pier #1. May 2014: Plinth and Column Reinforcement Inside the Cofferdam for Pier 2. June 2014: Placing and Vibrating Concrete for Plinth at Pier #1. Rebars for Column in Place. West Abutment of Bridge. New Roadway Under Construction at top Next to Westbound Lanes. East Abutment of Bridge. Crane on Barge at Cofferdam for New Pier #2. August 2014: Workers Inside Rebar Cage During Operation of Pumping Concrete Into Pier #2 Column. November 2014: Steel Sheeting in Place for the East Approach Temporary Access Roadway.

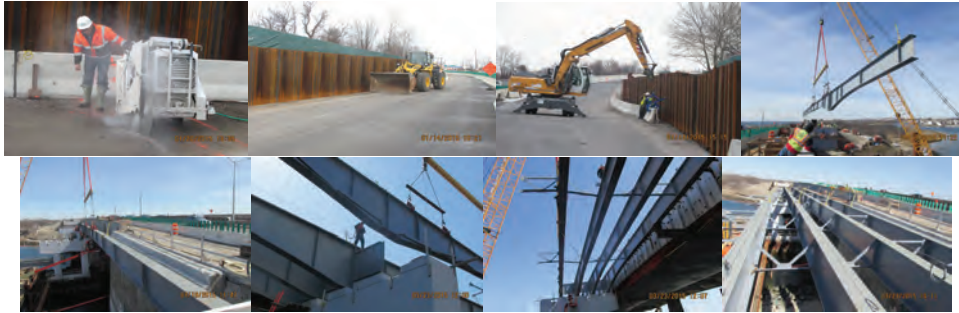
January 2015: Saw Cutting the Westbound Roadway to Install a Temporary Pipe and Catch Basin to Mitigate Flooding Conditions at East Side of the Bridge. Stage I Belt Parkway Temporary Westbound Approach to Bridge over Gerritsen Inlet. Steel Sheeting Located Between Roadway and Golf Course - Facing East. Placing Temporary Concrete Barrier in Front of Steel Sheeting at Stage I Temporary Westbound Roadway - Facing West. March 2015: Unloading Structural Steel From a Barge to set on West Abutment and Pier #1 on North Side of Bridge – Facing West. Lowering Girder onto West Abutment and Pier #1. Existing Bridge at Right - Facing East. Lowering a Girder onto the North Side of Pier #1 - Facing Southwest. Attaching Intermediate Braces Between Girders set Between the West Abutment and Pier #1 - Facing East. Girders set Between Pier #1 and West Abutment. Existing Bridge at Right Side - Facing East.

Fabrication of Stage 1 structural steel was completed in April 2015, followed by placement of stay in place forms, and stud shear connectors, and the placement of the concrete bridge deck in July. Approach slabs on both sides of the bridge were placed in July, and an armorless joint system was installed for the bridge.

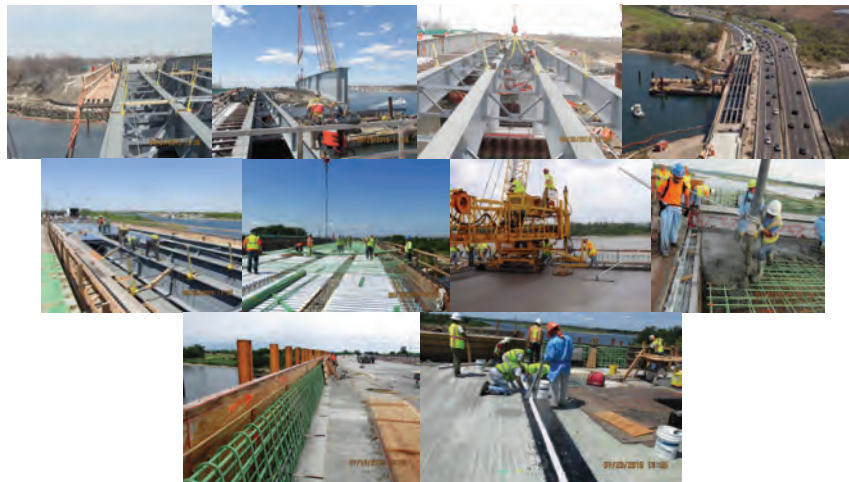
April 2015: Erecting Work Platform Supported by Brackets at Fascia Girder – Facing East. Lowering the Third of Five Gerritsen Bridge Girders Between the East Abutment and Pier #2 - Facing West. Four Girders With Diagonal Braces Set Between the East Abutment and Pier #2. May 2015: Barge-Mounted Crane Setting Structural Steel for Westbound Roadway. Eastbound Traffic at Right. Jamaica Bay at Top. Turbidity Curtains in Place at Both Sides of the Channel. Setting Stay-in-Place Galvanized Steel Forms at West Side of Bridge. June 2015: Placing Epoxy-Coated Deck Reinforcement Steel - Facing West. Placing and Finishing Deck Concrete. July 2015: Pumping Deck Concrete for Stage 1. Setting Forms and Rebars for the Parapet Barrier at New Westbound Deck. Placing Armorless Joint in the Deck of the Westbound Bridge.
