## ***DIVISION OVERVIEW***

## ACCOMPLISHMENTS & PLANNED PROJECTS

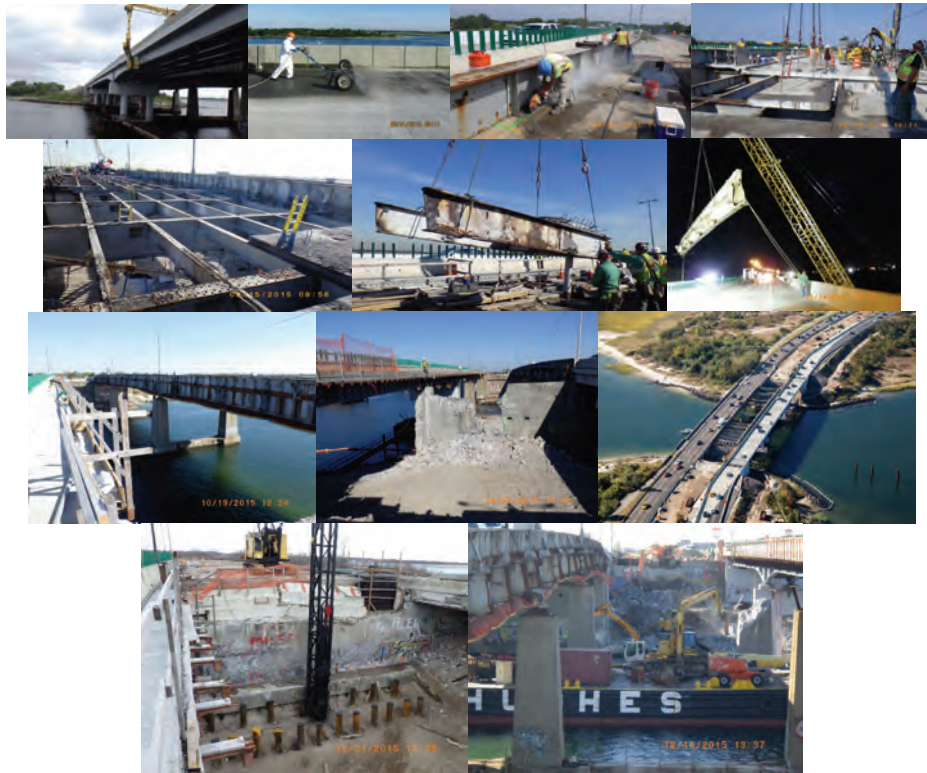
August 2015: Parapet Coating Operation at Westbound Bridge. Applying Sealing Compound to the Westbound Bridge Deck Prior to the Stage 2 Traffic Shift. Saw Cutting Deck of Bridge Prior to Removal. September 2015: Removing Saw-Cut Deck Panels. Deck Removed Prior to Steel Removal. Removing Stringers. October 2015: Removing Girder Over the Westbound Roadway With a Crane Mounted on a Barge on the North Side of the Bridge. Bridge After Removal of Steel Superstructure From North Side of Existing Bridge. South Half of Old Bridge at Right - Facing East. Partially Demolished Pier - Facing East. New Westbound Bridge at Left, Old East Bound Bridge at Right. Stage 2 Traffic Pattern. Westbound Traffic at Right on New Bridge. Eastbound Traffic at Left on Existing Bridge. December 2015: Driving 14-Inch Diameter Steel Shell Piles at East Abutment - Facing East. Barge-Mounted Hoe-Rams Demolishing Old Piers – Facing East.

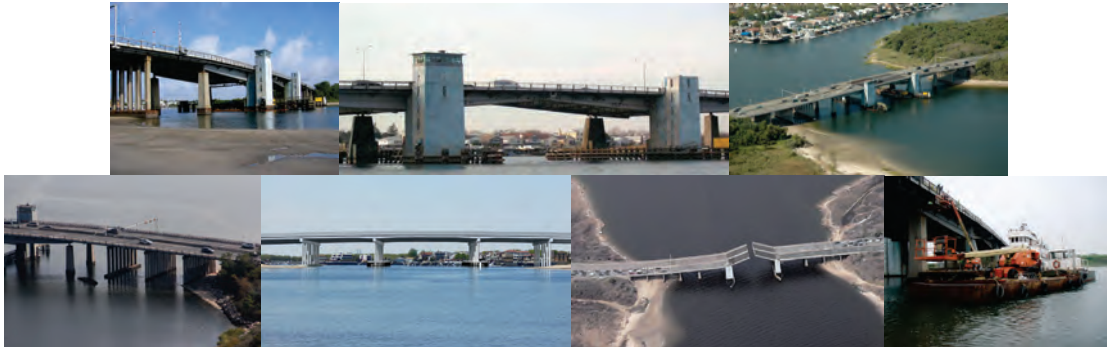
Current Belt Parkway Bridge Over Mill Basin. Aerial Views. Proposed Bridge. Open Bridge. May 2013 – Inspecting the Bridge From a Barge.

The replacement will be a 2,645-foot long, 17-span, 60-foot high fixed bridge. It will consist of a steel composite superstructure and reinforced concrete substructure on piled footings, and will be constructed on a new alignment set on the north side of the existing bridge and partially overlapping with the existing bridge. The new bridge and approach will have three 12-foot wide traffic lanes, a 12-foot wide right shoulder on the bridge, a 10-foot wide right shoulder on the approaches, and a minimum left shoulder in each direction. The eastbound side will carry a dedicated pedestrian/bicycle path along the south fascia. The new bridge will be a fixed structure with a 60-foot vertical clearance over Mean High Water, obviating the need for opening and closing the structure to accommodate tall vessels. The channel will remain navigable during construction, and the clear channel width will remain the same after the new structure is in place. A new fender system will be installed to protect the bridge substructure from marine traffic. The contract will be completed in four stages of work (including two additional sub-stages) and will maintain three lanes of vehicular traffic in each direction, as well as pedestrian and bicycle traffic during all construction stages. Construction began in the summer of 2015 and is scheduled to last for 5 ½ years, including demolition of the existing bridge.

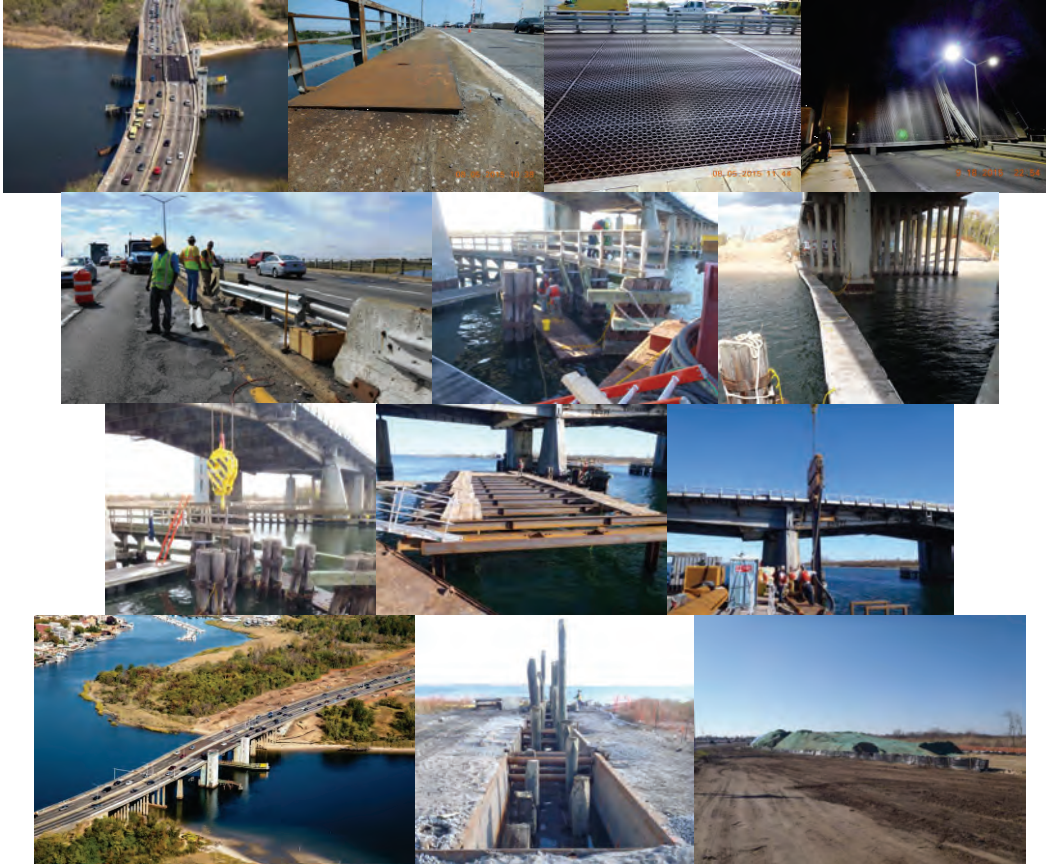
July 2015: Eastbound Traffic on Right. Westbound Traffic at Left. August 2015: Span 3, Top of Deck, Westbound (Left) Sidewalk. Span 8, Top of Deck, Steel Grating Side. September 2015: Bascule Span Fully Lifted. Median Guide Rail Repair Operations on East Side of Bridge. October 2015: Removal of Existing Fender at North Side of Pier #6. Temporary Walkway on North Side of Bridge for Access to Pier #9. November 2015: Extracting Wood Piles From the Existing Bridge Fender System at New Pier #9 Site. Pier #9 Steel Framing for the Cofferdam on the West Side of the Existing Bridge. Pier #9 – Driving “Pin Pile” for Support of the Cofferdam Steel Frame. Site After Completion of Tree Removal. December 2015: Outfall #2. Pressure Treated Wood Piles – Facing East. Hydroseeded Topsoil Stockpile to Prevent Erosion at Southwest Quadrant, Protected by a Silt Fence.

A Notice to Proceed for the replacement of this bridge was issued to the contractor with a start date of June 22, 2015. Bridge deck flag repairs were made in August. The contractor mobilized on the site, and completed all tree removal, guide rail repairs, and clearing and grubbing operations in September. Temporary, asphalt approach roadways were placed throughout the fall, and traffic was transitioned on to the temporary roadways in December.

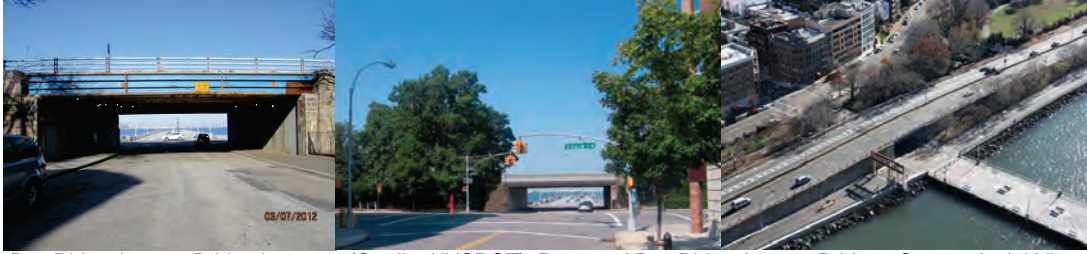
Bay Ridge Avenue Bridge in 2012. (Credit: NYSDOT) Proposed Bay Ridge Avenue Bridge. Current Aerial View.

The replacement bridge superstructure consists of precast, pre-stressed concrete box beams and a reinforced concrete slab. The bridge has three 12-foot wide lanes in the eastbound direction and two 12-foot wide lanes separated by a 4-foot wide painted stripe flush median in the westbound direction. There is no pedestrian/bicycle path on the structure. The clearance was increased to 14-feet 6-inches, which eliminated the need for clearance signs previously posted for a substandard condition. A Notice to Proceed was issued to the contractor with a start date of November 4, 2013. The only construction operations performed in fall 2013 were the survey and stake out of the project.

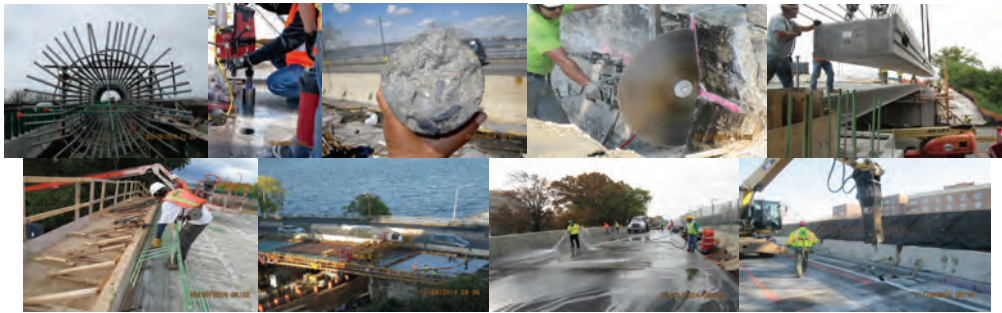
March 2014: Rebar Cage. May 2014: Core Sampling. July 2014: Saw Cutting the Existing Northwest Abutment. August 2014: Lowering the Last of the Seven Pre-cast Concrete Box Beams on the North Side Abutments. September 2014: Placing Rebar for the North Parapet. October 2014: The Main Bridge Deck Undergoing Wet Cure. November 2014: Washing the New Westbound Concrete Deck Prior to the Placement of the Temporary Barrier at Left Side Before Stage III Traffic Shift. Facing East. Demolition of the Saw Cut Westbound Bridge Deck During Stage III.

During 2014, two of the five construction stages were completed and commencement of the third stage was underway as of November. Work completed during this time included temporary deck reconstruction and flag repairs. Permanent reconstruction included the new concrete bridge barriers along the westbound roadway and new pre-stressed concrete box beams, superstructure slab, pavements, pressure relief joints, approach slabs and upper abutment stem wall reconstruction for the westbound segment of the new bridge and approaches.

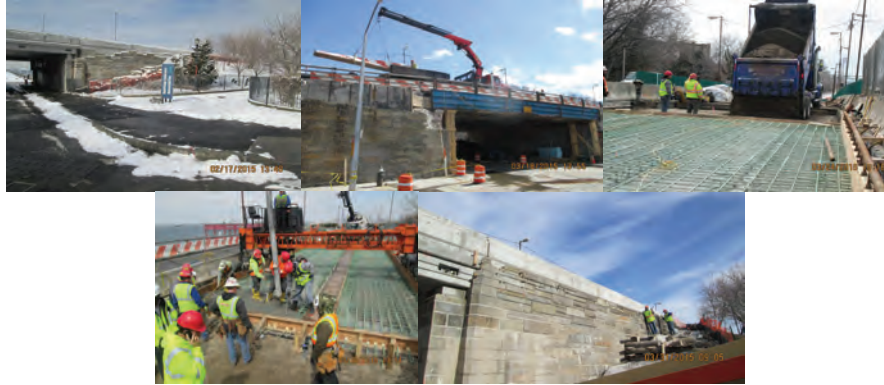
February 2015: Northwest Abutment and Wingwall Prior to Stonework Restoration.  
March 2015: Installation of Temporary Concrete Barrier on Eastbound Bridge in Response to a Red Structural Flag. Dumping Sub Base Soil for East Approach Deck. Placing and Finishing the Deck Wearing Surface for the Stage III Concrete Deck. Workers Resetting the Stone Facing on the Northwest Abutment and Retaining Wall.

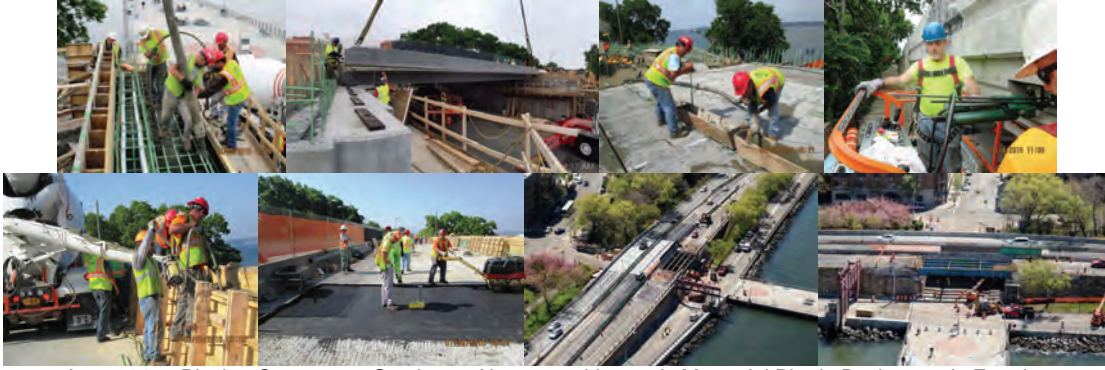
June 2015: Placing Concrete at Southeast Abutment - Veteran's Memorial Pier in Background. Erecting Precast Prestressed Concrete Beams at South Side of the Bridge Onto Elastomeric Bearing Pads. Placing Grout Between Recently Placed Precast Prestressed Beams - Facing Southeast. July 2015: Final Post-Tensioning of Precast Concrete Deck Beams From the North Fascia of the Bridge. Placing and Vibrating Concrete for the Parapet on the Eastbound Bridge. Compaction Testing of the Asphalt Pressure Relief Joint at the West Side of the Eastbound Roadway. Stage IV Existing Eastbound Bridge Deck Removed. Eastbound and Westbound Traffic on New Pre-Cast Pre-Stressed Beams. Westbound Traffic at Left. Veterans Pier at Right. Shore Road at Left. Stage IV - Preparing to Remove the Structural Steel From the South Side of the Existing Bridge.

In June and July 2015, the Stage IV precast/prestressed concrete beams were erected, the Stage IV concrete deck was placed and cured, approach slab form work and railing were installed, south fascia barriers, rebar, and concrete were placed, and the final post-tensioning of the bridge deck beams was completed.

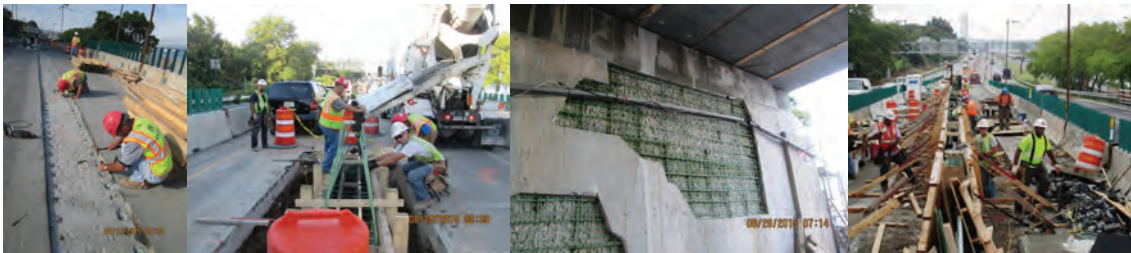
August 2015: Stage V Preparing Bridge Deck for Placement of Final Median Barrier. Placing Concrete for Final Median Barrier During Stage V - Facing East at East Approach. Epoxy Coated Reinforcing Mesh at Future Abutment Wall Repair. September 2015: Forming Operations at Final Median Barrier at East End of Bridge - Facing East.

In August 2015, the abutment fascia were repaired, and the bridge deck and approaches were saw cut and sealed. Eastbound traffic was shifted to the south side of the bridge for Stage V on August 13. In September and October, the contractor placed concrete for the median barriers, completed stone panel installation on the southeast wingwall, applied protective sealing and anti-graffiti coating to the bridge substructure, and made the final traffic switch. This concluded the three remaining construction stages. Permanent reconstruction of the bridge included the new concrete barriers along the median and eastbound roadway, new pre-stressed concrete box beams, superstructure slab, pavements, pressure relief joints, approach slabs, and upper abutment stem wall reconstruction for the center and eastbound segments of the new bridge and approaches. The Bay Ridge Avenue Bridge was substantially completed on November 2, 2015.

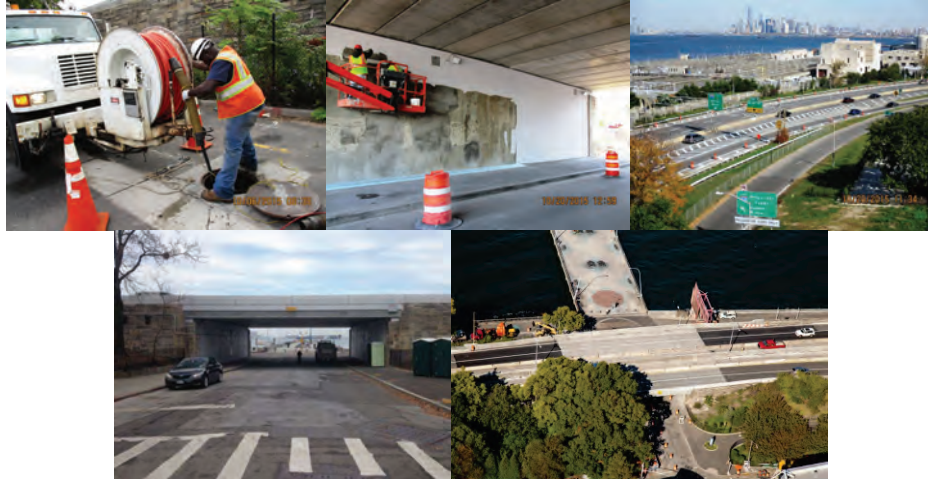
October 2015: Post-Construction Drainage Cleaning and Inspection at Southwest Abutment. Applying Protective Sealant to the East Abutment Wall. Belt Parkway Roadway at West Side of Bridge. NYCDEP Owl's Head Waste Water Treatment Plant at Top. November 2015: Construction Complete.

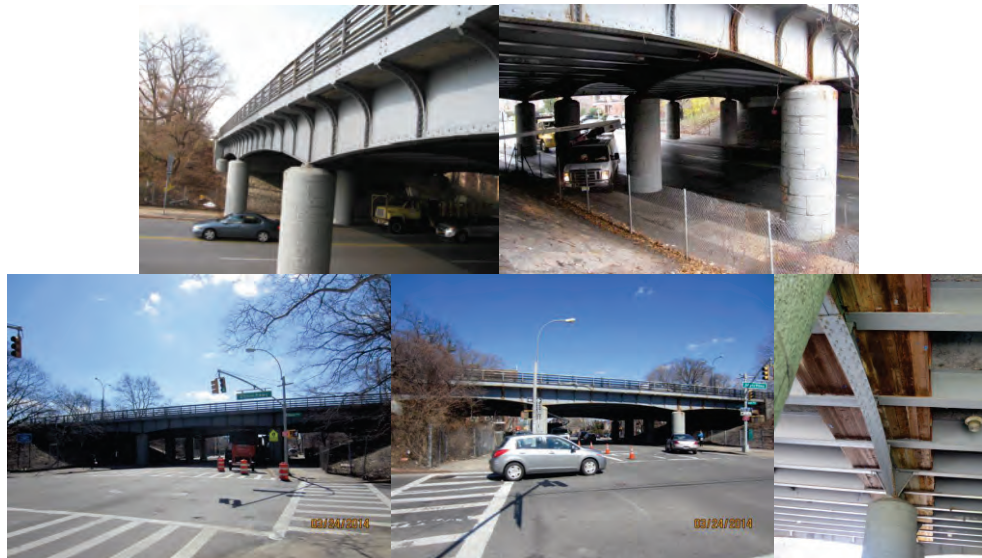
Nostrand Avenue Bridge Right Girder in November 2012. Pier 1 and 2 Columns in December 2014. Left and Right Elevations in 2014. Span 1 Deck – Hollow Sounding Concrete Areas are Covered by Timber Planks That are in Good Condition. (2014 and 2015 Credit: NYSDOT)

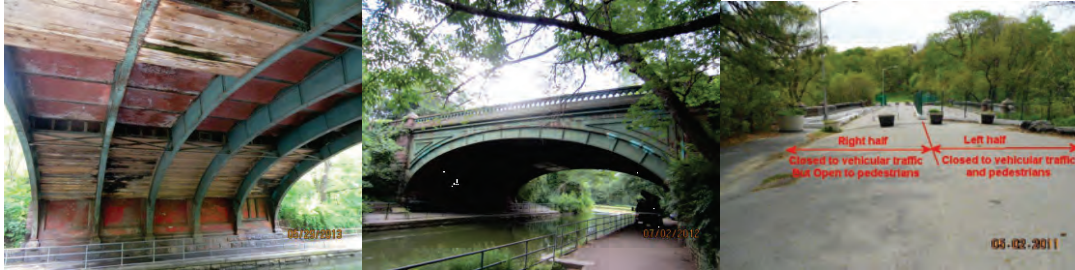
Hill Drive Bridge Span 2 Pier 1 End Face in 2013. View of Bridge in 2012. End Approach in May 2011: The Bridge is Closed to Vehicular Traffic. The Left Half of the Bridge is Closed to Pedestrians. (Credit: NYSDOT)

The project to reconstruct the bridge has been suspended until such time as Parks funding is available. Repairs requiring immediate attention are performed by the When and Where contractor. This bridge is closed to vehicular traffic.

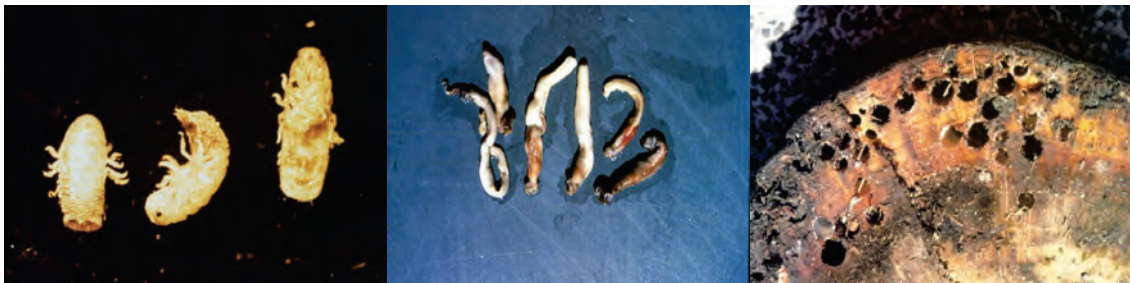
Marine Borer – Limnoria Species (the Common “Gribble,” a Genus of Crustacea Borers). Marine Borer – Teredo Species (a Genus of Molluscan Borers, Commonly Called the “Shipworm”). Teredo Damage (Holes up to ¼” Diameter).

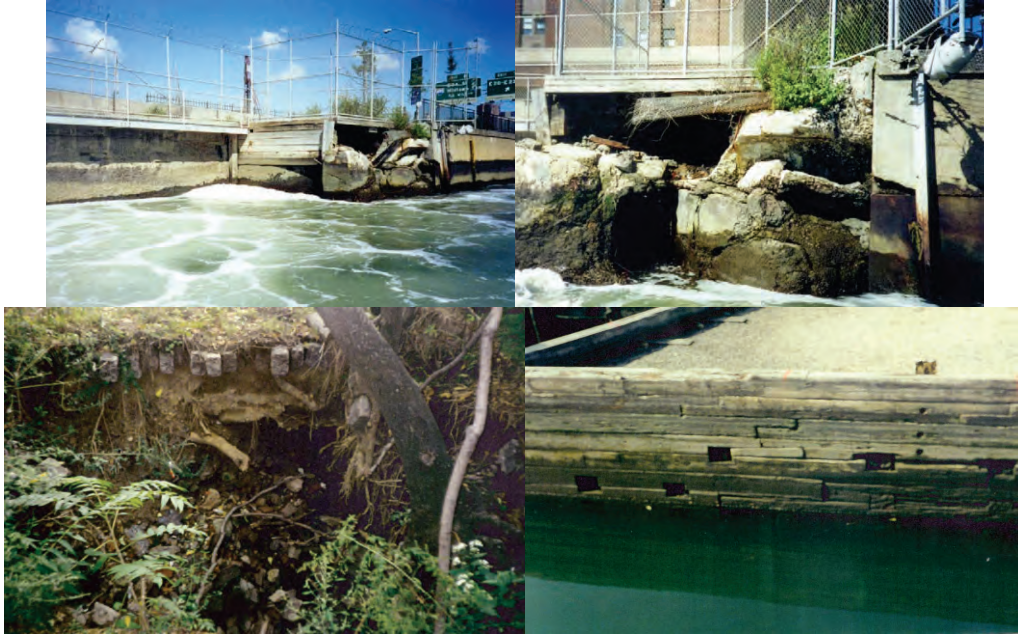
From Study of FDR Drive: Location #2 – Damaged Seawall at Segment #5. Sinkhole at Location #6 at East 59<sup>th</sup> Street. From Study of Carroll Street Bridge: General View of the Southwest Crib Wall With the Delamination of the Timber Stretchers in the Tidal Zone.

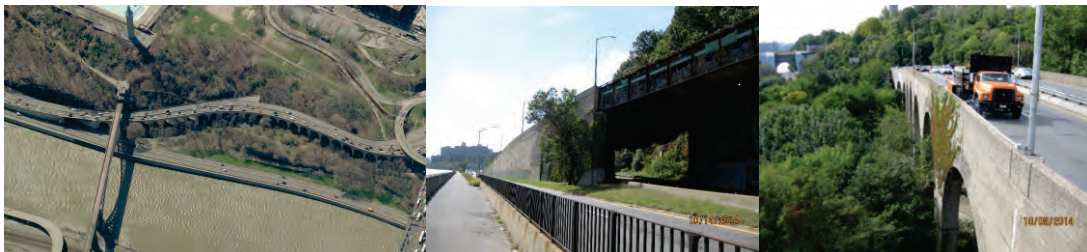
Aerial View. Trans-Manhattan Expressway Connector Ramp in 2014: Elevation Right Spans 1 – 25, 33 – 40. (Credit: NYSDOT)

The Trans-Manhattan Expressway Connector Ramp is an elevated viaduct that consists of a multi-span steel superstructure supporting a concrete deck. The ramp connects the Trans-Manhattan Expressway to the Harlem River Drive and it was built in 1939. It is a 2,080 foot long and 57 foot wide structure, consisting of 14 steel spans and 41 reinforced concrete spans, carrying two lanes of traffic in each direction, northbound and southbound. In 2008, New York State DOT completed an approximately \$4.5 million “top-side” repair project of the wearing surface, joints, median, parapets, and other above-deck elements. The scope of work includes rehabilitation of the bridge steel and concrete components; repairing outstanding structural flags on the ramp; repairing existing spalls and removing existing protective netting; and restoration of adjacent parkland including placement of a gravel base within the footprint of the bridge structure, construction of a paved access roadway, and landscape restoration including grass seeding. A Notice to Proceed for the \$10 million project was issued to the contractor with a start date of August 10, 2015. Construction is expected to be complete in February 2017.

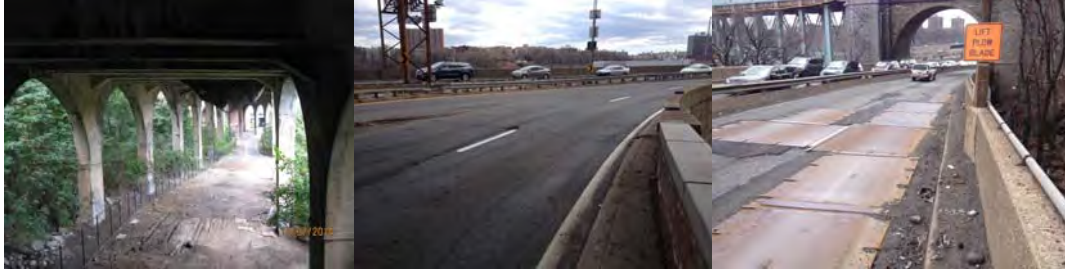
Span 42, Netting at Deck Underside, Looking Ahead. (Credit: NYSDOT) March 2015 Field Inspection.

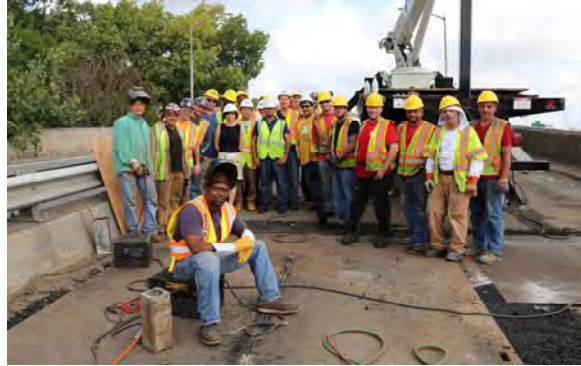
On September 29, 2015, Division Personnel Conducted Emergency Repairs on Two Punch-Through Locations on the Top of the Deck. Steel Plates Were Installed. The Repairs Were Then Added to the Contractor's Work Scope. From Left: Bridge Repairer and Riveters Charlie Zhao and Ignazio Trapani, Carpenter Gregory Nolan, Supervisor Bricklayer Edward Alfano, Cement Mason Luigi Mula, Commissioner Polly Trottenberg, Assistant Civil Engineer Andrew Hoang, Carpenter Edward Alfano Jr., Assistant Civil Engineer Fouad Althaibani, Area Supervisor Highway Maintenance Edward Pedersen, Supervisor Highway Repairer Andrew Bondi, Supervisor Carpenter Joseph Diblasi, Bridge Repairer and Riveter David Fontanez, Assistant City Highway Repairers James Cummings, Anthony Connelly, and James Kelleher, Bricklayer Stephen Daniel, and Cement Masons Victor Porowski and Frank Finzio. Foreground: Bridge Repairer and Riveter Chris Mauldin.

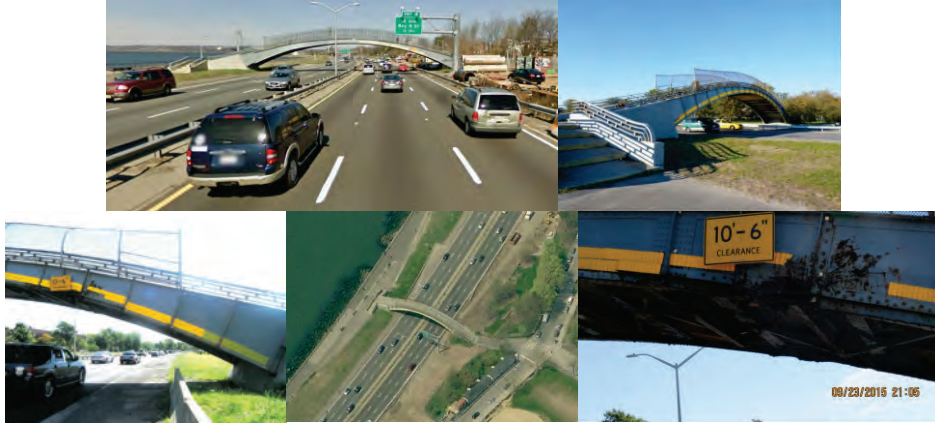
17<sup>th</sup> Avenue Bridge – Existing Conditions. Deteriorated Left Girder. Span 1 Left Girder over Belt Pkwy Eastbound Left Lane was Hit in September 2015.

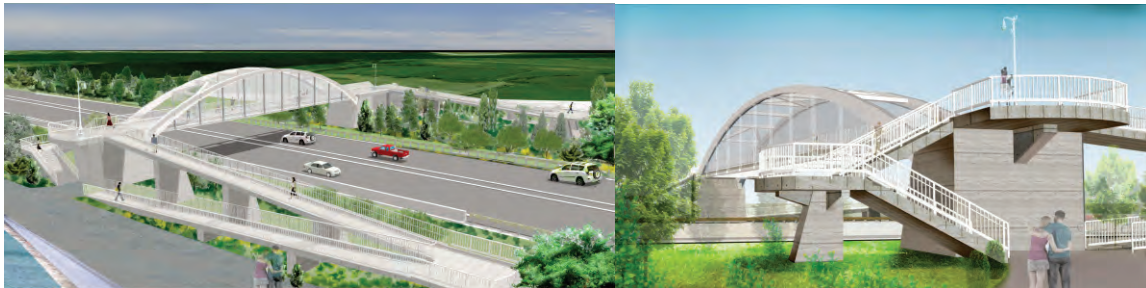
17<sup>th</sup> And 27<sup>th</sup> Avenue Bridges – Proposed Bridges.

In this project, the overpasses at 17<sup>th</sup> and 27<sup>th</sup> Avenues will be completely replaced. The structures will be designed to current codes and standards and all substandard features will be eliminated. Additionally, as the existing bridges were constructed under the Robert Moses era Master Plan for NYC, the proposed bridge designs will follow the Shore (Belt) Parkway Design Guidelines which were developed in November 2006, in order to preserve and reestablish the historic character of the parkway for drivers and pedestrians while enhancing and strengthening the visual cohesiveness of the greenspace connected to the adjacent park and recreation land. Construction is anticipated to begin in 2018, and is expected to be complete in 2020.

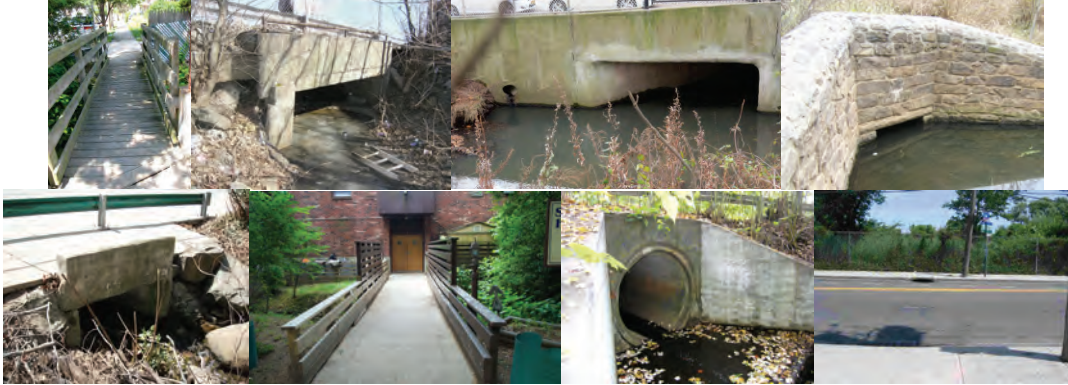
Galloway Avenue over Marianne Street – Wearing Surface, Looking Northwest. Forest Avenue over Crystal Avenue. Midland Avenue over Hylan Boulevard – Looking South. Rockland Avenue over Brielle Avenue. Forest Avenue over Randall Avenue. Gregg Place over Randall Avenue. Arthur Kill Road over Muldoon Avenue. Arthur Kill Road over Ridgewood Avenue.

The Forest Avenue culvert over Crystal Avenue is a single span reinforced concrete box culvert. It is located approximately 230' east of the intersection of Forest Avenue with Crystal Avenue. The reconstruction will consist of the demolition of the existing culvert, clearance of debris from the channel, replacement of the culvert with a concrete deck slab supported on steel beams on reinforced concrete abutment and wingwalls. The construction work is planned to be performed in four stages with proposed four traffic lanes being maintained at all times.

The Midland Avenue culvert consists of a single span reinforced concrete box, which will be replaced with a new pre-cast box culvert. It is located on Midland Avenue between Boundary Avenue and Mason Avenue. The rehabilitation will include replacing the existing concrete box structure with a new concrete box structure, new sidewalk, curb, pipe railing, chain link fence and asphalt wearing surface. The work will be performed in three stages, with one lane of traffic maintained in each direction at all times.

The Rockland Avenue reinforced concrete culvert project will include concrete repair and a lined and stabilized north embankment. It is located approximately 361' west of the intersection of Rockland and Manor Avenue. The rehabilitation work includes clearing the debris and vegetation from the channel and installing a structural lining. The construction is planned to be performed in one stage and no street closures will be required during construction.

The Forest Avenue culvert over Randall Avenue is a single span concrete box culvert, located at Forest Avenue between Randall Avenue and University Place. It will be replaced with a new precast concrete box culvert with new sidewalks and asphalt pavement. The work will take place in three stages while maintaining one traffic lane in each direction during construction.

The Arthur Kill Road culvert over Muldoon Avenue consists of a reinforced concrete pipe at north and a reinforced box culvert at south. It is located on Arthur Kill Road between Muldoon Avenue and Arden Avenue. The box culvert will be replaced with a new box culvert, and a structural lining will be installed in the pipe culvert. The construction will be performed in one stage with one lane of traffic maintained in each direction.

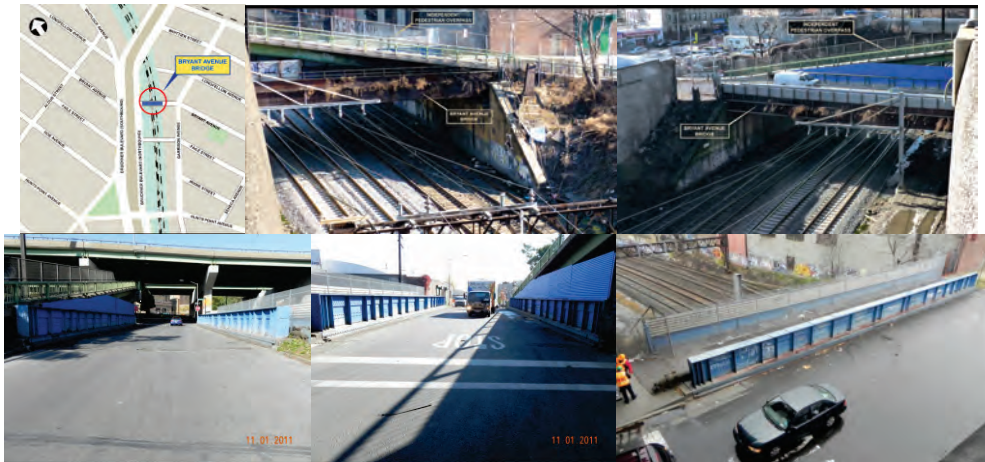
Location Map. Bridge Views Looking North and South. 11/1/11 Approach Begin and End. (Credit: NYSDOT) Bridge View From the Pedestrian Overpass.

The Bryant Avenue Bridge, oriented east to west between Buckner Boulevard and Garrison Avenue, is a one span structure constructed in 1908. It spans 90 feet over four railroad tracks. This project includes replacement of the steel superstructure, bearings, approaches, water mains and rehabilitation of the existing substructures by removing and replacing the top portion of the concrete abutments to accommodate the new superstructure. The abutments will be retrofitted to meet seismic criteria. The new superstructure consists of a reinforced concrete deck over pre-stressed concrete box beams. The two water mains were removed and replaced. Both water mains were installed on top of the north sidewalk in a fenced-off area. The Division's in-house design staff completed the design for this project. A Notice to Proceed for the project was issued to the contractor with a start date of August 18, 2014. The bridge is completely closed to vehicles during its construction; however, pedestrian access is being maintained.

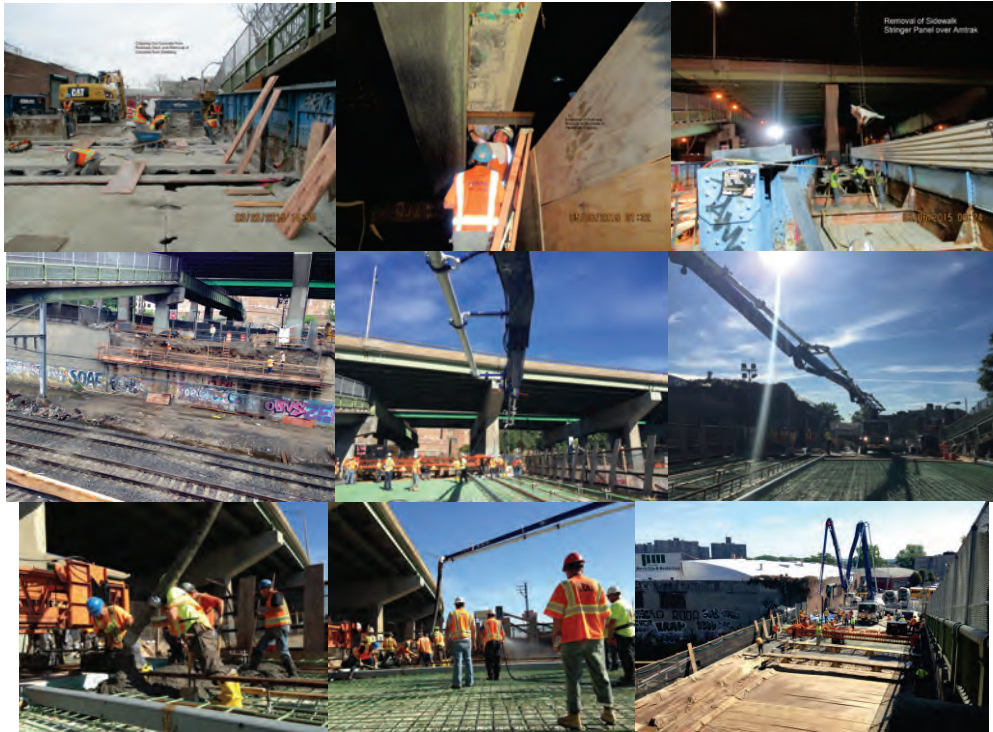
March 2015: Chipping Out Roadway Deck Concrete and Removing Shielding Concrete. May 2015: Installing Overhang Brackets on South Side of Pedestrian Walkway. Removal of Sidewalk Stringer Panel. Summer 2015: Existing Structure Removed. September 2015: Placing the Concrete for the Bridge Deck. The Concrete Pump Placed 110 Cubic Yards of Concrete Into the Deck. Covering and Protecting the Fresh Concrete with Wet Burlap.

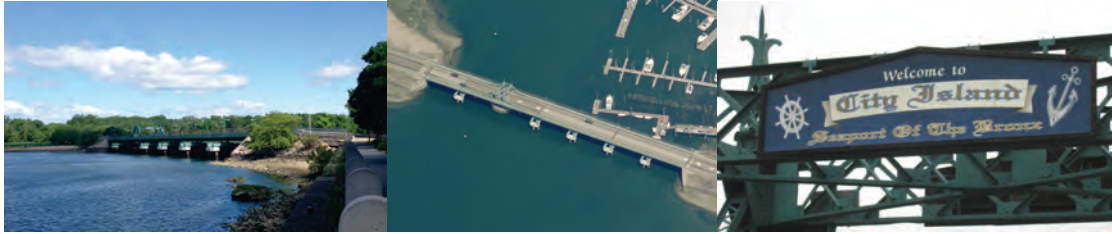
View of City Island Bridge From the Esplanade. Aerial View of Current Bridge. Welcome Sign.

Bay Park and crosses over Eastchester Bay. With seven spans and six piers in the water, the bridge has outlived its useful life and requires extensive continuous maintenance. Spans two and three are supported by an overhead truss that originally functioned as a movable swing span but was permanently fixed in 1963.

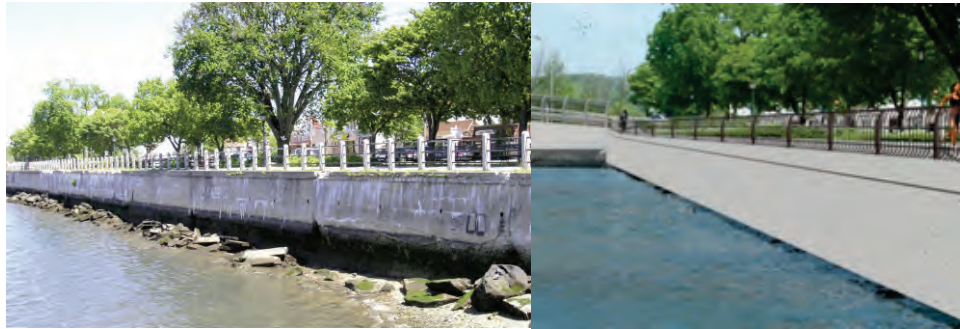
Existing Seawall. Proposed Treatment.

At the City Island side there is a seawall along the shore which is about 500 feet in length starting from the bridge and heading in a southerly direction. This seawall will be rehabilitated and turned over to the Department of Parks and Recreation along with the esplanade which it is supporting. The rehabilitation of the existing concrete seawall will include a steel rod tieback system as a precaution against loss of stability due to overturning or sliding. In addition, all unsound concrete will be removed from the face of the wall and a new reinforced concrete facing will be cast along the entire length. The esplanade will receive landscape improvements such as a new railing above the wall, new plantings, trees, grass, and paver blocks.

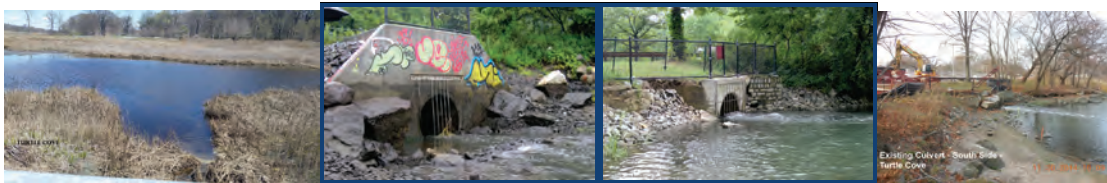
Turtle Cove. Existing Culvert – South Side.

Turtle Cove Culvert is located under City Island Road approximately half a mile west of the existing bridge. As part of the wetland impact mitigation activities for the project, this culvert will be replaced with a larger one that will allow for greater tidal flooding from Eastchester Bay to the upland portions of Turtle Cove.

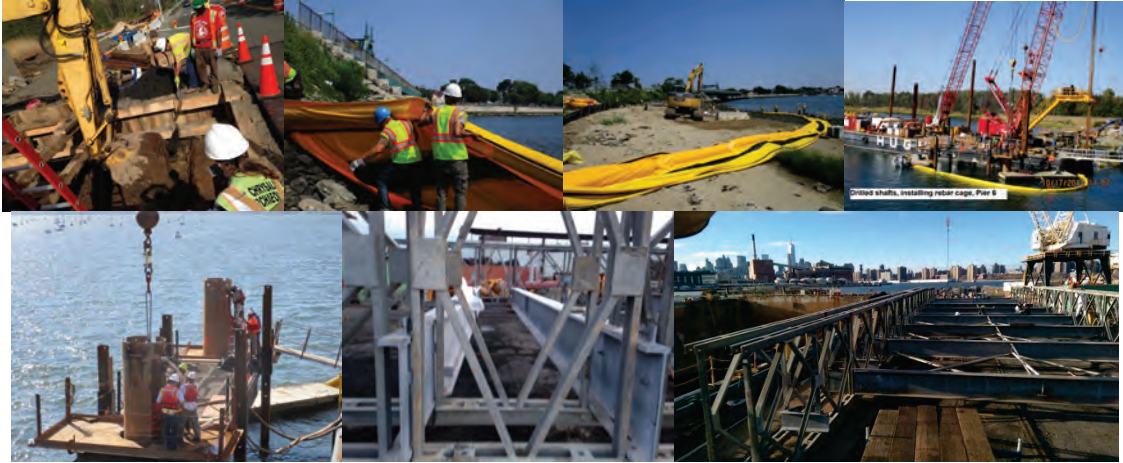
August 2014: Excavating on the West Side of the Bridge in the Presence of an Archeologist. Approximately 300 Linear Feet of a Turbidity Curtain was Installed on the Southwest Side of the Bridge to Protect the Shore During Construction. A Turbidity Curtain is a Floating Barrier Designed to Contain and Control the Dispersion of Sediment. October 2014: Drilled Shafts – Installing Rebar Cage at Pier 6. October 2014: The Contractor Airlifted Drilled Shaft Casings Into Position on a Platform Constructed Beside a Construction Barge. The Contractor Assembled the Temporary Bridge Segments at the Brooklyn Navy Yard. The Pieces Were Transported to City Island by Barge.

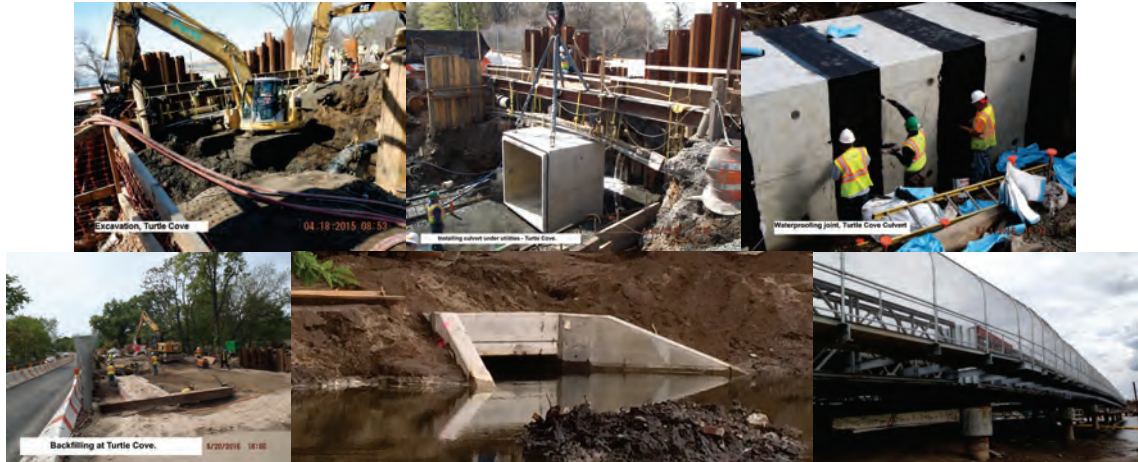
April 2015: Turtle Cove Culvert Replacement. Excavating. Installing Culvert Under Utilities. May 2015: Waterproofing the Joint. Backfilling. Completed Stage 1. Water Flow Inside the Culvert was Restored on May 18. The New Culvert is an 8 Foot by 7 Foot Concrete Box - About a 3x Larger Capacity. April 2015: - Installation of the Pedestrian Walkways for the Temporary Bridge. The contractor Constructed 2 Cantilevered Sidewalks - Approximately 5.5' Wide With a Chain-Link Fence.

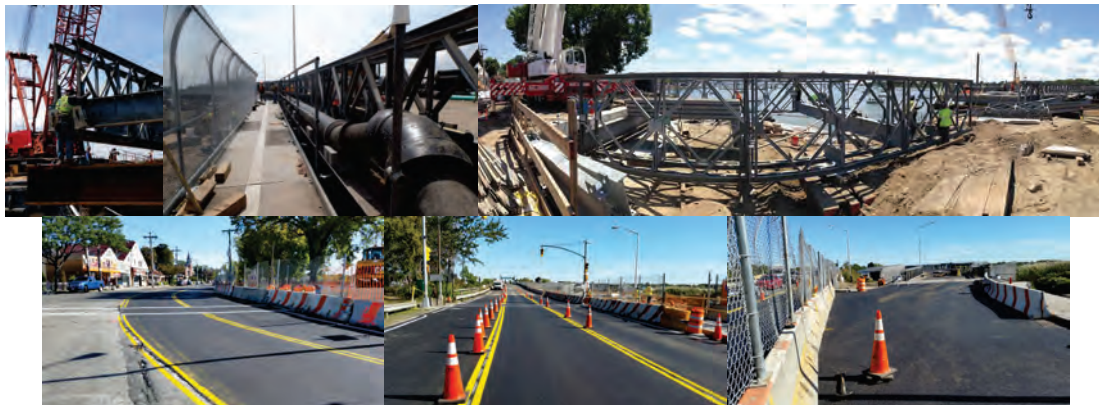
June 2015: Installing Marine Span 13 for the Temporary Bridge. July 2015: Installing Temporary Water Main on the Temporary Bridge. Installing Decking for Span 15. October 2015: Milling the Existing Asphalt Surface and Repaving at Both Approaches.

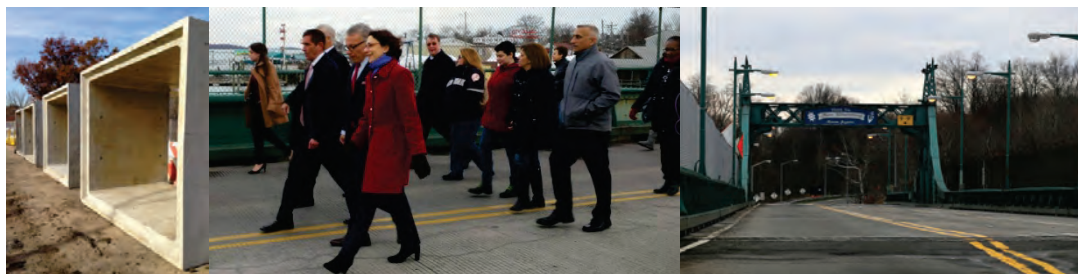
November 2015: New Culvert Boxes to Replace the Aging Conduit that Connects the Bay with Turtle Cove, Located Beneath City Island Road. December 18, 2015: Commissioner Polly Trottenberg Leading the Final Trip Over the Historic Bridge.

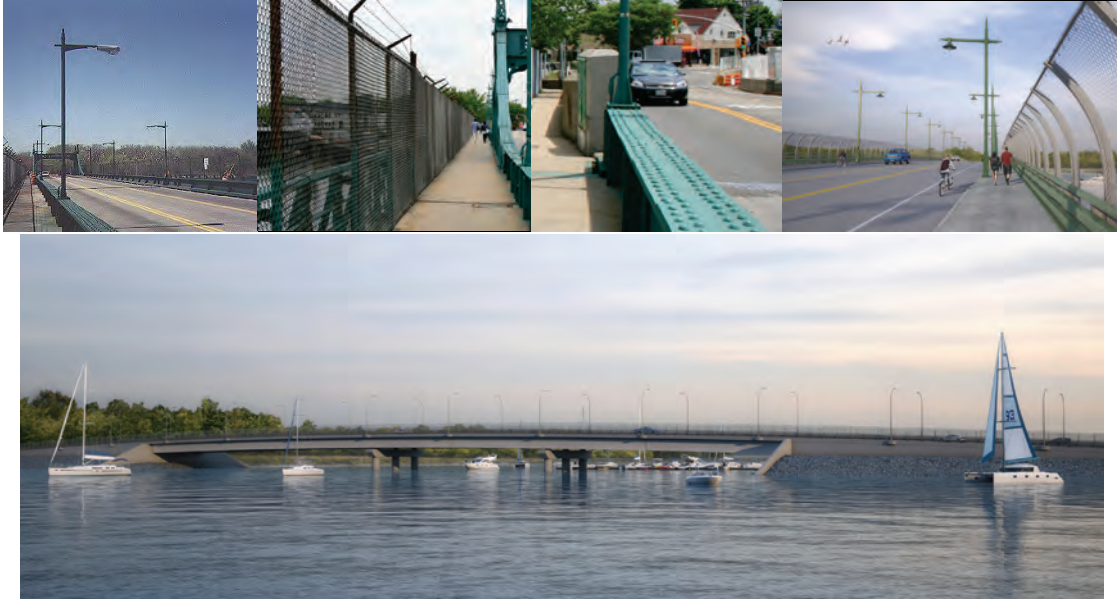
Existing and Proposed City Island Road Bridge Furnishings: Lighting, Fence, and Rail. Side View Rendering of New Bridge.

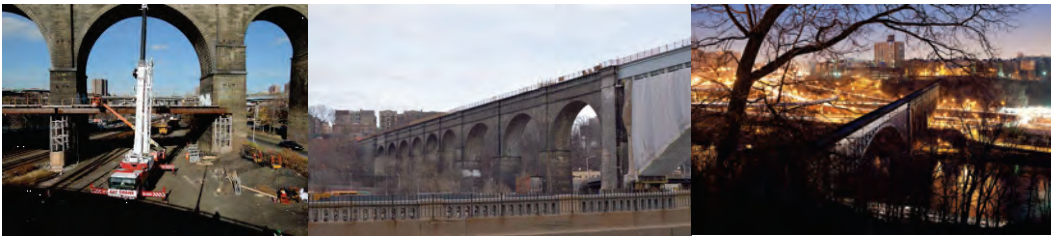
Late Fall 2013: Mast Climber Removal. Winter 2014: South View of the Bridge. (Credit: NYCDDC)

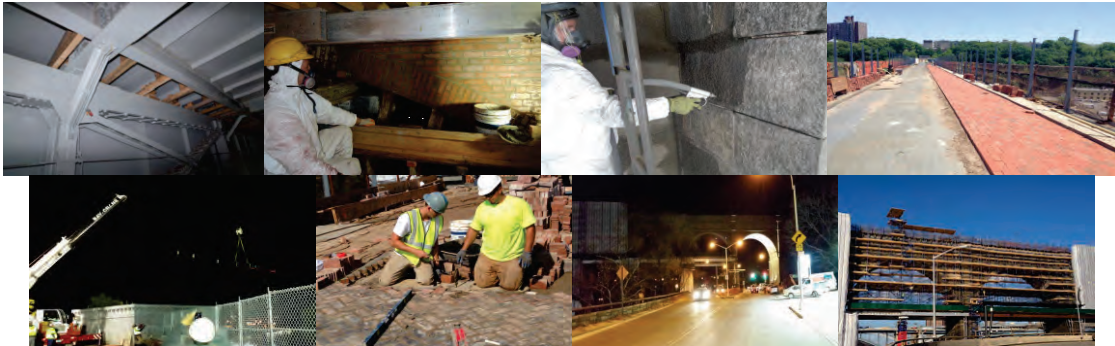
Winter 2014: Steel Stringer Installation. Spring 2014: Brick Repairs and Stone Cleaning. Summer 2014: Brick Installation. ADA Ramp Steel Installation. Summer 2014: Brick Installation. Winter 2015: LED Lighting on the Arch. Scaffolding. (Credit: NYCDDC)

From January through April of 2014, brick and concrete spall repairs and steel repairs continued. Installation of underlayment pavers on bridge deck began in May and June, and the steel installation for the Manhattan and Bronx ADA ramps was completed. In July and August, waterproofing operations on the bridge and lead abatement and painting operations were completed. In November and December, paver installation on the bridge deck was completed. At the end of 2014, continuing work included: steel repairs, scaffold installation for masonry stone cleaning and repointing work on the bridge, Manhattan gatehouse rehabilitation, and historic railing and ADA ramp installation.

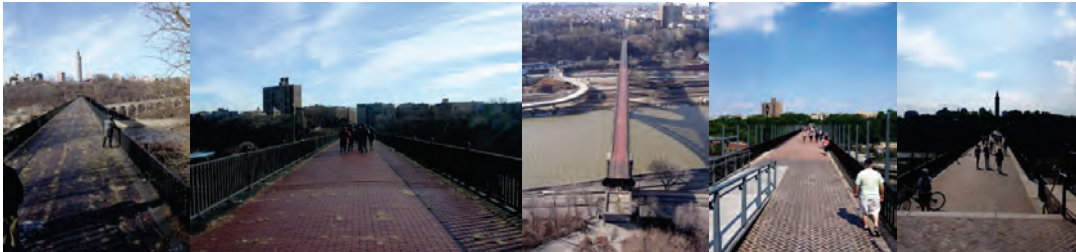
High Bridge Walkway in January 2004 and June 2015. The Brickwork Dating to the 1860's was Restored at Either End, With the Center Section was Completed With Replicas. (Credit: Gordon I. Goldberg)

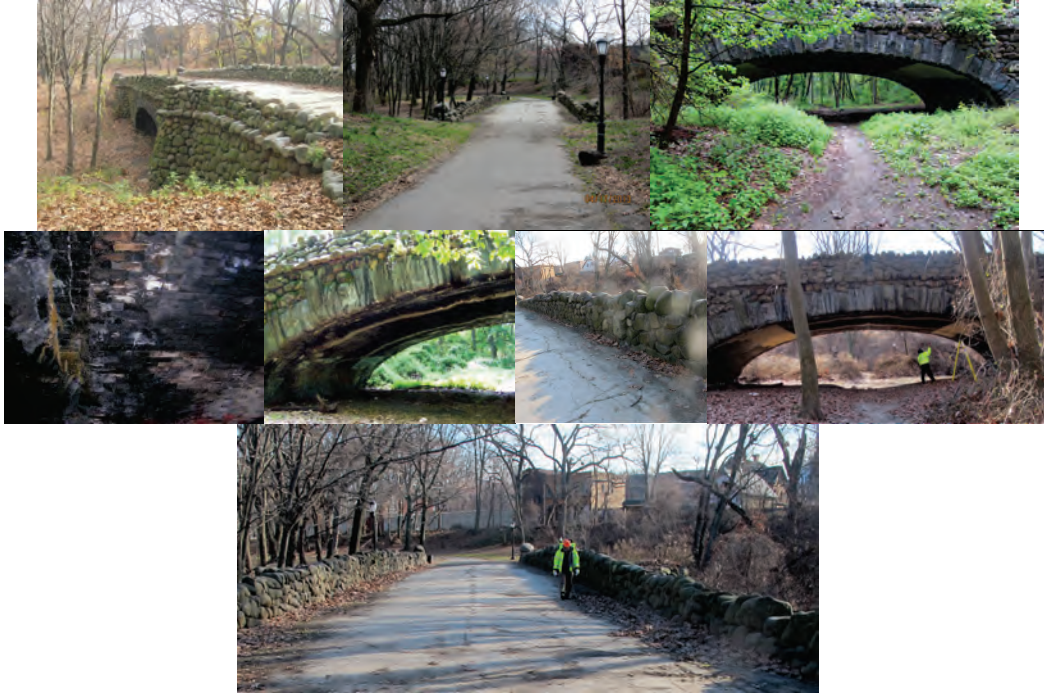
Highland Park Bridge. Dirt Pathway Under Bridge. Under-Deck Cracks and Missing Bricks - North-East Side. Under-Deck Arch Wall Showing Efflorescence Along the Cladding Stone and Brick Arch. Top of Bridge - Map Cracking, spalled, and Patched Areas. Inspecting the Bridge in December 2014.

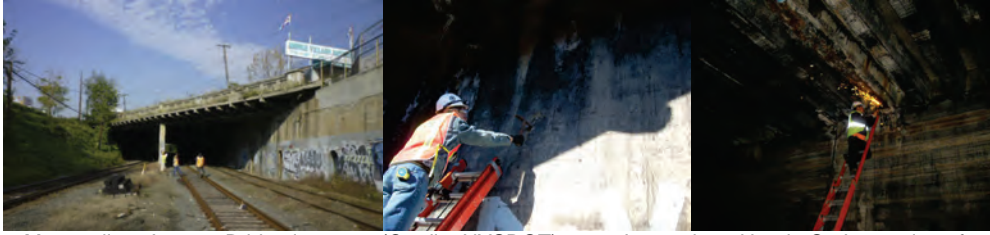
Metropolitan Avenue Bridge in 2009. (Credit: NYSDOT) 2010 Inspection - Hands-On Inspection of A Pier. Obtaining a Steel Coupon Sample From a Stringer.

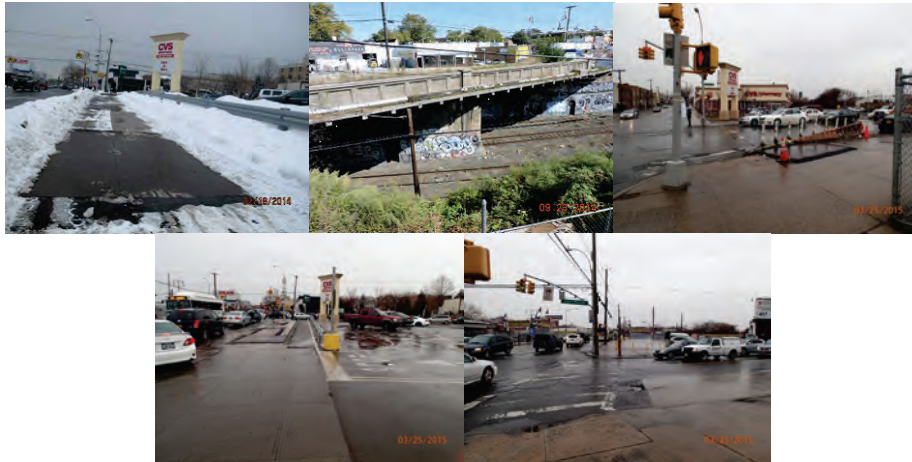
February 2014: View of Plates on Left Sidewalk (Fresh Pond Road). September 2014: Spans 1 and 2 Right Concrete Parapet. (Parapet Credit: NYSDOT) March 2015: Looking West, South, and East Across Bridge Deck.

The concrete deck is in very poor condition with several areas plated over with steel plates in order to maintain vehicular traffic and protect the LIRR below. The department does not have the available personnel or equipment to perform the necessary work. Therefore, the deck needs to be replaced immediately as there is potential for more damage to occur in the near future. The Agency is currently discussing the possibility of declaring that an emergency exists relative to the bridge. Due to the potentially serious danger to life and public safety posed by the current condition, it is critical that the repair work be performed as expeditiously as possible. The general proposed scope of work includes: replacement of the bridge deck, repair of the beam encasements, and necessary steel superstructure and substructure repairs.

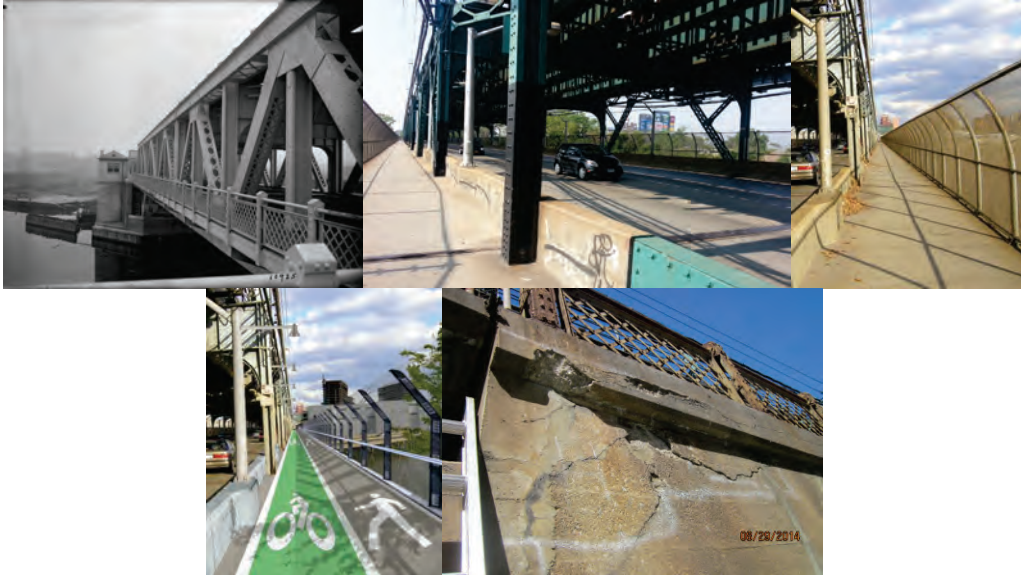
Roosevelt Avenue Bridge – In 1927. (Credit: NYC Records). Looking East. Existing and Proposed Bicycle/Pedestrian Path. 2014: Right Wingwall at the End Abutment. The Top Exhibits an area of Diagonal Cracks With Efflorescence and Spalls. The Deteriorated Concrete Areas are in Safe and Stable Condition. (Credit: NYSDOT)

The project will include the construction of a new concrete-filled steel grid deck, rehabilitation of the existing east and west viaduct sections, bascule span, piers, abutments, removal of the operator houses, and painting of the entire bridge. In addition, a new bicycle/pedestrian path will be constructed on the north and south sides of the bridge.

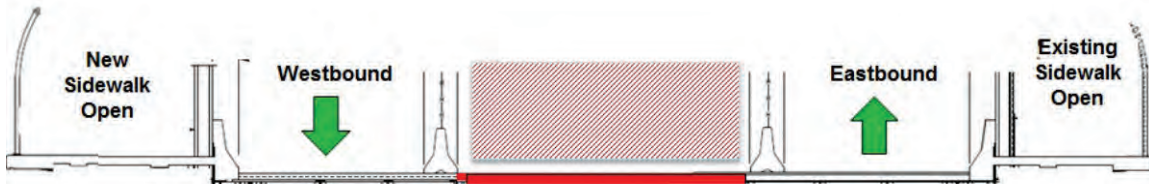
Stage 1 - Corona-Bound - 12 Months. The Two Westbound Lanes and Walkway Will be Closed. All Traffic Shifts Into Eastbound Lanes, One Lane in Each Direction.

Stage 2 - Center Roadway - 12 Months. The Center Roadway will be Closed. All Traffic Shifts to One Eastbound and One Westbound Lane in Each Direction.

The lower level carrying Roosevelt Avenue will be reconstructed in three stages. Both vehicular and pedestrian traffic will be maintained throughout the construction of the bridge, with one lane in each direction.
