## ***DIVISION OVERVIEW***

## ACCOMPLISHMENTS & PLANNED PROJECTS

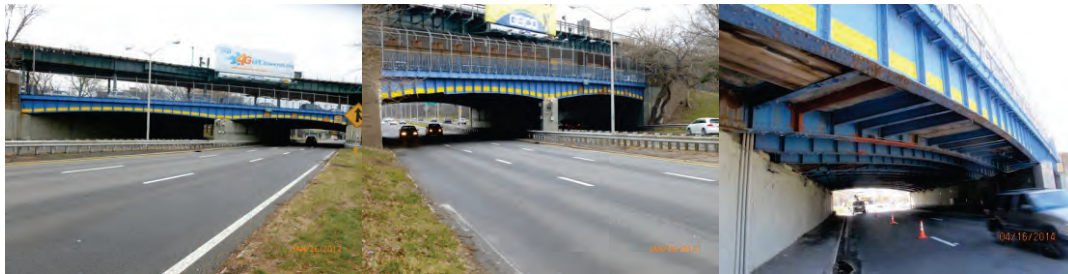
Westchester Avenue Bridge Elevation Left and Right in 2012. (Credit: NYSDOT) April 2014: Span 2 – Deteriorated Areas Shielded With Planks.

The bridge spans over the Hutchinson River Parkway and it supports the NYCT elevated subway structure of the Pelham Bay Line. Six of the transit columns are supported by the bridge girders. The bridge is located between Waters Place and Middletown Avenue. It has four travel lanes with parking lanes and sidewalks on both sides. This two span continuous multi-stringer bridge is supported by reinforced piers and abutments. It was built in 1940 by the Triborough Bridge and Tunnel Authority in conjunction with the construction of the Bronx-Whitestone Bridge approach. No major modifications to the bridge are recorded except for minor repairs at the south approach sidewalk and temporary flag repairs to bridge girders damaged by vehicle impacts in the southbound and northbound roadway. The underdeck at both spans is currently covered by approximately 154 square feet of timber planking. In addition, the underdeck at span 1 is covered with approximately 18 square feet of steel wire mesh netting.

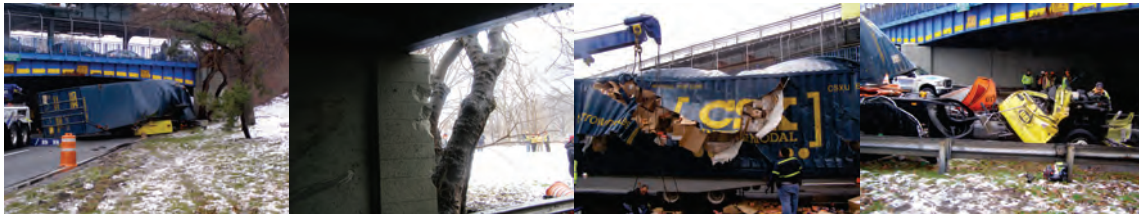
Damaged Bridge, Cargo Container, and Contractor Truck After An Over-Height Trailer Struck the Bridge in January 2012.

The Westchester Avenue Bridge's vertical clearance over the Hutchinson River Parkway is sub-standard. The existing posted vertical clearance of 10'-2" is far less than the 12'-6" minimum vertical clearance required per AASHTO standards for parkways with passenger cars only. Due to the number of truck and bus vehicles that mistakenly enter the Hutchinson River Parkway, where commercial vehicles are not allowed, the fascia steel girders of the bridge have been severely impacted and damaged numerous times. Between 2009 and October 2014, 32 freight vehicles struck this bridge at the southern approach. After a bridge strike, up to a four hour delay may occur before traffic can resume a normal pattern.

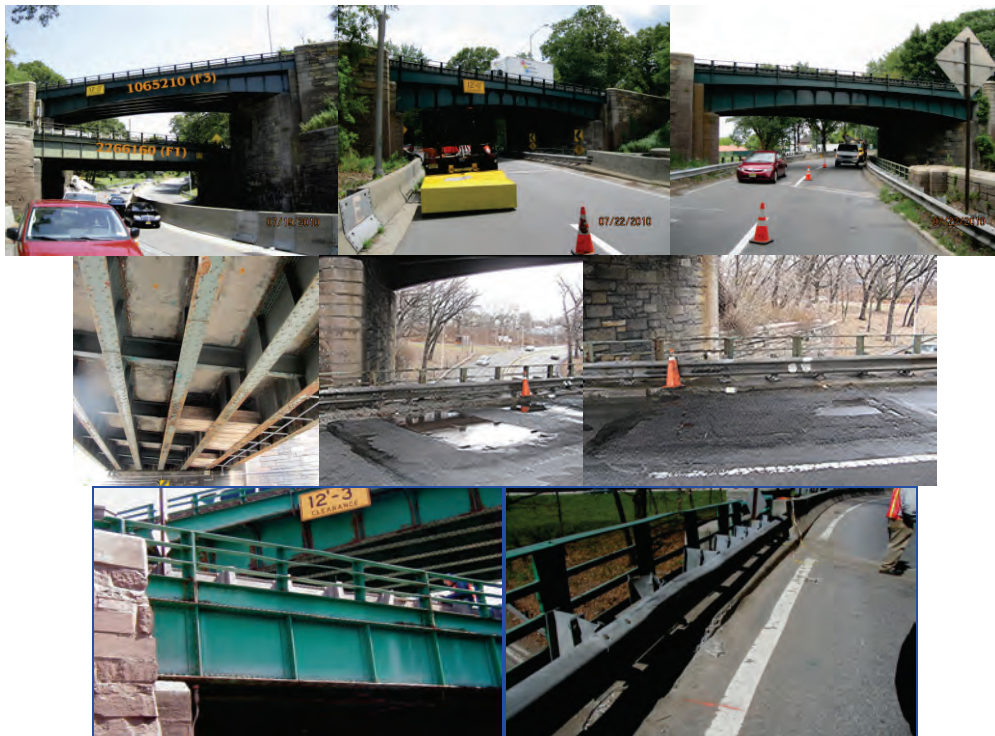
Bridge (Lower Structure) in 2010. Left and Right Elevations. (Credit: NYSDOT) August 2013: Span 1 Underside of Deck from End Abutment, Looking Northwest - Areas of Spalled Concrete Deck Are Protected With Timber Planks. March 2014: Steel Plates on Wearing Surface. South and North Fascia - Along the Fascias are Built-Up Riveted Steel Girders. The Steel Railing Posts are Welded at the Base to the Top Flange of the Fascia Steel Girders.

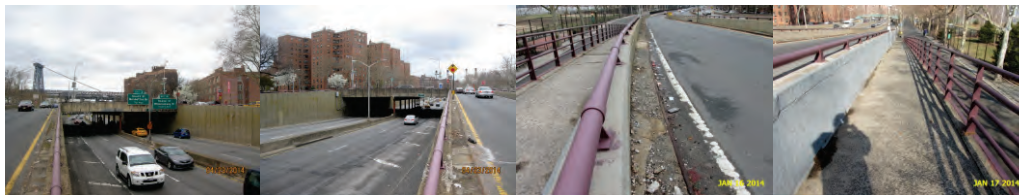
The Three Structures of the FDR Drive at Houston Street Overpass. 2014: Main Bridge – Left and Right Elevations. South Approach Ramp - Span 2, Left Side Safety Walk and Curb. North Approach Ramp - Span 2, Top of Cantilevered Pedestrian Walkway. (Credit: NYSDOT)

The rehabilitation of the two ramp structures (including the adjacent pedestrian ramp), includes the repair of the existing concrete slab and wall structures, removal of asphalt overlay, installation of waterproofing, repair of joints, removal of safety walks, replacing parapets with new concrete barriers, and the placement of new asphalt overlay over the existing deck slabs.

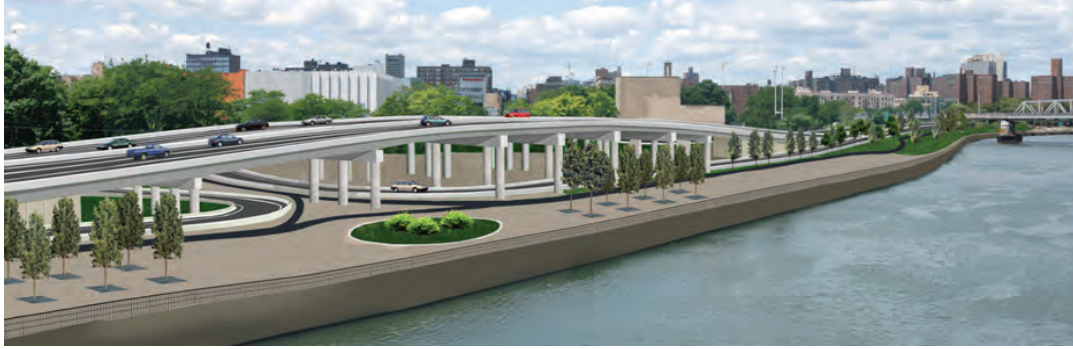
Rendering of New Harlem River Drive Bridge.

This project includes over \$82 million in Federal funds. Construction will follow the on-line bridge replacement with auxiliary exit and entrance lanes and left-lane exit to Second Avenue. It involves the replacement of the existing 11 span bridge and the reconstruction of the Harlem River Drive between the Willis Avenue and Third Avenue Bridges, in addition to various highway improvements. The northbound and southbound structures will share a single south abutment, but will be supported by independent abutments at the north. The new bridge will carry two through lanes in the northbound direction, and three lanes in the southbound direction; each lane will have an average width of 11 feet. The new bridge will also include new fascia and median barriers. The abutments, wingwalls and piers will be replaced with new substructures that will conform to current seismic design criteria. The project length is approximately 3,280 feet.

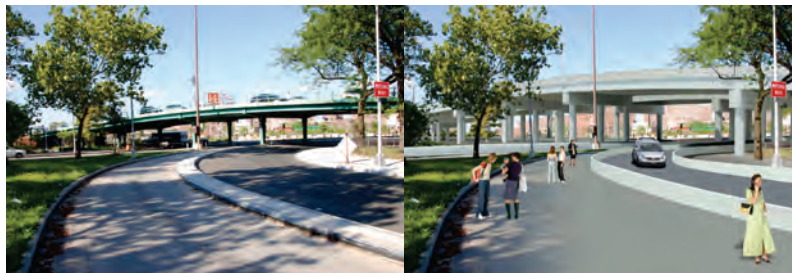
Looking East at the 127<sup>th</sup> Street Off-Ramp: Current and Proposed View.

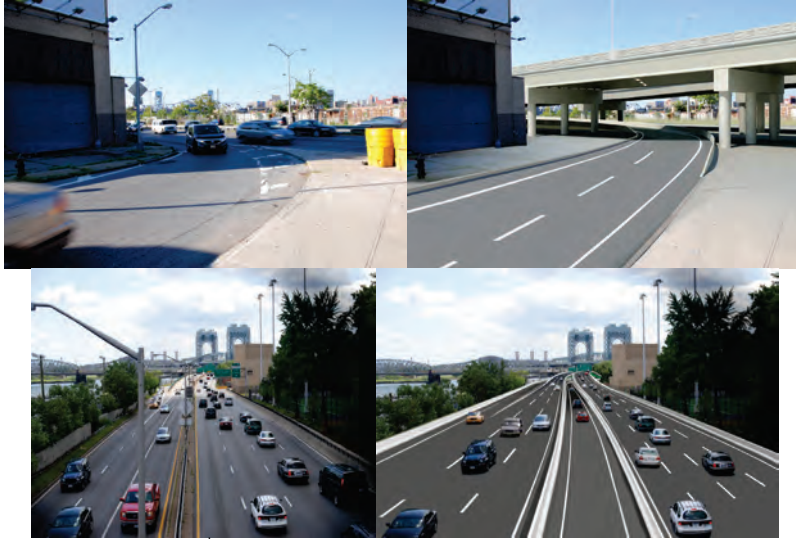
Looking East at 2<sup>nd</sup> Avenue: Current and Proposed View. Looking South From 3<sup>rd</sup> Avenue Bridge: Current Harlem River Drive and 2<sup>nd</sup> Avenue Exit and Proposed Harlem River Drive With Left Lane Exit to 2<sup>nd</sup> Avenue.

The viaduct currently serves approximately 79,000 vehicles per day. This area currently has 40 times the State average number of accidents. Two features of the viaduct contribute to the accidents. First, the hump as the Harlem River Drive passes over East 127<sup>th</sup> Street limits drivers' visibility; vehicles approach the hump at a higher speed only to find slow moving vehicles at the other side of the hump, and too often they are not successful in decelerating or stopping their vehicles on time to prevent an accident. Second, there are weaving movements as vehicles exiting the Third Avenue Bridge enter the southbound Harlem River Drive in the right but try to immediately pull to the left in order to continue their travel further south on the Harlem River Drive and the FDR Drive. At the same time and within the same stretch of highway, vehicles that are in the left lanes of the southbound Harlem River Drive immediately north of the Third Avenue Bridge try to pull to the right in order to exit at Second Avenue. The lack of an appropriate weaving distance is the root of many of the accidents in the area. The project will also allow at-grade access for a future Park/Promenade to be developed by the Department of Parks at 127<sup>th</sup> Street between the Harlem River Drive and the Harlem River. A Notice to Proceed for the reconstruction of this bridge was issued to the contractor with a start date of November 10, 2014.

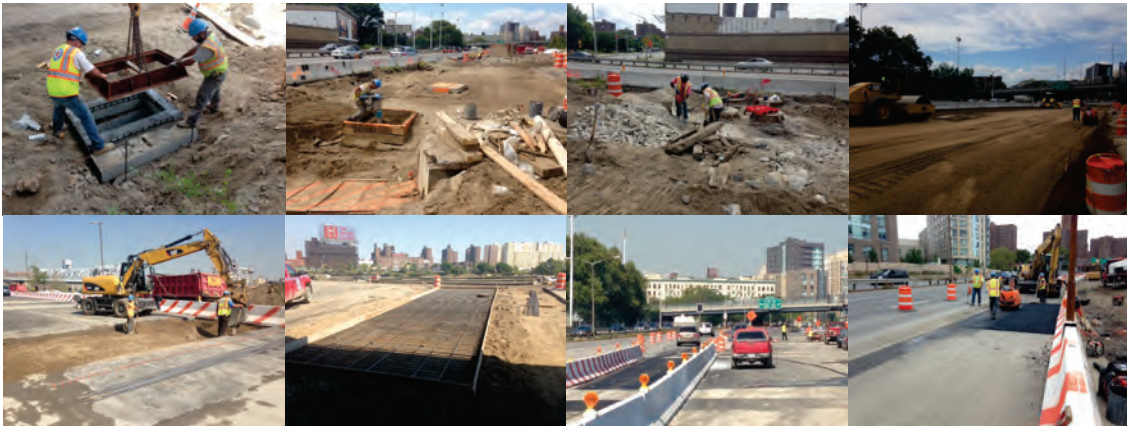
August 2015: Backfilling Utilities at Second Avenue. Contractor Working on the Temporary Roadway Placing the Sub-Base Second Layer. September 2015: Preparing New Concrete Crane Pads With Reinforcement. Painted Concrete Barriers Near Ramp C and Temporary Roadway. October 2015: Adjusting the Grading on the New Temporary Roadway. (Credit: Artemio Angeles)

This project will be completed in five stages in order to maintain the traffic flow on the active highway throughout the duration of the project. Stage 1 included the closure of the 127<sup>th</sup> Street northbound exit, construction of a temporary roadway for the northbound traffic, and relocation of traffic onto the temporary roadway. Stage 2 will include the relocation of three southbound traffic lanes to the existing northbound structure, demolition of the existing southbound structure, construction of the future southbound structure, and relocation of two southbound traffic lanes onto new southbound structure. Stage 3 will include the construction of the remaining portion of the southbound structure and the relocation of the remaining southbound traffic. Stage 4 will include the closure of the 2<sup>nd</sup> Avenue southbound exit, the relocation of two northbound traffic lanes onto future southbound structure, and the construction of northbound structure. Finally, Stage 5 will include opening the northbound lanes and the southbound 2<sup>nd</sup> Avenue exit, relocating the two northbound traffic lanes to the new northbound structure, and removing all of the temporary pavement near the East 127<sup>th</sup> Street viaduct.

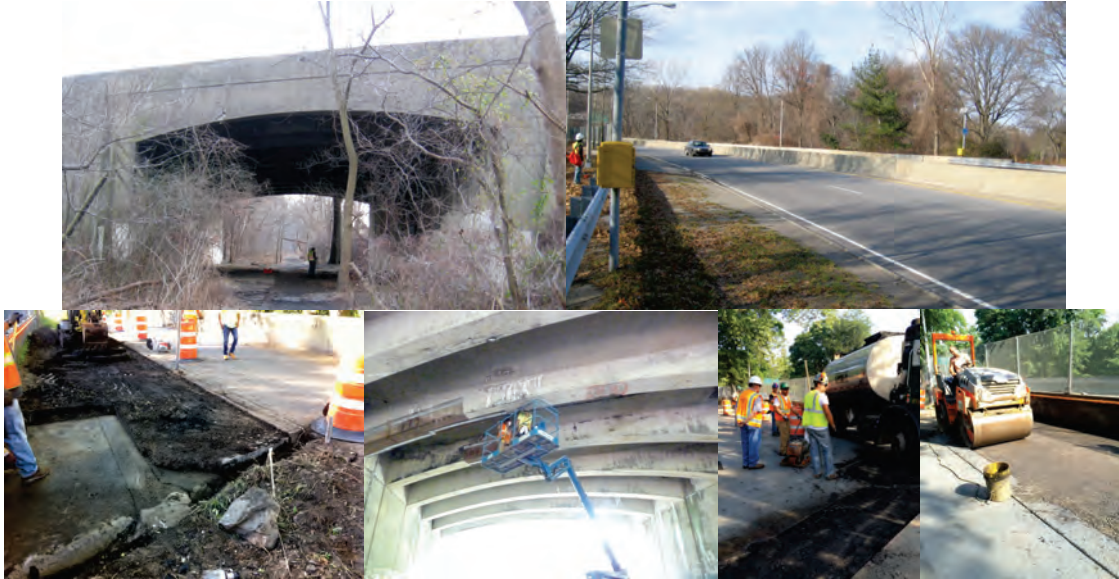
Mosholu Parkway Bridge over Conrail (Abandoned). Conditions in June 2015. Asphalt Work in July.

The Moshulu Parkway Bridge over Conrail (Abandoned) was built in 1939. It is a single span concrete arch bridge. There is a concrete parapet along both the north and south fascia of the bridge. The existing bridge geometry consists of two travel lanes and a shoulder in each direction, divided by a 4'-0" wide concrete median barrier, as well as a 15'-wide asphalt path for golf carts and pedestrians on the south side of the bridge. The scope of rehabilitation work includes the following: removing and replacing the asphalt overlay, waterproofing, pavement striping, north fascia barrier replacement and median barrier repairs, corrugated guide rail transition, and wingwall joint filler; removing, storing and reinstalling lighting lampposts on north fascia barrier and replacing luminaires with new luminaires; installing a temporary lighting system; excavating, backfilling and paving the local depression in the asphalt golf cart path; repairing

chain link fence section and concrete on the underdeck and abutment walls; installing weepholes in the abutments and preformed joint seal in the concrete parapet; cleaning and flushing catch basins; and removing graffiti by power wash and applying anti-graffiti protective coating. Vehicular and pedestrian access will be maintained during the 5-month rehabilitation period. Construction work began in June 2015. The project involves nighttime closures.

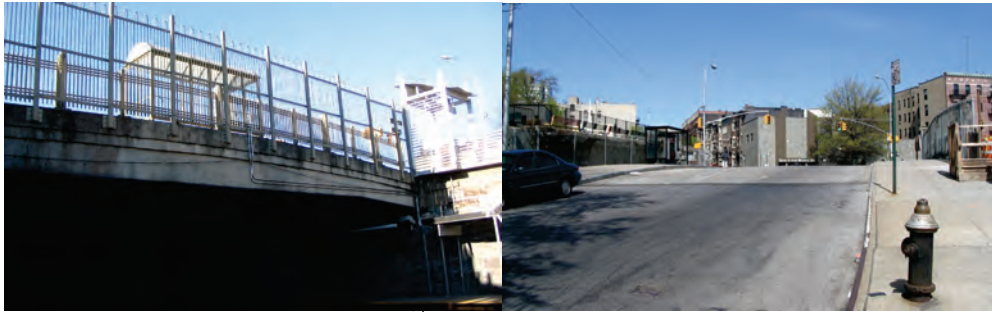
East 162<sup>nd</sup> Street Bridge over MNRR.

The East 162<sup>nd</sup> Street Bridge over Metro North was built in 1888. It is a single span steel jack arch bridge with built-up steel beams encased in concrete. There is a fence along both the north and south fascia of the bridge as well as a non-standard decorative bridge rail along the north fascia. The existing bridge geometry consists of one travel lane, a parking lane and a sidewalk in each direction. The scope of rehabilitation work shall include the following: locally removing and replacing the asphalt and concrete overlays and sidewalk; installing pavement striping; repairing guide railing, concrete on the underdeck and abutment, and cracks in the asphalt overlay and

sidewalk; cleaning and painting steel surfaces locally; resealing sidewalk joints; and repointing stone masonry. Vehicular and pedestrian access will be maintained during the estimated 4-month rehabilitation period.

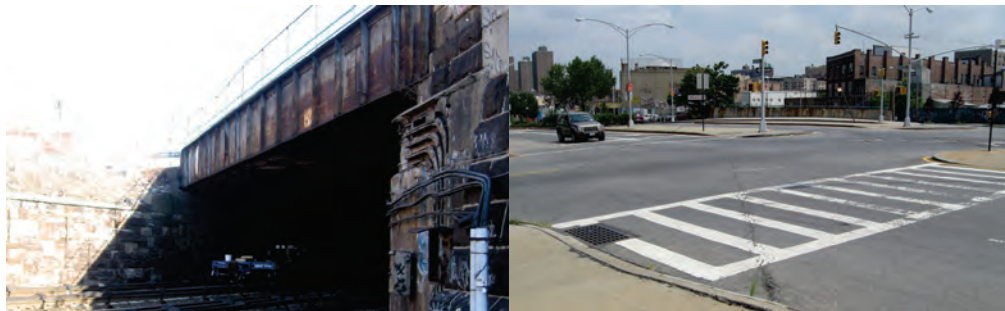
East 165<sup>th</sup> Street Bridge over MNRR.

The East 165<sup>th</sup> Street Bridge over Metro North was built in 1897. It is a single span steel jack arch bridge with built-up steel beams encased in concrete. . A chain link fence runs in front of steel railing atop both the west and east fascia of the bridge. The existing bridge geometry consists of one travel lane in each direction on East 165<sup>th</sup> Street, and one travel lane, a turning lane and a sidewalk in each direction on Melrose/Webster Avenue. The scope of rehabilitation work shall include the following: locally removing and replacing the asphalt overlay and sidewalk; repairing the concrete underdeck; cleaning and painting steel surfaces; resealing sidewalk joints; installing new multi-rotational bearings at the south abutment; partially removing and replacing the bridge seat at the new bearing locations; installing a temporary support system; and performing jacking operations. Vehicular and pedestrian access will be maintained during the estimated 8-month rehabilitation period.

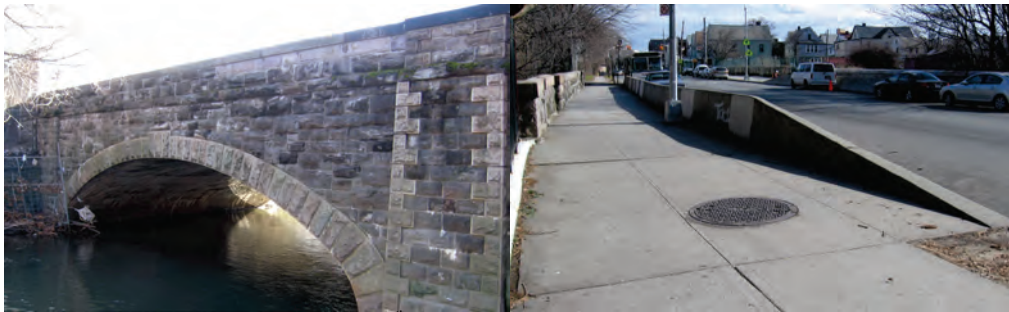
East 180<sup>th</sup> Street Bridge over Bronx River.

The East 180<sup>th</sup> Street Bridge over Bronx River was built in 1925. It is a single span concrete arch bridge with stone masonry facing. The bridge has a parapet at both the north and south fascia. The existing bridge geometry consists of one travel lane, a parking lane and a sidewalk in each direction; the sidewalks on both sides are protected from the roadway by a concrete barrier. The scope of rehabilitation work shall include the following: replacing pedestrian railing; repairing concrete underdeck, crack, spall and joint seal in concrete barrier, and the retaining wall at the northwest corner of the bridge; resealing sidewalk joints; repointing stone masonry and stone coping mortar joint; cleaning drain holes in the concrete barrier; removing a tree from the south fascia and northwest retaining wall; and removing graffiti by power wash and applying anti-graffiti protective coating. Vehicular and pedestrian access will be maintained during the estimated 4-month rehabilitation period.

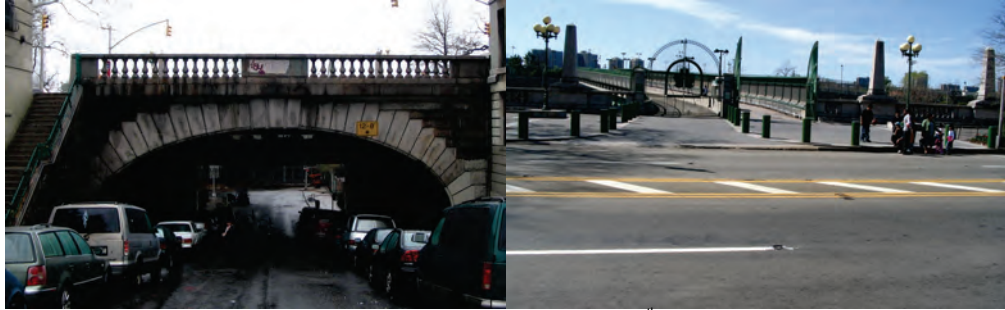
Riverside Drive Bridge over West 138<sup>th</sup> Street.

The Riverside Drive Bridge over West 138<sup>th</sup> Street was built in 1920. It is a single span concrete arch bridge with stone masonry facing on the abutments and spandrel walls. There is a stone parapet on the east and the west side of the bridge. The existing bridge geometry consists of two travel lanes and a parking lane in each direction; the bridge also contains a sidewalk on the east side and an entrance to Riverbank State Park on the west side. The scope of rehabilitation work shall include the following: removing and replacing the asphalt overlay; repairing granite and brick pavers and concrete on the underdeck and sidewalk; repointing and repairing cracks in stone masonry joints; resealing underdeck joints; installing weepholes in the concrete underdeck; installing pavement striping; removing graffiti by power wash and applying anti-graffiti protective coating; cleaning and painting steel staircase railing and bollards; and replacing lighting fixture and refurbishing existing fuse box. Vehicular and pedestrian access will be maintained during the estimated 4-month rehabilitation period.

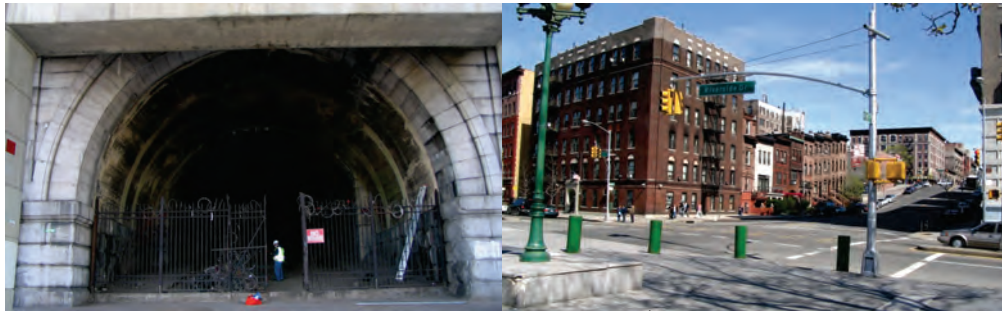
Riverside Drive Bridge over West 145<sup>th</sup> Street.

The Riverside Drive Bridge over West 145<sup>th</sup> Street was built in 1930. It is a single span concrete arch bridge with stone masonry facing on the abutments and west spandrel wall. There is only one fascia on this bridge; the east side of the arch bridge is a filled backwall. There is a stone parapet on the west side of the bridge. The existing bridge geometry consists of two travel lanes and a parking lane in each direction; the bridge also contains an entrance to Riverbank State Park on the west side. The scope of rehabilitation work shall include the following: clearing and grubbing; removing and replacing the asphalt overlay, concrete overlay, waterproofing membrane and granite and brick pavers; repairing concrete on the underdeck; repointing and repairing cracks in stone masonry joints; resealing underdeck joints; installing pavement striping; removing graffiti by power wash and applying anti-graffiti protective coating; removing and resetting steel gate; and cleaning and painting bollards. Vehicular and pedestrian access will be maintained during the estimated 4-month rehabilitation period.

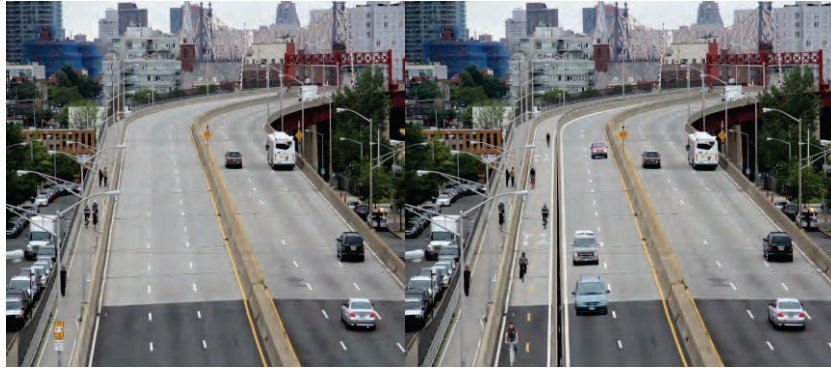
Existing and Planned Condition.

the bascule leaves to accommodate the load of the new barrier; and installing pavement markings and signs for the new bicycle path. Construction work began in September 2015.

By the end of 2015, all cast-in-place concrete barrier closure sections in Queens and Brooklyn were placed, the Brooklyn approach embedded precast concrete barriers were marked by the surveyor, reinforcement was completed for the cast-in-place concrete barrier on the turning lane to the bridge from Jackson Avenue, and the pedestrian/bicycle safety rails were fabricated off-site and delivered to the contractor. Both pre-cast and cast-in-place barriers are required because the cast-in-place sections are anchored to the bridge deck while the pre-cast sections are not. This enables the barriers to perform as a system, protecting all bridge users, by absorbing the energy if struck by a passing vehicle. The project involves nighttime and midday car lane closures, but bicycle and pedestrian access to the bridge are being maintained at all times during construction.

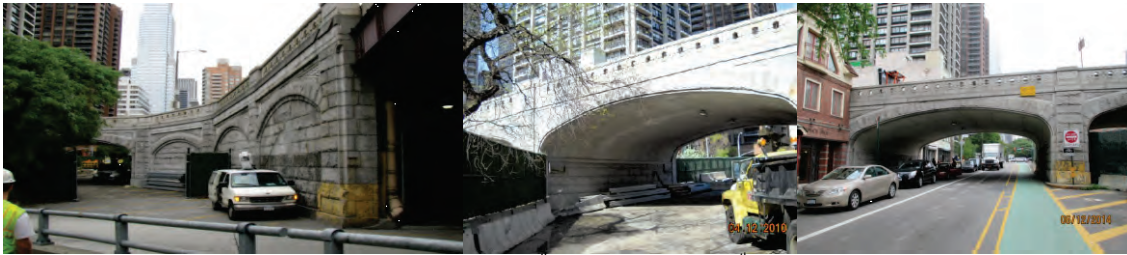
Ramp to the Ed Koch – Queensboro Bridge from East 58<sup>th</sup> Street over East 59<sup>th</sup> Street. Span 10 – Left Elevation. Span 11 – Left Side of Structure. (Spans 10 and 11 Credit: NYSDOT)

The Ramp to the Ed Koch – Queensboro Bridge from East 58<sup>th</sup> Street over East 59<sup>th</sup> Street was built in 1929. It is a twelve span ramp and carries two reversible travel lanes of traffic to (normal daily hours) and from (weekdays morning rush hours only) the Ed Koch - Queensboro Bridge south upper roadway. The bridge has a half jersey barrier running along both sides of the roadway and approaches. The scope of rehabilitation work includes the following: removing the concrete wearing surface and replacing with a thin polymer concrete overlay; repairing the deteriorated sections of concrete deck slab; removing armored joints and replacing with armorless joint system; removing and repairing the concrete in piers, the underside of the deck and the curtain walls; repointing of the stone masonry joints; repairing traffic signs and providing new pavement striping; and applying anti-graffiti coating on the repaired concrete surfaces. Vehicular and emergency access will be maintained during the estimated 5-month rehabilitation period.

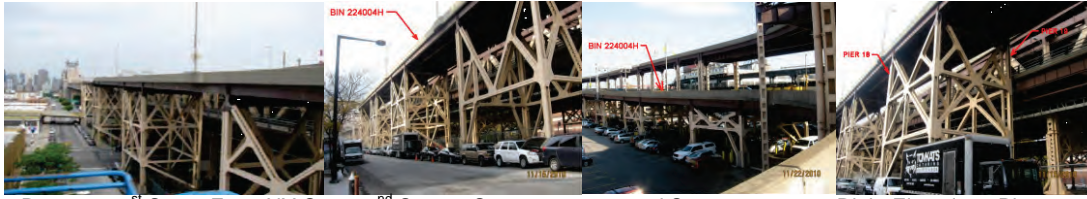
Ramp to 21<sup>st</sup> Street From NY Over 22<sup>nd</sup> Street. Spans 16 to 21, and Spans 22 to 38 – Right Elevation. Piers 18 and 19. (Spans and Piers Credit: NYSDOT)

The Ramp to 21<sup>st</sup> Street from NY over 22<sup>nd</sup> Street was built in 1929. It is a 43 span bridge ramp and carries two reversible travel lanes of traffic to (weekdays morning rush hours only) and from (normal daily hours) the Ed Koch - Queensboro Bridge's south upper roadway in one direction. The width of the bridge varies throughout the spans. The bridge has a half jersey barrier running along both sides of the roadway and the approaches. The bridge superstructure consists of four different types of framing plans and the bridge deck consists of a galvanized stay in place form, concrete filled steel grating and a monolithic concrete overfill. The scope of rehabilitation work includes the following: removing and replacing the concrete wearing surface with a thin polymer concrete overlay; repairing the deteriorated concrete deck slab locations; replacing armored joints with a new armorless joints system; repairing the concrete on the abutment; retrofitting the bearings; improving drainage by cleaning the scuppers; repairing the damaged traffic signs, and providing new pavement striping. Vehicular and emergency access will be maintained during the estimated 8-month rehabilitation period.

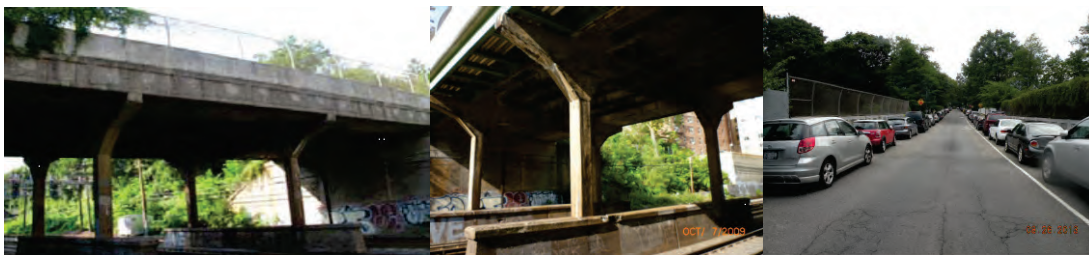
80<sup>th</sup> Road Bridge over LIRR Main Line. Piers 1 and 2. End Approach. (Pier and Approach Credit: NYSDOT)

The 80<sup>th</sup> Road Bridge over LIRR Main Line was built in 1909. It is a three span bridge over four railroad tracks. It carries one travel lane, parking lanes on each side, and a bike lane. The bridge has a sidewalk and a concrete parapet with chain-link fence running along both sides of the roadway and approaches. The bridge superstructure mostly consists of concrete encased steel girders with two exposed steel girders at the south fascia of the bridge. The scope of rehabilitation work includes the following: removing and replacing the north sidewalk, curb, parapet, and removing the sand fill in north sidewalk bay; removing the deteriorated concrete in the girders' encasement, north fascia, and underside of the deck; removing and replacing the asphalt wearing surfaces on the bridge and at the approaches; removing and replacing the existing northeast and southeast approach sidewalks, and erecting a temporary support shield on railroad tracks. Vehicular and pedestrian access will be maintained during the estimated 7-month rehabilitation period.

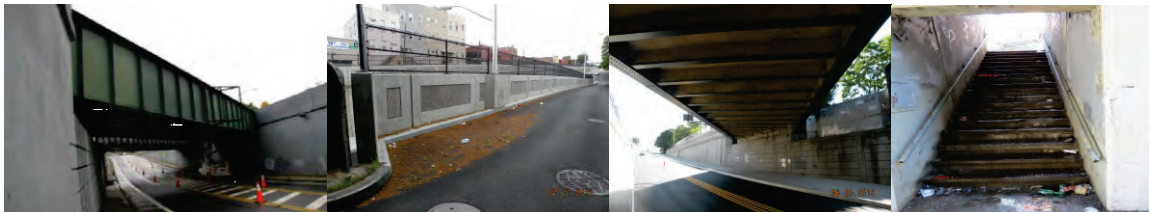
71<sup>st</sup> Avenue Bridge over Cooper Avenue. Left Concrete Parapet/Guide Rail. Span 1 Bridge Framing. (Parapet and Span Credit: NYSDOT) Stairway at Right Side of Beginning Abutment.

The 71<sup>st</sup> Avenue Bridge over Cooper Avenue was built in 1934. It is a single span bridge and carries one travel lane, a sidewalk and through girders (acting as a railing), running along both sides of the roadway. The scope of rehabilitation work includes the following: removing and replacing the asphalt wearing surfaces on the bridge and approaches; repairing the concrete on the abutments, wing-walls, and underside of the deck; constructing a retaining wall at the south west corner; removing and reconstructing the concrete curb, sidewalk and driveway at the east approaches, and improving the existing under deck lighting. Vehicular and pedestrian access will be maintained during the estimated 3-month rehabilitation period.

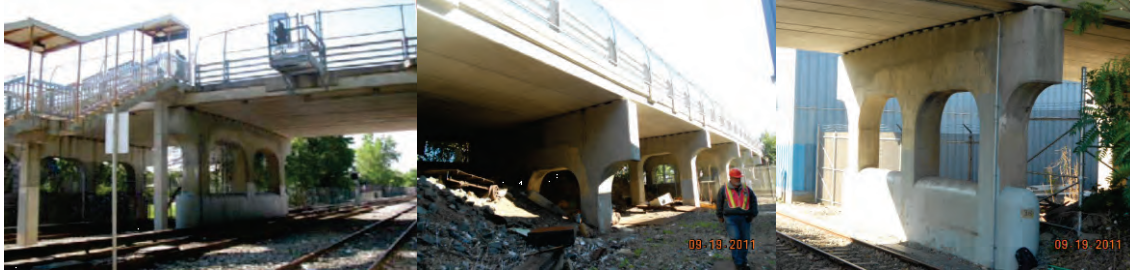
Hannah Street Bridge Over SIRT South Shore. Spans 1-4 - Right Elevation. Pier 3.  
(Span and Pier Credit: NYSDOT)

The Hannah Street Bridge over SIRT South Shore was built in 1935. It is a ten span bridge and carries one travel lane in each direction, a sidewalk, a railing and a steel mesh fence running along both sides of the roadway and approaches. The bridge deck has a steel bridge railing with a chain-link fence running alongside the roadway and approaches. The bridge deck consists of a reinforced concrete slab with integral wearing surface and prestressed concrete beams. The scope of rehabilitation work includes the following: removing and replacing the existing deck and

approaches' wearing surface; waterproofing; repairing the concrete on the abutments, piers and the underside of the deck; removing existing armored joints and replacing with armorless joint systems; cleaning of the curbs; repairing the embankment on the north east approach, and providing new striping. Vehicular and pedestrian access will be maintained during the estimated 3-month rehabilitation period.

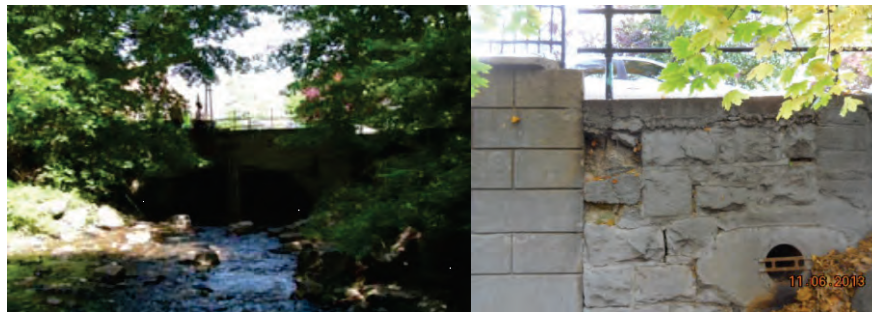
Forest Avenue Bridge Over Clove Lakes Park Stream. End Right Wingwall.  
(Wingwall Credit: NYSDOT)

The Forest Avenue Bridge over Clove Lakes Park Stream was built in 1906. It is a single span concrete arch bridge and carries one travel lane in each direction, a sidewalk, and a small parapet and low railing running along the southern sidewalk. The bridge deck has an asphalt wearing surface. The scope of rehabilitation work includes the following: removing and replacing the existing nonstandard railing with a standard bridge railing; repairing the concrete on the deteriorated sections of sidewalk; cleaning and repointing of the mortared joints at the wing-walls; installing a new guide railing at the bridge approach; and providing tree and landscape protection within the park land during construction and restoration after construction. Vehicular and pedestrian access will be maintained during the estimated 3-month rehabilitation period.

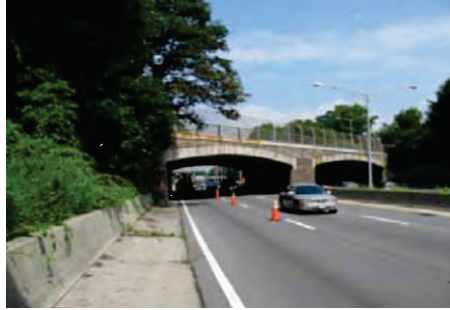
Douglaston Parkway Bridge Northbound Over Cross Island Parkway.

The Douglaston Parkway Bridge northbound over Cross Island Parkway was built in 1939. It is a single span bridge over three lanes on the northbound Cross Island Parkway and carries one travel lane, sidewalk, a wide shoulder, and a median. The bridge has a steel bridge railing with a chain-link fence running alongside of the roadway and approaches. The bridge superstructure consists of reinforced concrete beams acting as a rigid frame. The deck consists of a reinforced concrete slab with a concrete fill course and asphalt wearing surface. The scope of rehabilitation work includes the following: removing and replacing the bridge and approaches' asphalt wearing surfaces, repairing of concrete on abutments and the underside of the deck; cleaning and re-pointing of the mortared joints in the masonry wing walls; removing and replacing the concrete curbs at the approaches, improving lighting on the underside of the deck; providing new pavement striping, saw cutting the bridge joints on the roadway, and sealing with a sealant. Vehicular and pedestrian access will be maintained during the estimated 3 - month rehabilitation period.

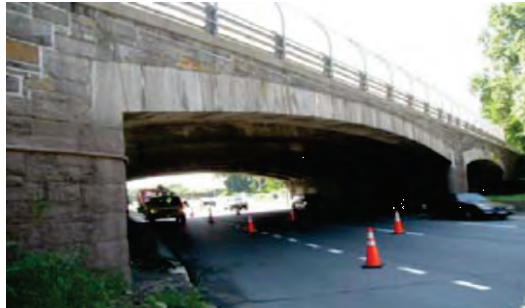
Douglaston Parkway Bridge Southbound Over Cross Island Parkway.

The Douglaston Parkway Bridge southbound over Cross Island Parkway was built in 1939. It is a single span bridge over three lanes on the southbound Cross Island Parkway and carries one travel lane, sidewalk, wide shoulder, and a median. The bridge has a steel bridge railing with a chain-link fence running alongside of the roadway and approaches. The bridge superstructure consists of reinforced concrete beams acting as a rigid frame. The deck consists of a reinforced concrete slab with a concrete fill course and an asphalt wearing surface. The scope of rehabilitation work includes the following: removing and replacing the bridge and approaches' asphalt wearing surfaces; repairing the concrete on the abutments and the underside of the deck; cleaning and re-pointing of the mortared joints in the masonry wing walls; removing and replacing the concrete curbs at the approaches; improving the lighting on the underside of the deck; providing new pavement striping, saw cutting bridge joints on roadway, and sealing with a sealant. Tree and landscape protection will be provided during the construction. Vehicular and pedestrian access will be maintained during the estimated 2-month rehabilitation period.

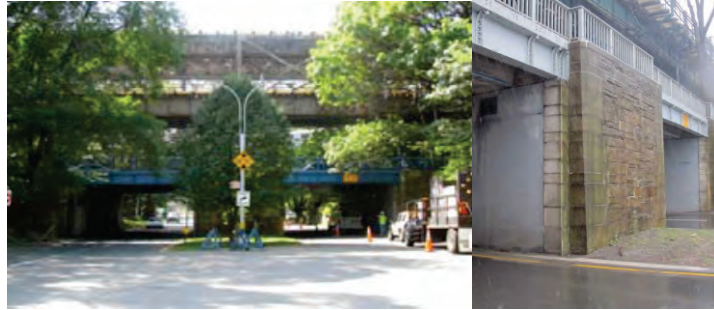
Roosevelt Avenue Bridge Over Flushing Meadow Park Road.  
Left Side Span 2.

The Roosevelt Avenue Bridge over Flushing Meadow Park Road was built in 1936. It is a four span bridge and carries two travel lanes in each direction, a wide sidewalk, and a railing running along both sides of the roadway and approaches. The bridge deck has a steel bridge railing with a chain-link fence running alongside the roadway and approaches. The bridge consists of a reinforced concrete slab. The scope of rehabilitation work includes the following: removing and replacing the existing deck and approaches' asphalt overlay, waterproofing membrane, and sidewalks; repairing the concrete on the abutments and underside of the deck; improving the existing roadway lighting and drainage systems; repointing the mortared joints in the wing-walls and piers; and providing new pavement striping. Tree and landscape protection will be provided during the construction. Vehicular and pedestrian access will be maintained during the estimated 5-month rehabilitation period.

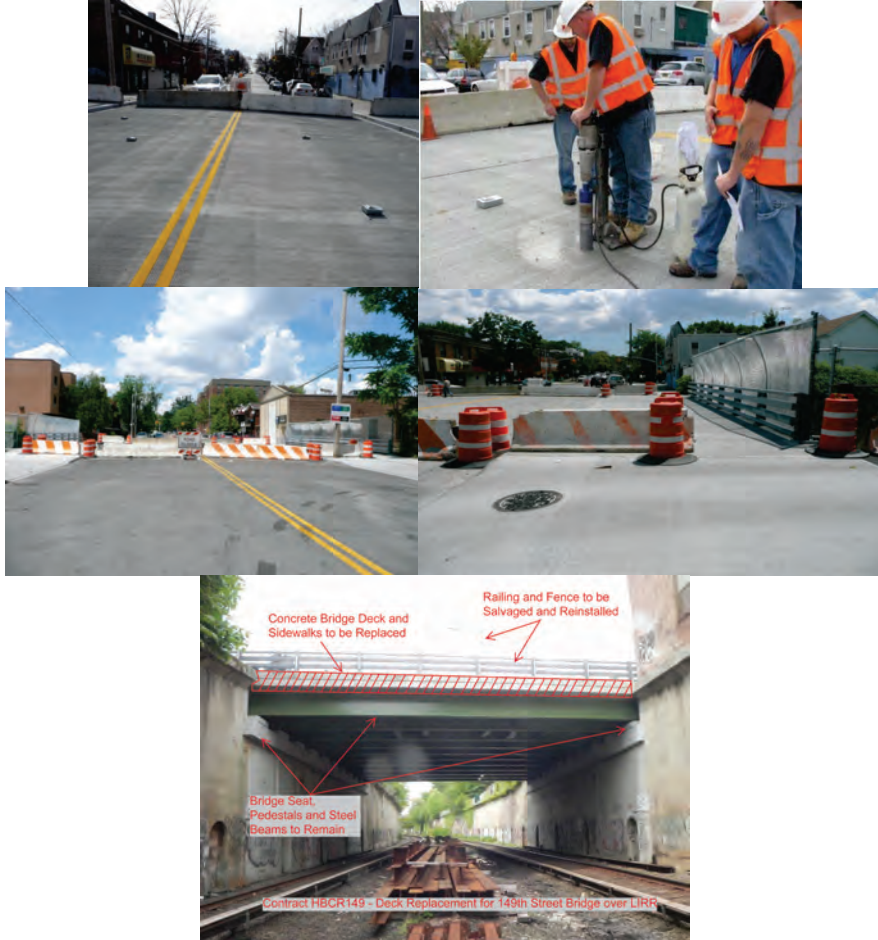
2014: Monitoring the Deck With Sensors. Taking Core Samples for Testing. Bridge is Closed to Traffic but Reopened for Pedestrians in June 2012.

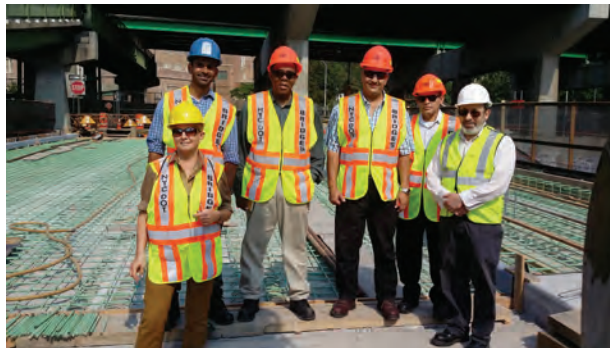
September 2015: Inspecting the Preparations for the Bridge Deck Concrete Pour at the Bryant Avenue Bridge over AMTRAK and CSXT. Assistant Civil Engineer Evgenia Campbell, Assistant Electrical Engineer Satpaul Jaswal, Director of In-House Design Ferdinand John, and Civil Engineers Kirolos Dimian, Kamran Sikandar, and Lev Gold. (Credit: Ludner Charles)

The Bryant Avenue Bridge over Amtrak and CSXT in the Bronx was designed by unit staff and is expected to remain under construction until early 2016. This is a one span structure with a span length of 90 feet. This project includes replacement of the steel superstructure, bearings, approaches, water mains, and rehabilitation of the abutments. The new superstructure consists of a reinforced concrete deck over prestressed concrete adjacent box beams. The two existing water mains will be replaced with two new pipes on top of the north sidewalk in a fenced-off area. As the designer of the bridge, In-House Design has also been involved in the construction support services for the duration of construction.

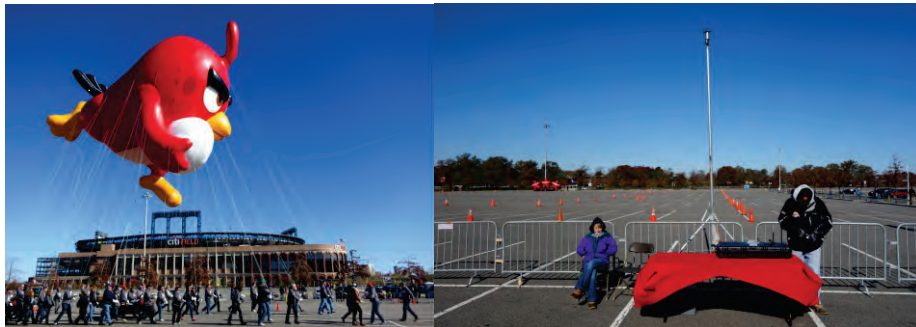
Balloons in Flushing on November 8. Angry Bird in Level Flight. Anemometer Station and Crew.

Division engineers reviewed and approved the design specifications of Scrat, Ronald McDonald, Angry Bird, and Dino, four new large balloons to be introduced in the parade. Director of Engineering Review Uday Dommaraju, Construction Project Manager George Jarvis, and two consultant engineers attended the test flights of the balloons at the CitiField parking lot in Flushing on November 8, 2015, with NYPD and other agencies. A wireless anemometer station was set up to give real time wind speed, and cones were placed out simulating the street envelope. Macy's performed test flights on each new balloon according to the current wind gust, and flew the balloons to the required flying height.

On November 26, 2015, wind speeds were relatively low and all 17 large balloons flew in the parade without incident. The wind gusts varied between 9 to 15 miles per hour. Chief Bridge Officer Robert O. Collyer, Director of Engineering Review Uday Dommaraju, Civil Engineers Ashok Chintakunta and Dilip Biswas, and College Aide Ediant Martinaj, and four consultant engineers were positioned at various locations along the parade route to observe compliance with the approved procedures. Seven anemometers were mounted on top of light poles along the route between 77<sup>th</sup> Street and 34<sup>th</sup> Street to measure the wind speed during the parade. Division and consultant engineers were assigned to the anemometer locations to monitor the wind gusts.

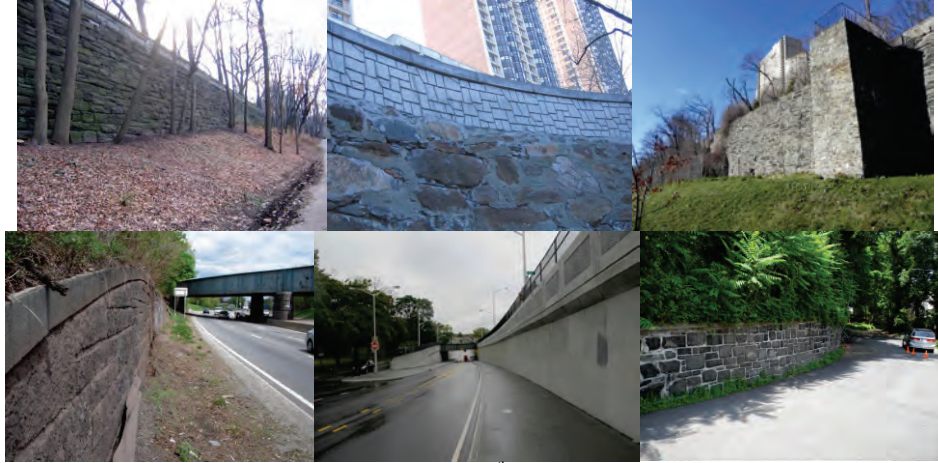
Retaining Walls: Southeast Corner of West 108<sup>th</sup> Street and Riverside Drive. Left Side of Ramp From Riverside Drive to George Washington Bridge. Irwin Avenue. Cross Island Parkway Southbound Before 100<sup>th</sup> Avenue. Cooper Avenue. Douglas Road.

In May 2005, the Department started a program for the periodic inspection of City-owned retaining walls. The City currently owns 634 retaining walls. Those retaining walls were built during the interstate construction program between the 1940's and 1970's and are an important part of the city's street infrastructure. However, some of them are approaching the end of their service lives and are falling into poor condition due to various factors such as spalling/cracking of concrete, loosened mortar joints, broken stone masonry, falling coping stones, deteriorated joints, leakage through the walls due to improper drainage arrangements (clogged weep holes), bulging of walls due to hydrostatic pressure build-up on the back of the walls, and many other problems. In order to protect the infrastructure they support, the retaining walls require regular inspections and monitoring, and depending upon the condition of the walls, rehabilitation/replacement is required. Since 2005, 18 retaining walls have completed rehabilitation/replacement, and 17 retaining walls are in various stages of design and construction. The retaining walls which are in fair to poor condition will be in a capital program for future rehabilitation.

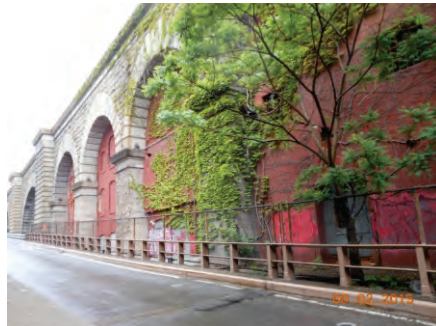
The Brooklyn Bridge Manhattan Approach, Arch Block B Elevation.

In 2014, an existing engineering services agreement (ESA) contract was used to install a remote monitoring system on selected spans of the Manhattan approach to the Brooklyn Bridge. Under the ESA, select locations were instrumented with fiber optic sensors that allow for real time, on-line monitoring of existing flagged conditions. Crack sensors, displacement sensors, temperature sensors, and tilt meters were utilized to monitor changes of crack widths, foundation settlement, temperature fluctuation, and wall rotation, respectively. The system was also designed to send out alert messages to Division personnel should certain conditions arise during the monitoring of these flags. The sensors have demonstrated which flagged conditions are the most active and will need to be watched carefully. The sub-consultant is recently completed the migration of the web-based system from their own servers to a cloud-based storage solution under the control of the Agency's information technology department. With the delay in the upcoming rehabilitation contract, this system has taken on added importance.

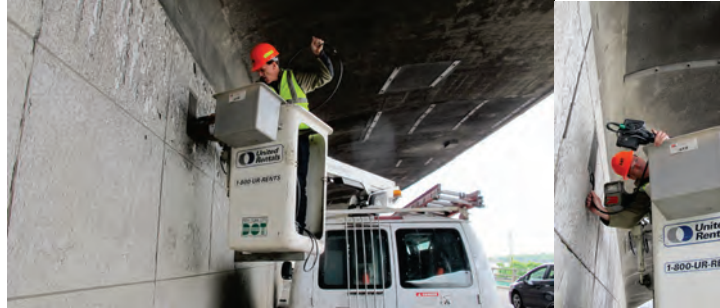
June 2015: Director of Bridge Management Kevin McNulty Inspecting the Brooklyn-Queens Expressway Between Cadman Plaza and Atlantic Avenue With a Borescope. (Credit: Bojdar Yanev)

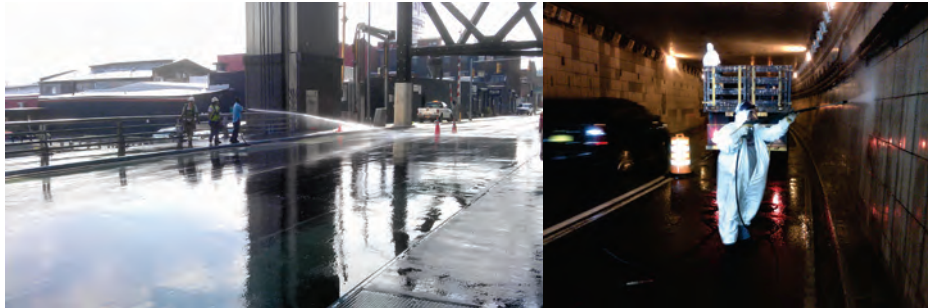
Water Spraying the 9<sup>th</sup> Street Bridge over Gowanus Canal in July 2012. July 2013: Power Washing the Battery Park Underpass. (Credit: Earlene Powell)

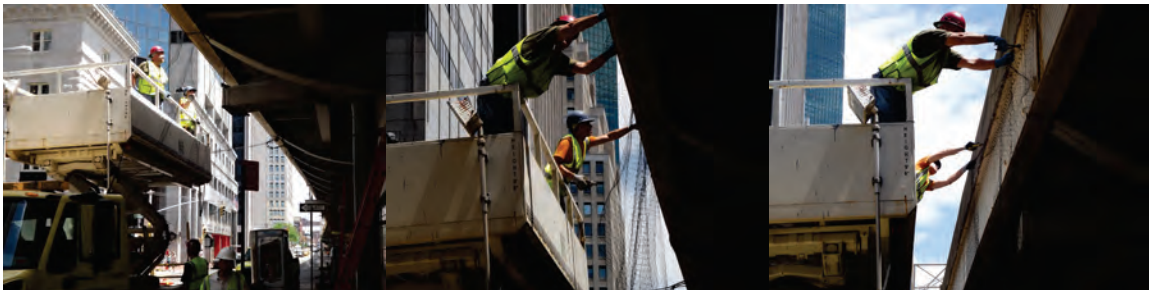
Installing Pigeon Netting at Old Slip (FDR Drive at the South Street Viaduct) in June 2012: Carpenters Stephen Buckley, William Sic, and Joseph Moschella, and Supervisor Carpenter Joseph Vaccaro. (Credit: Thomas Whitehouse)

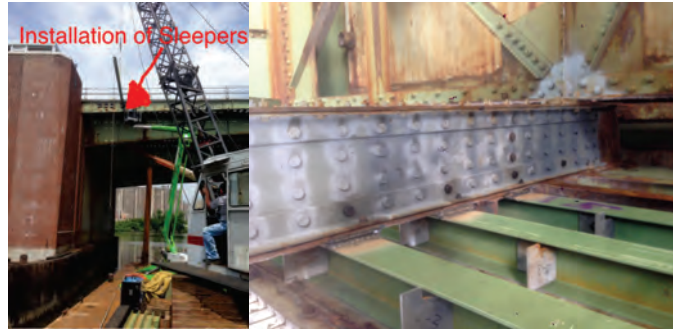
Hutchinson River Parkway Bridge - Installation of Sleeper Steel Beams to Directly Support the Steel Grating.

On the heavily traveled Hutchinson River Parkway Bridge over Hutchinson River, severe deterioration of key structural steel elements supporting the steel grid deck of the southeastern quadrant of the span forced urgent measures to be taken, first, by providing immediate temporary replacements to take over part of the lost support capability, and subsequently, by installing new steel replacement "sleeper" beams and heavy local support at deteriorated stringer sections.

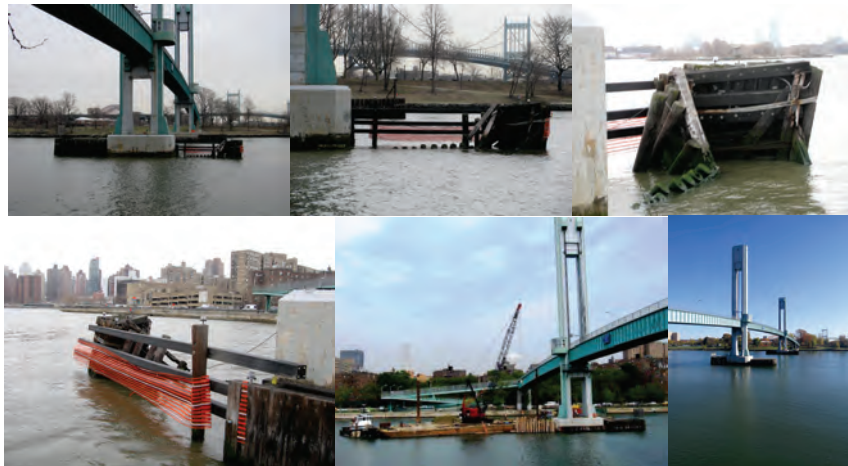
2014 - Wards Island Pedestrian Bridge – Collapsed Fender. July 2015 – Work Barge. November 2015. (2015 Credit: Jitendra Patel)

The southwest fender system of the Wards Island Pedestrian Bridge was severely battered by an impact from a large barge, leaving its timber structure dislocated, damaged and incapable of providing the designed protection from future barge hits. It was immediately necessary to temporarily provide safety measures to warn off mariners from coming too close to the debris field created as a result of that impact. Construction of a complete replacement fender system commenced in 2014 after a series of temporary measures were taken to protect the west tower of the bridge. Installation of an entirely new southwest fender replacement was completed in 2015.

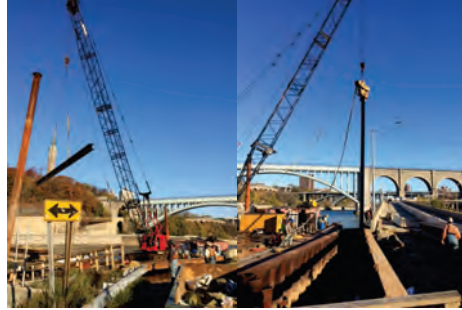
November 2015 - Depot Place over Conrail –  
Placing Piles to Build a Seawall.

The Depot Place Bridge over Conrail location had two major flag areas. The rip-rap areas stabilizing several piers supporting the end landing span were severely dissembled, rendering those piers less able to carry their intended loading. Special barriers had been in place for years to prevent vehicles from using the outer edge of the roadway to ameliorate the situation. In 2015, the entire flag area received a new fill system that provided a permanent correction. At the south end of the landing span, the existing steel sheet piling supporting the fill beneath the grade slabs was so deteriorated that it could not perform its function. In the past few years, temporary supports were installed to support this roadway, but in 2015, a new steel soldier beam and lagging retaining wall constructed to provide a permanent solution.

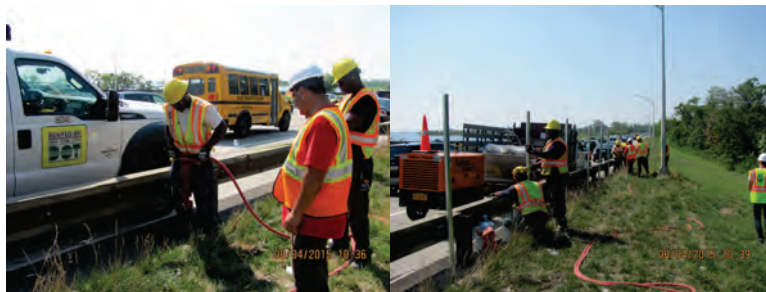
August 2015: Preventive Maintenance Crew Installing Approximately 900 Feet of Fencing Including Glare Protection on the West Side of the Westbound Paerdegat Basin Bridge. Supervisor Highway Repairer Luis Soto, Highway Repairer Luis Baez, and Assistant City Highway Repairers Devon Cromarty, Marlon Doyle, Krishna Evans, Michael Marquez, and Anthony Connelly.

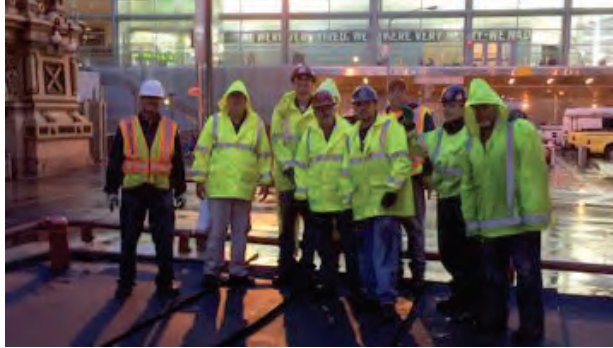
October 2015: Preparing for Hurricane Joaquin - Covering the Open Vents Over the Battery Park Underpass. The Hurricane Changed Course and Bypassed New York City. Supervisor Carpenter Joseph Vaccaro, Executive Director of Bridge Preventive Maintenance and Repair Thomas Whitehouse, and Carpenters Joseph Moschella, William Sic, Edward Alfano Jr., John Green, Gregory Nolan, and Stephen Buckley. (Credit: Thomas Whitehouse)

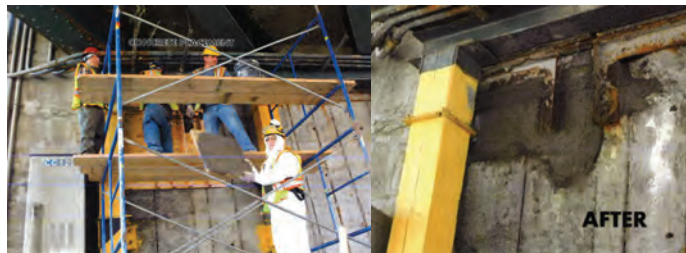
December 2015: Patching a Spall on the Beginning Abutment Stem of Brooklyn-Queens Expressway (Westbound) over Cadman Plaza.
