New York City  
Department of Buildings

**51st Street Crane  
Investigation**

51st Street Crane  
Investigation Report

March 2009

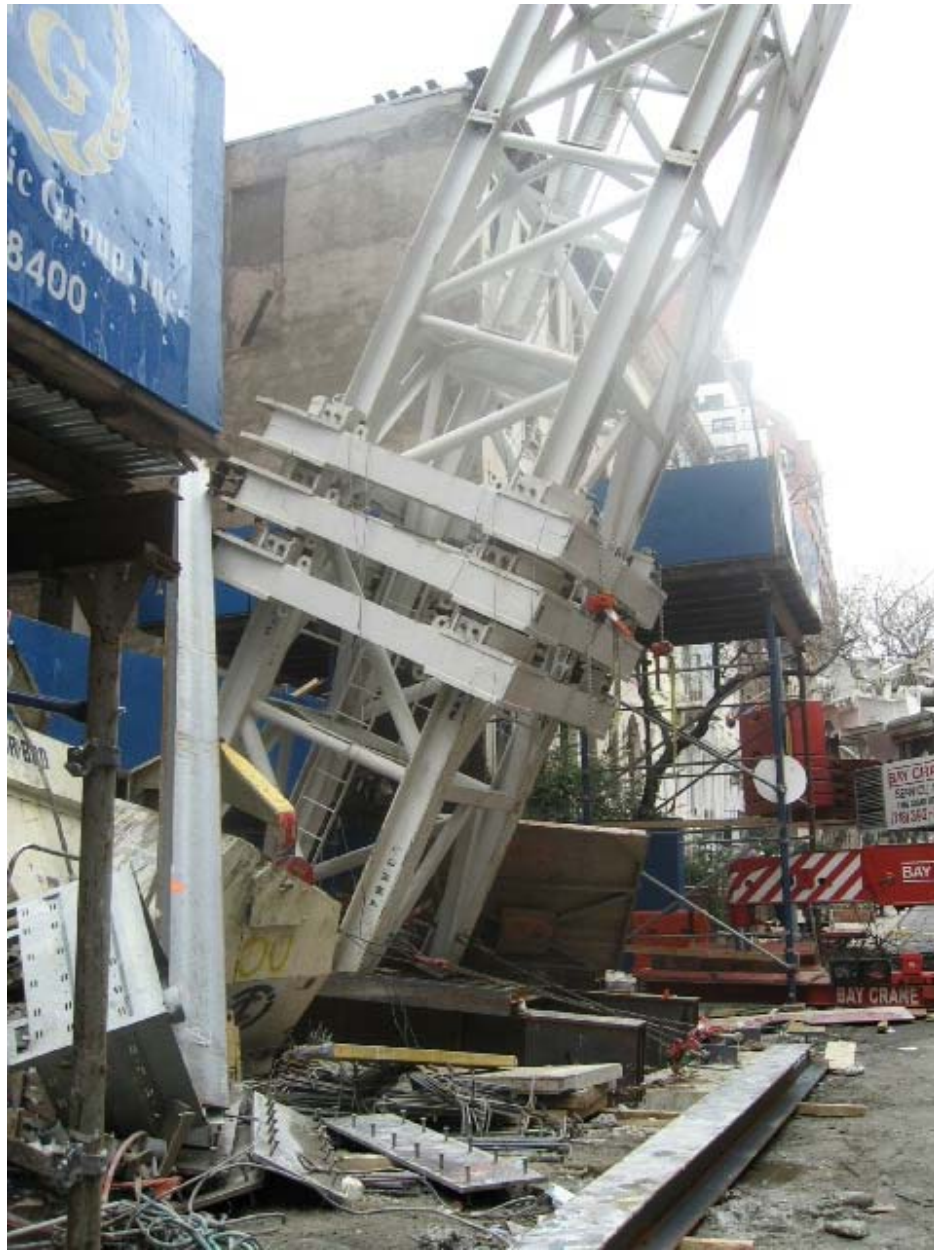
**Photograph 1.3 - Photograph showing conditions at tower base following the collapse (source: New York County District Attorney's Office, Photograph ID No. IMG-0326-056).**

The main dunnage beams (x2) are W24x194 steel sections with W24x55 bracing members (x2) between the main beams. The legs of the tower were restrained in the horizontal direction by W8x31 steel sections, which were welded to the top of the dunnage beams. The tower legs were not anchored to the top of the dunnage steel and as such were free to lift. Note that if the legs lift above the W8 restraints, friction between the top of the dunnage and the tower legs becomes the only restraint against sliding, which did occur during the tower crane collapse as shown in Photographs 1.3 through 1.6.

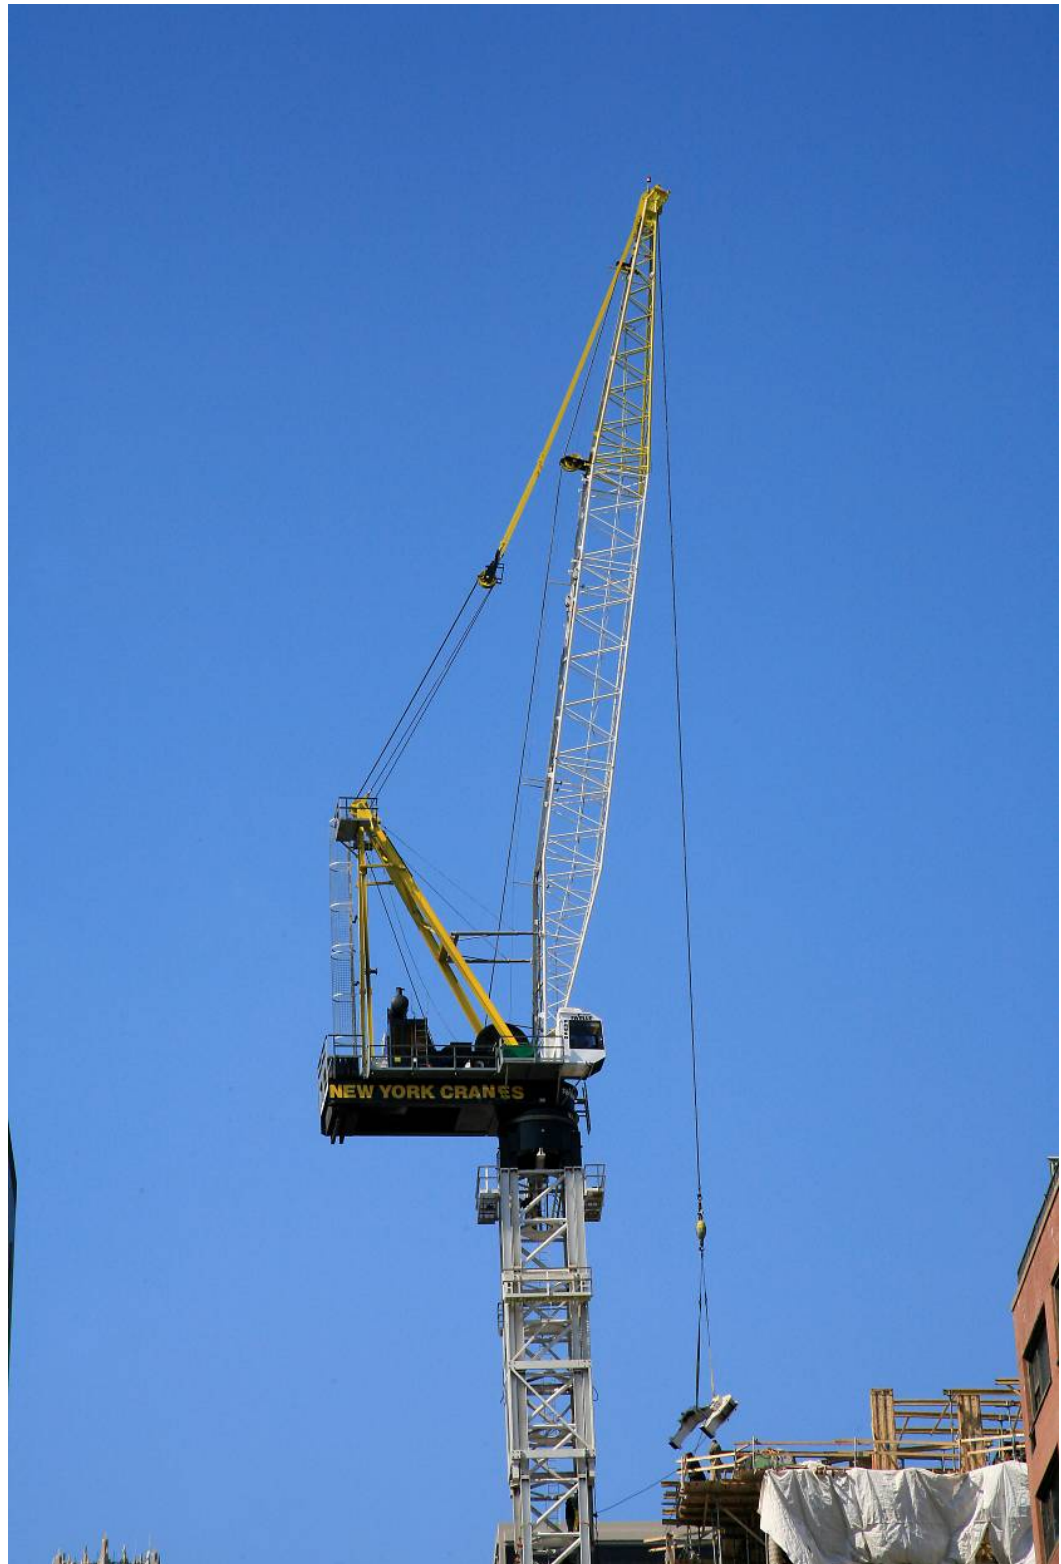
**Photograph 1.7 - Photograph showing the position of the crane boom during tie-in assembly, approximately 1 hour before the crane collapse (source: photograph by Gary Halby).**

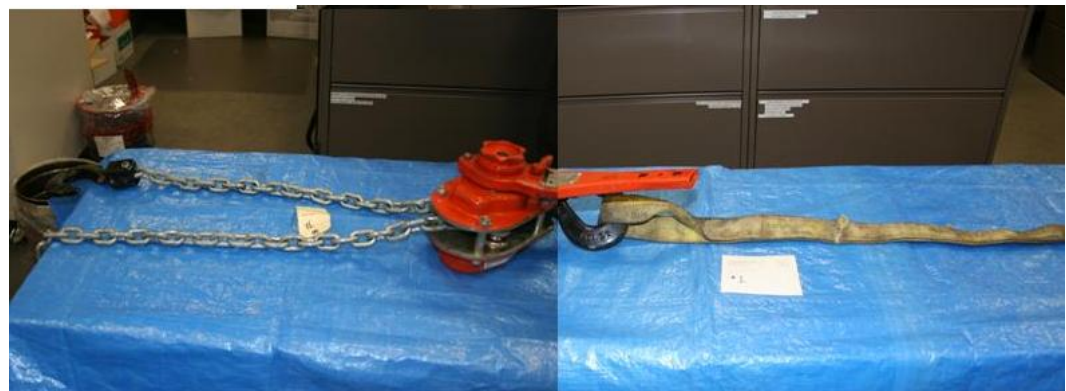
**Photograph 1.8 – Chain-fall and polyester sling assembly recovered from collapse site by Arup.**

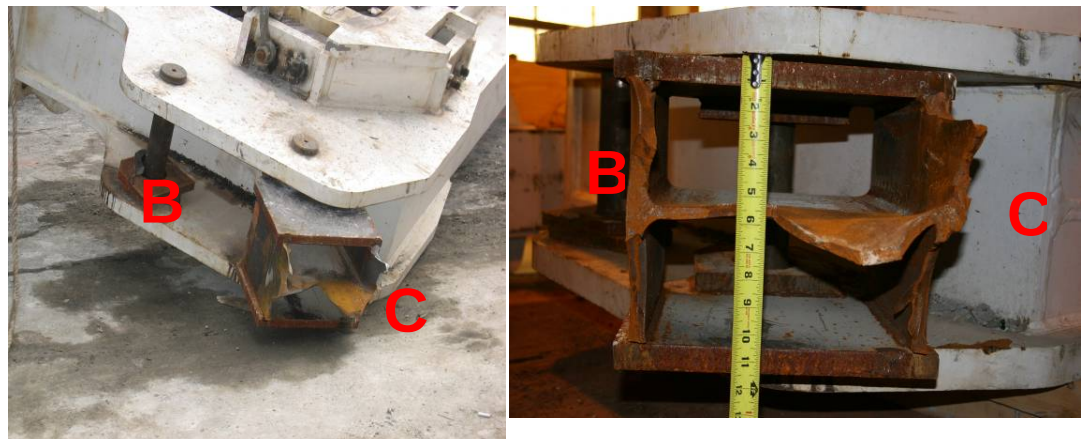
- Two (2) tie-beam to base plate welds (i.e., for base plates "9A" and "9C" as shown in Photographs 1.9 and 1.10);
- Two (2) tie-beam ends near the collar connection (i.e., at the other ends of Beams connected to base plates "B4" and "B5", as shown in Photographs 1.11 and 1.12); and
- One (1) failure of the tie-beam at the pin connection to the collar (i.e., Beam "9B", as shown in Photograph 1.13).

Photograph 1.11 – 9<sup>th</sup> Floor Collar: Top left corner shows the general layout of tie-beams to the collar. The lower left hand photograph shows the failed end for Beam B5 (labelled “B” in the photograph) prior to and after its removal from the site (the pin end of Beam 9B (labelled “C” in the photograph) sheared off). The lower right hand photograph is the same tie-beam end after removal to the NYCOEM warehouse. Photos by the crane engineer Peter Stroh IMG\_0093.jpg and Arup.

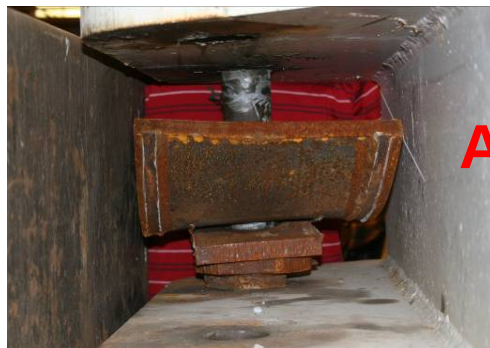
**Photograph 1.12** – The upper photograph shows the failed end of 9<sup>th</sup> floor tie-beam near collar connection (i.e., Beam B4 (“A”), at center of the photograph). The lower photograph is a close-up of the failed end of Beam B4 after removal to the NYCOEM warehouse. The top photo is by the crane engineer Peter Stroh IMG-0096.jpg. The bottom photo is provided by Arup.

Note that tie-beams B4 and B5 were welded to base plates 9A and 9C, respectively, in accordance with identification tags attached to these items by NYCDOB after recovery from the collapse site.

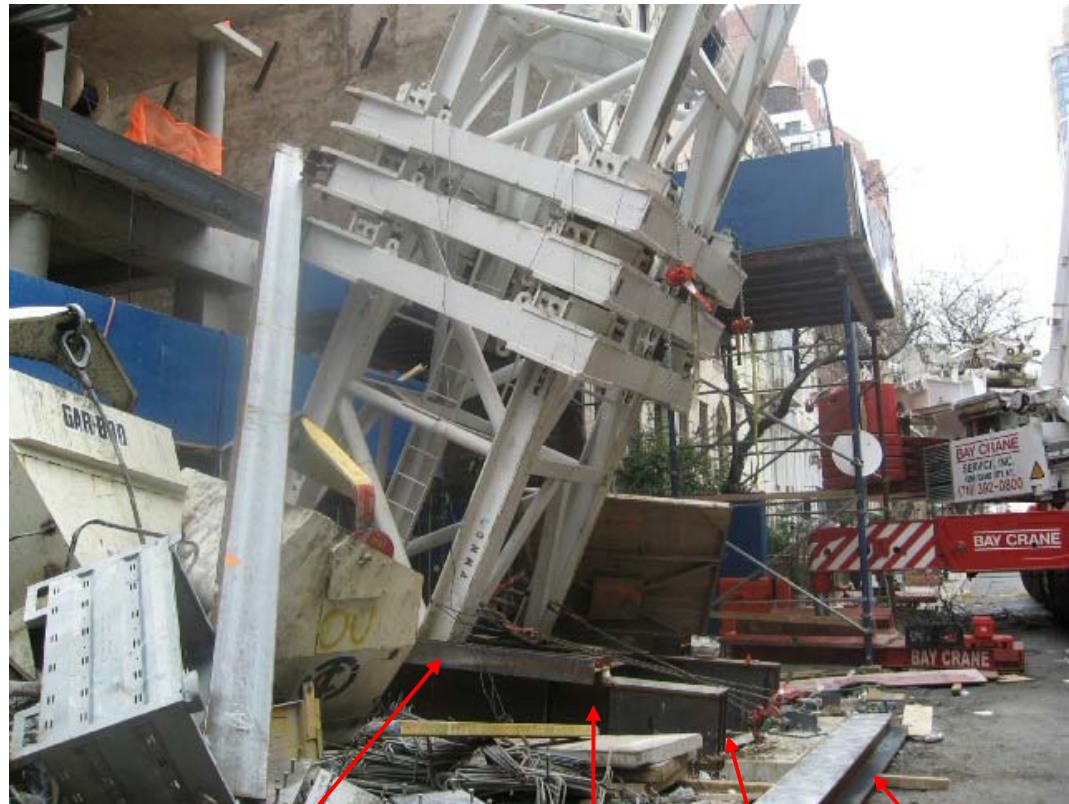
TOWER AFTER LEG  
SLIDING

ORIGINAL LOCATION OF TOWER  
LEG ON DUNNAGE BEAM

DUNNAGE BEAM AFTER SLIDING  
OFF THE FOUNDATION WALL

**Photograph 1.16 - View of street side (south) of tower base after failure. The dunnage beam is no longer on the supporting concrete foundation wall. Photo by New York County District Attorney IMG\_0327\_057.jpg.**

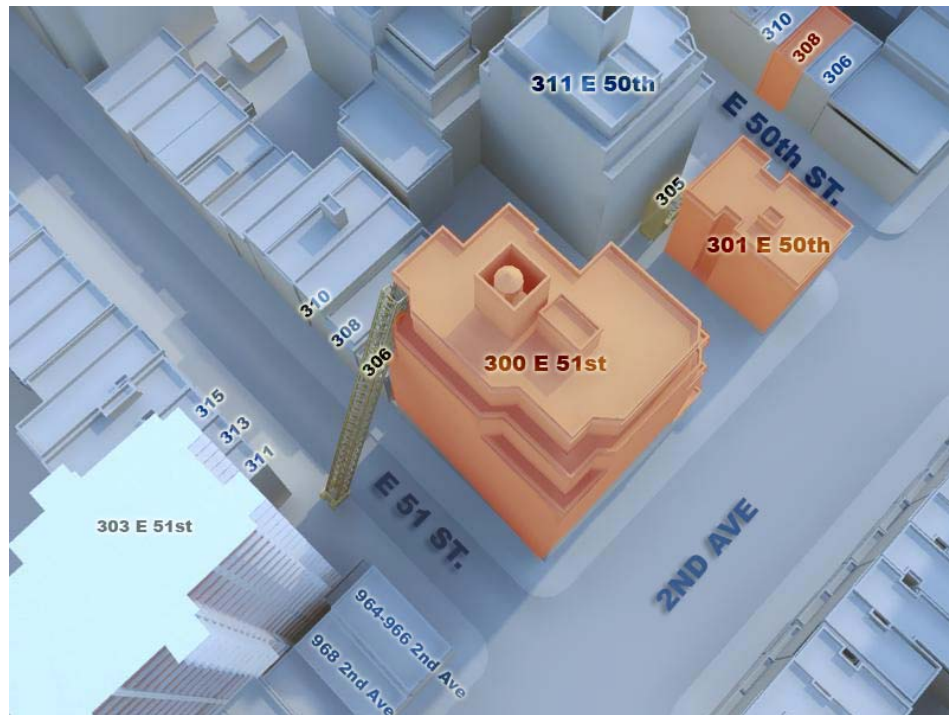
**Figure 1.12 - Representation of the tower crane after collapse. Reference Photograph 1.6 with regard to the position of the crane within 305 E 50<sup>th</sup> St. Prepared by Arup.**

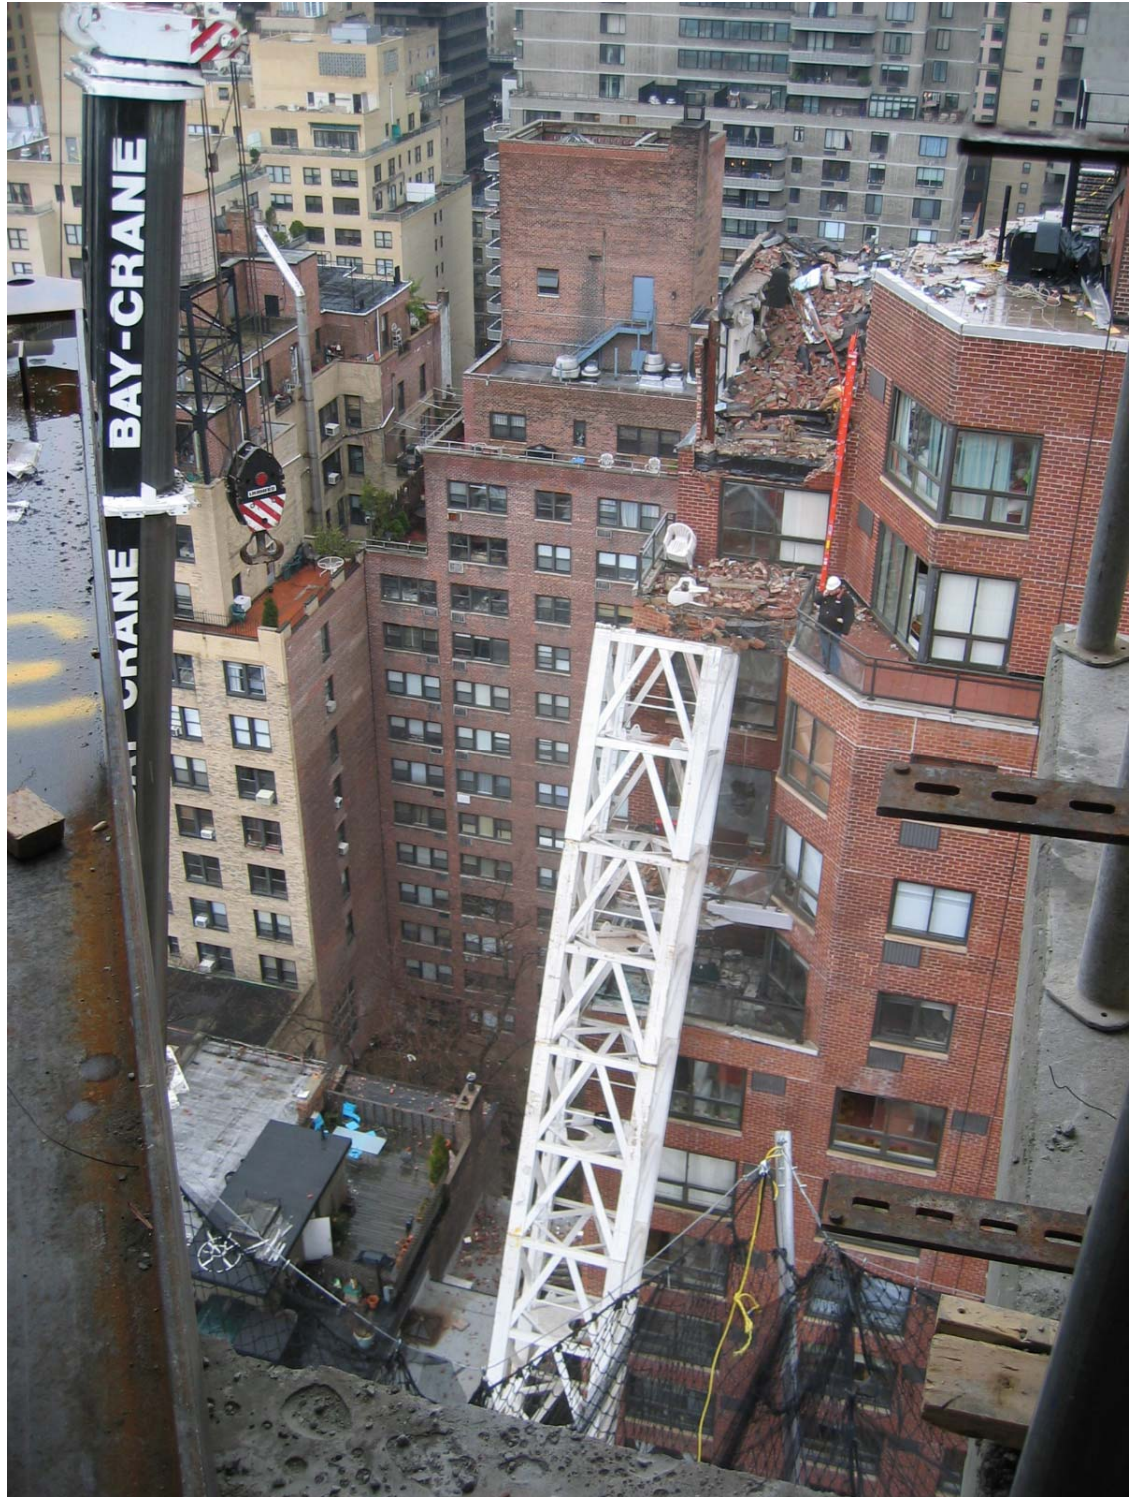
Of significant interest was the absence of failure of the tower crane sections themselves beyond that experienced by the impact of the upper sections with the building opposite (see Photographs 1.21 and 1.22 showing the lean of the tower across the street). The photographs also show the extent of the damage to the adjacent building caused by the crane collapse and the impact of the tower crane on these buildings. Figures 1.11 and 1.12 highlight the buildings affected by the collapse of the tower crane.

**Photograph 1. 21 – View of the intact tower crane after collapse. Photograph by the crane engineer Peter Stroh, “After” photographs, IMG\_066.jpg.**

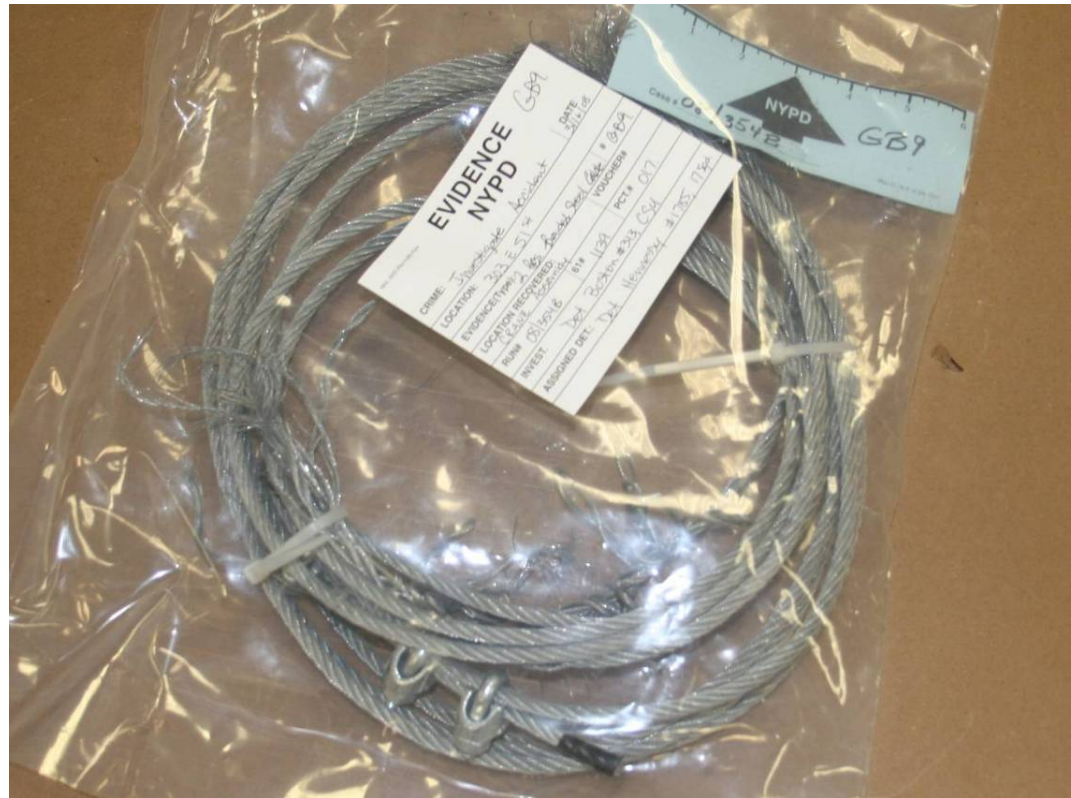
Wire rope U-bolt clip saddles were placed both on the live and dead ends of the wire ropes. An example can be seen in Photograph 3.2 taken of one of the wire ropes retained by OSHA.

**Photograph 3.2 - OSHA retained evidence from NYPD GB9. Note the two clips only, with the saddle on the dead end of the wire rope. Photo by Arup.**

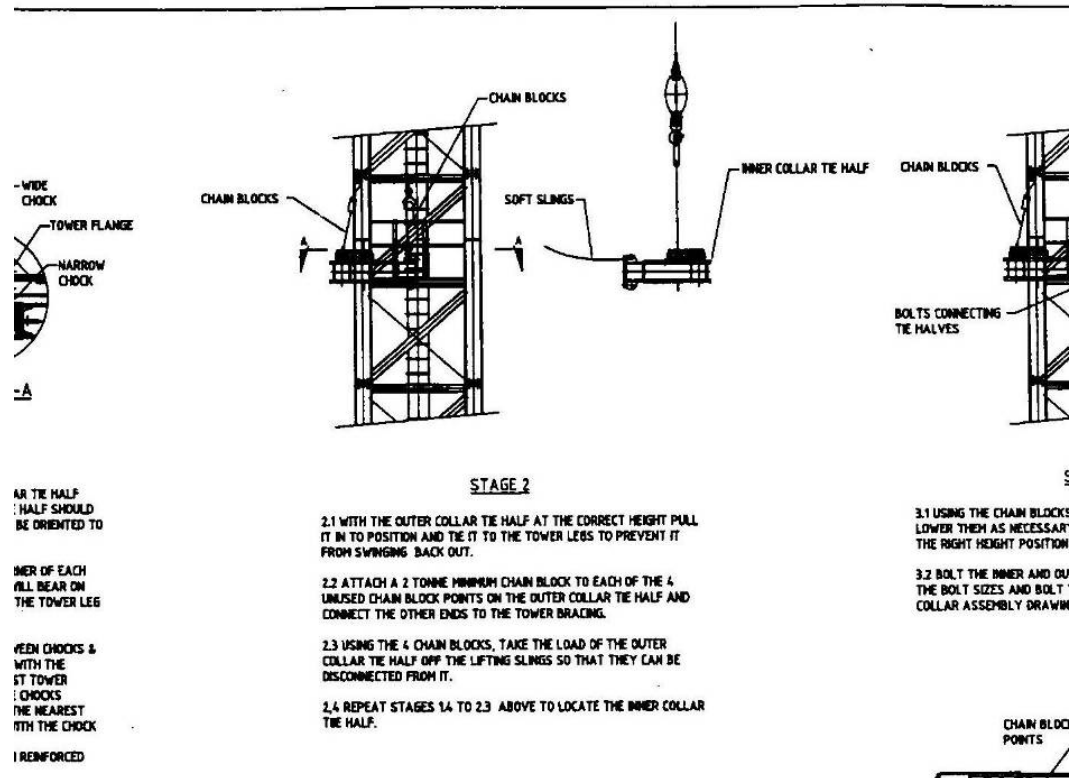
Figure 3.5 - Favelle Favco External Climbing Collar/Tie Erection Sequence Drawing A1-1100.123 Stage 2 details. Note clause 2.2 reference to a “2 ton minimum chain block.” There is no indication that this is a SWL, rated capacity or other.

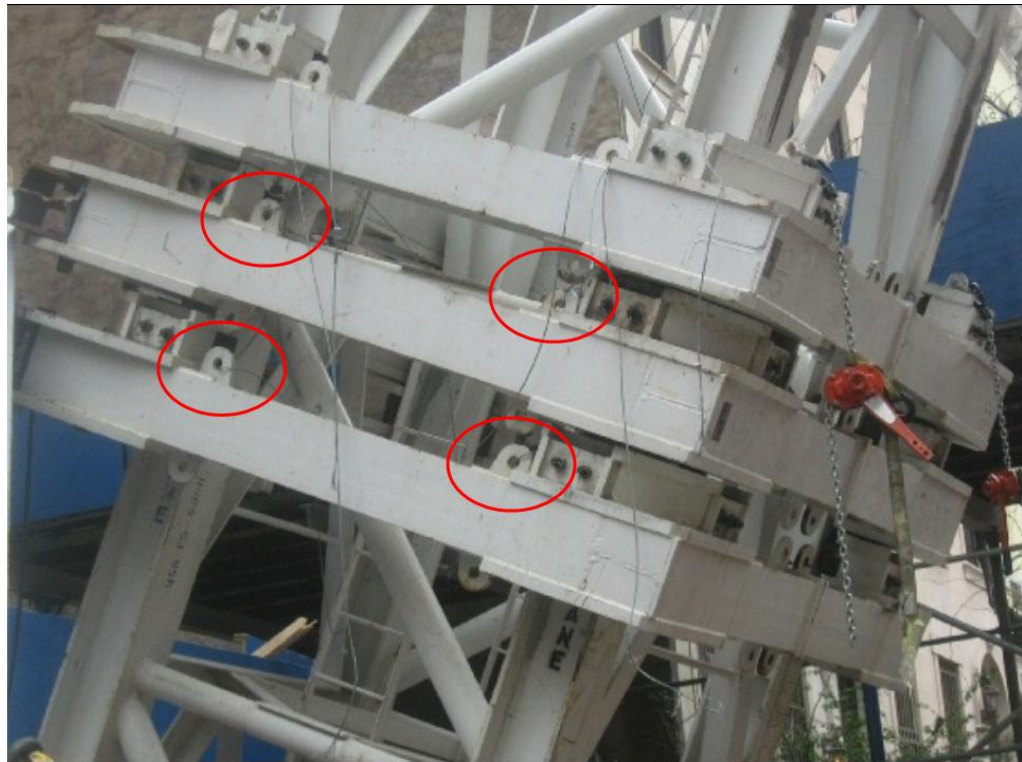
As part of the collar installation, wire ropes were implemented at completion of the tie-beam installation, as evidenced by post-collapse photographs as shown in Photographs 3.5 and 3.6.

**Photograph 3.5 - View of the west elevation of the collapsed tower collars. The location of visible wire rope attachments to the collars are circled. Note the lack of thimbles in the formed sling. Photo from New York County District Attorney 328\_58.jpg.**

As can be seen in the photographs, the ropes were attached directly to the lugs on the collars. As previously mentioned, the specific lugs to which they were attached are not consistent with Favelle Favco's recommendations regarding the location of the four chain block attachment points which were to remain on the collars after completion of the collar / tie-beam installation. See Figure 3.2, 3.3, 3.4 and 3.5 for extracts from the Favelle Favco External Climbing Collar/Tie Erection Sequence Drawing A1-1100.123.

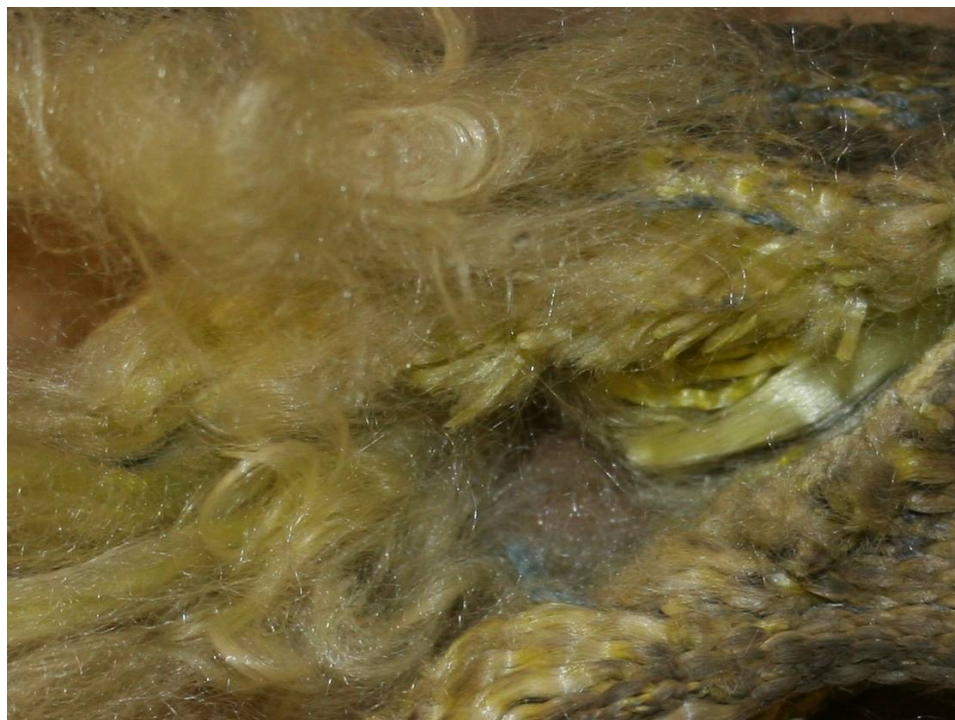
**Photograph 3.9 - OSHA evidence item 1. Polyester web sling removed from the collapse site. This was taken from the southwest corner of the 9th floor collar. Note the varying degrees of fading of the webbing coinciding with the relative degree of potential exposure to ultraviolet rays. Magnification is approximately 2.5x. Photo by Arup.**

As noted earlier, the Liftex Corporation was visibly bleached, indicating prolonged exposure to ultraviolet light. Close-up views and microphotographs also substantiate a range of color in fibers which would have had varying degrees of shielding due to overlying layers (see earlier Photographs 3.8, 3.9 AND 3.10).

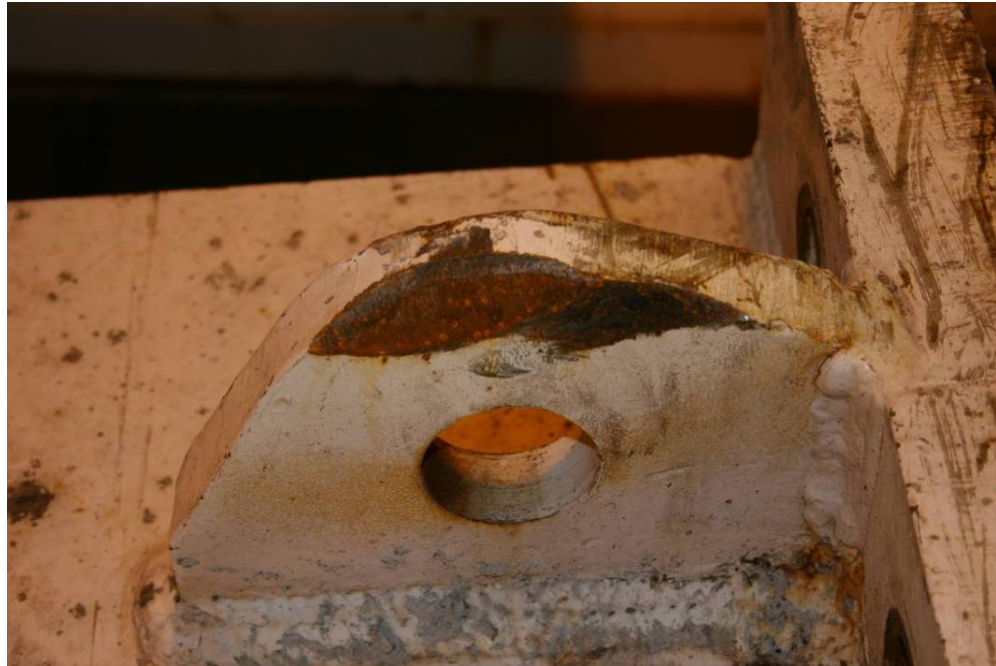
For a wire rope sling, this is normally controlled by use of a thimble inserted into the eye of the sling. As suggested by the lack of thimbles retrieved from the debris and photographs taken of the slings after the collapse, this was not done. As the wire rope needed to be threaded through the chain block attachment point, use of a thimble would have been impractical although it is possible that an open pattern thimble could also have been inserted around the chain block attachment, thereby creating an acceptable D/d ratio (where D is the minimum diameter of the sling formed by bending the wire rope and “d” is the diameter of the wire rope). A photo of the chain block attachment is given in Photograph 3.12 below. The unprotected/unpadded edge of the attachment is clearly visible. The chart which follows, Figure 3.6, taken from the Wire Rope Sling Users Manual published by the Wire Rope Technical Board provides information regarding the reduction in capacity arising from unacceptable D/d ratios.

Photograph 3.12 - Collar C2-A chain block attachment point. Note the unprotected edges on which the wire rope sling would have been bearing (typical for all chain block and lifting attachments for all collars).. Photo by Arup.

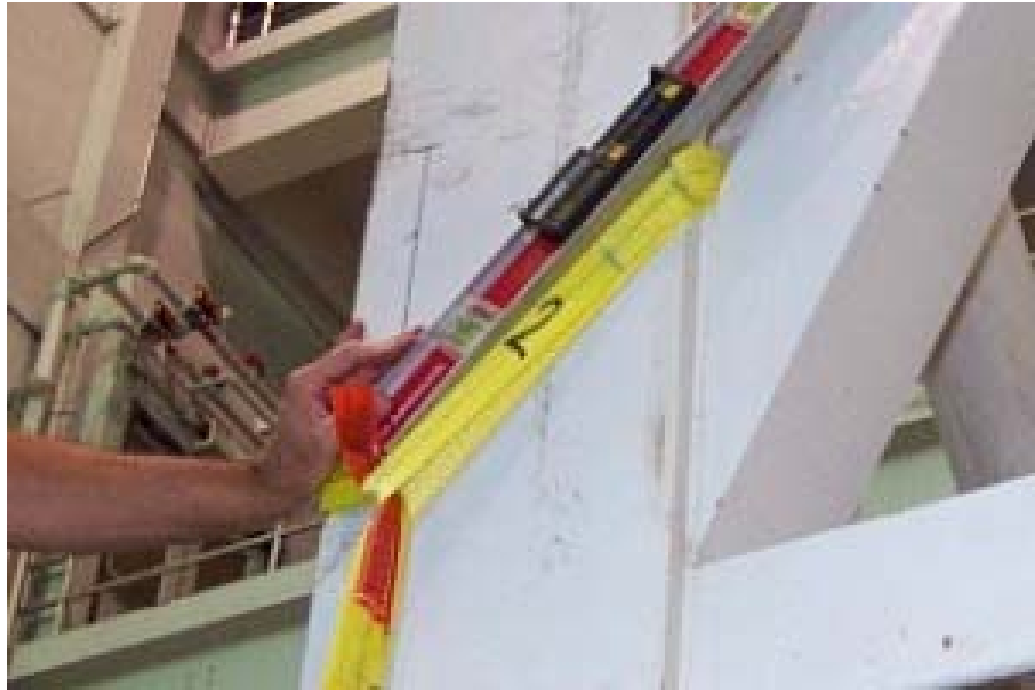
As the polyester web sling was choke hitched around the tower crane leg in the V-groove formed by the junction of the tower diagonal and leg, the sling, under load, would have necessarily been constricted, bunched and pinched. See Photograph 3.19 below.

**Photograph 3.19 - ATLSS test setup prior to testing. Note that, as installed around the tower leg in the V-groove formed between the diagonal and the leg, the sling will necessarily be constricted, bunched and pinched by the load. Photo provided by OSHA.**

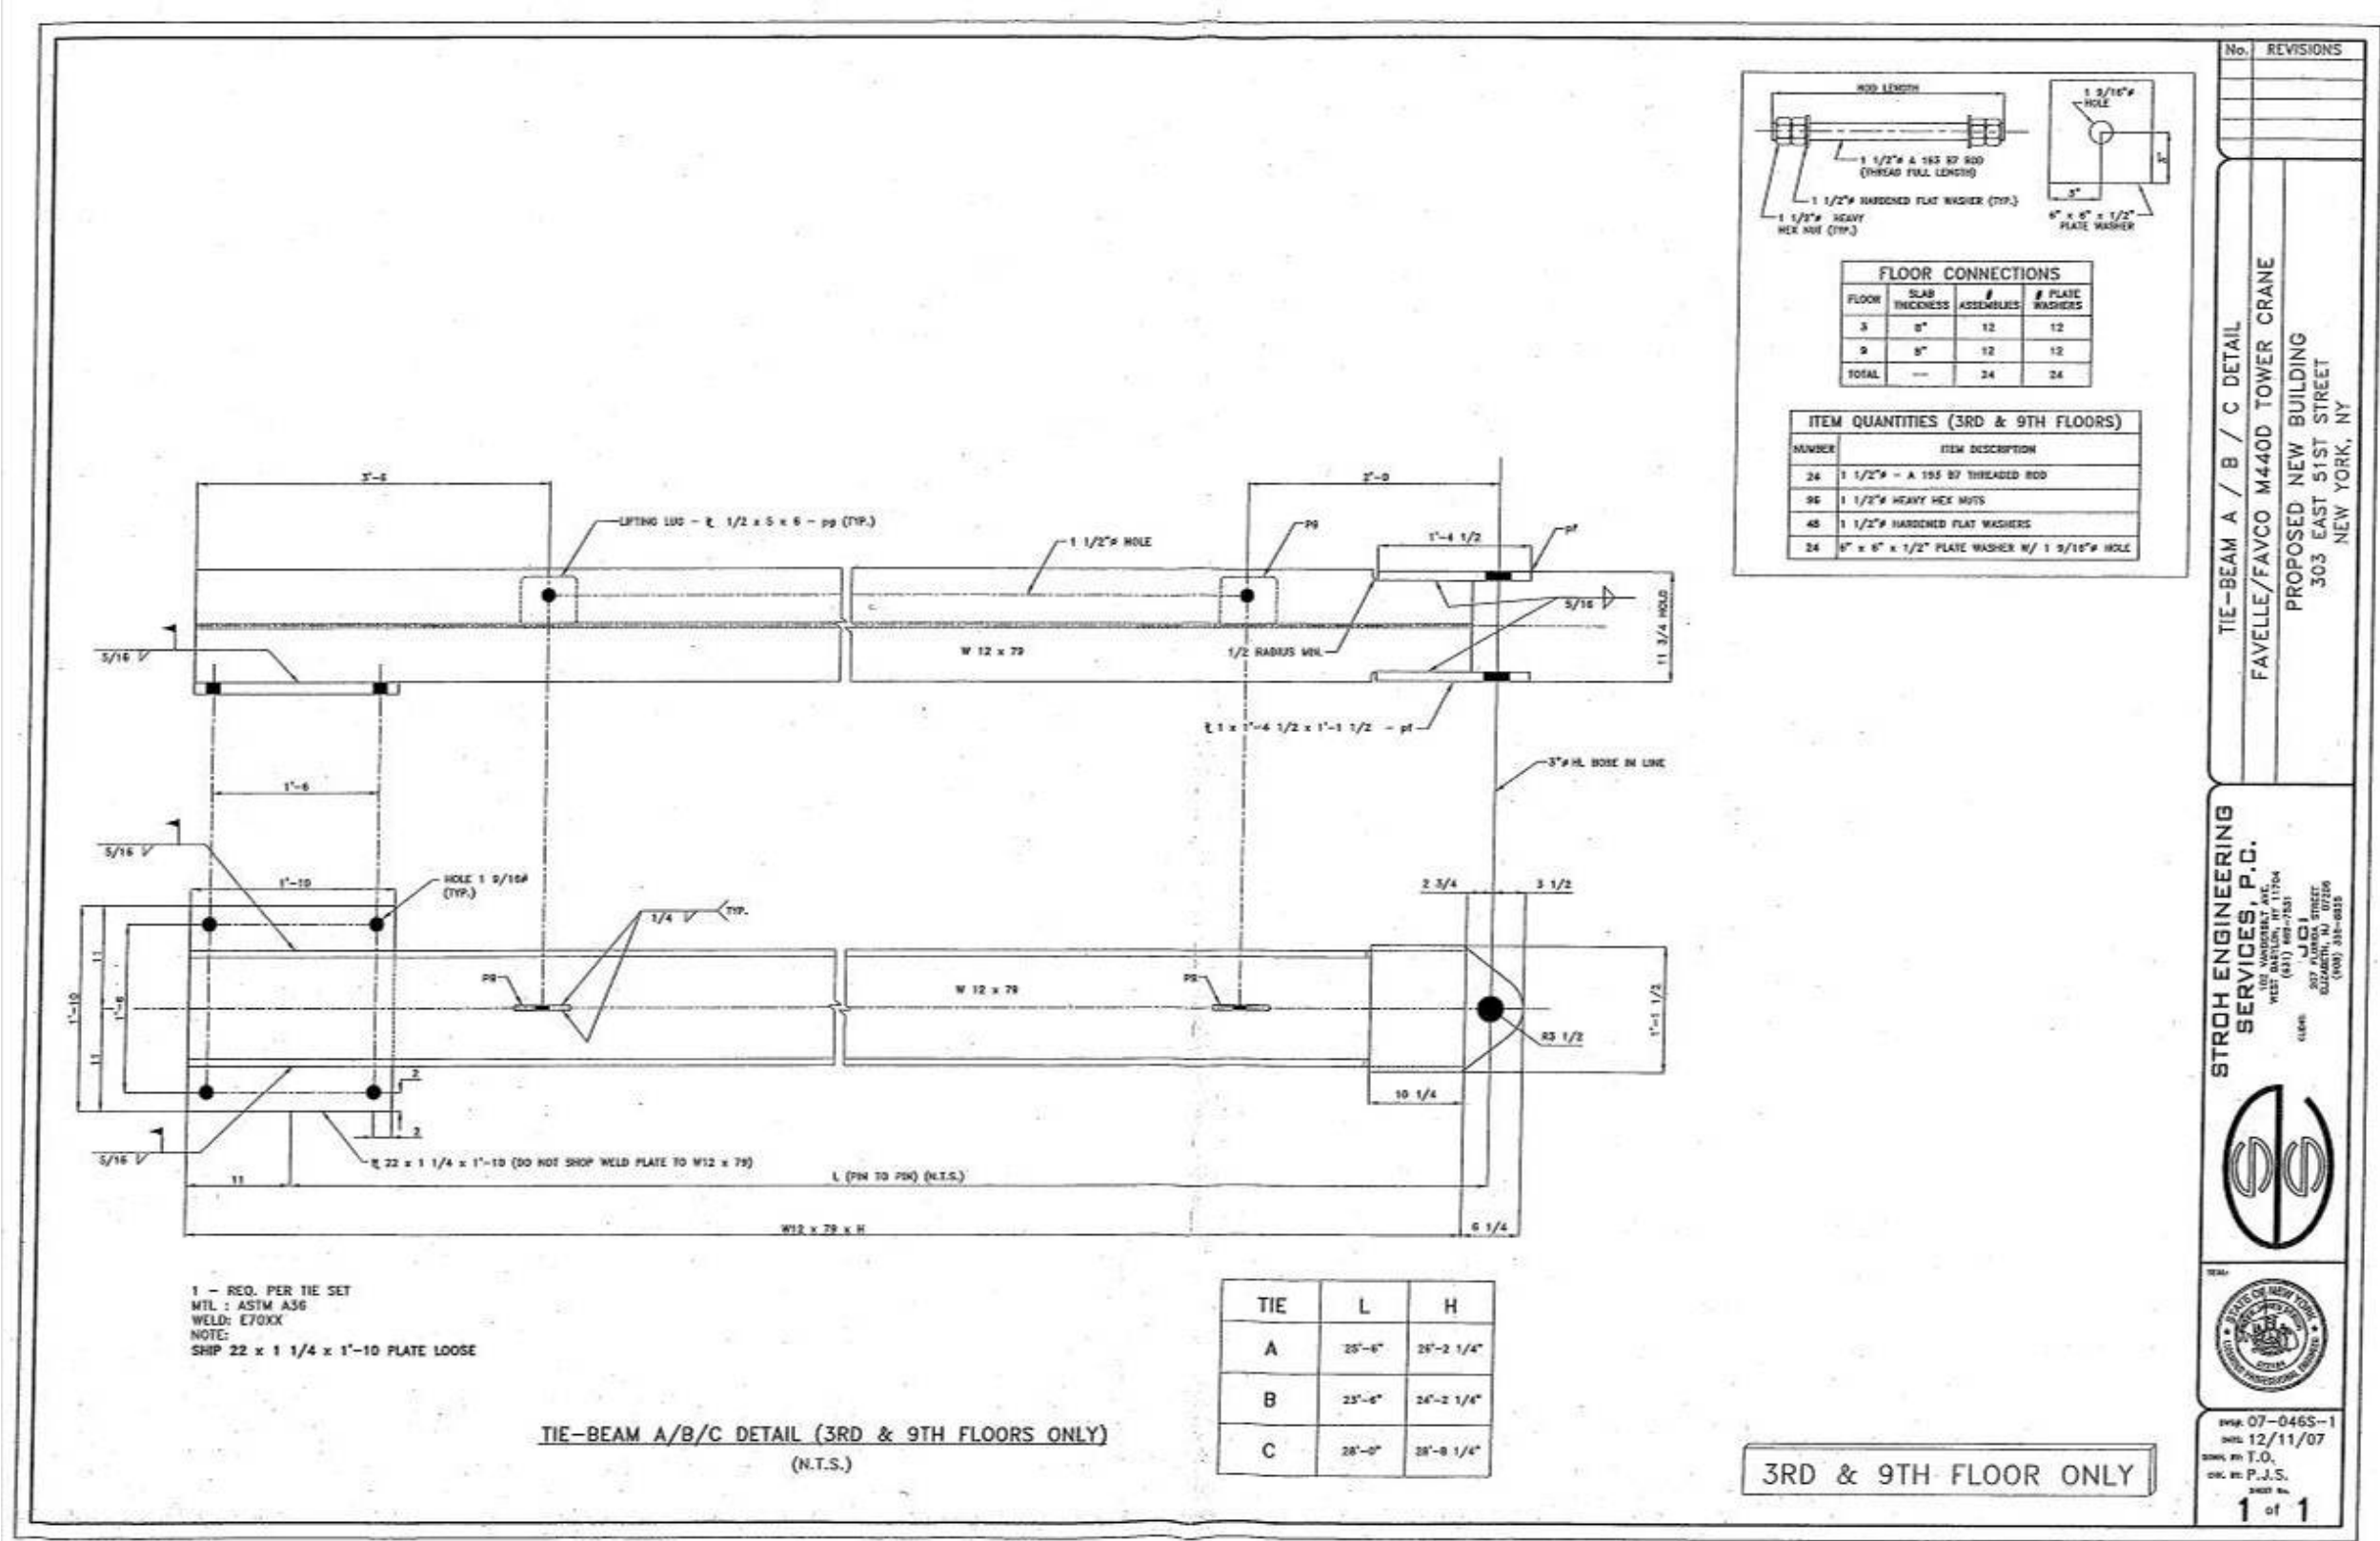
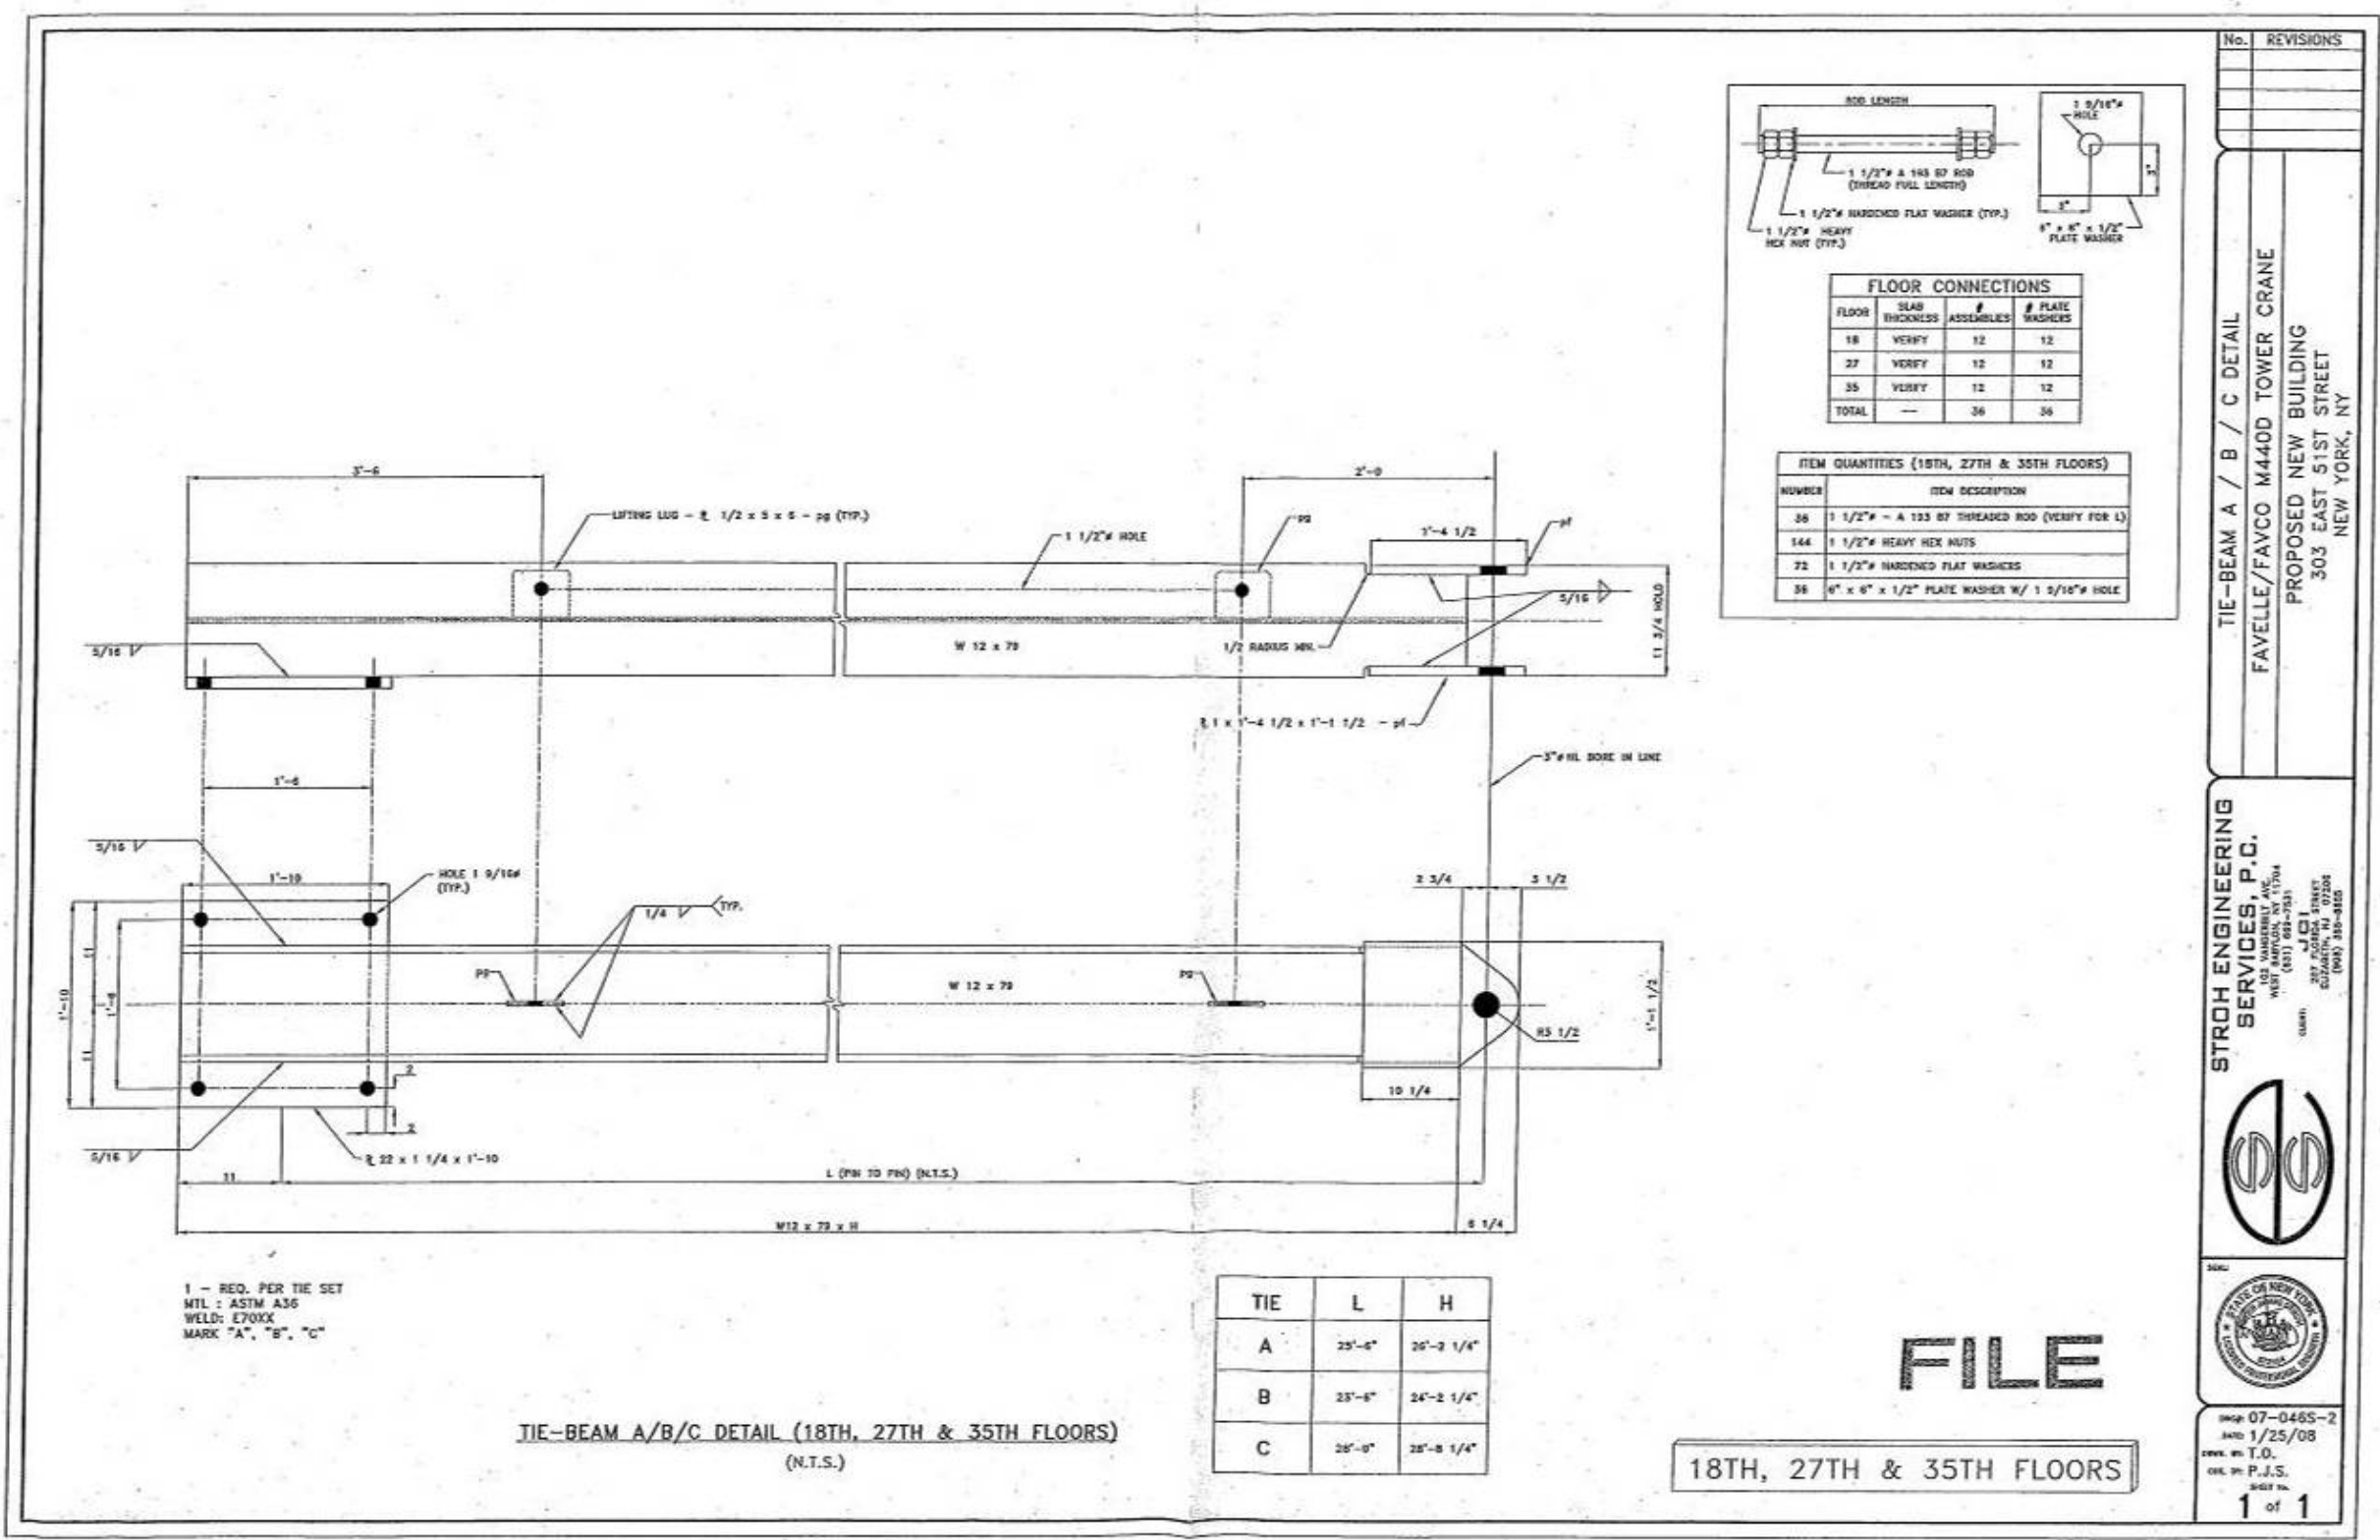
The fabrication drawings prepared by the crane engineer (Stroh Engineering) are given in the Figures 3.8 and 3.9 below. Minimal information is provided beyond the weld electrode, size and type of weld. NDT, verification inspection, weld acceptance criteria are all unspecified.

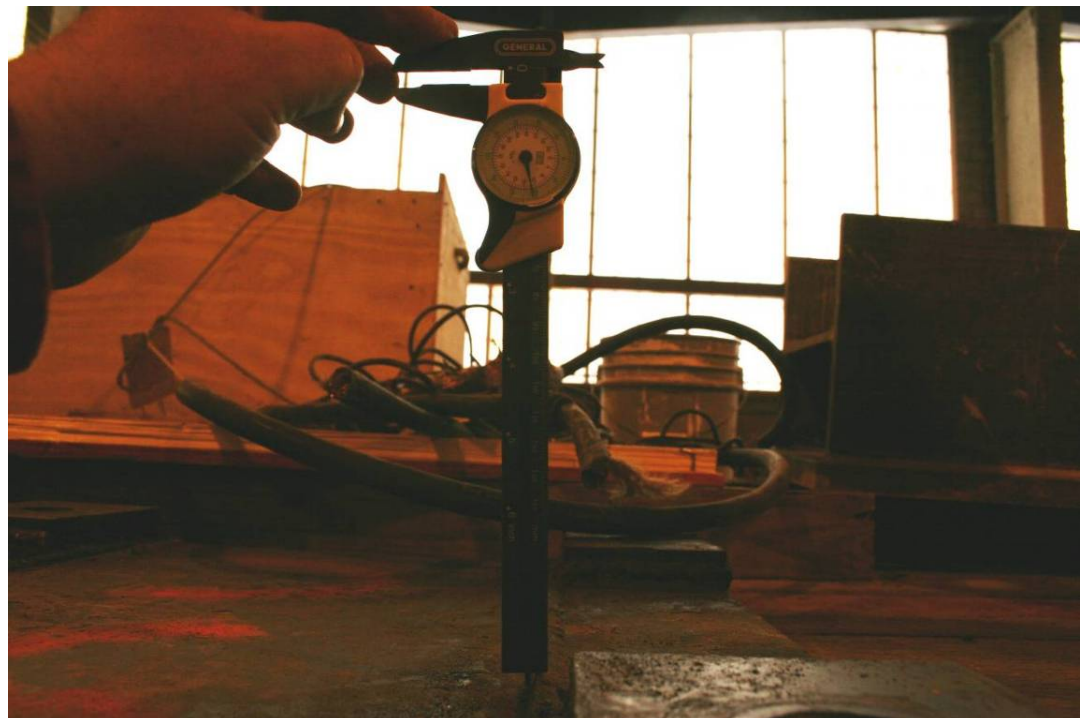
The fabrication drawings shown above reference 5/16 inch fillet welds connecting the base plates to the tie-beams at the building end of the tie-beams. It has been noted elsewhere that two of the base plates at the 9<sup>th</sup> floor level failed as a result of the impact of the 18<sup>th</sup> floor level collar. Photograph 3.22 below shows a typical measurement of the failed weld on the base plates. The measurement, taken on base plate 9C is 7 mm, or 0.275 inch. This is just under the specified 5/16 inch and represents approximately 11.8% less leg size than specified. Photograph 3.23, - which follows is a similar measurement on the same plate at another location. The latter fillet weld measured as 5 mm, or 0.197 inch. This is approximately 37.0% under the specified 5/16 inch weld. Note that both locations were randomly selected. Observations of base plates 9A and 9C indicated these would be typical measurements.

**Photograph 3.23 - Fillet weld measurement of base plate 9C. Measurement is shown to be 5 mm, just over 3/16 inch, which is 37.0% under the specified 5/16 inch. Photo by Arup.**
