New York City  
Department of Buildings

**51st Street Crane  
Investigation**

51st Street Crane  
Investigation Report

March 2009

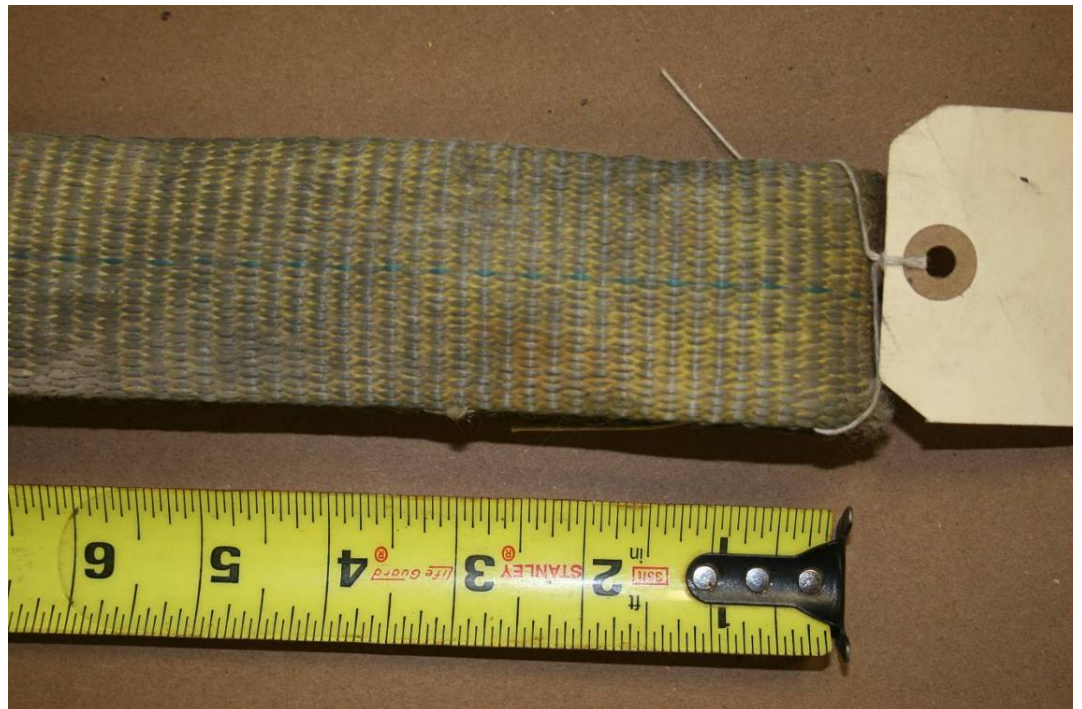
TYPE III - Web sling made with a flat loop eye on each end with loop eye opening on same plane as sling body. See Photograph 3.24 showing one of the slings used to temporarily support the collars during erection recovered from the collapsed crane.

**Photograph 3.24 - OSHA Evidence Item #4A, being the sling taken from a north leg. Photo by Arup.**

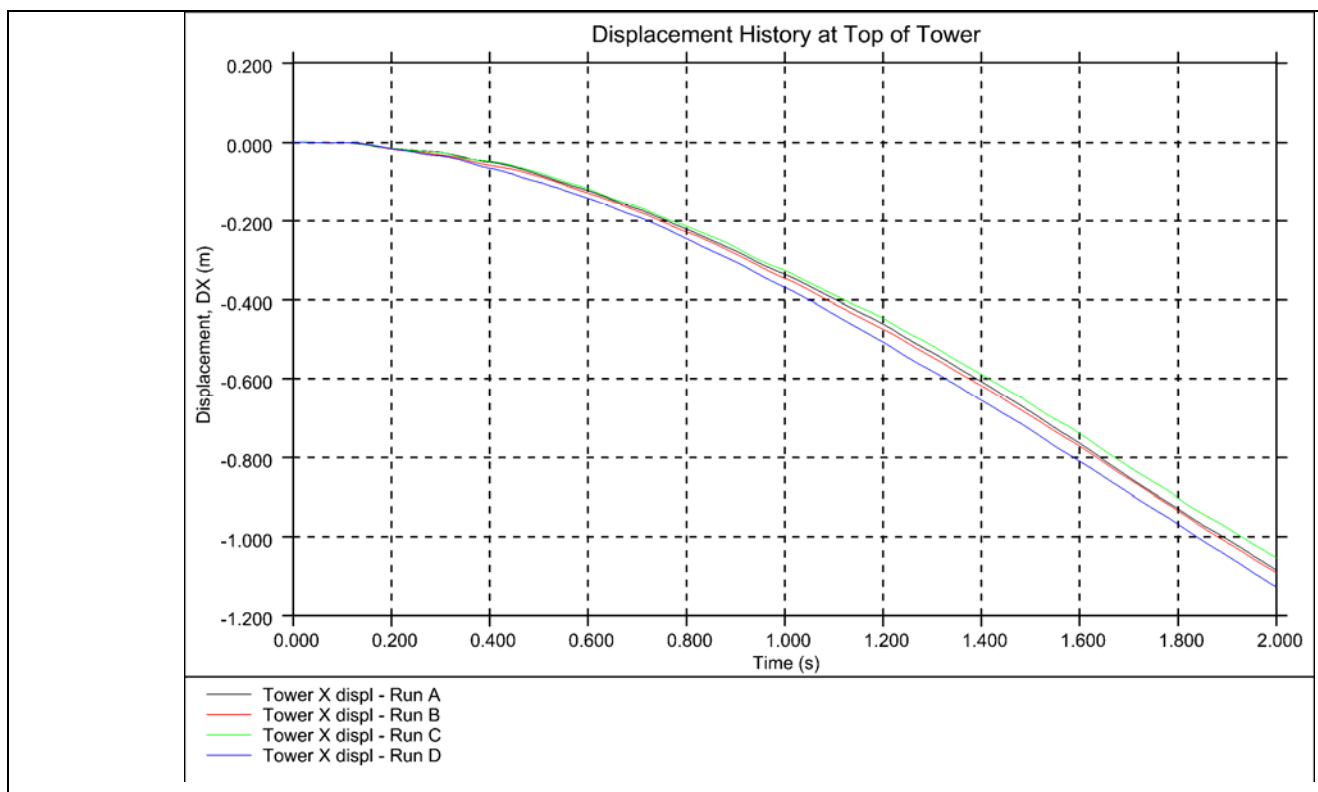
Without the tie-beam attaching the tower back to the building the tower moves away from it. This is illustrated by the negative x direction displacements of the top of the tower shown in Figure 7.12. The tower stability post impact is studied further in Section 7.5.

The horizontal displacement of the top of the tower is shown in Figure 7.12. For all four runs the crane is still moving at the end of the analysis, this is investigated further in the Global Tower Stability, see Section 5.

**Figure 7.12 - Displacement History at Top of Tower (-ve DX away from building). Prepared by Arup.**

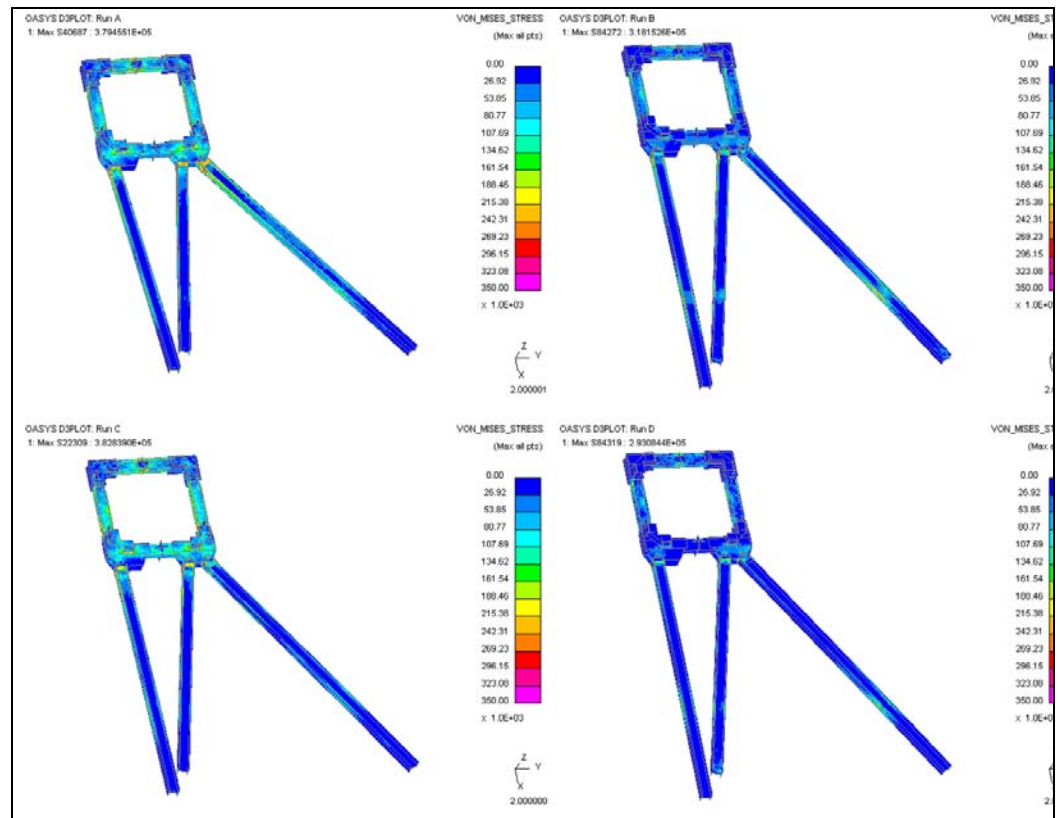
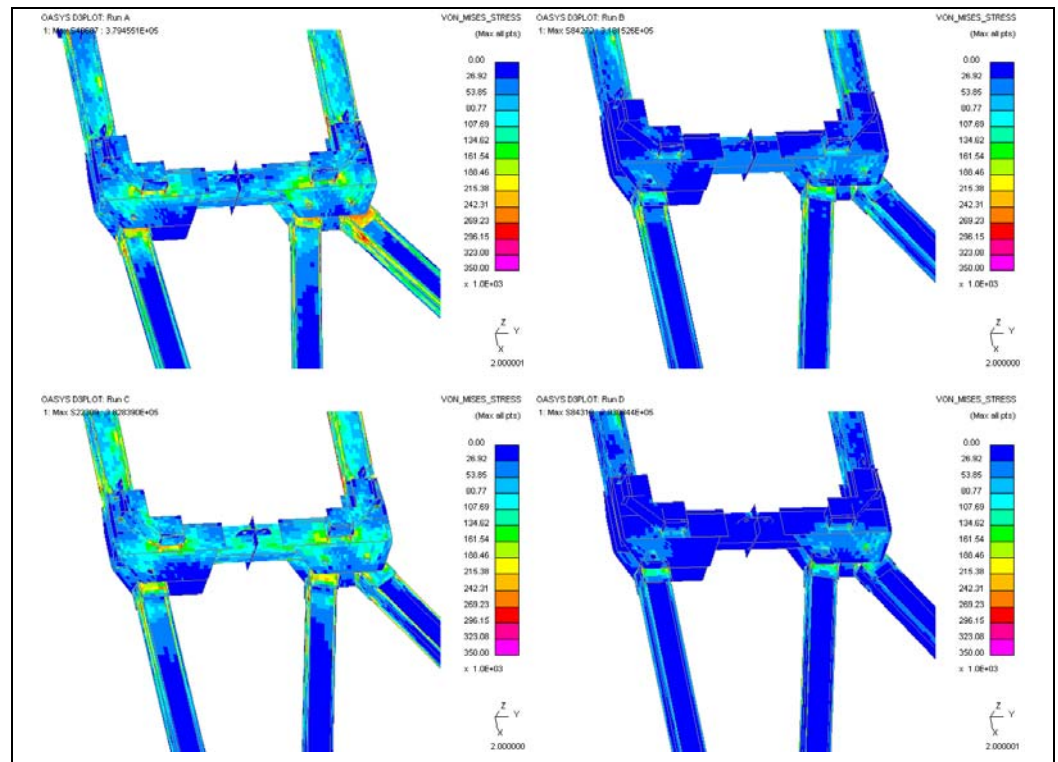
The von-Mises stress in the tie-beam lugs local to the pinned connection are above the yield of 36.25ksi (250MPa), as can be seen in Figures 7.15 and 7.16.

**Figure 7.15 - Contours of von-Mises Stress (kPa) in Bottom Collar and Tie-Beams. Prepared by Arup.**

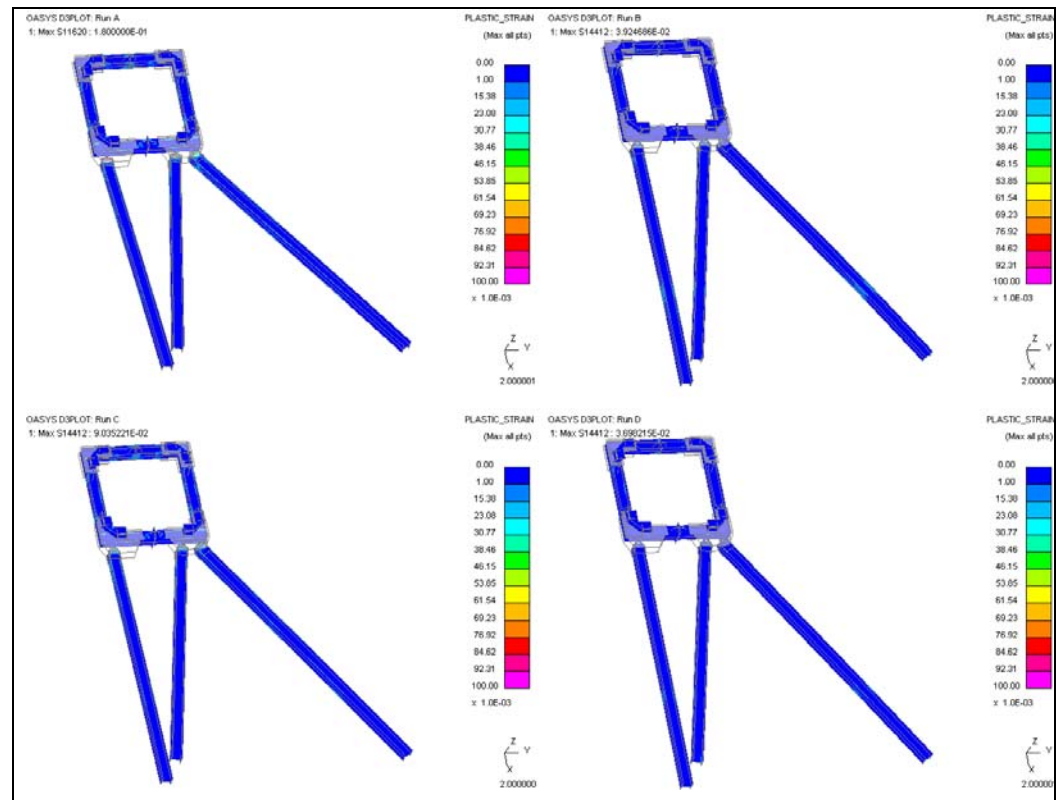
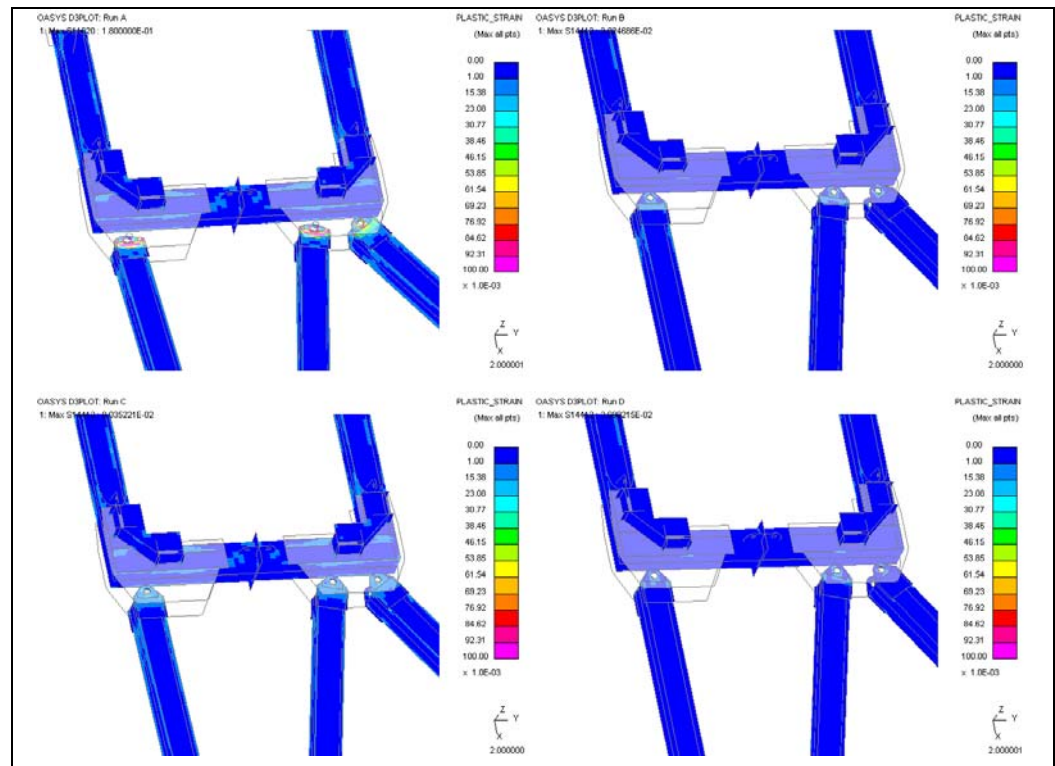
Plastic strains of 18.0% are predicted around the lug holes for run A, see Figures 7.17 and 7.18. The collar lugs have been drawn translucent so as not to obscure the tie-beam lugs. This region is highly stressed but the modeling issues discussed in Section 7.4.1.5 suggest that the idealization of the pinned connection and welded beam connection are over strong.

Figure 7.17 - Contours of Plastic Strain in Bottom Collar and Tie-Beam Lugs. Prepared by Arup.

**Figure 7.18 - Contours of Plastic Strain in Bottom Collar and Tie-Beam Lugs Close-up. Prepared by Arup.**

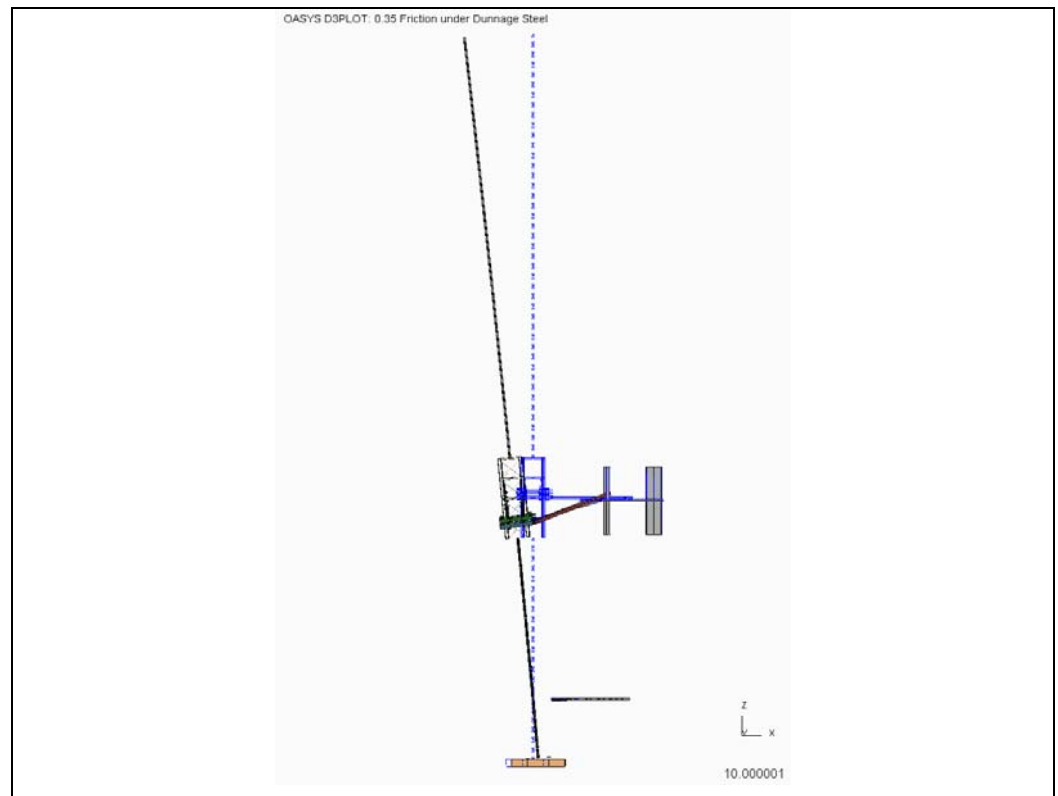
Analysis demonstrated that the horizontal force below the dunnage was great enough to overcome the frictional resistance due to the self-weight of the tower, hence the tower was predicted to fall, as can be seen in Figure 7.20. The dunnage movement can be seen in Figure 7.21. The tower tilts on top of the dunnage as there is no connection limiting this lift off.

Figure 7.20 - Deformed shape plots. Prepared by Arup.

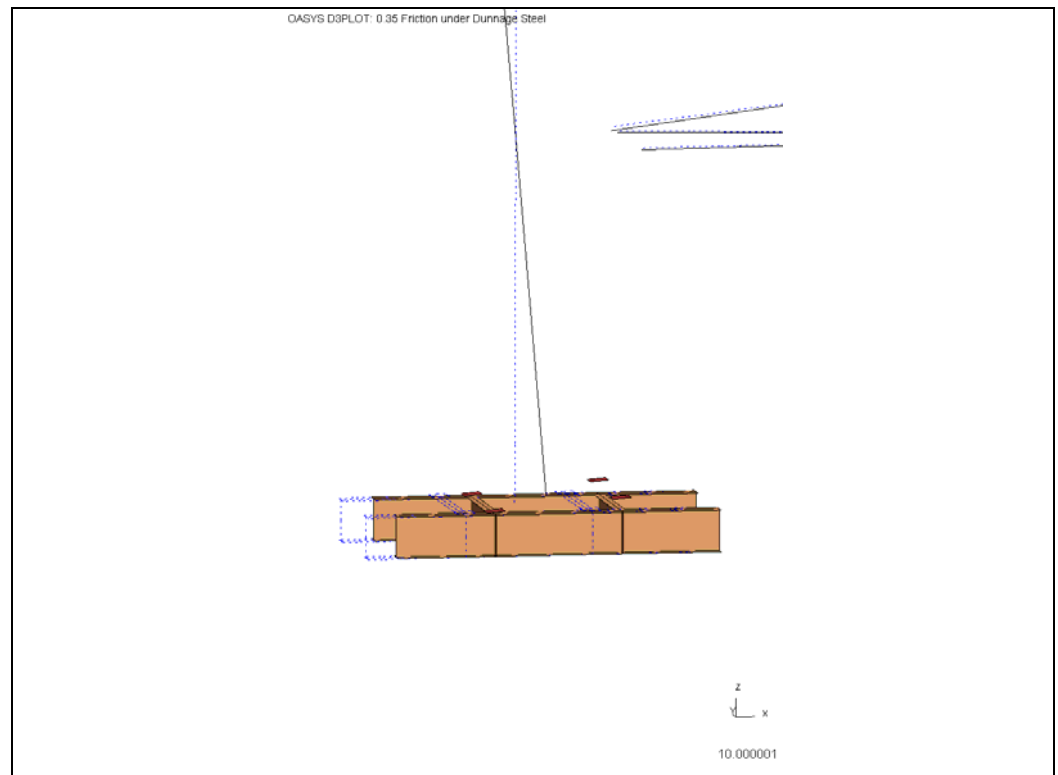
Figure 7.21 - Dunnage Steel close-up at the end the analyses. Prepared by Arup.

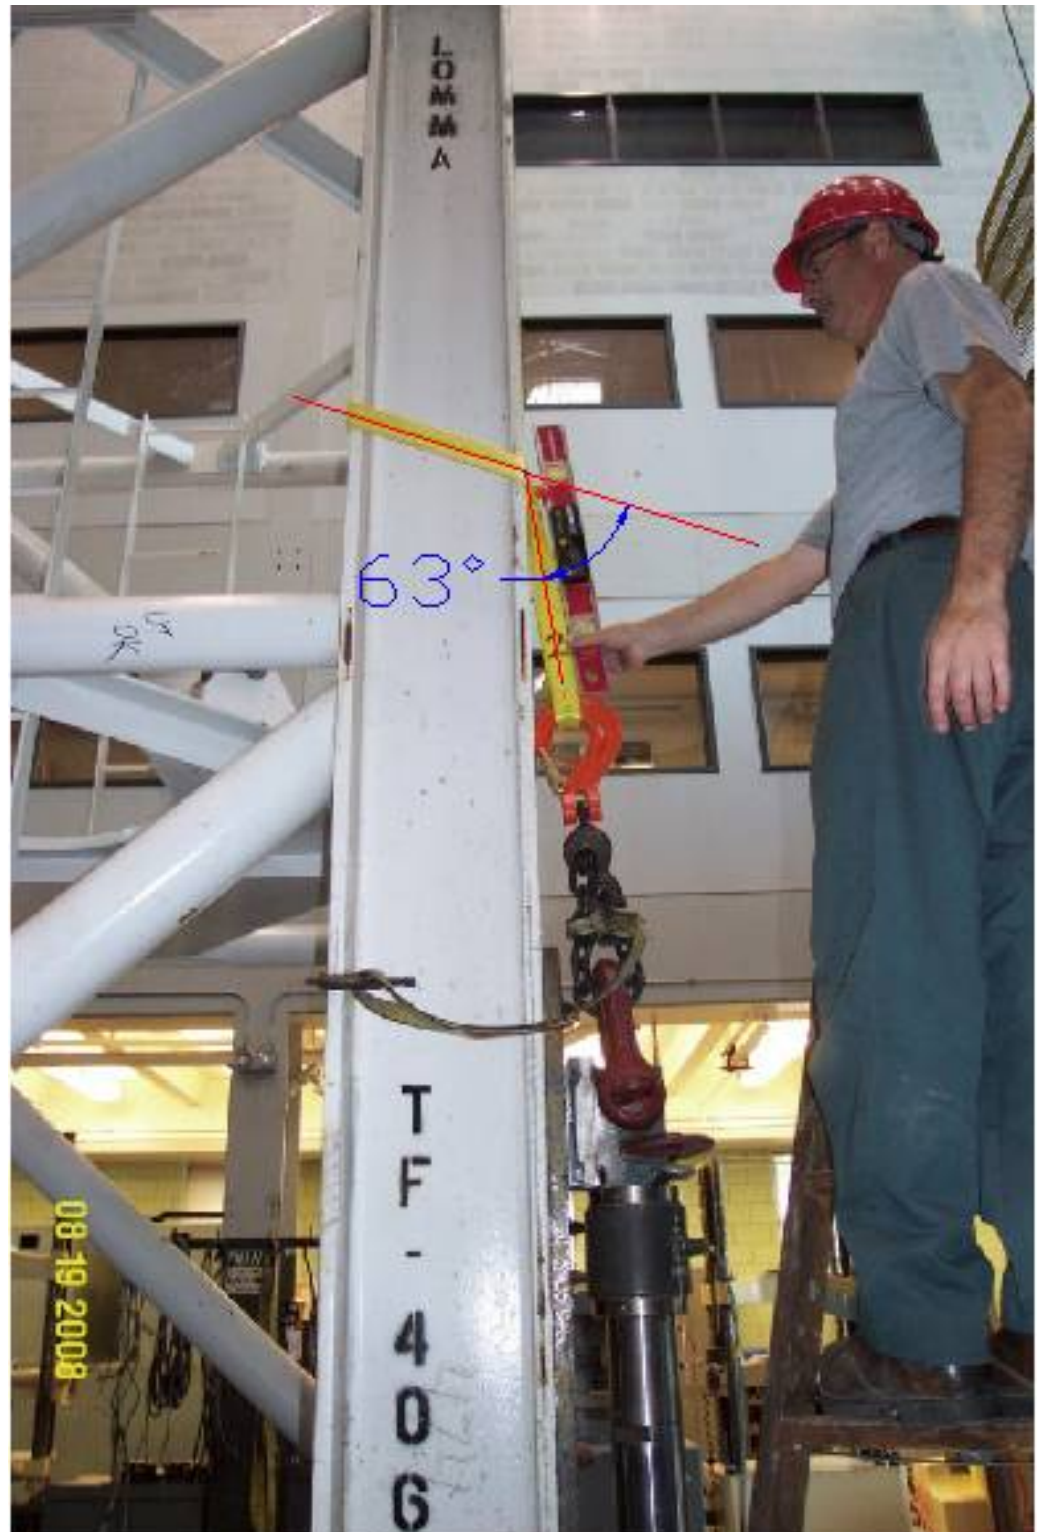
Photograph 8.2 - OSHA Sling Test - angle of pull. Photograph provided by OSHA.

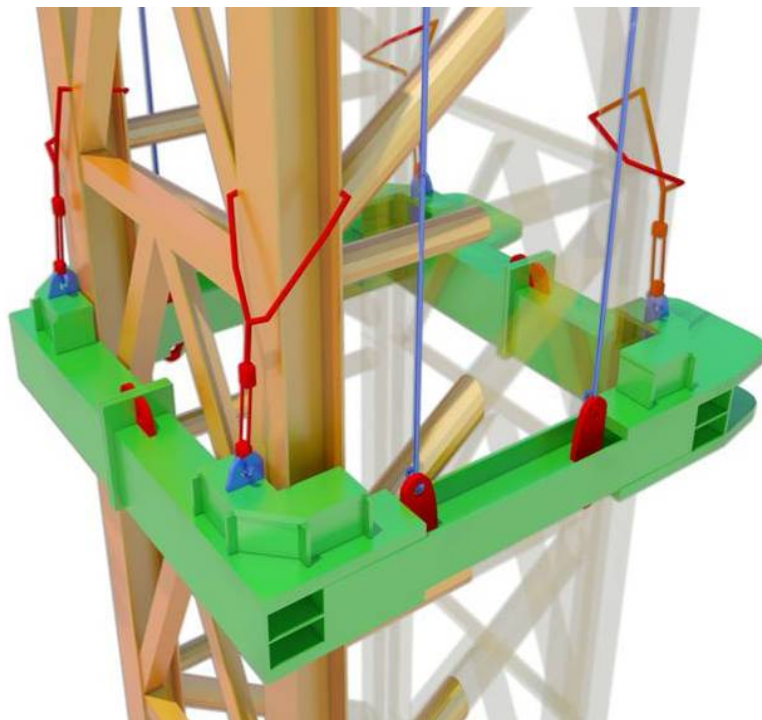
As previously noted in Section 1.2, the wrong lugs were used for the crane to lift the collar and for the slings to suspend the collar from the tower. The collar was actually lifted by the crane from lugs intended for the slings. With their point of attachment already in use, the slings were then attached to the lugs intended for lifting by the crane. This was quite significant as the points actually used for the slings aligned with the columns, which prevented a proper connection to the horizontal beams. Figure 8.10 illustrates the correct arrangement, including the use of the intended crane lifting points for the collar and the use of the intended sling attachments. This situation would have resulted in direct attachment of the slings to the horizontal steel as shown. Figure 8.11 shows actual points used to lift the collar and attach the slings.

Due to the use of the incorrect lugs, the positioning of the slings as installed was inconsistent with the manufacturer's instructions. The slings were choke-hitched around the crane tower columns and drawn into the V-shaped grooves between the diagonal trussed members and the columns. None of the slings were protected against the edges by padding or other means which was required by the sling manufacturers as stated on labels affixed to the slings. See Photograph 8.4 below.

**Figure 8.11 - Elevation of the Collar Tie showing the mix up in the use of the lifting points and the sling attachment- Result: choking the slings against unprotected edges. Prepared by Arup.**

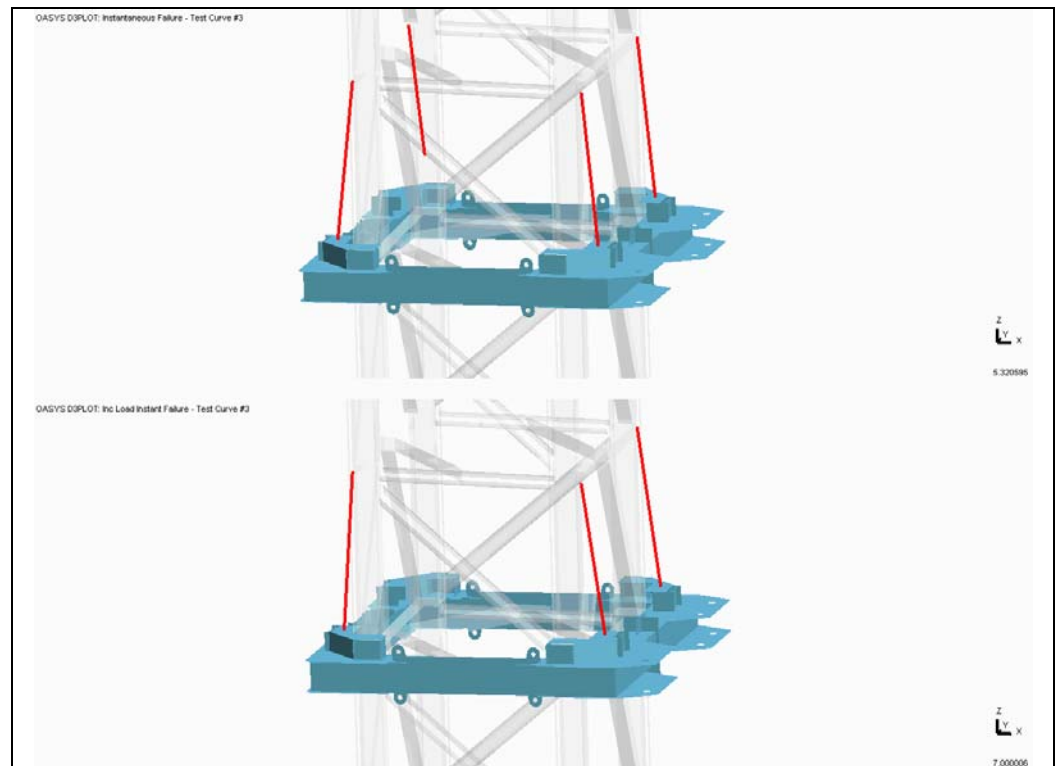
Neither of the analyses in which the sling properties from curve #3 are used result in failure of the remaining slings, see Figure 8.19. Most of the load is initially transferred onto the NW sling for both analyses. The uniform initial sling load analysis is less severe, in which the NW sling reaches approximately 90% of its capacity; see the orange response in Figure 8.20. When the SW sling fails the load is lifted off the NE sling which is then intermittently loaded and unloaded.

**Figure 8.19 - Deformed Mesh at end of Curve #3 Analyses (uniform initial sling load top – non uniform initial sling loads bottom). Prepared by Arup.**

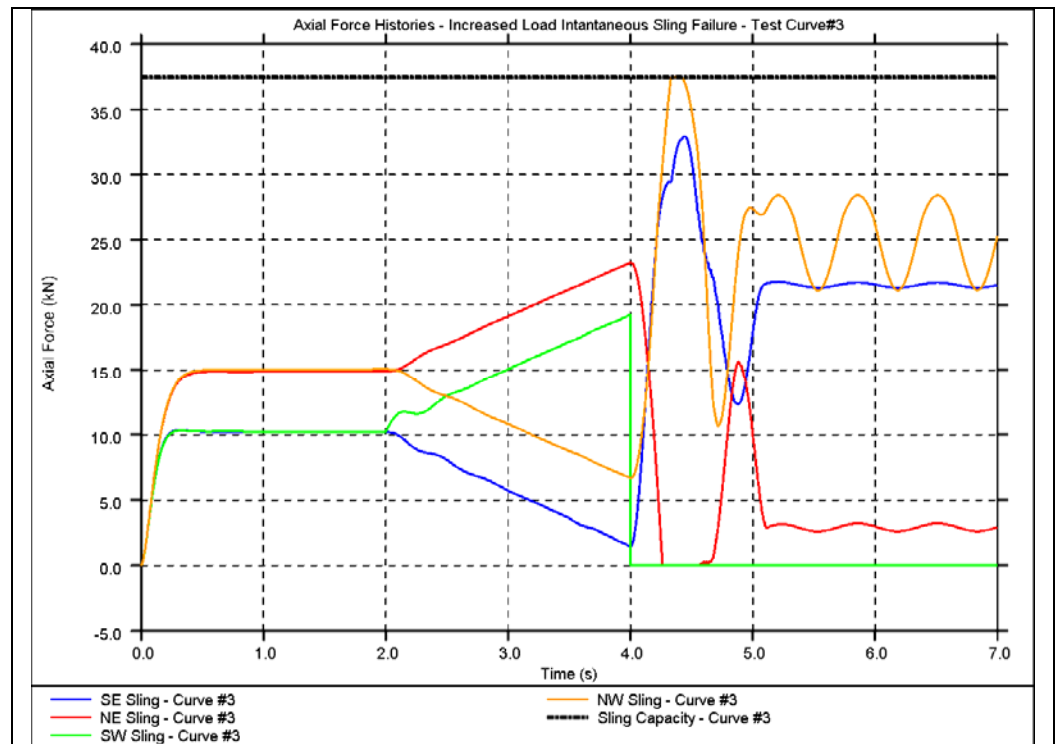
The non uniform initial sling load analysis causes some yielding in the NW sling, as can be seen by the plateau in the response at 4.4s, see Figure 8.21. The capacity of the sling, however, is enough to support the load it experiences.

**Figure 8.21 - Sling Force Time History –Non Uniform Initial Sling Loads – Test Curve #3.**  
Prepared by Arup.

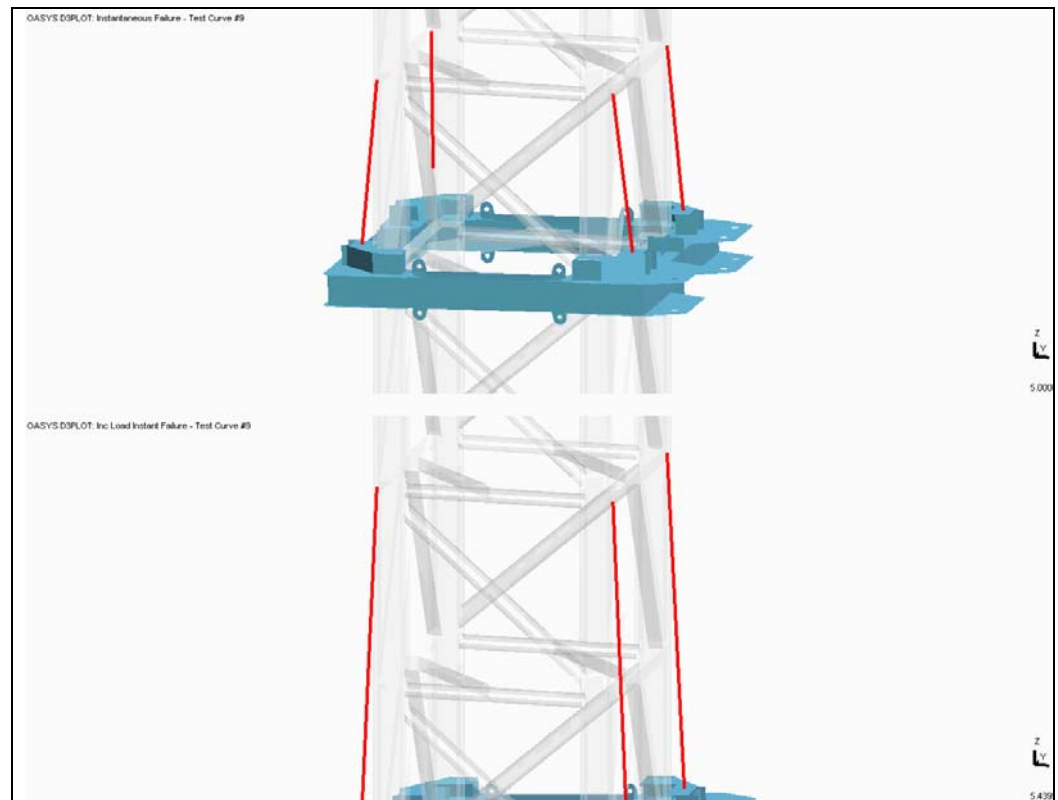
The uniform initial sling load analysis with curve #9 supports the collar after the initial sling failure, see Figure 8.22. Again, most of the load is initially transferred onto the NW sling, which reaches approximately 97% of its capacity; see the orange response in Figure 8.23. The remaining slings have sufficient capacity to support the collar.

**Figure 8.22 - Deformed Mesh at end of Curve #9 Analyses (uniform initial sling load top –non uniform initial sling load bottom). Prepared by Arup.**

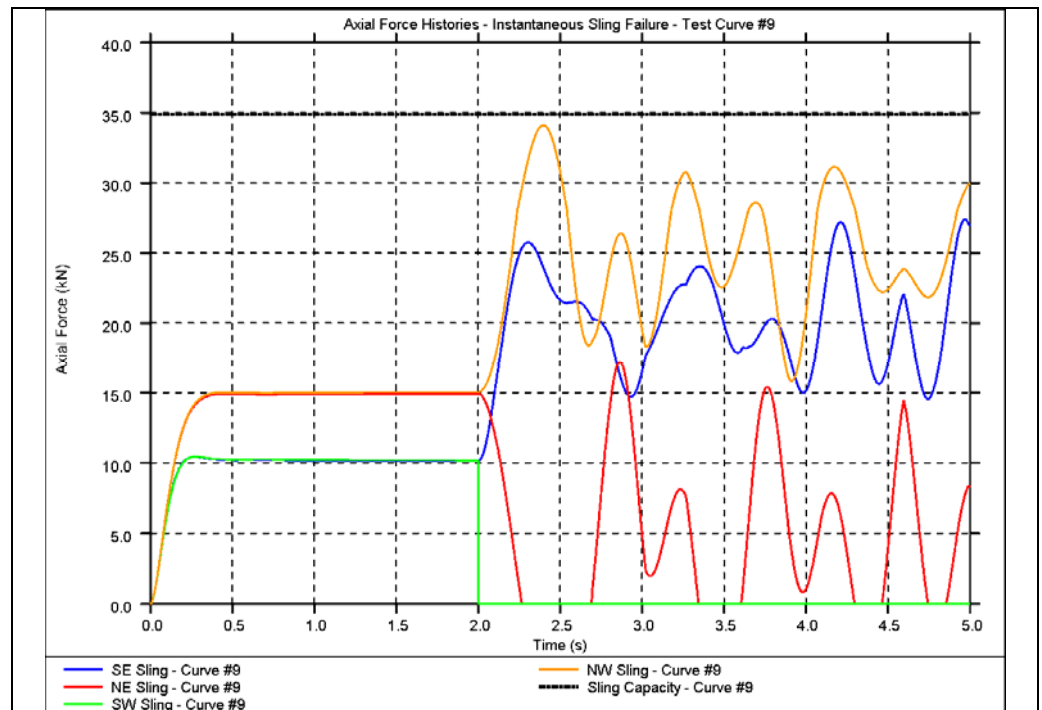
**Figure 8.23 - Sling Force Time History – Uniform Initial Sling Loads– Test Curve #9.**  
Prepared by Arup.

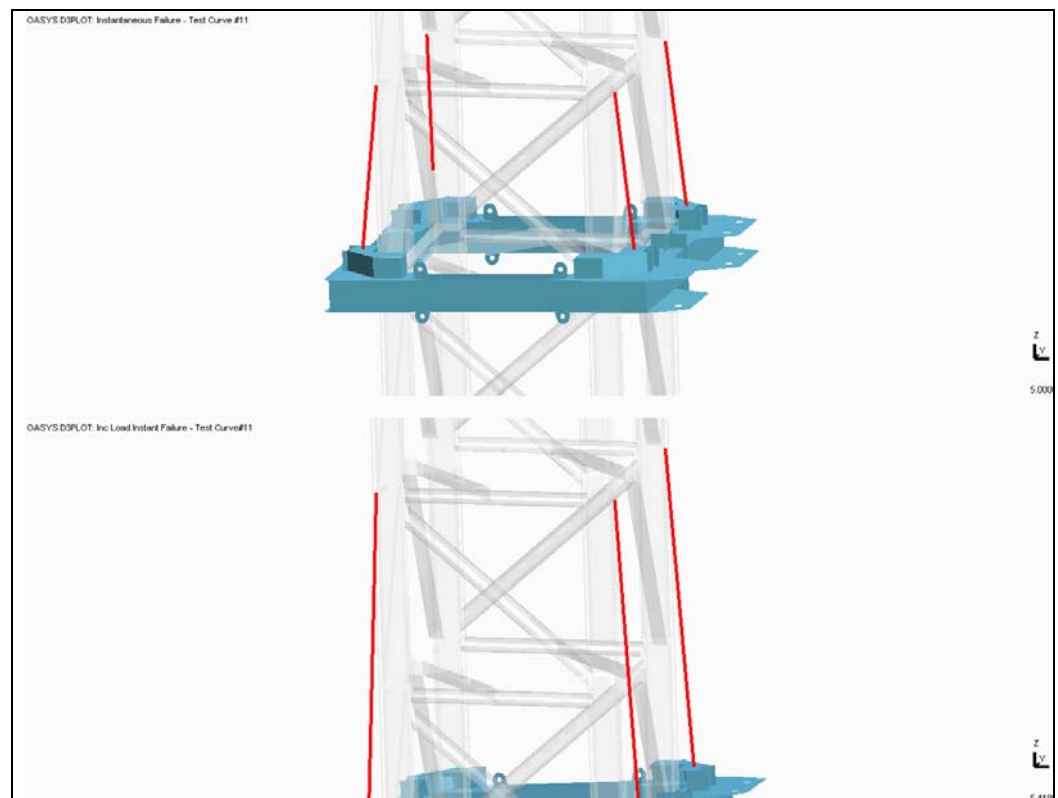
The uniform initial sling load analysis with curve #11 supports the collar after the initial sling failure, see Figure 8.25. Again, most of the load is initially transferred onto the NW sling, which causes some yielding, as can be seen by the plateau in the orange response at 2.4s (Figure 8.26). The sling yields again in subsequent load oscillations, but not enough to cause failure. The remaining slings have sufficient capacity to support the collar.

**Figure 8.25 - Deformed Mesh at end of Curve #11 Analyses (Uniform initial slings loads top – non-uniform initial sling loads bottom). Prepared by Arup.**

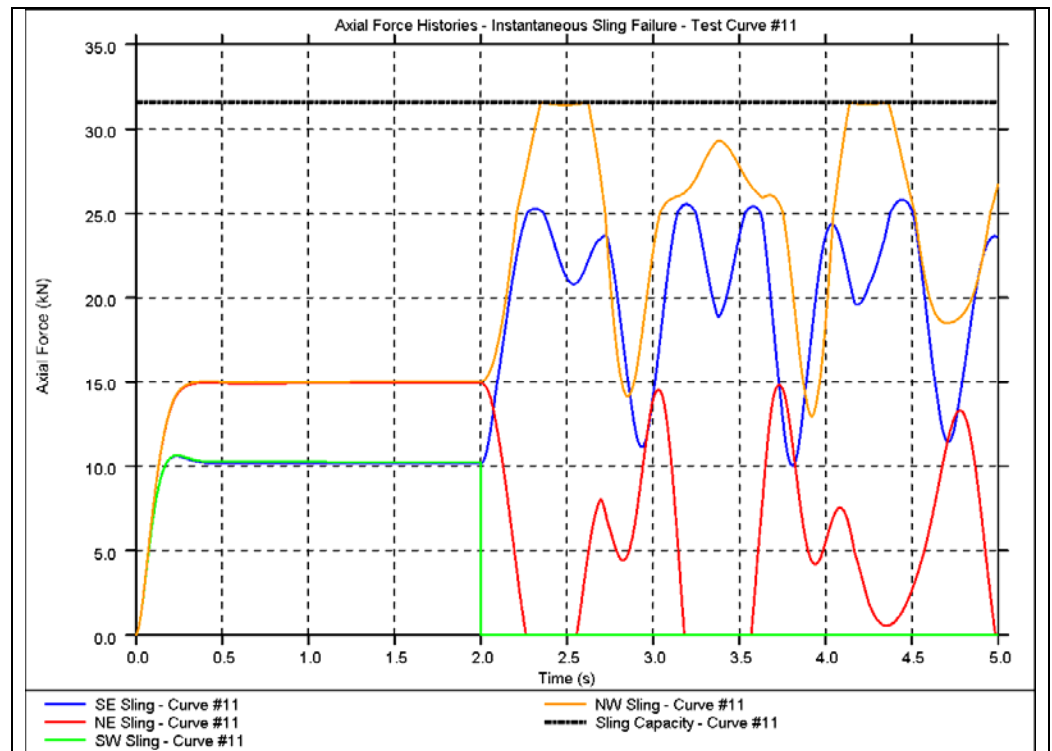
**Figure 8.26 - Sling Force Time History – Uniform Initial Sling Loads – Test Curve #11.**  
Prepared by Arup.

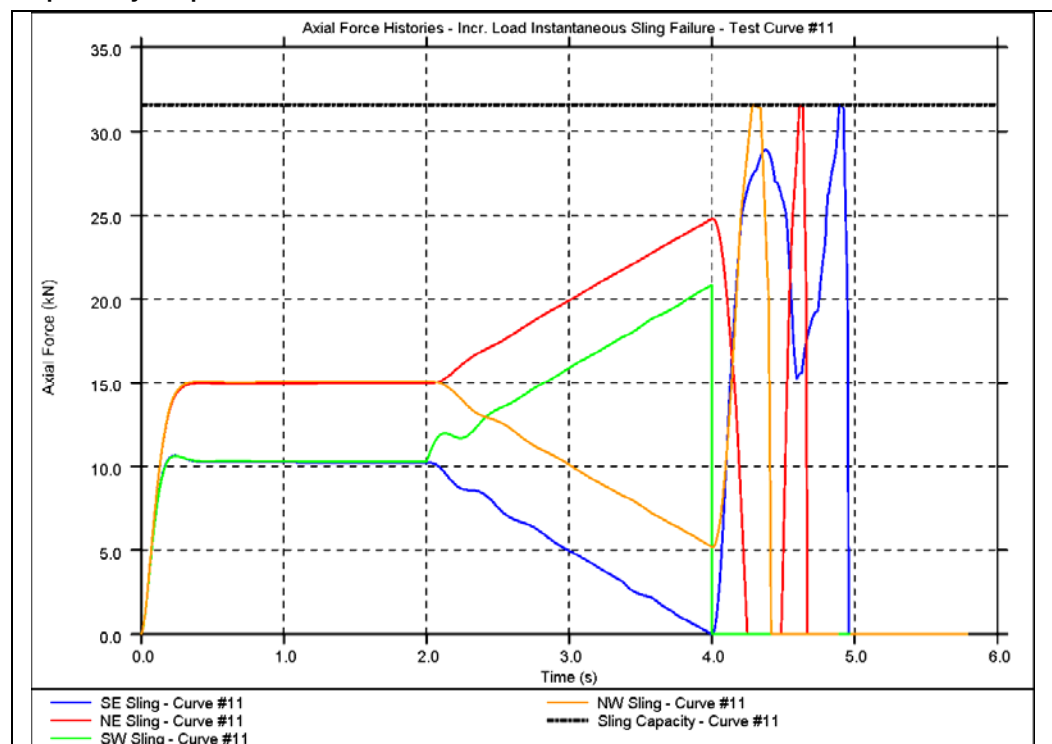
The non uniform initial sling load analysis with curve #11 predicts that support for the collar will fail, as shown by the axial force in all slings reducing to zero in Figure 8.27. The subsequent failure of the NW sling causes the entire load to be transferred to the remaining NE and SE slings, thus following the same failure mechanism described above for the curve #9 analysis. The disappearing collar in Figure 8.25 indicates that the support system has failed. It should be noted that the NW, SE and NE slings have failed even though they are still drawn in the figure.

**Figure 8.27 - Sling Force Time History –Non Uniform Initial Sling Loads– Test Curve #11.**  
Prepared by Arup.

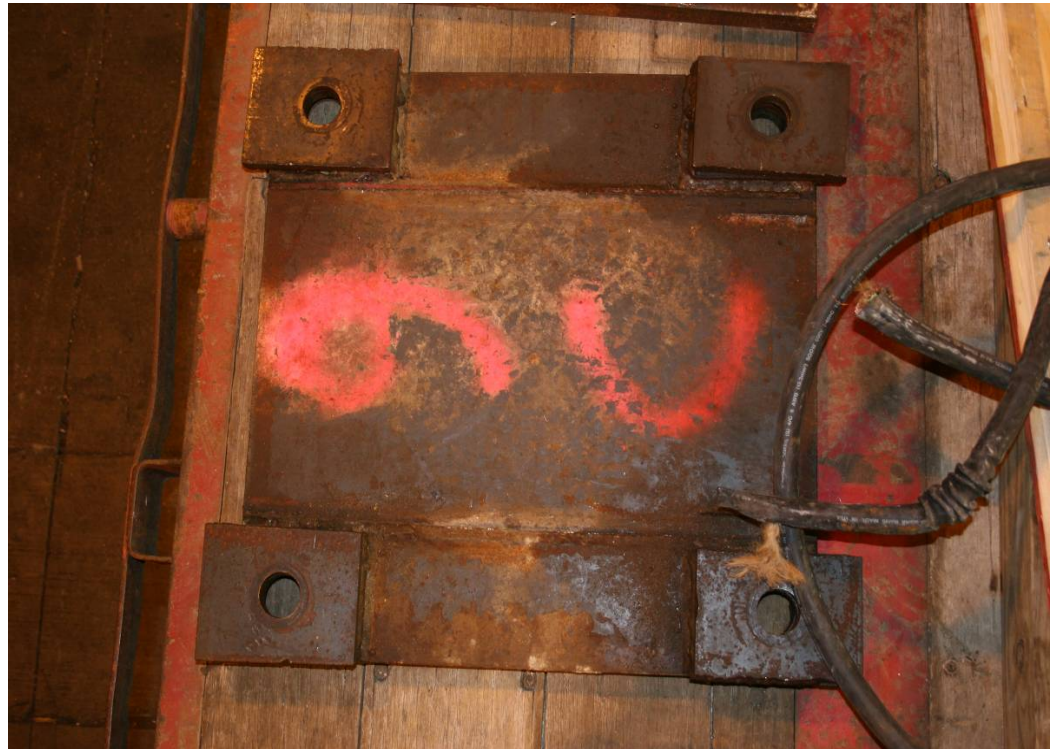
**Photograph 9.2 – Base plate 9B from floor level 9. Photo by Arup.**

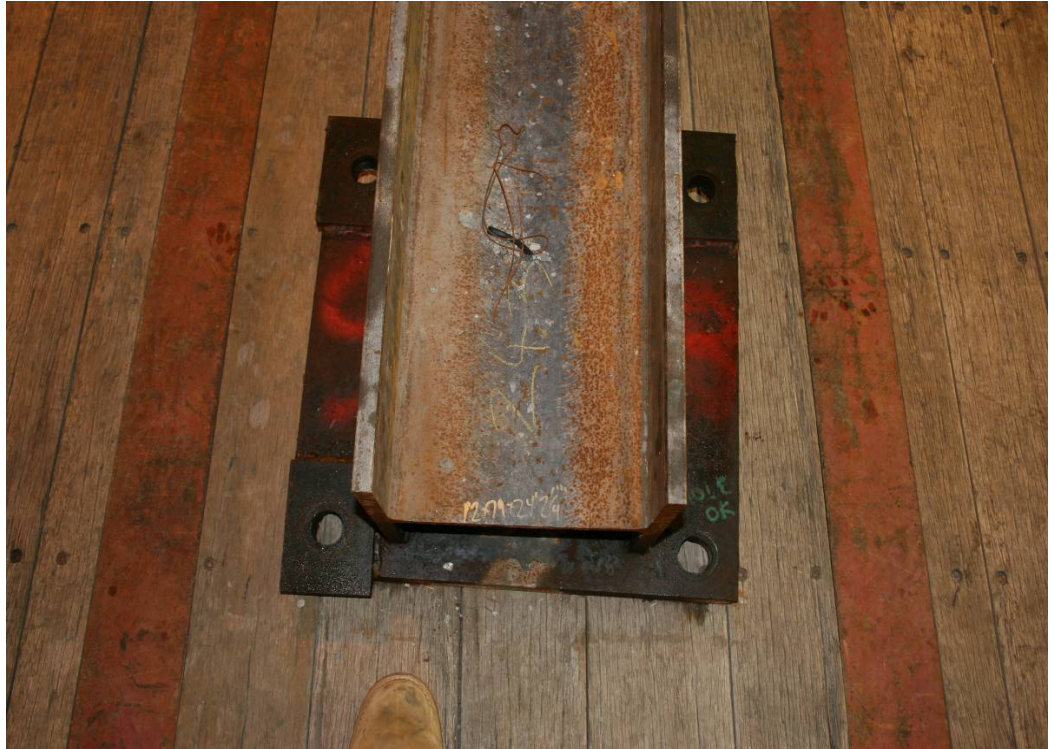
**Photograph 9.3 – Base plate 9B from floor level 9. The tie-beam is still attached. Photo by Arup.**

With regard to the still intact assembly, Base Plate/Tie-Beam 9B, the welds appeared to be sound and free of fabrication defects. A weld toe crack on the tie-beam leg was observed in one fillet weld at the weld end, although separation of the components had not yet occurred.

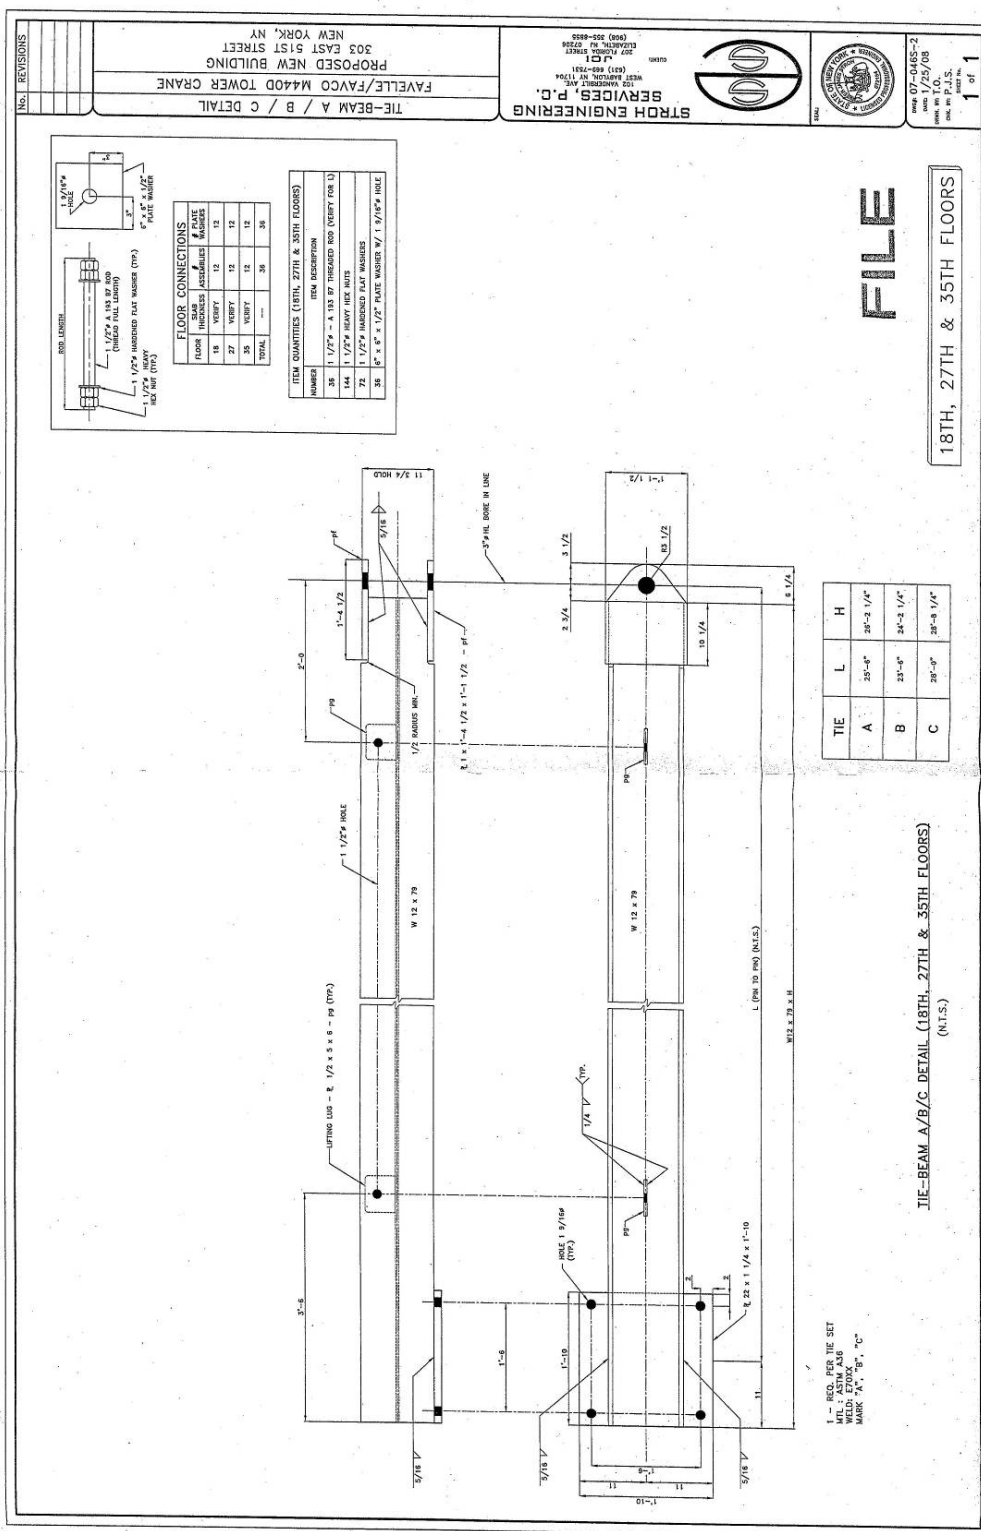
The measured weld lengths varied and ranged from 20 inches to nearly the full length of the base plate. A short length of fillet weld of variable length was also deposited along the interior flange tips at the beam end ranging from 2-1/2 in. to 4-5/16 in. This compares with the fabrication drawings which specified a 22 in. length with no weld along the interior flange tip. See Figure 9.1 below.

**Figure 9.1 - Tie-beam A / B / C Detail, Fabrication Drawing, by the crane engineer Stroth Engineering Services, P.C. Drawing 07-046S-2 Sheet 1 dated 1/25/08.**

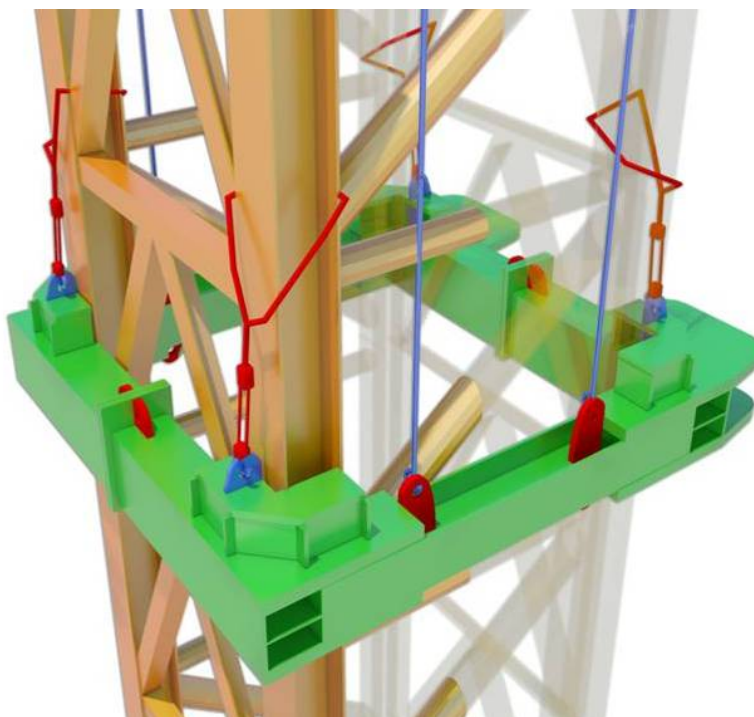
**Figure 11.1 - Elevation of the Collar Tie showing the mix up in the use of the lifting points and the sling attachment- Result: choking the slings against unprotected edges. Prepared by Arup.**

The two polyester web slings used to suspend the collar from the tower were attached to the lifting point lugs, rather than the designated chain block lugs. As a result, they were in the wrong location with regard to the tower face and had to be choked around the tower columns and diagonal bracing rather than the horizontal bracing. In that configuration, the polyester web slings were drawn into the "V" shaped groove between the bracing and the tower columns.

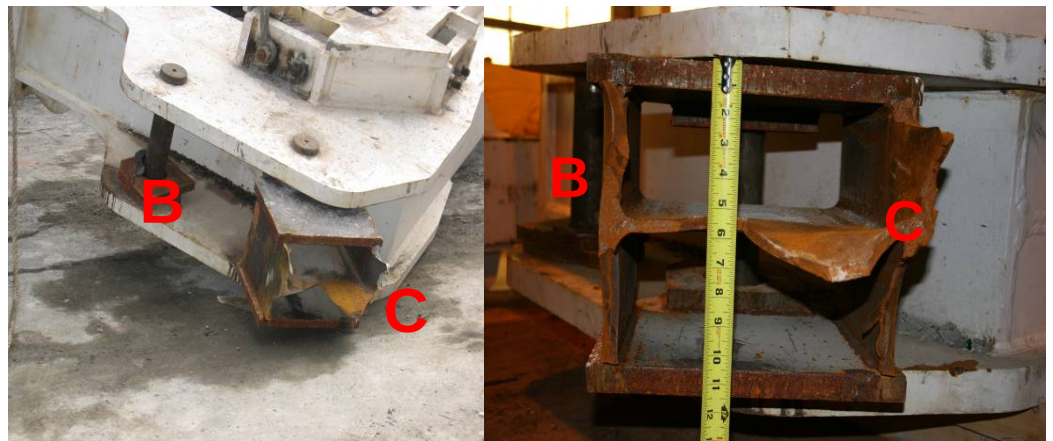
As demonstrated by structural analysis, the unanticipated loads arising from the dynamics of the collar falling from the 18<sup>th</sup> floor caused the failure of the collar connection at the 9<sup>th</sup> floor. The precise failure mode proved difficult to replicate analytically. However, even though the analysis over-estimated the strength of some components, it did demonstrate that the falling collar had ample energy to destroy the connection. Photographs 11.1 and 11.2 show the damaged end connections of the tie-beams at the tie-beams at the 9<sup>th</sup> floor. Photograph 11.1 shows the base plate connections after the incident. The tie-beams, marked 9A and 9C on the photograph, have completely separated from the base plates. Photograph 11.2 shows that all three tie-beams sheared off the collar near pins.

Photograph 11.2 - 9<sup>th</sup> Floor: Failed end for Beam B5 (labelled “C” in the photograph) prior to its removal from the site (the pin end of Beam B5 sheared off). Photos by Peter Stroh IMG 0093.jpg and Arup.

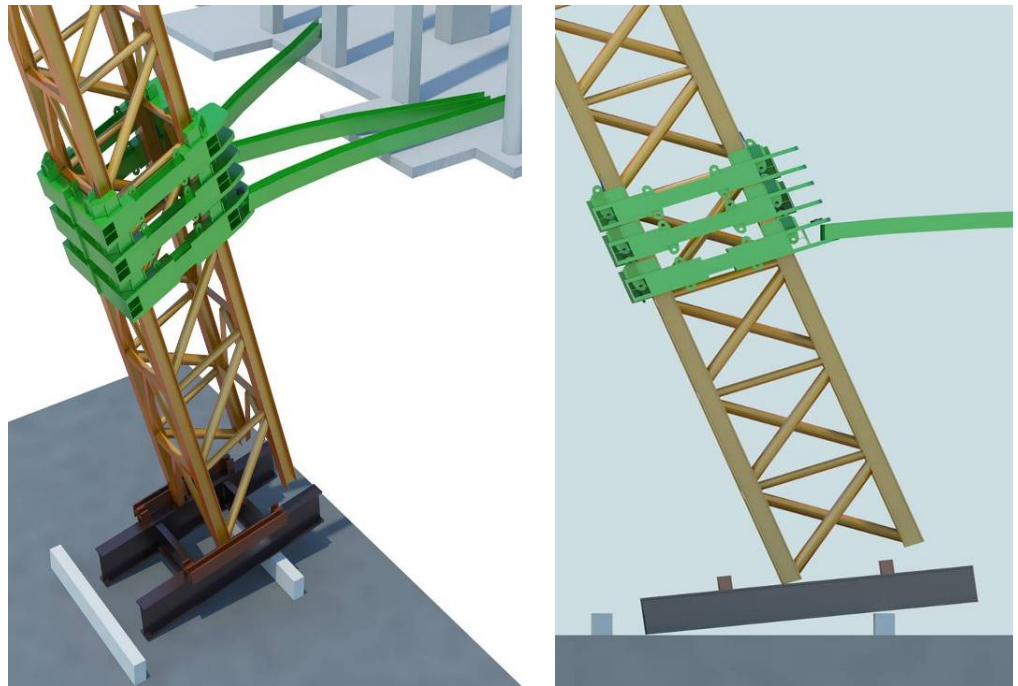
Figure 11.3 - Elevation of the tower at the 3rd floor showing dunnage slippage at the base and the uplift at the back legs of the tower and tower rotation. Prepared by Arup.

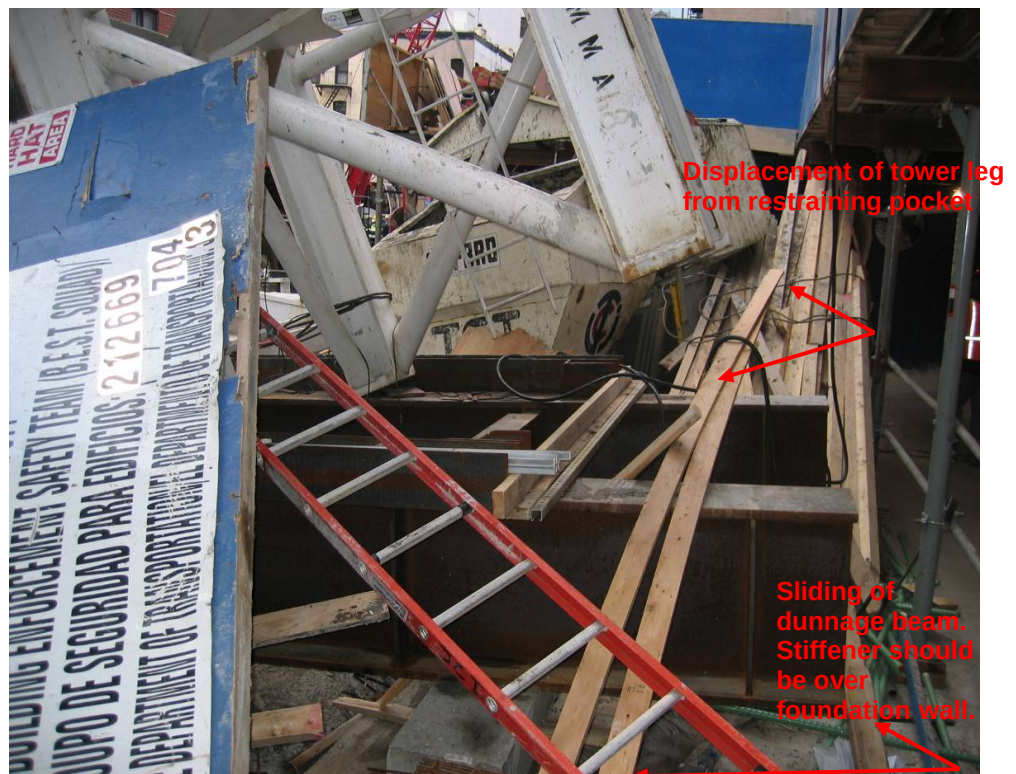
shows the slippage of the tower base towards the building and a rotation about the level 3 collar; resulting in the movement of the upper parts of the tower away from the building. As this movement continued, the tower legs at the base of the tower dislocated from the supporting pockets located on the dunnage beams; allowing another type of sliding as the tower legs slid along the dunnage. This is illustrated in Figure 11.3. The dunnage steel eventually slid completely off its foundation wall to the south. Photograph 11.3, taken after the collapse, clearly shows the movement of the dunnage beam and tower base.

Photograph 11.3 - Base of tower crane after collapse. Note the movement of the dunnage beam and displacement of the tower legs from their restraining pockets. Photo from New York County District Attorney IMG\_0379\_109.jpg.
