New York City  
Department of Buildings

**51st Street Crane  
Investigation**

51st Street Crane  
Investigation Report

March 2009

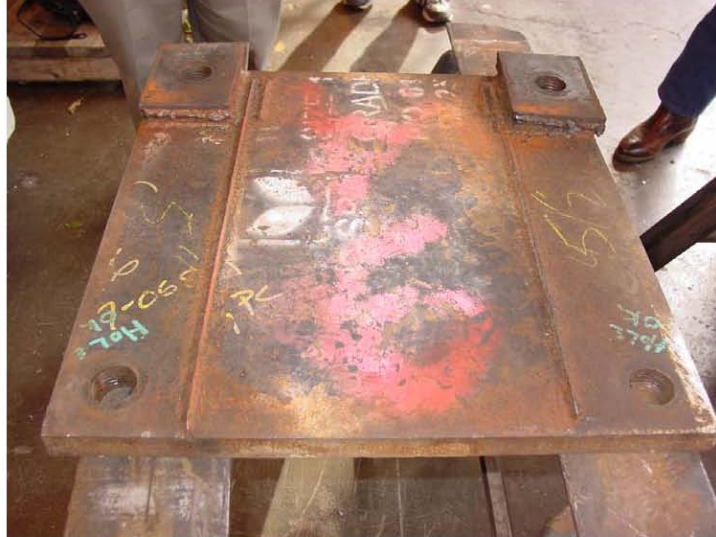
**Figure 1** Ninth Floor Horizontal Tie Beam Base Plate 9A With Weld Fractures.

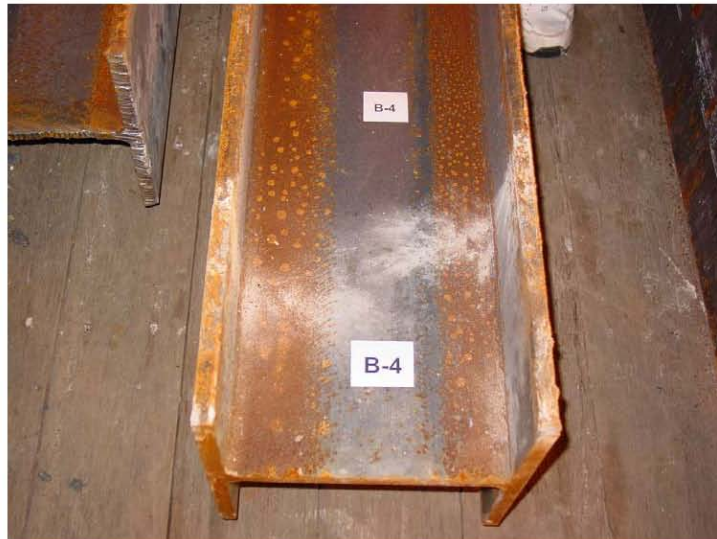
Tie-Beam B4 weld fractures showed similar fracture features but only a small amount of weld metal deposited on the tie-beam. The small amount of weld fracture observed on the tie-beam indicated an effective weld size much less than the deposited weld size previously measured on the base plate, arising from the tie-beam fit-up to the base plate. However, with the majority of weld having an effective weld size of 3/16", it is still sufficient to support the design loads (see Section 4 on Peer Review of Tower Crane On-Site Design) without failure, although not with the minimum required factor of safety. As for B-5, this is below the minimum specified by the American Welding Society.

**Figure 3** Ninth Floor Horizontal Tie Beam B4 End With Weld Fractures.  
(Welded to Base Plate 9A).

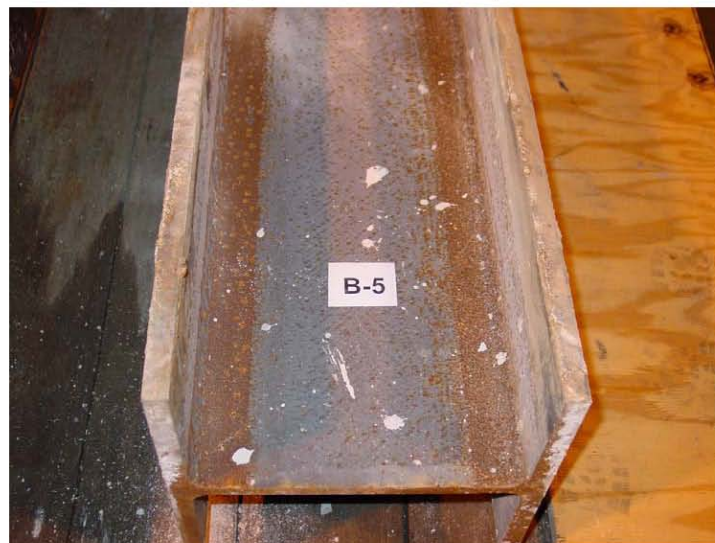
Visual examination of the weld fractures on tie-beam B-5 indicated that the welds fractured by ductile shear along the weld leg of the tie-beam. The welds were generally sound and free of weld defects with only isolated weld porosity. No evidence of weld cracking or incomplete fusion was observed.

**Figure 4** Ninth Floor Horizontal Tie Beam (B5) End With Weld Fractures.  
(Welded to Base Plate 9C).

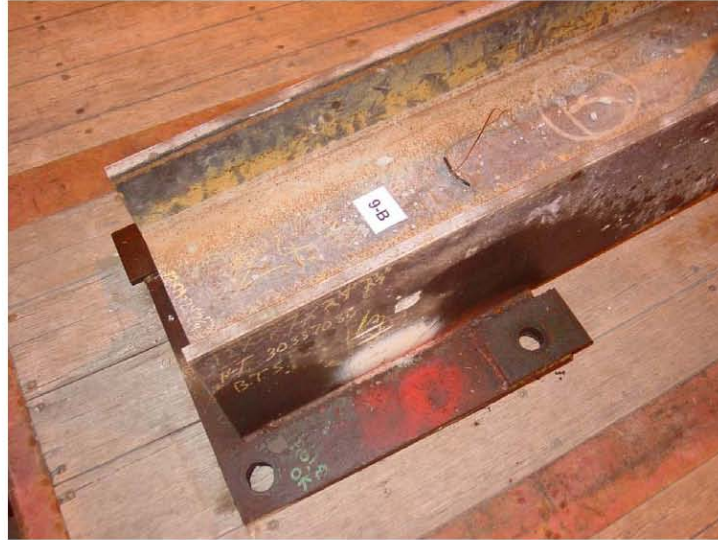
With regard to the still intact assembly, Base Plate/Tie-Beam 9B, the welds appeared to be sound and free of fabrication defects. A weld toe crack on the tie-beam leg was observed in one fillet weld at the weld end, although separation of the components had not yet occurred.

**Figure 5** Intact Ninth Floor Horizontal Tie Beam and Base Plate 9B.

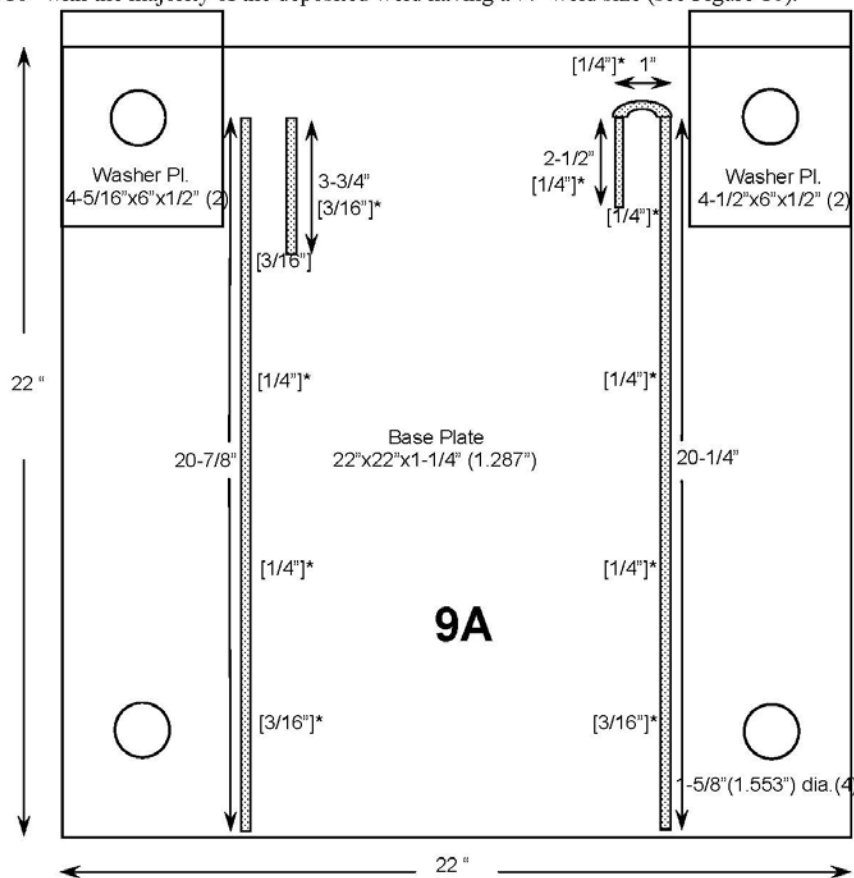
Examination of the weld fractures indicated that fracture occurred along the weld leg joining the tie beam and all or most of the deposited weld remained on the base plates. (Latter reassembly of the connections verified that the fractures occurred along the tie beam weld leg). Fillet welds generally exhibited unequal leg dimension with the shorter leg existing on the tie-beam. Fillet weld size measurements obtained on all three tie-beam/base plate components (see Figures 6-8) indicated a deposited weld size ranging from 3/16" to 5/16" with the majority of the deposited weld having a 1/4" weld size (see Figure 10).

\* Min. Weld Leg  
**Figure 6** Base Plate Dimensions and Weld Dimensions (Base Plate 9A).

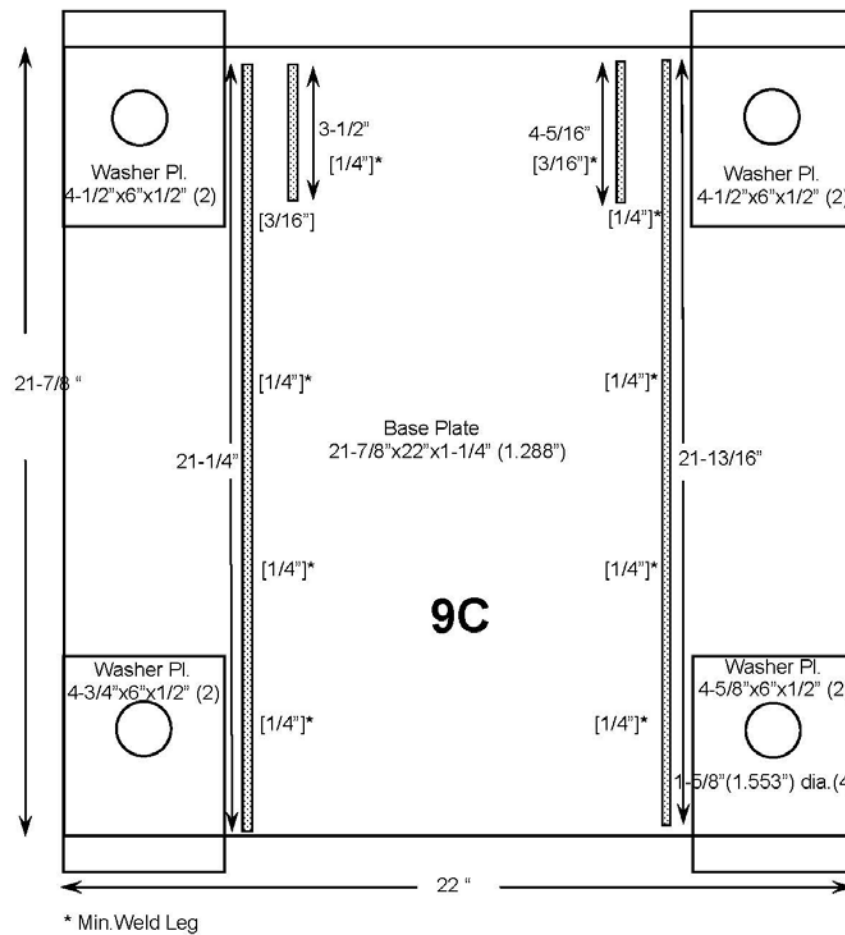
Figure 7 Base Plate Dimensions and Weld Dimensions (Base Plate 9C).

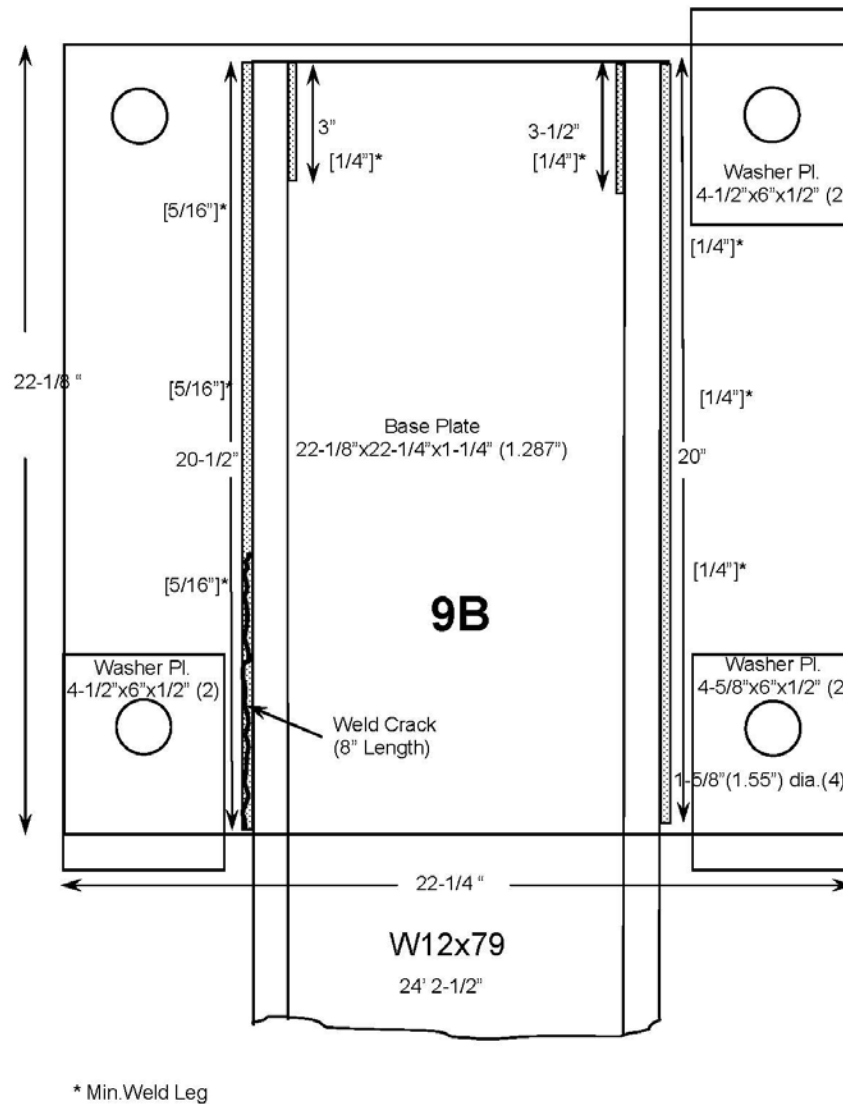
**Figure 8** Base Plate Dimensions and Weld Dimensions (Base Plate 9B).

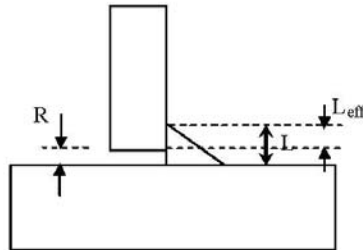
caused by root opening is shown schematically in Figure 15. Hence, because of the root opening the effective weld size of the base plate/tie beam connection was reduced to 1/8" to 1/4" with the majority of weld having an effective weld size of 3/16". Root openings of the size measured are not prohibited; the deposited weld size must be increased accordingly to result in the required weld size for the connection.

**Figure 15** Fillet Weld Dimensions.

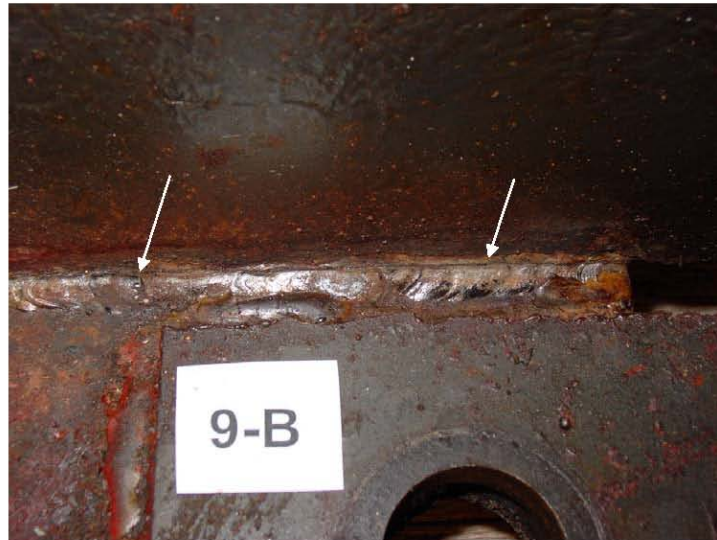
A visual examination of the intact base plate/tie beam welds was performed on Base Plate/Tie Beam 9B. General views of the welds are shown in Figure 20. Visual inspection of the welds indicated that they were generally sound and free of unacceptable defects. Deposited weld sizes ranged from 1/4" to 5/16". A crack was observed in one weld at the weld end that measured approximately 8 inches in length. The crack was located along the weld toe on the tie beam leg (See Figure 20 and Figure 21).

**Figure 21** Enlarged View of Weld Toe Crack Observed in Base Plate 9B Weld. (see Arrows)

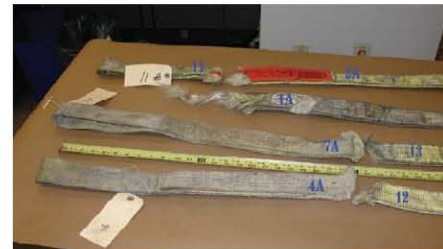
Pieces of the four slings involved in the incident are shown in Figure 2. Each piece is aligned with another, understood to possibly be the matching, missing part, to suggest the complete sling before failure. The numbers used in identifying are those assigned by OSHA. Note that one of the pieces that should be paired with piece 1A is missing and was reportedly not found.

Figure 2. Recovered pieces of slings involved in the crash.

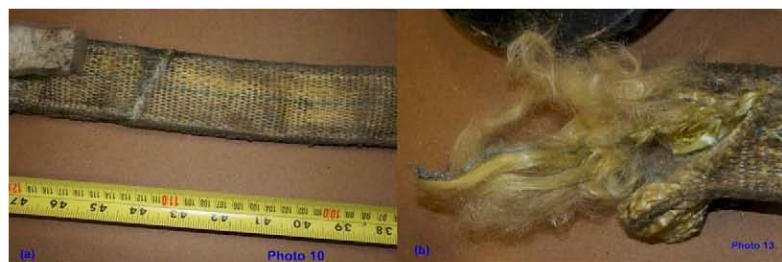
**Sling Piece 1A:** According to the label, the sling piece is made of polyester and manufactured by Metro Wire Rope Corporation. The piece, 57" in length, shows a number of high compressive stress and/or abrasion lines, approximately along the cross direction, see Figure 3a. In

Figure 3. (a) Sign of stress on sling piece 1A, (b) Fracture surface of sling piece 1A

some instances the fibers are broken (or cut) along the stress lines. Figure 3b shows a close up of the fractured end of the sling-piece 1A. The failure surface of the sling is along a diagonal line to the long direction of the sling. Visual examination of the fractured end clearly show two distinct areas. Almost  $\frac{3}{4}$  of the sling failure surface seems to present a high-stress compression and/or abrasion failure from a sharp edge while the rest looks almost like slow-speed tensile failure. The slow-speed tensile failure is

characterized by fiber pull-out and thinning of fibers as seen in Figure 3b. The evidence of abrasion damage in sling-piece 1A is clearly evident in a few micrographs presented in Figure 4. The fibers in the vicinity of failure show mangled ends and fibrillation. In addition, the striations along the cross direction of the fibers, visible in Figure 4b and in others could be signs of initiation of cracks during this incident or due to prior use.

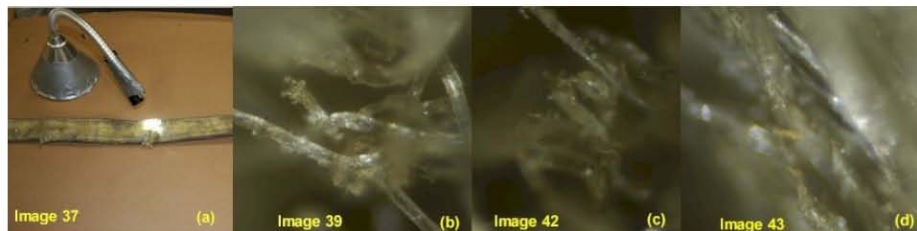
Figure 4. Micrographs (b-d) of fibers in sling 1A showing abrasion damage. Image (a) represents the position of the fibers presented in the micrographs.

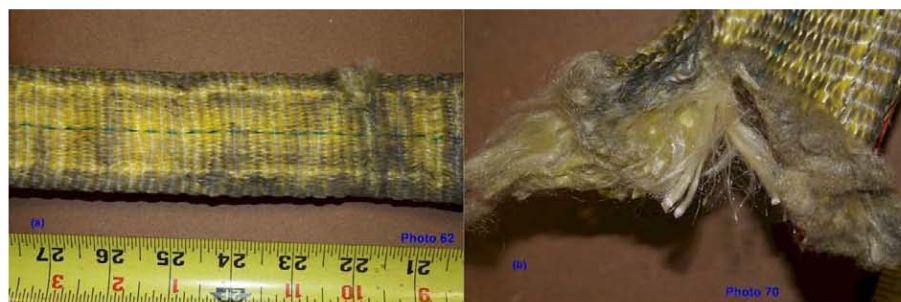
Figure 5. (a) Sign of stress on sling piece 2A, (b) Fracture surface of sling piece 2A

very high compressive stress, approximately along the cross direction as shown in Figure 5a. Some of the fibers along the stress line are broken.

The fracture surface is mostly at a diagonal to the axis of the sling, see Figure 5b. More than half of the failure surface seems to present a well-defined linear high-stress cut due to contact with a sharp edge. The evidence of abrasion melting is also present. The other part of the fracture surface presents a mix evidence of cutting, relatively slow tensile pull out, and high speed failure characterized by melting due to high-speed drawing. Limited evidence of mushroom-like fiber ends resulting from high speed failure are presented in Figure 6.

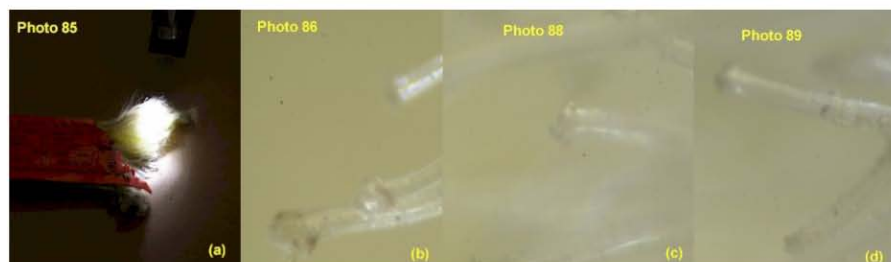
Figure 6. Micrographs (b-d) of fibers in sling 2A showing mushroom-like fracture ends . Image (a) represents the position of the fibers presented in the micrographs.

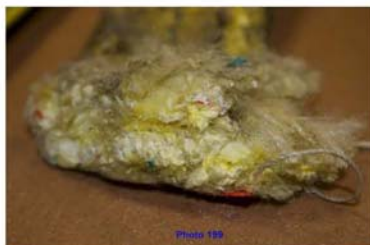
Figure 9. Fracture surface of sling piece 11.
