NYC WASTEWATER RESILIENCY PLAN

CLIMATE RISK ASSESSMENT AND ADAPTATION STUDY

October 2013

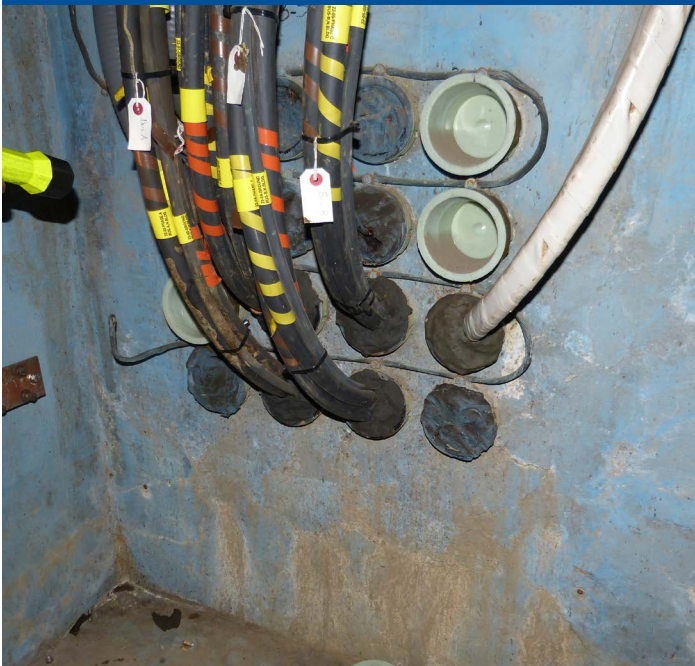
Electrical conduits in the basement of the Main Building provided a pathway for floodwaters during Hurricane Sandy.

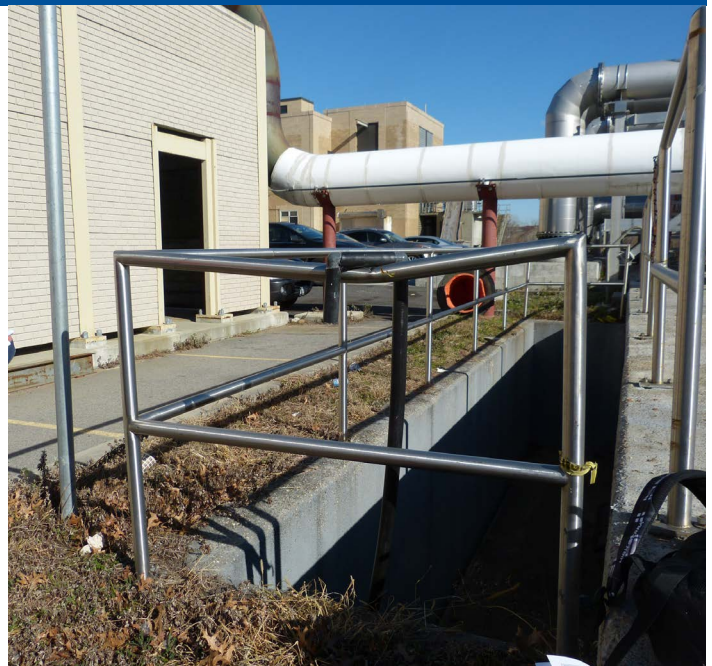
A basement access way leading to the Primary Sludge Gallery would be a flood pathway during the critical flood event.

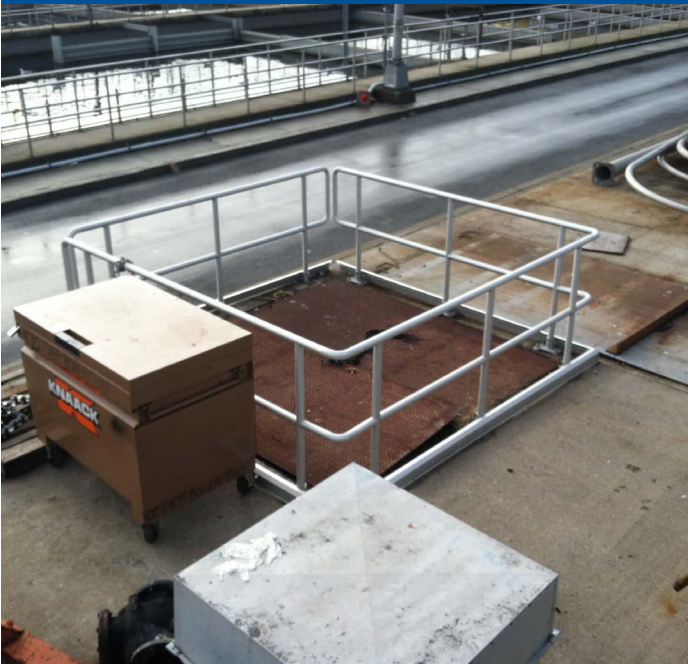
Typical hatch at grade level leading to tunnel system

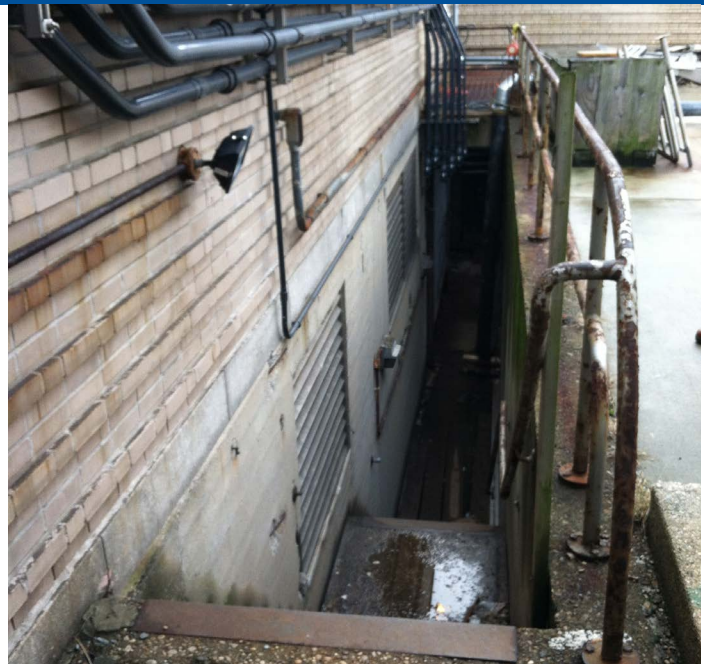
Stairway at grade leading to the Main Building

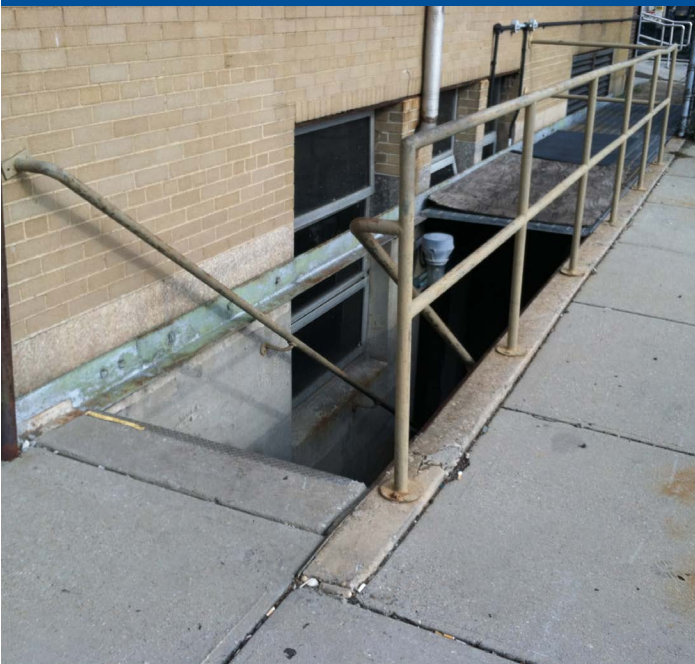
Access stairway to the basement and gas booster room of the Pump and Power Building

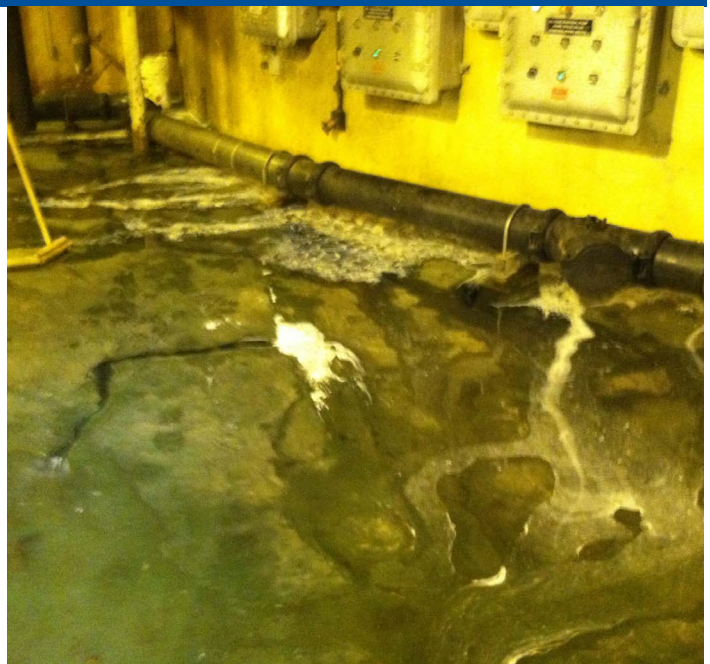
Sinkholes developed near the Sludge Storage Area after Hurricane Sandy. Groundwater may present a flood risk during the next critical flood event

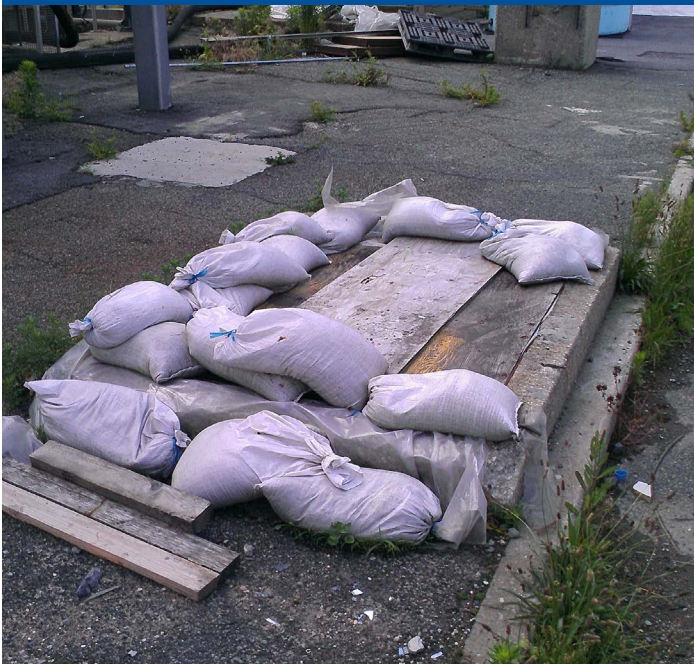
The overhead grate above the Aeration Gallery is a potential flood pathway to the sludge pumps.

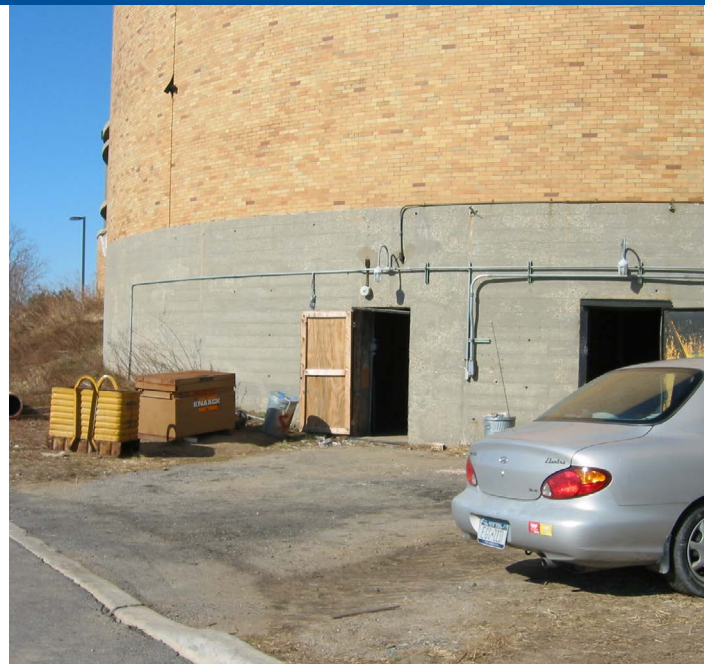
Access doors to the Sludge Storage Tanks next to the East River

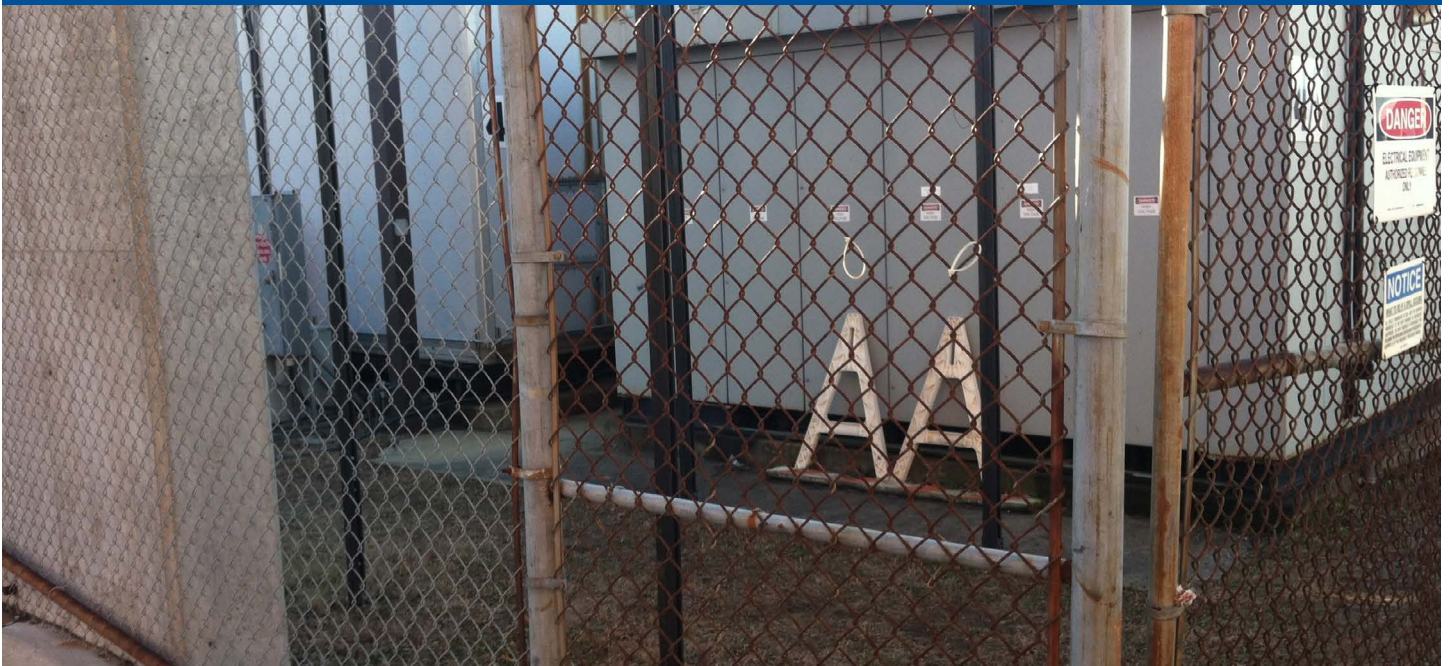
The Unit Substation adjacent to the Return Sludge Pump Station #3 would be flooded at grade level during the critical flood event.

The critical flood event would only result in half a foot of flooding near the Unit Substation; therefore, sandbagging around the Substation is recommended. This strategy is regularly employed at the Substation, already as staff know this area has the greatest potential for flooding. This option can be implemented as needed prior to large flood events. It is also affordable and provides an adequate level of protection for the Substation.

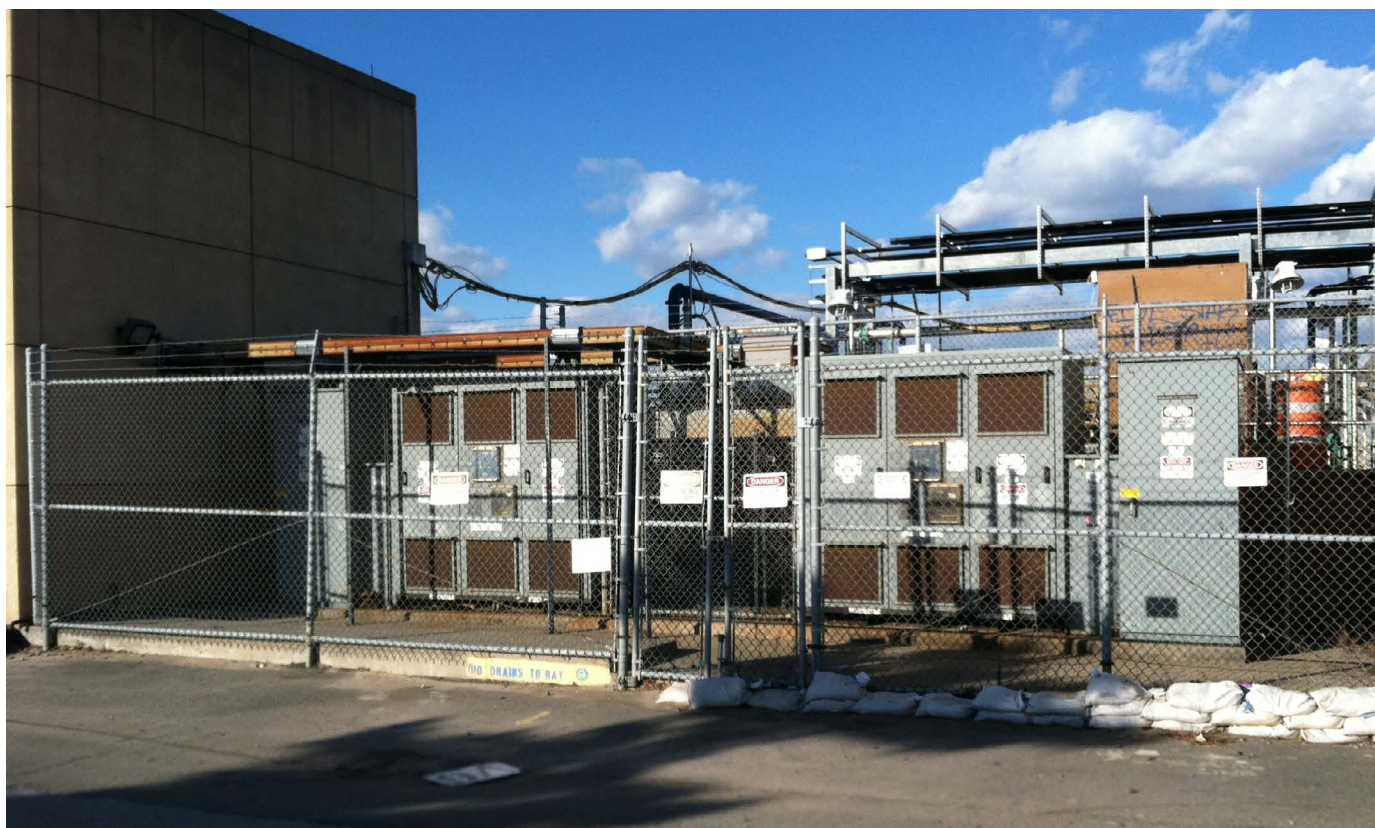
The Unit Substation (USS 1533) is currently protected with sandbags.

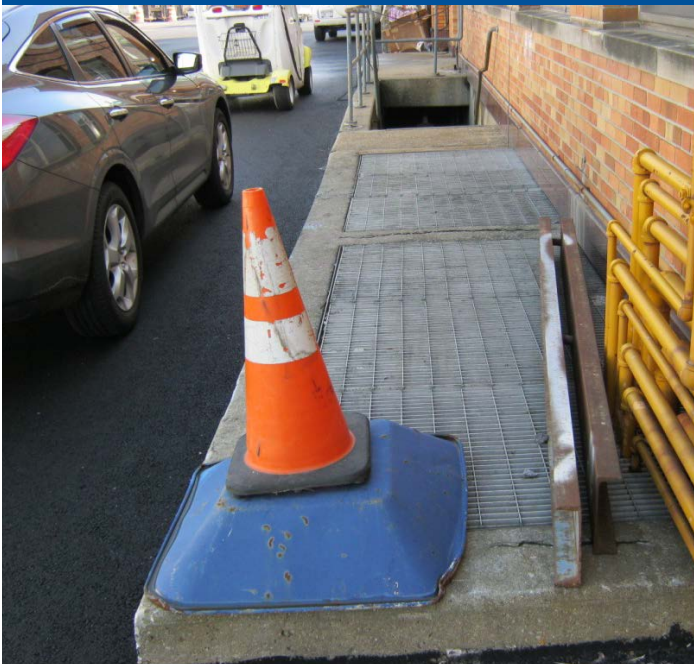
Basement access and floor grates on the perimeter of the Main Building

The Main Building contains several rooms that are susceptible to flooding under the critical flood event, such as the Main Pump Room, Old Facility Room, and Electrical Substation area. It is recommended to seal the building with water-tight doors and windows and flood-proof target pieces of equipment to provide adequate protection during the critical flood event and smaller storms.

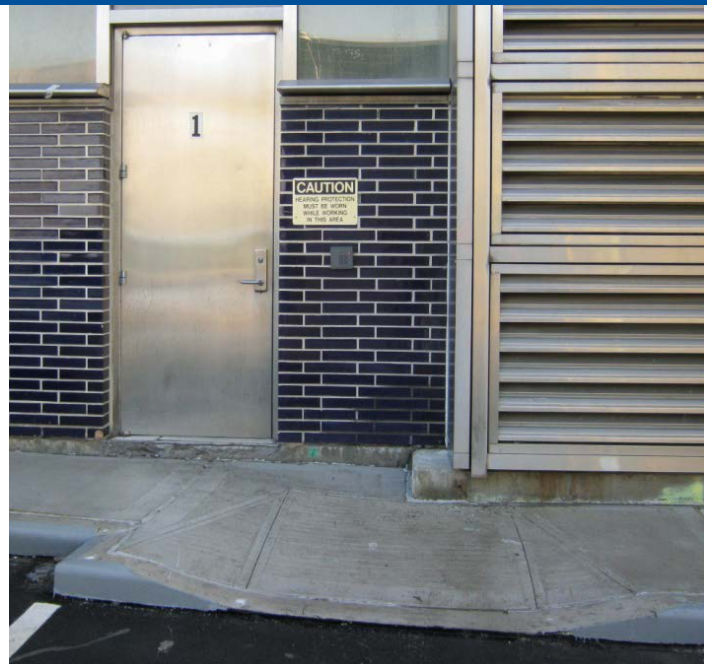
Low-lying louvers along-side the Main Building

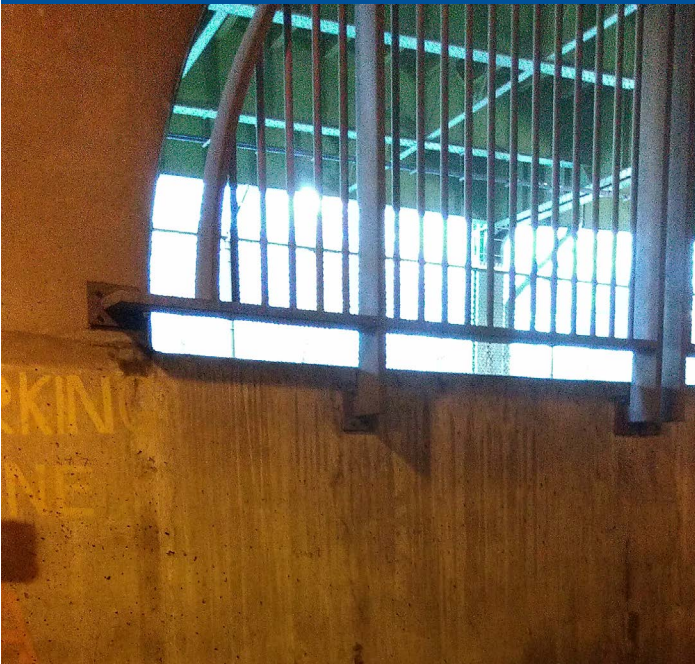
Arched windows around the perimeter of the ground level (EL 5) are considered pathways for flooding.

Since the first floor elevation (EL 5) at North River contains critical infrastructure, flood-proofing is recommended since it provides a high degree of protection. In areas of the first floor where not all infrastructure could be flood-proofed, sealing the openings to the building is recommended. Fortifying the manhole covers, driveway entrance, and arch openings along the perimeter of the building will greatly reduce the plant's risk and prevent floodwaters from entering the first floor, traveling throughout the plant, and damaging target pieces of equipment.

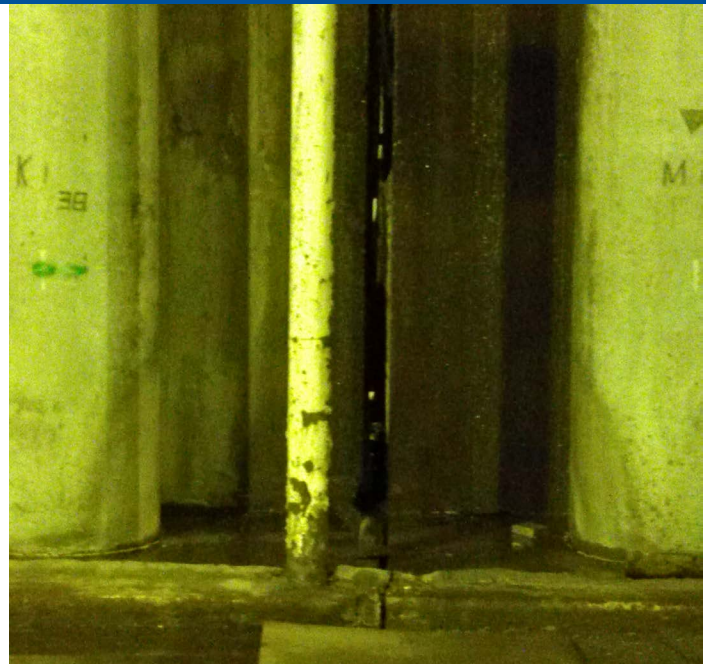
Expansion joints are flood pathways as experienced during Hurricane Sandy.

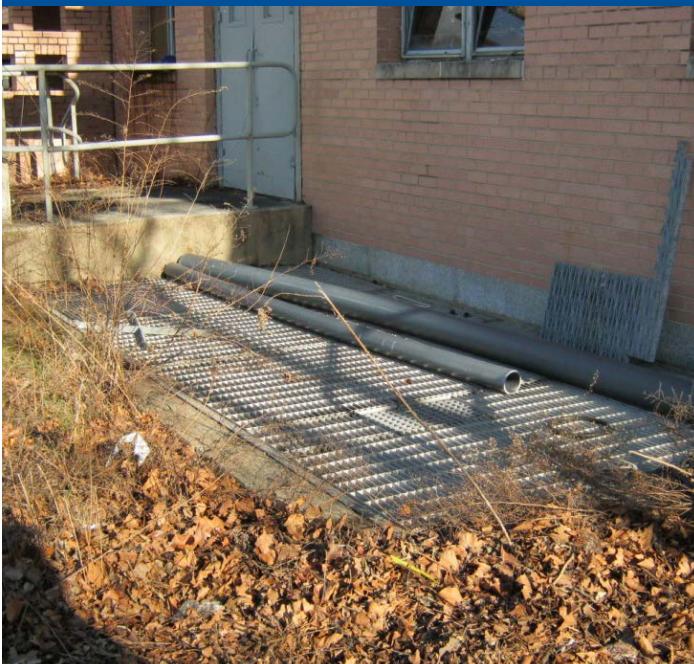
Floor grate outside of the Maintenance Building

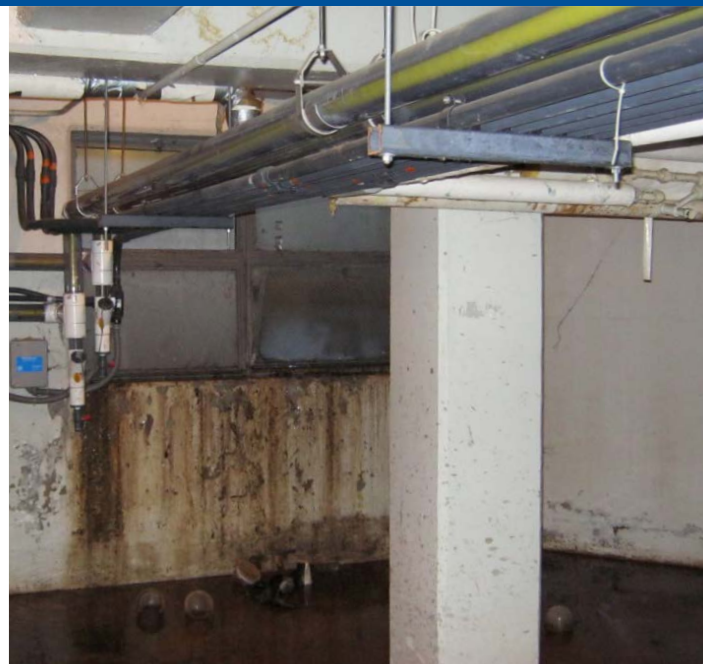
A window at the Sludge Storage Building was one of the main areaways for floodwater to enter during Hurricane Sandy.

In addition, Oakwood Beach is susceptible to flood damage from an interconnected tunnel system that has key at-risk flood pathways at the Sludge Storage Building. While flood-proofing and elevating equipment within the Sludge Storage Building would offer a high level of protection, constructing a static barrier around the areas and sealing the doorways and windows to prevent damage at the Main Building and Treatment Building is also recommended.

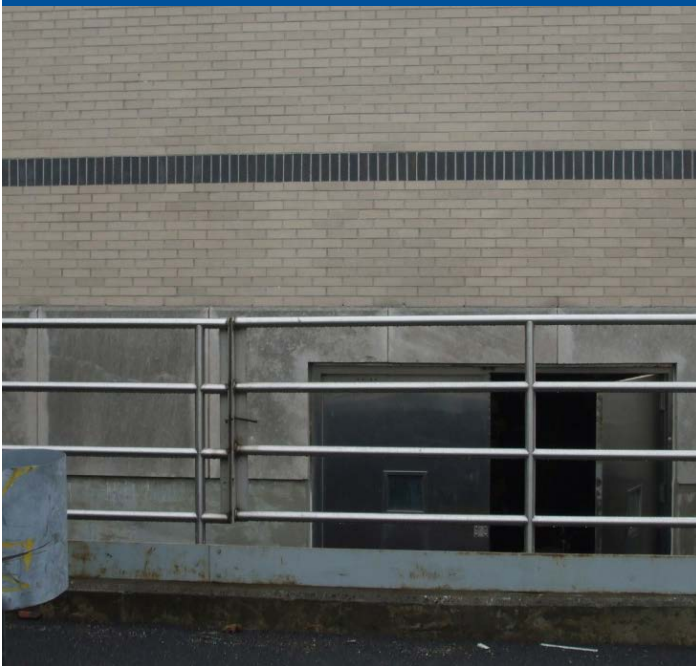
A pathway for flooding is around the perimeter of the Administration Building.

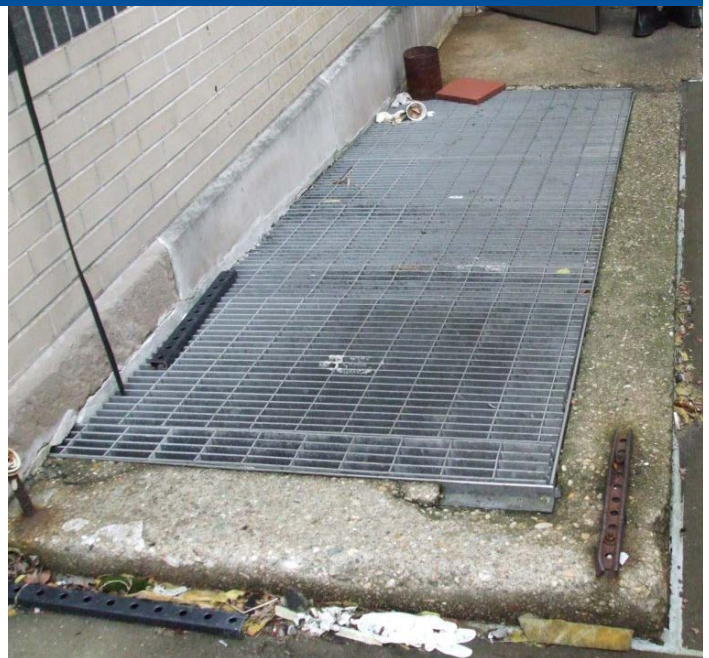
Floor grates near the Generator Room may allow floodwater to enter.

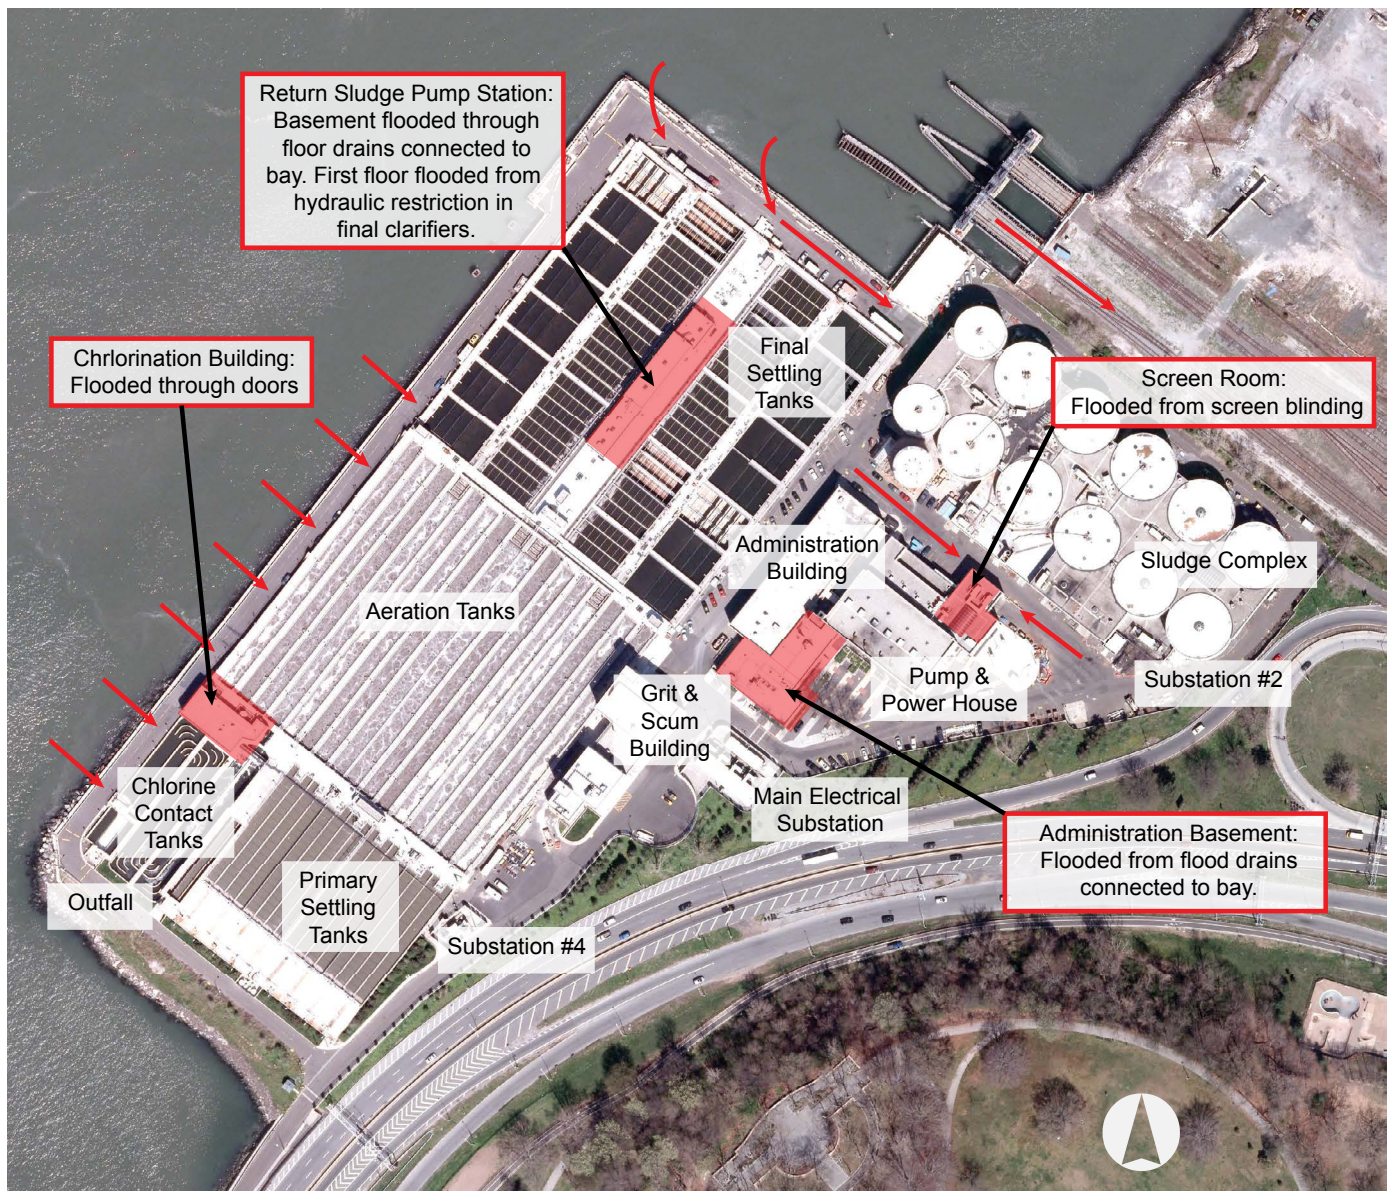
ing was flooded when sump pumps were unable to keep up with the rising water levels. Due to the high storm surge levels, both entrances to the plant were blocked which prevented staff from entering or exiting the site for two days after the storm.

Flood pathways and areas flooded during Hurricane Sandy are highlighted in red.

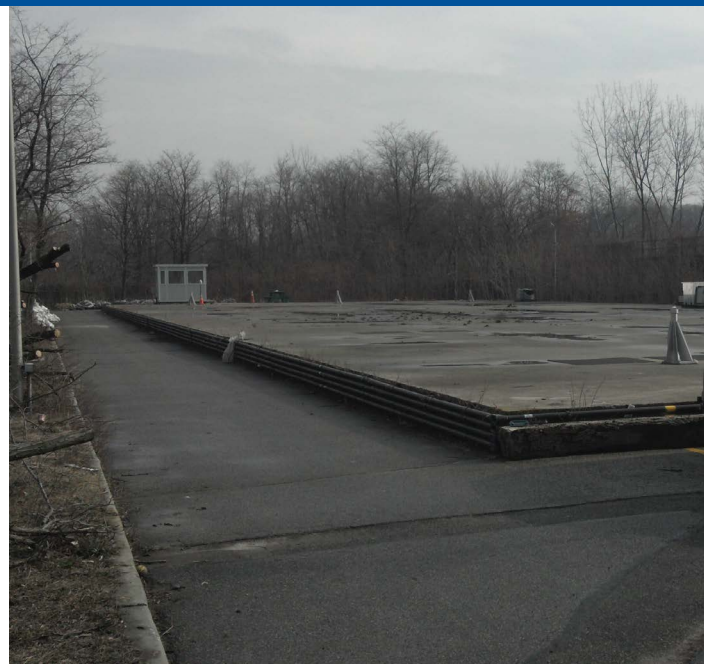
Chlorine Contact Tanks are potentially at risk of flooding during a large storm event.

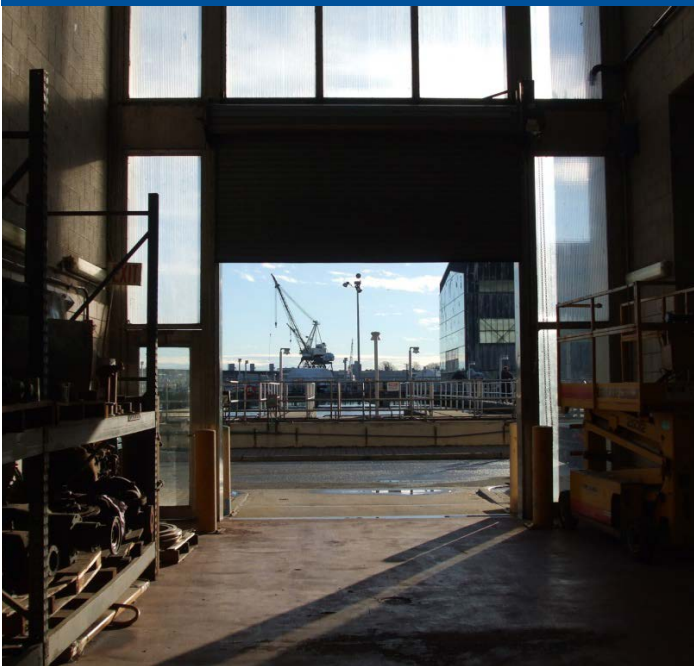
Rollup doors at the Main Building

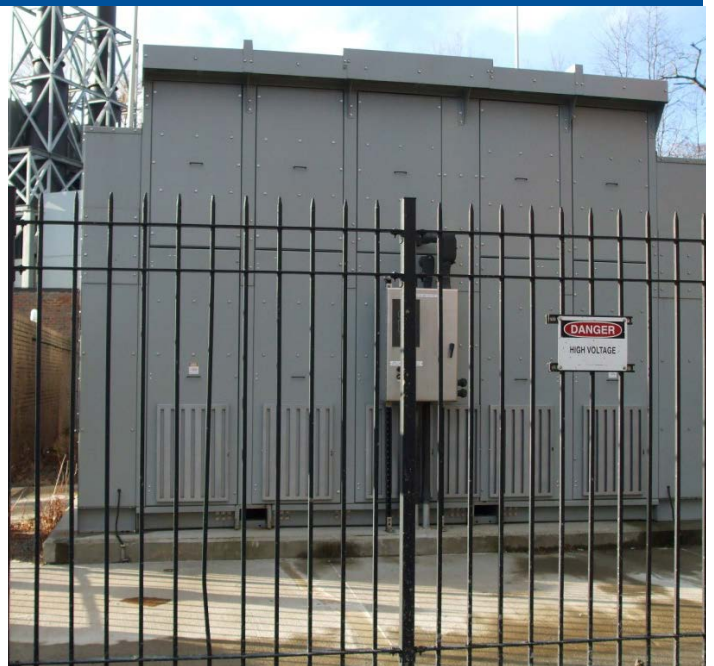
Fencing surrounding the outdoor Electrical Substation

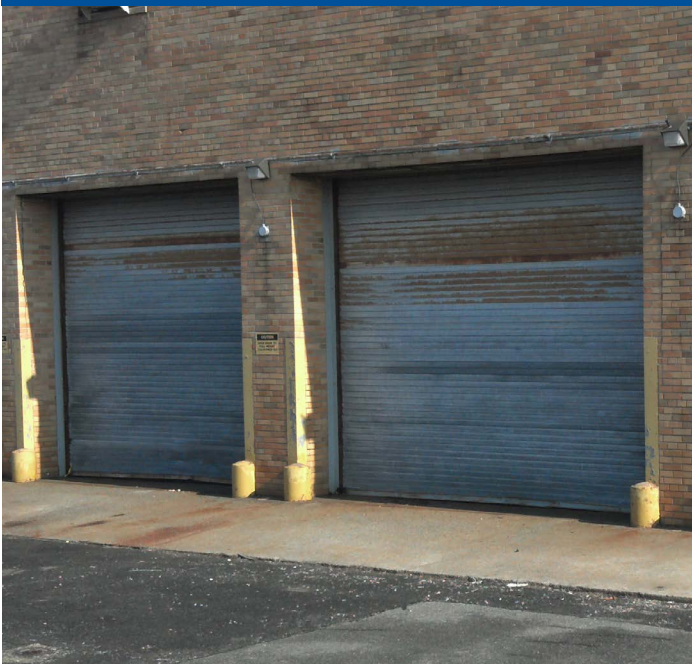
Rollup doors on the Sludge Storage Building adjacent to Jamaica Bay are potential pathways for flooding as experienced during Hurricane Sandy. The Sludge Storage Building is also an access point into the plant's interconnected tunnel system.

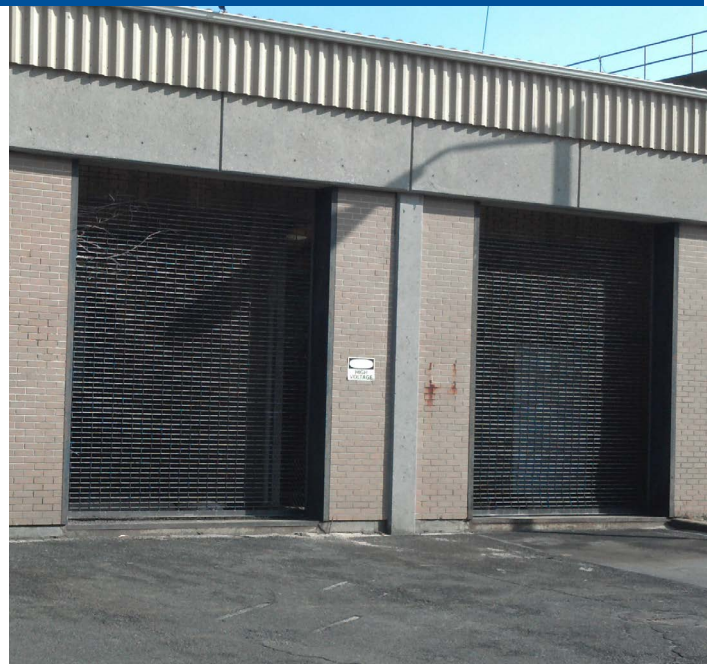
Rollup doors at the Electrical Substation Building

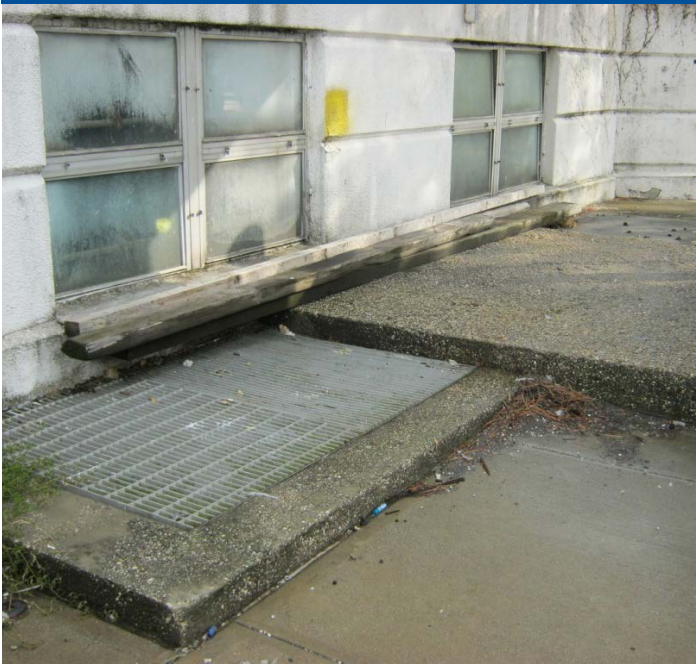
Grate and windows leading to the basement of the Sludge Thickener Building and tunnel system

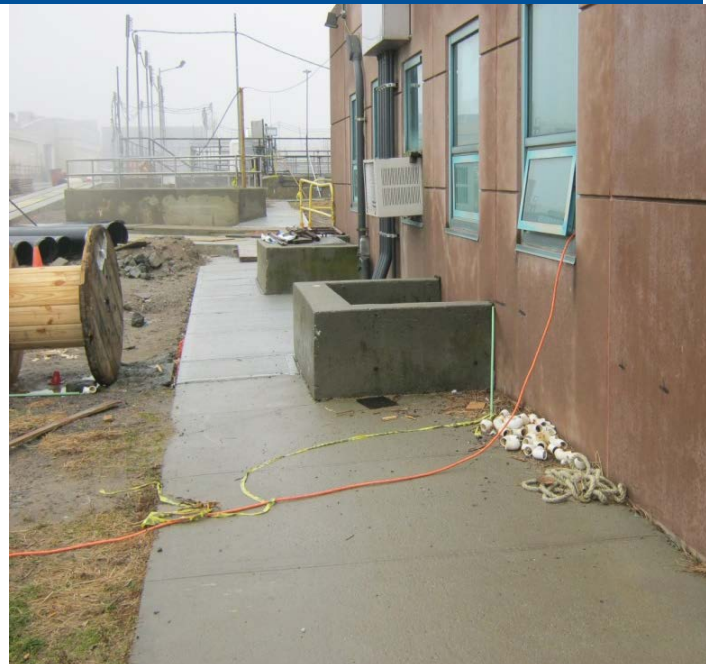
Basement access ways into the Chlorine Building

The Chlorine Building, in particular, requires robust protection as it would experience several feet of flooding under the critical flood event and contains numerous pieces of equipment needed to disinfect wastewater. As such, waterproofing chemical feed pumps and sealing the building with water-tight windows and doors is recommended. Likewise, the Grit Building and Thickener Building are also key locations that require several protection measures, since they have thresholds below the critical flood which lead to the tunnel system.

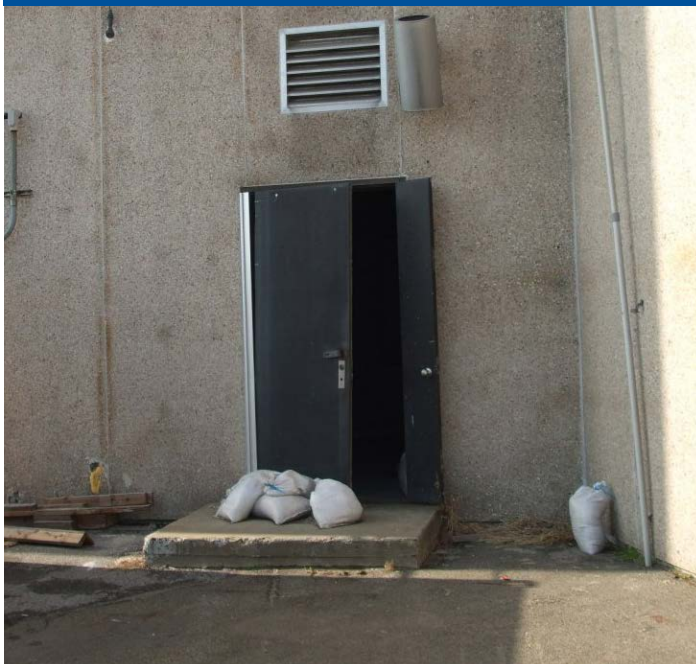
Access door leading to the equipment rooms in the Sludge Storage Tank Building

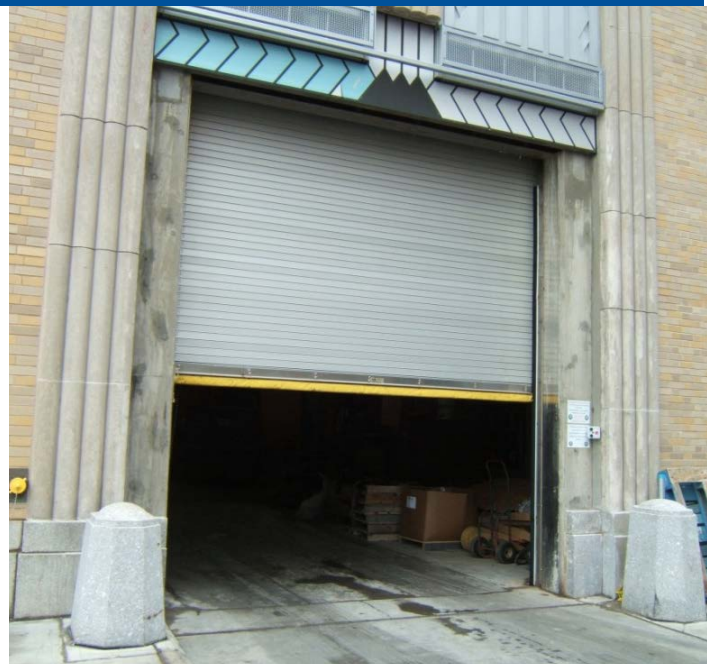
This rollup door at the Manhattan Grit Chamber was a pathway for flooding during Hurricane Sandy and may be flooded during the critical flood event.

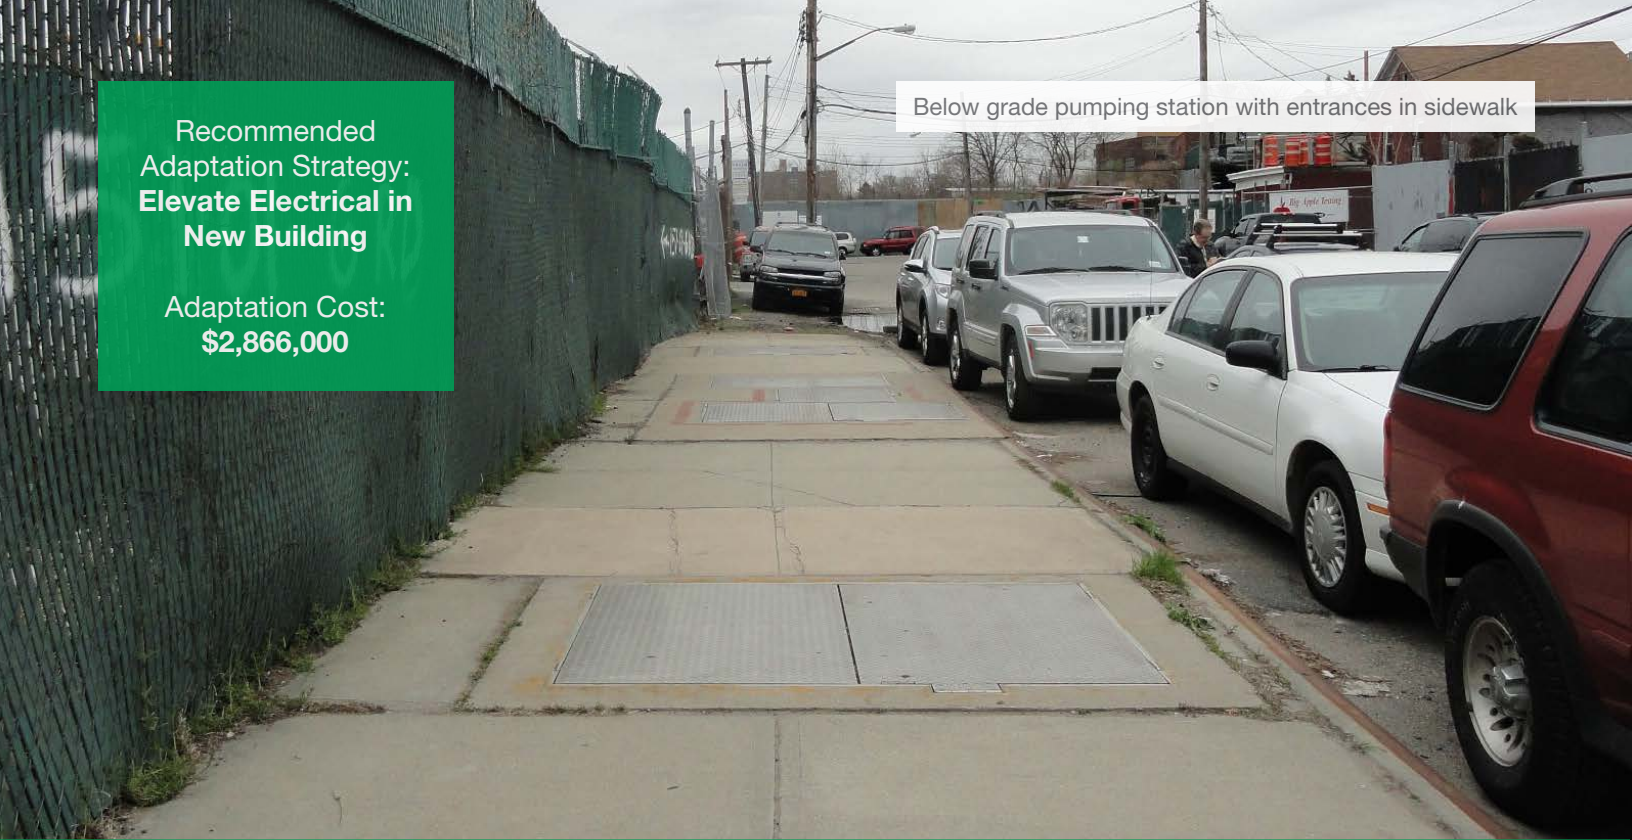
6th Road Pumping Station

Below grade pumping station with entrances in sidewalk

ing station to view its exterior confirmed that it appears consistent with the plan drawings. Submersible pumps were confirmed but the condition of the pumps and the resiliency of supporting equipment is not known.

The critical flood elevation would completely inundate the below grade station, and the surrounding flood would be nearly 5 feet above local grade. Water would flood and damage the pump controls. The submersible pumps should withstand flooding.

Recommended
Adaptation Strategy:
**Elevate Electrical in
New Building**

The 6th Road pumping station requires adaptive measures to withstand the critical flood elevation. Potential strategies were evaluated against such factors as flood depth, equipment location, and space. Viable strategies were reviewed to identify the most cost-effective, resilient option. The significant flood depth of about five feet and the station's location in an industrial area led to the selection of the most resilient option; the recommended strategy at 6th Road is to elevate the pumping station's controls in a new building. Residual risk is related to a greater depth of flooding from larger storms or more extreme climate change.

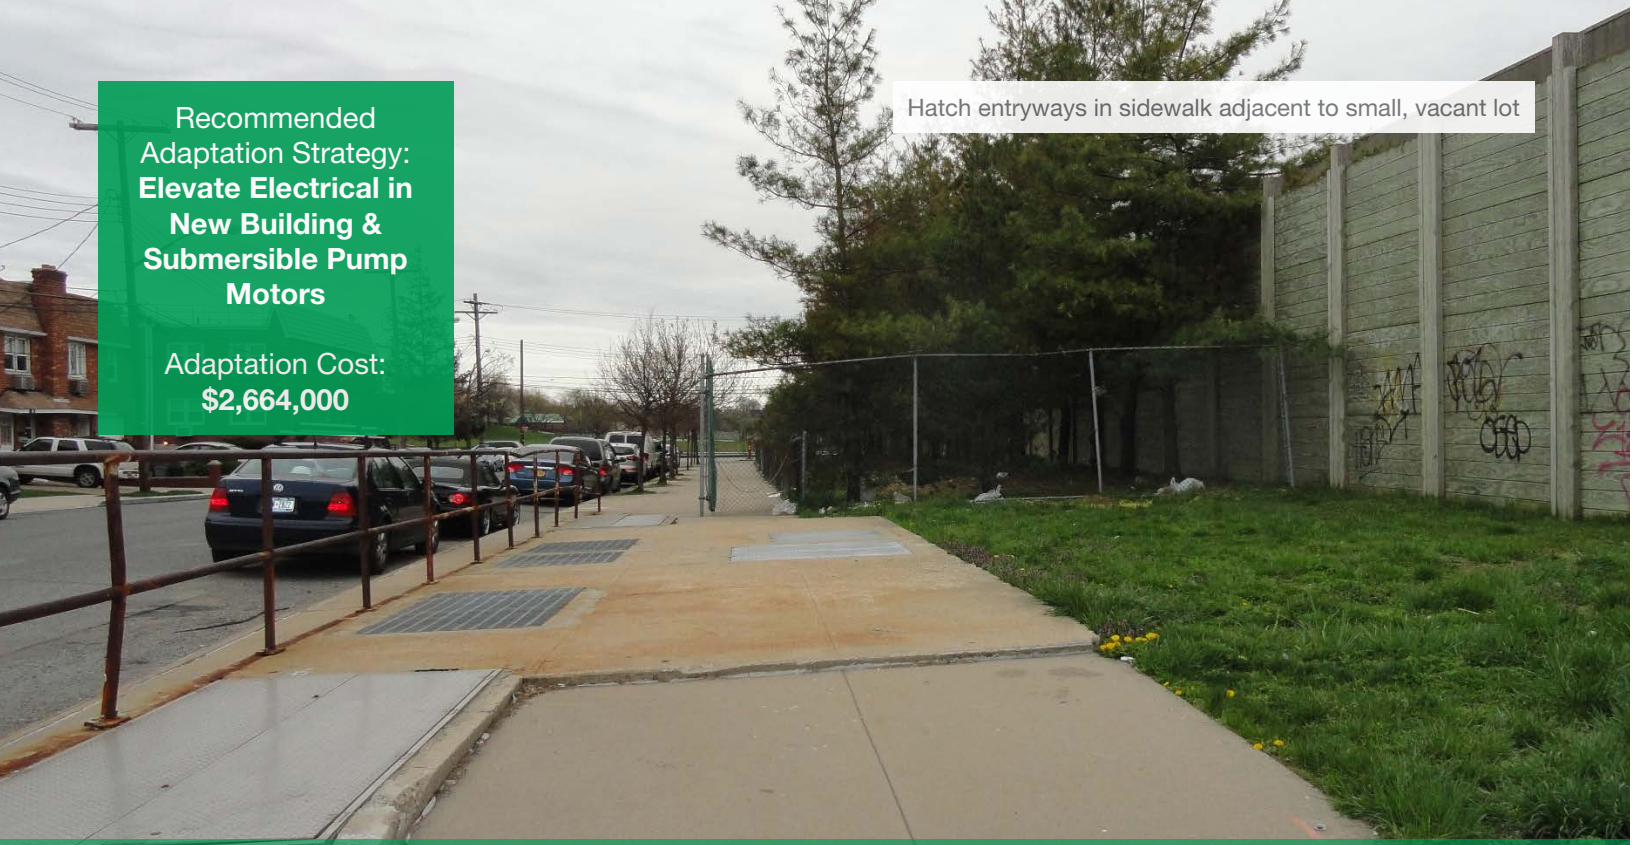
Hatch entryways in sidewalk adjacent to small, vacant lot

The critical flood elevation would flood the local grade to a depth of about 4 inches. Because the station is entirely below grade, and access hatches and grating are very near to grade level, even this minor flood could significantly affect the station. Electrical controls and non-submersible pumps could be damaged if flood waters enter the pumping station.

Recommended
Adaptation Strategy:
**Elevate Electrical in
New Building &
Submersible Pump
Motors**

The 15th Avenue pumping station requires adaptive measures to withstand the critical flood elevation. Potential strategies were evaluated against such factors as flood depth, equipment location, and space. Viable strategies were reviewed to identify the most cost-effective, resilient option. The station entrances are currently located in a sidewalk, there is a plot of vacant land bordering the sidewalk, and a concrete wall approximately 15 feet high runs along the back of the lot. With space available and no apparent limitations on structure height, the recommended strategy at 15th Avenue is to elevate the electrical controls in a new building and install submersible pumps. Residual risk is related to a greater depth of flooding from larger storms or more extreme climate change.

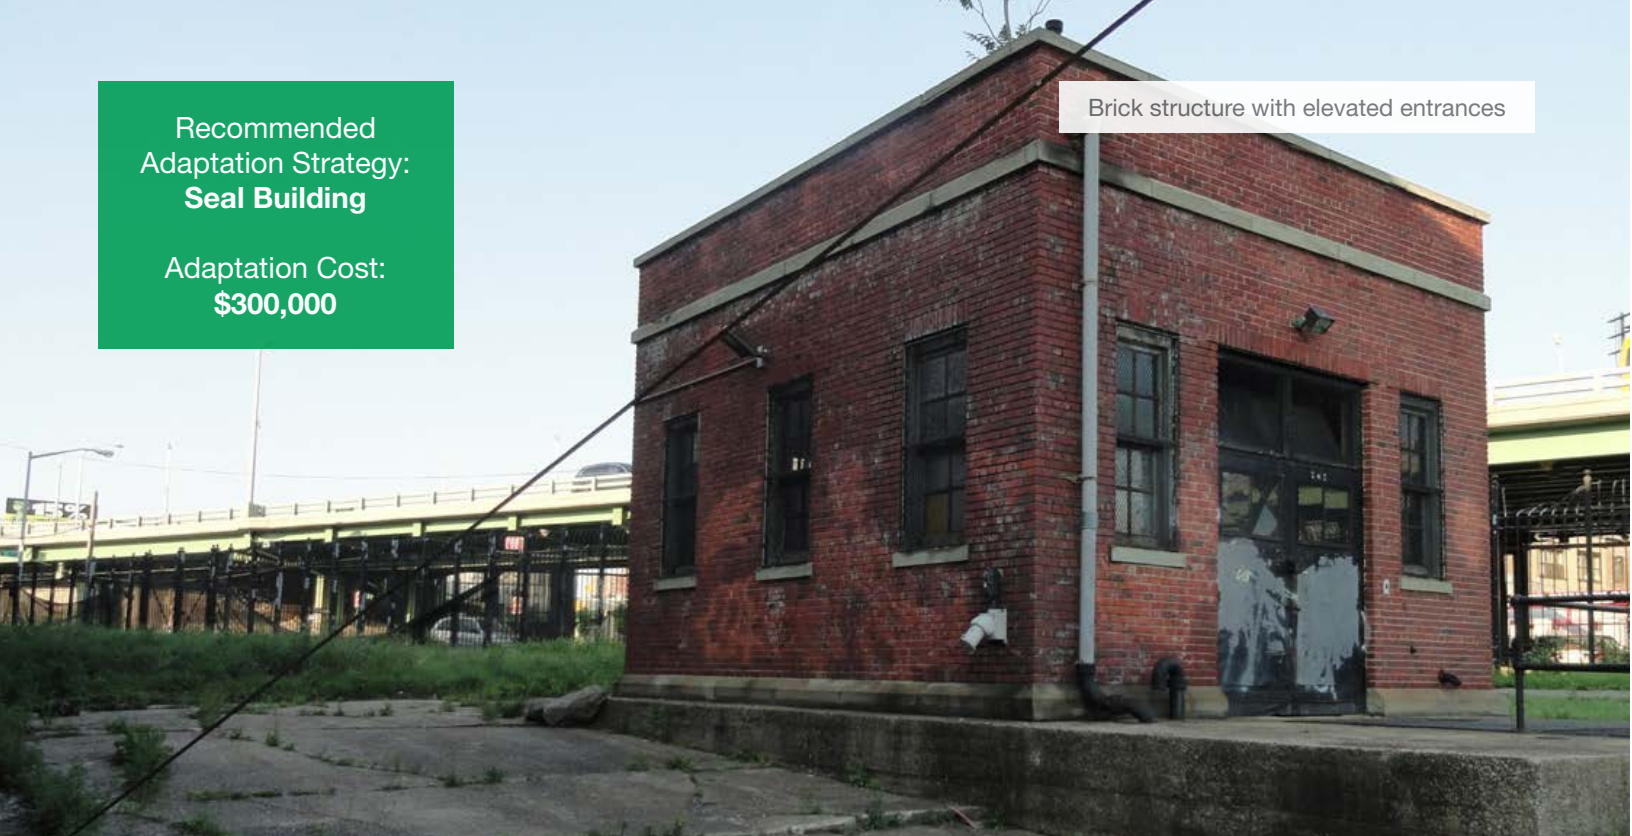
19th Street Pumping Station

Brick structure with elevated entrances

The critical flood elevation would flood the local grade to a depth of about 6 inches above local grade. This would not reach the electrical controls, which are located nearly 3 feet above grade. If water enters the building, it could damage the non-submersible pumps located well below grade.

Recommended
Adaptation Strategy:
Seal Building

The 19th Street pumping station requires adaptive measures to withstand the critical flood elevation. Potential strategies were evaluated against such factors as flood depth, equipment location, and space. Viable strategies were reviewed to identify the most cost-effective, resilient option. Because there is a substantial existing structure with entrances above the critical flood elevation, the recommended strategy at 19th Street is to seal the building. Because water tight cases, doors, and building sealants are only rated up to a certain pressure, if flood depth is greater than expected the water pressure could exceed the rating and the building sealing could fail. Therefore, residual risk is related to a greater depth of flooding from larger storms or more extreme climate change and the potential for water pressure to exceed the rating of the sealing measures.
