NYC WASTEWATER RESILIENCY PLAN

CLIMATE RISK ASSESSMENT AND ADAPTATION STUDY

October 2013

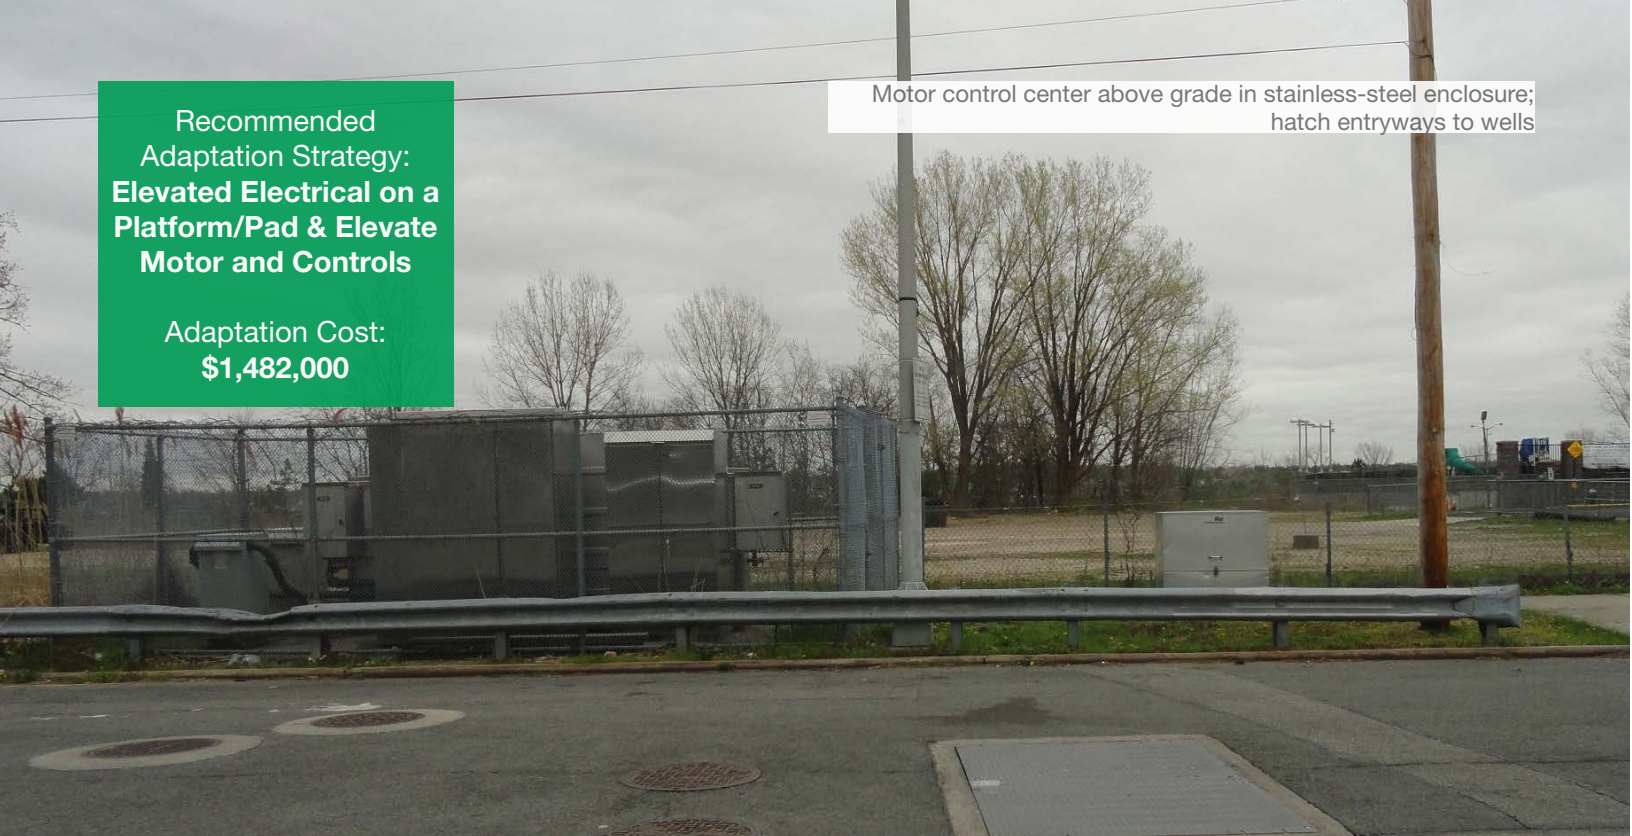
24th Avenue Pumping Station

Motor control center above grade in stainless-steel enclosure;
hatch entryways to wells

The critical flood elevation would flood the local grade to a depth of nearly 4 feet. This would completely inundate the wells, damaging the non-submersible pumps. It would also submerge and damage the MCC and other grade-level electrical components.

Recommended
Adaptation Strategy:
**Elevated Electrical on a
Platform/Pad & Elevate
Motor and Controls**

The 24th Avenue pumping station requires adaptive measures to withstand the critical flood elevation. Potential strategies were evaluated against such factors as flood depth, equipment location, and space. Viable strategies were reviewed to identify the most cost-effective, resilient option. The pumping station's electrical components are visible in their current location above grade, and the station borders an empty lot. Because the appearance of elevated components should not be a concern, the recommended strategy at 24th Avenue is to elevate both the electrical controls and the pump motors on a platform. This would achieve resiliency without the expense of constructing a building or replacing pumps. Elevating pump motors and replacing existing motors with submersibles are both acceptable solutions, however elevating pump motors may be a more cost-effective adaptation for this pumping station. Residual risk is related to the potential for greater storms or climate change impacts.

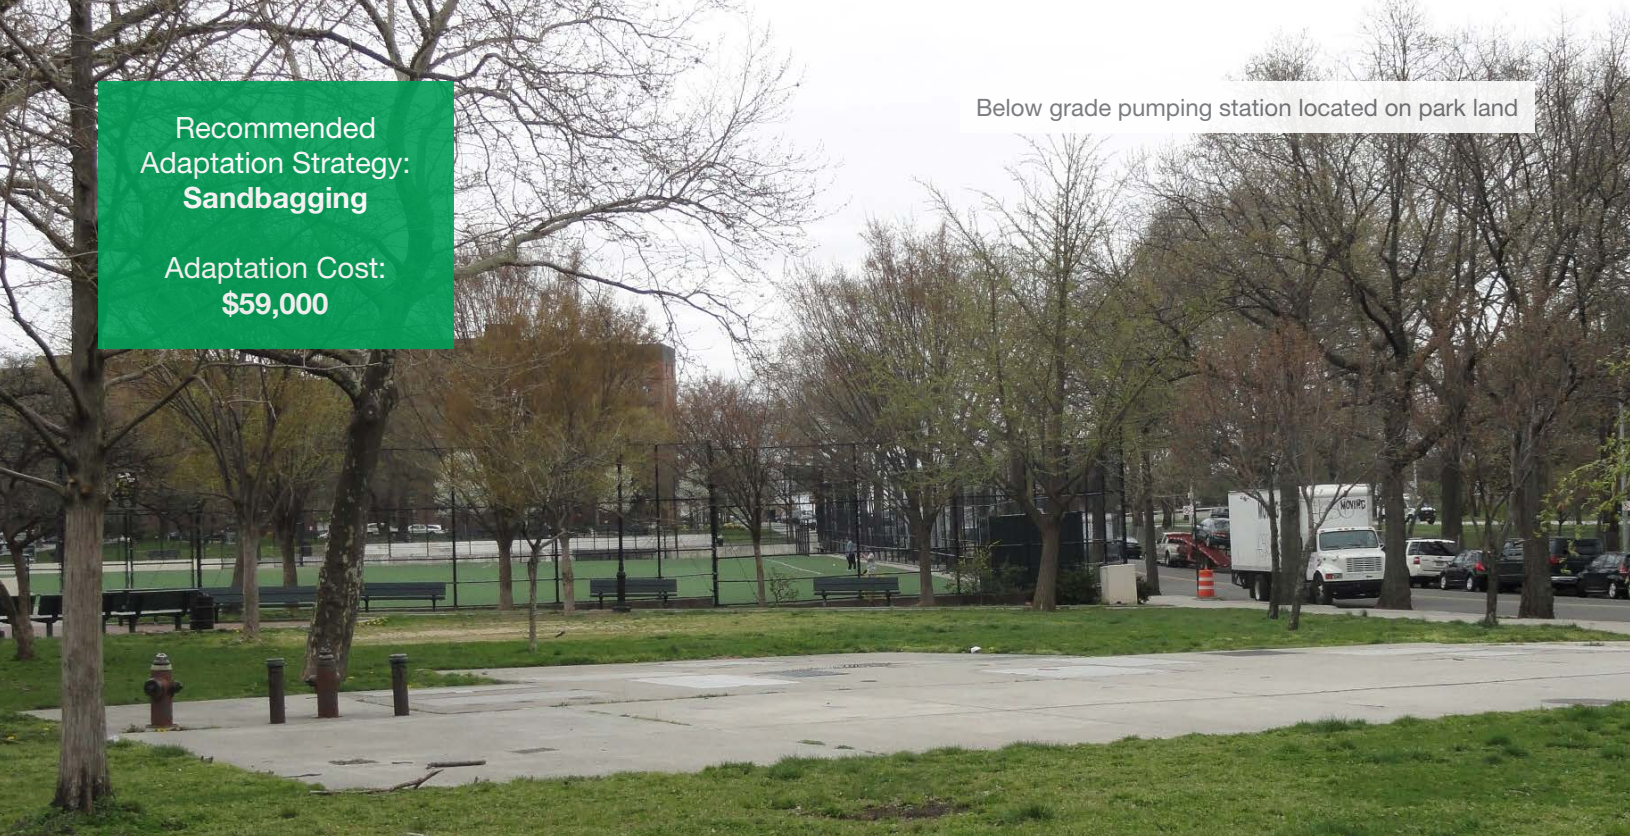
37th Avenue Pumping Station

The critical flood elevation would result in a flood depth of 1.6 feet above grade, and it would inundate the below grade station. This would damage electrical controls but would not affect the submersible pumps.

Recommended
Adaptation Strategy:
Sandbagging

The 37th Avenue pumping station requires adaptive measures to withstand the critical flood elevation. Potential strategies were evaluated against such factors as flood depth, equipment location, and space. Viable strategies were reviewed to identify the most cost-effective, resilient option. Due to the shallow flood depth and the station's location, in park land out of the way of vehicles and pedestrians, the recommended strategy is to place sandbags around potential water-entry points prior to flooding events. Residual risk is related to sandbags being stacked improperly or being disturbed by residents.

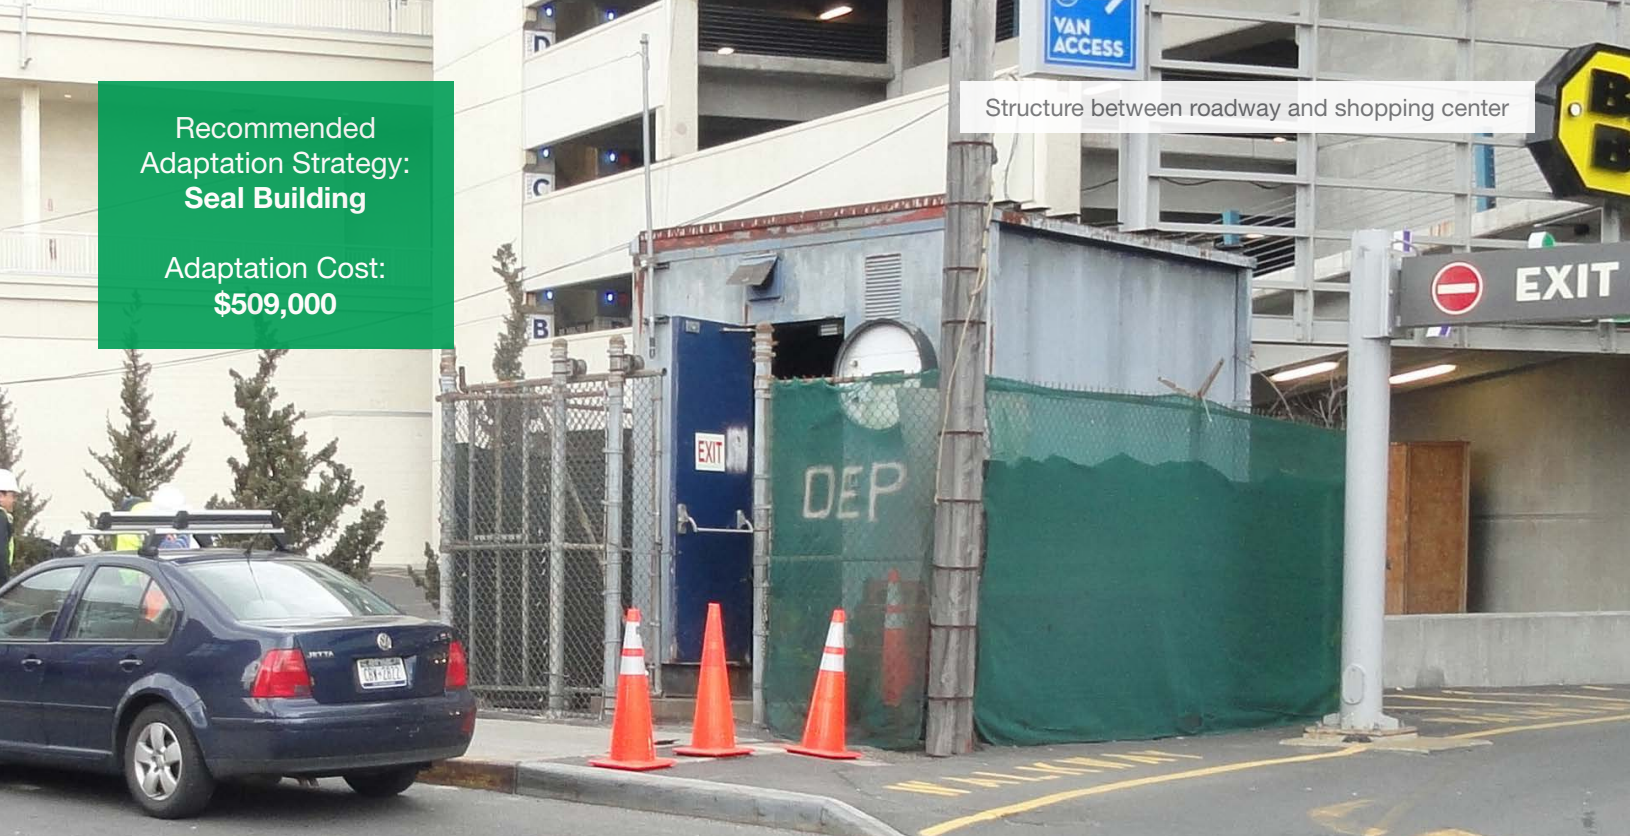
40th Road Pumping Station

Structure between roadway and shopping center

This pumping station flooded during Hurricane Sandy. The control room flooded to a depth of approximately 3 inches, and the surrounding area was flooded to a depth of 2 to 3 feet. The station suffered damage to lighting and ventilation equipment, but the submersible pumps remained operating throughout the storm and were not damaged. There is no history of flooding aside from Hurricane Sandy.

The critical flood elevation would completely inundate the station, and the surrounding flood would be more than 6 feet above local grade. This would flood and damage the pump controls, a compressor, and the lighting panel. The submersible pumps should withstand flooding.

Recommended
Adaptation Strategy:
Seal Building

The 40th Road pumping station requires adaptive measures to withstand the critical flood elevation. Potential strategies were evaluated against such factors as flood depth, equipment location, and space. Pumps are submersible and do not require any modifications, but electrical controls, located in the existing above grade structure, are vulnerable to flood water. Property size and location limits the potential for a new, larger structure. Viable strategies include moving controls to the walls or roof of the existing structure as well as sealing the building; these strategies were reviewed to identify the most cost-effective, resilient option. The recommended strategy at 40th Road is to seal the existing building and add sluice gates to restrict inflows. Because water tight cases, doors, and building sealants are only rated up to a certain pressure, if flood depth is greater than expected the water pressure could exceed the rating and the building sealing could fail. Therefore, residual risk is related to a greater depth of flooding from larger storms or more extreme climate change and the potential for water pressure to exceed the rating of the sealing measures.

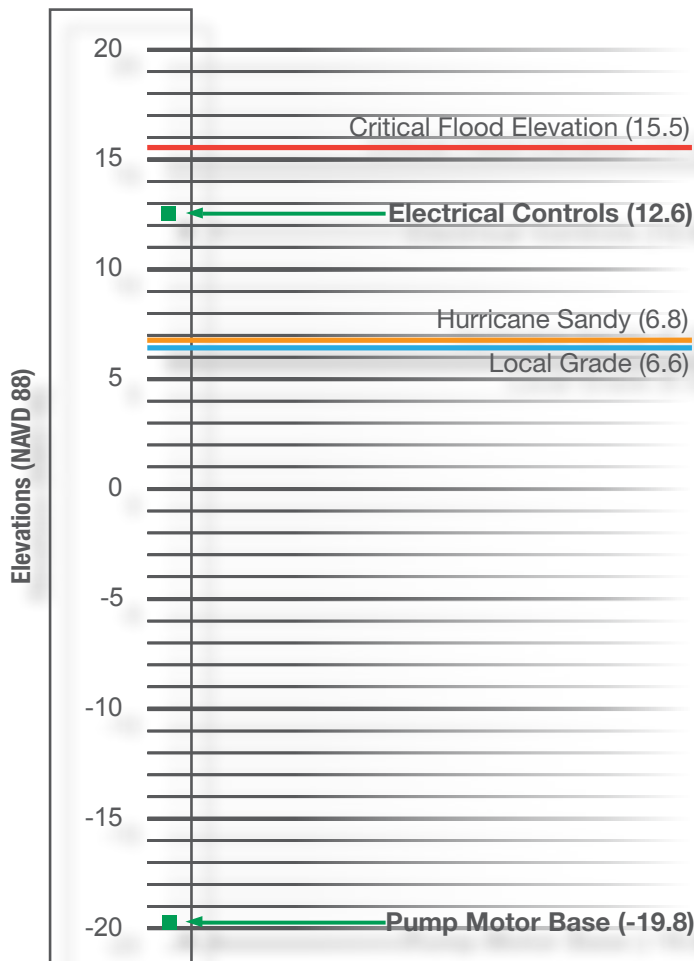
Critical Elevations

The critical flood elevation would be nearly 9 feet above grade. The electrical controls, mounted about 6 feet above grade, would be flooded and would sustain damage. The submersible pumps should withstand flooding.

The Bayswater Avenue pumping station requires adaptive measures to withstand the critical flood elevation. Potential strategies were evaluated against such factors as flood depth, equipment location, and space. Viable strategies were reviewed to identify the most cost-effective, resilient option. Because controls are currently exposed but would be submerged by the critical flood, the recommended strategy at Bayswater Avenue is to waterproof controls. Further review and design may indicate that this option is not sufficiently resilient in which case electrical controls will be elevated on a platform. Residual risk is related to a greater depth of flooding from larger storms or more extreme climate change.

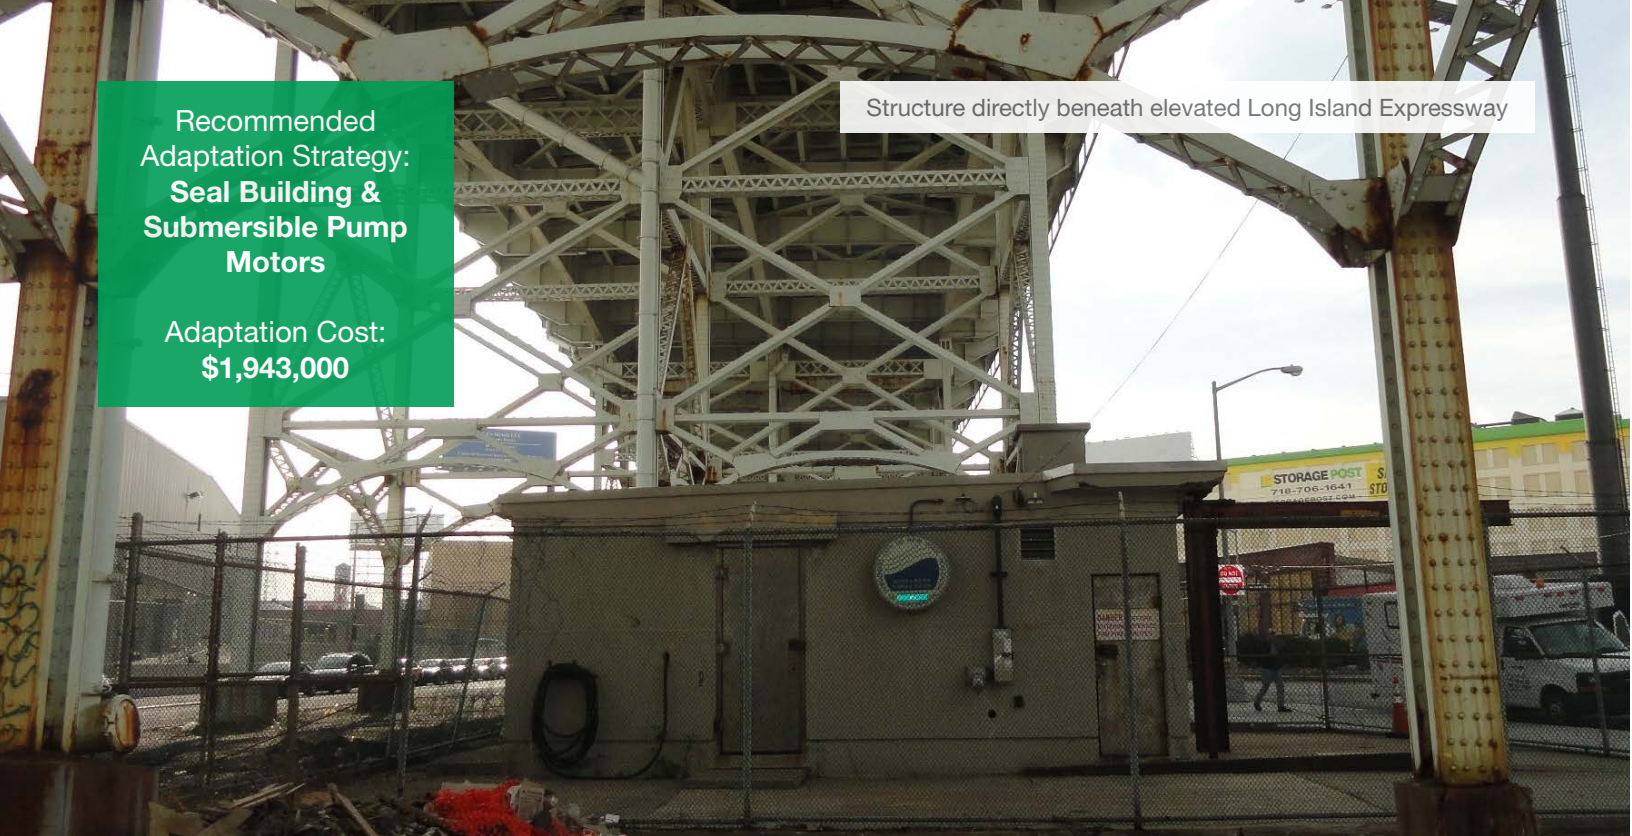
Structure directly beneath elevated Long Island Expressway

The critical flood elevation would be 4 feet above grade. It would also flood and damage the control panels, which are located on the main floor of the structure less than 2 feet above grade. The non-submersible pumps located below grade would also be damaged.

Recommended
Adaptation Strategy:
**Seal Building &
Submersible Pump
Motors**

The Borden Avenue pumping station requires adaptive measures to withstand the critical flood elevation. Potential strategies were evaluated against such factors as flood depth, equipment location, and space. Viable strategies were reviewed to identify the most cost-effective, resilient option. Because there is a substantial existing building but non-submersible pumps are below grade, the recommended strategy at Borden Avenue is to seal the building and install submersible pumps.

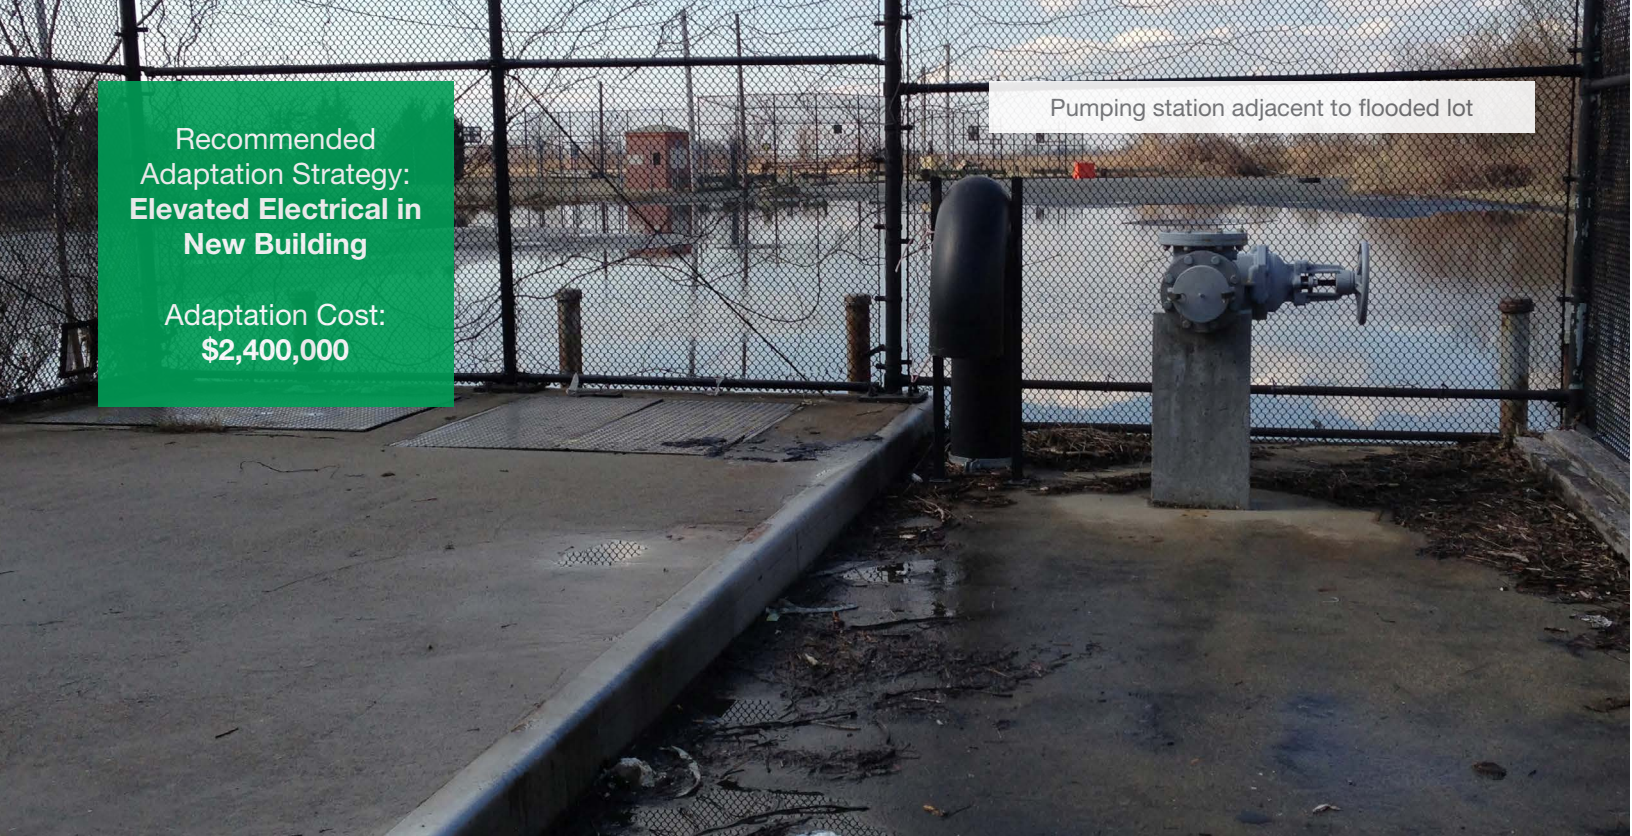
Pumping station adjacent to flooded lot

The area surrounding the pumping station is flat and at risk of experiencing overland flooding. Hurricane Sandy caused flooding more than 3.5 feet above grade.

The critical flood elevation would be nearly 9 feet above grade, inundating all components both above and below grade. This would damage the pump controls, but the submersible pumps should withstand flooding.

Recommended
Adaptation Strategy:
**Elevated Electrical in
New Building**

The Broad Channel pumping station requires adaptive measures to withstand the critical flood elevation. Potential strategies were evaluated against such factors as flood depth, equipment location, and space. Viable strategies were reviewed to identify the most cost-effective, resilient option. Because space is available and flood depth is extreme at 9 feet, the most resilient option was selected; the recommended strategy at Broad Channel is to elevate the pumping station's controls in a new building.

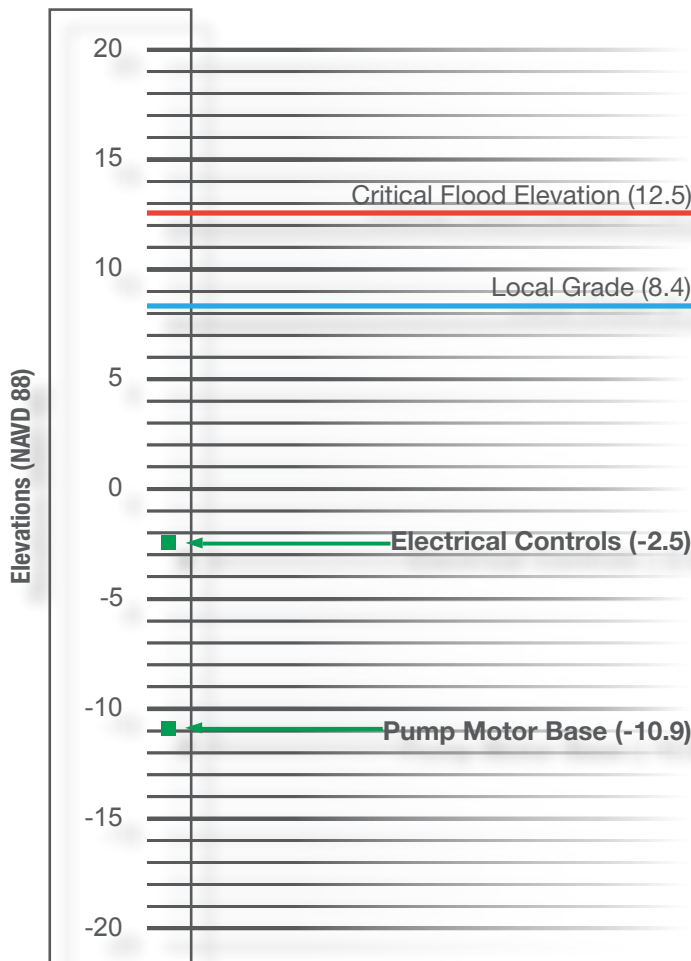
Critical Elevations

The critical flood elevation would be approximately 4 feet above local grade, completely inundating the entire station. The electrical controls and non-submersible pumps are all located below grade and would be flooded and damaged.

The Canal Street pumping station requires adaptive measures to withstand the critical flood elevation. Potential strategies were evaluated against such factors as flood depth, equipment location, and space. Viable strategies were reviewed to identify the most cost-effective, resilient option. Due to the depth of the critical flood, controls must be elevated and pumps must be submersible to withstand the flood. The pumping station's entrances are located in a sidewalk, but there is a small park directly behind the sidewalk; the recommended strategy at Canal Street is to elevate electrical controls on a platform and install submersible pumps. Residual risk is related to a greater depth of flooding from larger storms or more extreme climate change.

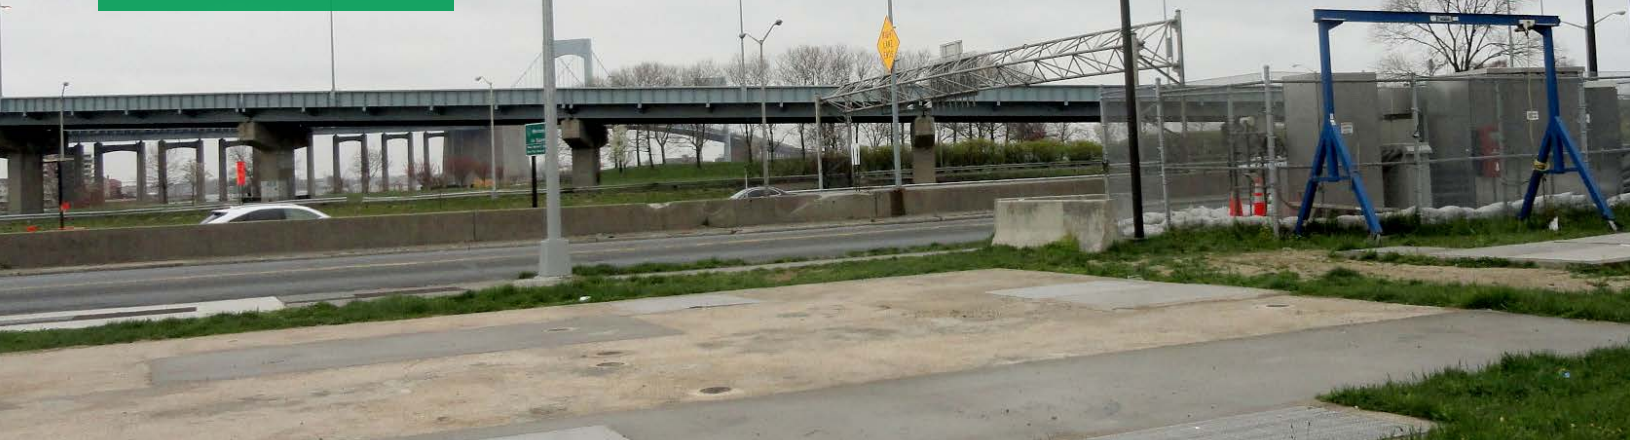
Clearview Pumping Station

Motor control center above grade in stainless-steel enclosure;
hatch entryways to wells

that of the March 2013 FEMA Advisory Base Flood Elevation (ABFE) 100-year flood plus 30 inches of sea level rise (critical flood elevation). A visit to the pumping station to view its exterior revealed that the Motor Control Center (MCC) and other electrical controls, which were shown below grade in the drawings, had been moved to a slab above grade. DEP data also indicate that the pumps had been replaced with submersibles.

The critical flood elevation would be more than 3 feet above grade. This would flood and damage the grade-level motor control center and pump.

Recommended
Adaptation Strategy:
**Elevate Electrical in New
Building**

The Clearview pumping station requires adaptive measures to withstand the critical flood elevation. Potential strategies were evaluated against such factors as flood depth, equipment location, and space. Viable strategies were reviewed to identify the most cost-effective, resilient option. Due to the critical flood depth and the lack of an existing structure, the recommended strategy at Clearview is to elevate the pumping station's controls in a new building. Residual risk is related to a greater depth of flooding from larger storms or more extreme climate change.

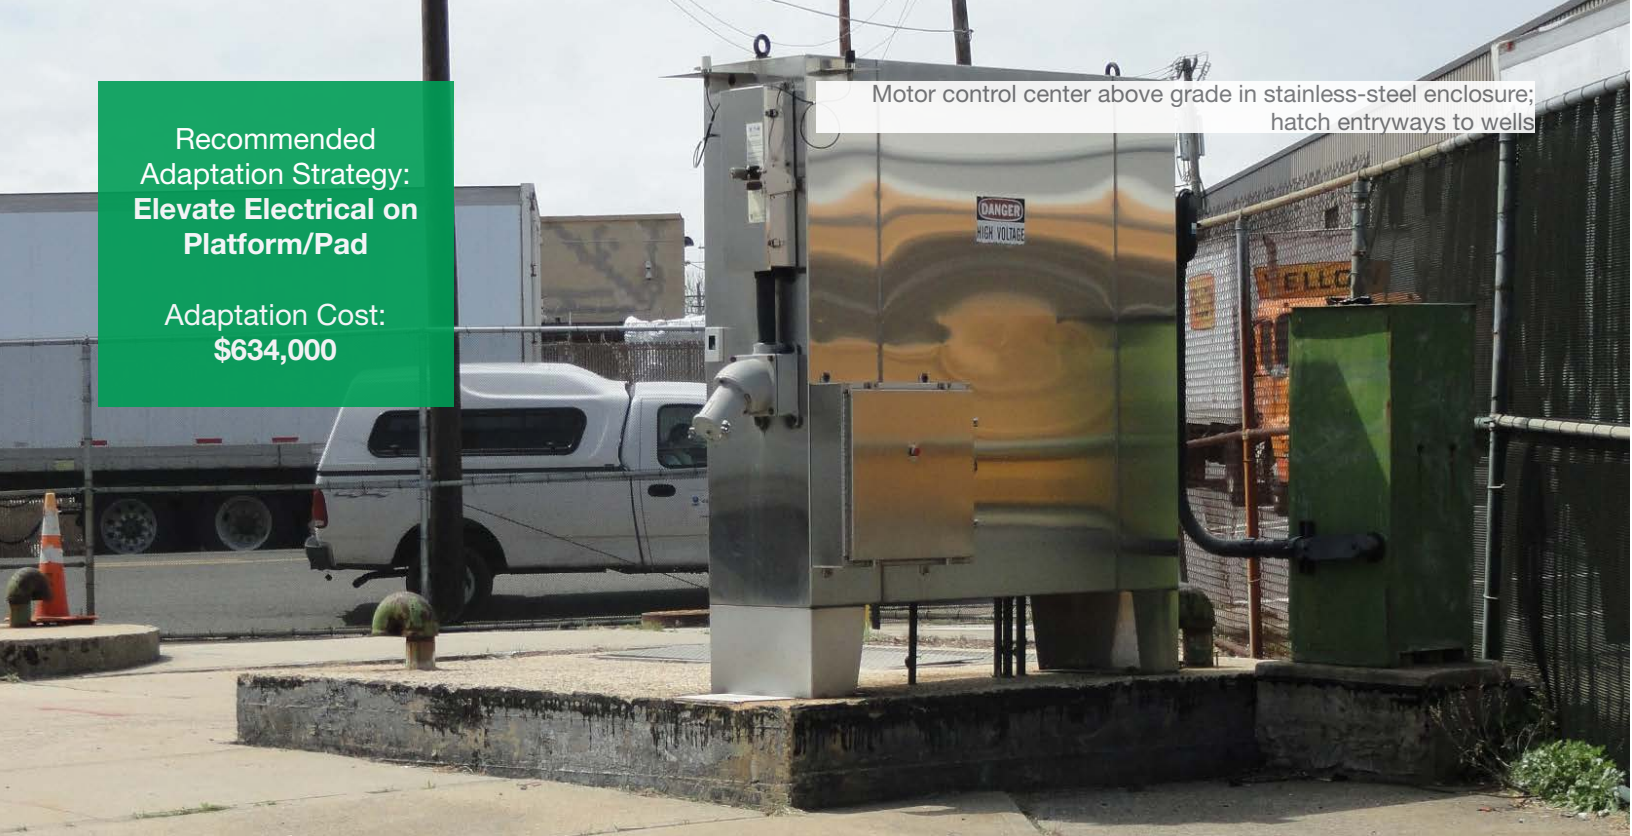
Commerce Avenue Pumping Station

Motor control center above grade in stainless-steel enclosure;
hatch entryways to wells

Base Flood Elevation (ABFE) 100- year flood plus 30 inches of sea level rise (critical flood elevation). A visit to the pumping station to view its exterior revealed that the electrical controls, which are shown below grade in the drawings, have been moved to a slab above grade. The critical flood elevation would be 5 feet above grade. Water would flood and damage the motor control center. The submersible pumps should withstand flooding.

Recommended
Adaptation Strategy:
**Elevate Electrical on
Platform/Pad**

The Commerce Avenue pumping station requires adaptive measures to withstand the critical flood elevation. Potential strategies were evaluated against such factors as flood depth, equipment location, and space. Viable strategies were reviewed to identify the most cost-effective, resilient option. Controls should be elevated to withstand the critical flood, and there is ample space to do so on the current lot. Because the station is located in an industrial area, a building is not necessary for aesthetic reasons. Components are currently exposed above grade, and there have been no known incidents of vandalism, so a building should not be necessary for security reasons, either. Therefore, the recommended strategy at Commerce Avenue is to elevate electrical controls onto a platform. Residual risk is related to a greater depth of flooding from larger storms or more extreme climate change.

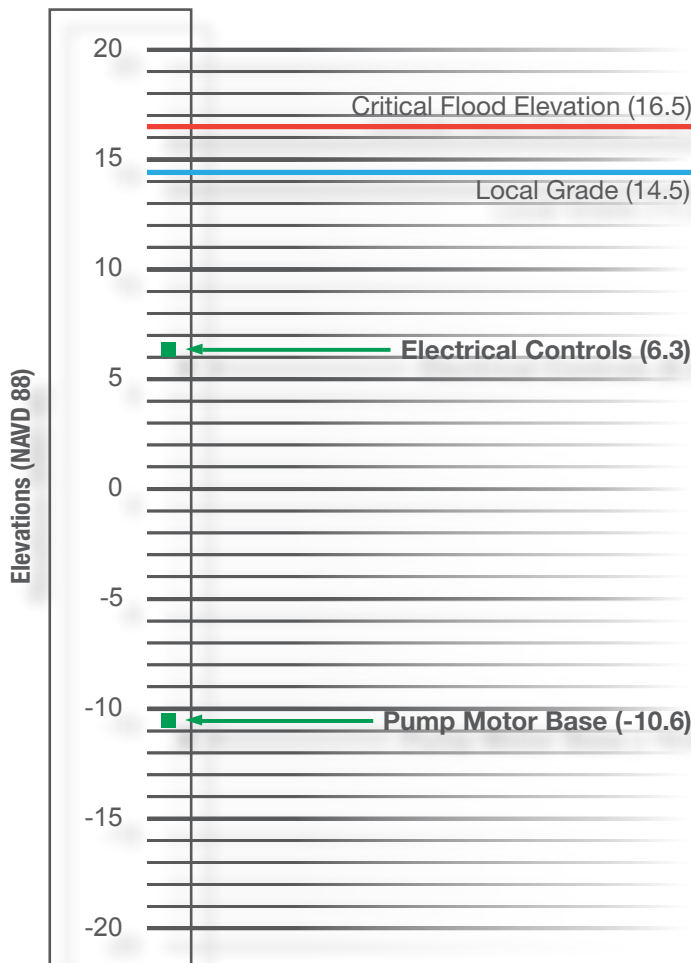
Critical Elevations

The critical flood elevation would be 2 feet above local grade. Electrical controls are below grade within the structure, and the doorway threshold into the structure is about 1 foot above grade, which is 1 foot below the critical flood elevation. Flood waters could enter the structure and damage the electrical controls. The submersible pumps should withstand flooding. The Co-op City North pumping station has the ability to receive flow from another pumping station. Therefore, loss of function at Co-op City North increases the vulnerability of an additional pumping station, tributary area, and population.

Recommended
Adaptation Strategy:
**Elevate Electrical
in New Building**

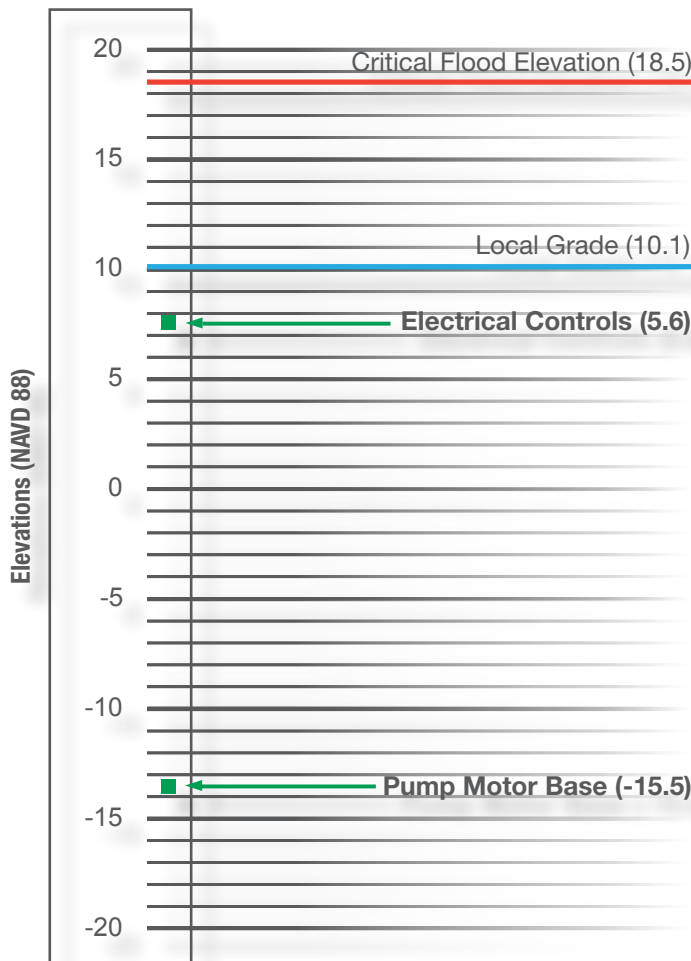
Critical Elevations

Collection Systems staff provided further details on the station's flooding history and vulnerability. The critical flood elevation would be more than 8 feet above local grade, completely inundating the entire station. The electrical controls, which are below grade, would be flooded and damaged. The submersible pumps should withstand flooding.

The Doug Bay pumping station requires adaptive measures to withstand the critical flood elevation. Potential strategies were evaluated against such factors as flood depth, equipment location, and space. Viable strategies were reviewed to identify the most cost-effective, resilient option. Due to the 8-foot depth of the critical flood and the lack of an existing structure, the recommended strategy at Doug Bay is to elevate electrical controls in a new building. Residual risk is related to a greater depth of flooding from larger storms or more extreme climate change.

Recommended
Adaptation Strategy:
Seal Building

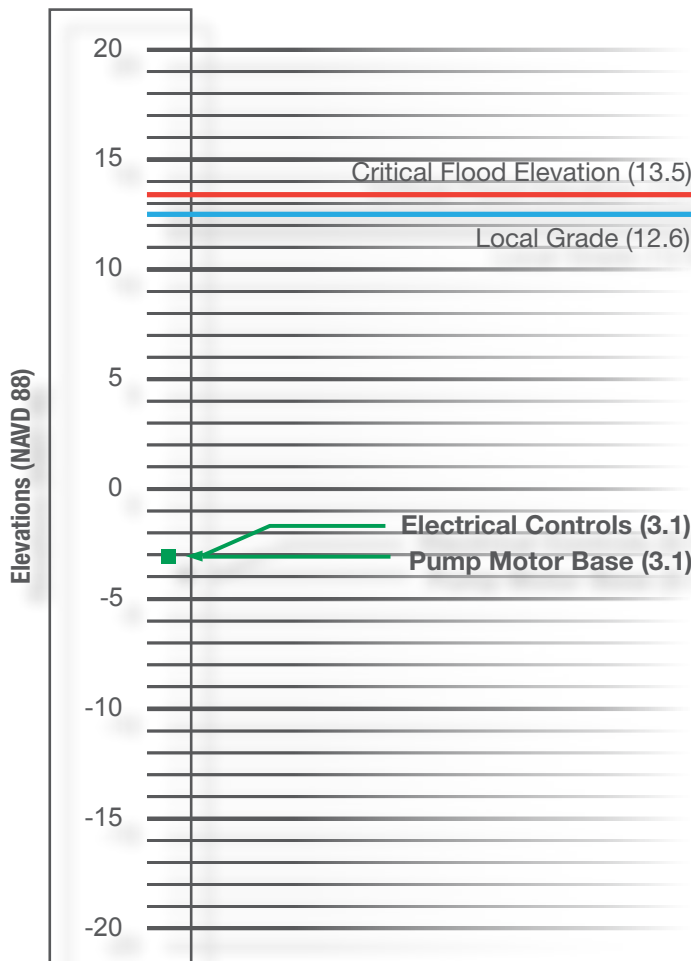
Critical Elevations

The critical flood elevation would be just under 1 foot above local grade. Because electrical controls and non-submersible pumps are located below grade and below the flood elevation, they could be damaged if water enters the structure.

The Eltingville pumping station requires adaptive measures to withstand the critical flood elevation. Potential strategies were evaluated against such factors as flood depth, equipment location, and space. Viable strategies were reviewed to identify the most cost-effective, resilient option. Because there is a significant existing structure, the recommended strategy at Eltingville is to seal the building so that flood waters cannot enter; this is a less expensive option than those that involve moving electrical controls or motors. While this strategy will provide resilient protection, there is the potential for leaks, inflows to the wells, or unidentified flow paths. DEP will consider replacing the non-submersible pumps with submersibles as normal replacement is needed as part of regular maintenance. Because water tight cases, doors, and building sealants are only rated up to a certain pressure, if flood depth is greater than expected the water pressure could exceed the rating and the building sealing could fail. Therefore, residual risk is related to a greater depth of flooding from larger storms or more extreme climate change and the potential for water pressure to exceed the rating of the sealing measures.

Recommended
Adaptation Strategy:
Seal Building

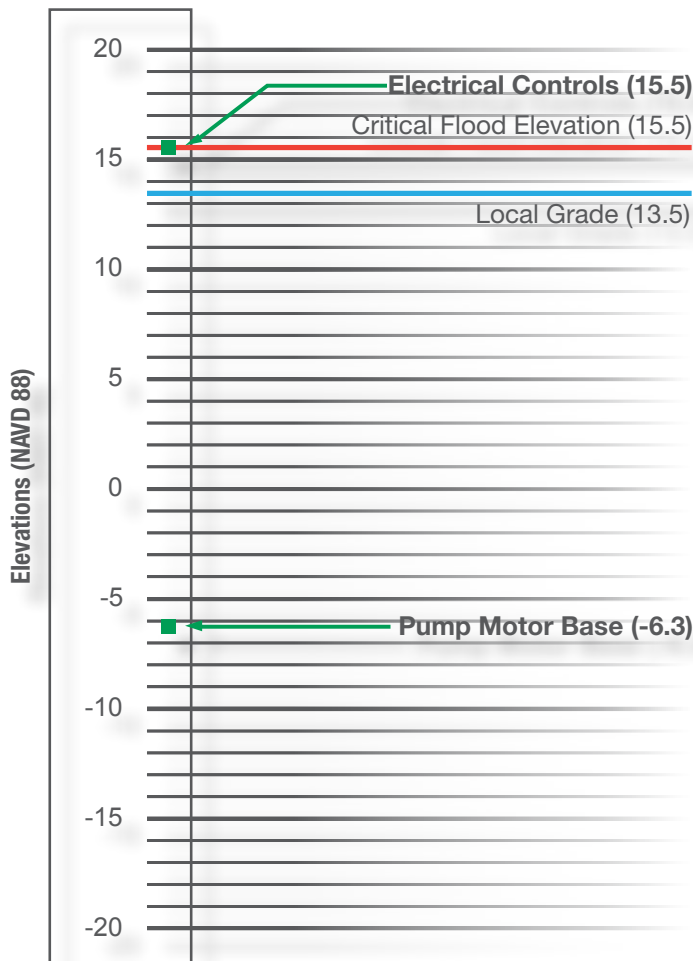
Critical Elevations

The critical flood elevation would be 2 feet above local grade, which is equal to the elevation of the main floor of the structure where electrical controls are housed. This could cause damage to the electrical controls; submersible pumps should be unaffected.

The Ely Avenue pumping station requires adaptive measures to withstand the critical flood elevation. Potential strategies were evaluated against such factors as flood depth, equipment location, and space. Viable strategies were reviewed to identify the most cost-effective, resilient option. Because there is a substantial existing structure with entrances above the critical flood elevation, the recommended strategy at Ely Avenue is to seal the building. Because water tight cases, doors, and building sealants are only rated up to a certain pressure, if flood depth is greater than expected the water pressure could exceed the rating and the building sealing could fail. Therefore, residual risk is related to a greater depth of flooding from larger storms or more extreme climate change and the potential for water pressure to exceed the rating of the sealing measures.

Recommended
Adaptation Strategy:
Construct Barrier

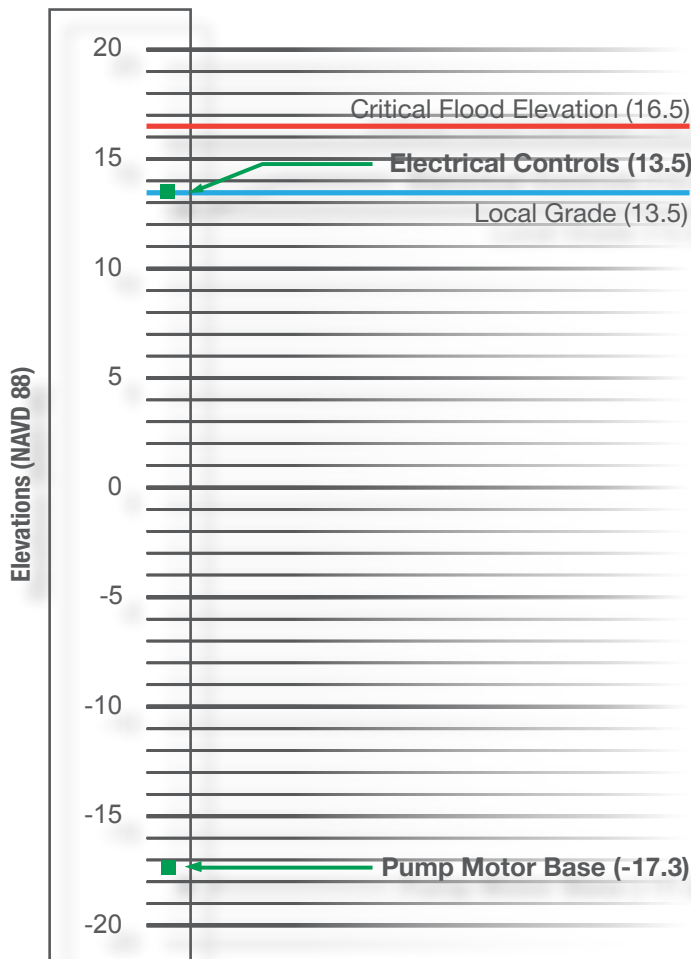
Critical Elevations

The critical flood elevation would be 3 feet above local grade. Electrical controls sit only a few inches above grade on the sidewalk, and they would be damaged. The submersible pumps should withstand flooding.

The Gildersleeve Avenue pumping station requires adaptive measures to withstand the critical flood elevation. Potential strategies were evaluated against such factors as flood depth, equipment location, and space. Viable strategies were reviewed to identify the most cost-effective, resilient option. Due to the flood depth and the fact that exposed above grade components are acceptable in this location, the recommended strategy at Gildersleeve Avenue is to elevate electrical controls on a platform. Residual risk is related to a greater depth of flooding from larger storms or more extreme climate change.

Recommended
Adaptation Strategy:
**Elevate Electrical in New
Building & Submersible
Pump Motors**

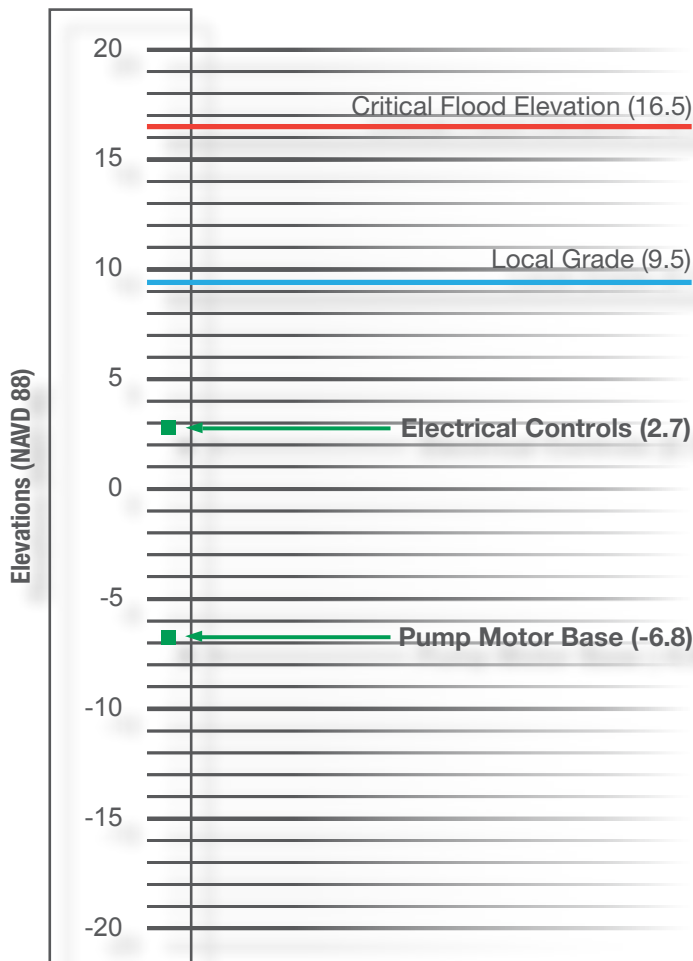
Critical Elevations

The predicted critical flood elevation would be 7 feet above local grade. This would damage the below grade electrical controls. The submersible pumps should be unaffected.

The Hollers Avenue pumping station requires adaptive measures to withstand the critical flood elevation. Potential strategies were evaluated against such factors as flood depth, equipment location, and space. Viable strategies were reviewed to identify the most cost-effective, resilient option. Due to the significant depth of the critical flood, the lack of an existing structure, and the available space, the recommended strategy at Hollers Avenue is to elevate electrical controls in a new building. Residual risk is related to a greater depth of flooding from larger storms or more extreme climate change.

Recommended
Adaptation Strategy:
Construct Barrier

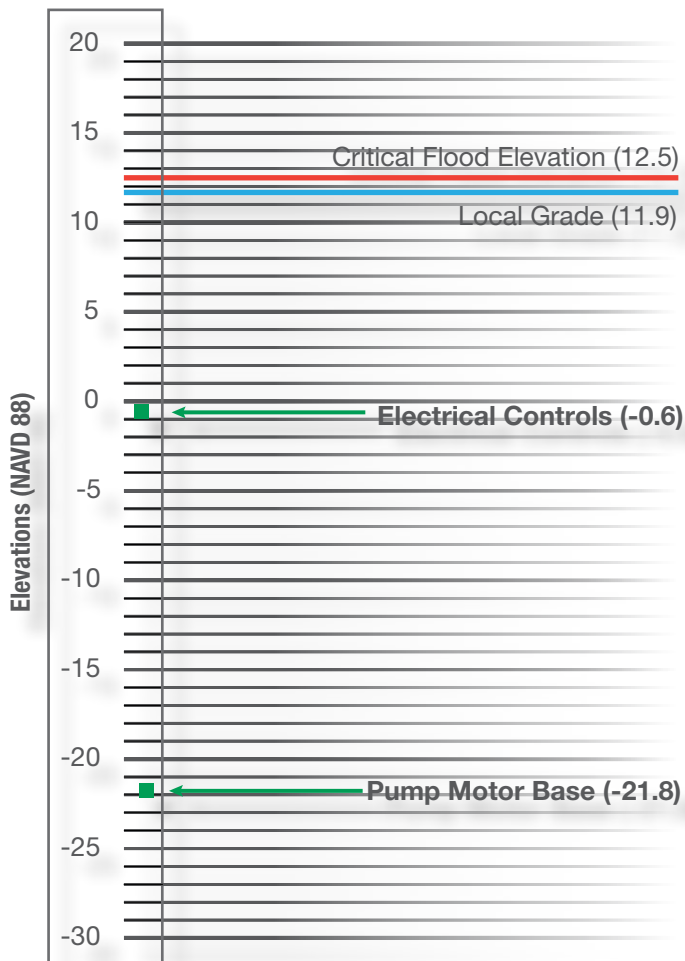
Critical Elevations

The critical flood elevation would be about 7 inches above local grade. While entrances are elevated above the flood height, the structure is not flood-proof, and the below grade electrical controls and non-submersible pumps could be flooded and damaged.

The Howard Beach pumping station requires adaptive measures to withstand the critical flood elevation. Potential strategies were evaluated against such factors as flood depth, equipment location, and space. Viable strategies were reviewed to identify the most cost-effective, resilient option. Because of the shallow depth of the critical flood and the location of most entrances above the flood elevation, the recommended strategy at Howard Beach is to add watertight doors in the existing wall at pedestrian and vehicle entry points. Sandbagging is also a potential option but water tight access doors provide a permanent and more resilient solution. The installation of emergency generators is also recommended. Residual risk is related to a greater depth of flooding from larger storms or more extreme climate change.

Recommended
Adaptation Strategy:
**Elevate Electrical on a
Platform/Pad &
Sandbagging**

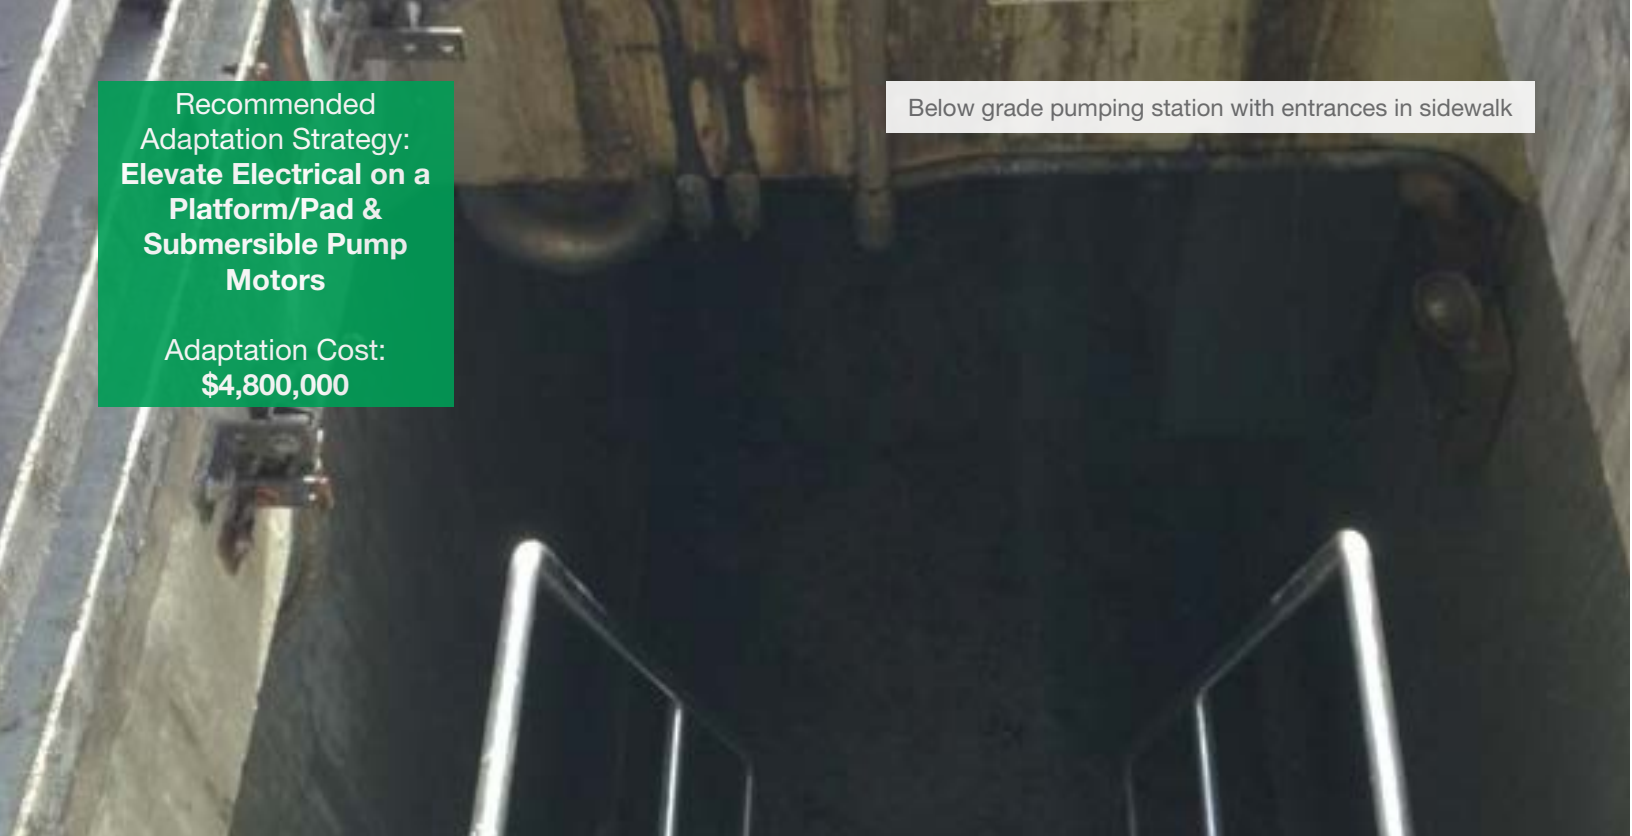
Below grade pumping station with entrances in sidewalk

The predicted critical flood elevation would be more than 2 feet above local grade. This would damage the electrical controls and the non-submersible pumps, all of which are located below grade.

**Recommended
Adaptation Strategy:
Elevate Electrical on a
Platform/Pad &
Submersible Pump
Motors**

The Kane Street pumping station requires adaptive measures to withstand the critical flood elevation. Potential strategies were evaluated against such factors as flood depth, equipment location, and space. Viable strategies were reviewed to identify the most cost-effective, resilient option. Due to space limitations, the lack of an existing structure, and the current vulnerability of the pumping station, the recommended strategy at Kane Street is to elevate electrical controls on an aboveground platform and install submersible pumps. Residual risk is related to a greater depth of flooding from larger storms or more extreme climate change.
