NYC WASTEWATER RESILIENCY PLAN

CLIMATE RISK ASSESSMENT AND ADAPTATION STUDY

October 2013

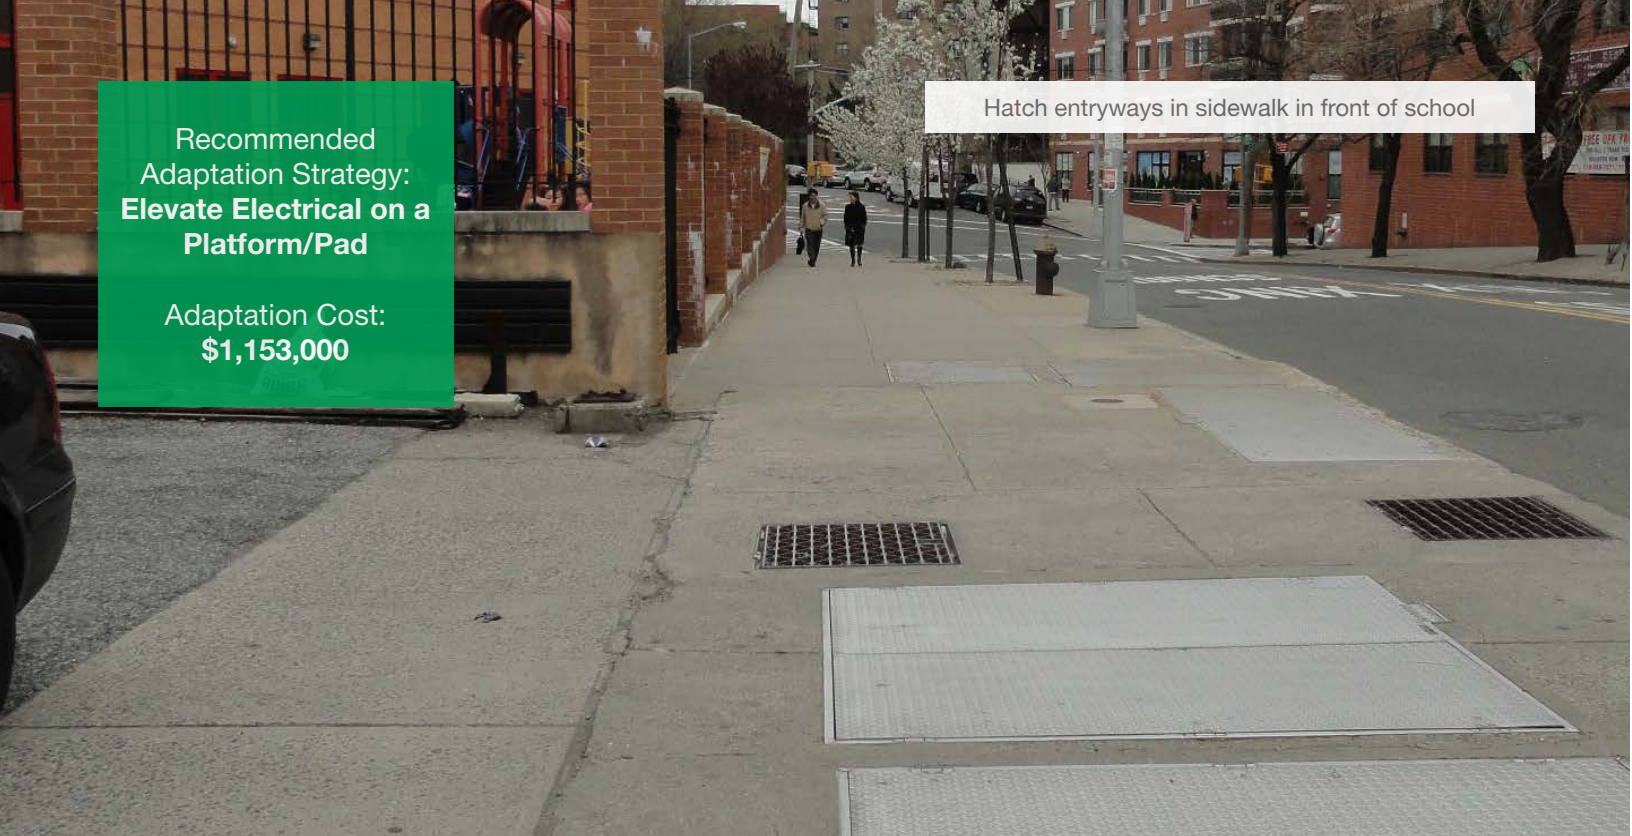
Hatch entryways in sidewalk in front of school

The critical flood elevation would be more than 2 feet above local grade, completely inundating this below grade station. Water would damage the electrical controls, but the submersible pumps should be unaffected.

Recommended
Adaptation Strategy:
**Elevate Electrical on a
Platform/Pad**

The Linden Place pumping station requires adaptive measures to withstand the critical flood elevation. Potential strategies were evaluated against such factors as flood depth, equipment location, and space. Viable strategies were reviewed to identify the most cost-effective, resilient option. Due to the need to move electrical controls out of the reach of flood waters and limited available space, the recommended strategy at Linden Place is to elevate electrical controls on a platform. Residual risk is related to a greater depth of flooding from larger storms or more extreme climate change.

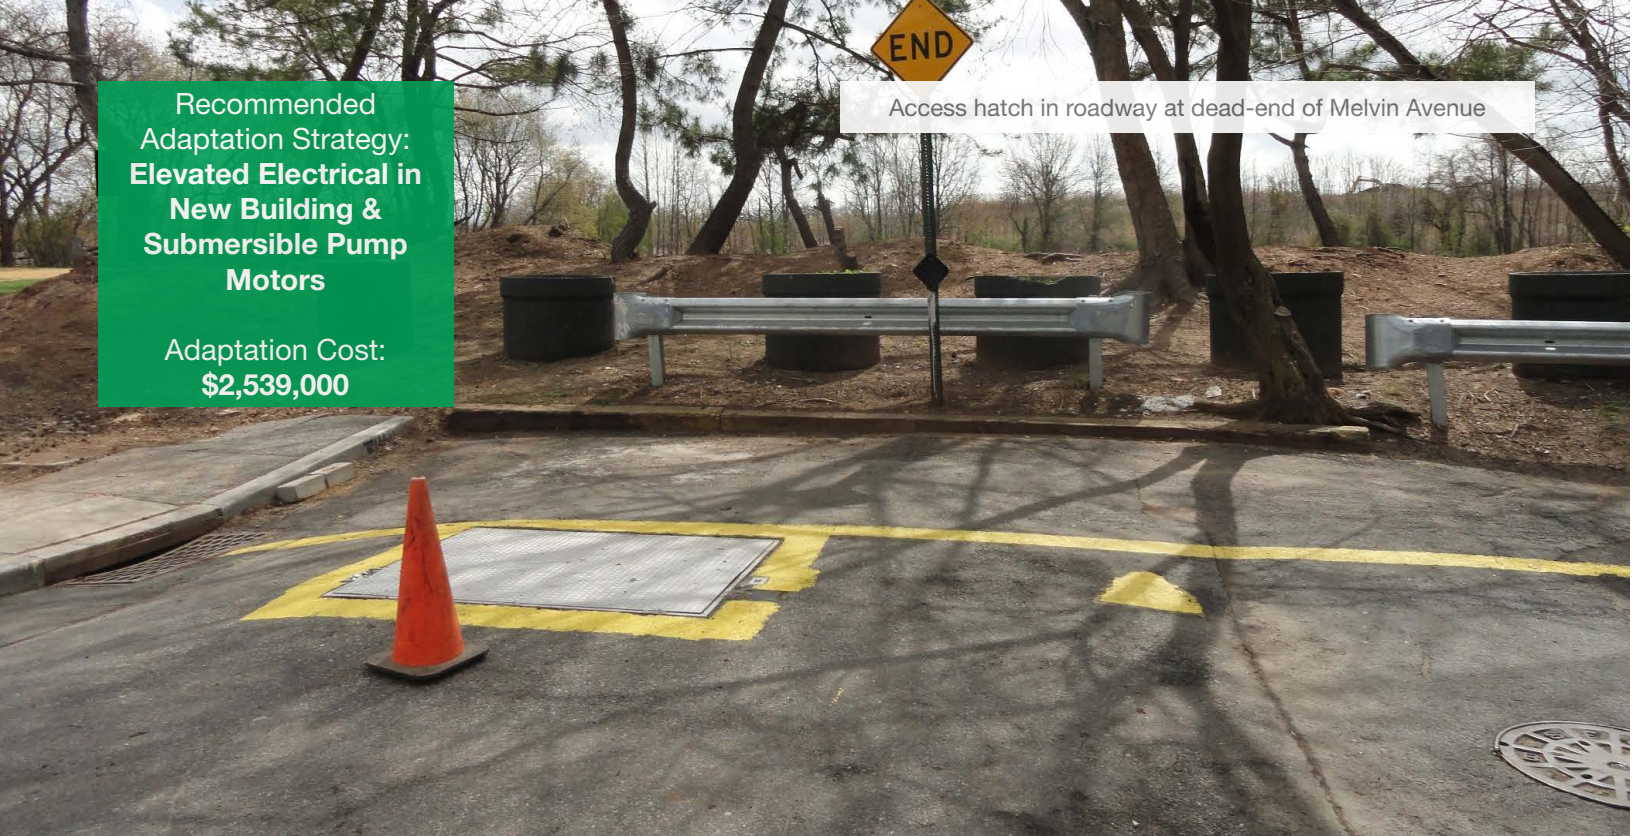
Melvin Avenue Pumping Station

Access hatch in roadway at dead-end of Melvin Avenue

The Melvin Avenue pumping station requires adaptive measures to withstand the critical flood elevation. Potential strategies were evaluated against such factors as flood depth, equipment location, and space. Viable strategies were reviewed to identify the most cost-effective, resilient option. Due to the station's current vulnerability, the extreme depth of the critical flood, and available space nearby, the recommended strategy at Melvin Avenue is to elevate electrical controls in a new building and install submersible pumps. Residual risk is related to a greater depth of flooding from larger storms or more extreme climate change.

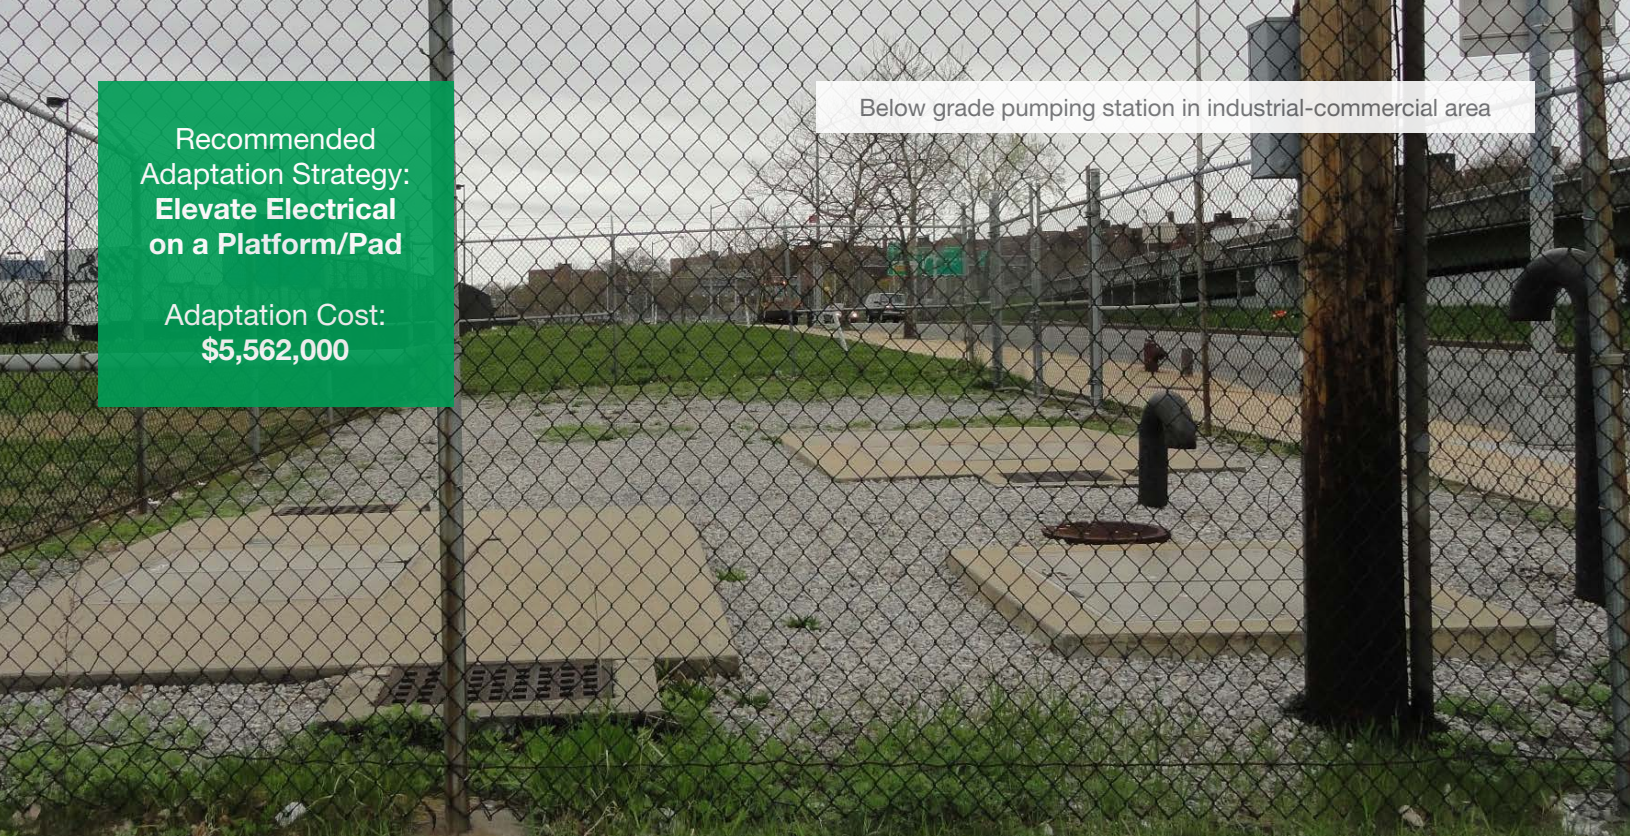
Below grade pumping station in industrial-commercial area

Recommended
Adaptation Strategy:
**Elevate Electrical
on a Platform/Pad**

The New York Times pumping station requires adaptive measures to withstand the critical flood elevation. Potential strategies were evaluated against such factors as flood depth, equipment location, and space. Viable strategies were reviewed to identify the most cost-effective, resilient option. Because of the significant depth of the critical flood, the recommended strategy at New York Times is to elevate electrical controls on a platform. The installation of backup generators is also recommended. Residual risk is related to a greater depth of flooding from larger storms or more extreme climate change.

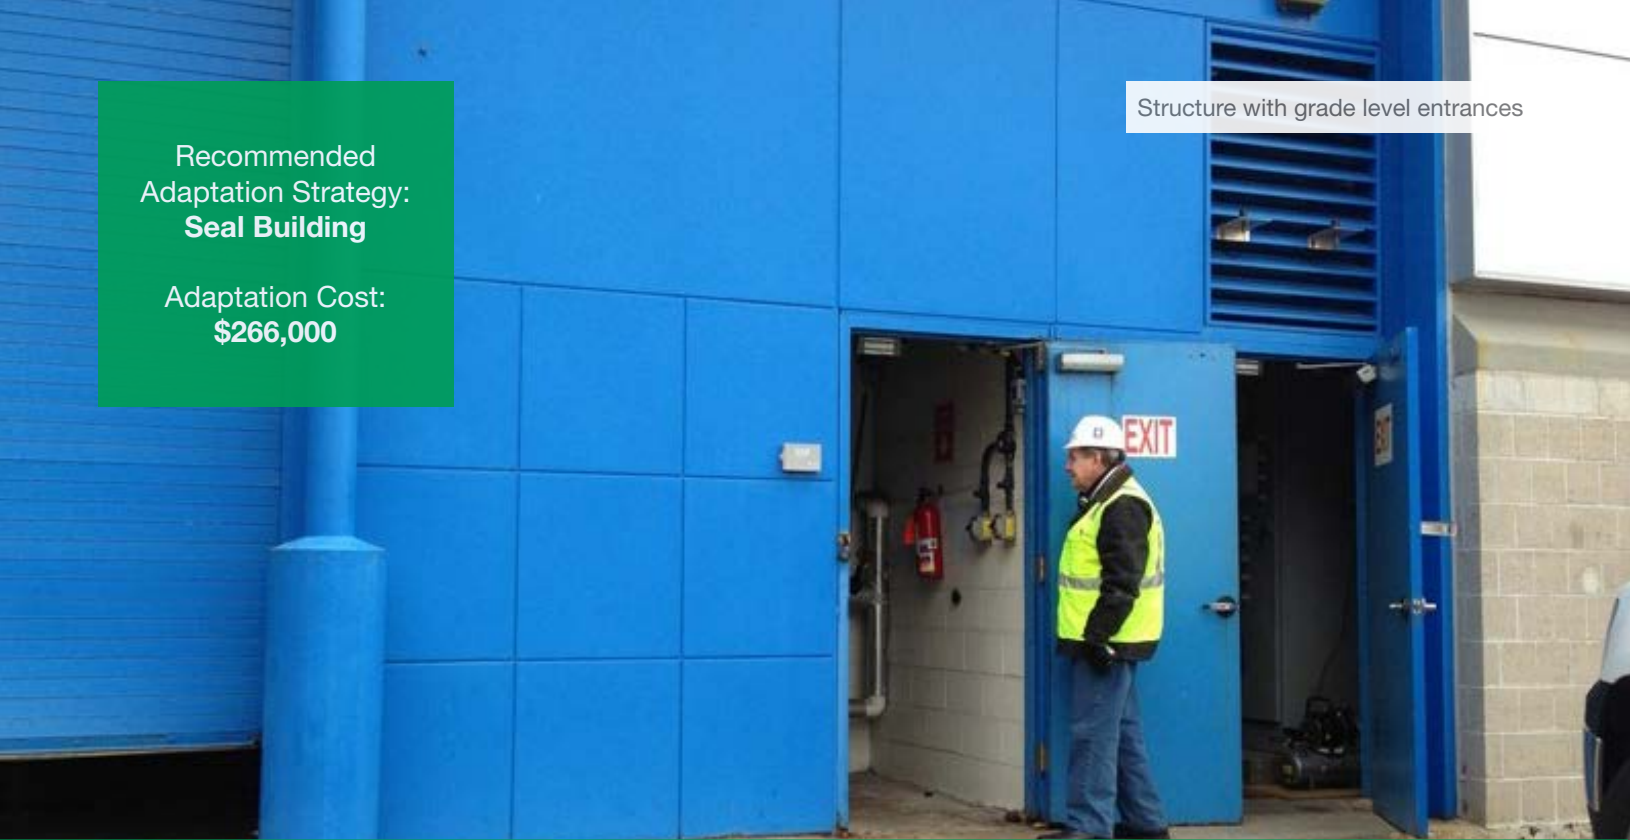
The critical flood elevation would be more than 3 feet above local grade. If water entered the building, the control room could be flooded to a depth of about 3 feet as well. This would damage the electrical controls. The submersible pumps should withstand flooding. The Rikers Island North pumping station is connected to another station; however it discharges to it rather than receiving flow. Therefore loss of function at Rikers Island North does not increase the vulnerability of an additional pumping station.

Recommended
Adaptation Strategy:
Seal Building

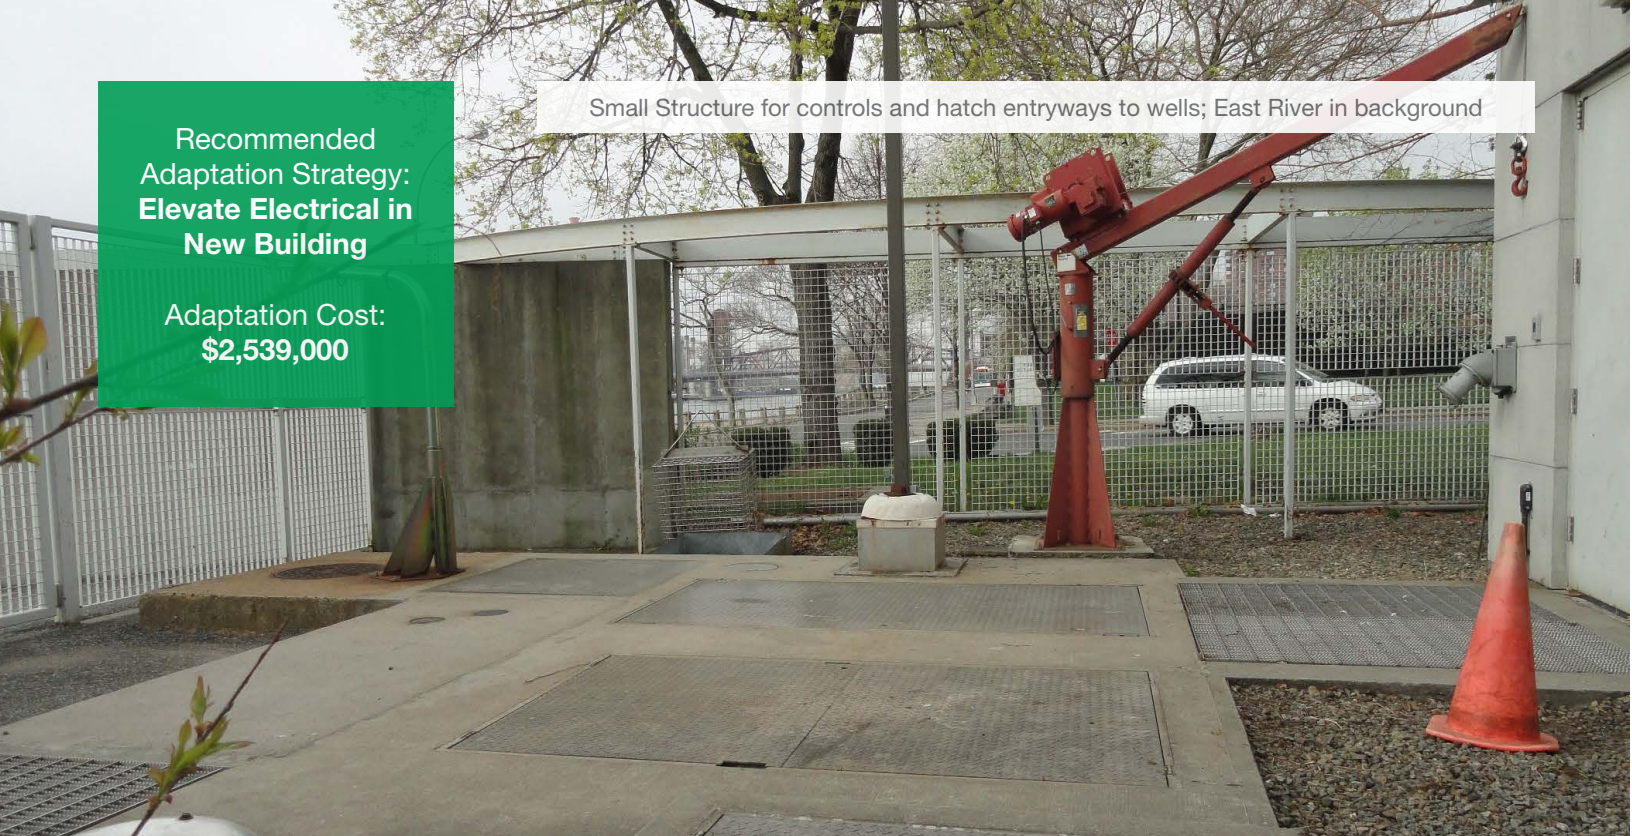
The critical flood elevation would inundate the area surrounding the facility with about 1.6 feet of water. This flood elevation could damage the electrical controls housed in the above grade structure as well as any electrical components below grade. The submersible pumps would not be affected by a flood. The Roosevelt Island Main pumping station receives flow from two additional stations. Therefore loss of function at Roosevelt Island Main increases the vulnerability of additional pumping stations, tributary areas, and populations.

Small Structure for controls and hatch entryways to wells; East River in background

Recommended
Adaptation Strategy:
**Elevate Electrical in
New Building**

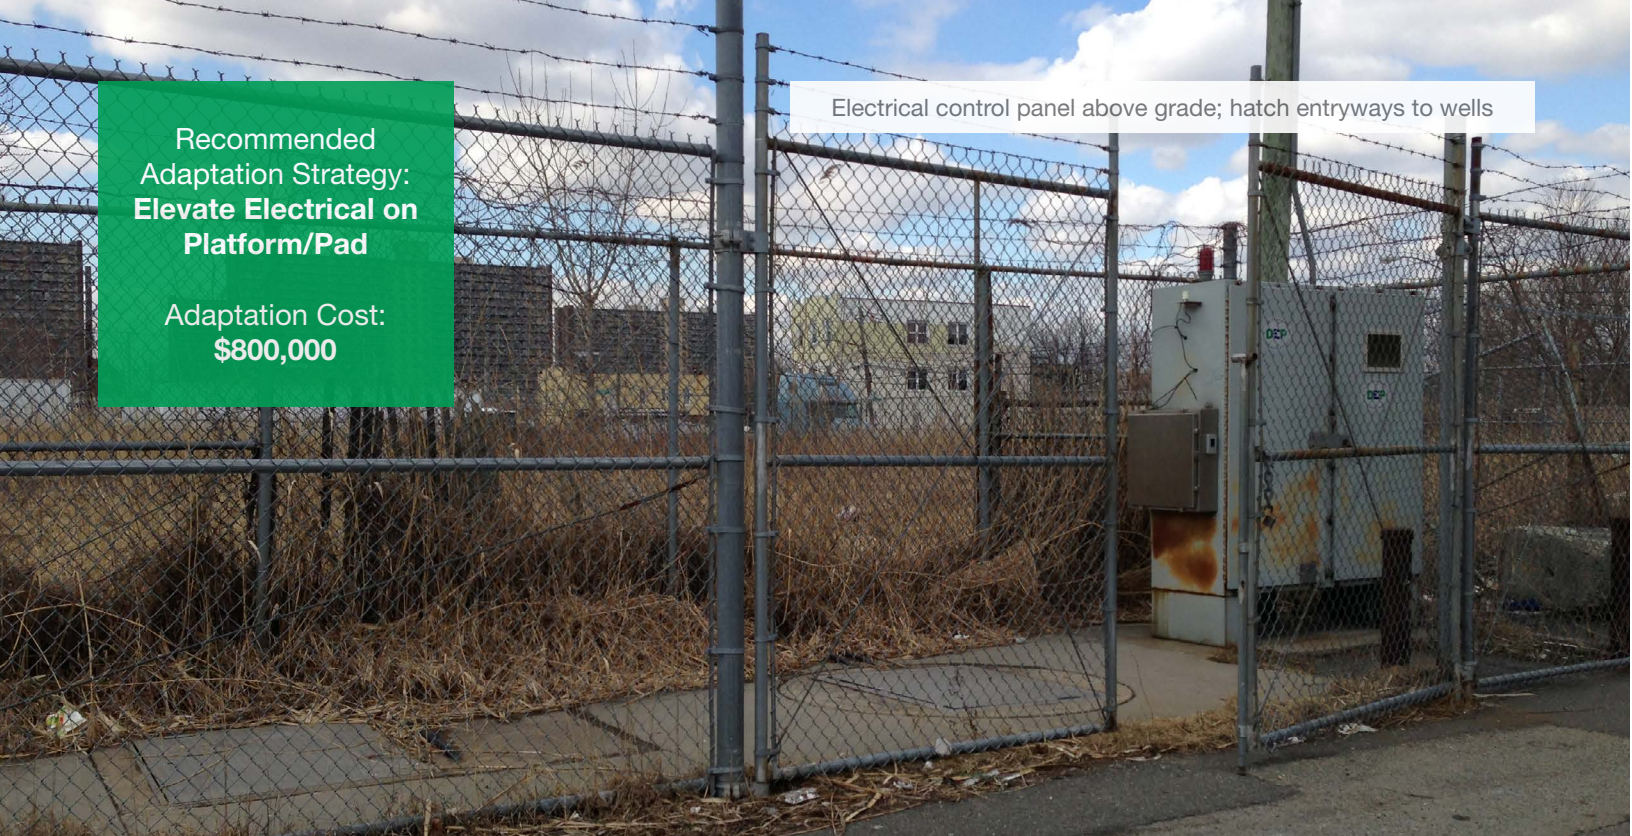
Rosedale pumping station was completely inundated by the storm surge during Hurricane Sandy, which damaged the electrical controls and non-submersible pump motors. DEP staff indicated there is also a history of flooding at this location due to smaller storms.

Electrical control panel above grade; hatch entryways to wells

Recommended
Adaptation Strategy:
**Elevate Electrical on
Platform/Pad**
