**808 COLUMBUS AVENUE
REPORT OF INVESTIGATION
FEBRUARY 15, 2008**

**DAN ESCHENASY, PE
DEPUTY ASSISTANT COMMISSIONER
FORENSIC ENGINEERING UNIT**

I. EXECUTIVE SUMMARY

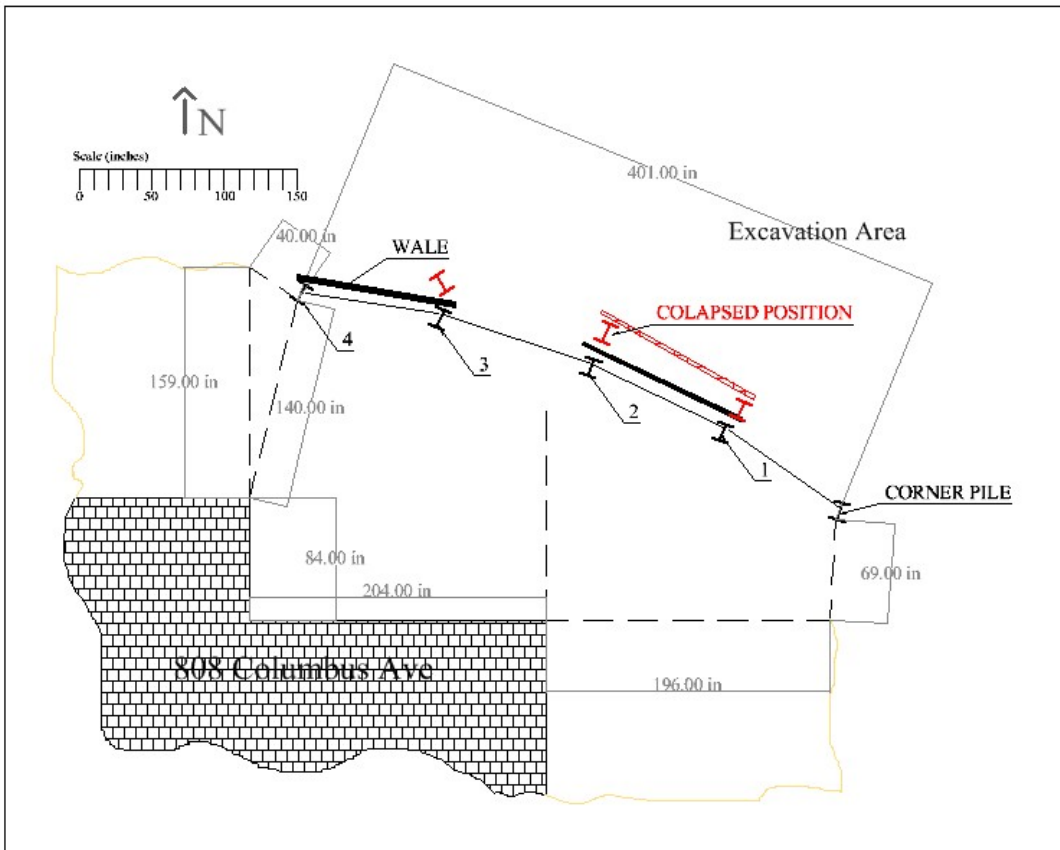
Figure 2 – Approximate Layout of Sheeting Before and After Collapse. The number identifying each pile is for this investigation only.

The segment of the sheet piling system wall that failed was the southeast corner of a bay approximately mid-way along the length of the west wall of the excavation. The start of the bay was the Corner Pile and there is a curved section to #5. The investigation could not establish with absolute precision the location of piles 1, 2, 3 and 4. The attached plan sketch [Figure 2] was created based on field observations and drawings from Mayrich. The piles might have been located +/- 1 foot from the position shown on the drawing. The sketch of the vertical configuration is based on the Bernstein July 20 (photo 4), on photos submitted by neighbors (Photo 8) and on examination of steel debris.

These and other photographs show that the excavation was down to the final grade level as far as Pile #2 and all of the toe of the wall was exposed, apart from the rubble covering.

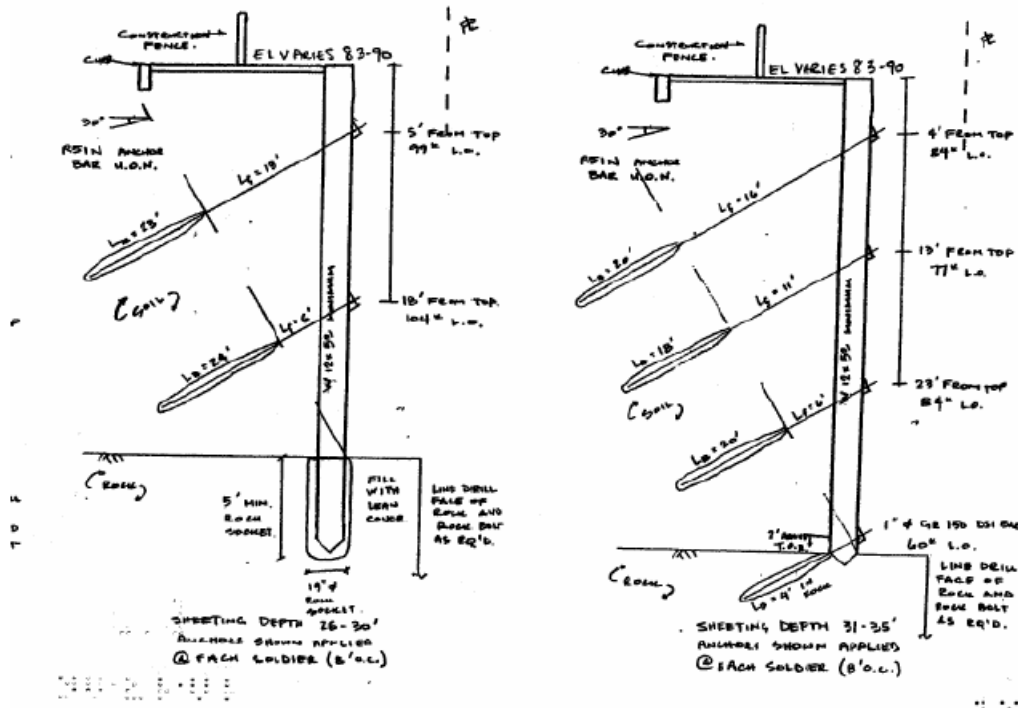
Figure 6 Sheeting Installation (from Drawing No. 2006-45-06s)

Figure shows the approximate bottom of piles obtained from observations of the debris. The drawings require four anchors be installed for piles at sheeting deeper than 30 feet (no socket). According to James Sheld, the piles were HP 12x74, grade 50.

The original design of the temporary soldier pile and lagging wall, and the anchor system is shown on Drawing No. 2006-45-06, Revision 1 prepared by Mayrich. Figure 6 shows the design drawing for the wall section that failed.

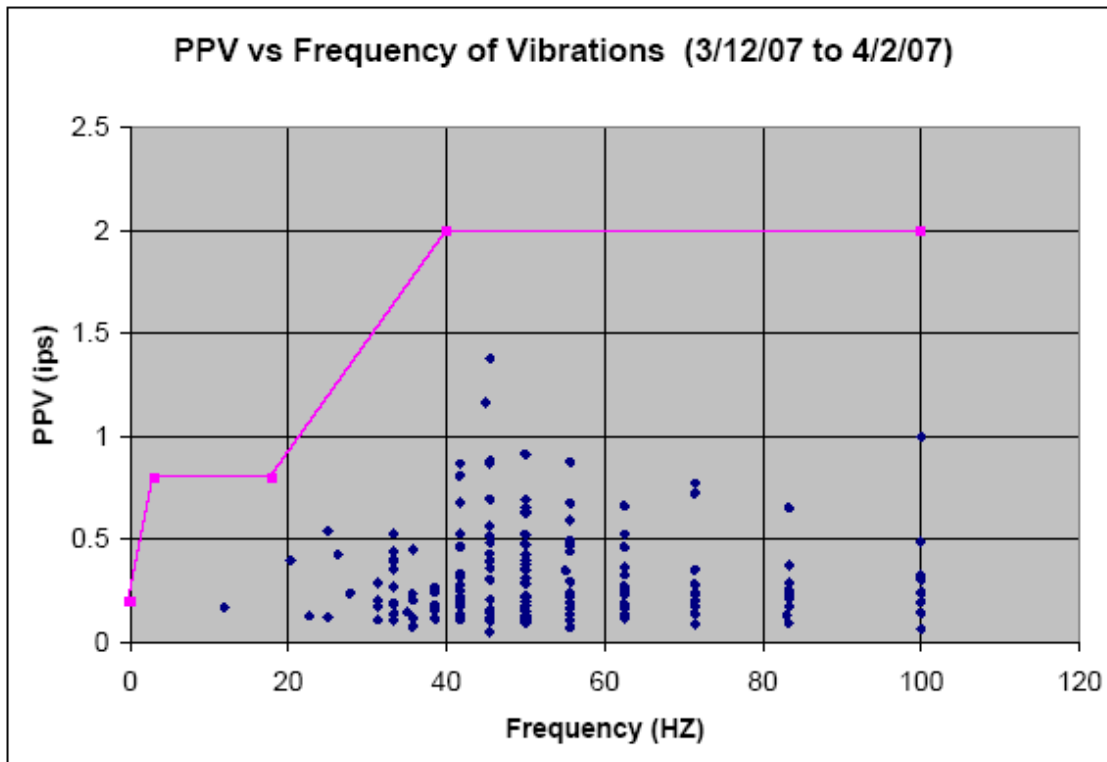
Figure 7 – Particle Velocity v. Frequency

It is clear from the vibration records that with one exception all vibration frequencies exceeded 20 Hz. Most of the frequencies were in the 40-60 Hz range. This compares well with the usual building structures frequencies that are in the 5-10 Hz range.

The graph of particle velocity versus frequency meets the criteria of the Bureau of Mines study. These data are represented by the pink line in the chart. The particle velocity also met, except in two cases, the requirements of FDNY.

The absence of cracks on the building interior and exterior is consistent with the vibration measurements performed by Metric (see Figure 7). The frequency is higher than 20Hz. Of the few cracks observed in the building practically none could be attributed to blast. This is a positive indication that the level of blasting that occurred without dynamic monitoring was within acceptable limits for cosmetic damage of permanent buildings.

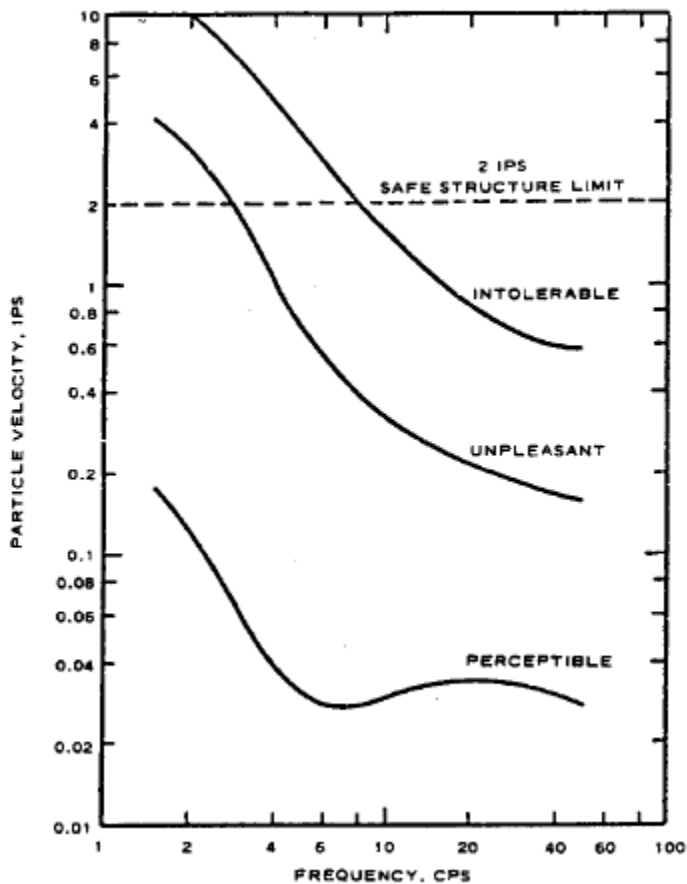
Figure 8 Subjective response of the human body to vibrations
From EM 1110-2-3800

Vibration resulting from blasting operations can be annoying and discomforting to the public, even when the blasting procedure is safe. The human reaction to vibration is subjective and many studies have been performed to analyze the level of public complaints. See attached graph from EM 1110-2-3800. An interpretation of seismic readings from the Metric monitoring places some of the vibrations between the unpleasant and intolerable level. This explains the complaints from residents of 784 Columbus.

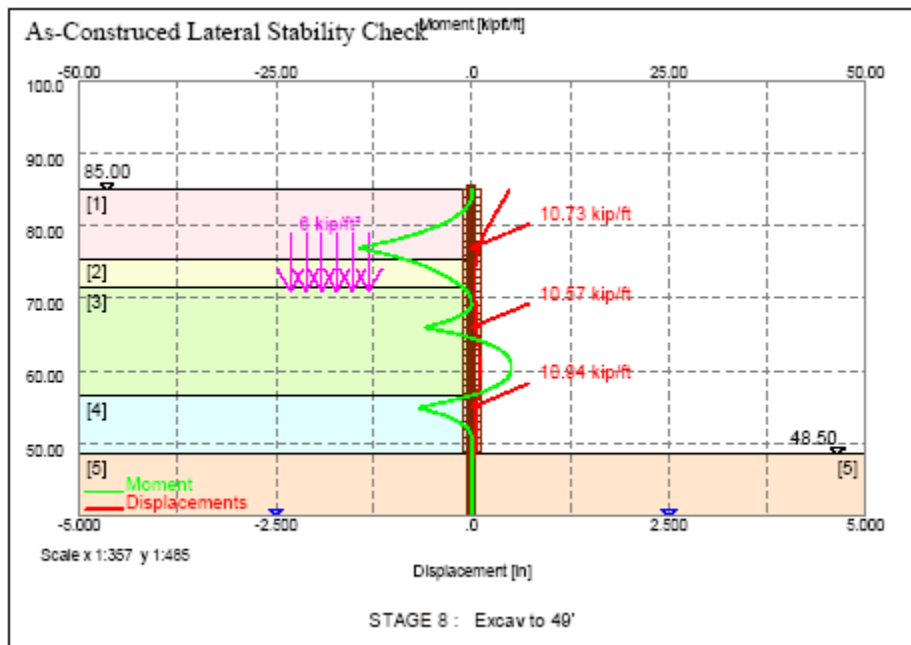
Figure 12 FREW Analysis –As-Constructed wall design check

Since pile 2 is the deepest pile with the largest distance between the bottom anchor and the pile toe, that pile would provide the largest wall moment and forces in the anchors. The anchor lengths were assumed to be similar to the design drawing, using a bond length of 20 feet. Likewise, the pre-stress loads were assumed to be the same as the design drawing.

The existing building 784 Columbus Ave is supported on shallow footings. The footing load is applied to the FREW analyses as six ksf vertical pressure acting at elevation 71 ft, 10.5 feet from the wall. The following construction sequences are analyzed in the FREW analysis:

- (a) Set up initial stress, including the existing building footing load
- (b) Install soldier pile and lagging wall
- (c) Excavate to EL. 76 ft
- (d) Install Anchor 1 at EL. 77 ft, preload to 84 kips
- (e) Excavate to EL. 65 ft
- (f) Install Anchor 2 at EL. 66 ft, preload to 77 kips
- (g) Excavate to EL. 54 ft
- (h) Install Anchor 3 at EL. 55 ft, preload to 84 kips
- (i) Excavate to bottom of pile

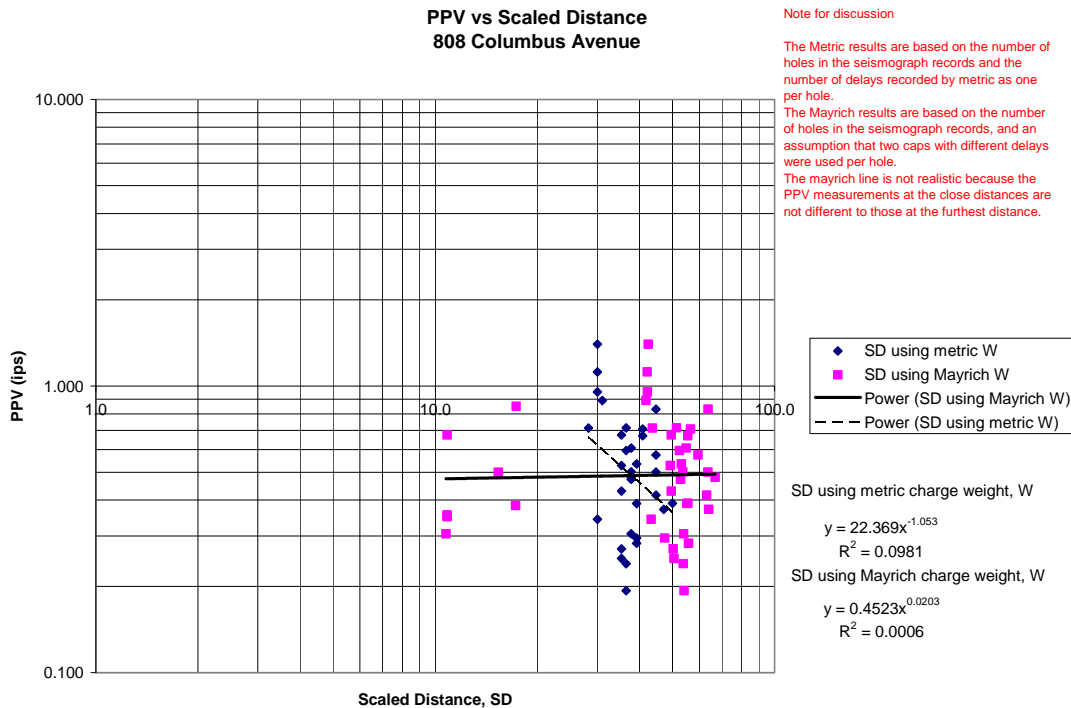
Figure 18 PPV vs Scaled Distance.

The PPV vs. Scaled distance (SD) plot using the Metric data for charge weight, distance and vector sum velocity gives the following relationship:

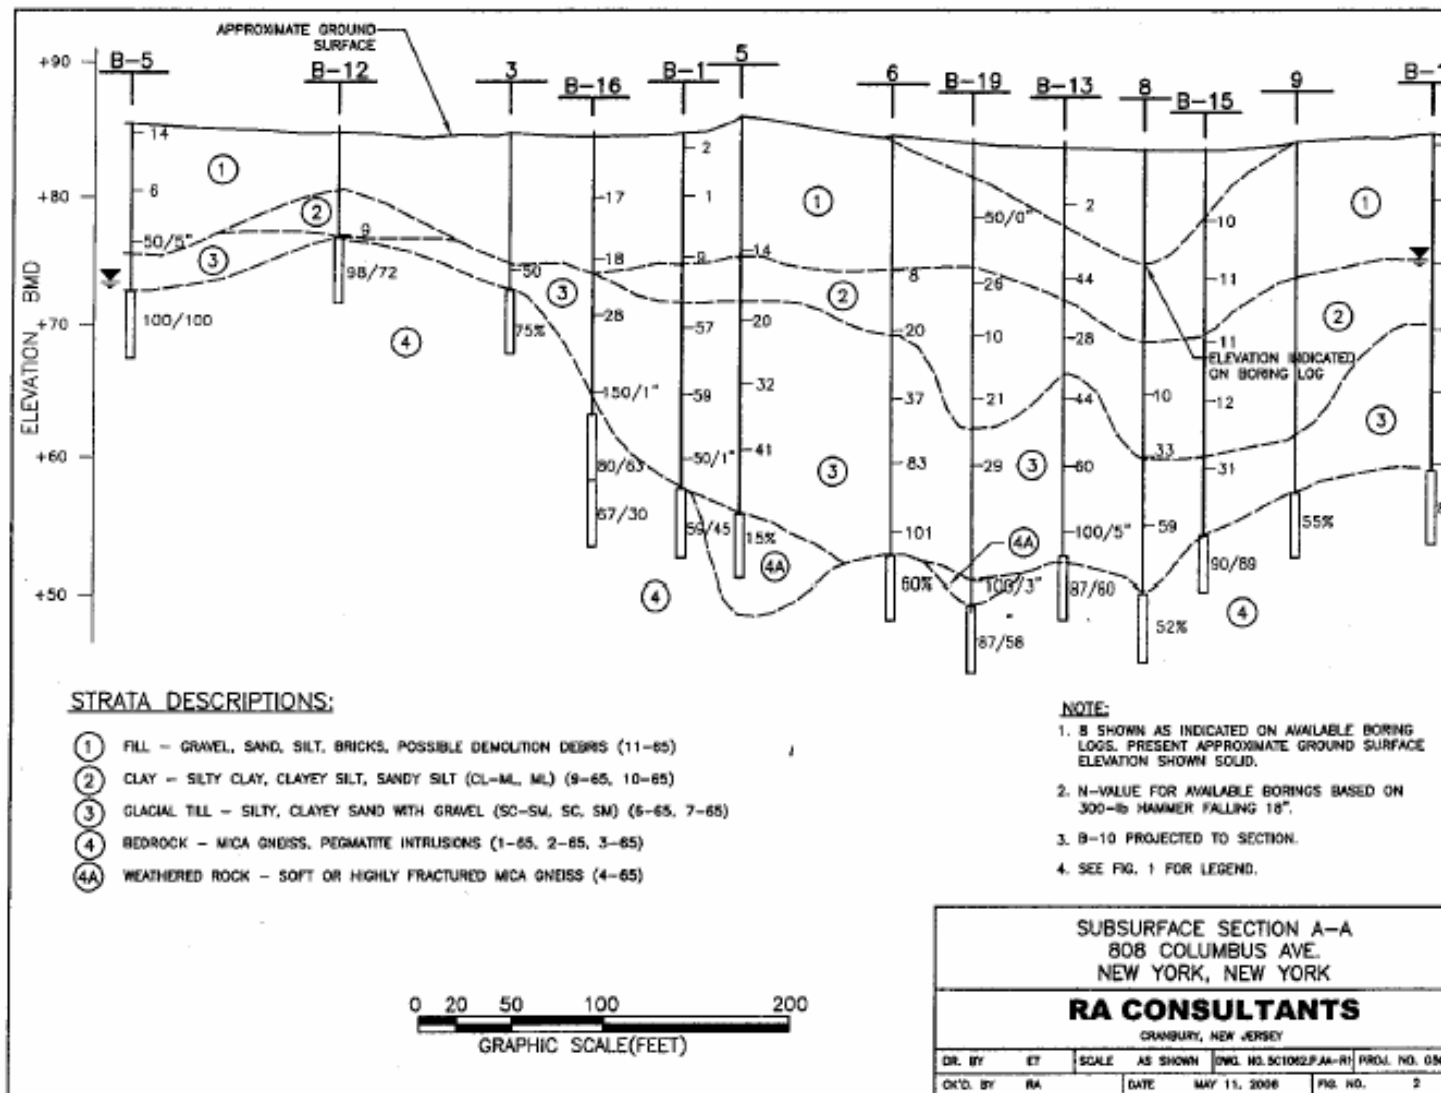
Figure 24 Section thru Site -RA Consultants (Alperstein)

- The drilling for the pile found soft rock and the socket for pile #3 was over-drilled because the piles were not driven and we can see the extension of the top of the pile with timber.
- The drilling for the blast holes encountered soft drilling in the same area.
- Test borings performed before construction had revealed a location of poor quality rock. This was interpreted as such and put on a geological section by Alperstein. (figure 24)
